REPORT NUMBER 138-STF-07-001

SAFETY COMPLIANCE TESTING FOR FMVSS NO. 138 TIRE PRESSURE MONITORING SYSTEMS

KIA MOTORS CORPORATION
2007 HYUNDAI ENTOURAGE
FOUR-DOOR MPV
NHTSA NO. C70504

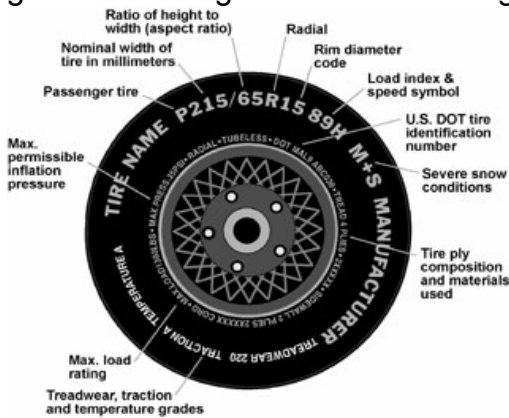
Diagram - Passenger Car Tire Labeling

Diagram - Other Markings on Light Trucks

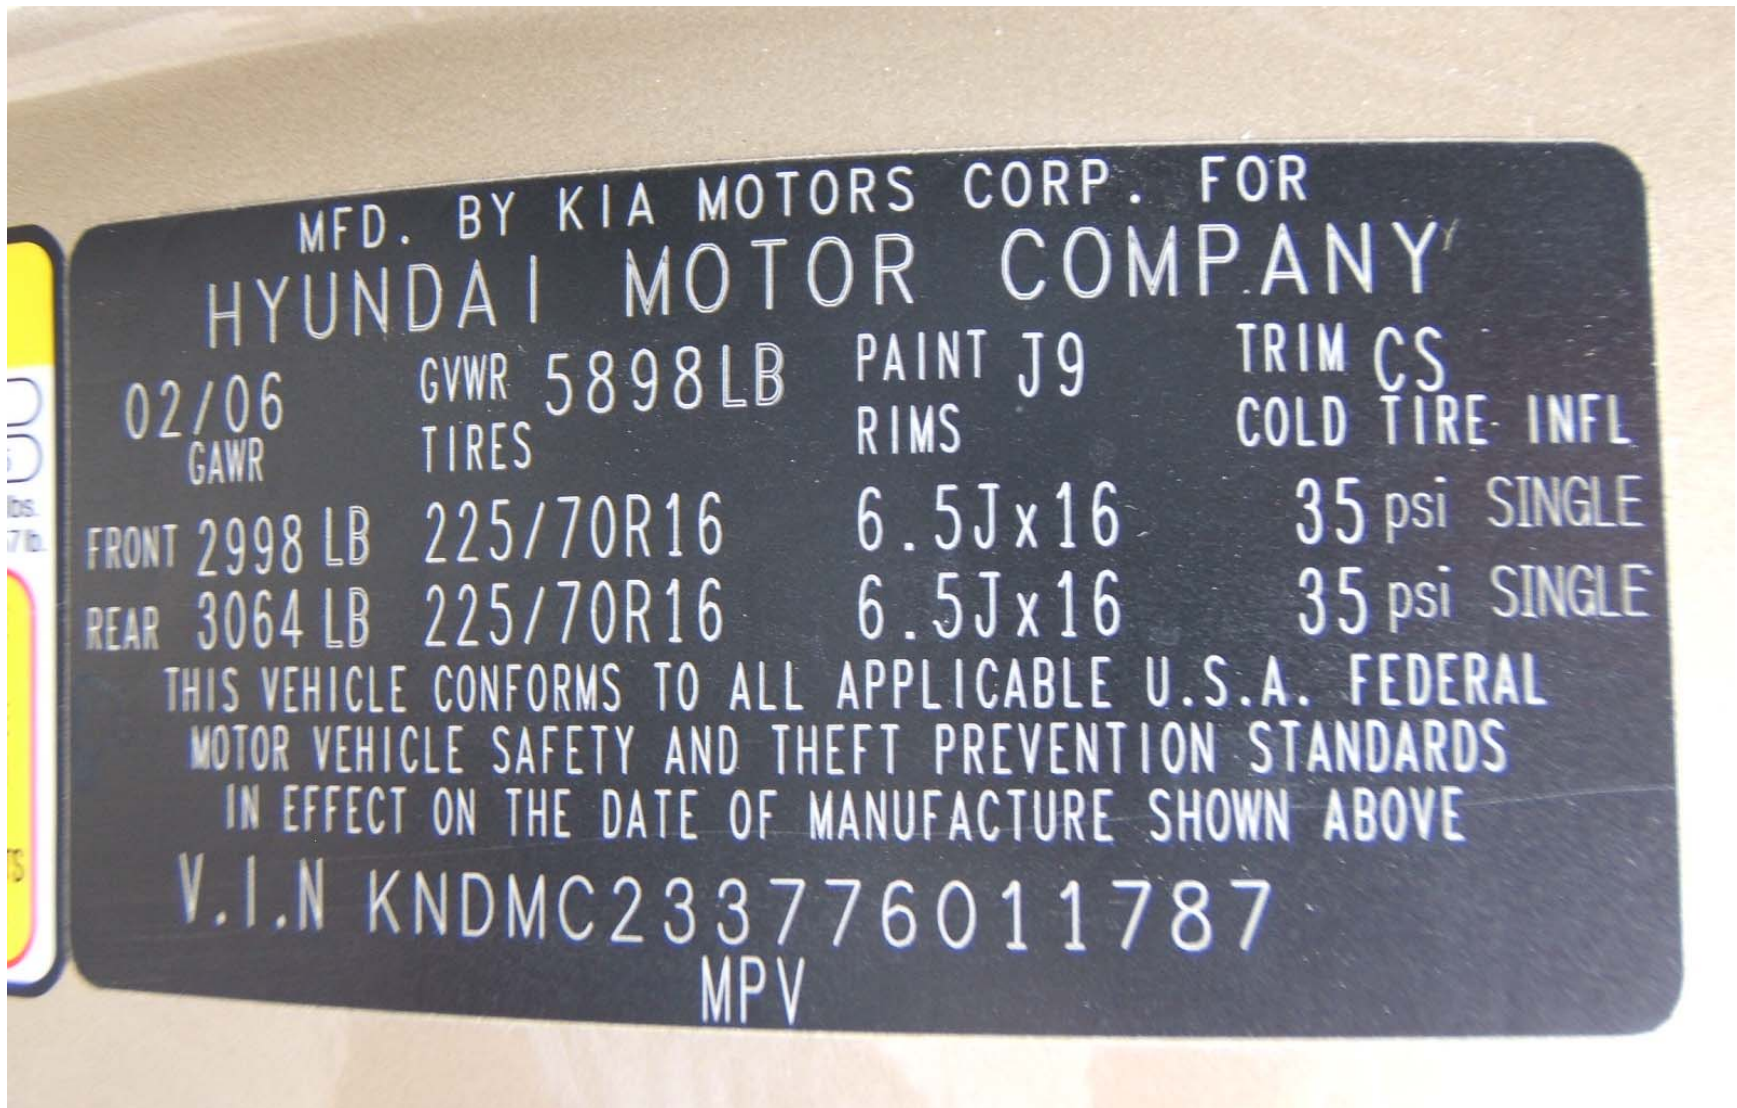
FIGURE 5.2
VEHICLE CERTIFICATION LABEL

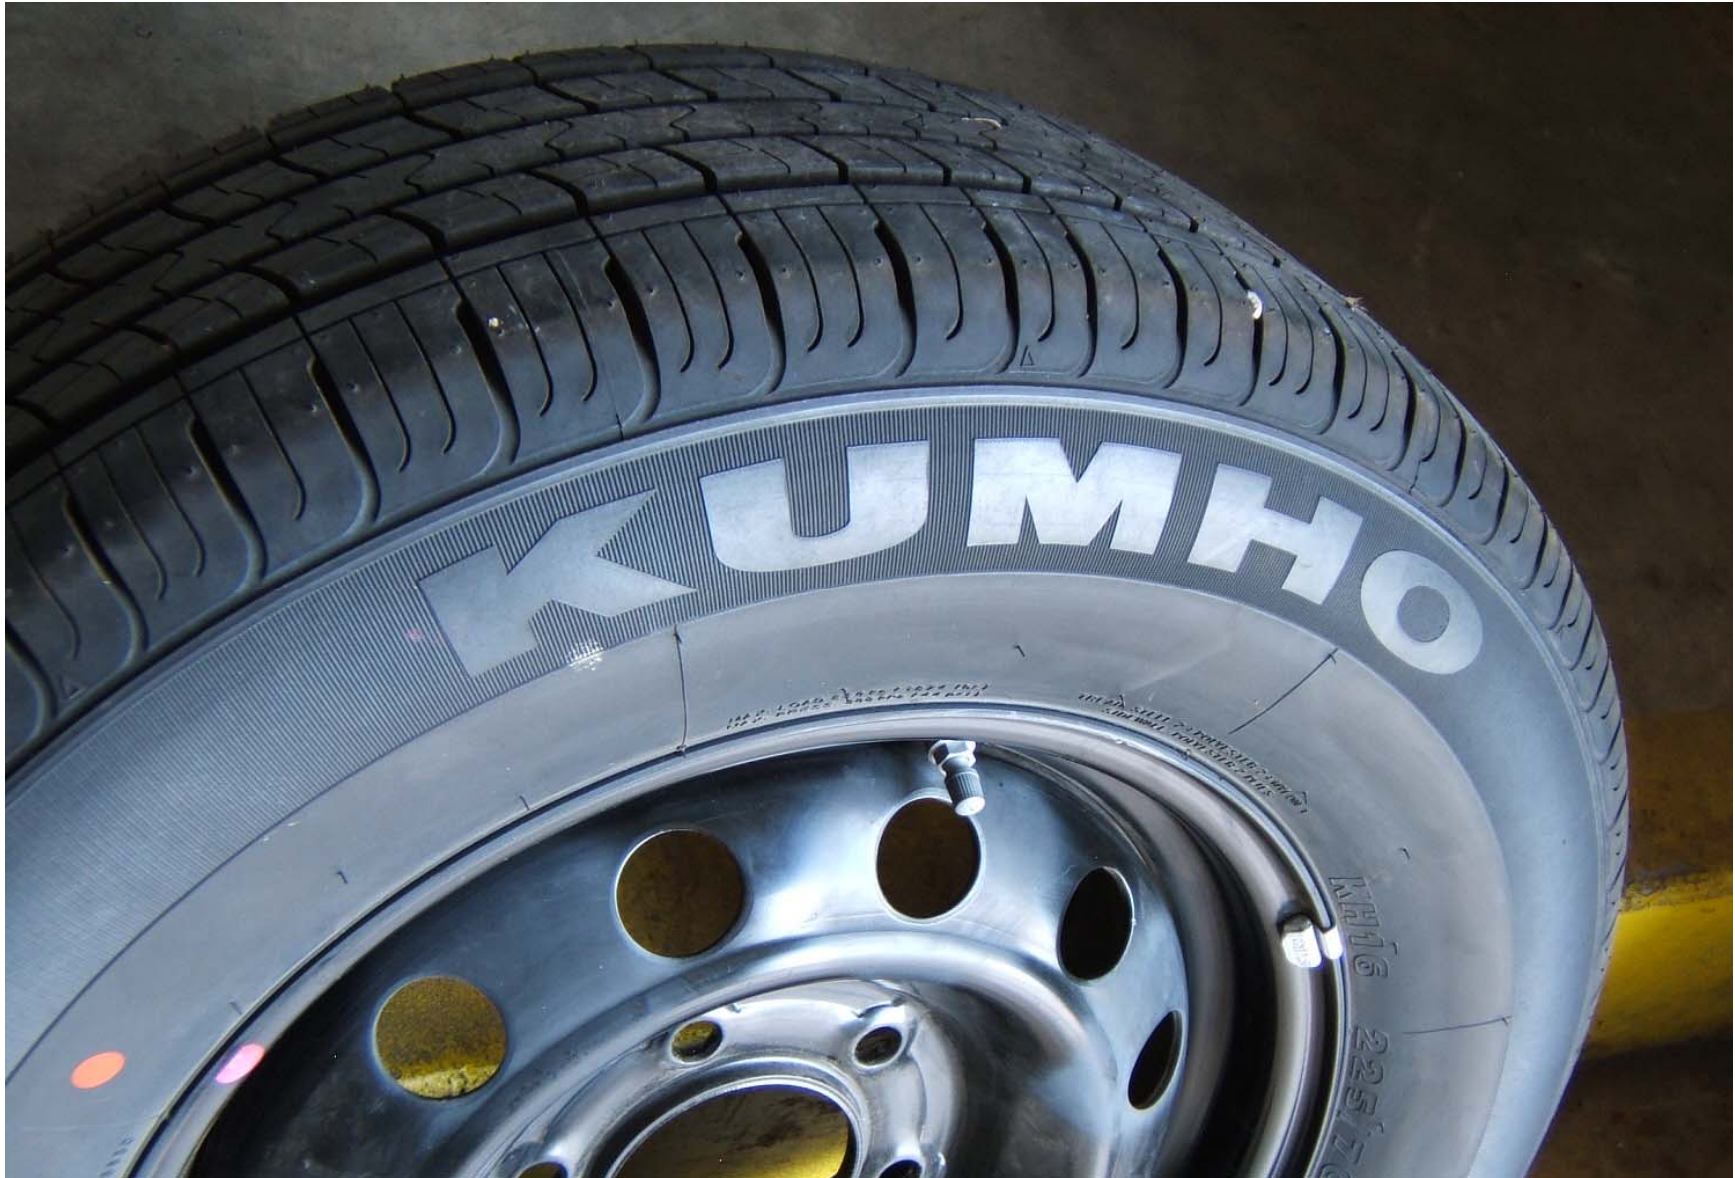
FIGURE 5.4
TIRE SHOWING BRAND

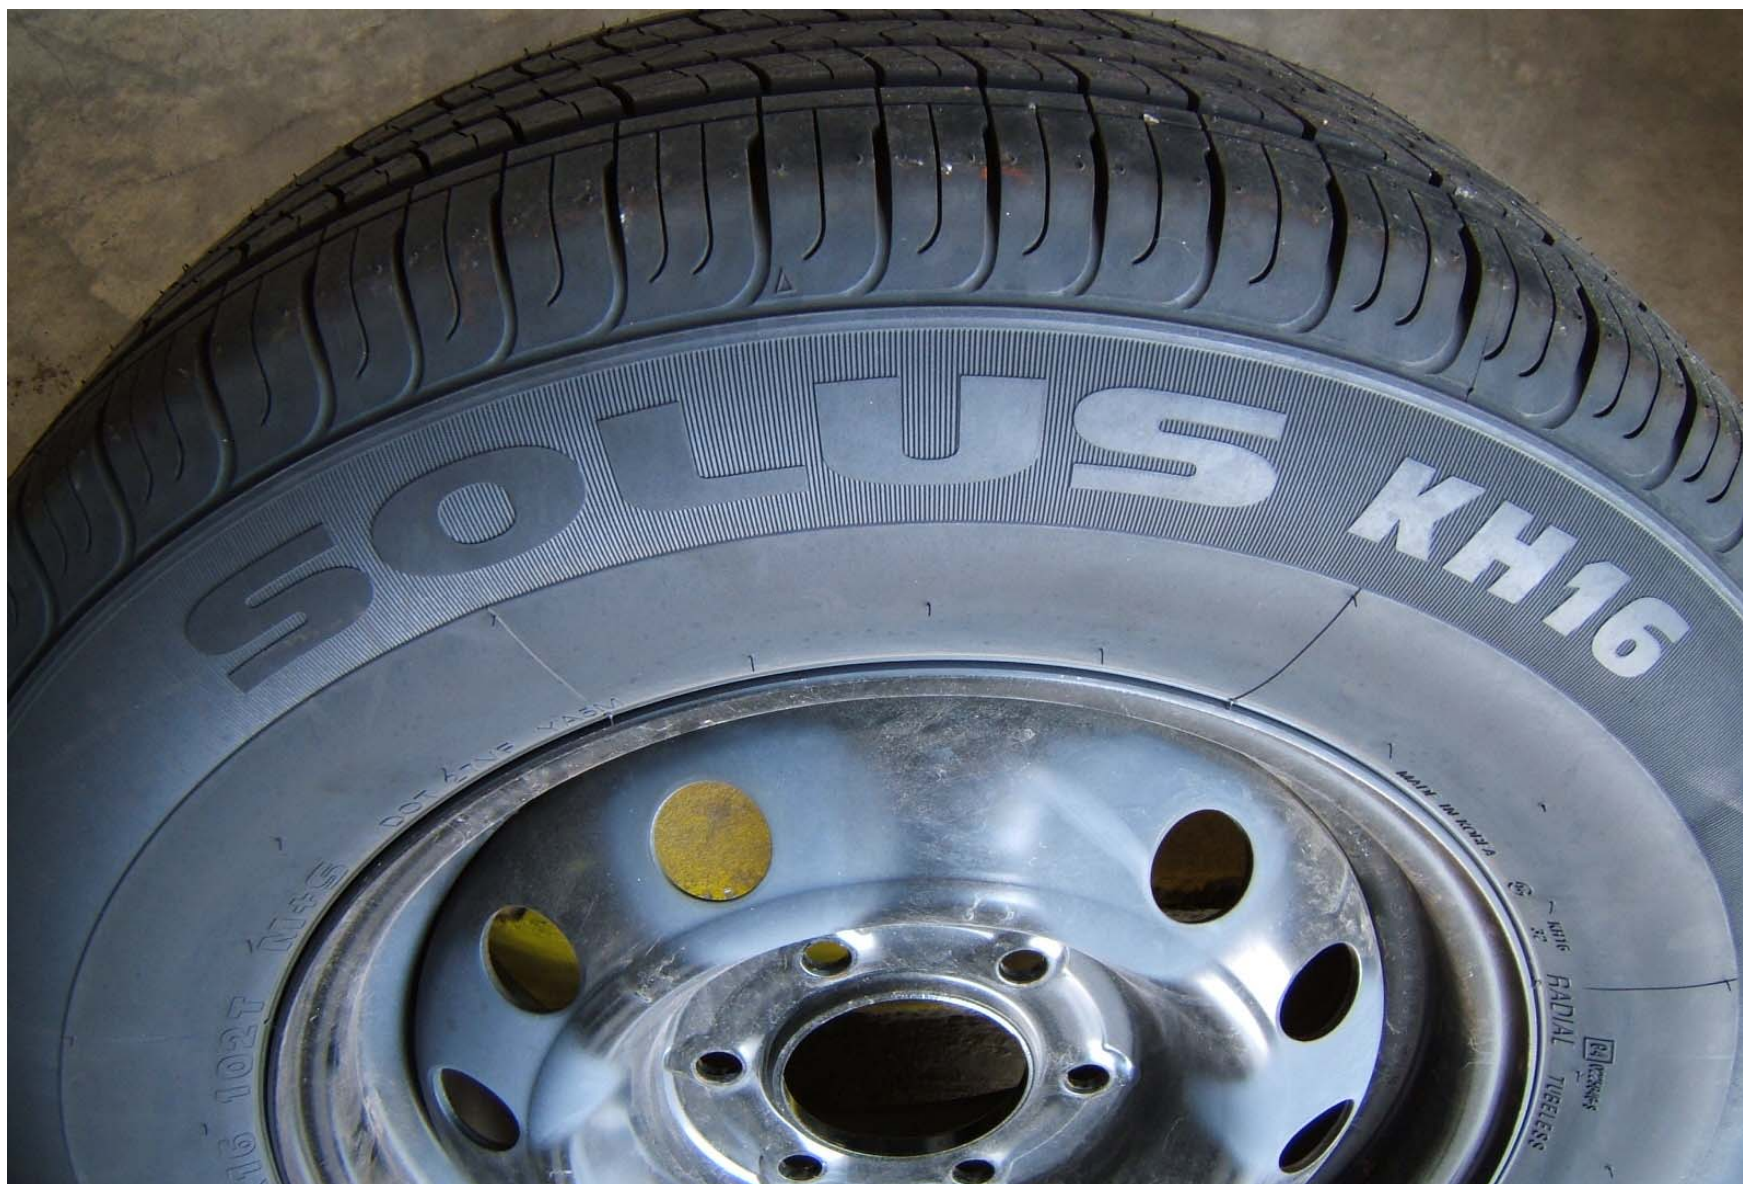
FIGURE 5.5
TIRE SHOWING MODEL

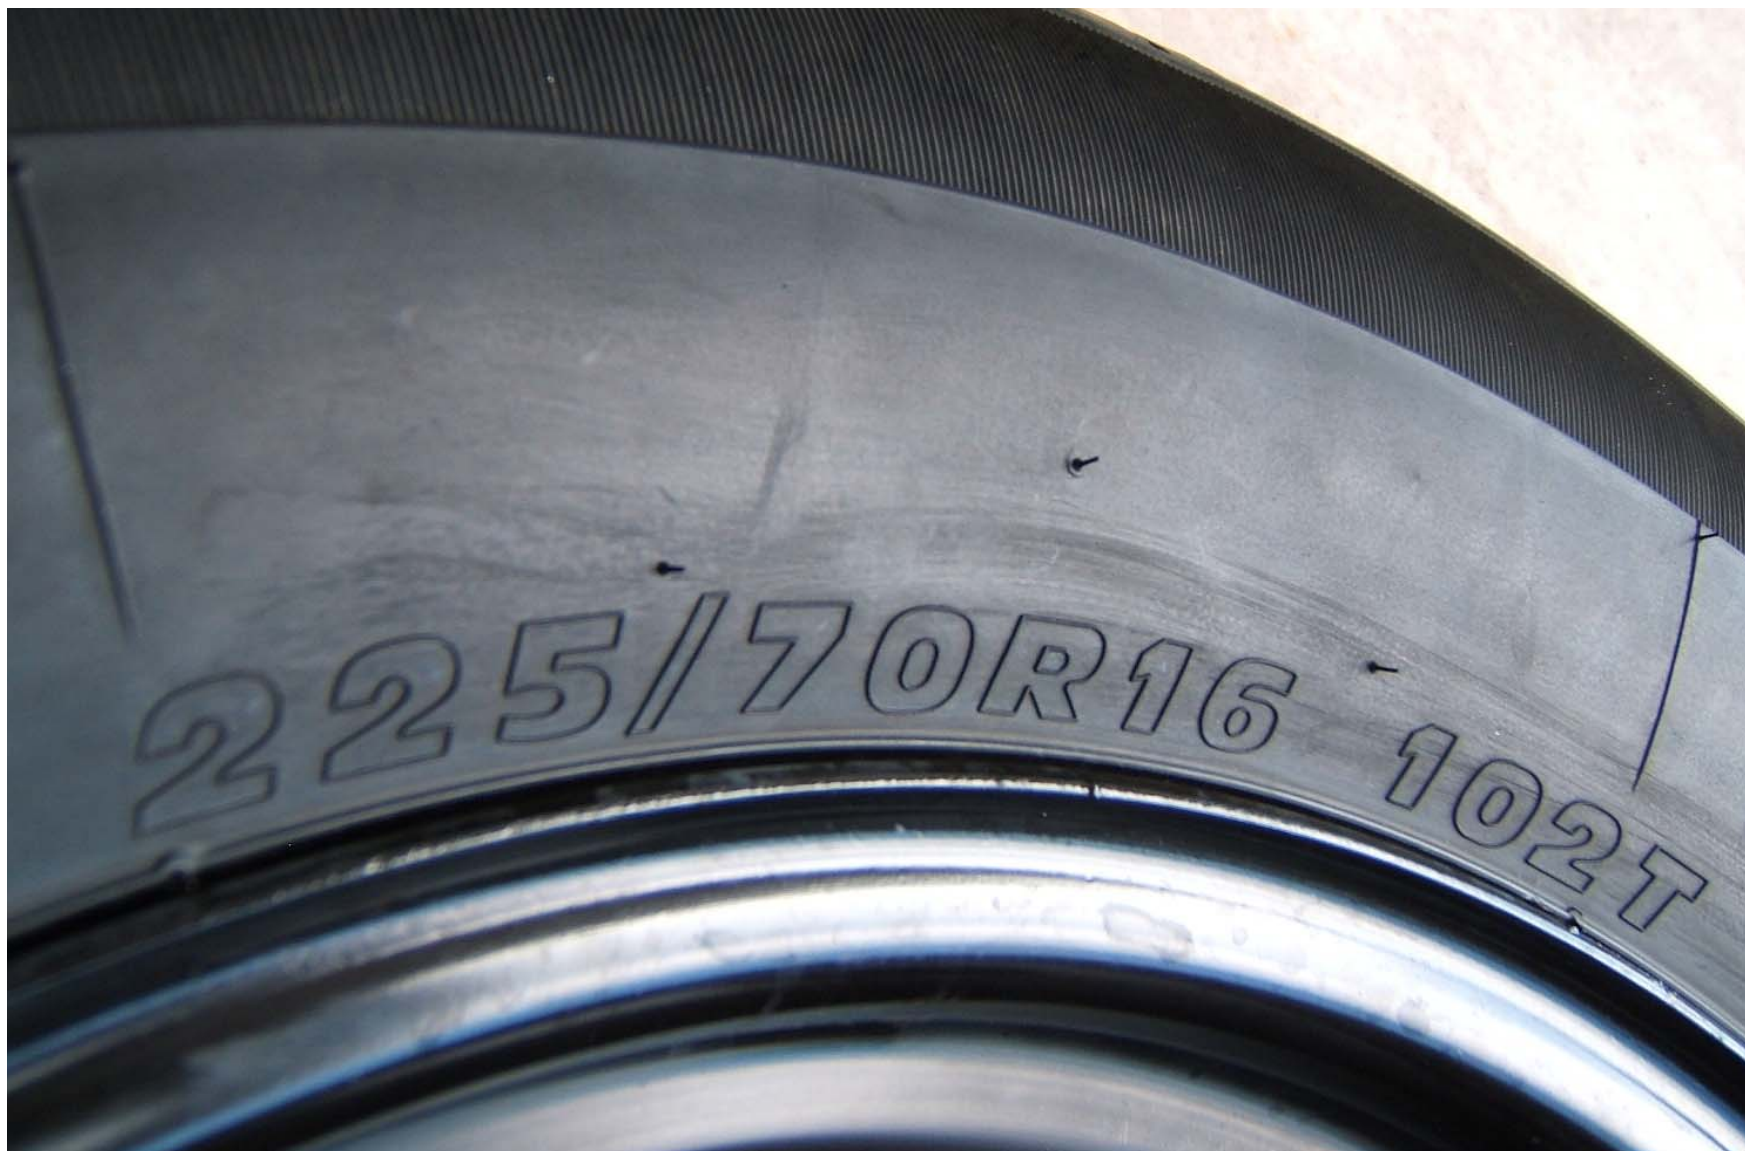
FIGURE 5.6
TIRE SHOWING SIZE, LOAD INDEX, AND SPEED RATING

Tire Size (ex. P225/65R15 89H): 225/70R16 102T

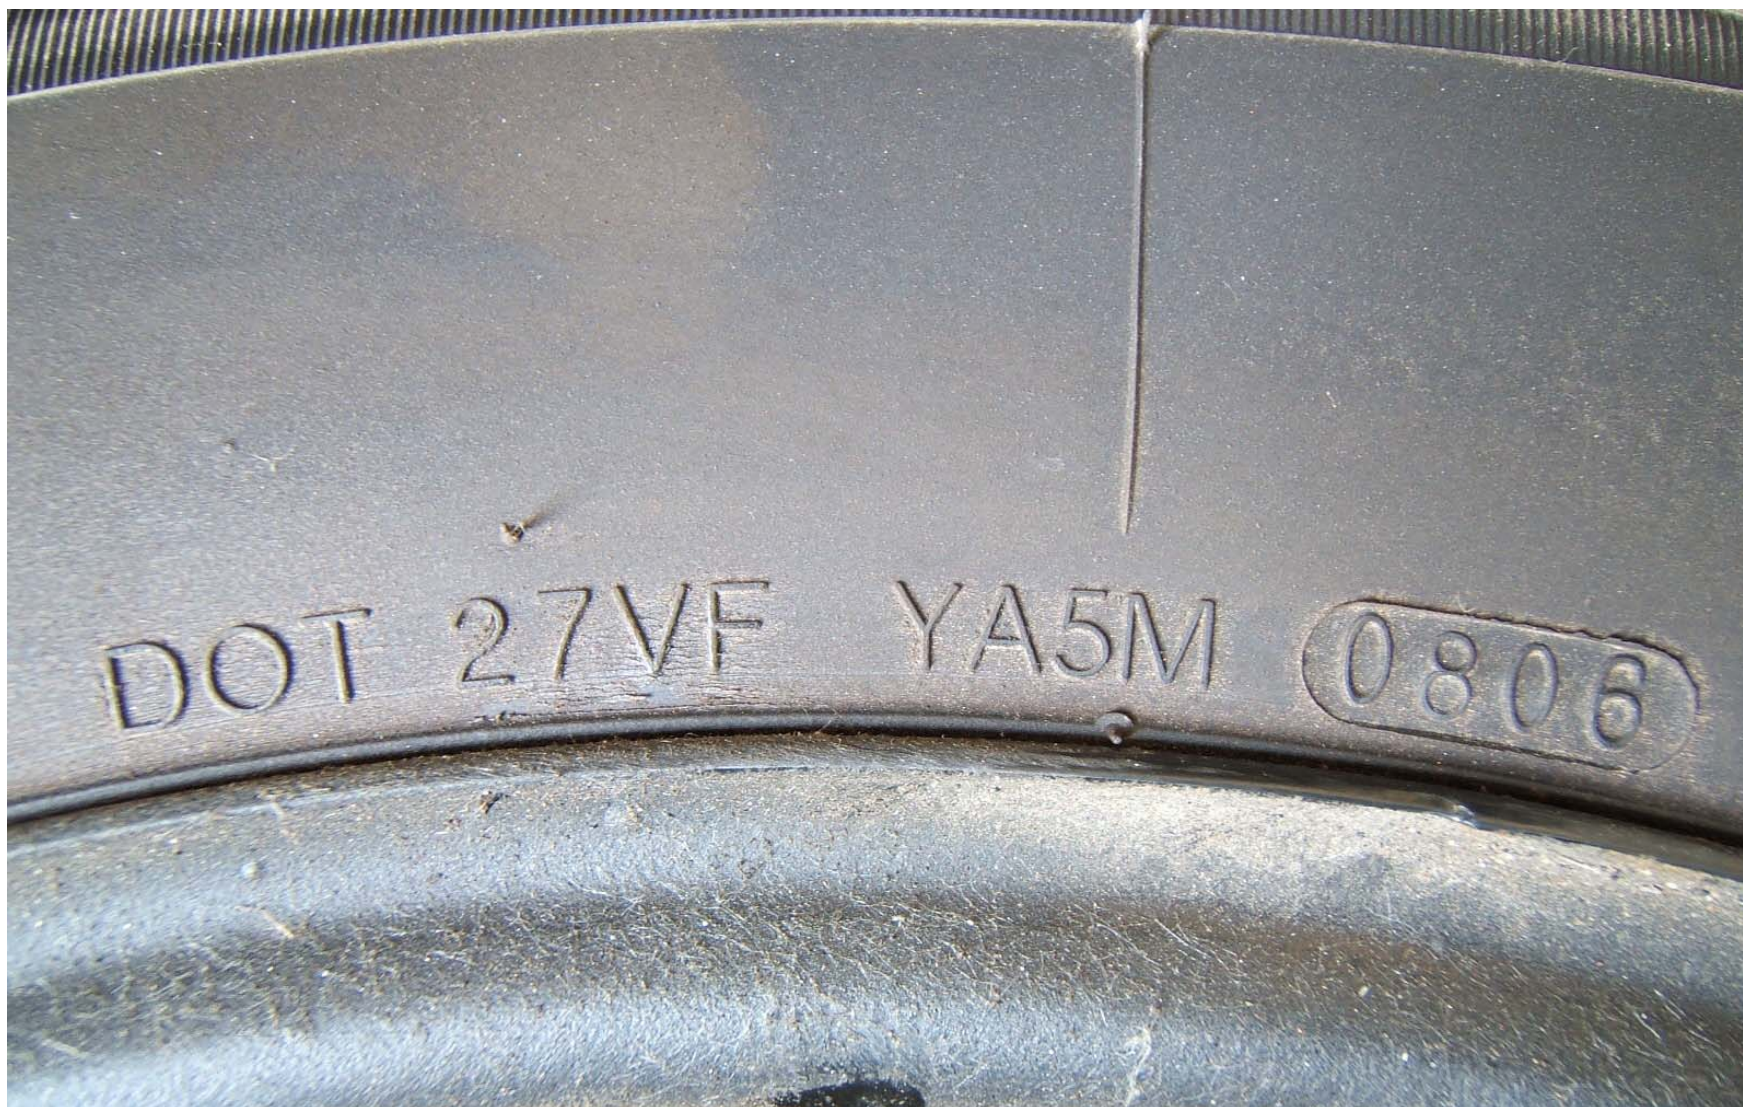
FIGURE 5.7
TIRE SHOWING DOT SERIAL NUMBER

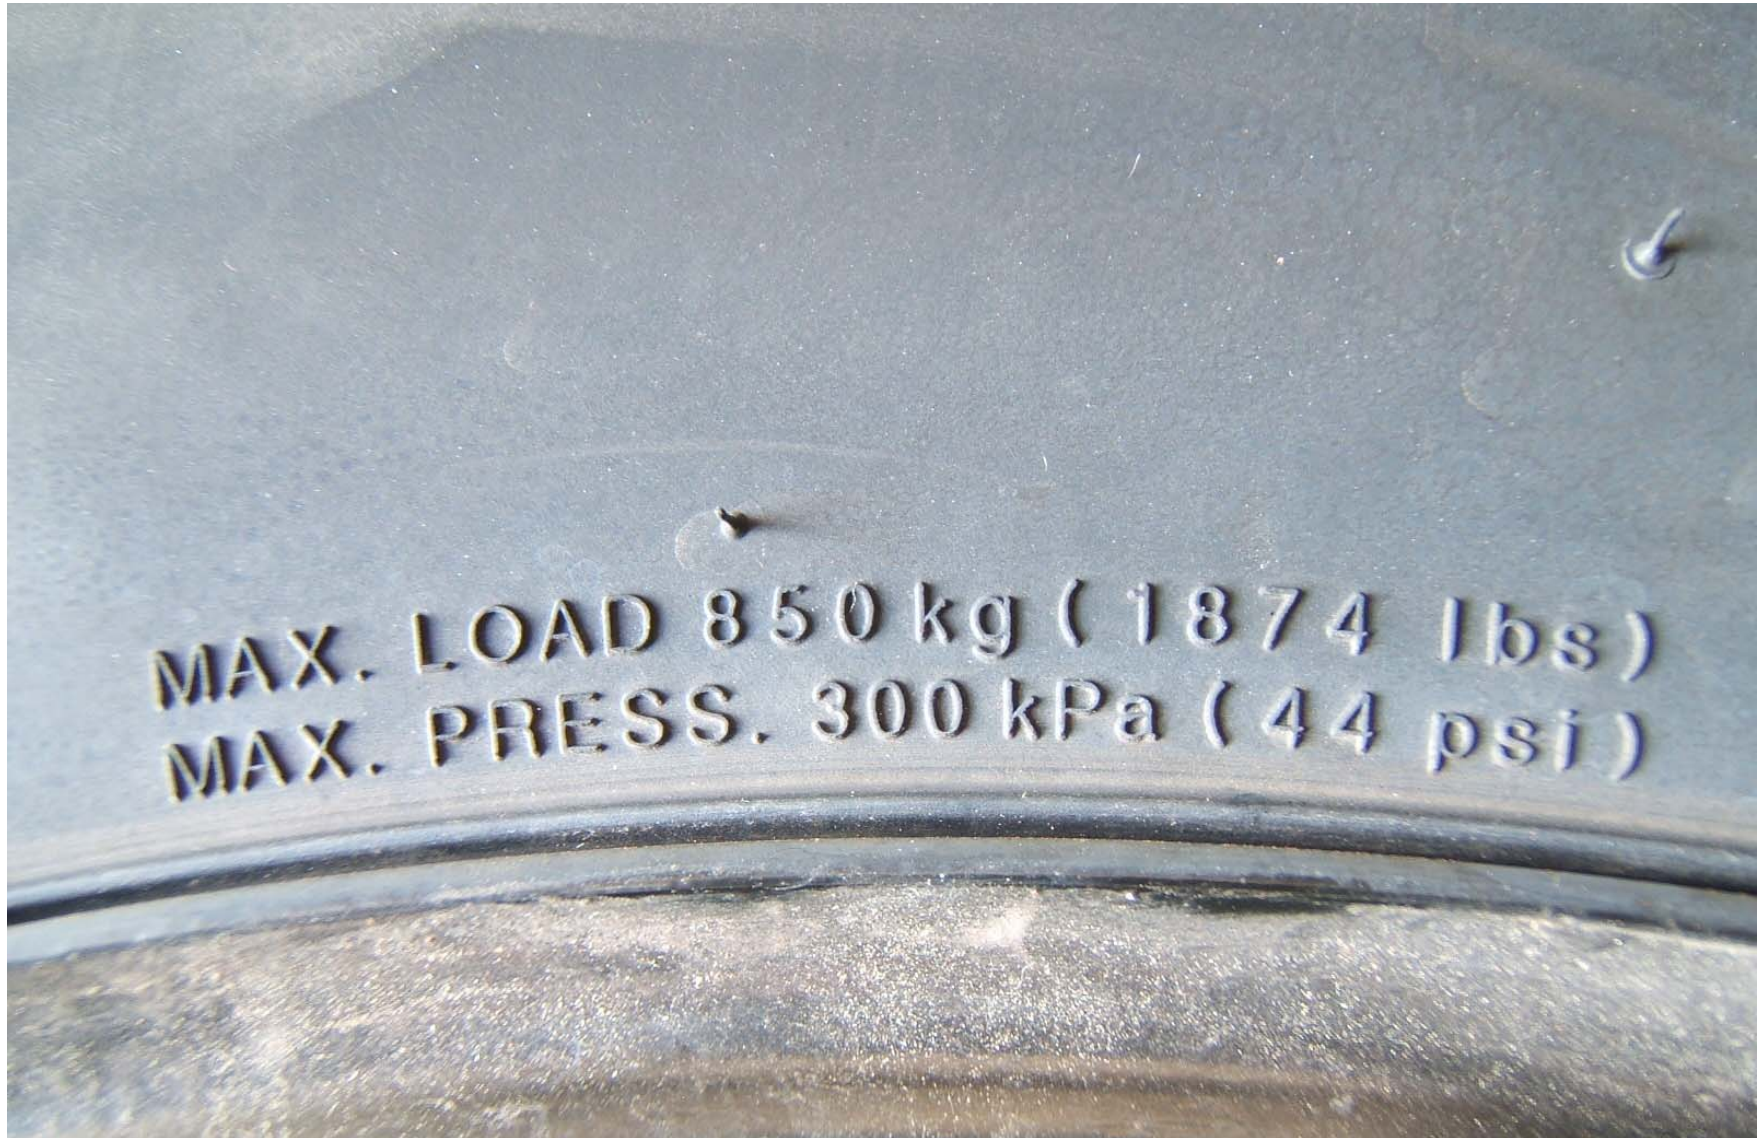
FIGURE 5.8
TIRE SHOWING MAX LOAD RATING AND
MAX COLD INFLATION PRESSURE

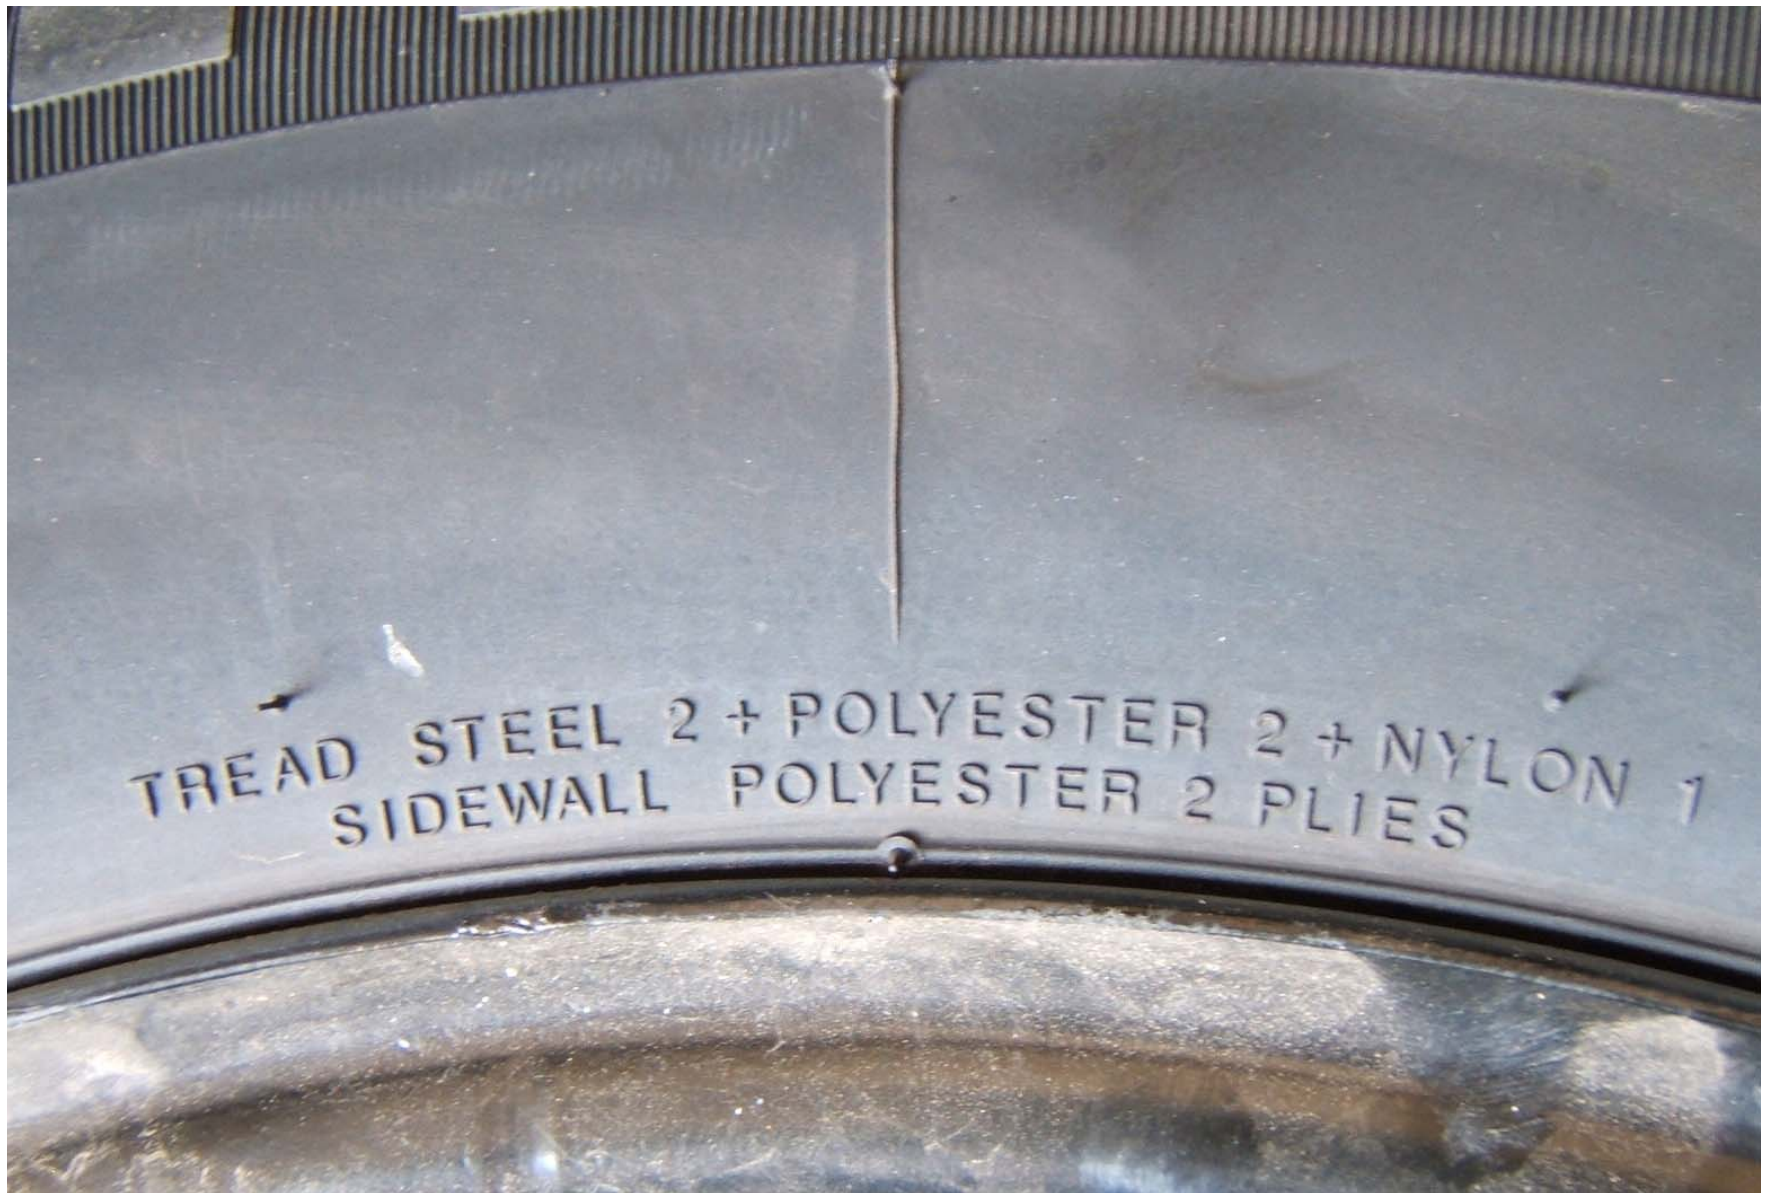
FIGURE 5.9
TIRE SHOWING SIDEWALL/TREAD CONSTRUCTION

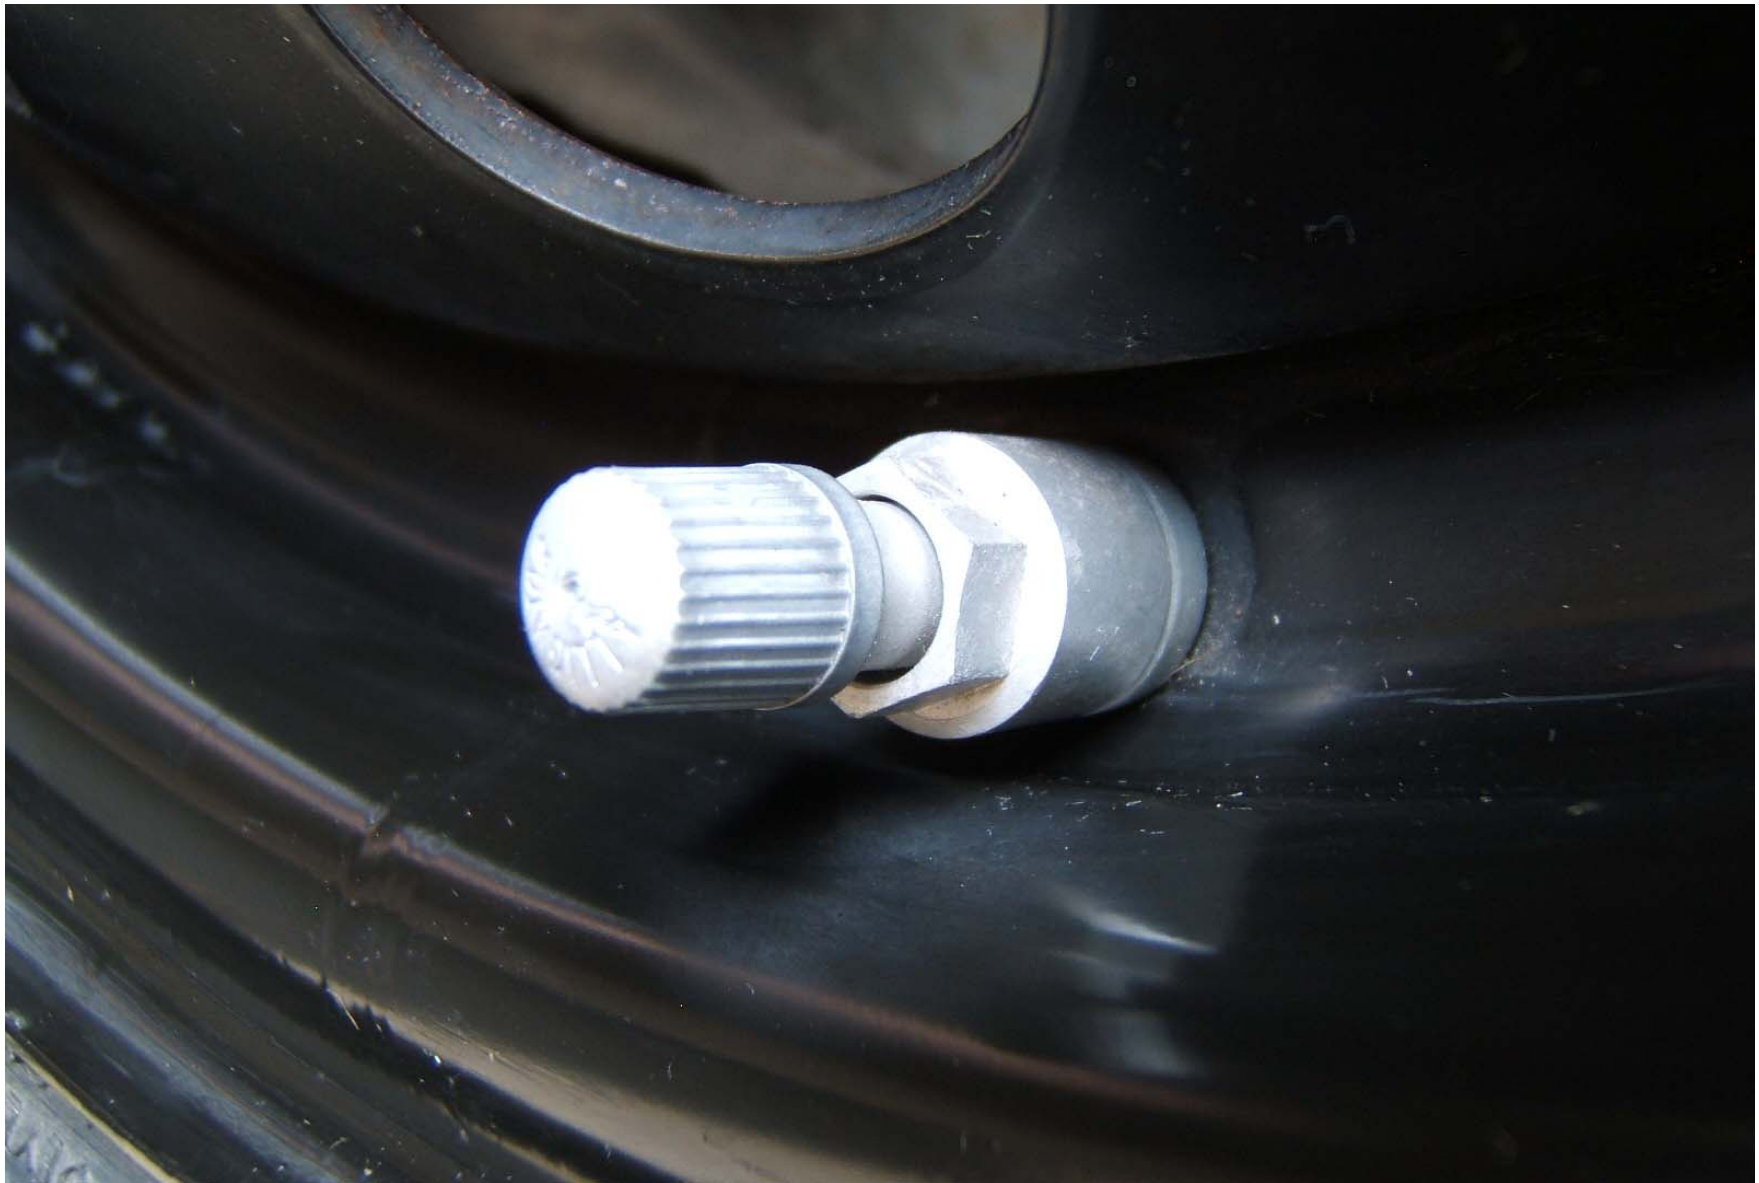
FIGURE 5.10
RIM SHOWING VALVE STEM

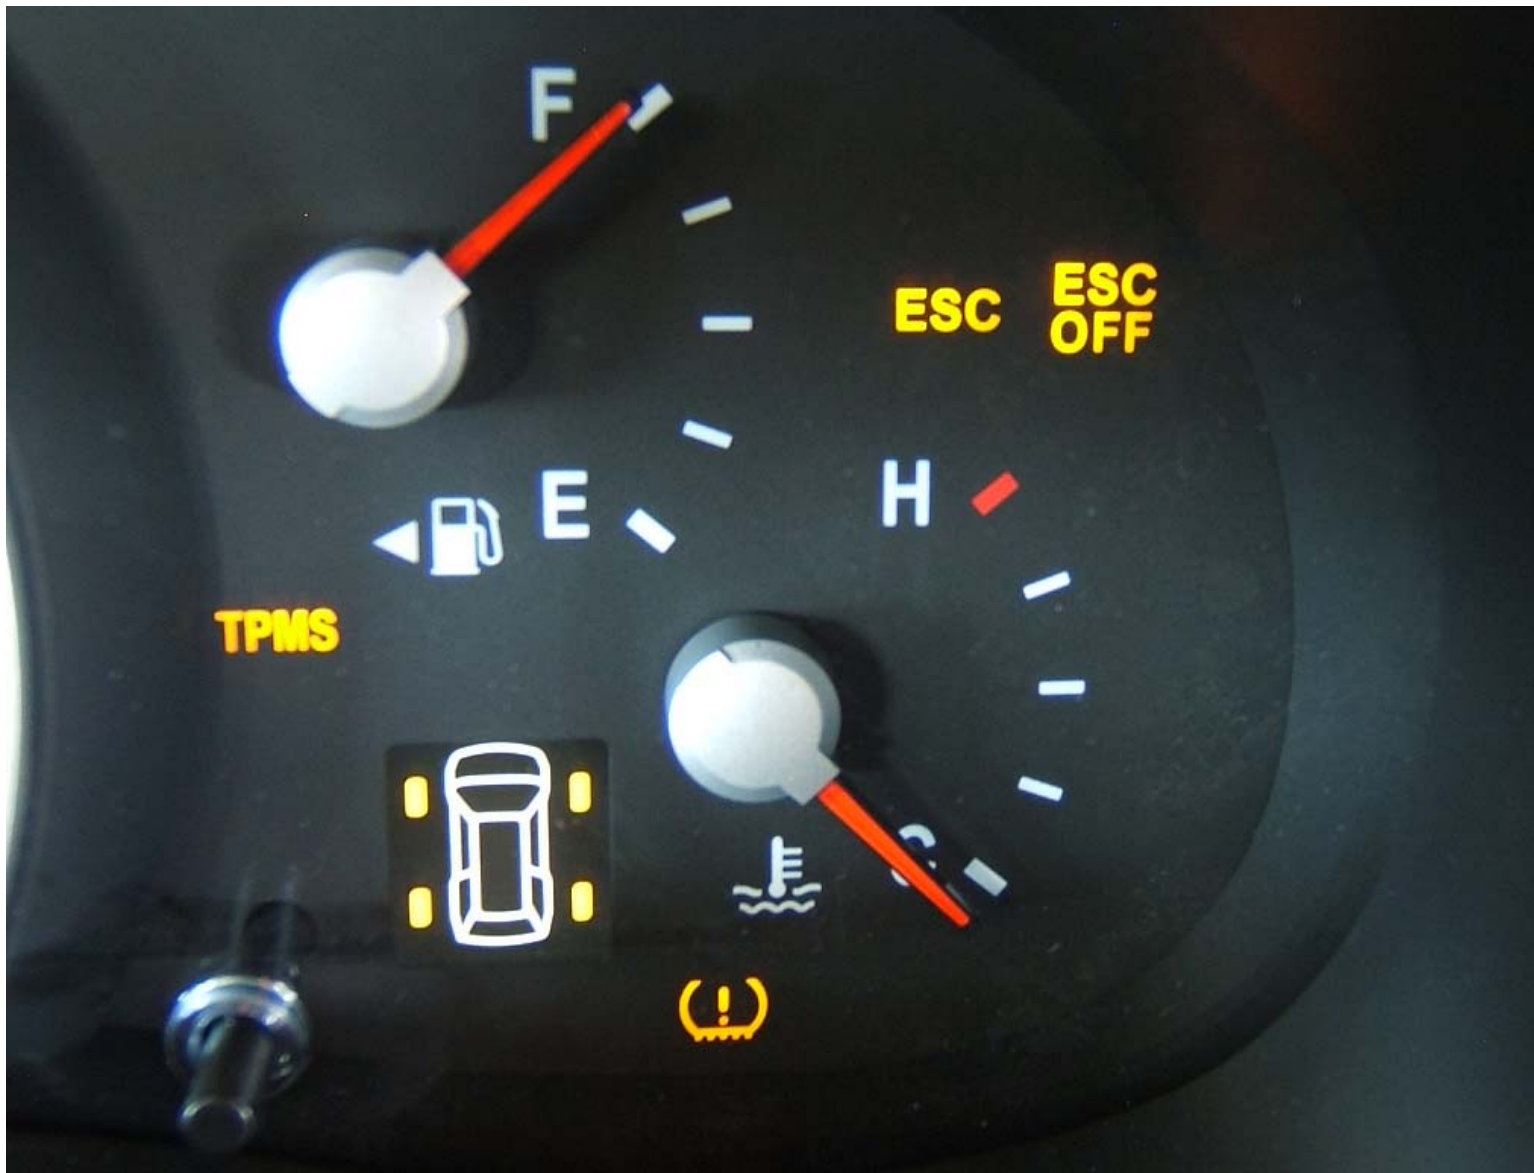
FIGURE 5.11
INSTRUMENT PANEL LAMP CHECK SHOWING LOW TIRE PRESSURE
WARNING TELLTALES AND DEDICATED MALFUNCTION TELLTALE

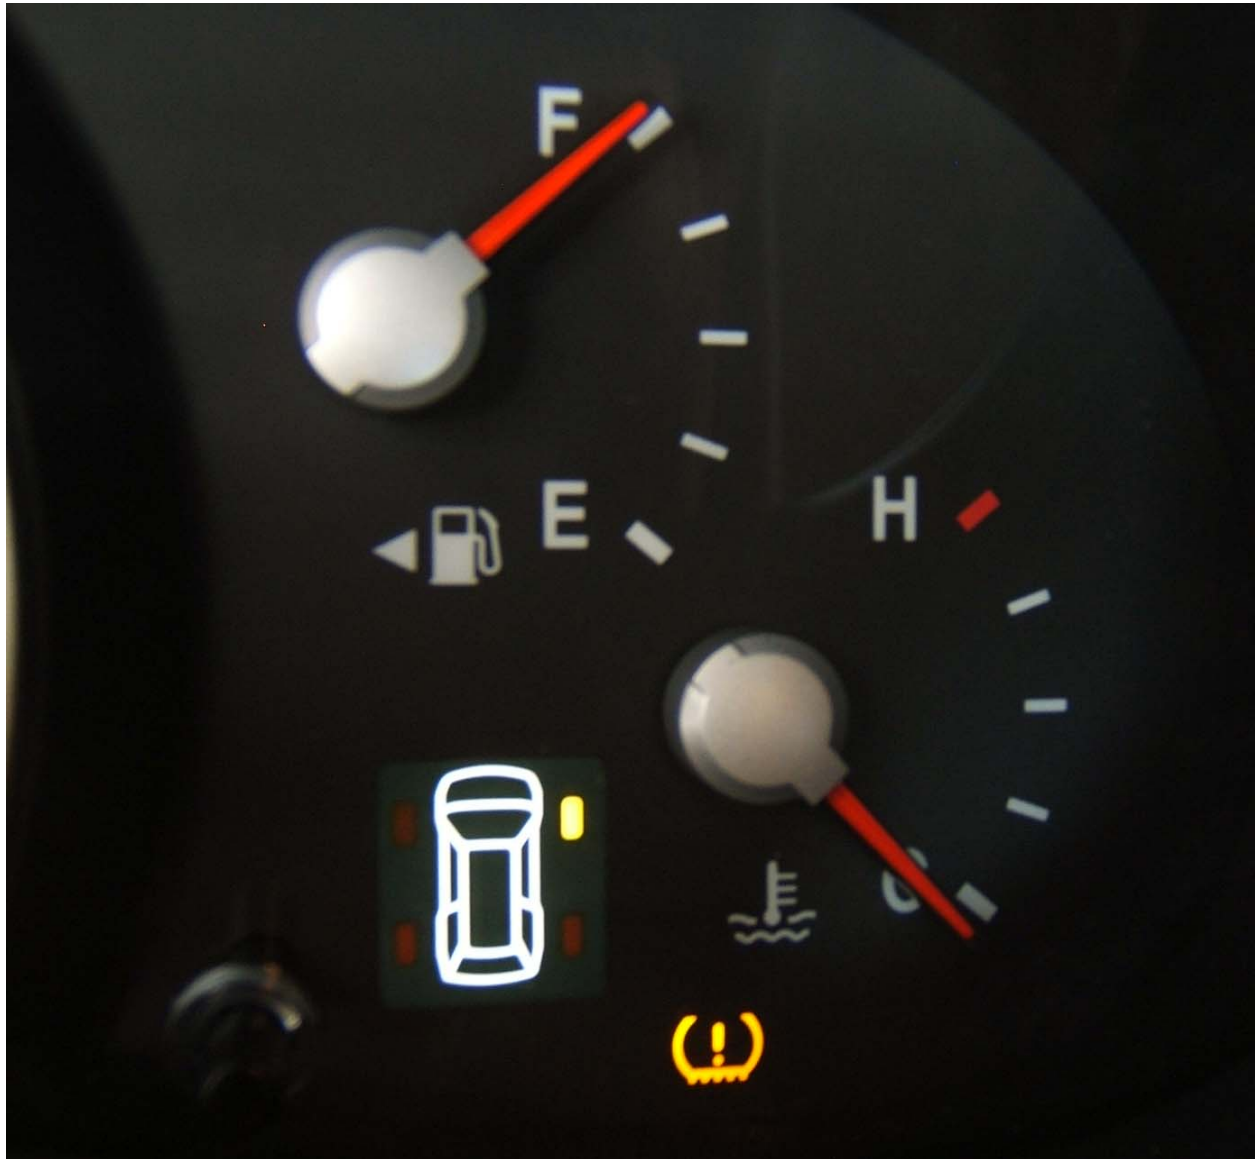
FIGURE 5.12
INSTRUMENT PANEL SHOWING RIGHT
FRONT TIRE LOW TIRE PRESSURE WARNING

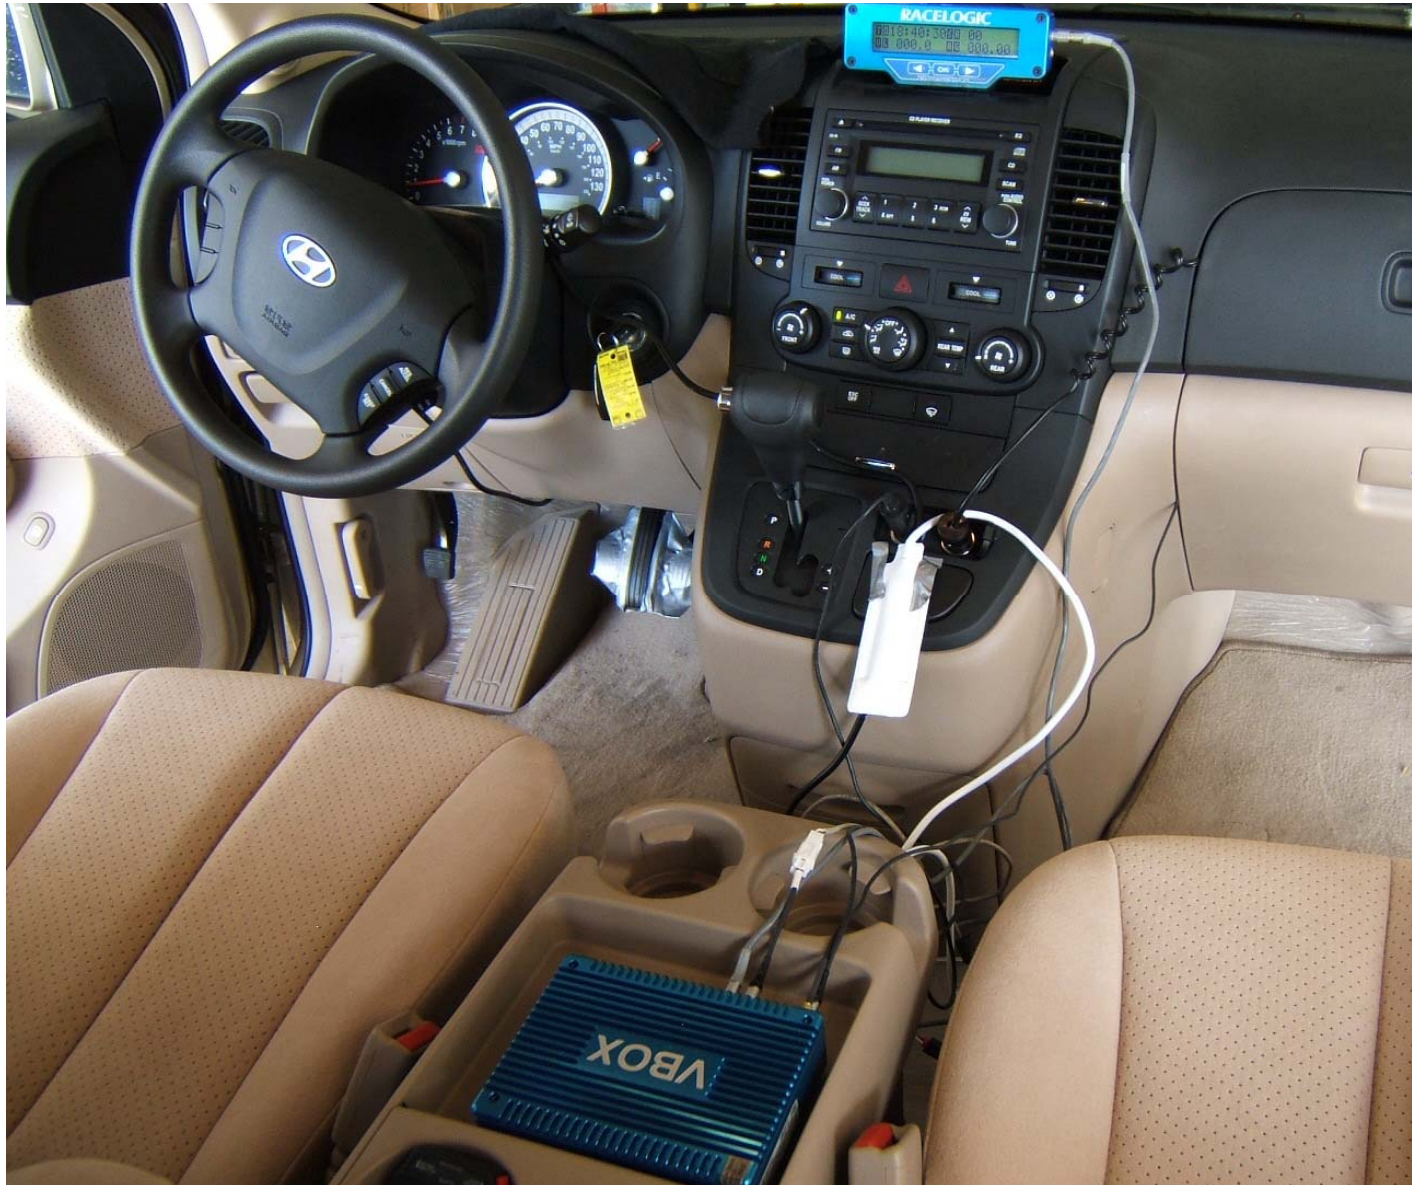
FIGURE 5.13
TEST INSTRUMENTATION ON VEHICLE

The vehicle was instrumented with a Racelogic VBOX III 100 Hz GPS Data Logger and brake pedal trigger. The VBOX uses GPS to measure vehicle speed, time, and distance. Test data were recorded to a compact flash card. During the test, a stopwatch was used to determine the approximate "cumulative driving time" during each test phase. Cumulative driving time does not include time during the brake application or when the vehicle speed was below 50 km/h or above 100 km/h. Upon completion of a tire deflation test, graph(s) were generated by VBOX software showing vehicle speed versus time during the test procedure calibration phase and detection phase. The graphs furnish a second-by-second analysis of each test phase. The cumulative driving time for each test was calculated by post processing the VBOX graph data and is reported in Section 3 (Test Data) as 'Total Driving Time'.

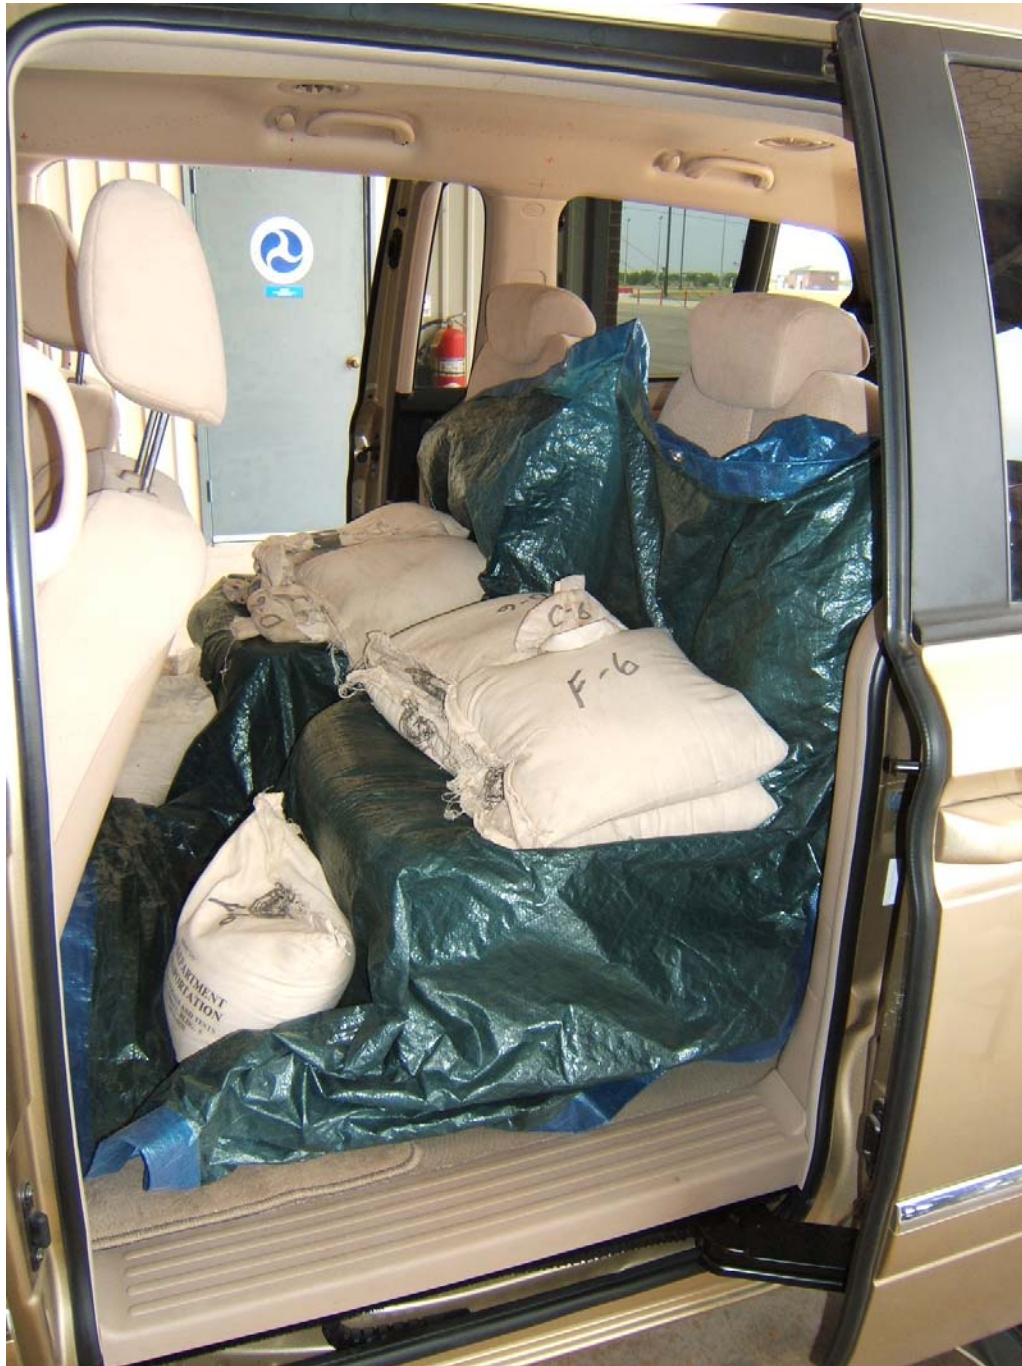
FIGURE 5.14
VEHICLE CENTER SEAT BALLAST
FOR VCW LOAD
