REPORT NUMBER 138-STF-07-001

SAFETY COMPLIANCE TESTING FOR FMVSS NO. 138 TIRE PRESSURE MONITORING SYSTEMS

KIA MOTORS CORPORATION
2007 HYUNDAI ENTOURAGE
FOUR-DOOR MPV
NHTSA NO. C70504

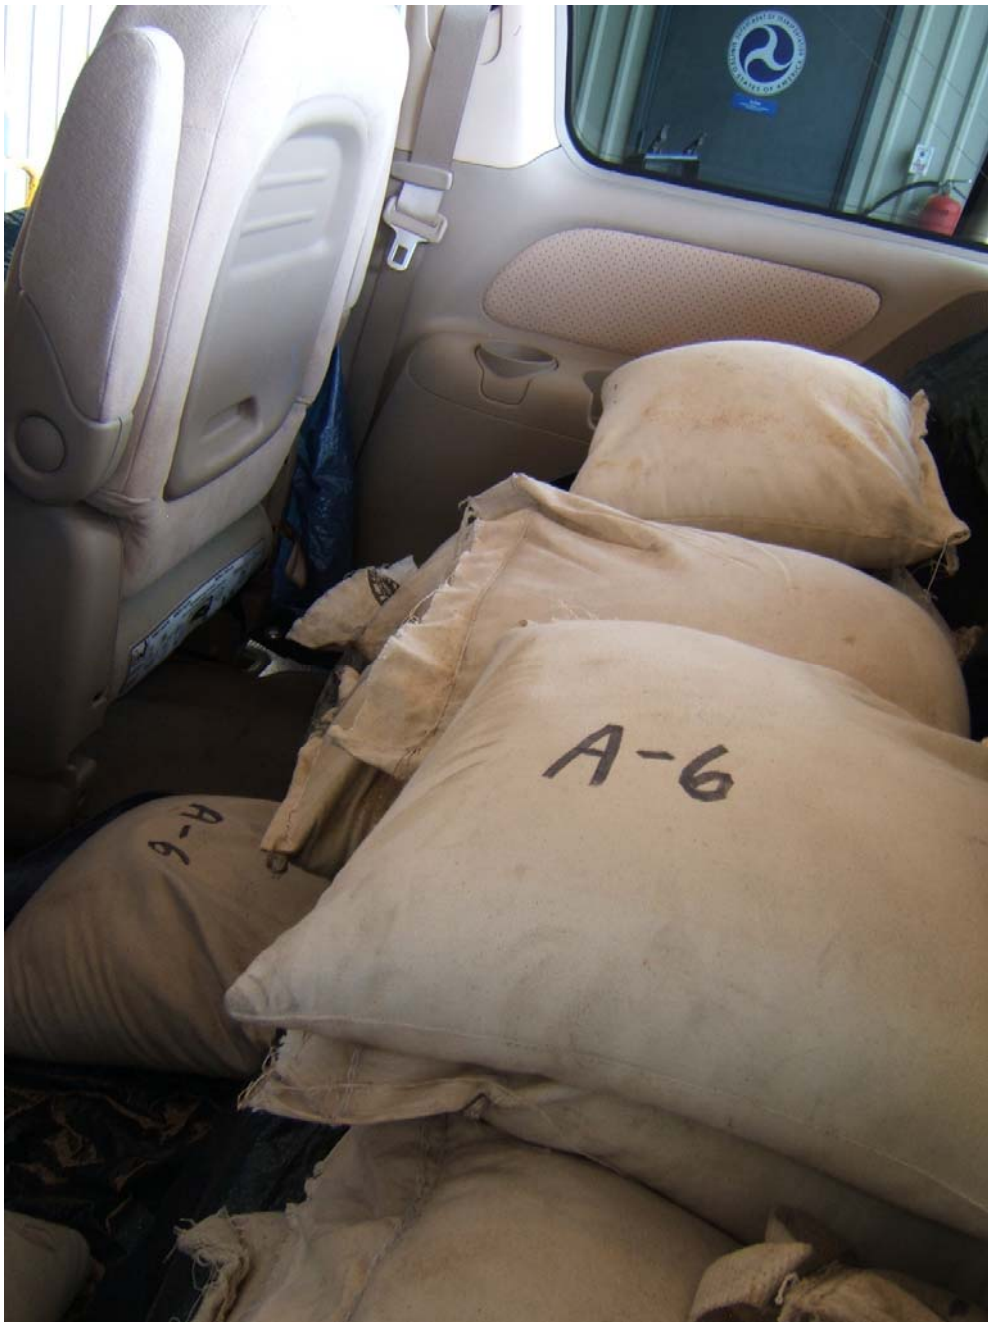
FIGURE 5.15
VEHICLE REAR SEAT BALLAST FOR
VCW LOAD

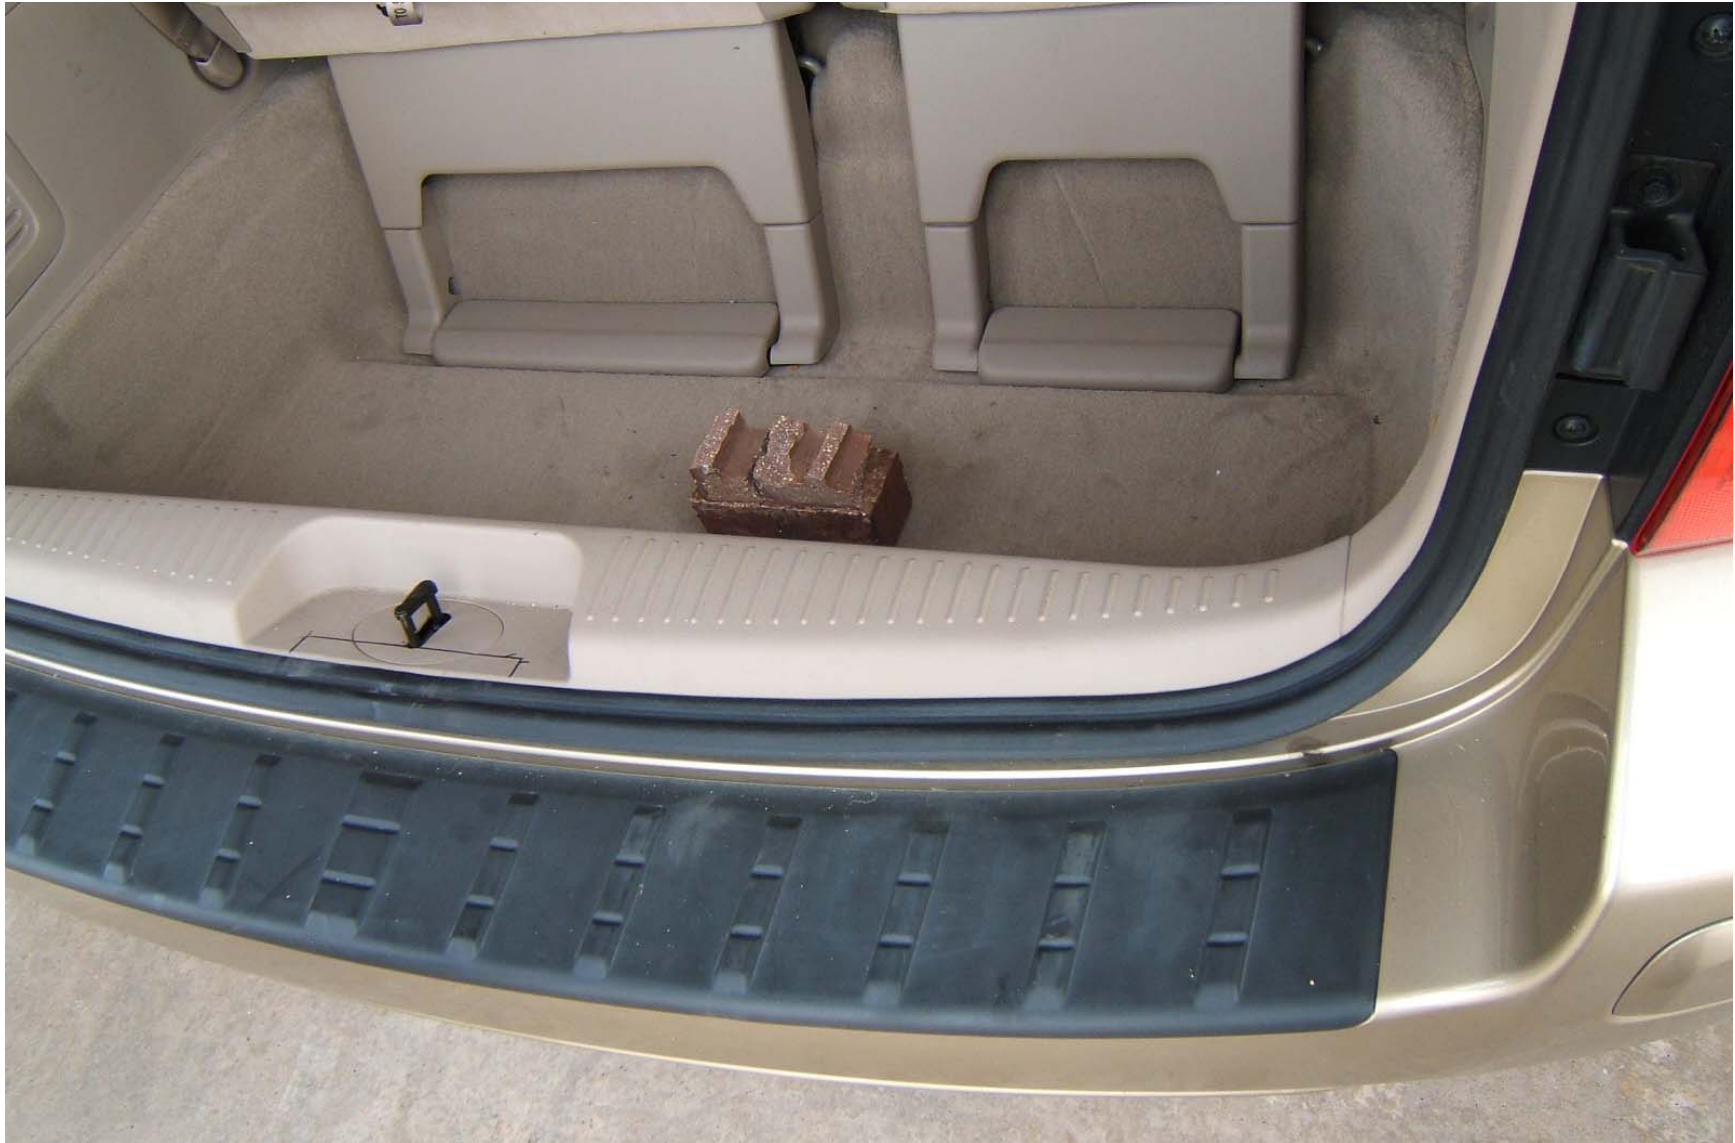
FIGURE 5.16
REAR OF VEHICLE BALLASTED
FOR VCW LOAD

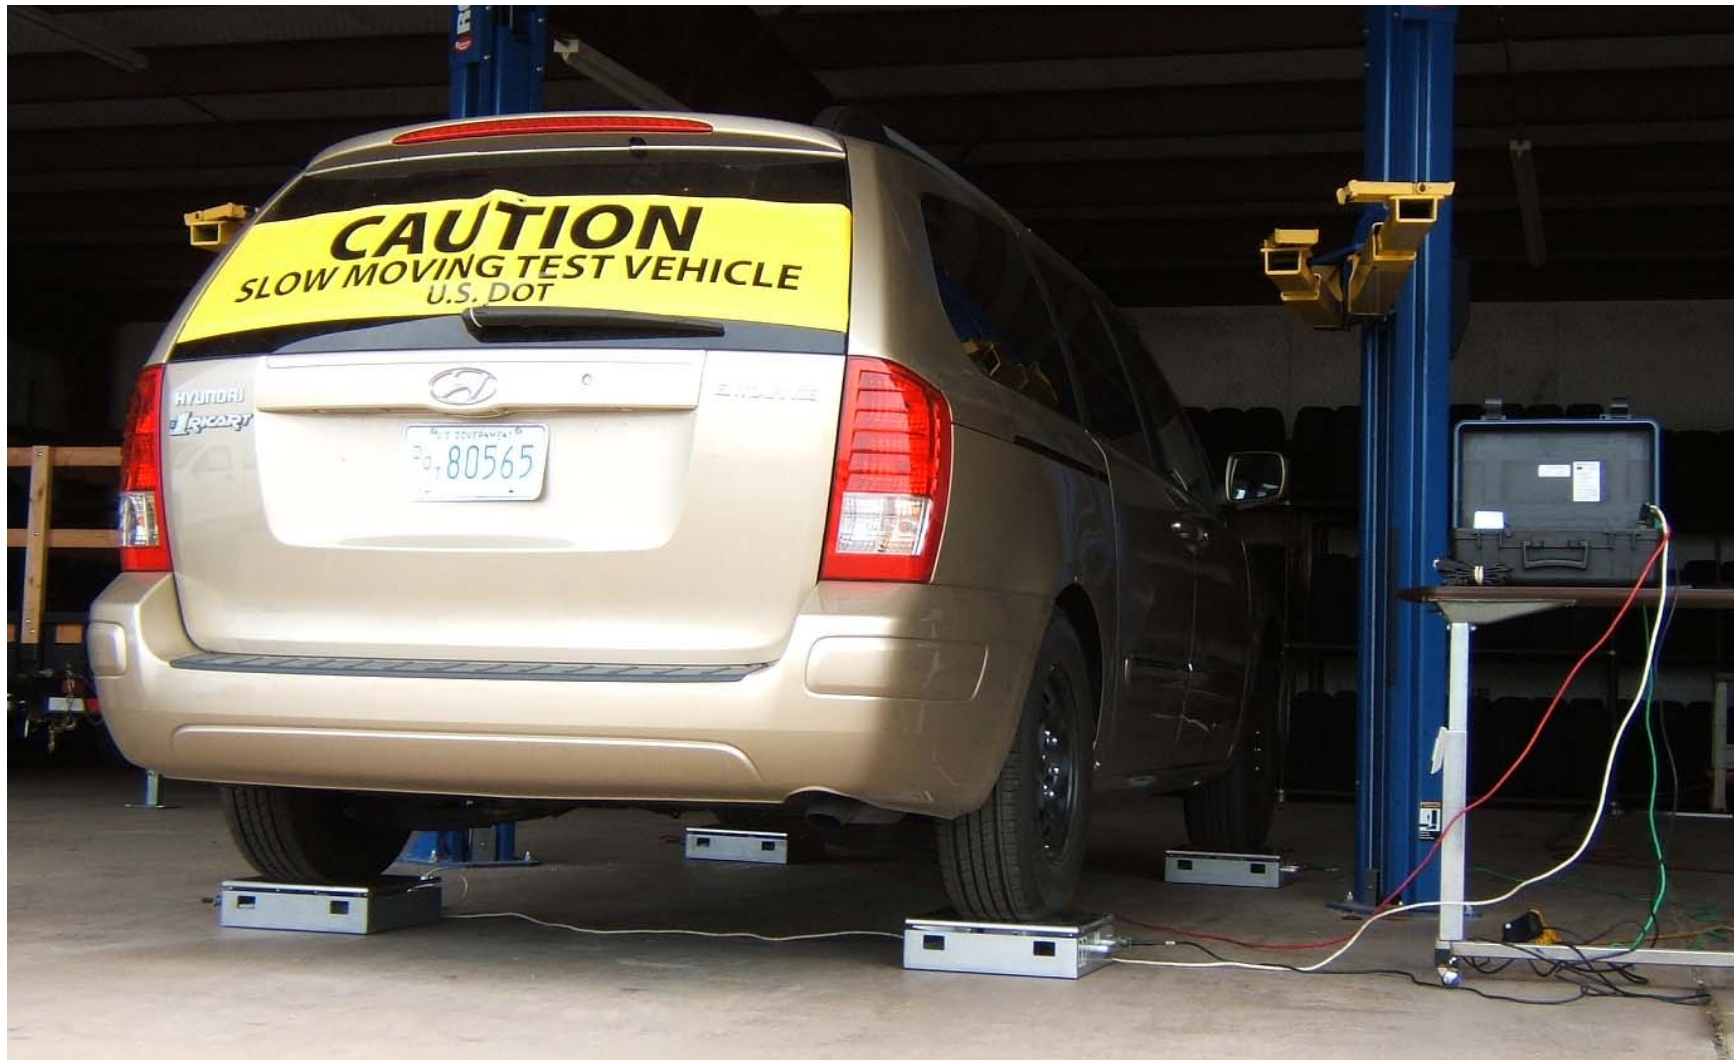
FIGURE 5.17
VEHICLE ON WEIGHT SCALES

Subsequent events included weighing the vehicle to establish the Unloaded Vehicle Weight (UVW) and the distribution of weight on the front and rear axles and each wheel position. The vehicle was loaded to its Lightly Loaded Vehicle Weight (LLVW) for four tire deflation scenarios. This LLVW included the weights of driver, one passenger, and test equipment. The vehicle was loaded to its Vehicle Capacity Weight (VCW) for four tire deflation scenarios. The Vehicle Capacity Weight included the weights of driver, one passenger, equipment, ballast in the mid and rear seats, and ballast in the internal cargo area. For determination of the telltale warning activation pressure, the recommended cold inflation pressure was identified from the vehicle placard.

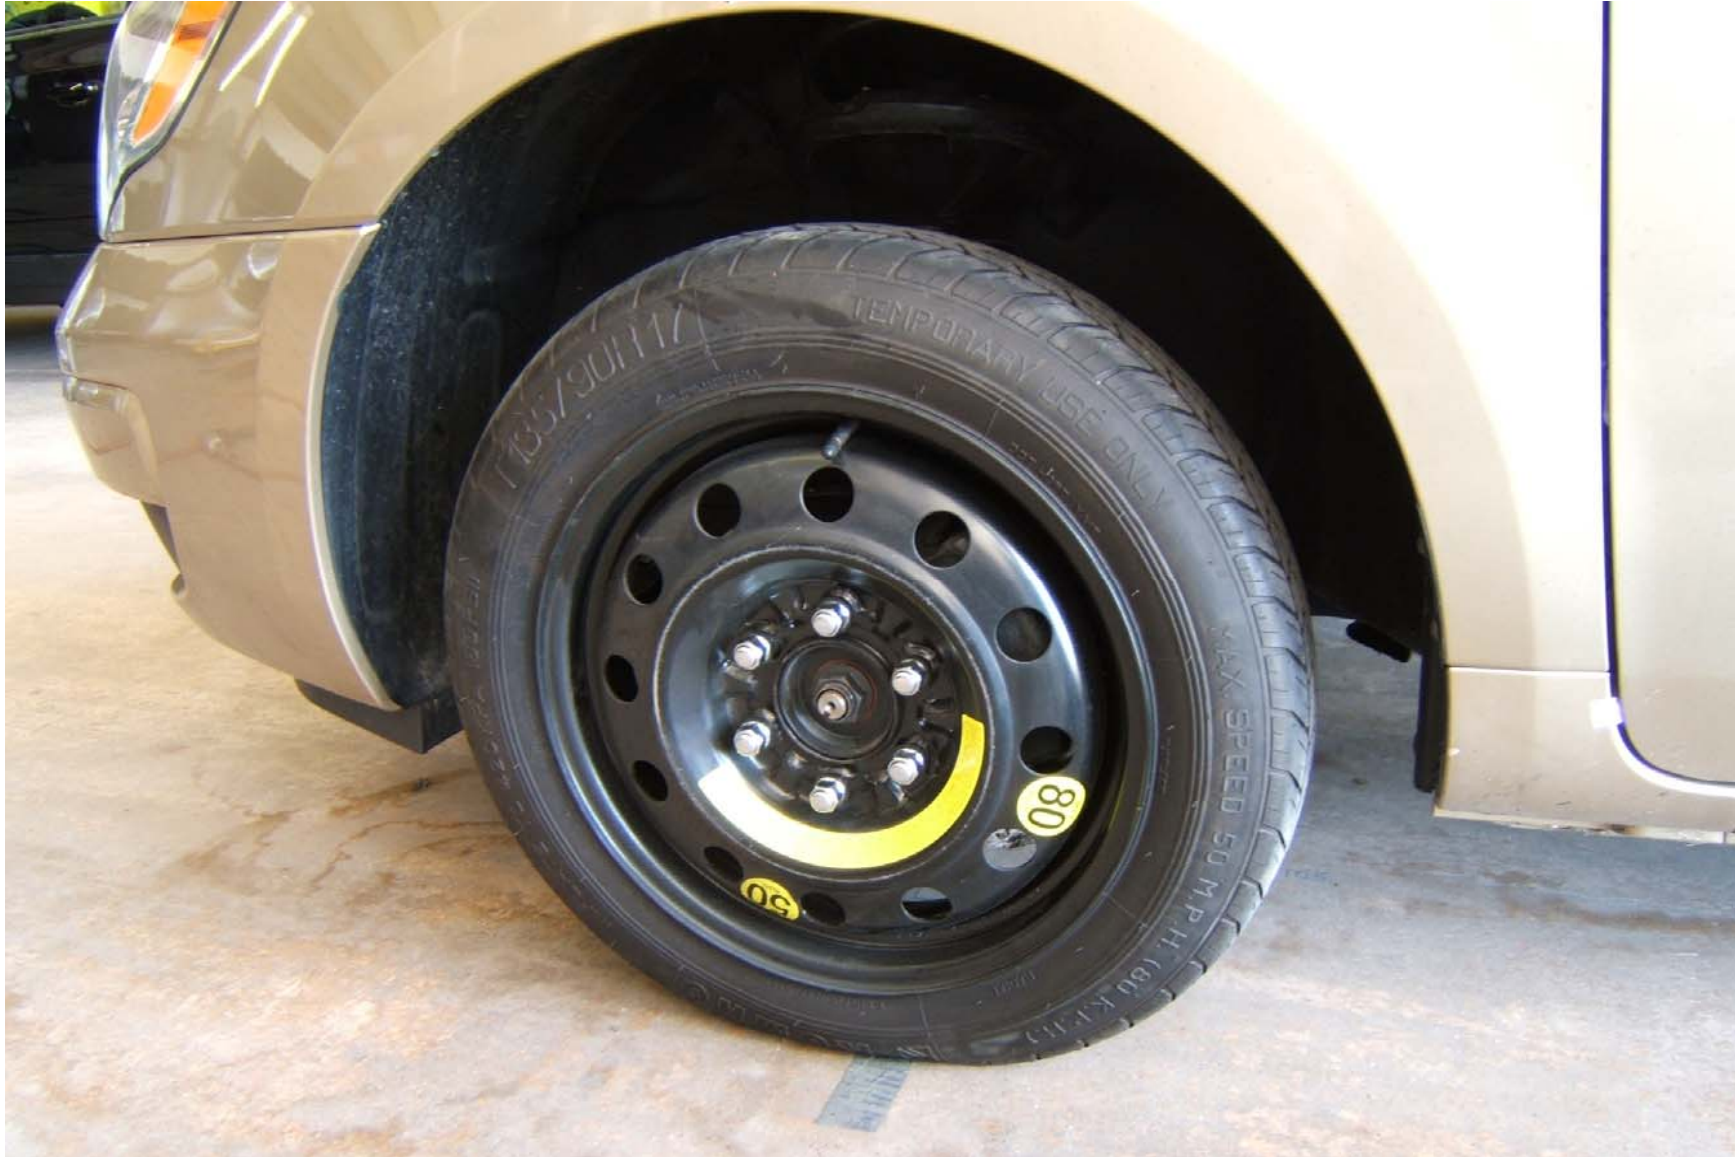
FIGURE 5.18
SPARE INSTALLED ON LEFT FRONT POSITION
FOR MALFUNCTION DETECTION TEST

An indicant malfunction detection scenario was performed with the vehicle loaded to its LLVW. A malfunction was simulated by placing the compact spare tire (with no TPMS sensor) on the left front wheel position. The vehicle was driven until telltale illumination was attained.

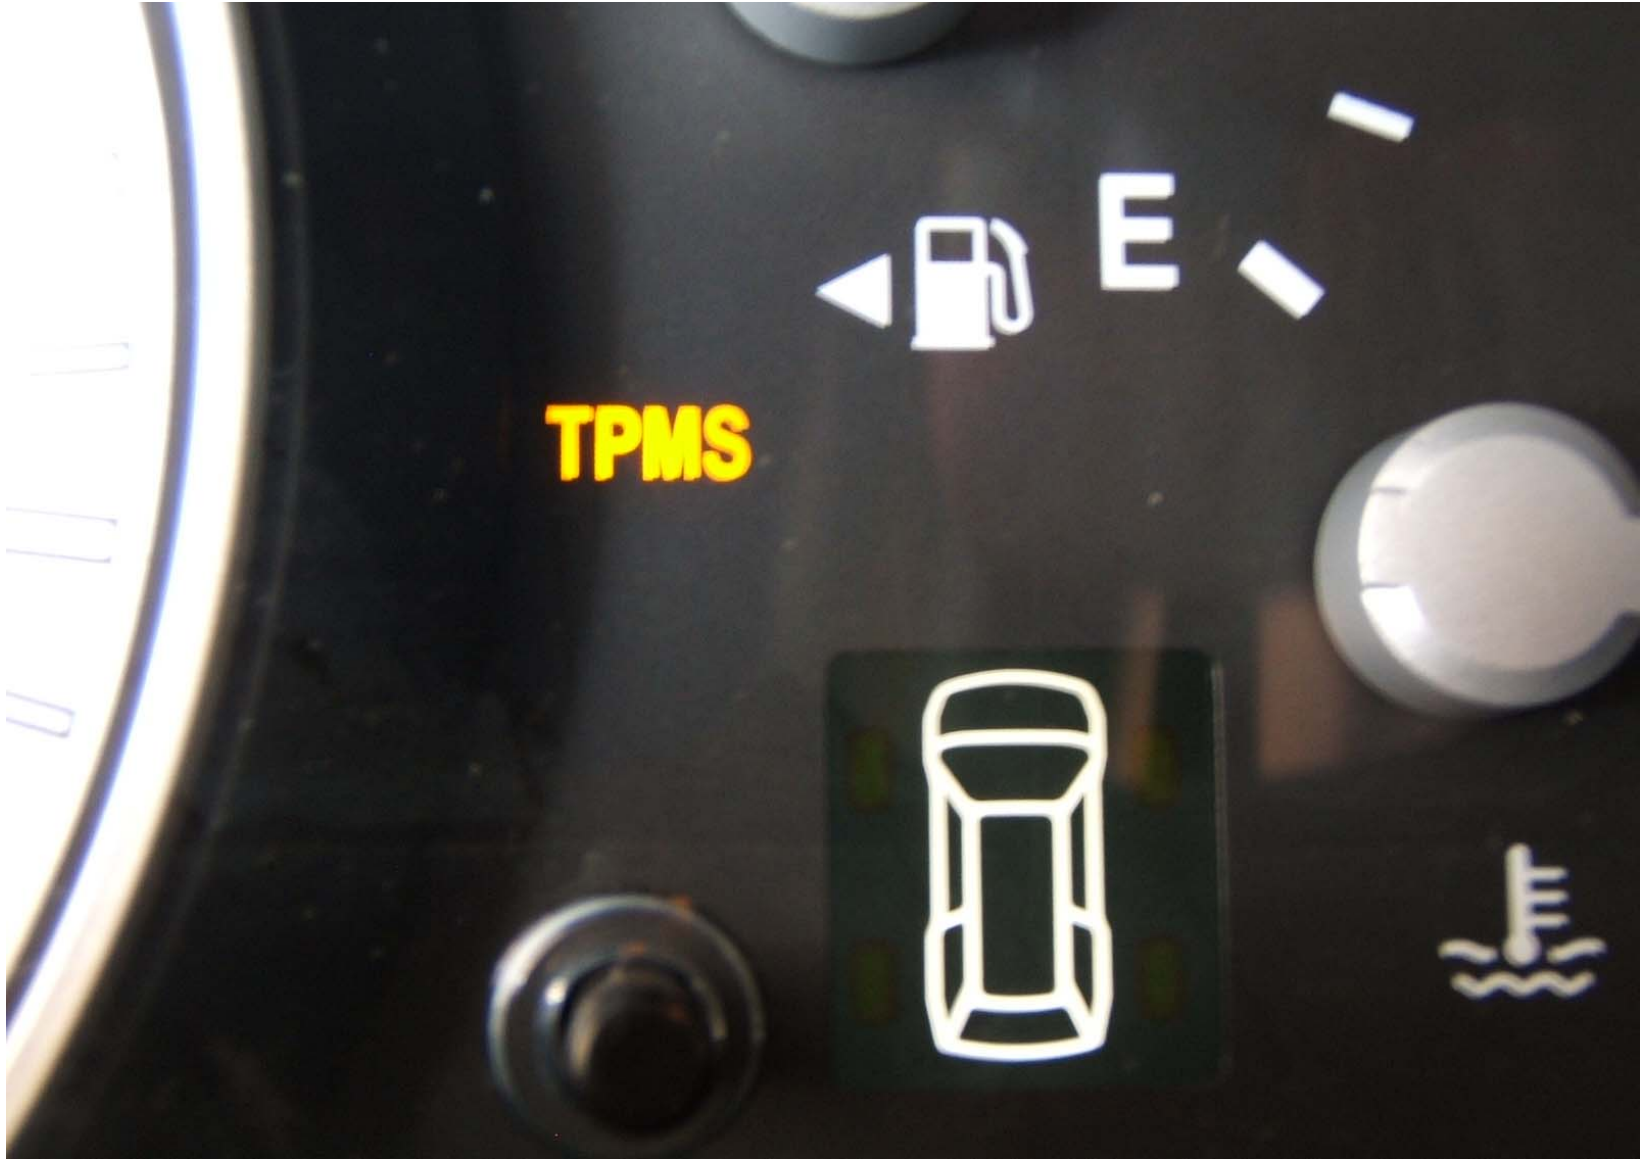
FIGURE 5.19
INSTRUMENT PANEL SHOWING
DEDICATED MALFUNCTION TELLTALE

One indicant malfunction detection scenario was performed on the test vehicle at LLVW. The vehicle's dedicated malfunction telltale indicated a malfunction per the standard's requirements effective September 1, 2007.

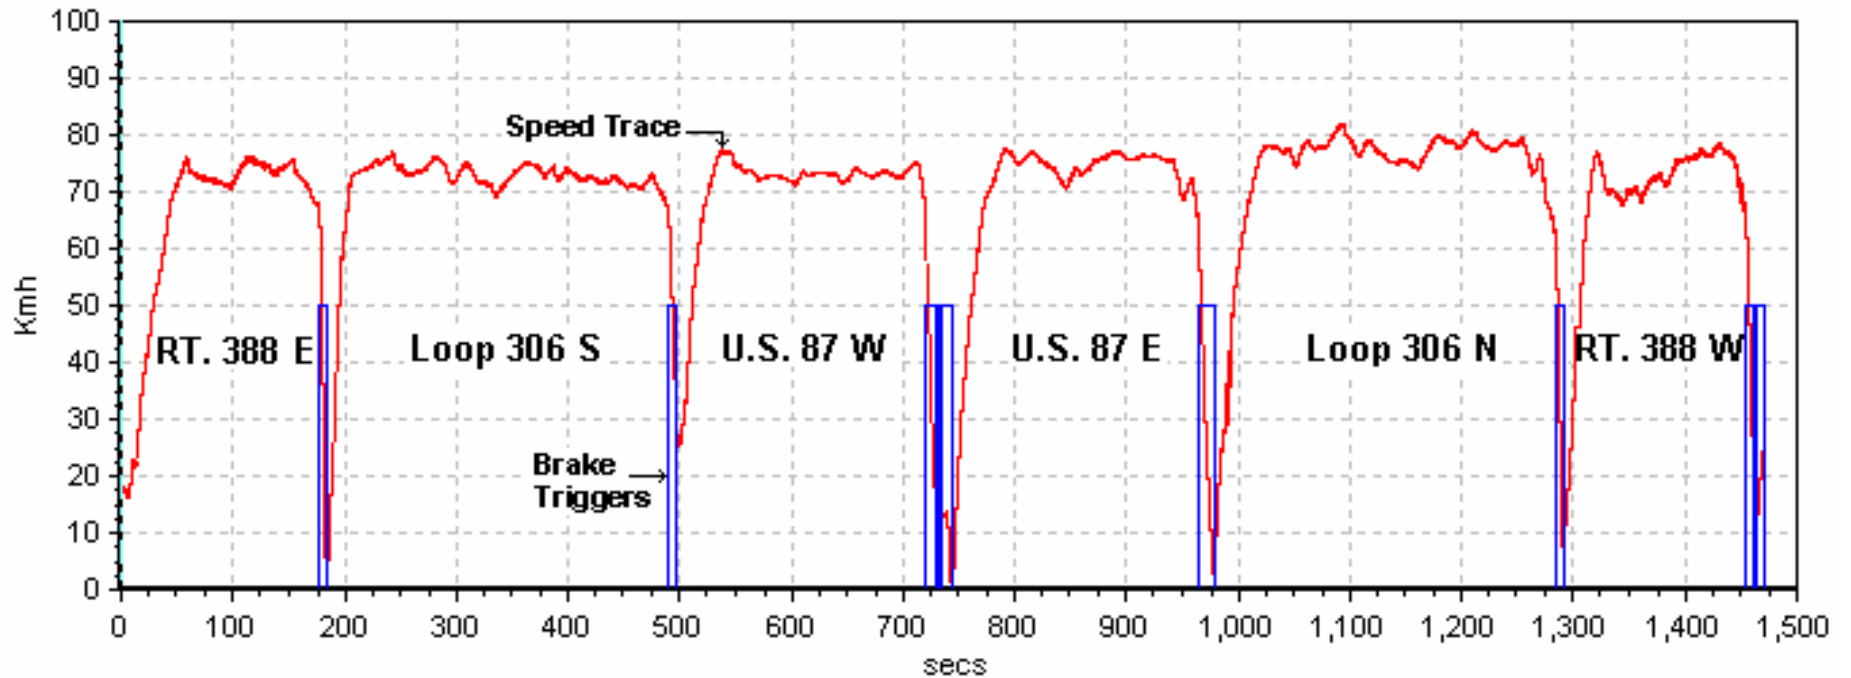
2007 Hyundai Entourage (C70504) LF Calibration / LLWW

LF Detection Phase: Telltale illumination in 3 seconds. Driving was not required.

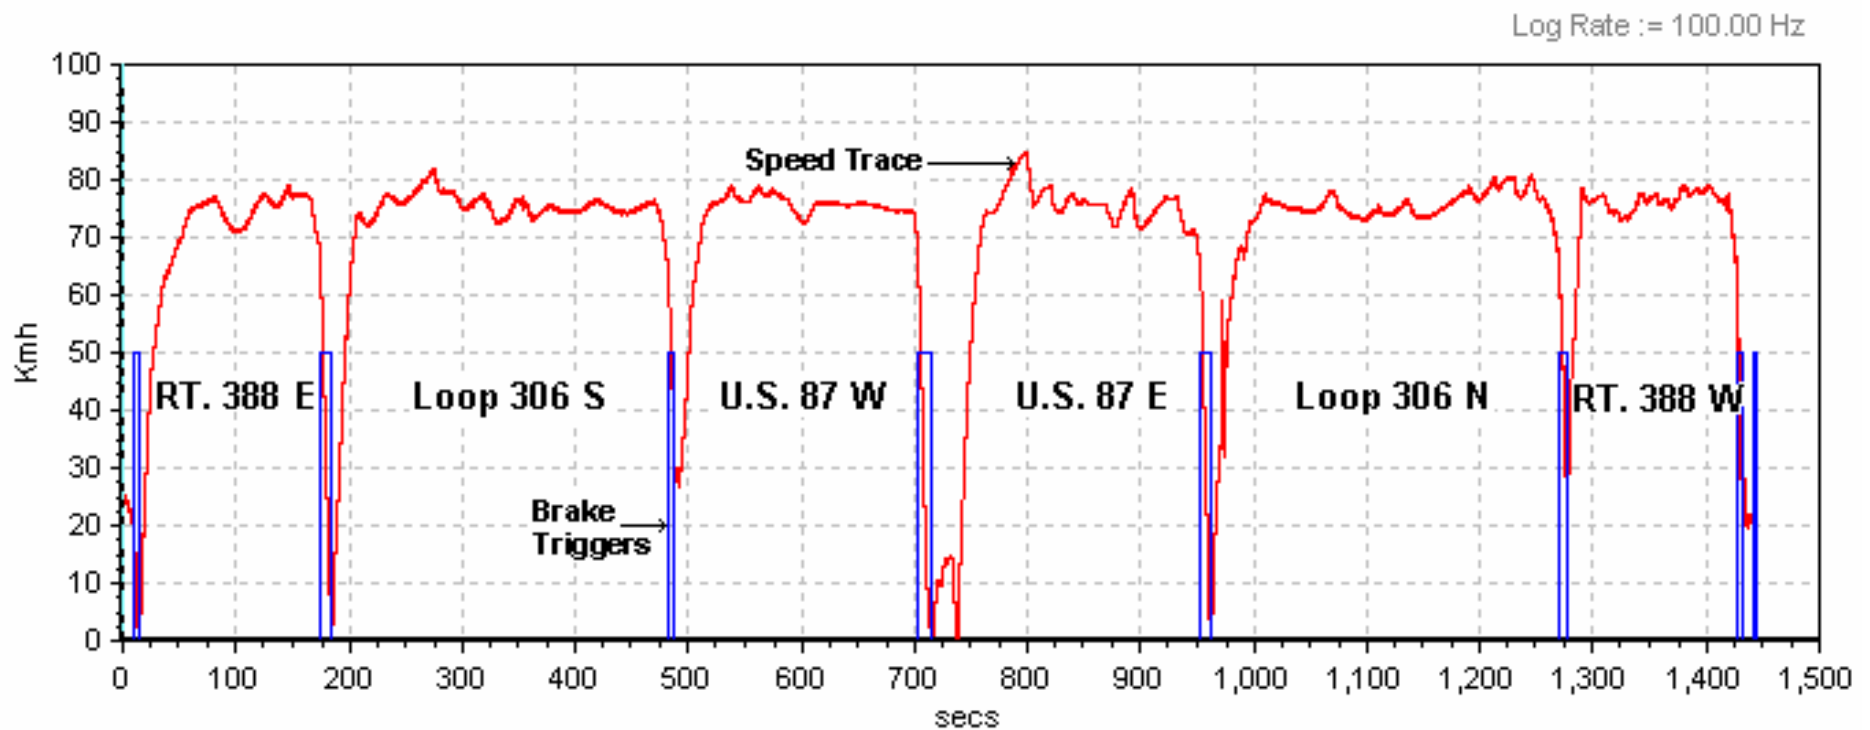
2007 Hyundai Entourage (C70504) RR Calibration / LLWW

RR Detection Phase: Illumination in 40 seconds. Driving was not required.

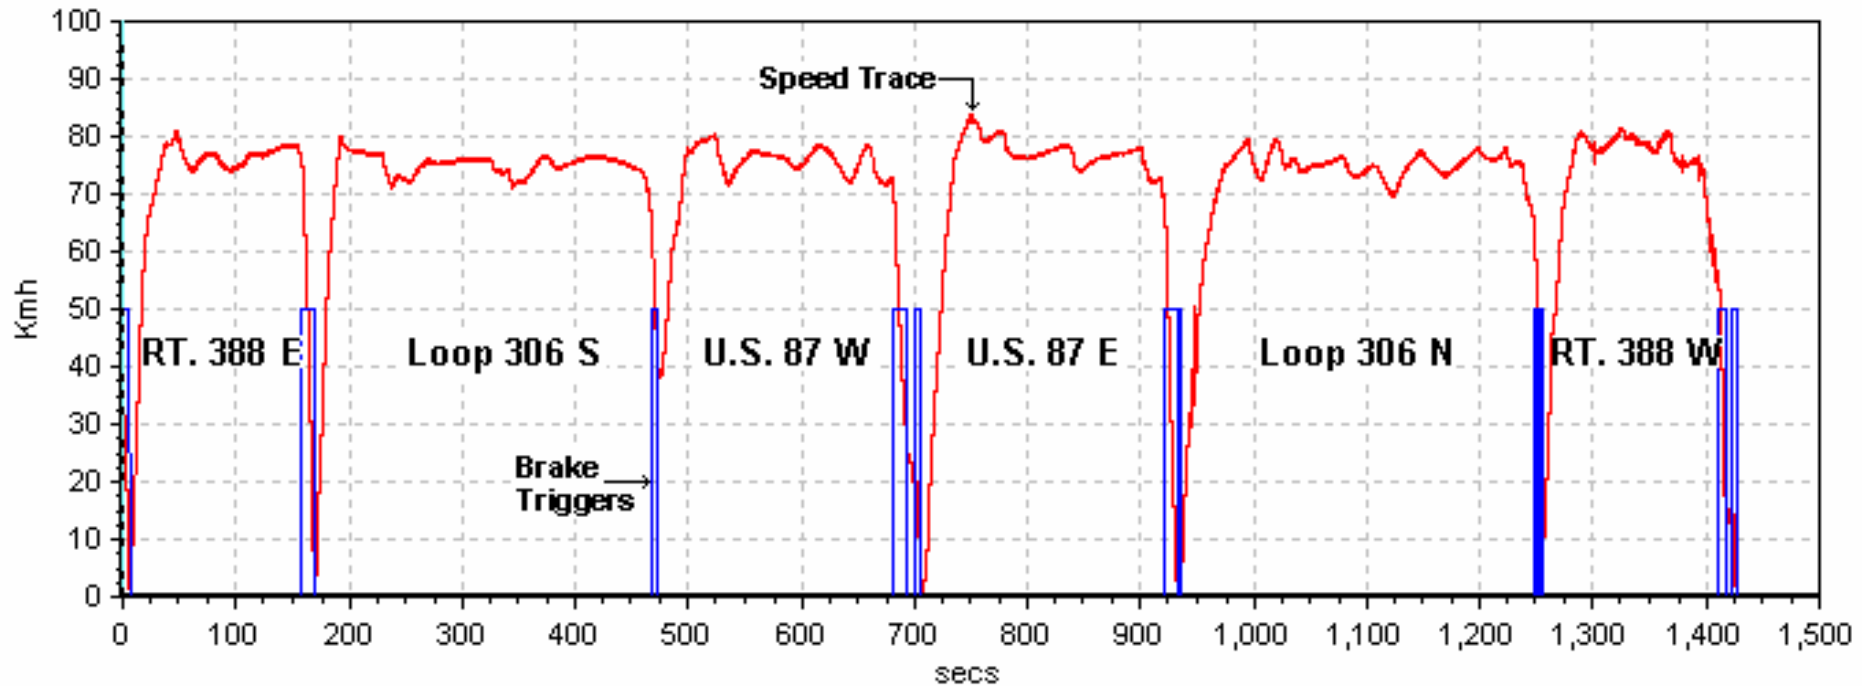
2007 Hyundai Entourage (C70504) LR, RF Calibration / LLWW

LR, RF Detection Phase: Illumination 3.12 seconds. Driving was not required.

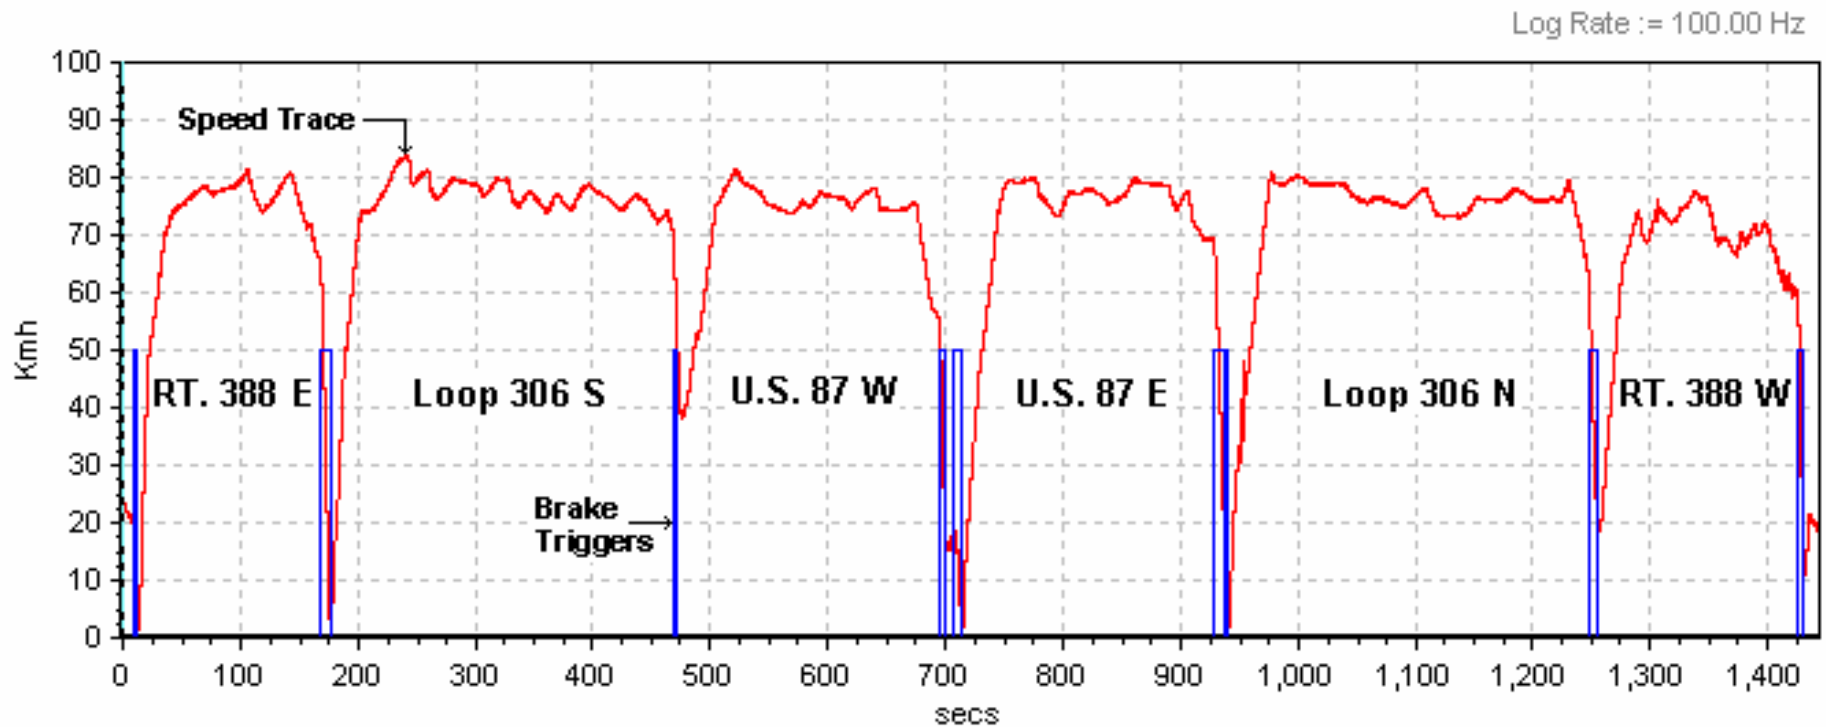
2007 Hyundai Entourage (C70504) LF, LR, RR, RF Calibration / LLWW

LF, LR, RR, RF Detection Phase: Illumination in 5.5 seconds. Driving was not required.

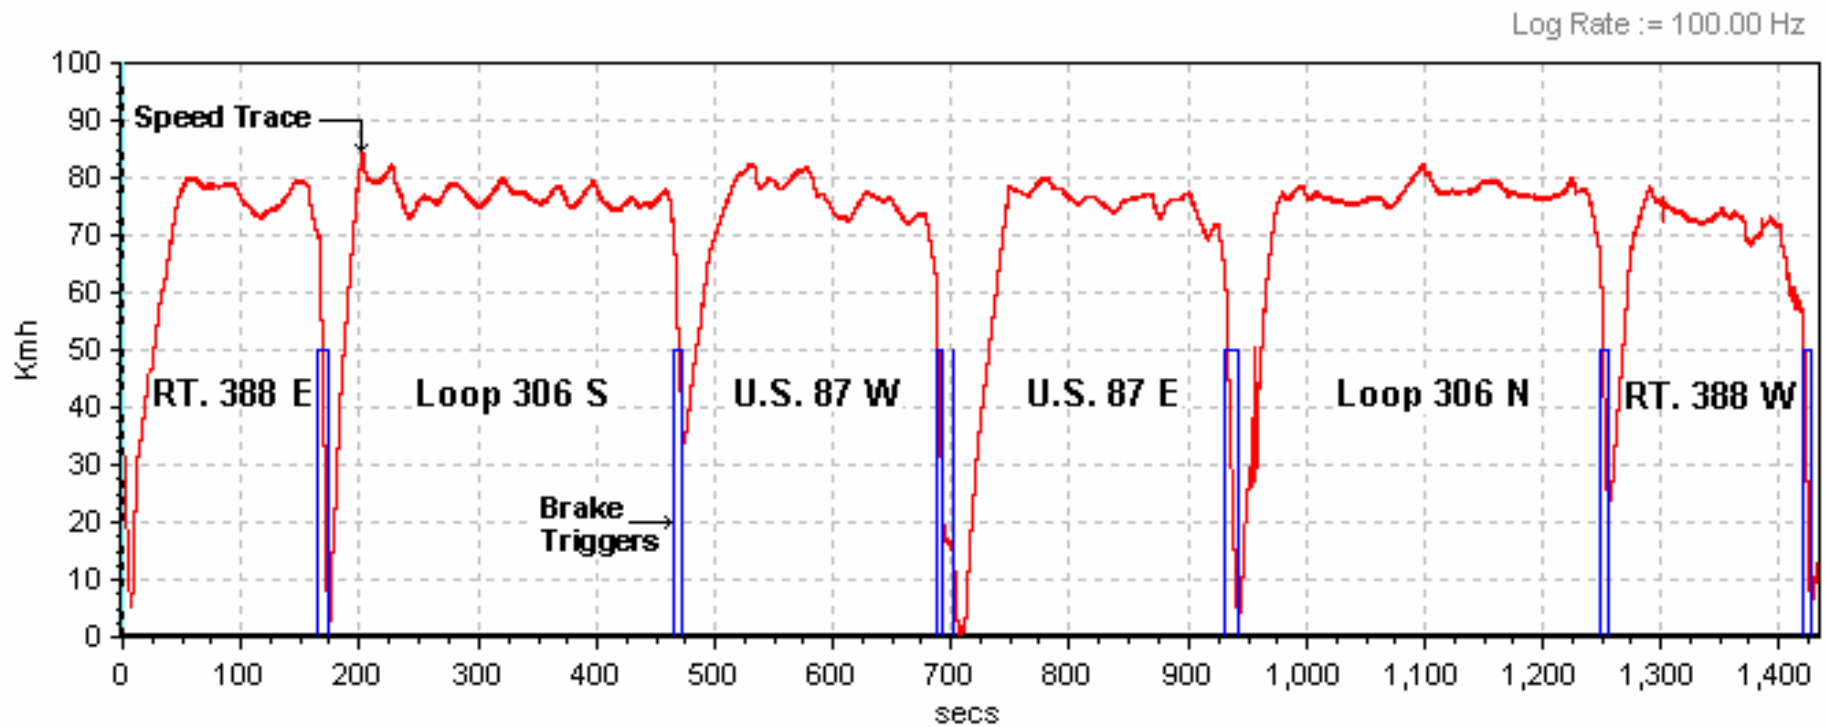
2007 Hyundai Entourage (C70504) LR Calibration / VCW

LR Detection Phase: Illumination in 2.8 seconds. Driving was not required.

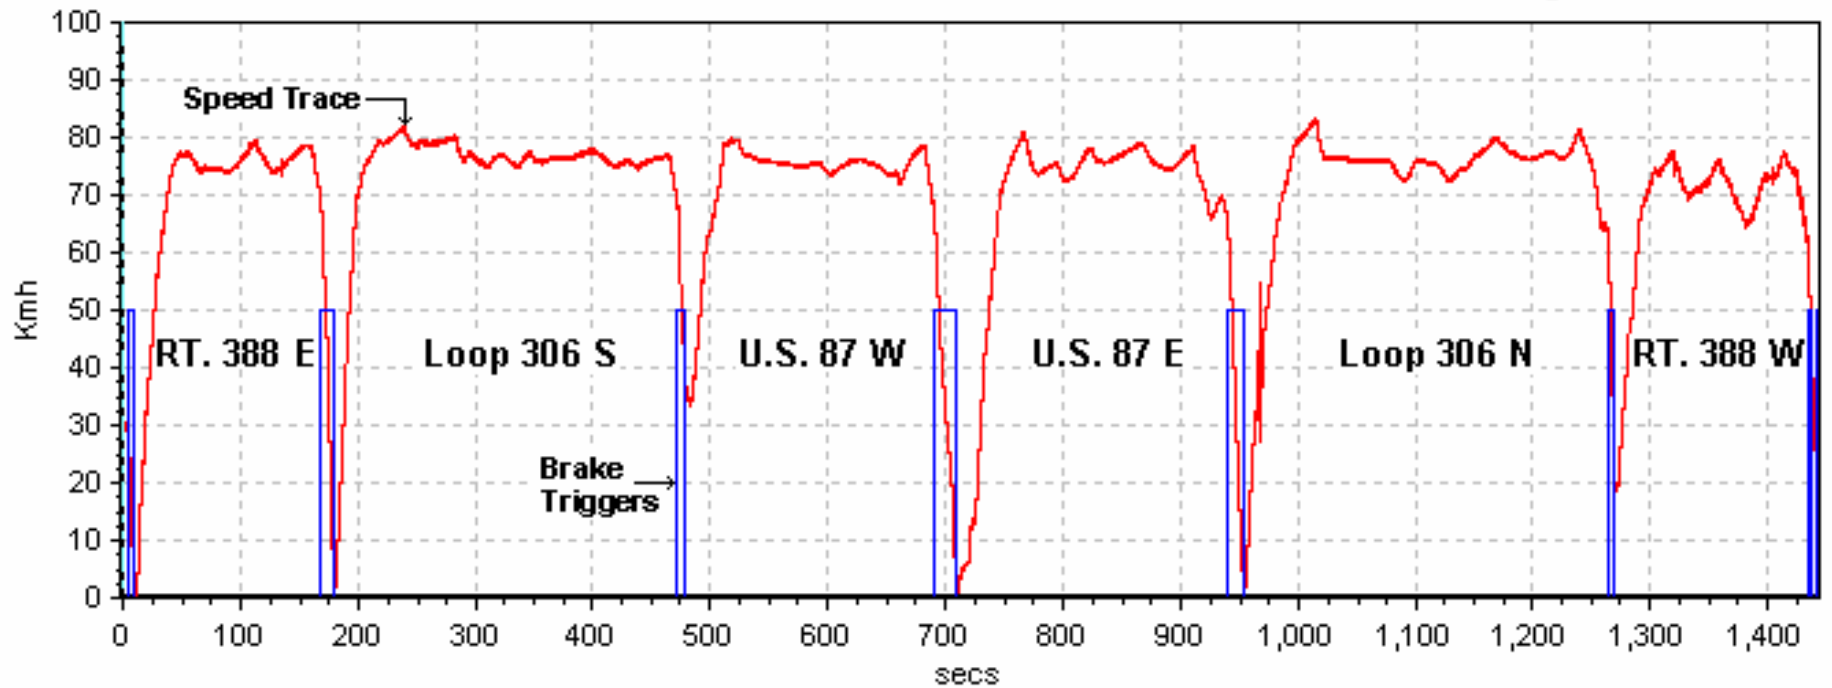
2007 Hyundai Entourage (C70504) RF Calibration / VCW

RF Detection Phase: Illumination in 6.3 seconds. Driving was not required.

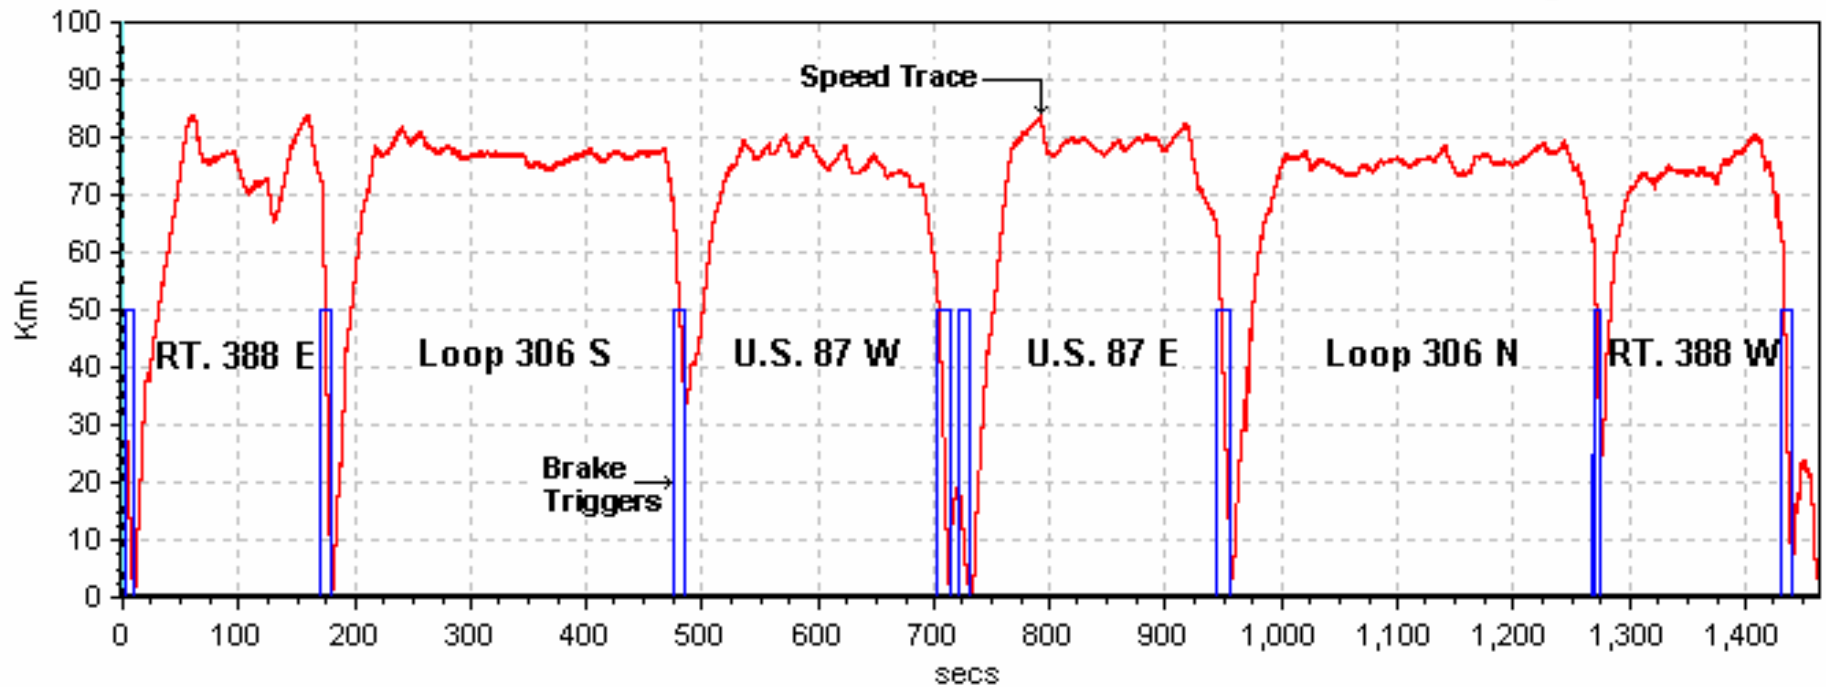
2007 Hyundai Entourage (C70504) LR, RR Calibration / VCW

LR, RR Detection Phase: Illumination in 6.4 seconds. Driving was not required.

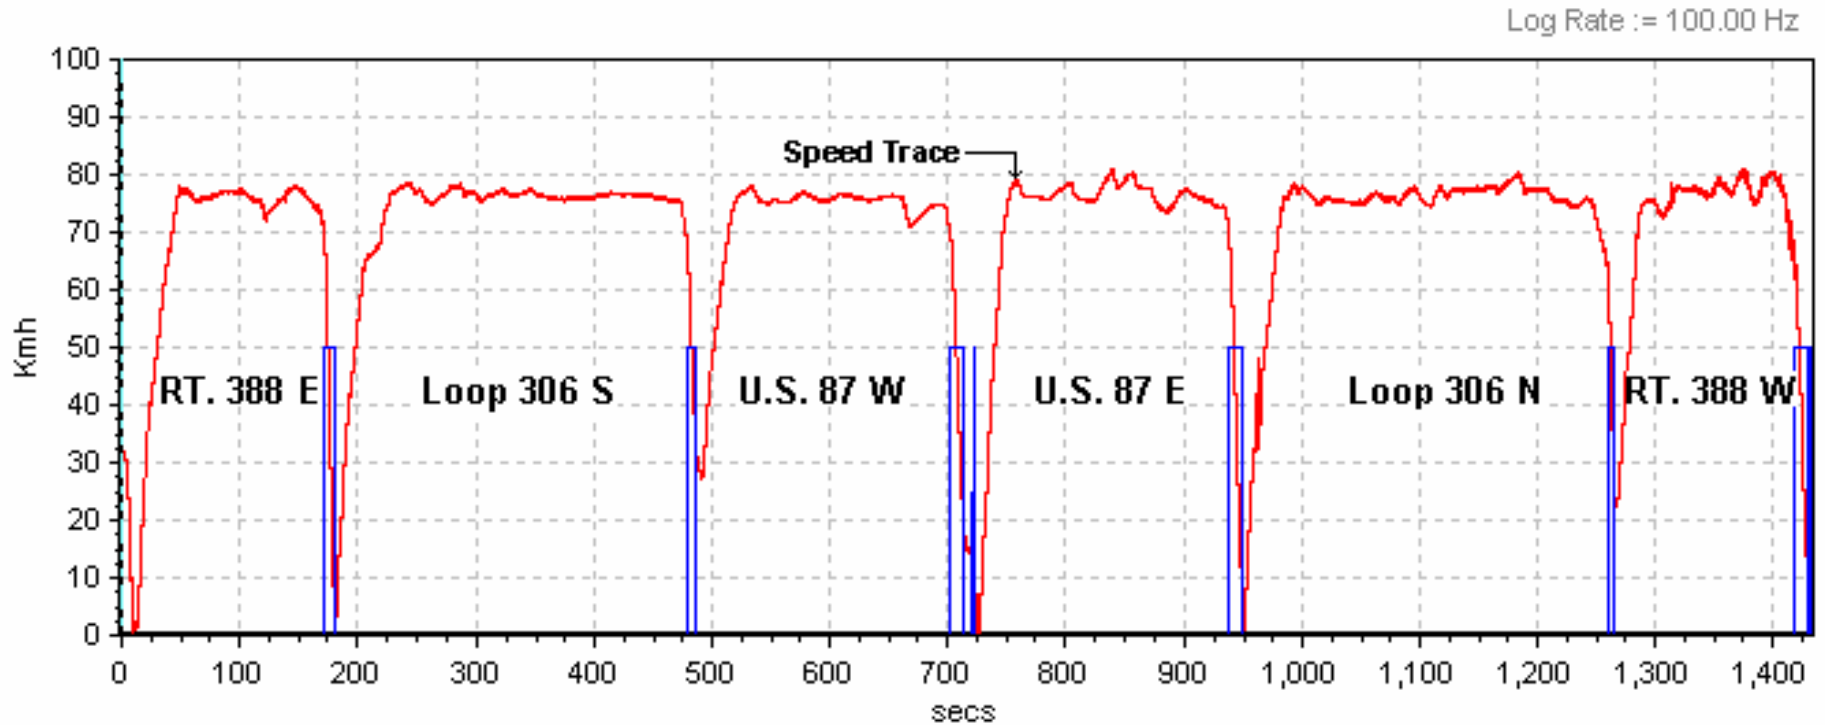
2007 Hyundai Entourage (C70504) LF, LR, RR, RF Calibration / VCW

LF, LR, RR, RF Detection Phase: Illumination in 9.8 seconds. Driving was not required.

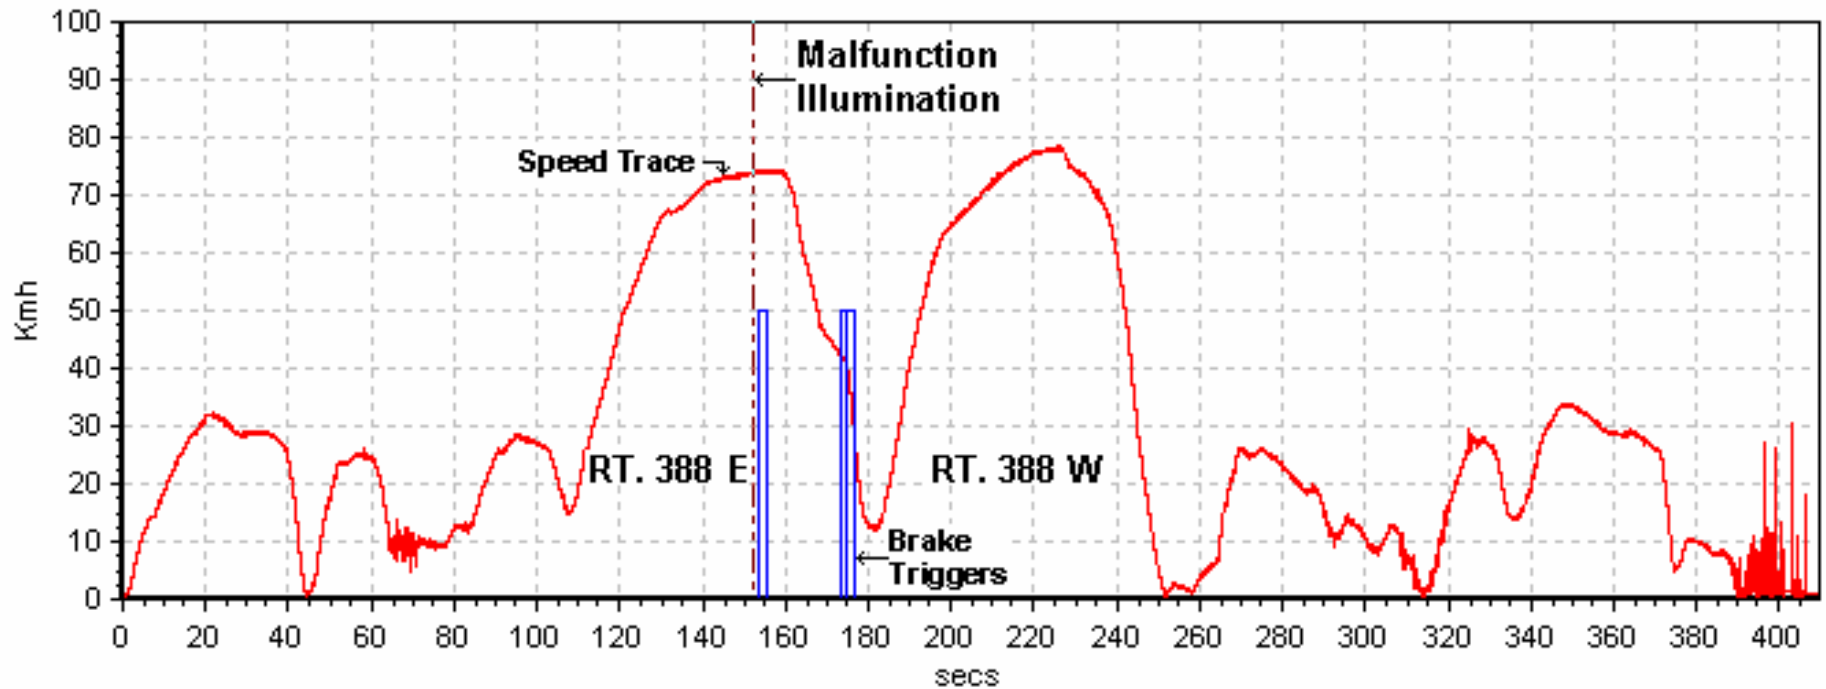
Scenario I: Compact Spare without Sensor Installed on Left Front Position at LLVW
Test Date: 8/21/07
Data File Time: 6:50 minutes
Cumulative Driving Time to Illumination: 00:32 minutes
Start Point: San Angelo Test Facility Shop

2007 Hyundai Entourage (C70504) LF Spare Tire / Dedicated Low Tire / Malfunction Telltale Illumination / LLVW
