REPORT NUMBER 124-GTL-07-003

SAFETY COMPLIANCE TESTING FOR FMVSS 124 ACCELERATOR CONTROL SYSTEMS

NISSAN MOTOR CO., LTD.
2007 NISSAN VERSA,
4-DOOR PASSENGER CAR
NHTSA NO. C75201

FINAL REPORT

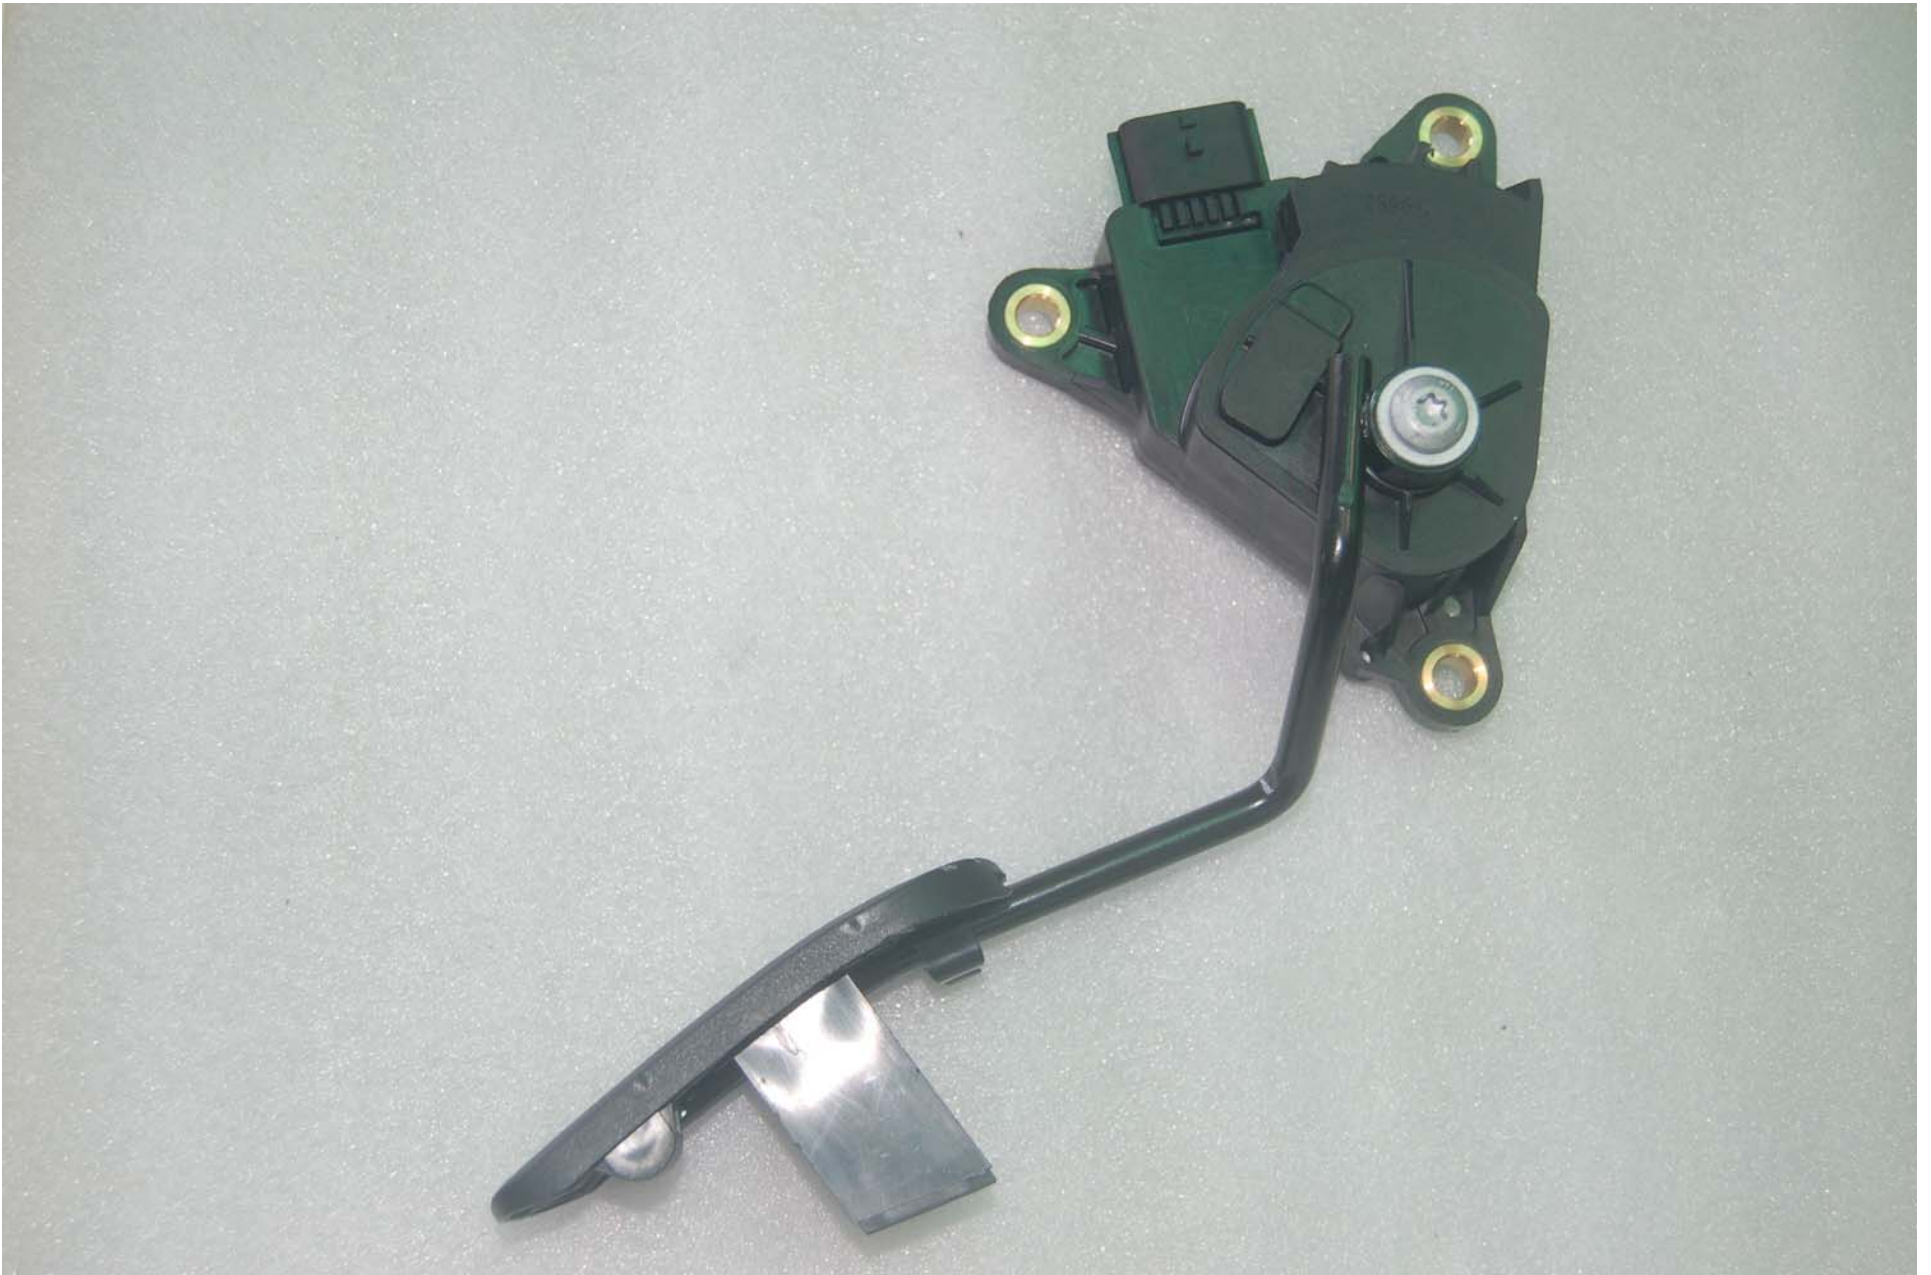
FIGURE 5.6
ACCELERATOR PEDAL ASSEMBLY (APS)

The vehicle is equipped with an electronic throttle control system with an Accelerator Pedal Position Sensor (APS), a Throttle Plate Position Sensor (TPS), an Electronic control Module (ECM) and an Air Throttle Plate Actuator Motor.

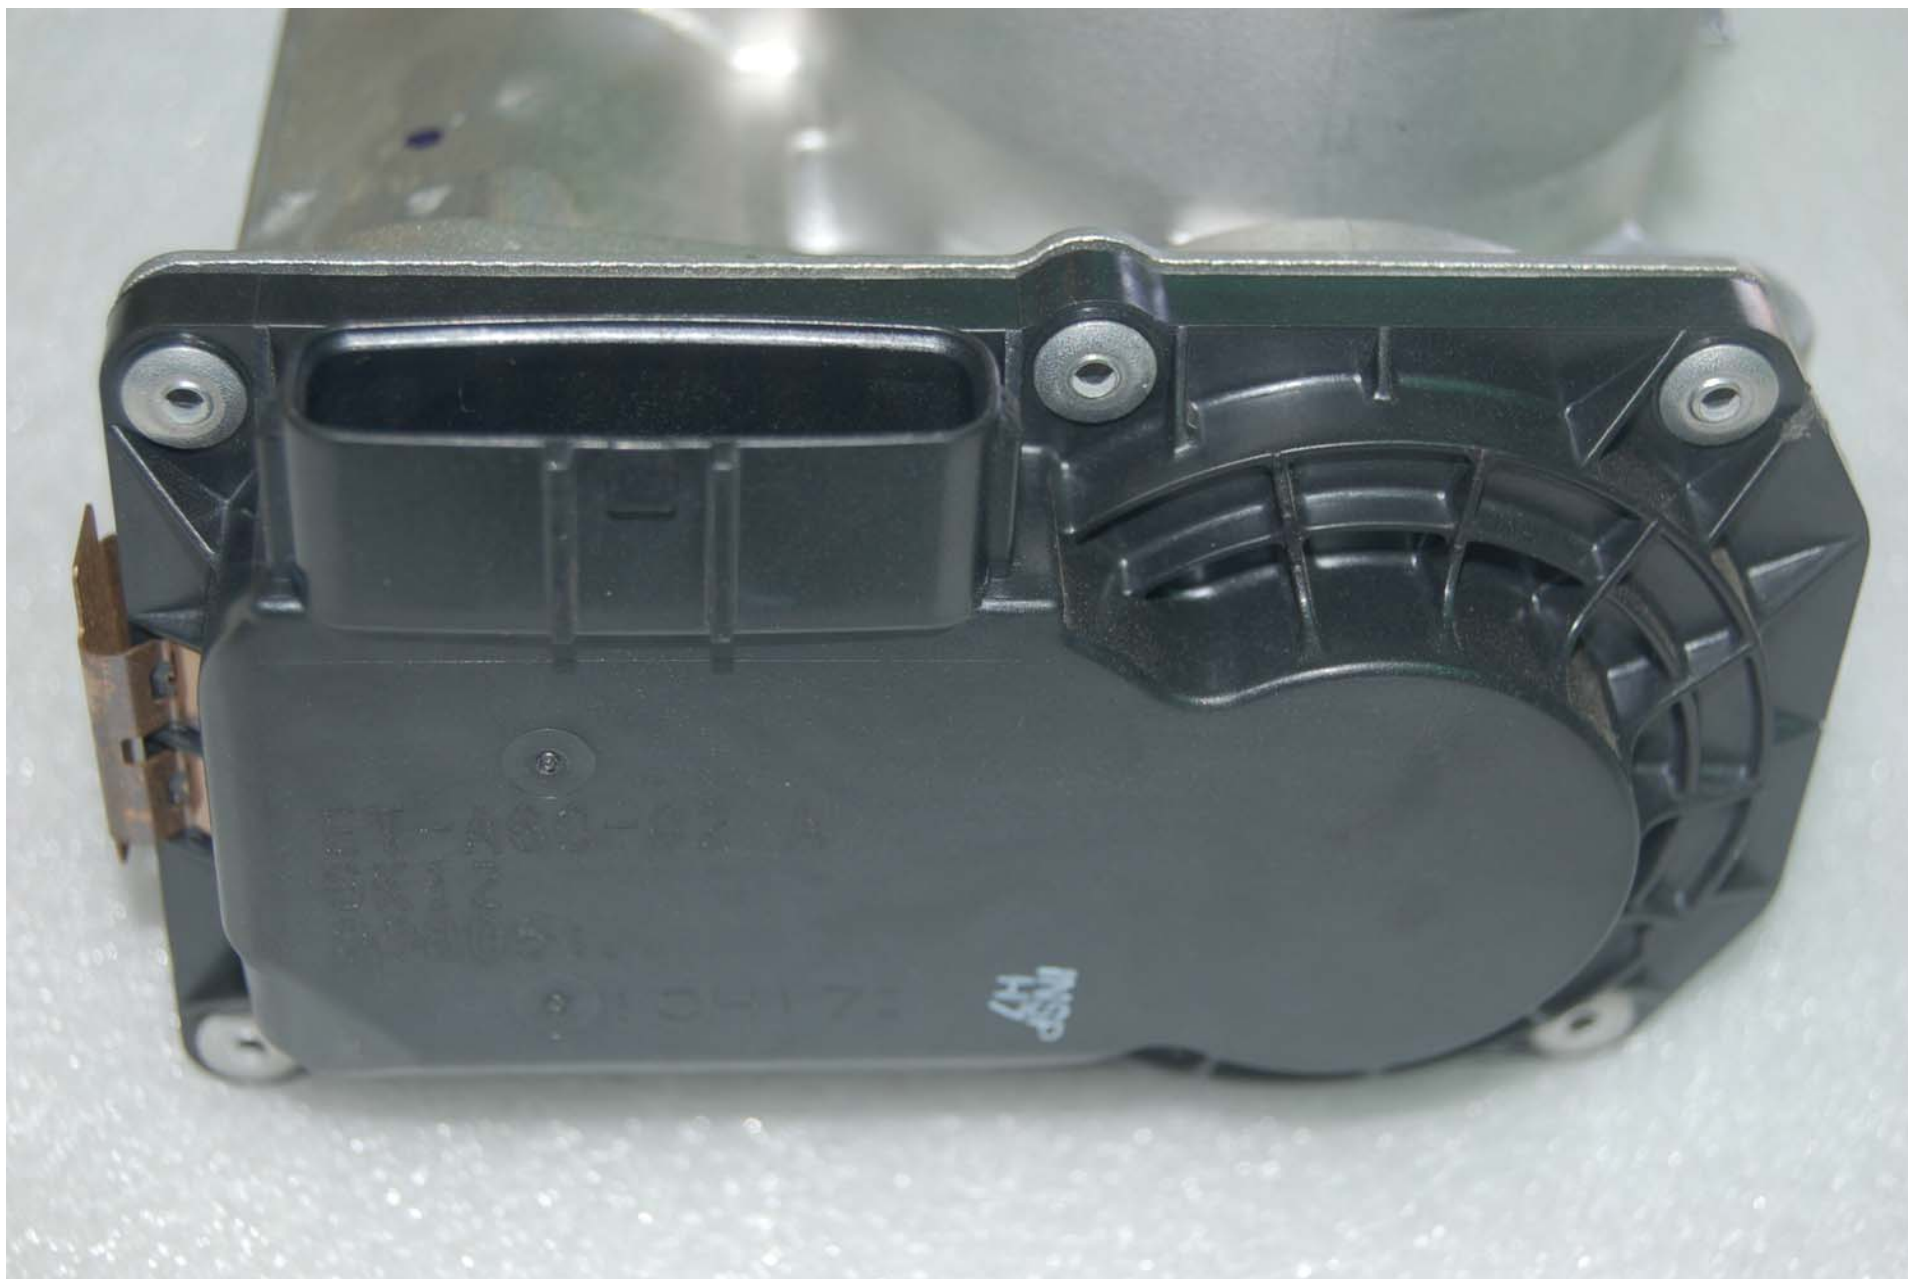
FIGURE 5.13
CLOSE-UP VIEW OF THROTTLE POSITION SENSOR
ASSEMBLY

Output from the vehicle throttle position sensor on the air throttle plate shaft was used to measure throttle position and data was recorded at 100 HZ with GTL's data acquisition system. Testing was conducted to simulate the normal removal of the driver's foot from the accelerator pedal. This was performed by depressing the accelerator with a gloved hand which incorporated an electrical contact strip in the depressing forefinger. The accelerator was depressed to the required amount and then the forefinger was quickly removed from the pedal, releasing the accelerator and activating the contact strip for time zero. Failures were induced simultaneously with release of the accelerator pedal. Testing was performed with the vehicle in park and the engine running. Return to idle times were determined for four throttle plate positions (25%, 50%, 75% and 100%) with the accelerator control system complete. With each of the wires to the APS and throttle plate position sensor disconnected and shorted to ground, return to idle times were determined at the worst case condition – wide open throttle (100%).

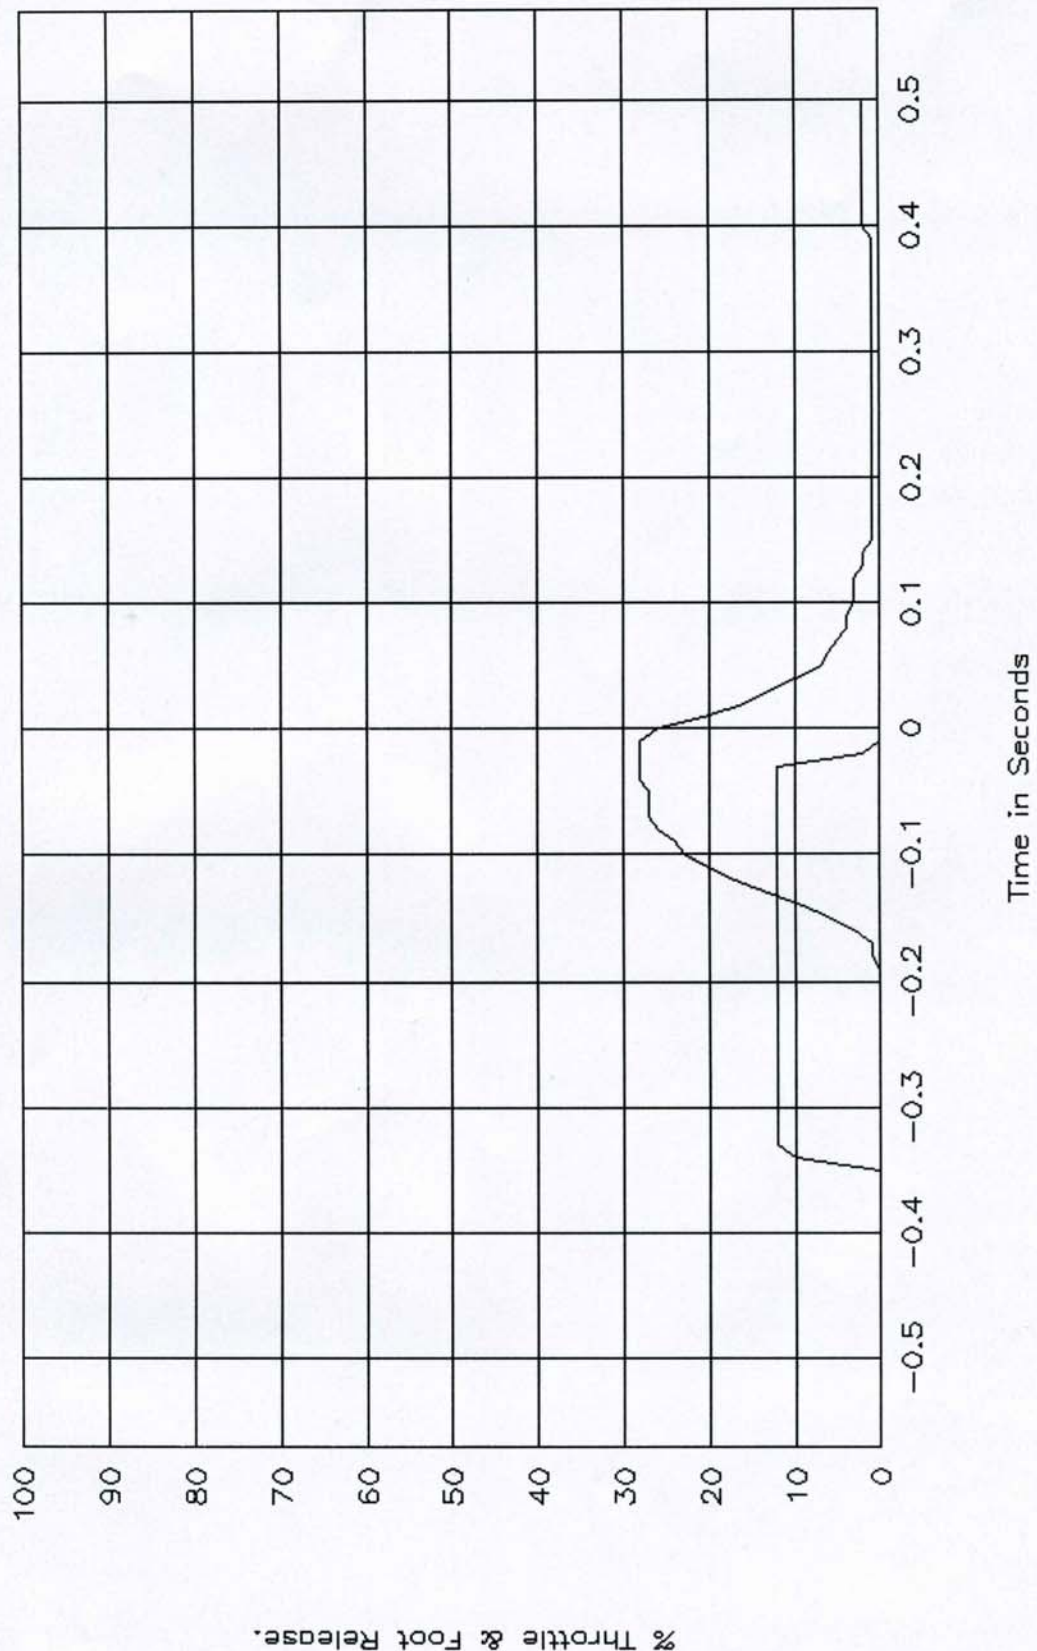
GTL 5799, FMVSS 124

Normal Operation, 25% Throttle.

GTL #	ACCELERATOR POSITION % WIDE OPEN THROTTLE (WOT)	THROTTLE POSITION SENSOR READING	RPM	TEMPERATURE (°C)		THROTTLE POSITION SENSOR READING @ IDLE (BASELINE)	RETURN TIME TO IDLE (Msec)	PASS/ FAIL
				ENGINE COOLANT	AMBIENT			
5799	25%	28%	715	87	26	0-2%	130	P
5800	50%	61%	715	87	26	0-2%	1210	*
5801	75%	68%	710	87	26	0-2%	1420	*
5802	100%	88%	710	87	26	0-2%	2150	*

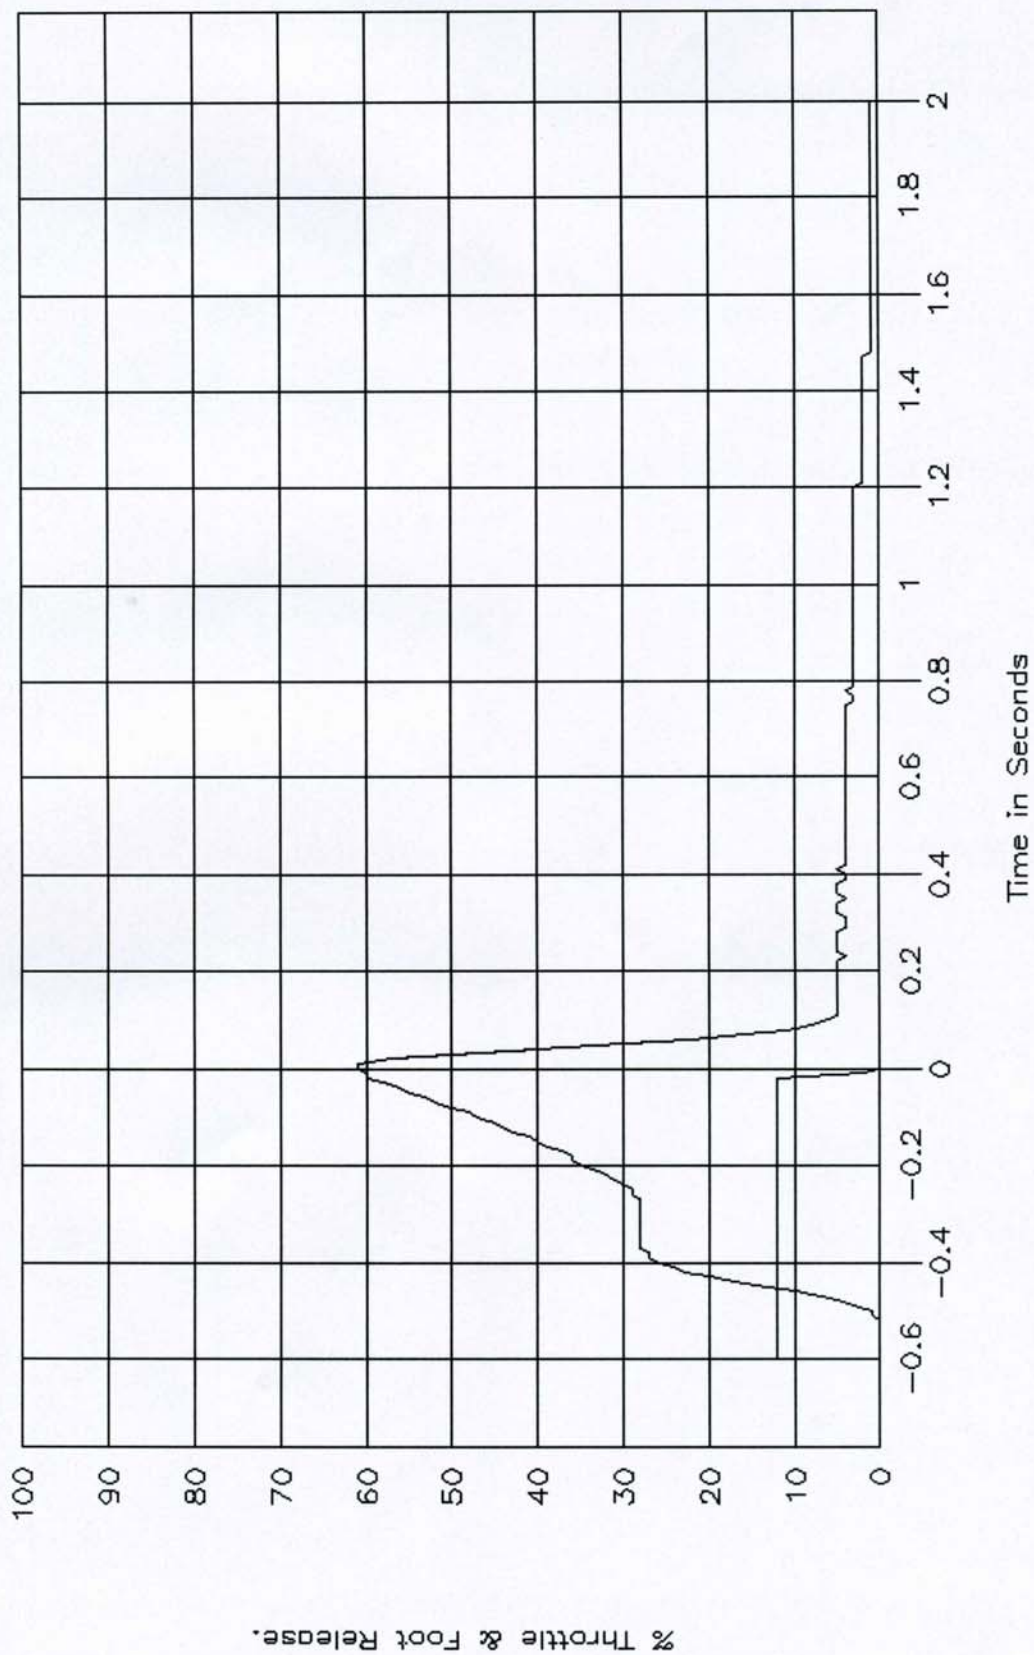
GTL 5800, FMVSS 124

Normal Operation, 50% Throttle.

The return times from some normal operation and fault conditions resulted in return times greater than 1 second. In these cases, throttle angle position decreased rapidly followed by a controlled ramp down to the original idle position. Manufacturers sometimes use this ramp-down strategy for improved emission control which may be the case here. No engine "racing" was observed at any point in the testing.

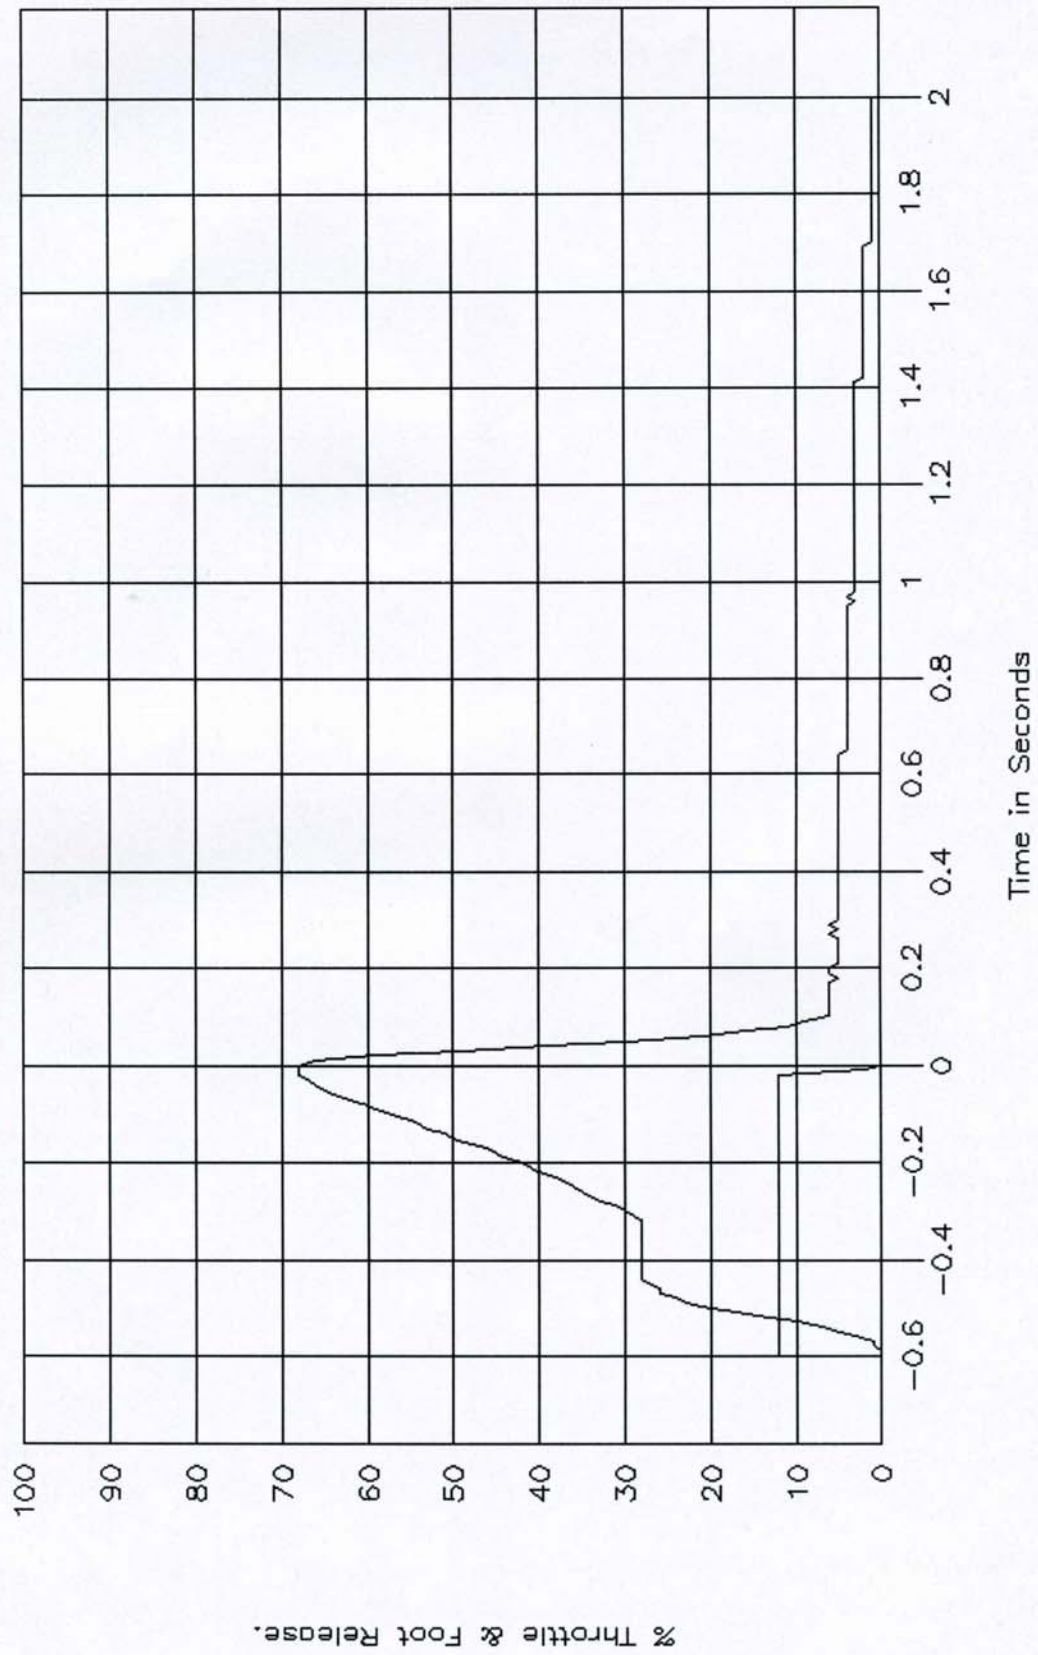
GTL 5801, FMVSS 124

Normal Operation, 75% Throttle.

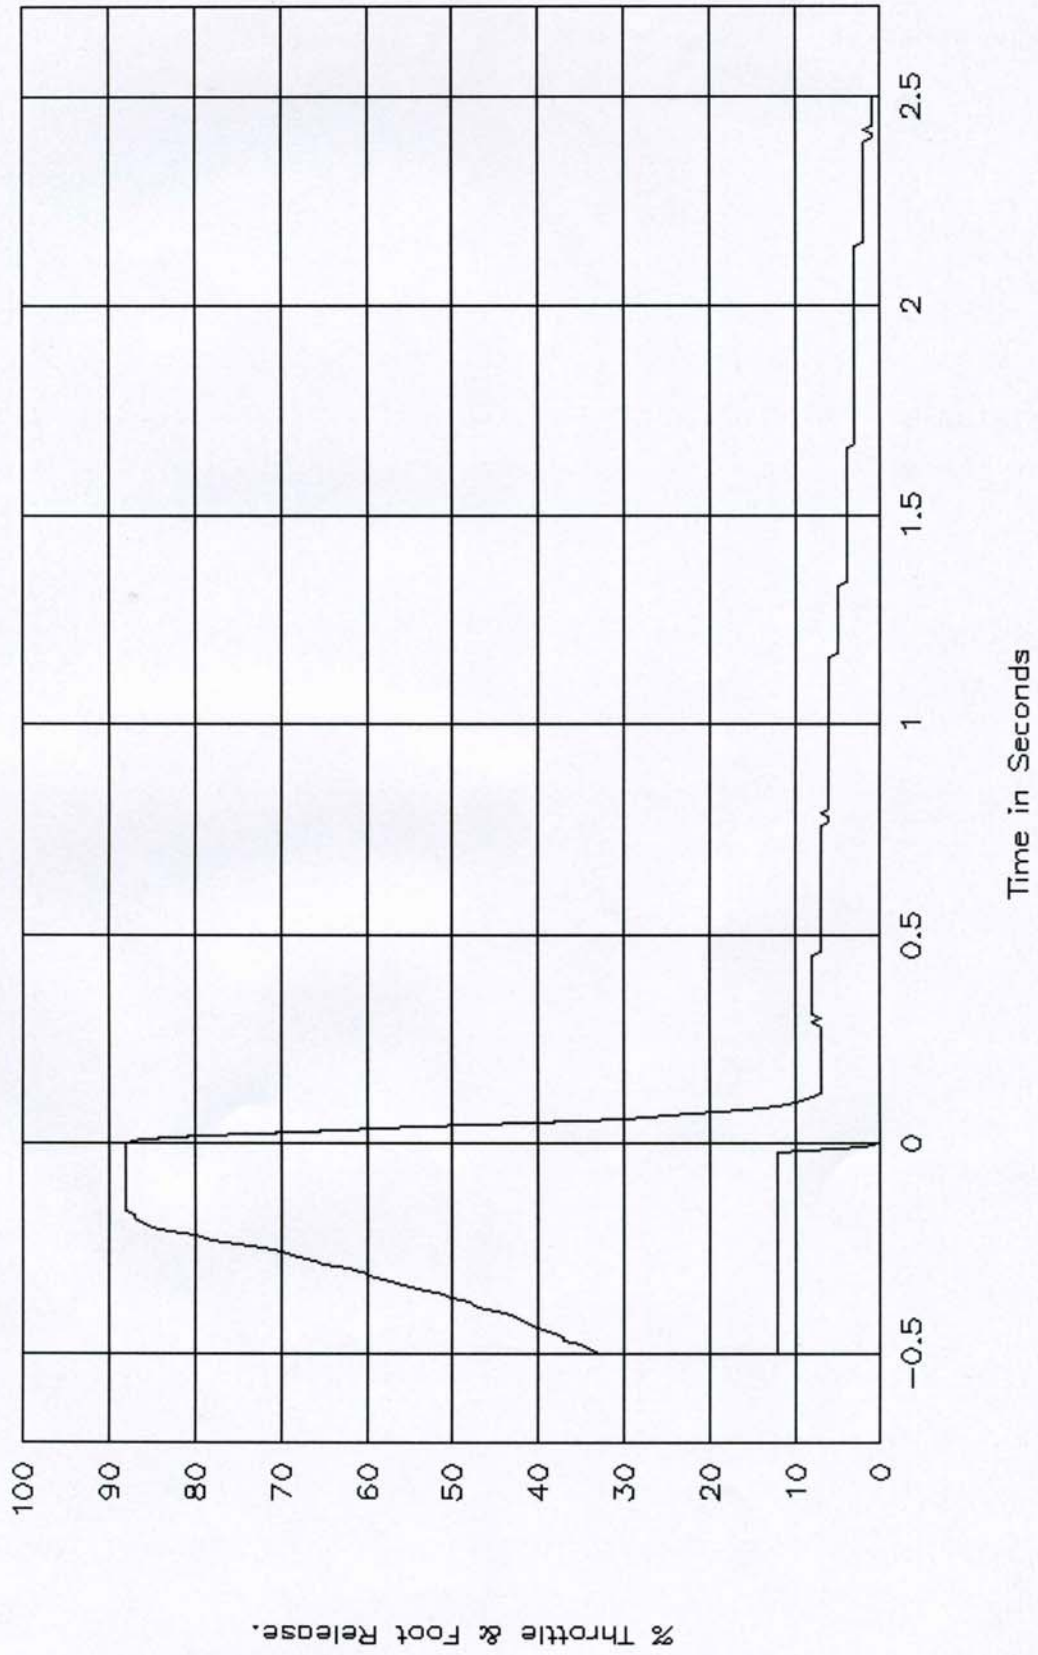
GTL 5802, FMVSS 124

Normal Operation, 100% Throttle.

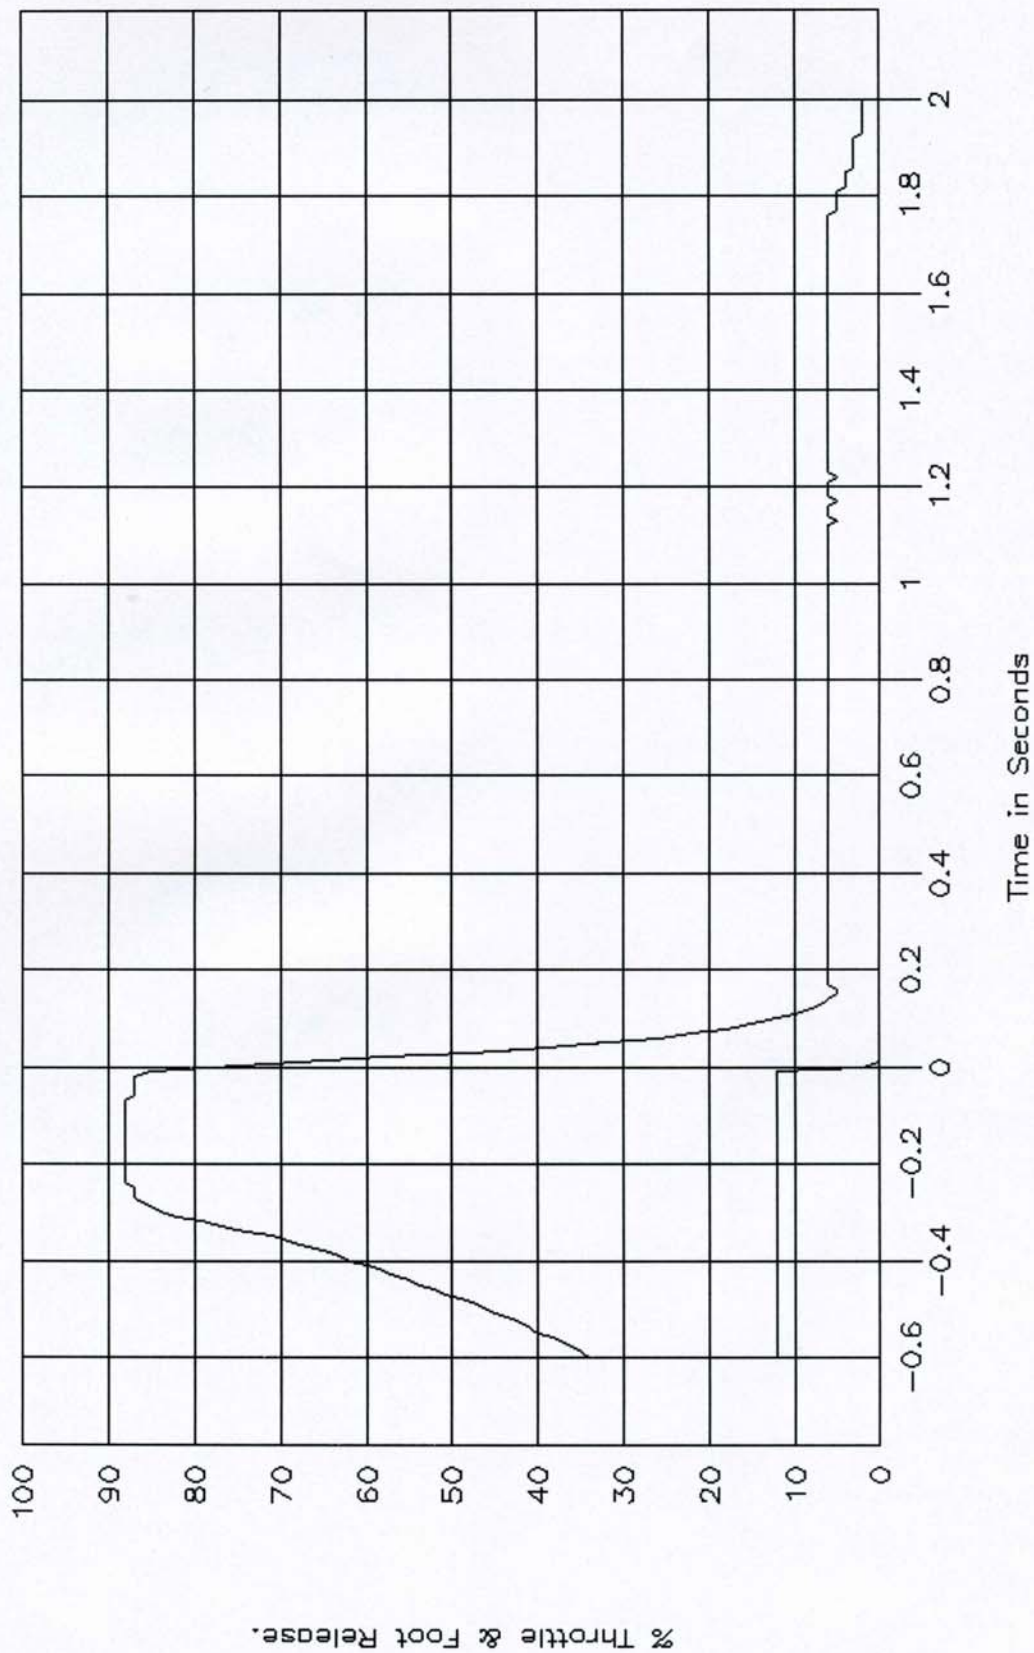
GTL 5806, FMVSS 124

TPS Wire 4 Open, 100% Throttle.

GTL #	CONNECTOR	WIRE/PIN DESCRIPTION	FAULT CONDITION	ENGINE TEMP. °C	% THROTTLE/ RETURN TIME (MS)	PASS/FAIL/NOTES
5803	TPS	#1/BLUE	OPEN	87	100/230	P Limp Home @6%
5804	TPS	#2/PINK	OPEN	87	100/200	P Limp Home @6%
5805	TPS	#3/YELLOW	OPEN	87	100/10	P Limp Home @6%
5806	TPS	#4/ORANGE	OPEN	87	100/1930	*
5807	TPS	#5/PURPLE	OPEN	87	100/10	P Limp Home @6%
5808	TPS	#6/GREEN	OPEN	87	100/1830	*
5809	APS	#7/GRAY	OPEN	87	100/2030	*
5810	APS	#8 LT. BLUE	OPEN	87	100/2000	*
5811	APS	#9/PINK	OPEN	87	100/1760	*
5812	APS	#10/GREEN	OPEN	87	100/2180	*
5813	APS	#11/RED	OPEN	87	100/2050	*
5814	APS	#12/YELLOW	OPEN	87	100/2140	*
5815	TPS	#1/BLUE	SHORT	87	100/2480	*
5816	TPS	#2/PINK	SHORT	87	100/340	P Limp Home @6%
5817	TPS	#3/YELLOW	SHORT	87	100/4020	*
5818	TPS	#4/ORANGE	SHORT	87	100/0 No Data after Short	**P
5819	TPS	#5/PURPLE	SHORT	87	No Data after Short	P **Limp Home @6%
5820	TPS	#6/GREEN	SHORT	87	100/2240	*
5821	APS	#7/GRAY	SHORT	87	100/1420	*

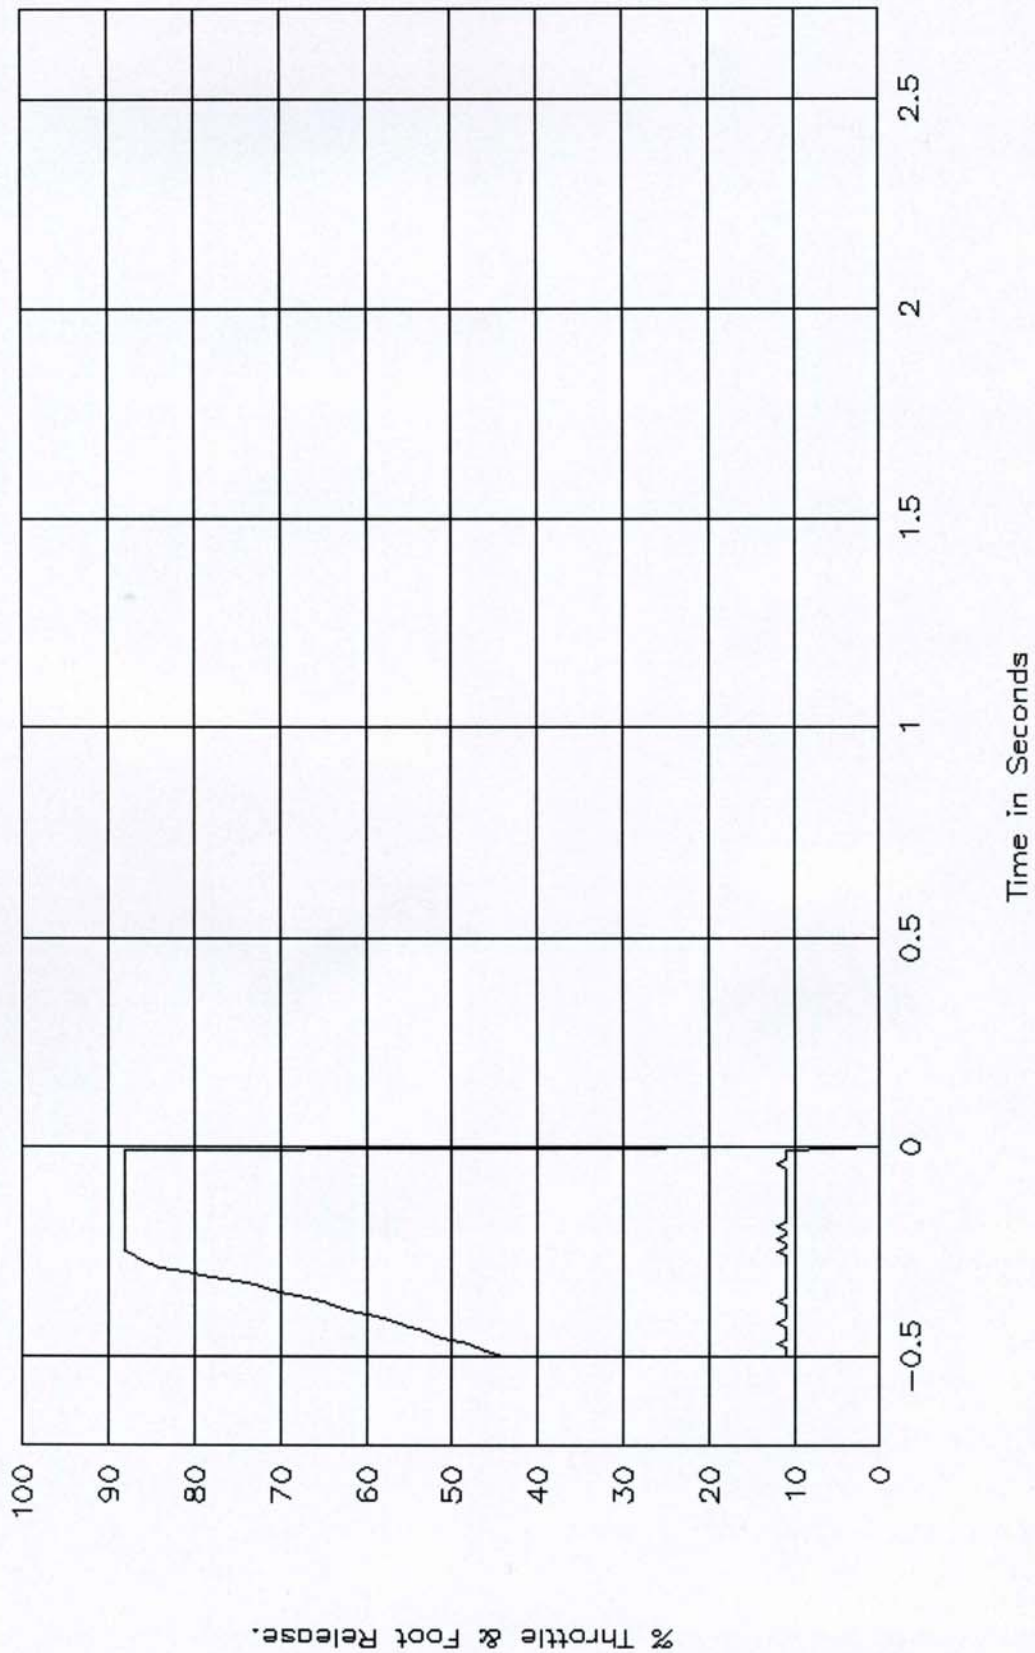
GTL 5827, FMVSS 124

TPS Connector Disconnect, 100% Throttle.

5822	APS	#8/LT. BLUE	SHORT	87	100/0 Engine Stopped	P
5823	APS	#9/PINK	SHORT	87	No Data	P **Limp Home
5824	APS	#10/GREEN	SHORT	87	100/2060	*
5825	APS	#11/RED	SHORT	87	100/2470	*
5826	APS	#12/YELLOW	SHORT	87	100/2540	*
5827	TPS	CONNECTOR	DISCONNECT	87	100/10	P Limp Home
5828	APS	CONNECTOR	DISCONNECT	87	100/90 Engine Stopped	P

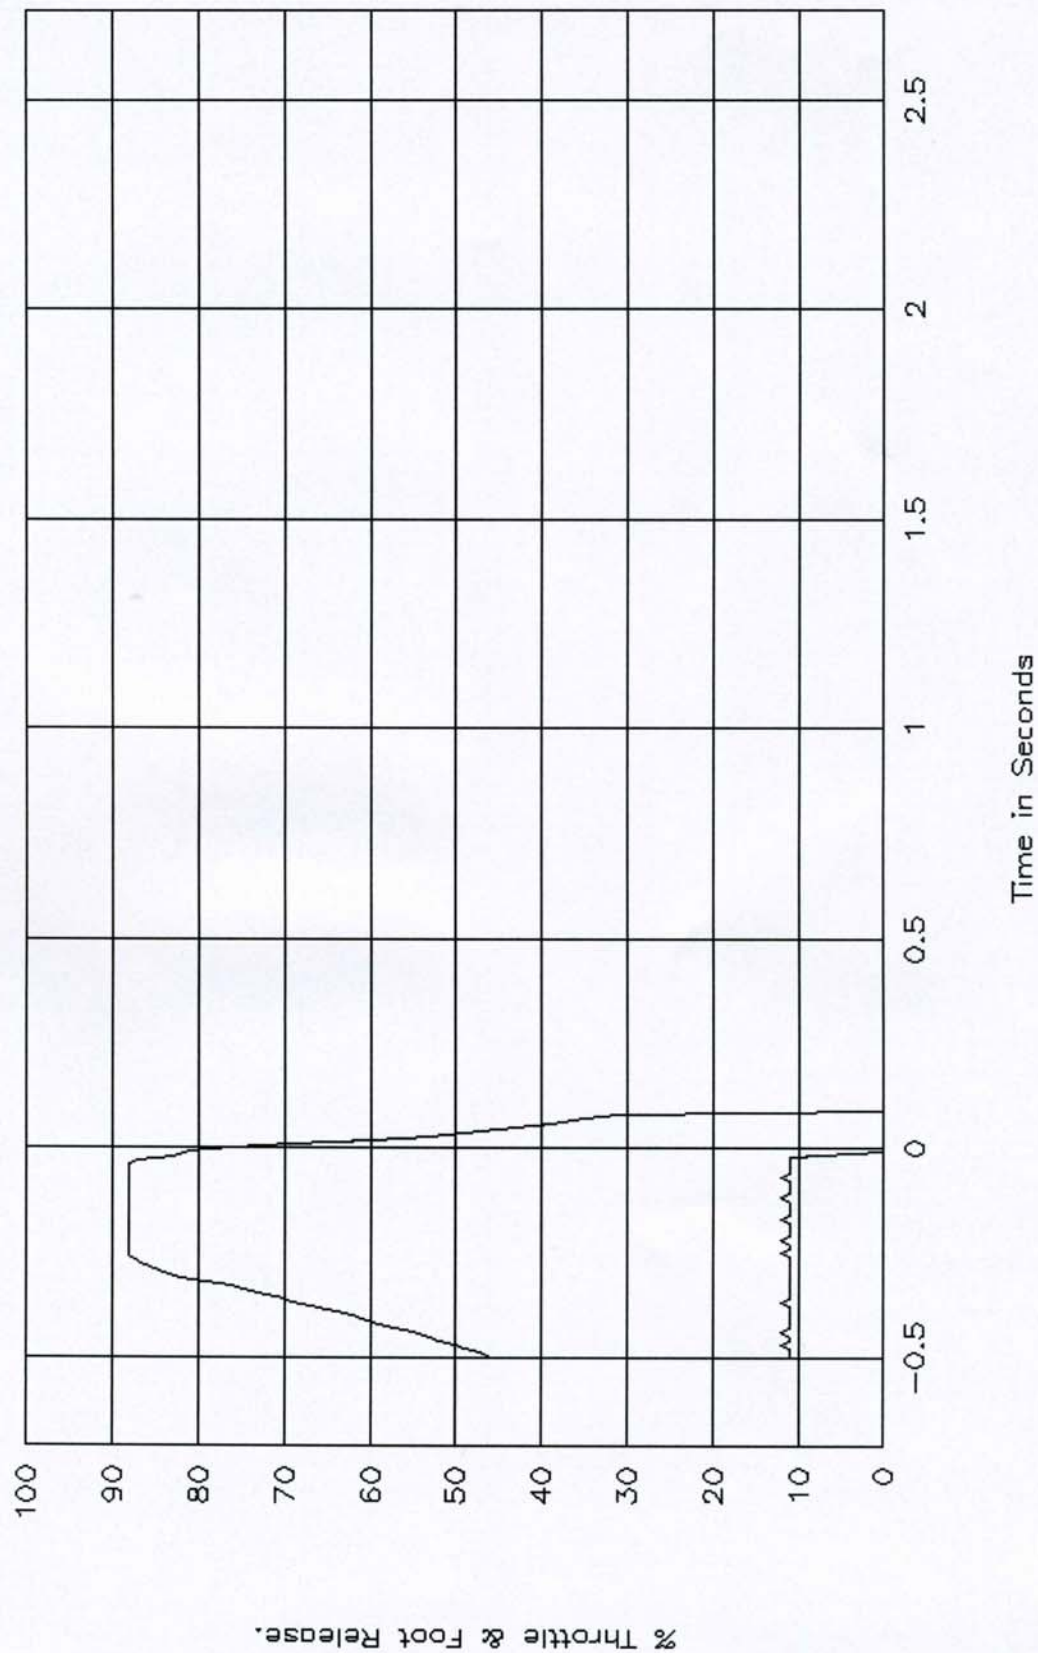
GTL 5828, FMVSS 124

APS Connector Disconnect, 100% Throttle.

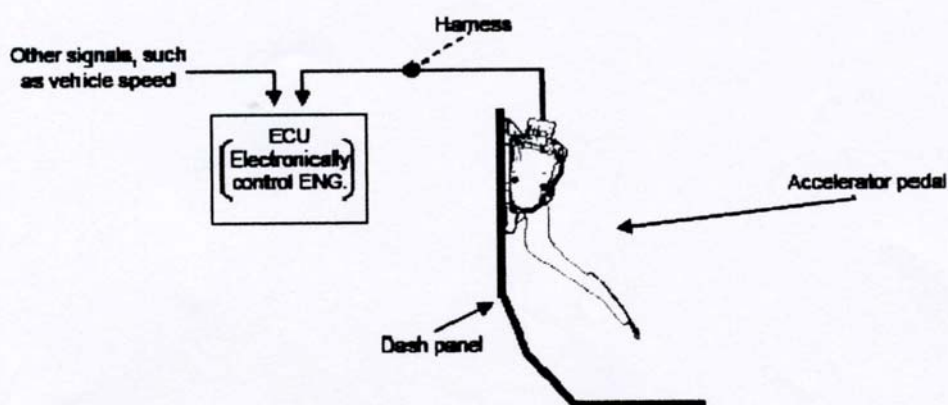
1. A sketch of the driver operated accelerator control system (ACS) starting from the accelerator pedal up to and including the fuel metering device (carburetor, fuel injectors, fuel distributor, or fuel injection pump).

Fig.1-2 Outline of electronically controlled accelerator pedal

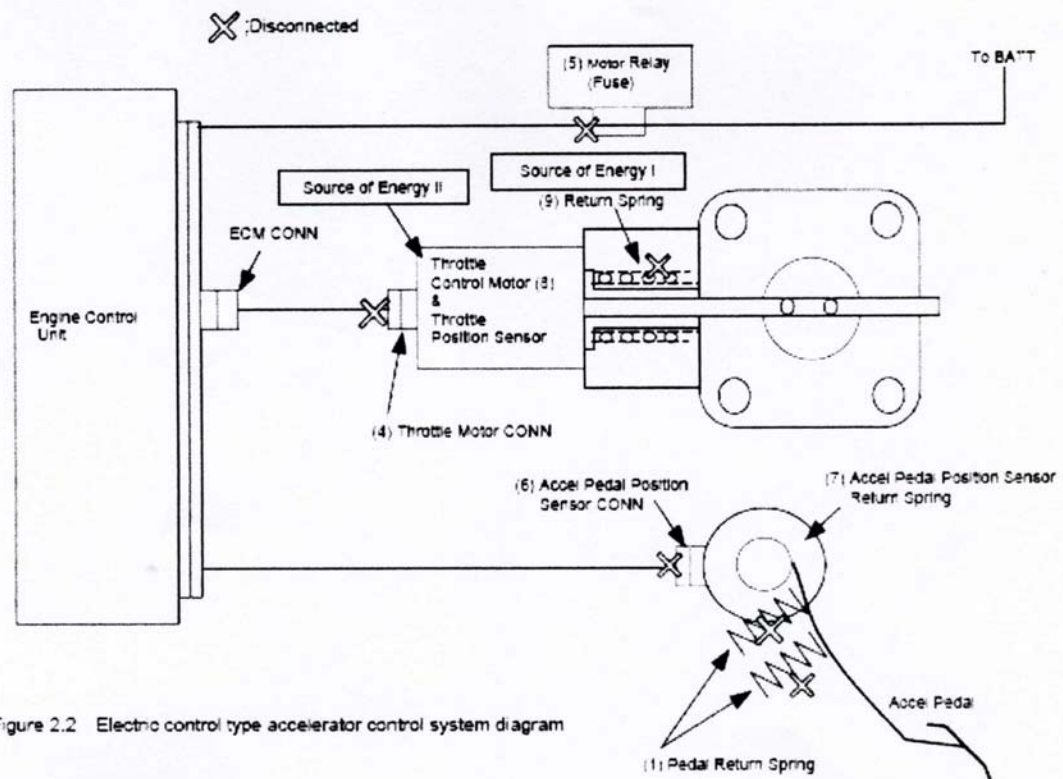
6. Point(s) chosen to demonstrate compliance with FMVSS No. 124 for single point disconnect and severance. See sketch below

Figure 2.2 Electric control type accelerator control system diagram
