REPORT NUMBER 124-GTL-07-002

SAFETY COMPLIANCE TESTING FOR FMVSS 124 ACCELERATOR CONTROL SYSTEMS

VOLKSWAGEN AG GERMANY
2007 VOLKSWAGEN RABBIT,
4-DOOR PASSENGER CAR
NHTSA NO. C75800

FINAL REPORT

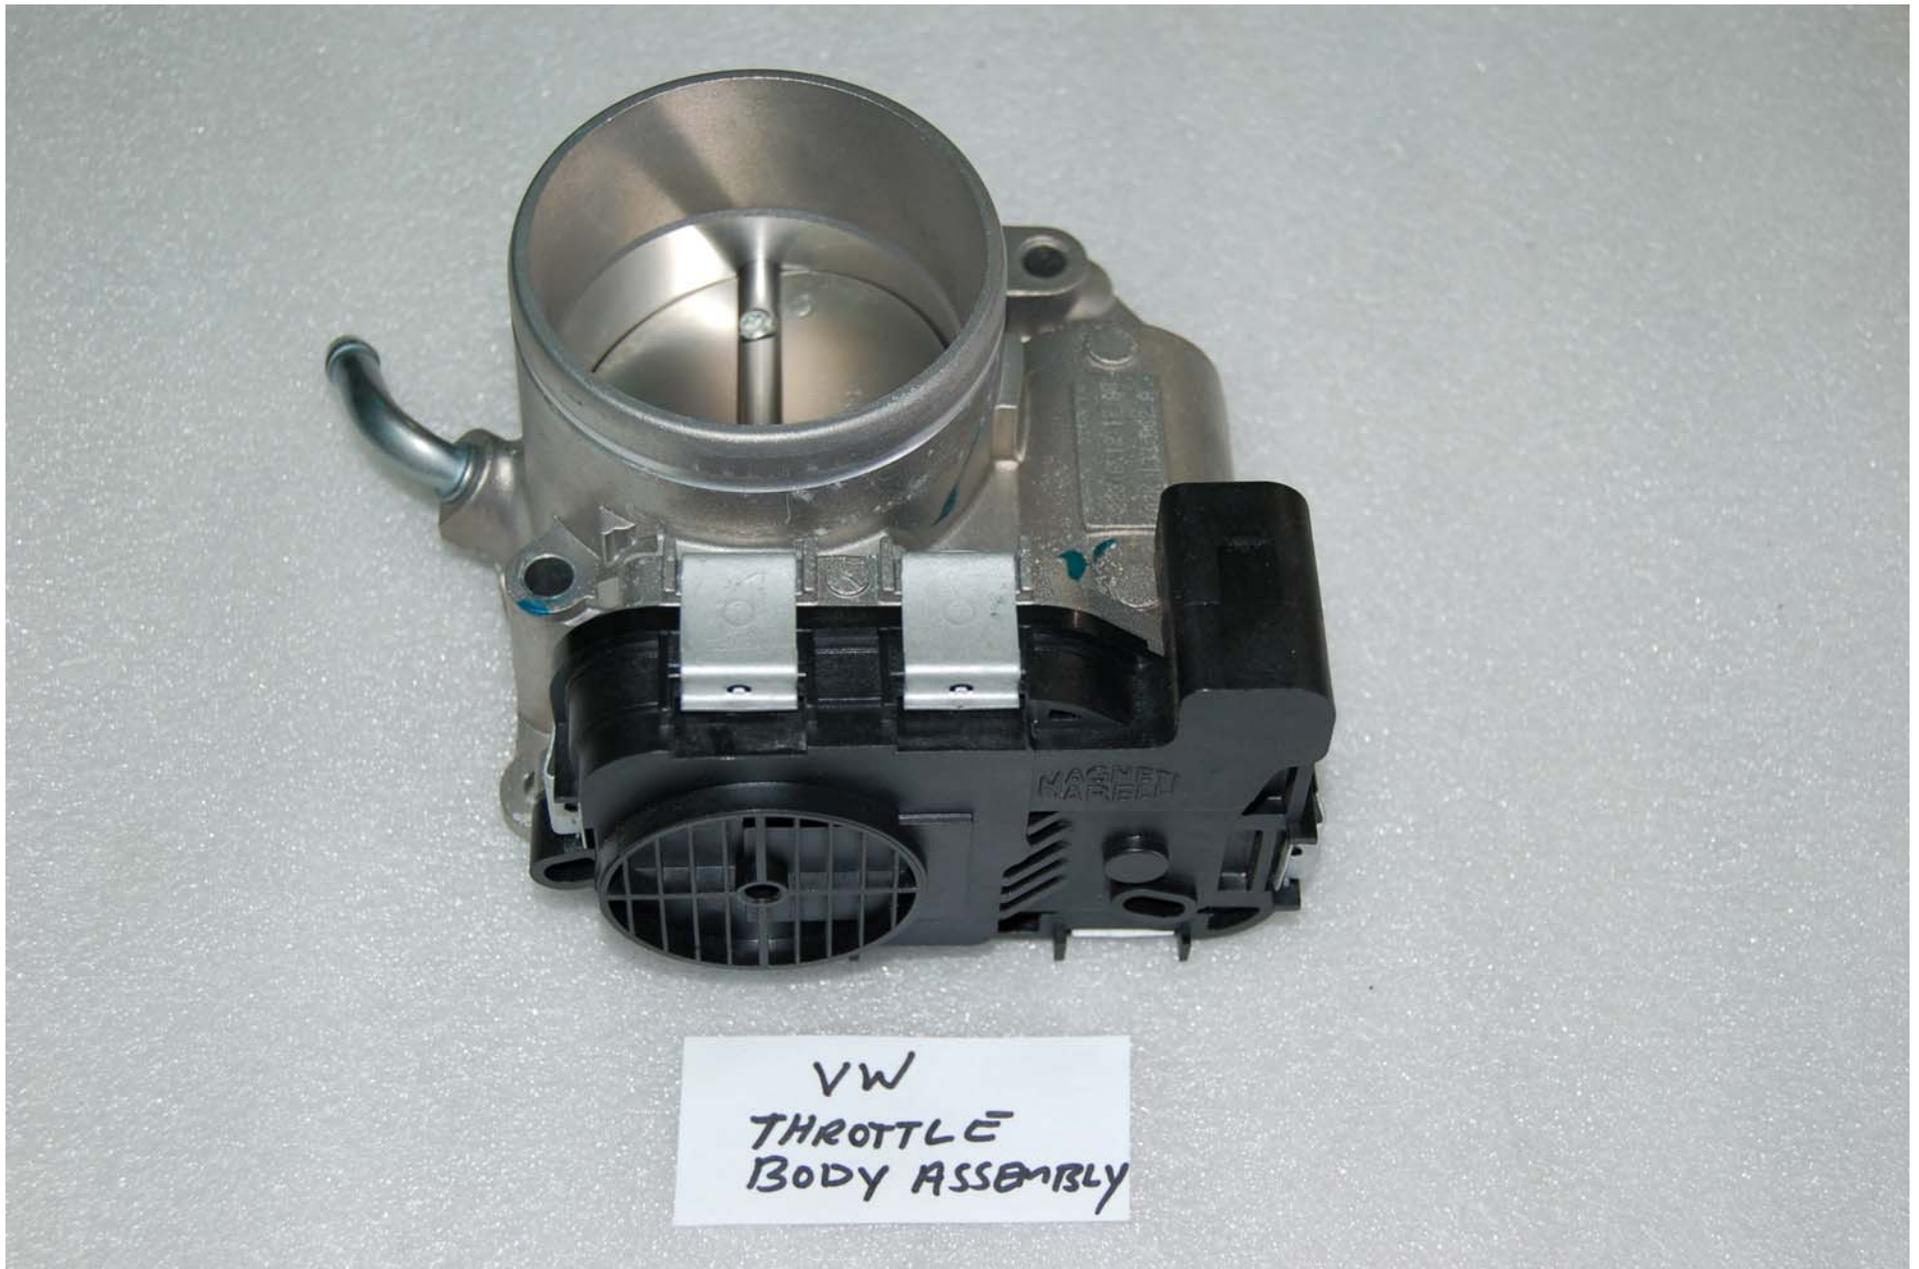
FIGURE 5.7
SIDE VIEW OF THROTTLE BODY

VW
THROTTLE
BODY ASSEMBLY

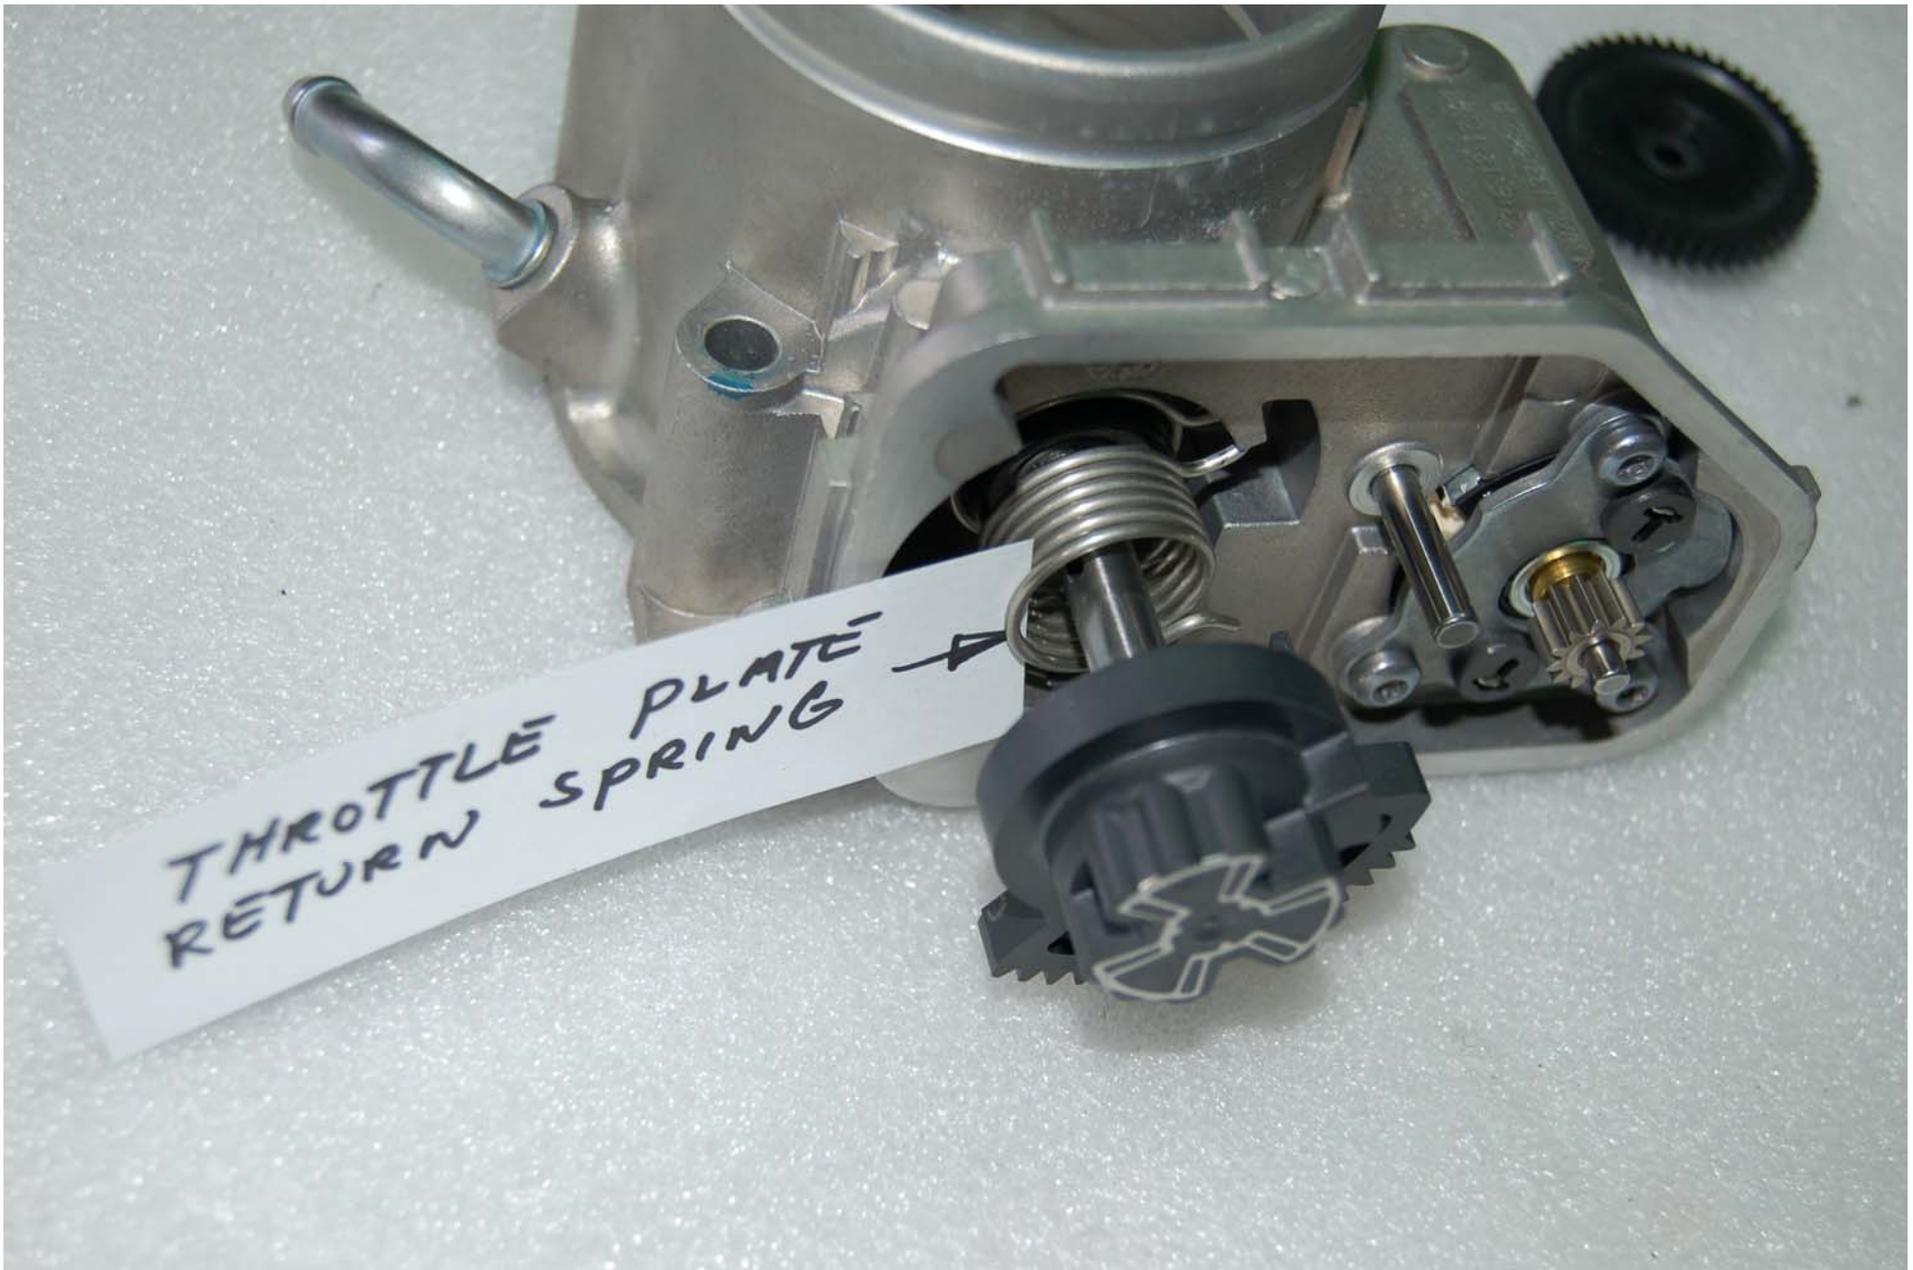
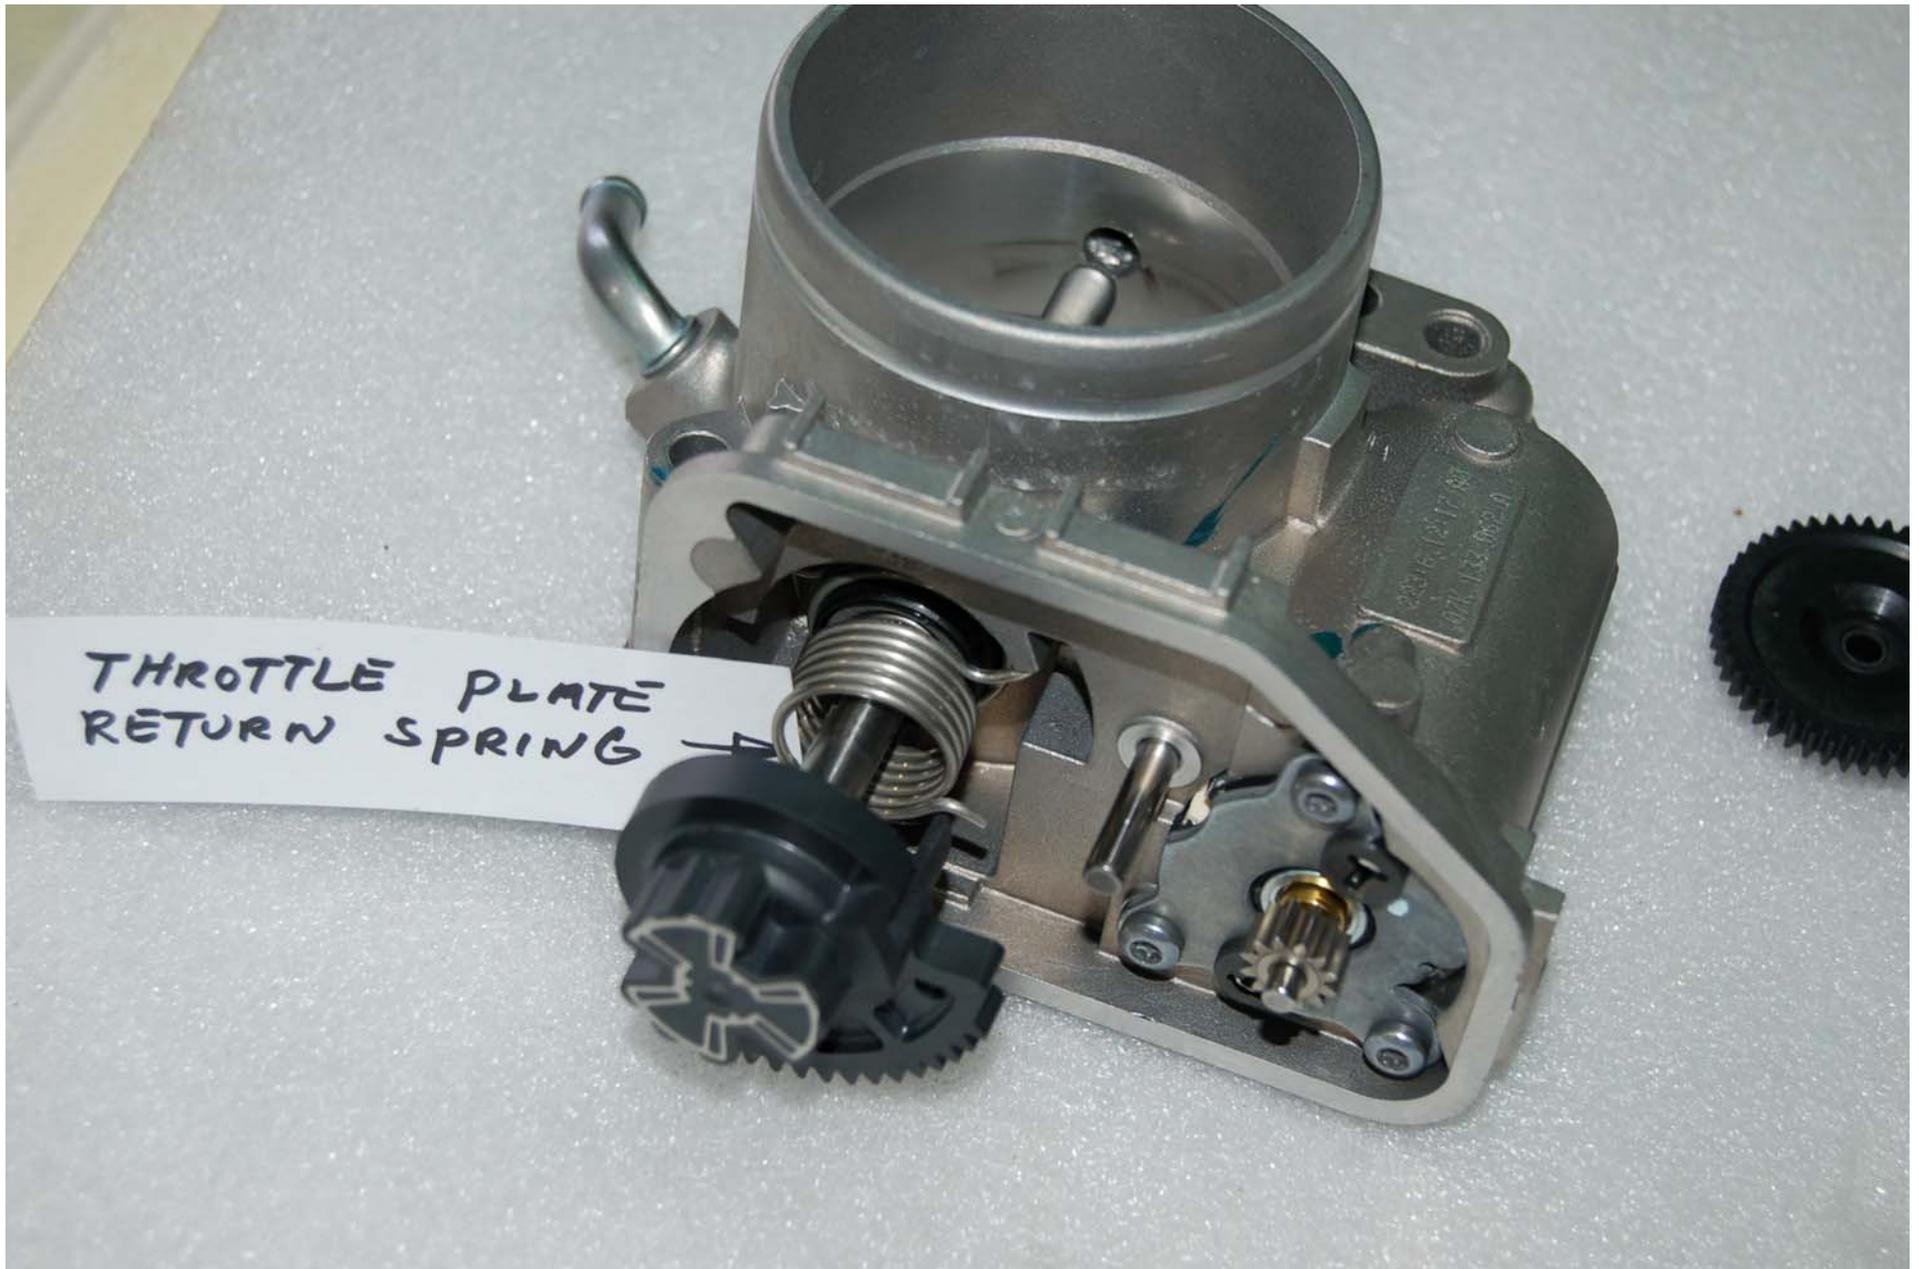
FIGURE 5.9
THROTTLE PLATE RETURN SPRING

FIGURE 5.10
THROTTLE PLATE RETURN SPRING

REMARKS: *Engine would not rev above limp home mode with spring #3 removed. Engine control computer would not let throttle butterfly open when accelerator was depressed.

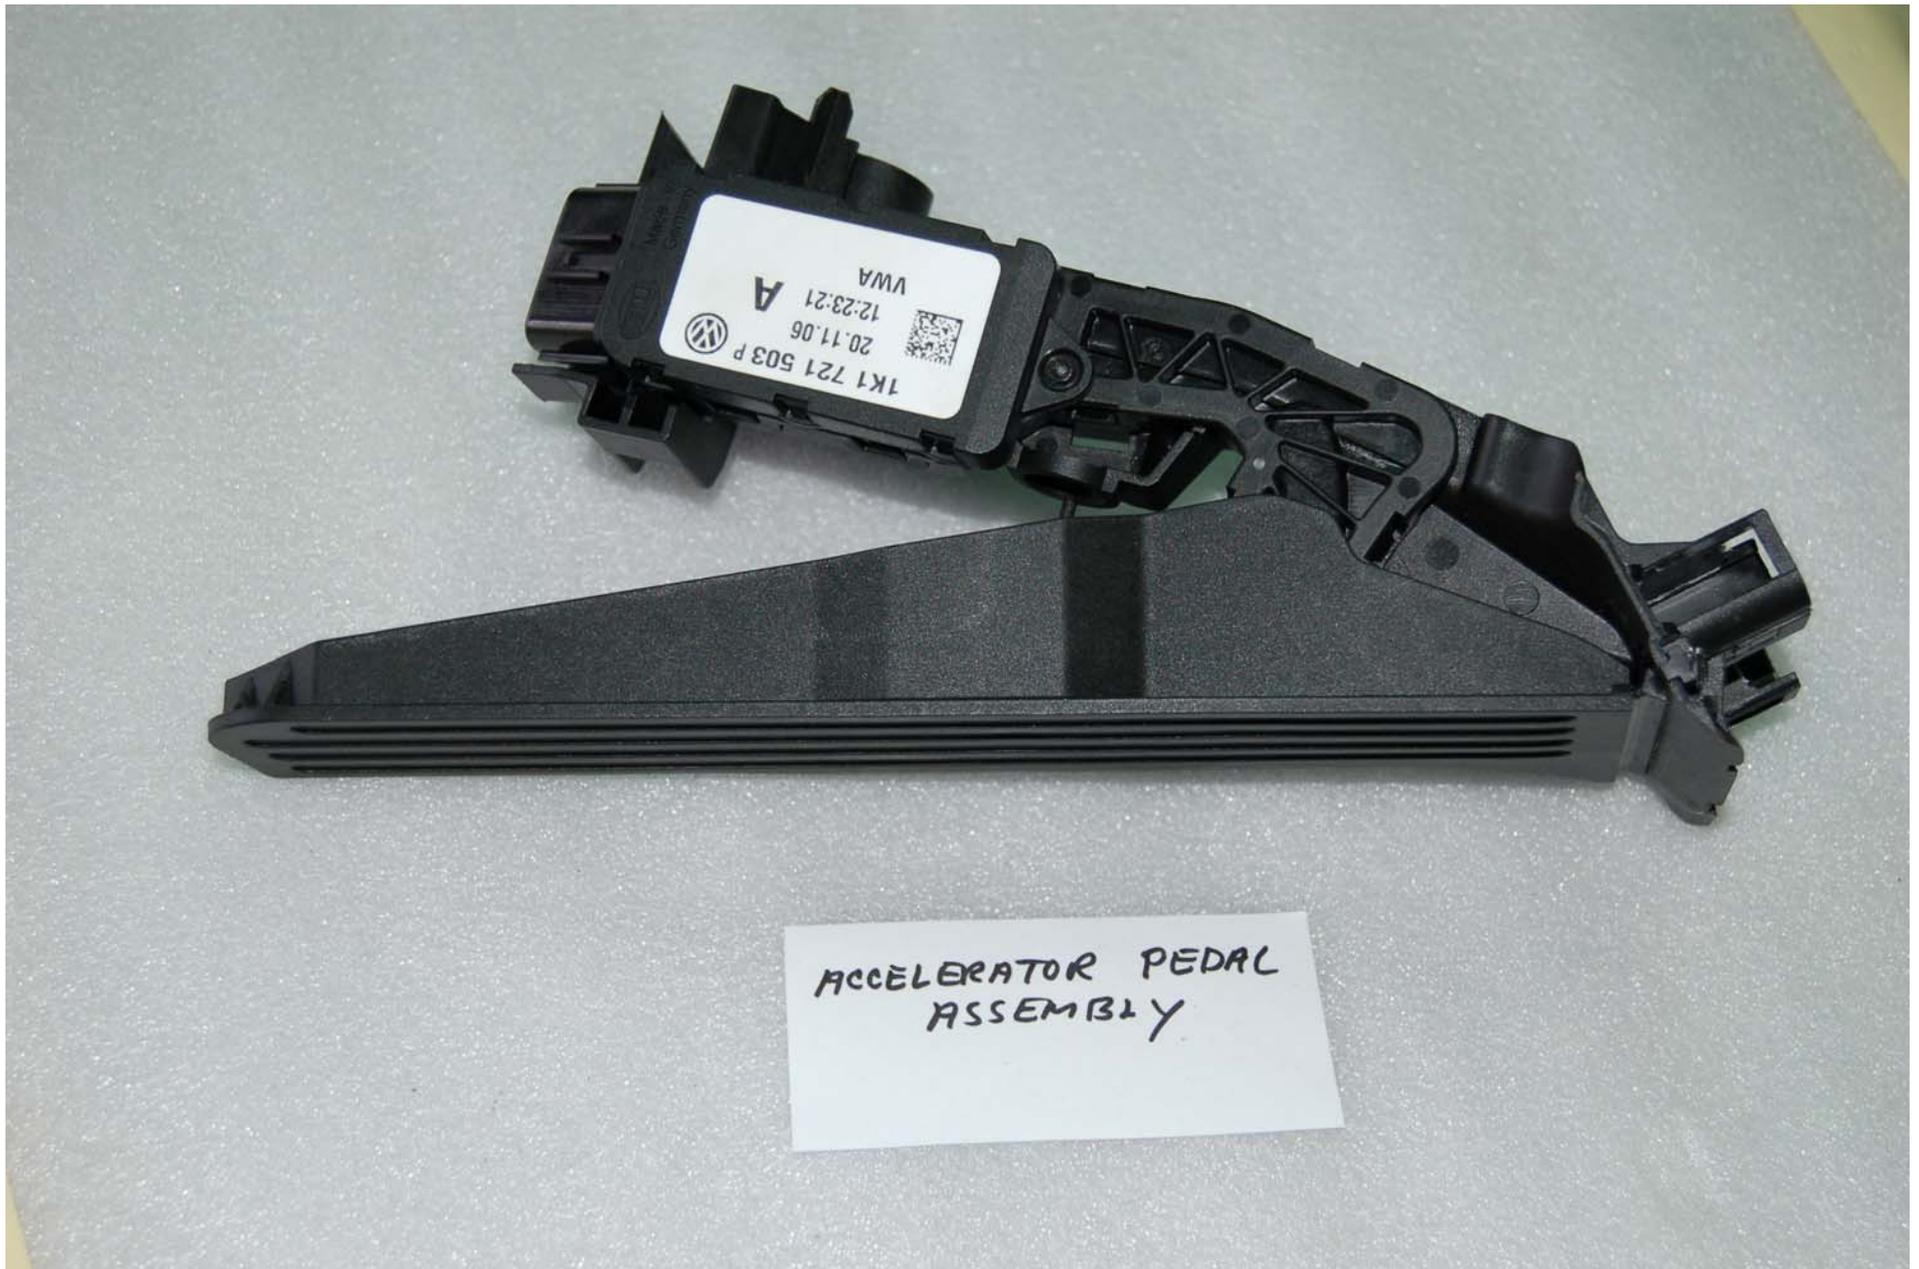
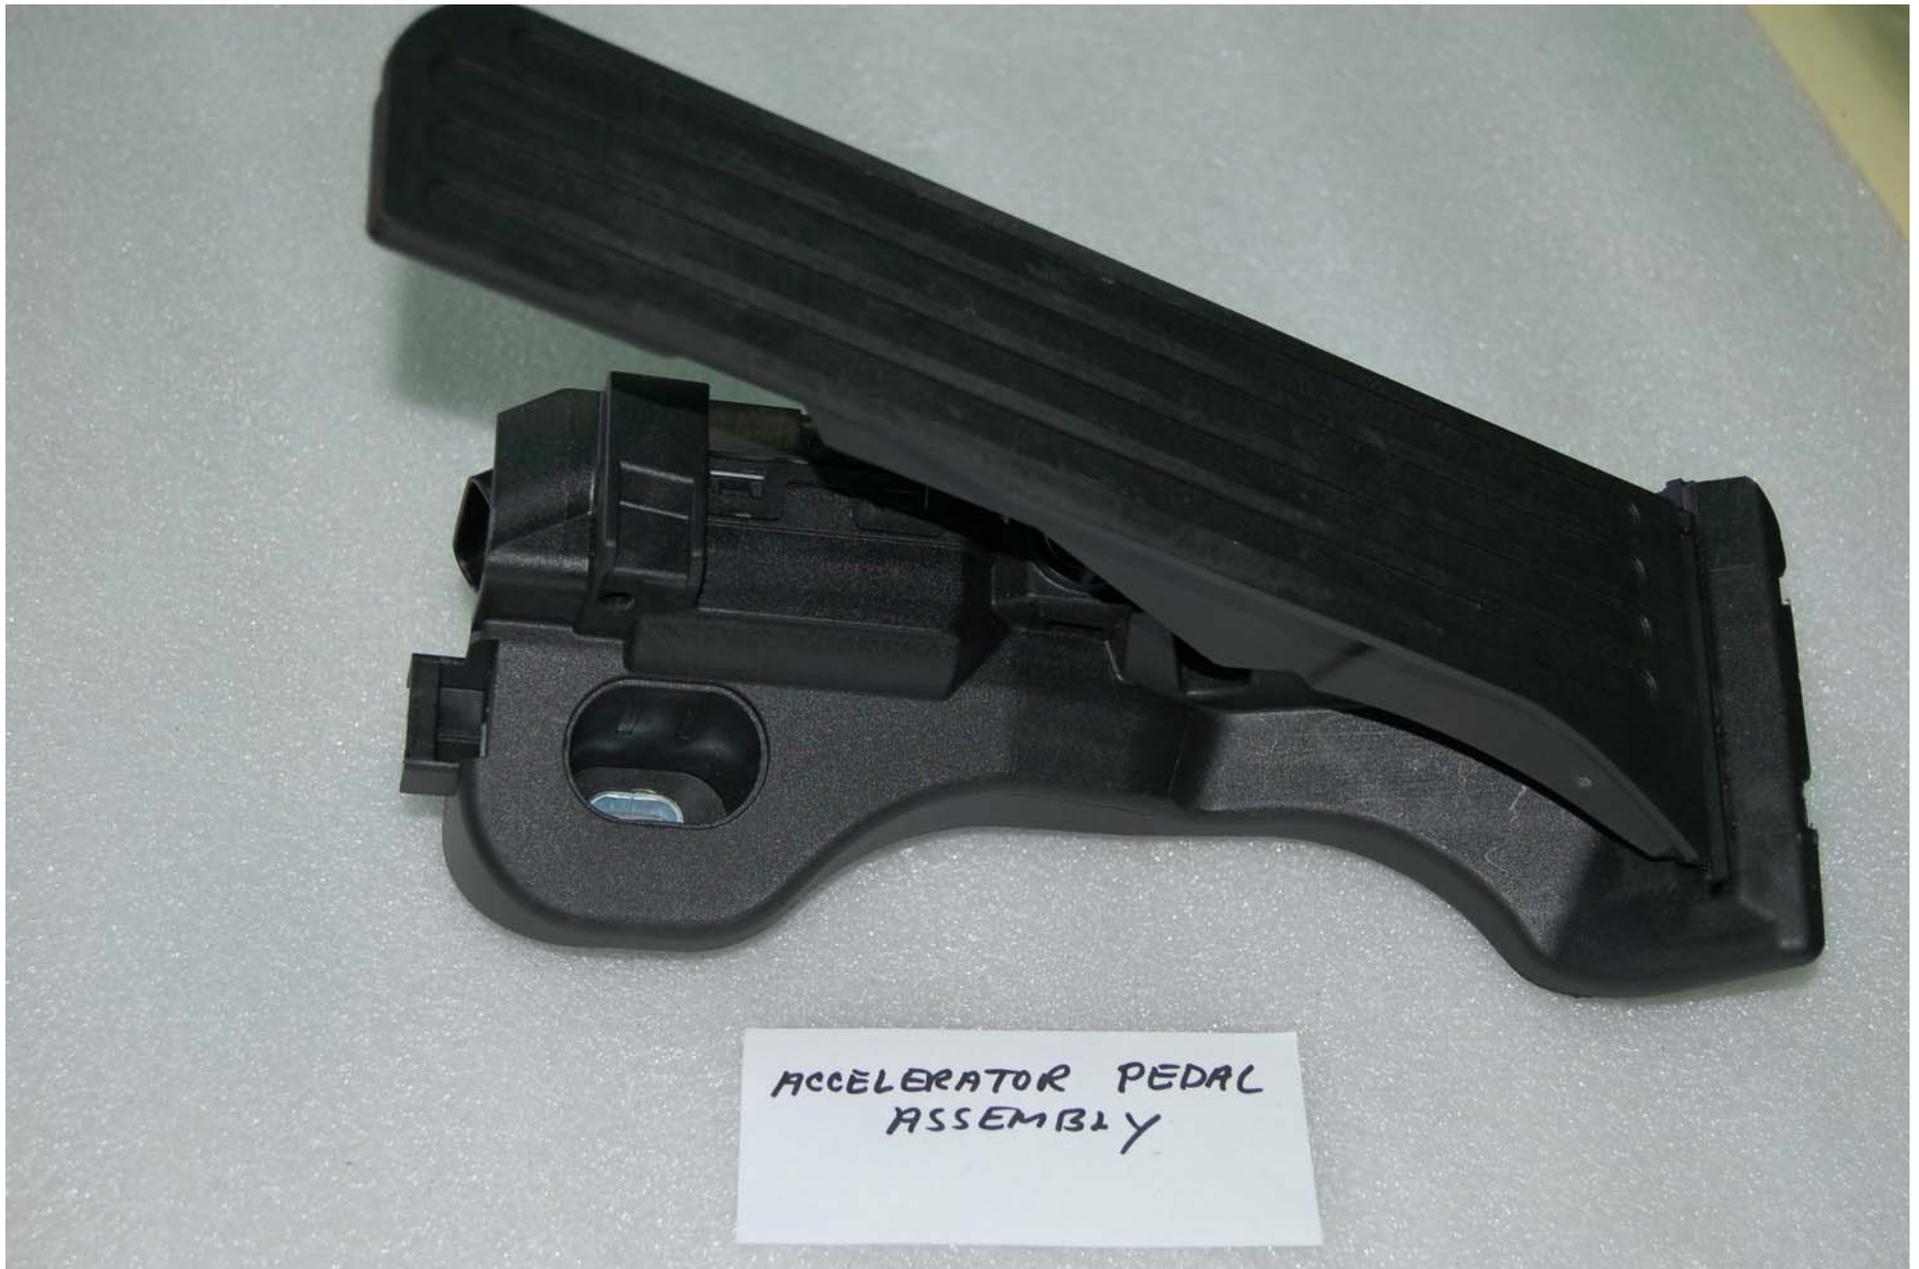
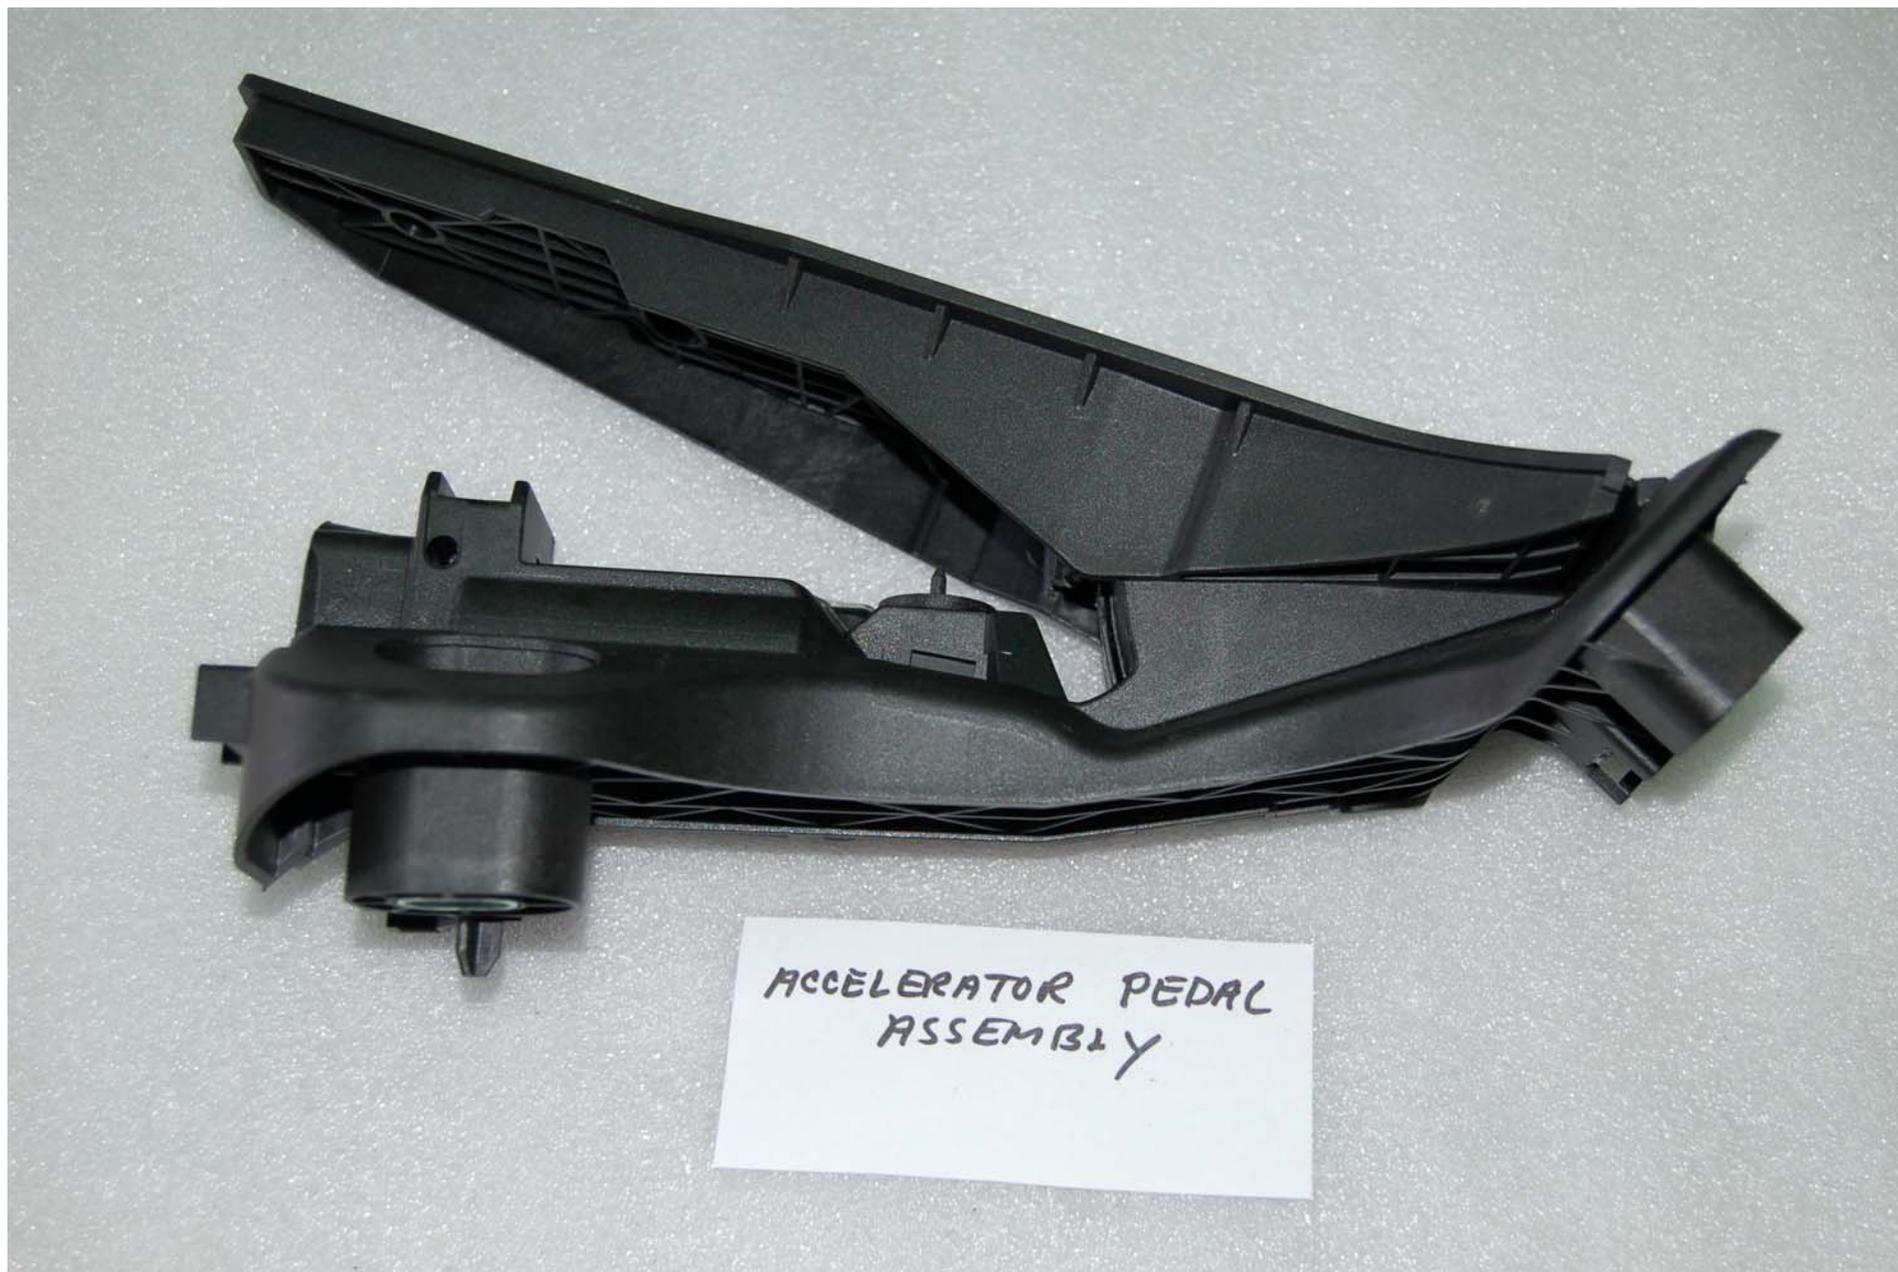
FIGURE 5.12
ACCELERATOR PEDAL ASSEMBLY

FIGURE 5.13
ACCELERATOR PEDAL ASSEMBLY

FIGURE 5.14
ACCELERATOR PEDAL ASSEMBLY

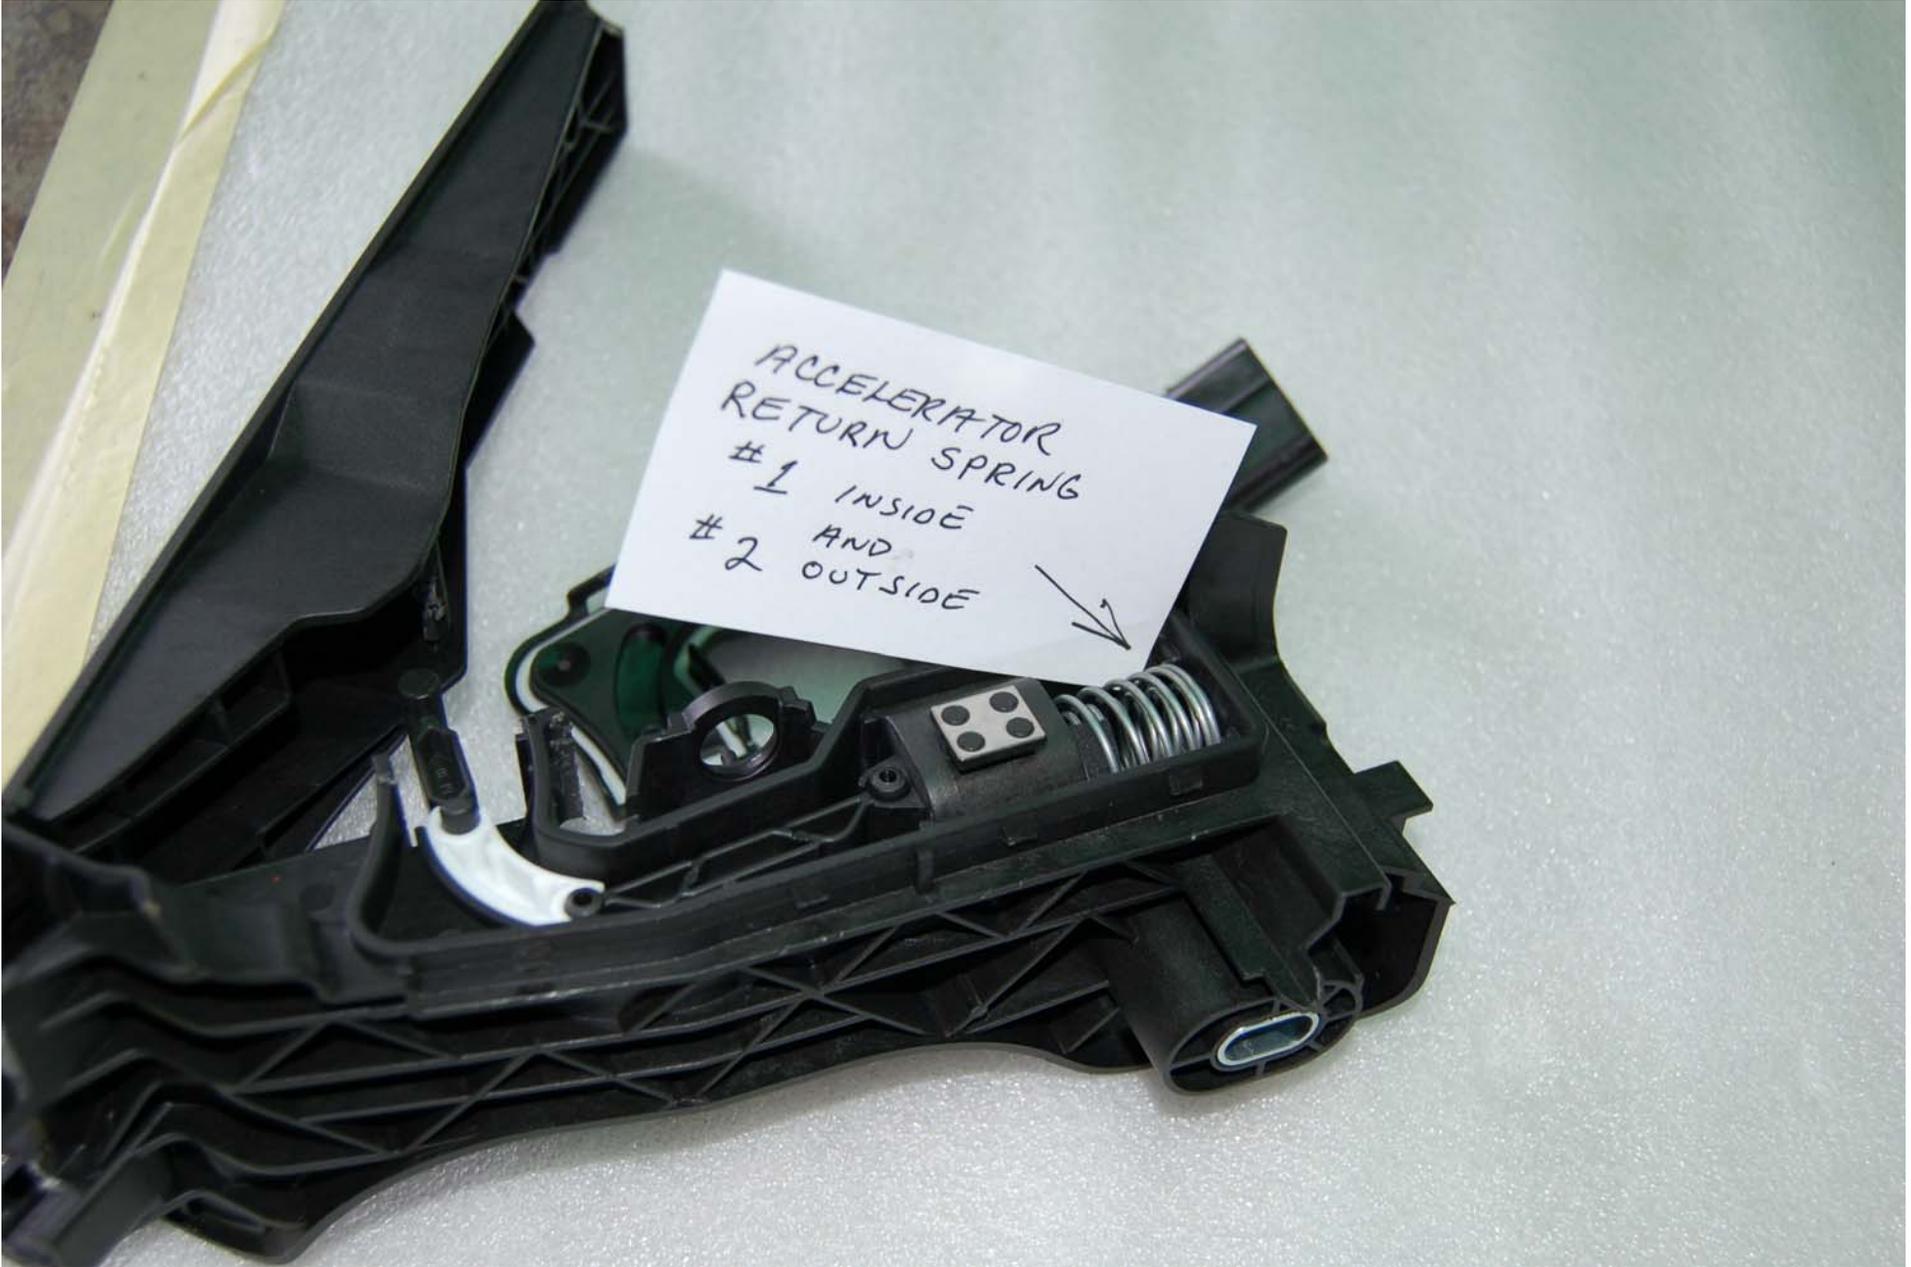
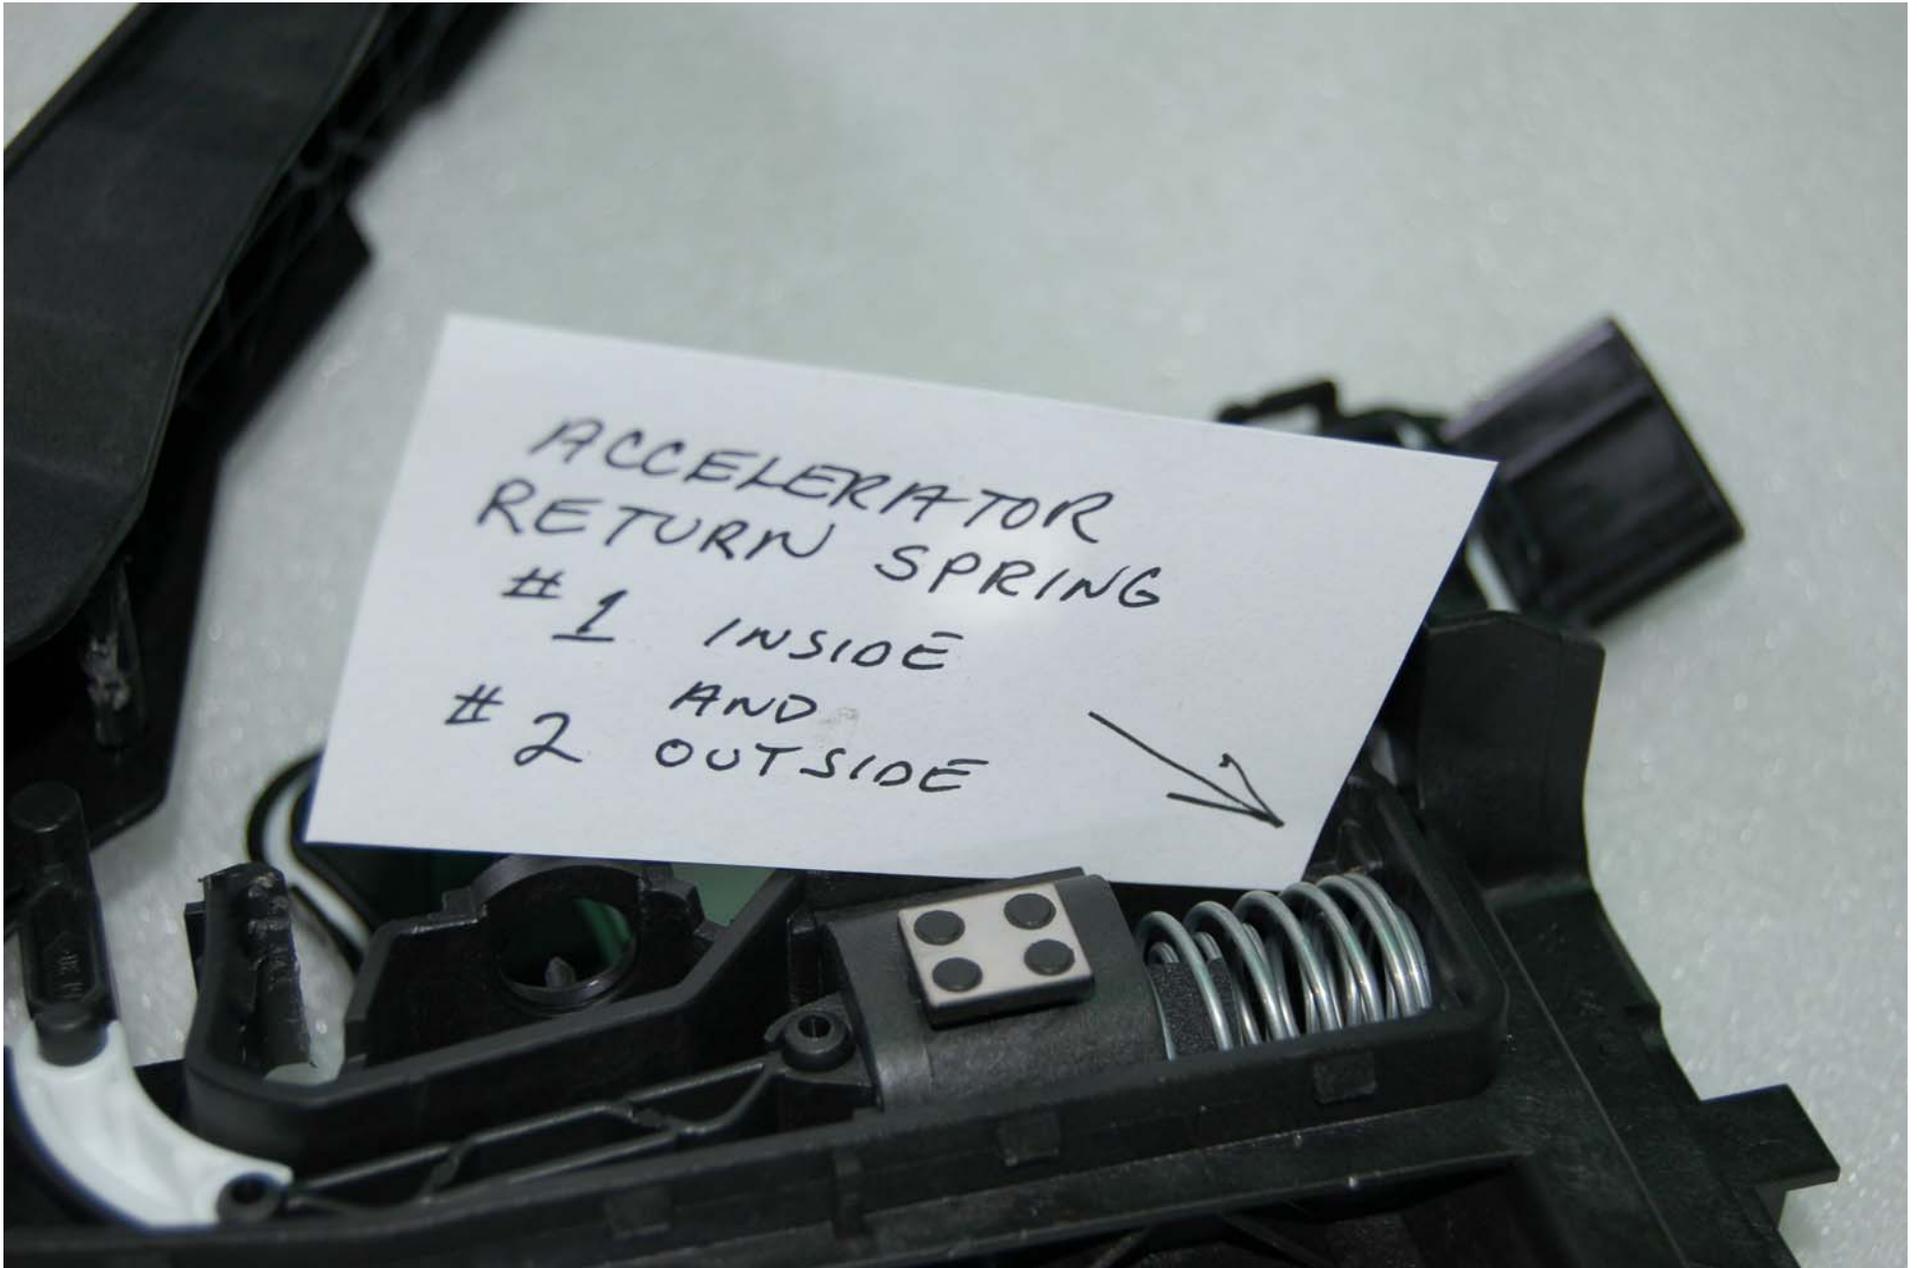
FIGURE 5.15
ACCELERATOR RETURN SPRINGS

FIGURE 5.16
ACCELERATOR RETURN SPRINGS CLOSE-UP

Accelerator Pedal - The accelerator pedal has two redundant working springs that return the pedal to the starting position.
