REPORT NUMBER 124-GTL-07-002

SAFETY COMPLIANCE TESTING FOR FMVSS 124 ACCELERATOR CONTROL SYSTEMS

VOLKSWAGEN AG GERMANY
2007 VOLKSWAGEN RABBIT,
4-DOOR PASSENGER CAR
NHTSA NO. C75800

FINAL REPORT

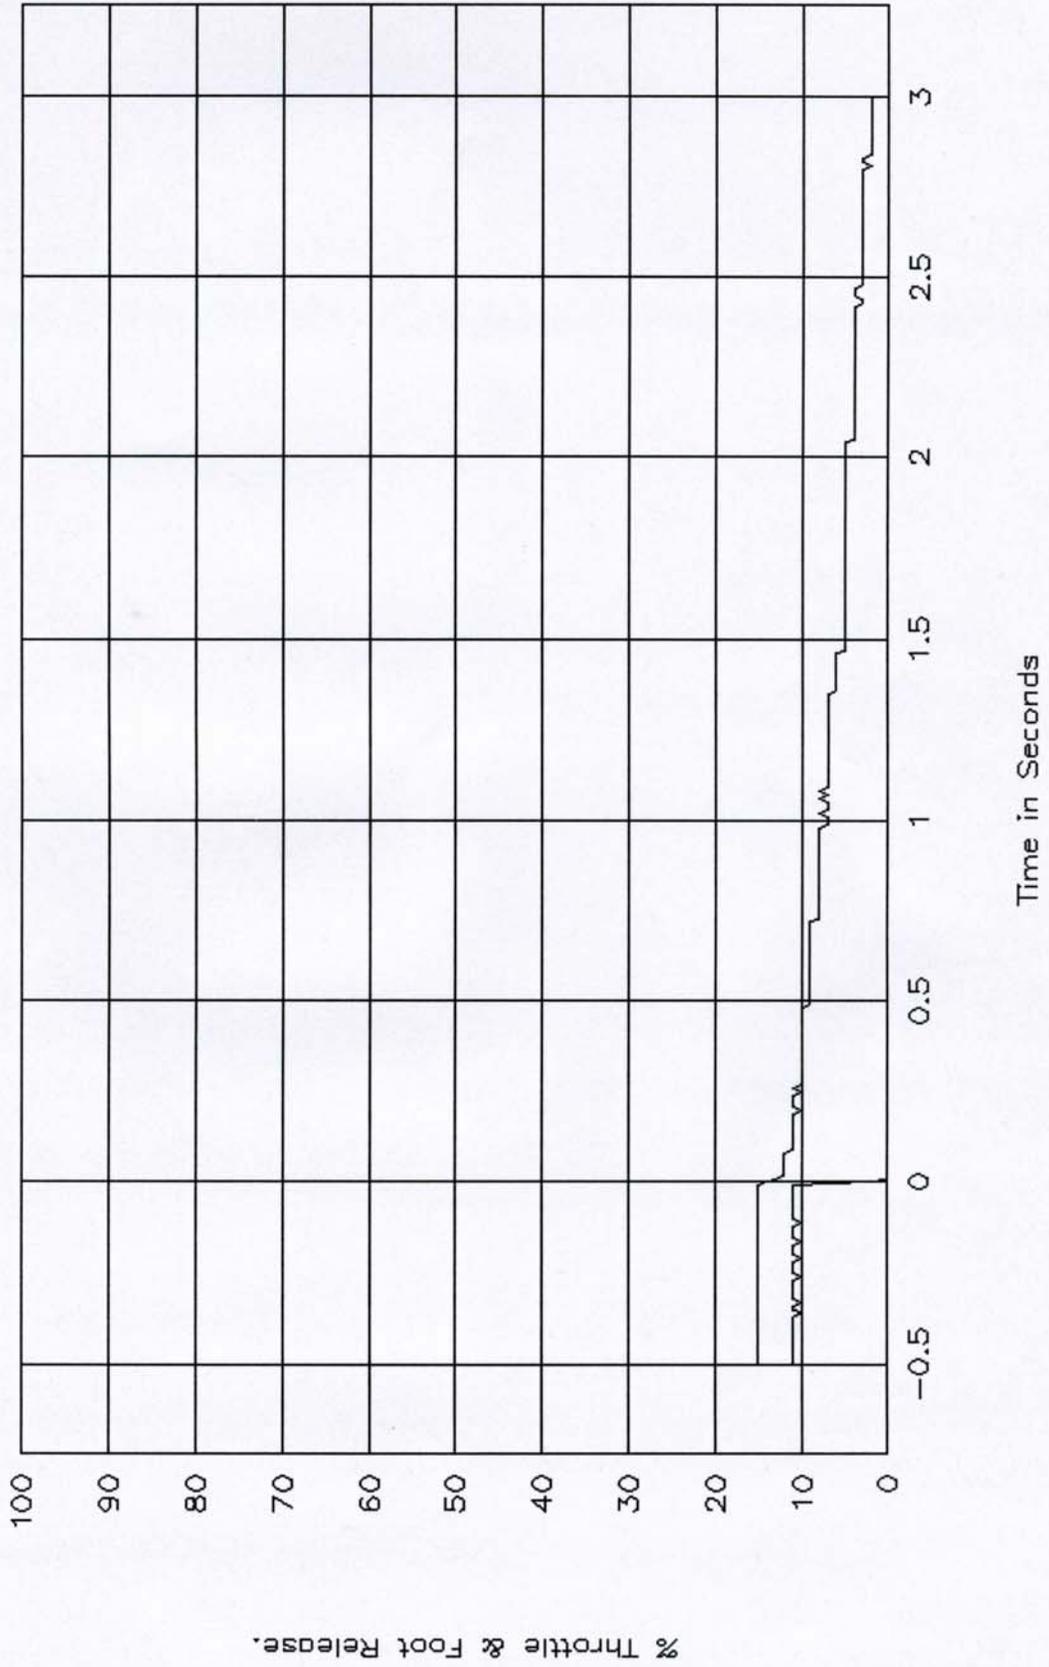
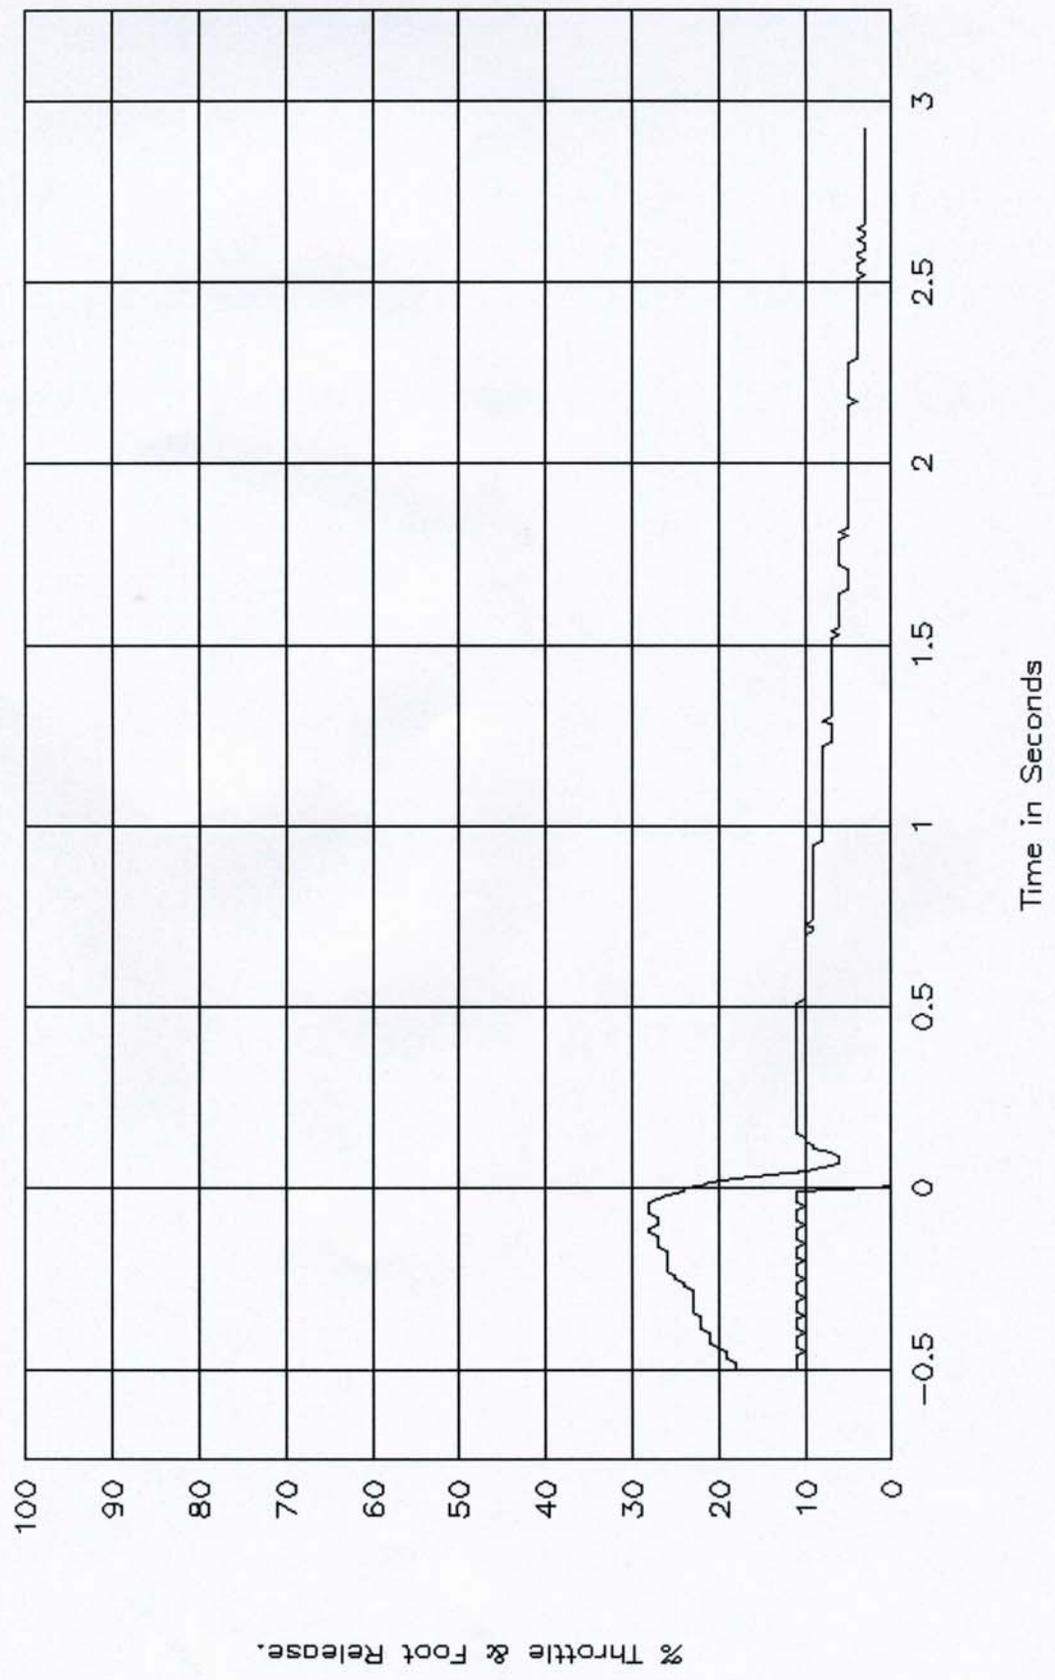
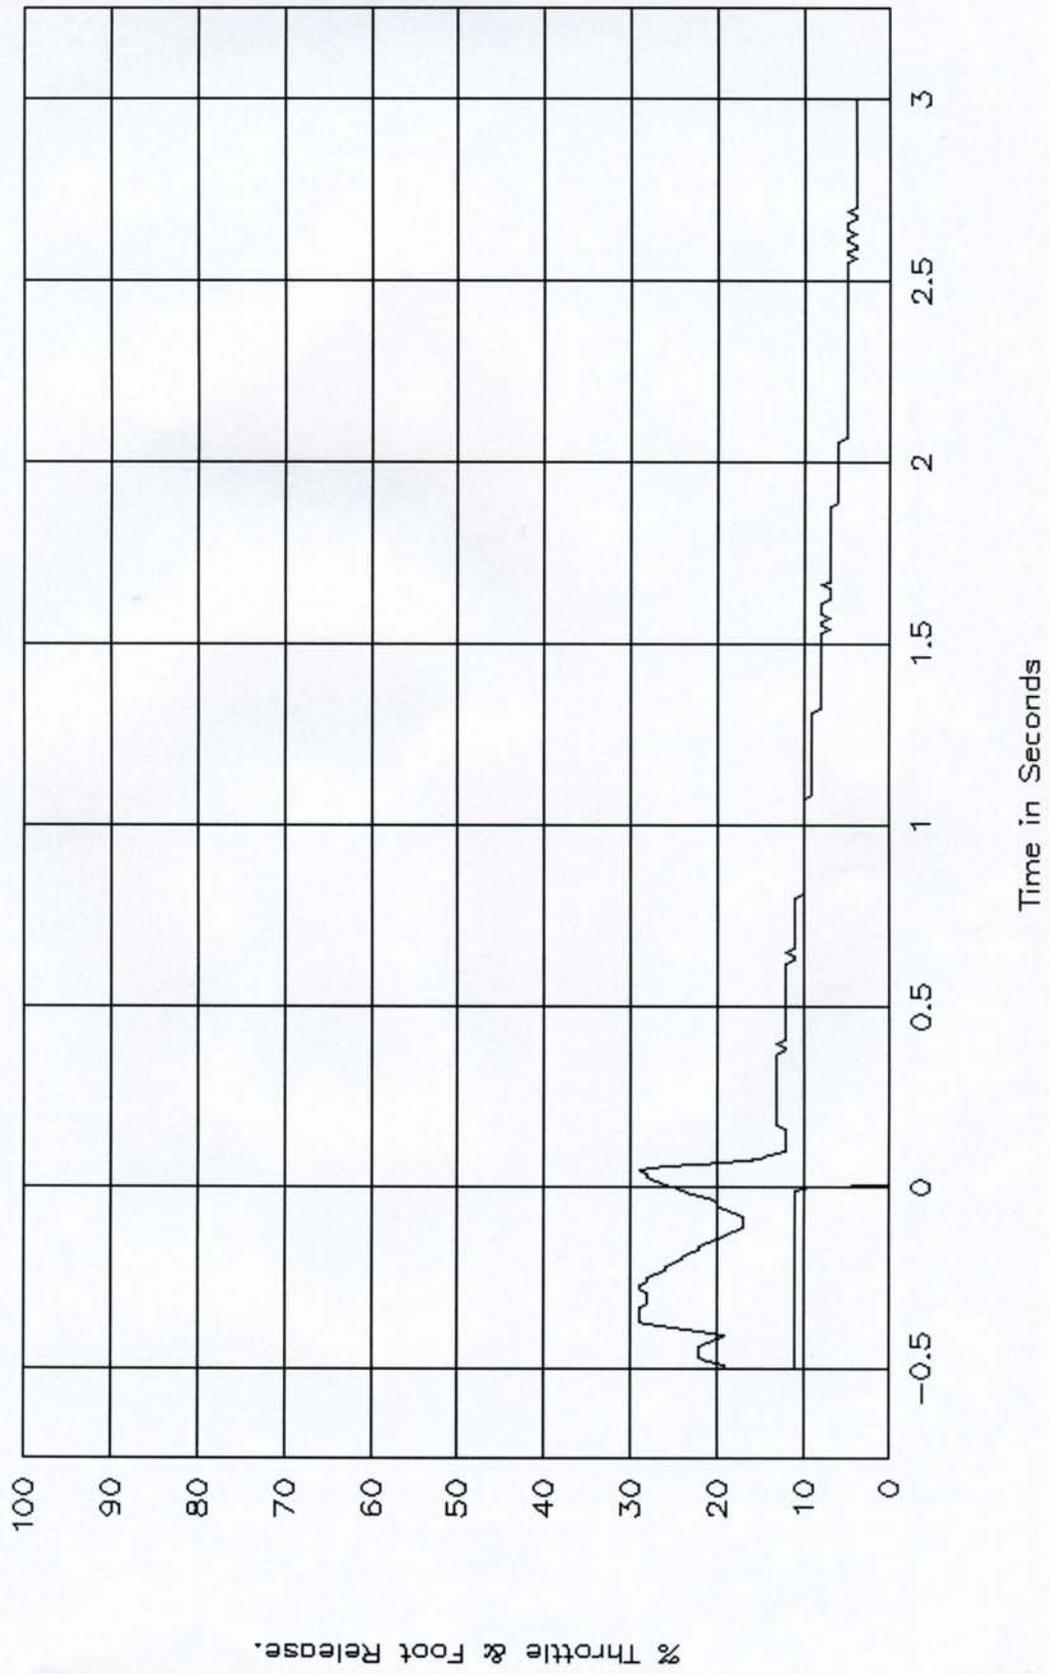
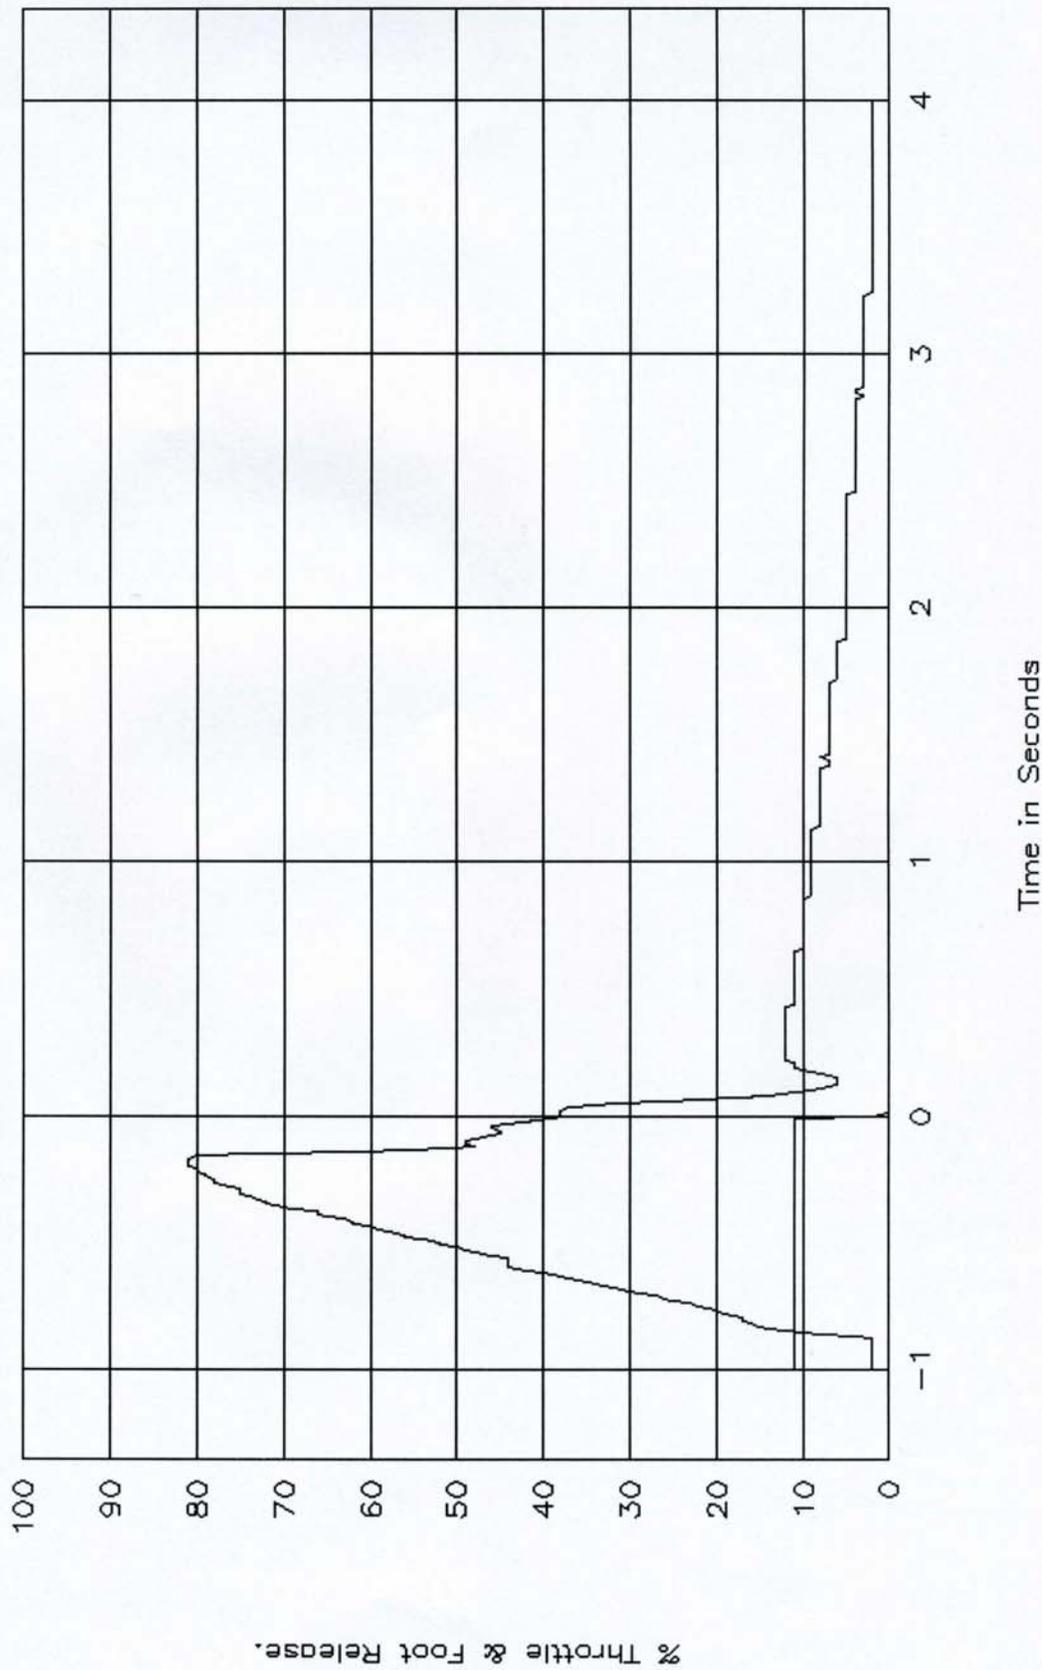
GTL 5761, FMVSS 124

Normal Operation, 25% Throttle.

Normal Operation, 50% Throttle.

Normal Operation, 75% Throttle.

Normal Operation, 100% Throttle.

The return times for some normal operation and fault conditions resulted in return time greater than 1 second. In these cases, throttle angle position decreased rapidly followed by a controlled ramp down to the original idle position. Manufacturers sometimes use this ramp-down strategy for improved emission control which may be the case here. No engine "racing" was observed at any point in the testing.

REMARKS: When driver accelerator control is moved to 25, 50, 75 and 100% throttle positions, the throttle body butterfly only opens to a position as controlled by the engine control computer and oscillates open/close even though accelerator is held at a steady state.

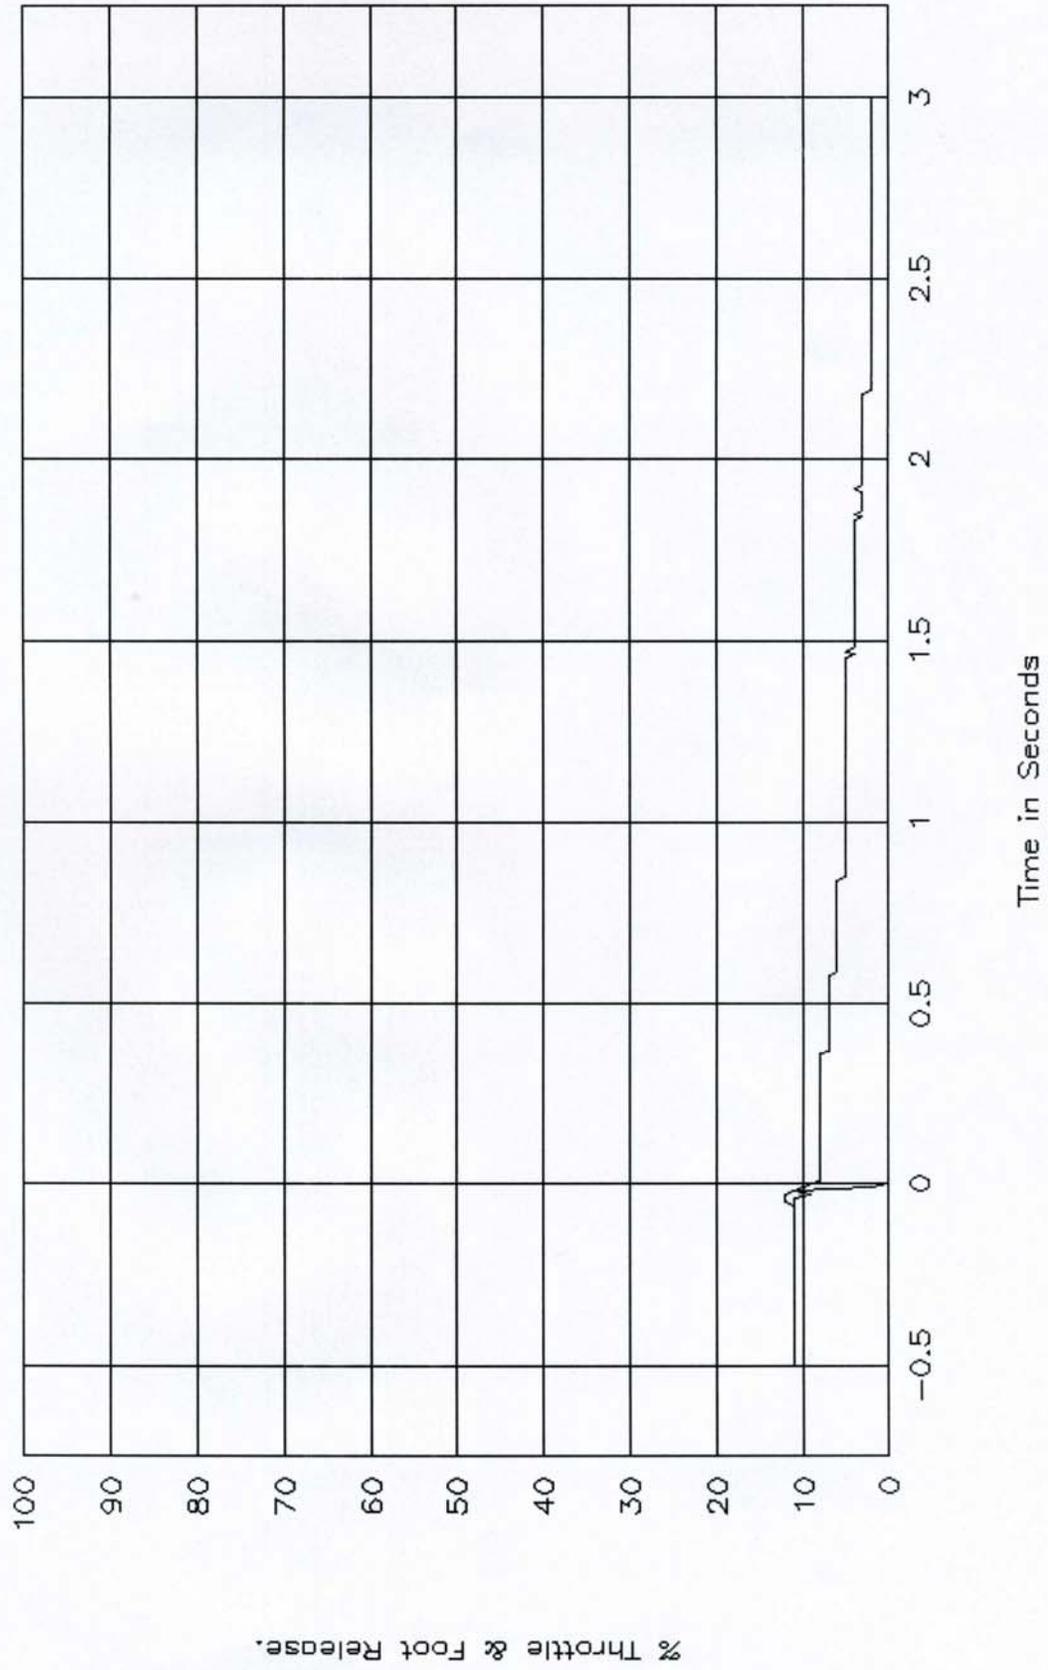
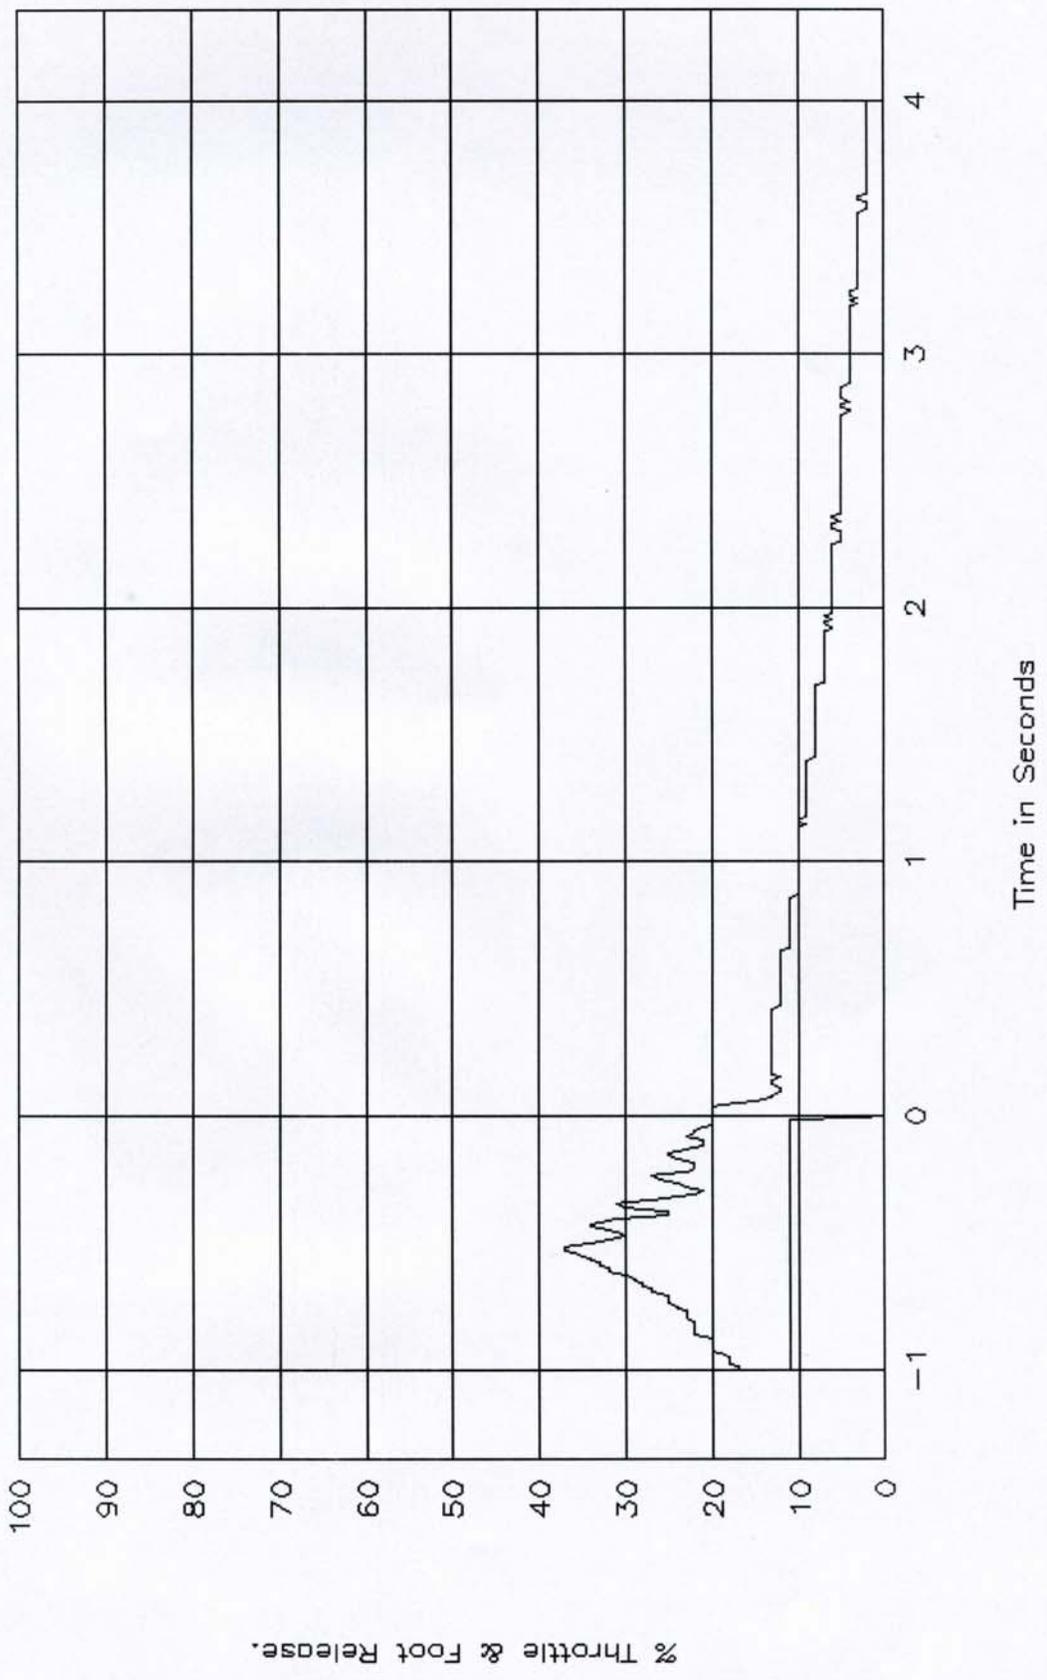
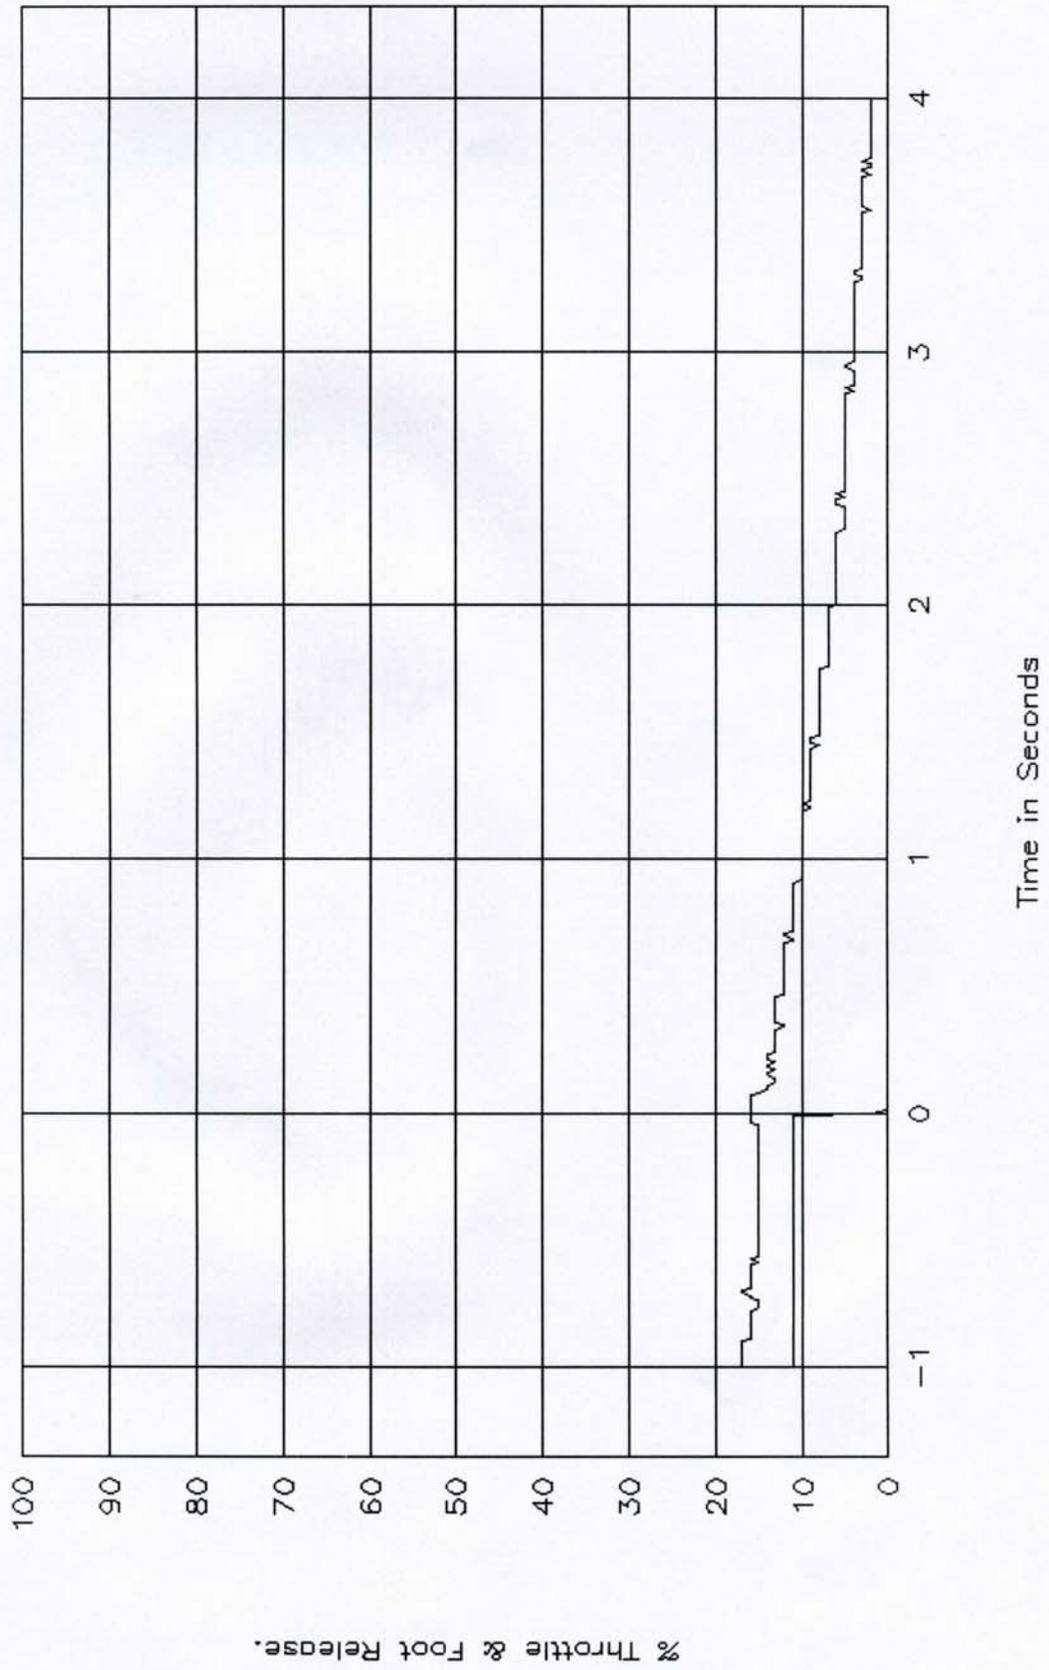
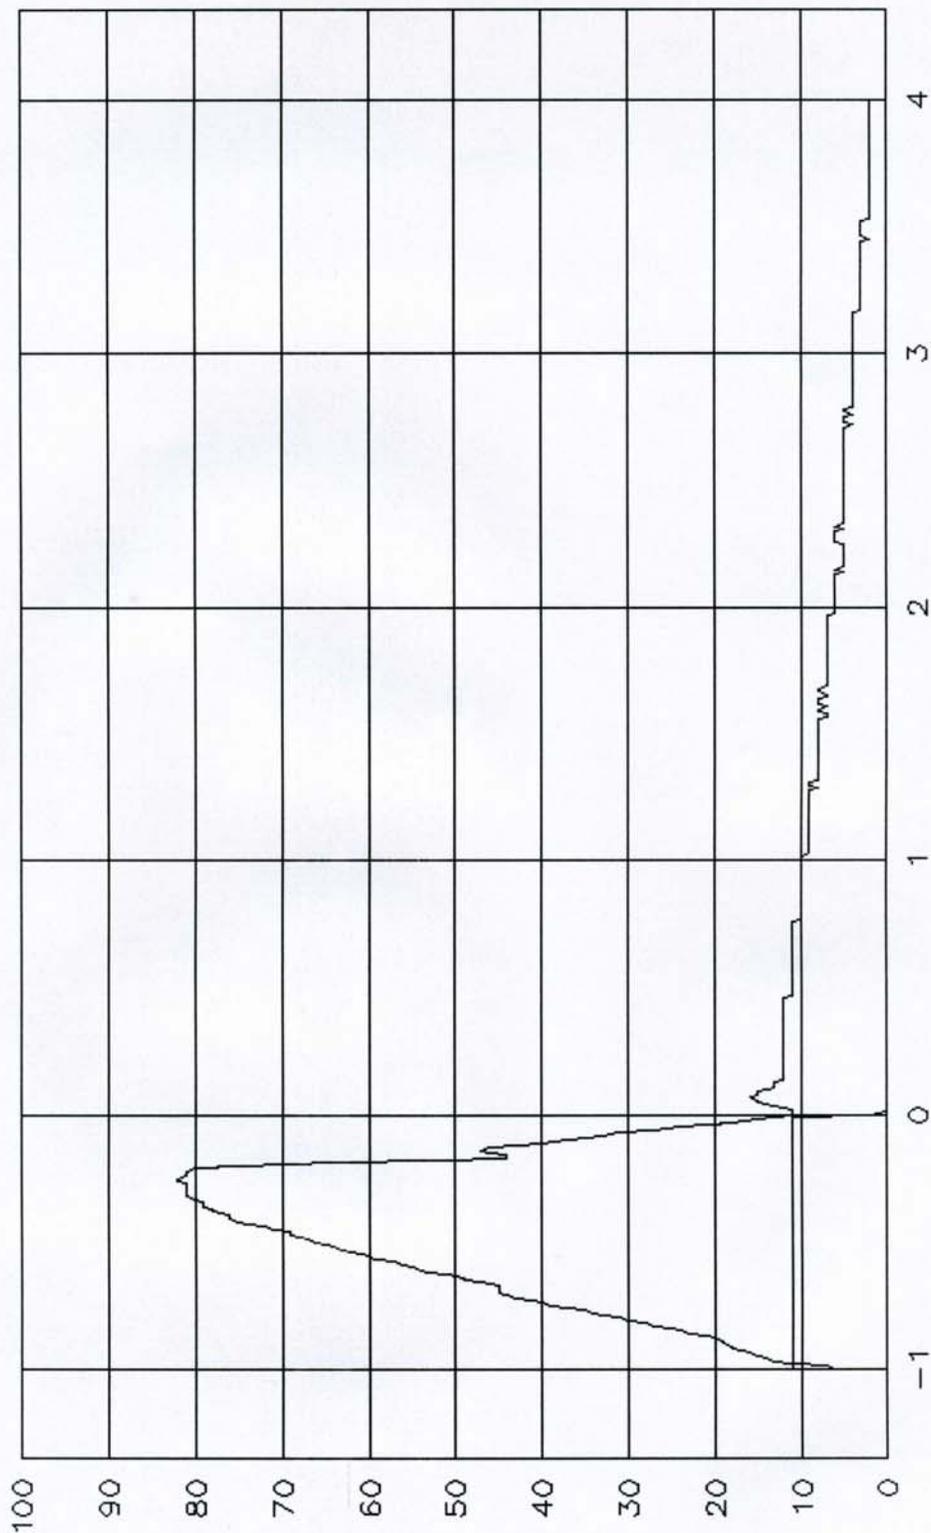
GTL 5791, FMVSS 124

APS Spring #1 Removed, 25% Throttle.

APS Spring #1 Removed, 50% Throttle.

APS Spring #1 Removed, 75% Throttle.

APS Spring #1 Removed, 100% Throttle.

SYSTEM CONDITION: #1 SPRING DISCONNECTED IN APS (INNER SPRING)

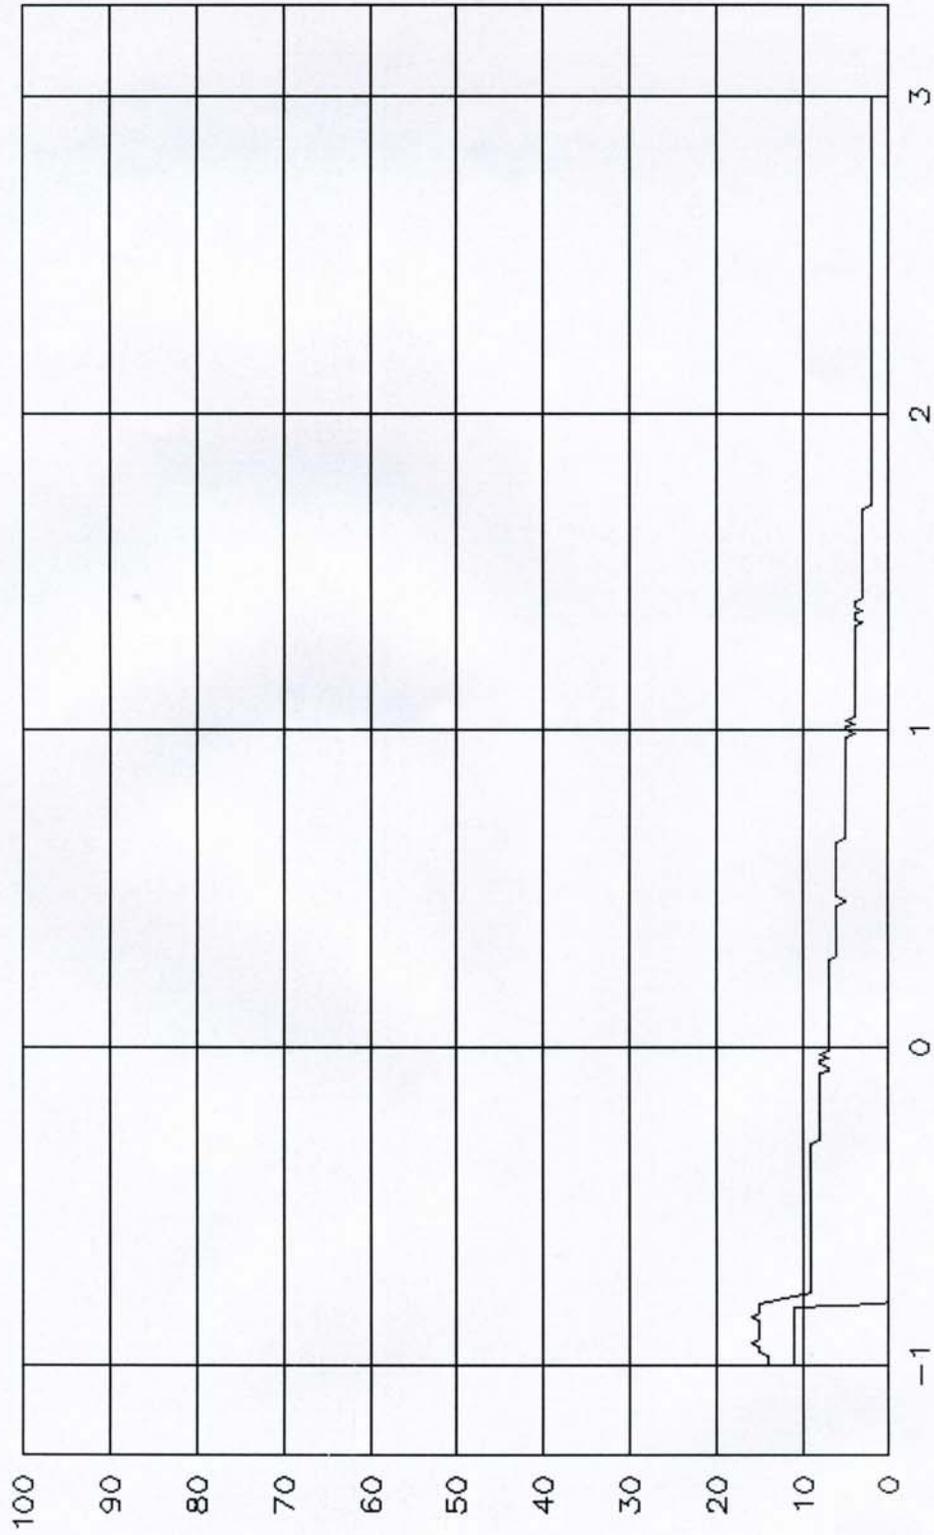
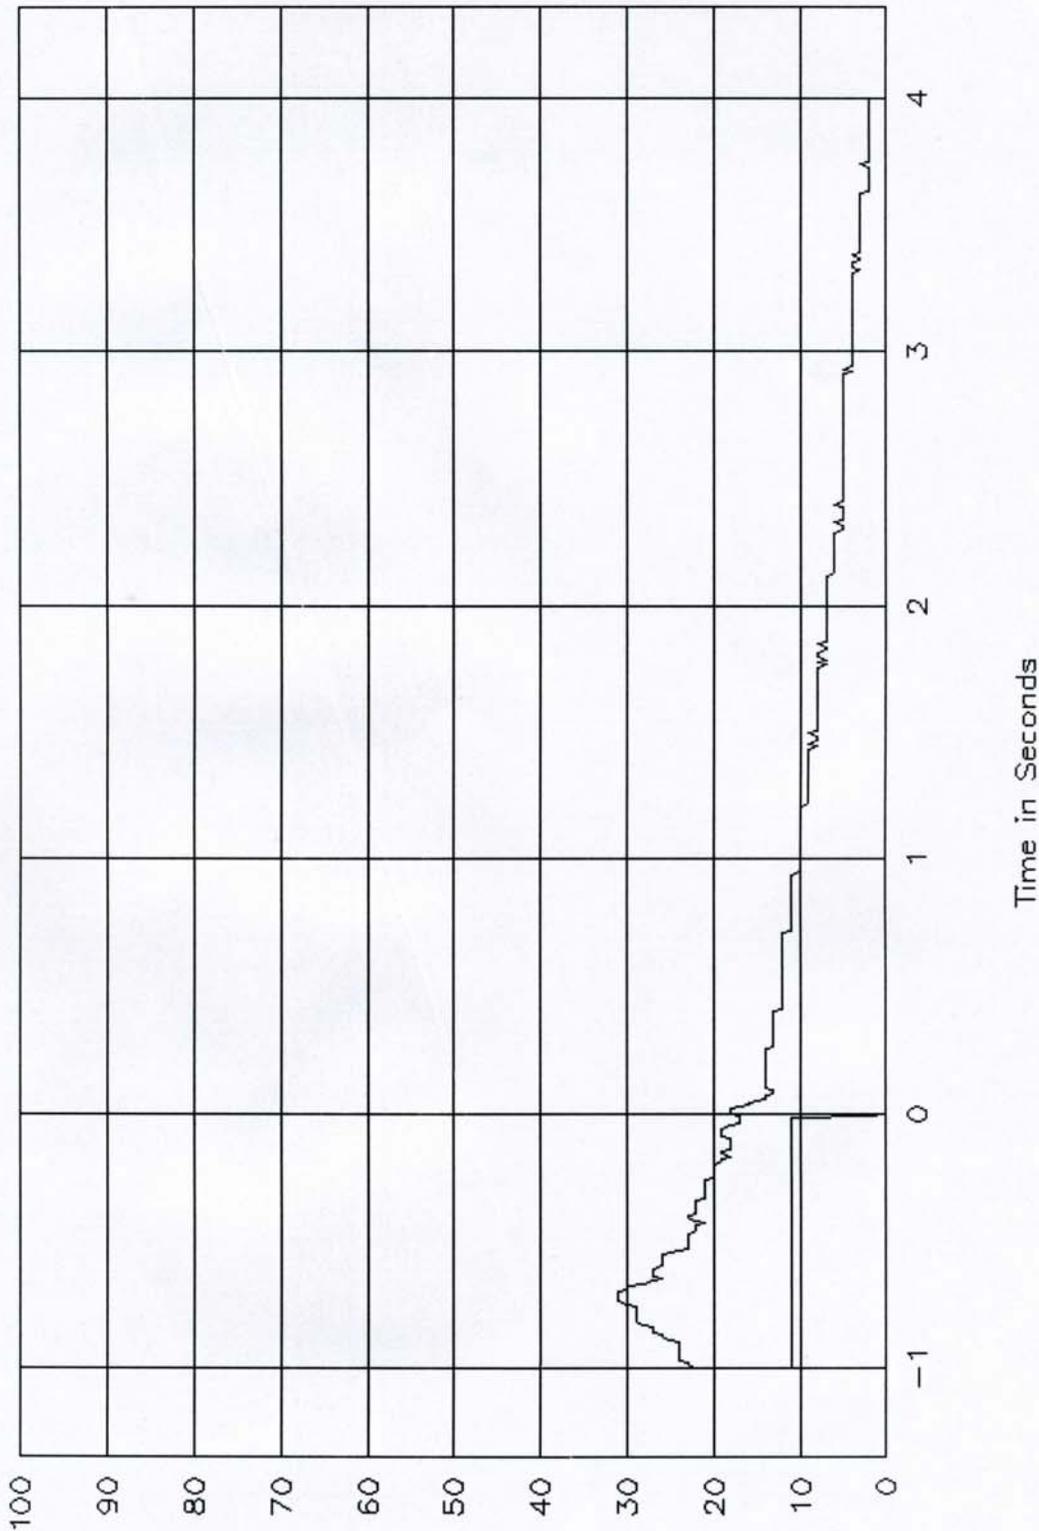
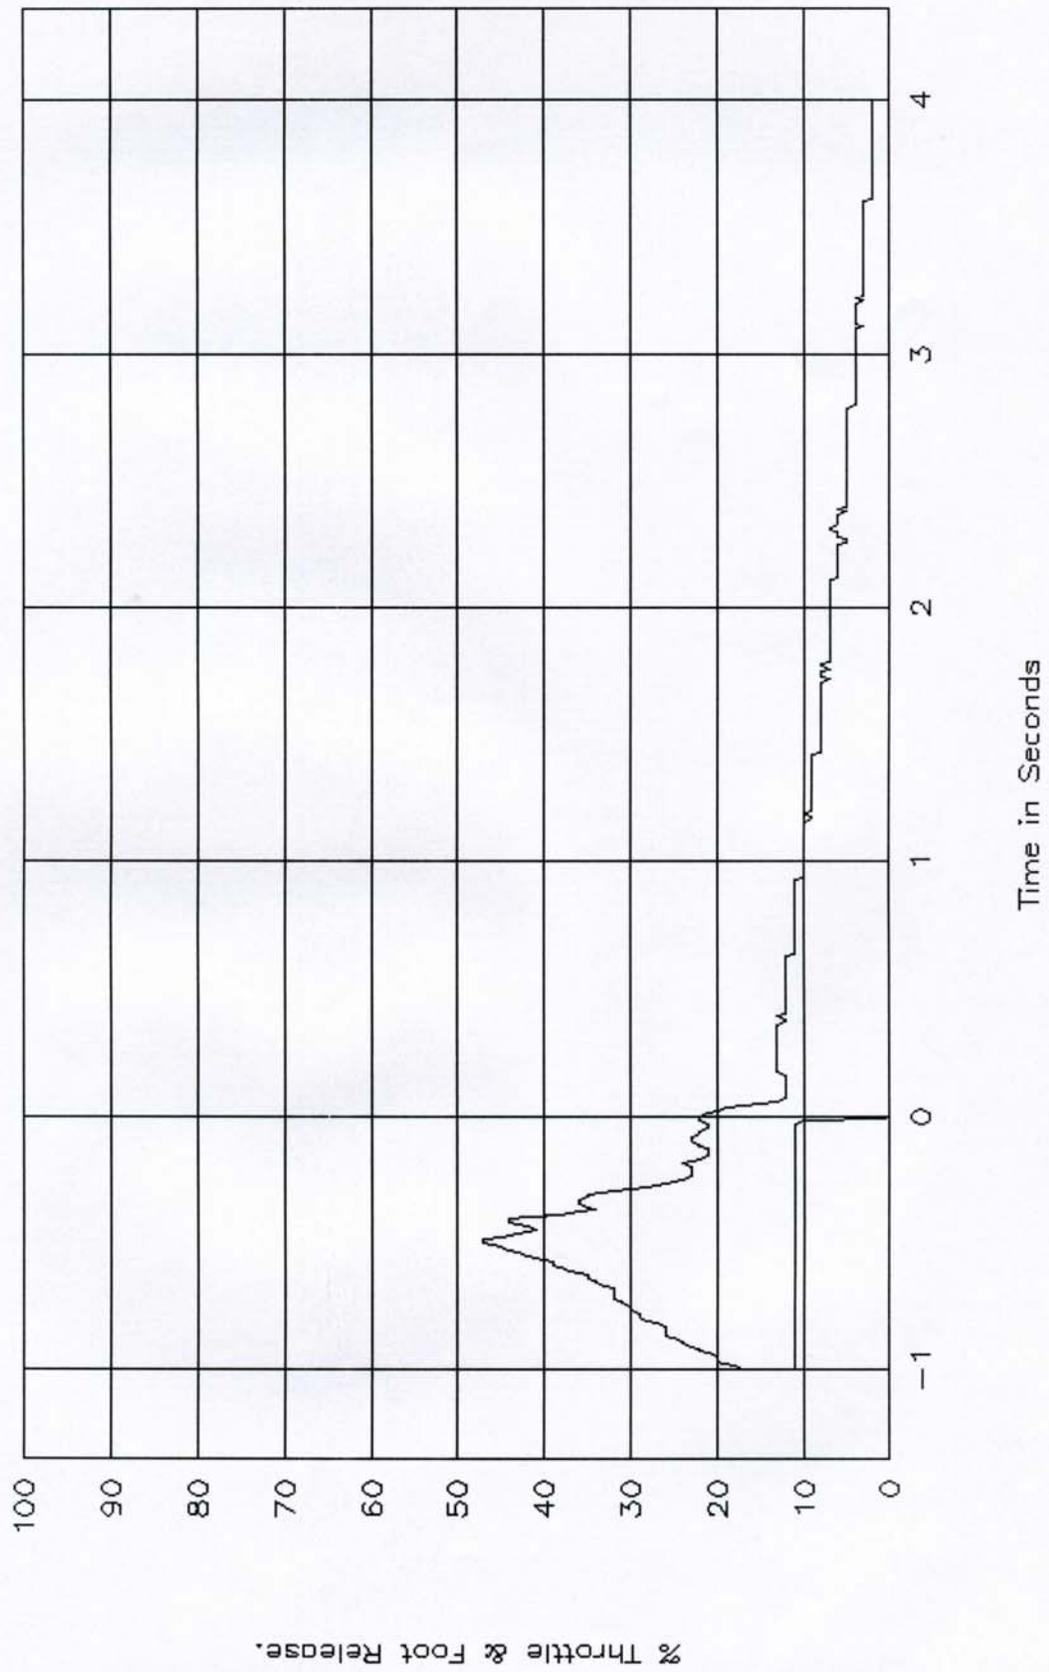
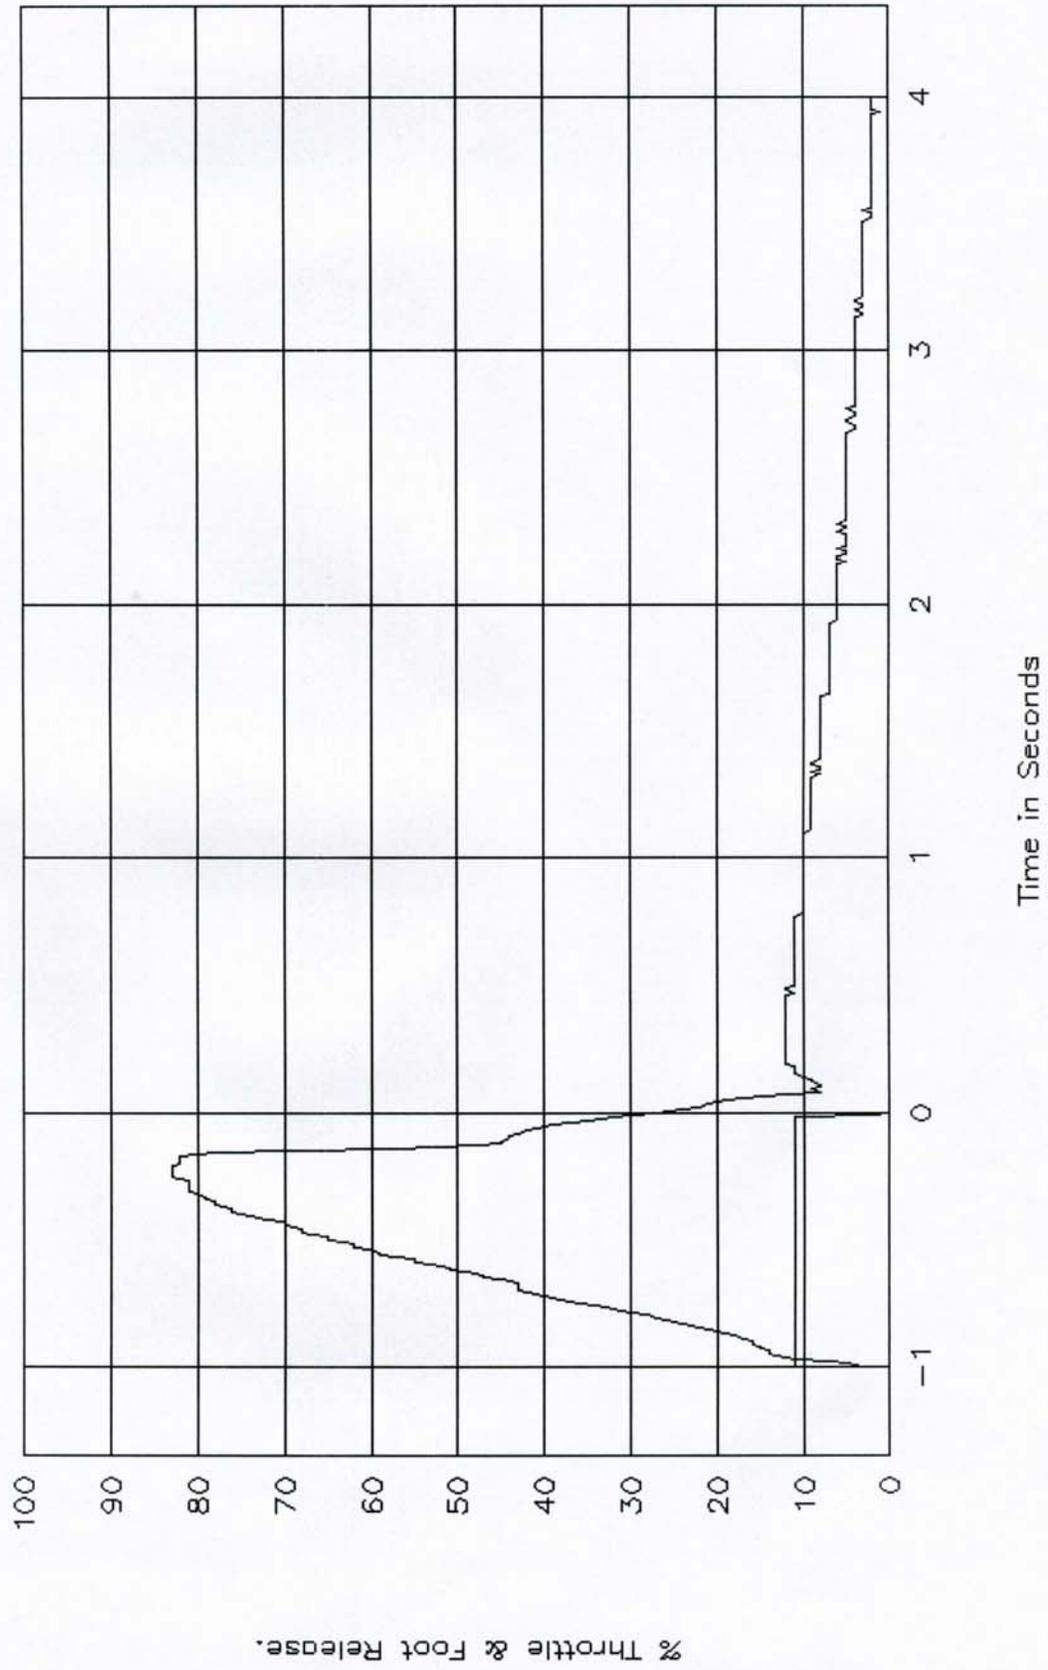
GTL 5795, FMVSS 124

APS Spring 2 Disconnected, 25% Throttle.

APS Spring 2 Disconnected, 50% Throttle.

APS Spring 2 Disconnected, 75% Throttle.

APS Spring 2 Disconnected, 100%Throttle.

SYSTEM CONDITION: #2 SPRING DISCONNECTED IN APS (OUTER SPRING)

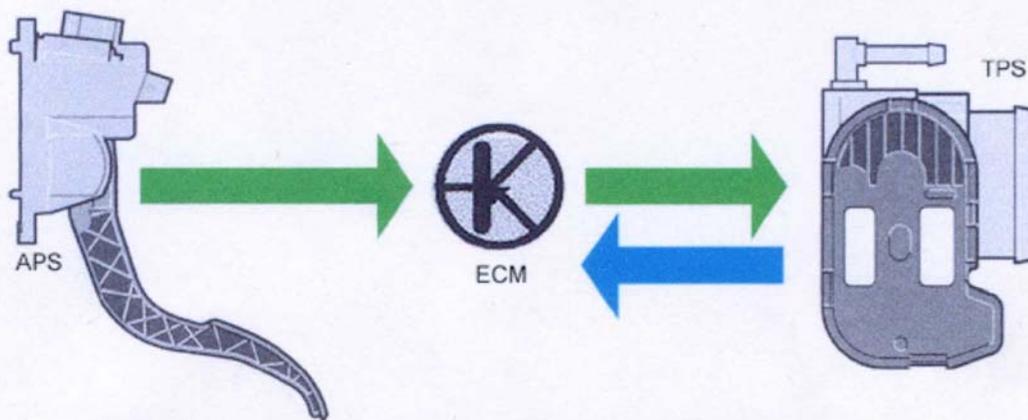
Figure 1: Schematic representation of the ACS of a gasoline passenger car

APS Accelerator Pedal Position Sensor
 ECM Electronic Control Module
 TPS Throttle Plate Position Sensor

The electronic throttle valve is adjusted by an electric motor which moves the throttle valve over the complete range from zero to full open throttle. The driver depresses the accelerator pedal which corresponds to the driver's requested engine torque. The accelerator pedal position is captured by a signal from the pedal sensor system. This activates the throttle valve adjustment motor and adjusts the throttle valve from a closed to open position in direct response to driver input. With the information from the throttle valve position sensor system the throttle valve position can be determined at any time.

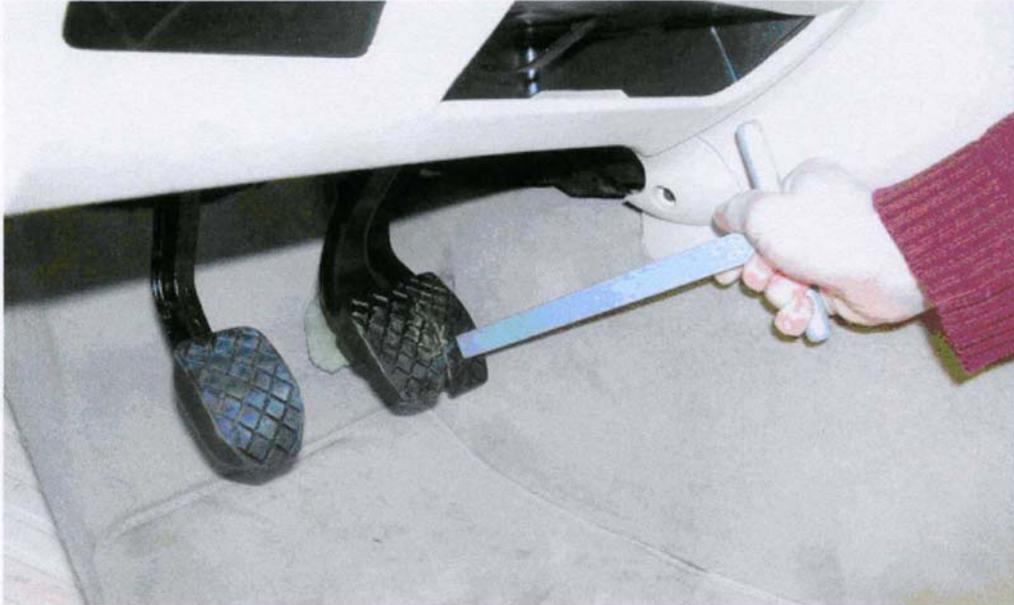
Figure 2: Operating means for accelerator pedal movement.

During the depressing of the accelerator pedal with an operating unit and switch will be electrically opened (see Figure 2). Then the accelerator pedal is quickly released, at which time the switch closes, and that signal is the trigger for the timing of the measurement.

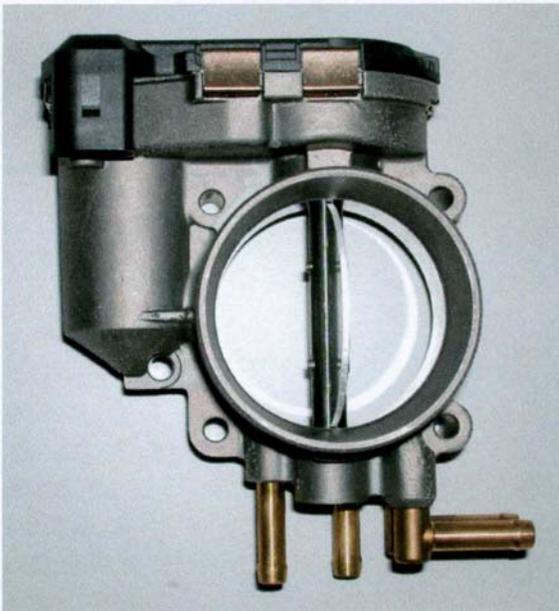
Figure 3: Throttle valve with return spring released (not actuated ► fully opened !
Using the measuring technique represented in Figure 4, the timing of the throttle valve movement to the idle operating position can be noted and evaluated.

To test the throttle valve adjustment motor and the throttle plate independently from the return spring, the return spring is released. Figure 3 shows such a throttle valve.

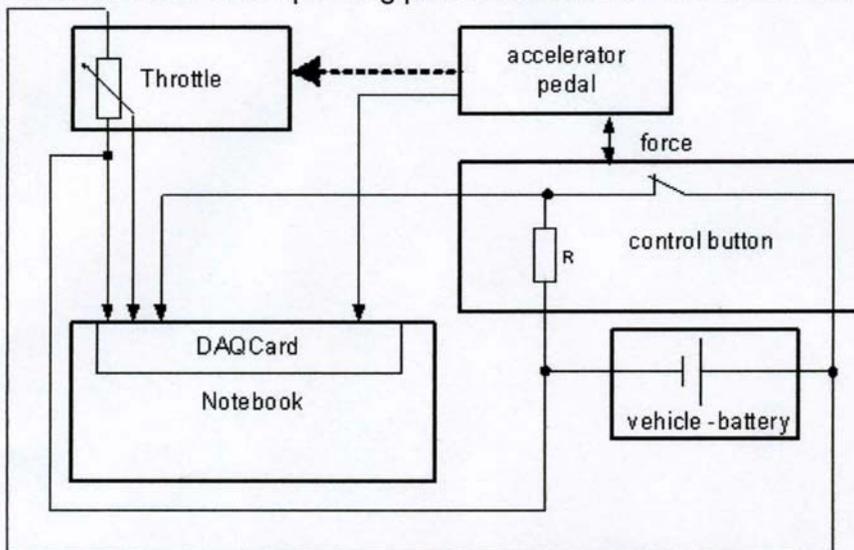
Figure 4: Schematic representation of measuring technique.

To test the function of the return spring in the throttle valve housing a complete throttle valve with return spring is used and the voltage supply to the throttle valve adjustment motor is cut-off. The time required for the throttle valve to return to the idle position is evaluated and analyzed.
