FINAL REPORT NUMBER 201UI-MGA-07-05

**SAFETY COMPLIANCE TESTING FOR FMVSS 201
Occupant Protection In Interior Impact
Upper Interior Head Impact Protection**

**HYUNDAI MOTOR COMPANY
2007 Hyundai Veracruz GLS, 4-Door SUV
NHTSA No. C70507**

**MGA RESEARCH CORPORATION
446 Executive Drive
Troy, Michigan 48083**

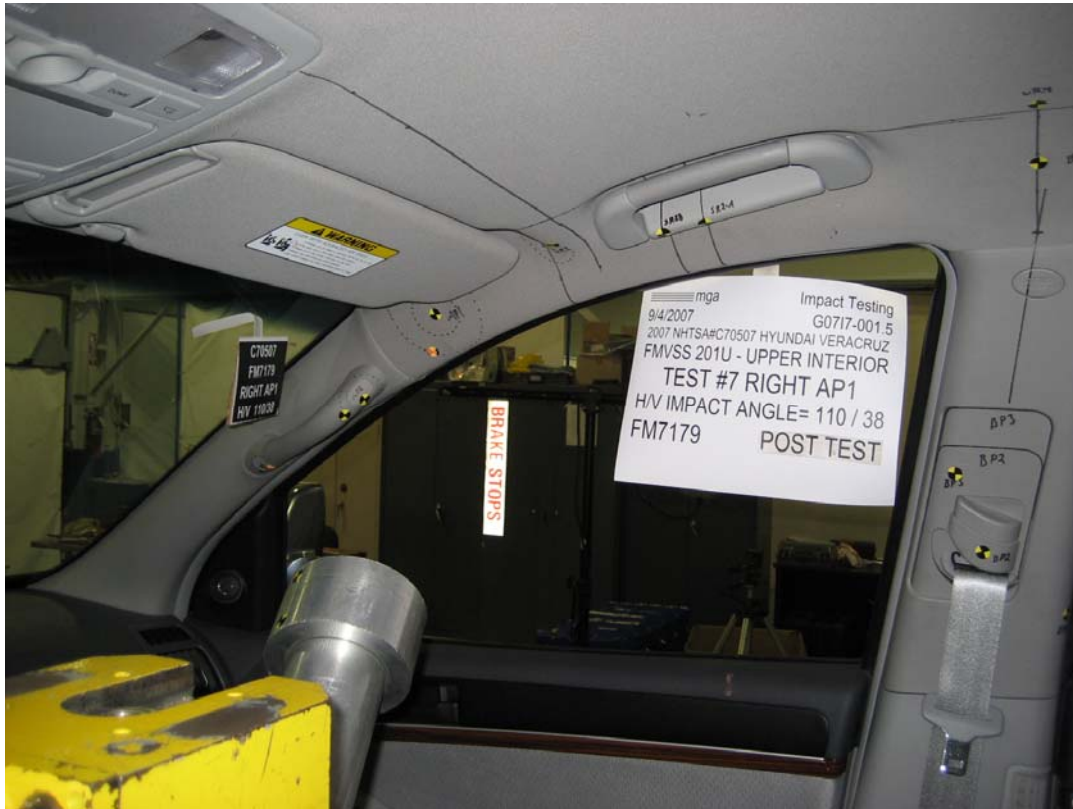
C70507
FM7179
RIGHT AP1
HV 110/38

mga Impact Testing
9/4/2007 G0717-001.5
2007 NHTSA#C70507 HYUNDAI VERACRUZ
FMVSS 201U - UPPER INTERIOR
TEST #7 RIGHT AP1
H/V IMPACT ANGLE= 110 / 38
FM7179 POST TEST

No visible damage.

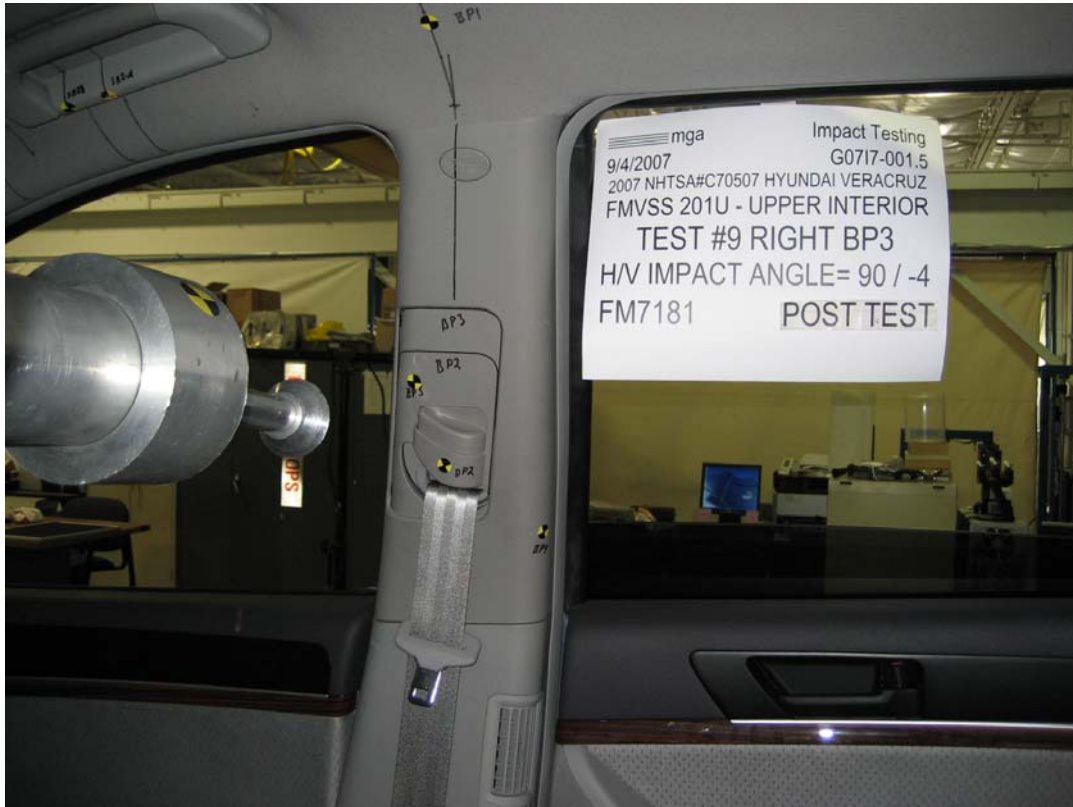
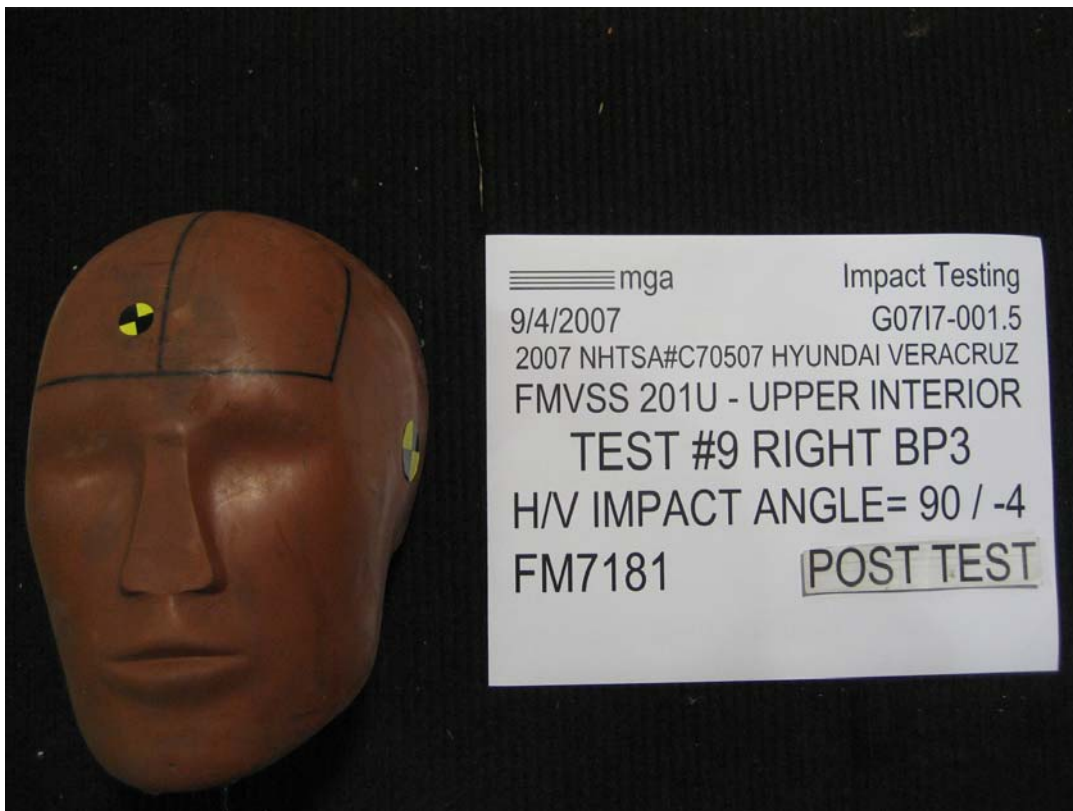
BP3 Right: D-ring cover cracked.

Test Number:#9
 Target (Vehicle Side): BP3 Right Temperature:22C
 MGA Test Reference No.:FM7181 Humidity:57%
 Approach Horizontal Angles:90° Time of Test:3:54:00 PM
 Approach Vertical Angles:-4° FMH Serial No:[038]
 Additional Description:

D-ring cover cracked.

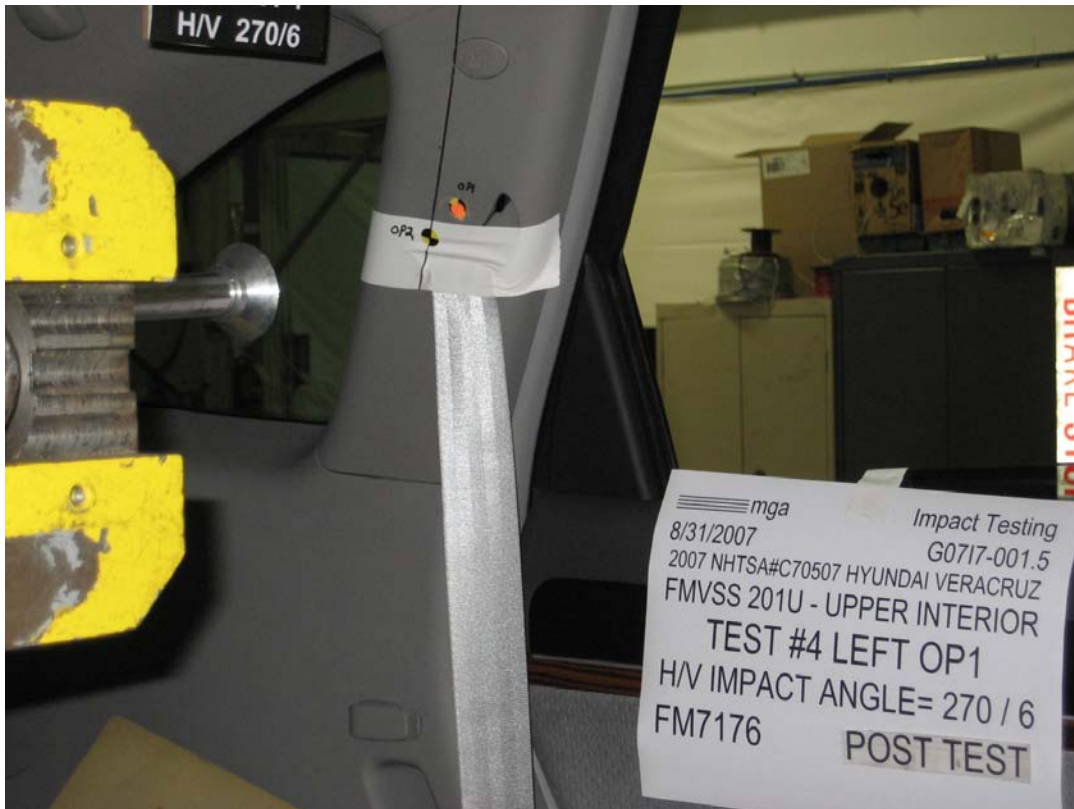
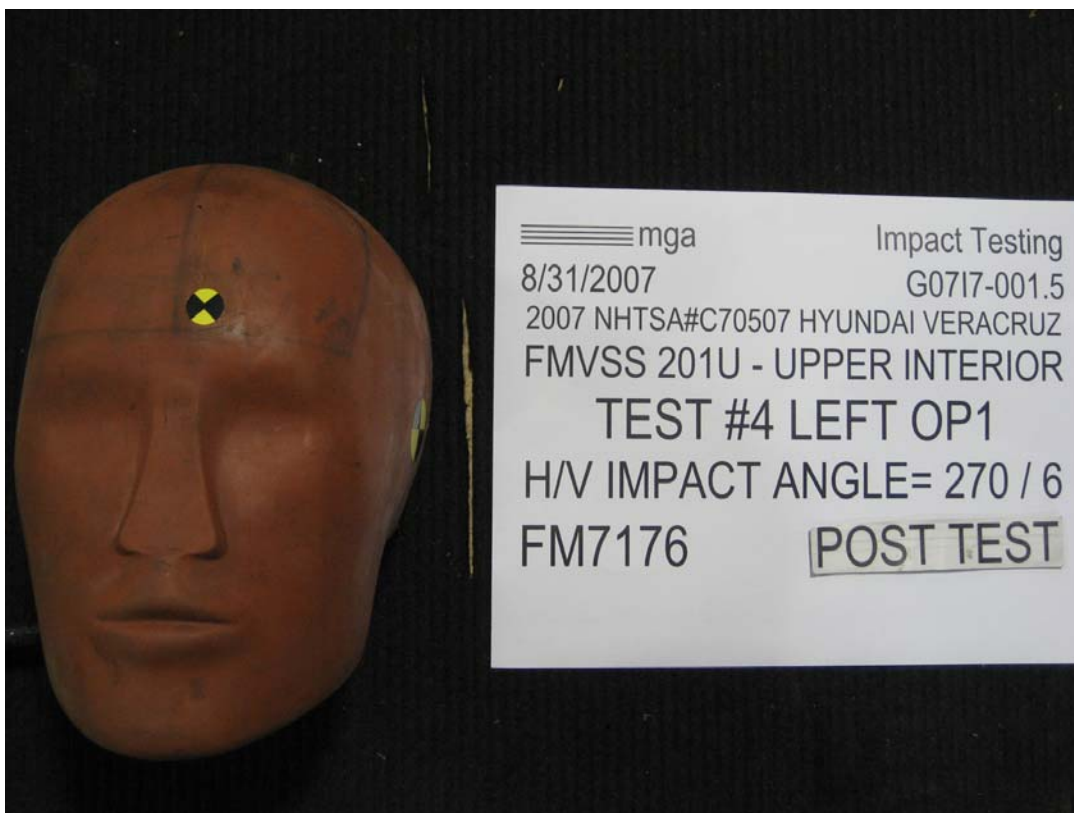
OP1 Left: O-pillar cracked.

Test Number:#4
Target (Vehicle Side): OP1 Left Temperature:22C
MGA Test Reference No.:FM7176 Humidity:57%
Approach Horizontal Angles:270° Time of Test:4:53:36 PM
Approach Vertical Angles:6° FMH Serial No:[035]
Additional Description:

O-pillar cracked.

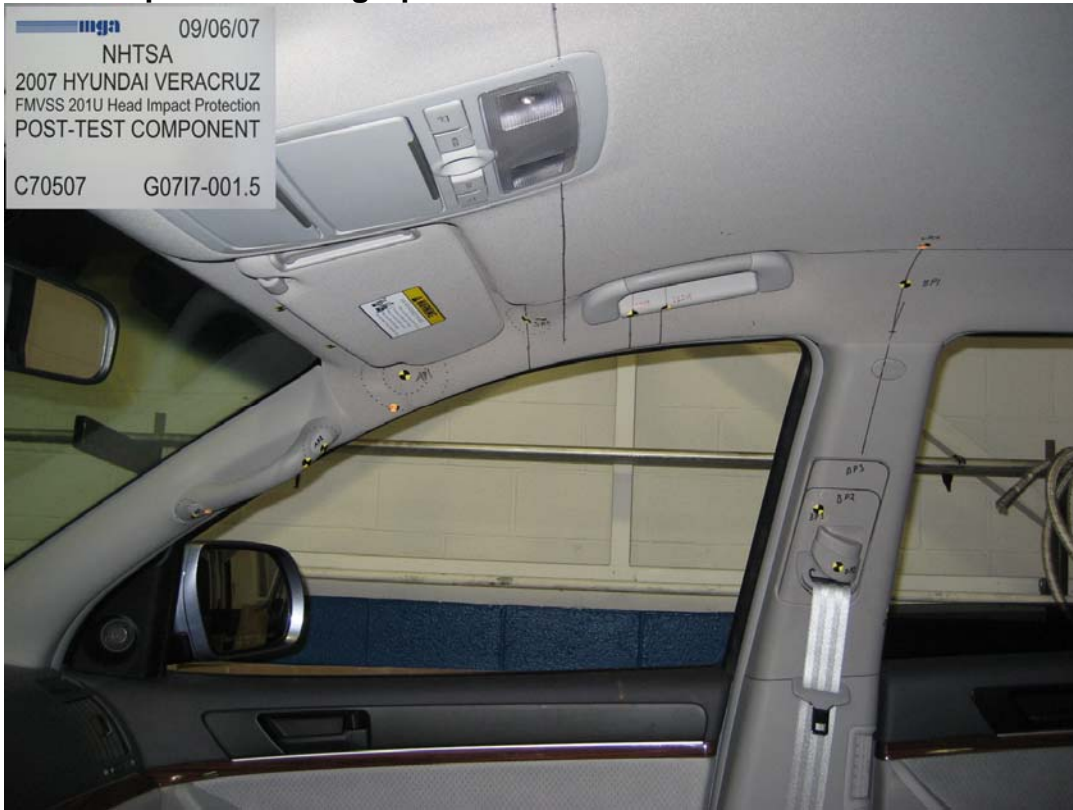
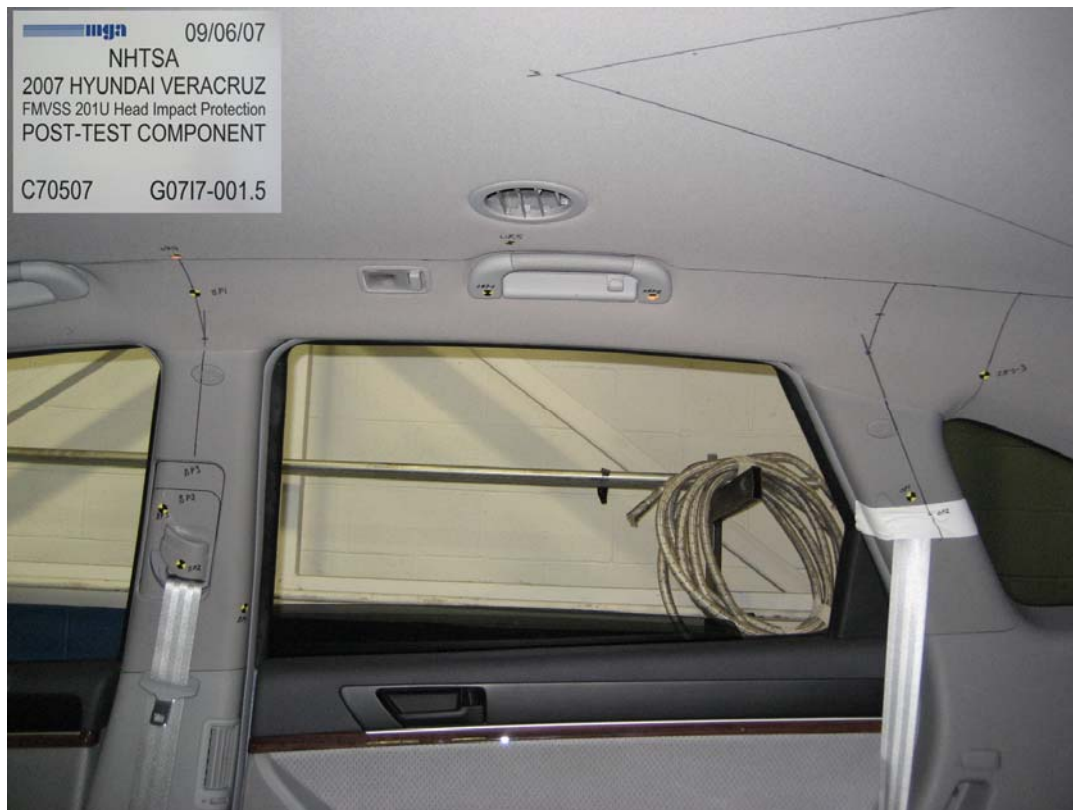
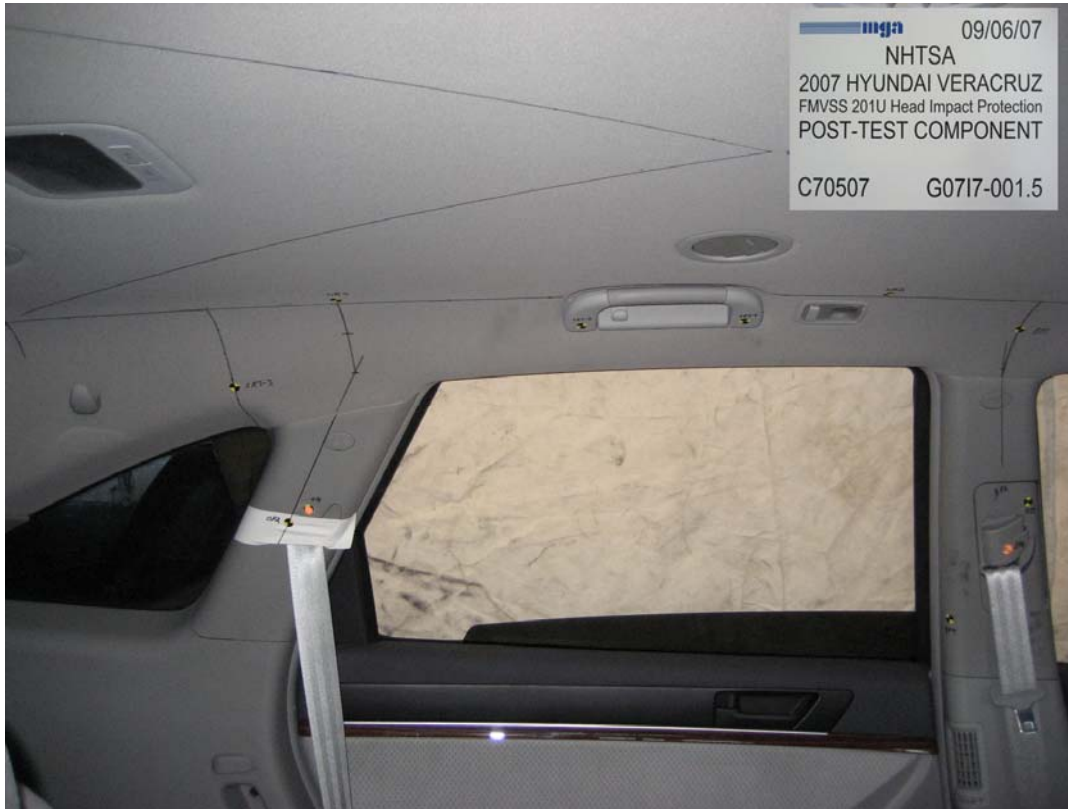
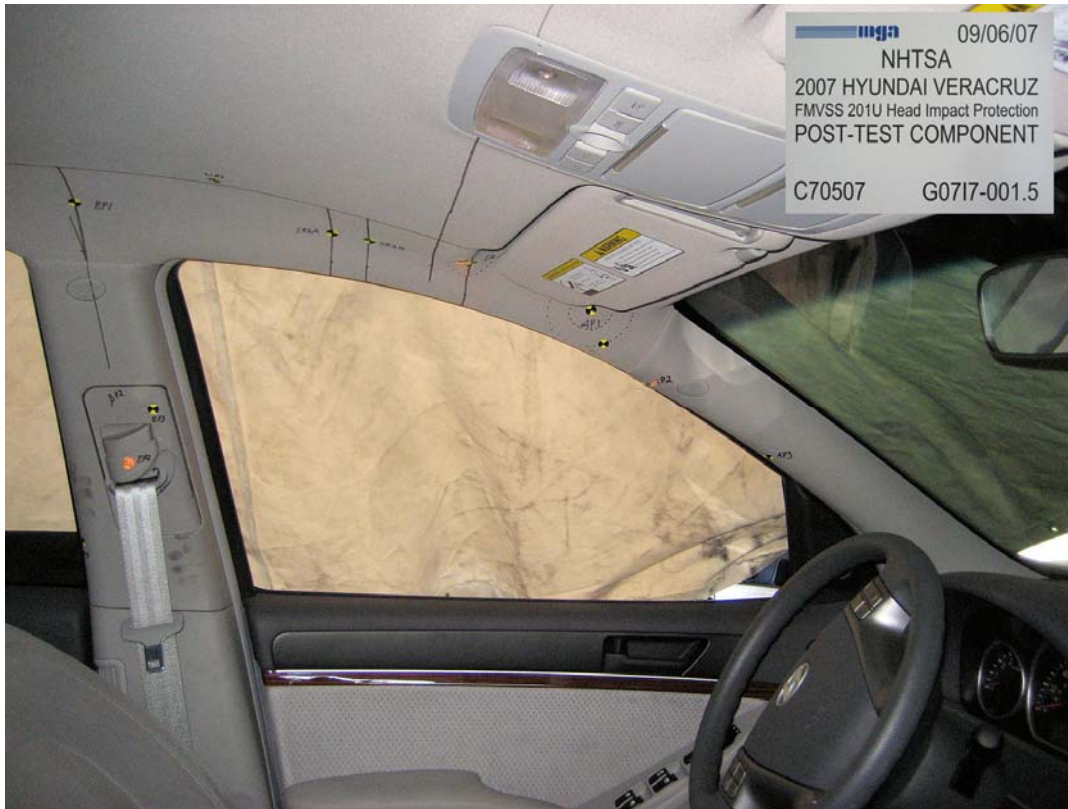
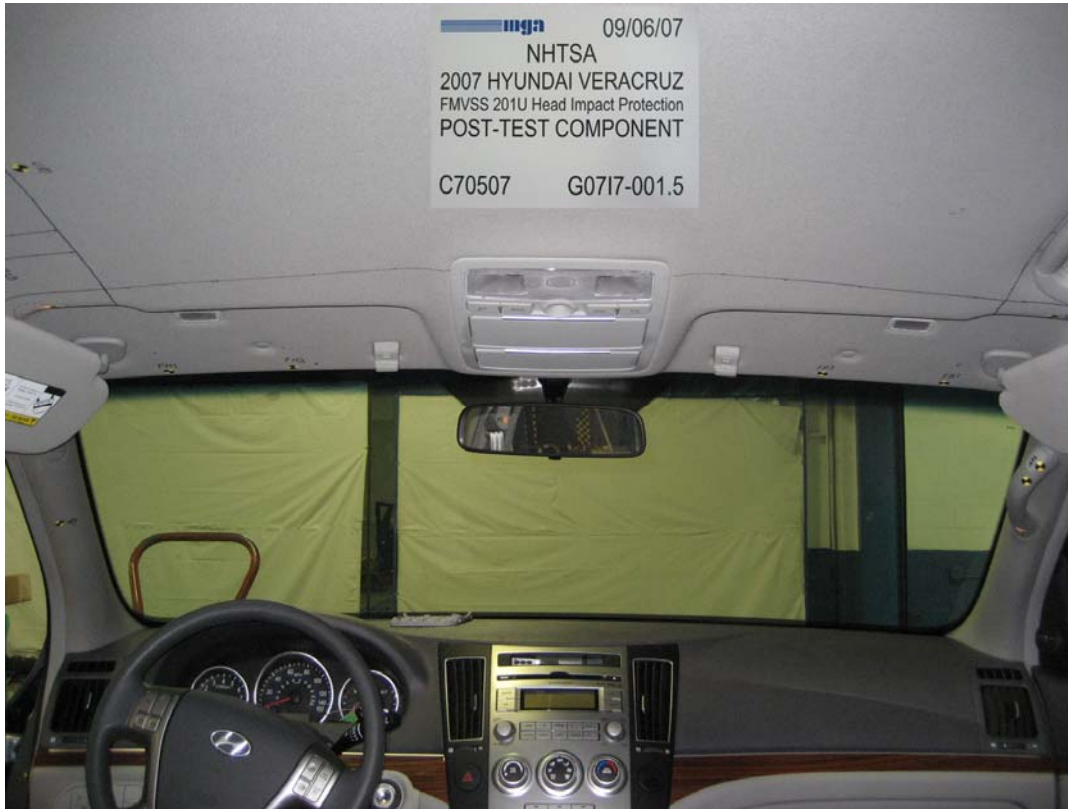
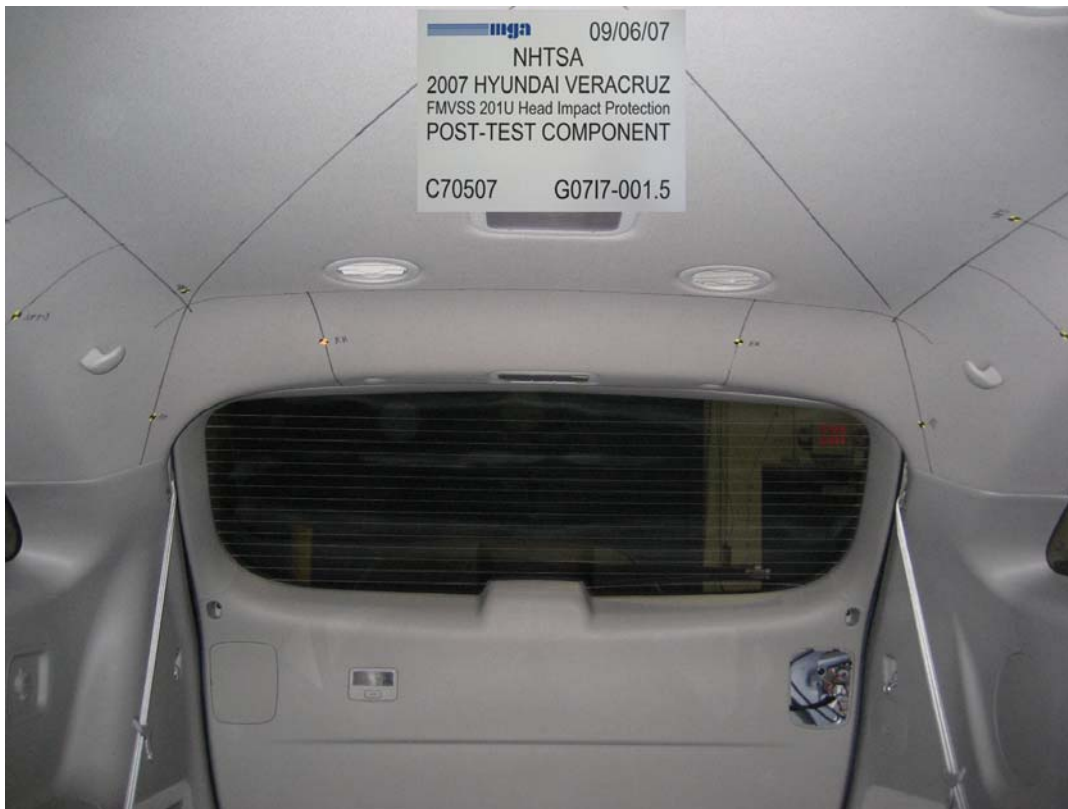
Post-Test Component Photographs

BP2 Left: D-ring cover displacement.

RP2 Left: Seat belt path trim displacement.
