FINAL REPORT NUMBER 201UI-MGA-07-06

**SAFETY COMPLIANCE TESTING FOR FMVSS 201  
Occupant Protection In Interior Impact  
Upper Interior Head Impact Protection**

**HONDA MOTOR CO., LTD.  
2007 Honda Fit, 5-Door Sport  
NHTSA No. C75302**

**MGA RESEARCH CORPORATION  
446 Executive Drive  
Troy, Michigan 48083**

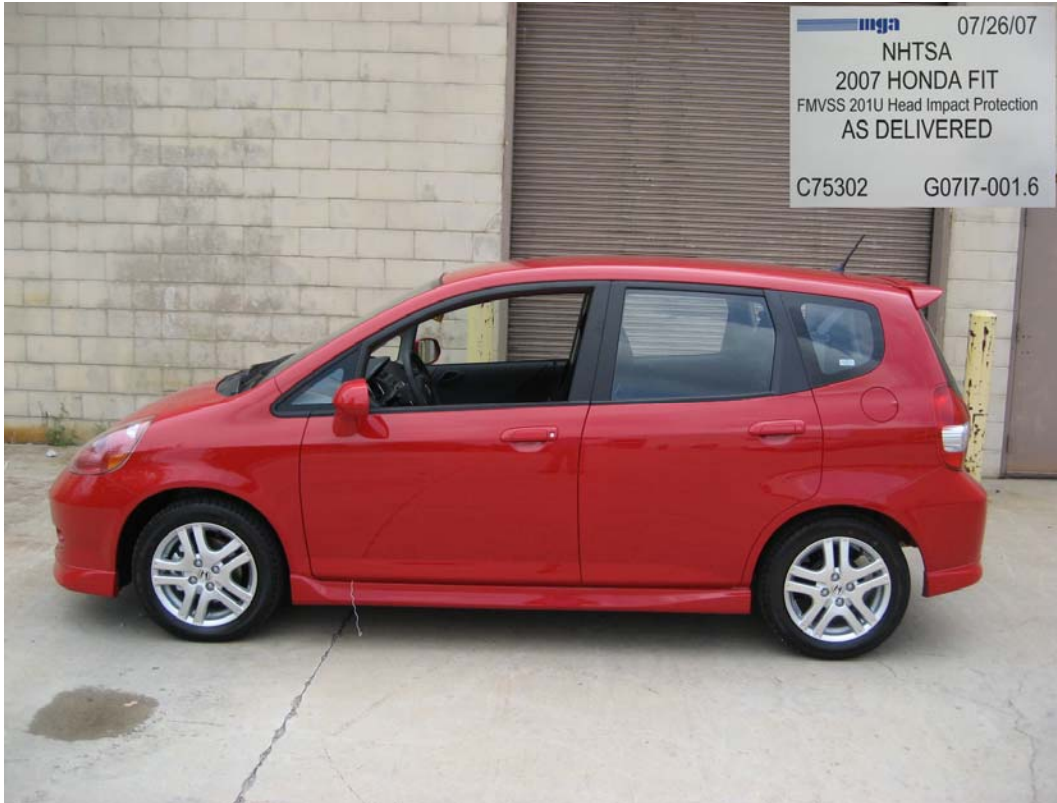
**As Delivered – Left Side View**

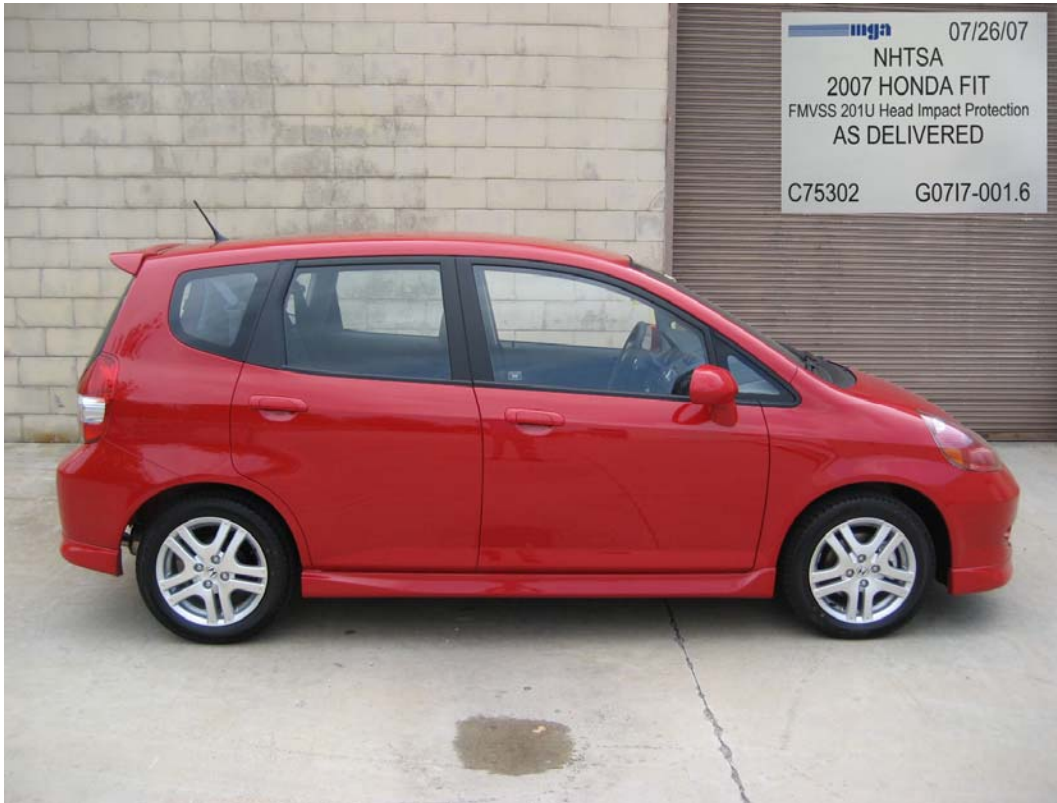
**As Delivered – Right Side View**

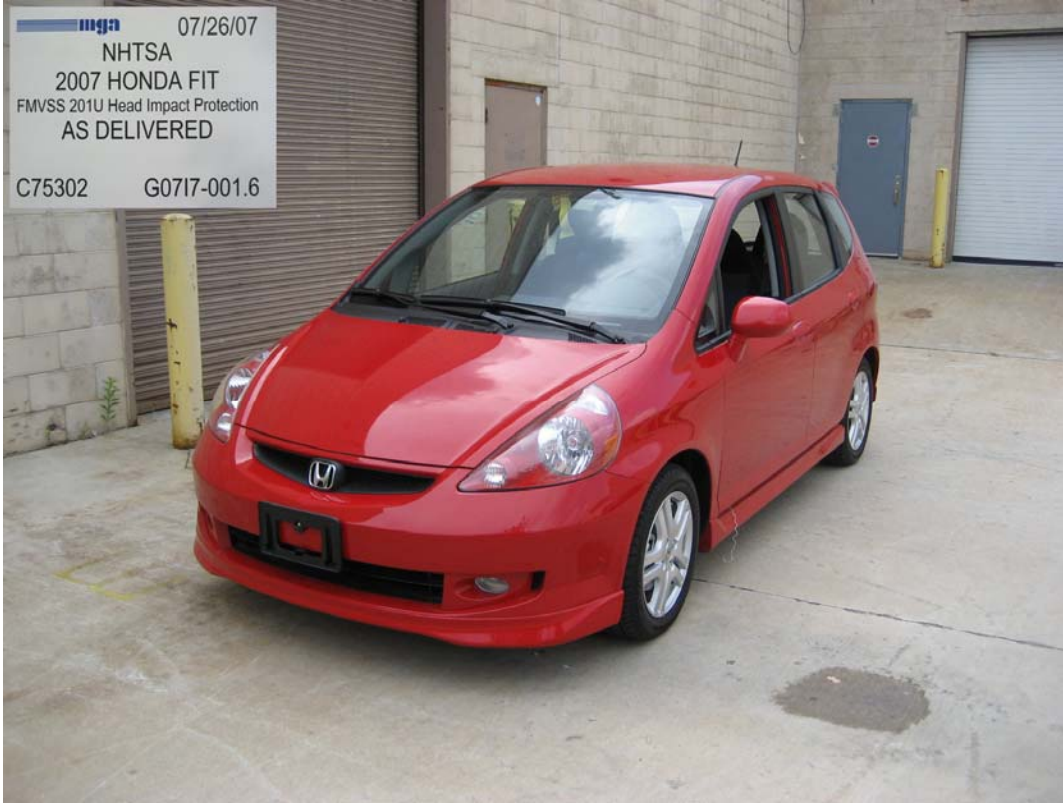
**As Delivered – ¾ Front View From Left Side**

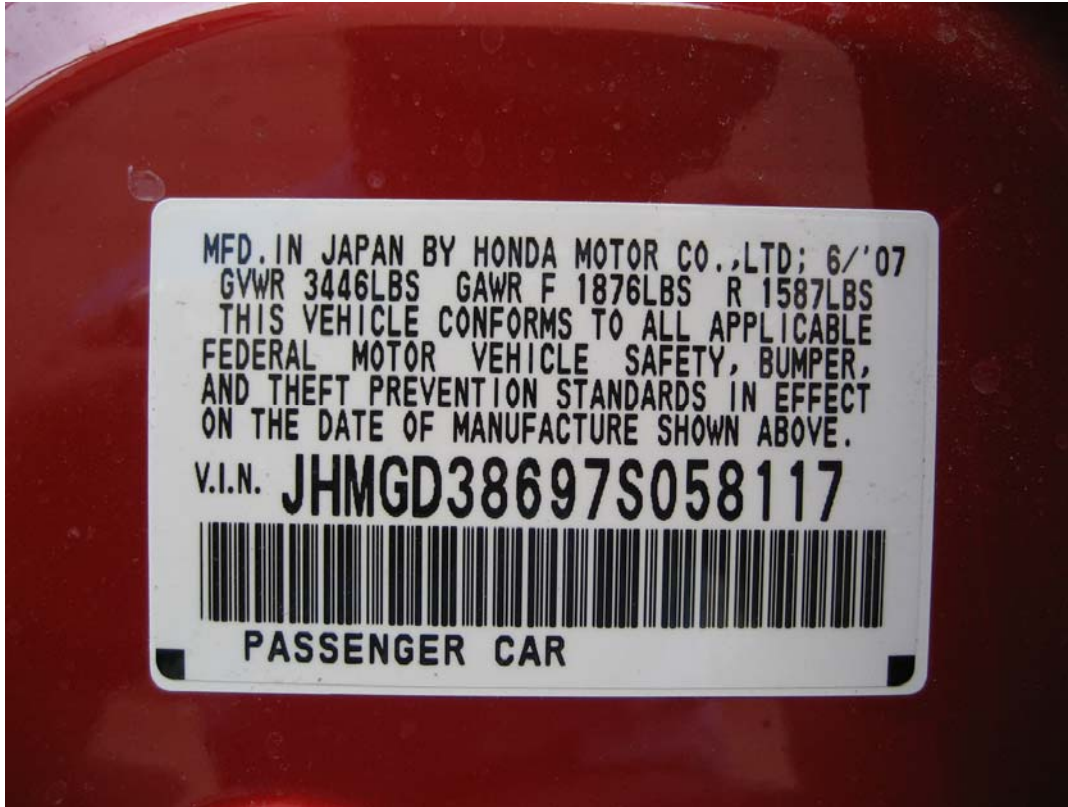
As Delivered – Vehicle’s Certification Label

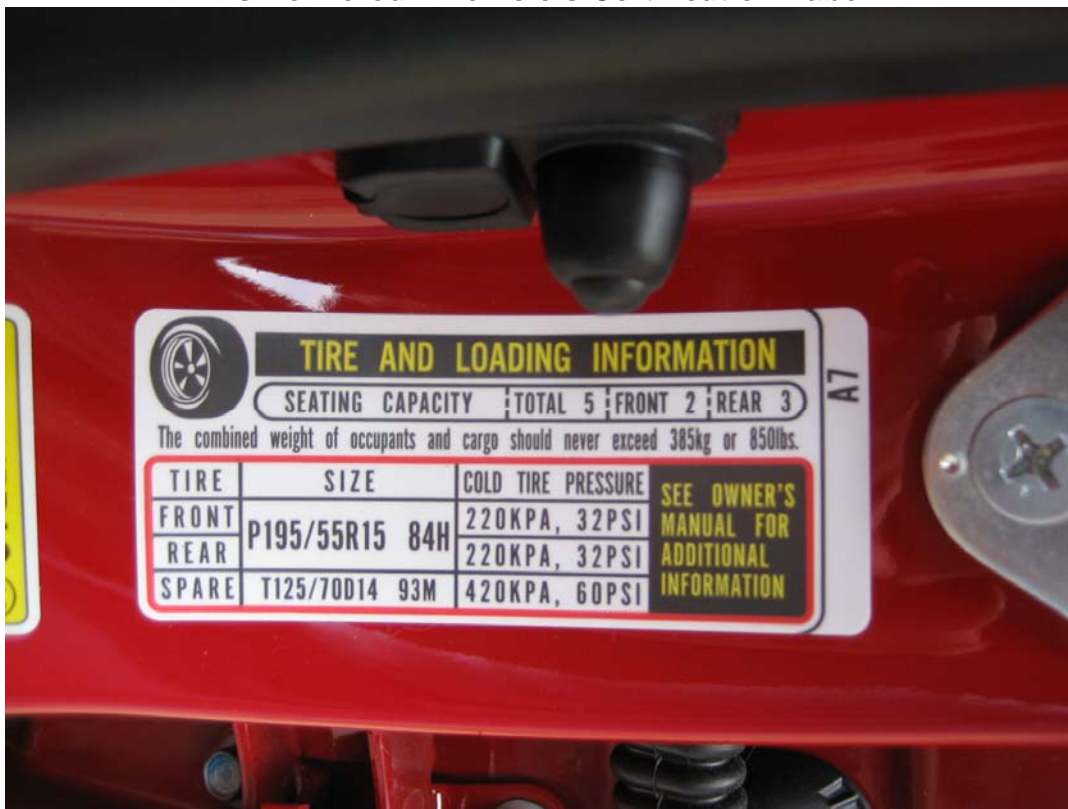
As Delivered – Vehicle’s Tire Information Label

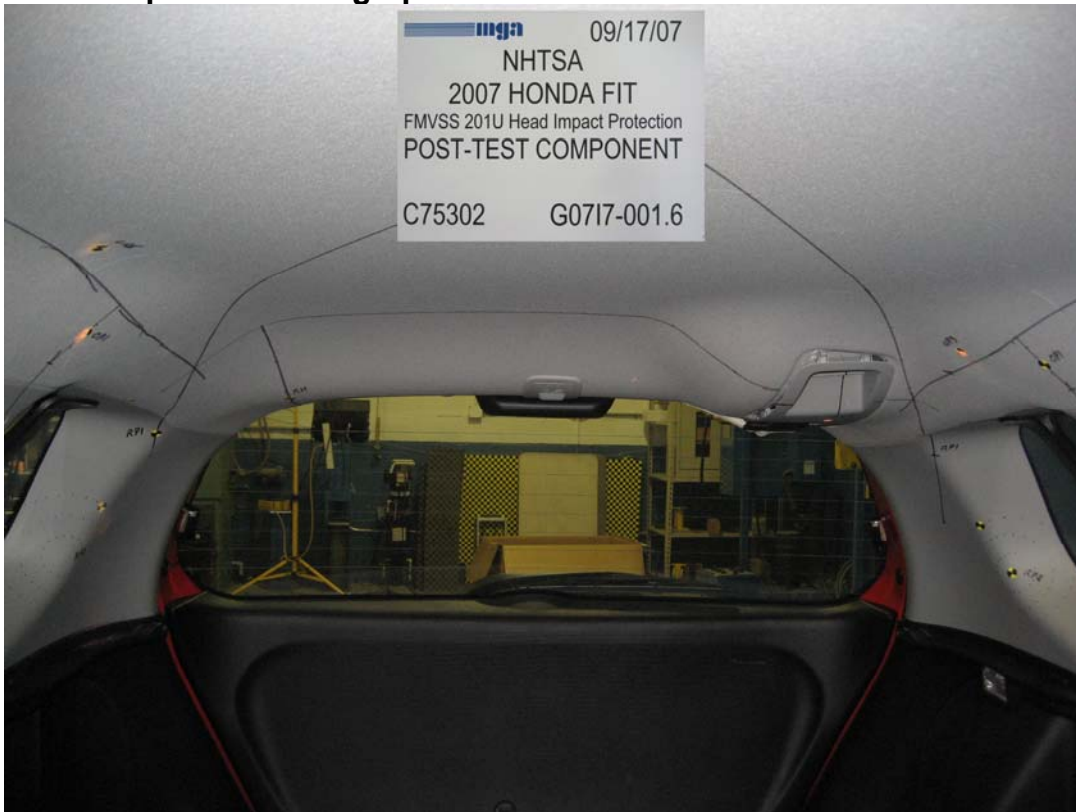
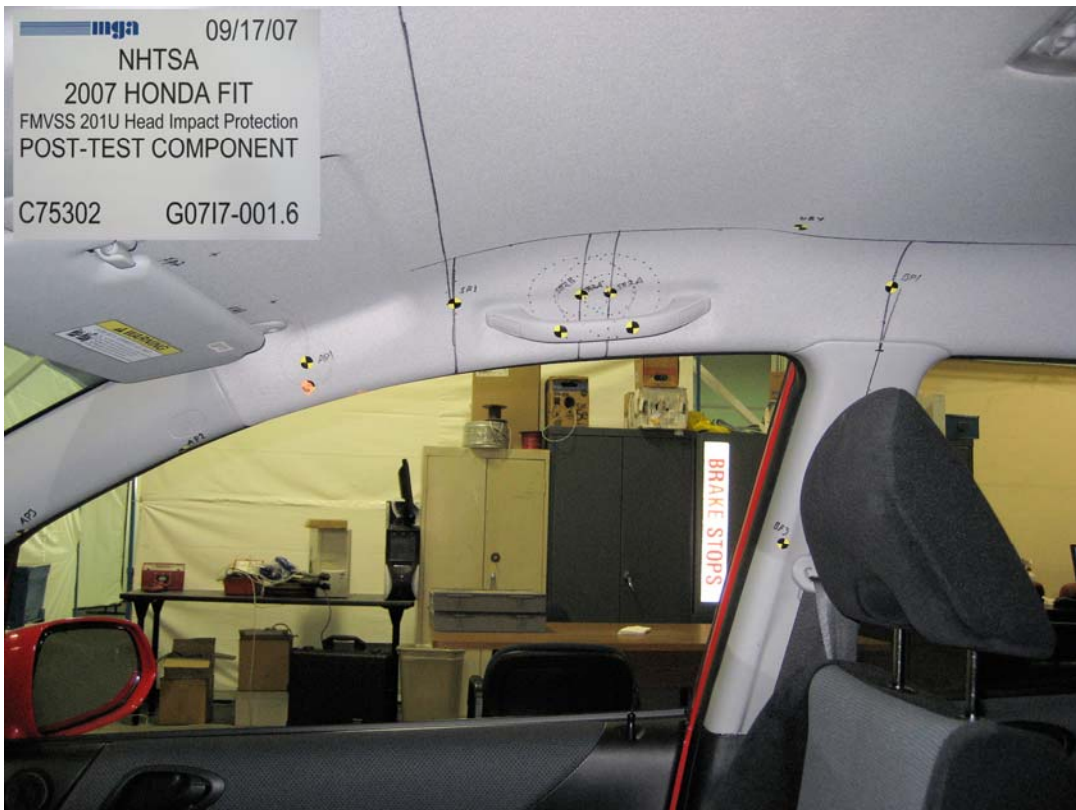
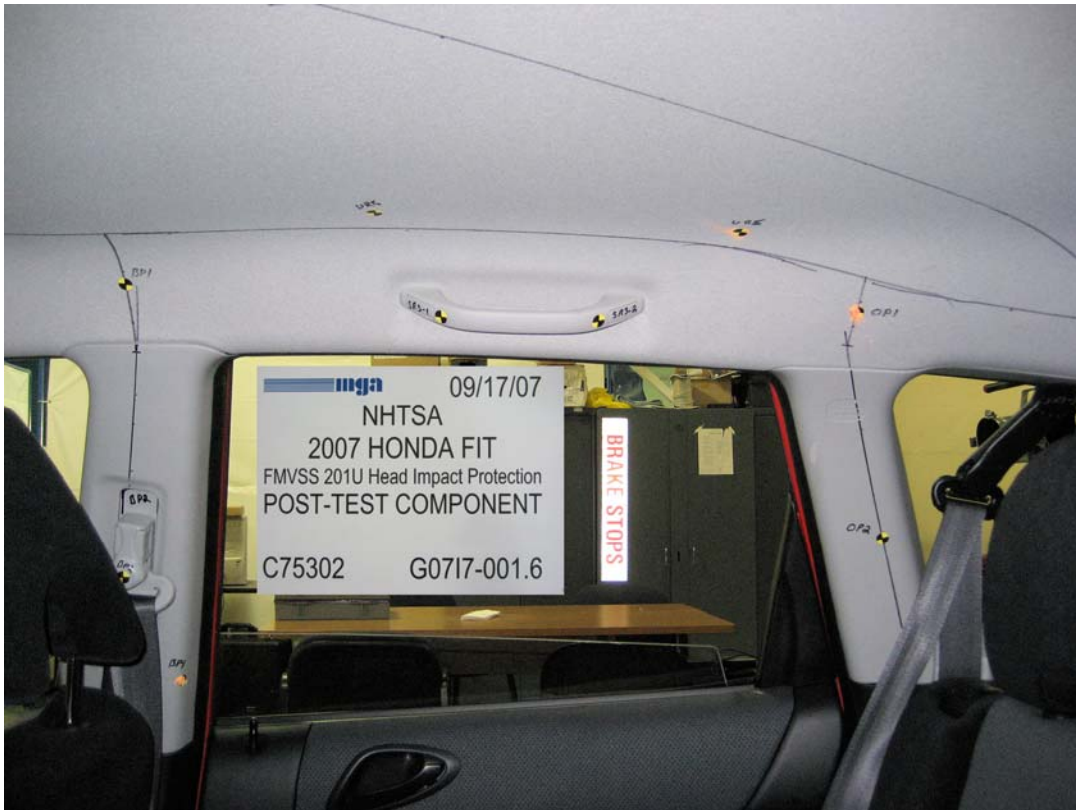
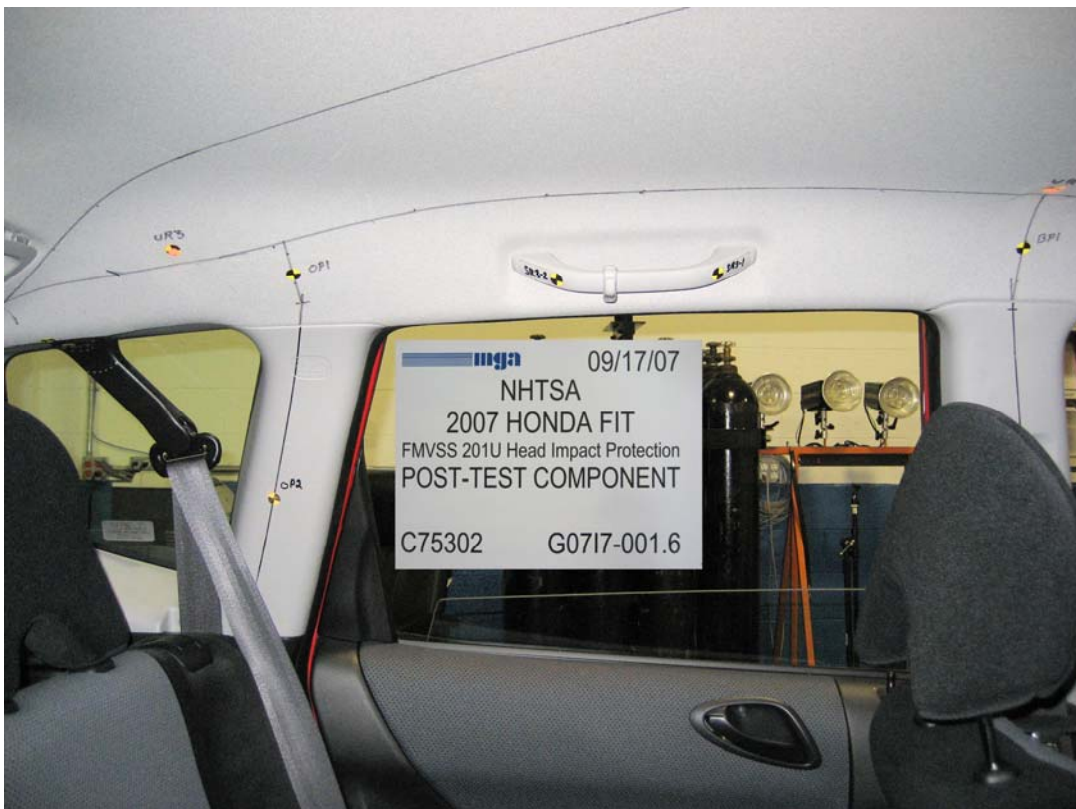
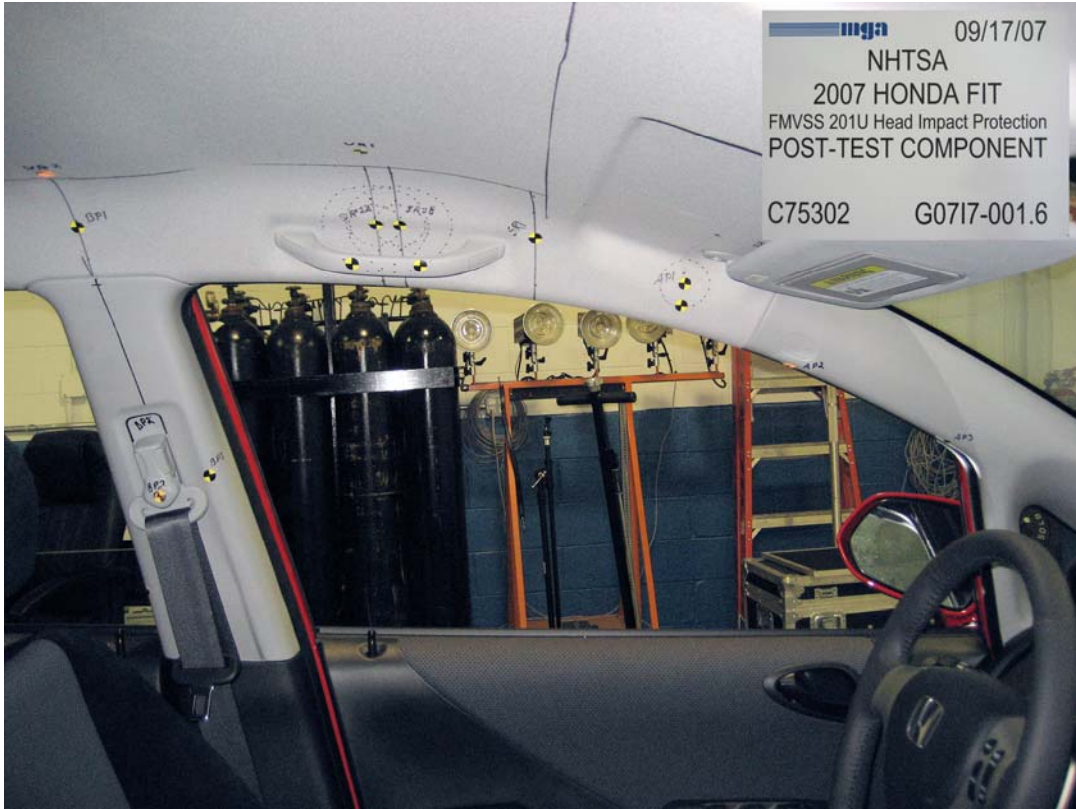
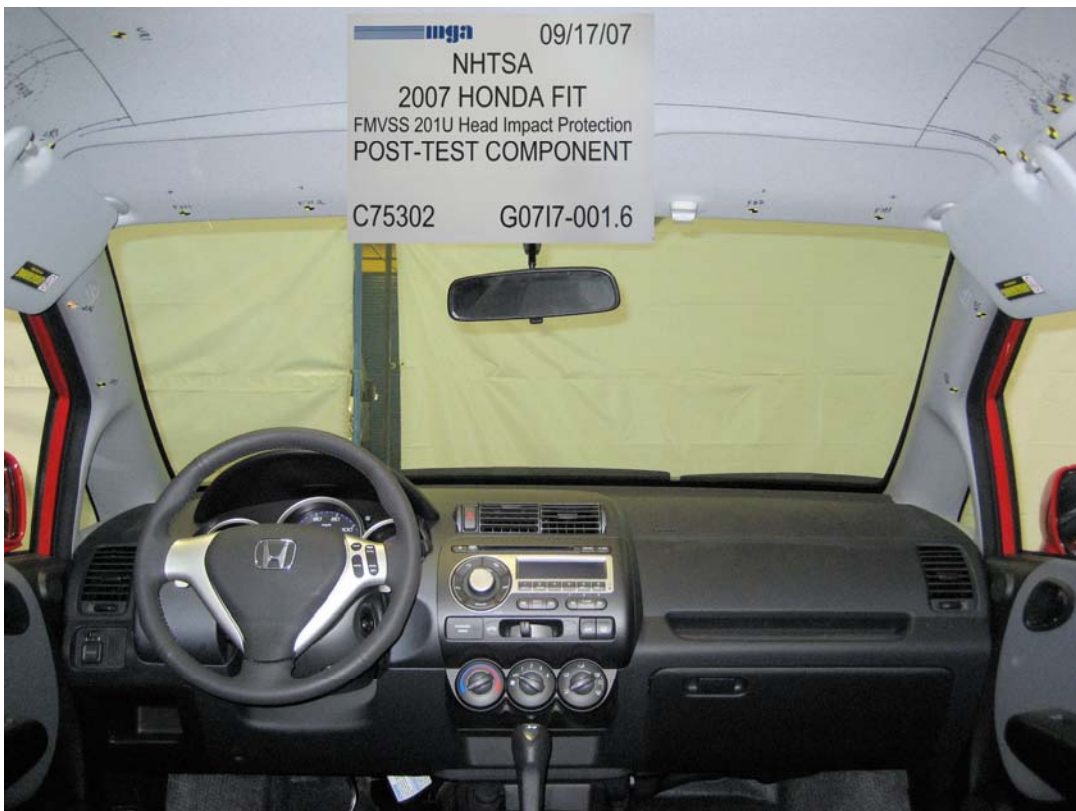
### Post-Test Component Photographs

AP2 Left: Slight displacement on top of A-Pillar trim.

BP4 Right: Slight displacement on bottom of B-Pillar trim.

RH Left: Seat belt retractor cover displacement.

UR2 Left: Indent on upper roof.
