REPORT NUMBER 103-GTL-07-005

**SAFETY COMPLIANCE TESTING FOR  
FMVSS NO. 103  
WINDSHIELD DEFROSTING AND  
DEFOGGING SYSTEMS**

**HONDA MOTOR CO.  
2007 HONDA FIT, PASSENGER CAR  
NHTSA NO. C75300**

**FINAL REPORT**

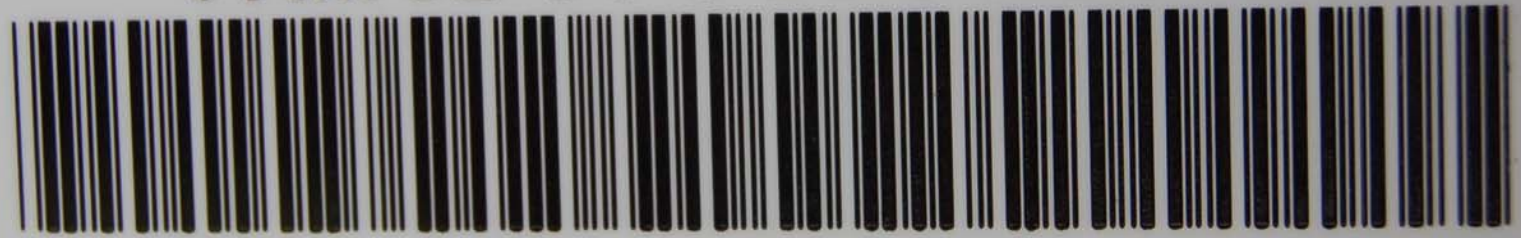
FIGURE 5.5  
VEHICLE CERTIFICATION LABEL

MFD. IN JAPAN BY HONDA MOTOR CO., LTD; 6/'07  
GVWR 3446LBS GAWR F 1876LBS R 1587LBS  
THIS VEHICLE CONFORMS TO ALL APPLICABLE  
FEDERAL MOTOR VEHICLE SAFETY, BUMPER,  
AND THEFT PREVENTION STANDARDS IN EFFECT  
ON THE DATE OF MANUFACTURE SHOWN ABOVE.

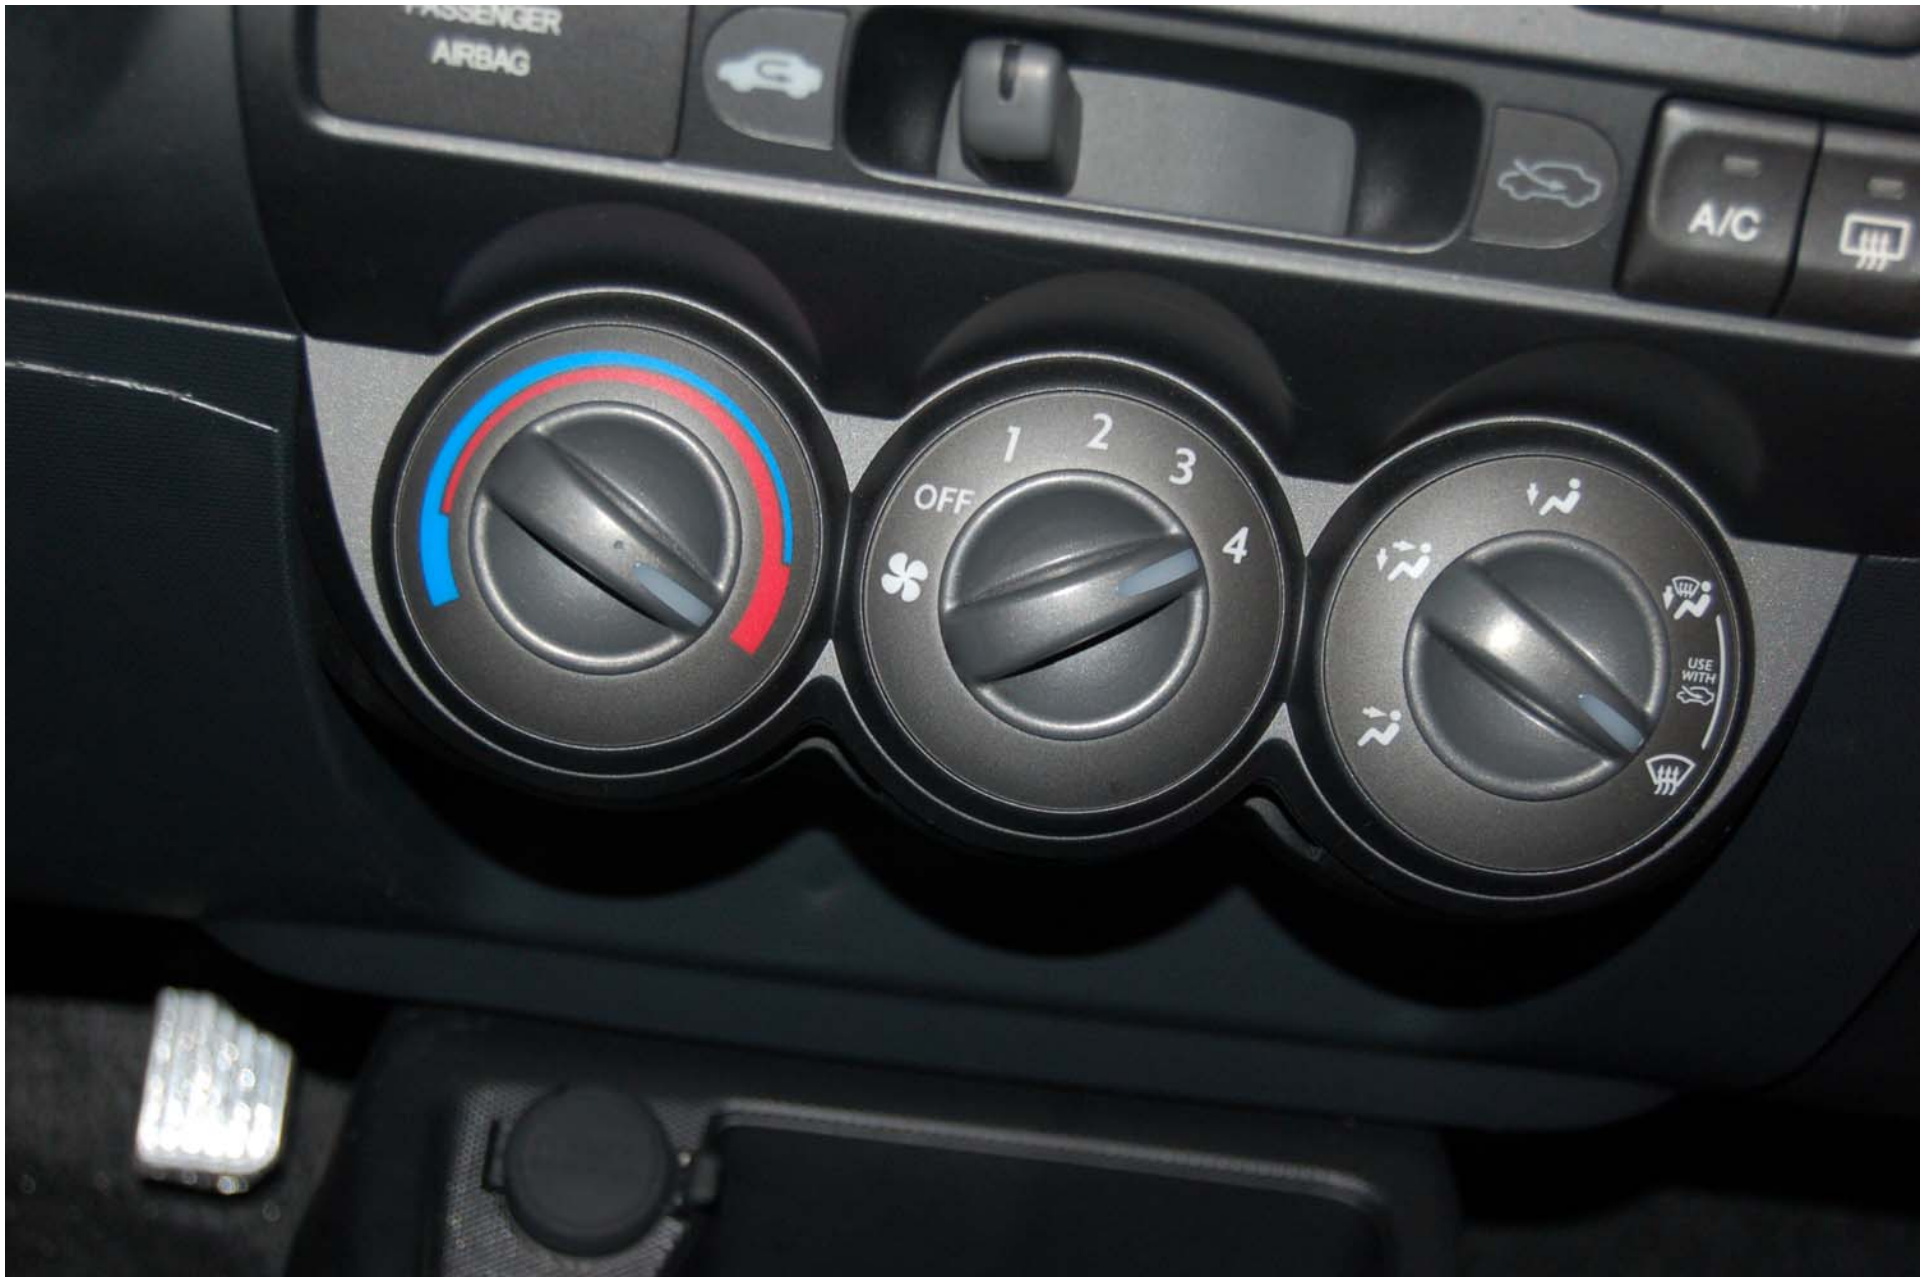
FIGURE 5.7  
CLOSE-UP VIEW OF DEFROSTER CONTROL SETTING  
ON DASH

DESCRIBE UNUSUAL FEATURES OF DEFROSTING SYSTEM: Close side defroster  
Vents and do not use A/C

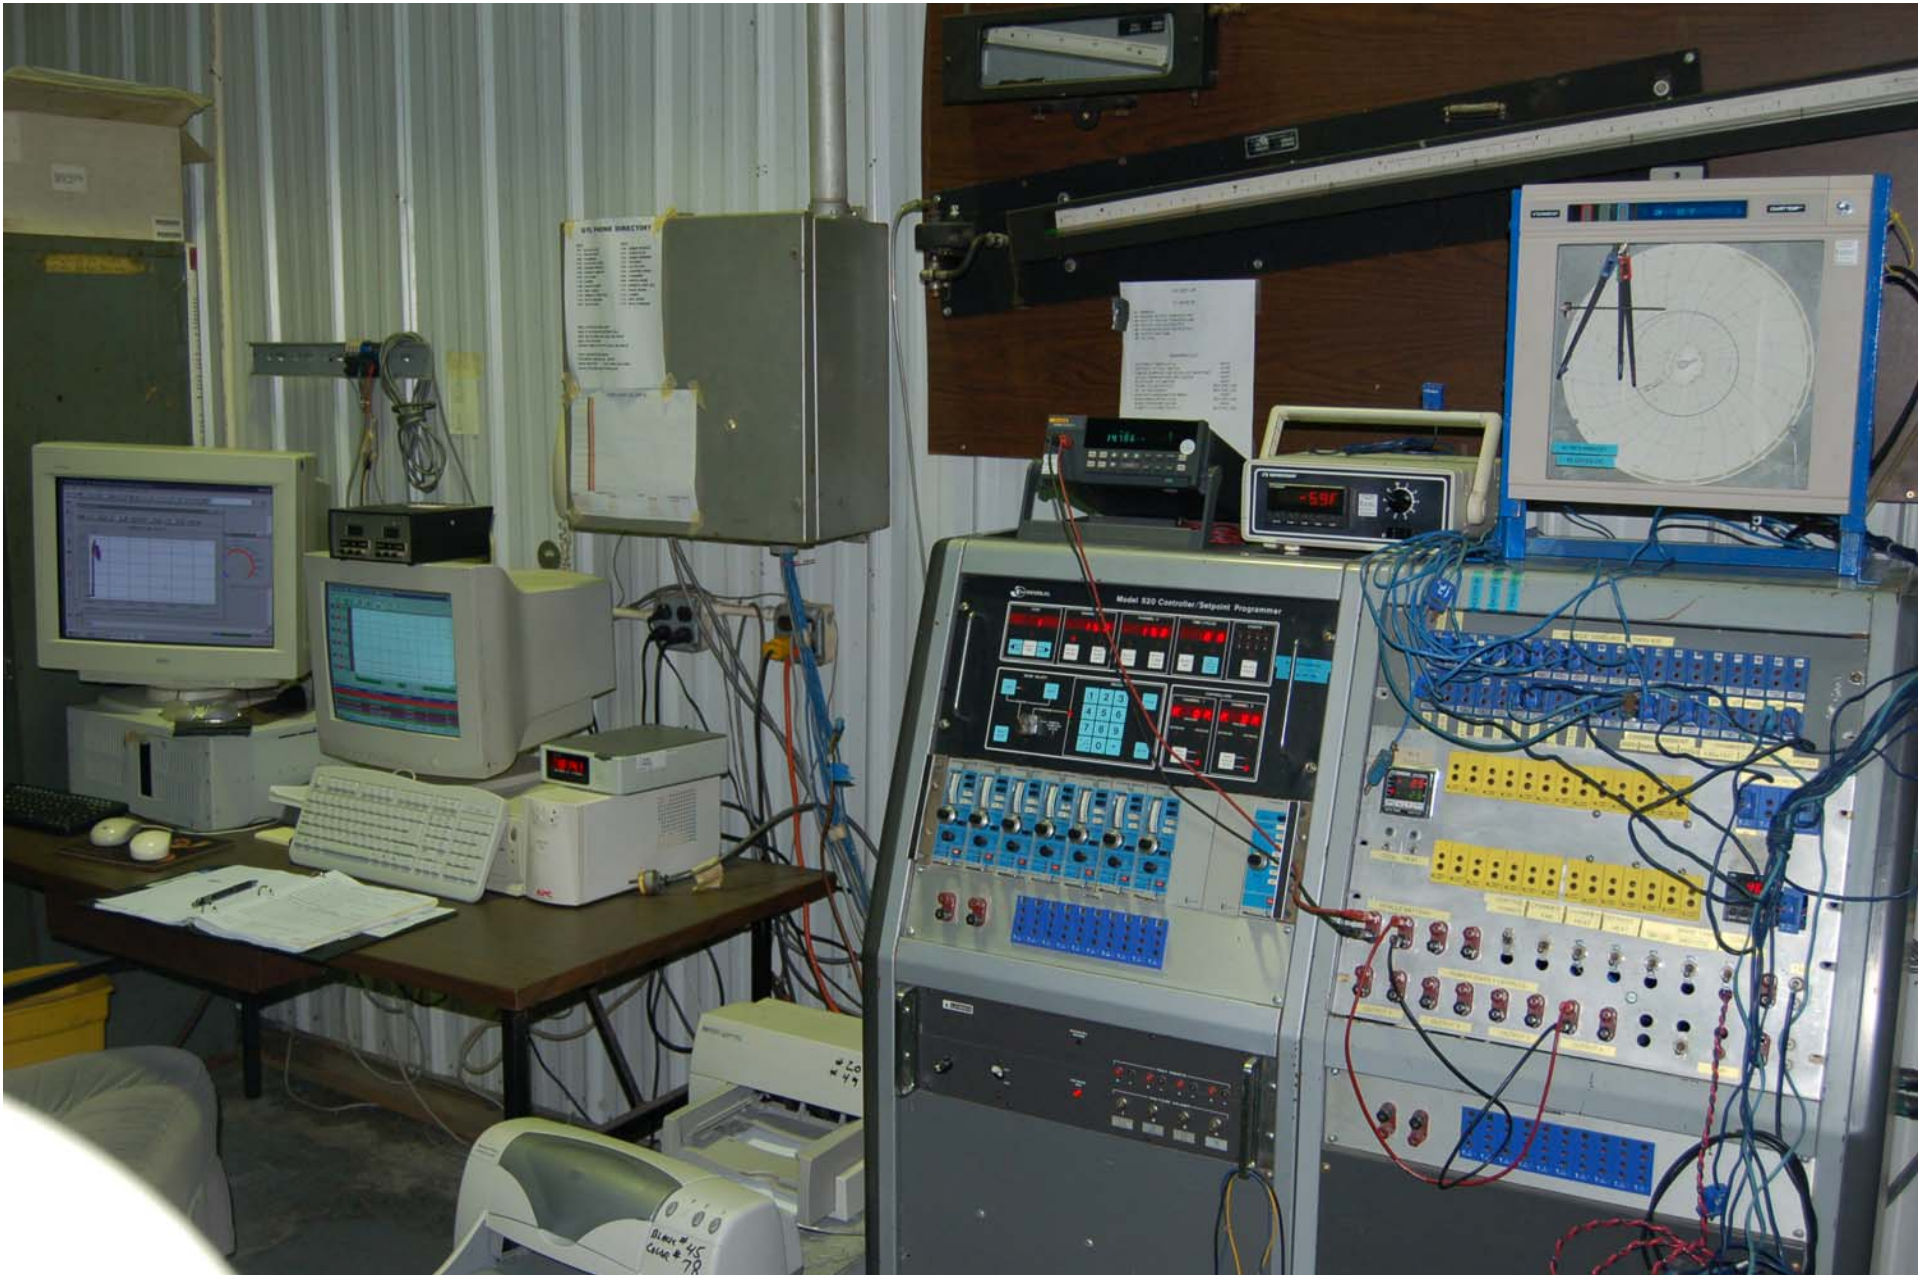
FIGURE 5.8  
INSTRUMENTATION SET-UP

REMARKS: \*Heater Water In thermocouple is located on outside of heater hose due to location of fittings.

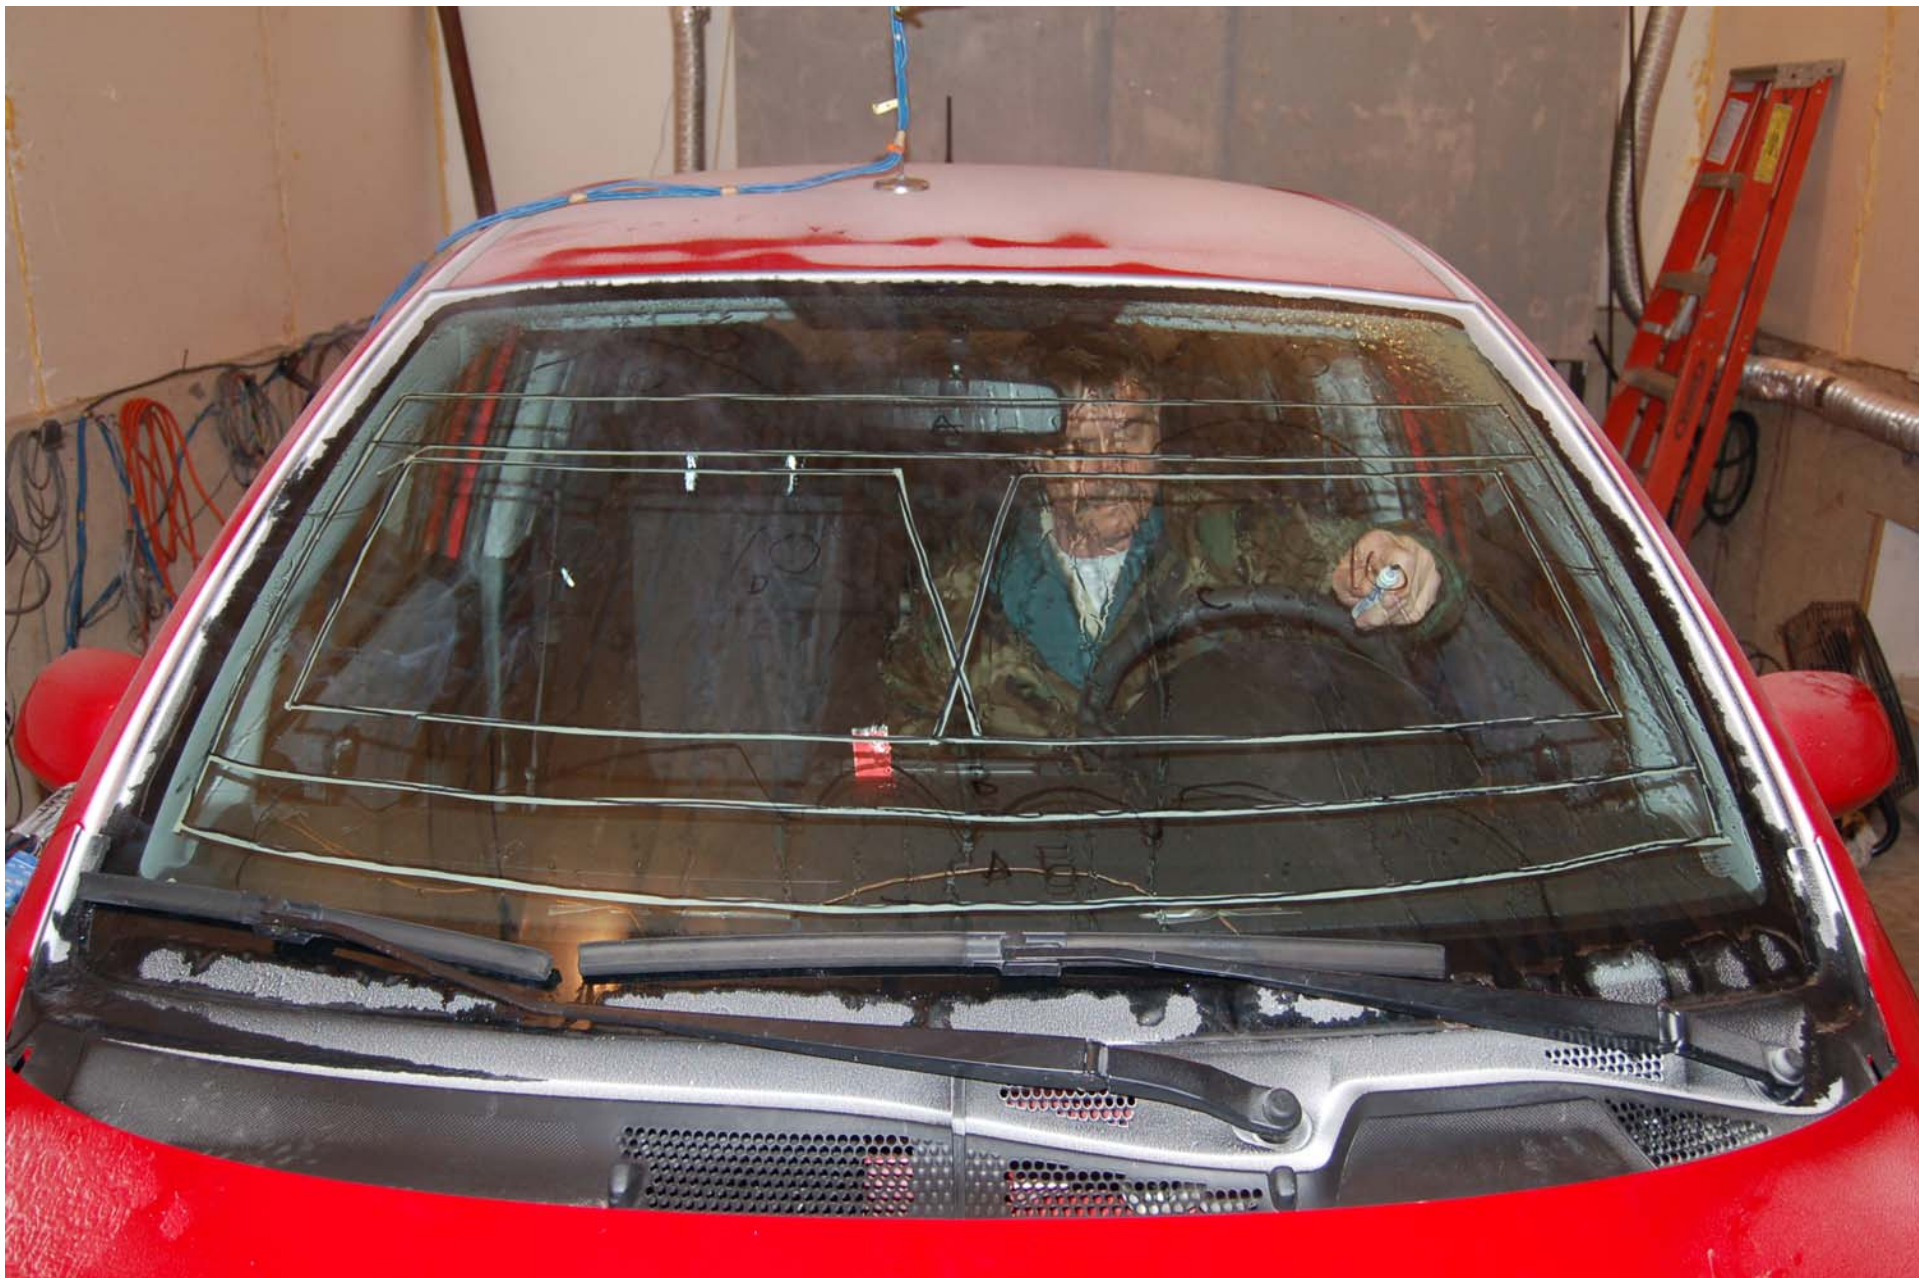
FIGURE 5.10  
DEFROSTED AREA AT 15 MINUTES TEST #1

TIME FROM START (minutes)	MOTOR VOLTAGE (volts)	TEMPERATURE, °F					DEFROSTED AREA, %		
		TEST ROOM	ENGINE WATER	HEATER WATER IN	DEFROSTER AIR		A	C	D
					DRVR	PSGR			
0	13.5	-1.0	-.7	-.7*	-.5	-.2	0%	0%	0%
5	14.8	-1.3	31.0	53.6*	79.5	87.5	13.5%	0%	0%
10	14.7	-.2	73.6	111.9*	133.2	136.5	89.1%	95.1%	100%
15	14.6	0.0	114.9	145.7*	152.4	158.2	100%	100%	100%

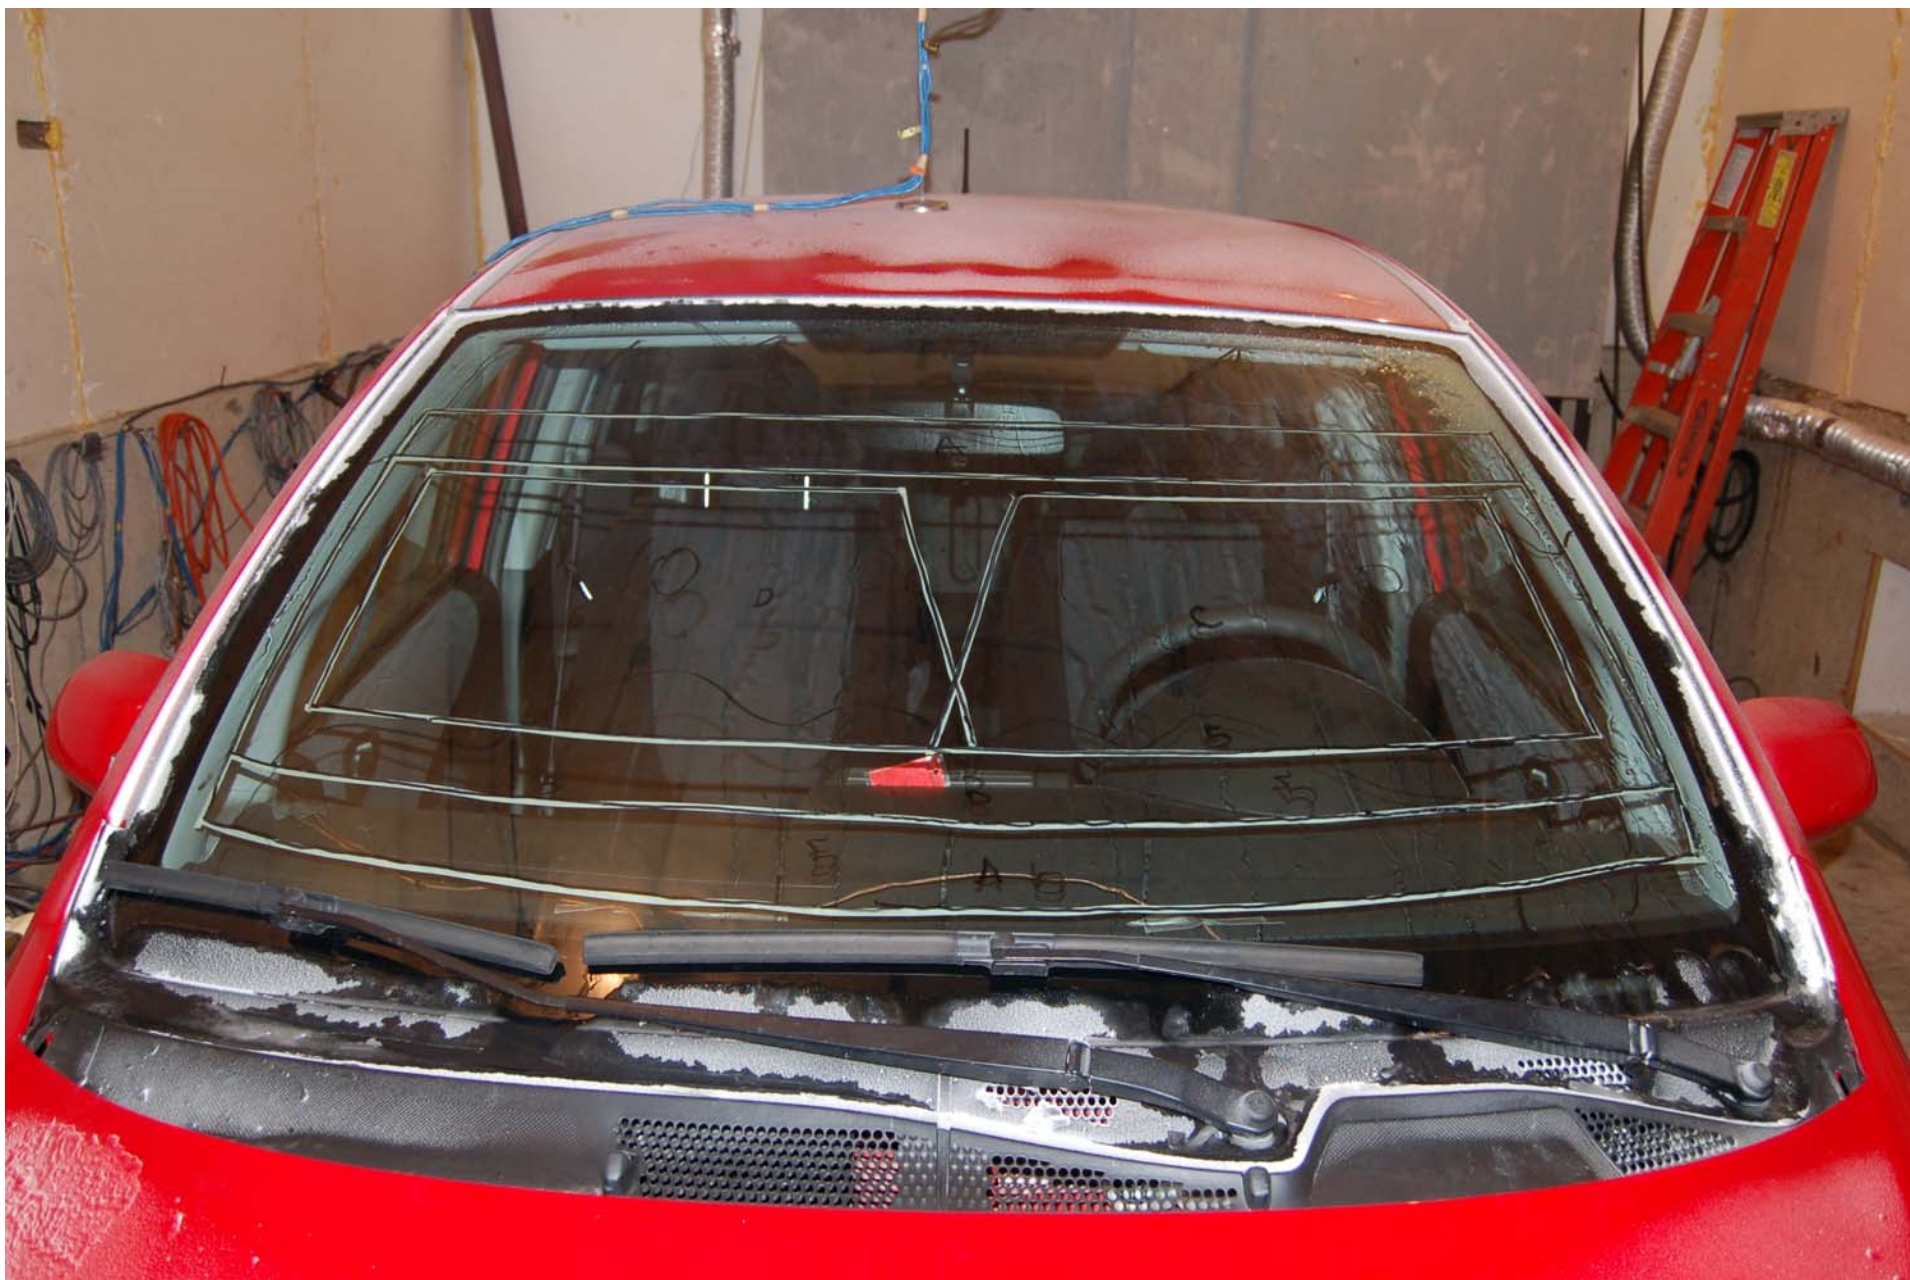
FIGURE 5.13  
DEFROSTED AREA AT 15 MINUTES TEST #2

TIME FROM START (minutes)	MOTOR VOLTAGE (volts)	TEMPERATURE, °F					DEFROSTED AREA, %		
		TEST ROOM	ENGINE WATER	HEATER WATER IN	DEFROSTER AIR		A	C	D
					DRVR	PSGR			
0	13.5	-0.7	-0.5	0.0*	-0.4	-0.3	0%	0%	0%
5	14.7	-1.7	33.2	76.3*	103.7	106.9	24.2%	4.2%	10.3%
10	14.6	-1.1	87.3	131.1*	140.0	144.7	97.0%	99.7%	100%
15	14.6	0.7	122.5	158.1*	163.8	169.9	100%	100%	100%
