REPORT NUMBER: 201UI-CAL-08-04

**SAFETY COMPLIANCE TESTING FOR FMVSS 201
OCCUPANT PROTECTION IN INTERIOR IMPACT
UPPER INTERIOR HEAD IMPACT PROTECTION**

**BAYERISCHE MOTORENWERKE
2008 BMW 328i 4-DOOR SEDAN**

NHTSA NUMBER: C80509

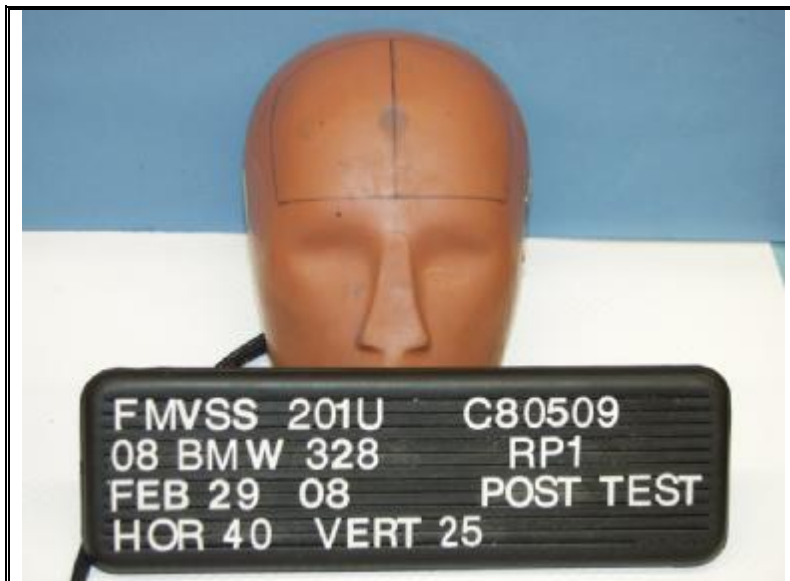
POST-IMPACT RP1 HEADFORM

Free Motion HIC	371.6
HIC(d)	446.8
Impact Velocity (kph)	18.34
HIC T1 (msec)	3.5
HIC T2 (msec)	12.7

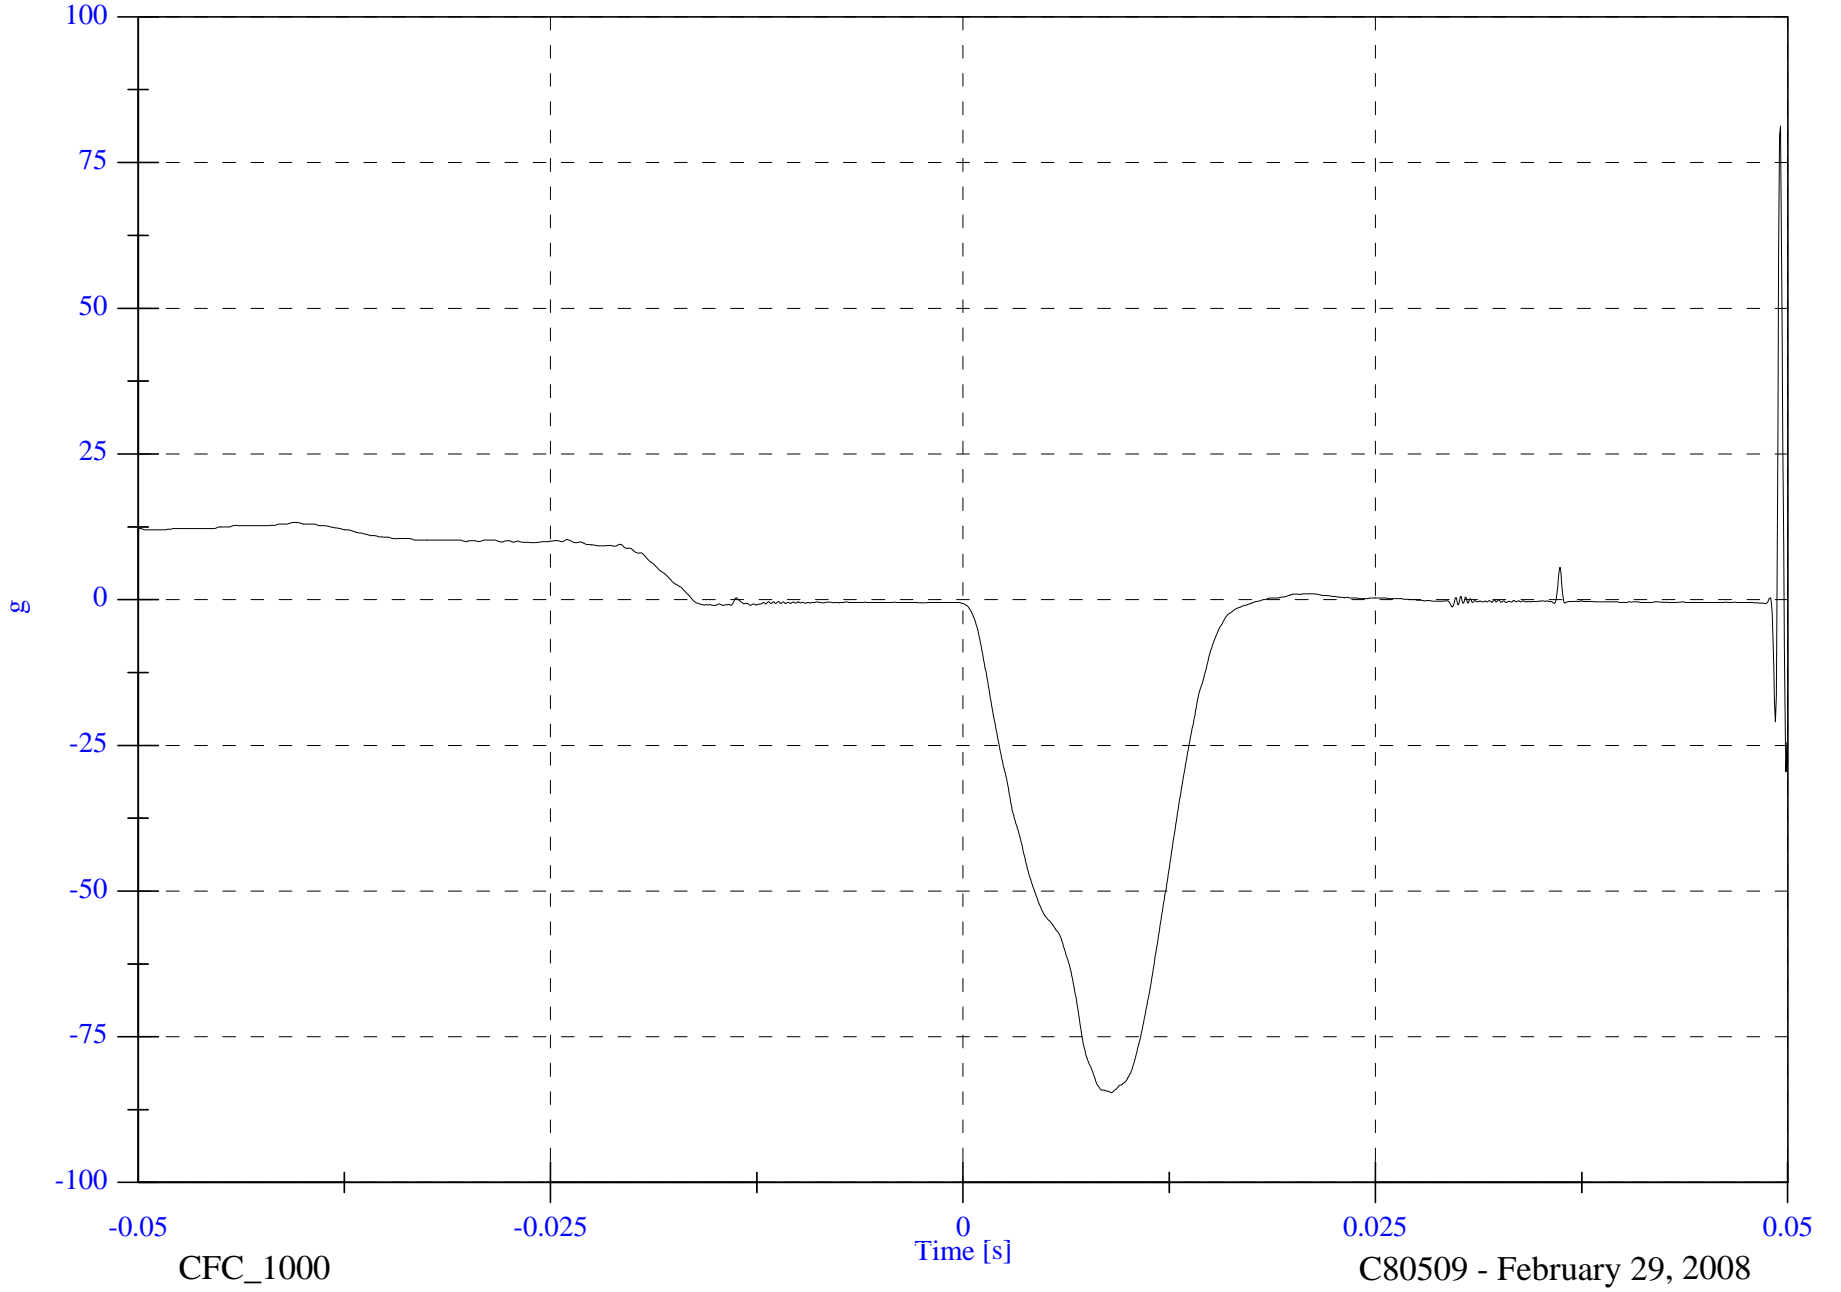
C80509 PASSENGER SIDE RPI IMPACT PLOT #2

Headform X Acceleration

Max: 81.3 [g] at 0.050 [s]

Min: -84.6 [g] at 0.009 [s]

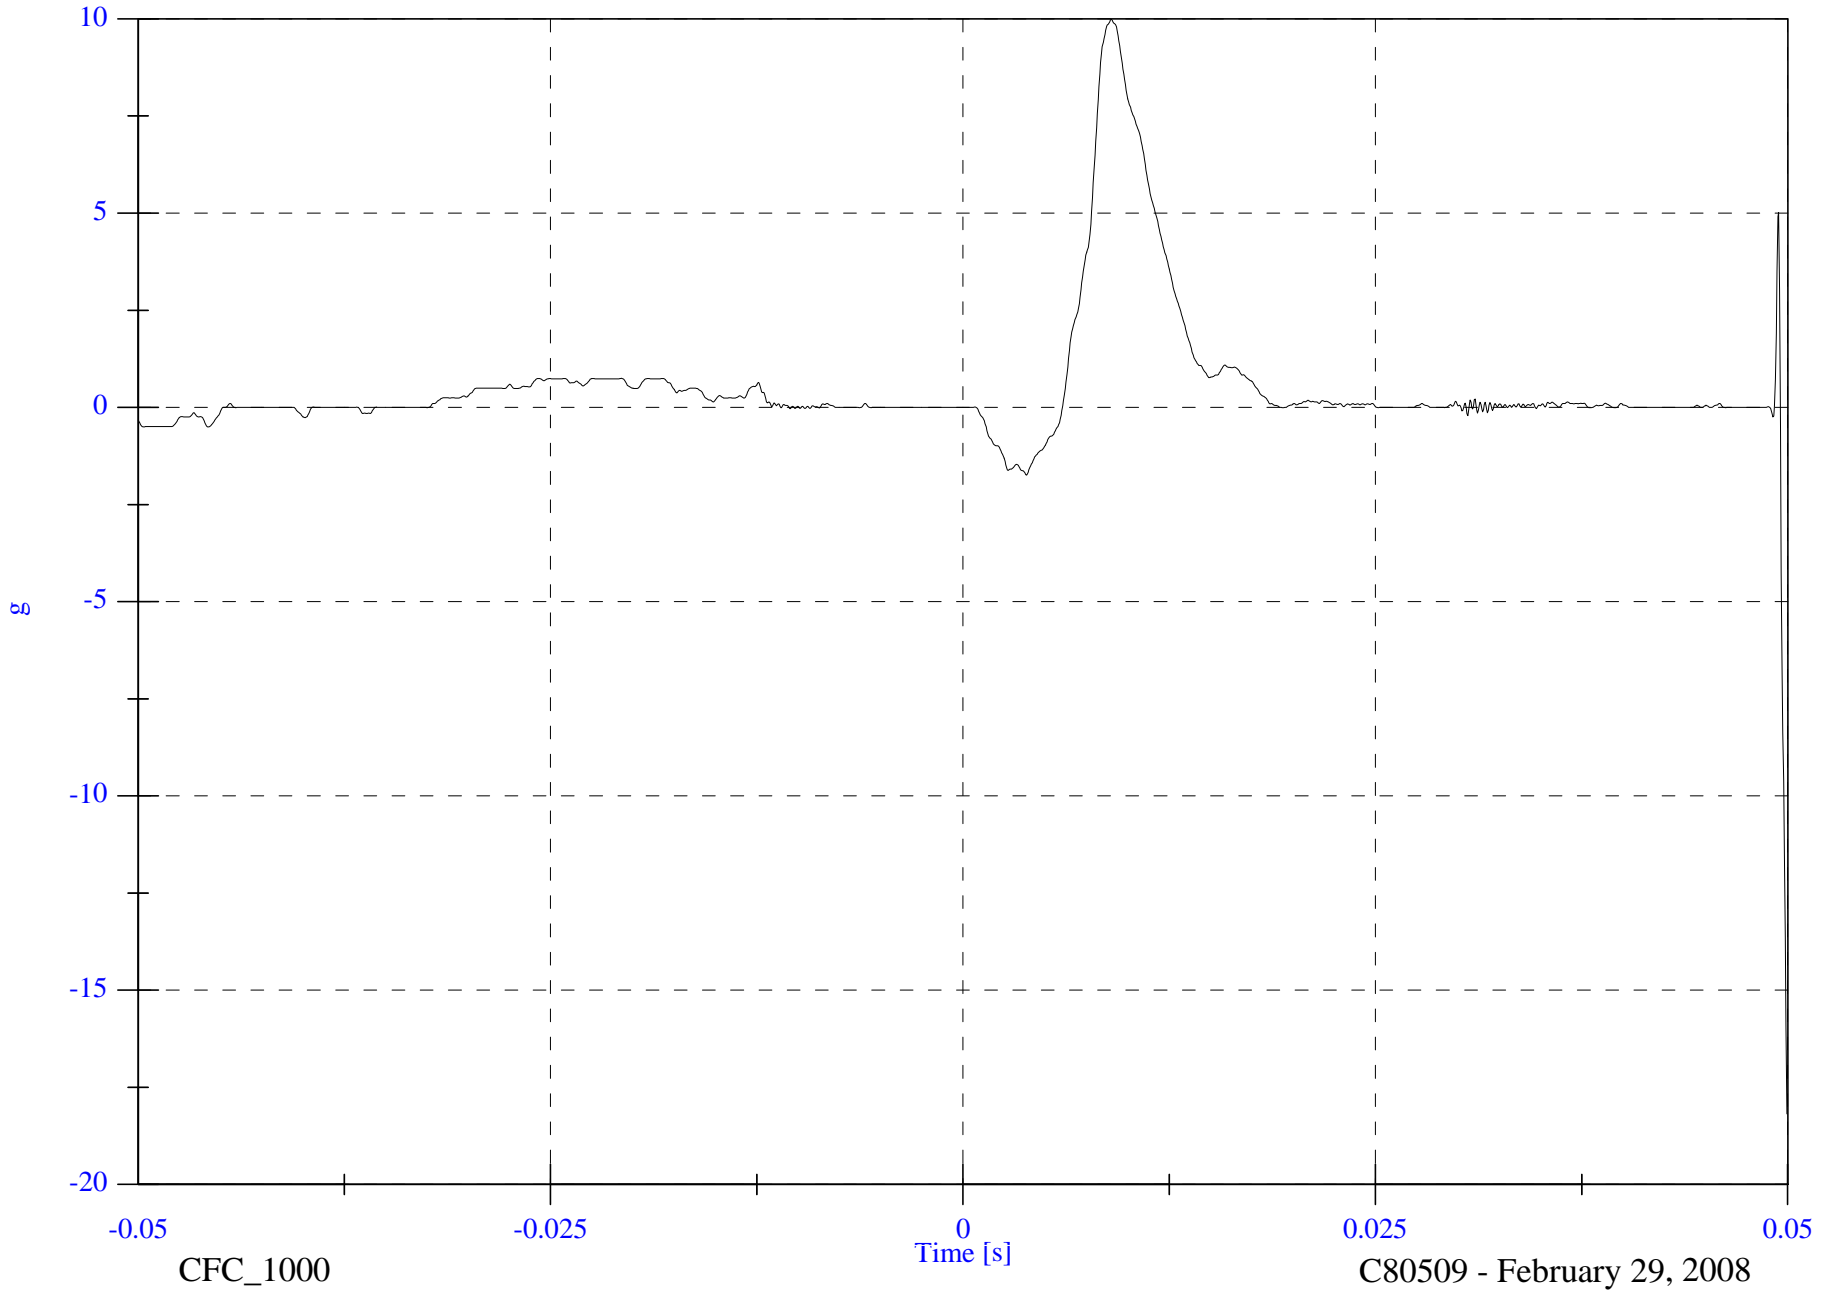
C80509 PASSENGER SIDE RPI IMPACT PLOT #3

Max: 10.0 [g] at 0.009 [s]

Min: -18.2 [g] at 0.050 [s]

Headform Y Acceleration

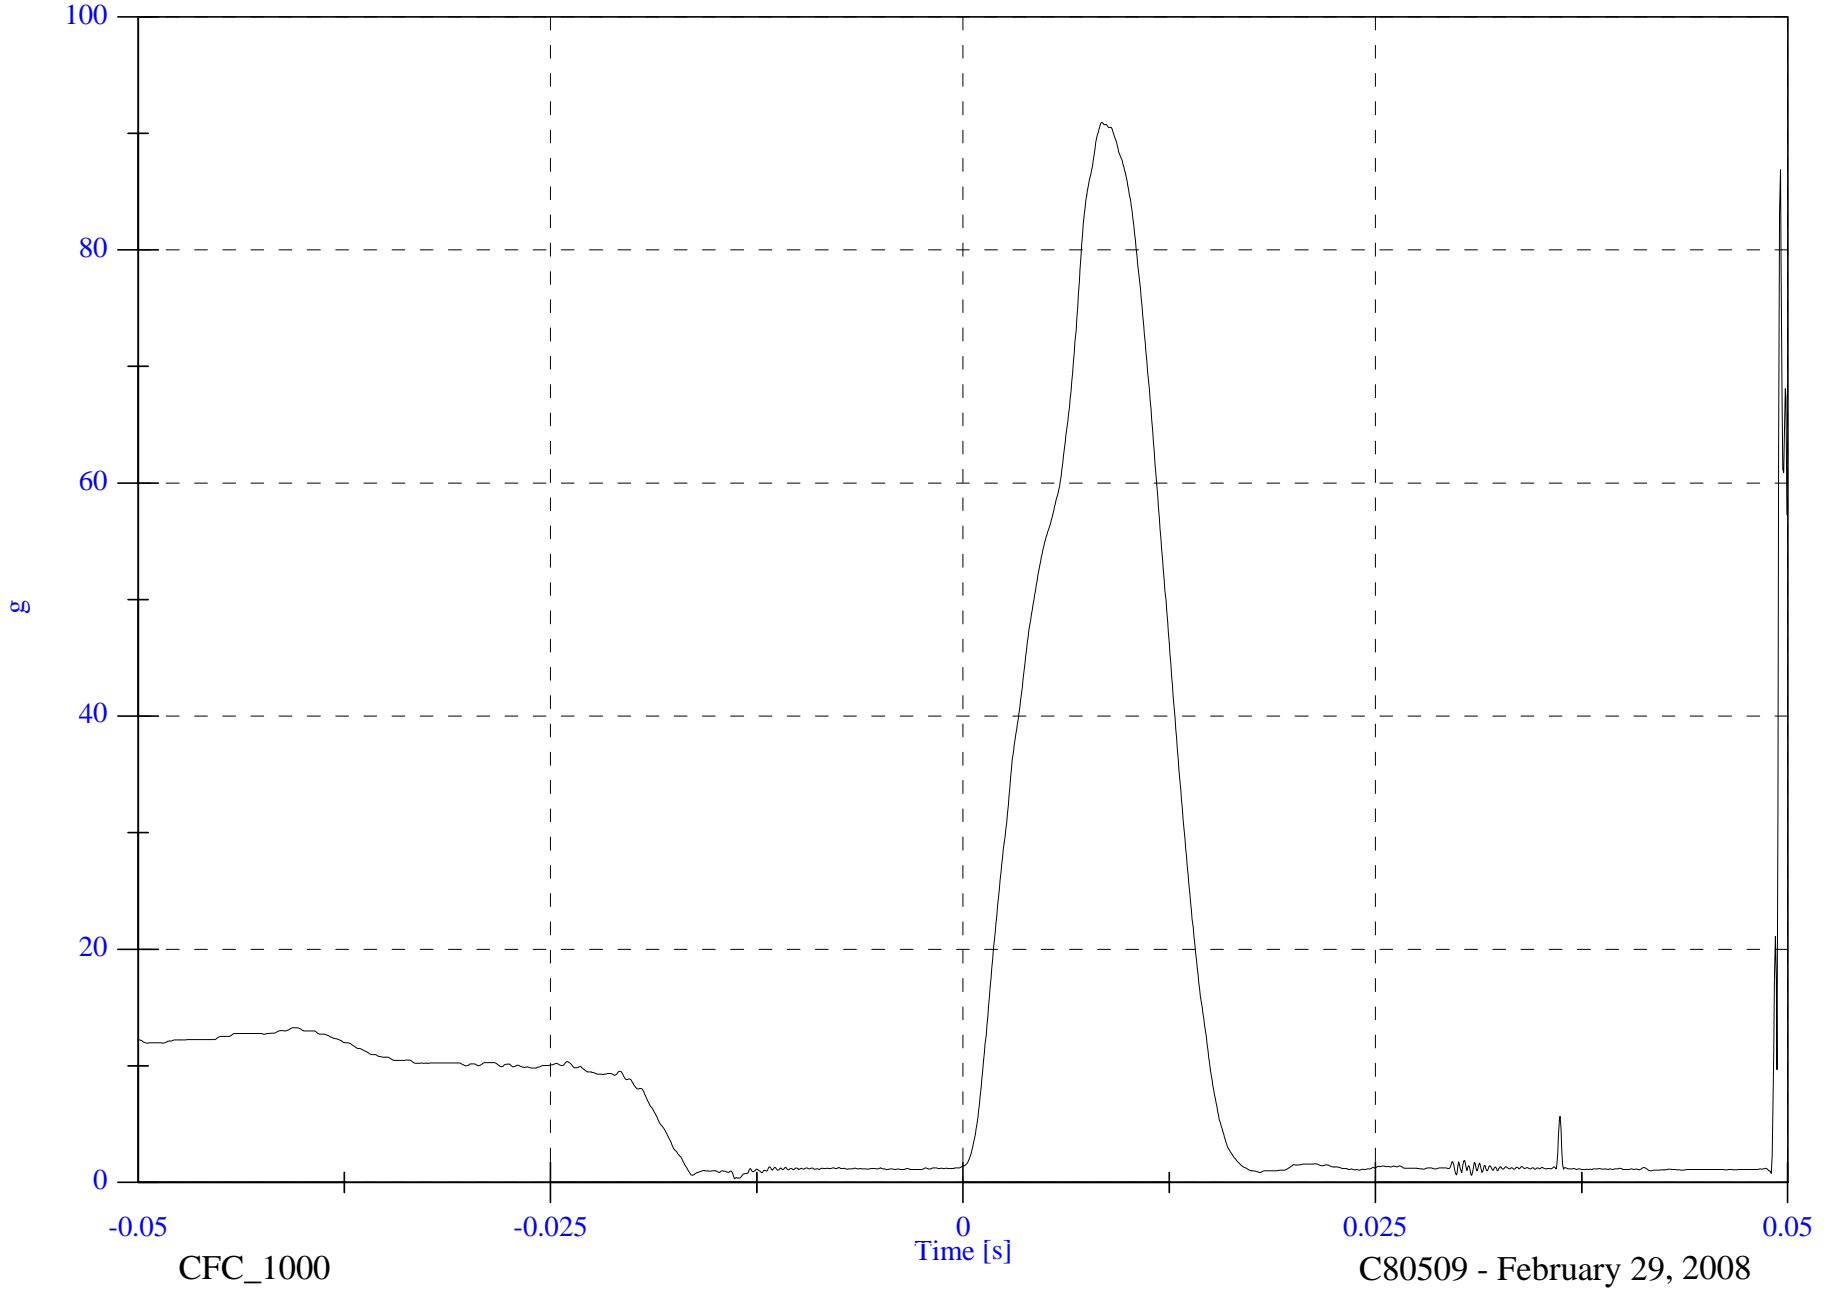
C80509 PASSENGER SIDE RPI IMPACT PLOT #5

Headform Resultant

Max: 90.9 [g] at 0.008 [s]

Min: 0.3 [g] at -0.014 [s]

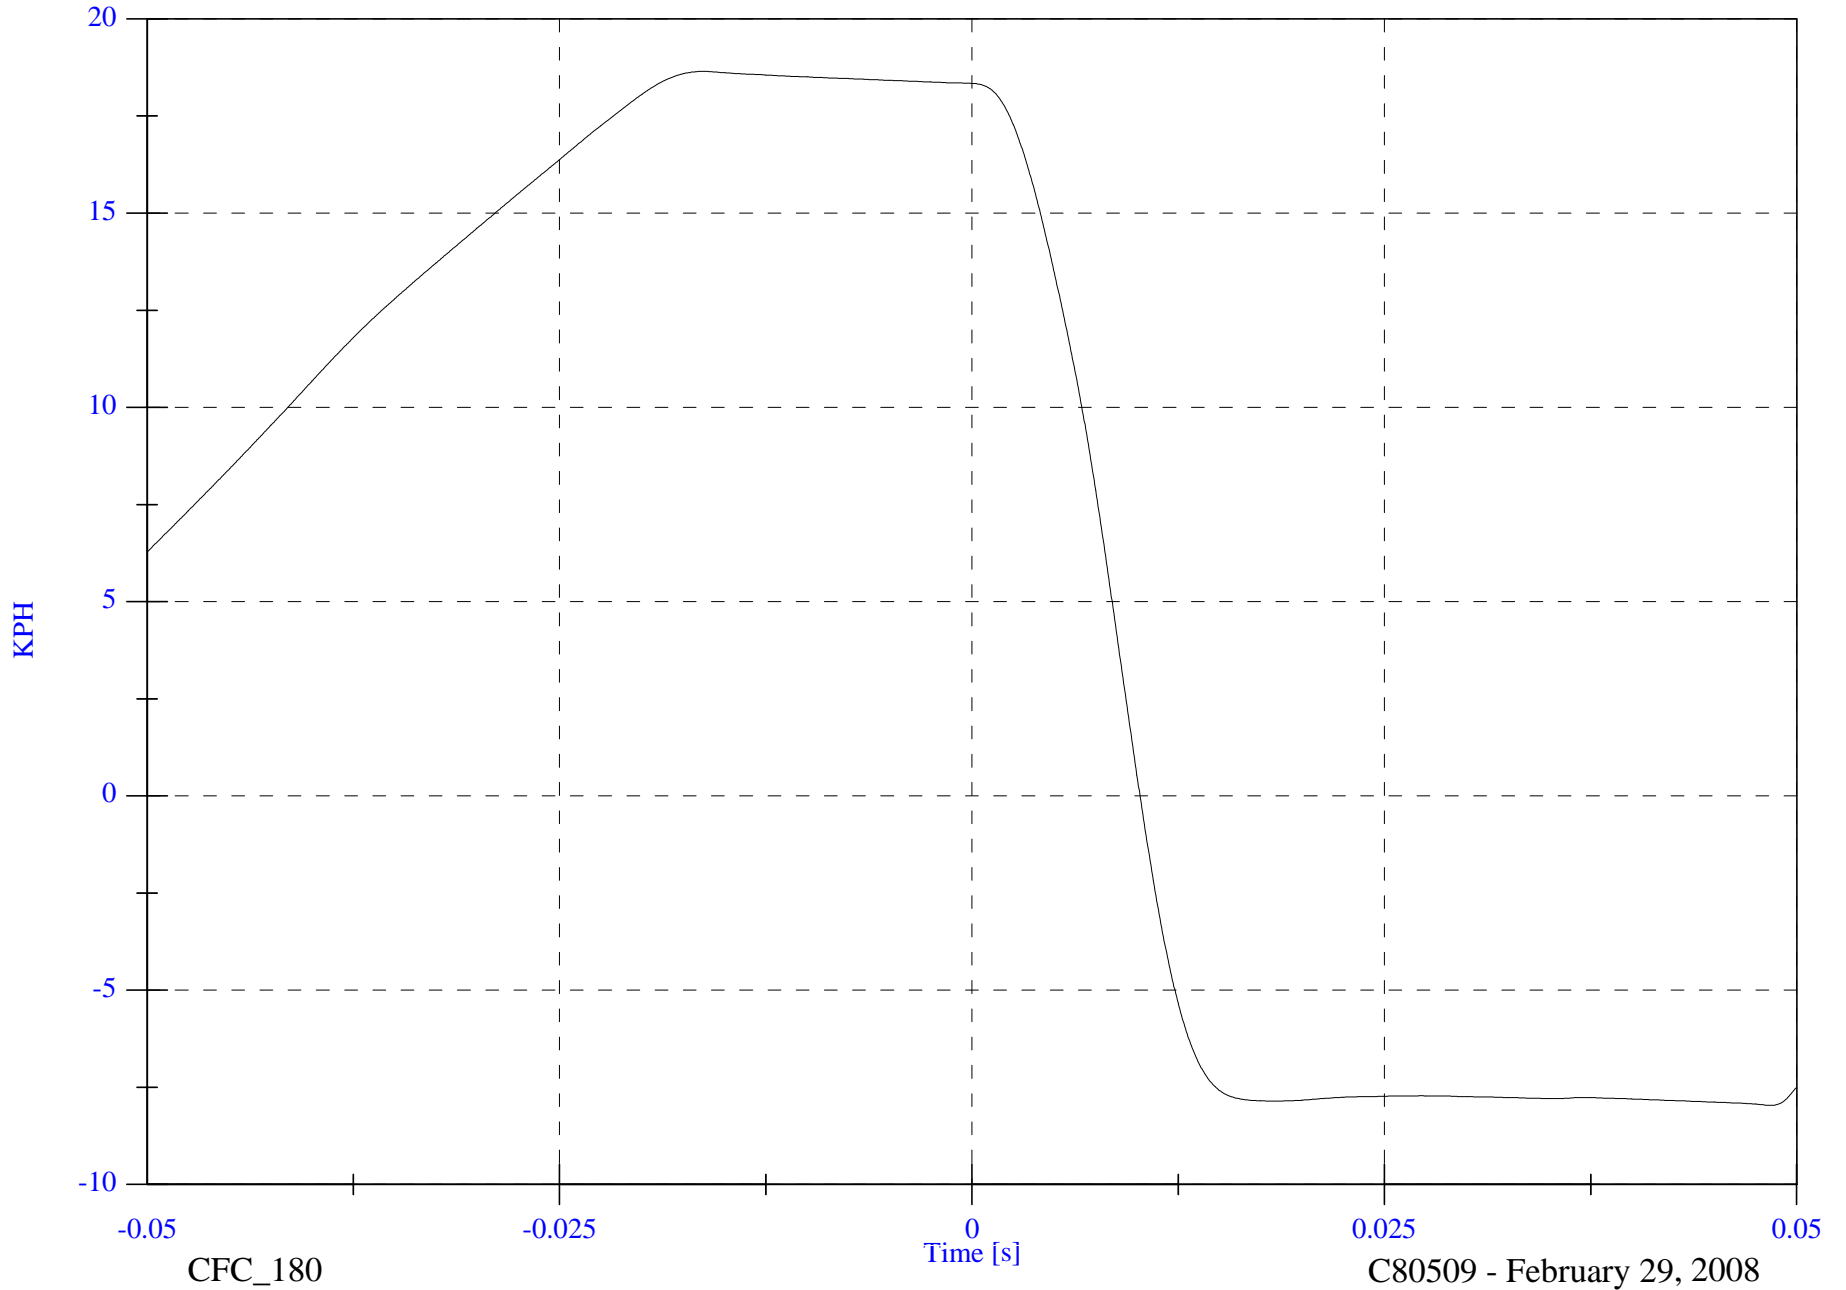
C80509 PASSENGER SIDE RPI IMPACT PLOT #6

Max: 18.6 [KPH] at -0.016 [s]

Min: -8.0 [KPH] at 0.048 [s]

Headform Velocity

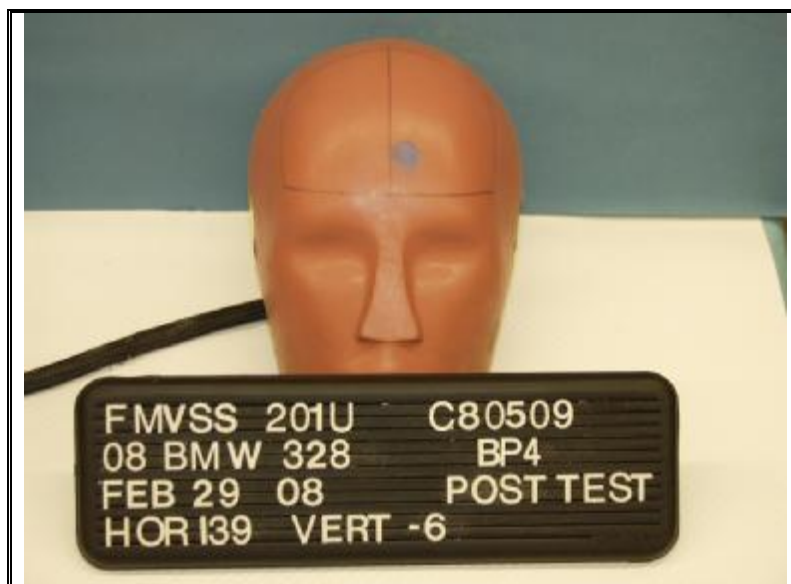
POST-IMPACT BP4 HEADFORM

Free Motion HIC	590.6
HIC(d)	612
Impact Velocity (kph)	23.77
HIC T1 (msec)	5.8
HIC T2 (msec)	10.2

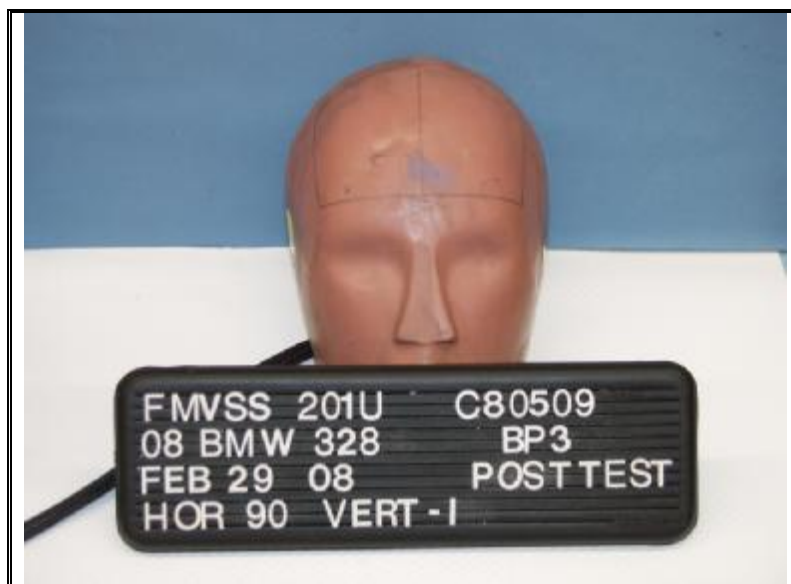
POST-IMPACT BP3 HEADFORM

Free Motion HIC	610.5
HIC(d)	627.0
Impact Velocity (kph)	23.78
HIC T1 (msec)	3.6
HIC T2 (msec)	10.6

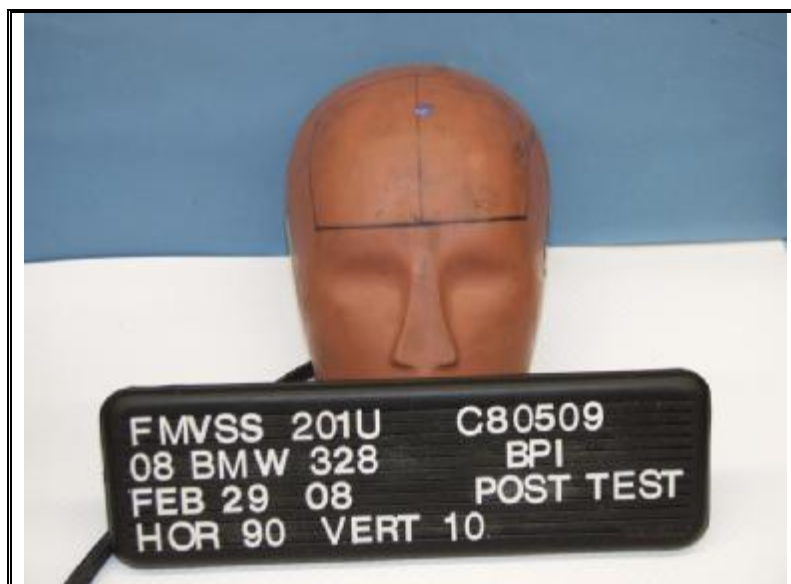
POST-IMPACT BP1 HEADFORM

Free Motion HIC	245.8
HIC(d)	351.8
Impact Velocity (kph)	18.6
HIC T1 (msec)	7.8
HIC T2 (msec)	14.8

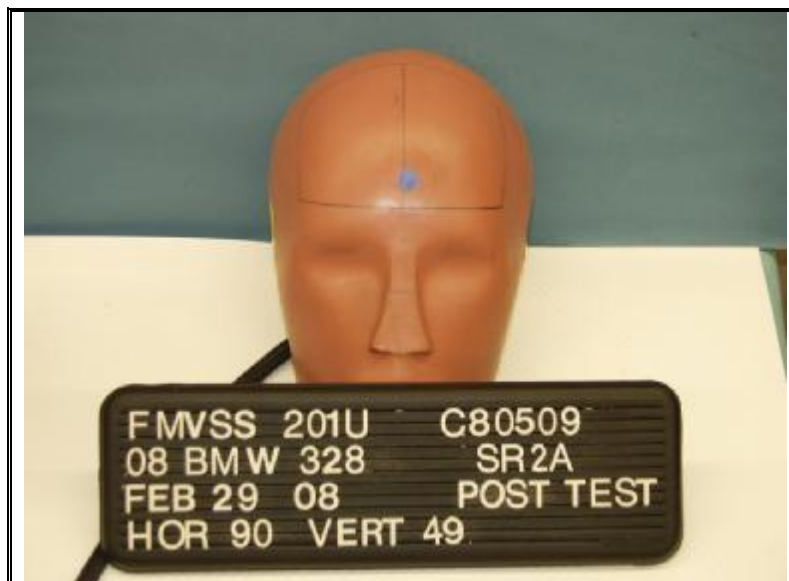
POST-IMPACT SR2A HEADFORM

Free Motion HIC	345.5
HIC(d)	427.1
Impact Velocity (kph)	18.66
HIC T1 (msec)	1.6
HIC T2 (msec)	11.1

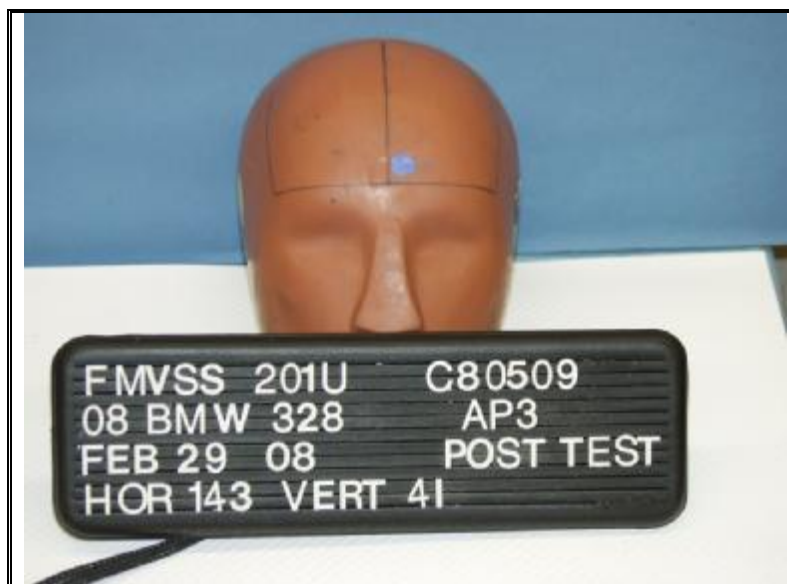
POST-IMPACT AP3 HEADFORM

Free Motion HIC	849.5
HIC(d)	807.3
Impact Velocity (kph)	18.54
HIC T1 (msec)	1.8
HIC T2 (msec)	6.1

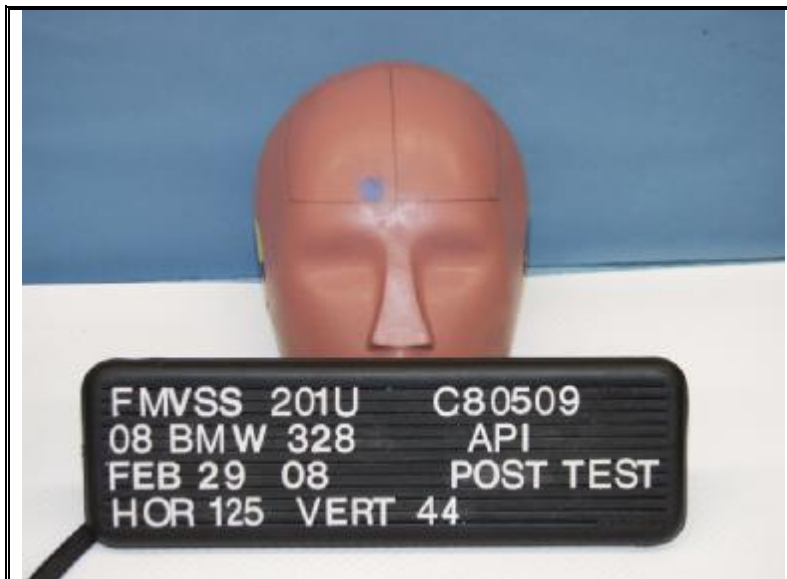
POST-IMPACT AP1 HEADFORM

Free Motion HIC	622.1
HIC(d)	635.7
Impact Velocity (kph)	18.84
HIC T1 (msec)	3.4
HIC T2 (msec)	8.2

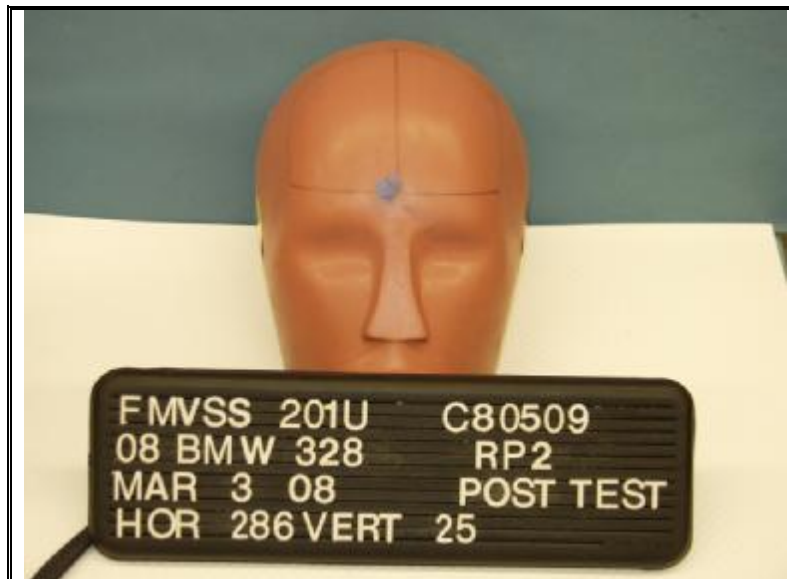
POST-IMPACT RP2 HEADFORM

Free Motion HIC	594.0
HIC(d)	614.5
Impact Velocity (kph)	18.8
HIC T1 (msec)	5.8
HIC T2 (msec)	11.5

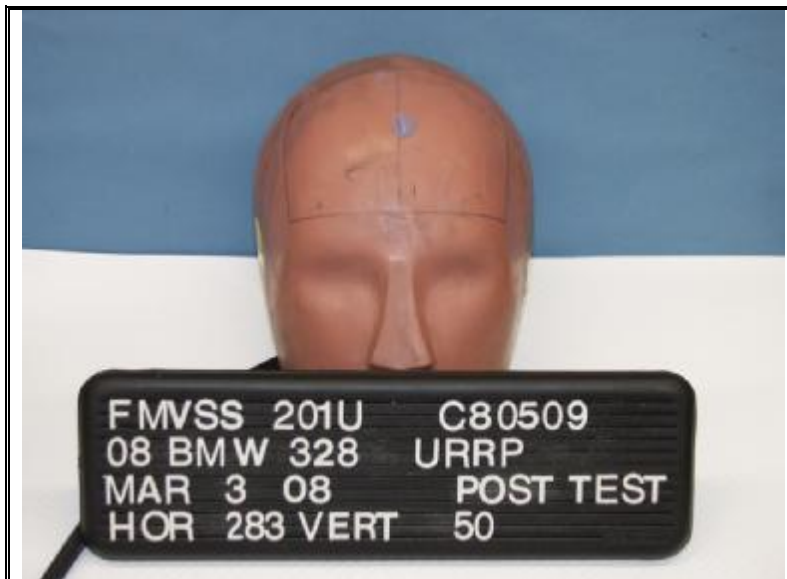
POST-IMPACT URRP HEADFORM

Free Motion HIC	681.6
HIC(d)	680.6
Impact Velocity (kph)	23.81
HIC T1 (msec)	2.8
HIC T2 (msec)	8.1

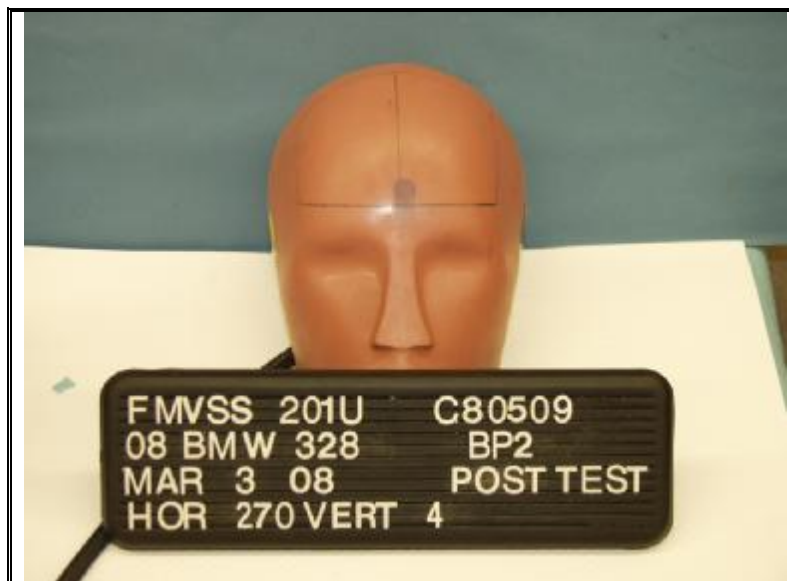
POST-IMPACT BP2 HEADFORM

Free Motion HIC	648.7
HIC(d)	655.8
Impact Velocity (kph)	23.59
HIC T1 (msec)	1.6
HIC T2 (msec)	9.4

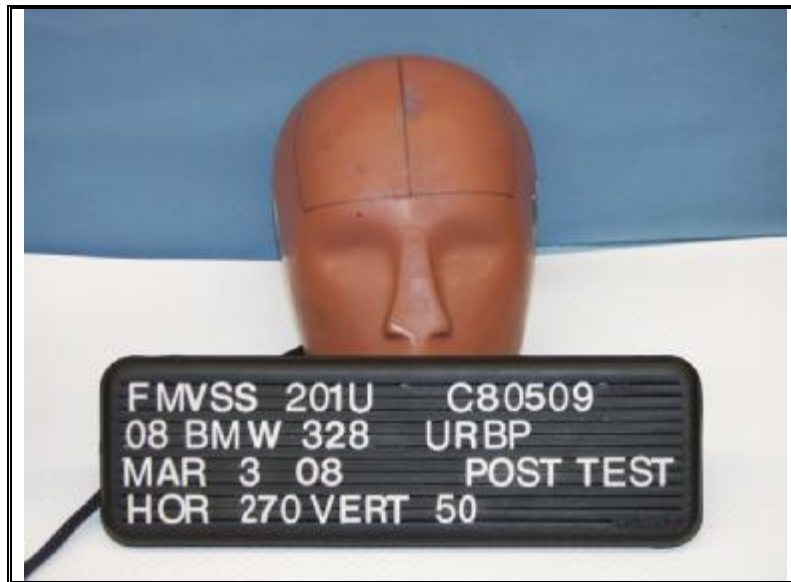
POST-IMPACT URBP HEADFORM

Free Motion HIC	326.9
HIC(d)	413.0
Impact Velocity (kph)	23.53
HIC T1 (msec)	3.7
HIC T2 (msec)	17.0

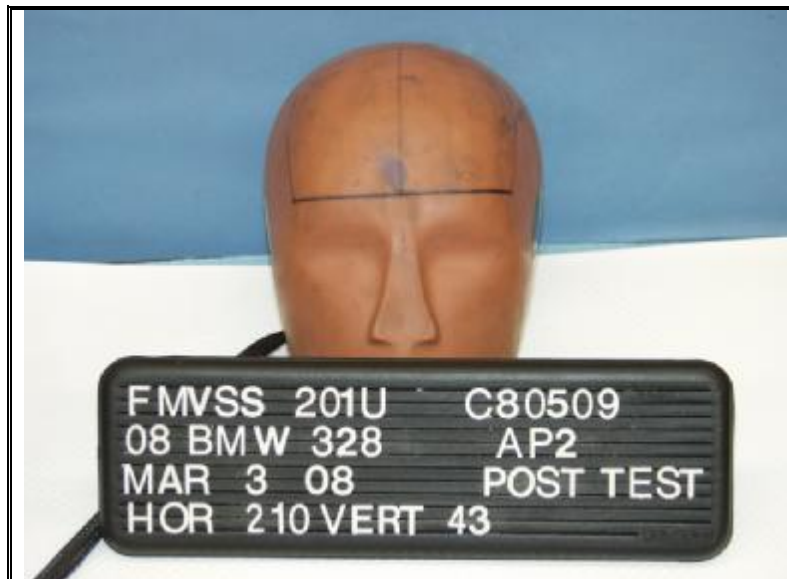
POST-IMPACT AP2 HEADFORM

Free Motion HIC	828.6
HIC(d)	791.5
Impact Velocity (kph)	18.56
HIC T1 (msec)	2.3
HIC T2 (msec)	6.6
