REPORT NUMBER: 214I-MGA-2008-005

**SAFETY COMPLIANCE TESTING FOR
FMVSS 214 INDICANT
SIDE IMPACT PROTECTION**

**FUJI HEAVY INDUSTRIES LTD.
2009 SUBARU FORESTER
NHTSA NUMBER: C95500**

**PREPARED BY:
MGA RESEARCH CORPORATION
5000 WARREN ROAD
BURLINGTON, WI 53105**

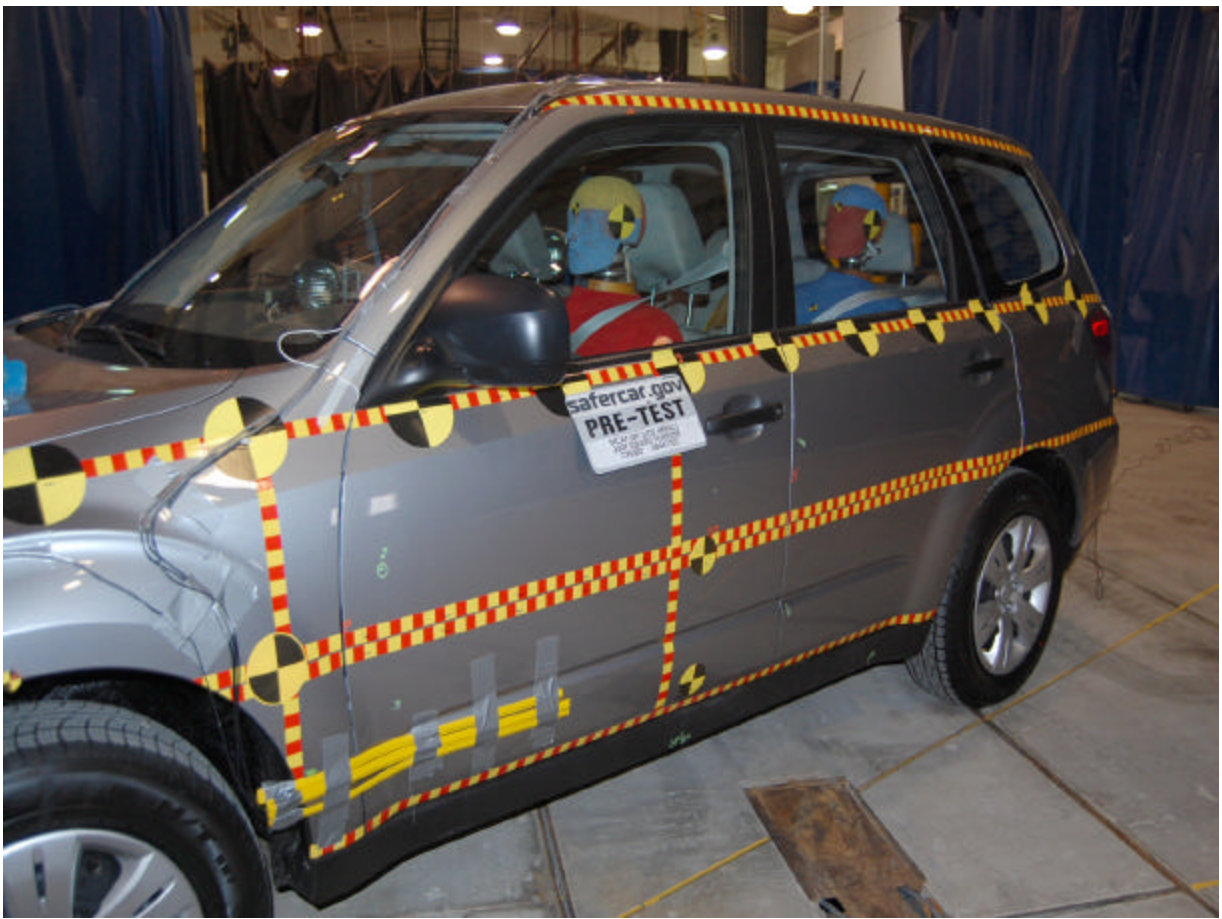
Post-Test Left Impact Point

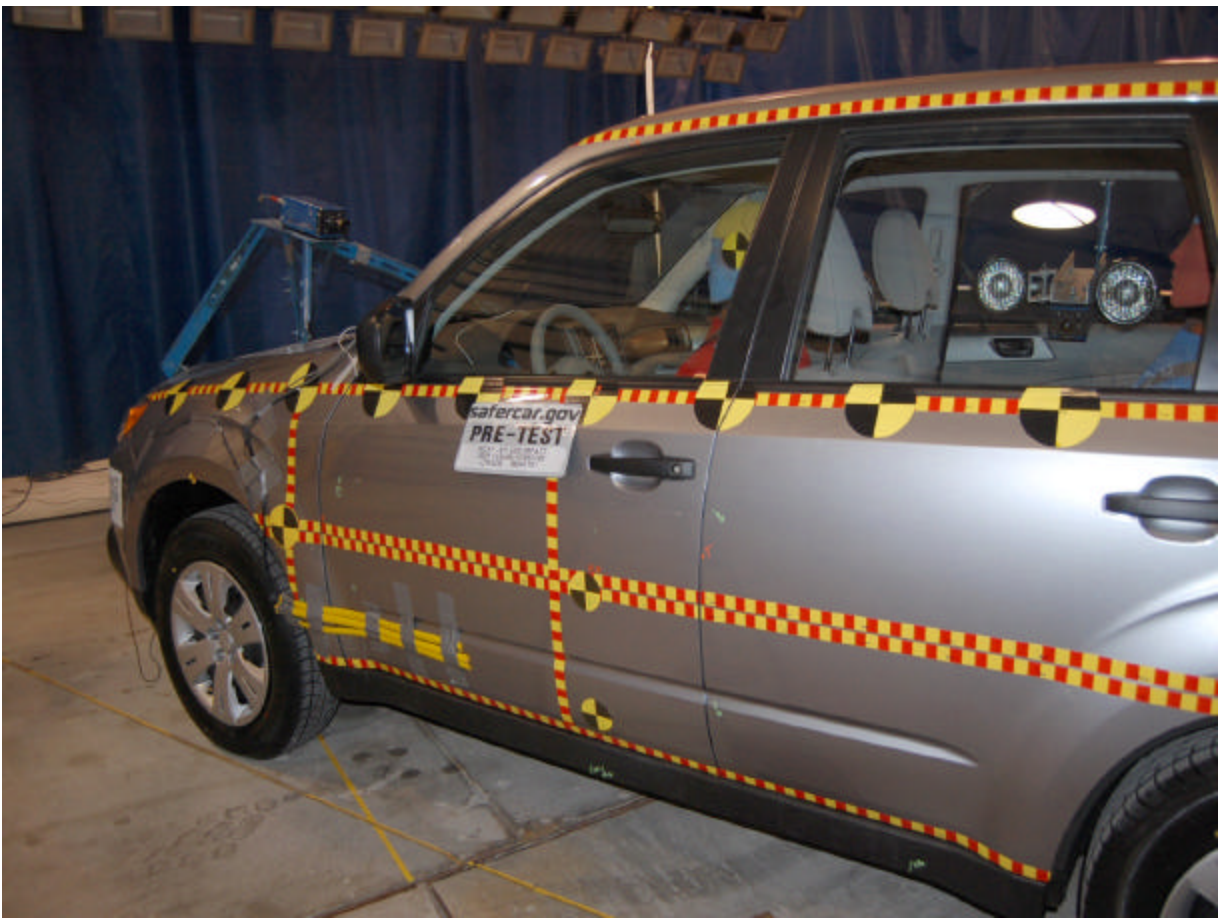
Post-Test Front 3/4 View of Left Side Doors

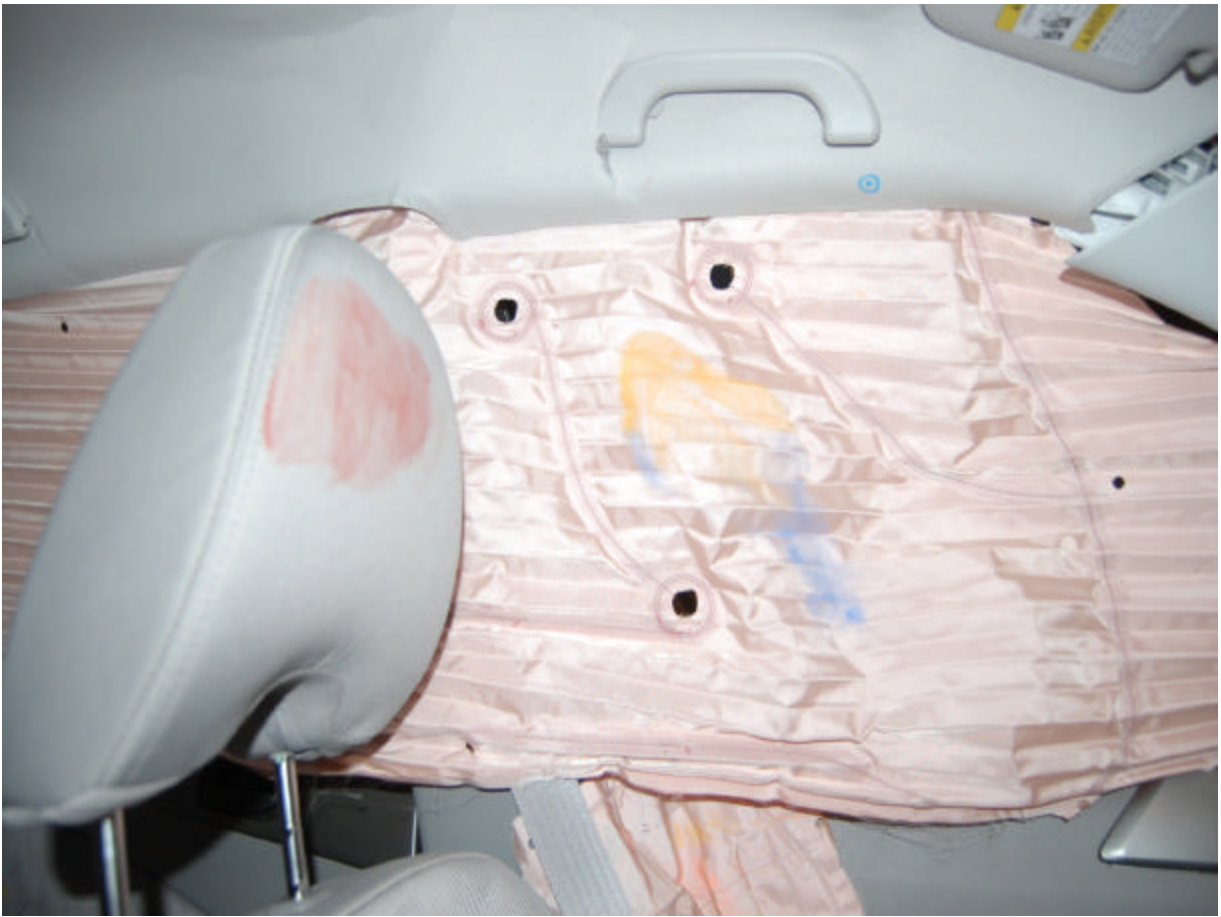
Vehicle Impact
