REPORT NUMBER 138-STF-08-007

# SAFETY COMPLIANCE TESTING FOR FMVSS NO. 138 TIRE PRESSURE MONITORING SYSTEMS

MITSUBISHI MOTORS CORPORATION  
2008 MITSUBISHI LANCER  
FOUR-DOOR PASSENGER CAR  
NHTSA NO. C85603

FINAL REPORT

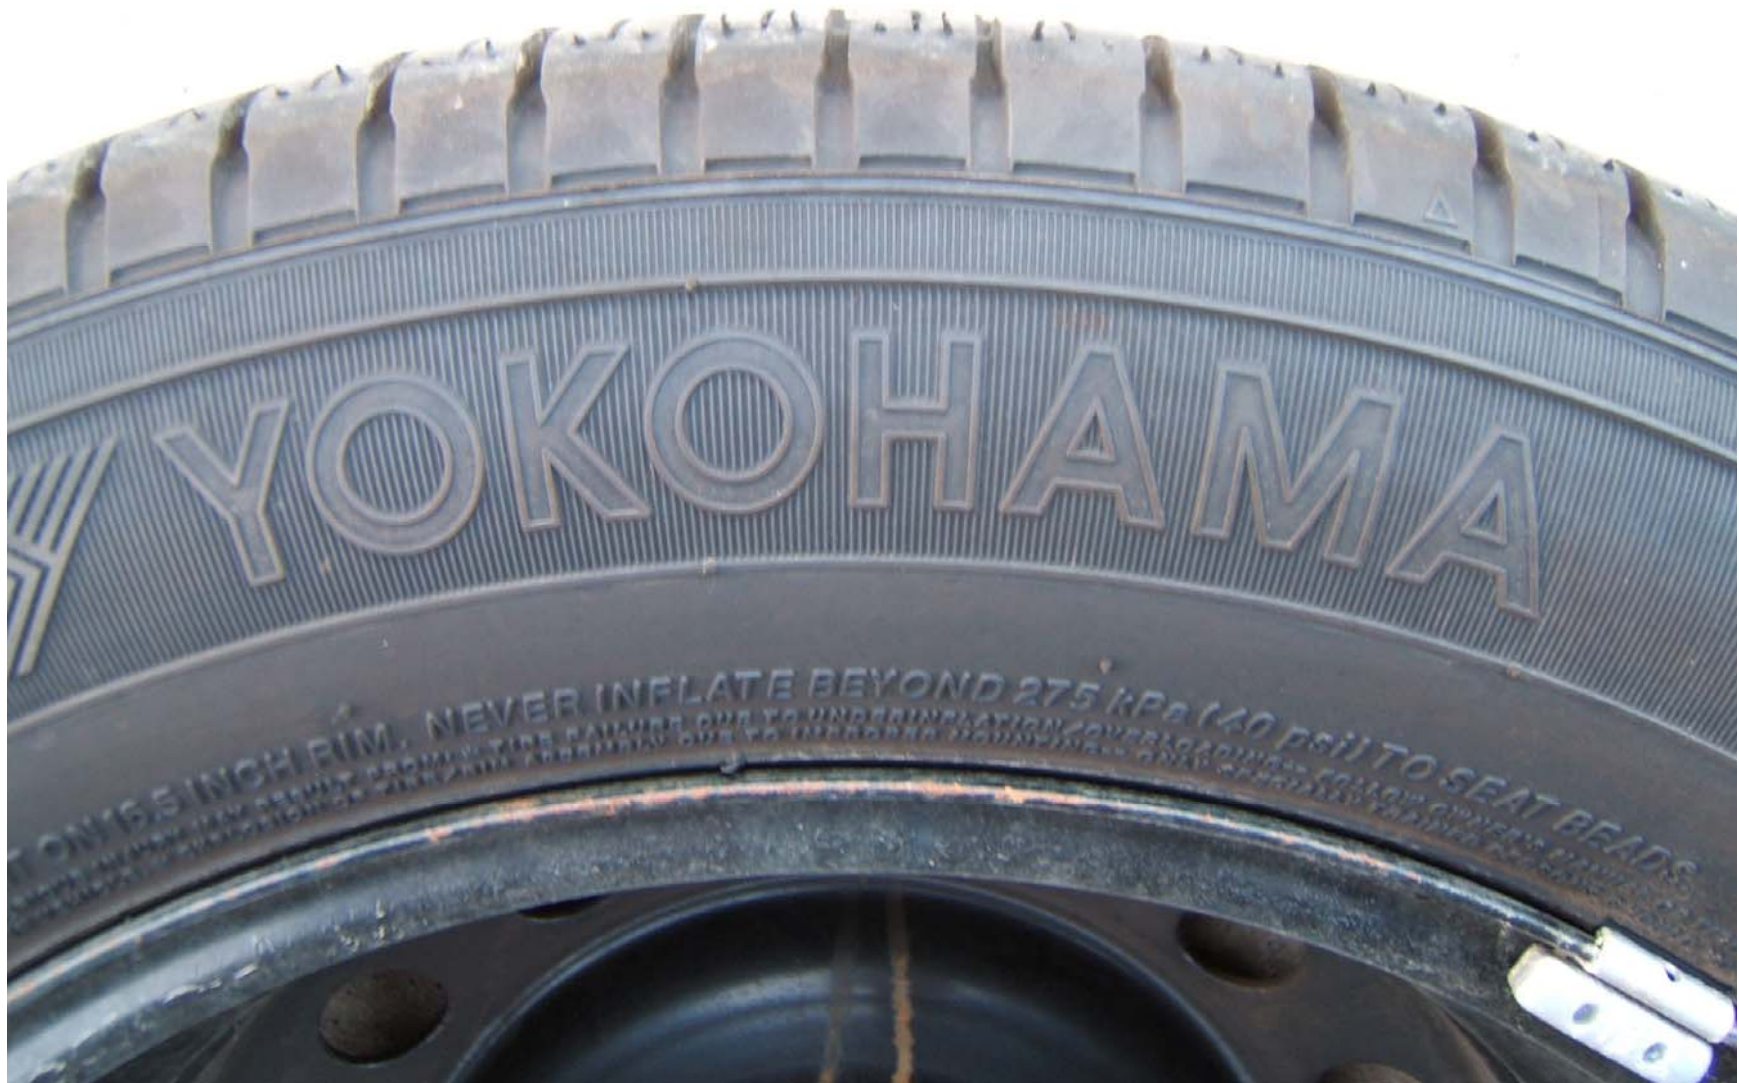
FIGURE 5.4  
TIRE SHOWING BRAND

Manufacturer/Tire Name: Yokohama Avid S34

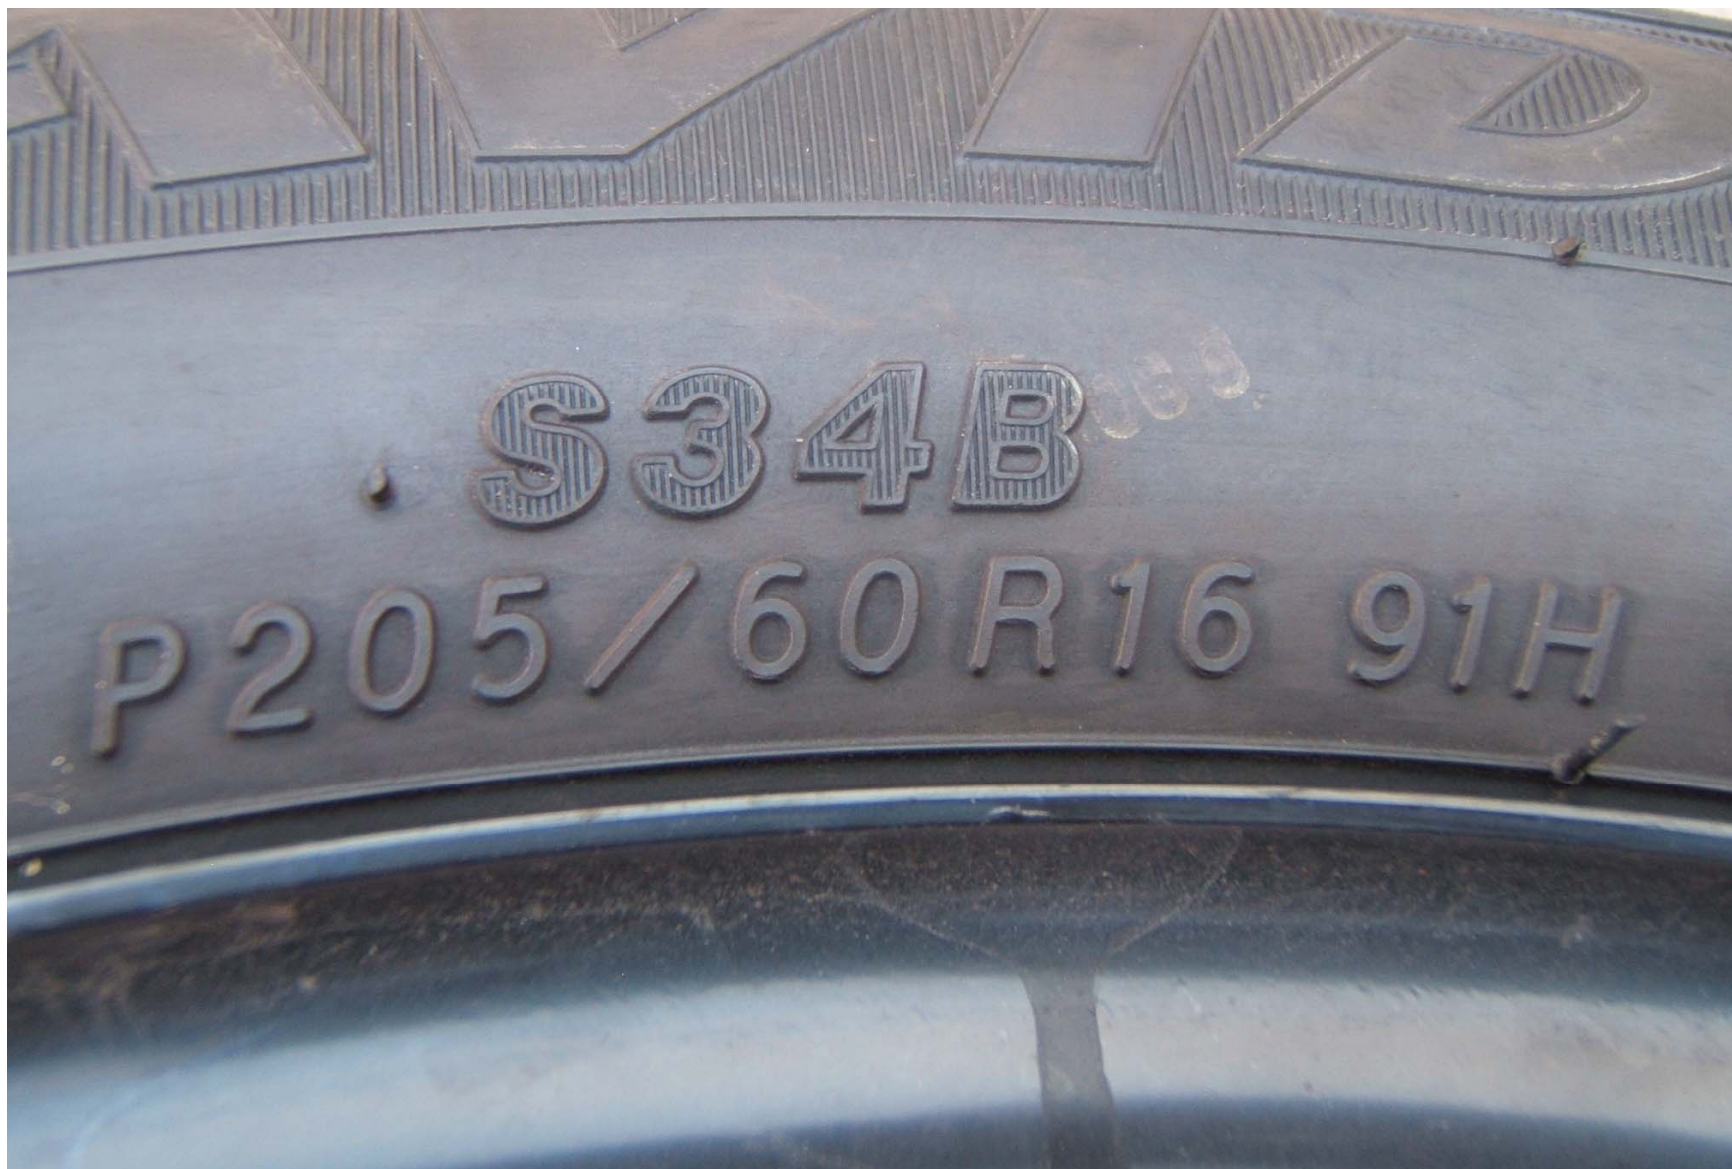
FIGURE 5.6  
TIRE SHOWING SIZE AND LOAD INDEX / SPEED RATING

Tire Size and Load Index / Speed Rating: P205/60R16 91H

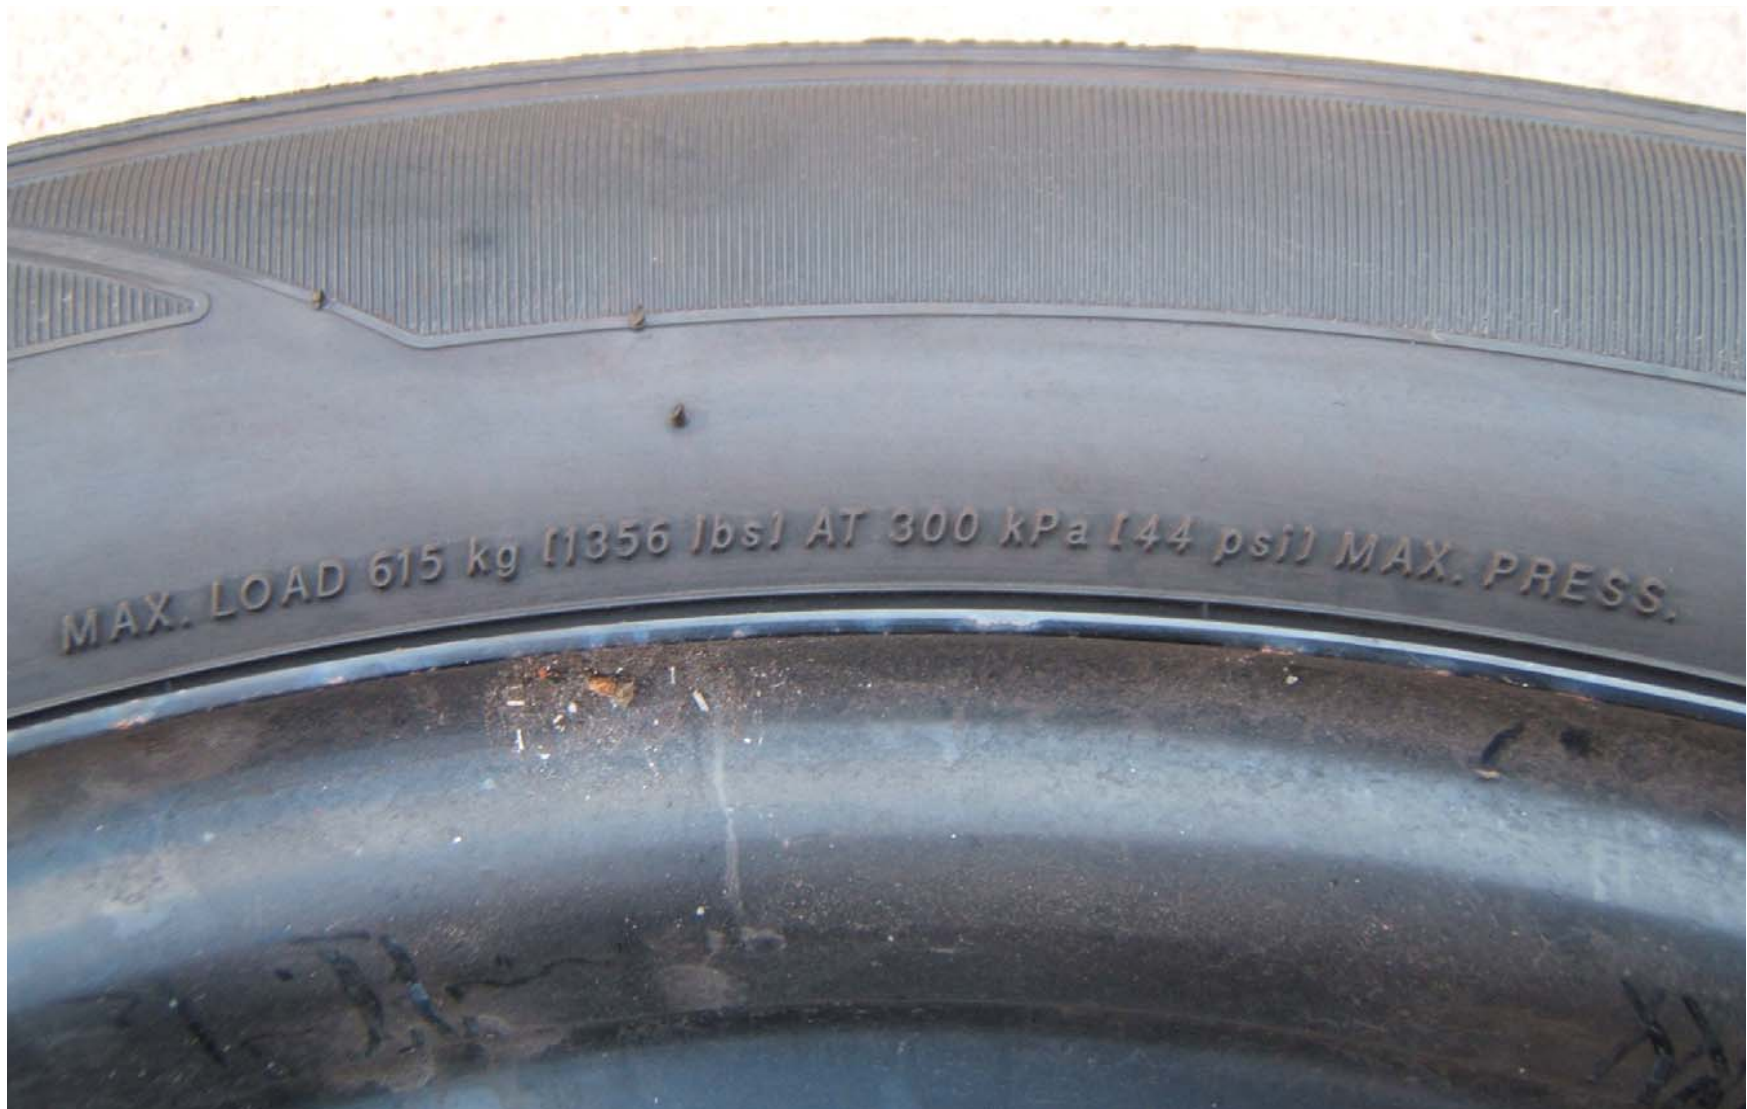
FIGURE 5.8  
TIRE SHOWING MAX LOAD RATING  
AND MAX COLD INFLATION PRESSURE

Sidewall Max Load Rating: 615 kg (1,356 lbs)

Max Inflation Pressure: 300 kPa (44 psi)

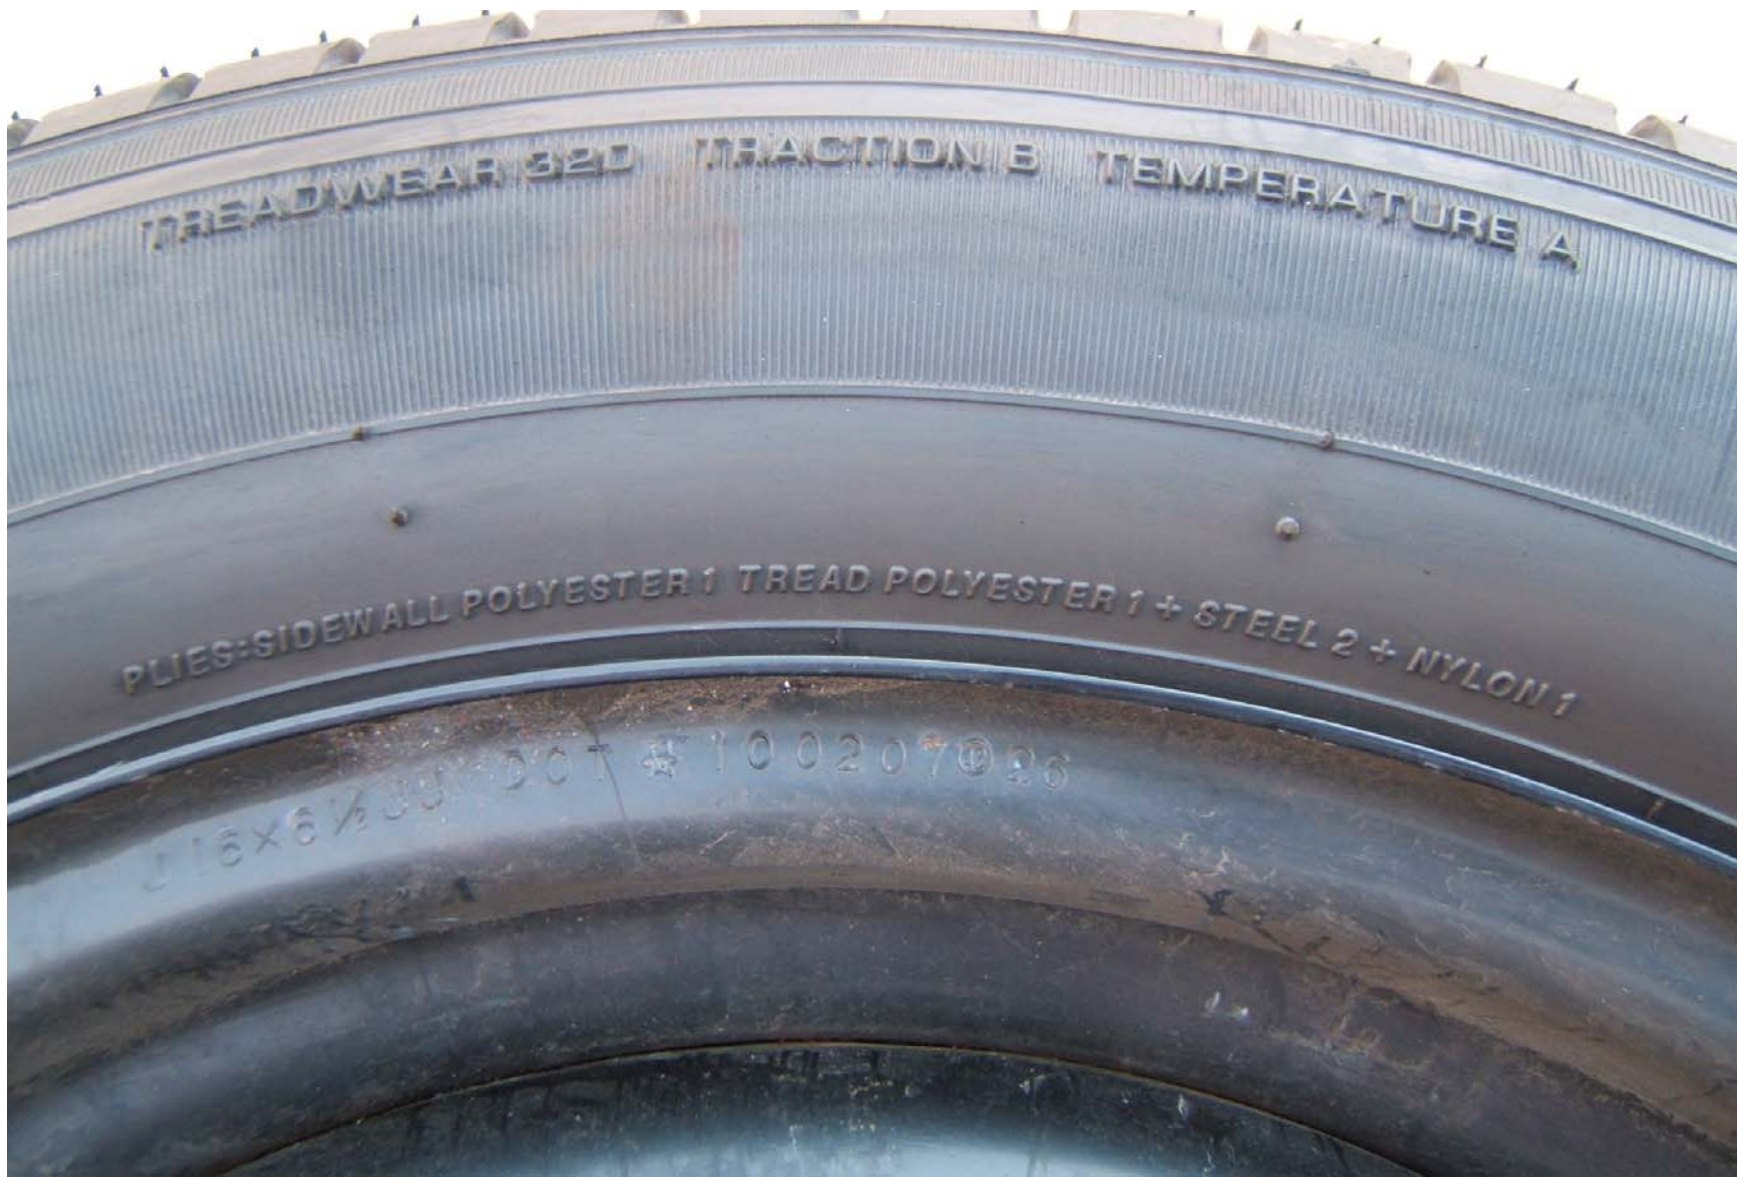
FIGURE 5.9  
TIRE SHOWING SIDEWALL / TREAD CONSTRUCTION

Sidewall Construction (number of plies and ply material): 1 polyester

Tread Construction (number of plies and ply material): 1 polyester, 2 steel, 1 nylon

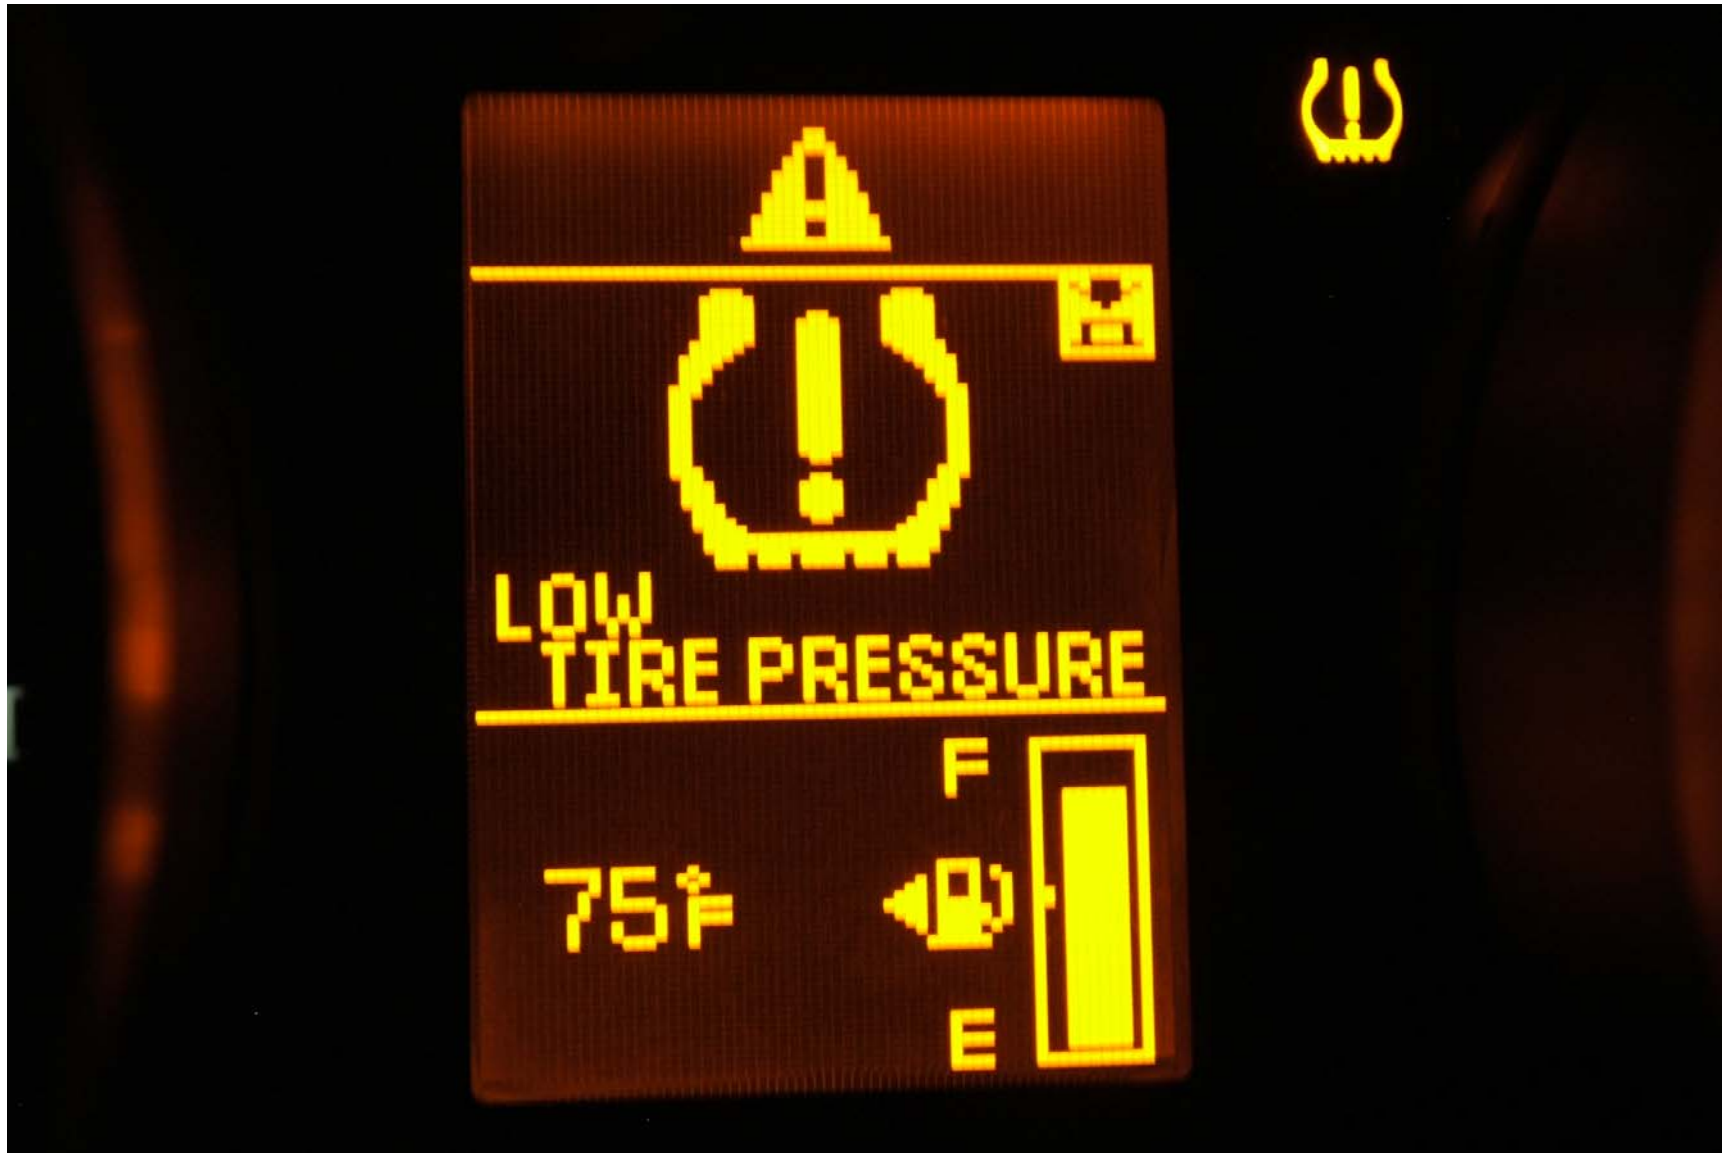
FIGURE 5.11  
DISPLAY SHOWING COMBINATION LOW TIRE PRESSURE / MALFUNCTION  
TELLTALE AND MESSAGE CENTER LOW PRESSURE WARNING

TPMS Low Tire Pressure Warning Telltale Location: Upper right center of instrument panel,  
adjacent to upper left of tachometer

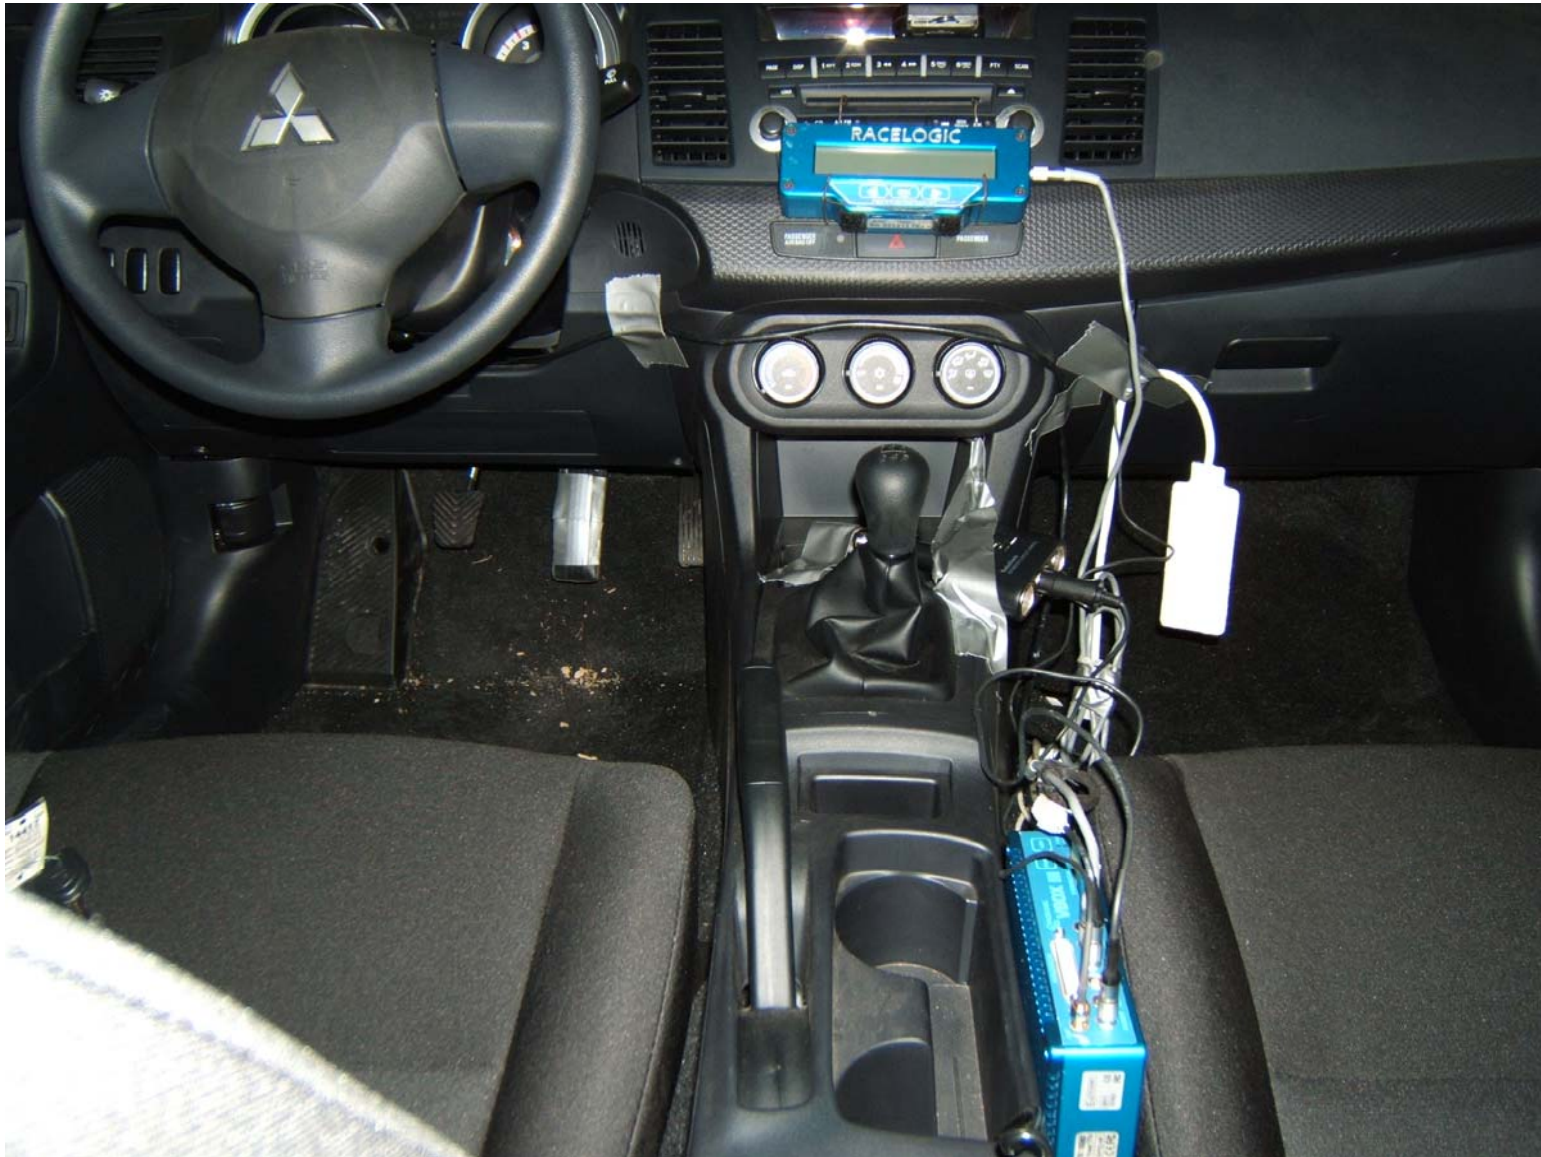
FIGURE 5.13  
TEST INSTRUMENTATION ON VEHICLE

The vehicle was instrumented with a Racelogic VBOX III 100 Hz GPS Data Logger and brake pedal trigger. The VBOX uses GPS to measure vehicle speed, time, and distance. Test data were recorded to a compact flash card. During the test, a stopwatch was used to determine the approximate "cumulative driving time" during each test phase. Cumulative driving time does not include time during the brake application or when the vehicle speed was below 50 km/h or above 100 km/h. Upon completion of a tire deflation scenario, graphs were generated by VBOX software showing vehicle speed versus time during the test procedures. The graphs furnish a second-by-second analysis of each calibration phase. The cumulative driving time was calculated by post processing the VBOX graph data and is reported in Section 3 (Test Data) as 'Total Driving Time'. Driving above 50 km/h was not required for the detection phases.

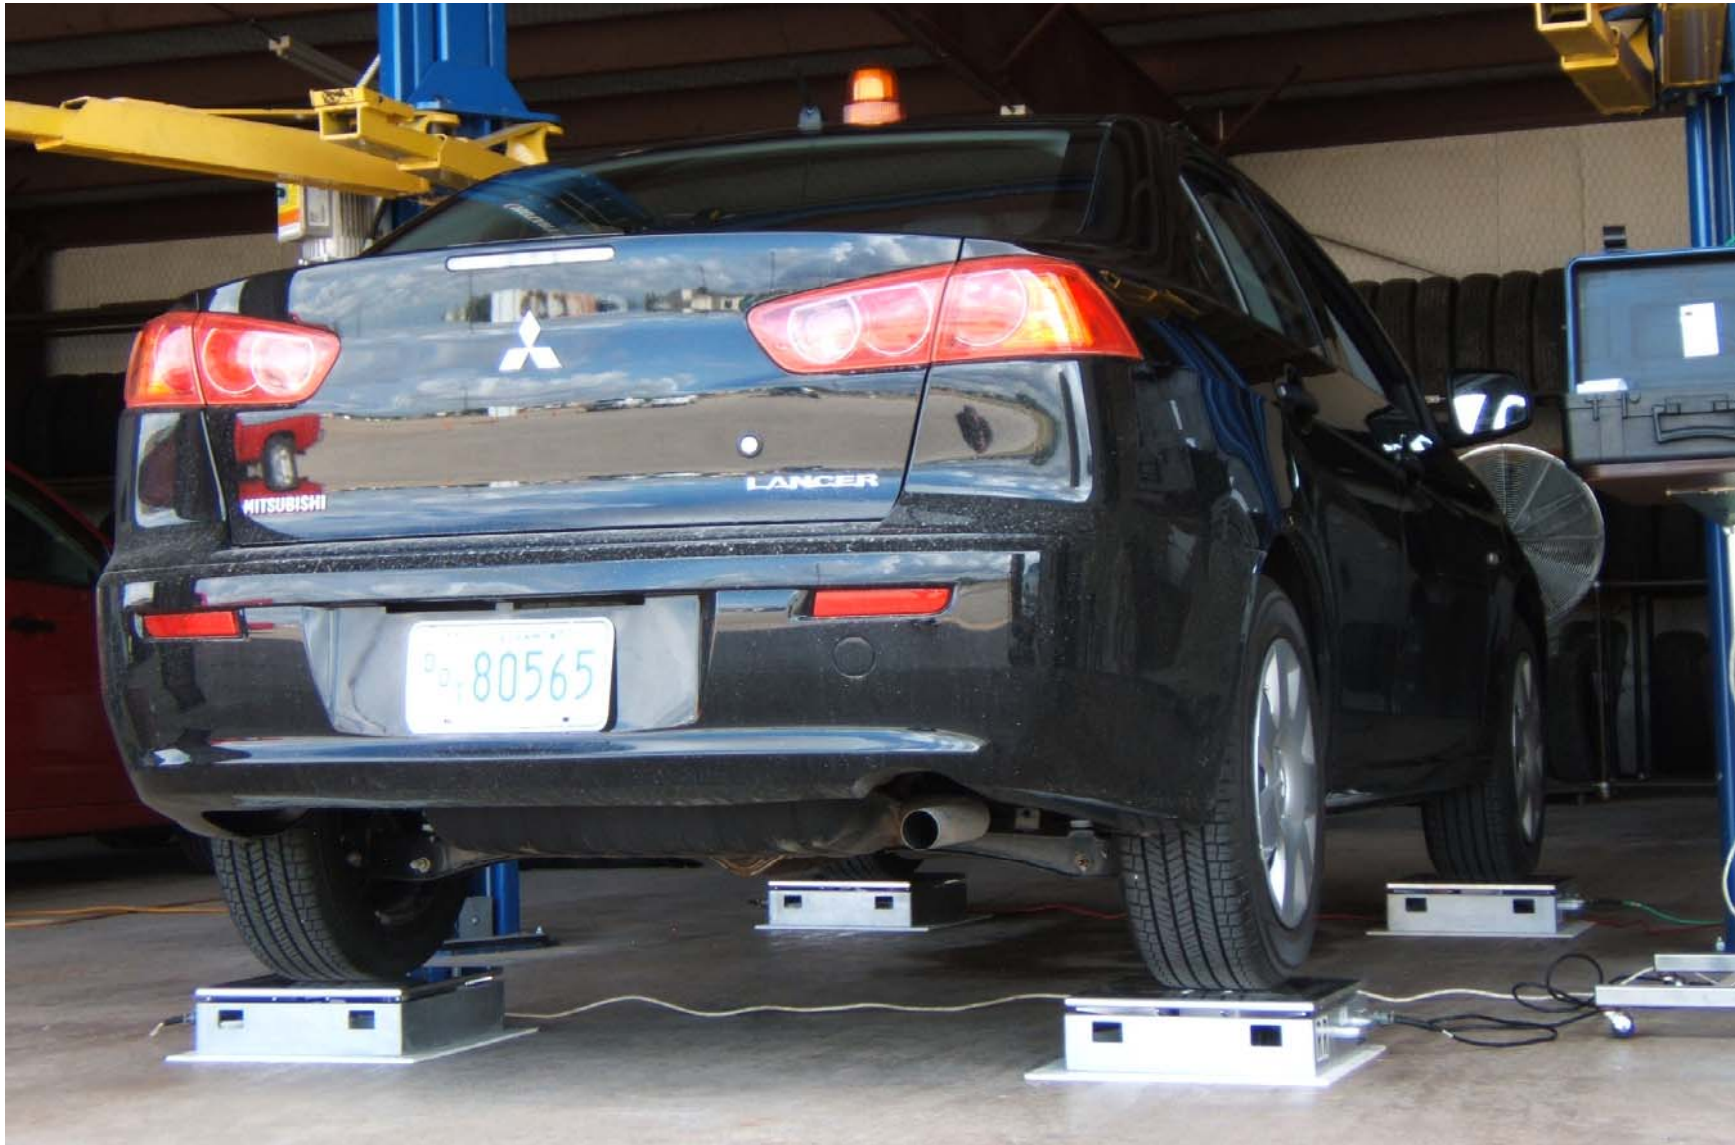
FIGURE 5.16  
VEHICLE ON WEIGHT SCALES

Subsequent events included weighing the vehicle to establish the Unloaded Vehicle Weight (UVW) and the distribution of weight on the front and rear axles and each wheel position. The vehicle was loaded to its Lightly Loaded Vehicle Weight (LLVW) for two tire deflation scenarios. This LLVW included the weights of driver, one passenger, and test equipment. The vehicle was loaded to its Unloaded Vehicle Weight plus Vehicle Capacity Weight (VCW) for two additional tire deflation scenarios. The VCW included the weights of driver, one passenger, test equipment, ballast in the rear seat, and ballast in the internal cargo area. The vehicle is required to be loaded to its maximum capacity without exceeding either the Vehicle Capacity Weight or Gross Vehicle Weight Rating (GVWR). For determination of the telltale warning activation pressure, the recommended cold inflation pressure was identified from the vehicle placard.

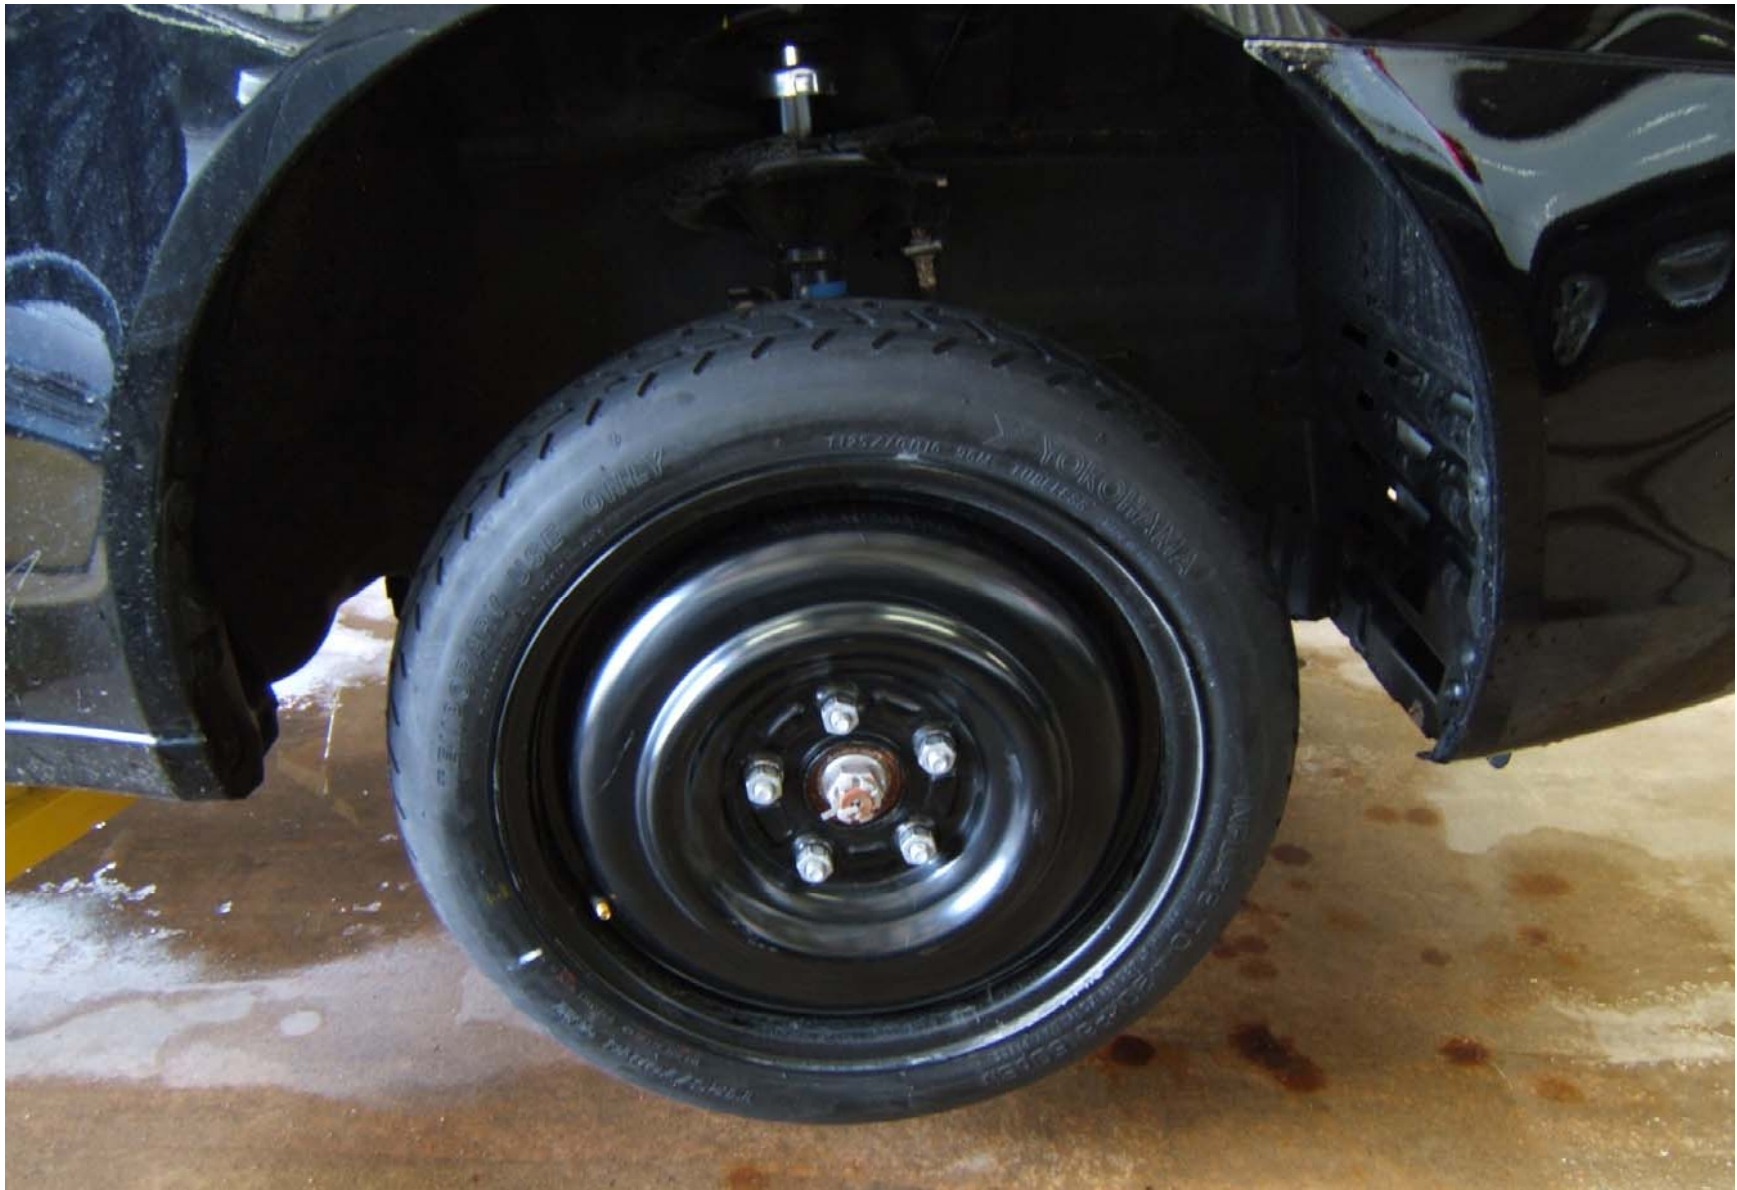
FIGURE 5.17  
SPARE INSTALLED ON RIGHT FRONT  
FOR MALFUNCTION DETECTION TEST

Two malfunction detection scenarios were performed with the vehicle loaded to its LLVW. The first malfunction was simulated by placing the compact spare tire, with no TPMS sensor, on the right front wheel position. The malfunction telltale properly operated within the requisite driving period. The second malfunction was simulated by disconnecting the TPMS ECU by removing a wiring connection on the steering column. The malfunction telltale sequence properly operated immediately upon engine ignition. Driving the vehicle was not necessary for this scenario.

**TPMS MALFUNCTION PERFORMANCE TEST RESULTS (PASS/FAIL)   PASS**  
Spare without TPMS sensor was applied to right front at LLVW.

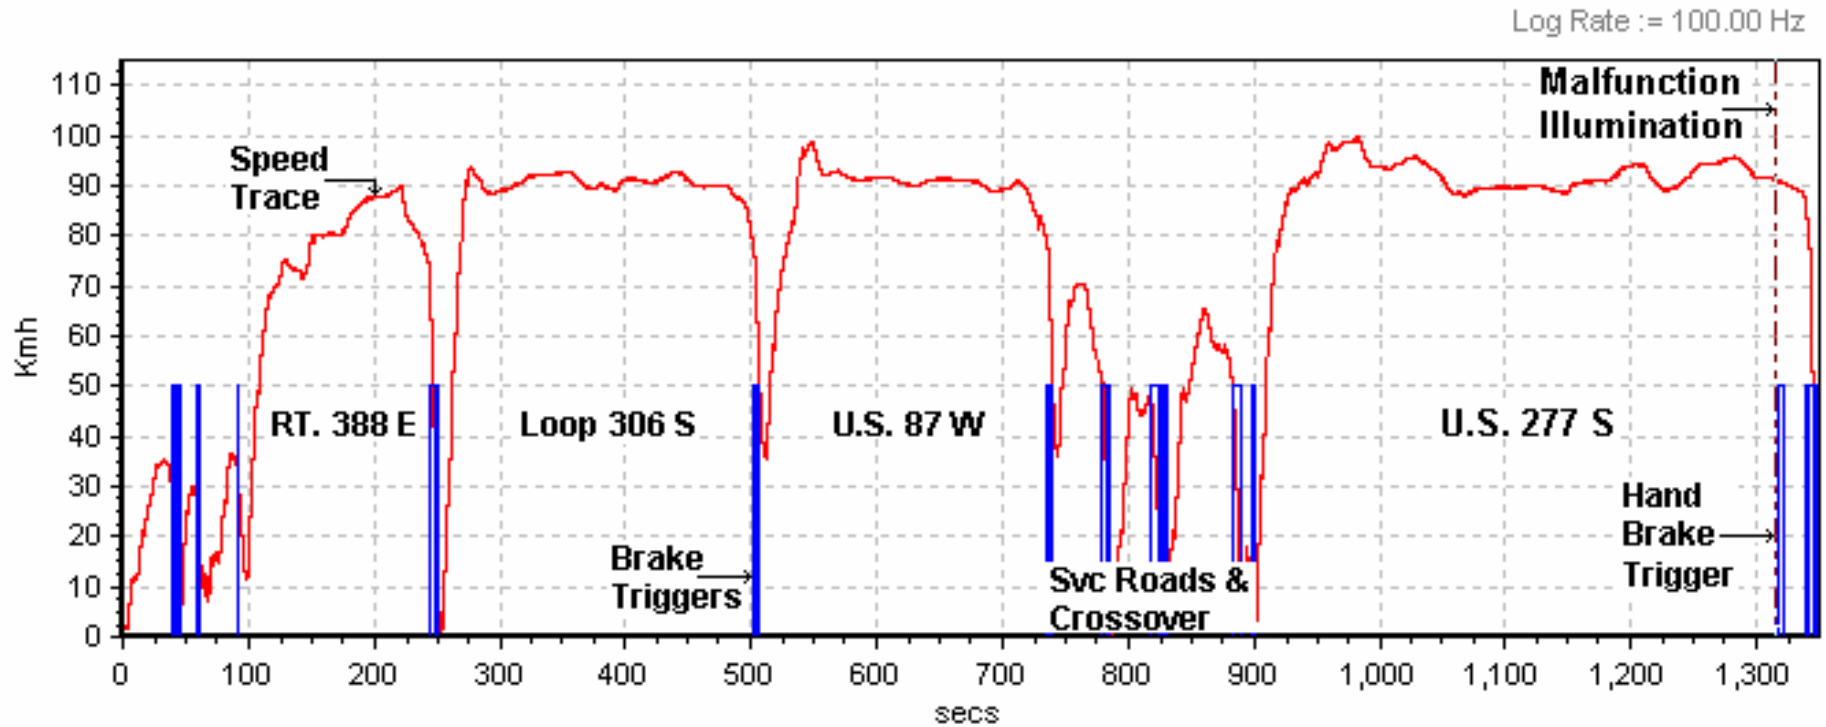
2008 Mitsubishi Lancer (C85603) RF Spare Tire Malfunction Illumination LLVW

Scenario E Malfunction Illumination: Spare without TPMS sensor was applied to right front at LLVW.  
Test Date: 8/18/08  
Data File Time: 22:30 minutes  
Cumulative Driving Time: 18:09 minutes  
Start Point: GAFB North Gate
