REPORT NUMBER: 301-CAL-08-05

**SAFETY COMPLIANCE TESTING FOR FMVSS 301  
FUEL SYSTEM INTEGRITY**

FORD MOTOR COMPANY  
2008 FORD RANGER  
2-DOOR PICK-UP

NHTSA NUMBER: C80205

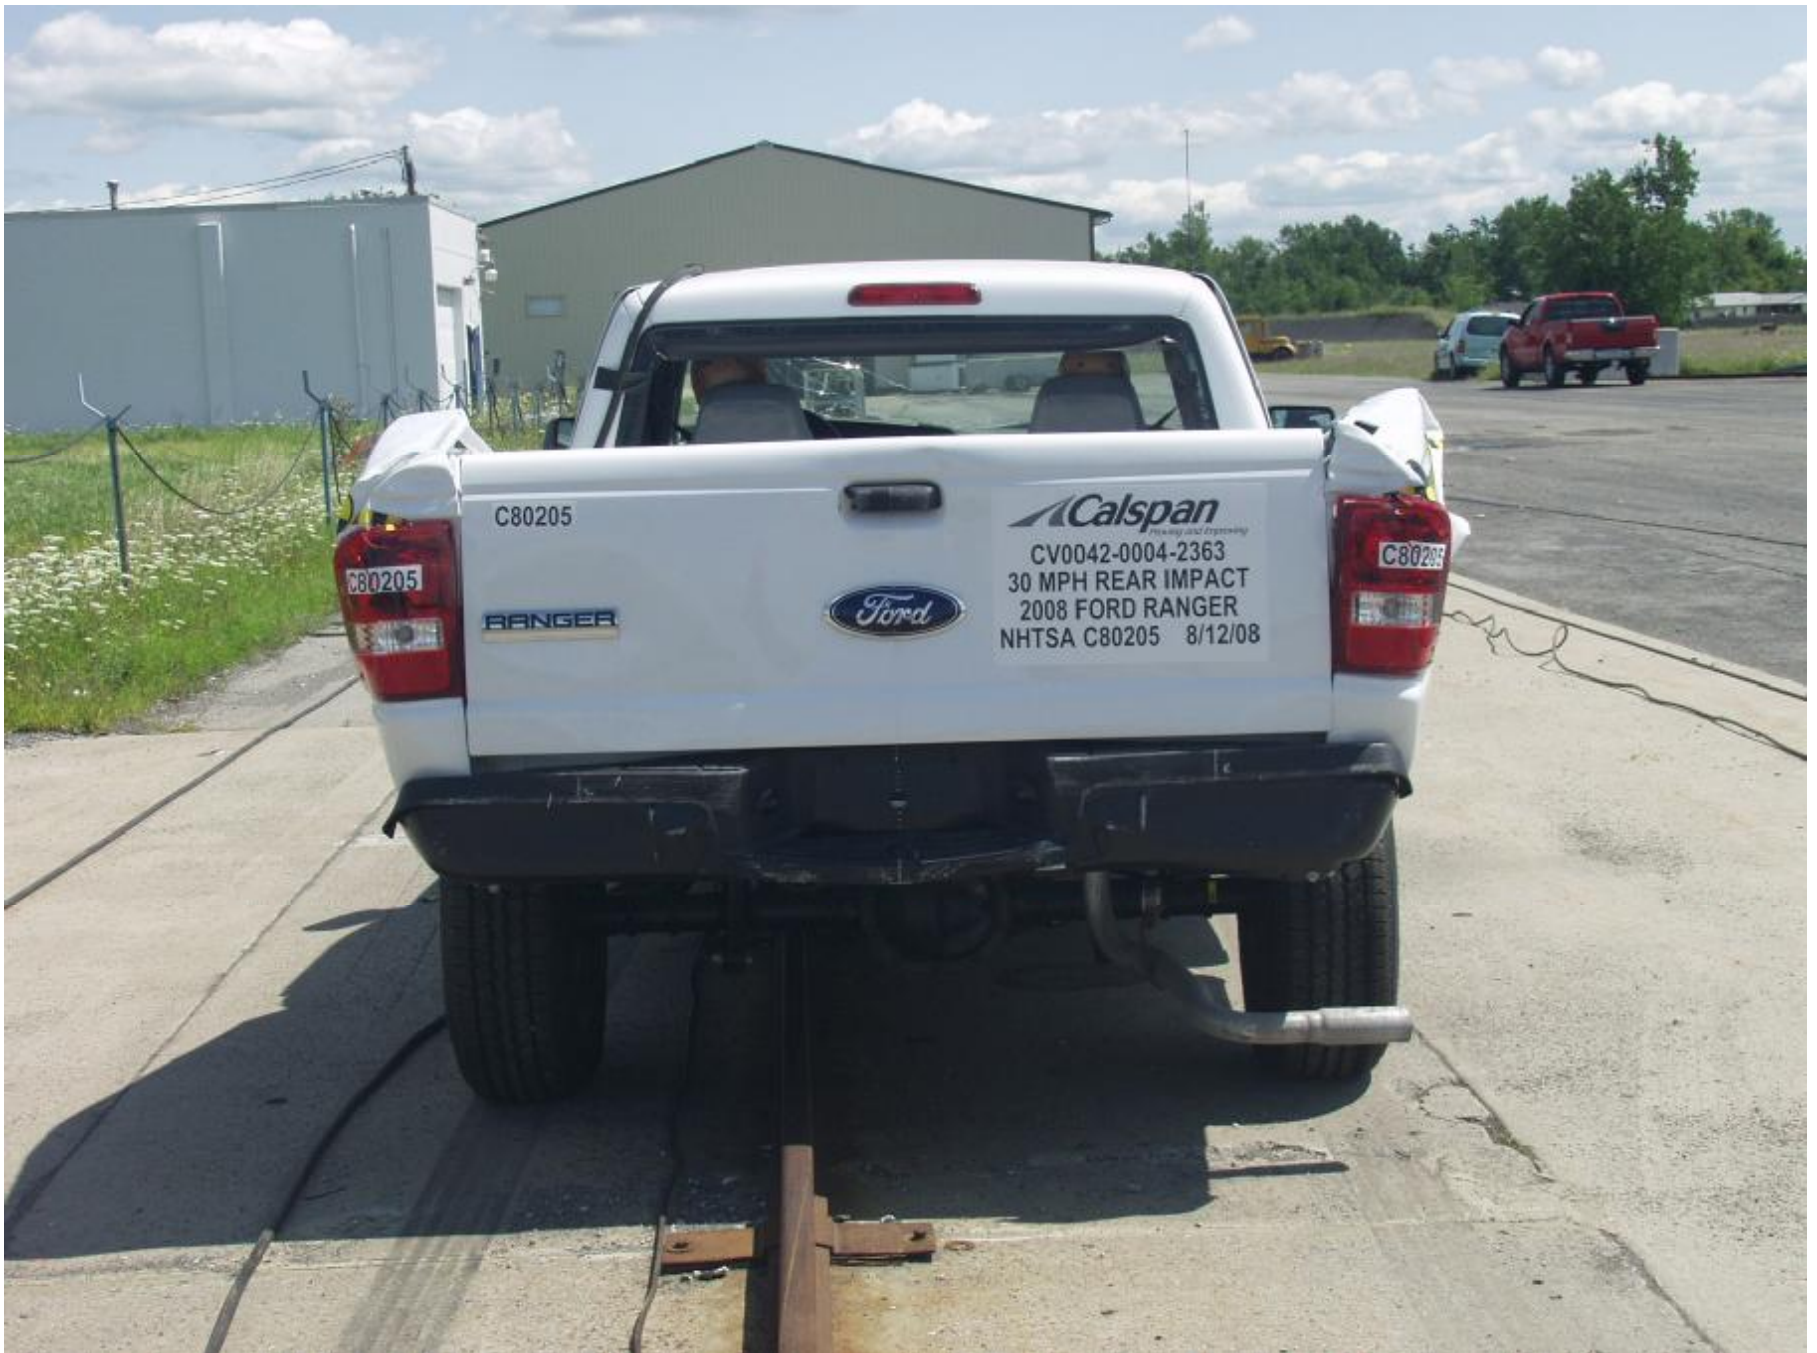
Figure A-8 POST-TEST REAR VIEW

Pre-Test Left = 4711 ; C/L = 4803 Right = 4710  
Post-Test Left = 4417 ; C/L = 4475 Right = 4429  
Crush Left = 294 ; C/L = 328 Right = 281  
AVERAGE = 301 millimeters

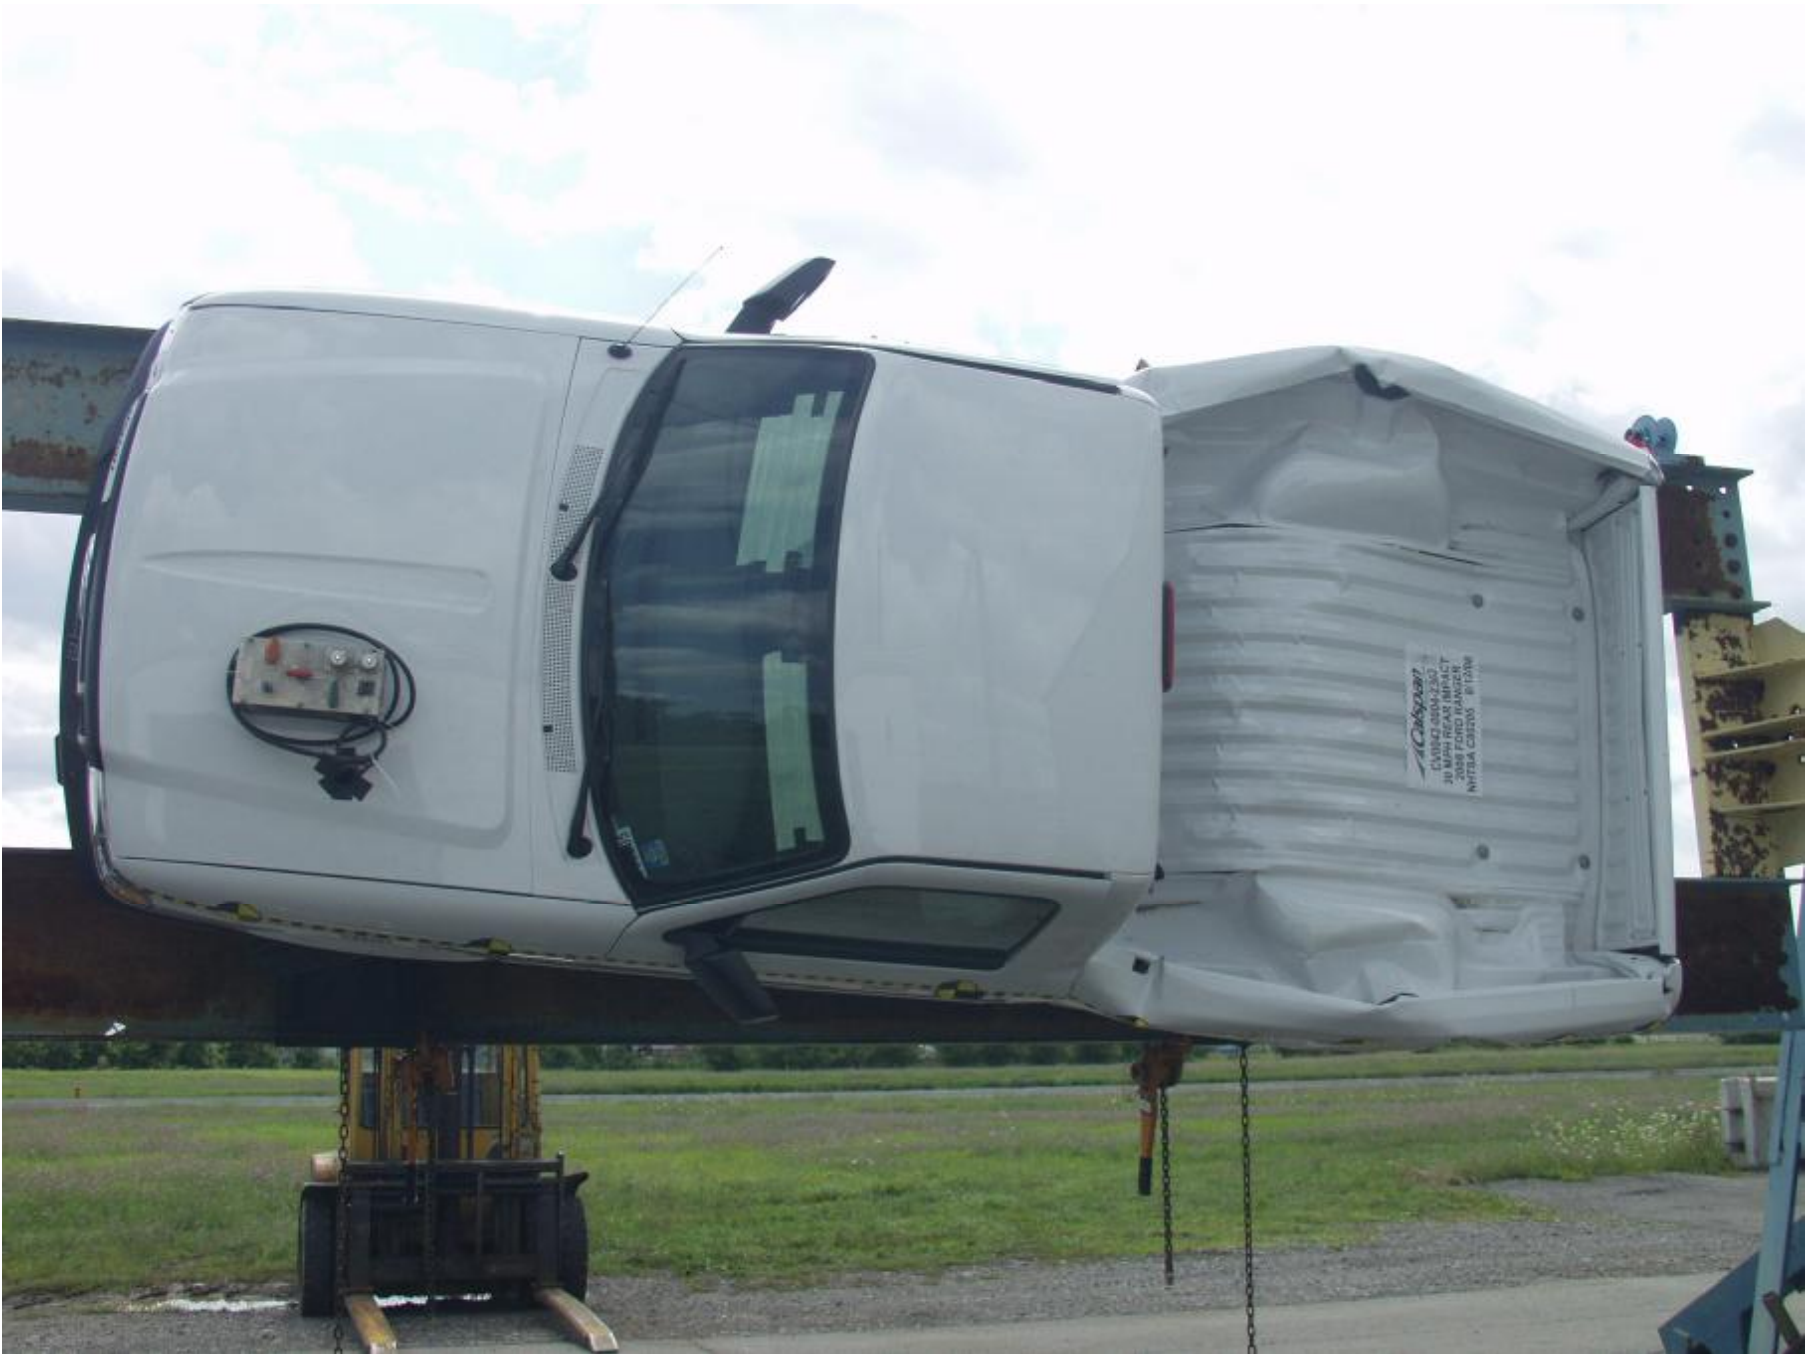
Figure A-19 ROLLOVER 90°

Rollover Stage	Spillage Location
0° - 90°	None
90° - 180°	None
180°-270°	None
270°-360°	None
