REPORT NUMBER 225-GTL-08-005

**SAFETY COMPLIANCE TESTING FOR
FMVSS NO. 225
CHILD RESTRAINT ANCHORAGE SYSTEMS
LOWER AND TETHER ANCHORAGES**

**BAYERISCHE MOTORENWERKE
2008 BMW 328i, PASSENGER CAR
NHTSA NO. C80509**

FINAL REPORT

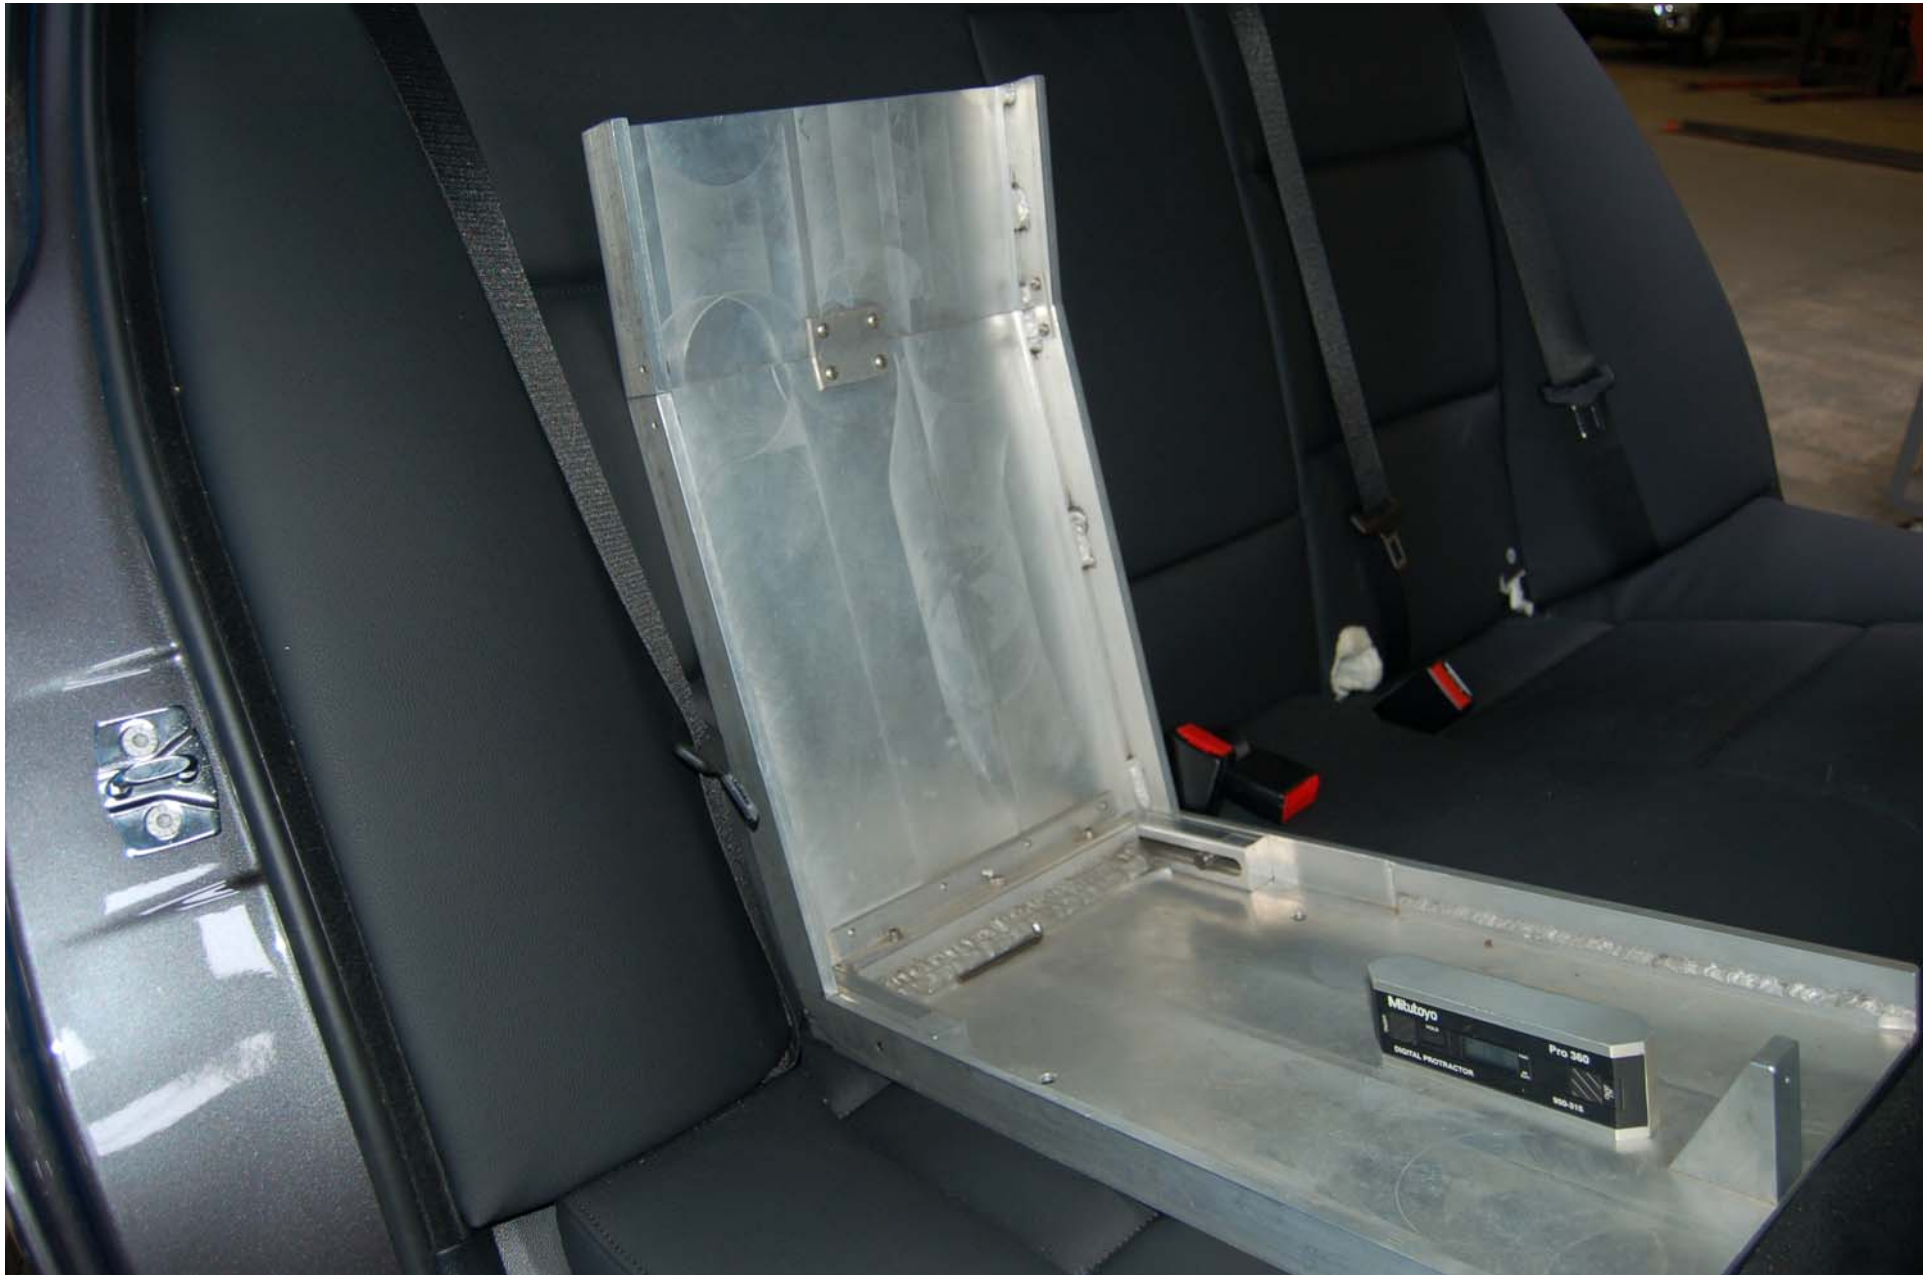
FIGURE 5.18
ROW 2, RIGHT SIDE WITH CRF

CRF Pitch angle: 17.8°
 Angle = 15° ± 10° = PASS Angle ≠ 15° ± 10° = FAIL (S9.2.1)

CRF Roll angle: 0°
 Angle = 0° ± 5° = PASS Angle ≠ 0° ± 5° = FAIL (S9.2.1)

CRF Yaw angle: 0°
 Angle = 0° ± 10° = PASS Angle ≠ 0° ± 10° = FAIL (S9.2.1)

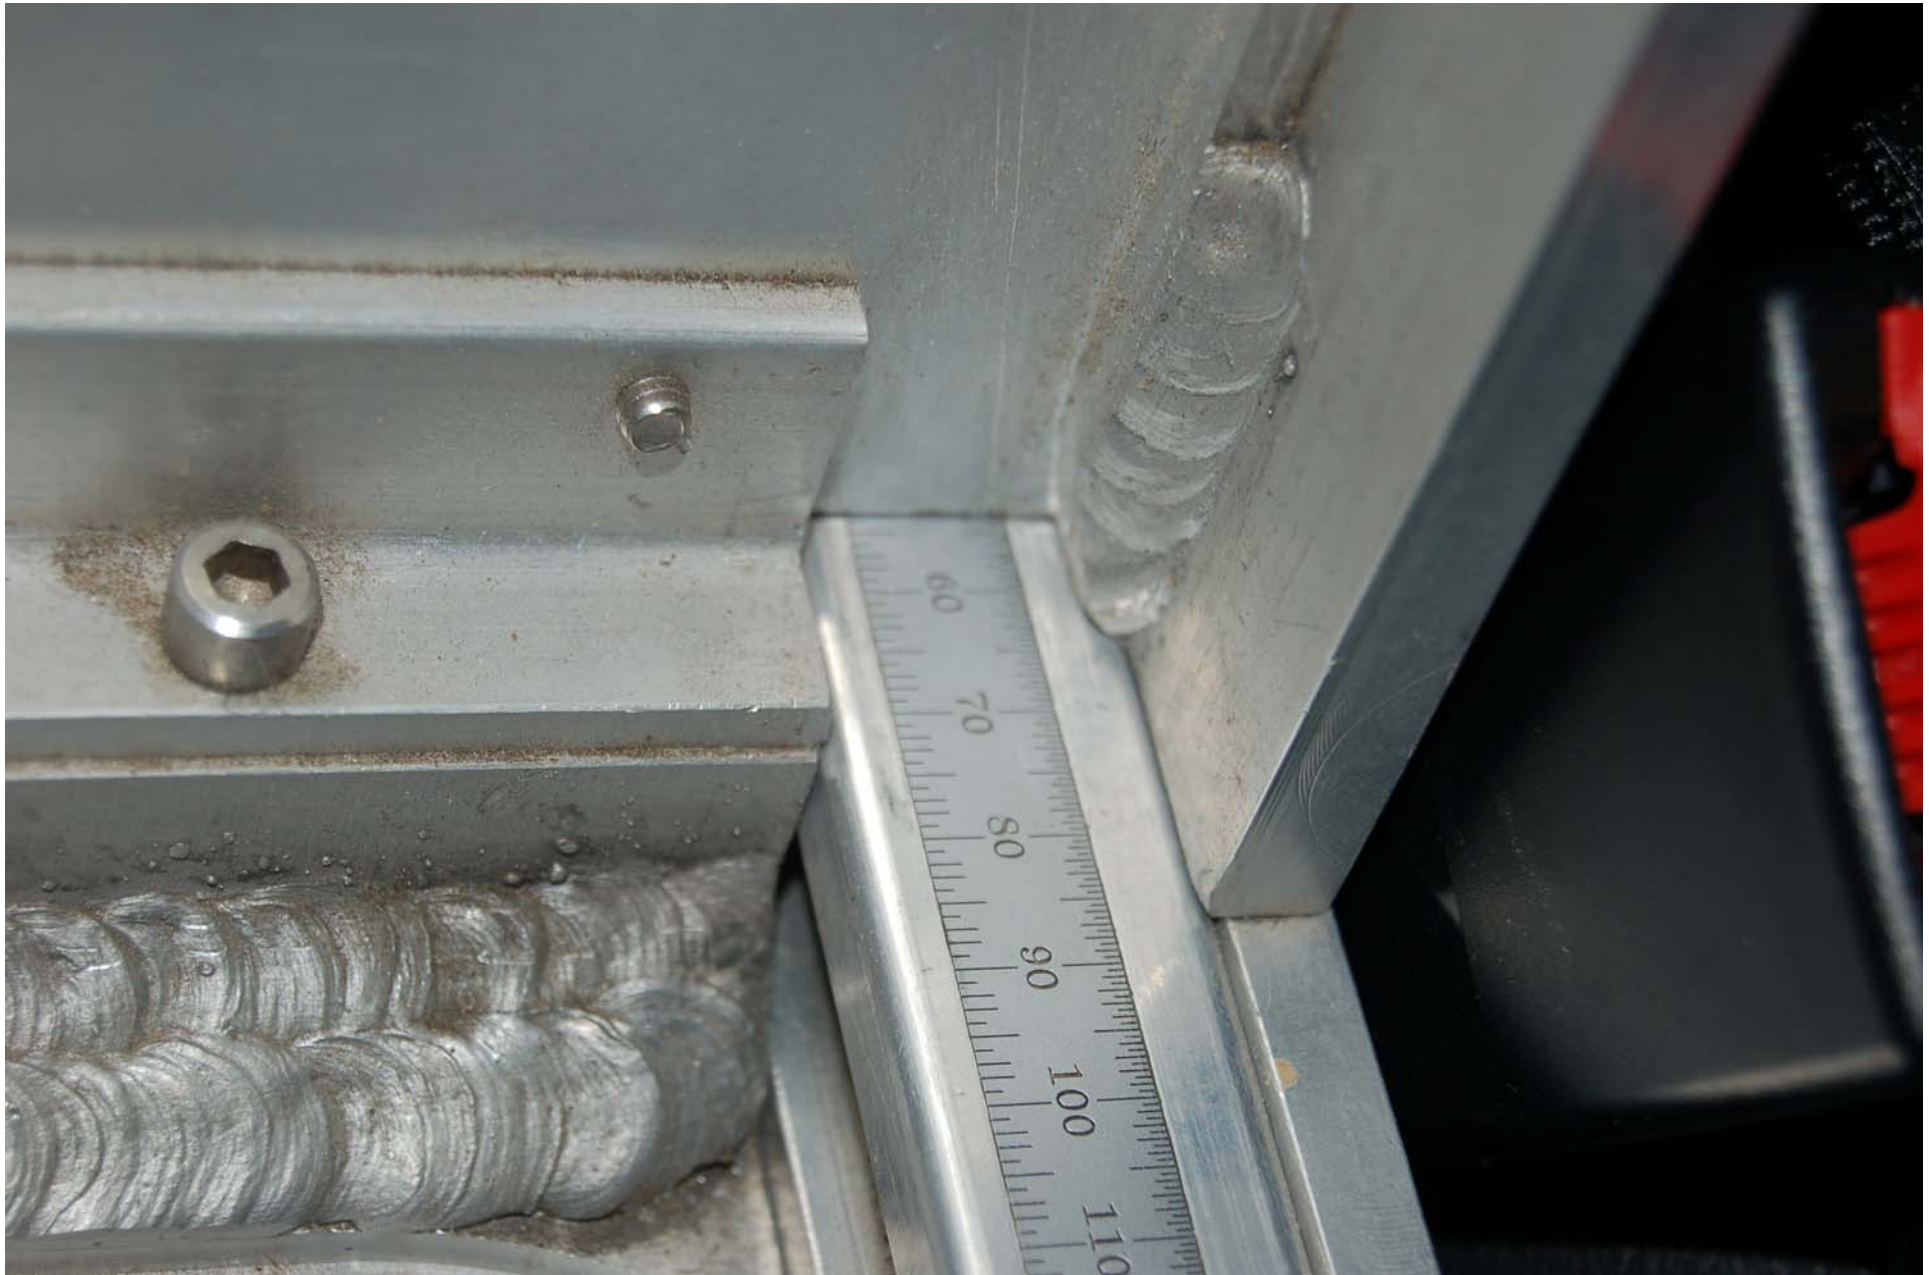
FIGURE 5.23
ROW 2, RIGHT SIDE INBOARD CRF MEASUREMENT

Distance between point Z on the CRF and the front surface of inboard anchor bar: 54 mm
 Distance ≤ 70mm = PASS Distance > 70mm = FAIL

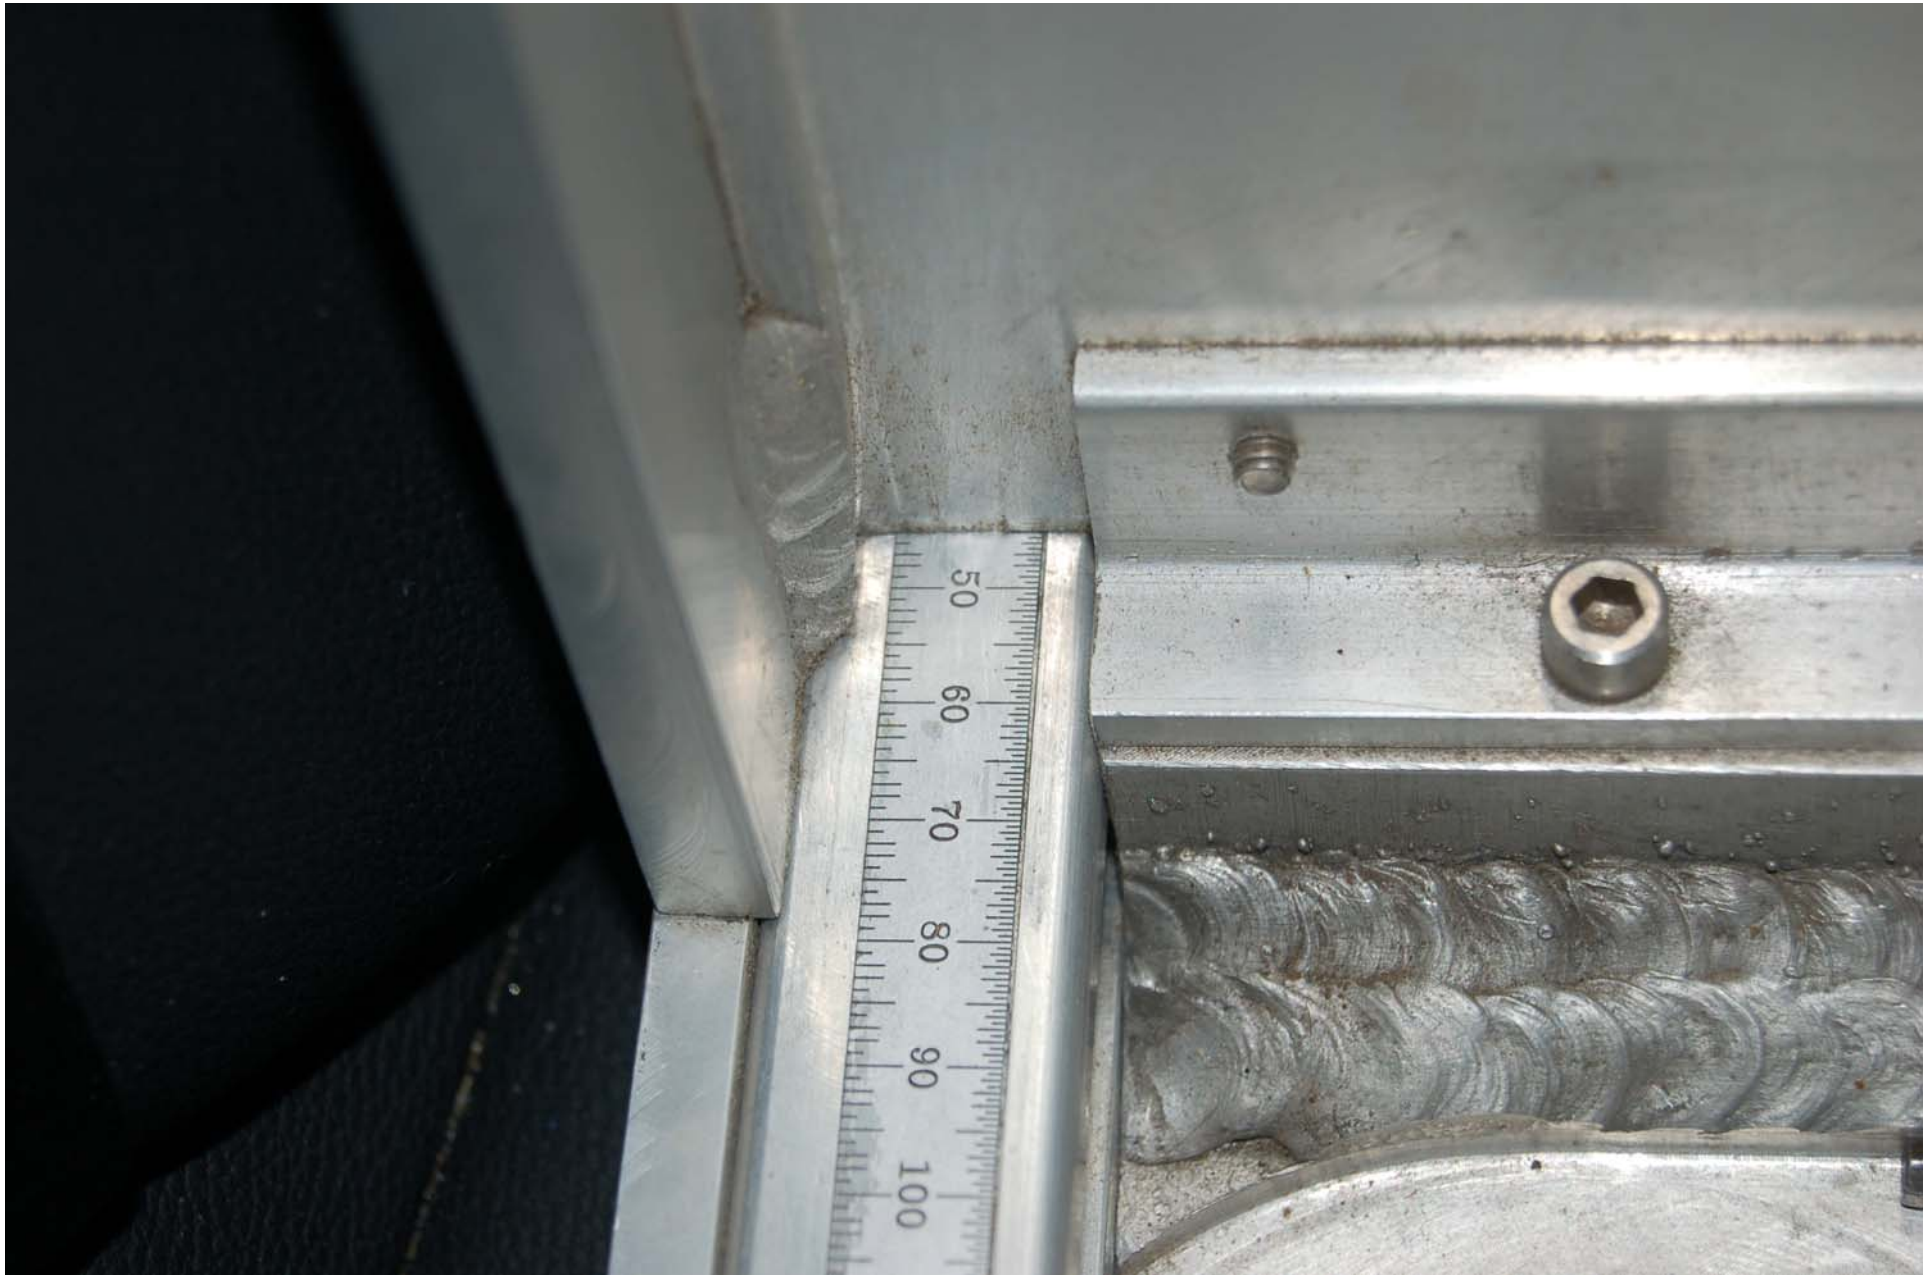
FIGURE 5.24
ROW 2, RIGHT SIDE OUTBOARD CRF MEASUREMENT

Distance between point Z on the CRF and the front surface of outboard anchor bar: 45 mm
 Distance ≤ 70mm = PASS Distance > 70mm = FAIL

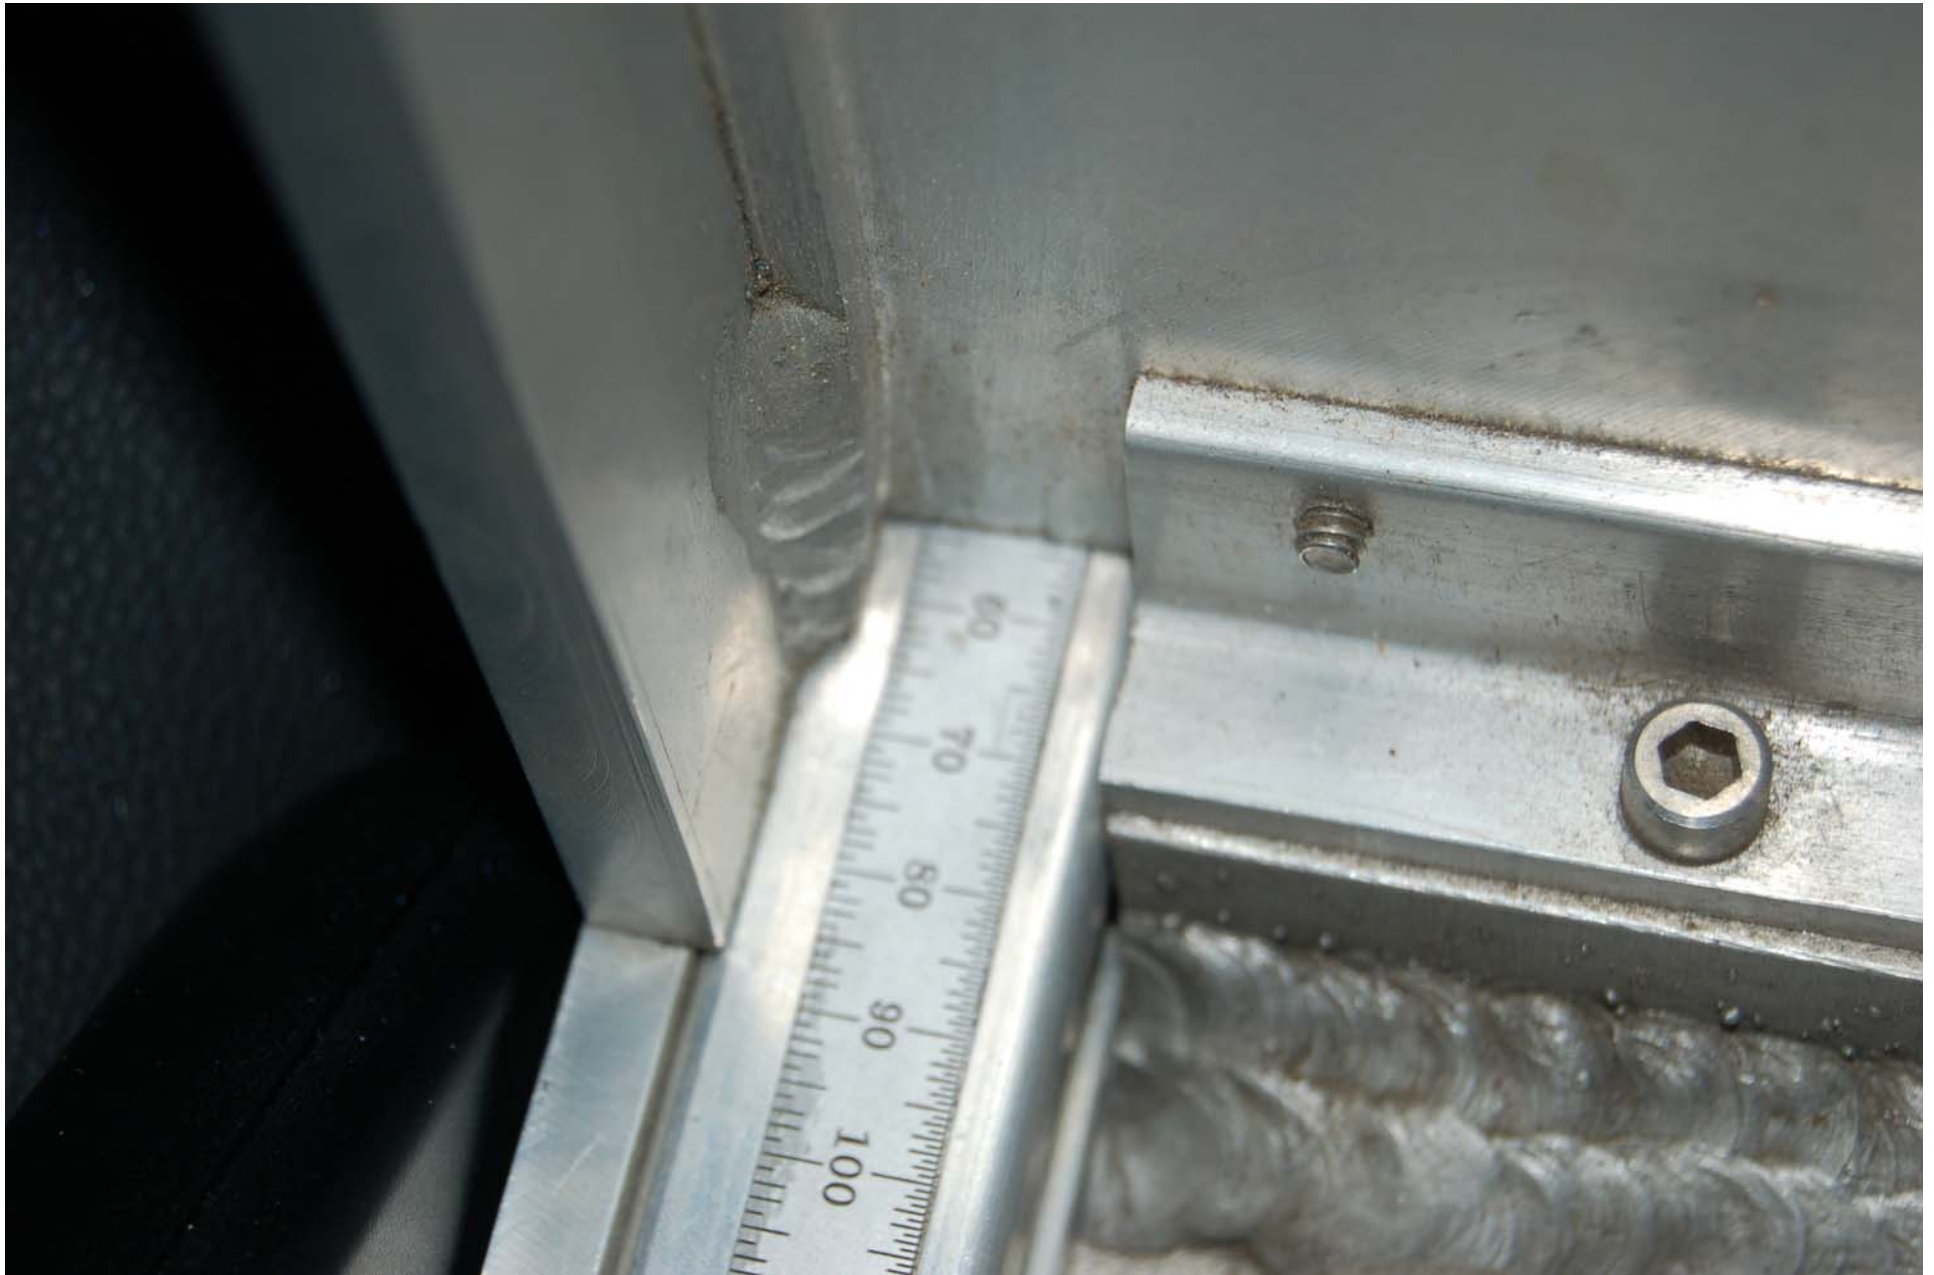
FIGURE 5.25
ROW 2, LEFT SIDE INBOARD CRF MEASUREMENT

Distance between point Z on the CRF and the front surface of inboard anchor bar: 54 mm
 Distance ≤ 70mm = PASS Distance > 70mm = FAIL

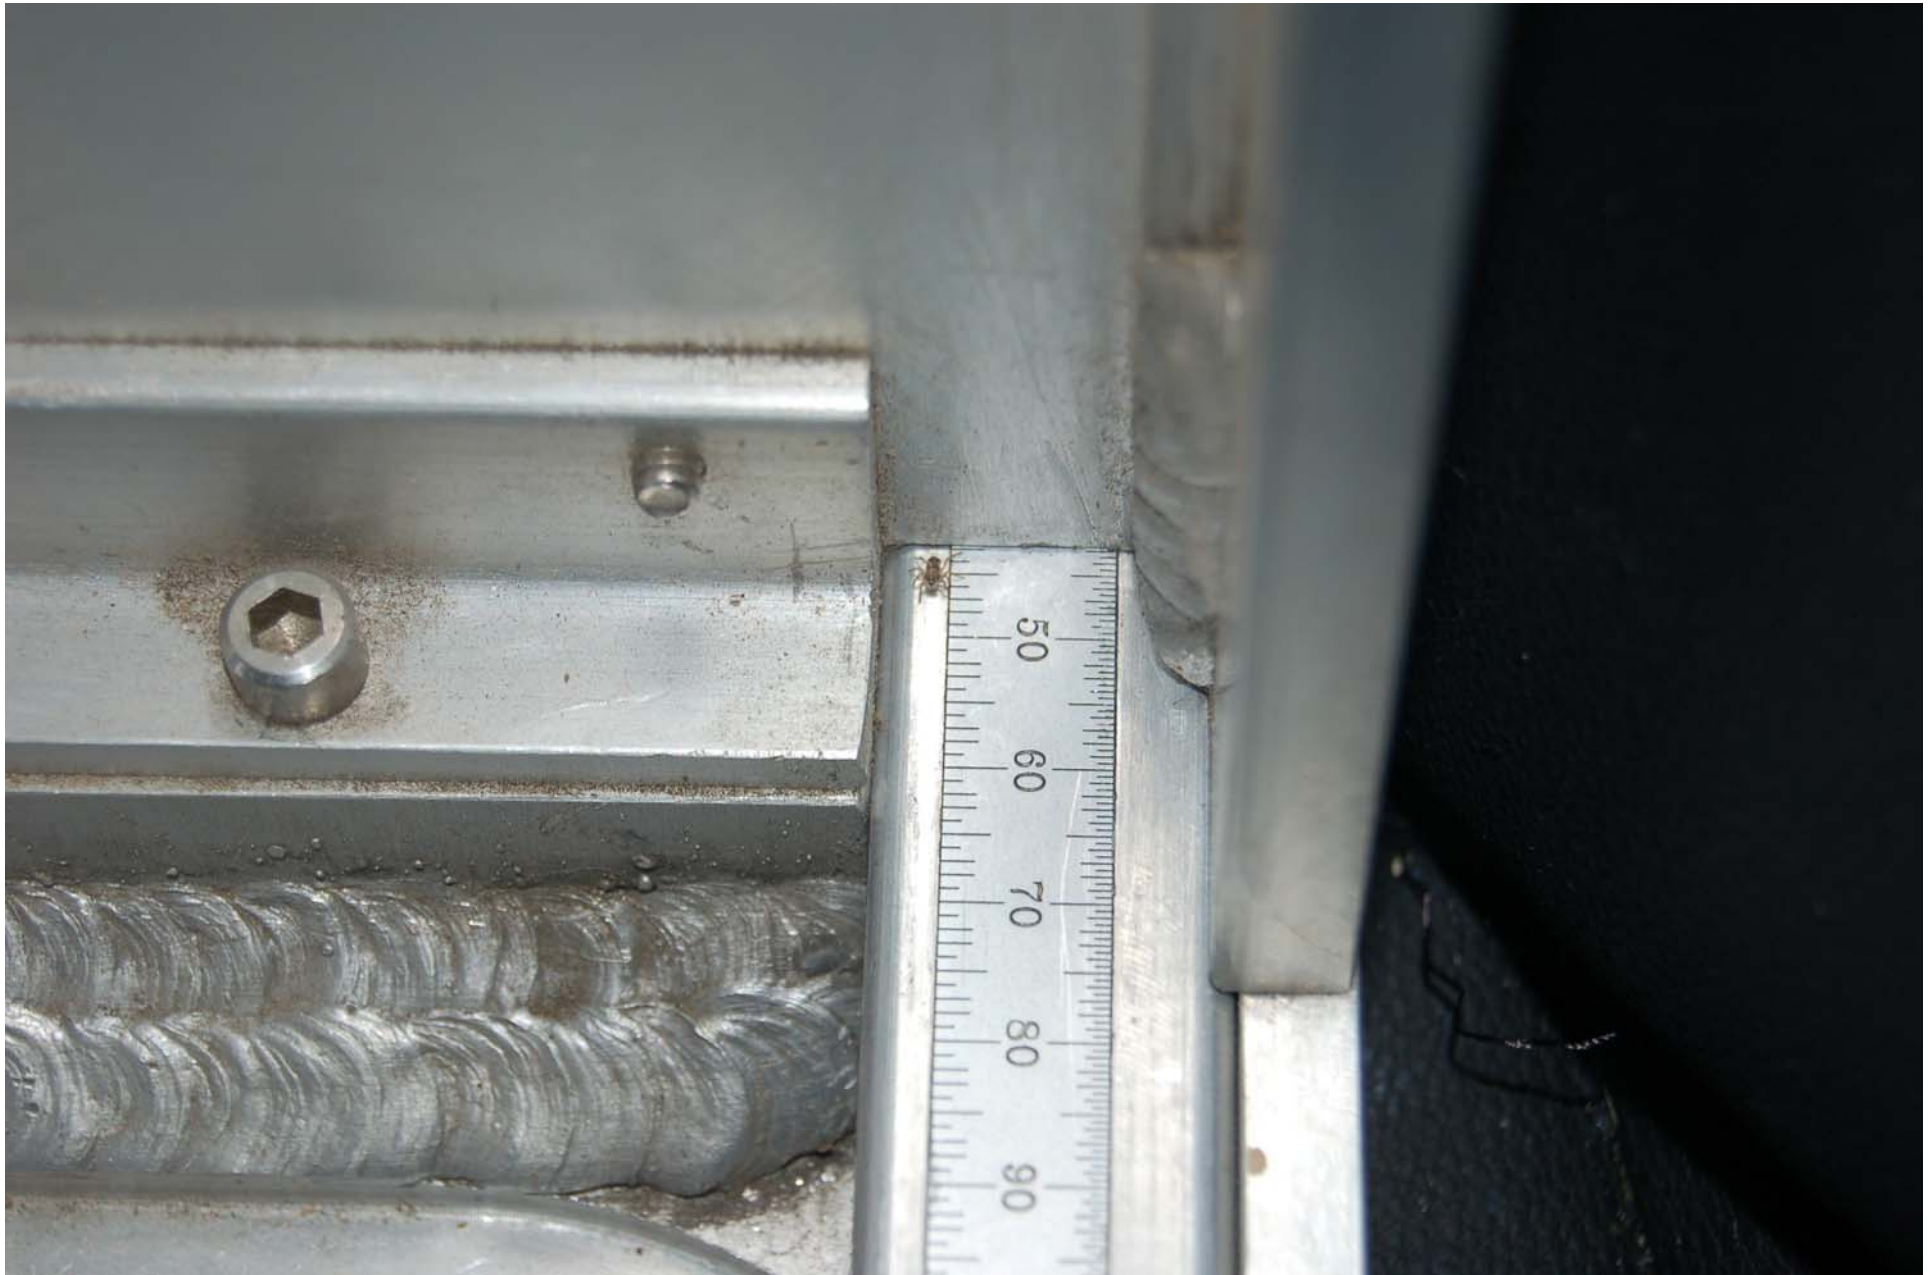
FIGURE 5.26
ROW 2, LEFT SIDE OUTBOARD CRF MEASUREMENT

Distance between point Z on the CRF and the front surface of outboard anchor bar: 43 mm
 Distance ≤ 70mm = PASS Distance > 70mm = FAIL

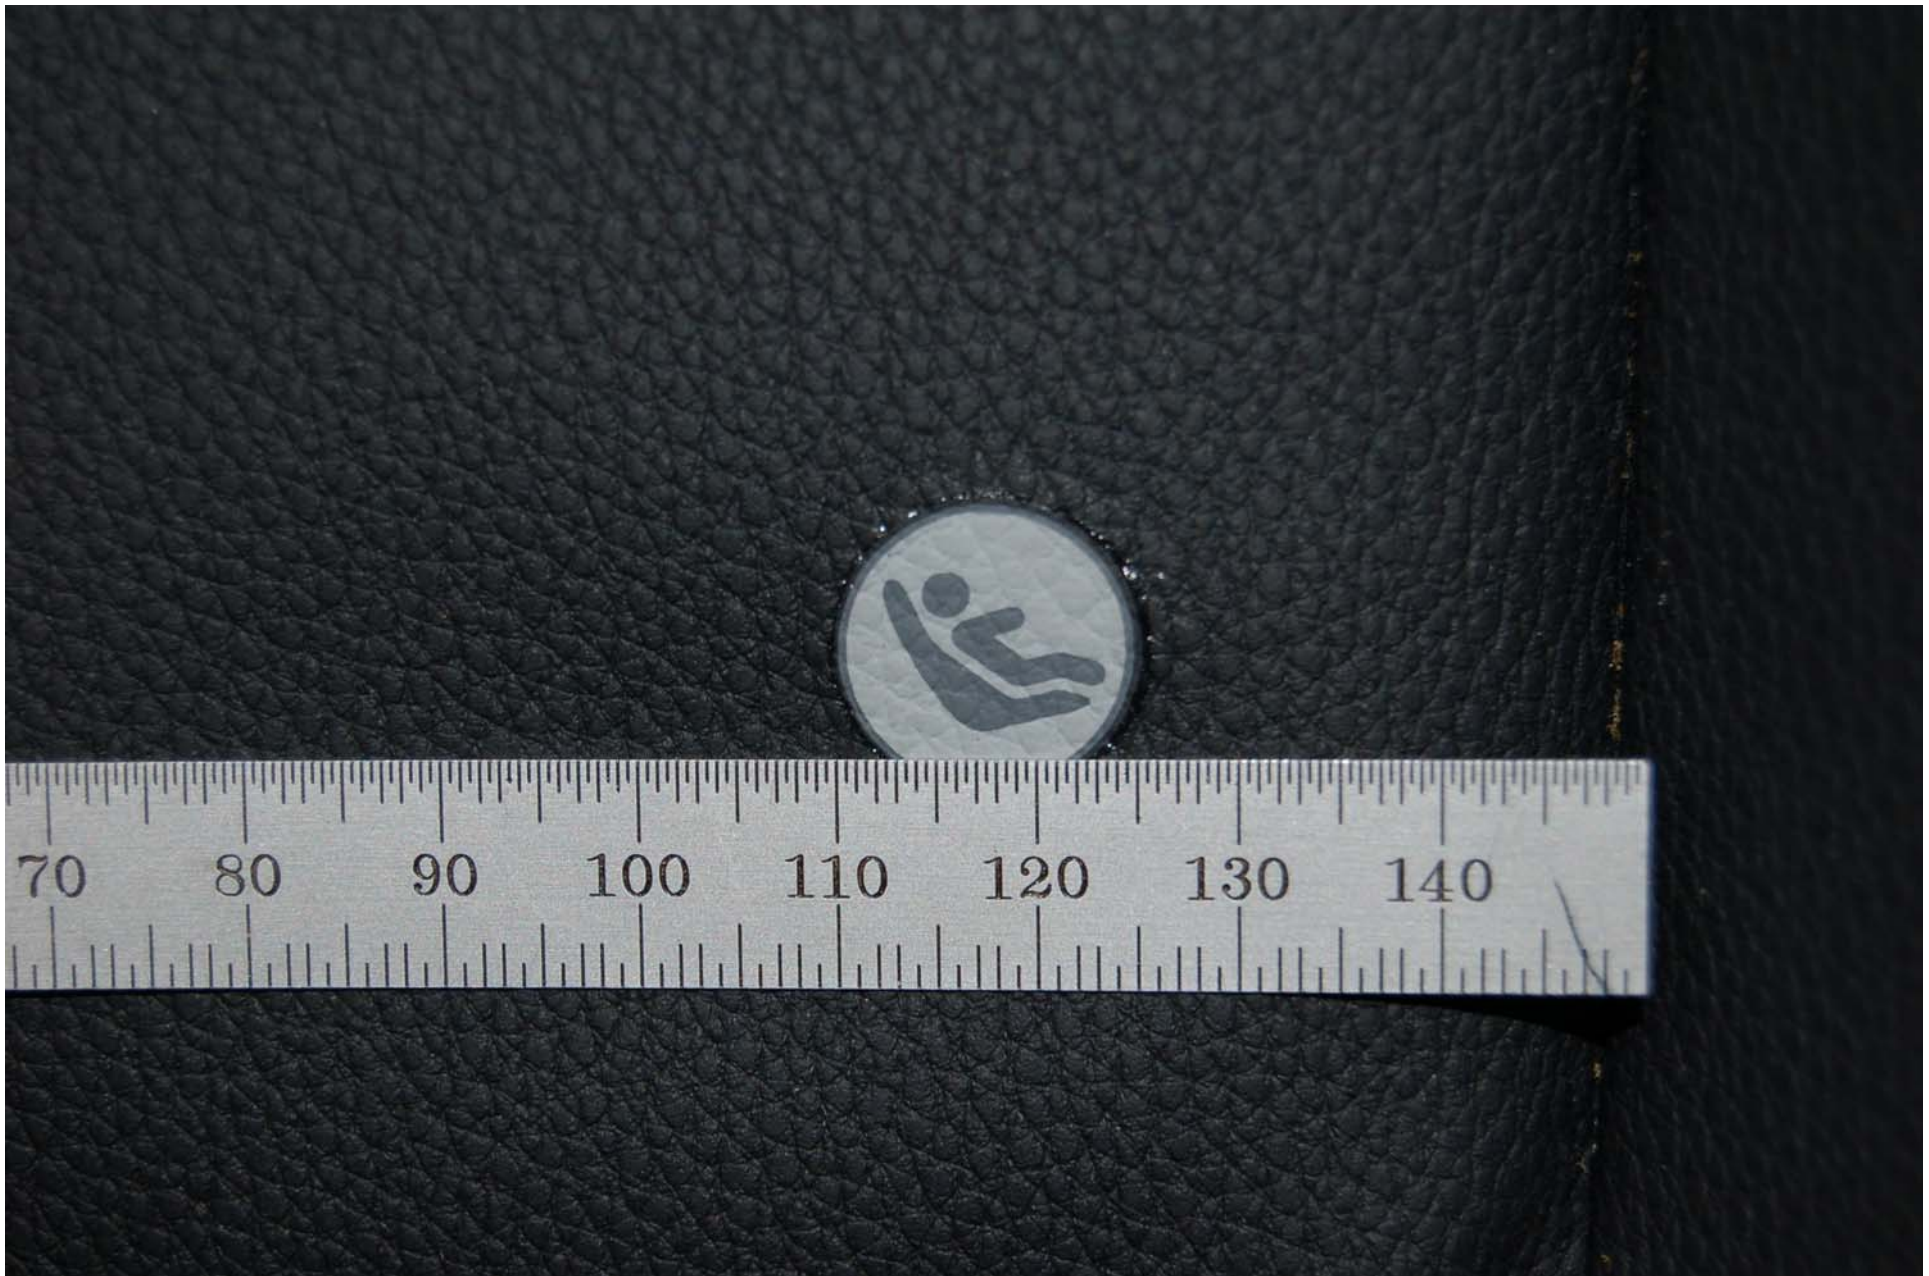
FIGURE 5.27
MEASUREMENT OF SYMBOL

Diameter of the circle: 15.0 mm
 Diameter $\geq 13\text{mm}$ = PASS Diameter $< 13\text{mm}$ = FAIL (S9.5(a)(1))

For circles on seat backs, vertical distance from the center of the circle to the center of the anchor bar: 80 mm
 Distance between 50&100mm = PASS Other Distance=FAIL (S9.5(a)(3))

Lateral distance from the center of the circle to the center of the anchor bar: 10 mm
 Distance $\leq 25\text{mm}$ = PASS Distance $> 25\text{mm}$ = FAIL (S9.5(a)(3))

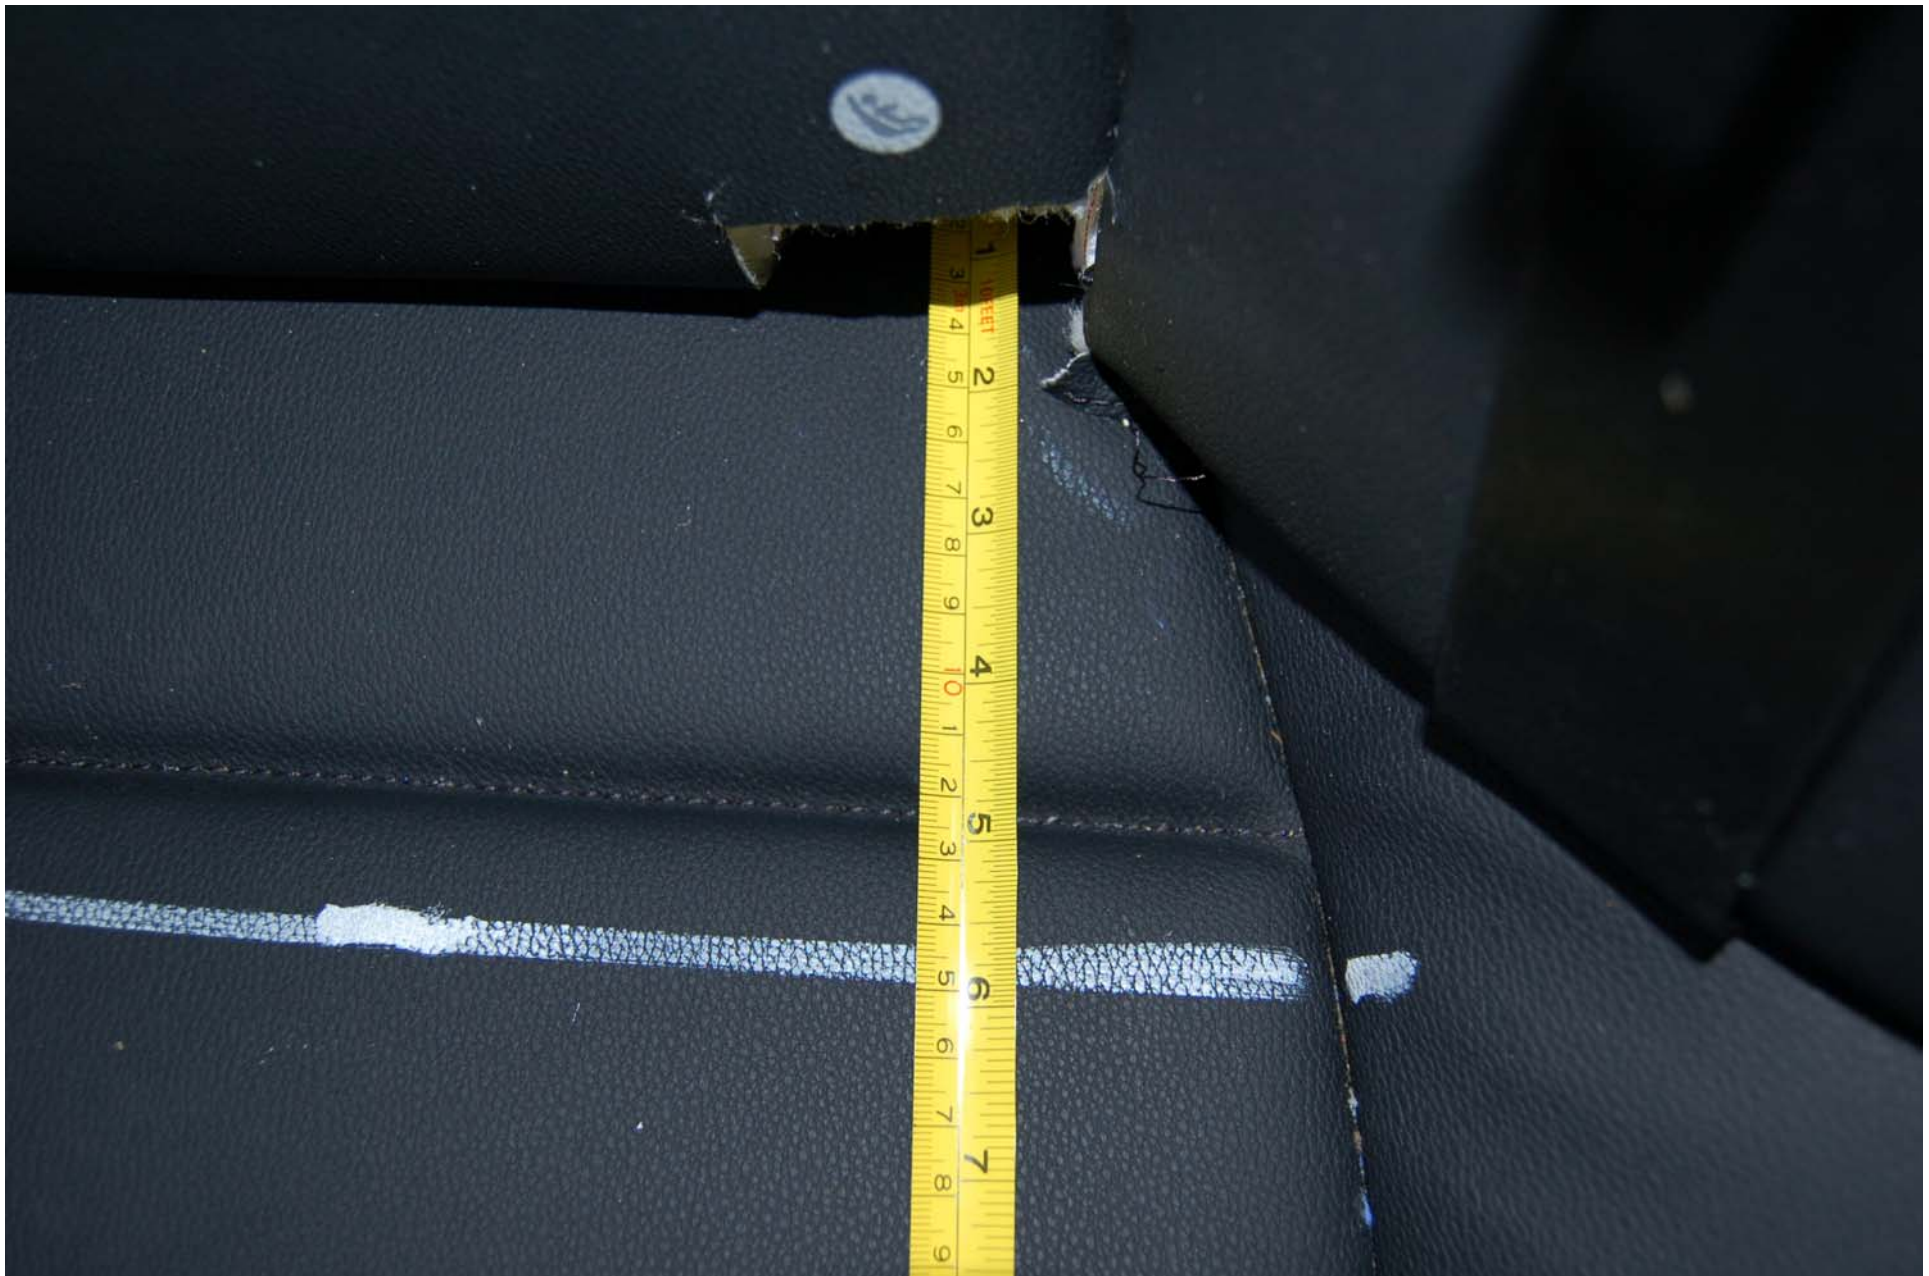
FIGURE 5.30
ROW 2, LEFT SIDE, OUTBOARD SRP MEASUREMENT

DESIGNATED SEATING POSITION: ROW 2 LEFT SIDE (DSP A)Distance between SgRP and the front surface of outboard anchor bar: 147 mm
Distance \geq 120mm = PASS Distance $<$ 120mm = FAILDistance between SgRP and the front surface of inboard anchor bar: 145 mm
Distance \geq 120mm = PASS Distance $<$ 120mm = FAILBased on visual observation, would a 100 N load cause the anchor bar to deform more than 5 mm?
NO

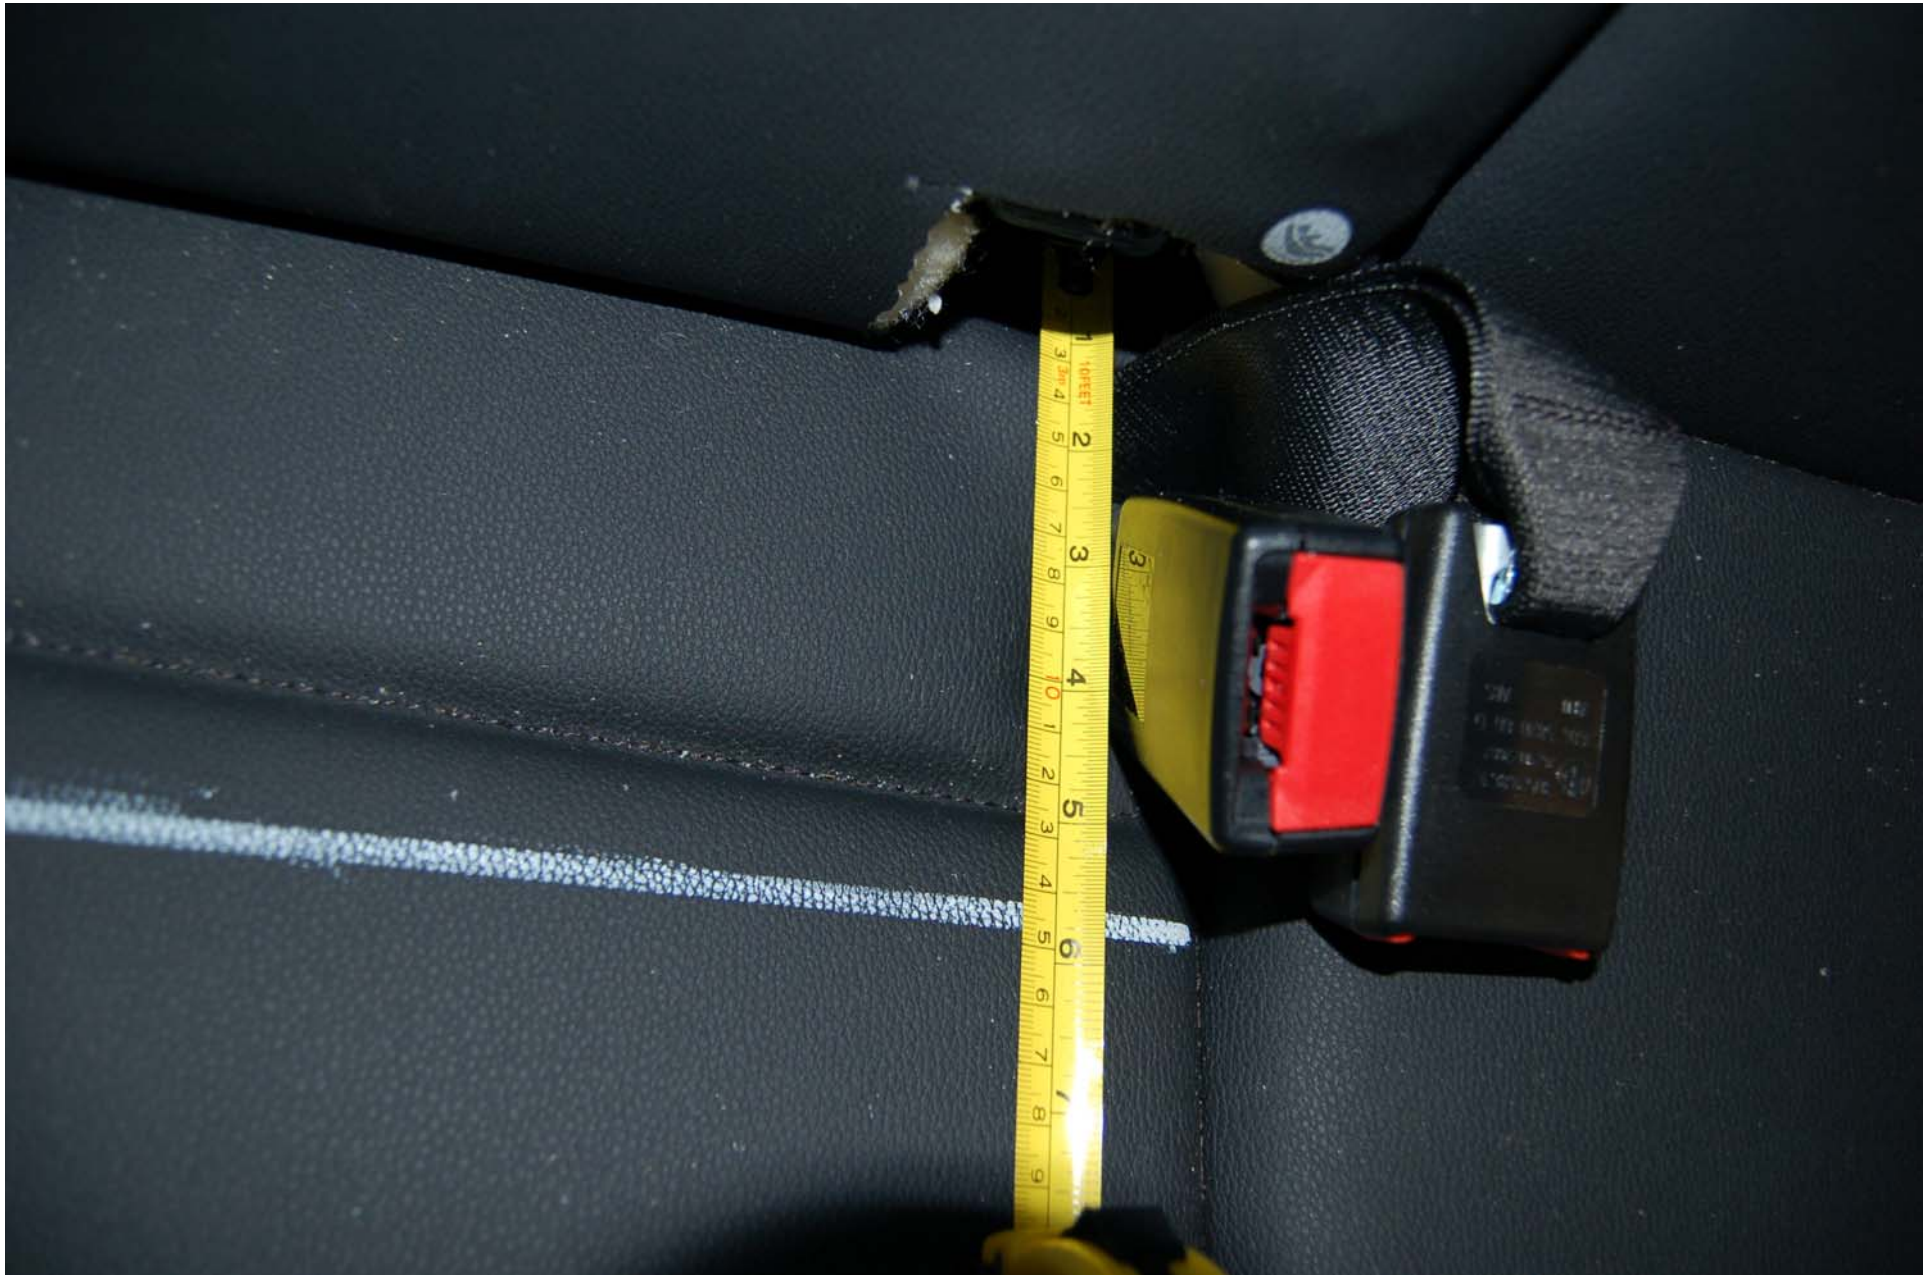
FIGURE 5.32
ROW 2, RIGHT SIDE, INBOARD SRP MEASUREMENT

DESIGNATED SEATING POSITION: ROW 2 RIGHT SIDE (DSP C)Distance between SgRP and the front surface of outboard anchor bar: 142 mm
Distance \geq 120mm = PASS Distance $<$ 120mm = FAILDistance between SgRP and the front surface of inboard anchor bar: 147 mm
Distance \geq 120mm = PASS Distance $<$ 120mm = FAILBased on visual observation, would a 100 N load cause the anchor bar to deform more than 5 mm?
NO
