REPORT NUMBER: 201UI-CAL-08-07

**SAFETY COMPLIANCE TESTING FOR FMVSS 201
OCCUPANT PROTECTION IN INTERIOR IMPACT
UPPER INTERIOR HEAD IMPACT PROTECTION**

**CHRYSLER LLC
2008 JEEP LIBERTY SPORT 4X4**

CALSPAN TEST NUMBER: 8851-07

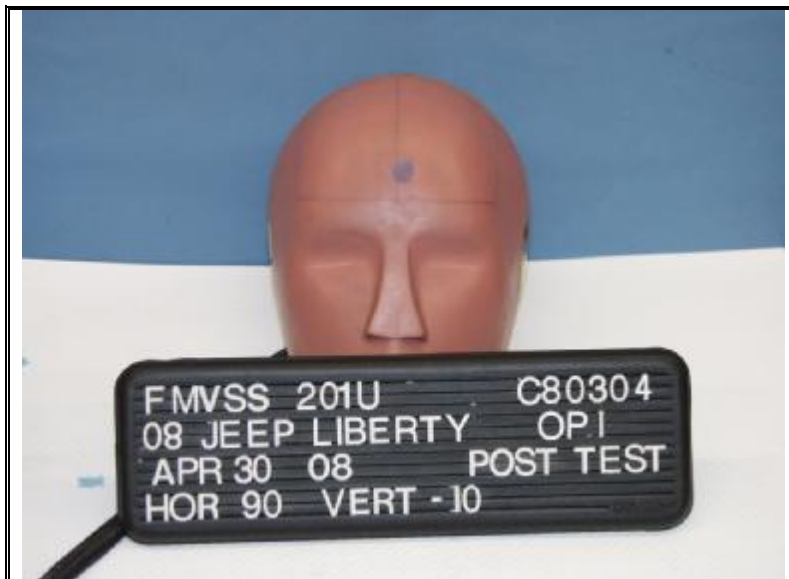
POST-IMPACT OP1 HEADFORM

Test Number:	01
Test Date:	04/30/08
Target Location:	OTHER PILLAR
Target Code:	OP1
Horizontal Impact Angle:	90°
Vertical Impact Angle:	NEG10°
Ambient Temperature:	20.5° C
Relative Humidity:	23.6 %
Time of Impact:	9:25
Headform Number:	1142

Impact Point Description (from lower midpoint on midsagittal line)			
On Centerline	3	mm right	x mm left
On Centerline	14	mm up

Free Motion HIC	599.5
HIC(d)	618.7
Impact Velocity (kph)	23.69
HIC T1 (msec)	2.6
HIC T2 (msec)	12.2

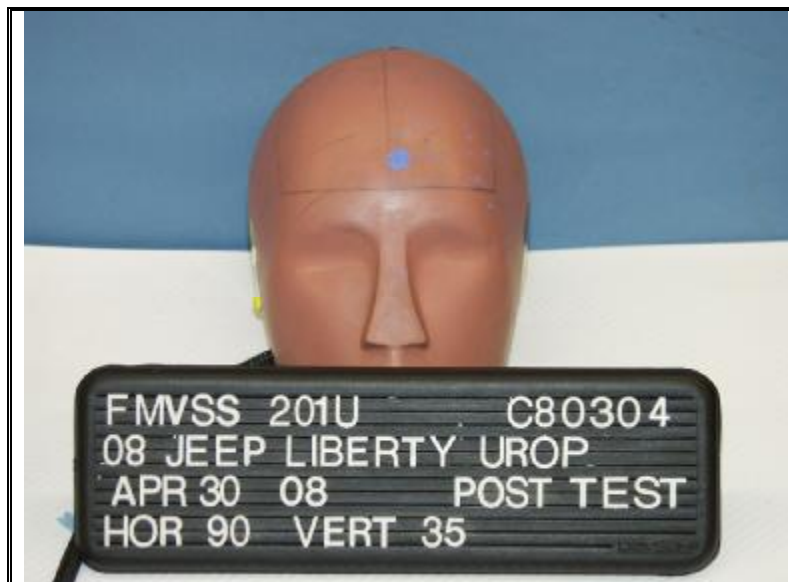
POST-IMPACT UROP HEADFORM

Test Number:	02
Test Date:	04/30/08
Target Location:	UPPER ROOF
Target Code:	UROP
Horizontal Impact Angle:	90°
Vertical Impact Angle:	35°
Ambient Temperature:	20.5° C
Relative Humidity:	22.5%
Time of Impact:	9:59
Headform Number:	1140

Impact Point Description (from lower midpoint on midsagittal line)			
On Centerline	5	mm right	x mm left
On Centerline	15	mm up

Free Motion HIC	404.7
HIC(d)	315.9
Impact Velocity (kph)	23.76
HIC T1 (msec)	2.4
HIC T2 (msec)	18.7

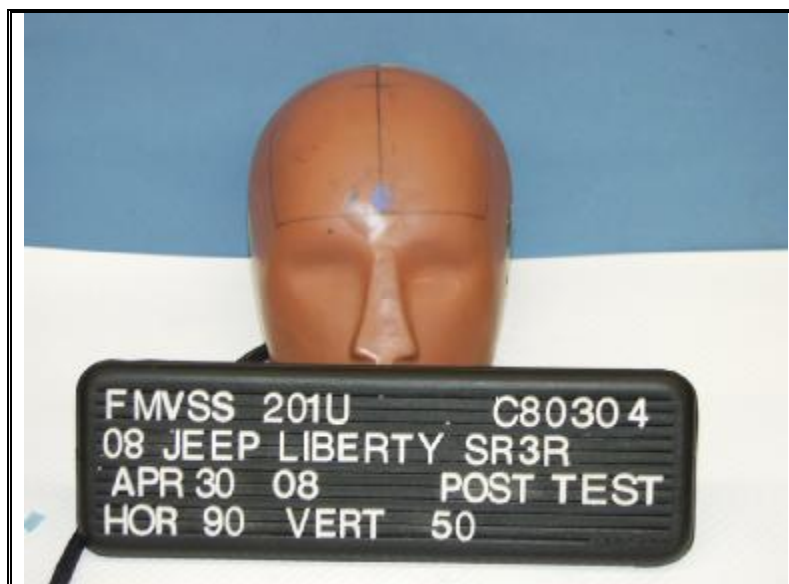
POST-IMPACT SR3R HEADFORM

Test Number:	03
Test Date:	04/30/08
Target Location:	SIDE RAIL
Target Code:	SR3R
Horizontal Impact Angle:	90°
Vertical Impact Angle:	50°
Ambient Temperature:	20.5° C
Relative Humidity:	22.6%
Time of Impact:	10:30
Headform Number:	0355

Impact Point Description (from lower midpoint on midsagittal line)					
On Centerline	0	<input type="checkbox"/>	mm right	<input type="checkbox"/>	mm left
On Centerline	6				mm up

Free Motion HIC	356.0
HIC(d)	435.0
Impact Velocity (kph)	18.46
HIC T1 (msec)	3.0
HIC T2 (msec)	10.3

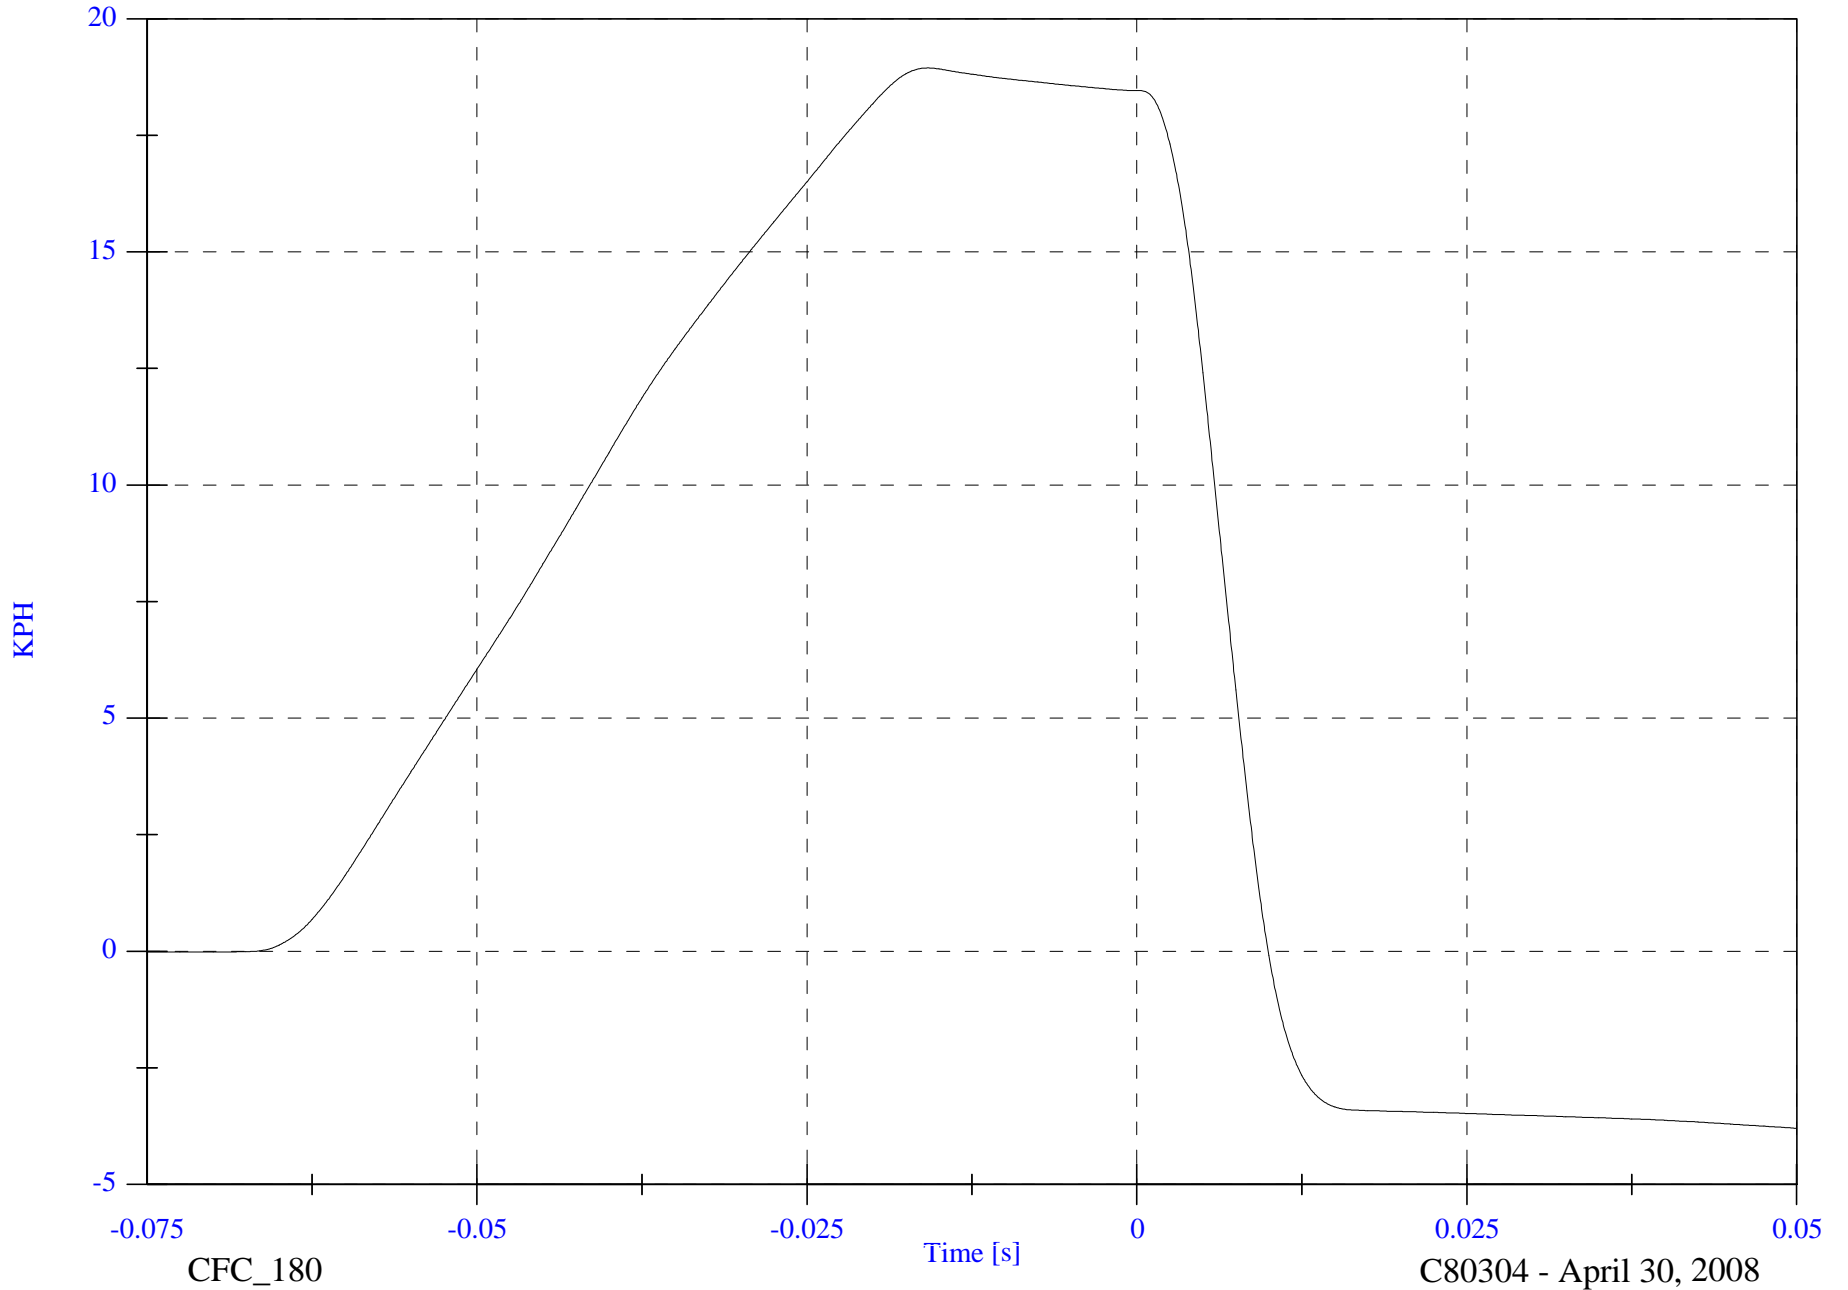
C80304 PASSENGER SIDE SR3R IMPACT PLOT #6

Min: -3.8 [KPH] at 0.050 [s]

Headform Velocity

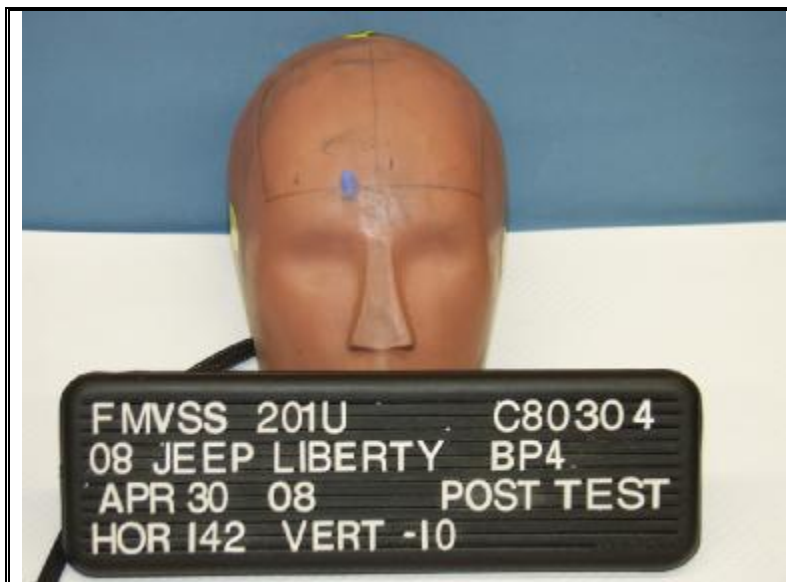
POST-IMPACT BP4 HEADFORM

Test Number:	04
Test Date:	04/30/08
Target Location:	B-PILLAR
Target Code:	BP4
Horizontal Impact Angle:	142°
Vertical Impact Angle:	-10°
Ambient Temperature:	20.5° C
Relative Humidity:	22.8%
Time of Impact:	11:20
Headform Number:	0805

Impact Point Description (from lower midpoint on midsagittal line)			
On Centerline	15	<input checked="" type="checkbox"/> mm right	<input type="checkbox"/> mm left
On Centerline	4	mm up

Free Motion HIC	177.3
HIC(d)	300.2
Impact Velocity (kph)	23.53
HIC T1 (msec)	4.3
HIC T2 (msec)	19.6

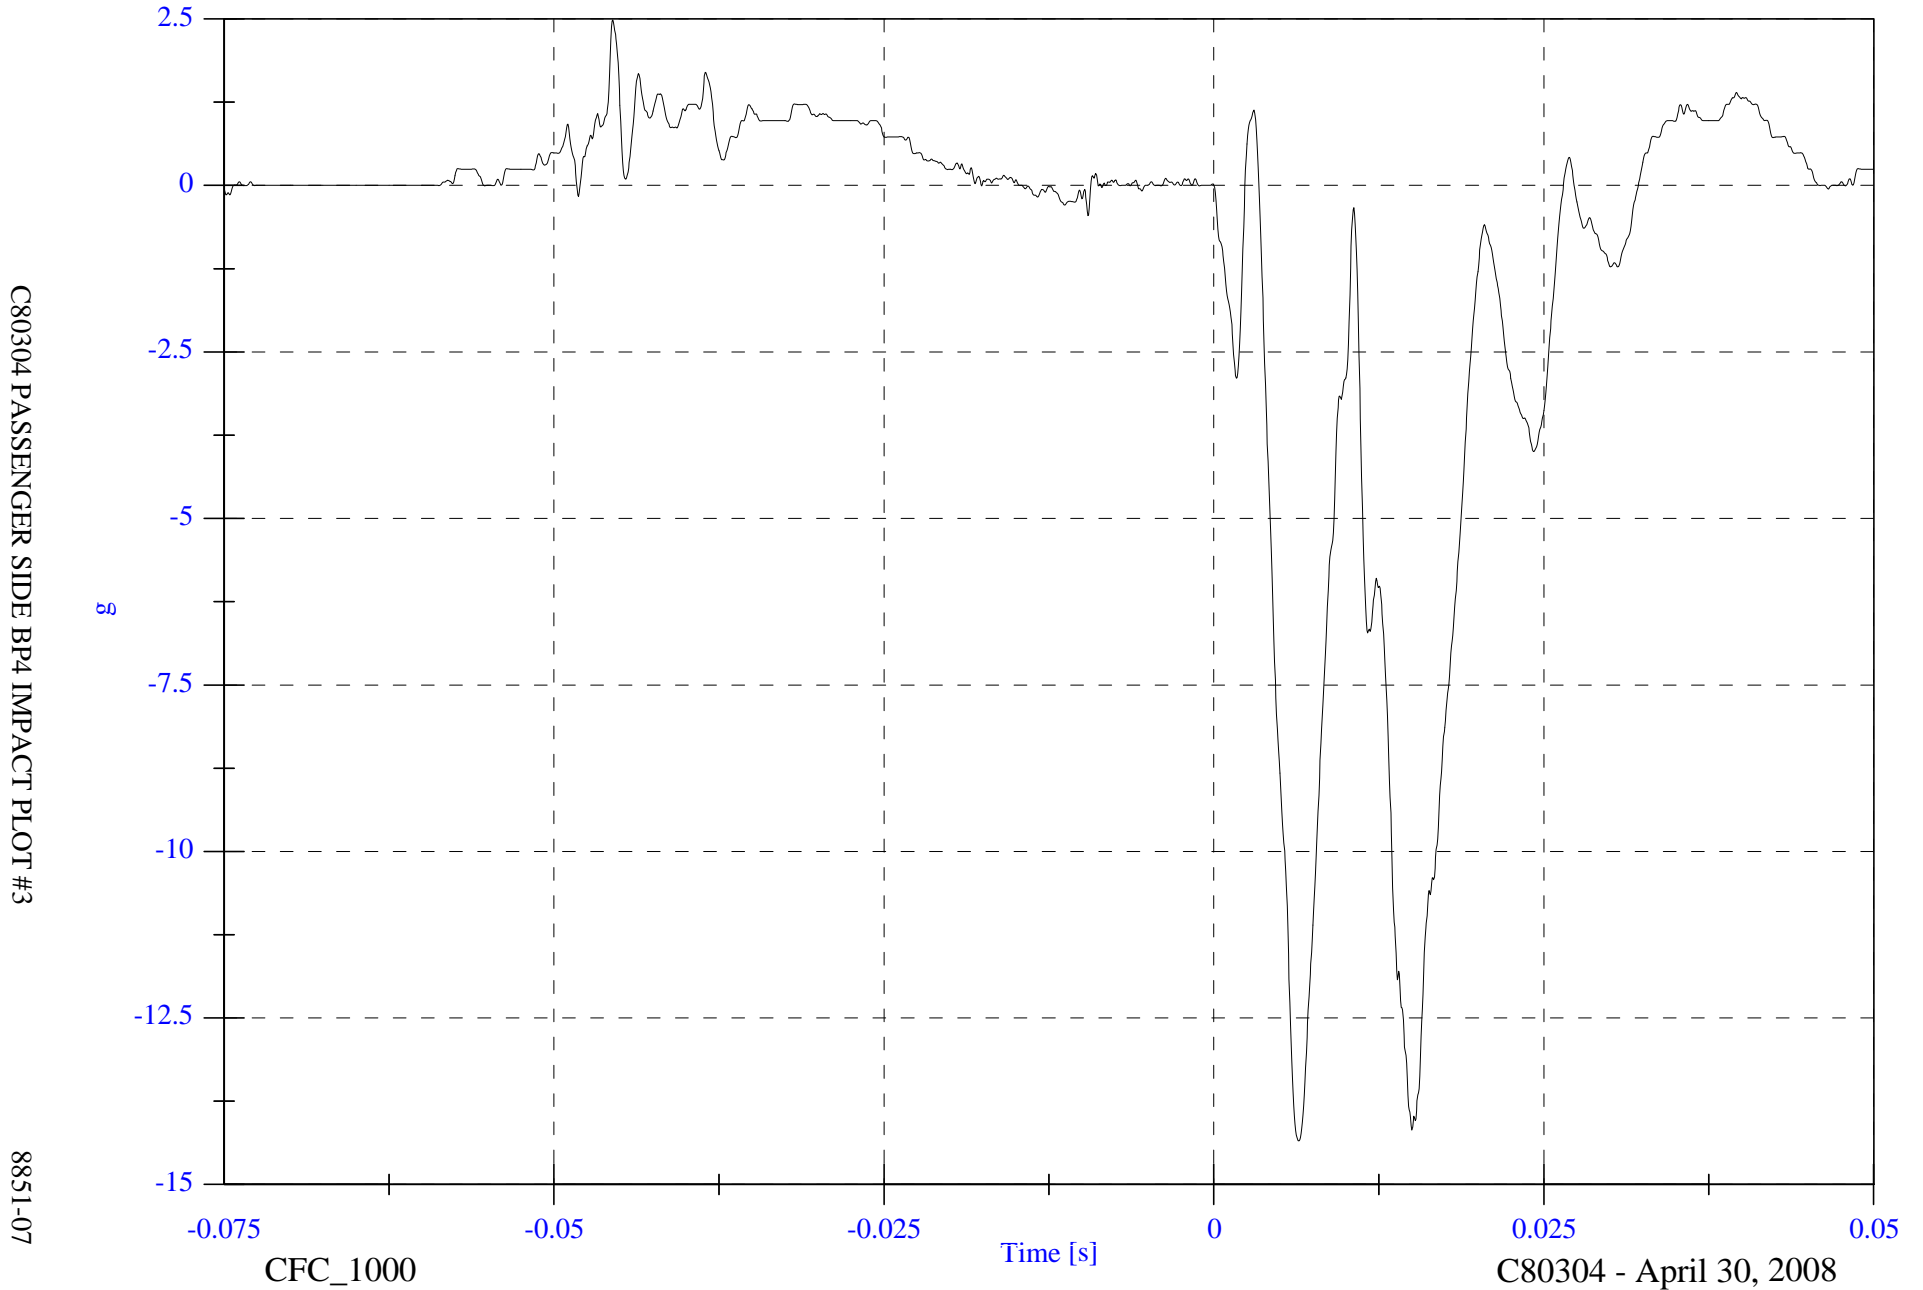
C80304 PASSENGER SIDE BP4 IMPACT PLOT #3

Max: 2.5 [g] at -0.046 [s]
Min: -14.3 [g] at 0.006 [s]

Headform Y Acceleration

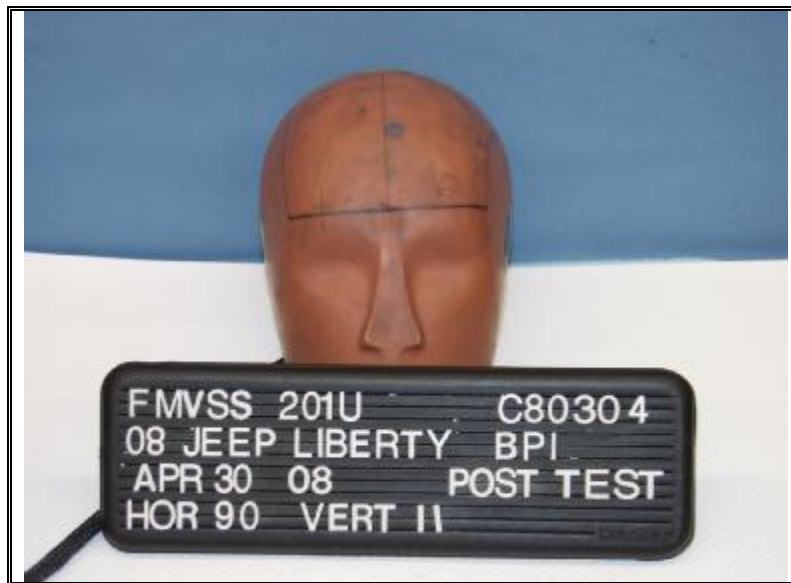
POST-IMPACT BP1 HEADFORM

Test Number:	05
Test Date:	04/30/08
Target Location:	B-PILLAR
Target Code:	BP1
Horizontal Impact Angle:	90°
Vertical Impact Angle:	11°
Ambient Temperature:	20.5° C
Relative Humidity:	22.6%
Time of Impact:	13:24
Headform Number:	0062

Impact Point Description (from lower midpoint on midsagittal line)			
On Centerline	6	mm right	x mm left
On Centerline	23	mm up

Free Motion HIC	127.6
HIC(d)	262.6
Impact Velocity (kph)	18.57
HIC T1 (msec)	7.2
HIC T2 (msec)	24.7

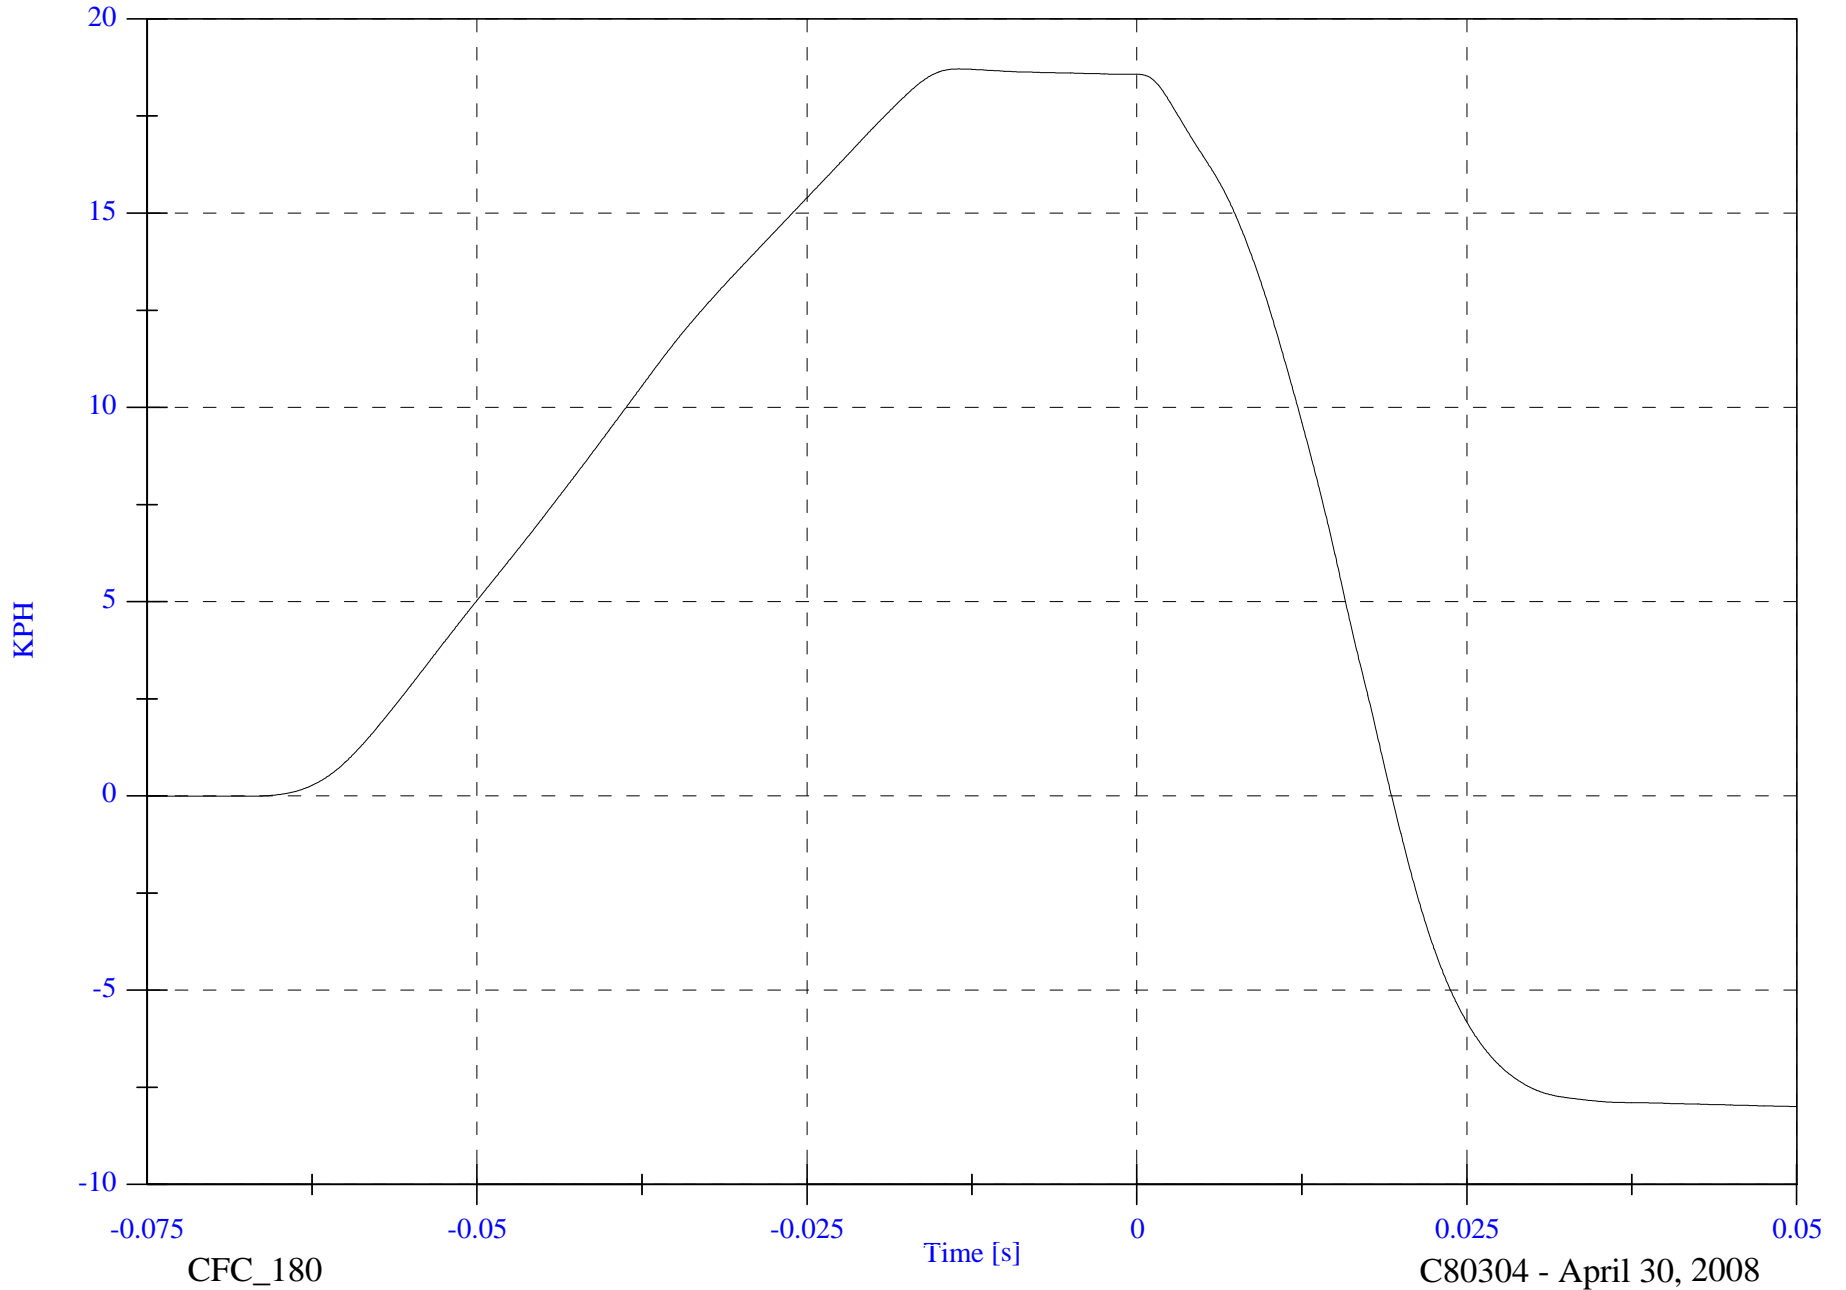
C80304 PASSENGER SIDE BP1 IMPACT PLOT #6

Min: -8.0 [KPH] at 0.050 [s]

Headform Velocity

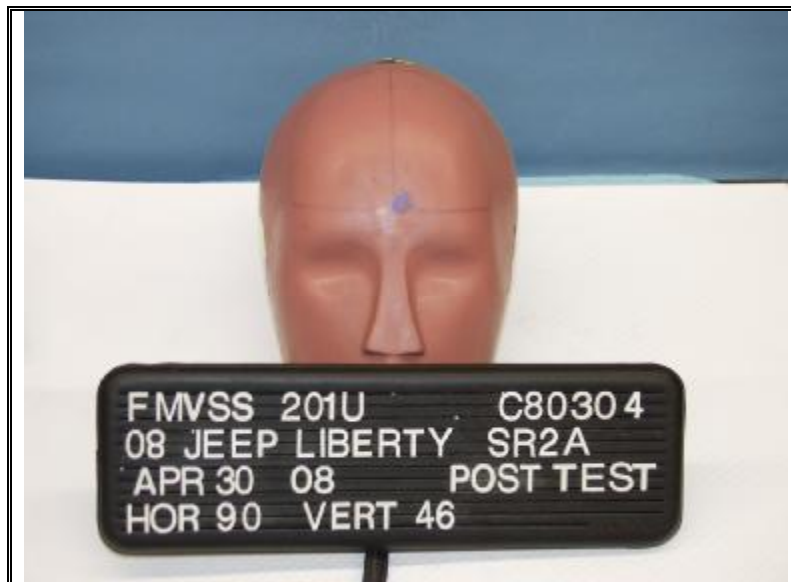
POST-IMPACT SR2A HEADFORM

Test Number:	06
Test Date:	04/30/08
Target Location:	SIDE RAIL
Target Code:	SR2A
Horizontal Impact Angle:	90°
Vertical Impact Angle:	46°
Ambient Temperature:	20.5° C
Relative Humidity:	22.1%
Time of Impact:	13:55
Headform Number:	1142

Impact Point Description (from lower midpoint on midsagittal line)			
On Centerline	5	mm right	x mm left
On Centerline	3	mm up

Free Motion HIC	277.2
HIC(d)	375.6
Impact Velocity (kph)	18.69
HIC T1 (msec)	3.3
HIC T2 (msec)	13.3

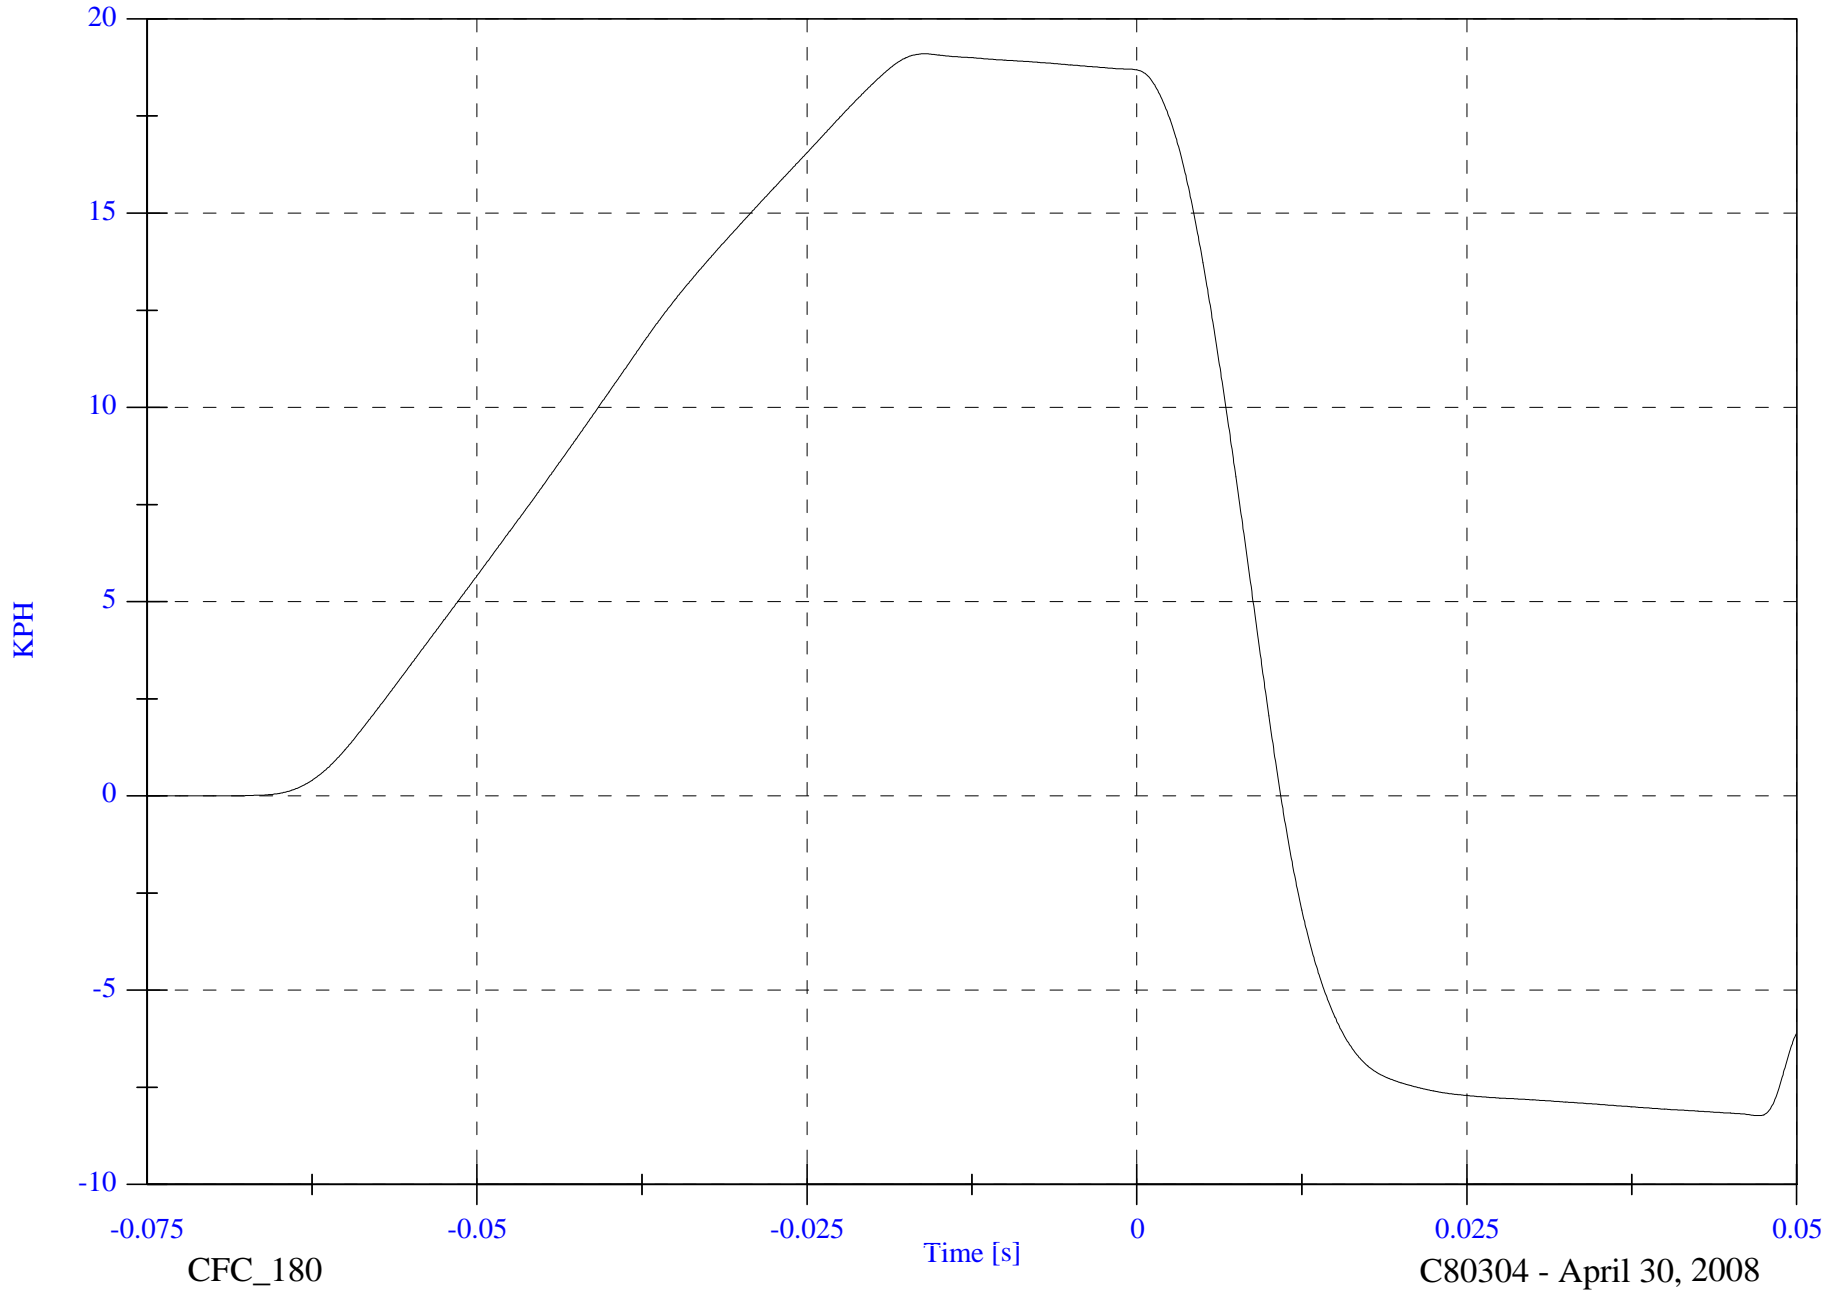
C80304 PASSENGER SIDE SR2A IMPACT PLOT #6

Max: 19.1 [KPH] at -0.016 [s]

Min: -8.2 [KPH] at 0.047 [s]

Headform Velocity

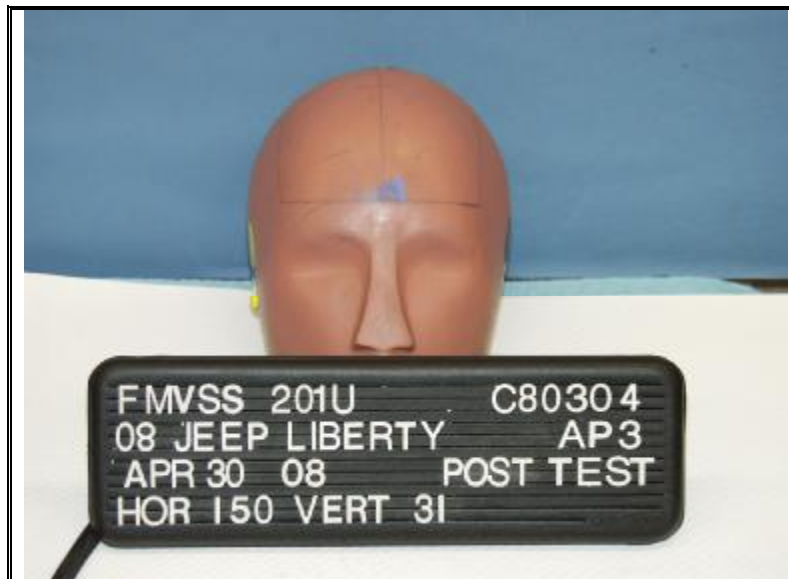
POST-IMPACT AP3 HEADFORM

Test Number:	07
Test Date:	04/30/08
Target Location:	A-PILLAR
Target Code:	AP3
Horizontal Impact Angle:	150°
Vertical Impact Angle:	31°
Ambient Temperature:	20.5° C
Relative Humidity:	21.3%
Time of Impact:	14:30
Headform Number:	1140

Impact Point Description (from lower midpoint on midsagittal line)			
On Centerline	7	mm right	x mm left
On Centerline	5	mm up

Free Motion HIC	218.7
HIC(d)	331.4
Impact Velocity (kph)	18.48
HIC T1 (msec)	2.2
HIC T2 (msec)	12.2

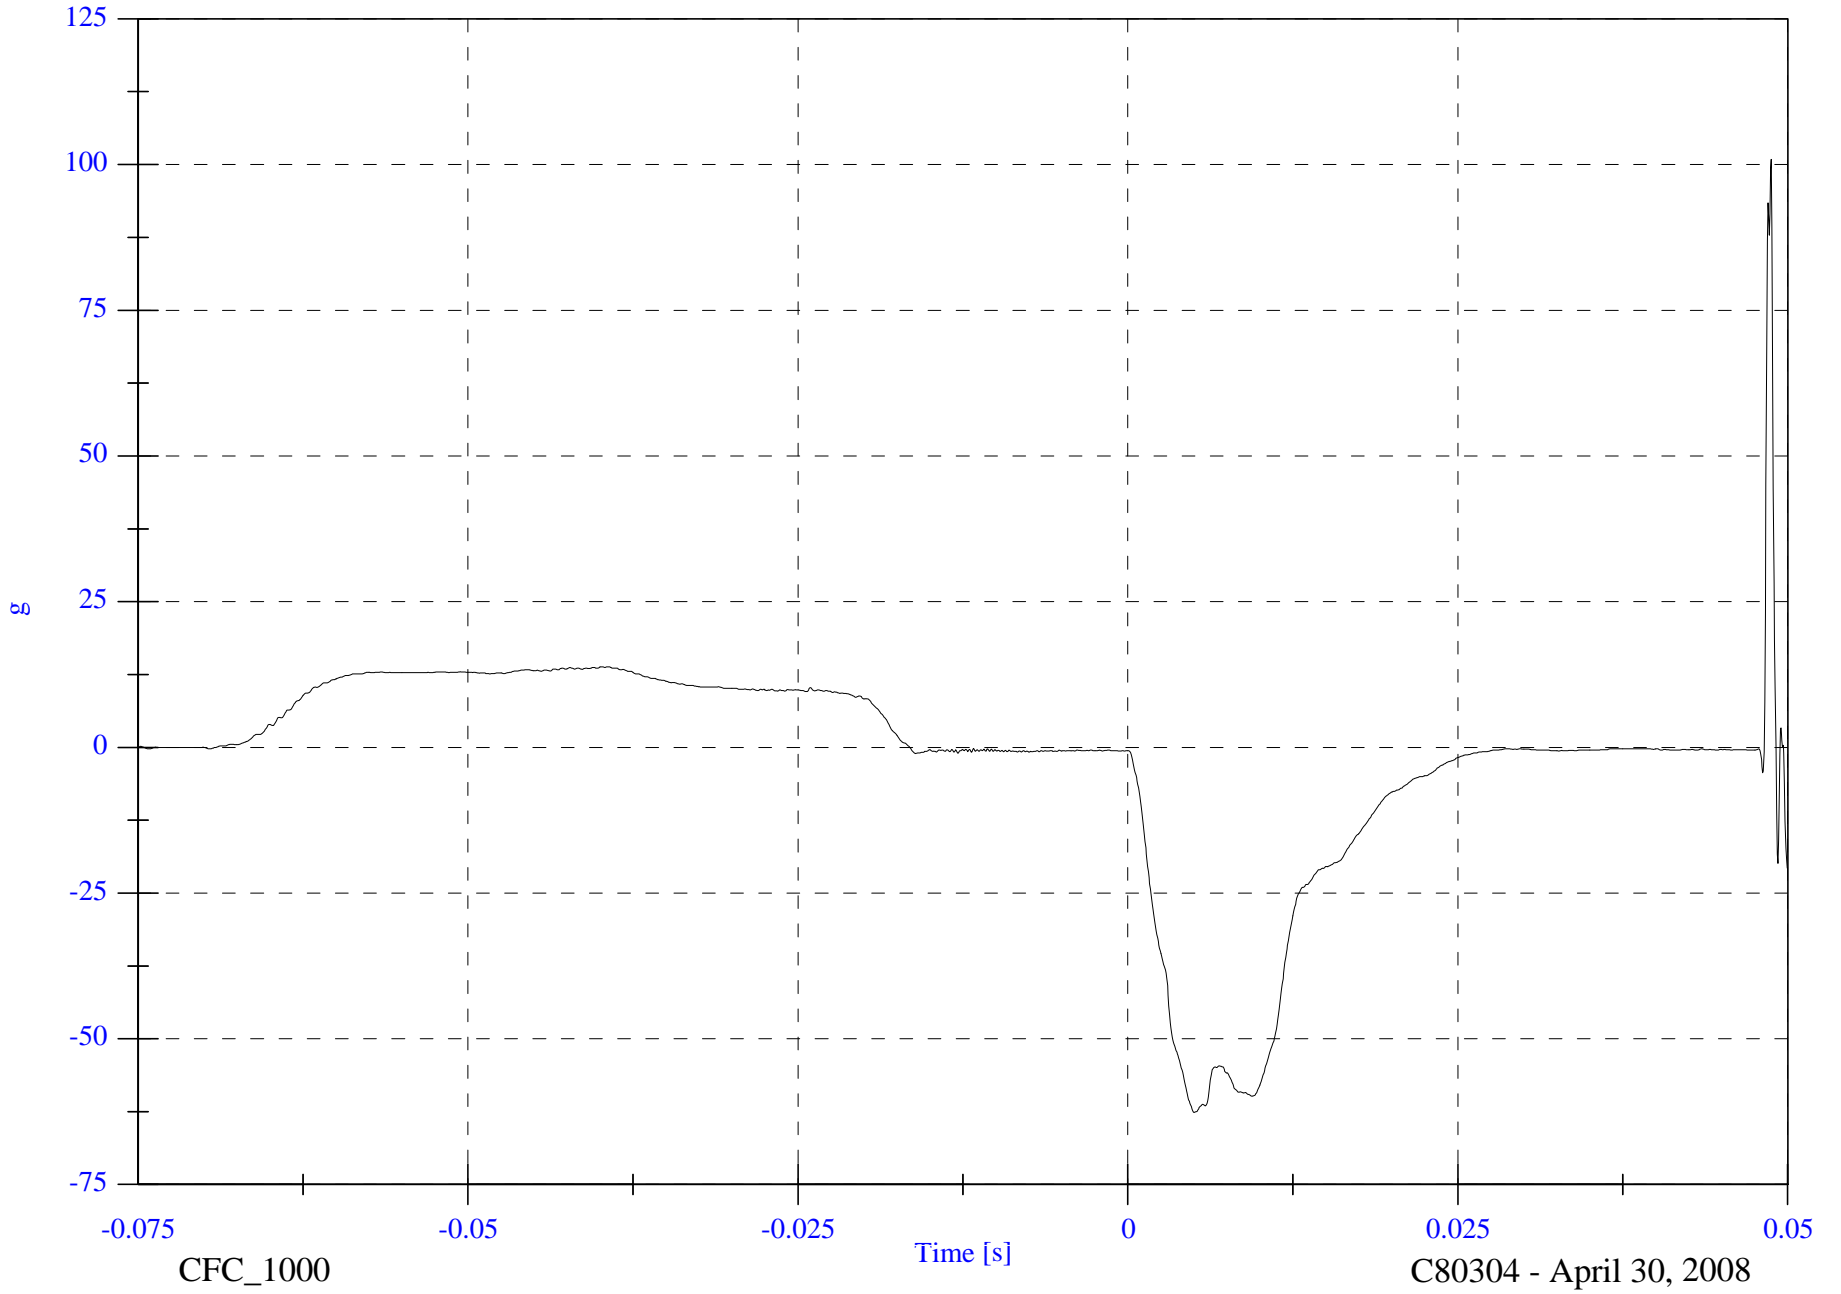
C80304 PASSENGER SIDE AP3 IMPACT PLOT #2

Min: -62.6 [g] at 0.005 [s]

Headform X Acceleration

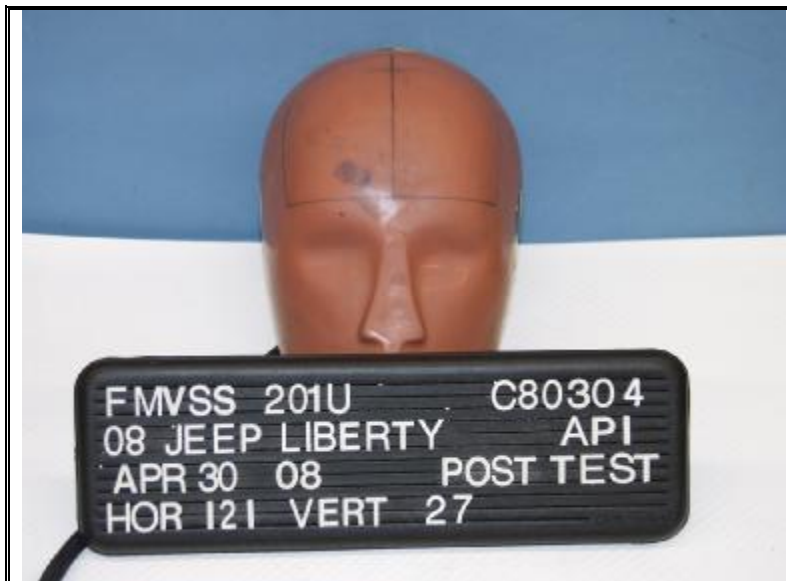
POST-IMPACT AP1 HEADFORM

Test Number:	08
Test Date:	04/30/08
Target Location:	A-PILLAR
Target Code:	AP1
Horizontal Impact Angle:	121°
Vertical Impact Angle:	27°
Ambient Temperature:	20.0° C
Relative Humidity:	21.1%
Time of Impact:	15:05
Headform Number:	355

Impact Point Description (from lower midpoint on midsagittal line)			
On Centerline	25	<input checked="" type="checkbox"/> mm right	<input type="checkbox"/> mm left
On Centerline	12	mm up

Free Motion HIC	212.3
HIC(d)	326.6
Impact Velocity (kph)	18.78
HIC T1 (msec)	3.7
HIC T2 (msec)	16.4

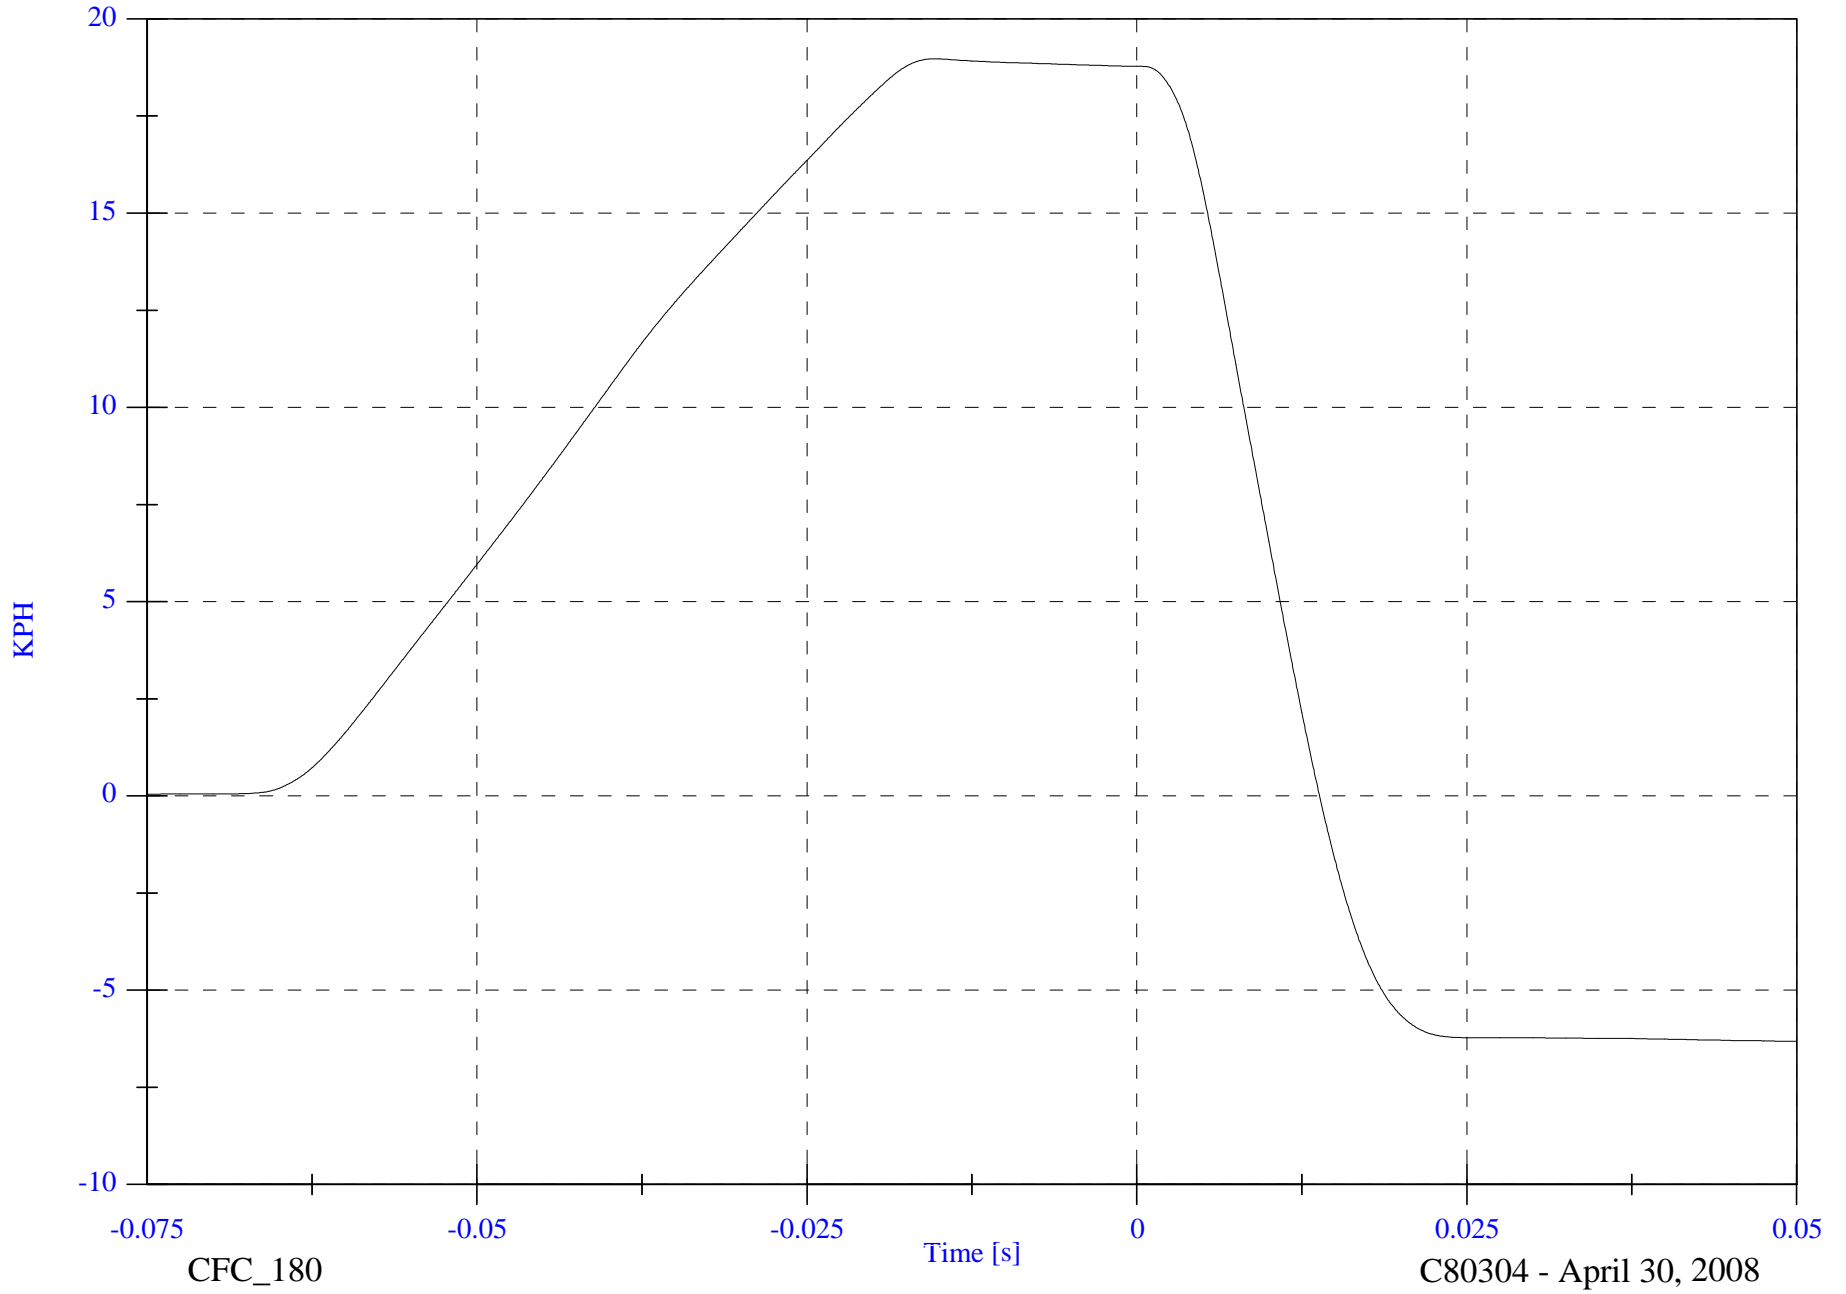
C80304 PASSENGER SIDE AP1 IMPACT PLOT #6

Min: -6.3 [KPH] at 0.050 [s]

Headform Velocity

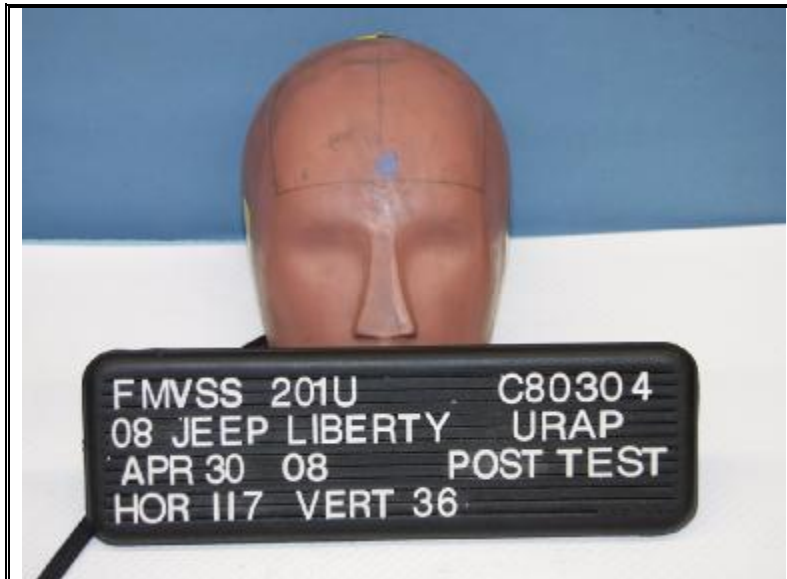
POST-IMPACT URAP HEADFORM

Test Number:	09
Test Date:	04/30/08
Target Location:	UPPER ROOF
Target Code:	URAP
Horizontal Impact Angle:	117°
Vertical Impact Angle:	36°
Ambient Temperature:	20.0° C
Relative Humidity:	20.8%
Time of Impact:	15:40
Headform Number:	0805

Impact Point Description (from lower midpoint on midsagittal line)			
On Centerline	2	mm right	x mm left
On Centerline	11	mm up

Free Motion HIC	532.8
HIC(d)	568.4
Impact Velocity (kph)	23.75
HIC T1 (msec)	2.1
HIC T2 (msec)	13.4

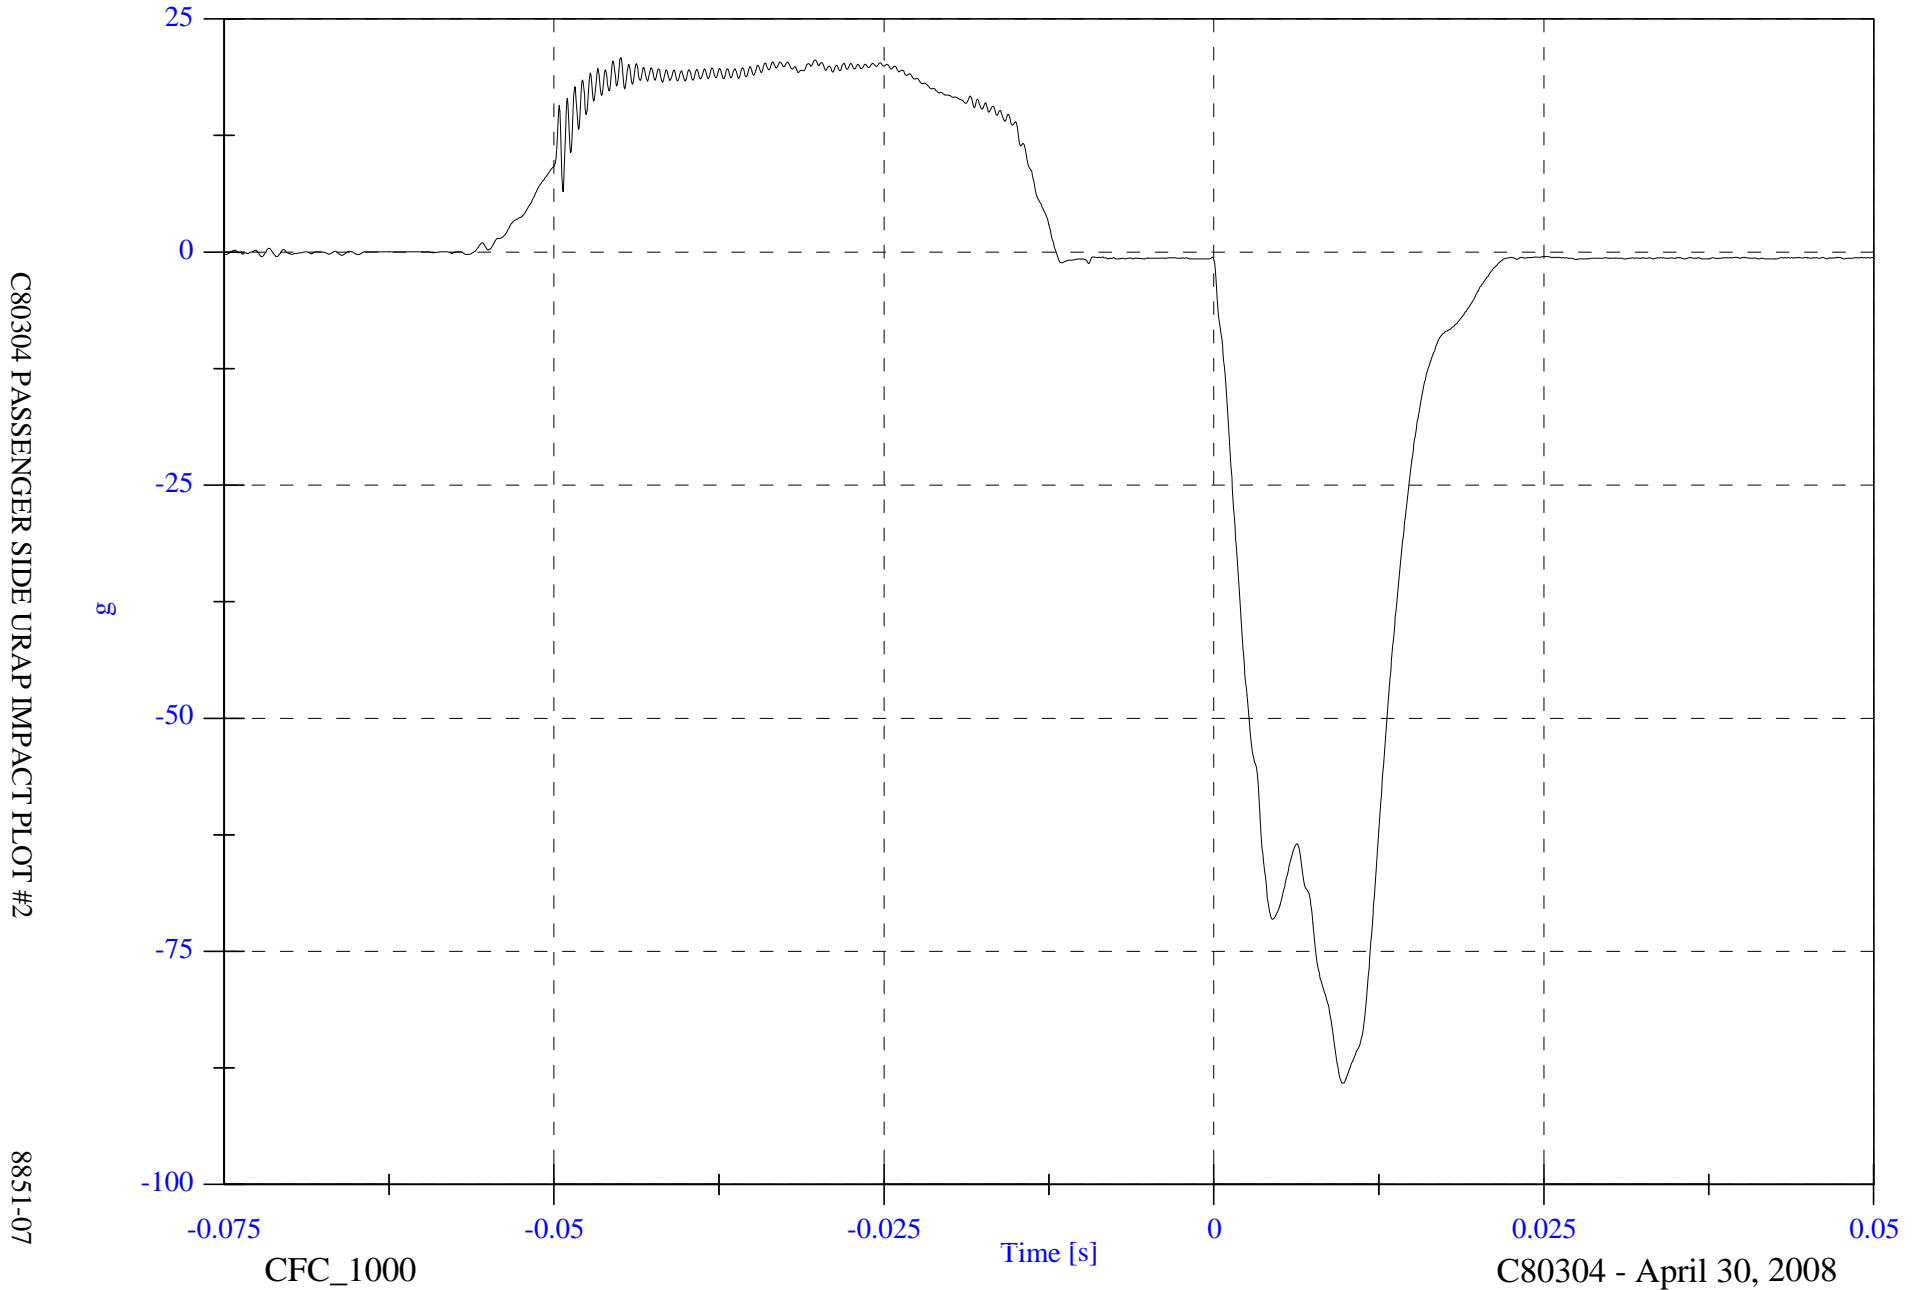
C80304 PASSENGER SIDE URAP IMPACT PLOT #2

Min: -89.1 [g] at 0.010 [s]

Headform X Acceleration

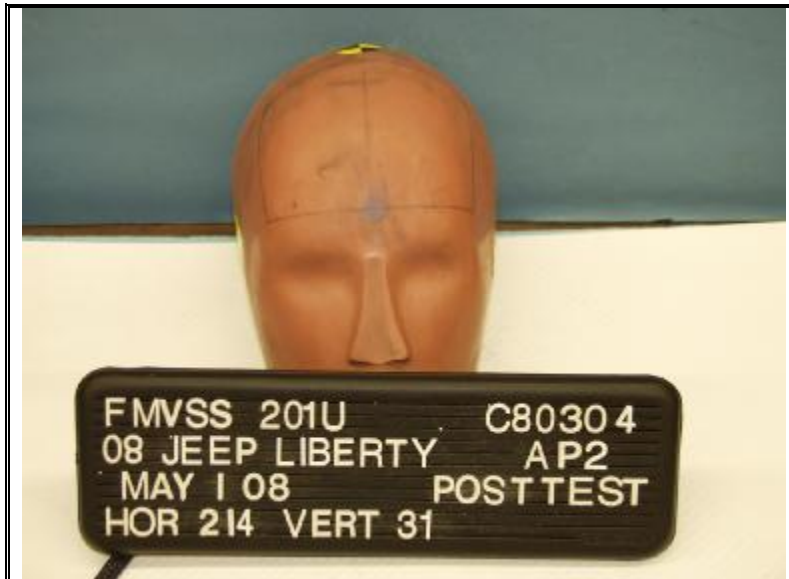
POST-IMPACT AP2 HEADFORM

Test Number:	10
Test Date:	05/01/08
Target Location:	A-PILLAR
Target Code:	AP2
Horizontal Impact Angle:	214°
Vertical Impact Angle:	31°
Ambient Temperature:	20.0° C
Relative Humidity:	19.7%
Time of Impact:	9:00
Headform Number:	0805

Impact Point Description (from lower midpoint on midsagittal line)					
On Centerline	0	<input type="checkbox"/>	mm right	<input type="checkbox"/>	mm left
On Centerline	3				mm up

Free Motion HIC	468.8
HIC(d)	520.1
Impact Velocity (kph)	18.63
HIC T1 (msec)	2.2
HIC T2 (msec)	9.8
