REPORT NUMBER: 201UI-CAL-08-07

**SAFETY COMPLIANCE TESTING FOR FMVSS 201
OCCUPANT PROTECTION IN INTERIOR IMPACT
UPPER INTERIOR HEAD IMPACT PROTECTION**

**CHRYSLER LLC
2008 JEEP LIBERTY SPORT 4X4**

CALSPAN TEST NUMBER: 8851-07

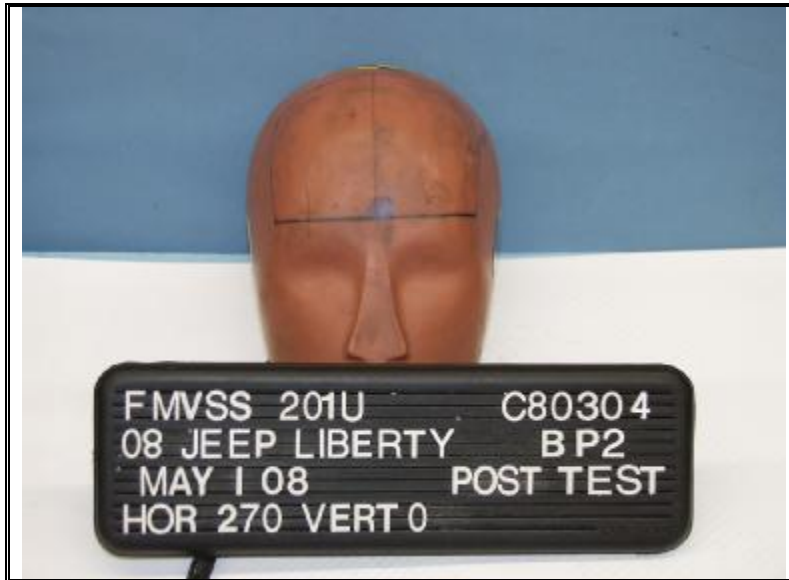
POST-IMPACT BP2HEADFORM

Test Number:	11
Test Date:	05/01/08
Target Location:	B-PILLAR
Target Code:	BP2
Horizontal Impact Angle:	270°
Vertical Impact Angle:	0°
Ambient Temperature:	20.5° C
Relative Humidity:	19.5%
Time of Impact:	9:50
Headform Number:	0062

Impact Point Description (from lower midpoint on midsagittal line)			
On Centerline	5	mm right	x mm left
On Centerline	5	mm up

Free Motion HIC	523.6
HIC(d)	561.5
Impact Velocity (kph)	23.7
HIC T1 (msec)	5.5
HIC T2 (msec)	13.1

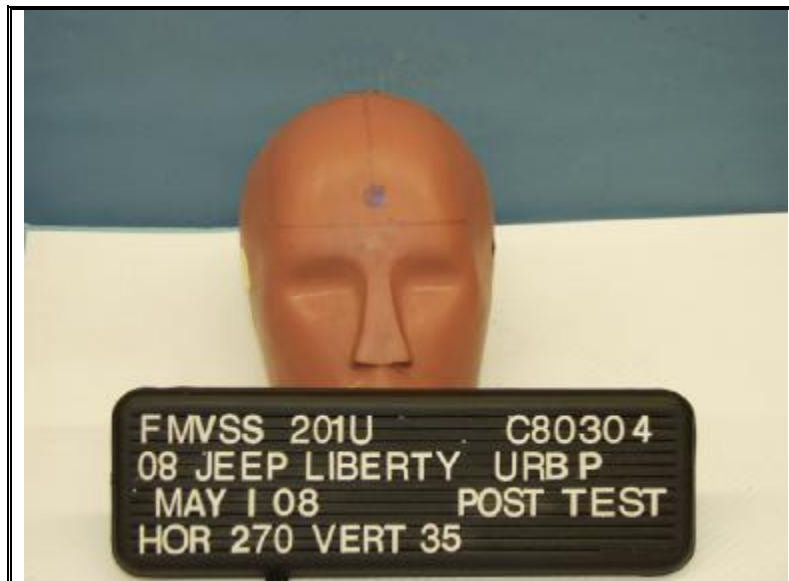
POST-IMPACT URBP HEADFORM

Test Number:	12
Test Date:	05/01/08
Target Location:	UPPER ROOF
Target Code:	URBP
Horizontal Impact Angle:	270°
Vertical Impact Angle:	35°
Ambient Temperature:	21.0° C
Relative Humidity:	19.7%
Time of Impact:	10:40
Headform Number:	1142

Impact Point Description (from lower midpoint on midsagittal line)					
On Centerline	0	<input type="checkbox"/>	mm right	<input type="checkbox"/>	mm left
On Centerline	16				mm up

Free Motion HIC	312.5
HIC(d)	402.2
Impact Velocity (kph)	23.74
HIC T1 (msec)	3.0
HIC T2 (msec)	17.6

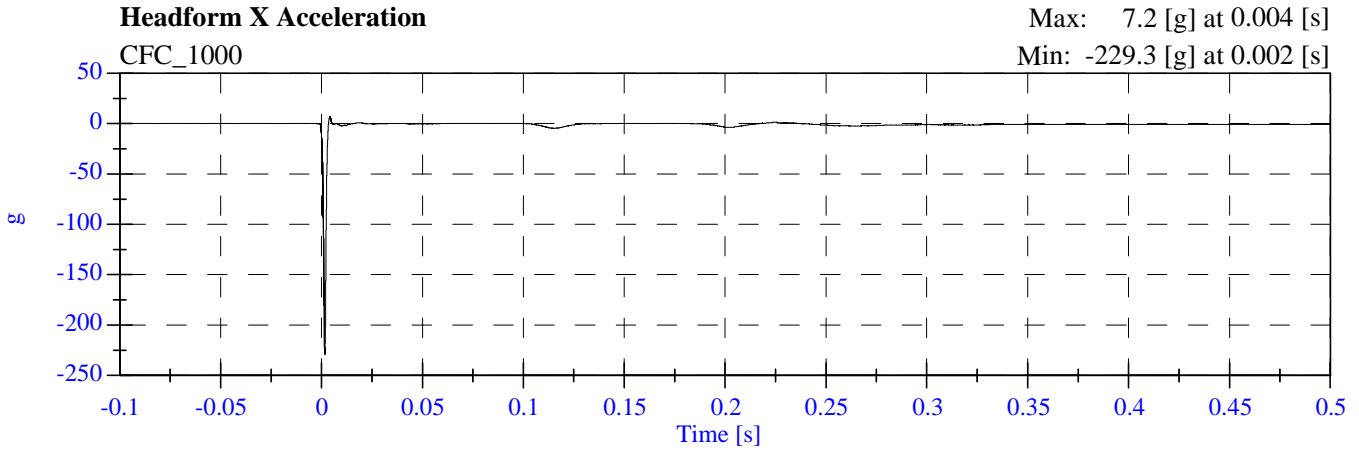
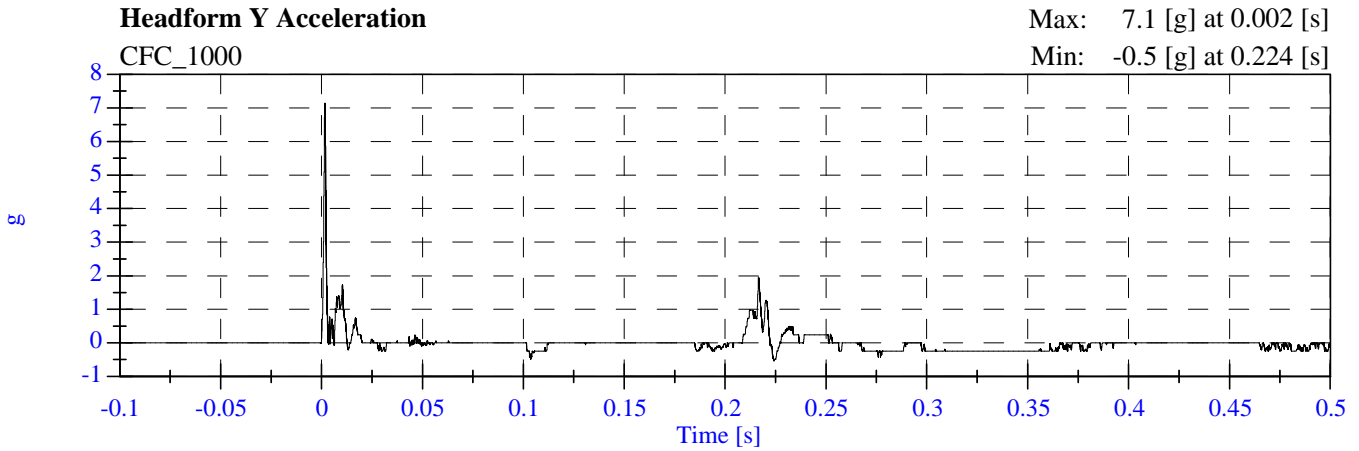
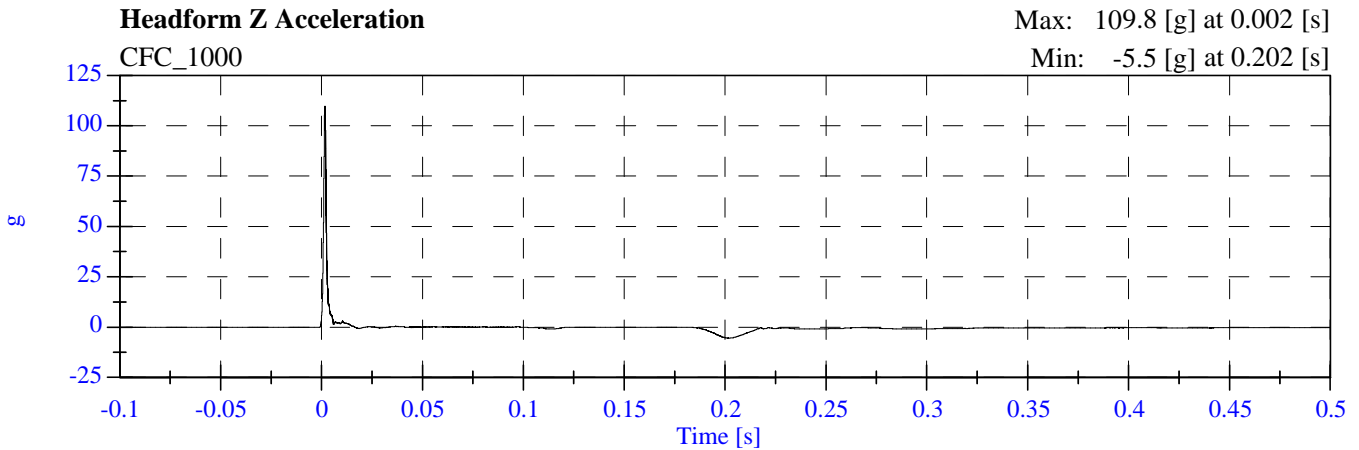
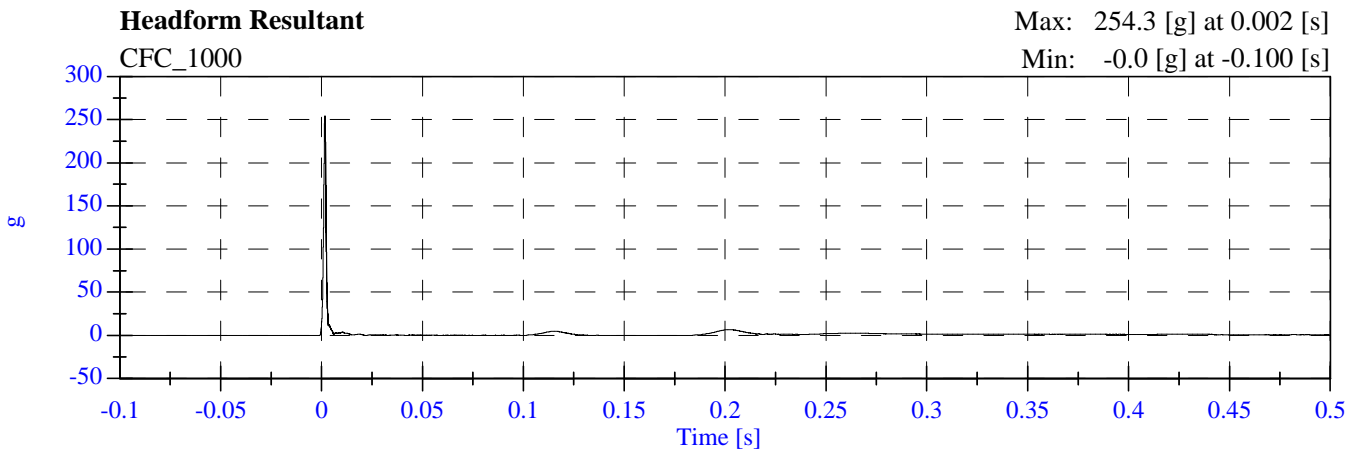
MANUFACTURER:		FIRST TECHNOLOGY SAFETY SYSTEMS	
SERIAL NUMBER:		1140	
CALIBRATION DATE:		APRIL 28, 2008	
TEST PARAMETER	SPECIFICATION	TEST RESULTS	
TEMPERATURE	19°C to 26°C	21.1	
RELATIVE HUMIDITY	10% to 70%	25	
PEAK RESULTANT ACCELERATION	225 Gs to 275 Gs	254.3	
PEAK LATERAL ACCELERATION	15 Gs Maximum	7.1	
IS ACCELERATION CURVE UNIMODAL?	YES	YES
