REPORT NUMBER 118-GTL-08-008

**SAFETY COMPLIANCE TESTING FOR
FMVSS NO. 118
POWER-OPERATED WINDOW, PARTITION
AND ROOF PANEL SYSTEMS**

**TOYOTA MOTOR CORPORATION
2008 SCION XD PASSENGER CAR
NHTSA NO. C85107**

**GENERAL TESTING LABORATORIES, INC.
1623 LEEDSTOWN ROAD
COLONIAL BEACH, VIRGINIA 22443**

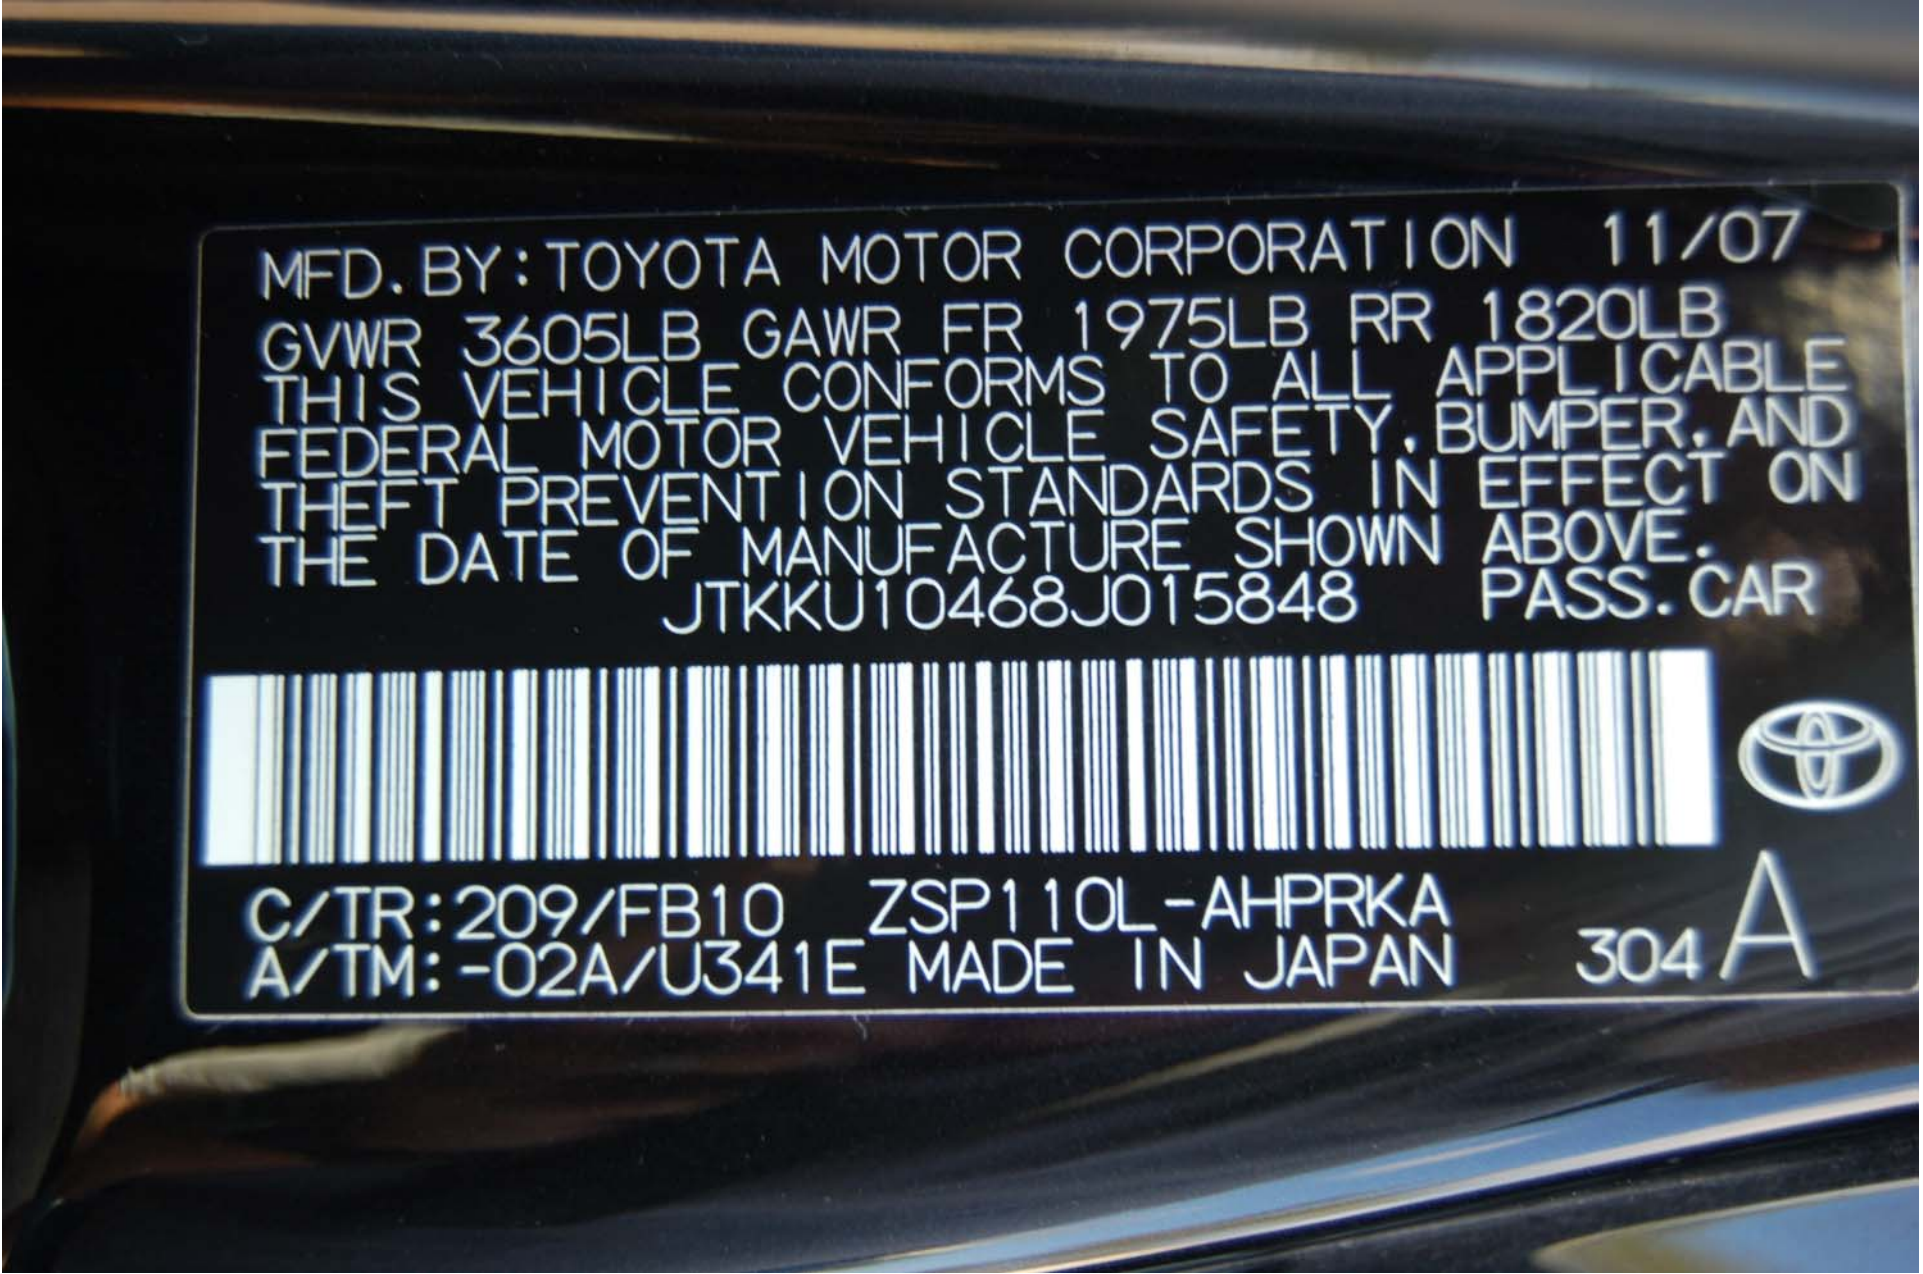
FIGURE 5.3
CLOSE-UP VIEW OF VEHICLE CERTIFICATION LABEL

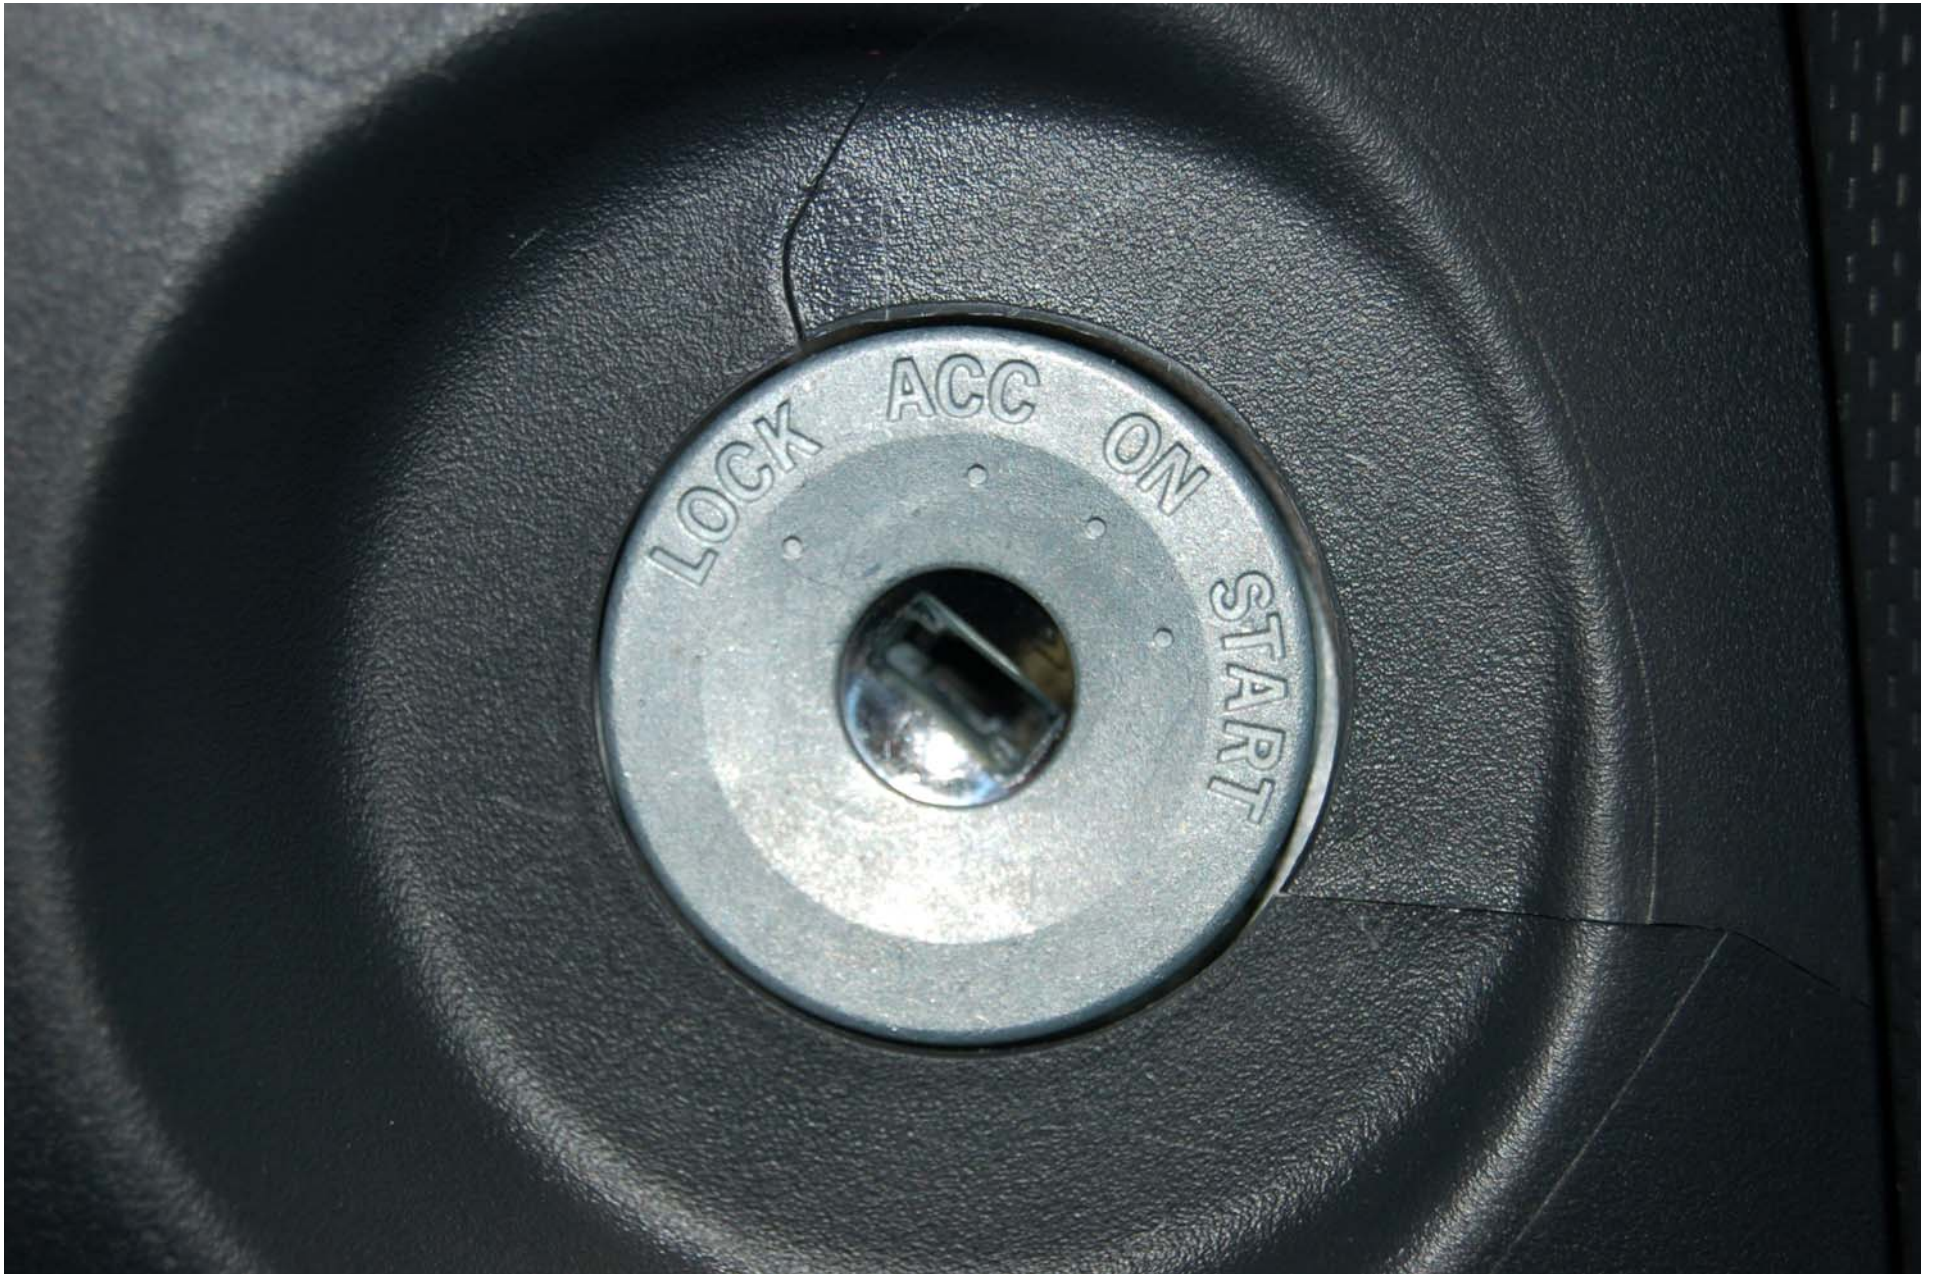
Interior Locking System Key Positions (clockwise): LOCK, ACC, ON, START

FIGURE 5.5
CLOSE-UP VIEW OF VEHICLE IGNITION SWITCH

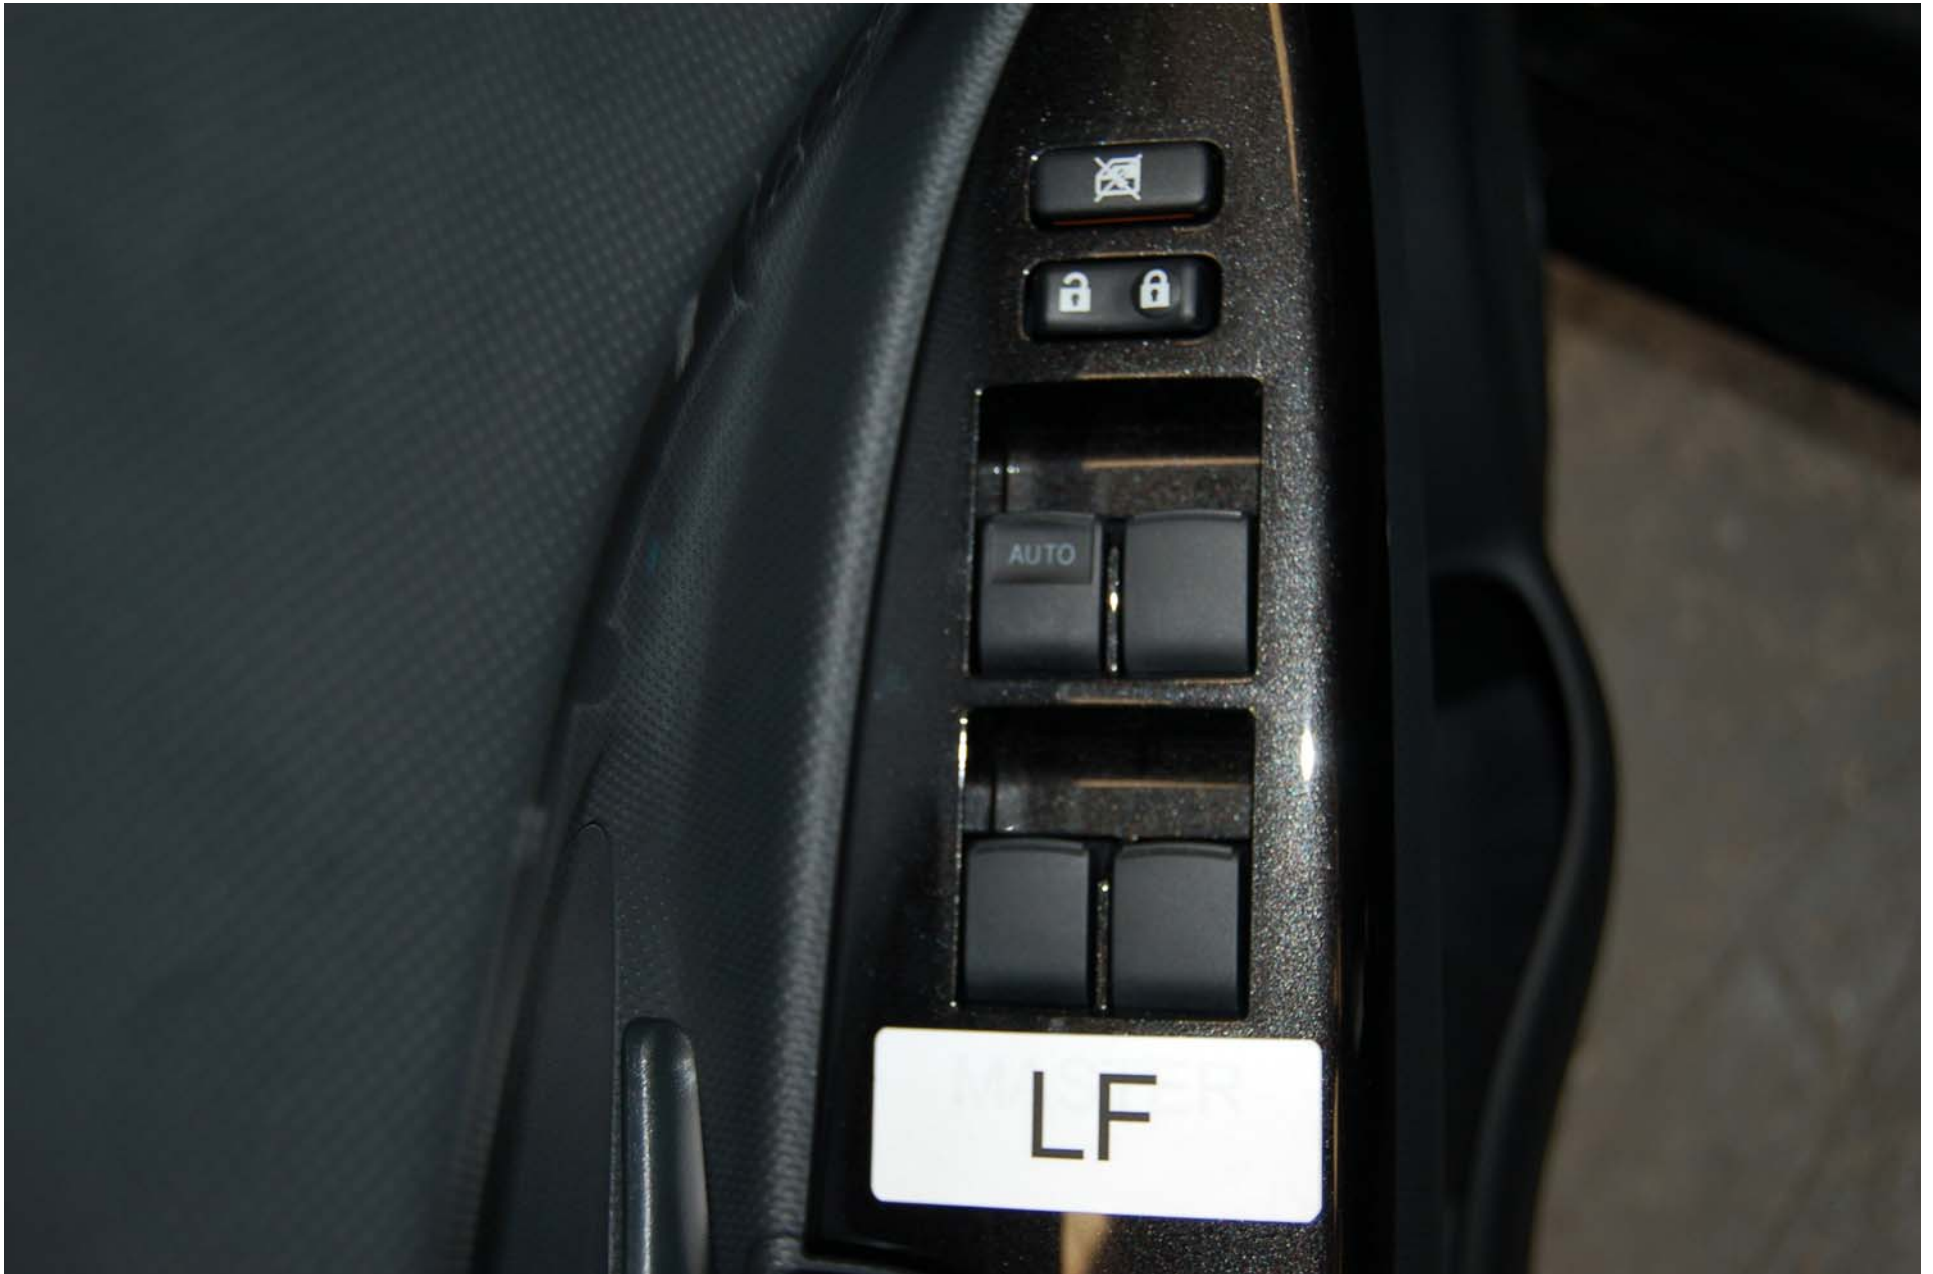
FIGURE 5.6
CLOSE-UP VIEW OF LEFT FRONT POWER WINDOW
SWITCH

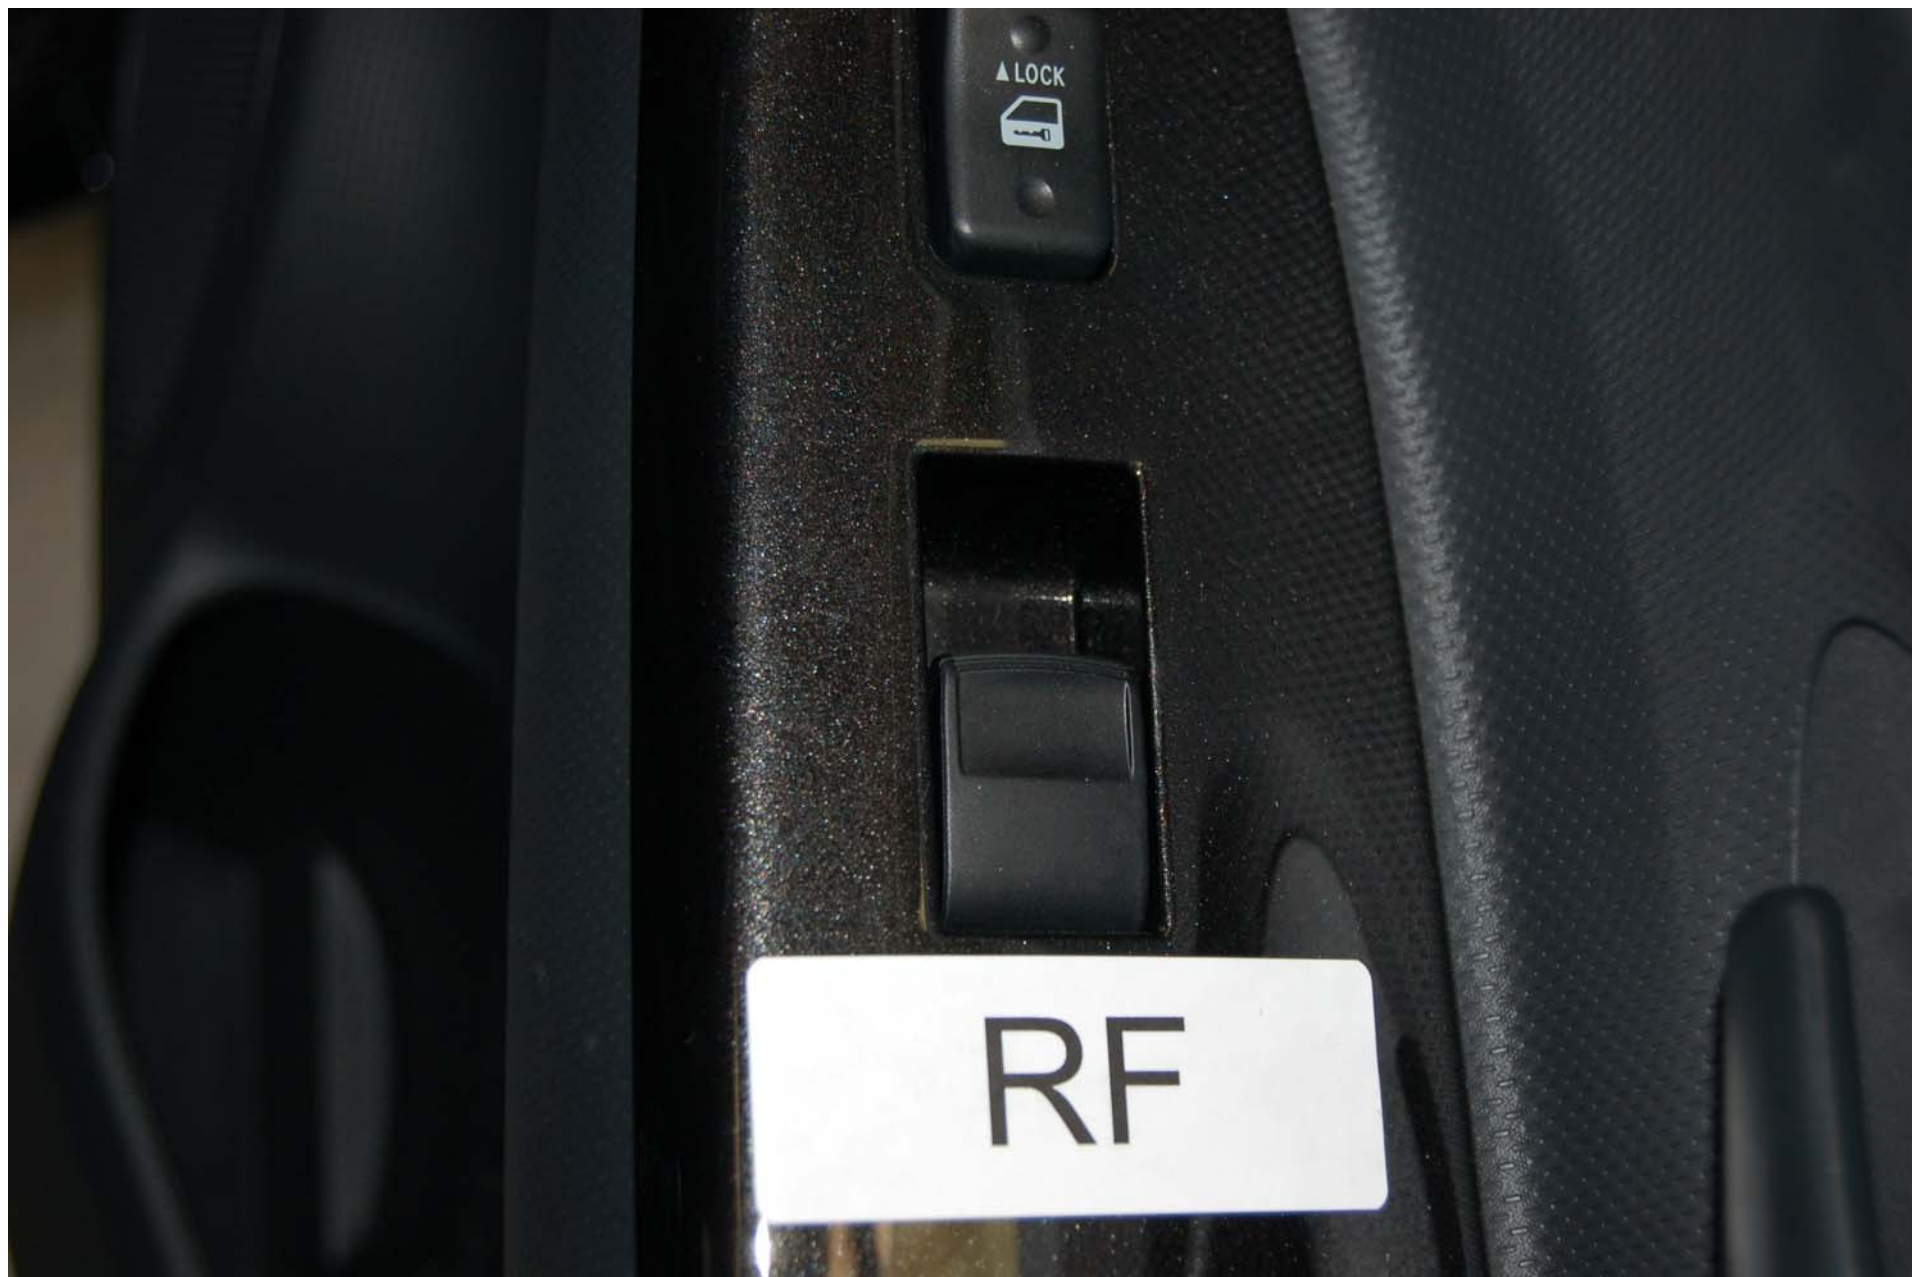
FIGURE 5.7
CLOSE-UP VIEW OF RIGHT FRONT POWER WINDOW
SWITCH

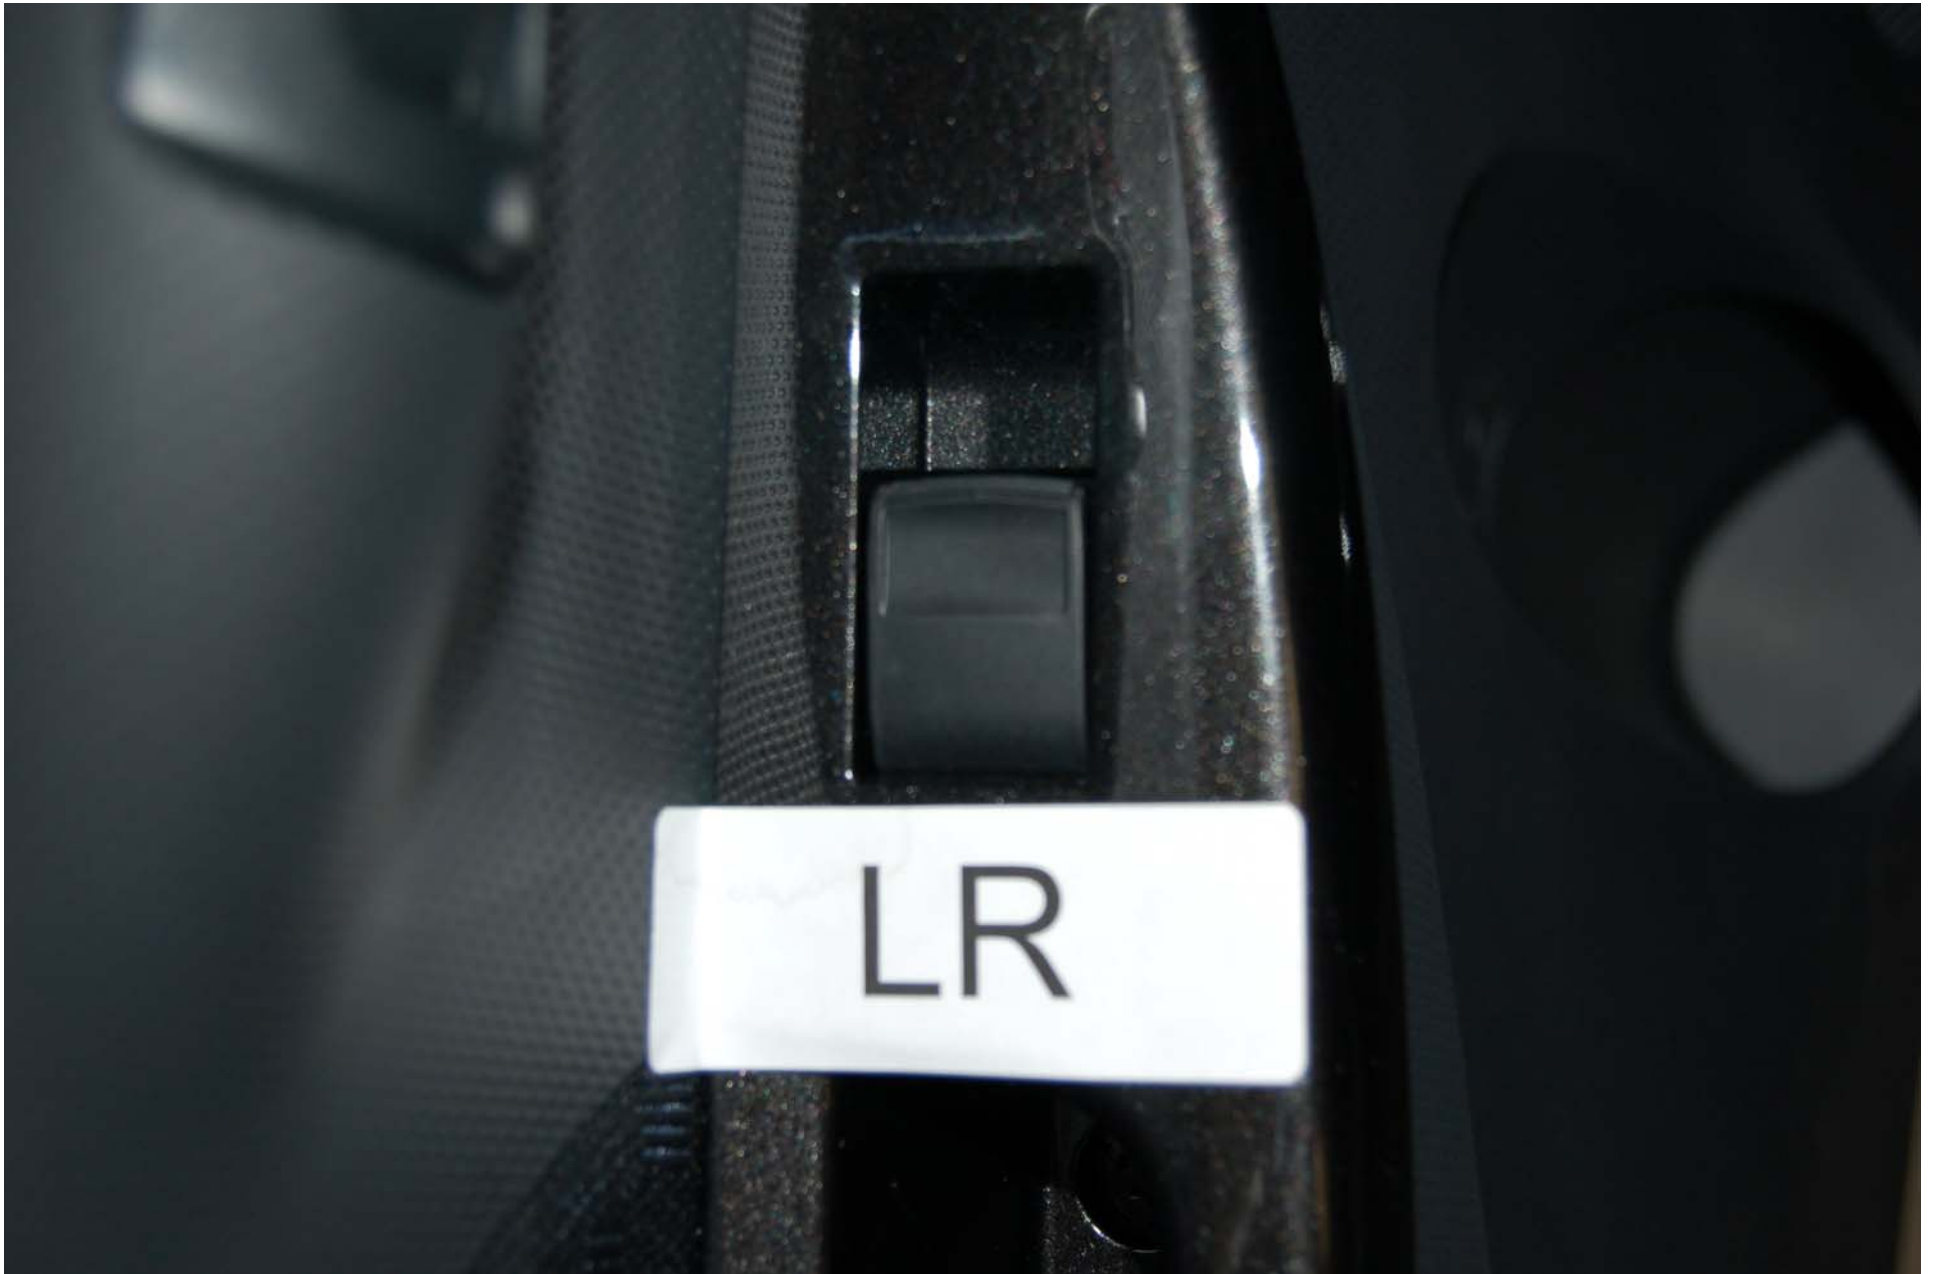
FIGURE 5.8
CLOSE-UP VIEW OF LEFT REAR POWER WINDOW
SWITCH

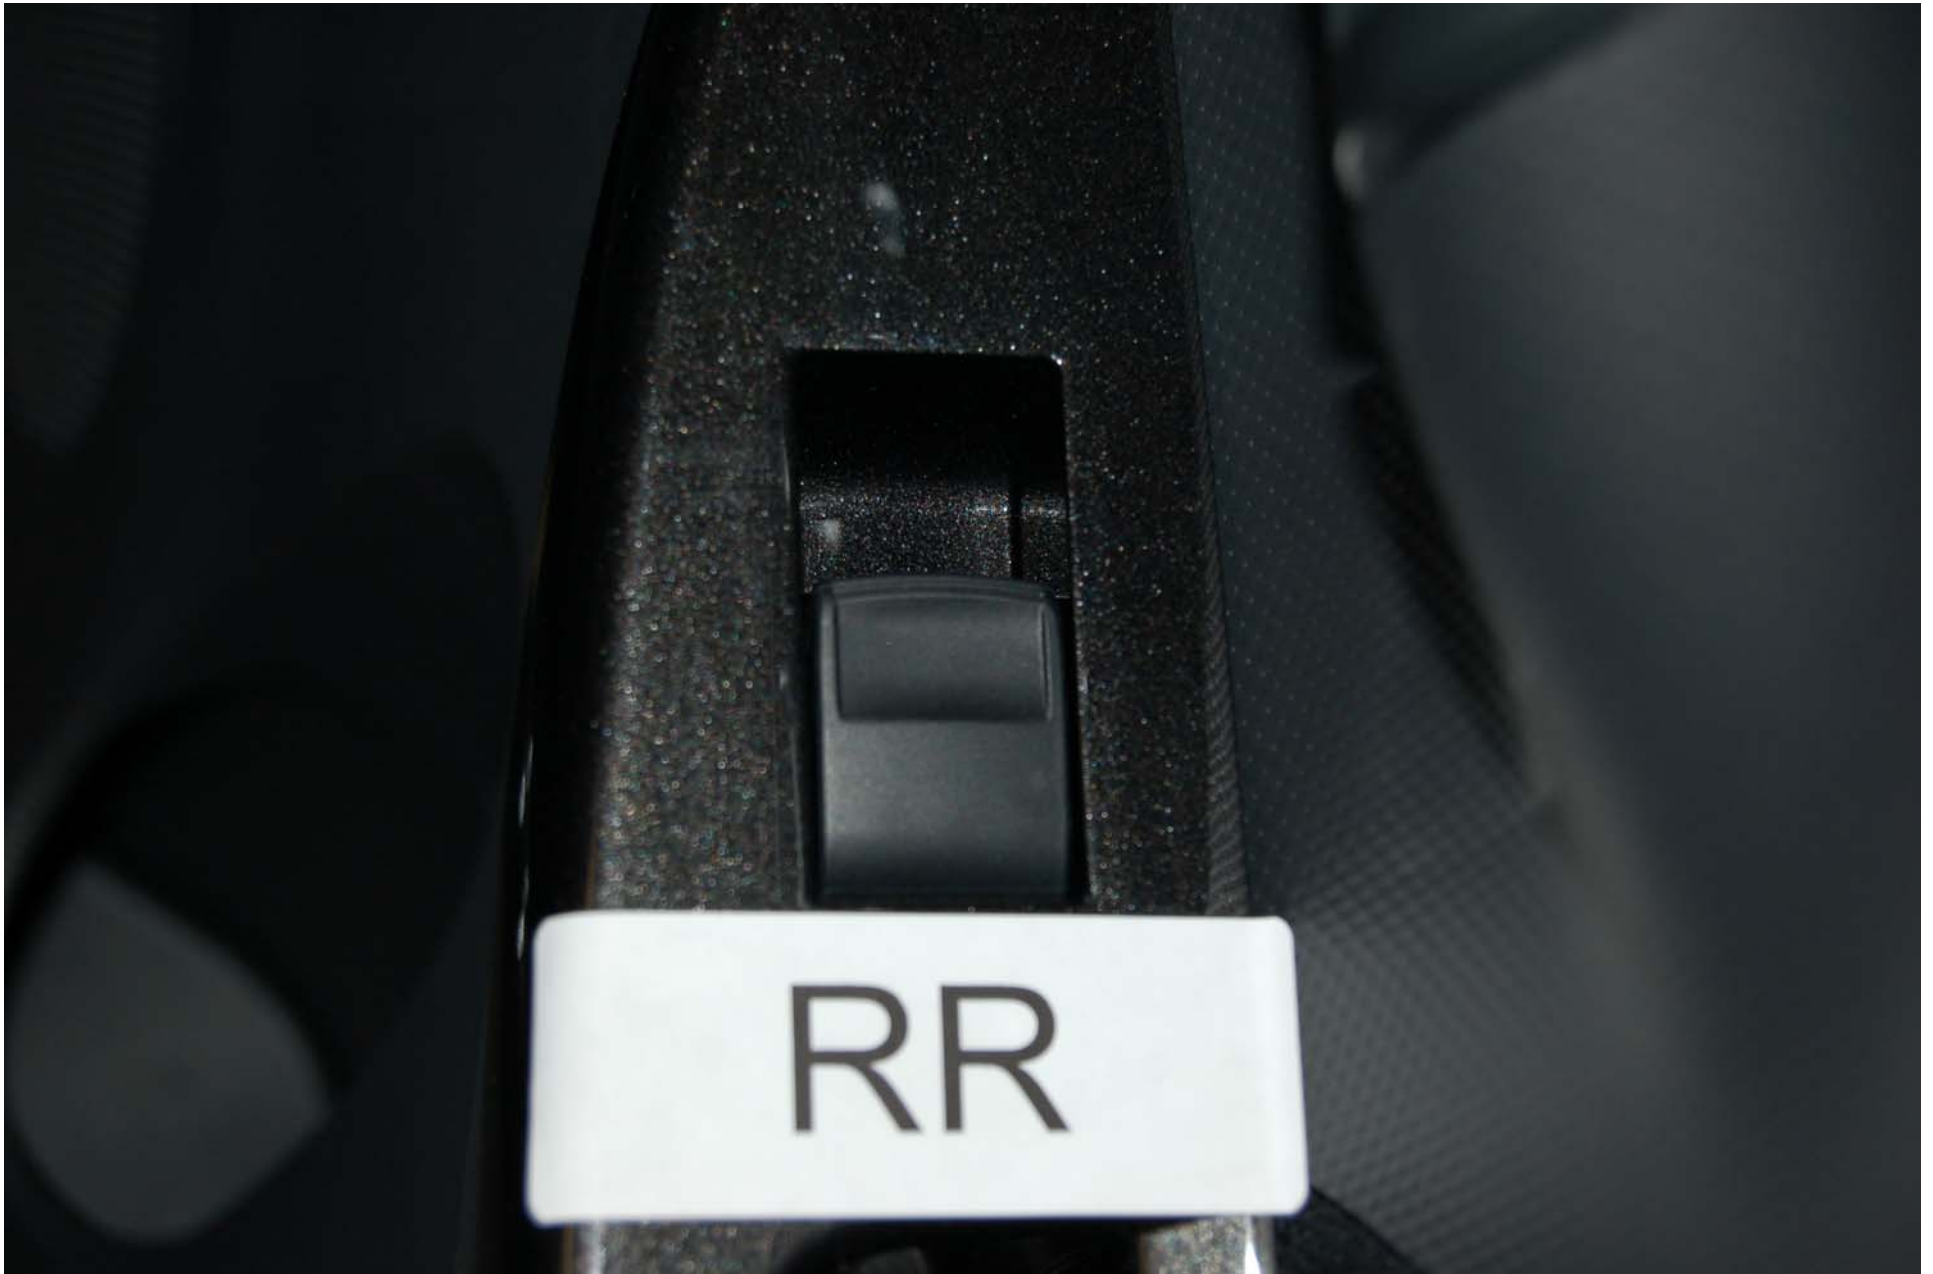
FIGURE 5.9
CLOSE-UP VIEW OF RIGHT REAR POWER WINDOW
SWITCH

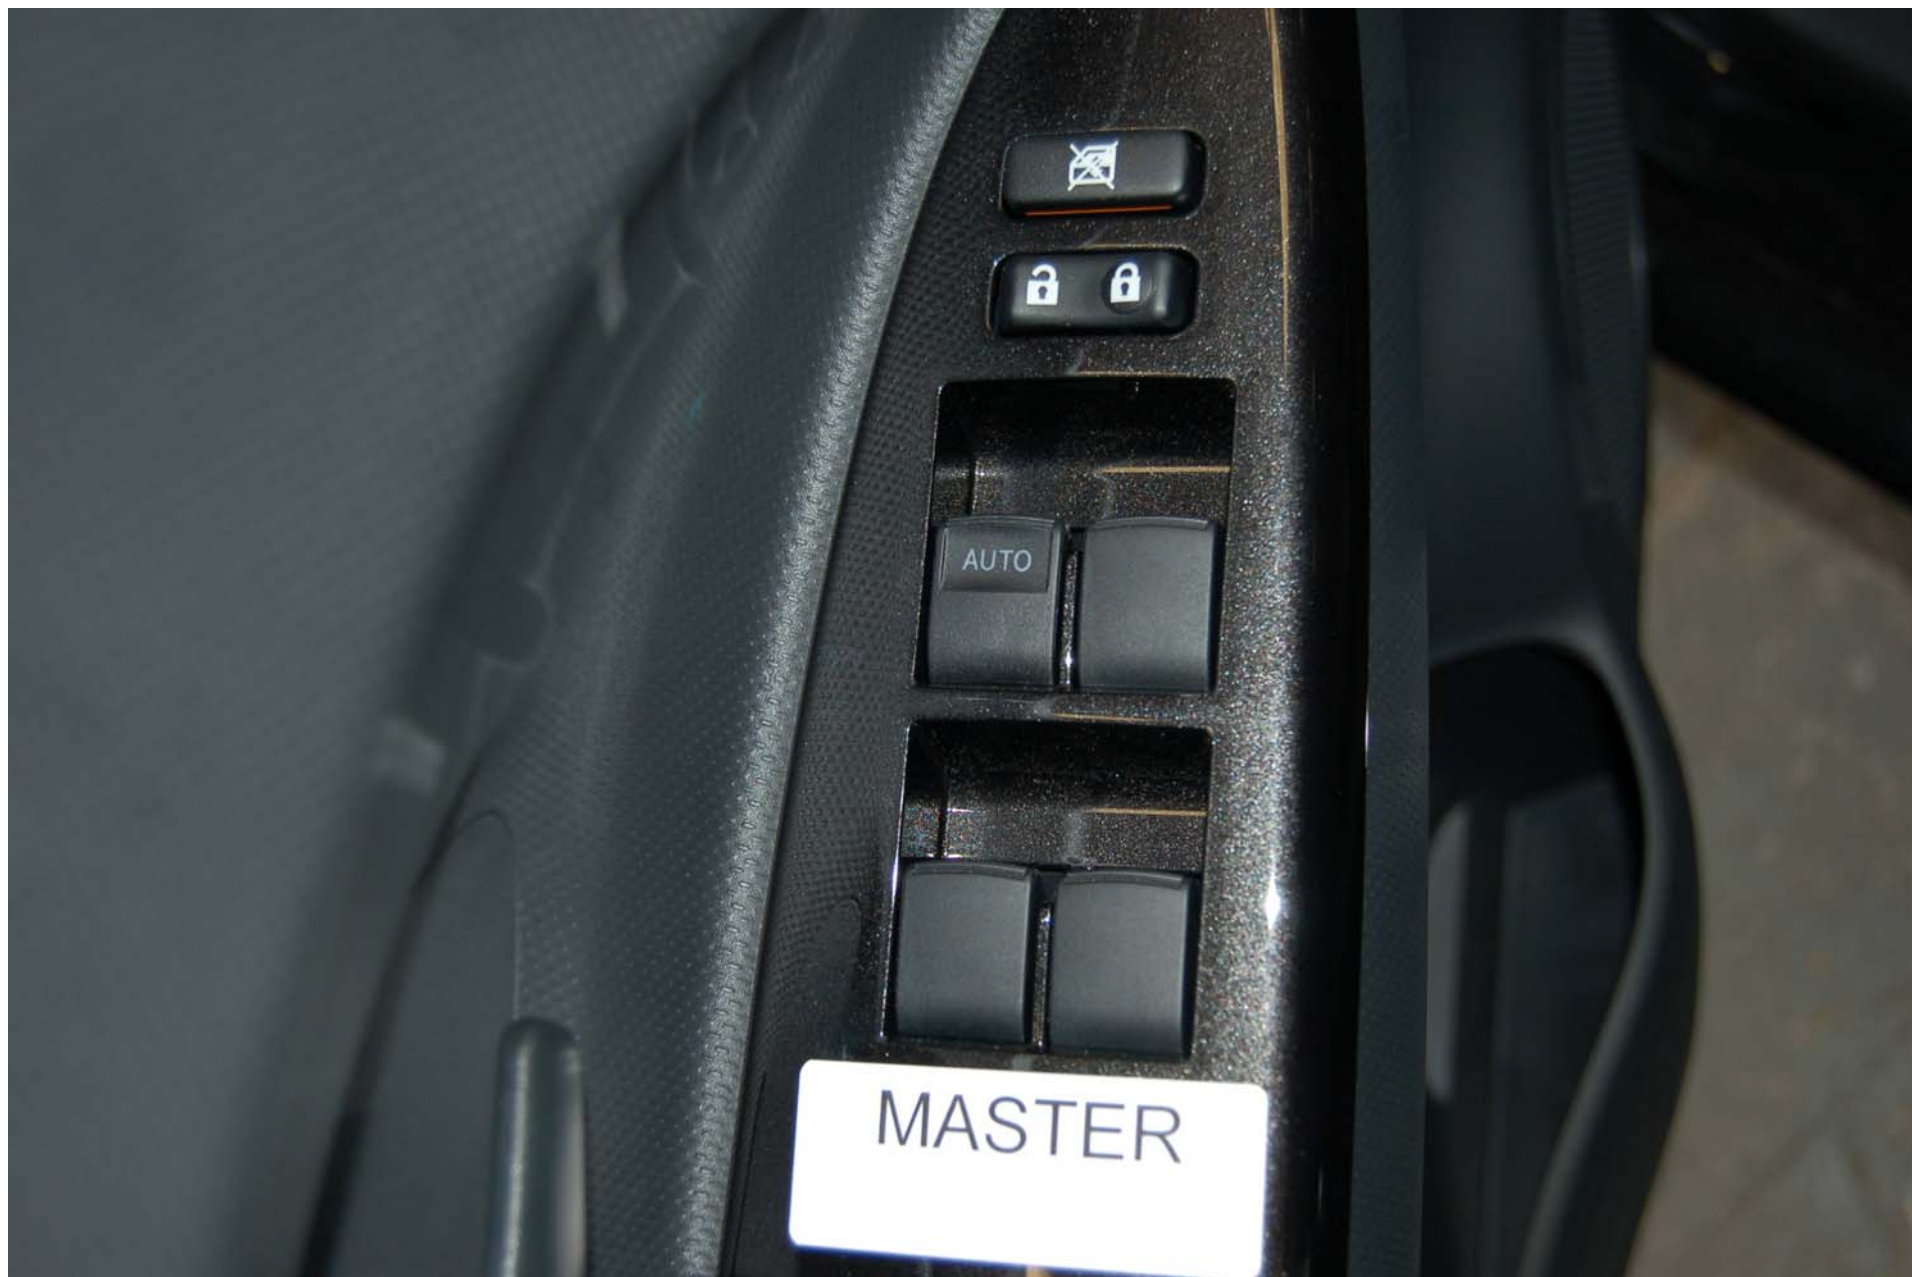
Master Control Panel Location: DRIVER'S DOOR PANELExterior Locking System Location: N/A

FIGURE 5.10
CLOSE-UP VIEW OF POWER WINDOW MASTER SWITCH

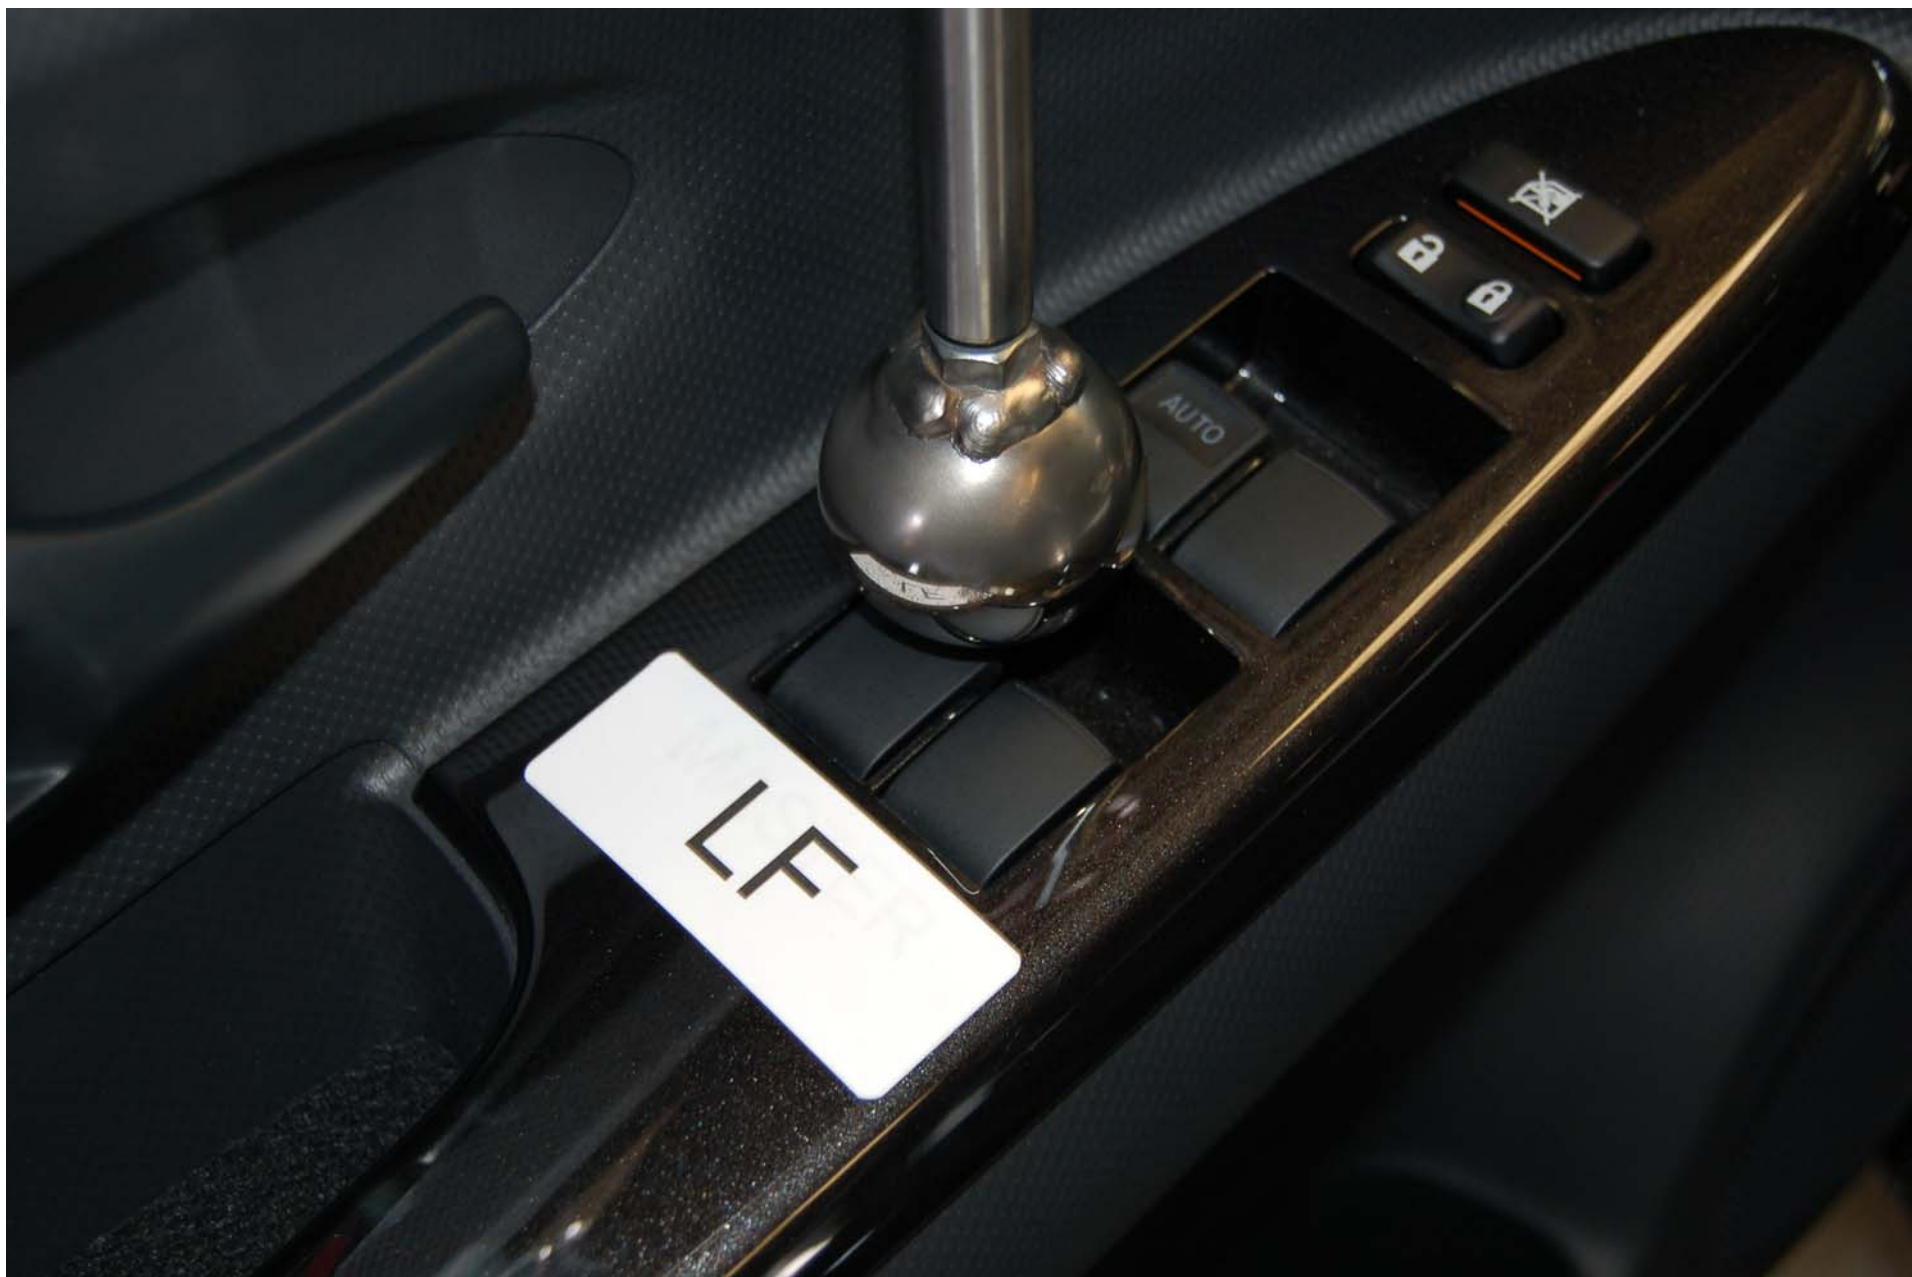
ACTUATION DEVICES	APPLICABLE (YES/NO*)	SPHERE ACTIVATED ACTUATION DEVICE CLOSES WPRP (YES/NO)	TEST RESULT PASS/FAIL	COMPLIANCE REQUIRED (Y/N**)
MASTER CONTROL PANEL ACTUATION DEVICES				
Left Front (LF)	No	No	Pass	No
Right Front (RF)	No	No	Pass	No
Left Rear (LR)	No	No	Pass	No
Right Rear (RR)	No	No	Pass	No
Tail Gate (TG)				
Vent Window(s)				
Partition (P)				
Roof Panel (RP)				
INDIVIDUAL ACTUATION DEVICES				
Left Front (LF)	No	No	Pass	No
Right Front (RF)	No	No	Pass	No
Left Rear (LR)	No	No	Pass	No
Right Rear (RR)	No	No	Pass	No
Tail Gate (TG)				
Vent Window (s)				
Partition(P)				
Roof Panel (RP)

ACTUATION DEVICES	SWITCH ORIENTATION A – horizontal B – vertical C - angled	CLOSES POWER-OPERATED WINDOW ONLY IF: PULL UP OR PULL OUT	TEST RESULT PASS/FAIL	COMPLIANCE REQUIRED (Y/N**)
MASTER CONTROL PANEL ACTUATION DEVICES				
Left Front (LF)	A	Pull Up	Pass	No
Right Front (RF)	A	Pull Up	Pass	No
Left Rear (LR)	A	Pull Up	Pass	No
Right Rear (RR)	A	Pull Up	Pass	No
Vent Window(s)				
INDIVIDUAL ACTUATION DEVICES				
Left Front (LF)	A	Pull Up	Pass	No
Right Front (RF)	A	Pull Up	Pass	No
Left Rear (LR)	A	Pull Up	Pass	No
Right Rear (RR)	A	Pull Up	Pass	No
Vent Window(s)

FIGURE 5.11
TYPICAL SWITCH/SPHERE TEST SET-UP
