REPORT NUMBER: 214-CAL-09-02

**SAFETY COMPLIANCE TESTING FOR FMVSS 214
SIDE IMPACT PROTECTION
INDICANT**

**HONDA MOTOR COMPANY
2009 HONDA FIT
5-DOOR HATCHBACK**

NHTSA NUMBER: C95308

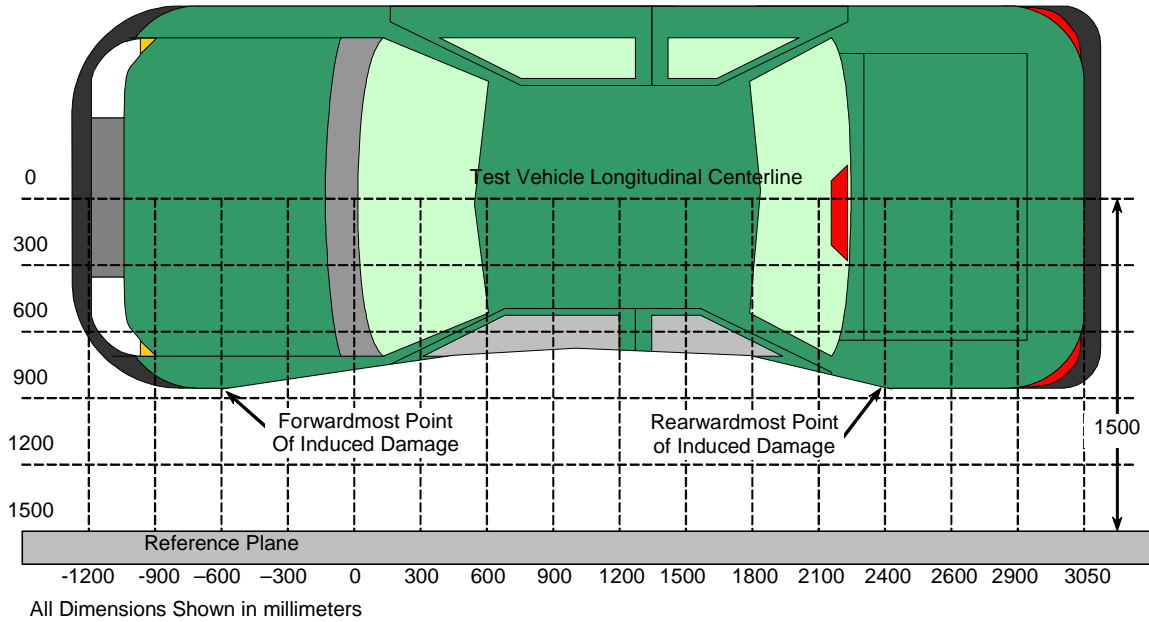
VEHICLE DAMAGE PROFILE DISTANCES

TOP VIEW

DAMAGE PROFILE DISTANCES

The test vehicle sustained a maximum static crush of 236 mm at level 2, 900 mm rearward of the left vertical impact point. The driver and passenger SID/HIII's, Serial Nos. 905 and 906 respectively, were calibrated just prior to this test.

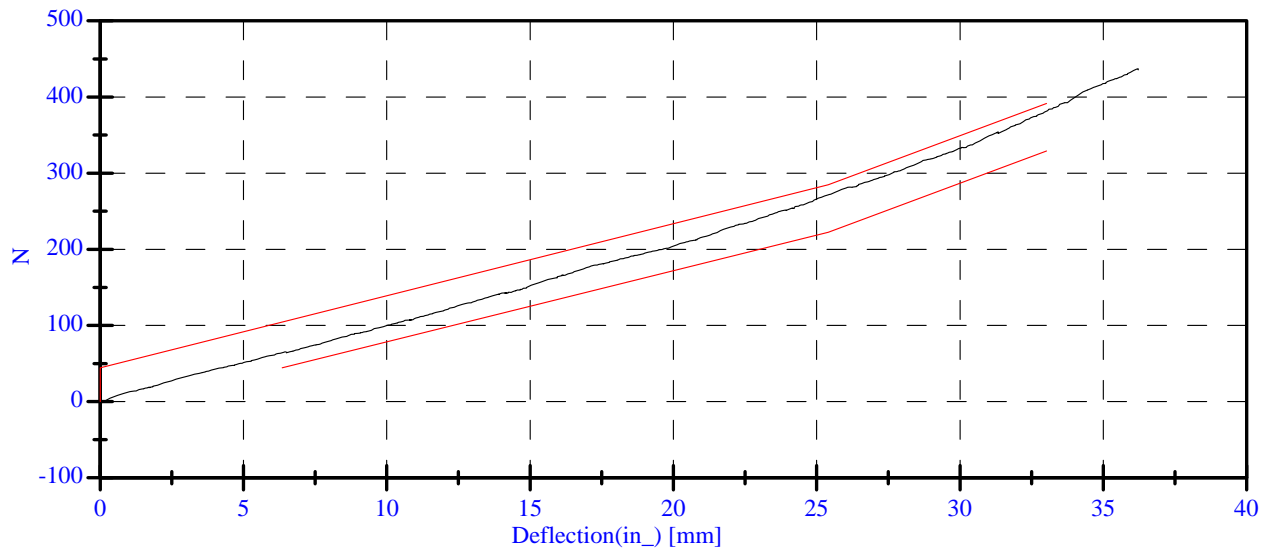
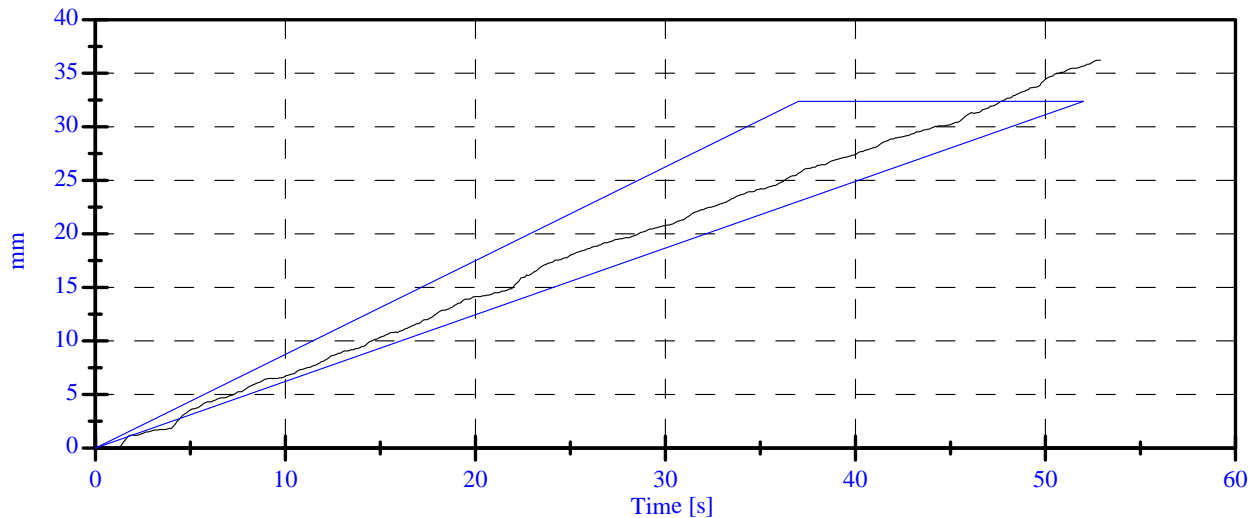
ABDOMINAL COMPRESSION TEST

<u>TEST PARAMETER</u>	<u>SPECIFICATION</u>	<u>TEST RESULTS</u>	<u>STATUS</u>
Lab Temperature:	18.9-25.5 C	21.7 C	Passed
Lab Humidity:	10-70 %	28.00 %	Passed
Force at 12.95 mm :	104.00-162.00 N	129.75 N	Passed
Force at 19.05 mm :	162.98-220.99 N	195.10 N	Passed
Force at 25.40 mm :	221.97-280.02 N	271.39 N	Passed
Force at 33.02 mm :	324.99-391.00 N	382.00 N	Passed

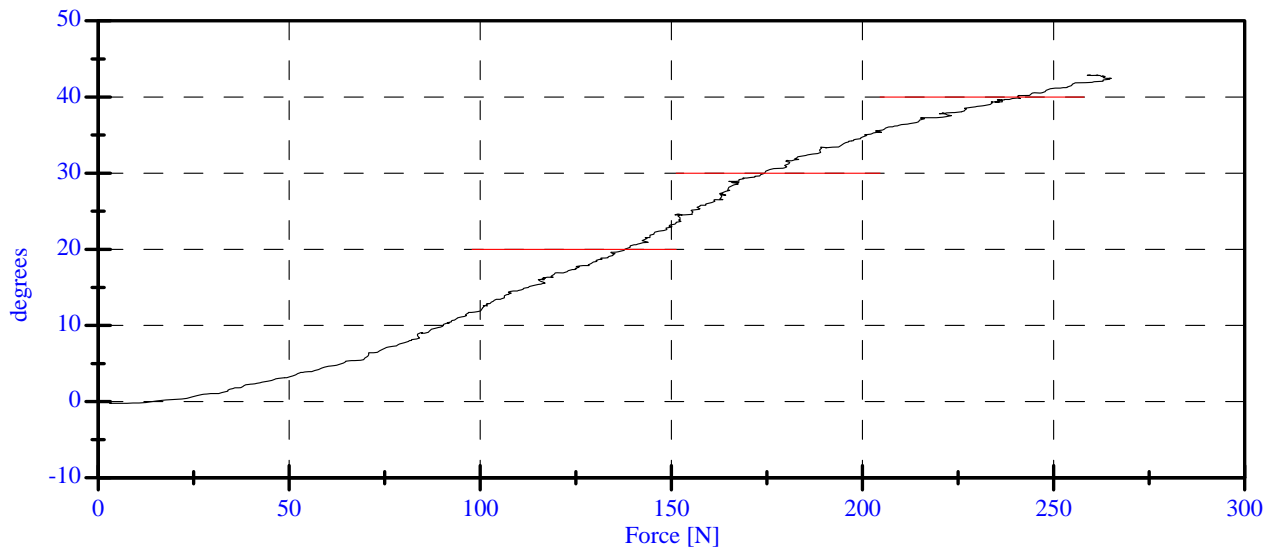
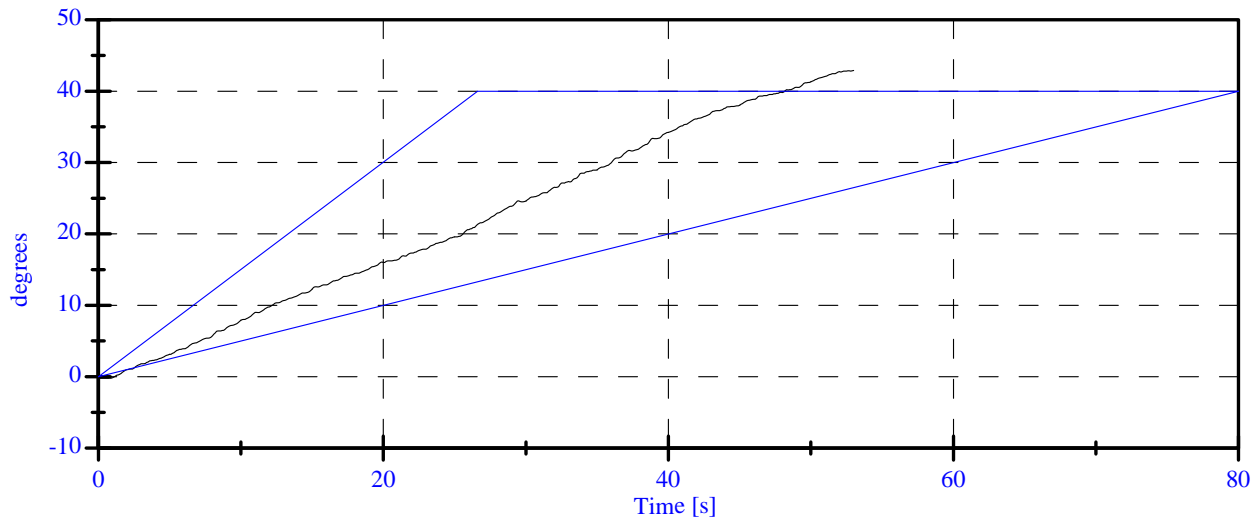
LUMBAR SPINE FLEXION TEST

<u>TEST PARAMETER</u>	<u>SPECIFICATION</u>	<u>TEST RESULTS</u>	<u>STATUS</u>
Lab Temperature:	18.9-25.5 C	21.7 C	Passed
Lab Humidity:	10-70 %	29.00 %	Passed
Force at 0 Deg:	0.00-26.69 N	13.58 N	Passed
Force at 20 Deg:	97.86-151.24 N	137.89 N	Passed
Force at 30 Deg:	151.24-204.62 N	174.45 N	Passed
Force at 40 Deg:	204.62-258.00 N	240.52 N	Passed
Return Angle	12 Deg Max	5.93 deg	Passed

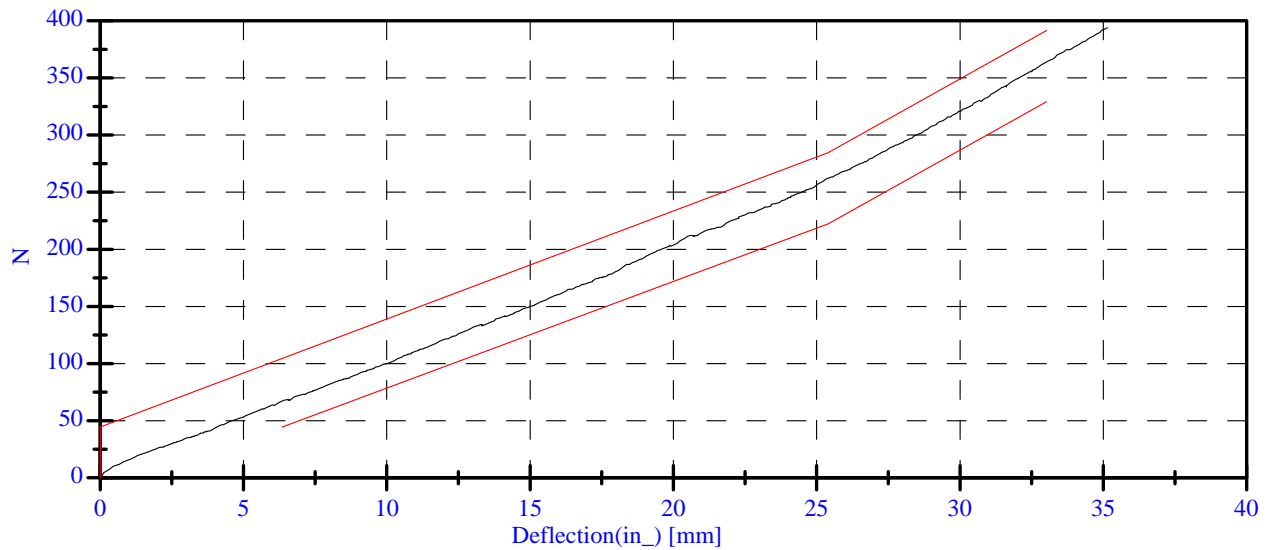
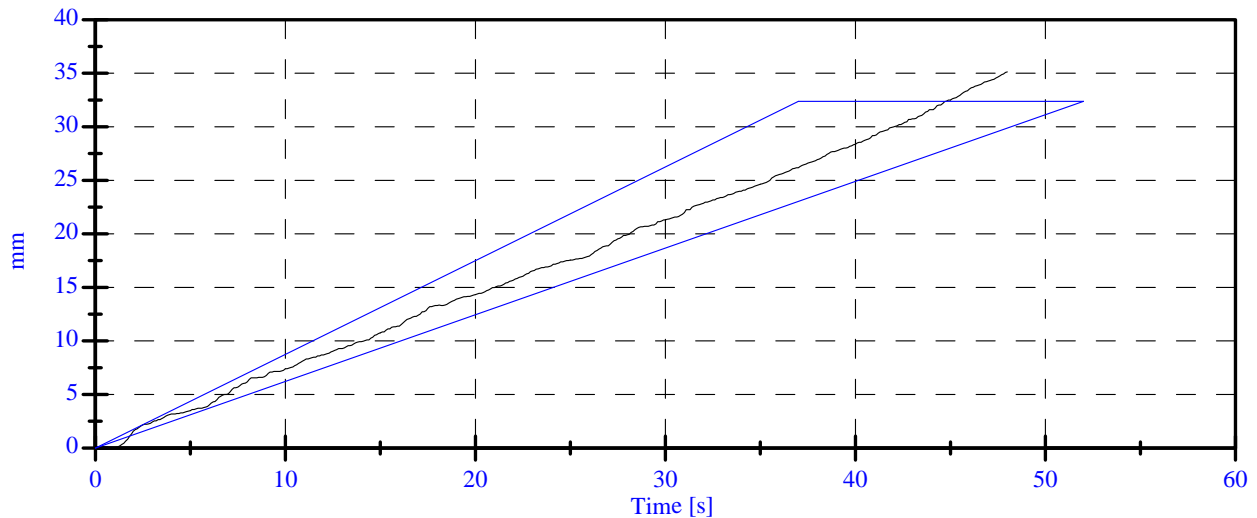
ABDOMINAL COMPRESSION TEST

<u>TEST PARAMETER</u>	<u>SPECIFICATION</u>	<u>TEST RESULTS</u>	<u>STATUS</u>
Lab Temperature:	18.9-25.5 C	21.7 C	Passed
Lab Humidity:	10-70 %	30.00 %	Passed
Force at 12.95 mm :	104.00-162.00 N	132.31 N	Passed
Force at 19.05 mm :	162.98-220.99 N	194.00 N	Passed
Force at 25.40 mm :	221.97-280.02 N	262.63 N	Passed
Force at 33.02 mm :	324.99-391.00 N	363.01 N	Passed

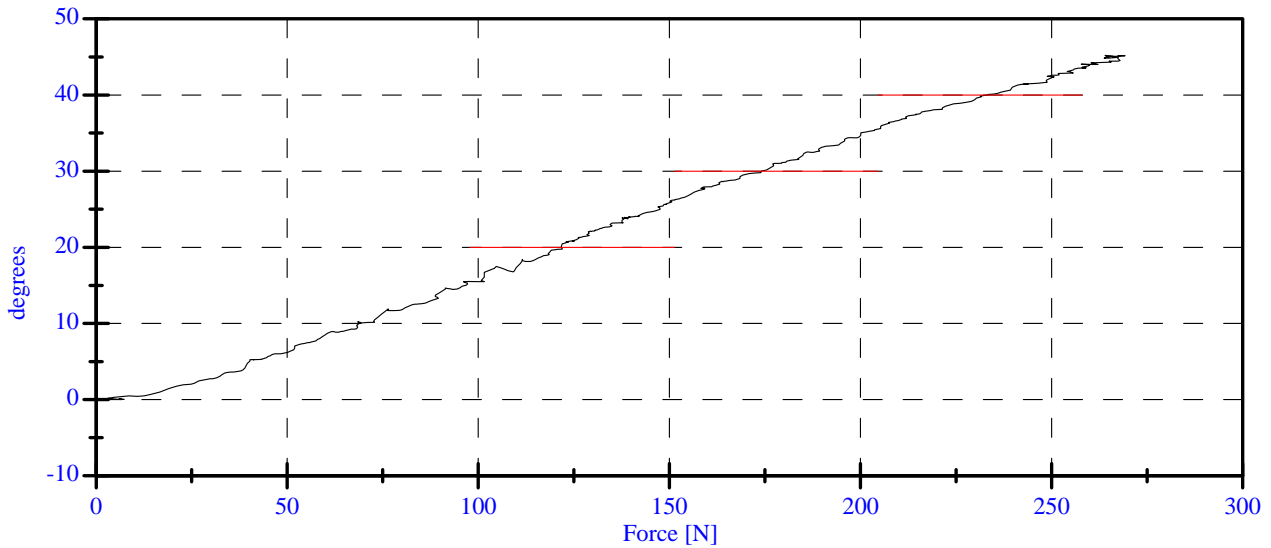
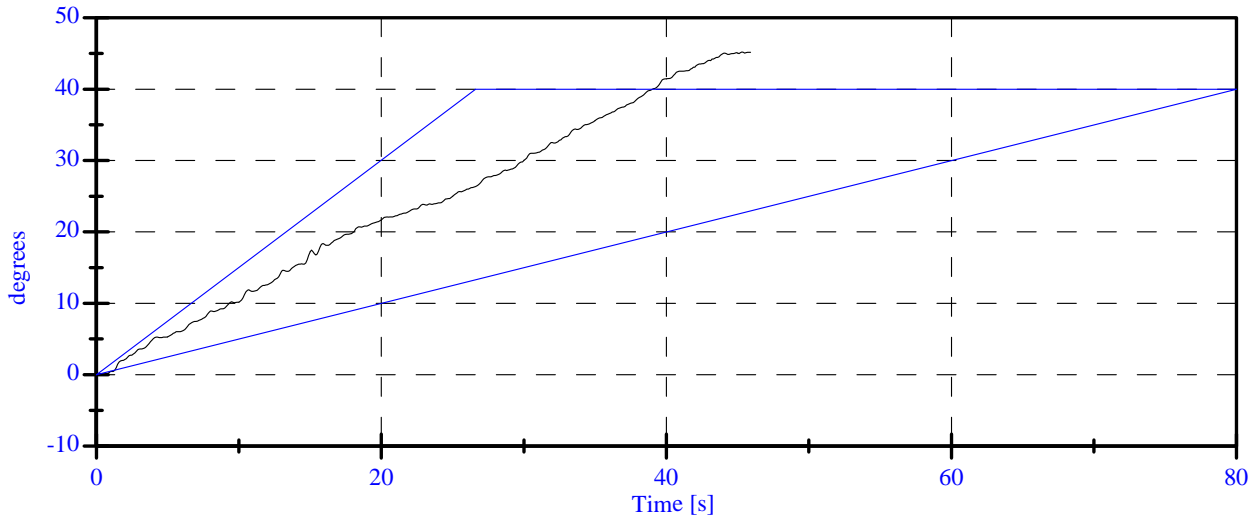
LUMBAR SPINE FLEXION TEST

<u>TEST PARAMETER</u>	<u>SPECIFICATION</u>	<u>TEST RESULTS</u>	<u>STATUS</u>
Lab Temperature:	18.9-25.5 C	21.1 C	Passed
Lab Humidity:	10-70 %	31.00 %	Passed
Force at 0 Deg:	0.00-26.69 N	6.53 N	Passed
Force at 20 Deg:	97.86-151.24 N	121.70 N	Passed
Force at 30 Deg:	151.24-204.62 N	174.19 N	Passed
Force at 40 Deg:	204.62-258.00 N	233.21 N	Passed
Return Angle	12 Deg Max	6.10 deg	Passed

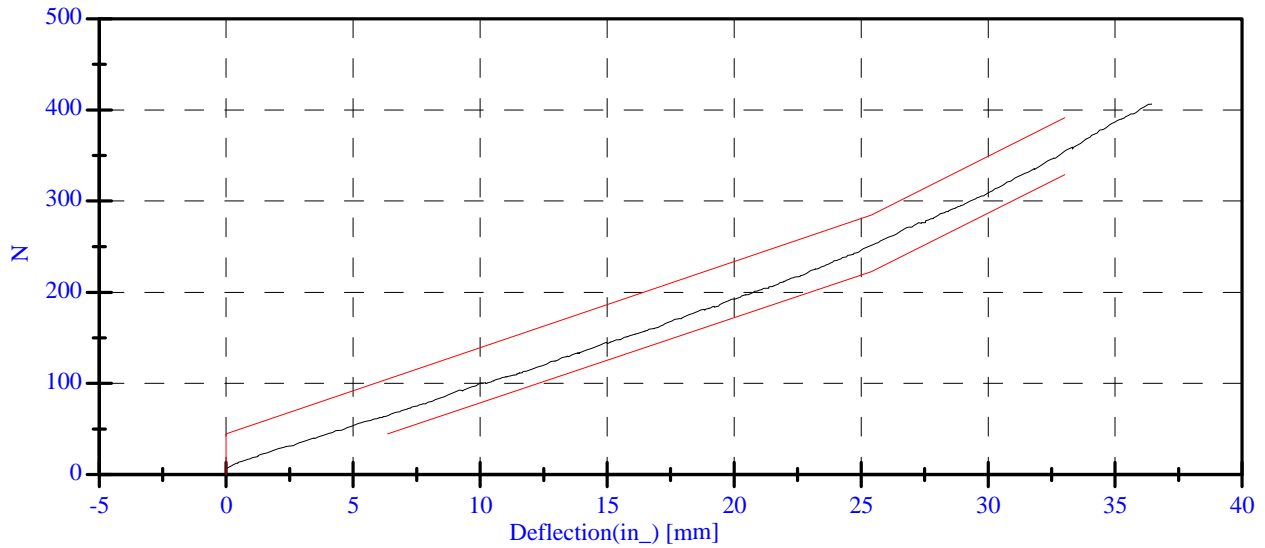
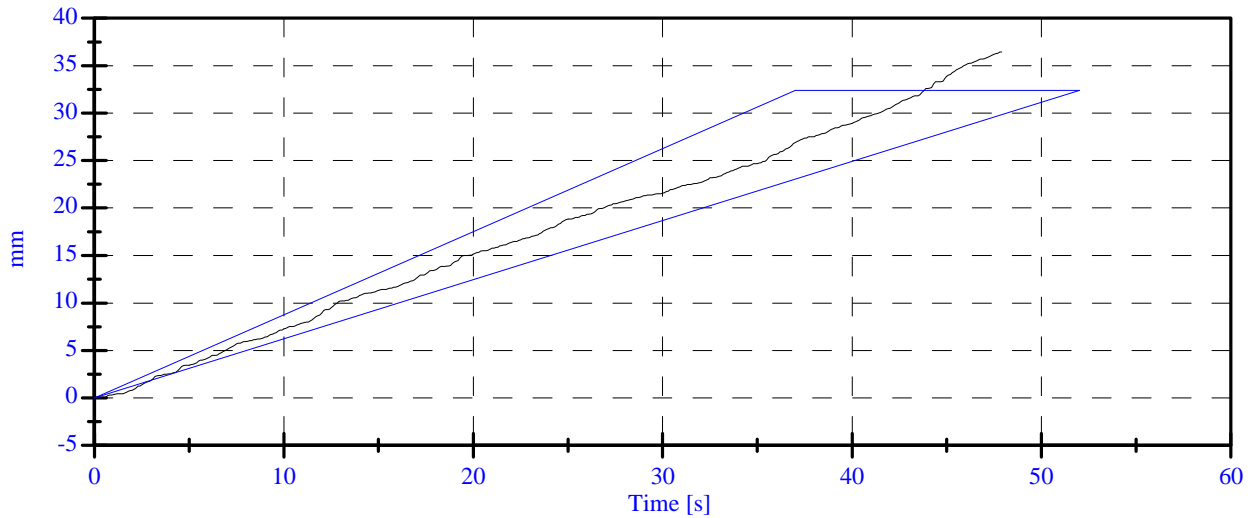
ABDOMINAL COMPRESSION TEST

<u>TEST PARAMETER</u>	<u>SPECIFICATION</u>	<u>TEST RESULTS</u>	<u>STATUS</u>
Lab Temperature:	18.9-25.5 C	21.7 C	Passed
Lab Humidity:	10-70 %	23.00 %	Passed
Force at 12.95 mm :	104.00-162.00 N	124.64 N	Passed
Force at 19.05 mm :	162.98-220.99 N	182.68 N	Passed
Force at 25.40 mm :	221.97-280.02 N	250.95 N	Passed
Force at 33.02 mm :	324.99-391.00 N	355.71 N	Passed

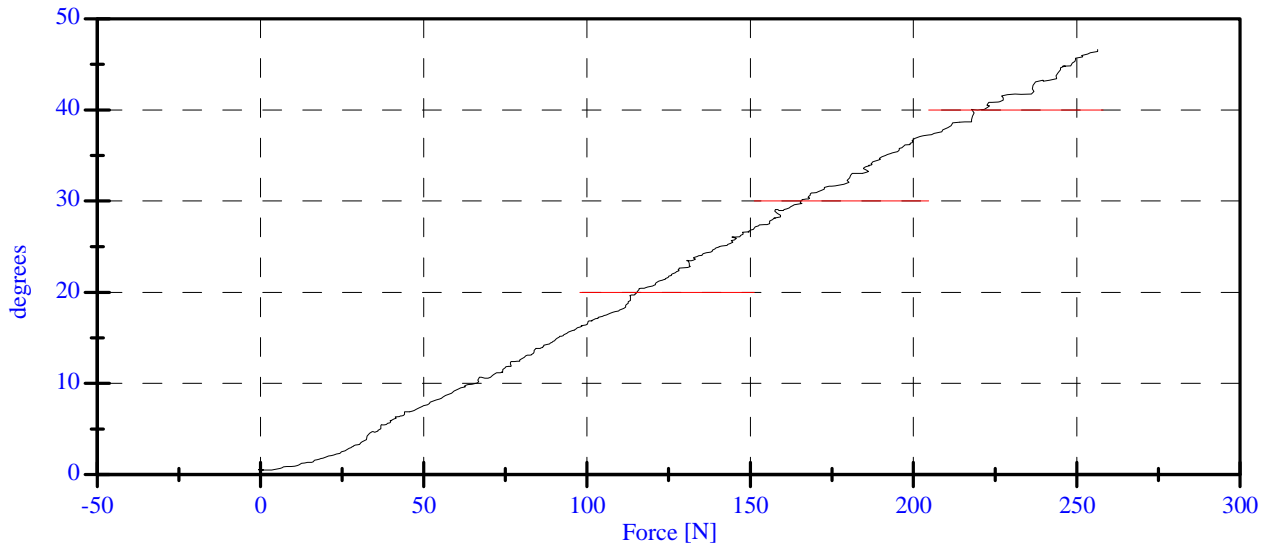
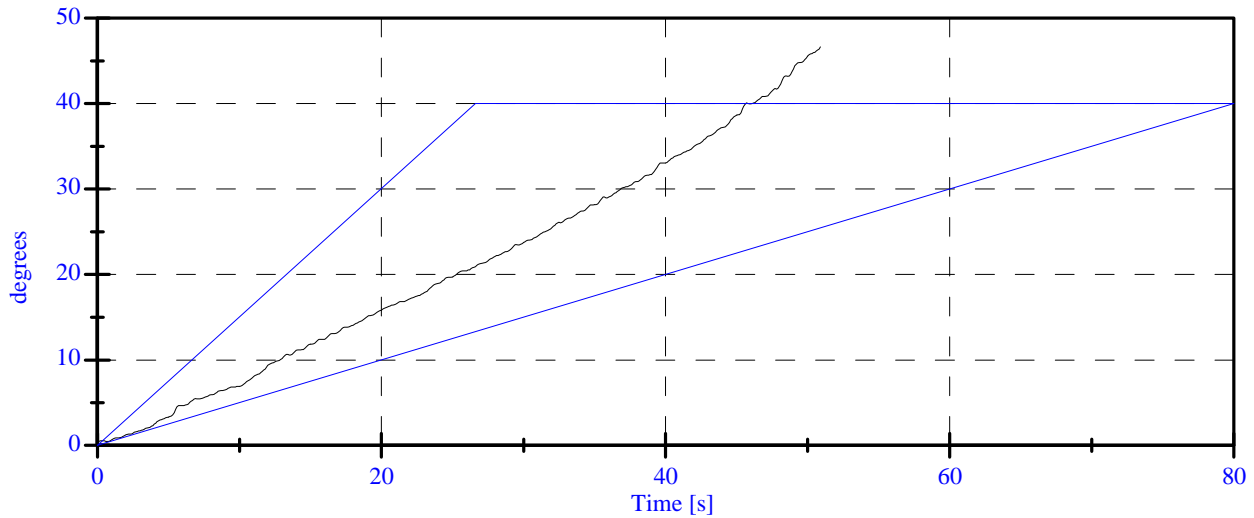
LUMBAR SPINE FLEXION TEST

<u>TEST PARAMETER</u>	<u>SPECIFICATION</u>	<u>TEST RESULTS</u>	<u>STATUS</u>
Lab Temperature:	18.9-25.5 C	21.7 C	Passed
Lab Humidity:	10-70 %	23.00 %	Passed
Force at 0 Deg:	0.00-26.69 N	0.78 N	Passed
Force at 20 Deg:	97.86-151.24 N	115.43 N	Passed
Force at 30 Deg:	151.24-204.62 N	165.31 N	Passed
Force at 40 Deg:	204.62-258.00 N	219.63 N	Passed
Return Angle	12 Deg Max	8.85 deg	Passed

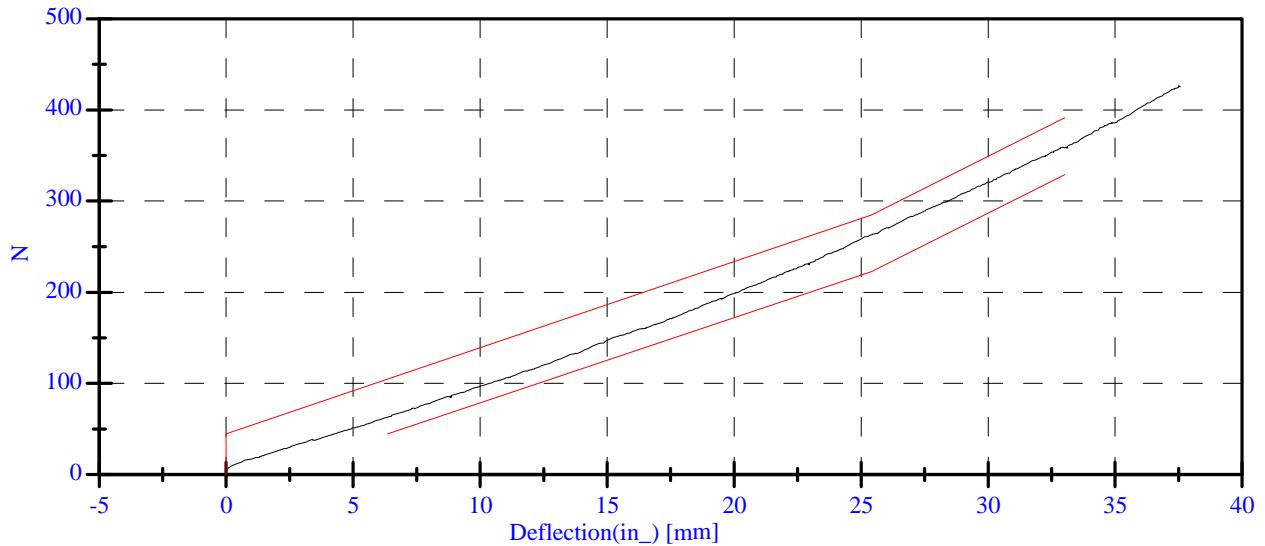
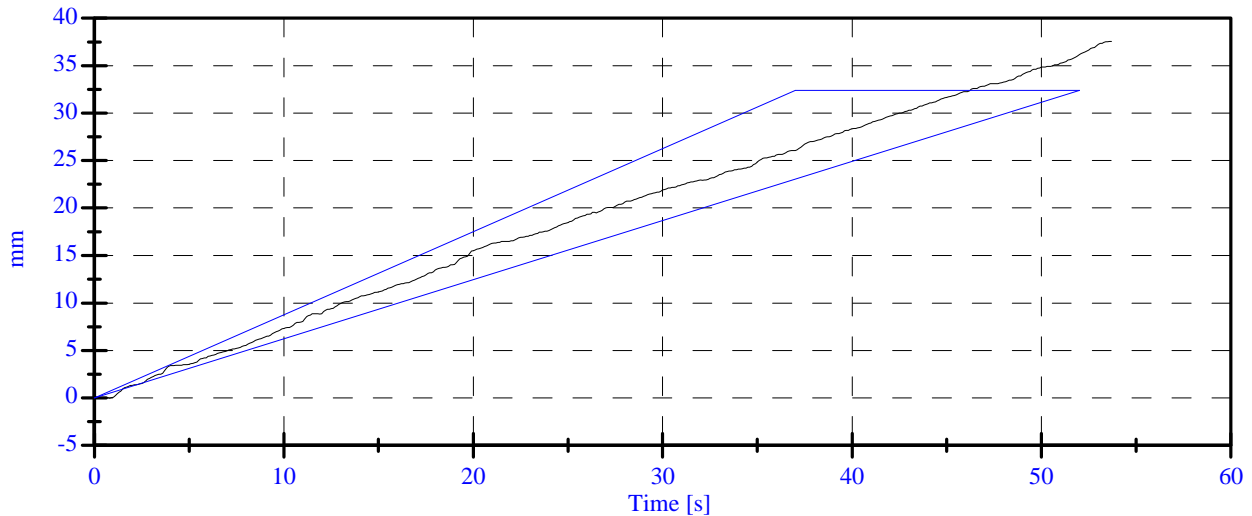
ABDOMINAL COMPRESSION TEST

<u>TEST PARAMETER</u>	<u>SPECIFICATION</u>	<u>TEST RESULTS</u>	<u>STATUS</u>
Lab Temperature:	18.9-25.5 C	21.7 C	Passed
Lab Humidity:	10-70 %	23.00 %	Passed
Force at 12.95 mm :	104.00-162.00 N	125.01 N	Passed
Force at 19.05 mm :	162.98-220.99 N	188.53 N	Passed
Force at 25.40 mm :	221.97-280.02 N	262.99 N	Passed
Force at 33.02 mm :	324.99-391.00 N	358.63 N	Passed

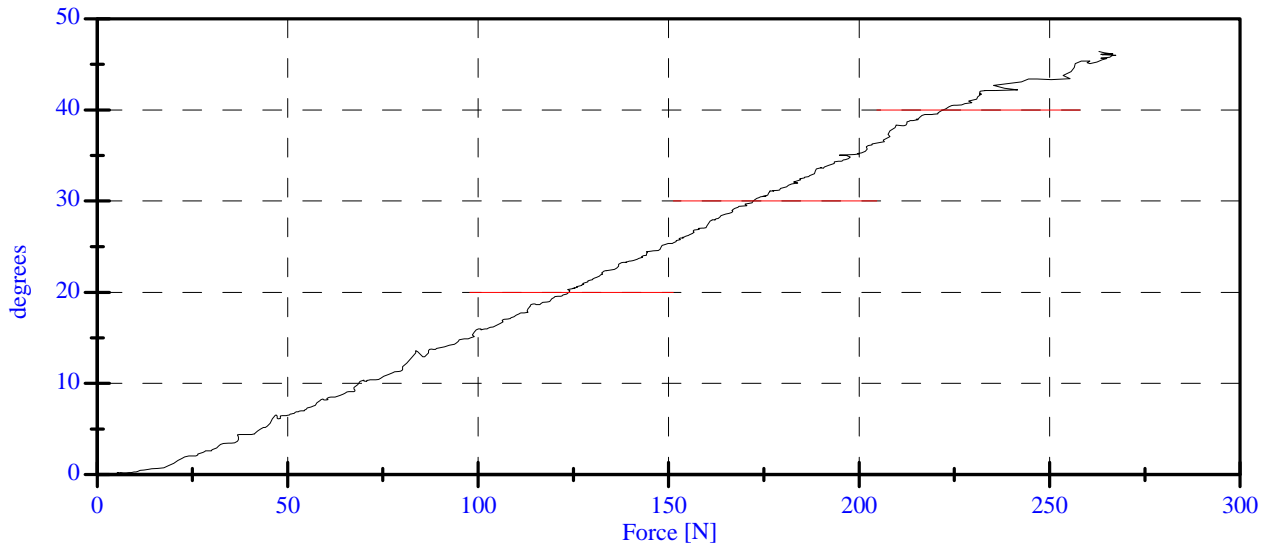
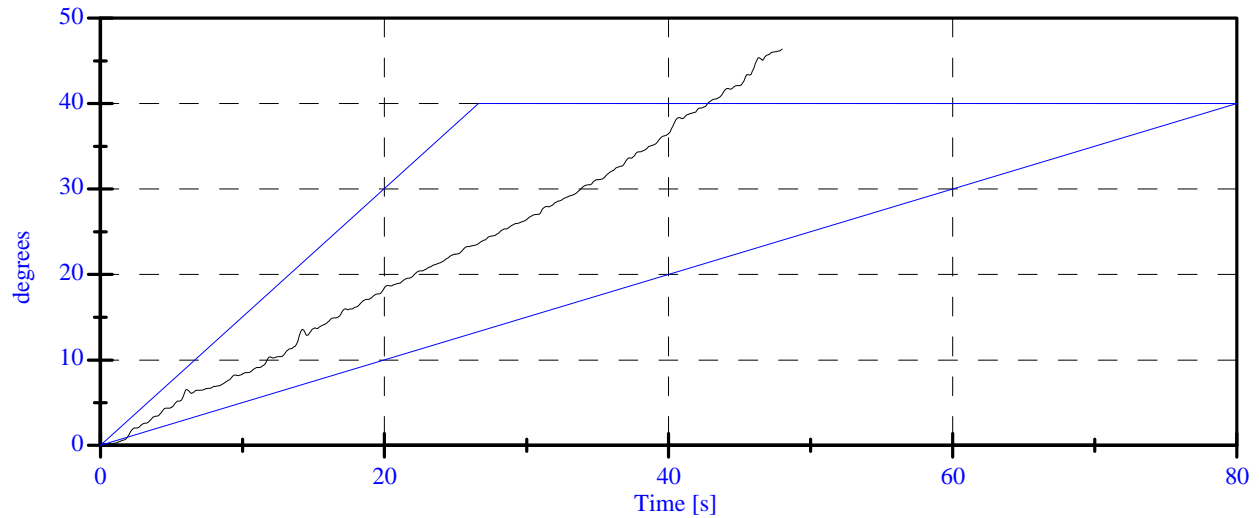
LUMBAR SPINE FLEXION TEST

<u>TEST PARAMETER</u>	<u>SPECIFICATION</u>	<u>TEST RESULTS</u>	<u>STATUS</u>
Lab Temperature:	18.9-25.5 C	21.7 C	Passed
Lab Humidity:	10-70 %	22.00 %	Passed
Force at 0 Deg:	0.00-26.69 N	5.48 N	Passed
Force at 20 Deg:	97.86-151.24 N	123.79 N	Passed
Force at 30 Deg:	151.24-204.62 N	172.10 N	Passed
Force at 40 Deg:	204.62-258.00 N	221.46 N	Passed
Return Angle	12 Deg Max	7.43 deg	Passed

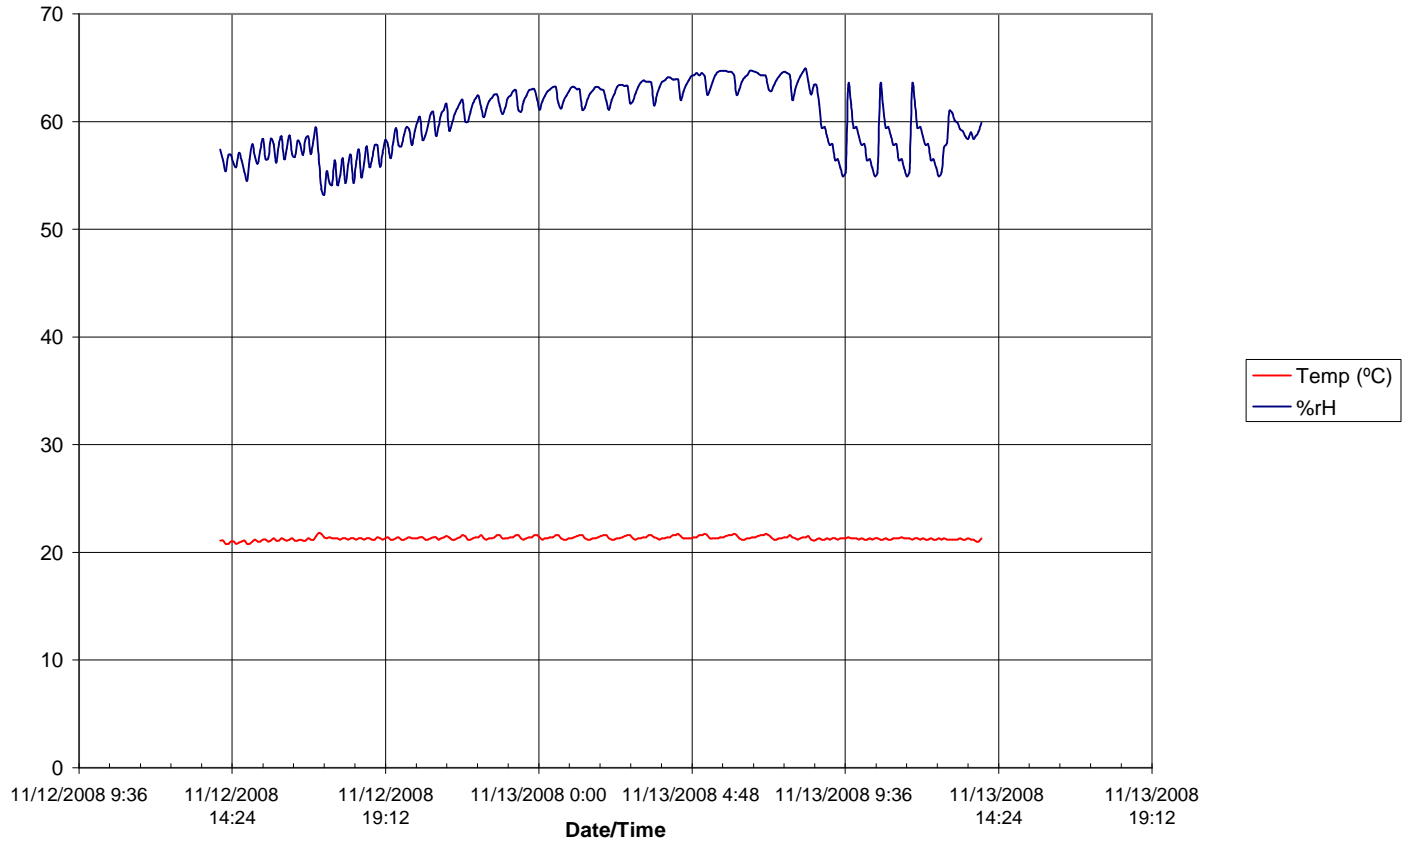
TEMPERATURE TRACE

2009 Honda Fit C95308 Environmental Conditions
