REPORT NUMBER: 214-CAL-08-04

**SAFETY COMPLIANCE TESTING FOR FMVSS 214
SIDE IMPACT PROTECTION**

HYUNDAI MOTOR COMPANY
2009 HYUNDAI GENESIS
4-DOOR SEDAN

NHTSA NUMBER: C90504

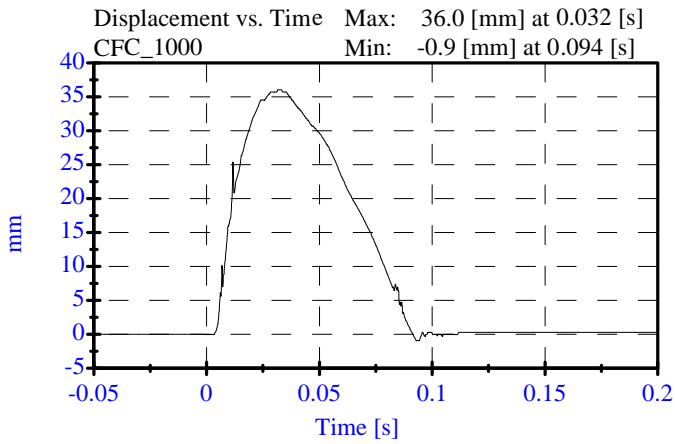
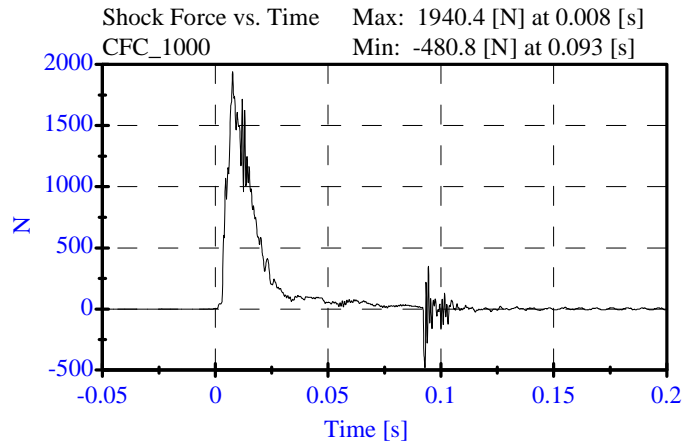
Shock Test (4.27 m/s)

<u>TEST PARAMETER</u>	<u>SPECIFICATION</u>	<u>TEST RESULTS</u>	<u>STATUS</u>
Lab Temperature:	18.9-25.5 C	21.7 C	Passed
Lab Humidity:	10-70 %	24.00 %	Passed
Displacement:	32.00-37.00 mm	36.04 mm	Passed
Maximum Force:	1730.00-2099.00 N	1940.35 N	Passed
Impact Test Velocity:	4.27 m/s		
Damper Identification:	013		
Damper Setting:	5

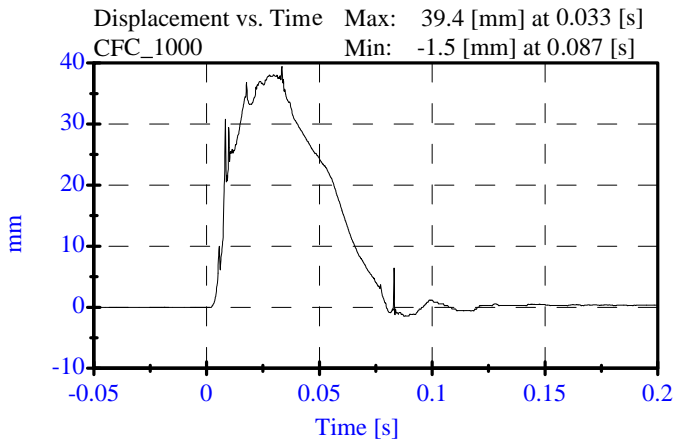
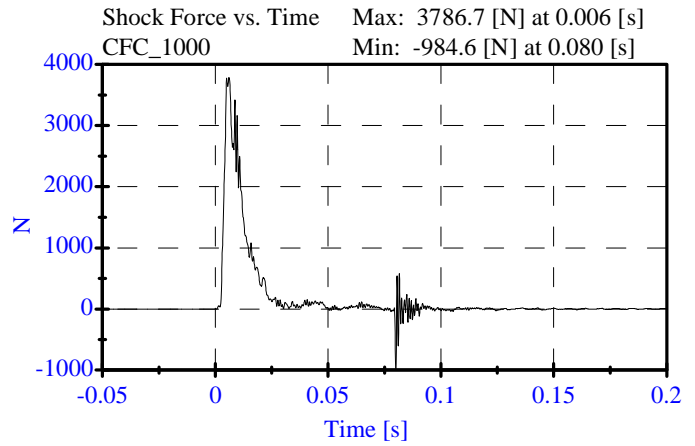
Shock Test (6.10 m/s)

<u>TEST PARAMETER</u>	<u>SPECIFICATION</u>	<u>TEST RESULTS</u>	<u>STATUS</u>
Lab Temperature:	18.9-25.5 C	21.7 C	Passed
Lab Humidity:	10-70 %	24.00 %	Passed
Displacement:	33.00-40.00 mm	39.41 mm	Passed
Maximum Force:	3741.00-4448.00 N	3786.69 N	Passed
Impact Test Velocity:	6.10 m/s		
Damper Identification:	013		
Damper Setting:	5

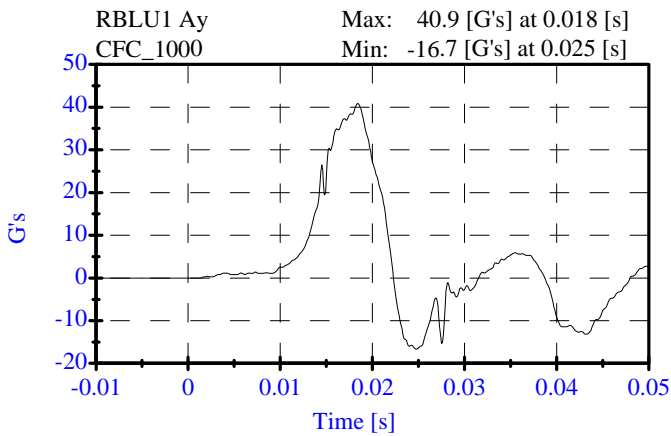
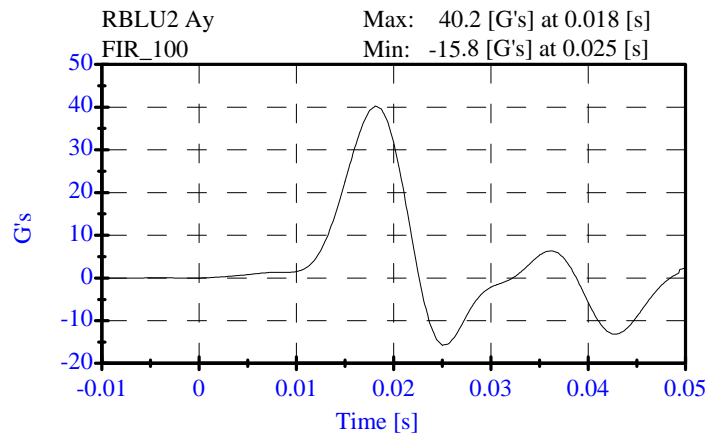
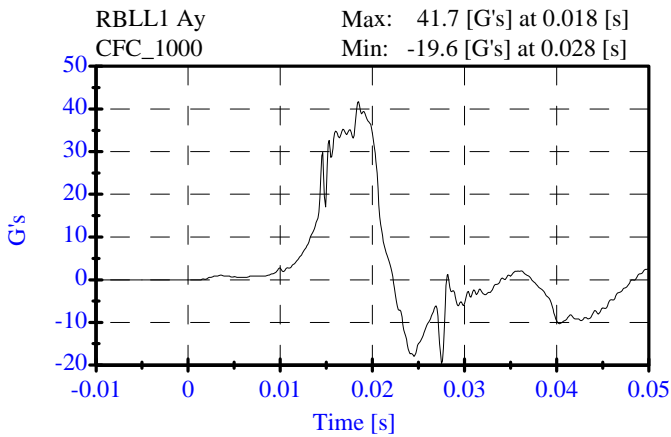
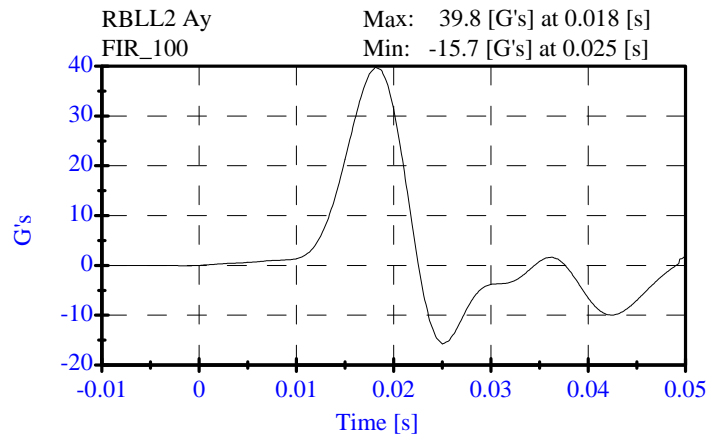
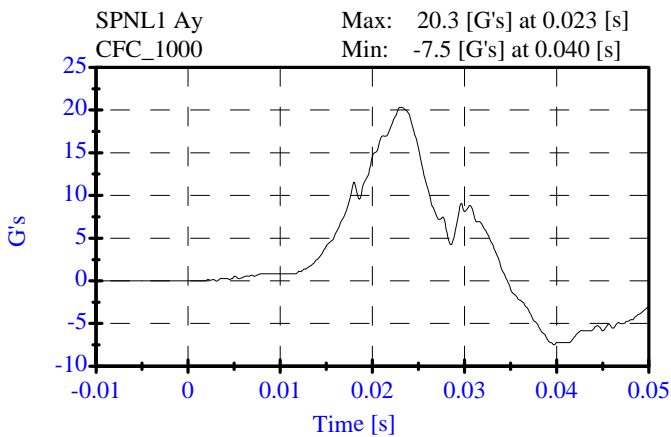
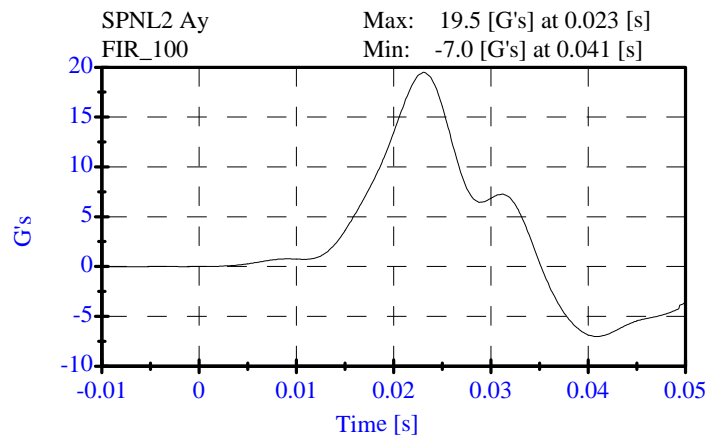
Thorax Impact
Pre-Test
CONFIGURED FOR LEFT SIDE IMPACT

<u>TEST PARAMETER</u>	<u>SPECIFICATION</u>	<u>TEST RESULTS</u>	<u>STATUS</u>
Lab Temperature:	18.9-25.5 C	21.7 C	Passed
Lab Humidity:	10-70 %	22.00 %	Passed
Probe Velocity:	4.27- 4.33 m/s	4.31 m/s	Passed
Upper Rib Acceleration:	37.00-46.00 G's	40.24 G's	Passed
Lower Rib Acceleration:	37.00-46.00 G's	39.80 G's	Passed
Lower Spine Acceleration:	15.00-22.00 G's	19.51 G's	Passed

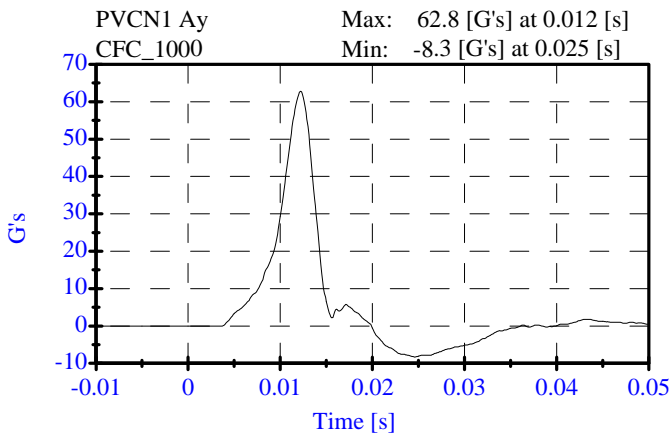
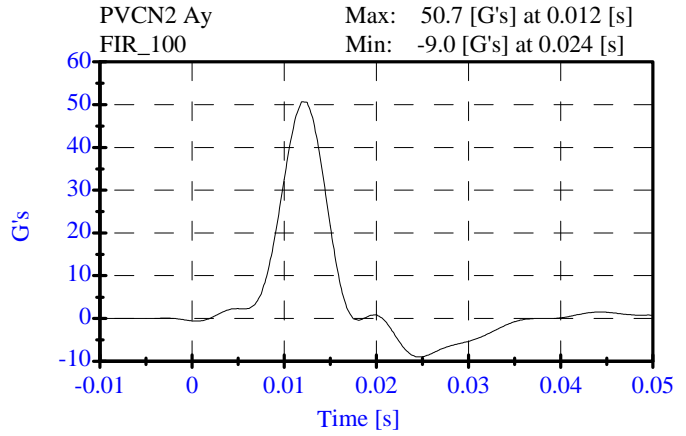
**Pelvis Impact
Pre-Test**

<u>TEST PARAMETER</u>	<u>SPECIFICATION</u>	<u>TEST RESULTS</u>	<u>STATUS</u>
Lab Temperature:	18.9-25.5 C	21.7 C	Passed
Lab Humidity:	10-70 %	21.00 %	Passed
Probe Velocity:	4.27- 4.33 m/s	4.28 m/s	Passed
Pelvis Y Acceleration:	40.00-60.00 G's	50.68 G's	Passed
Time Above 20 Gs	3.0-7.0 ms	6.1 ms	Passed

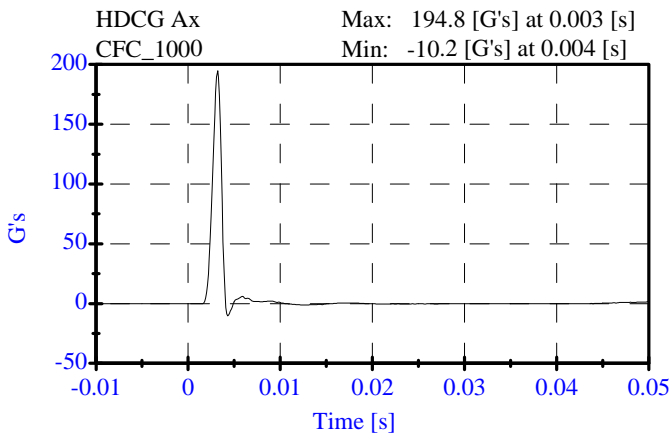
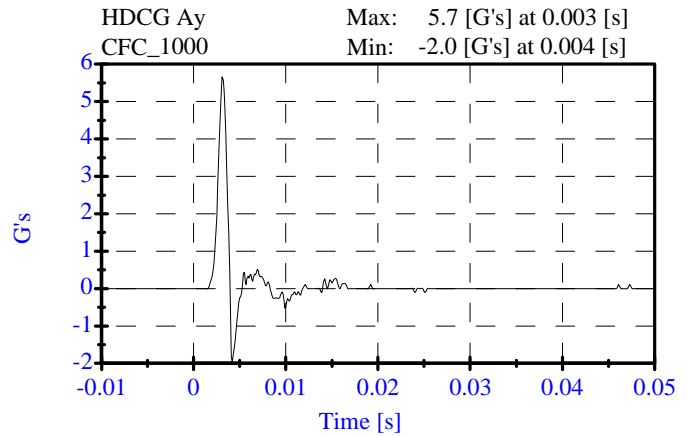
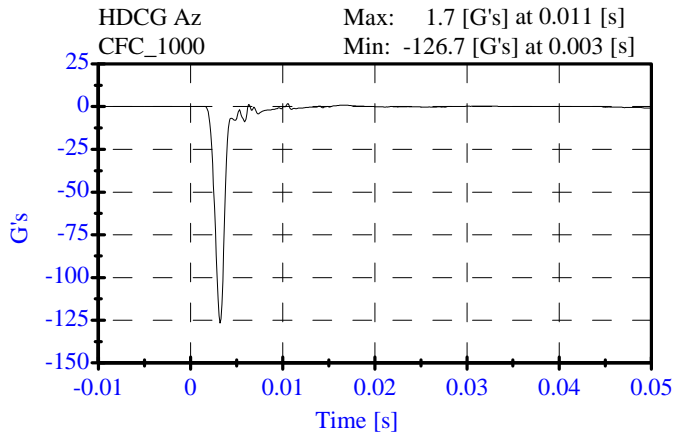
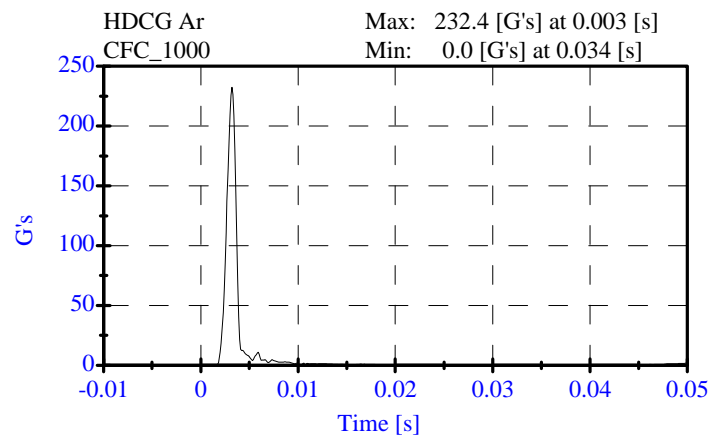
**Head Drop
Pre-Test**

<u>TEST PARAMETER</u>	<u>SPECIFICATION</u>	<u>TEST RESULTS</u>	<u>STATUS</u>
Lab Temperature:	18.9-25.6 C	21.1 C	Passed
Lab Humidity:	10-70 %	31.00 %	Passed
Peak Resultant Accel.:	210-260 Gs	232.44 Gs	Passed
Peak Lateral Accel.:	10 Gs Max	5.66 Gs	Passed
Unimodal Criteria Above 100 Gs:	0.9-1.5 ms	1.16 ms	Passed
Curve PerCent NonModal:	< 10%	5.44 %	Passed

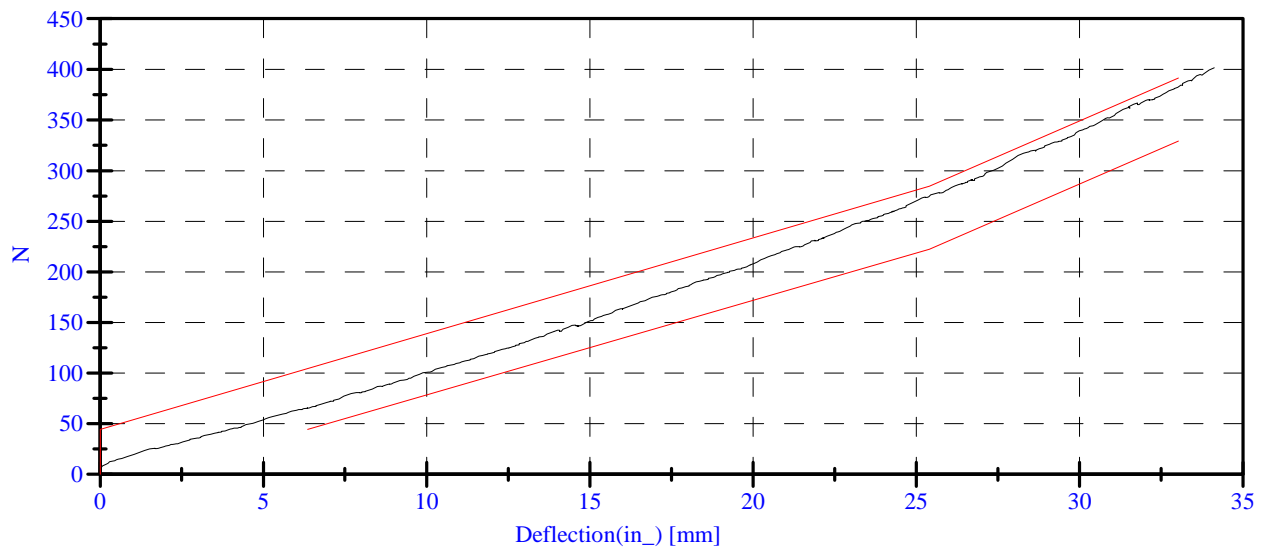
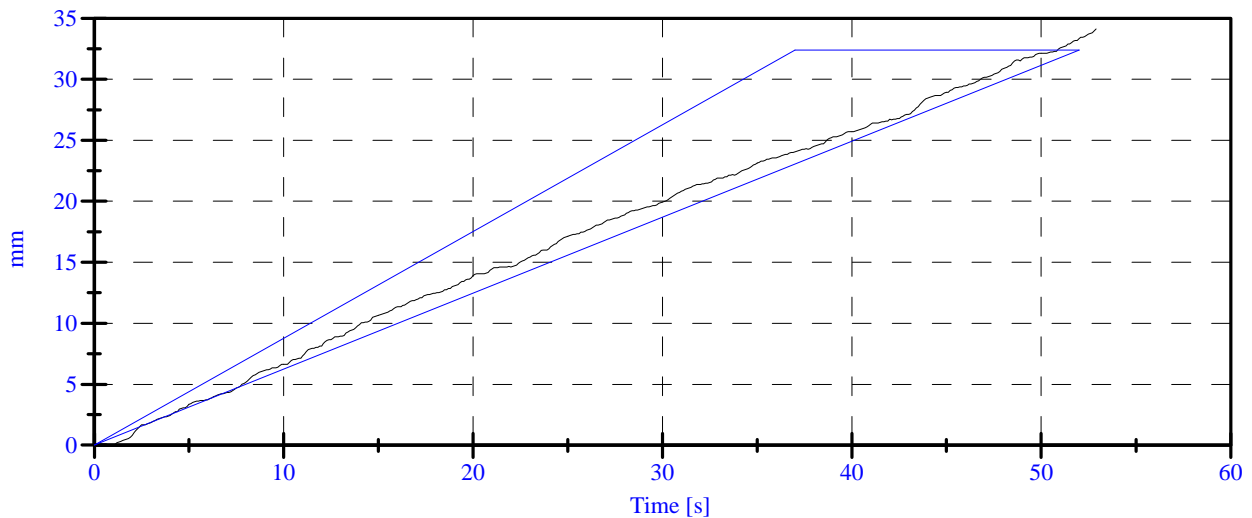
ABDOMINAL COMPRESSION TEST

<u>TEST PARAMETER</u>	<u>SPECIFICATION</u>	<u>TEST RESULTS</u>	<u>STATUS</u>
Lab Temperature:	18.9-25.5 C	21.7 C	Passed
Lab Humidity:	10-70 %	22.00 %	Passed
Force at 12.95 mm :	104.00-162.00 N	130.12 N	Passed
Force at 19.05 mm :	162.98-220.99 N	198.02 N	Passed
Force at 25.40 mm :	221.97-280.02 N	274.31 N	Passed
Force at 33.02 mm :	324.99-391.00 N	382.36 N	Passed

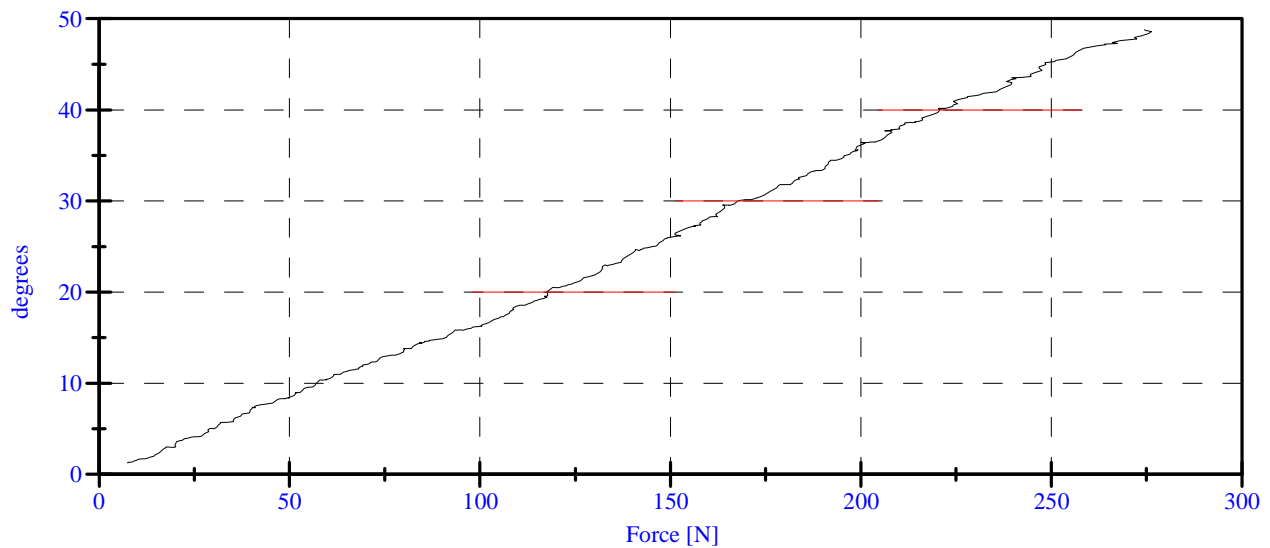
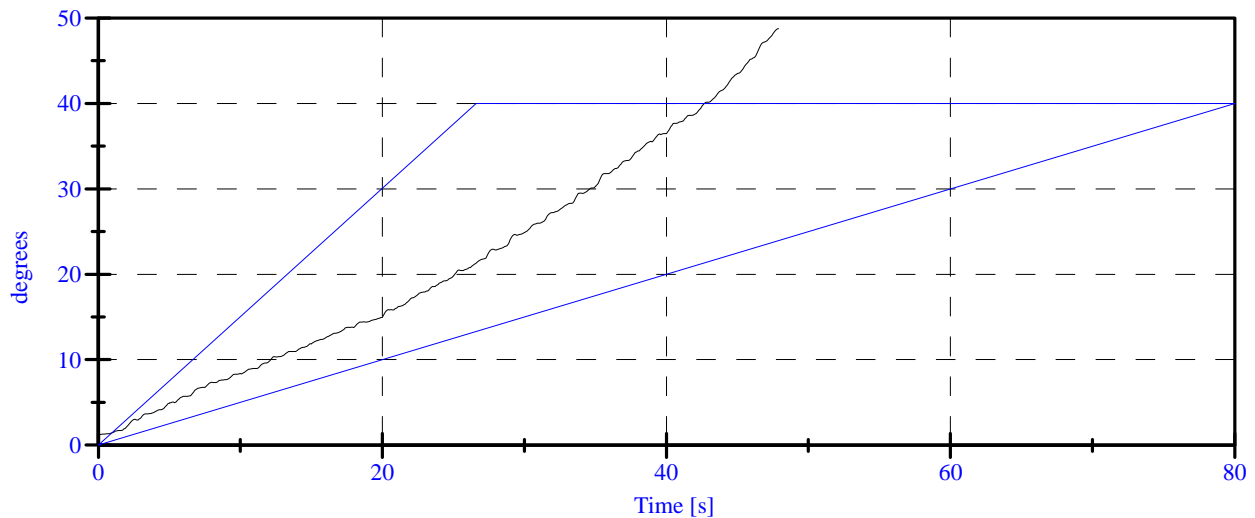
LUMBAR SPINE FLEXION TEST

<u>TEST PARAMETER</u>	<u>SPECIFICATION</u>	<u>TEST RESULTS</u>	<u>STATUS</u>
Lab Temperature:	18.9-25.5 C	21.7 C	Passed
Lab Humidity:	10-70 %	22.00 %	Passed
Force at 0 Deg:	0.00-26.69 N	7.57 N	Passed
Force at 20 Deg:	97.86-151.24 N	117.52 N	Passed
Force at 30 Deg:	151.24-204.62 N	167.92 N	Passed
Force at 40 Deg:	204.62-258.00 N	220.67 N	Passed
Return Angle	12 Deg Max	6.63 deg	Passed

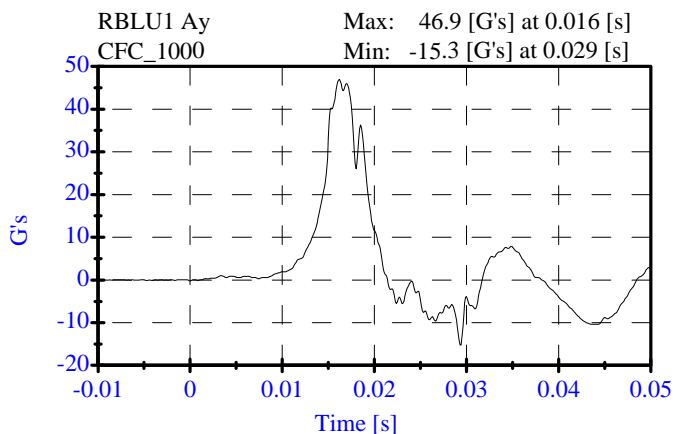
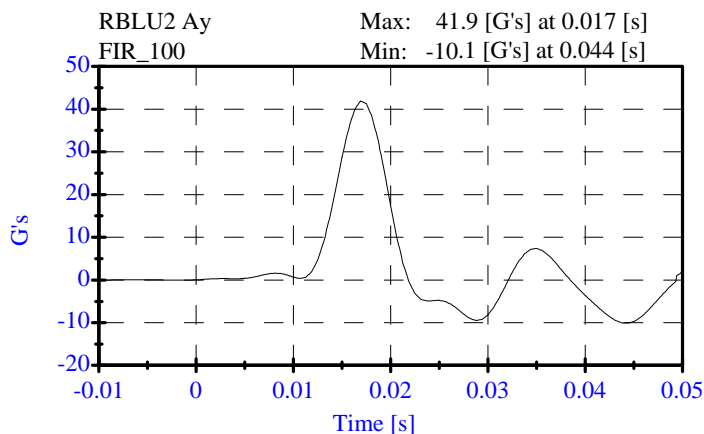
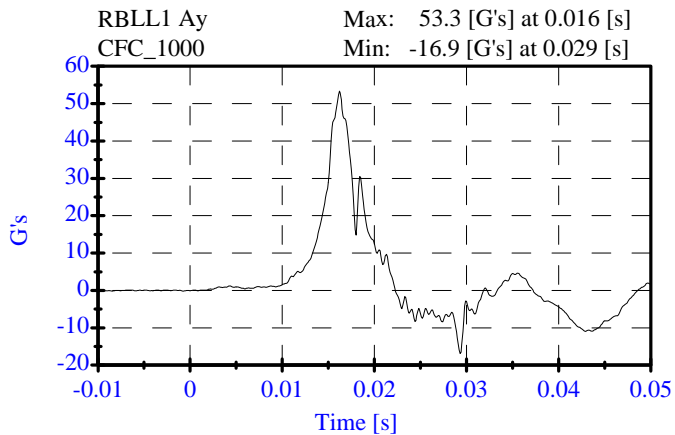
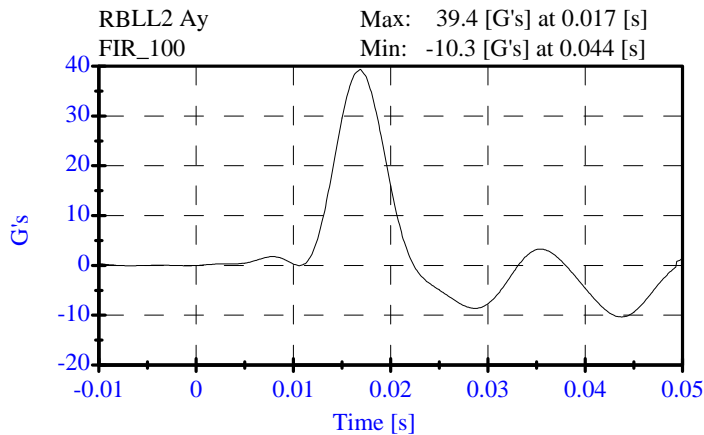
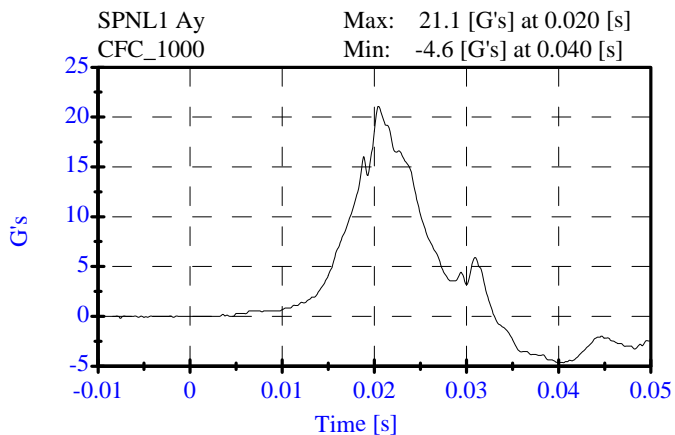
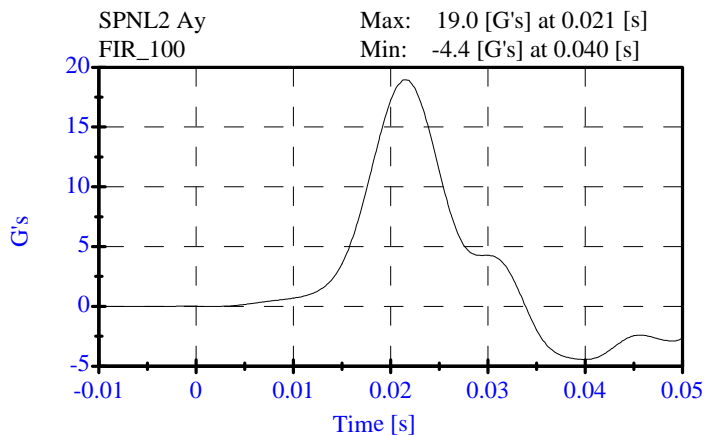
**Thorax Impact
Pre-Test**

<u>TEST PARAMETER</u>	<u>SPECIFICATION</u>	<u>TEST RESULTS</u>	<u>STATUS</u>
Lab Temperature:	18.9-25.5 C	21.7 C	Passed
Lab Humidity:	10-70 %	21.00 %	Passed
Probe Velocity:	4.27- 4.33 m/s	4.31 m/s	Passed
Upper Rib Acceleration:	37.00-46.00 G's	41.89 G's	Passed
Lower Rib Acceleration:	37.00-46.00 G's	39.37 G's	Passed
Lower Spine Acceleration:	15.00-22.00 G's	18.96 G's	Passed

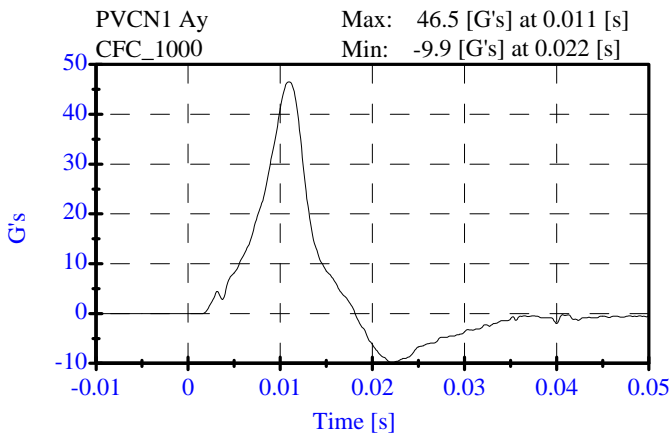
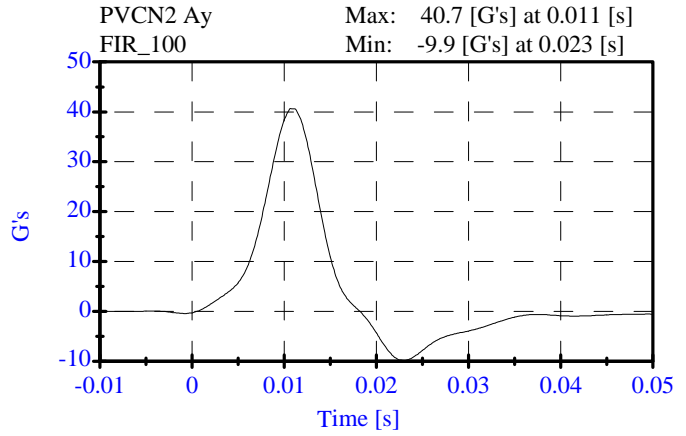
**Pelvis Impact
Pre-Test**

<u>TEST PARAMETER</u>	<u>SPECIFICATION</u>	<u>TEST RESULTS</u>	<u>STATUS</u>
Lab Temperature:	18.9-25.5 C	21.7 C	Passed
Lab Humidity:	10-70 %	22.00 %	Passed
Probe Velocity:	4.27- 4.33 m/s	4.28 m/s	Passed
Pelvis Y Acceleration:	40.00-60.00 G's	40.66 G's	Passed
Time Above 20 Gs	3.0-7.0 ms	6.2 ms	Passed

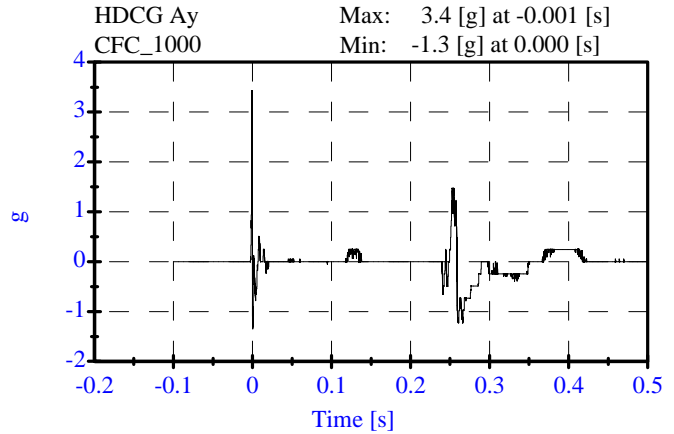
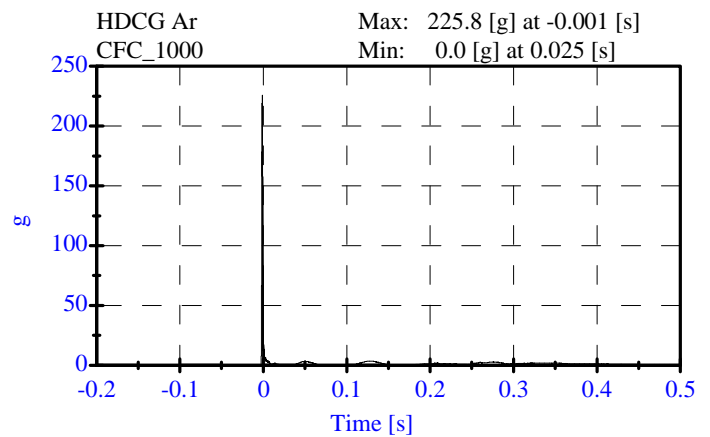
Head Drops

<u>TEST PARAMETER</u>	<u>SPECIFICATION</u>	<u>TEST RESULTS</u>	<u>STATUS</u>
Lab Temperature:	18.9-25.6 C	21.7 C	Passed
Lab Humidity:	10-70 %	24.00 %	Passed
Peak Resultant Accel.:	210-260 Gs	225.77 Gs	Passed
Peak Lateral Accel.:	10 Gs Max	3.43 Gs	Passed
Unimodal Criteria Above 100 Gs:	0.9-1.5 ms	1.21 ms	Passed
Curve PerCent NonModal:	< 10%	9.27 %	Passed

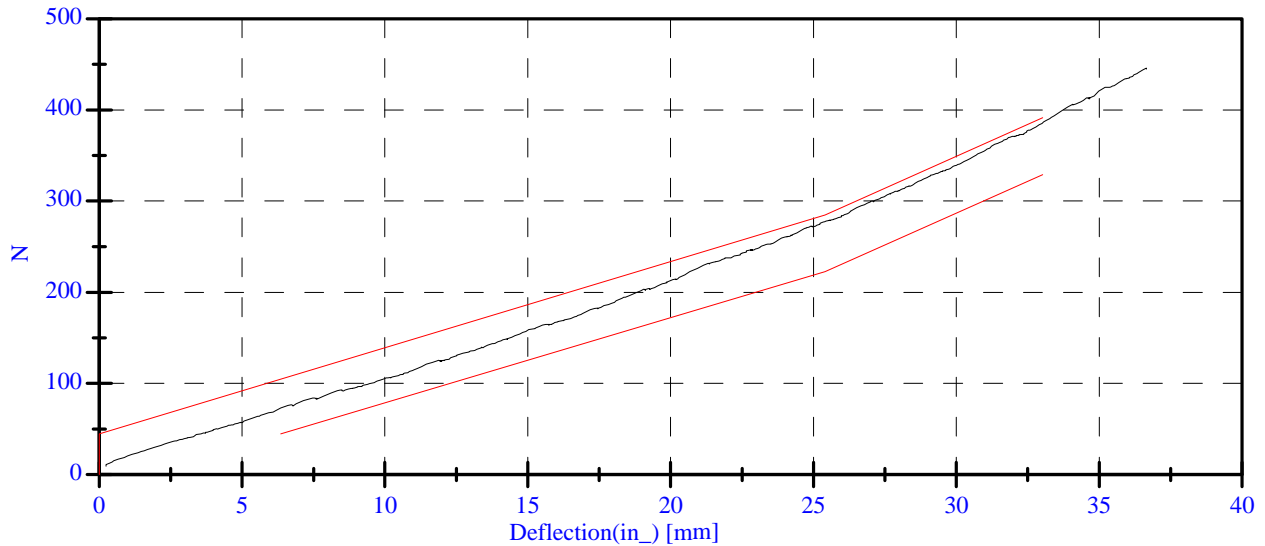
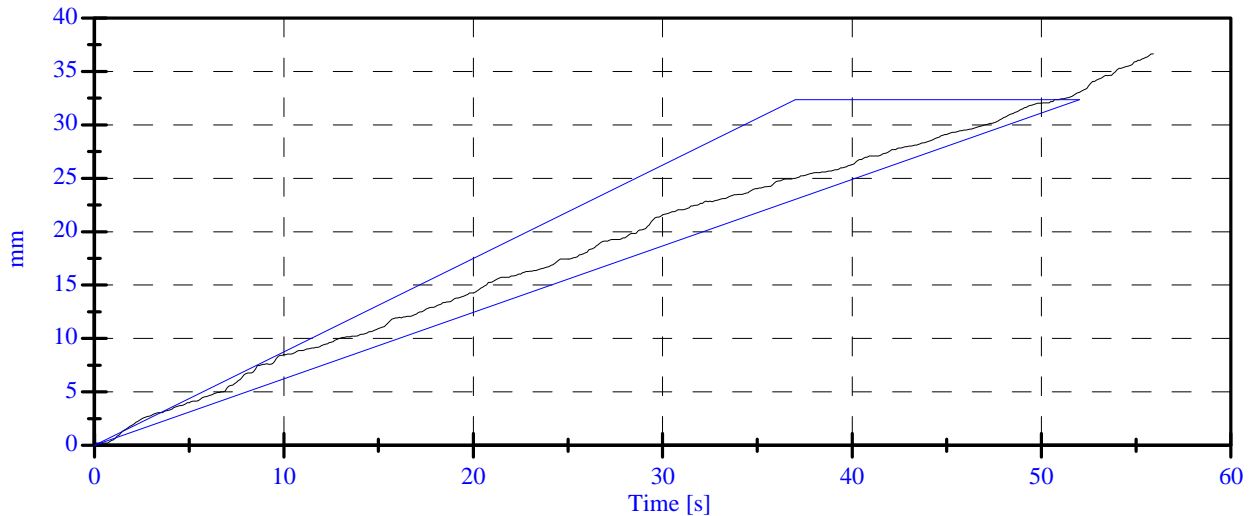
ABDOMINAL COMPRESSION TEST

<u>TEST PARAMETER</u>	<u>SPECIFICATION</u>	<u>TEST RESULTS</u>	<u>STATUS</u>
Lab Temperature:	18.9-25.5 C	21.7 C	Passed
Lab Humidity:	10-70 %	22.00 %	Passed
Force at 12.95 mm :	104.00-162.00 N	134.50 N	Passed
Force at 19.05 mm :	162.98-220.99 N	203.13 N	Passed
Force at 25.40 mm :	221.97-280.02 N	277.59 N	Passed
Force at 33.02 mm :	324.99-391.00 N	385.28 N	Passed

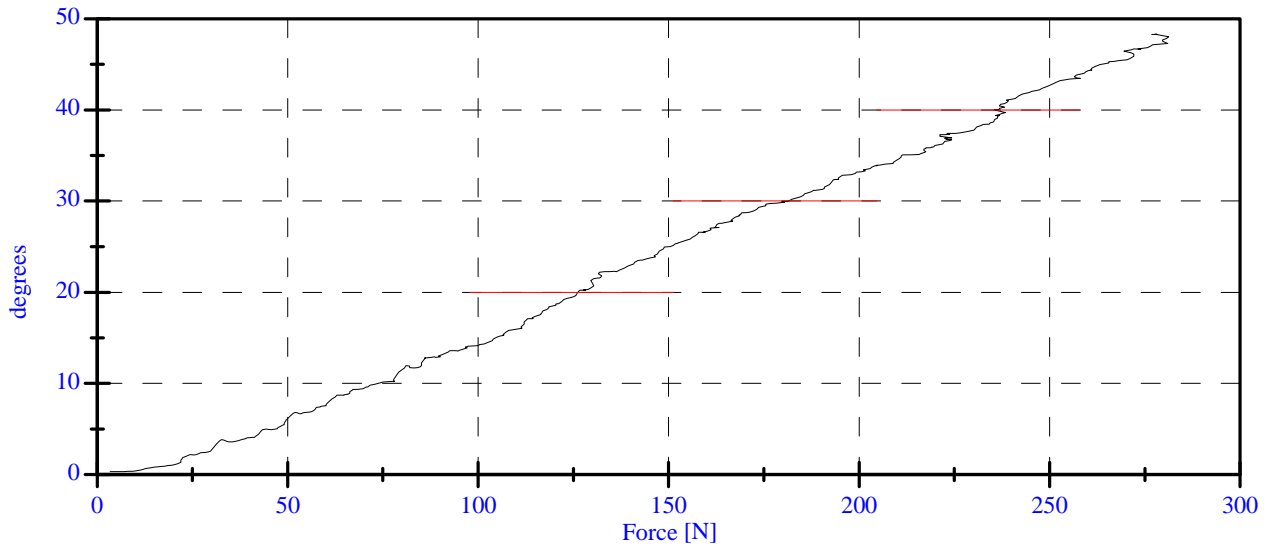
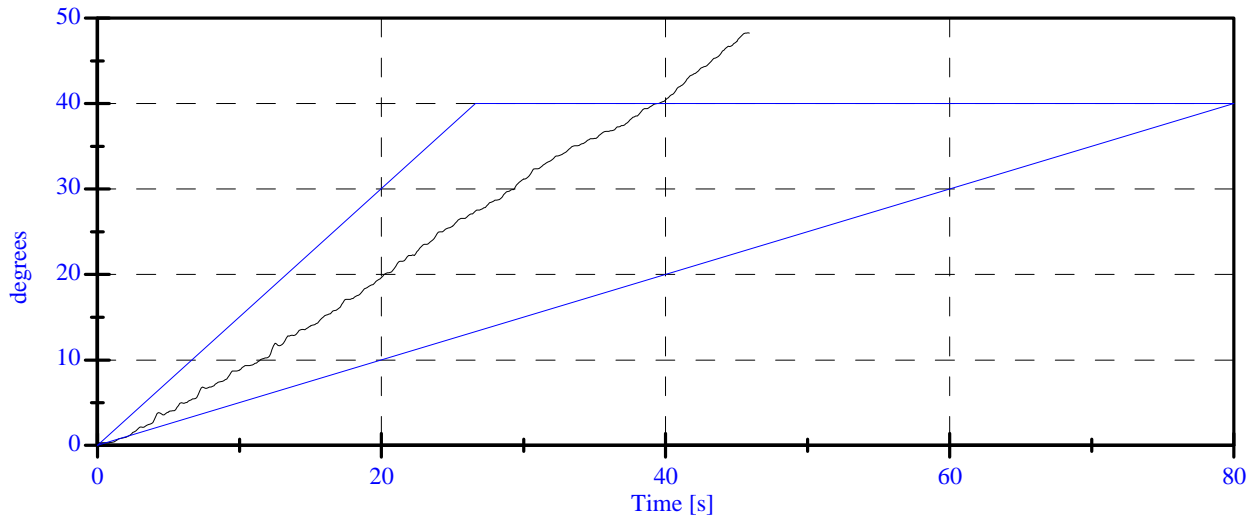
LUMBAR SPINE FLEXION TEST

<u>TEST PARAMETER</u>	<u>SPECIFICATION</u>	<u>TEST RESULTS</u>	<u>STATUS</u>
Lab Temperature:	18.9-25.5 C	21.7 C	Passed
Lab Humidity:	10-70 %	22.00 %	Passed
Force at 0 Deg:	0.00-26.69 N	3.39 N	Passed
Force at 20 Deg:	97.86-151.24 N	126.14 N	Passed
Force at 30 Deg:	151.24-204.62 N	179.67 N	Passed
Force at 40 Deg:	204.62-258.00 N	235.82 N	Passed
Return Angle	12 Deg Max	7.03 deg	Passed

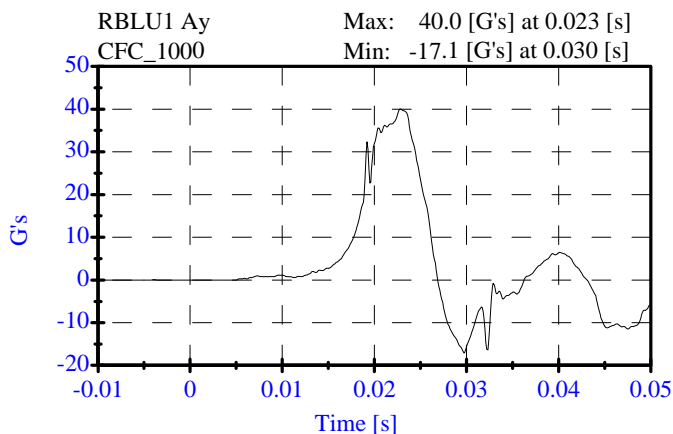
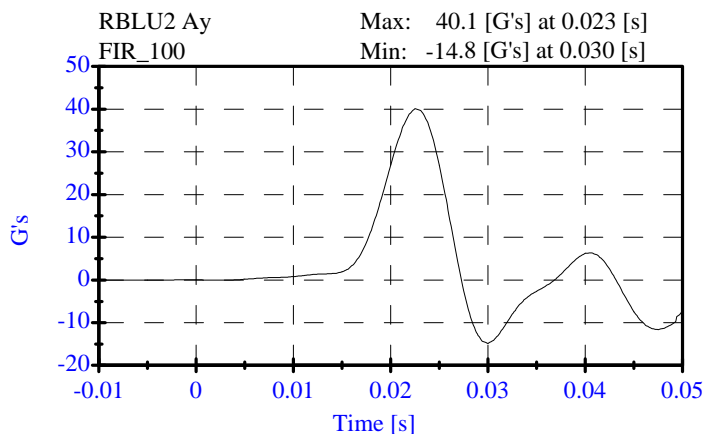
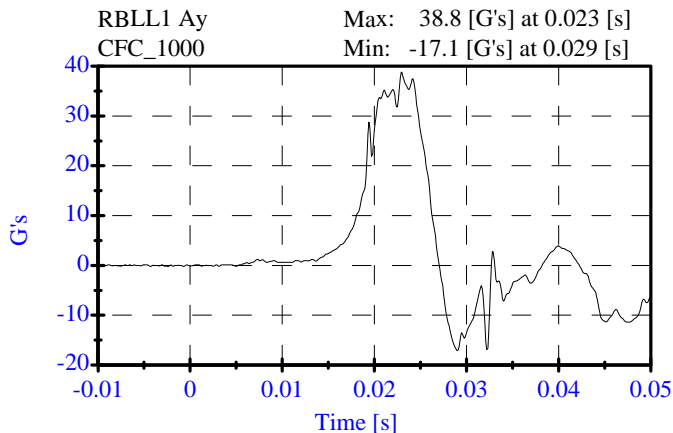
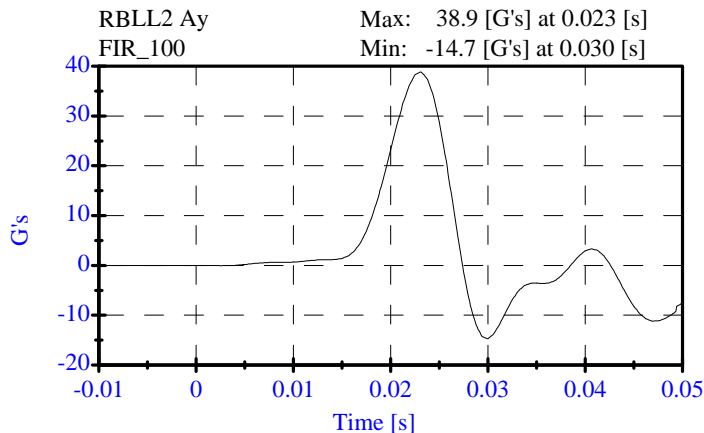
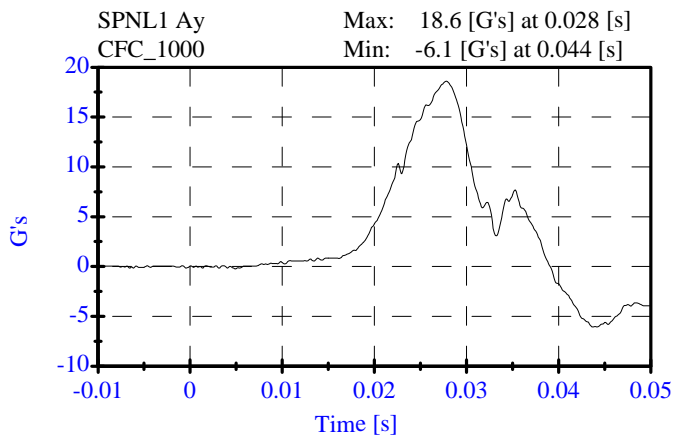
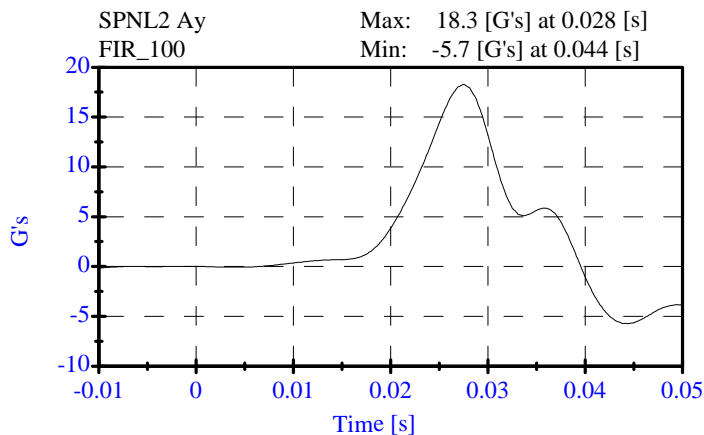
<u>TEST PARAMETER</u>	<u>SPECIFICATION</u>	<u>TEST RESULTS</u>	<u>STATUS</u>
Lab Temperature:	18.9-25.5 C	21.7 C	Passed
Lab Humidity:	10-70 %	34.00 %	Passed
Probe Velocity:	4.27- 4.33 m/s	4.31 m/s	Passed
Upper Rib Acceleration:	37.00-46.00 G's	40.13 G's	Passed
Lower Rib Acceleration:	37.00-46.00 G's	38.87 G's	Passed
Lower Spine Acceleration:	15.00-22.00 G's	18.31 G's	Passed

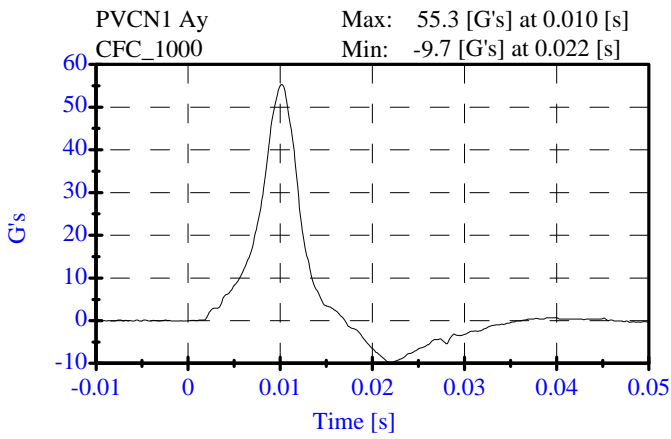
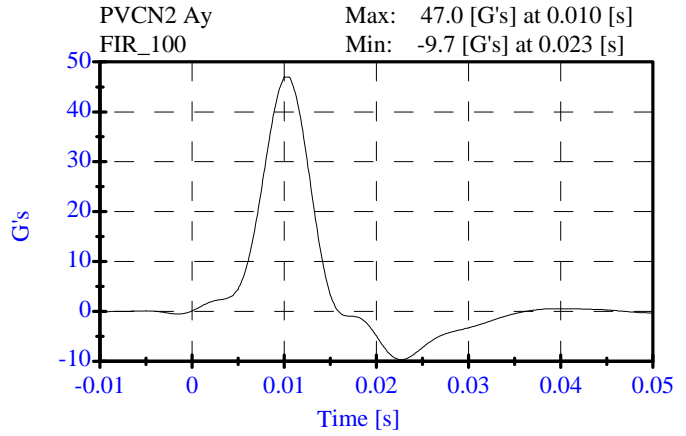
**Pelvis Impact
Post-Test**

<u>TEST PARAMETER</u>	<u>SPECIFICATION</u>	<u>TEST RESULTS</u>	<u>STATUS</u>
Lab Temperature:	18.9-25.5 C	21.7 C	Passed
Lab Humidity:	10-70 %	34.00 %	Passed
Probe Velocity:	4.27- 4.33 m/s	4.30 m/s	Passed
Pelvis Y Acceleration:	40.00-60.00 G's	47.02 G's	Passed
Time Above 20 Gs	3.0-7.0 ms	6.1 ms	Passed

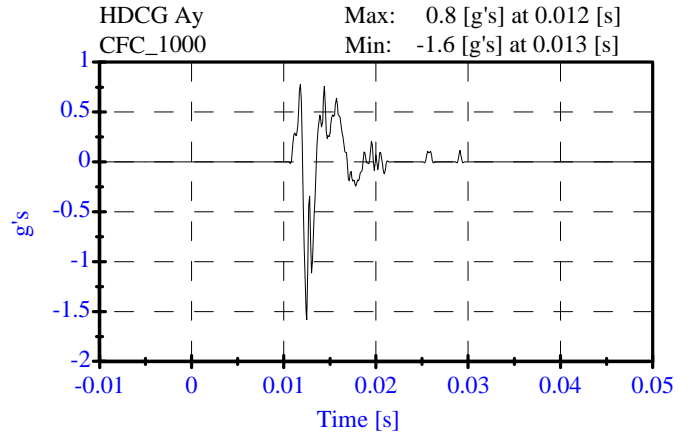
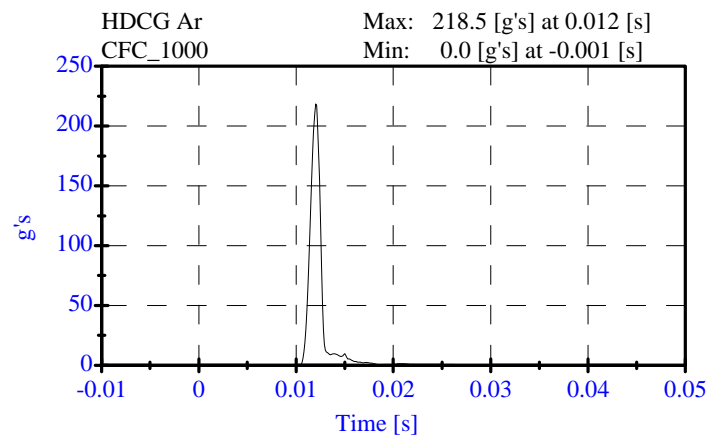
Head Drop Test

<u>TEST PARAMETER</u>	<u>SPECIFICATION</u>	<u>TEST RESULTS</u>	<u>STATUS</u>
Lab Temperature:	18.9-25.6 C	21.1 C	Passed
Lab Humidity:	10-70 %	20.00 %	Passed
Peak Resultant Accel.:	210-260 Gs	218.46 Gs	Passed
Peak Lateral Accel.:	10 Gs Max	1.58 Gs	Passed
Unimodal Criteria Above 100 Gs:	0.9-1.5 ms	1.18 ms	Passed
Curve PerCent NonModal:	< 10%	4.41 %	Passed

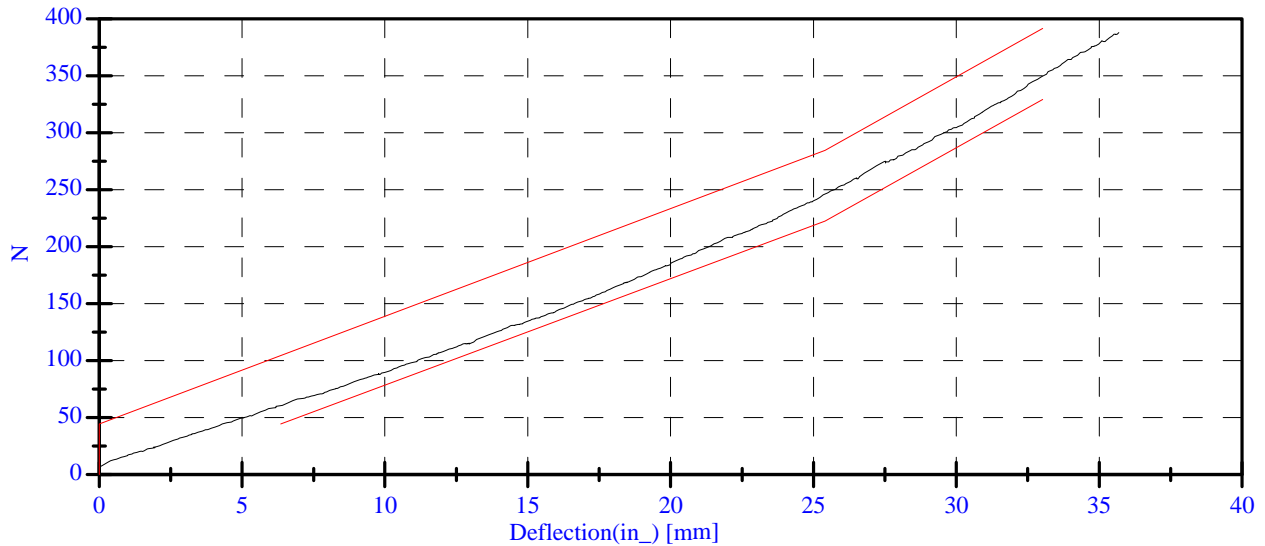
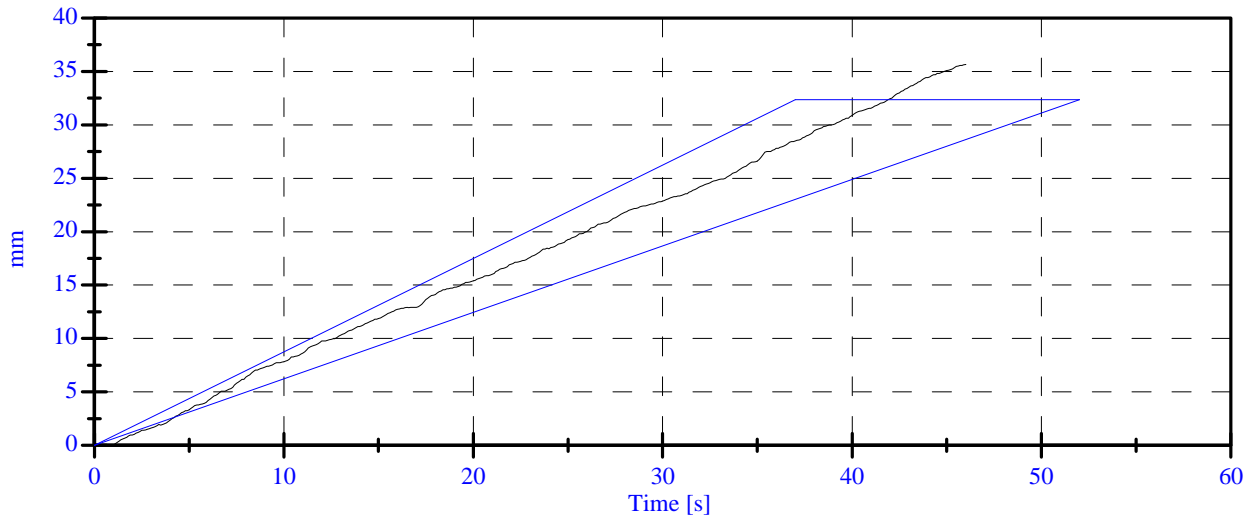
ABDOMINAL COMPRESSION TEST

<u>TEST PARAMETER</u>	<u>SPECIFICATION</u>	<u>TEST RESULTS</u>	<u>STATUS</u>
Lab Temperature:	18.9-25.5 C	21.7 C	Passed
Lab Humidity:	10-70 %	25.00 %	Passed
Force at 12.95 mm :	104.00-162.00 N	115.15 N	Passed
Force at 19.05 mm :	162.98-220.99 N	174.29 N	Passed
Force at 25.40 mm :	221.97-280.02 N	245.47 N	Passed
Force at 33.02 mm :	324.99-391.00 N	349.51 N	Passed

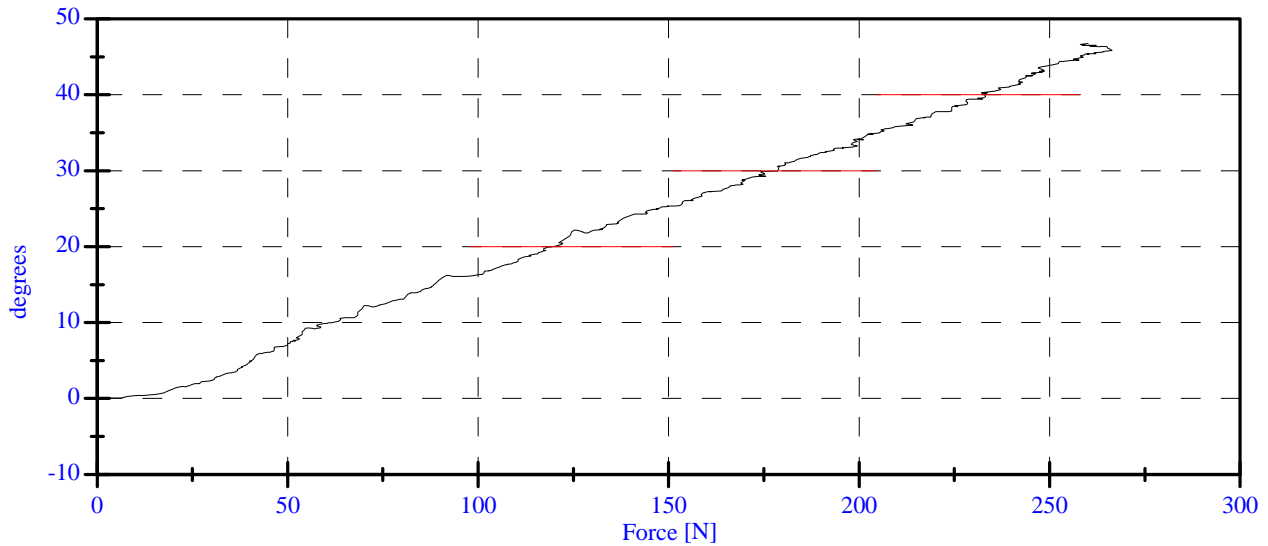
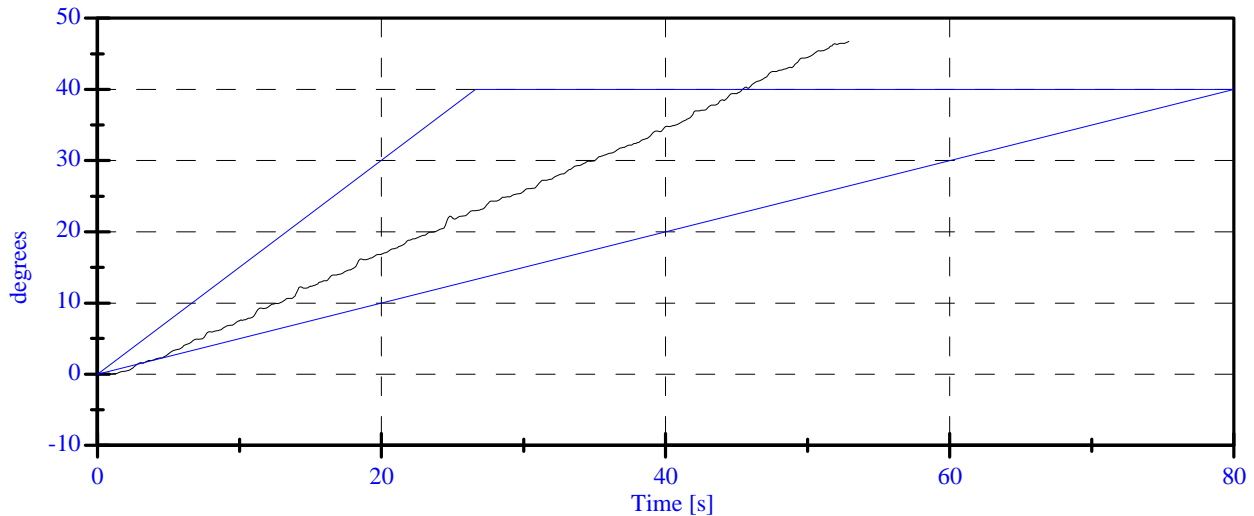
LUMBAR SPINE FLEXION TEST

<u>TEST PARAMETER</u>	<u>SPECIFICATION</u>	<u>TEST RESULTS</u>	<u>STATUS</u>
Lab Temperature:	18.9-25.5 C	21.7 C	Passed
Lab Humidity:	10-70 %	34.00 %	Passed
Force at 0 Deg:	0.00-26.69 N	1.83 N	Passed
Force at 20 Deg:	97.86-151.24 N	119.35 N	Passed
Force at 30 Deg:	151.24-204.62 N	178.63 N	Passed
Force at 40 Deg:	204.62-258.00 N	232.95 N	Passed
Return Angle	12 Deg Max	7.87 deg	Passed

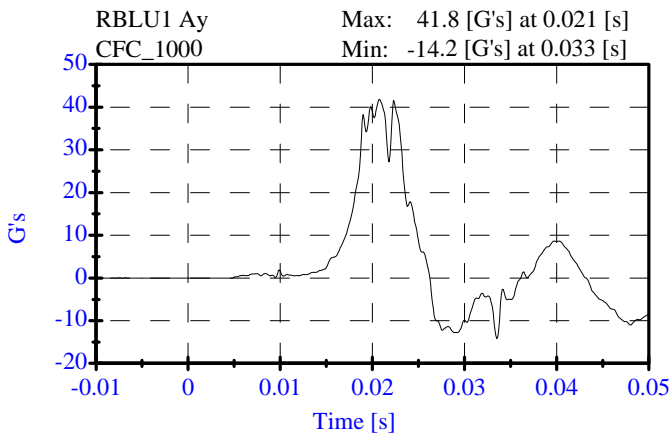
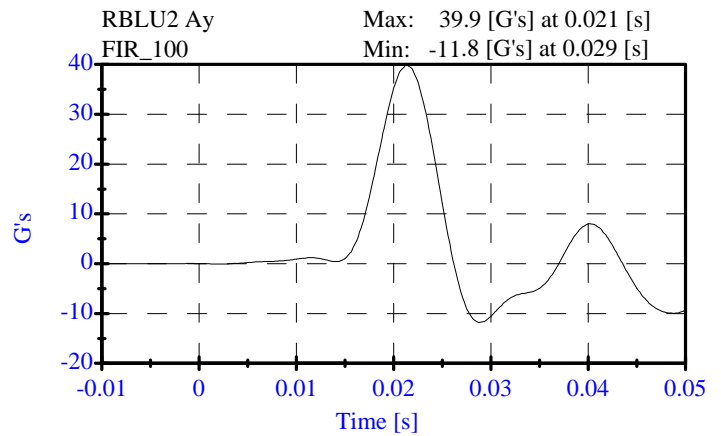
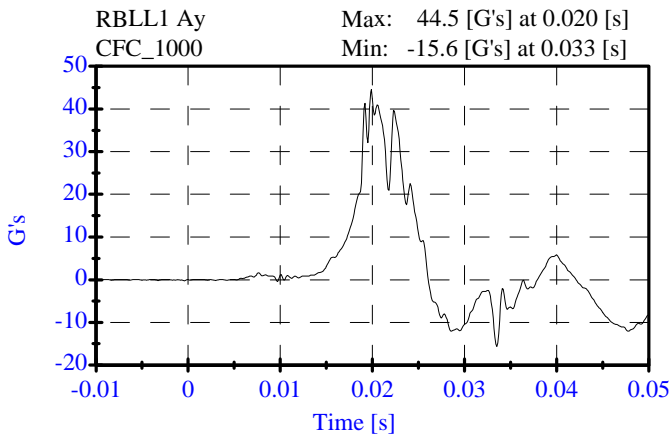
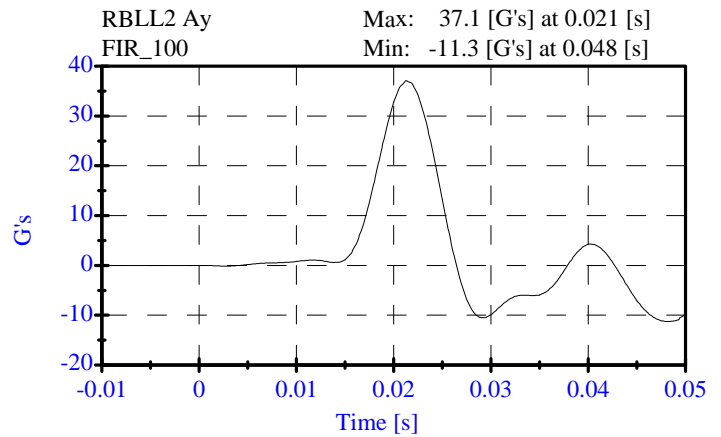
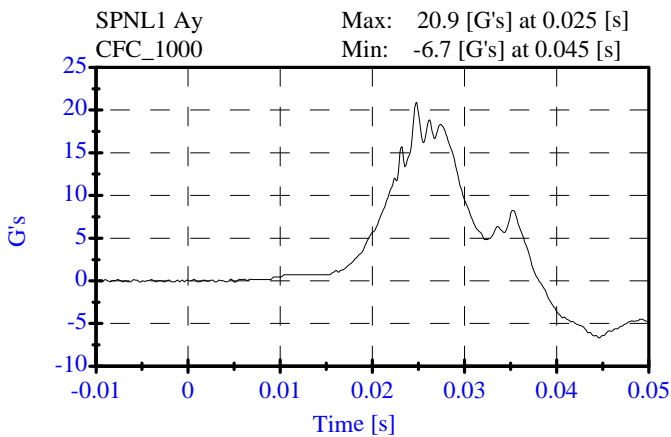
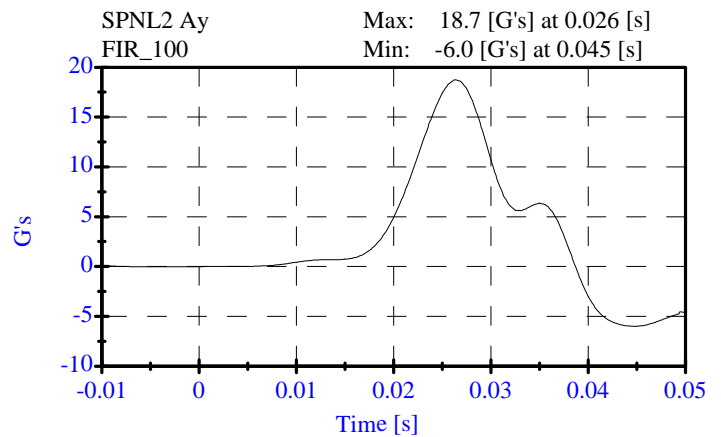
<u>TEST PARAMETER</u>	<u>SPECIFICATION</u>	<u>TEST RESULTS</u>	<u>STATUS</u>
Lab Temperature:	18.9-25.5 C	21.7 C	Passed
Lab Humidity:	10-70 %	34.00 %	Passed
Probe Velocity:	4.27- 4.33 m/s	4.32 m/s	Passed
Upper Rib Acceleration:	37.00-46.00 G's	39.86 G's	Passed
Lower Rib Acceleration:	37.00-46.00 G's	37.08 G's	Passed
Lower Spine Acceleration:	15.00-22.00 G's	18.75 G's	Passed
