REPORT NUMBER: 214-CAL-08-04

**SAFETY COMPLIANCE TESTING FOR FMVSS 214
SIDE IMPACT PROTECTION**

HYUNDAI MOTOR COMPANY
2009 HYUNDAI GENESIS
4-DOOR SEDAN

NHTSA NUMBER: C90504

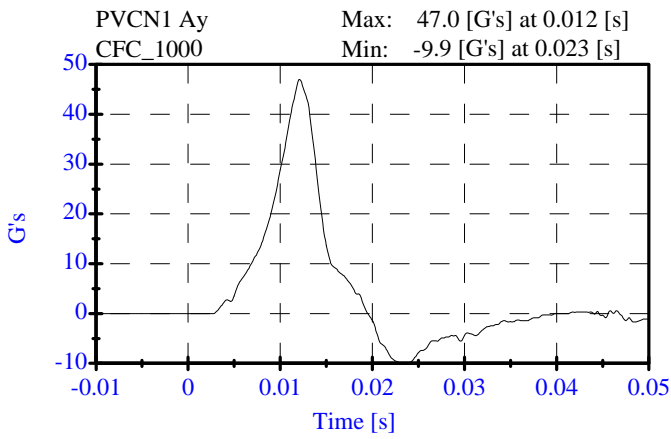
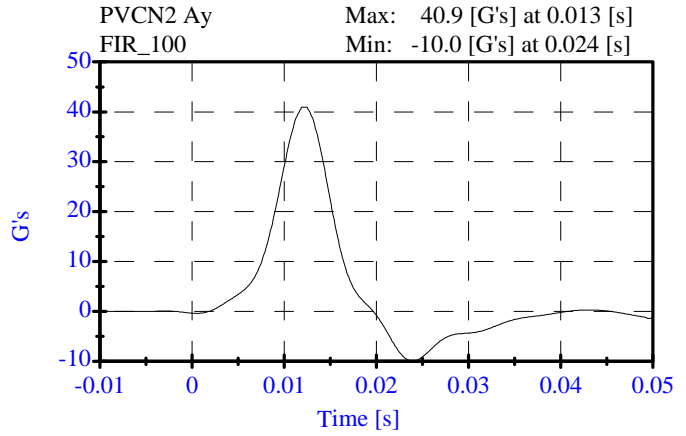
**Pelvis Impact
Post-Test**

<u>TEST PARAMETER</u>	<u>SPECIFICATION</u>	<u>TEST RESULTS</u>	<u>STATUS</u>
Lab Temperature:	18.9-25.5 C	21.7 C	Passed
Lab Humidity:	10-70 %	34.00 %	Passed
Probe Velocity:	4.27- 4.33 m/s	4.29 m/s	Passed
Pelvis Y Acceleration:	40.00-60.00 G's	40.93 G's	Passed
Time Above 20 Gs	3.0-7.0 ms	6.3 ms	Passed

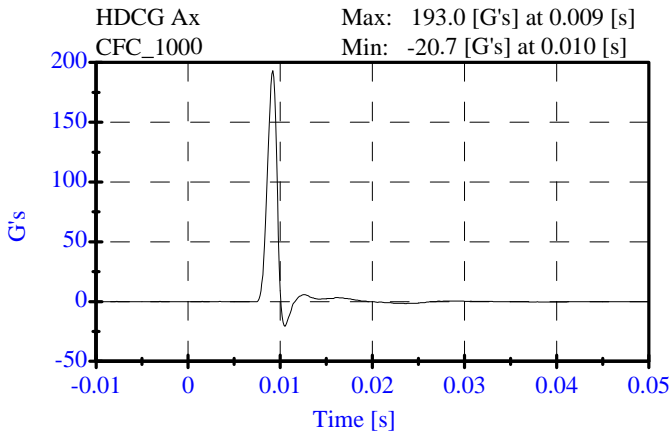
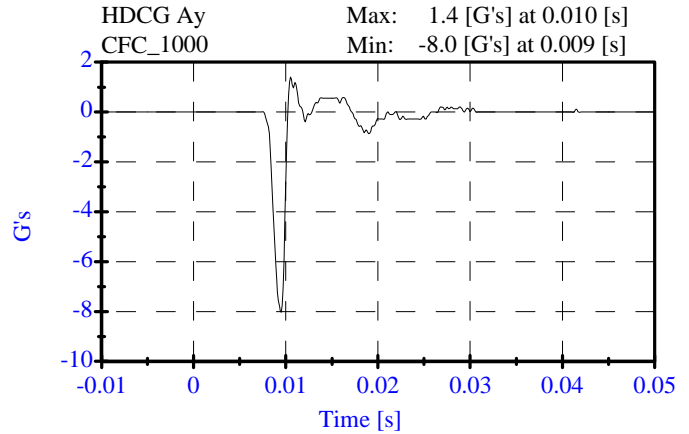
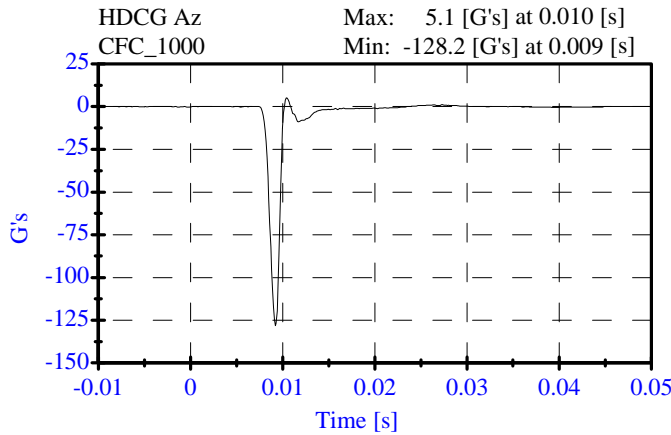
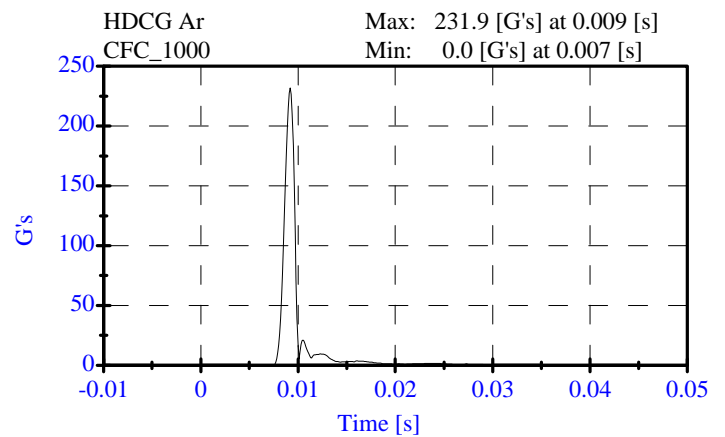
Head Drop Test

<u>TEST PARAMETER</u>	<u>SPECIFICATION</u>	<u>TEST RESULTS</u>	<u>STATUS</u>
Lab Temperature:	18.9-25.6 C	21.1 C	Passed
Lab Humidity:	10-70 %	20.00 %	Passed
Peak Resultant Accel.:	210-260 Gs	231.87 Gs	Passed
Peak Lateral Accel.:	10 Gs Max	8.02 Gs	Passed
Unimodal Criteria Above 100 Gs:	0.9-1.5 ms	1.23 ms	Passed
Curve PerCent NonModal:	< 10%	9.18 %	Passed

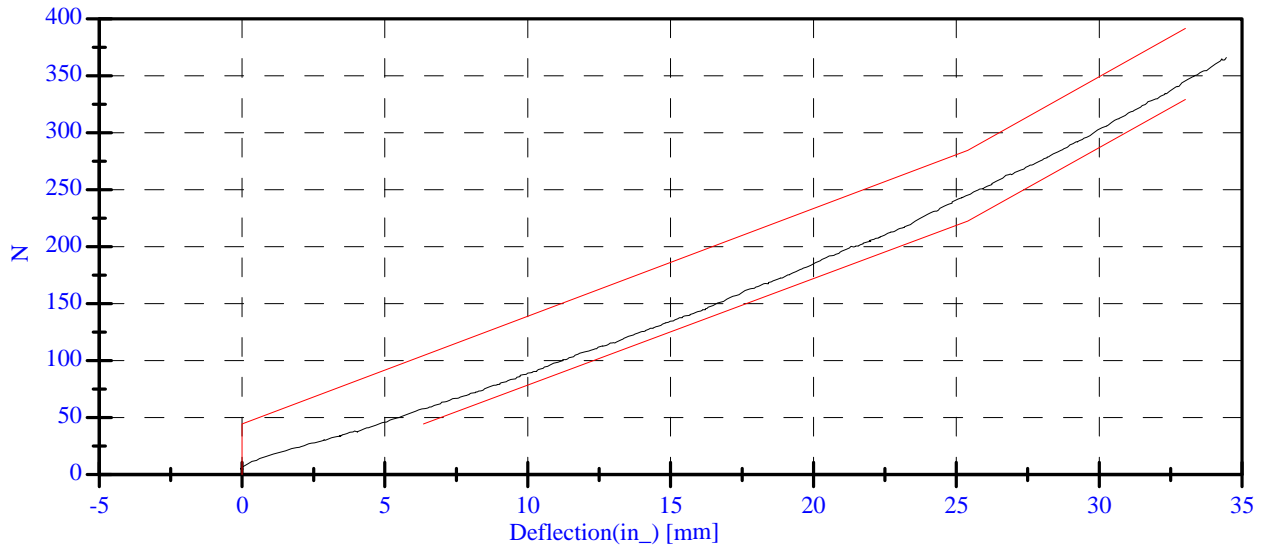
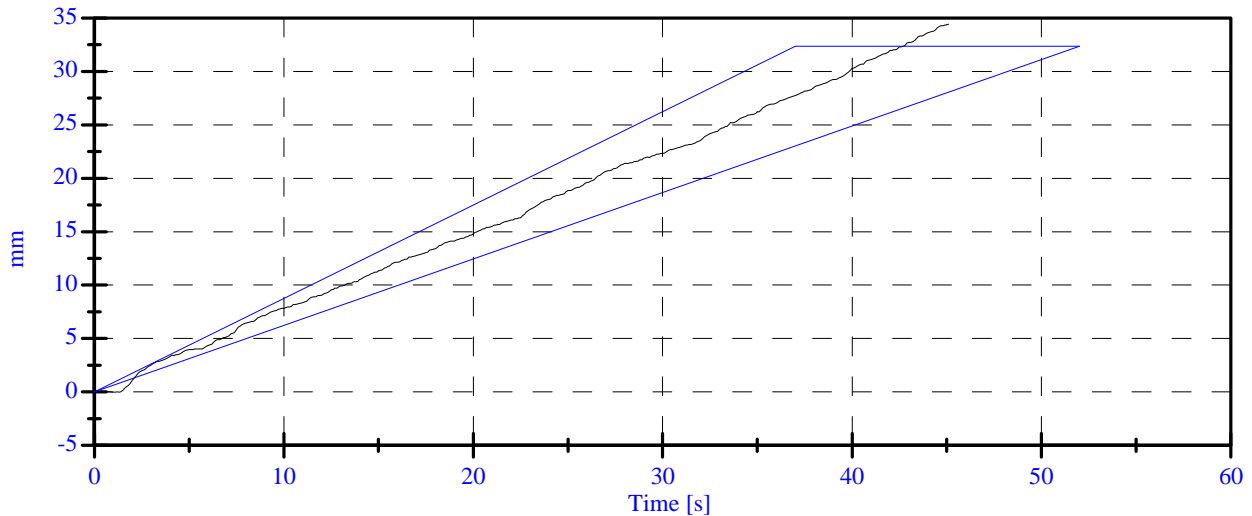
ABDOMINAL COMPRESSION TEST

<u>TEST PARAMETER</u>	<u>SPECIFICATION</u>	<u>TEST RESULTS</u>	<u>STATUS</u>
Lab Temperature:	18.9-25.5 C	21.7 C	Passed
Lab Humidity:	10-70 %	25.00 %	Passed
Force at 12.95 mm :	104.00-162.00 N	115.52 N	Passed
Force at 19.05 mm :	162.98-220.99 N	173.92 N	Passed
Force at 25.40 mm :	221.97-280.02 N	244.74 N	Passed
Force at 33.02 mm :	324.99-391.00 N	346.95 N	Passed

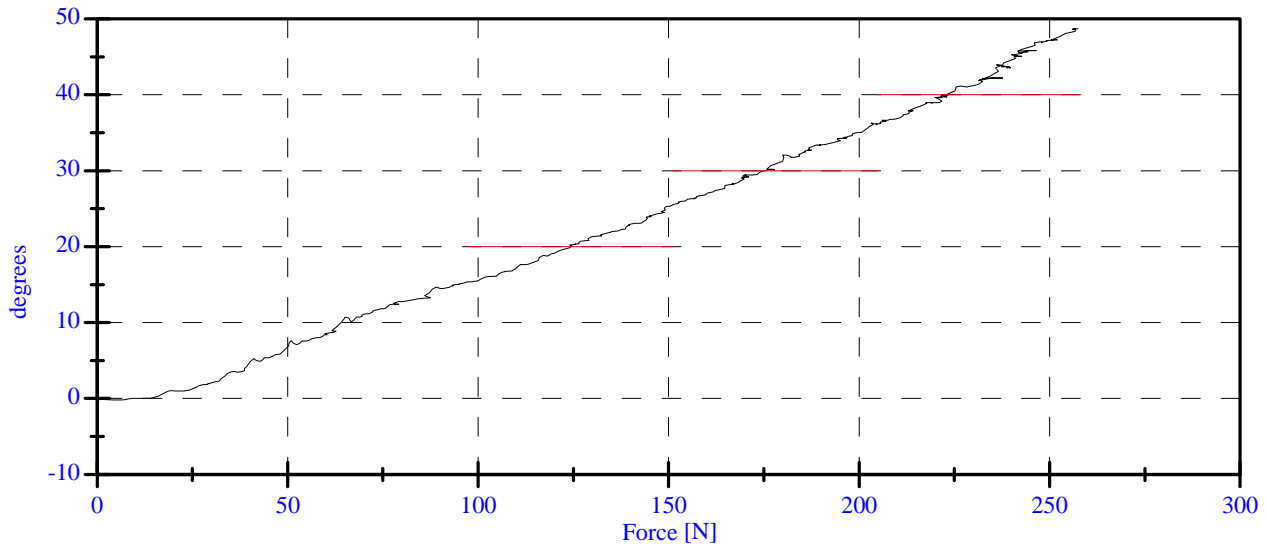
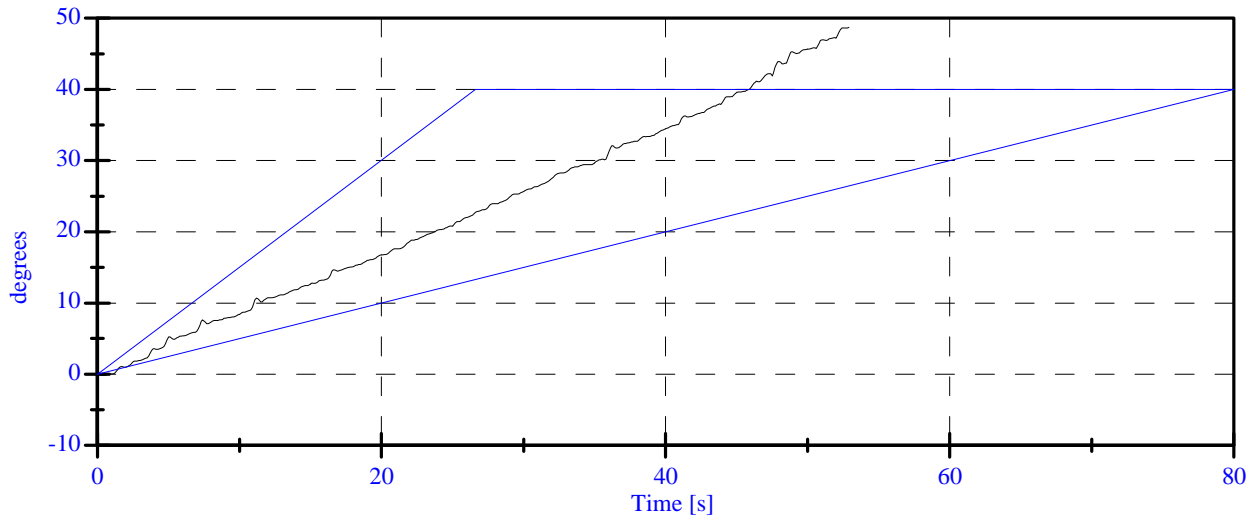
LUMBAR SPINE FLEXION TEST

<u>TEST PARAMETER</u>	<u>SPECIFICATION</u>	<u>TEST RESULTS</u>	<u>STATUS</u>
Lab Temperature:	18.9-25.5 C	21.7 C	Passed
Lab Humidity:	10-70 %	34.00 %	Passed
Force at 0 Deg:	0.00-26.69 N	9.14 N	Passed
Force at 20 Deg:	97.86-151.24 N	124.31 N	Passed
Force at 30 Deg:	151.24-204.62 N	175.23 N	Passed
Force at 40 Deg:	204.62-258.00 N	222.76 N	Passed
Return Angle	12 Deg Max	9.07 deg	Passed
