REPORT NUMBER 138-STF-09-003

# SAFETY COMPLIANCE TESTING FOR FMVSS NO. 138 TIRE PRESSURE MONITORING SYSTEMS

HYUNDAI MOTOR COMPANY  
2009 HYUNDAI GENESIS  
FOUR-DOOR PASSENGER CAR  
NHTSA NO. C90501

U.S. DOT SAN ANGELO TEST FACILITY  
131 COMANCHE TRAIL, BUILDING 3527  
GOODFELLOW AFB, TEXAS 76908

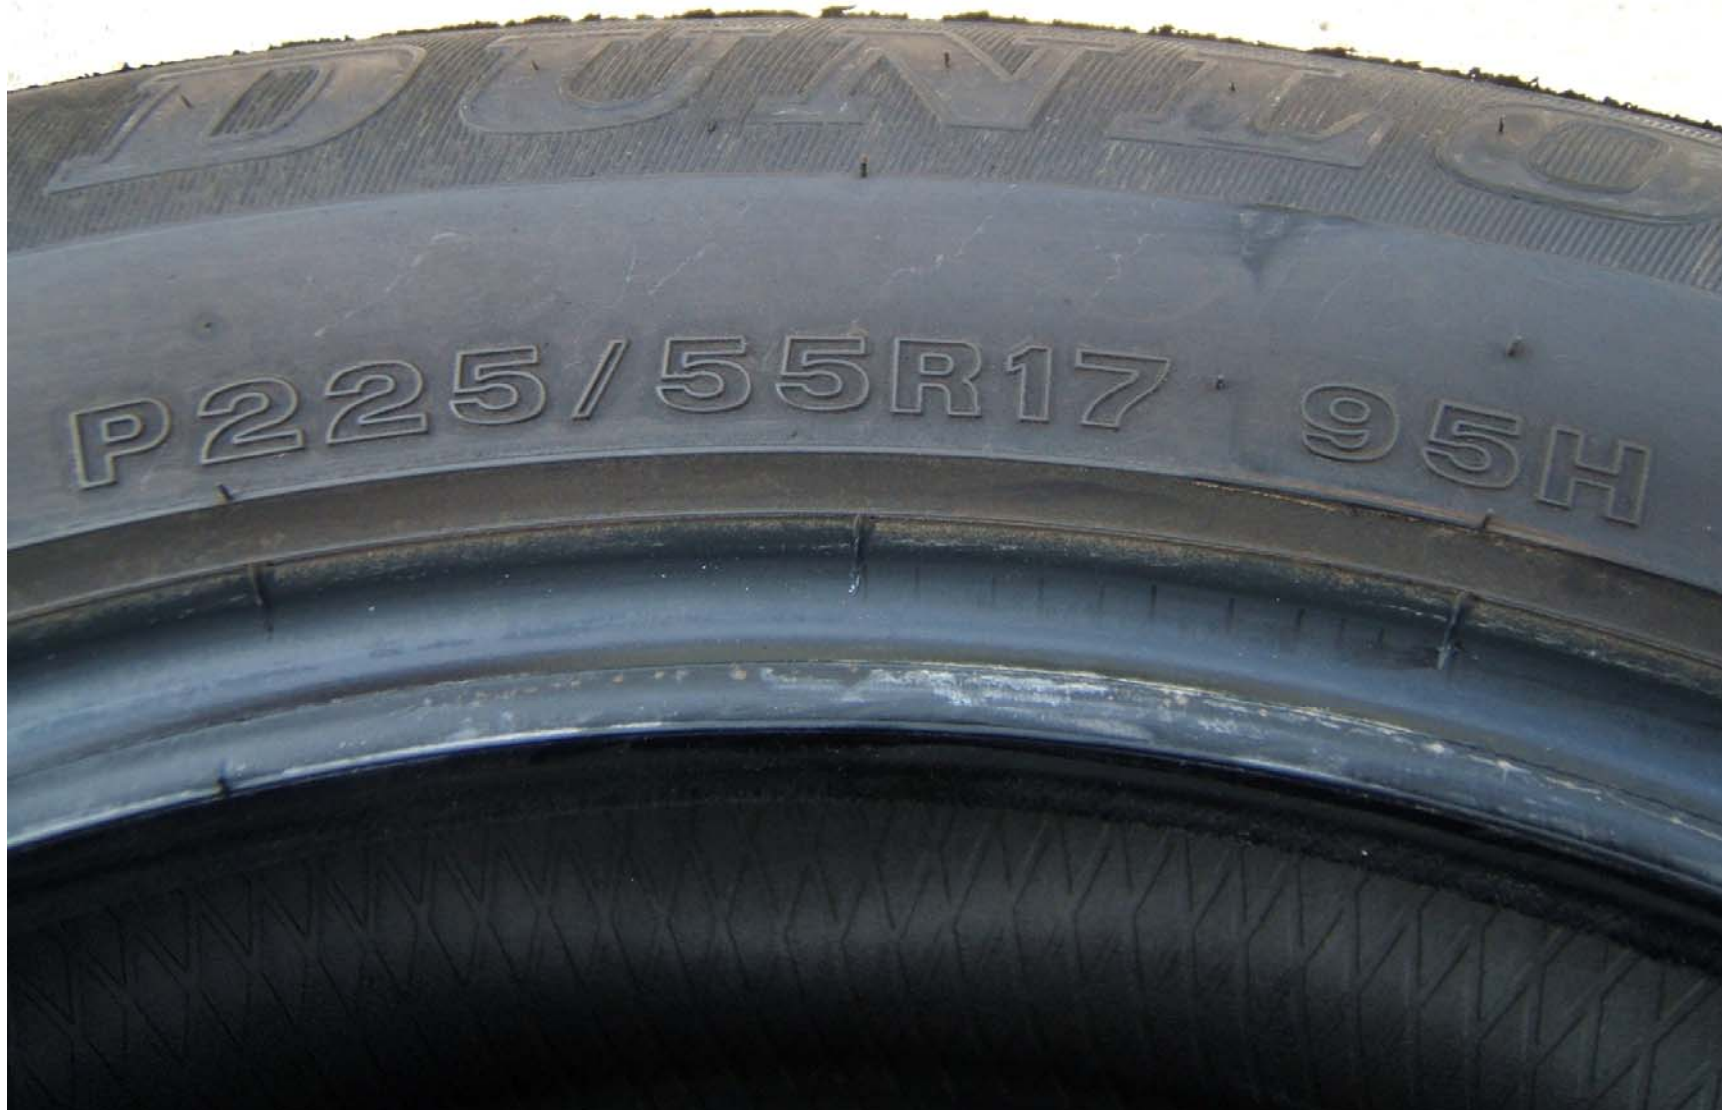
FIGURE 5.6  
TIRE SHOWING SIZE AND LOAD INDEX / SPEED RATING

Tire Size and Load Index / Speed Rating: P225/55R17 95H

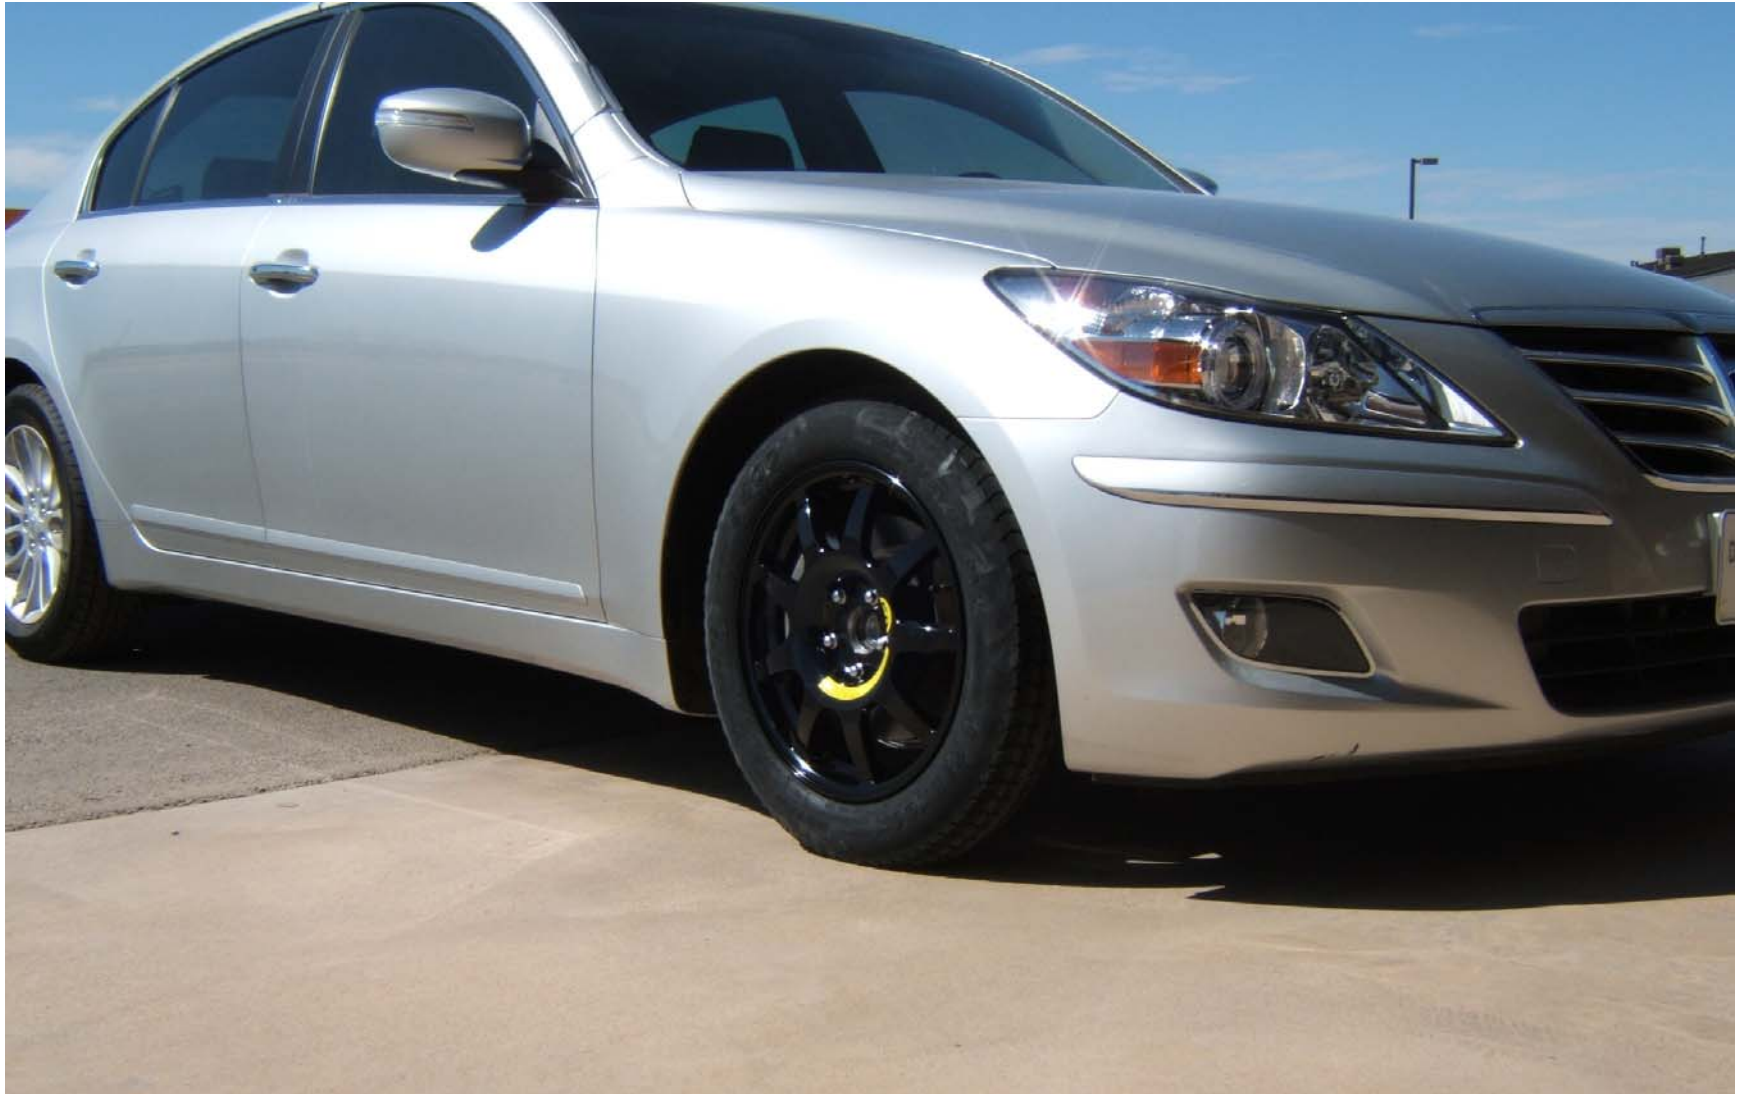
FIGURE 5.20  
SPARE INSTALLED ON RIGHT FRONT  
FOR MALFUNCTION DETECTION TEST

**TPMS MALFUNCTION PERFORMANCE TEST RESULTS (PASS/FAIL)**                        **PASS**  
Spare without TPMS sensor was applied to right front at LLVW.

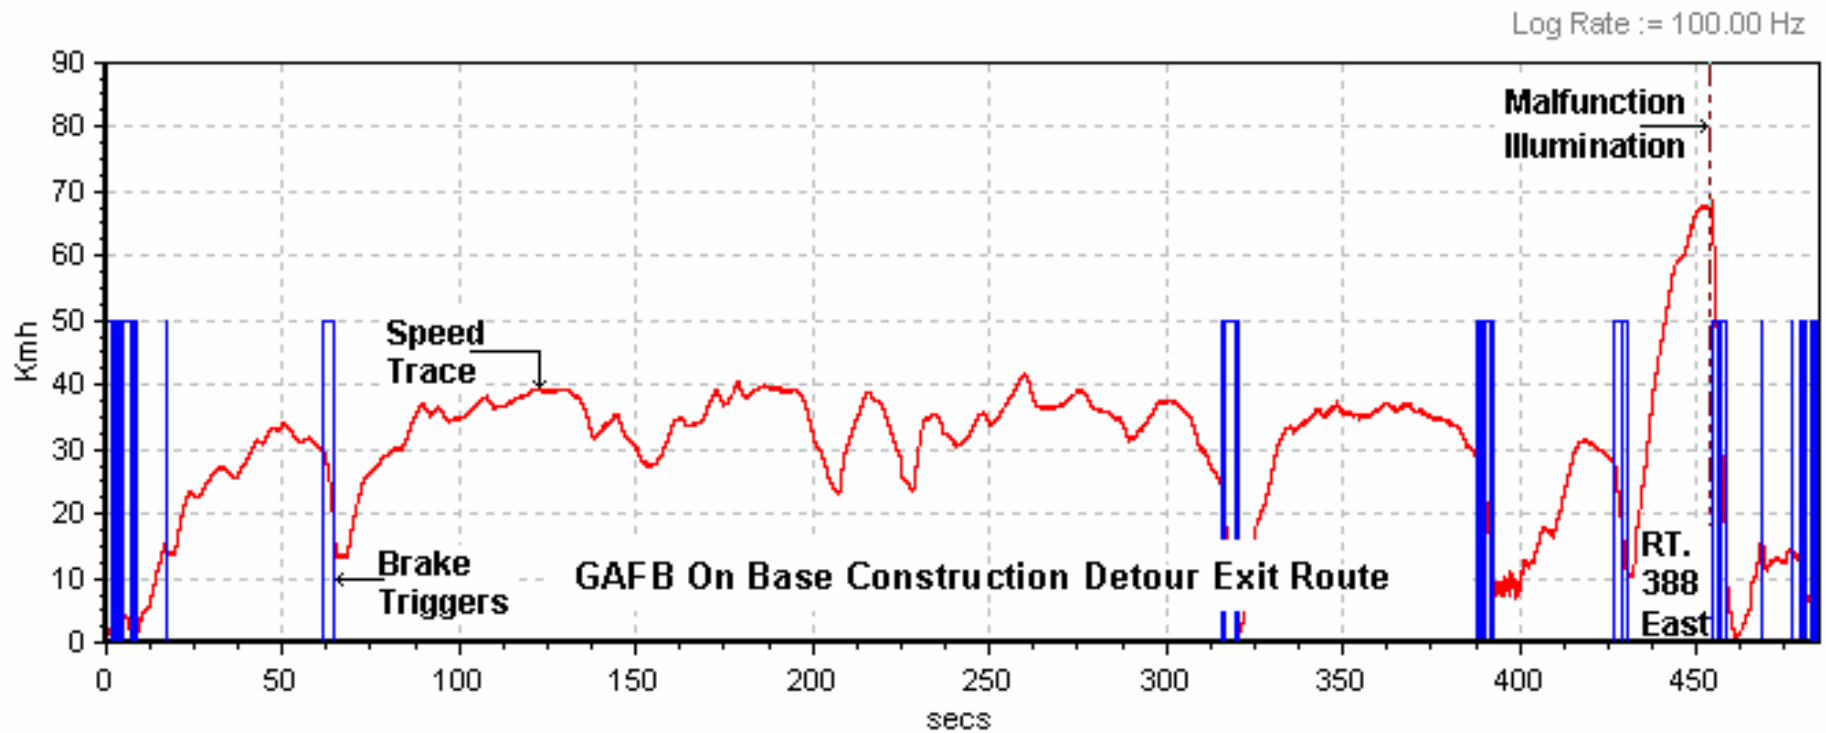
2009 Hyundai Genesis (C90501) RF Spare Tire Malfunction Illumination LLVW

Scenario G Malfunction Illumination: Spare Tire without TPMS Sensor Applied to Right Front at LLVW.  
Test Date: 2/23/09  
Data File Time: 08:05 minutes  
Cumulative Driving Time: 0:14 minutes  
Start Point: GAFB North Gate

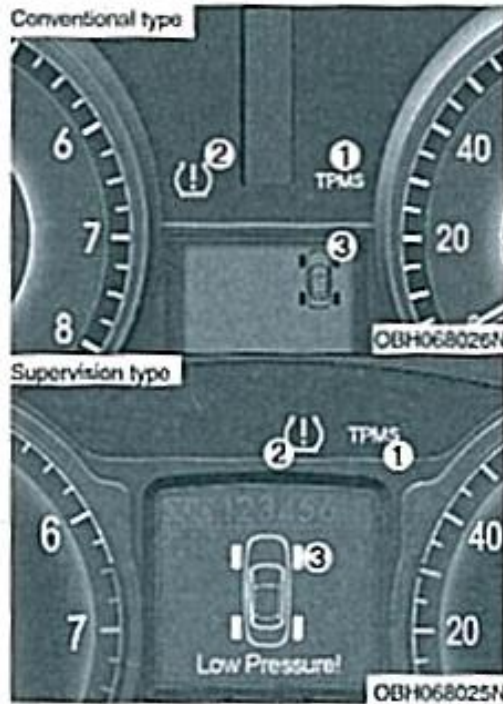
- (1) TPMS Malfunction Indicator
- (2) Low Tire Pressure Telltale
- (3) Low Tire Pressure Position indicator (if equipped)
