REPORT NUMBER: 301-CAL-09-03

**SAFETY COMPLIANCE TESTING FOR FMVSS 301  
FUEL SYSTEM INTEGRITY – REAR IMPACT**

**FORD MOTOR COMPANY  
2009 FORD F150  
2-DOOR PICKUP**

NHTSA NUMBER: C90206

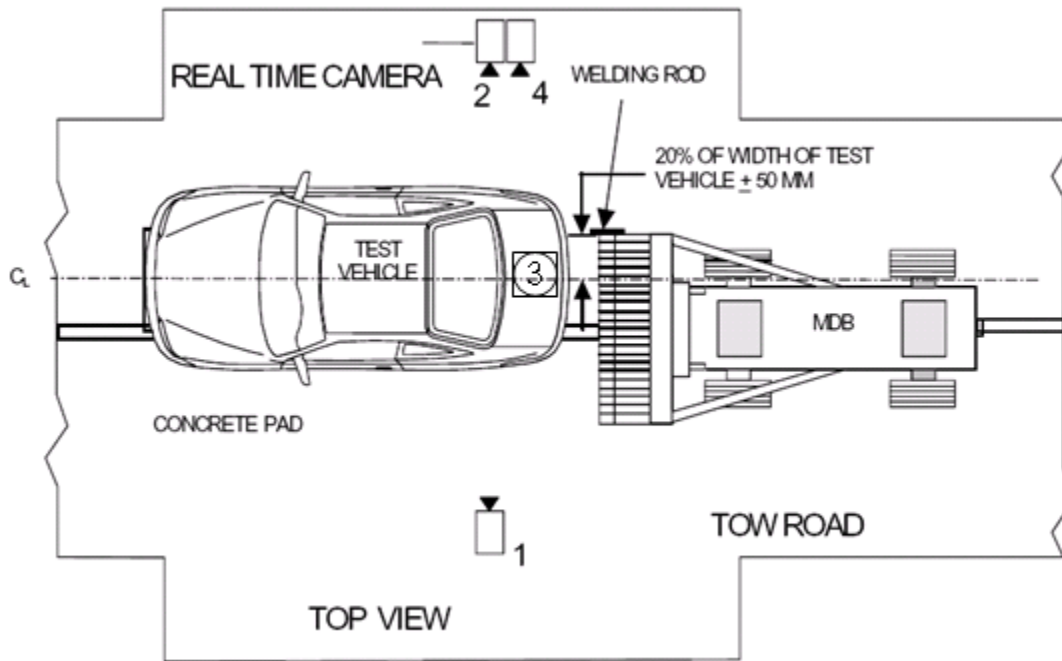
Camera No.	View	Coordinates (millimeters)			Angle (deg.)	Lens (mm)	Film Speed (fps)
		X*	Y*	Z*			
1	Left Side View	7117	1805	1094	3.6	25	1000
2	Real-Time Camera	-	-	-	-	-	30
3	Overhead View	0	0	4880	90	12.5	1000
4	Right Side View	7764	1423	954	1.1	25	1000

\* Reference (from point of impact); all measurements accurate to within  $\pm 6$  mm.

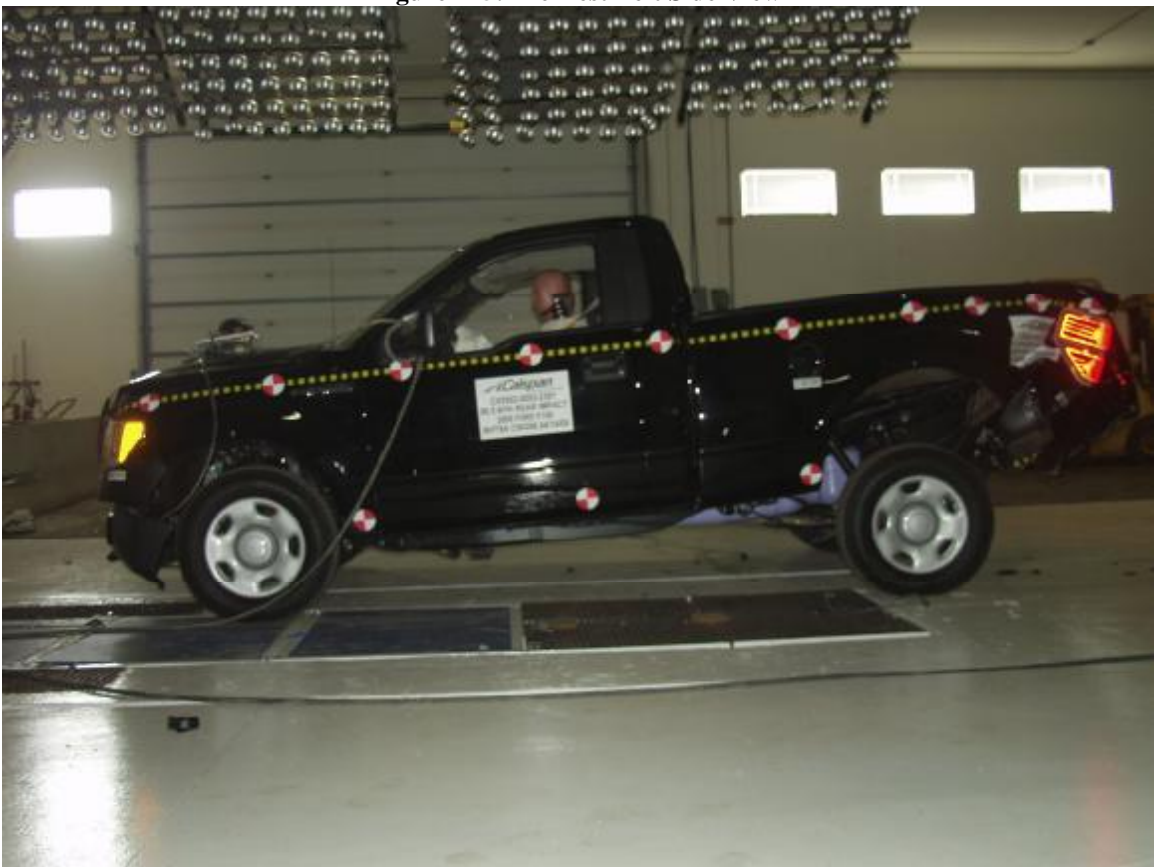
**Figure A-6: Post-Test Left Side View**

<b>Left Side</b>	<b>Centerline</b>	<b>Right Side</b>
Pre-Test	5353	5405	5352
Post-Test	4829	4870	5060
Crush	524	535	292

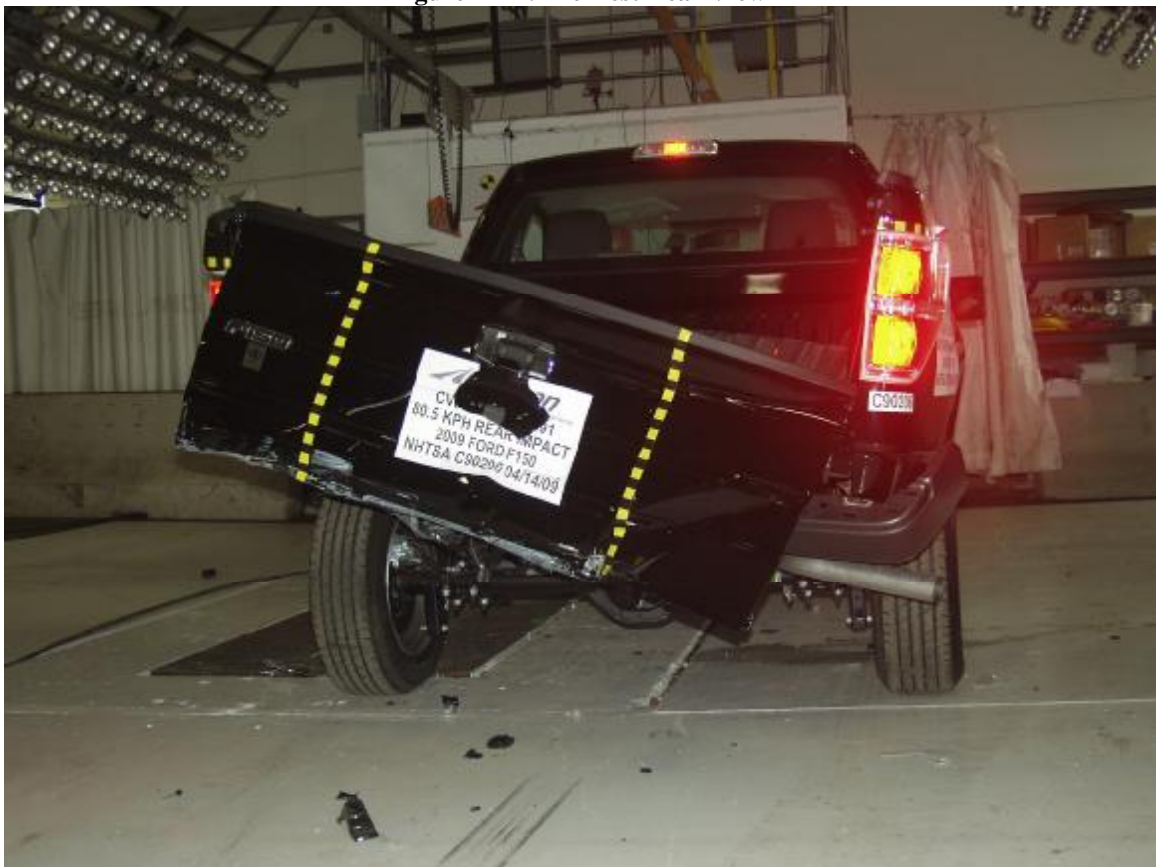
**Figure A-18: Post-Test Rear View**

There was no fuel system fluid spillage following the impact or during any portion of the static rollover test. The average vehicle longitudinal crush was 535 millimeters. The vehicle appeared to comply with all the requirements of FMVSS No. 301 "Fuel System Integrity."

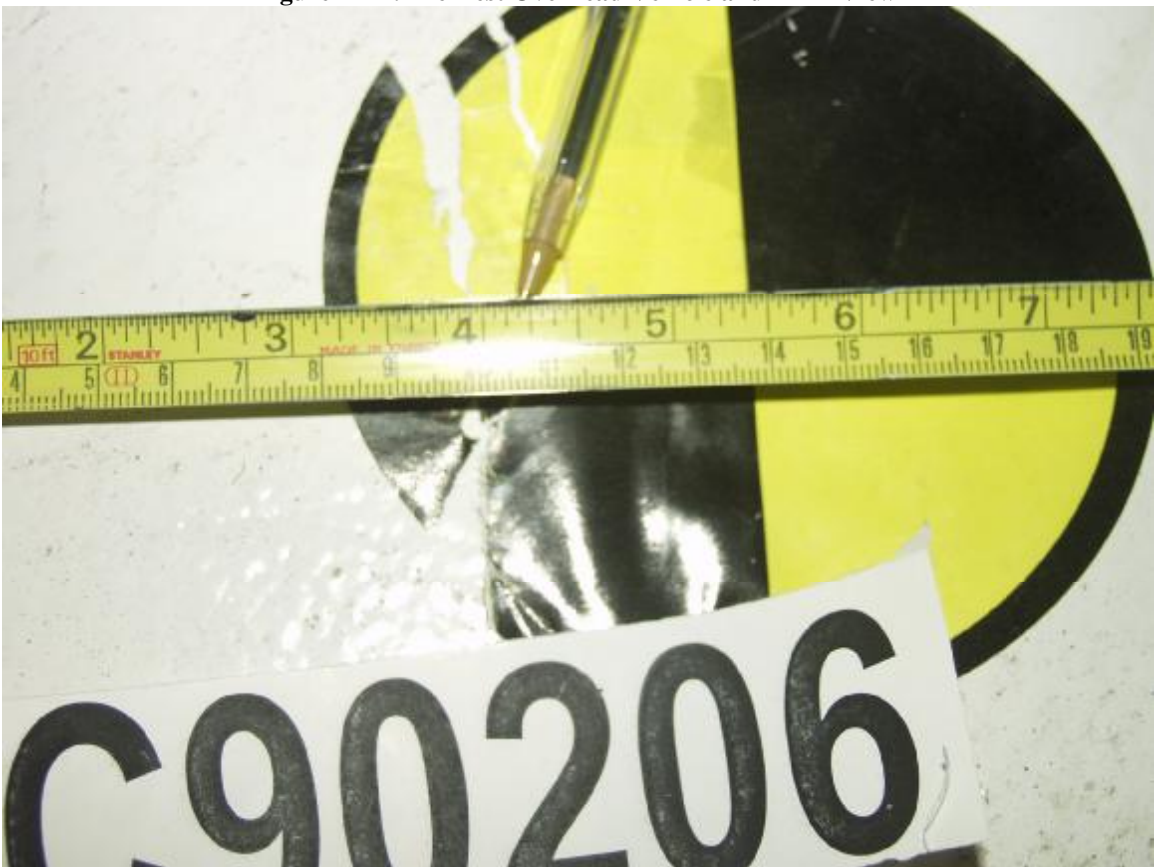
Figure A-28: Post-Test Impact Target View

-12    Vertical distance from target center (+ is above) Tolerance:  $\pm 40$  mm

-38    Horizontal distance from target center (+ is right) Tolerance:  $\pm 50$  mm

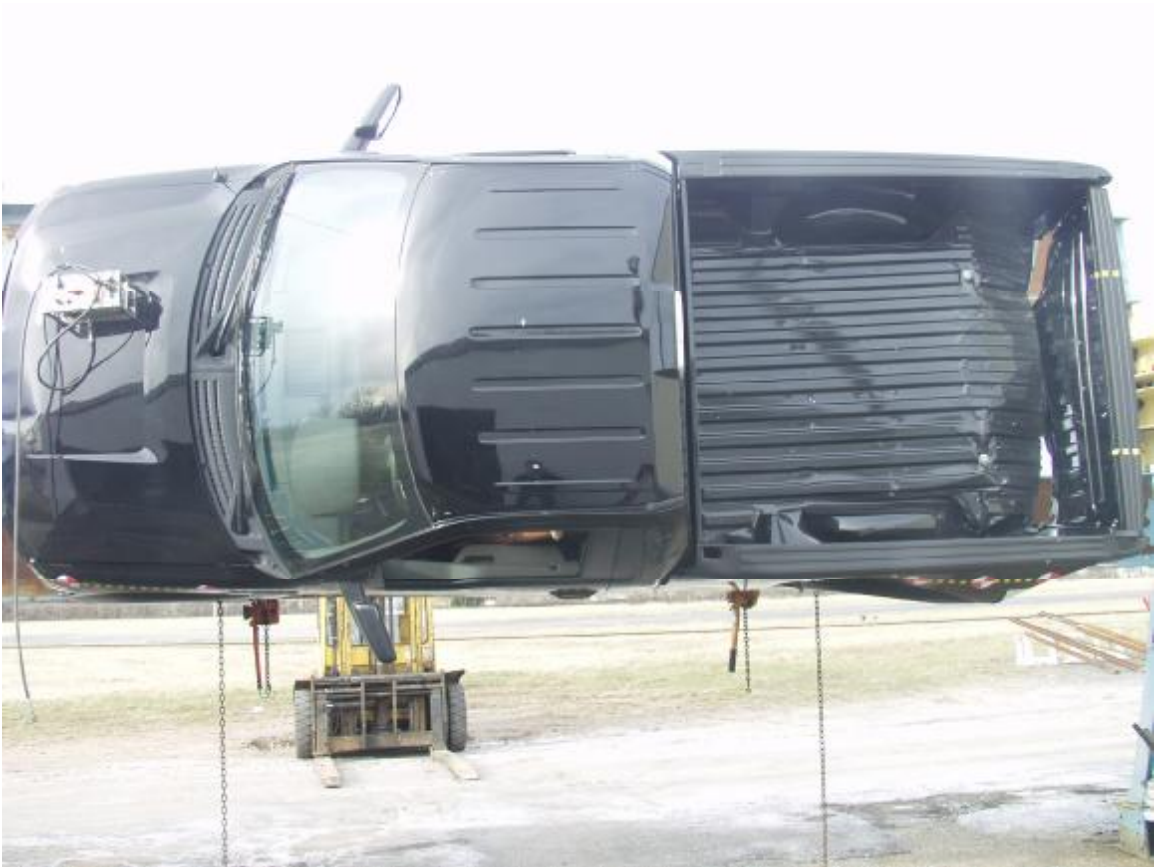
**Figure A-38: Rollover 90° View**

Rollover Stage	First 5 minutes from onset of rotation (g)	6th min. (g)	7th min. (g)	8th min. (if required) (g)
0° - 90°	0	0	0	N/A
90° - 180°	0	0	0	N/A
180°-270°	0	0	0	N/A
270°-360°	0	0	0	N/A
