**REPORT NUMBER TR-P29009-02-NC**

**SAFETY COMPLIANCE TESTING FOR FMVSS 124  
ACCELERATOR CONTROL SYSTEMS**

**CHRYSLER LLC  
2009 DODGE JOURNEY  
5-DOOR MPV**

**NHTSA NUMBER: C90302**

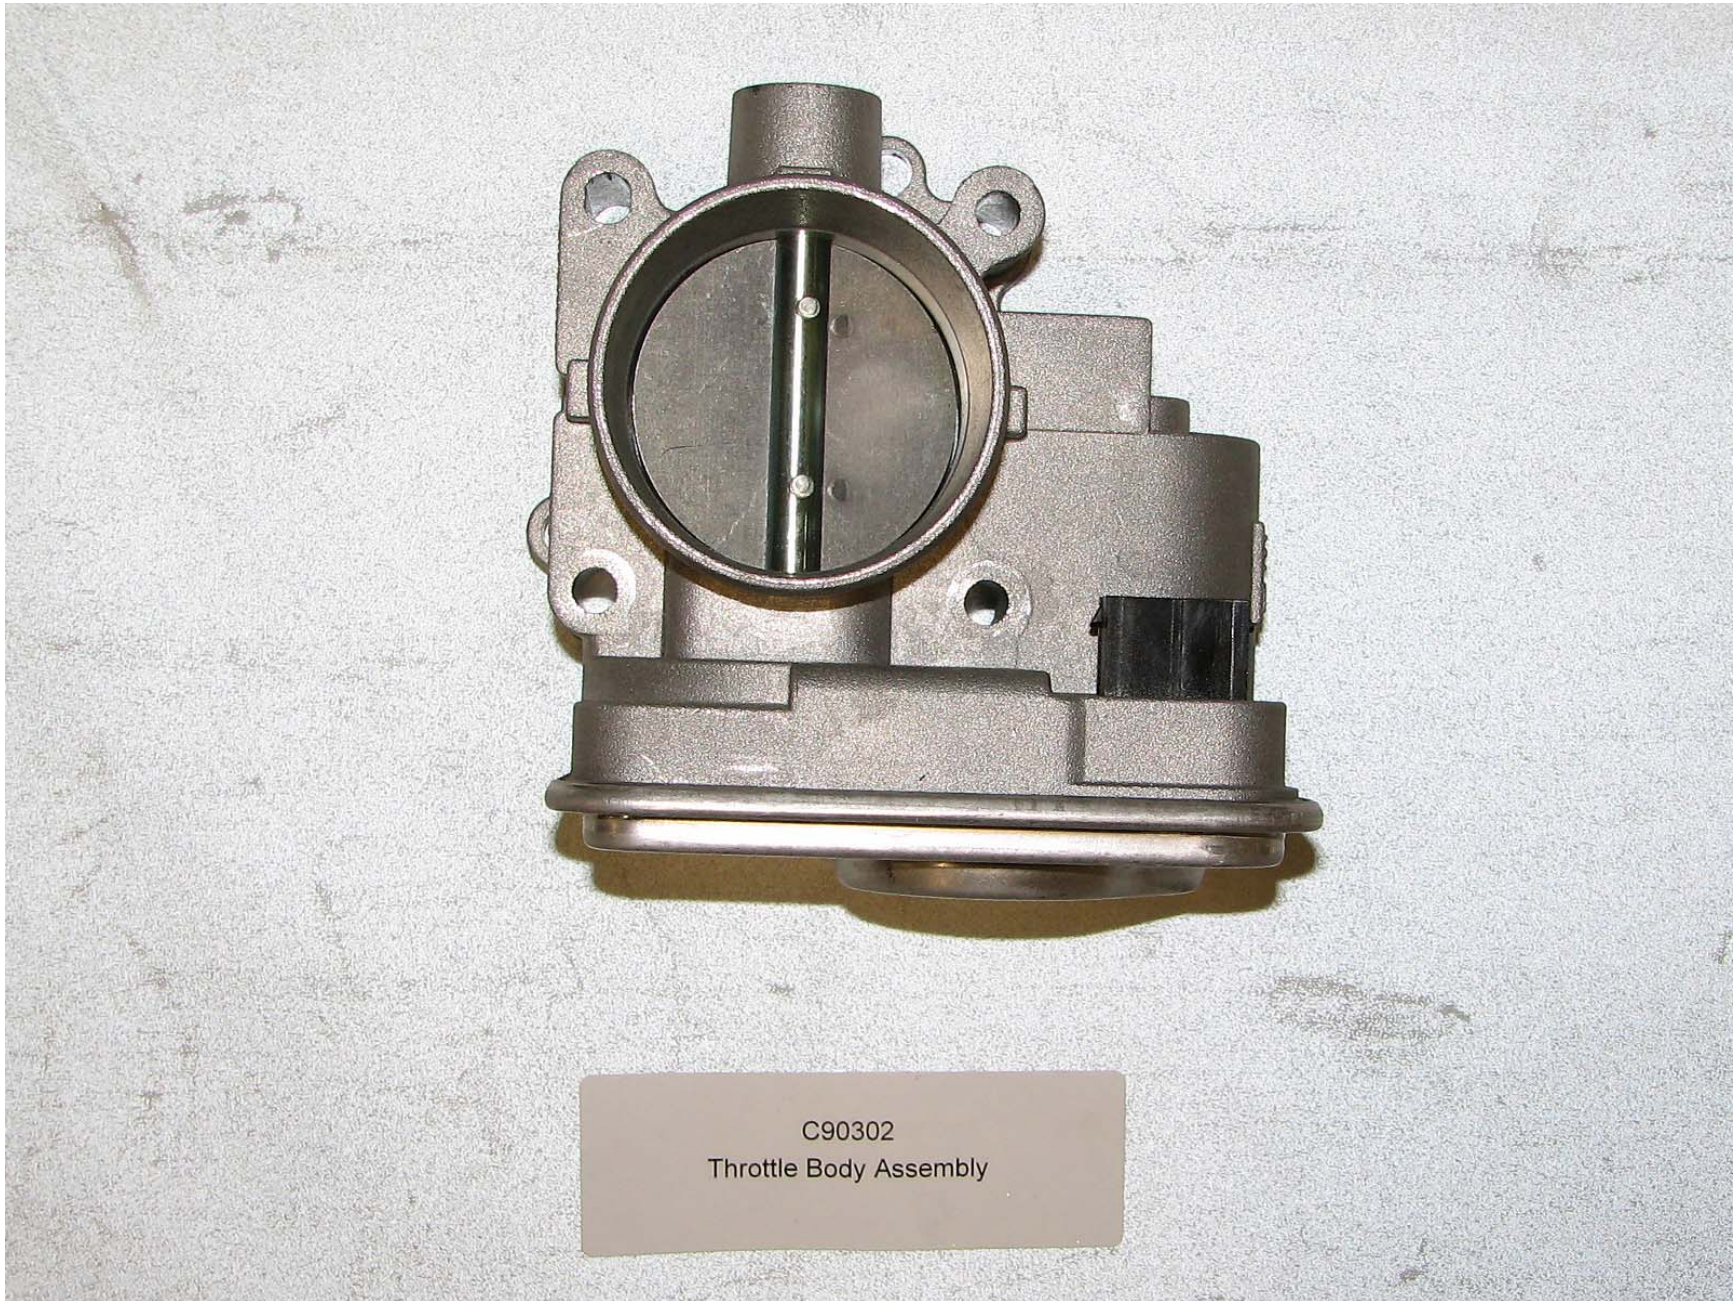
Figure A-6: Throttle Body Assembly

C90302  
Throttle Body Assembly

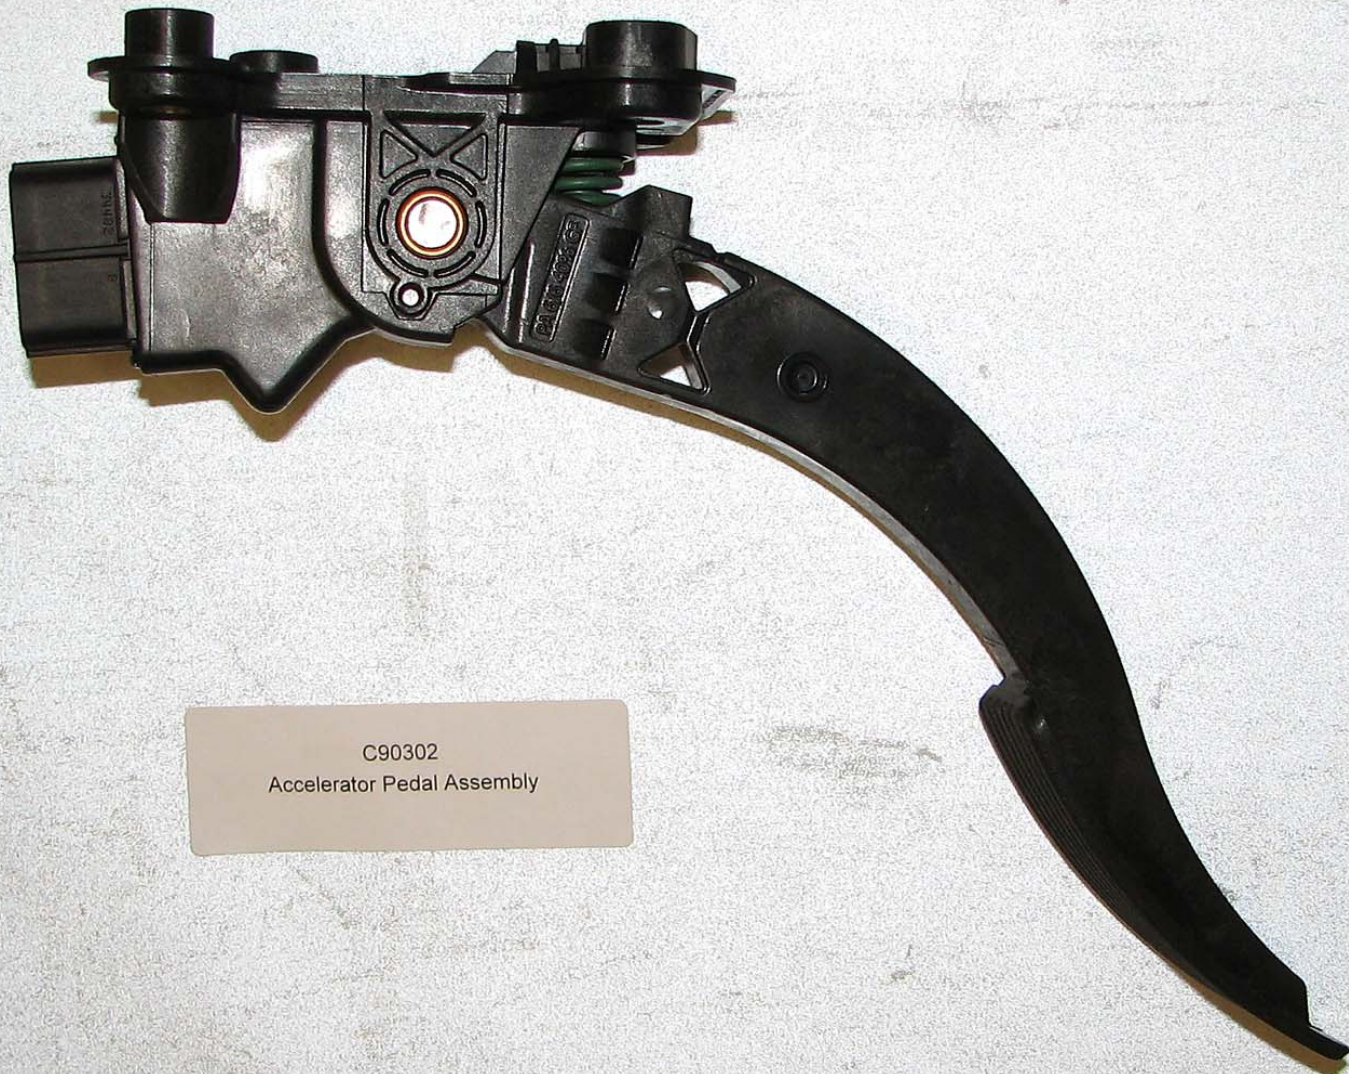
Figure A-8: Accelerator Pedal Assembly

C90302  
Accelerator Pedal Assembly

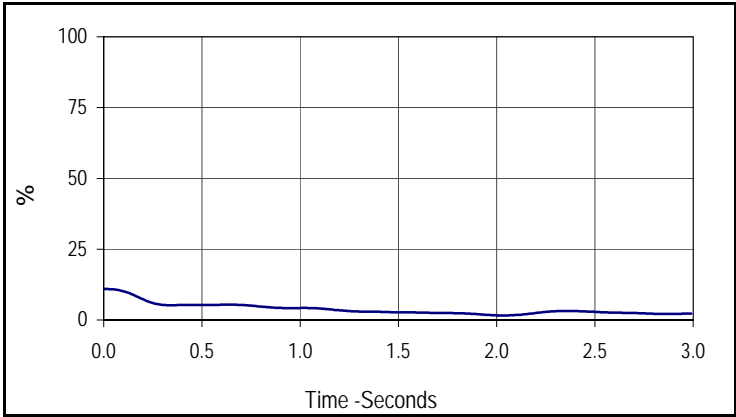
Curve Description			
Throttle Position (Normal Operation)			
CURNO	Type	Filter Freq	Units
001	FIL	2	%
Max	Time	Return Time (msec)	
10.9	0.0	*

Throttle % reading at baseline (idle) is 1%  
 \* Throttle returned to baseline position at approximately 6 seconds

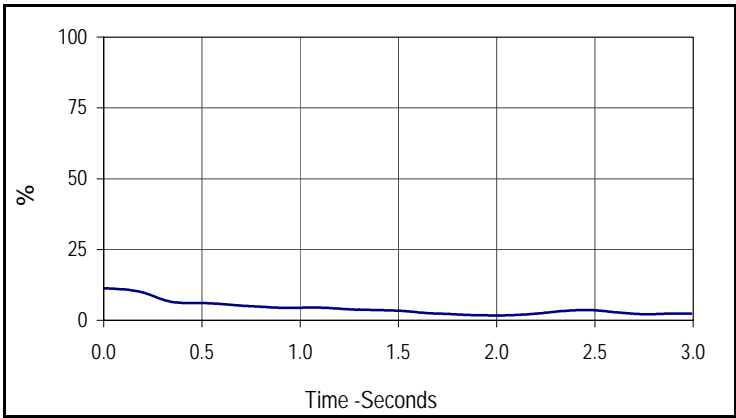
Curve Description			
Throttle Position (Normal Operation)			
CURNO	Type	Filter Freq	Units
002	FIL	2	%
Max	Time	Return Time (msec)	
11.3	0.0	*

Throttle % reading at baseline (idle) is 1%  
 \* Throttle returned to baseline position at approximately 6 seconds

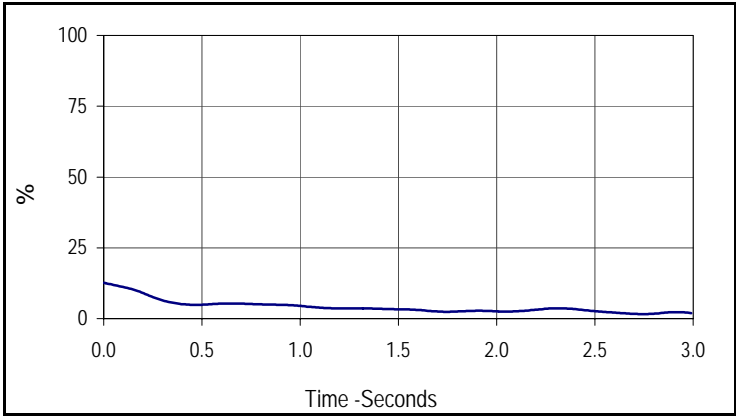
Curve Description			
Throttle Position (Normal Operation)			
CURNO	Type	Filter Freq	Units
003	FIL	2	%
Max	Time	Return Time (msec)	
12.7	0.0	*

Throttle % reading at baseline (idle) is 1%  
 \* Throttle returned to baseline position at approximately 6 seconds

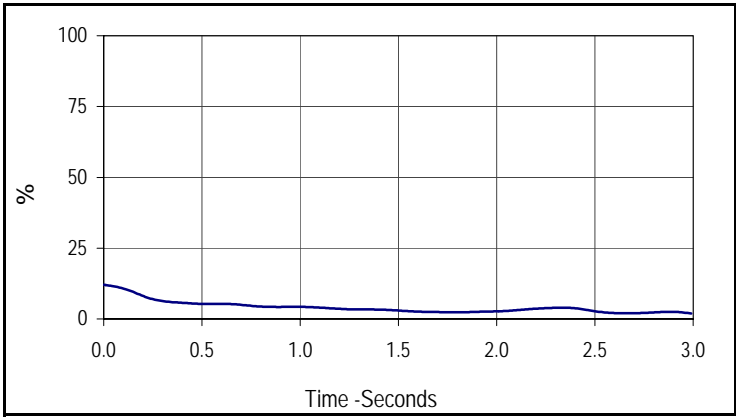
Curve Description			
Throttle Position (Normal Operation)			
CURNO	Type	Filter Freq	Units
004	FIL	2	%
Max	Time	Return Time (msec)	
12.0	0.0	*

Throttle % reading at baseline (idle) is 1%  
 \* Throttle returned to baseline position at approximately 6 seconds

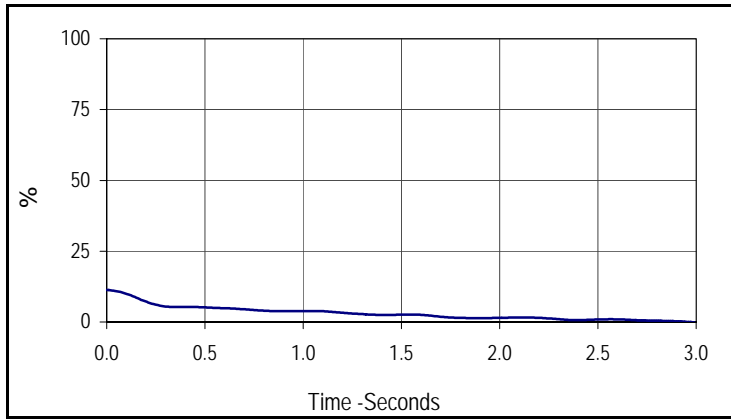
Curve Description			
Throttle Position (APS Disconnect)			
CURNO	Type	Filter Freq	Units
005	FIL	2	%
Max	Time	Return Time (msec)	
11.3	0.0	1780.0

Throttle % reading at baseline (idle) is 1%  
 All return times were calculated at a return to 1%

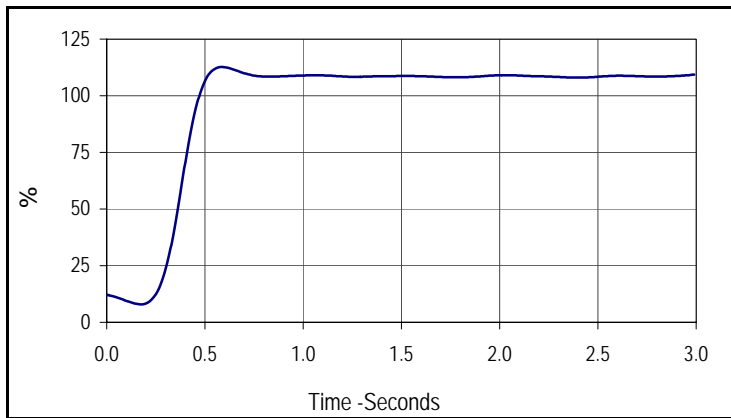
Curve Description			
Throttle Position (TPS/ Throttle Plate Motor Disconnect)			
CURNO	Type	Filter Freq	Units
006	FIL	2	%
Max	Time	Return Time (msec)	
112.7	0.6	*

Throttle % reading at baseline (idle) is 1%  
 \* Induced wire fault caused loss of sensor reading

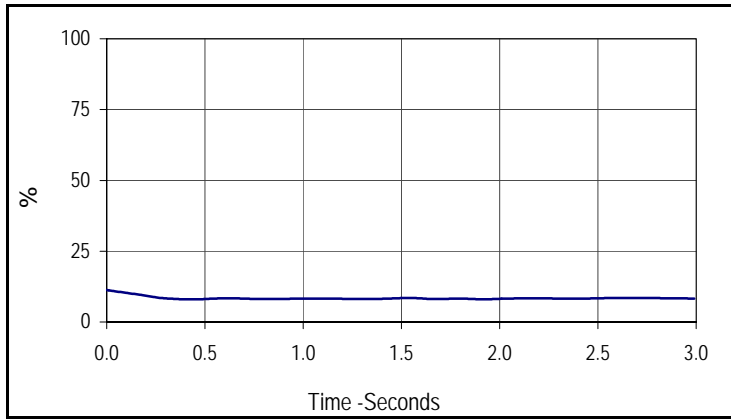
Curve Description			
Throttle Position (TPS Wire 1 Open)			
CURNO	Type	Filter Freq	Units
007	FIL	2	%
Max	Time	Return Time (msec)	
11.3	0.0	*

Throttle % reading at baseline (idle) is 1%  
 \* Throttle never returned to baseline position.

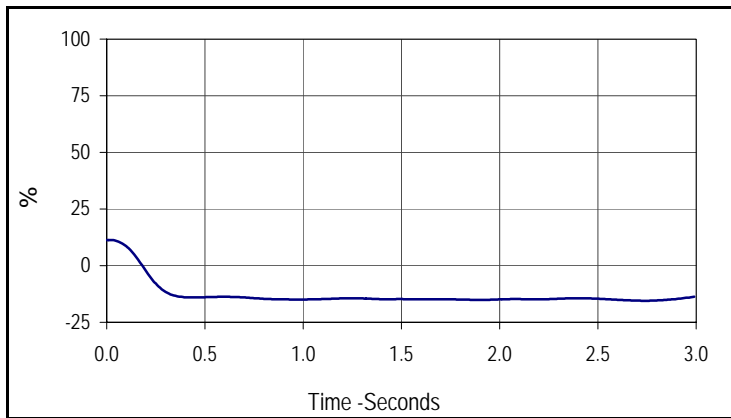
Curve Description			
Throttle Position (TPS Wire 2 Open)			
CURNO	Type	Filter Freq	Units
008	FIL	2	%
Max	Time	Return Time (msec)	
11.4	0.0	170.0

Throttle % reading at baseline (idle) is 1%  
 All return times were calculated at a return to 1%

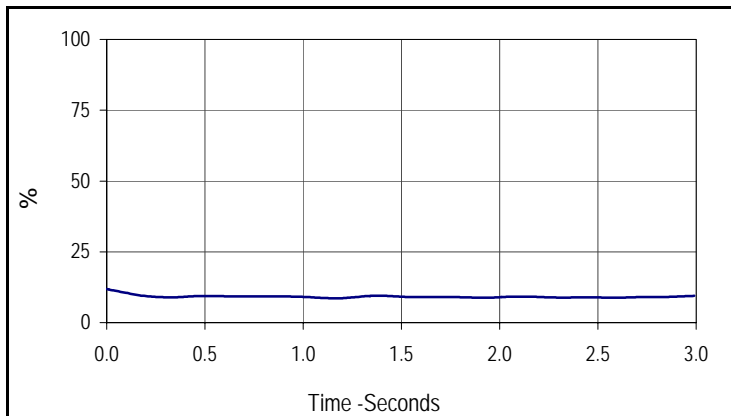
Curve Description			
Throttle Position (TPS Wire 3 Open)			
CURNO	Type	Filter Freq	Units
009	FIL	2	%
Max	Time	Return Time (msec)	
11.8	0.0	*

Throttle % reading at baseline (idle) is 1%  
 \* Throttle never returned to baseline position.  
 \* Induced wire fault caused loss of sensor reading

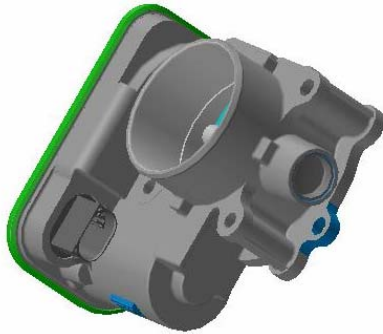
Throttle Body

<b>FMVSS124 Dynamic Testing</b>
<b>ETC Throttle Body:</b>
<b>DC Motor circuits</b>
Create open circuit in motor positive
Create open circuit in motor negative
Short ETC throttle body motor positive circuit to ground
Short ETC throttle body motor negative circuit to ground
<b>throttle position sensor #1 signal circuit</b>
Create open ETC throttle position sensor #1 signal circuit
Short to ground the ETC throttle position sensor #1 signal circuit
<b>throttle position sensor #2 signal circuit</b>
Create open ETC throttle position sensor #2 signal circuit
Short to ground the ETC throttle position sensor #2 signal circuit
<b>throttle position sensor 5 volt power circuit</b>
Create open ETC throttle position sensor power circuit
Short to ground the ETC throttle position sensor power circuit
<b>throttle position sensor ground circuit</b>
Create open ETC throttle position sensor ground circuit
<b>ETC Pedal Assembly:</b>

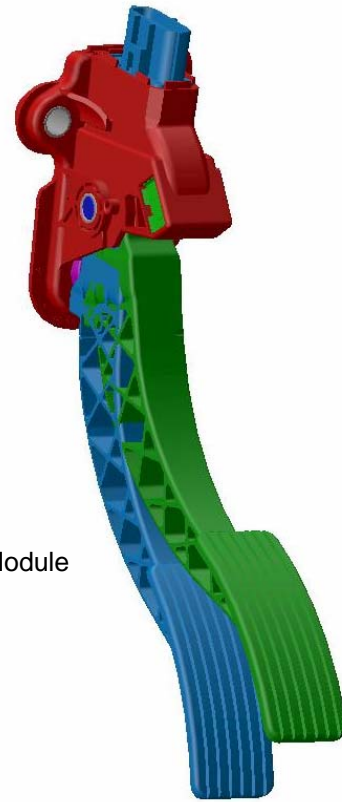
Accelerator Pedal Module

<b>pedal value sensor #1 signal circuit</b>
Create open ETC pedal value sensor #1 signal circuit
Short to ground the ETC pedal value sensor #1 signal circuit
<b>pedal value sensor #1 5 volt power circuit</b>
Create open ETC pedal value sensor power circuit
Short to ground the ETC pedal value sensor power circuit
<b>pedal value sensor 1 ground circuit</b>
Create open ETC pedal value sensor no. 1 ground circuit
<b>pedal value sensor #2 signal circuit</b>
Create open ETC pedal value sensor #2 signal circuit
Short to ground the ETC pedal value sensor #2 signal circuit
<b>pedal value sensor #2 5 volt power circuit</b>
Create open ETC pedal value sensor #2 power circuit
Short to ground the ETC pedal value sensor #2 power circuit
<b>pedal value sensor #2 ground circuit (unique for each pedal sensor)</b>
Create open ETC pedal value sensor #2 ground circuit
<b>pedal assy spring modification</b>
Test with primary spring removed to alter normal pedal mechanical return

Test with secondary spring removed to alter normal pedal mechanical return

Vehicle	Body Style	Engine	Trans	Return Springs	Accelerator Pedal Return Springs	
					Inner (Newtons)	Outer (Newtons)
JCD	49	All	All	2	Idle Load = 28 N WOT Load = 61 N Rate = 4.0 N/mm	Idle Load = 67N WOT Load = 131 N Rate = 7.7 N/mm
