REPORT NUMBER: 201UI-CAL-09-07

**SAFETY COMPLIANCE TESTING FOR FMVSS 201  
OCCUPANT PROTECTION IN INTERIOR IMPACT  
UPPER INTERIOR HEAD IMPACT PROTECTION**

**HYUNDAI MOTOR COMPANY  
2009 HYUNDAI ELANTRA**

NHTSA NUMBER: C90506

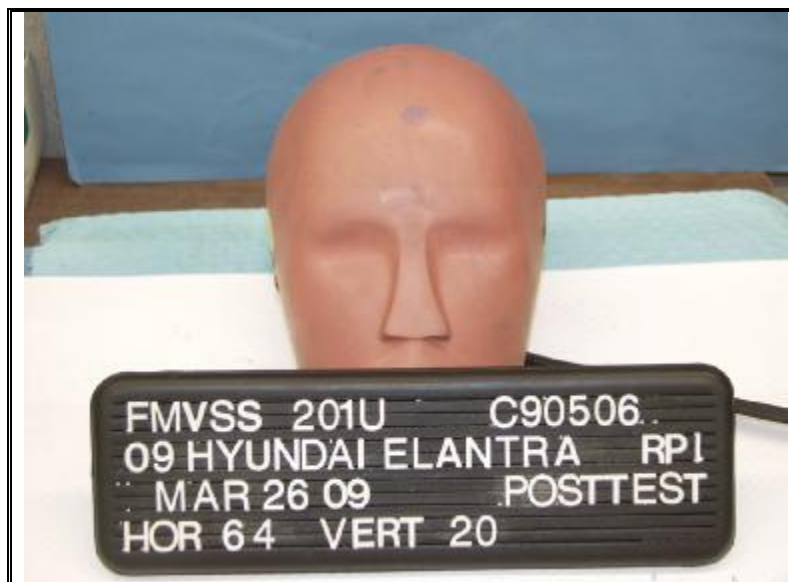
POST-IMPACT RP1 HEADFORM

Test Number:	01
Test Date:	03/26/09
Target Location:	REAR PILLAR
Target Code:	RP1
Horizontal Impact Angle:	64°
Vertical Impact Angle:	20°
Ambient Temperature:	23°C
Relative Humidity:	24
Time of Impact:	9:30
Headform Number:	1142

Impact Point Description (from lower midpoint on midsagittal line)					
On Centerline	1	<input type="checkbox"/>	mm right	<input checked="" type="checkbox"/>	mm left
On Centerline	35				mm up

Free Motion HIC	402.7
HIC(d)	470.2
Impact Velocity (kph)	18.42
HIC T1 (msec)	4.0
HIC T2 (msec)	11.3

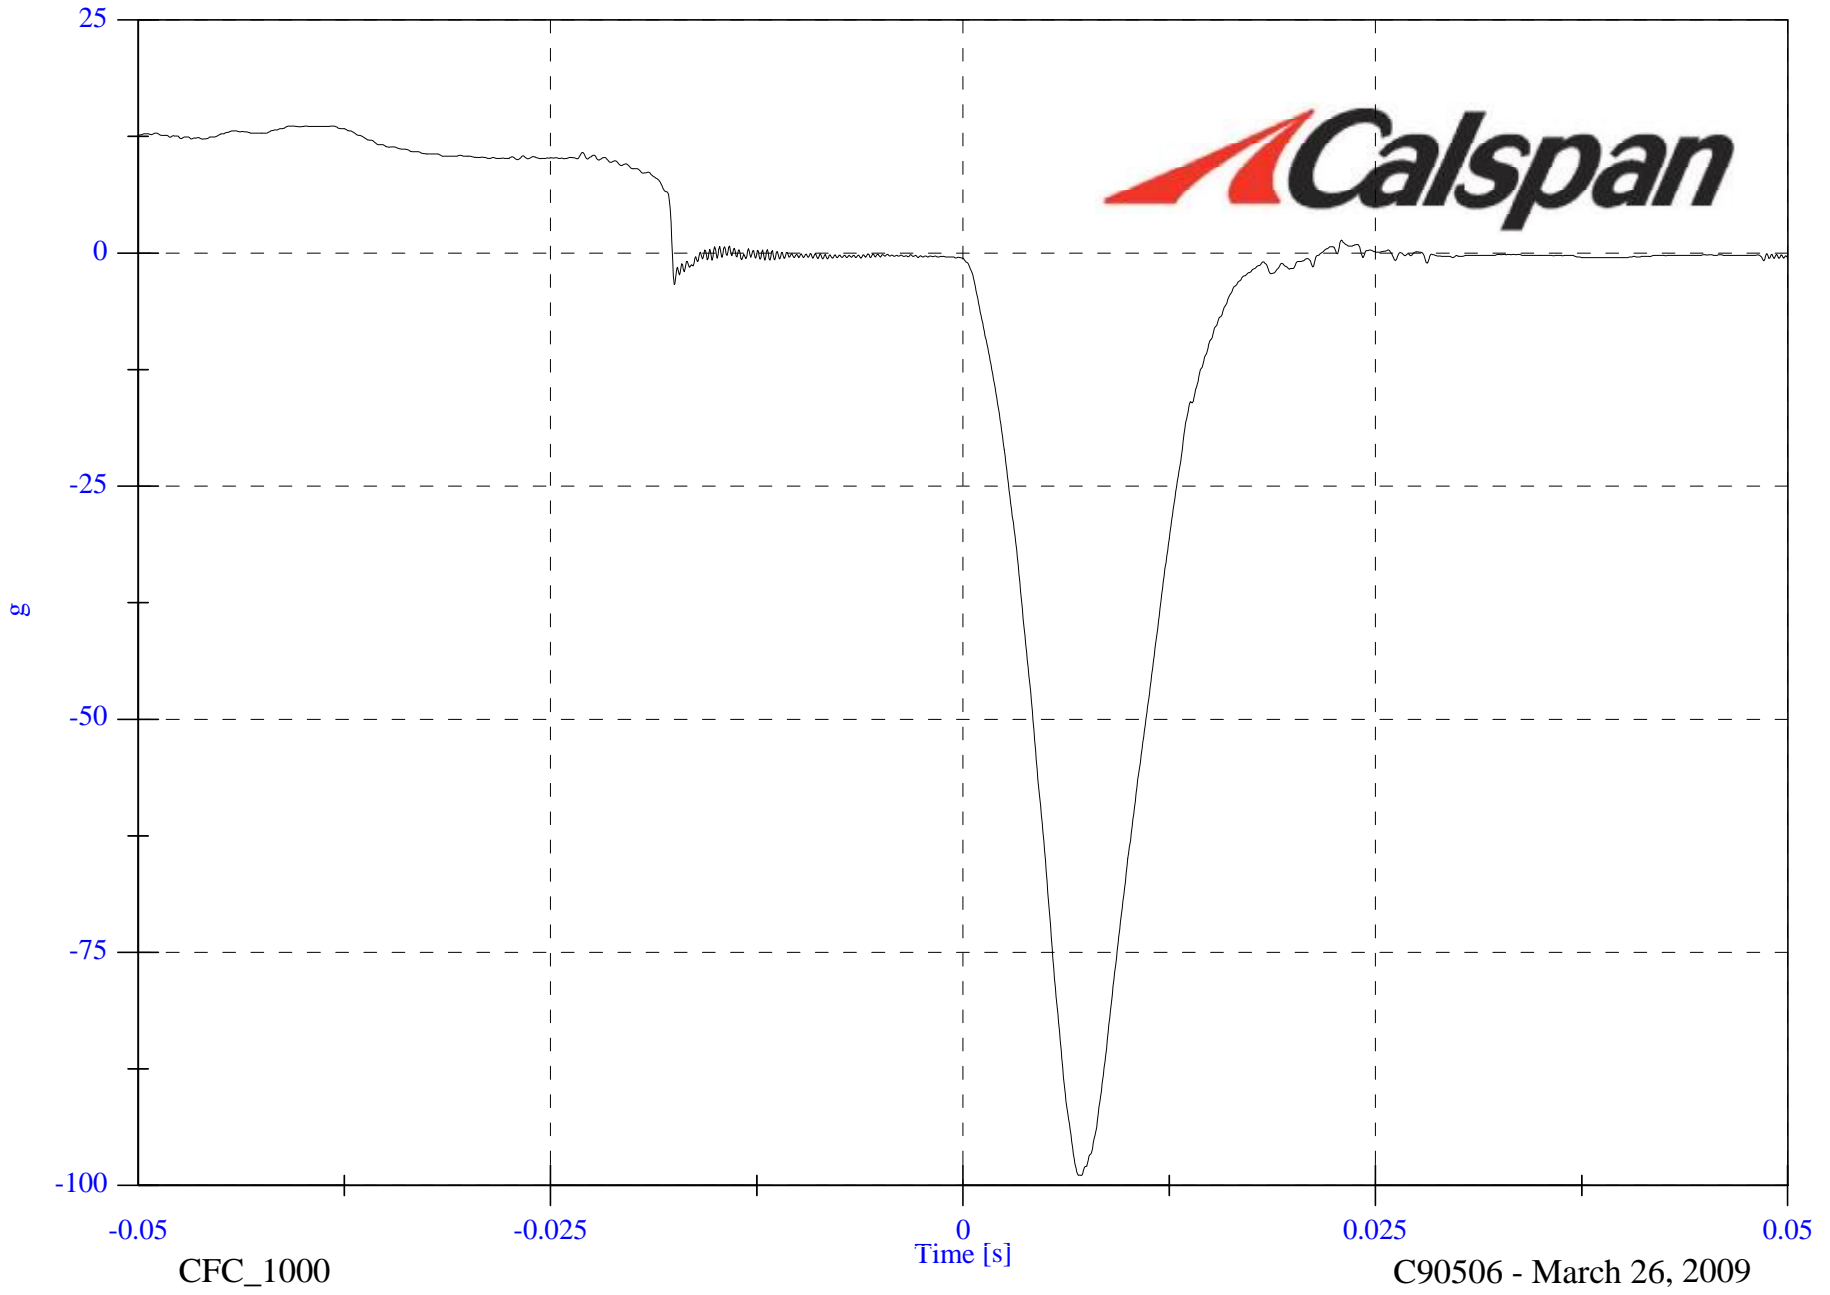
C90506 PASSENGER SIDE RPI IMPACT PLOT #1

FMVSS 201U 09 HYUNDAI ELANTRA

Headform X Acceleration

Max: 13.6 [g] at -0.038 [s]

Min: -98.9 [g] at 0.007 [s]

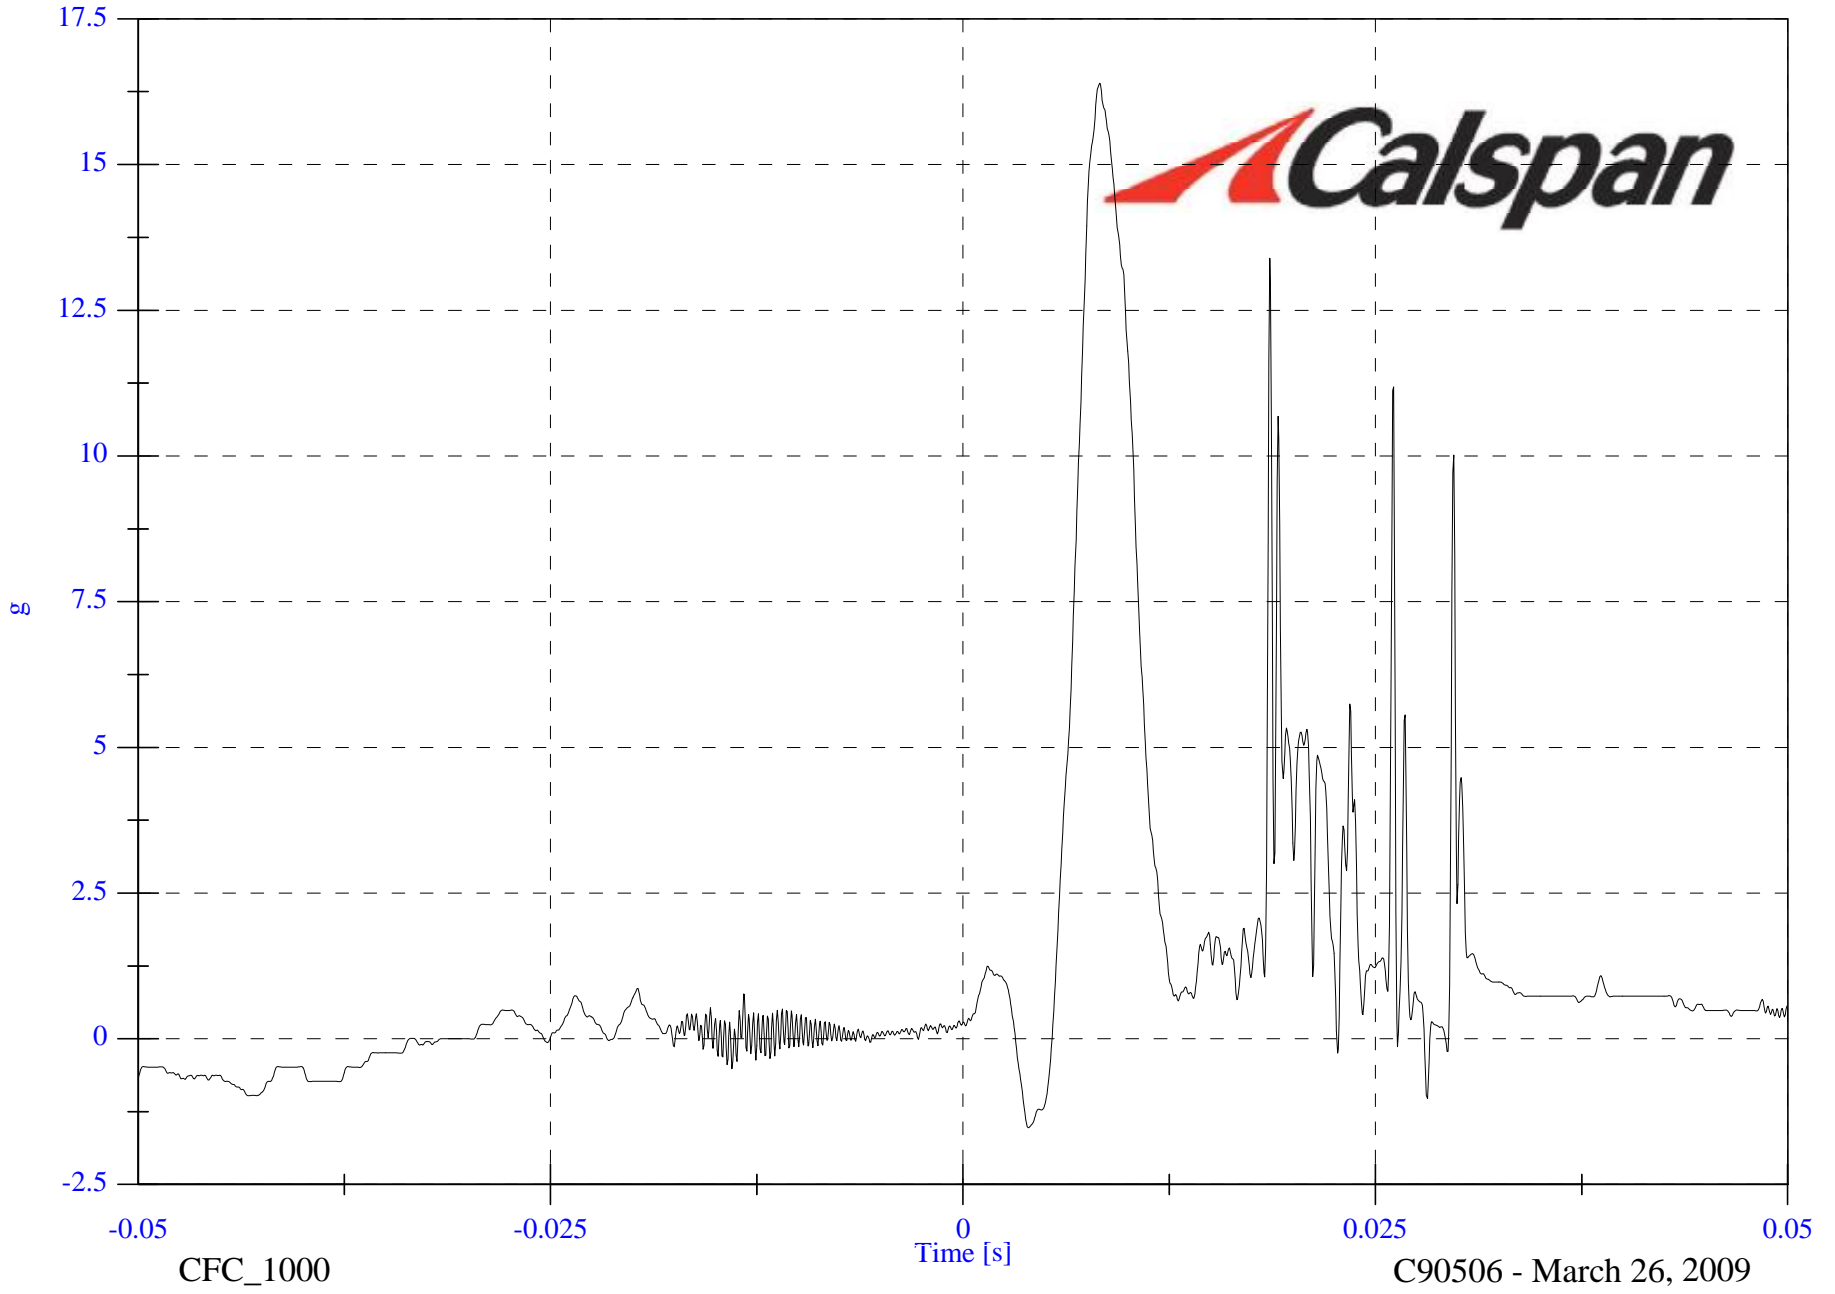
C90506 PASSENGER SIDE RPI IMPACT PLOT #2

FMVSS 201U 09 HYUNDAI ELANTRA

Headform Y Acceleration

Max: 16.4 [g] at 0.008 [s]

Min: -1.5 [g] at 0.004 [s]

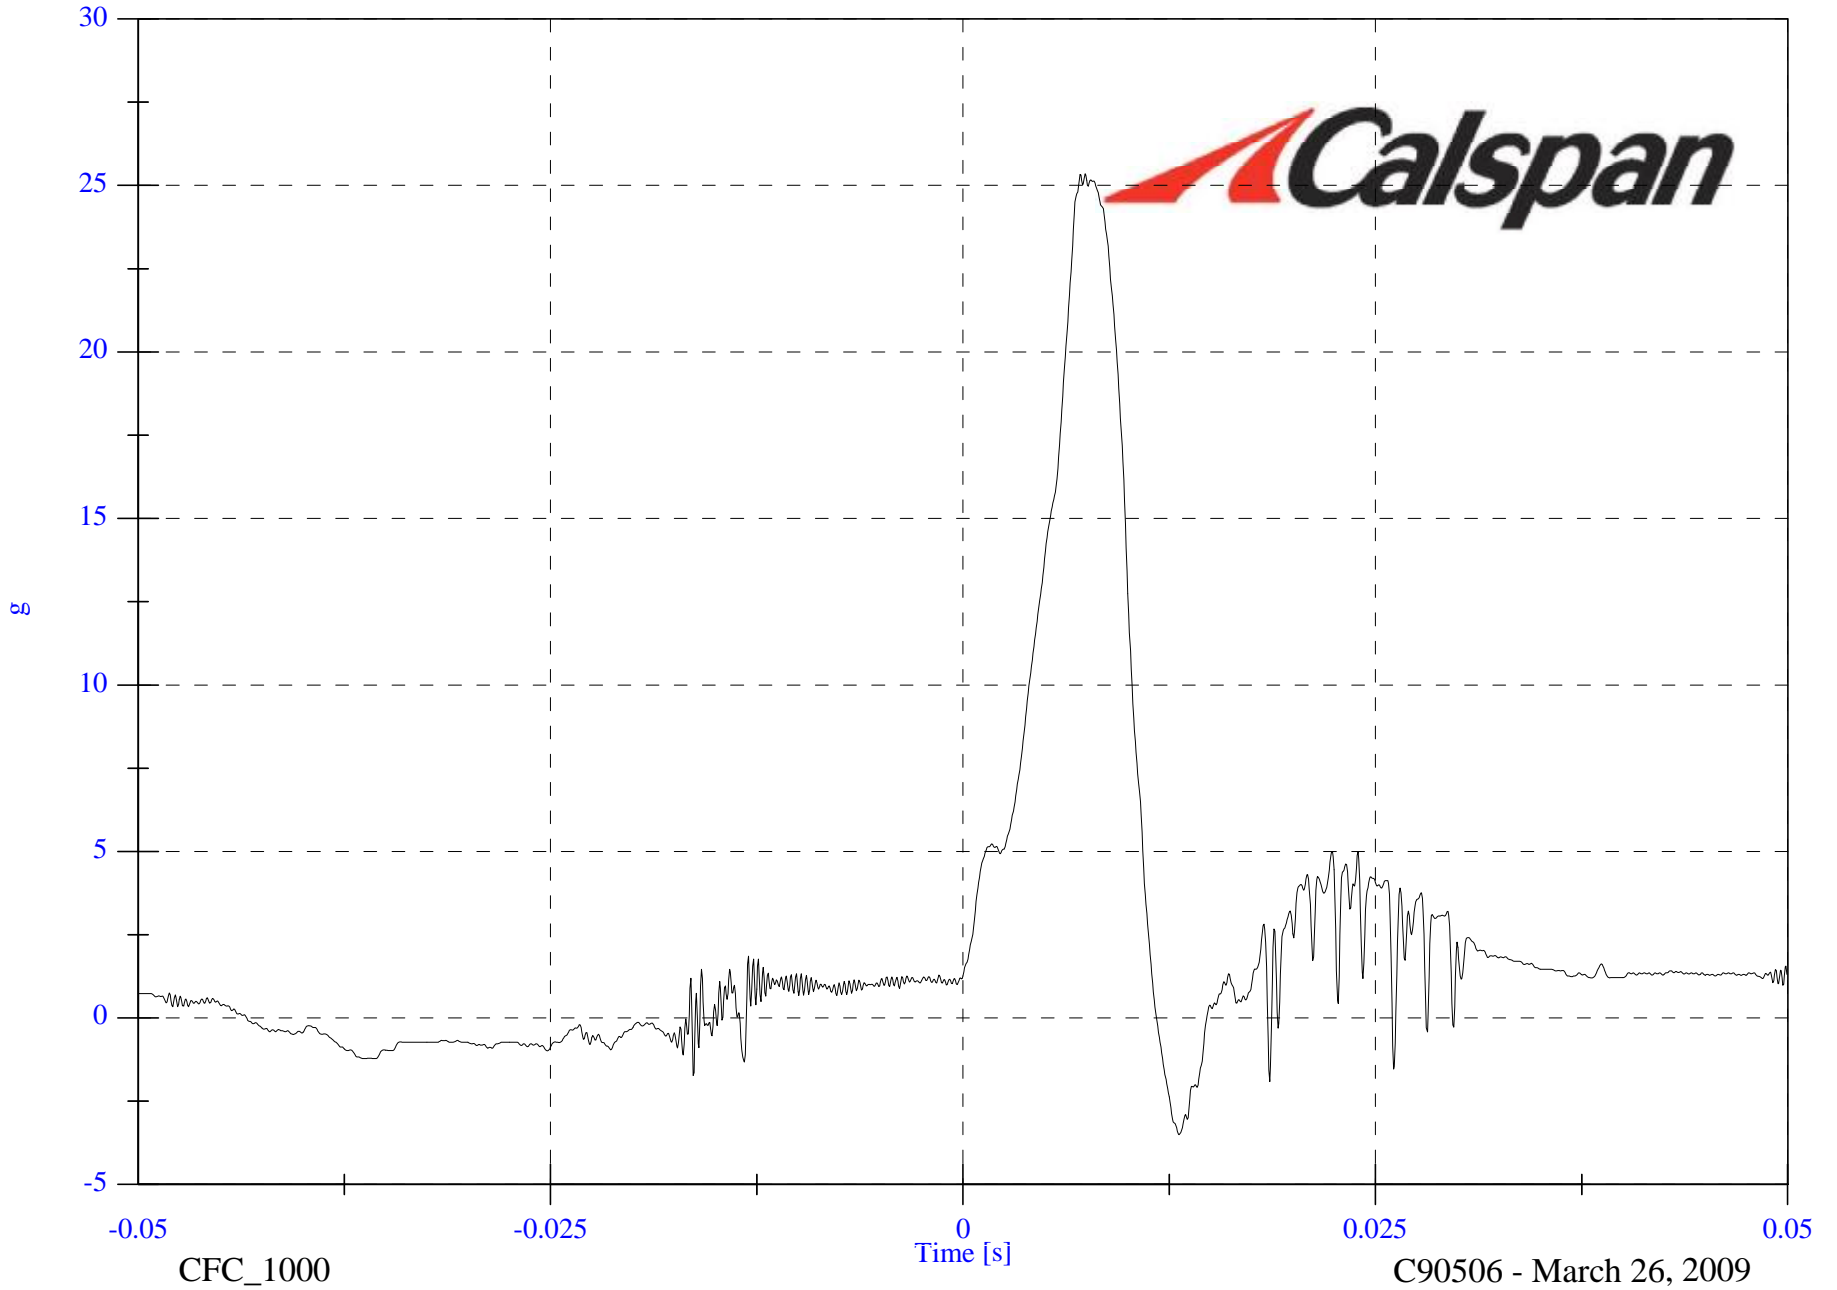
C90506 PASSENGER SIDE RPI IMPACT PLOT #3

FMVSS 201U 09 HYUNDAI ELANTRA

Headform Z Acceleration

Min: -3.5 [g] at 0.013 [s]

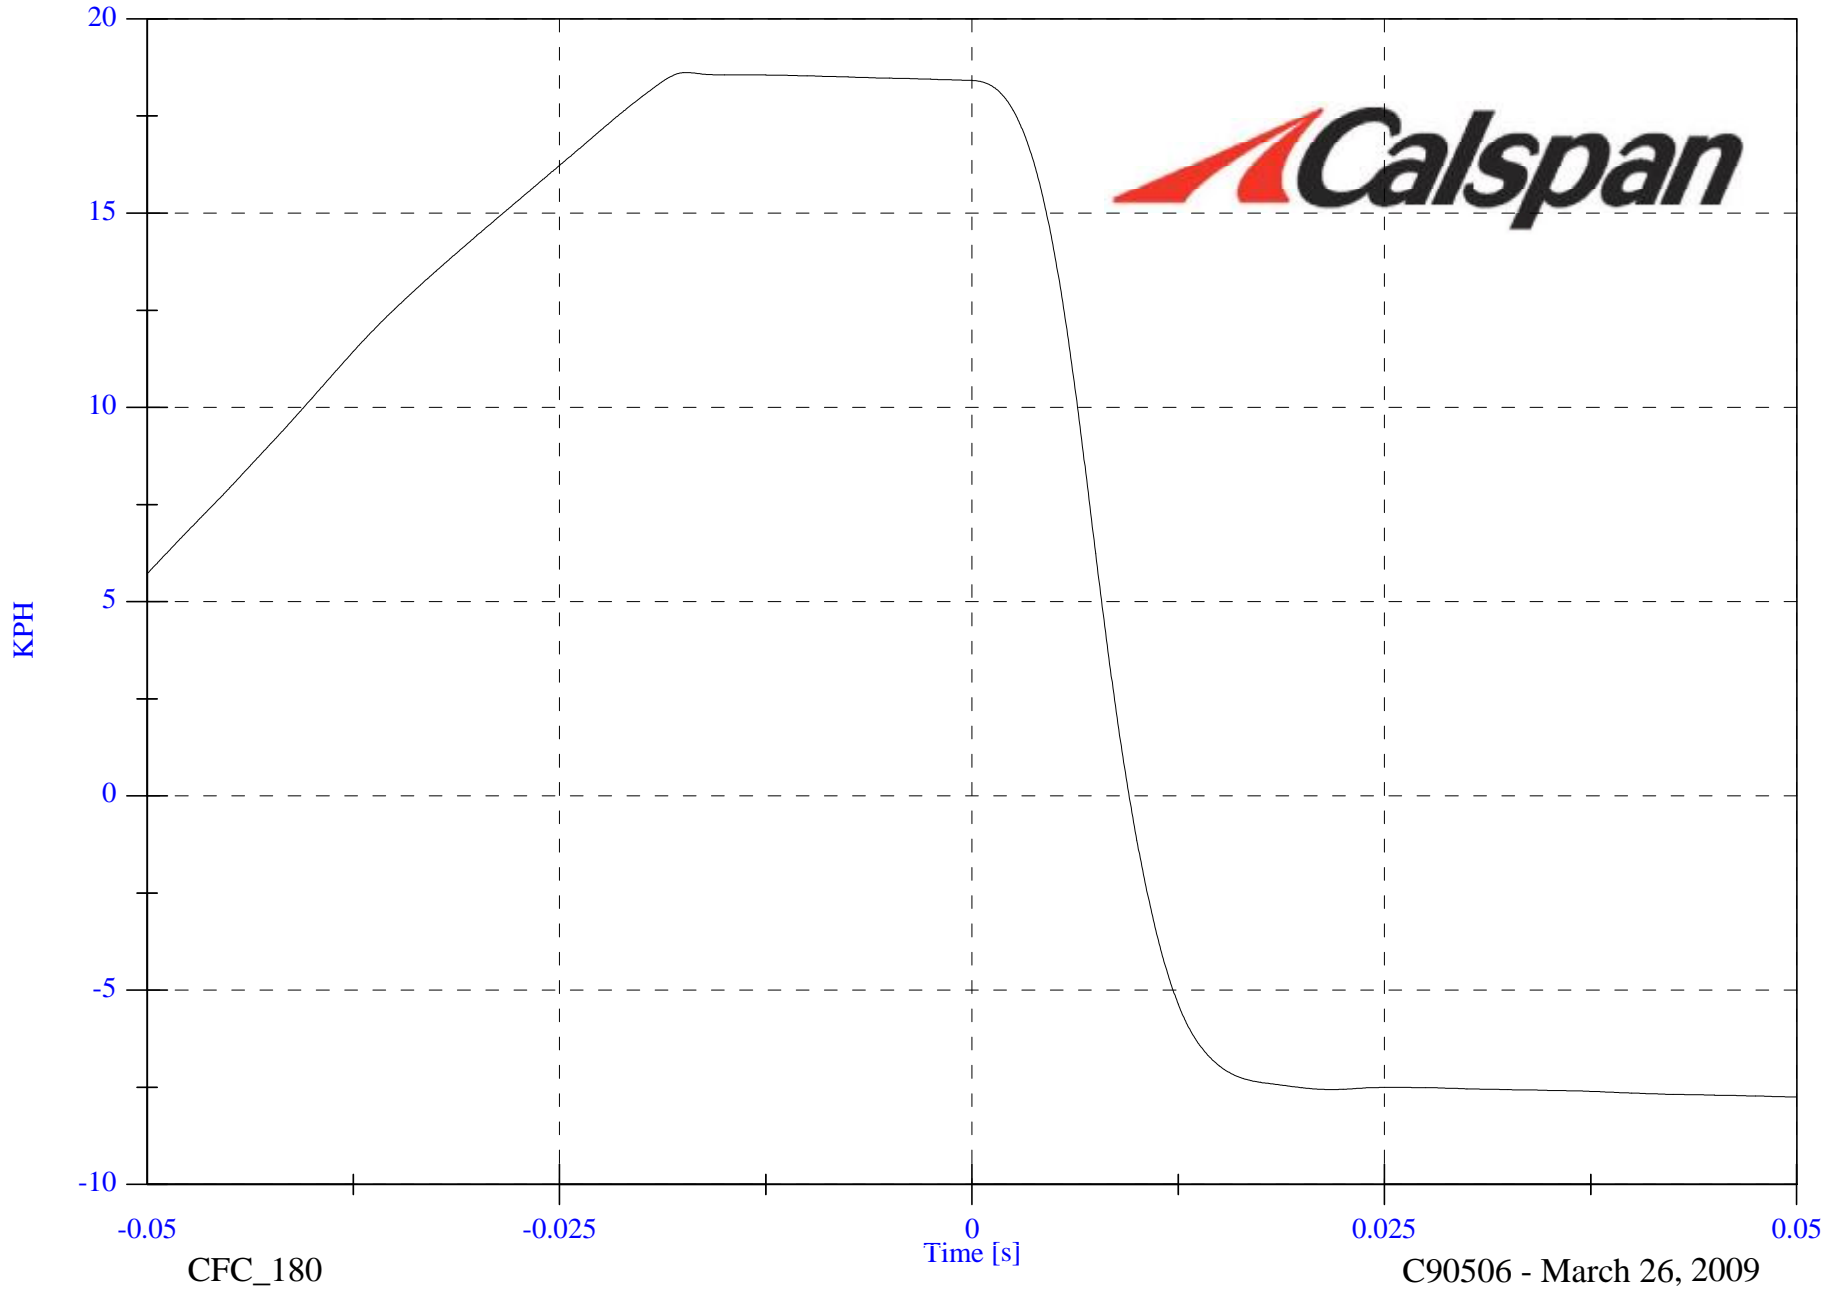
C90506 PASSENGER SIDE RPI IMPACT PLOT #5

Headform Velocity

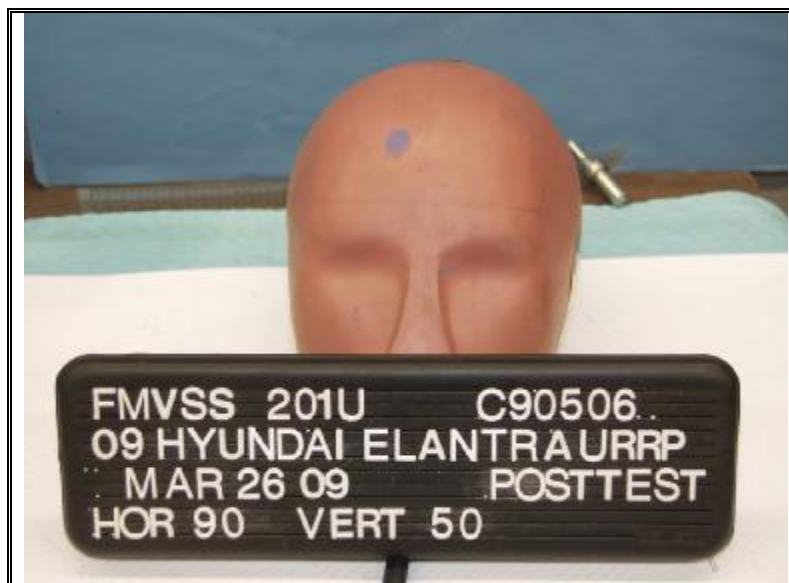
POST-IMPACT URRP HEADFORM

Test Number:	02
Test Date:	03/26/09
Target Location:	UPPER ROOF
Target Code:	URRP
Horizontal Impact Angle:	90°
Vertical Impact Angle:	50°
Ambient Temperature:	23°C
Relative Humidity:	24
Time of Impact:	9:58
Headform Number:	1140

Impact Point Description (from lower midpoint on midsagittal line)					
On Centerline	14	<input checked="" type="checkbox"/>	mm right	<input type="checkbox"/>	mm left
On Centerline	31				mm up

Free Motion HIC	499.8
HIC(d)	543.5
Impact Velocity (kph)	23.57
HIC T1 (msec)	6.7
HIC T2 (msec)	14.3

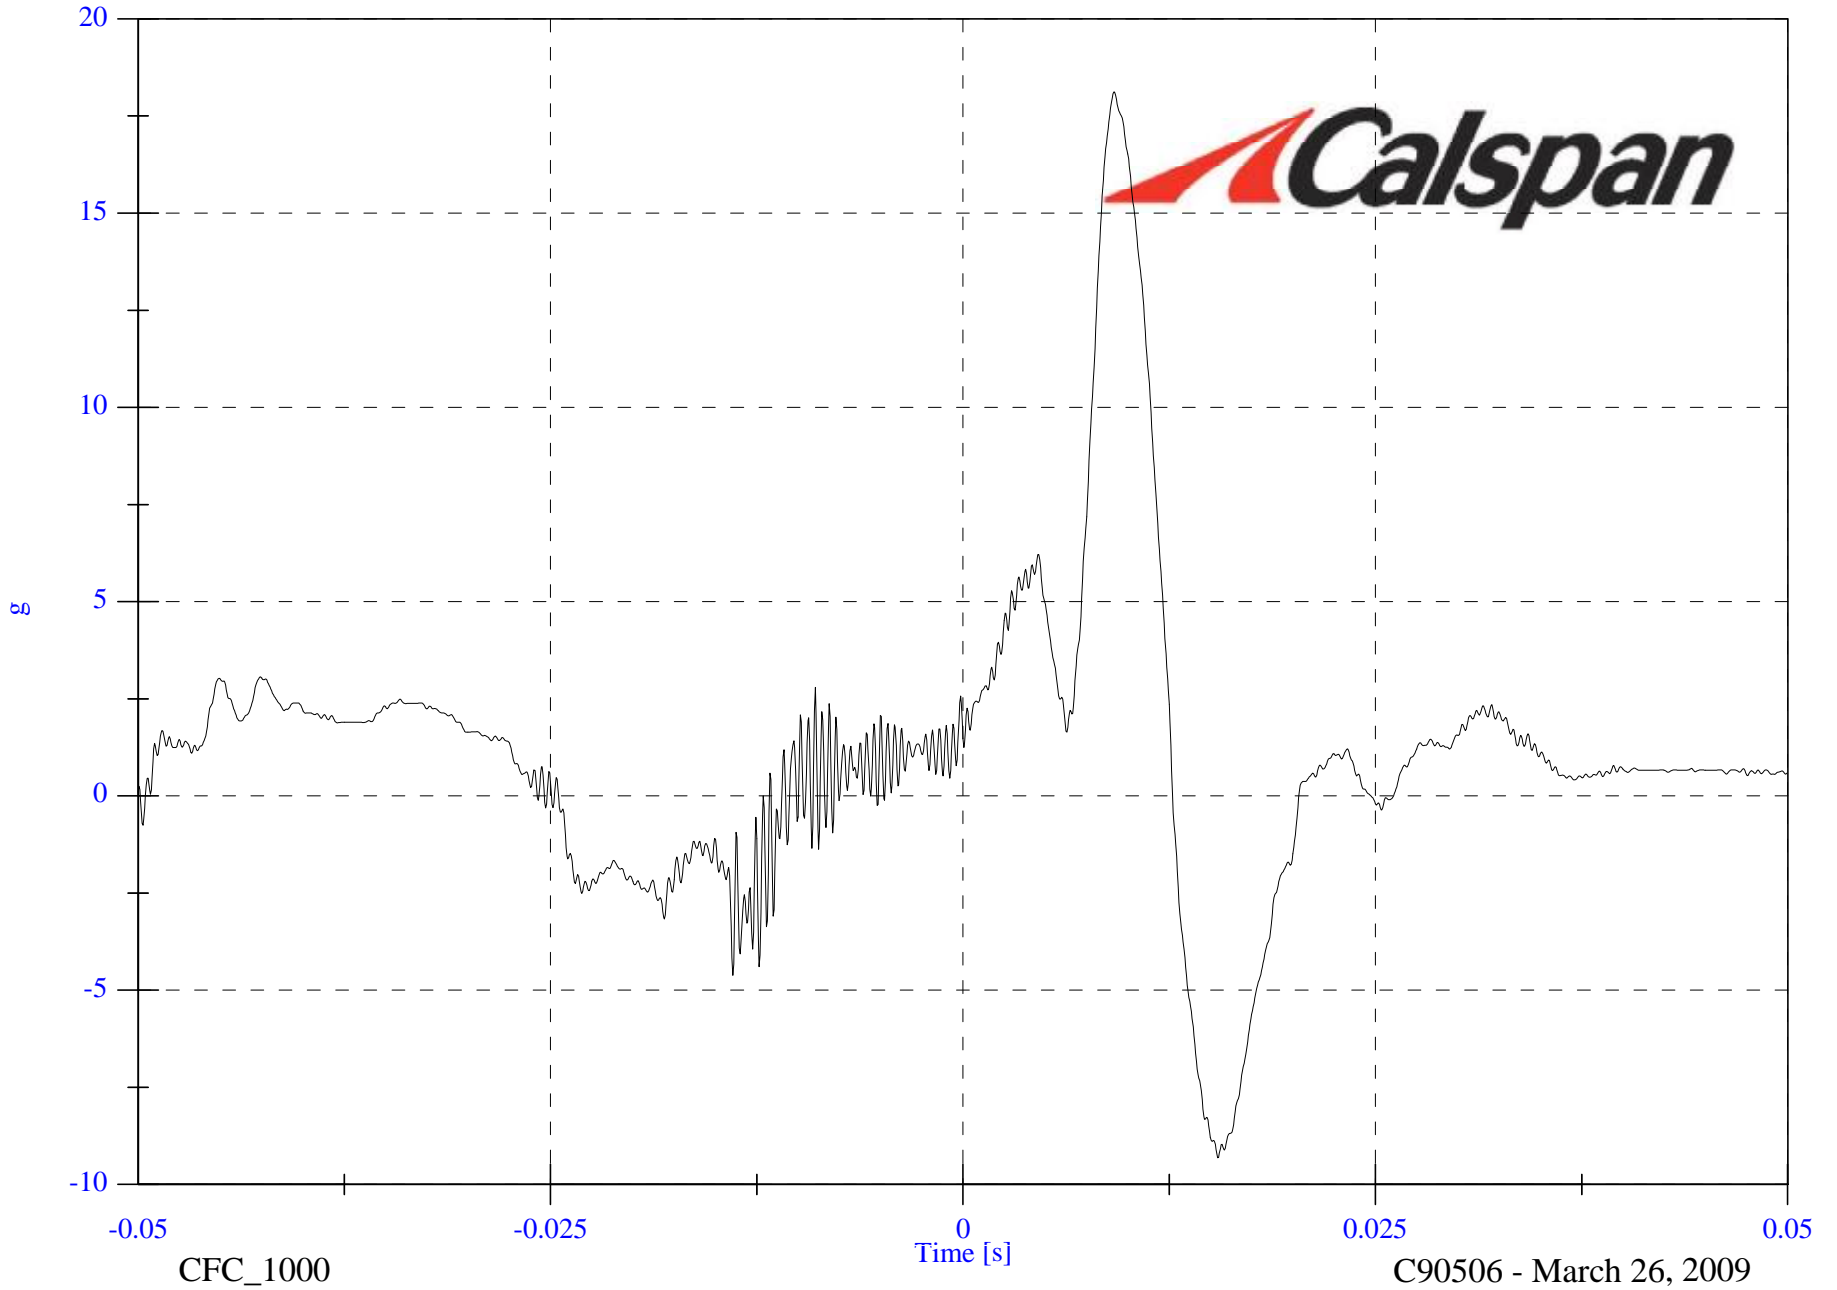
C90506 PASSENGER SIDE URRP IMPACT PLOT #3

Min: -9.3 [g] at 0.015 [s]

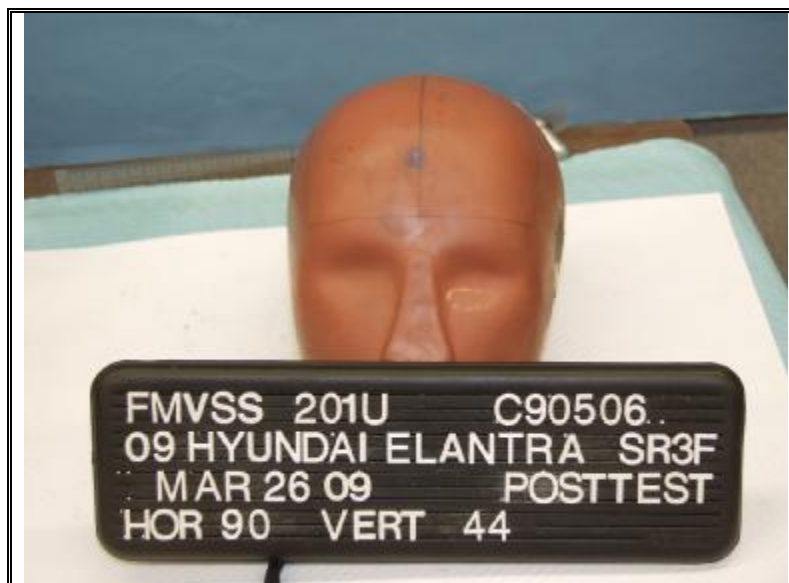
POST-IMPACT SR3F HEADFORM

Test Number:	03
Test Date:	03/26/09
Target Location:	SIDE RAIL
Target Code:	SR3F
Horizontal Impact Angle:	90°
Vertical Impact Angle:	44°
Ambient Temperature:	23°C
Relative Humidity:	24
Time of Impact:	10:20
Headform Number:	0355

Impact Point Description (from lower midpoint on midsagittal line)					
On Centerline	2	<input checked="" type="checkbox"/>	mm right	<input type="checkbox"/>	mm left
On Centerline	29				mm up

Free Motion HIC	238.6
HIC(d)	346.4
Impact Velocity (kph)	18.32
HIC T1 (msec)	2.2
HIC T2 (msec)	14.1

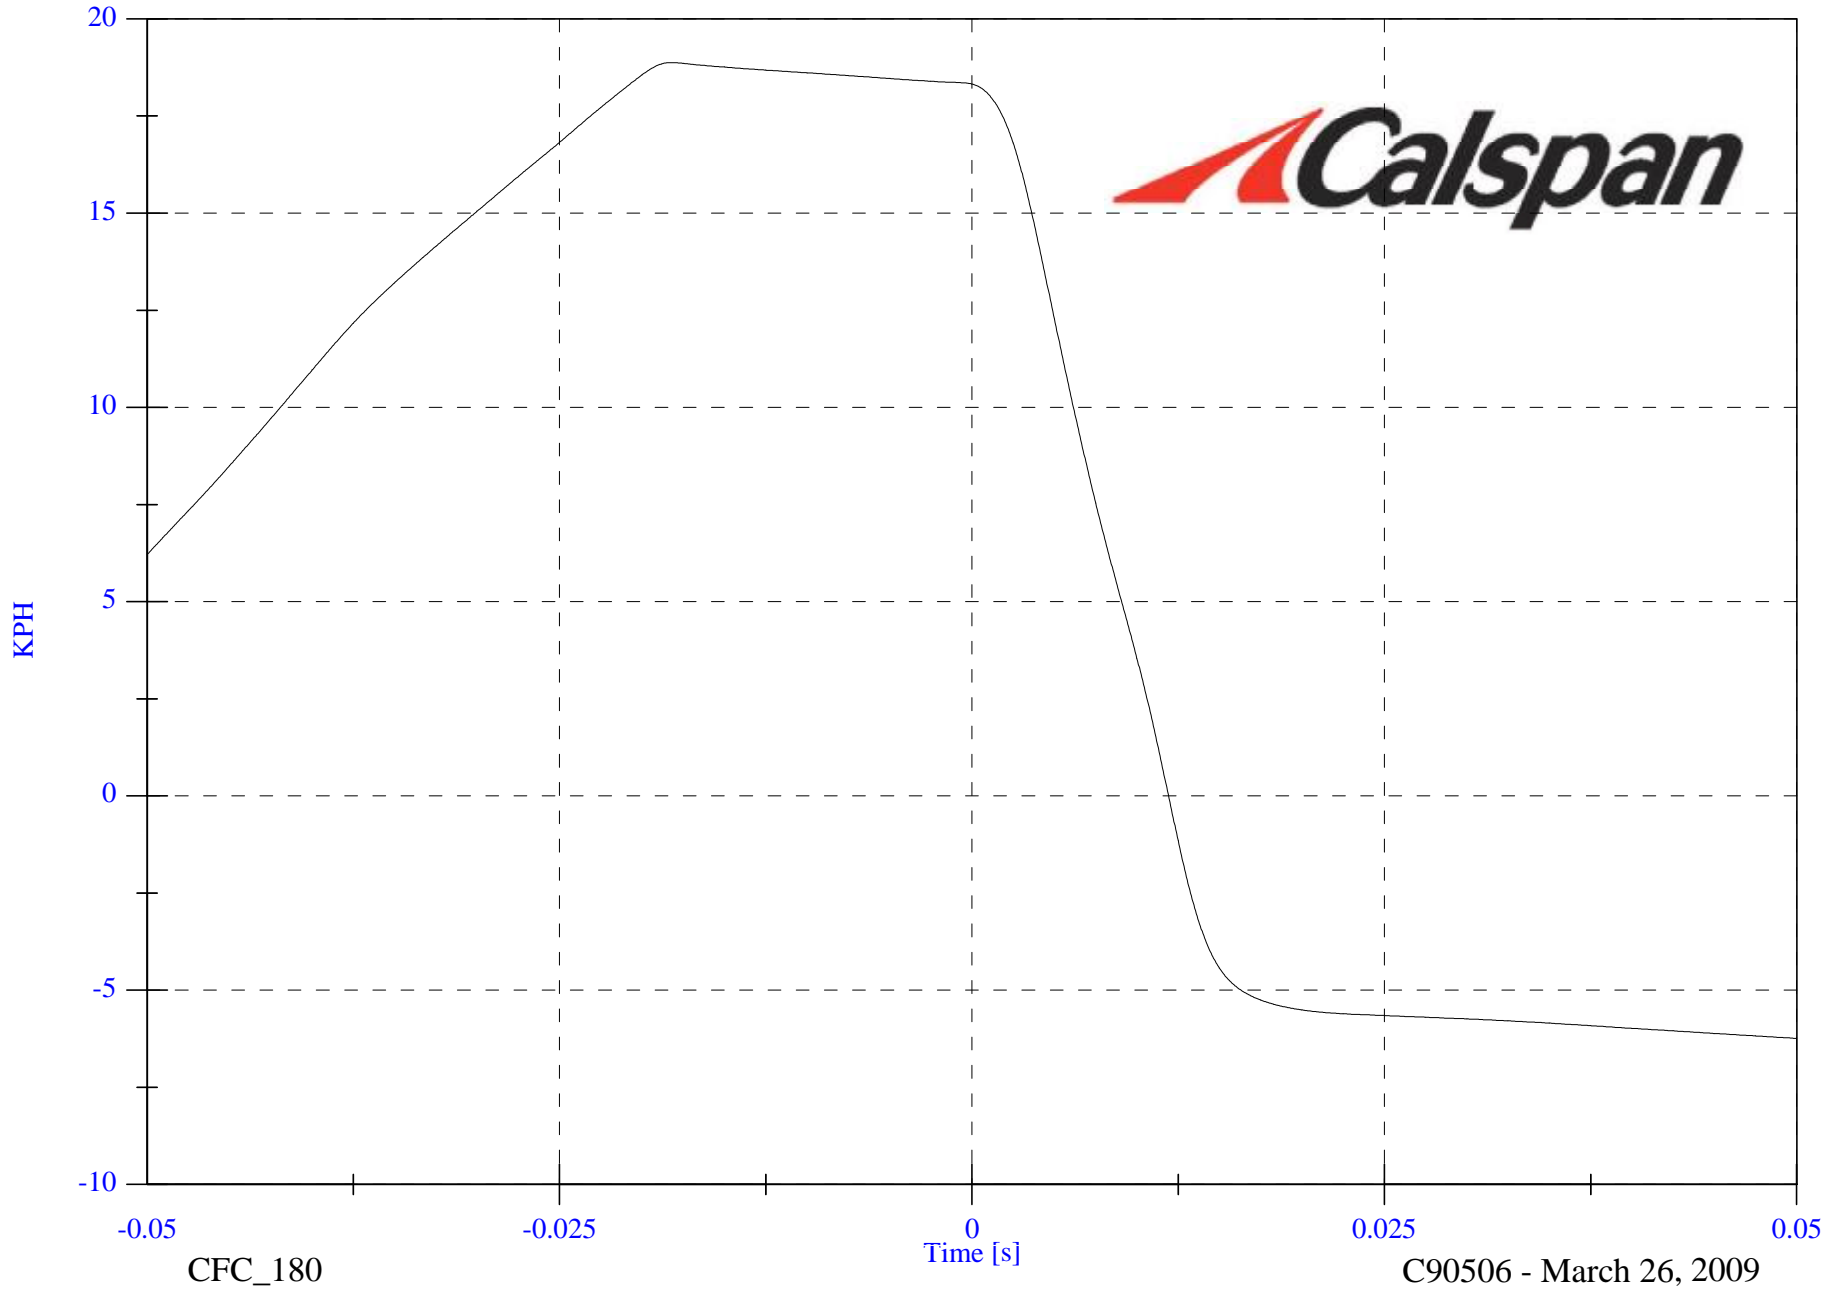
C90506 PASSENGER SIDE SR3F IMPACT PLOT #5

Headform Velocity

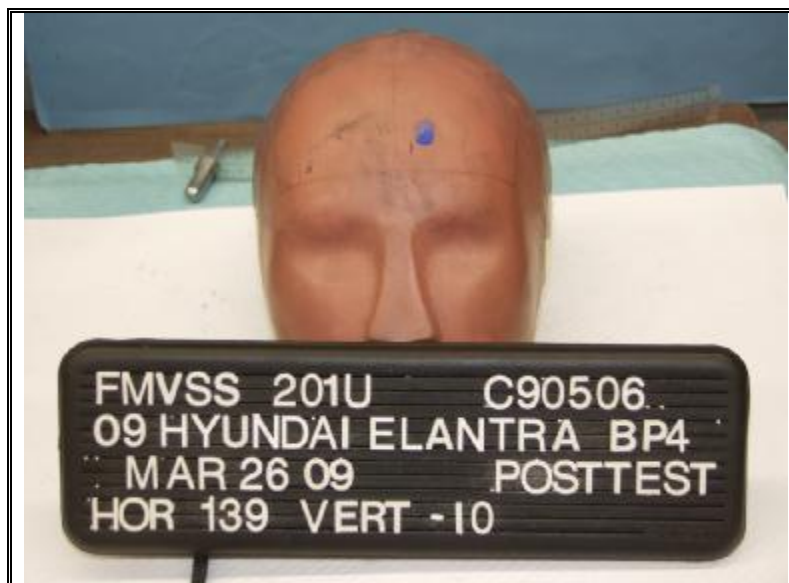
POST-IMPACT BP4 HEADFORM

Test Number:	04
Test Date:	03/26/09
Target Location:	B-PILLAR
Target Code:	BP4
Horizontal Impact Angle:	139°
Vertical Impact Angle:	-10°
Ambient Temperature:	23°C
Relative Humidity:	24
Time of Impact:	10:50
Headform Number:	0805

Impact Point Description (from lower midpoint on midsagittal line)			
On Centerline	14	<input type="checkbox"/>	mm right <input checked="" type="checkbox"/> mm left
On Centerline	21		mm up

Free Motion HIC	437.9
HIC(d)	496.7
Impact Velocity (kph)	23.47
HIC T1 (msec)	0.9
HIC T2 (msec)	13.3

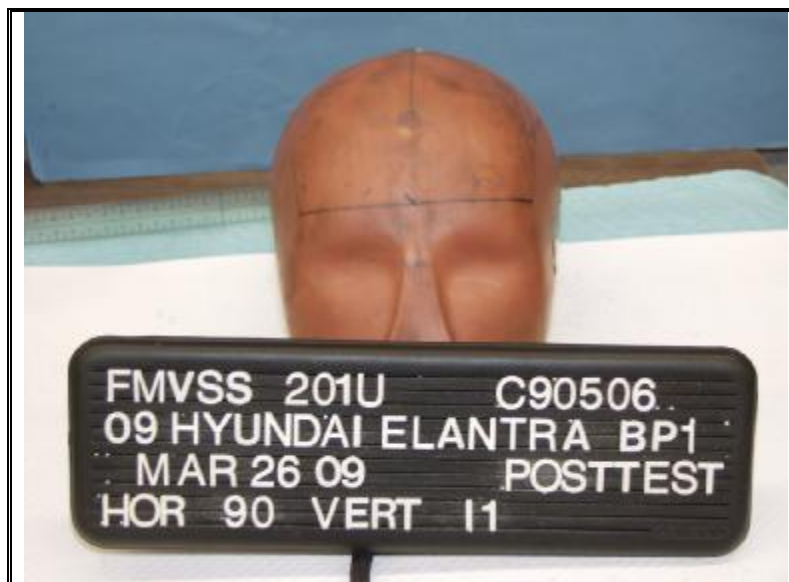
POST-IMPACT BP1 HEADFORM

Test Number:	05
Test Date:	03/26/09
Target Location:	B-PILLAR
Target Code:	BP1
Horizontal Impact Angle:	90°
Vertical Impact Angle:	11°
Ambient Temperature:	23°C
Relative Humidity:	24
Time of Impact:	11:25
Headform Number:	0062

Impact Point Description (from lower midpoint on midsagittal line)			
On Centerline	0	<input type="checkbox"/>	mm right <input type="checkbox"/> mm left
On Centerline	40		mm up

Free Motion HIC	377.3
HIC(d)	451.1
Impact Velocity (kph)	18.51
HIC T1 (msec)	4.7
HIC T2 (msec)	12.4

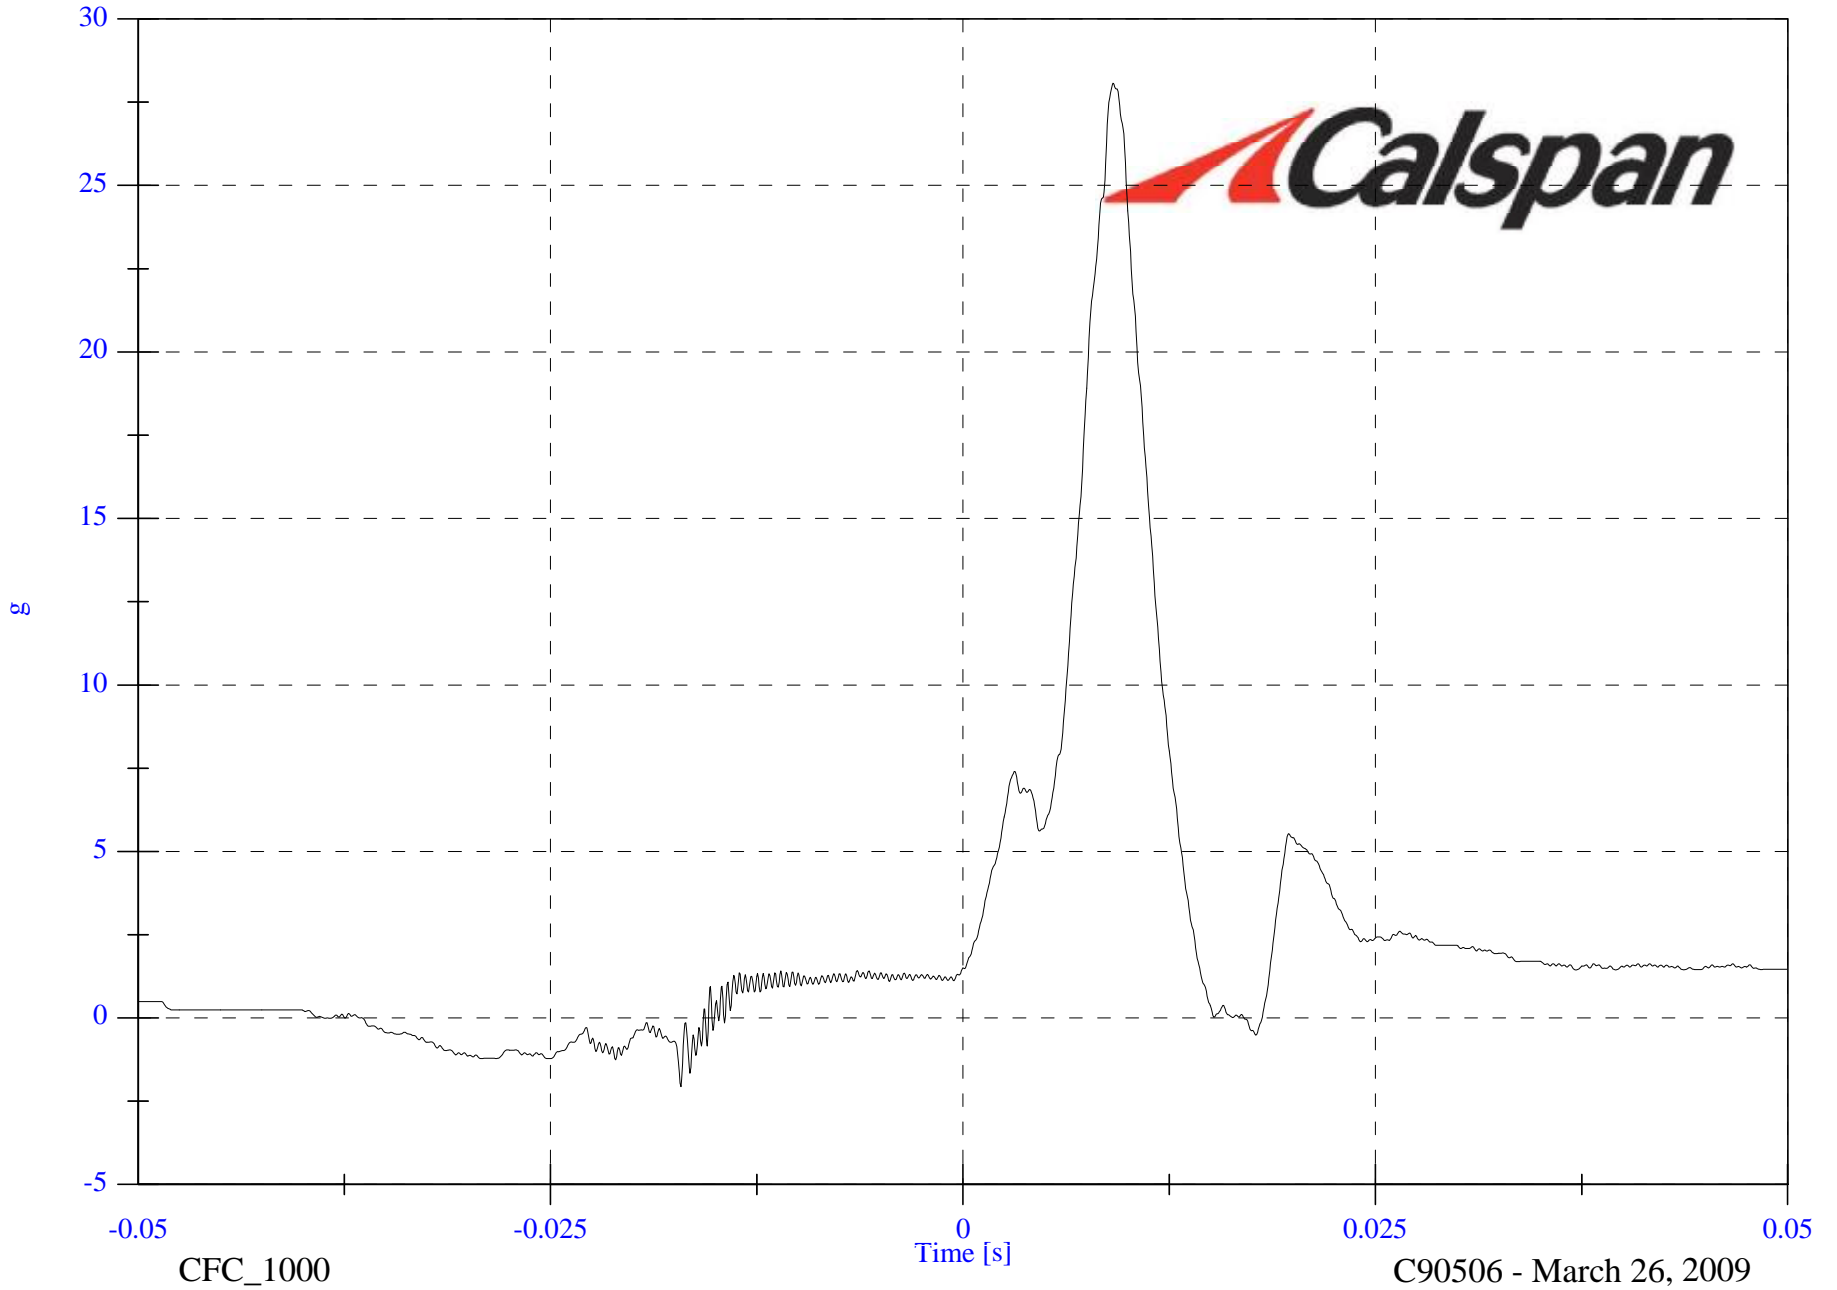
C90506 PASSENGER SIDE BPI IMPACT PLOT #3

Min: -2.1 [g] at -0.017 [s]

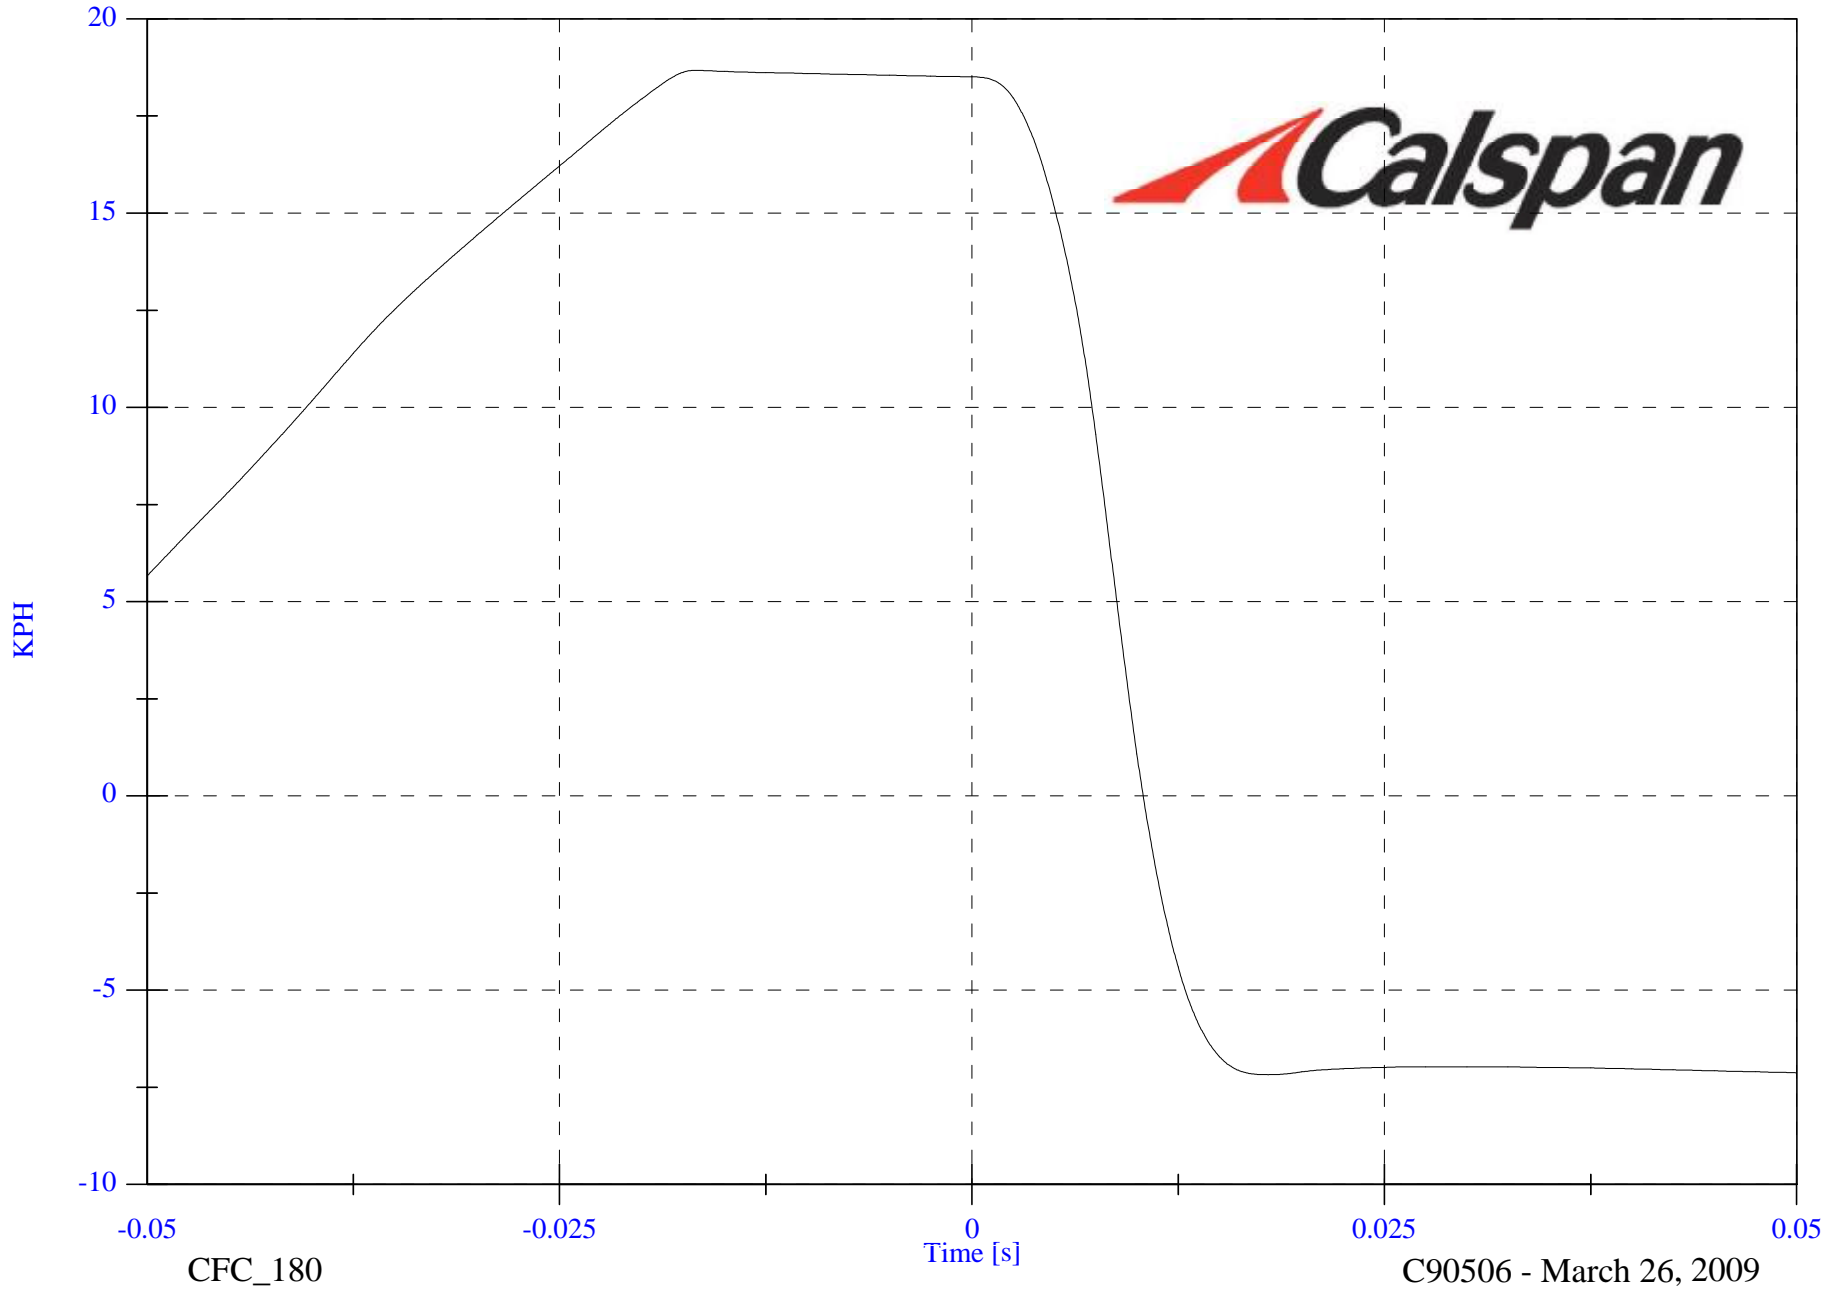
C90506 PASSENGER SIDE BPI IMPACT PLOT #5

Headform Velocity

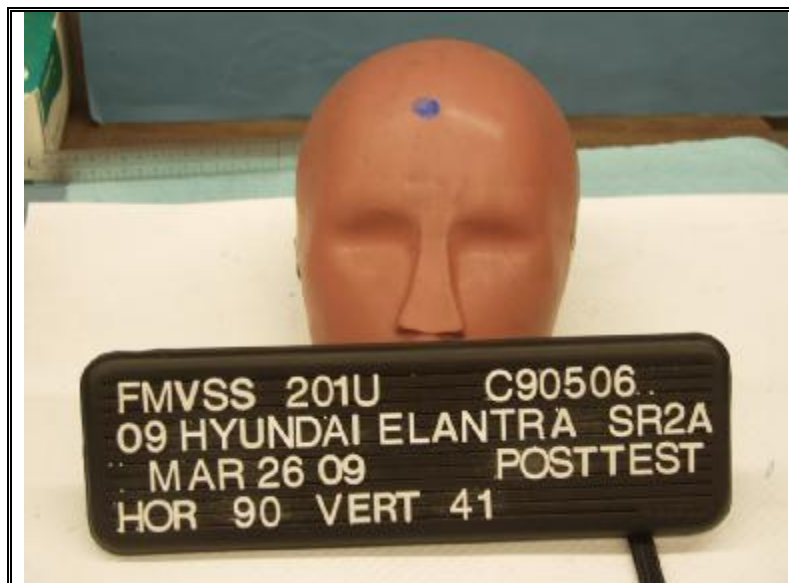
POST-IMPACT SR2A HEADFORM

Test Number:	06
Test Date:	03/26/09
Target Location:	SIDE RAIL
Target Code:	SR2A
Horizontal Impact Angle:	90°
Vertical Impact Angle:	41°
Ambient Temperature:	23°C
Relative Humidity:	24
Time of Impact:	12:45
Headform Number:	1142

Impact Point Description (from lower midpoint on midsagittal line)					
On Centerline	5	<input checked="" type="checkbox"/>	mm right	<input type="checkbox"/>	mm left
On Centerline	36				mm up

Free Motion HIC	186.5
HIC(d)	307.1
Impact Velocity (kph)	18.54
HIC T1 (msec)	2.8
HIC T2 (msec)	16.1
