REPORT NUMBER: 201UI-CAL-09-07

**SAFETY COMPLIANCE TESTING FOR FMVSS 201  
OCCUPANT PROTECTION IN INTERIOR IMPACT  
UPPER INTERIOR HEAD IMPACT PROTECTION**

**HYUNDAI MOTOR COMPANY  
2009 HYUNDAI ELANTRA**

NHTSA NUMBER: C90506

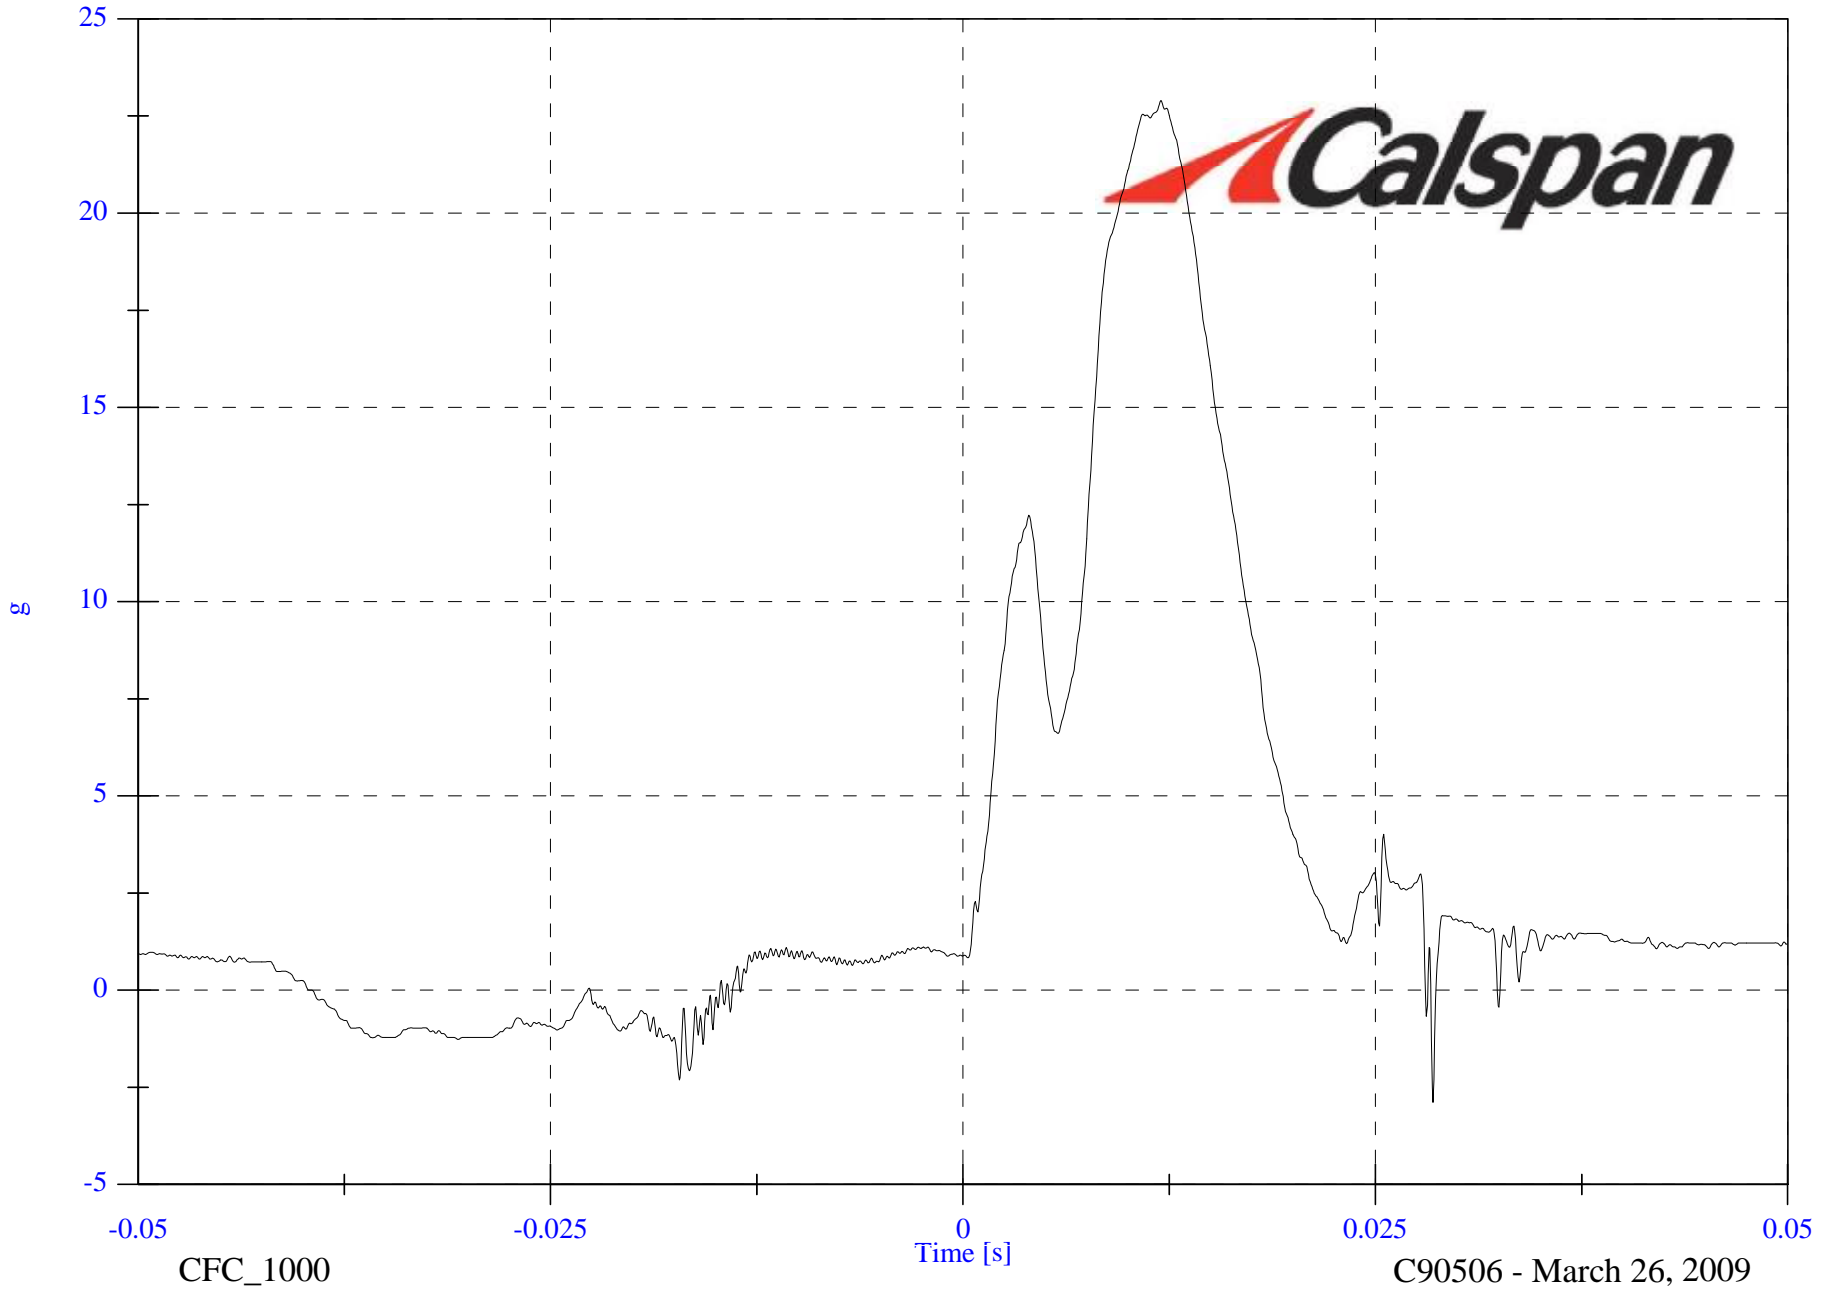
C90506 PASSENGER SIDE SR2A IMPACT PLOT #3

Min: -2.9 [g] at 0.029 [s]

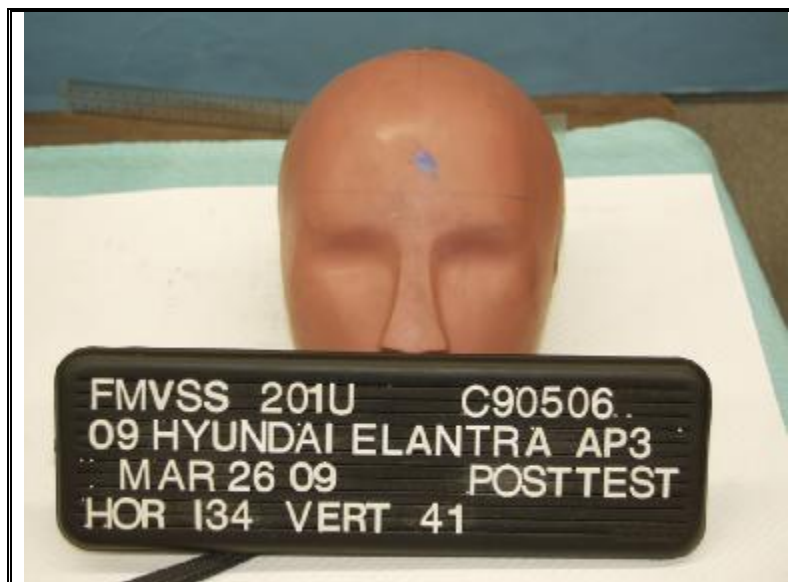
POST-IMPACT AP3 PASS HEADFORM

Test Number:	07
Test Date:	03/26/09
Target Location:	A-PILLAR
Target Code:	AP3
Horizontal Impact Angle:	134°
Vertical Impact Angle:	41°
Ambient Temperature:	23°C
Relative Humidity:	24
Time of Impact:	13:20
Headform Number:	1140

Impact Point Description (from lower midpoint on midsagittal line)			
On Centerline	5	<input type="checkbox"/>	mm right <input checked="" type="checkbox"/> mm left
On Centerline	16		mm up

Free Motion HIC	1265.0
HIC(d)	1121.0
Impact Velocity (kph)	23.65
HIC T1 (msec)	5.3
HIC T2 (msec)	8.7

TRIM CRACKED UPON IMPACT

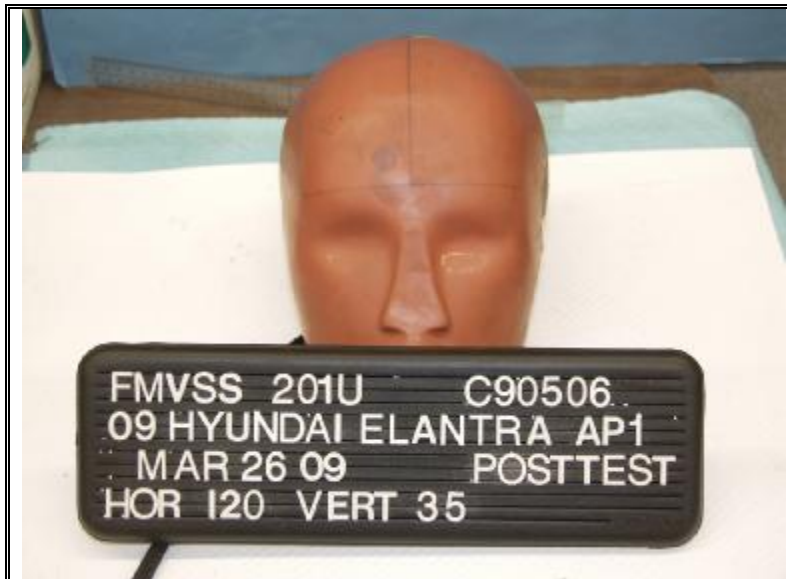
POST-IMPACT AP1 HEADFORM

Test Number:	08
Test Date:	03/26/09
Target Location:	A-PILLAR
Target Code:	AP1
Horizontal Impact Angle:	120°
Vertical Impact Angle:	35°
Ambient Temperature:	23°C
Relative Humidity:	24
Time of Impact:	15:05
Headform Number:	0355

Impact Point Description (from lower midpoint on midsagittal line)					
On Centerline	8	<input checked="" type="checkbox"/>	mm right	<input type="checkbox"/>	mm left
On Centerline	13				mm up

Free Motion HIC	599.5
HIC(d)	618.7
Impact Velocity (kph)	18.41
HIC T1 (msec)	7.0
HIC T2 (msec)	11.1

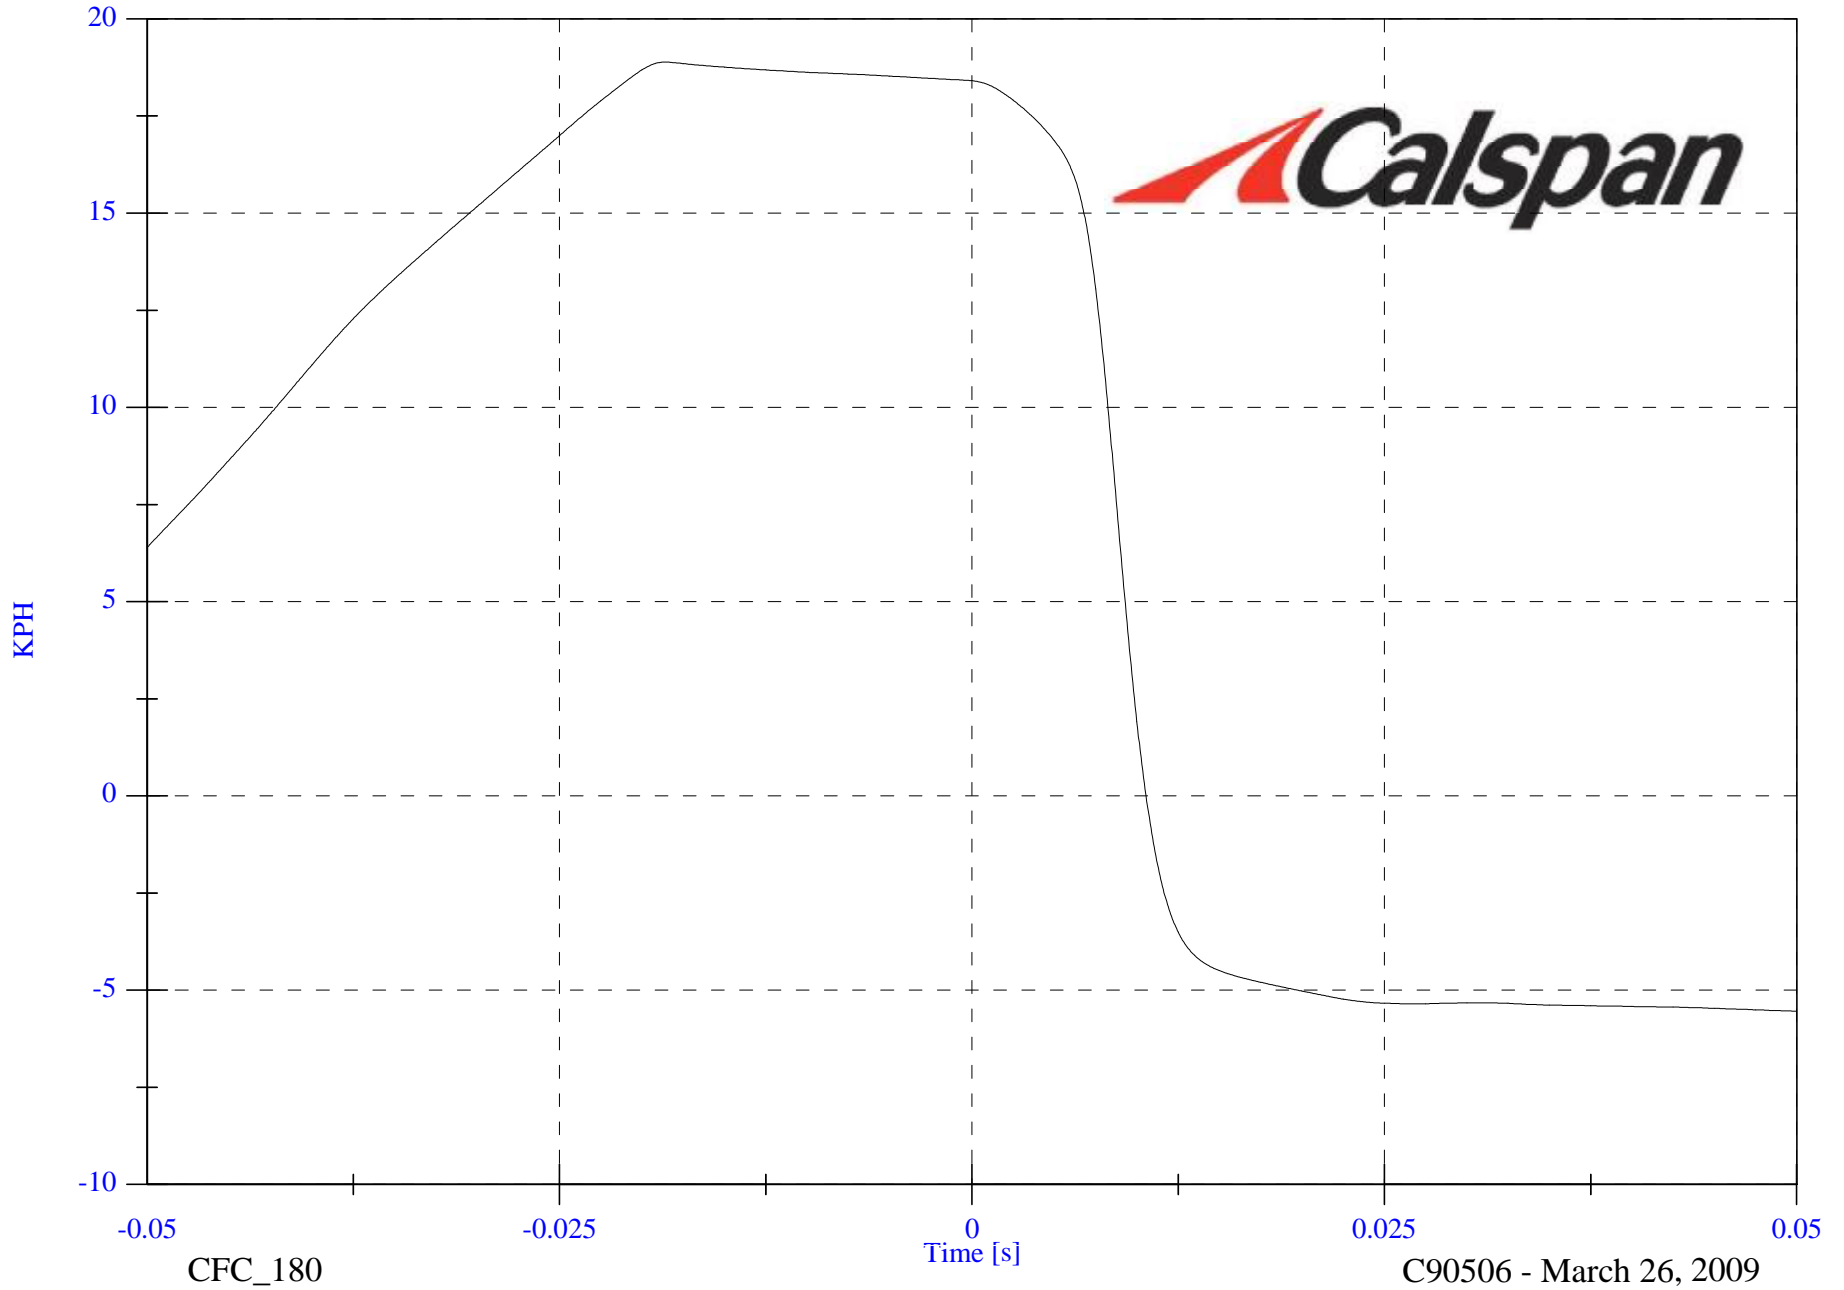
C90506 PASSENGER SIDE AP1 IMPACT PLOT #5

Headform Velocity

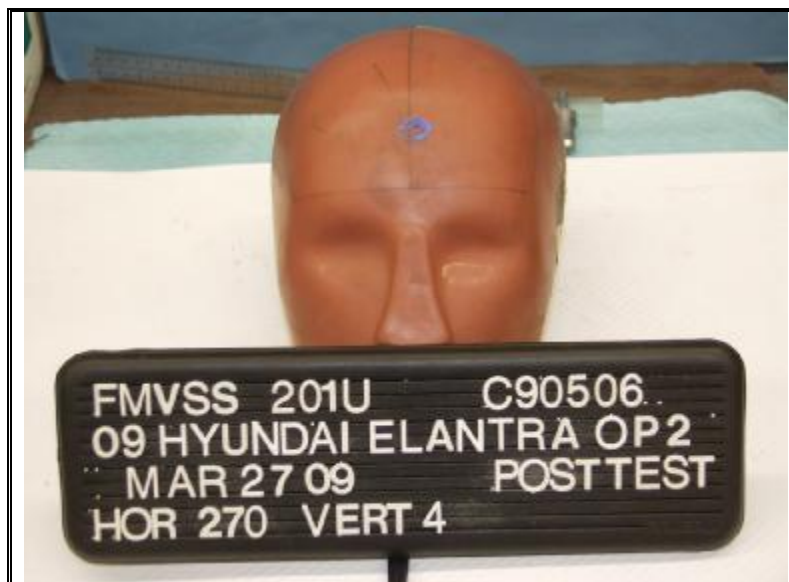
POST-IMPACT OP2 HEADFORM

Test Number:	09
Test Date:	03/27/09
Target Location:	OTHER PILLAR
Target Code:	OP2
Horizontal Impact Angle:	270°
Vertical Impact Angle:	4°
Ambient Temperature:	23°C
Relative Humidity:	23
Time of Impact:	9:15
Headform Number:	0355

Impact Point Description (from lower midpoint on midsagittal line)			
On Centerline	0	<input type="checkbox"/>	mm right <input type="checkbox"/> mm left
On Centerline	26		mm up

Free Motion HIC	316.0
HIC(d)	404.8
Impact Velocity (kph)	23.55
HIC T1 (msec)	2.4
HIC T2 (msec)	13.9

TRIM CRACKED UPON IMPACT

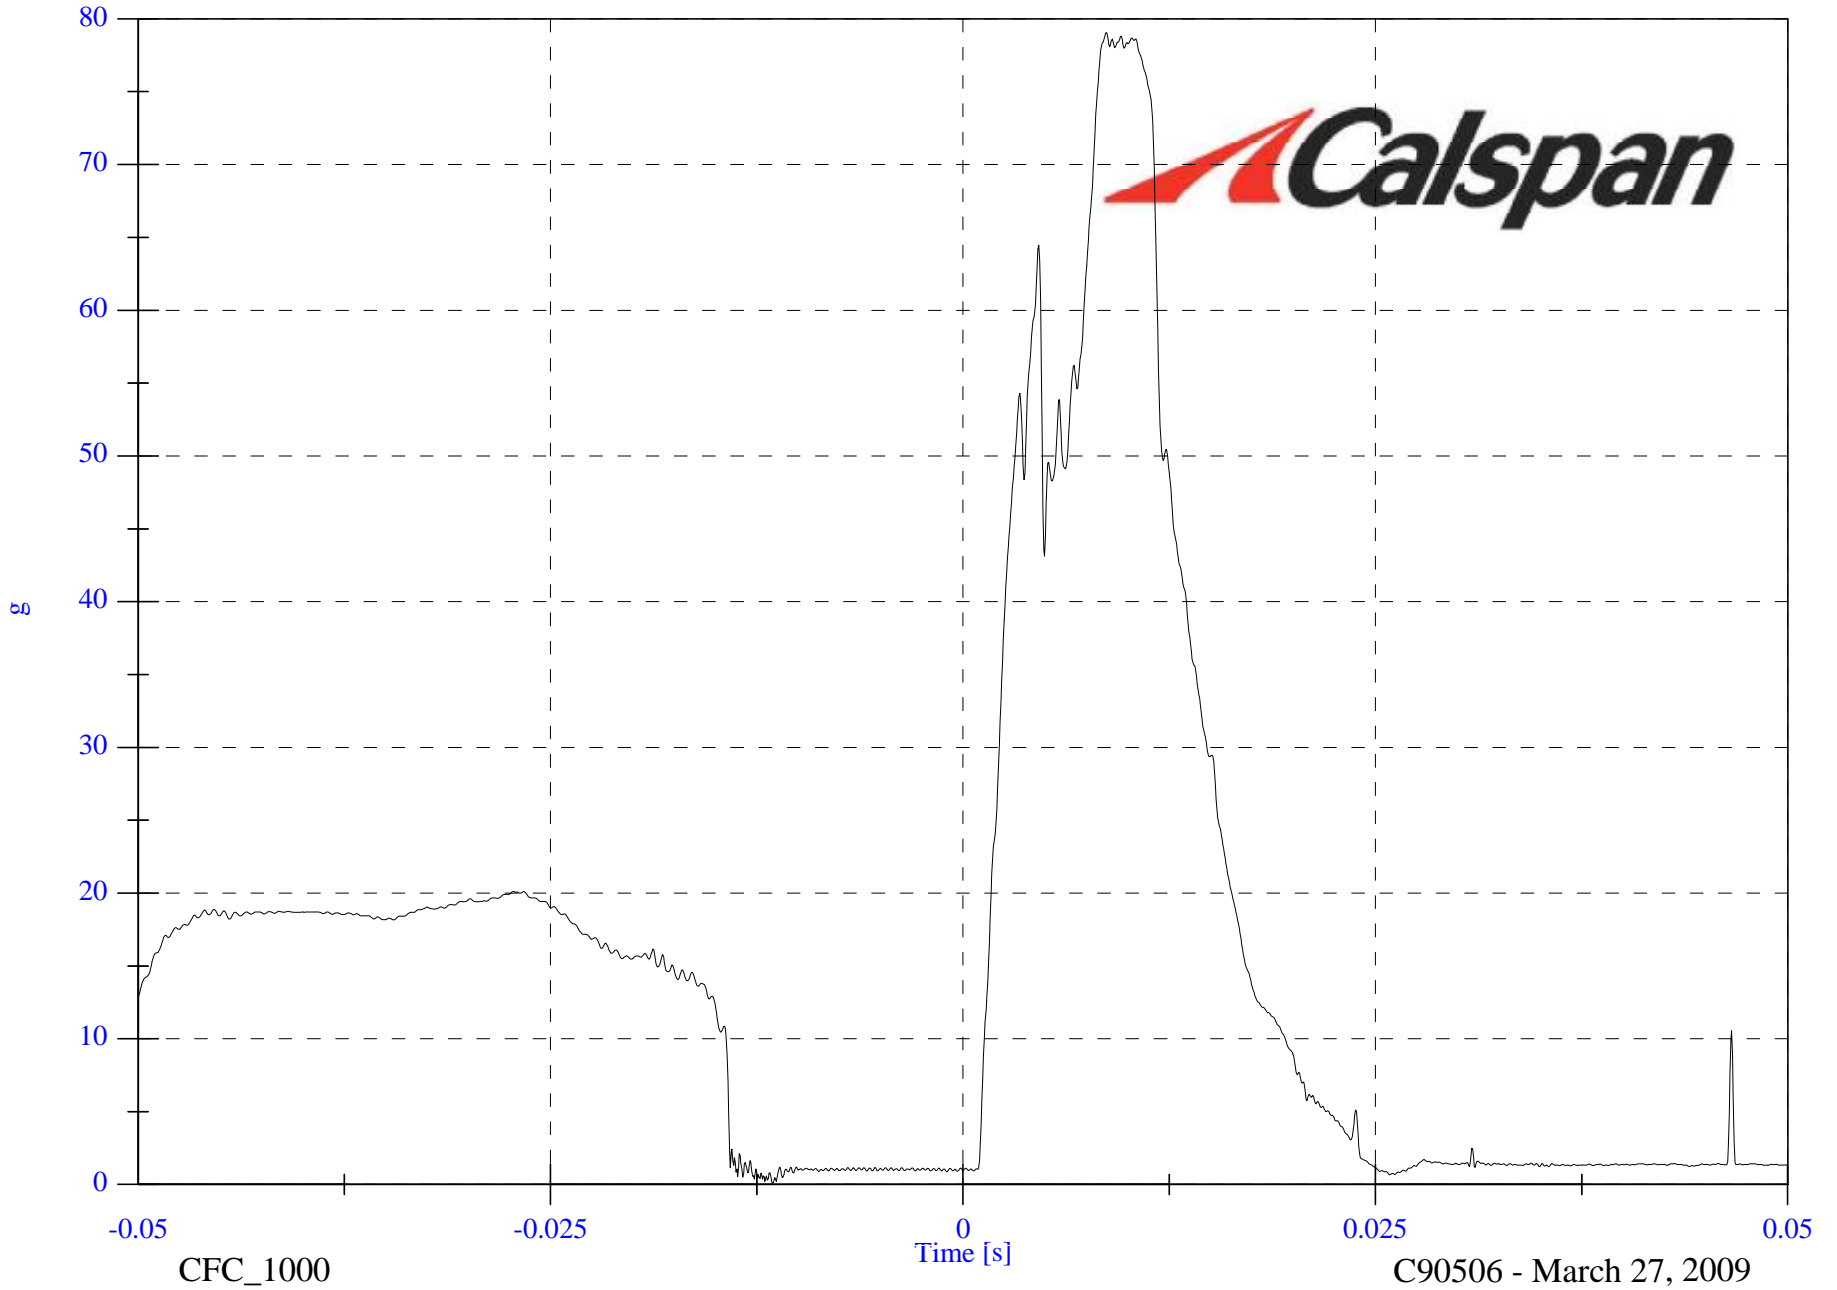
C90506 DRIVER SIDE OP2 IMPACT PLOT #4

Min: 0.1 [g] at -0.012 [s]

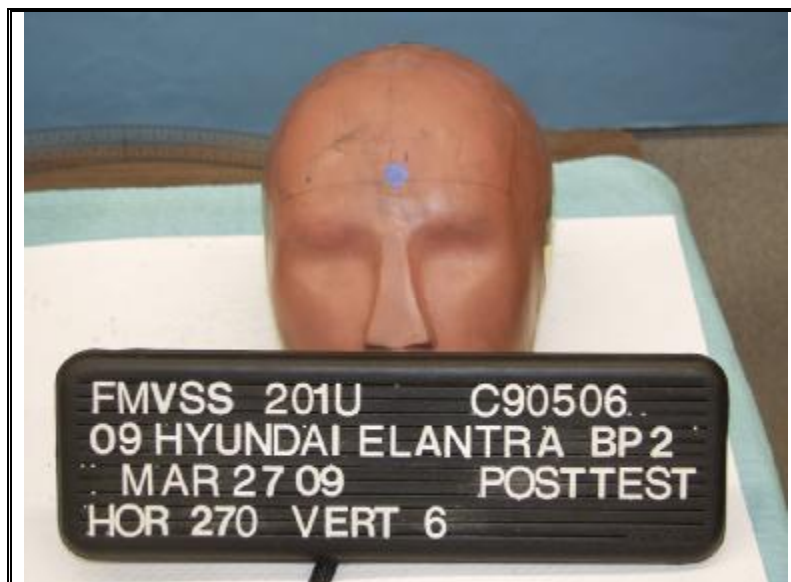
POST-IMPACT BP2 HEADFORM

Test Number:	10
Test Date:	03/27/09
Target Location:	B-PILLAR
Target Code:	BP2
Horizontal Impact Angle:	270°
Vertical Impact Angle:	6°
Ambient Temperature:	23°C
Relative Humidity:	23
Time of Impact:	10:00
Headform Number:	0805

Impact Point Description (from lower midpoint on midsagittal line)			
On Centerline	0	<input type="checkbox"/>	mm right <input type="checkbox"/> mm left
On Centerline	5		mm up

Free Motion HIC	721.7
HIC(d)	710.9
Impact Velocity (kph)	23.49
HIC T1 (msec)	3.3
HIC T2 (msec)	8.6

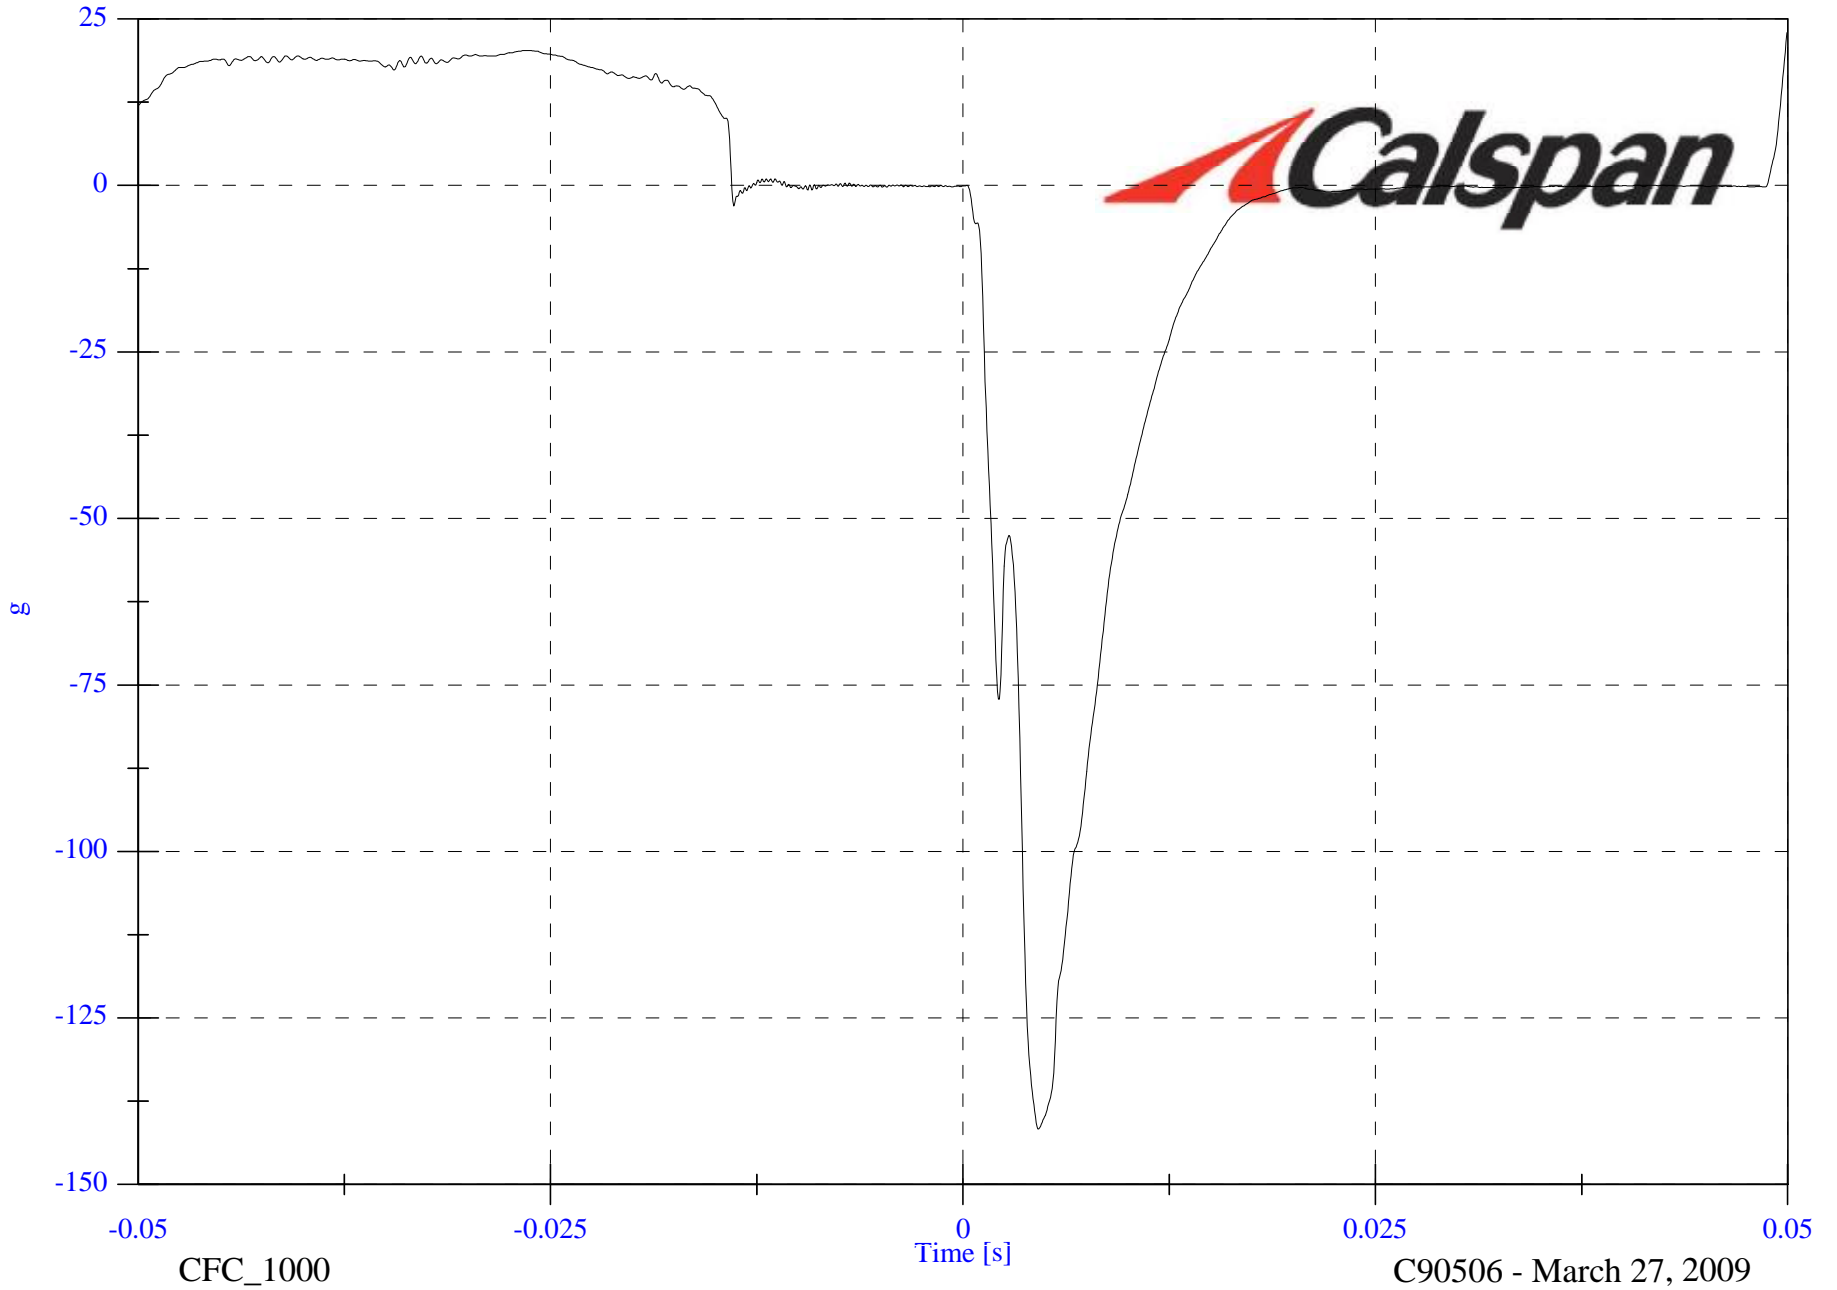
C90506 DRIVER SIDE BP2 IMPACT PLOT #1

Max: 23.0 [g] at 0.050 [s]  
Min: -141.7 [g] at 0.005 [s]

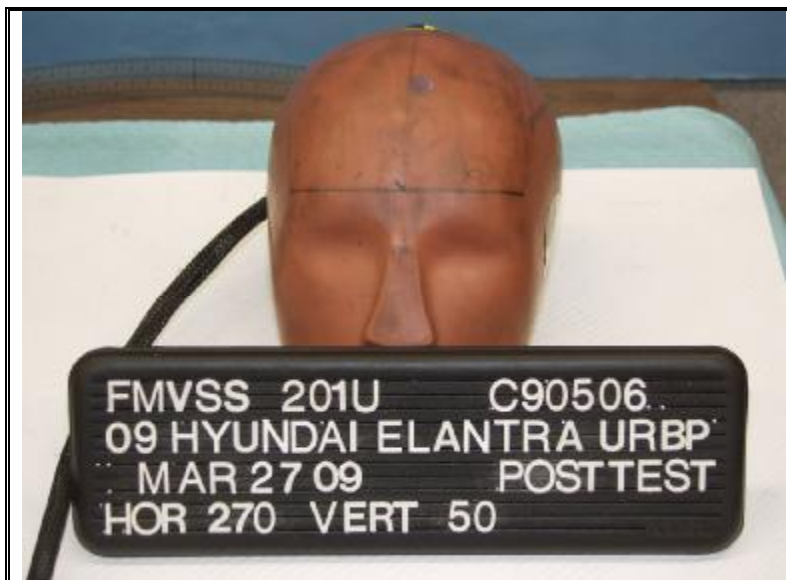
POST-IMPACT URBPHEADFORM

Test Number:	11
Test Date:	03/27/09
Target Location:	UPPER ROOF
Target Code:	URBP
Horizontal Impact Angle:	270°
Vertical Impact Angle:	50°
Ambient Temperature:	23°C
Relative Humidity:	23
Time of Impact:	10:35
Headform Number:	0062

Impact Point Description (from lower midpoint on midsagittal line)					
On Centerline	5	<input type="checkbox"/>	mm right	<input checked="" type="checkbox"/>	mm left
On Centerline	54				mm up

Free Motion HIC	726.8
HIC(d)	714.8
Impact Velocity (kph)	23.39
HIC T1 (msec)	4.5
HIC T2 (msec)	12.2

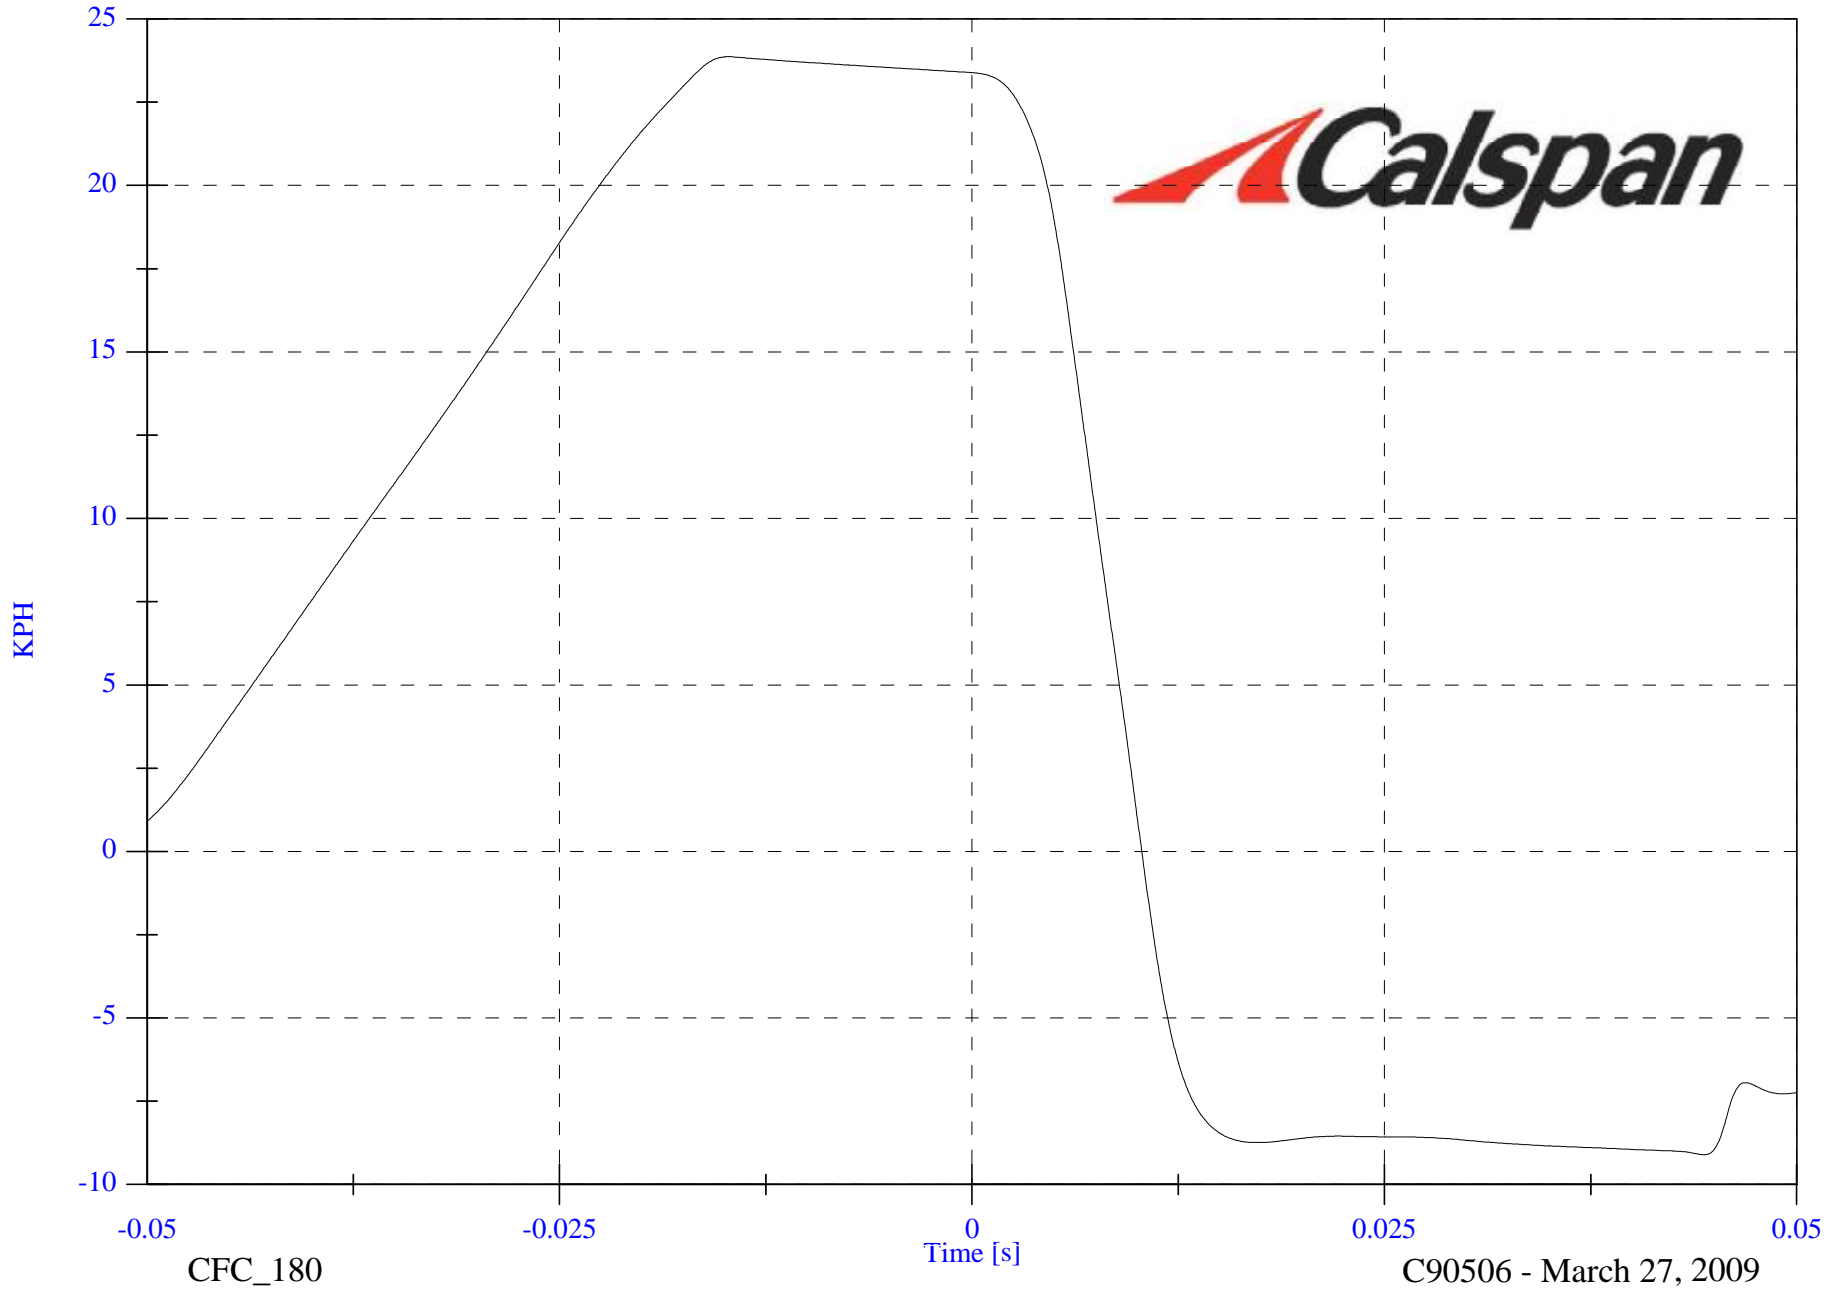
C90506 DRIVER SIDE URBP IMPACT PLOT #5

Headform Velocity

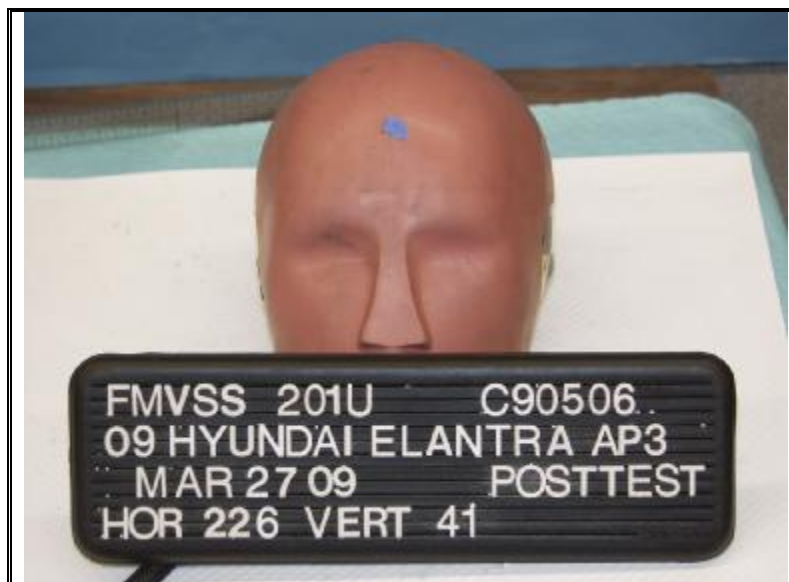
POST-IMPACT AP3 DRIV HEADFORM

Test Number:	12
Test Date:	03/27/09
Target Location:	A-PILLAR
Target Code:	AP3
Horizontal Impact Angle:	226°
Vertical Impact Angle:	41°
Ambient Temperature:	23°C
Relative Humidity:	23
Time of Impact:	12:05
Headform Number:	1142

Impact Point Description (from lower midpoint on midsagittal line)			
On Centerline	5	<input type="checkbox"/>	mm right <input checked="" type="checkbox"/> mm left
On Centerline	26		mm up

Free Motion HIC	417.9
HIC(d)	481.9
Impact Velocity (kph)	18.69
HIC T1 (msec)	6.7
HIC T2 (msec)	10.9

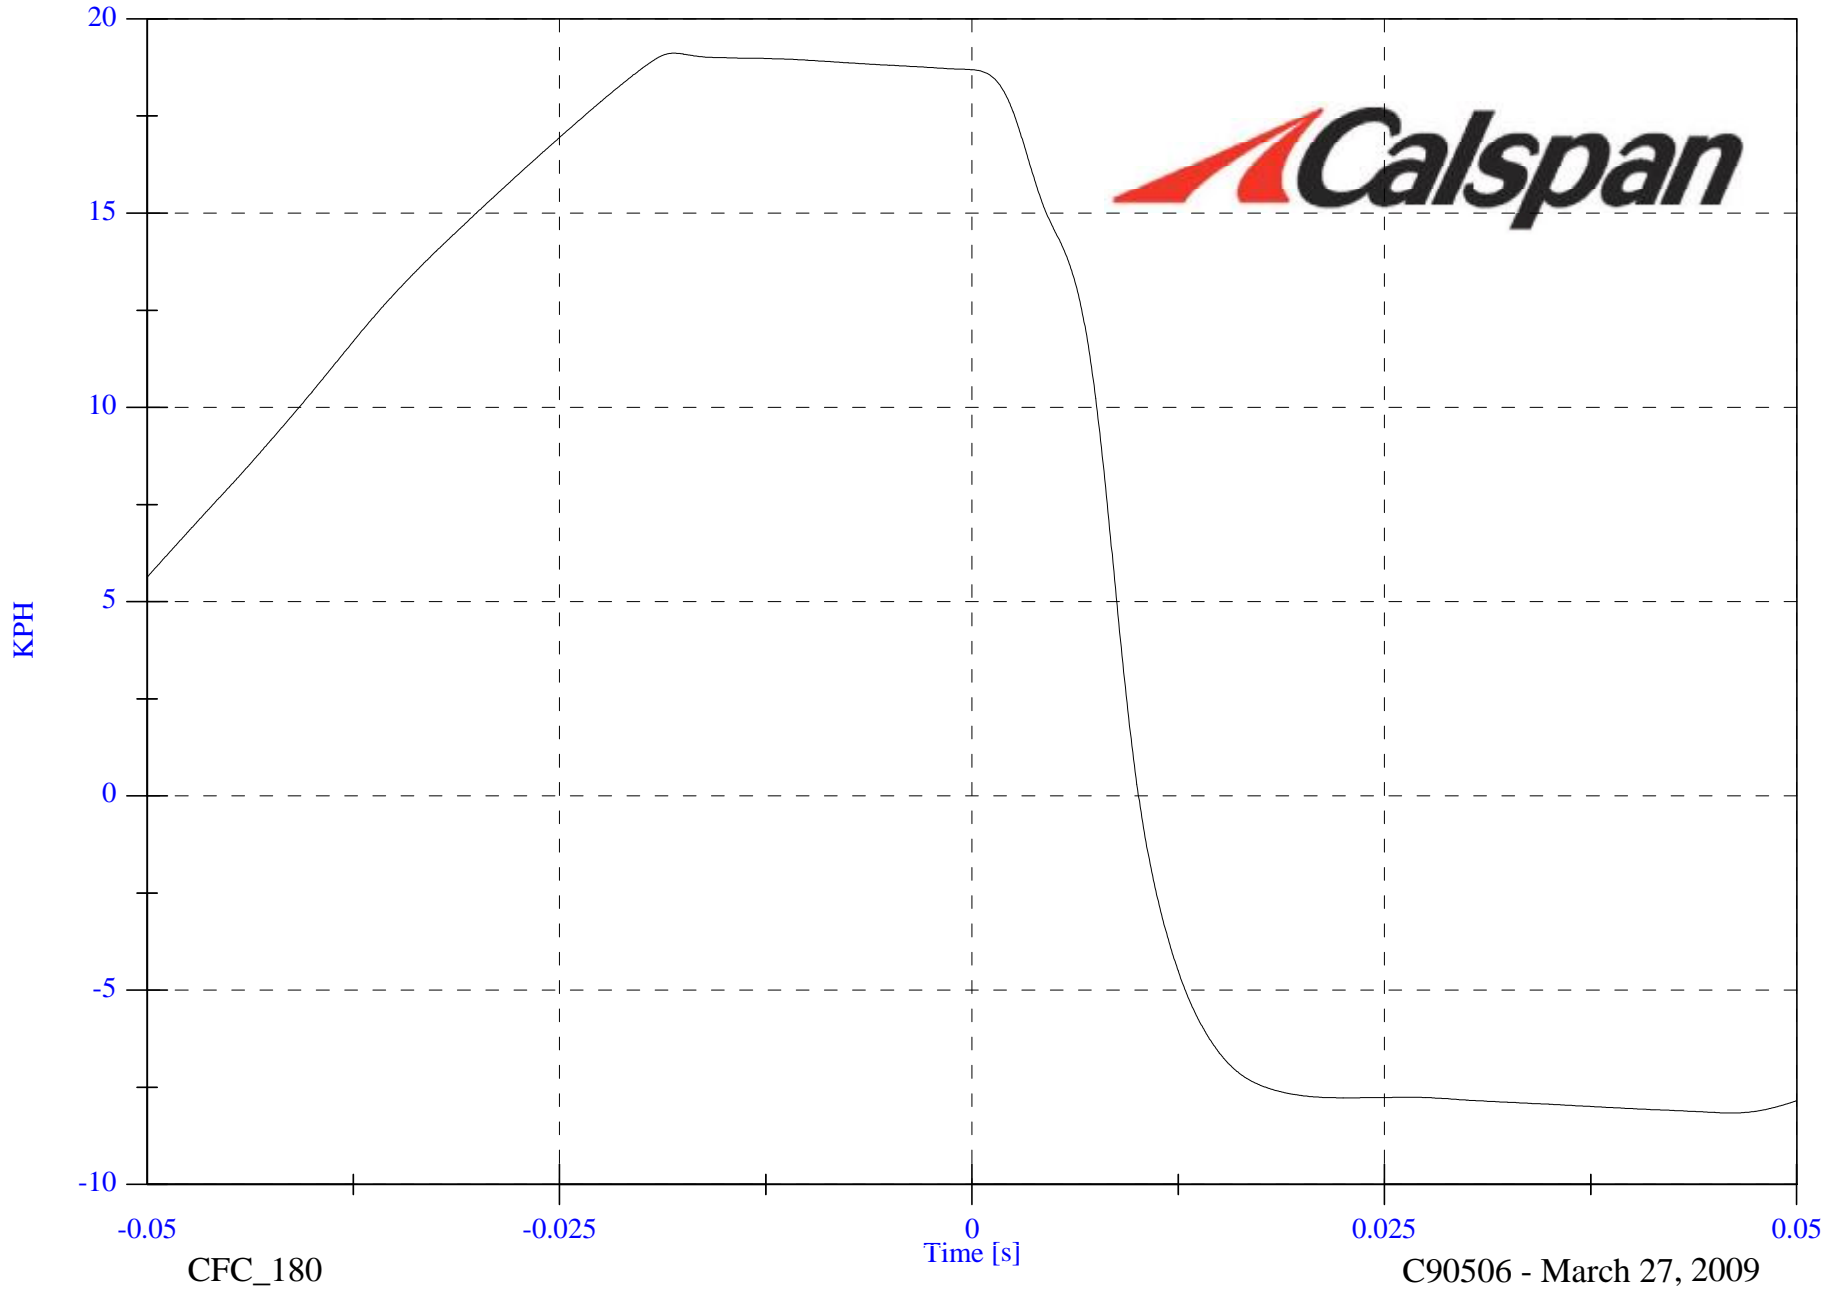
C90506 DRIVER SIDE AP3 IMPACT PLOT #5

Headform Velocity

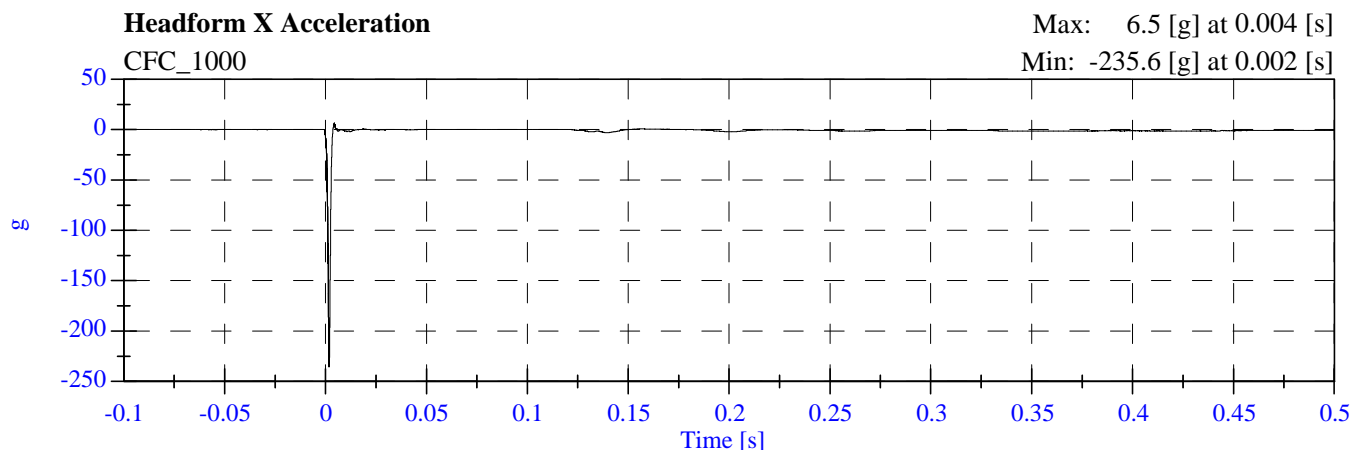
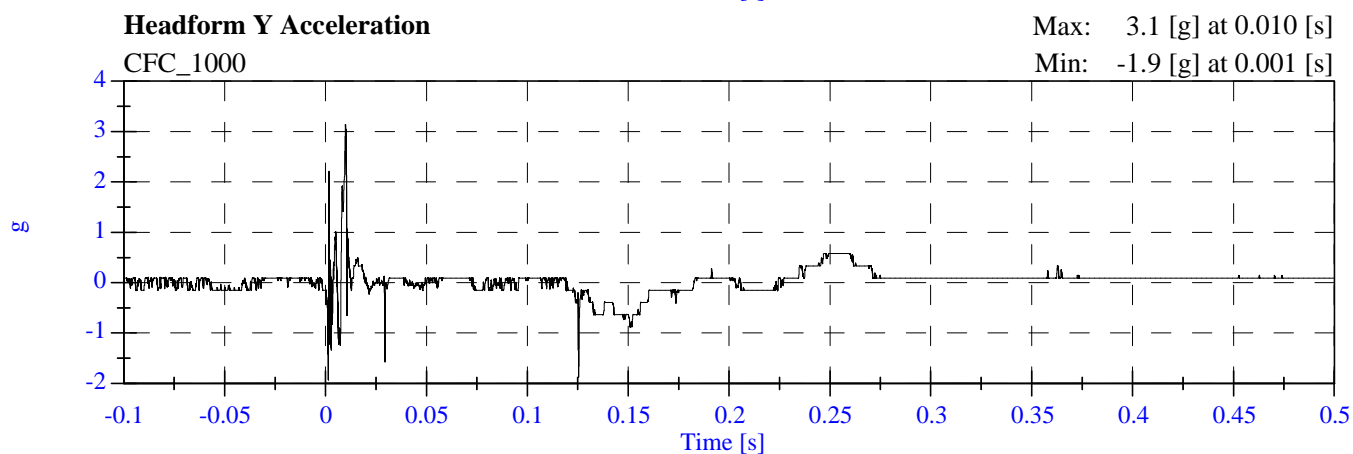
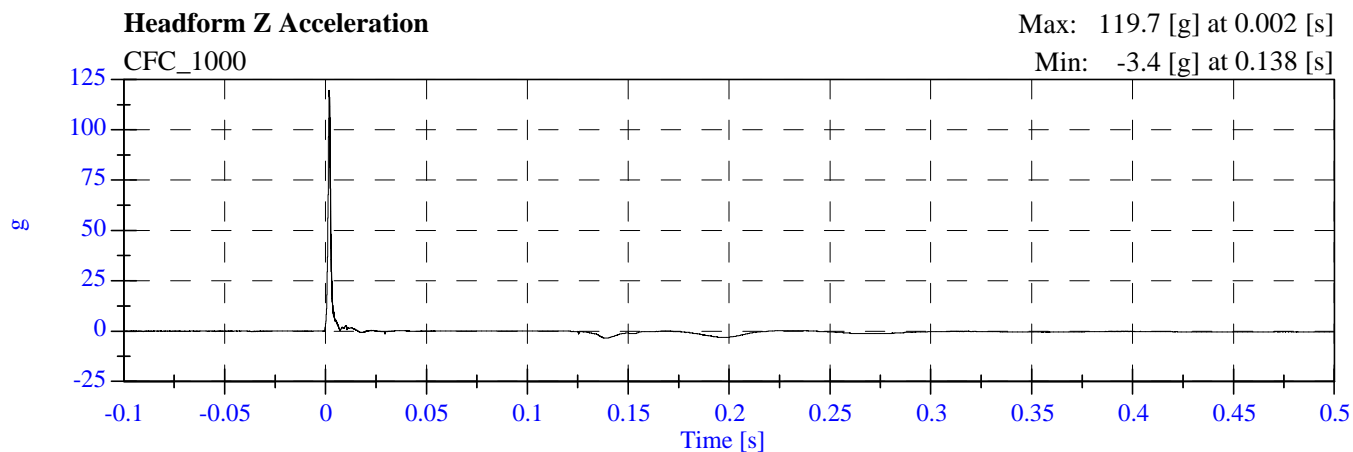
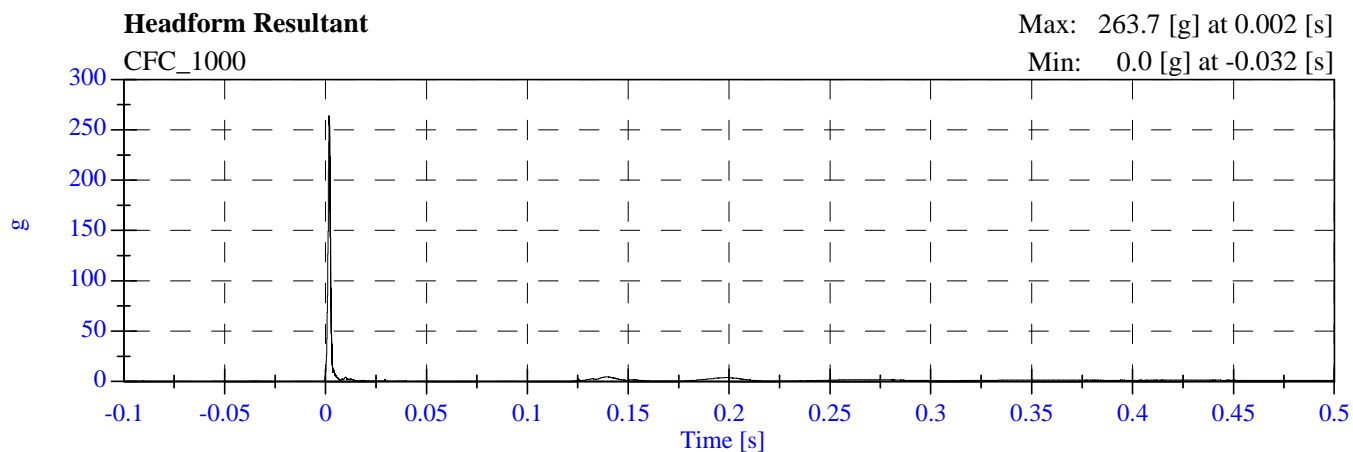
# FMVSS 201U - Headform Calibration Drops

<b>MANUFACTURER:</b>		<b>FIRST TECHNOLOGY SAFETY SYSTEMS</b>	
<b>SERIAL NUMBER:</b>		1142	
<b>CALIBRATION DATE:</b>		MARCH 16, 2009	
<b>TEST PARAMETER</b>	<b>SPECIFICATION</b>	<b>TEST RESULTS</b>	
TEMPERATURE	19°C to 26°C	21	
RELATIVE HUMIDITY	10% to 70%	24	
PEAK RESULTANT ACCELERATION	225 Gs to 275 Gs	263.7	
PEAK LATERAL ACCELERATION	15 Gs Maximum	3.1	
IS ACCELERATION CURVE UNIMODAL?	YES	YES

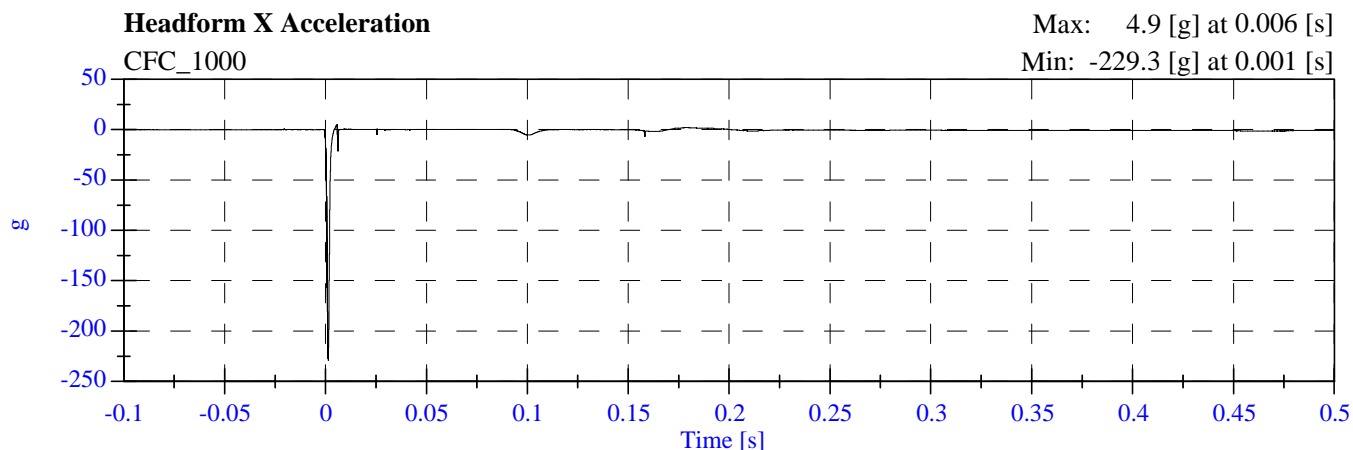
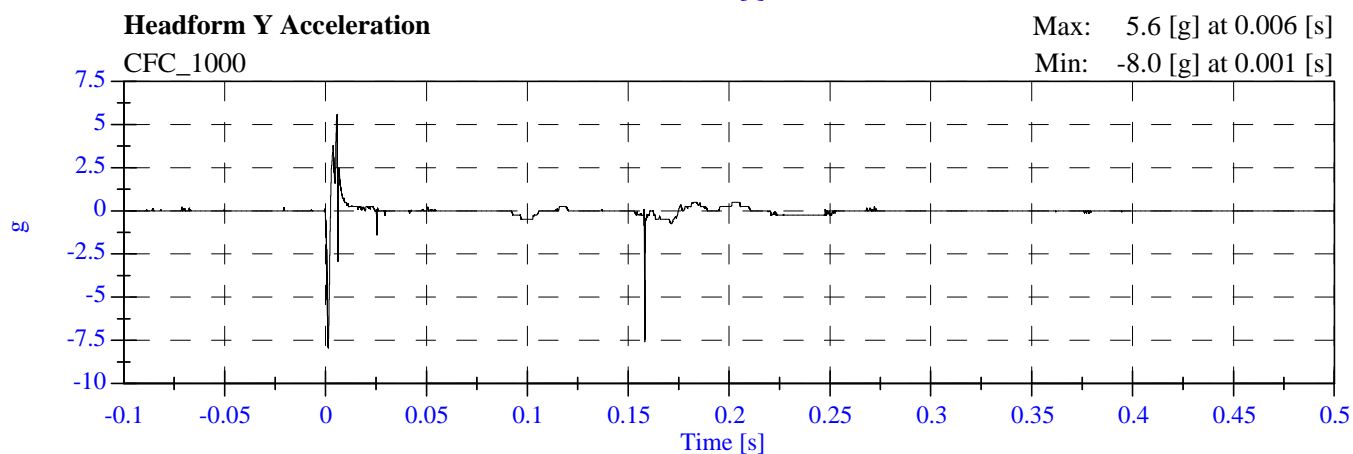
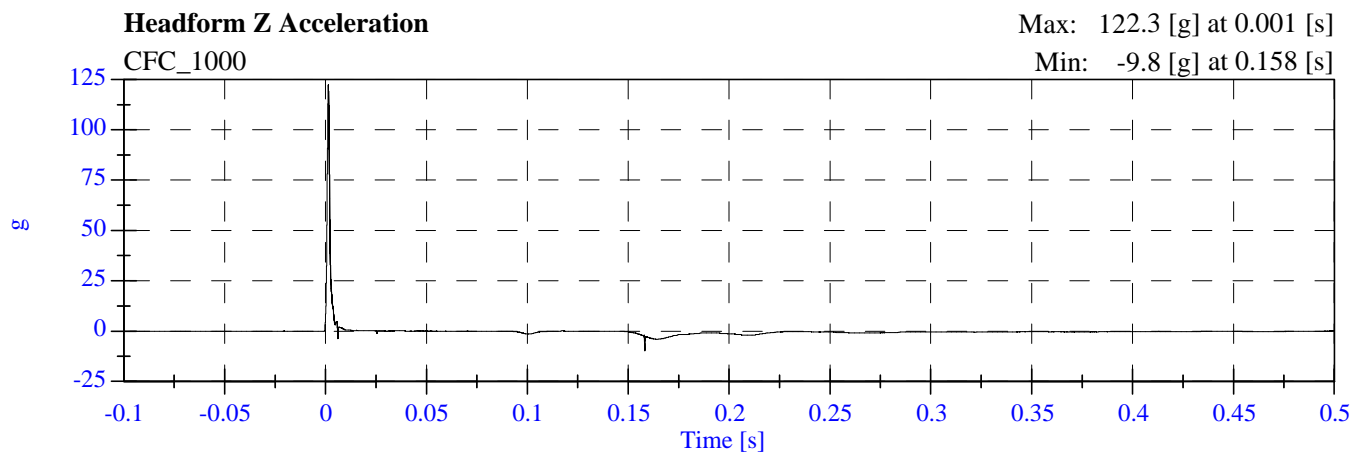
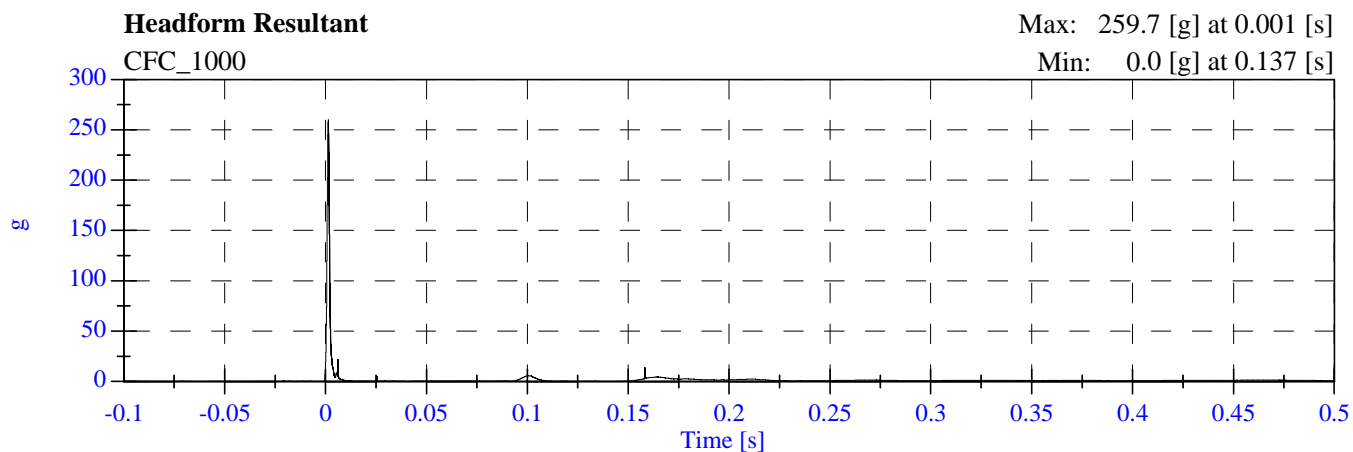
<b>MANUFACTURER:</b>		<b>DENTON ATD INC.</b>	
<b>SERIAL NUMBER:</b>		<b>0062</b>	
<b>CALIBRATION DATE:</b>		<b>MARCH 16, 2009</b>	
<b>TEST PARAMETER</b>	<b>SPECIFICATION</b>	<b>TEST RESULTS</b>	
<b>TEMPERATURE</b>	<b>19°C to 26°C</b>	<b>21</b>	
<b>RELATIVE HUMIDITY</b>	<b>10% to 70%</b>	<b>24</b>	
<b>PEAK RESULTANT ACCELERATION</b>	<b>225 Gs to 275 Gs</b>	<b>259.7</b>	
<b>PEAK LATERAL ACCELERATION</b>	<b>15 Gs Maximum</b>	<b>8.0</b>	
<b>IS ACCELERATION CURVE UNIMODAL?</b>	<b>YES</b>	<b>YES</b>
