REPORT NUMBER: 201UI-CAL-09-07

**SAFETY COMPLIANCE TESTING FOR FMVSS 201  
OCCUPANT PROTECTION IN INTERIOR IMPACT  
UPPER INTERIOR HEAD IMPACT PROTECTION**

**HYUNDAI MOTOR COMPANY  
2009 HYUNDAI ELANTRA**

NHTSA NUMBER: C90506

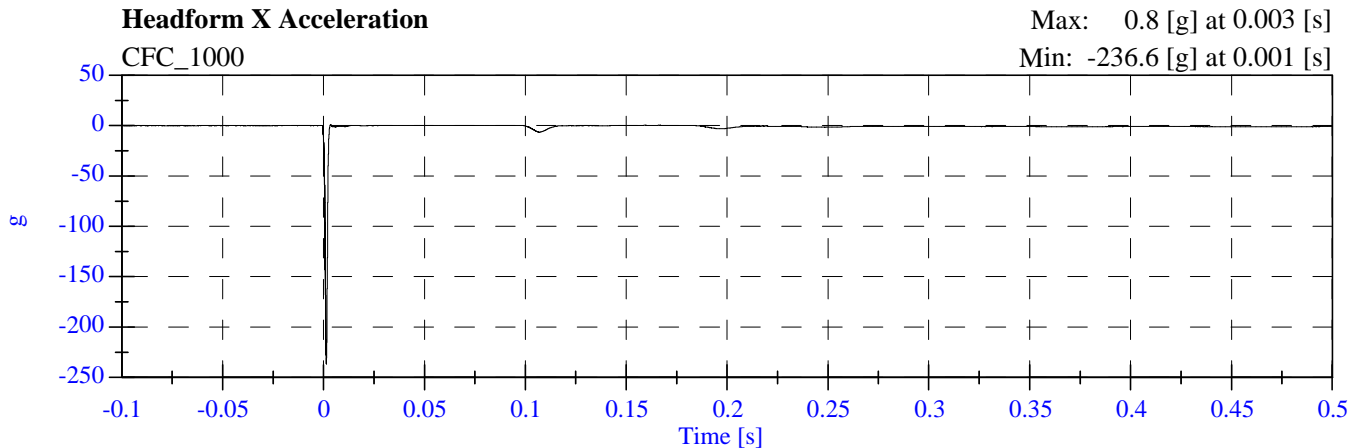
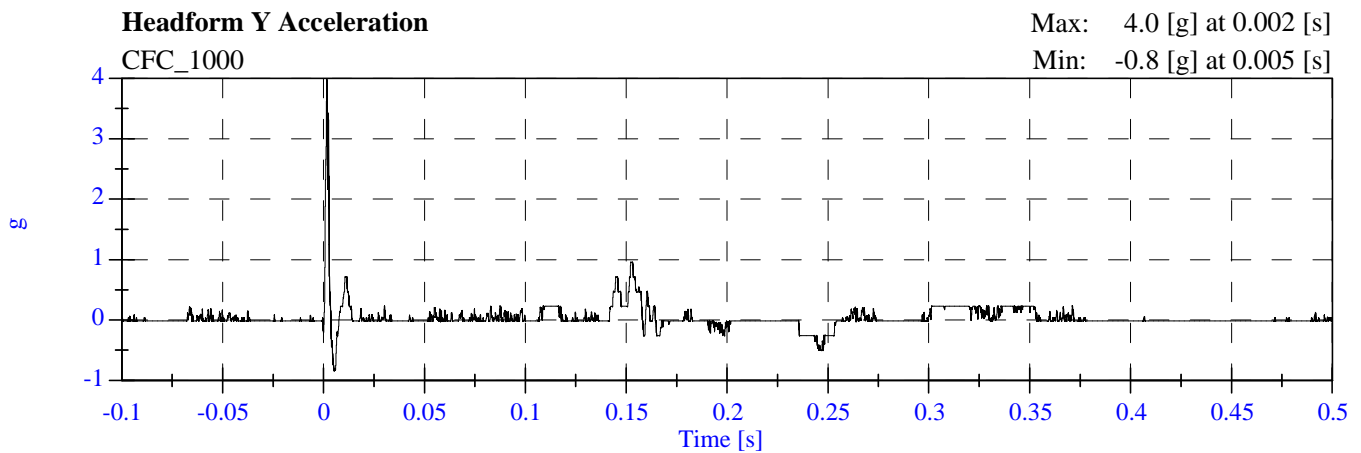
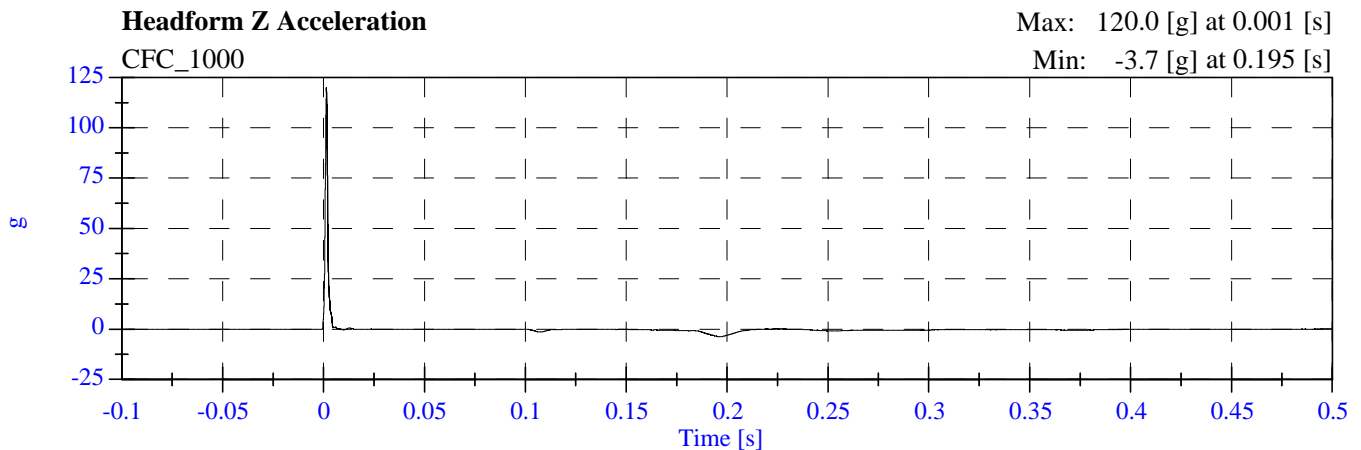
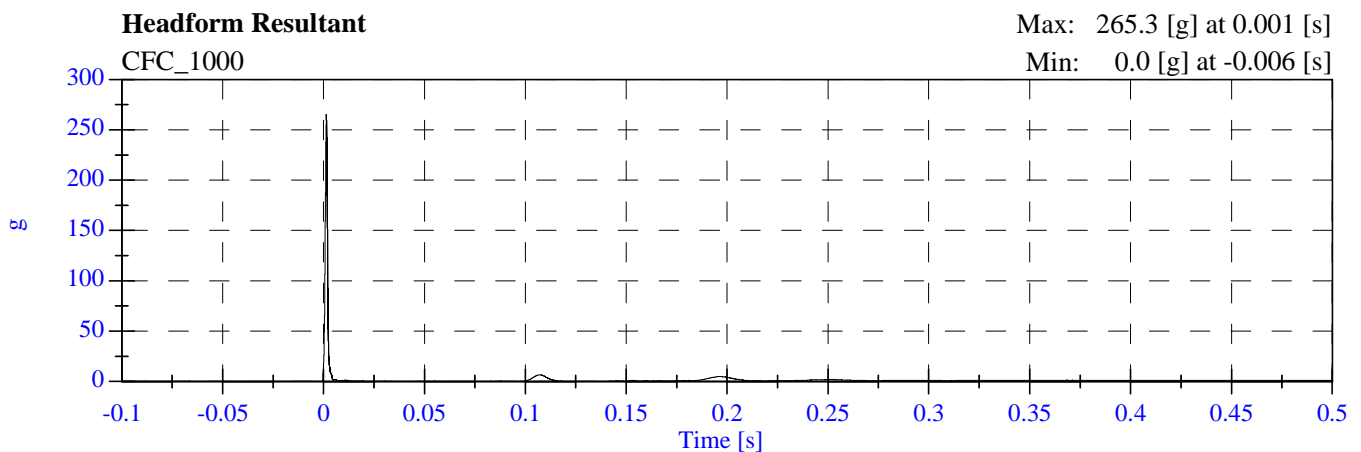
<b>MANUFACTURER:</b>		<b>FIRST TECHNOLOGY SAFETY SYSTEMS</b>	
<b>SERIAL NUMBER:</b>		<b>805</b>	
<b>CALIBRATION DATE:</b>		<b>MARCH 16, 2009</b>	
<b>TEST PARAMETER</b>	<b>SPECIFICATION</b>	<b>TEST RESULTS</b>	
<b>TEMPERATURE</b>	<b>19°C to 26°C</b>	<b>21</b>	
<b>RELATIVE HUMIDITY</b>	<b>10% to 70%</b>	<b>24</b>	
<b>PEAK RESULTANT ACCELERATION</b>	<b>225 Gs to 275 Gs</b>	<b>265.3</b>	
<b>PEAK LATERAL ACCELERATION</b>	<b>15 Gs Maximum</b>	<b>4.0</b>	
<b>IS ACCELERATION CURVE UNIMODAL?</b>	<b>YES</b>	<b>YES</b>

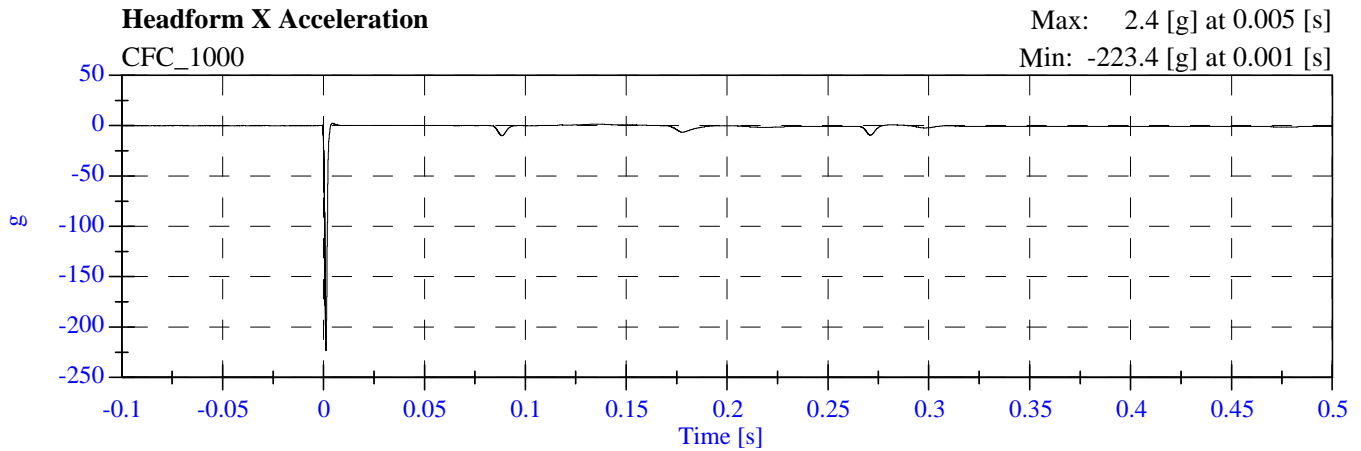
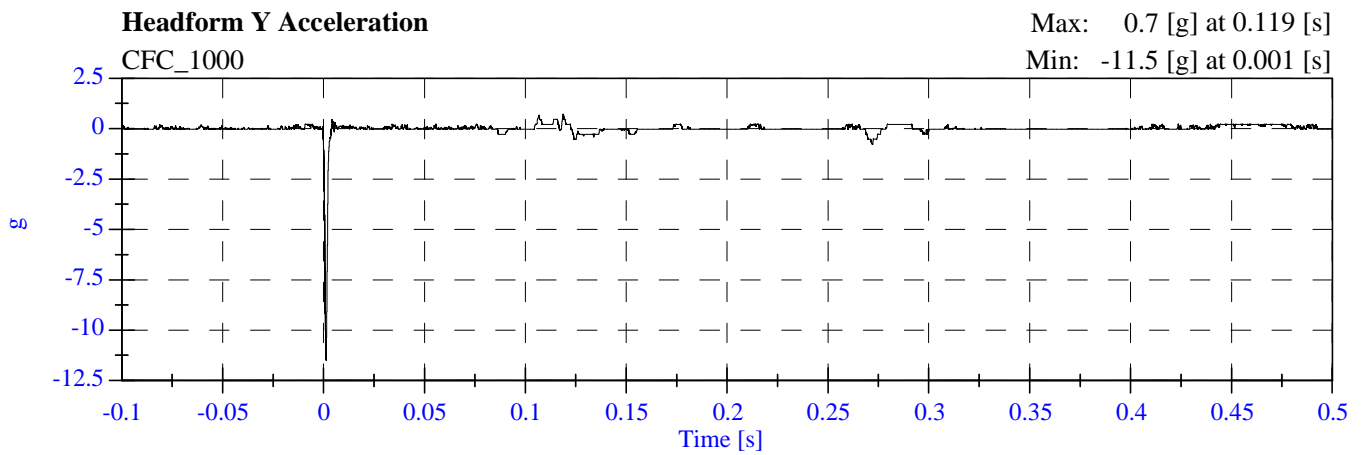
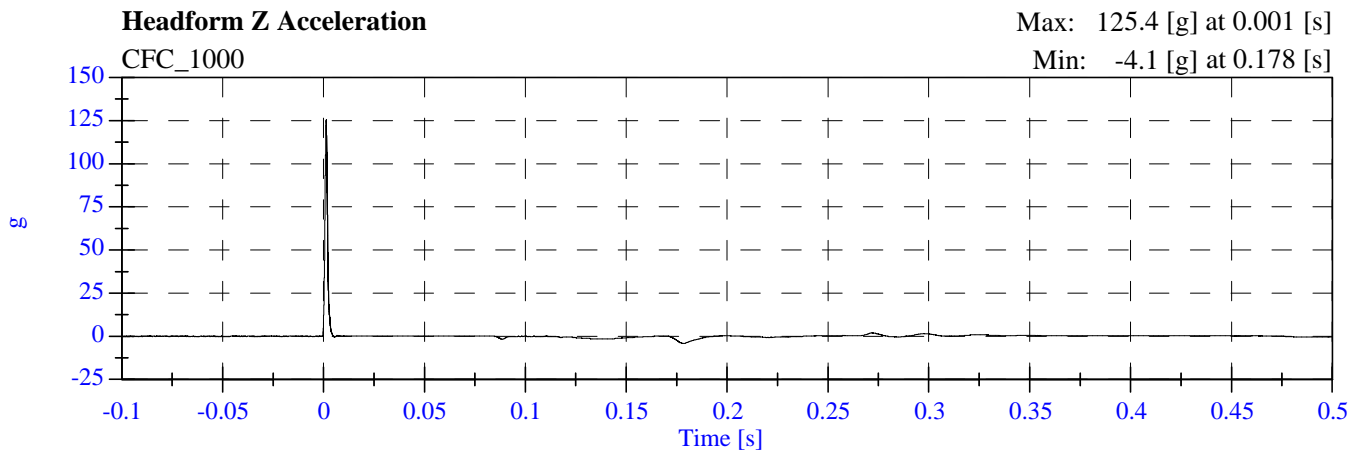
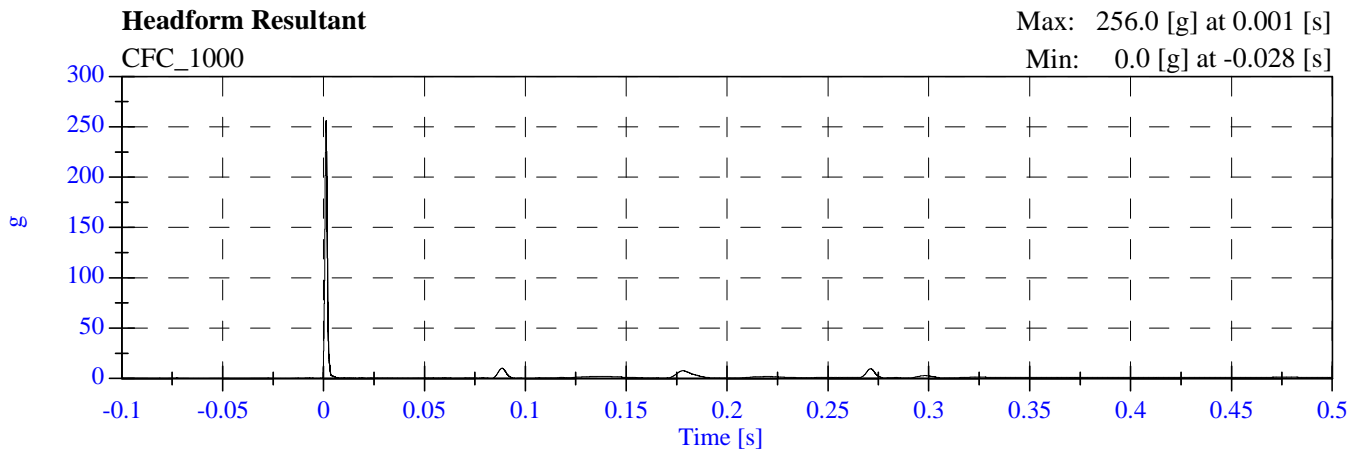
<b>MANUFACTURER:</b>		<b>DENTON ATD INC.</b>	
<b>SERIAL NUMBER:</b>		<b>0355</b>	
<b>CALIBRATION DATE:</b>		<b>MARCH 16, 2009</b>	
<b>TEST PARAMETER</b>	<b>SPECIFICATION</b>	<b>TEST RESULTS</b>	
<b>TEMPERATURE</b>	<b>19°C to 26°C</b>	<b>21</b>	
<b>RELATIVE HUMIDITY</b>	<b>10% to 70%</b>	<b>24</b>	
<b>PEAK RESULTANT ACCELERATION</b>	<b>225 Gs to 275 Gs</b>	<b>256.0</b>	
<b>PEAK LATERAL ACCELERATION</b>	<b>15 Gs Maximum</b>	<b>11.5</b>	
<b>IS ACCELERATION CURVE UNIMODAL?</b>	<b>YES</b>	<b>YES</b>

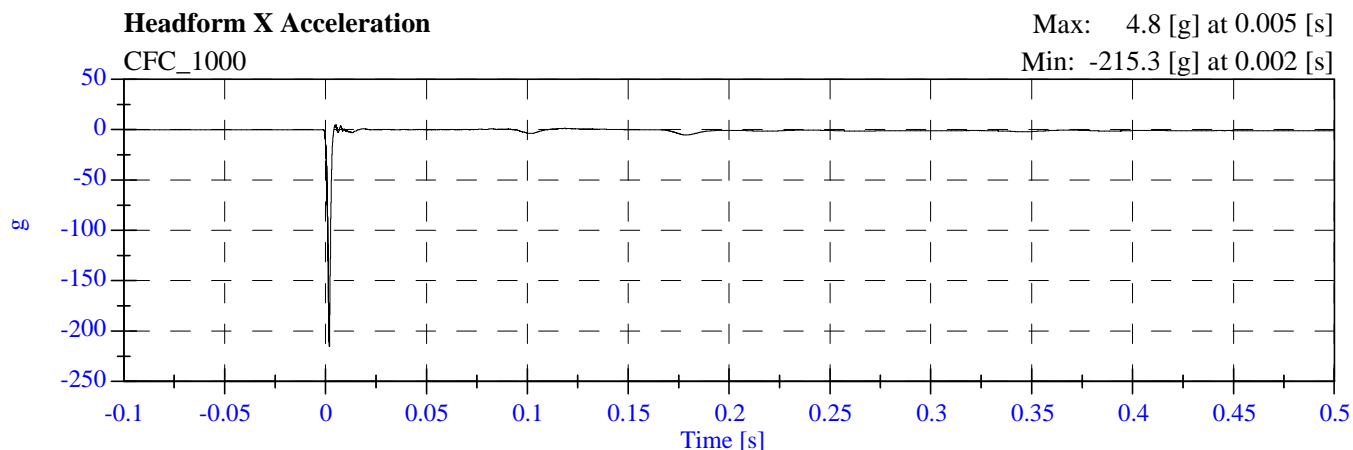
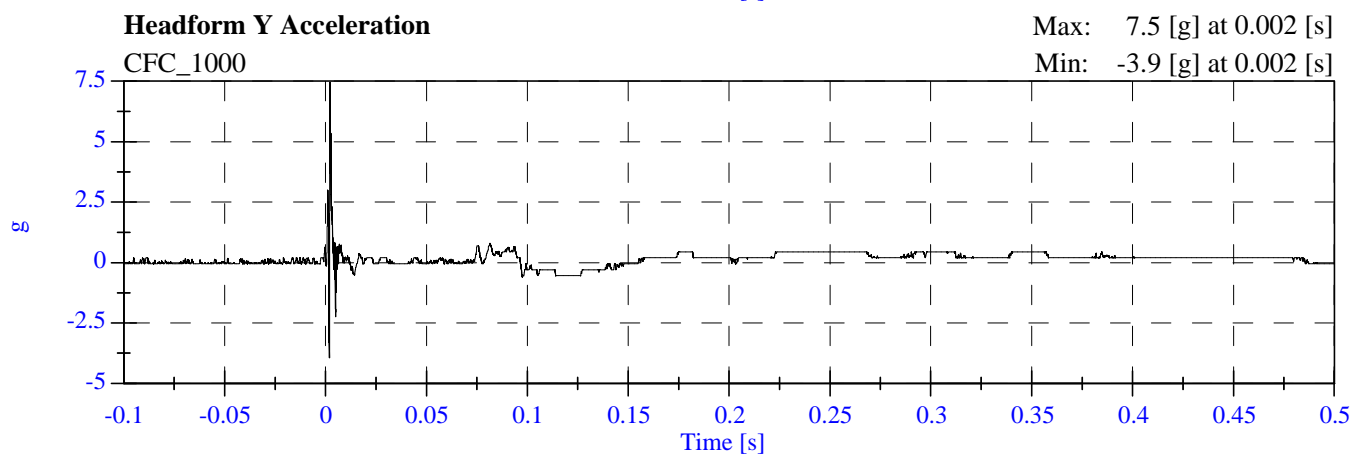
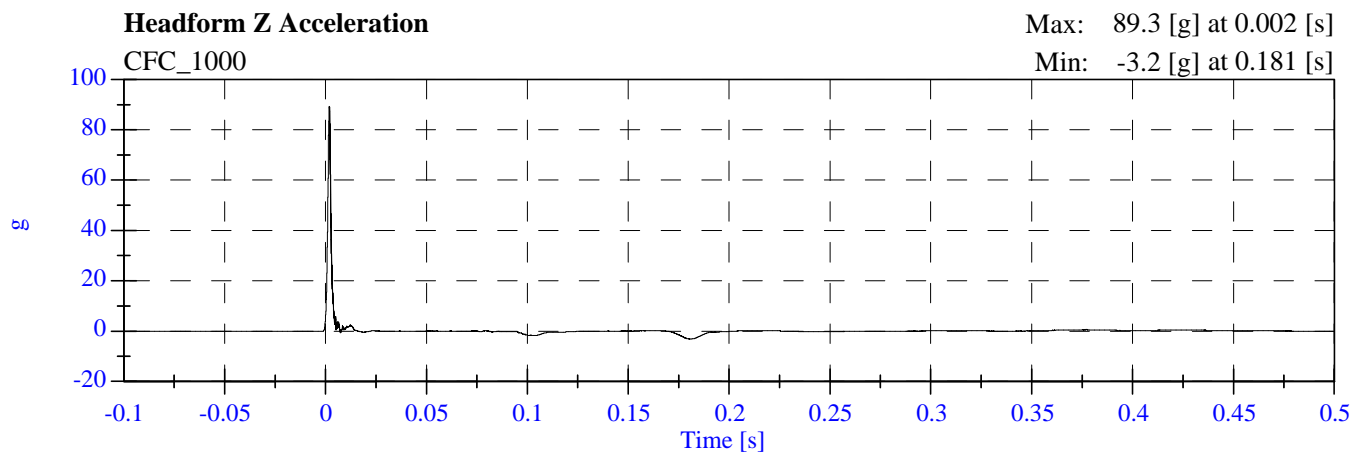
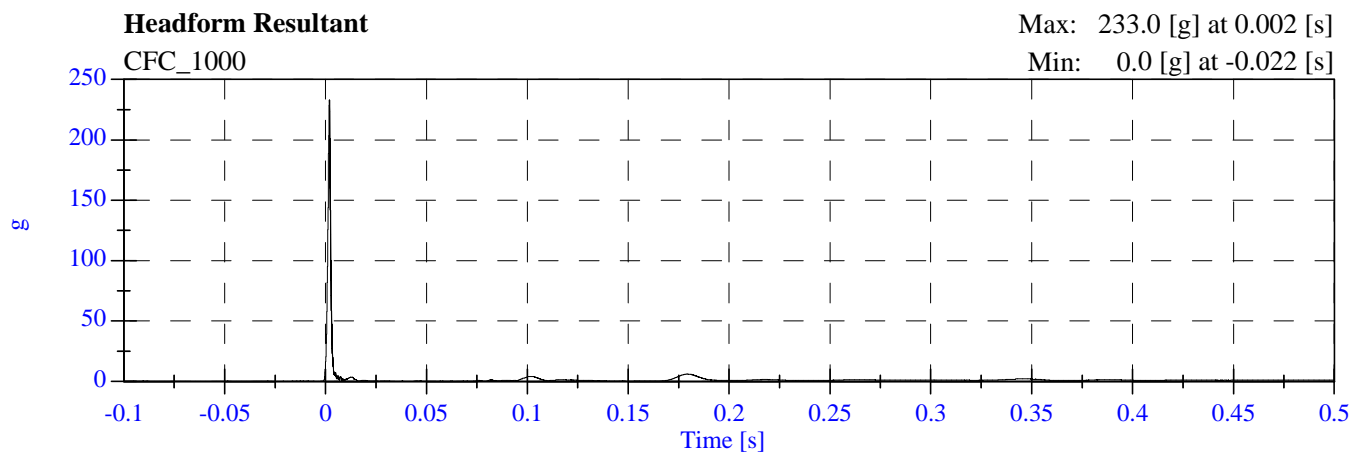
<b>MANUFACTURER:</b>		<b>FIRST TECHNOLOGY SAFETY SYSTEMS</b>	
<b>SERIAL NUMBER:</b>		<b>1140</b>	
<b>CALIBRATION DATE:</b>		<b>MARCH 16, 2009</b>	
<b>TEST PARAMETER</b>	<b>SPECIFICATION</b>	<b>TEST RESULTS</b>	
<b>TEMPERATURE</b>	<b>19°C to 26°C</b>	<b>21</b>	
<b>RELATIVE HUMIDITY</b>	<b>10% to 70%</b>	<b>24</b>	
<b>PEAK RESULTANT ACCELERATION</b>	<b>225 Gs to 275 Gs</b>	<b>233.0</b>	
<b>PEAK LATERAL ACCELERATION</b>	<b>15 Gs Maximum</b>	<b>7.5</b>	
<b>IS ACCELERATION CURVE UNIMODAL?</b>	<b>YES</b>	<b>YES</b>

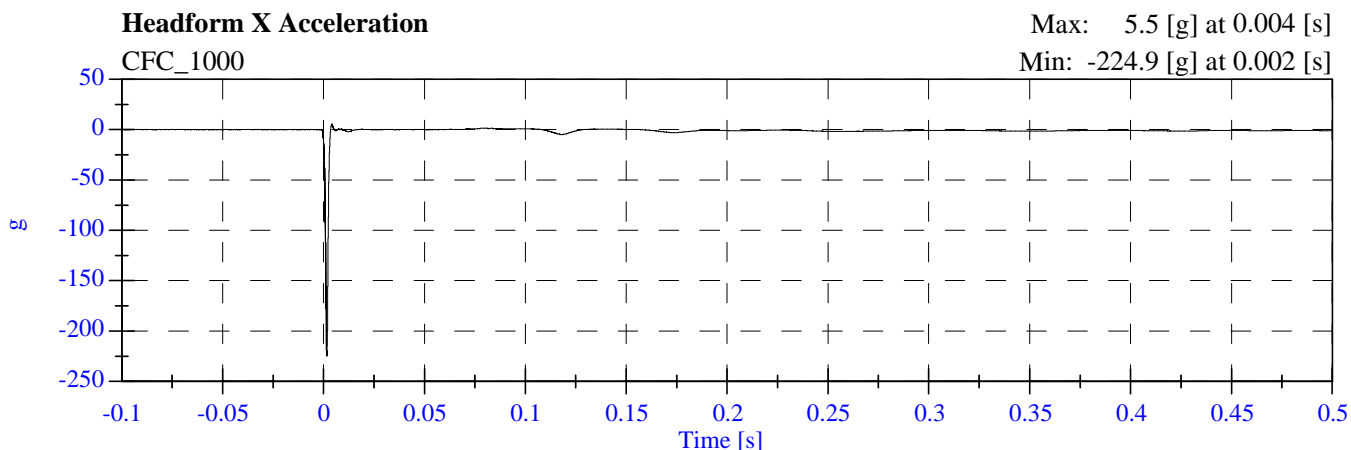
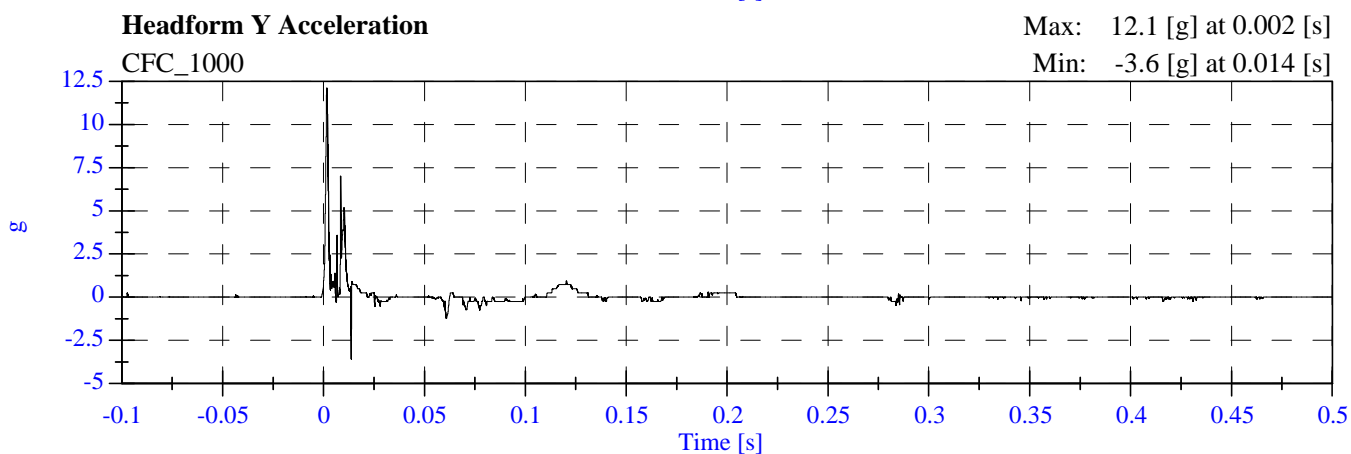
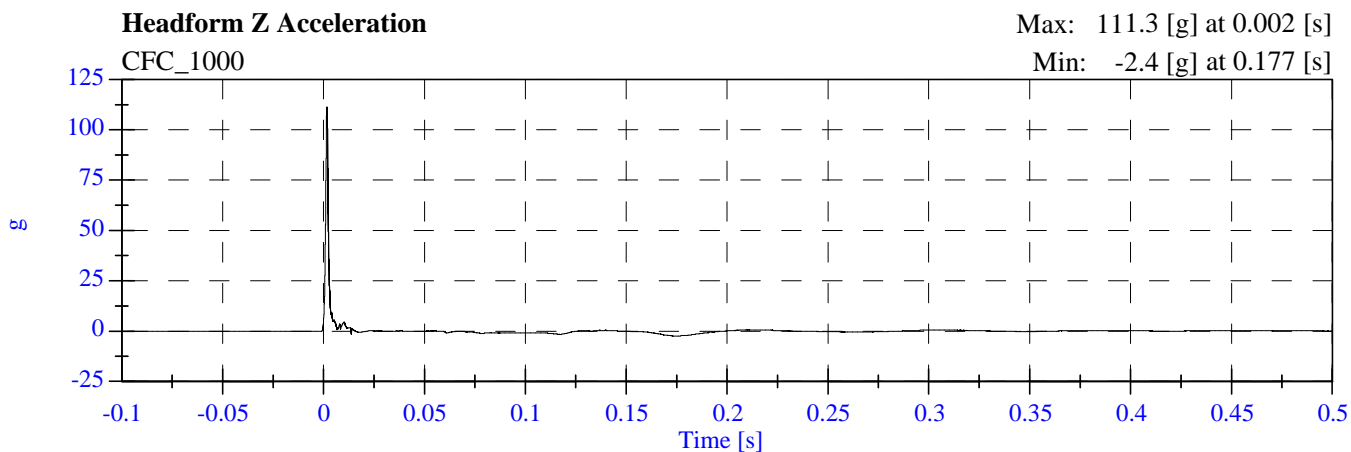
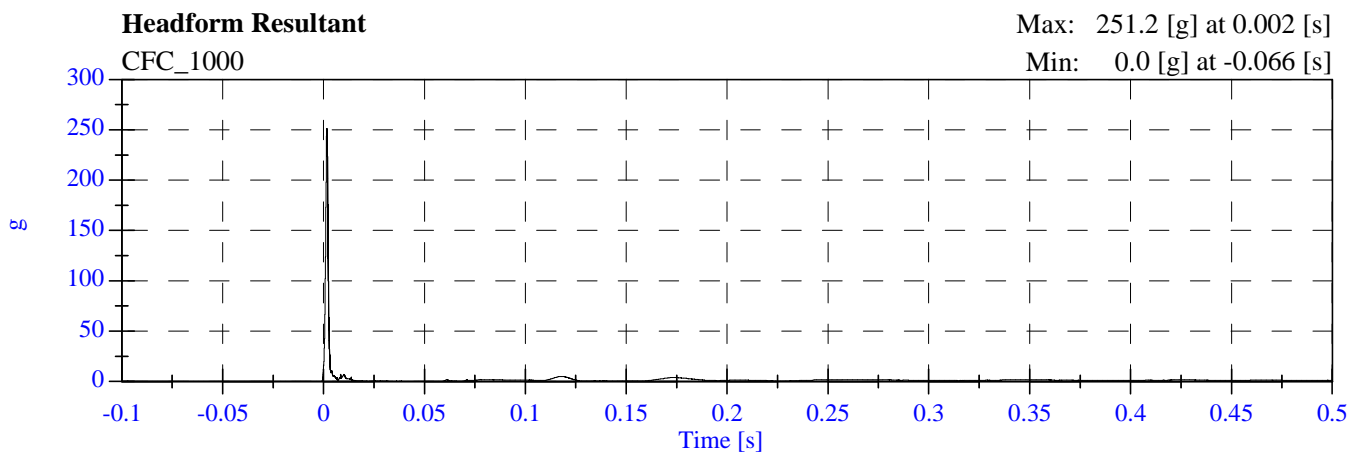
<b>MANUFACTURER:</b>		<b>FIRST TECHNOLOGY SAFETY SYSTEMS</b>
<b>SERIAL NUMBER:</b>		<b>1142</b>
<b>CALIBRATION DATE:</b>		<b>March 31,2009</b>
<b>TEST PARAMETER</b>	<b>SPECIFICATION</b>	<b>TEST RESULTS</b>
<b>TEMPERATURE</b>	<b>19°C to 26°C</b>	<b>22</b>
<b>RELATIVE HUMIDITY</b>	<b>10% to 70%</b>	<b>24</b>
<b>PEAK RESULTANT ACCELERATION</b>	<b>225 Gs to 275 Gs</b>	<b>251.2</b>
<b>PEAK LATERAL ACCELERATION</b>	<b>15 Gs Maximum</b>	<b>12.1</b>
<b>IS ACCELERATION CURVE UNIMODAL?</b>	<b>YES</b>	<b>YES</b>

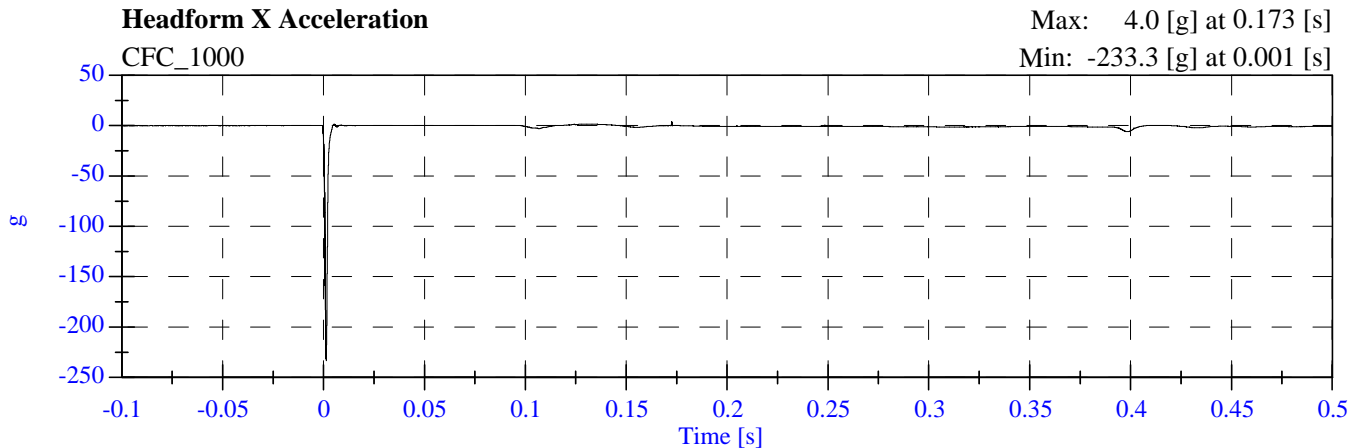
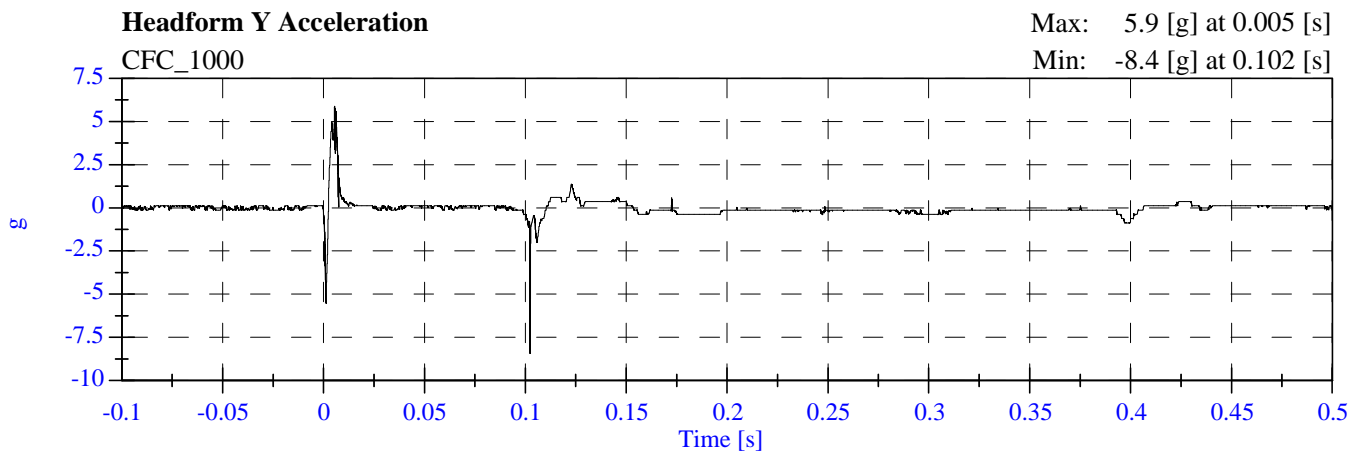
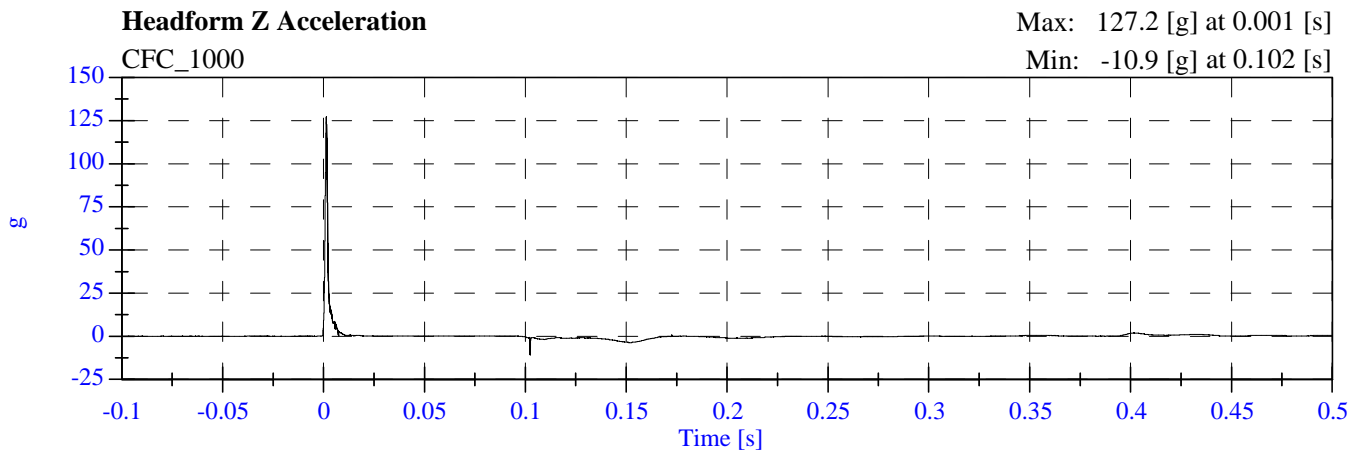
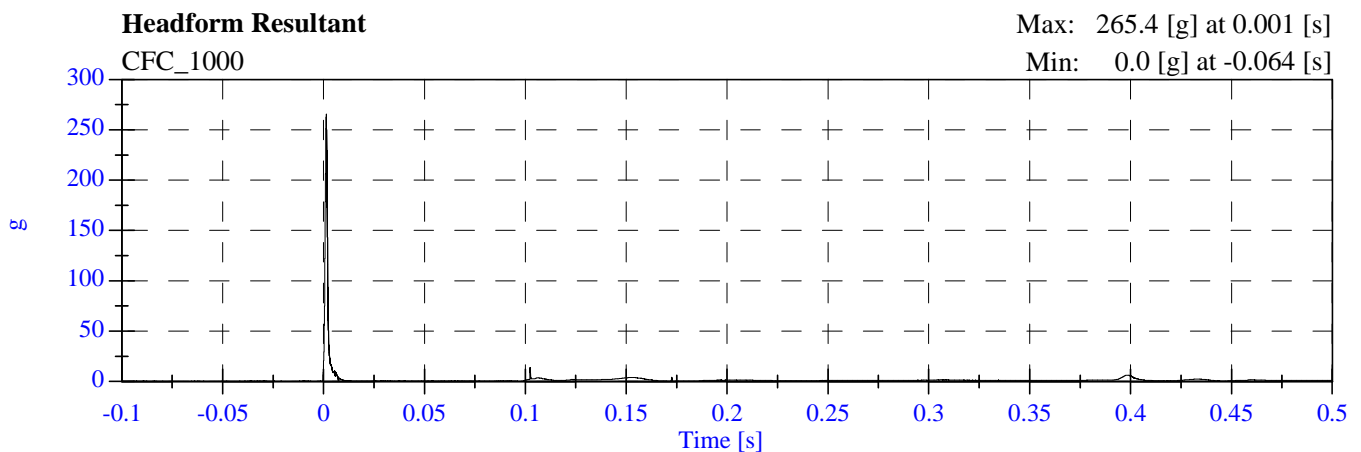
<b>MANUFACTURER:</b>		<b>DENTON ATD INC.</b>	
<b>SERIAL NUMBER:</b>		<b>0062</b>	
<b>CALIBRATION DATE:</b>		<b>March 31,2009</b>	
<b>TEST PARAMETER</b>	<b>SPECIFICATION</b>	<b>TEST RESULTS</b>	
<b>TEMPERATURE</b>	<b>19°C to 26°C</b>	<b>22</b>	
<b>RELATIVE HUMIDITY</b>	<b>10% to 70%</b>	<b>24</b>	
<b>PEAK RESULTANT ACCELERATION</b>	<b>225 Gs to 275 Gs</b>	<b>265.4</b>	
<b>PEAK LATERAL ACCELERATION</b>	<b>15 Gs Maximum</b>	<b>8.5</b>	
<b>IS ACCELERATION CURVE UNIMODAL?</b>	<b>YES</b>	<b>YES</b>

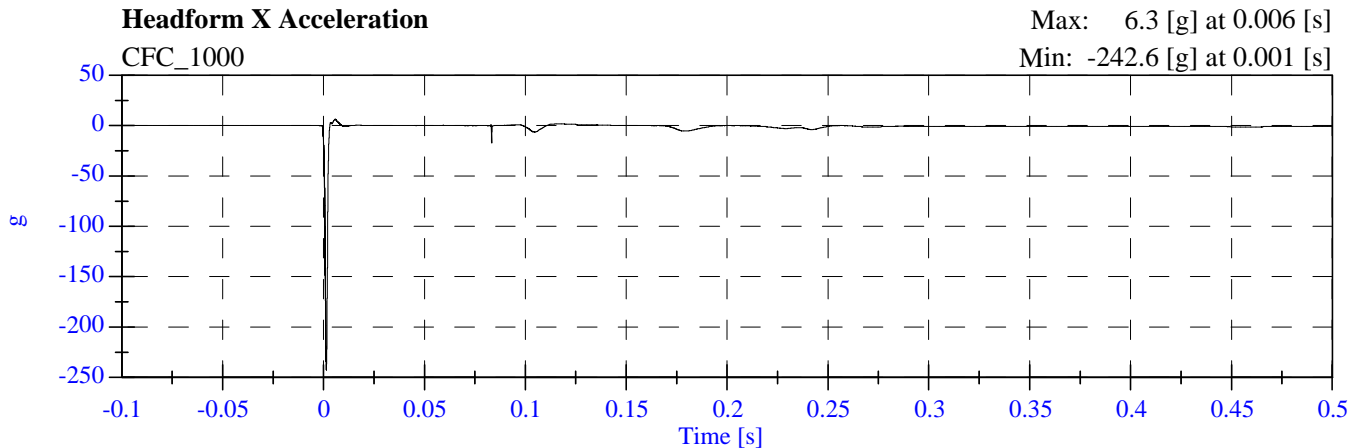
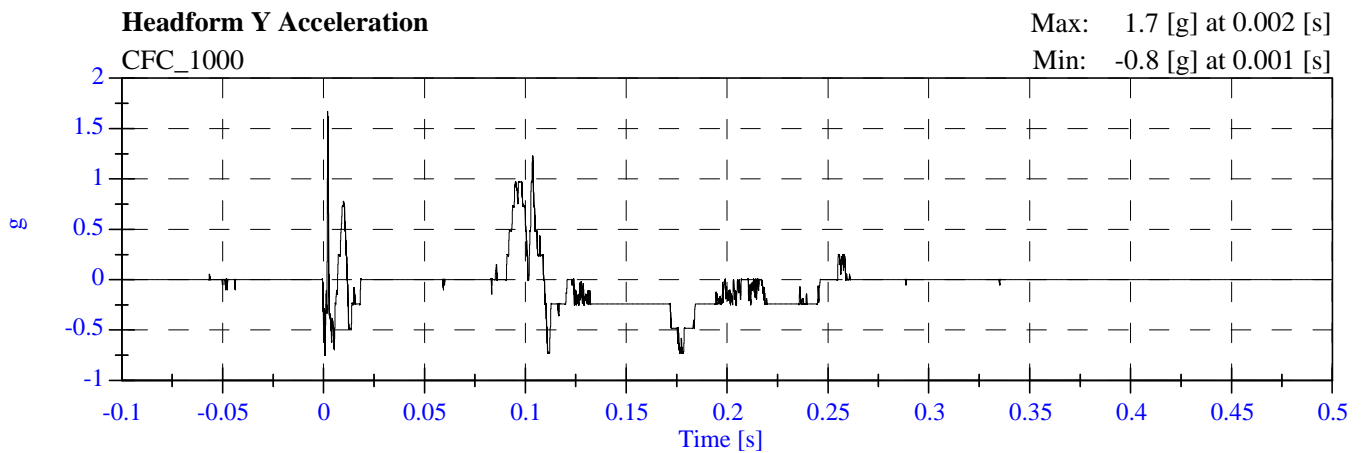
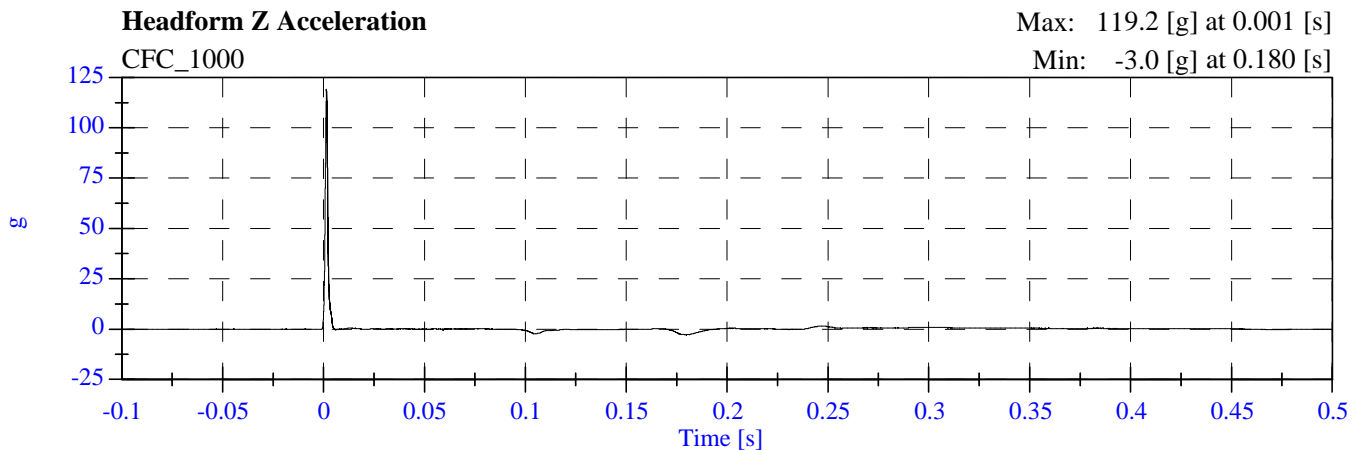
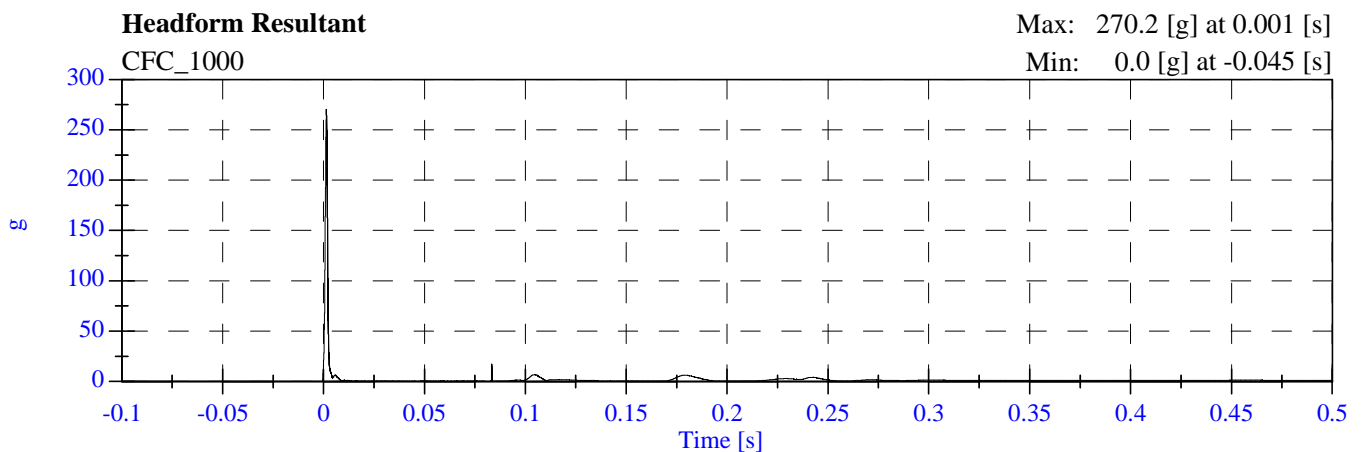
<b>MANUFACTURER:</b>		<b>FIRST TECHNOLOGY SAFETY SYSTEMS</b>	
<b>SERIAL NUMBER:</b>		<b>805</b>	
<b>CALIBRATION DATE:</b>		<b>March 31,2009</b>	
<b>TEST PARAMETER</b>	<b>SPECIFICATION</b>	<b>TEST RESULTS</b>	
<b>TEMPERATURE</b>	<b>19°C to 26°C</b>	<b>22</b>	
<b>RELATIVE HUMIDITY</b>	<b>10% to 70%</b>	<b>24</b>	
<b>PEAK RESULTANT ACCELERATION</b>	<b>225 Gs to 275 Gs</b>	<b>270.3</b>	
<b>PEAK LATERAL ACCELERATION</b>	<b>15 Gs Maximum</b>	<b>1.7</b>	
<b>IS ACCELERATION CURVE UNIMODAL?</b>	<b>YES</b>	<b>YES</b>

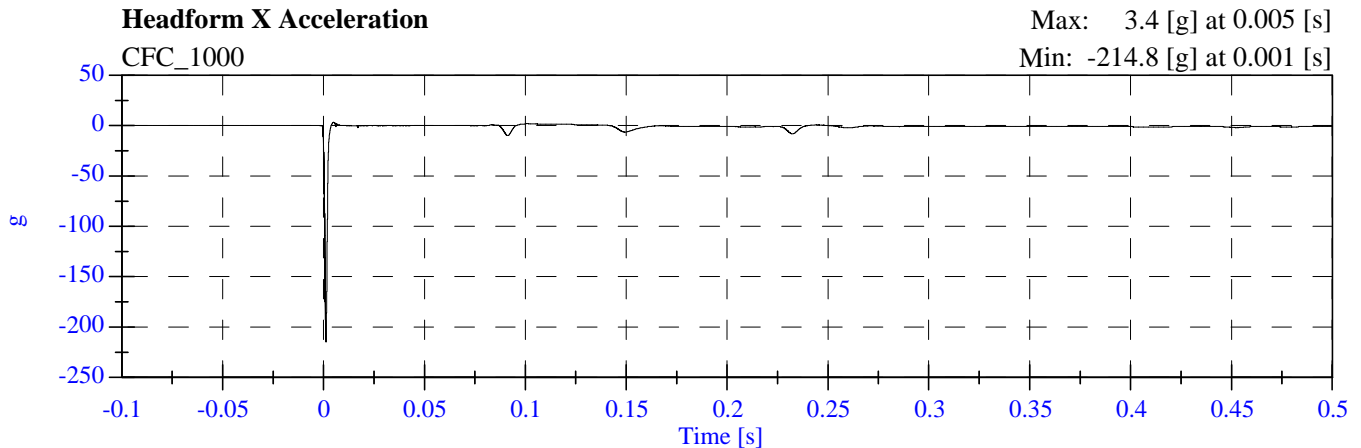
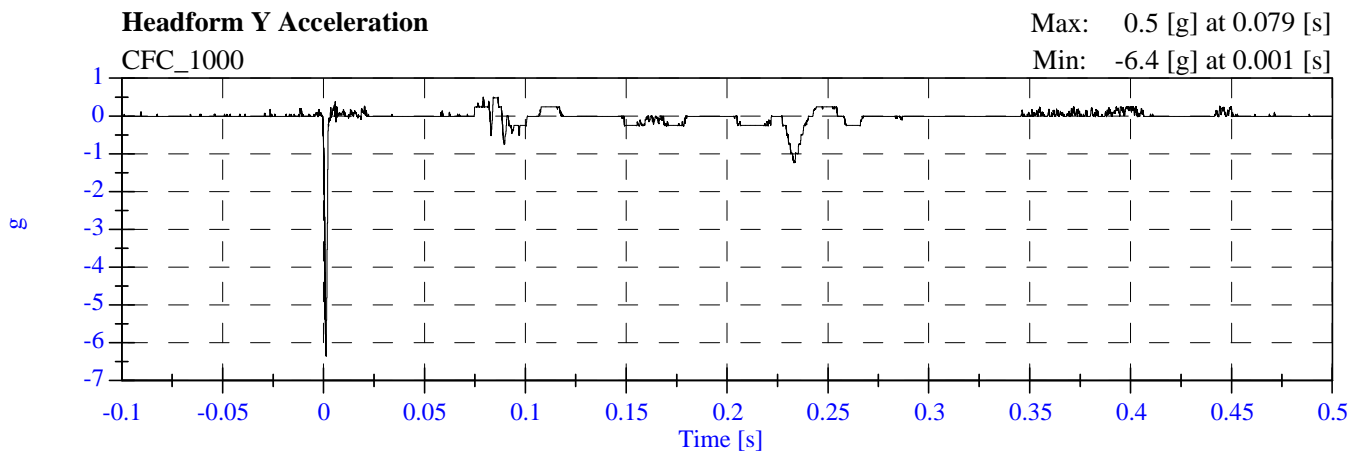
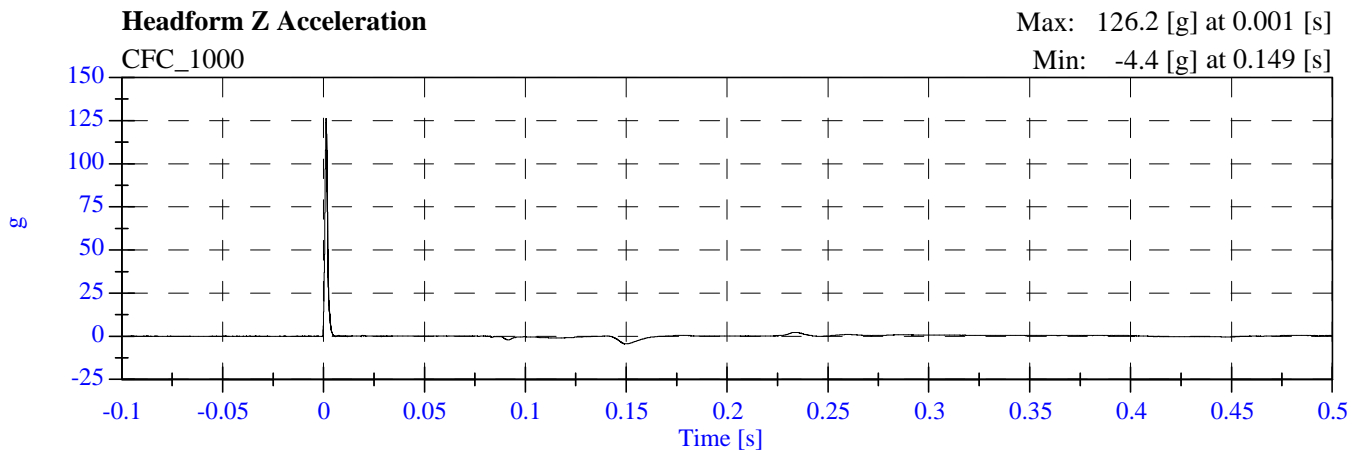
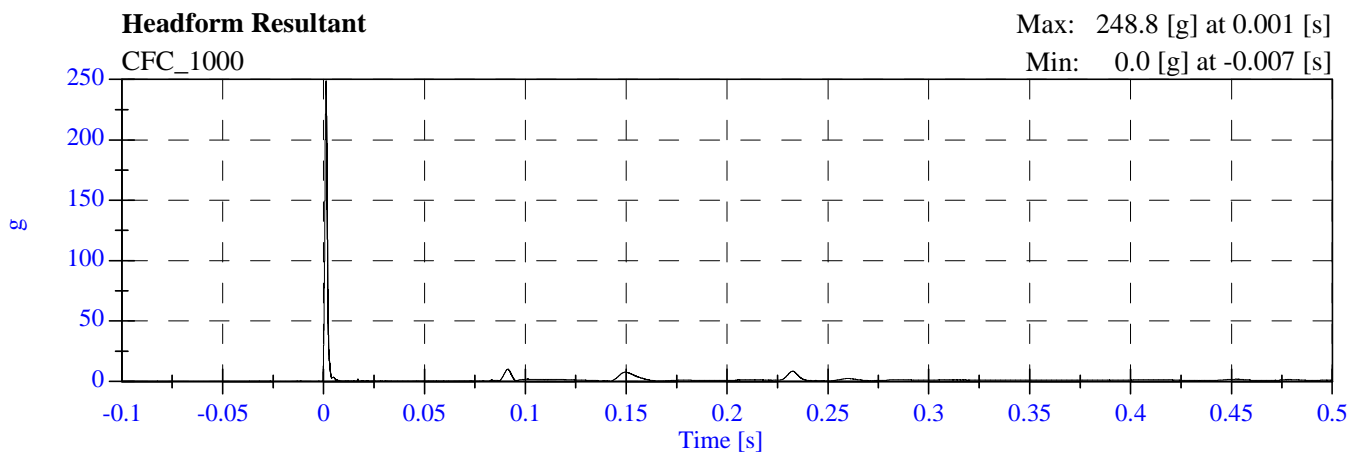
<b>MANUFACTURER:</b>		<b>DENTON ATD INC.</b>	
<b>SERIAL NUMBER:</b>		<b>0355</b>	
<b>CALIBRATION DATE:</b>		<b>March 31,2009</b>	
<b>TEST PARAMETER</b>	<b>SPECIFICATION</b>	<b>TEST RESULTS</b>	
<b>TEMPERATURE</b>	<b>19°C to 26°C</b>	<b>22</b>	
<b>RELATIVE HUMIDITY</b>	<b>10% to 70%</b>	<b>24</b>	
<b>PEAK RESULTANT ACCELERATION</b>	<b>225 Gs to 275 Gs</b>	<b>248.8</b>	
<b>PEAK LATERAL ACCELERATION</b>	<b>15 Gs Maximum</b>	<b>6.4</b>	
<b>IS ACCELERATION CURVE UNIMODAL?</b>	<b>YES</b>	<b>YES</b>
