REPORT NUMBER: 201P-CAL-09-01

**SAFETY COMPLIANCE TESTING FOR FMVSS 201  
RIGID POLE SIDE IMPACT TEST**

HYUNDAI MOTOR COMPANY  
2009 HYUNDAI ELANTRA GLS  
4-DOOR SEDAN

NHTSA NUMBER: C90511

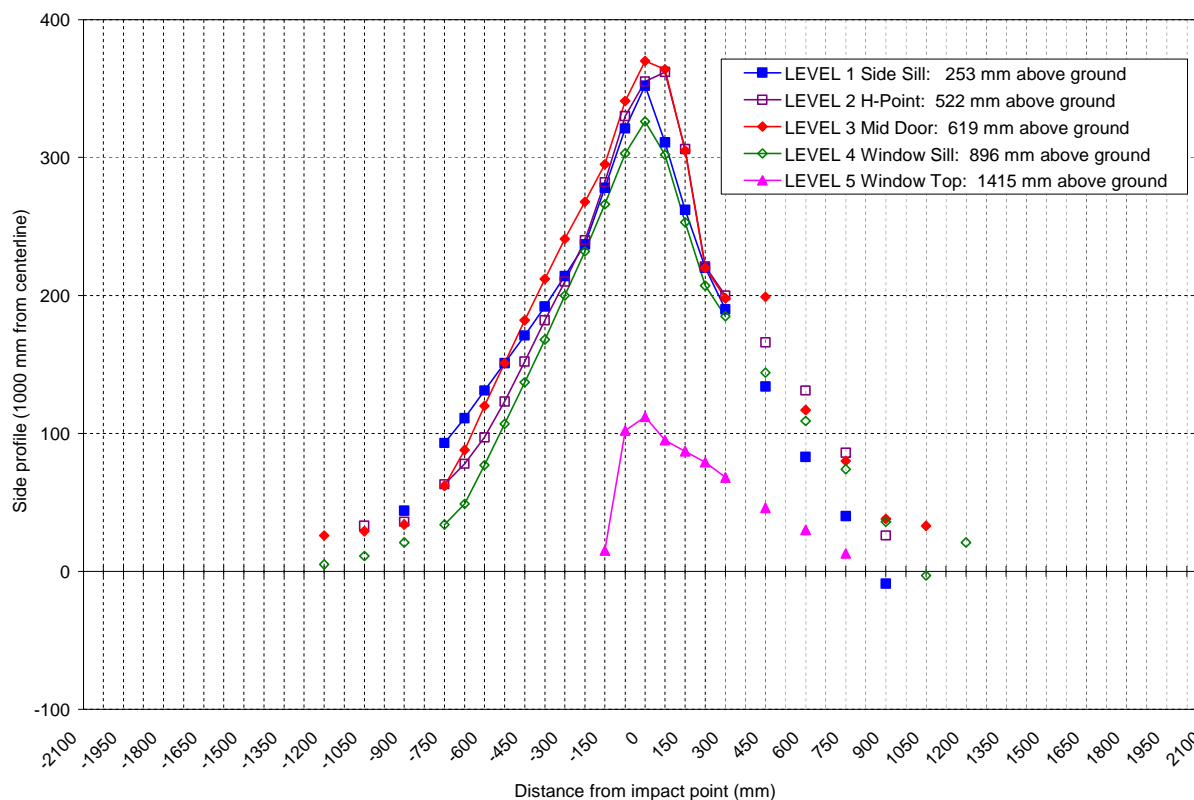
LEVEL	HEIGHT (mm)		DISTANCE IN MILLIMETERS (mm) FROM IMPACT POINT																						
			-1125	-1050	-900	-750	-675	-600	-525	-450	-375	-300	-225	-150	-75	0	75	150	225	300	450	600	750	900	1050
LEVEL 1 SIDE SILL	253	PRE	--	--	172	171	171	170	170	170	169	169	169	169	169	169	169	169	169	169	169	169	168	--	
		POST	--	--	216	264	282	301	321	341	361	383	406	447	490	521	480	431	389	359	303	252	209	159	--
		CRUSH	N/A	N/A	44	93	111	131	151	171	192	214	237	278	321	352	311	262	220	190	134	83	40	-9	N/A
LEVEL 2 H POINT	522	PRE	--	126	130	132	132	133	134	134	134	134	134	134	134	134	134	133	133	132	131	130	128	127	--
		POST	159	159	166	195	210	230	257	286	316	344	374	416	464	489	496	439	354	332	297	261	214	153	--
		CRUSH	N/A	33	36	63	78	97	123	152	182	210	240	282	330	355	362	306	221	200	166	131	86	26	N/A
LEVEL 3 MID DOOR	619	PRE	--	122	124	125	126	126	127	127	127	128	128	128	127	127	127	126	126	125	124	123	122	119

POST	--	151	158	187	214	246	278	309	339	368	396	423	469	497	491	432	346	324	324	241	203	160	152
		CRUSH	N/A	29	34	62	88	120	151	182	212	241	268	295	341	370	364	305	220	198	199	117	80	38	33
LEVEL 4 WINDOW SILL	896	PRE	--	191	187	184	182	180	178	177	176	175	174	173	172	172	172	171	170	169	168	166	163	161	158
		POST	--	202	208	218	231	257	285	314	344	375	406	439	475	498	474	424	377	354	312	275	237	197	155
		CRUSH	N/A	11	21	34	49	77	107	137	168	200	232	266	303	326	302	253	207	185	144	109	74	36	-3
LEVEL 5 WINDOW TOP	1415	PRE	--	--	--	--	--	--	--	--	--	--	579	432	414	412	409	406	407	408	409	420	--	--	
		POST	--	--	--	--	--	--	--	--	--	--	594	534	526	507	496	485	475	454	439	433	--	--	
		CRUSH	N/A	N/A	N/A	N/A	N/A	N/A	N/A	N/A	N/A	N/A	15	102	112	95	87	79	68	46	30	13	N/A	N/A

MAXIMUM EXTERIOR STATIC CRUSH:

1. LEVEL 1 ( 253 mm above ground) = 352 millimeters

2. LEVEL 2 ( 522 mm above ground) = 362 millimeters

3. LEVEL 3 ( 619 mm above ground) = 370 millimeters

4. LEVEL 4 ( 896 mm above ground) = 326 millimeters

5. LEVEL 5 ( 1415 mm above ground) = 112 millimeters

Maximum Post-Test Intrusion = 370 millimeters

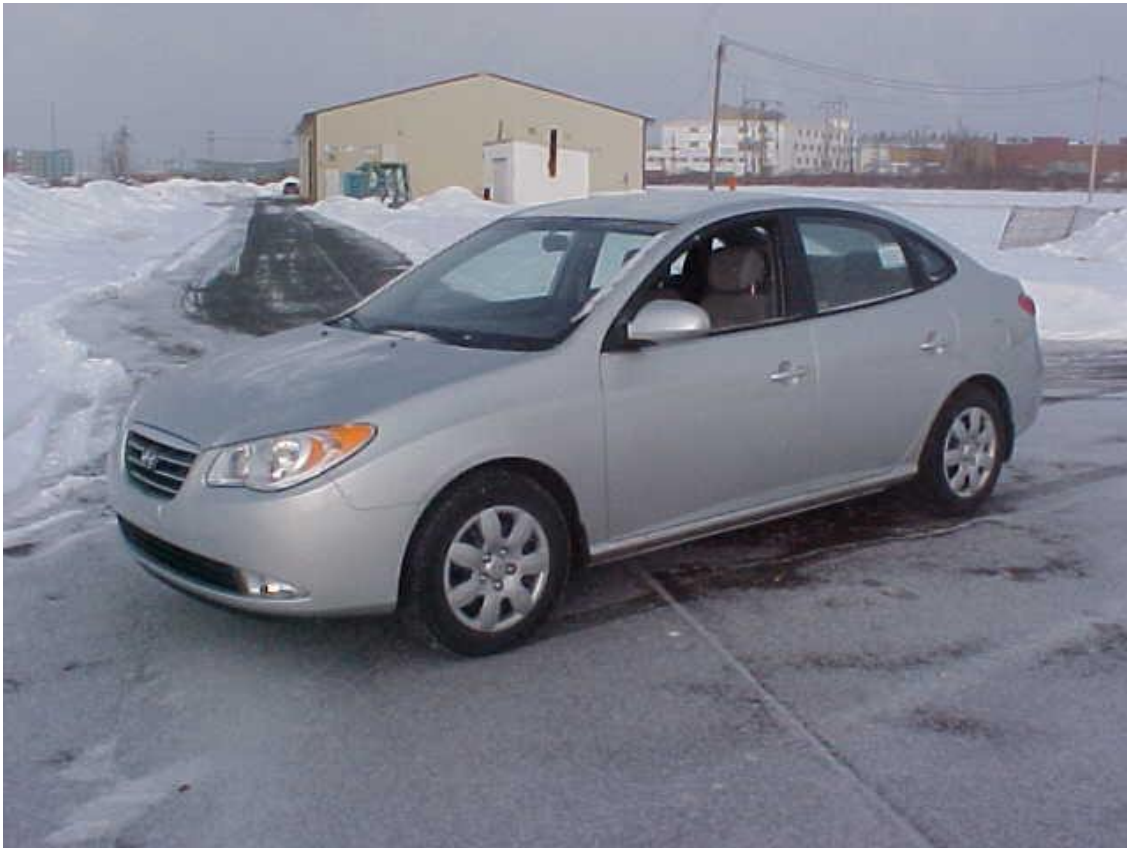
**Figure A-1: As Received Left Front  $\frac{3}{4}$  View**

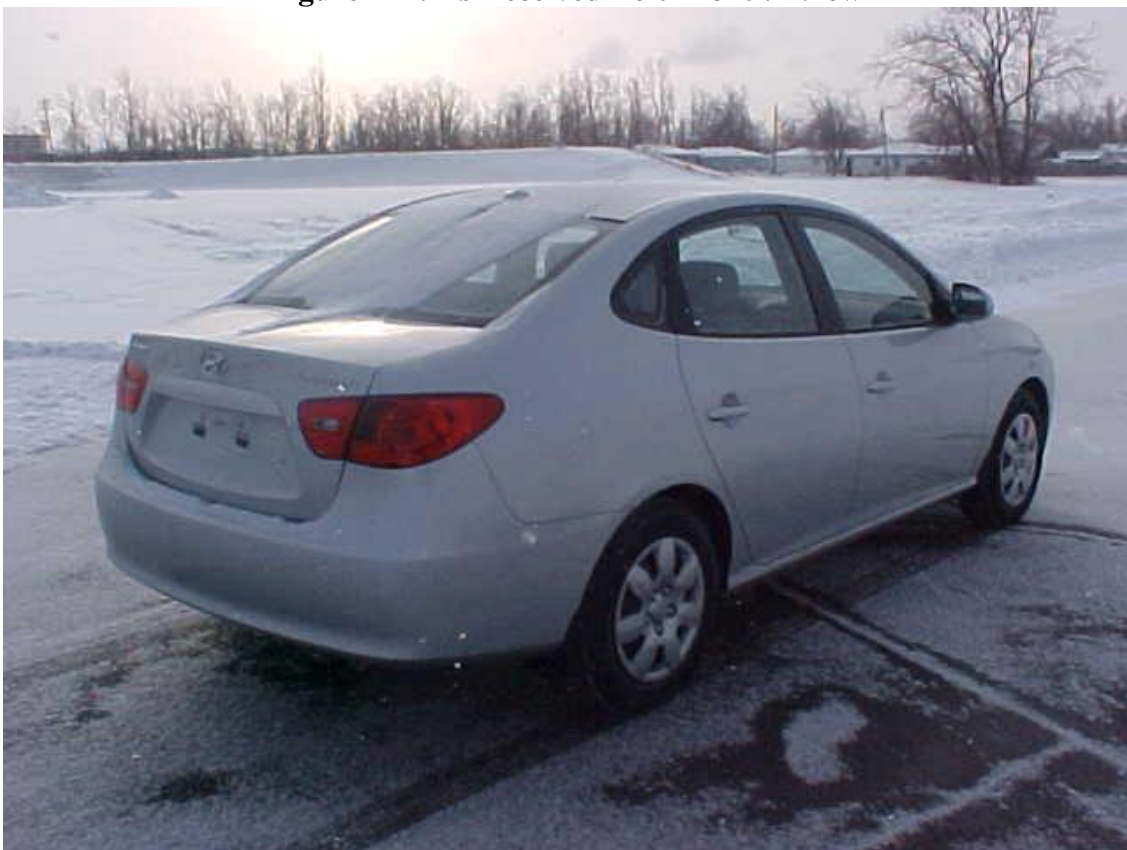
**Figure A-2: As Received Right Rear  $\frac{3}{4}$  View**

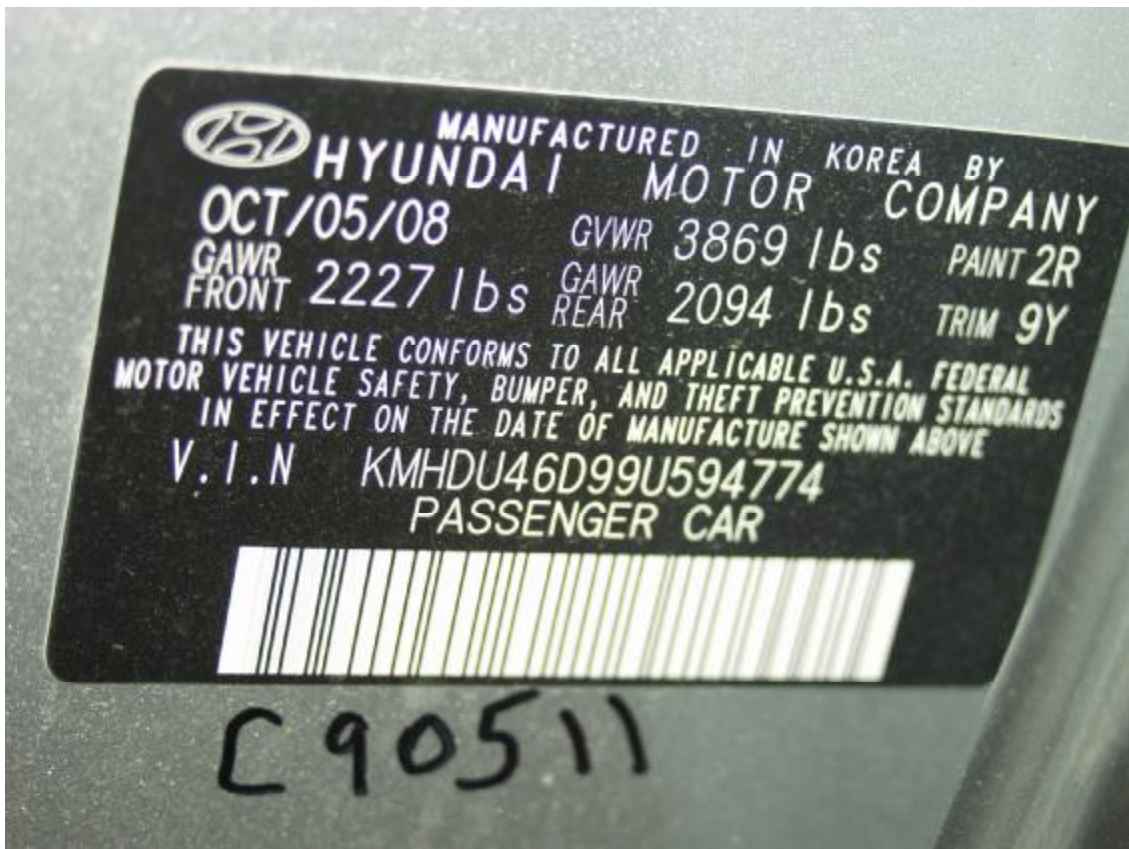
Figure A-3: Vehicle Certification Label

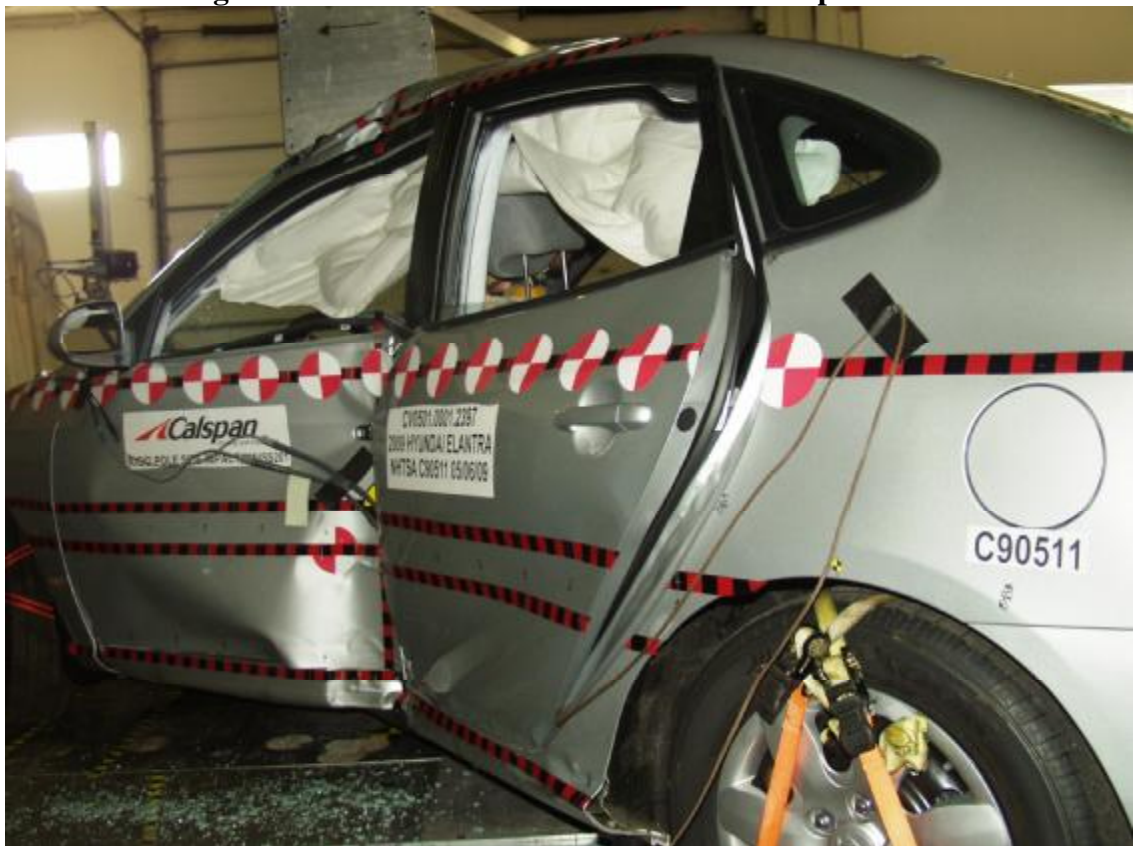
**Figure A-39: Post-Test Left Rear  $\frac{3}{4}$  View of Impact Zone**
