FINAL REPORT NUMBER 201UI-MGA-09-07

**SAFETY COMPLIANCE TESTING FOR FMVSS 201
Occupant Protection In Interior Impact
Upper Interior Head Impact Protection**

**AUTO ALLIANCE INTERNATIONAL, INC.
2009 Mazda 6 I Sedan Base
NHTSA No. C95401**

**MGA RESEARCH CORPORATION
446 Executive Drive
Troy, Michigan 48083**

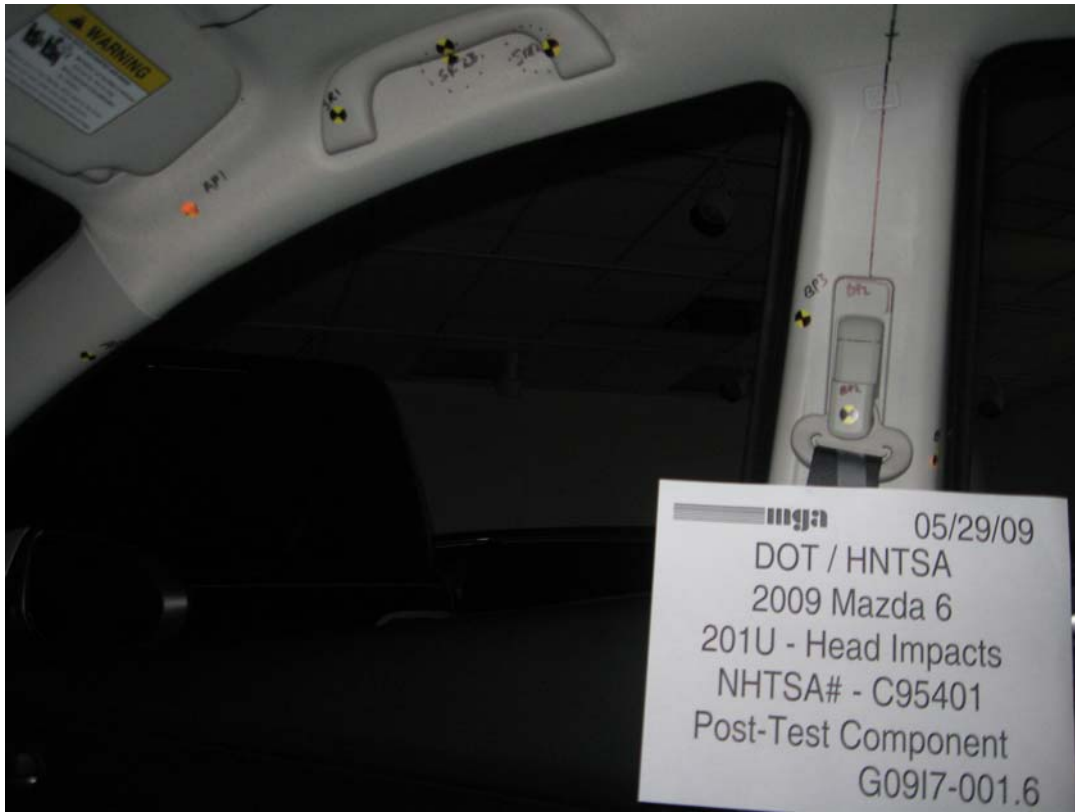
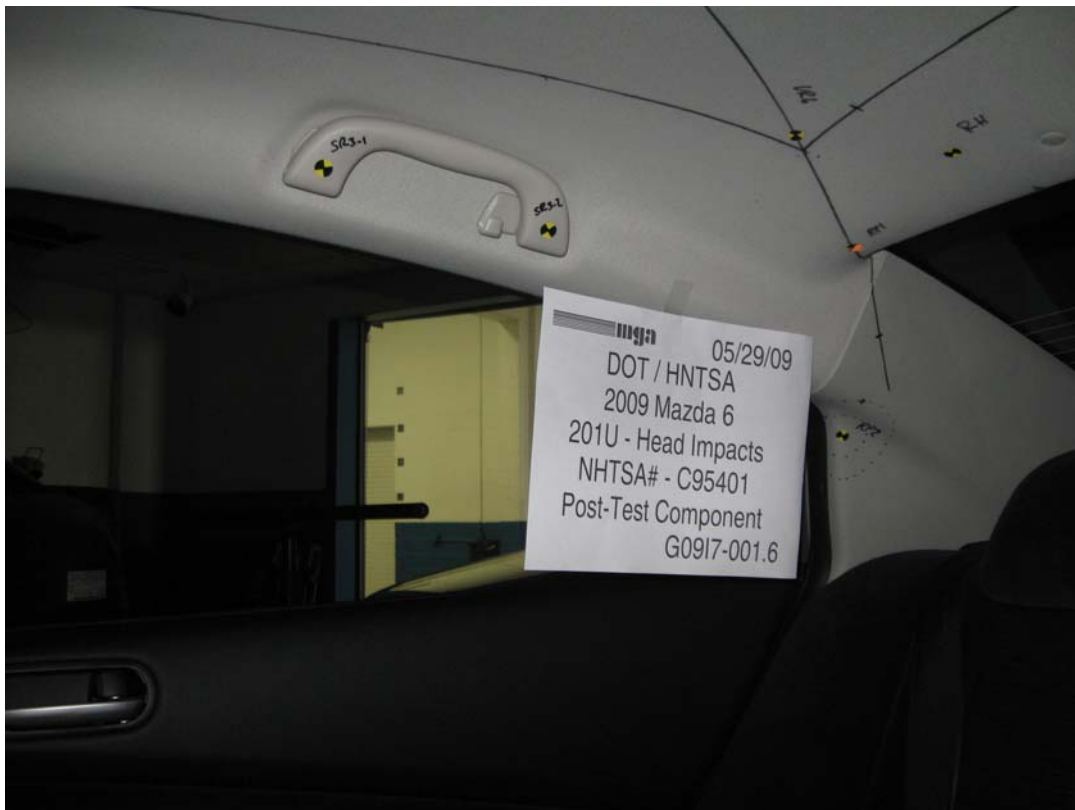
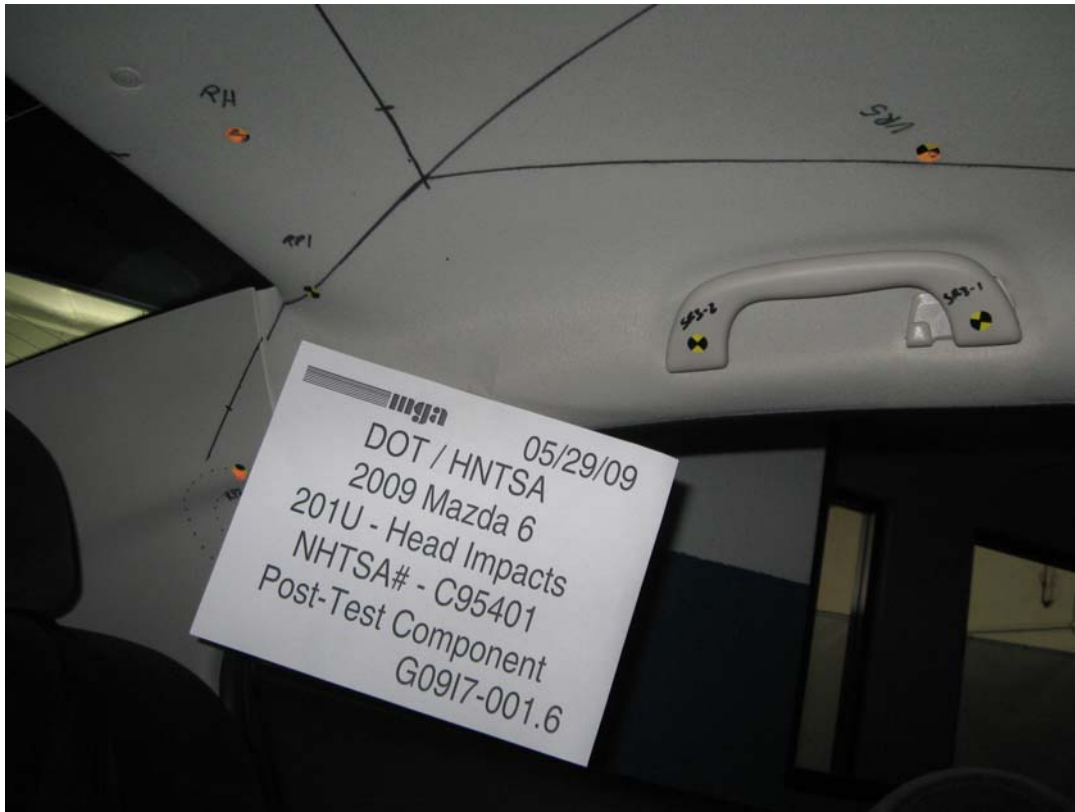
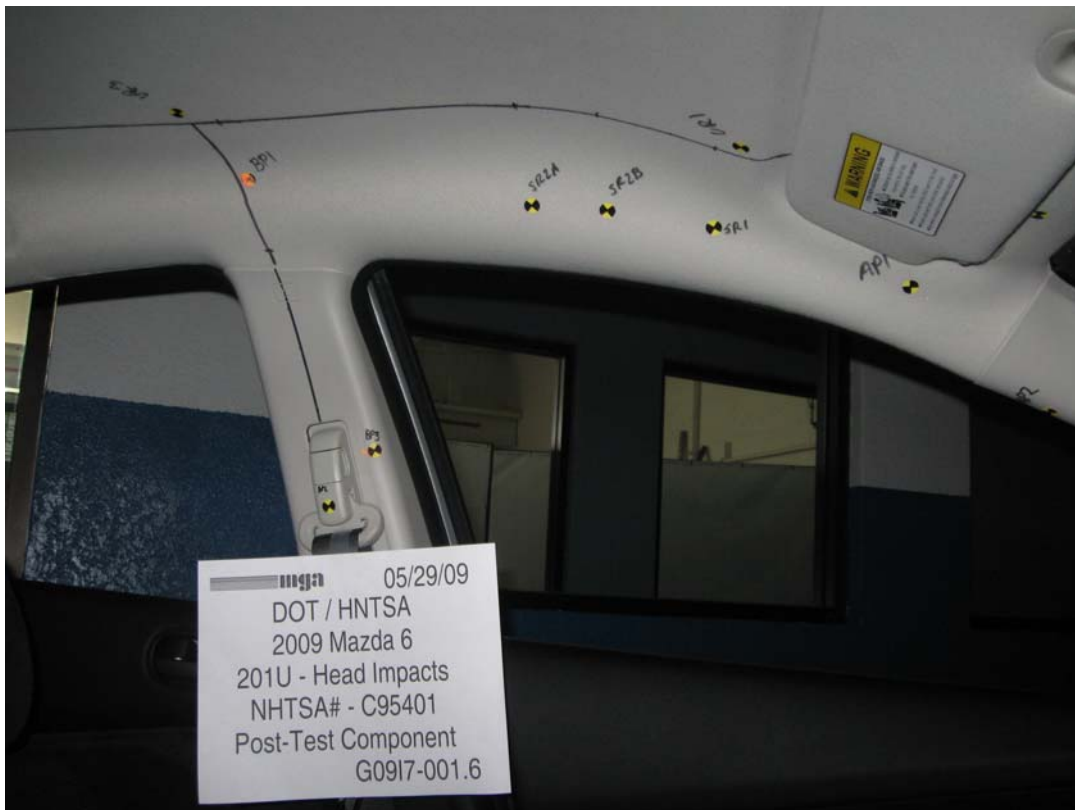
Post-Test Component Photographs

SR2A Right: Grab handle does not return unassisted.

UR4@BPR Right: Small indentation in headliner.

UR5@SR3-1 Left: Crease in the headliner.
