FINAL REPORT NUMBER 201UI-MGA-09-08

**SAFETY COMPLIANCE TESTING FOR FMVSS 201
Occupant Protection In Interior Impact
Upper Interior Head Impact Protection**

**FUJI HEAVY INDUSTRIES LTD.
2009 Subaru Forester 2.5X / 9FA
NHTSA No. C95501**

**MGA RESEARCH CORPORATION
446 Executive Drive
Troy, Michigan 48083**

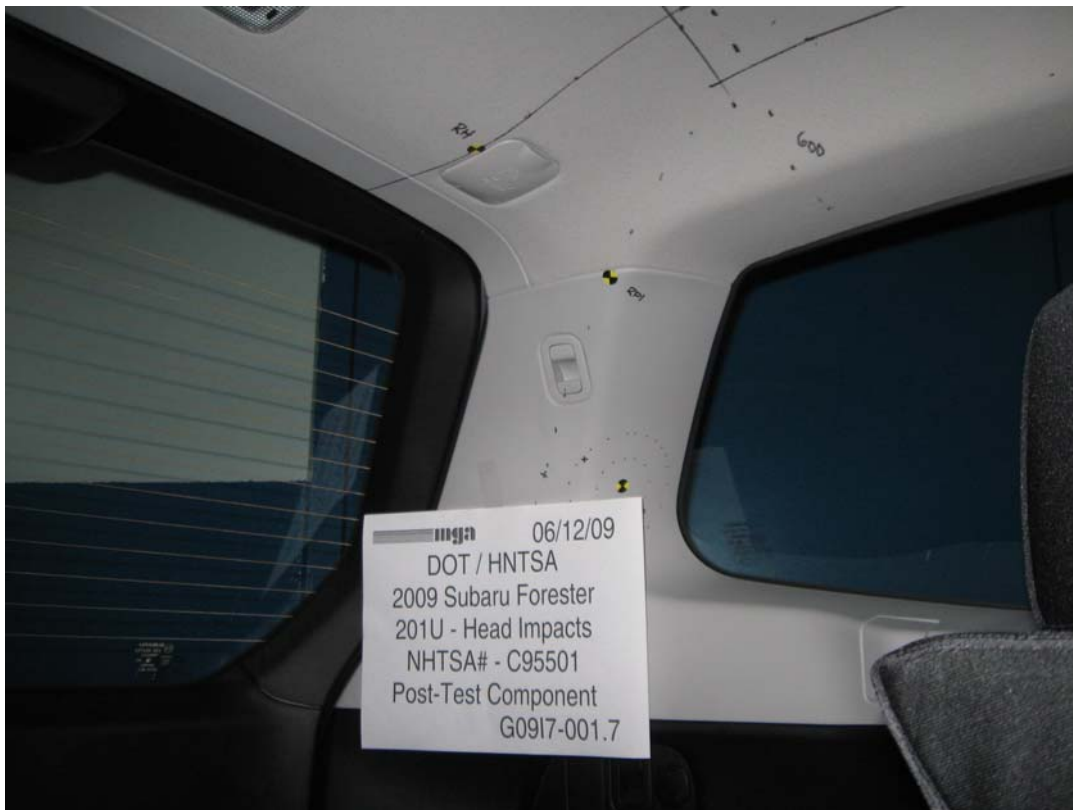
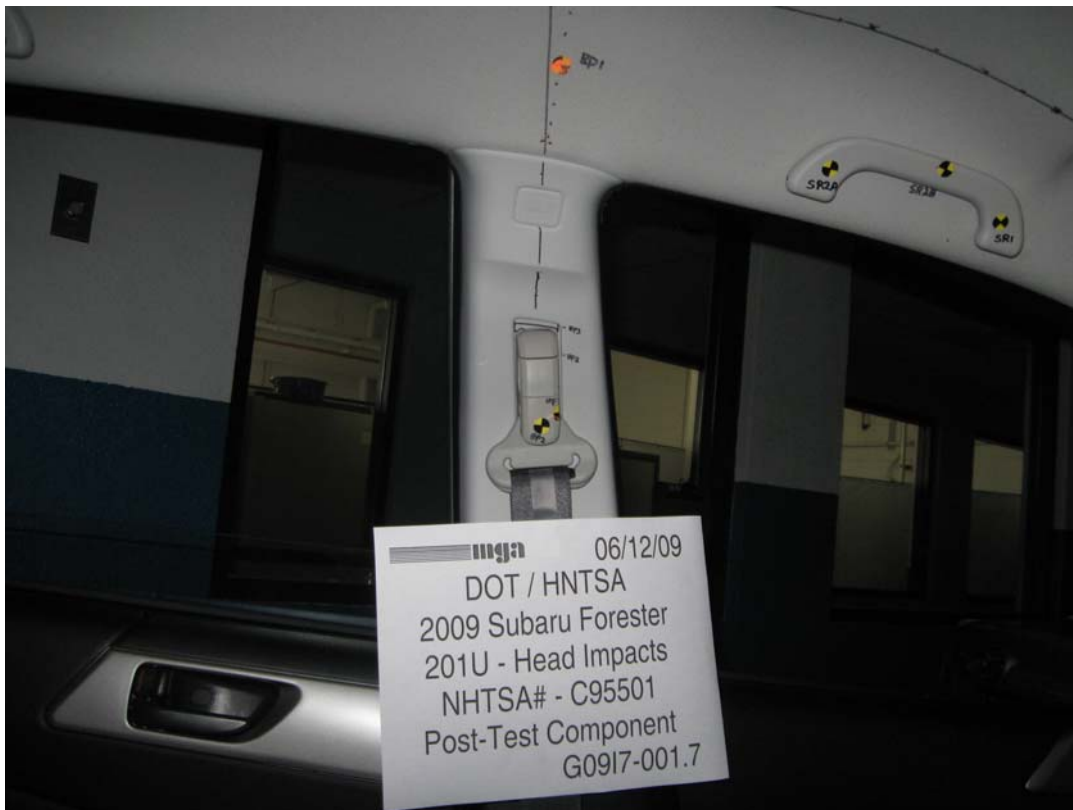
Post-Test Component Photographs

AP2 Left: Loose trim piece.

BP3 Left: Crack in adjuster cover; adjuster non-functional.

FH1 Left: Overhead console opened on impact.

FH2 Right: Windshield cracked due to head rotation; overhead console opened on impact.

SR3-3 Right: Side window shattered after initial contact.
