REPORT NUMBER: 214P-MGA-2010-002

**SAFETY COMPLIANCE TESTING FOR FMVSS 214
DYNAMIC SIDE IMPACT PROTECTION
RIGID POLE**

**KIA MOTORS CORPORATION
2010 KIA FORTE LX 4-DR SEDAN
NHTSA NUMBER: CA0505**

**PREPARED BY:
MGA RESEARCH CORPORATION
5000 WARREN ROAD
BURLINGTON, WI 53105**

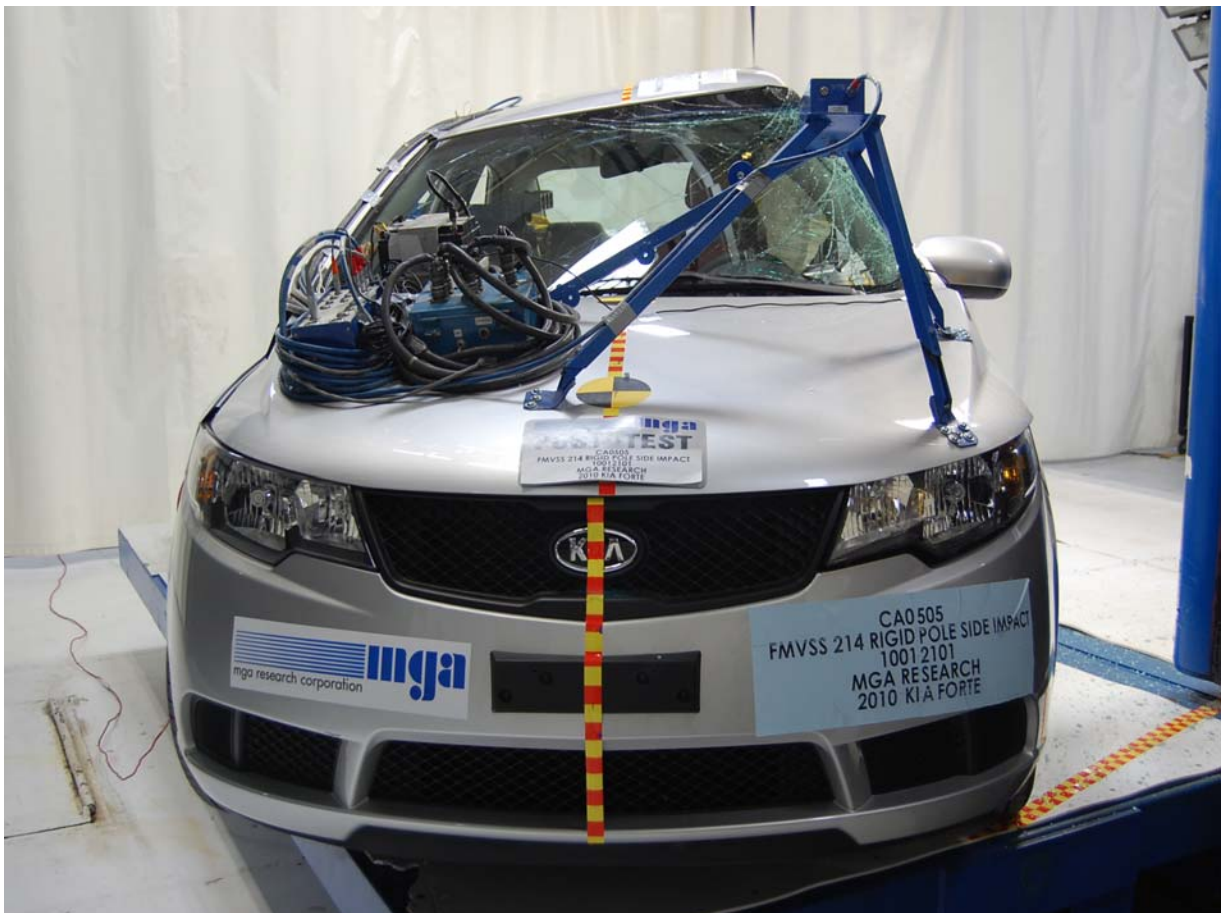
Post-Test Frontal View of Test Vehicle

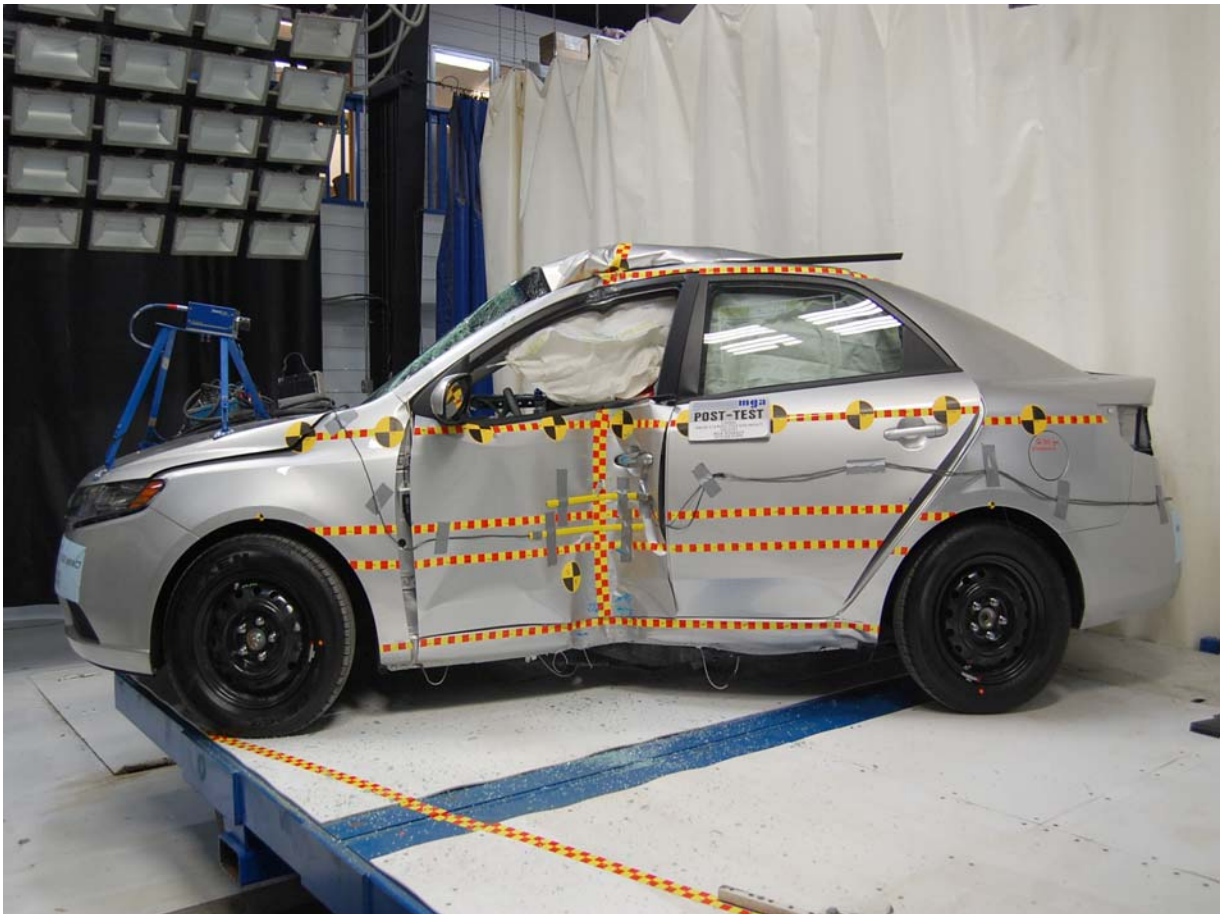
Post-Test Impacted Side View of Test Vehicle

Critical Areas of Performance	Observations and Conclusions
Pillar Performance	No Separation
Sill Separation	None
Windshield Damage	Cracked
Window Damage	Left Front Window Broke
Other Notable Effects	None

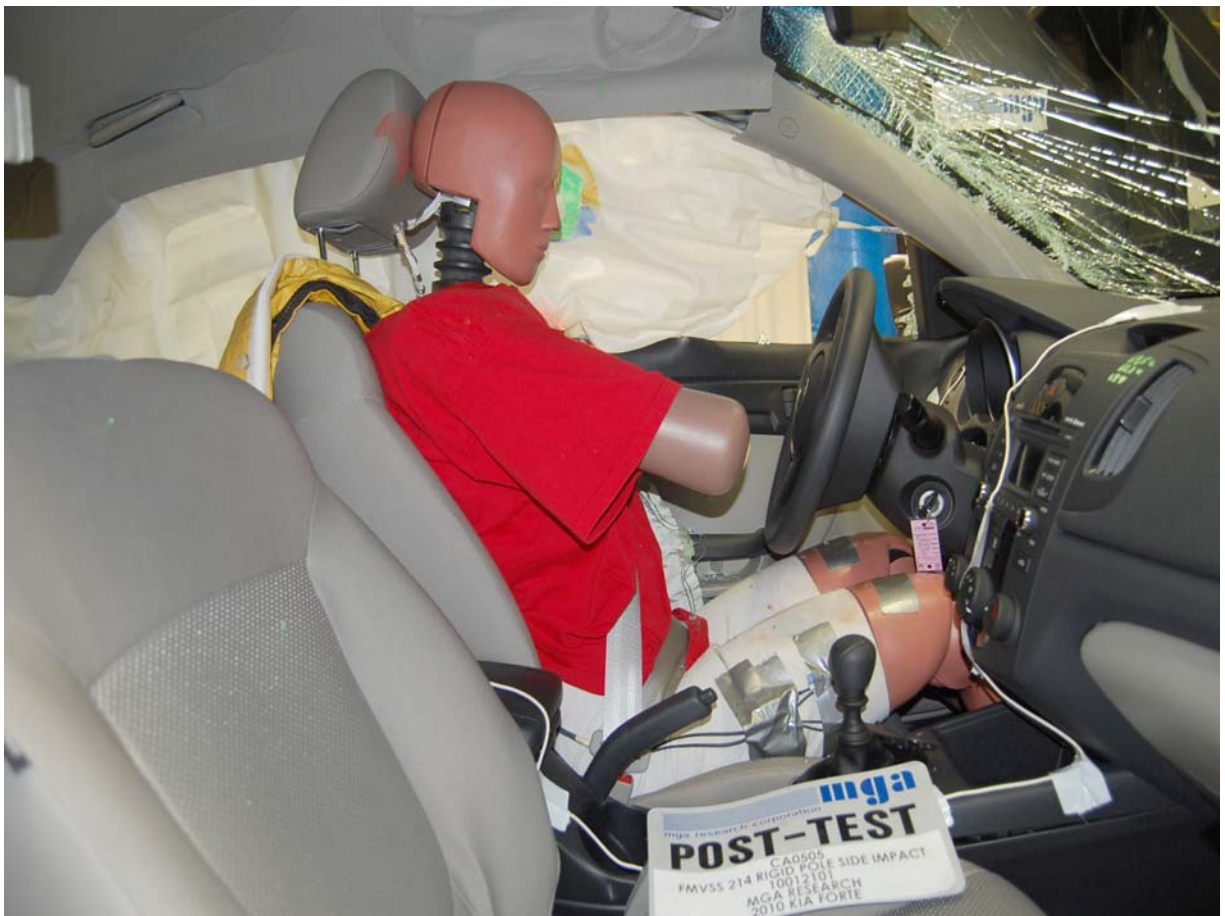
Post-Test Dummy Through Opposite Window

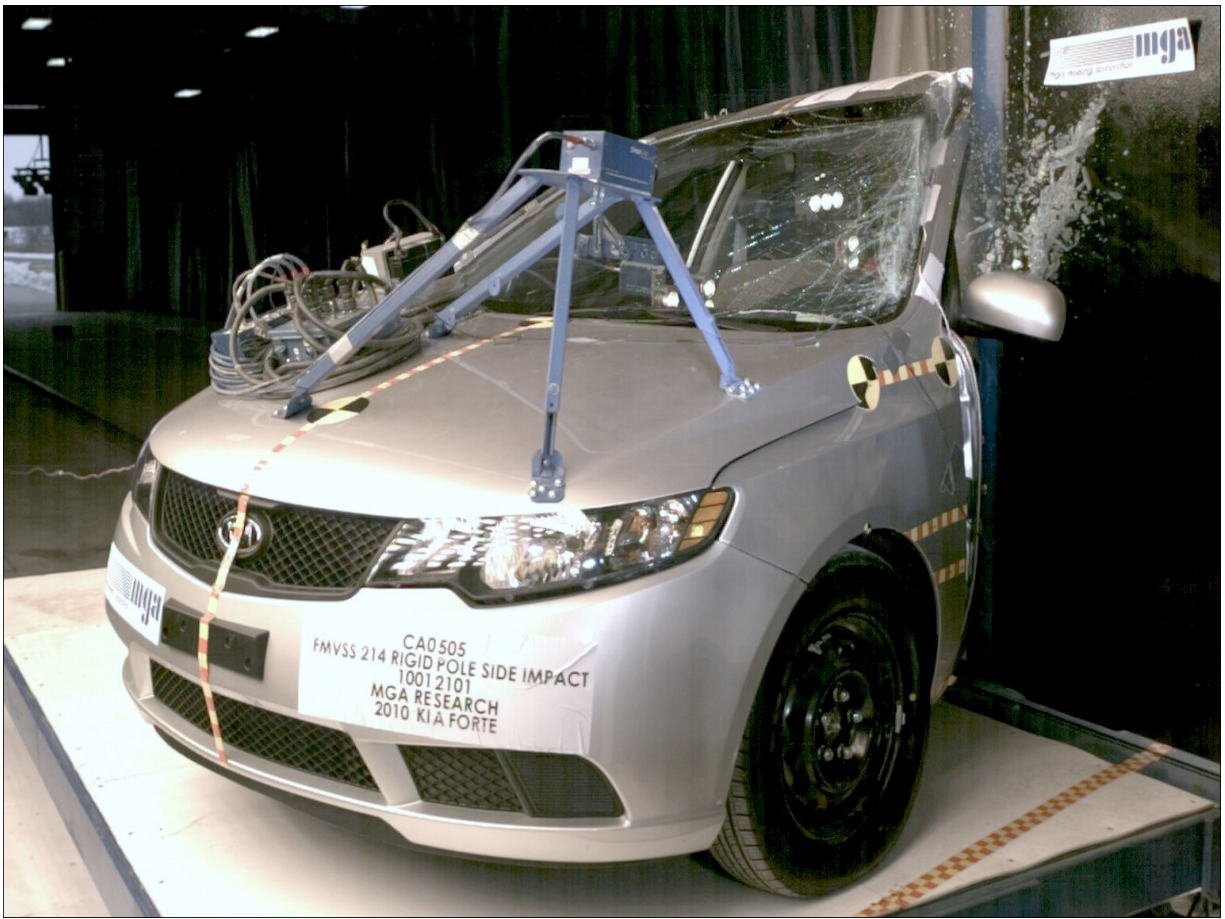
Impact Event (Struck Side)

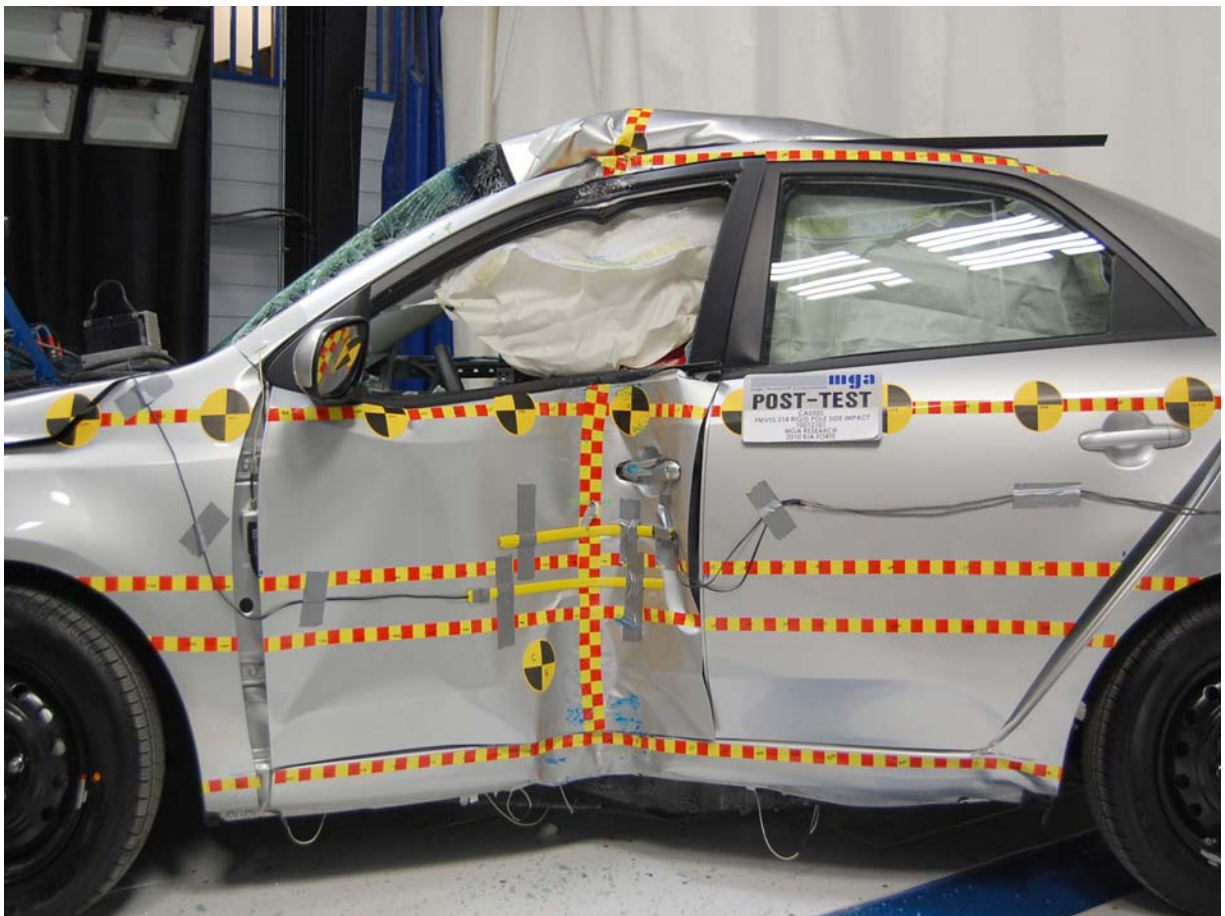
Post-Test Impact Zone Close-up View

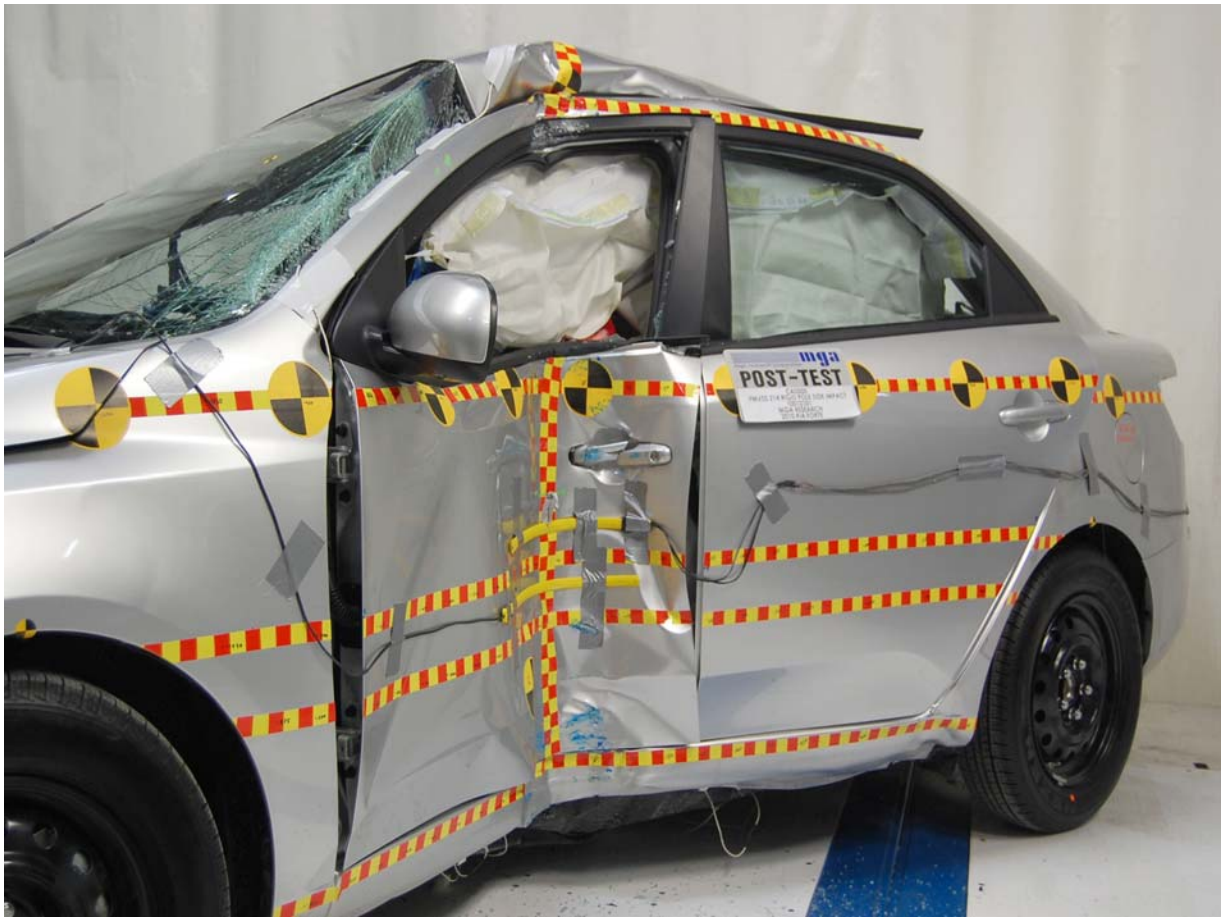
Post-Test $\frac{3}{4}$ Front View of Impact Zone

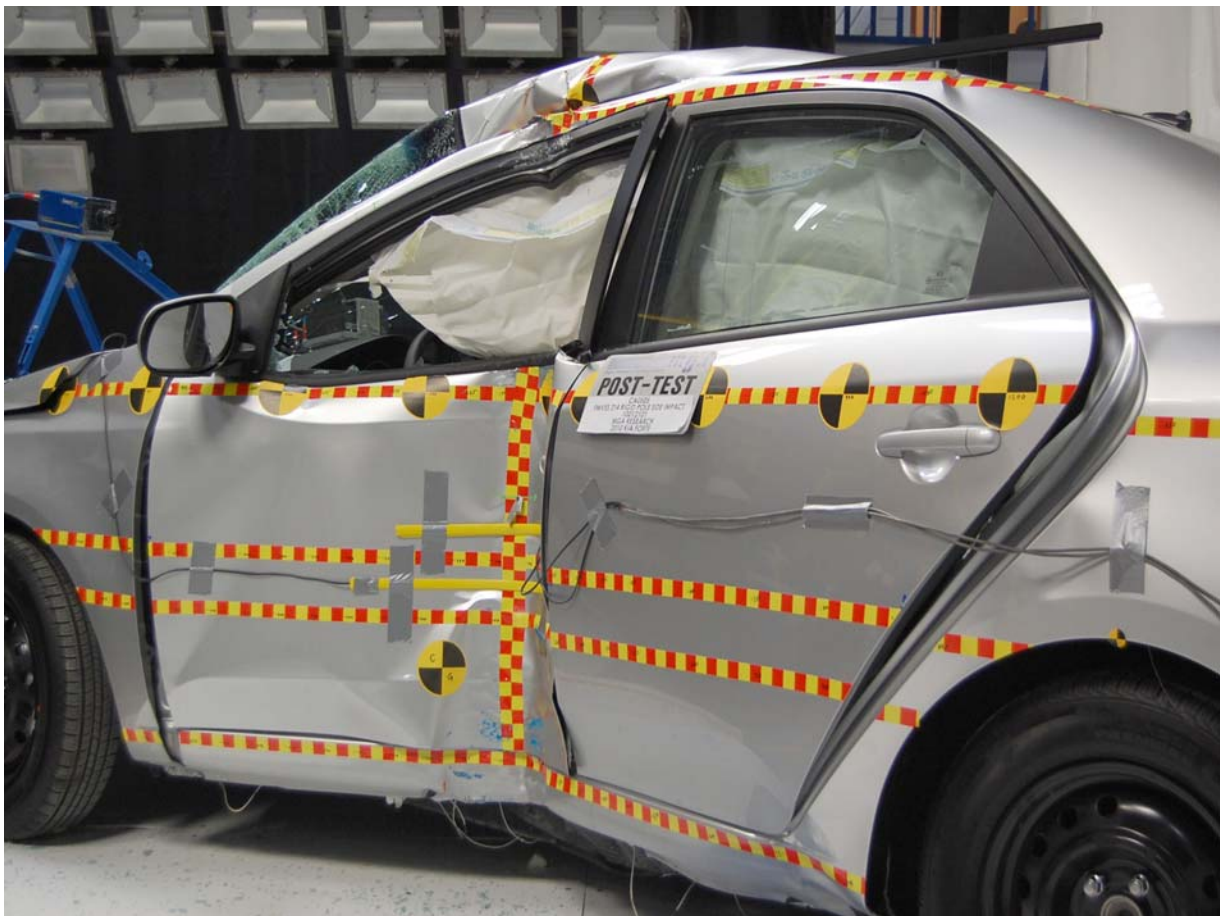
Post-Test $\frac{3}{4}$ Rear View of Impact Zone

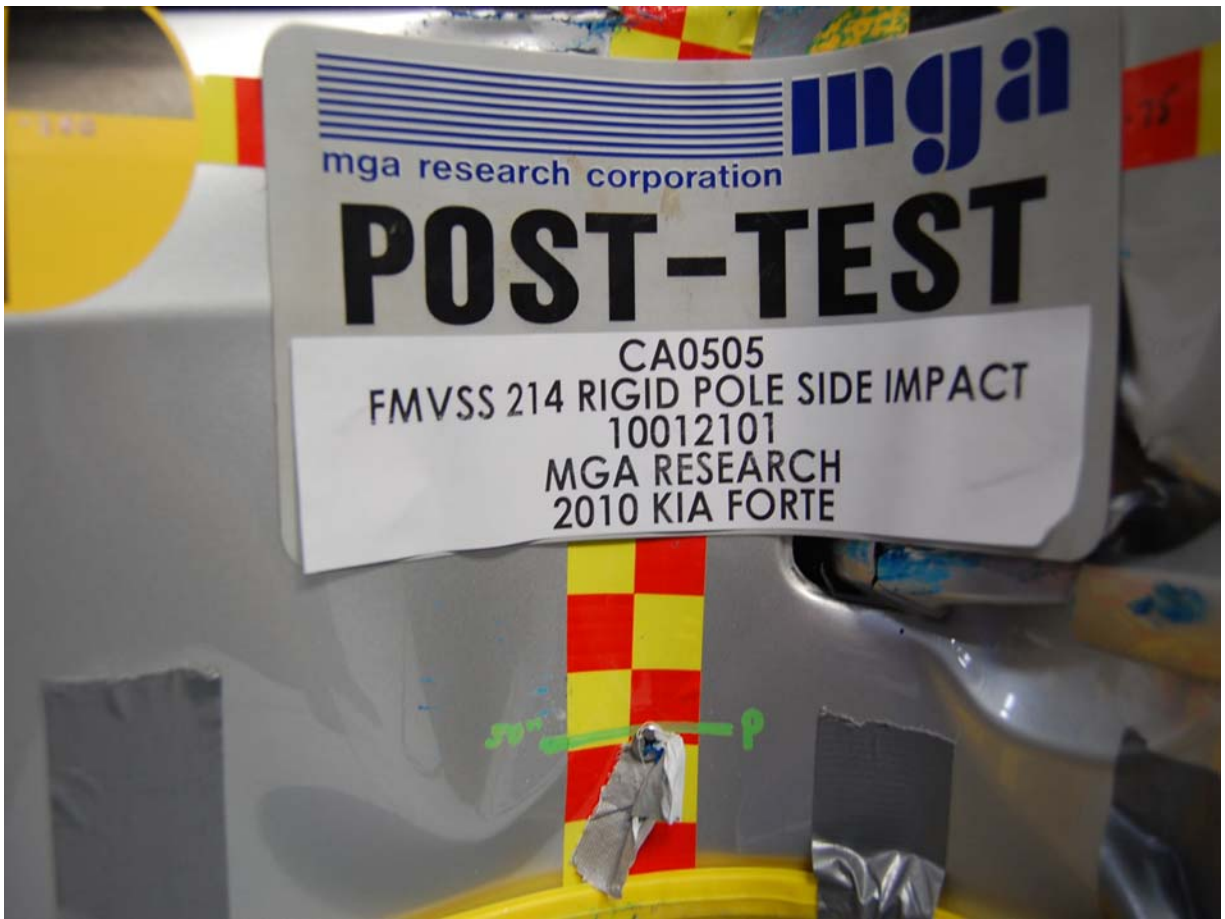
Post-Test Close-up View of Impact Point Target

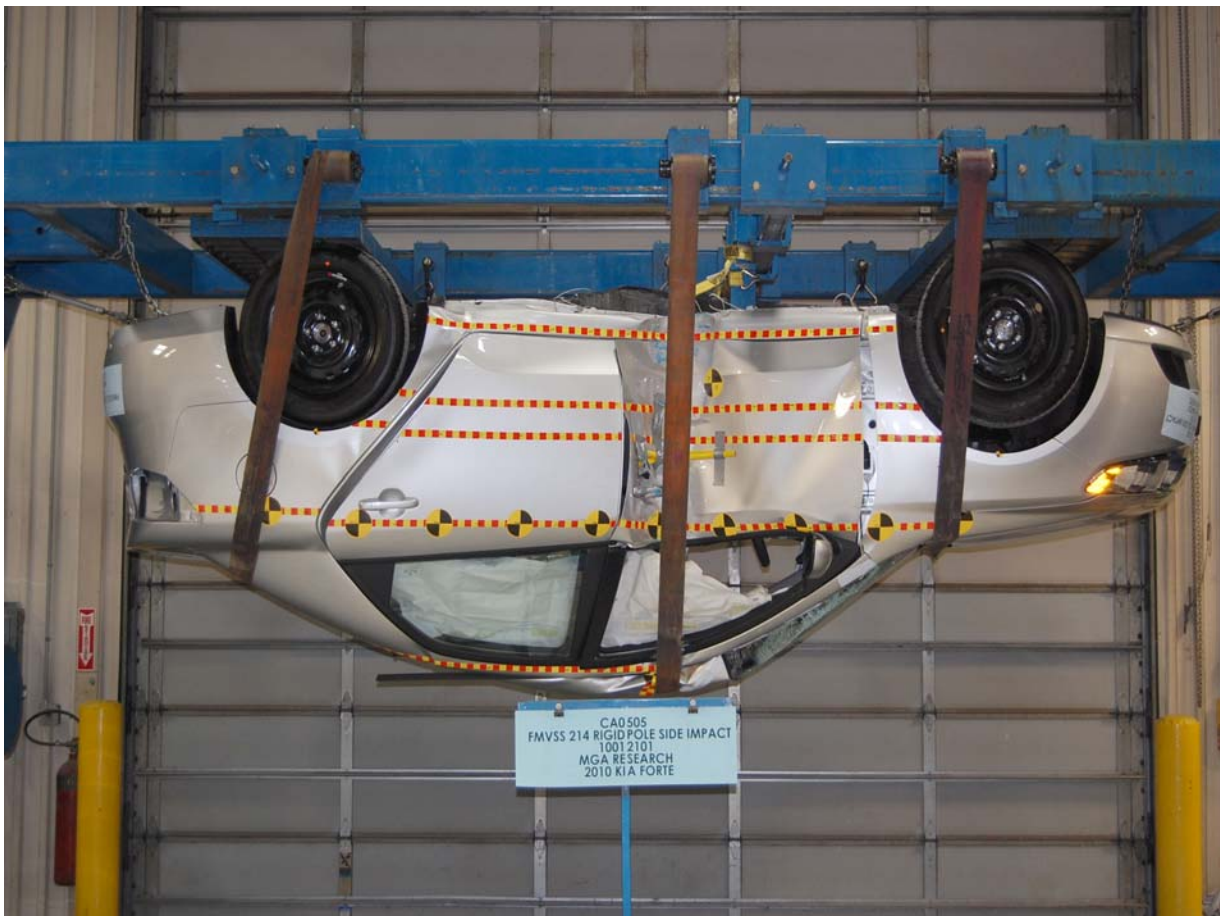
Post-Test Vehicle at 180 Degree Rollover

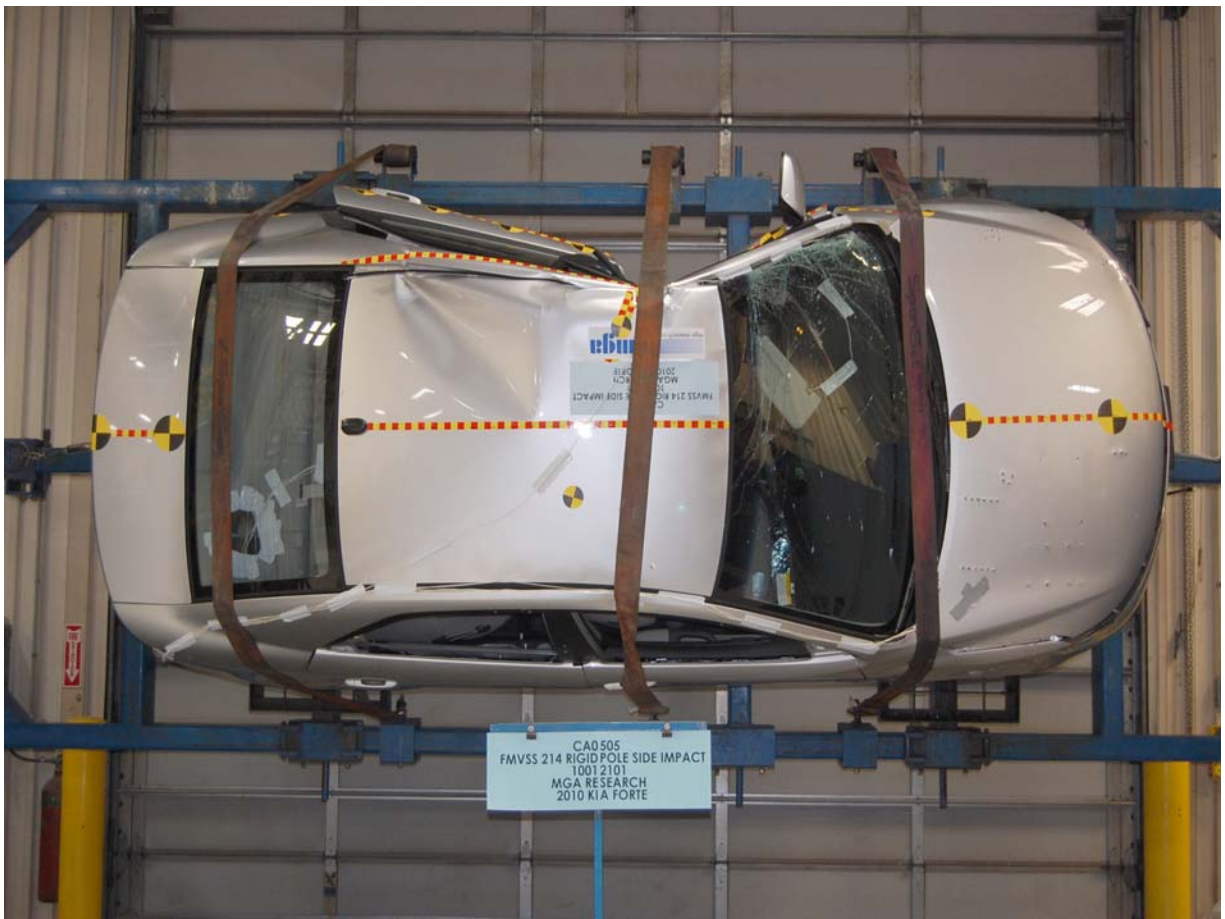
Post-Test Vehicle at 270 Degree Rollover

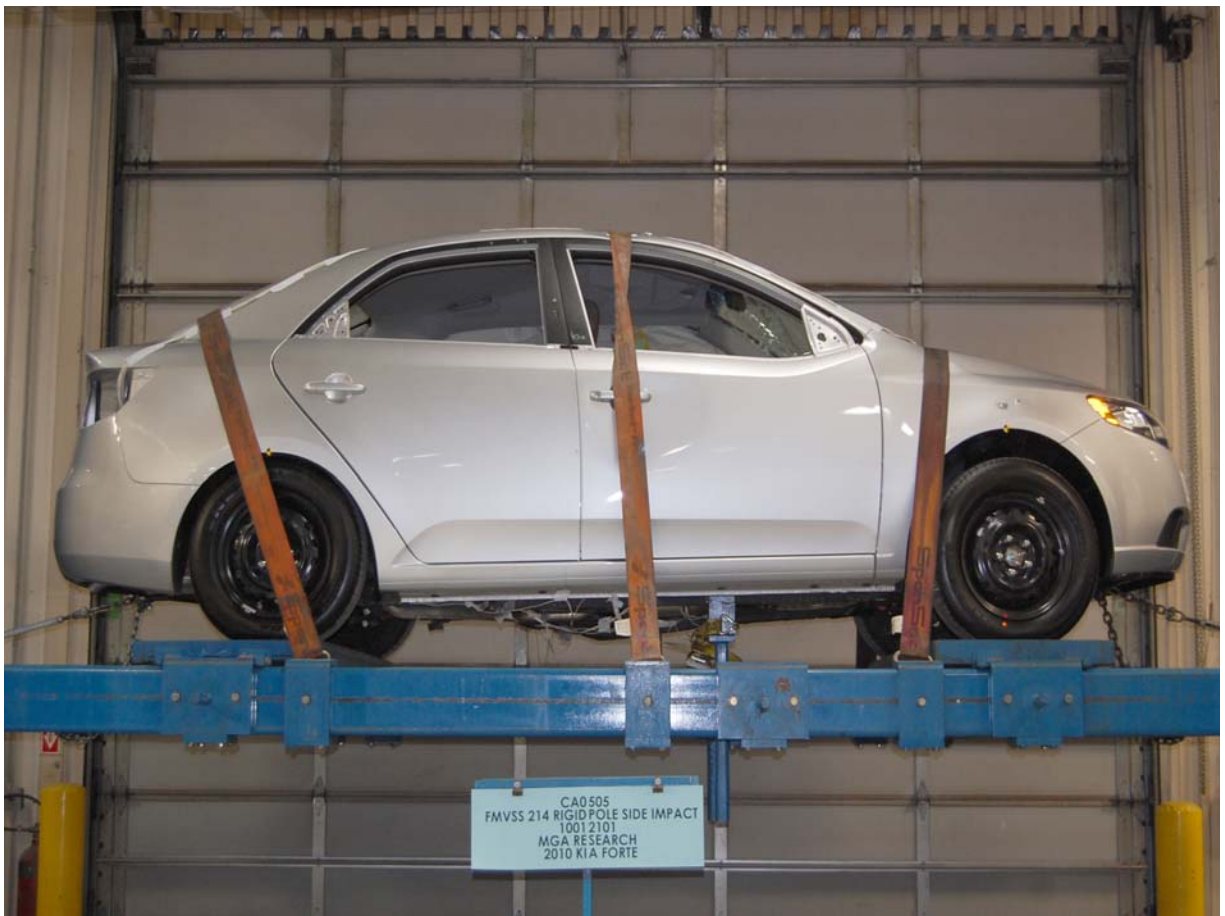
Post-Test Vehicle at 360 Degree Rollover
