**REPORT NUMBER: 214P-MGA-2010-003**

**SAFETY COMPLIANCE TESTING FOR FMVSS 214  
DYNAMIC SIDE IMPACT PROTECTION  
RIGID POLE**

**FORD MOTOR COMPANY  
2010 FORD F-150 4x2 REGULAR CAB  
NHTSA NUMBER: CA0208**

**PREPARED BY:  
MGA RESEARCH CORPORATION  
5000 WARREN ROAD  
BURLINGTON, WI 53105**

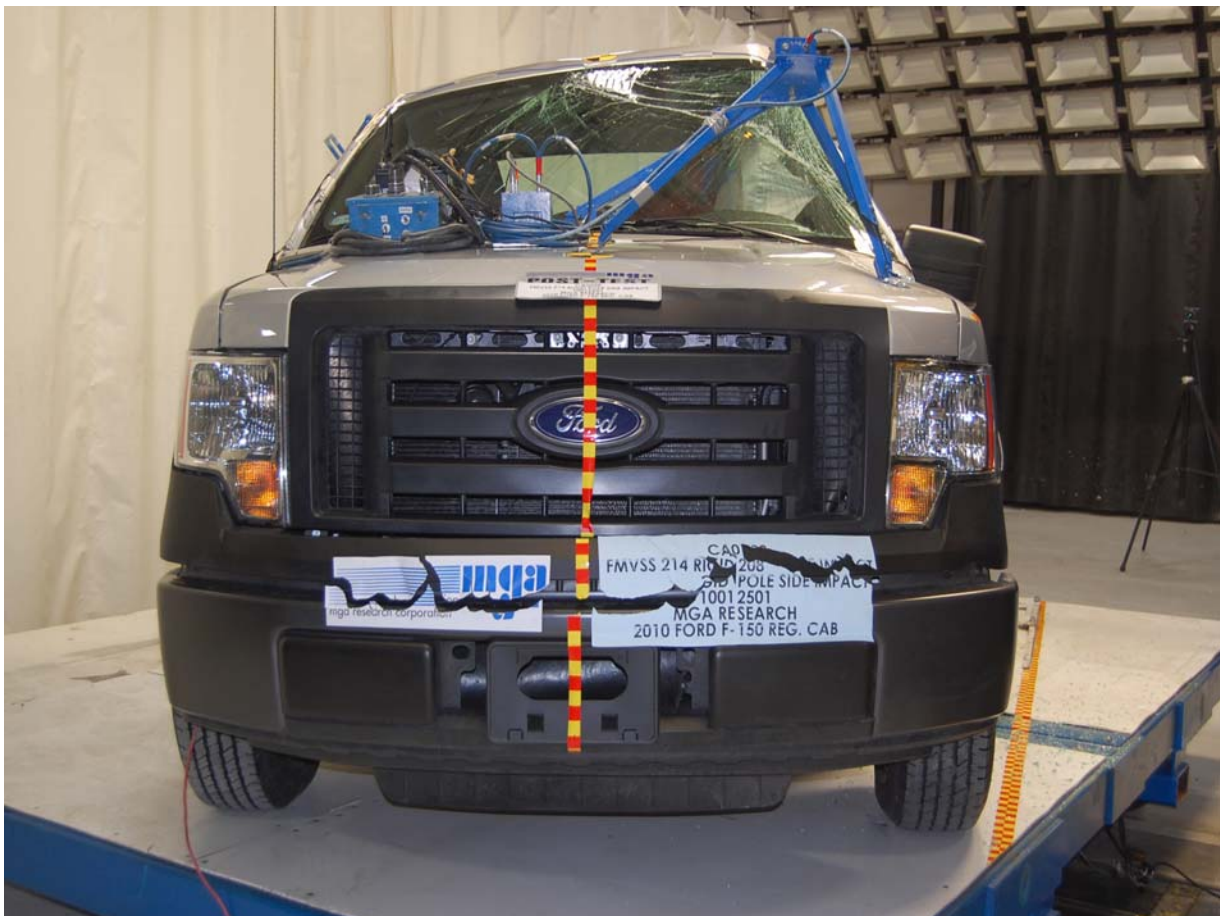
Post-Test Frontal View of Test Vehicle

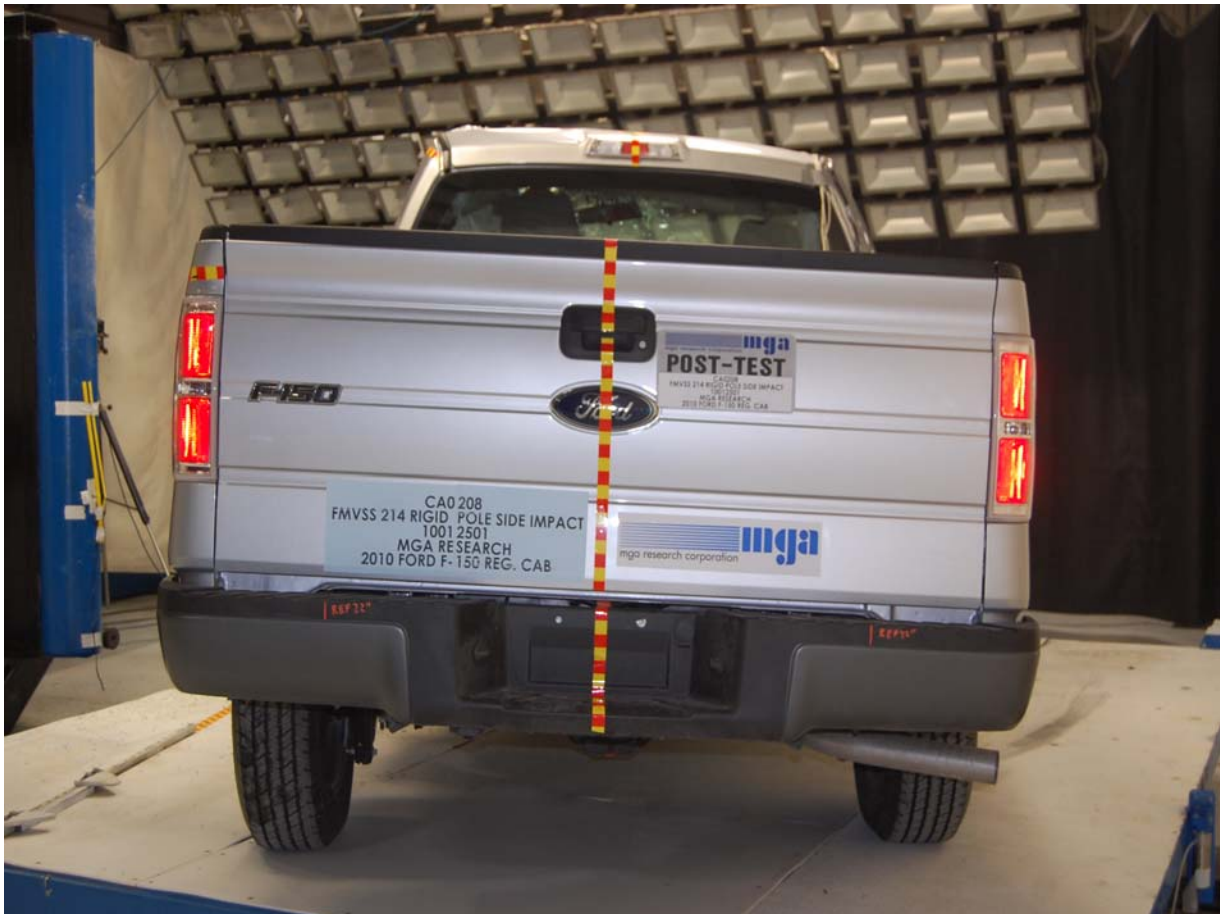
Post-Test Rear View of Test Vehicle

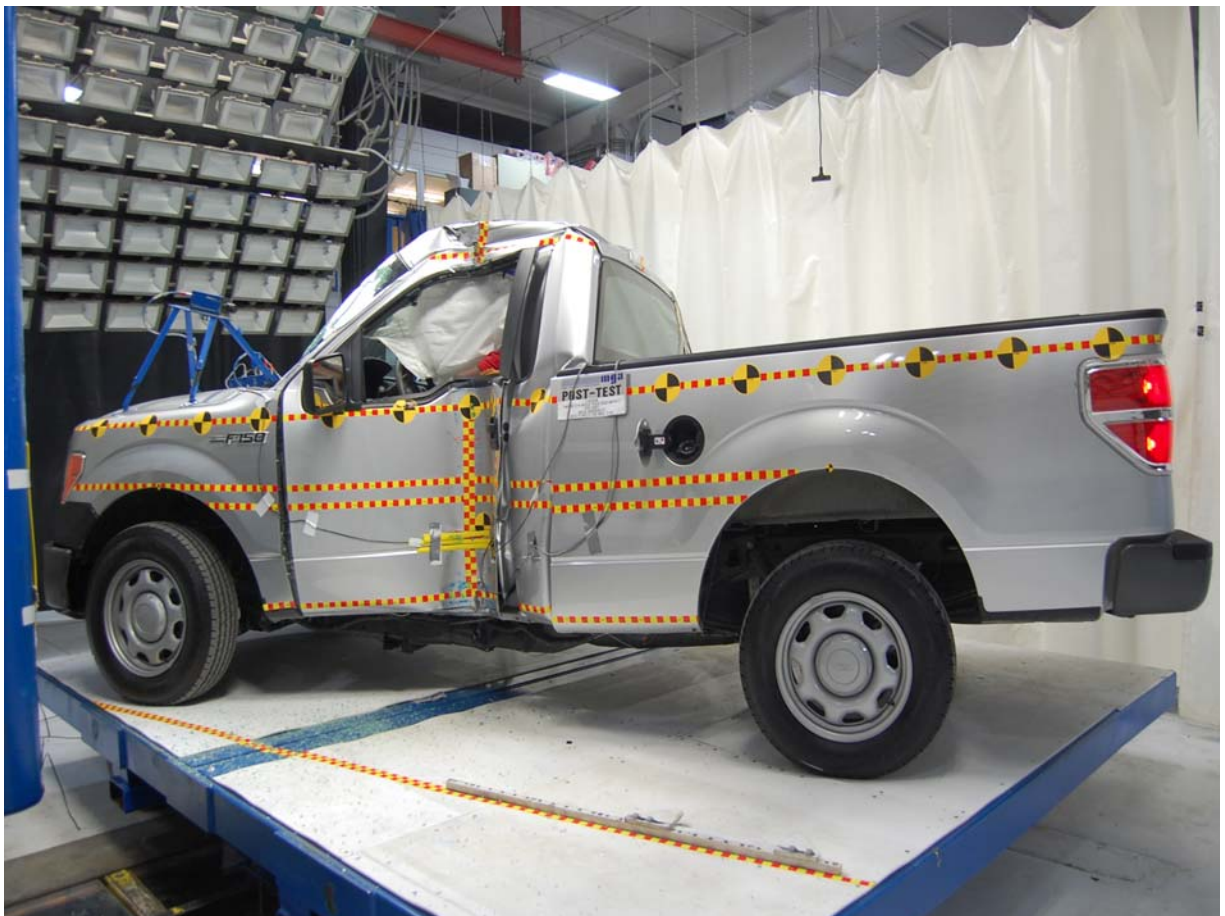
Post-Test Impacted Side View of Test Vehicle

Critical Areas of Performance	Observations and Conclusions
Pillar Performance	No Separation
Sill Separation	None
Windshield Damage	Cracked
Window Damage	Left Front Window Broke
Other Notable Effects	None

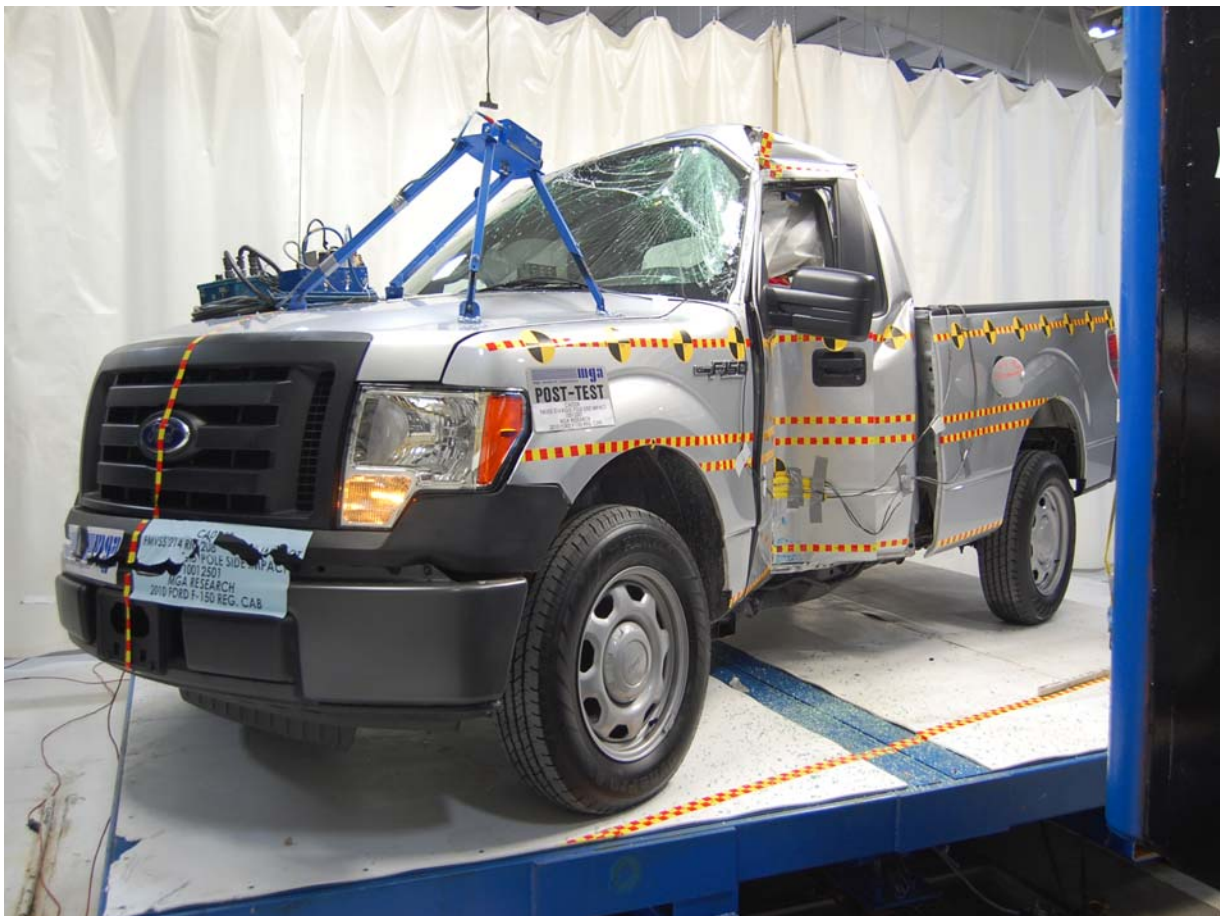
Post-Test Left  $\frac{3}{4}$  Front View of Vehicle and Pole

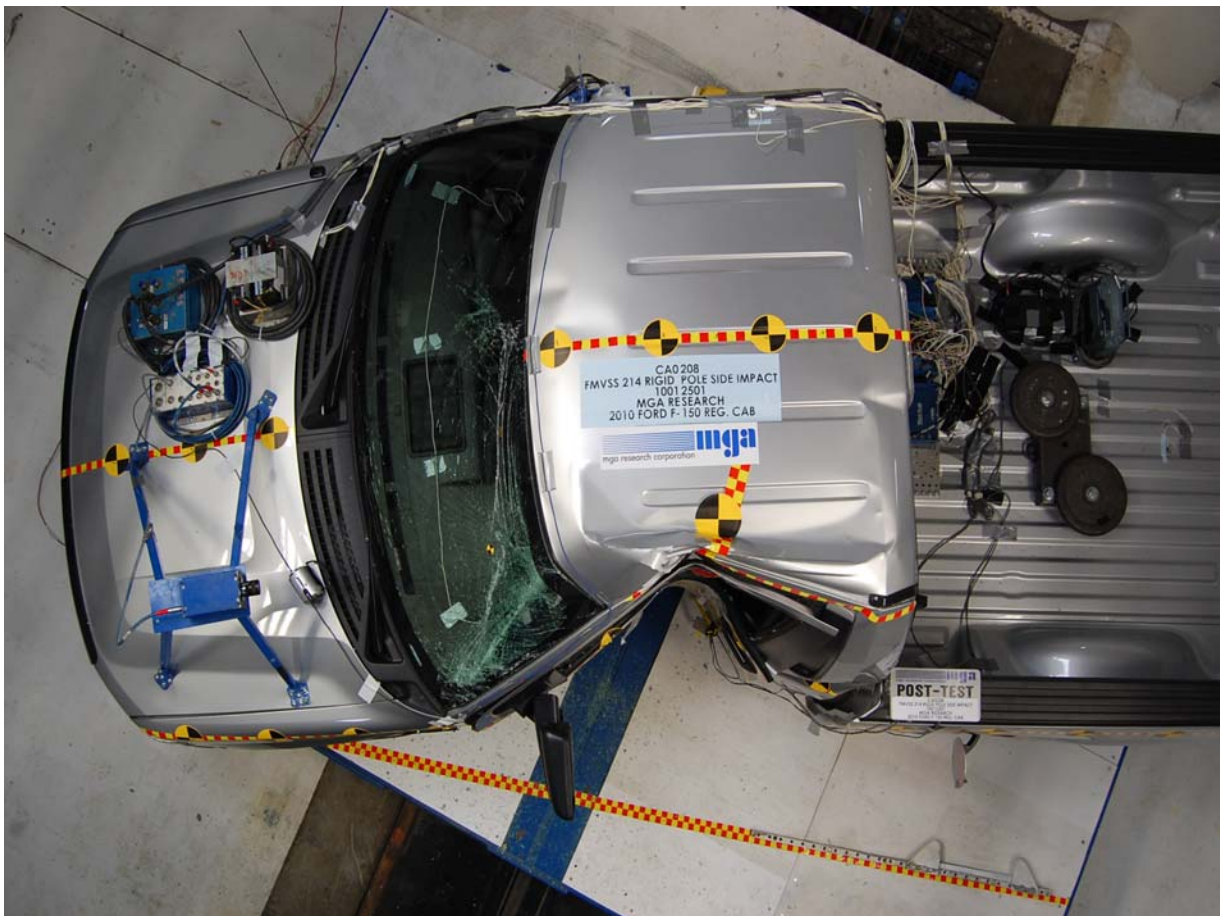
Post-Test Overhead View of Test Vehicle

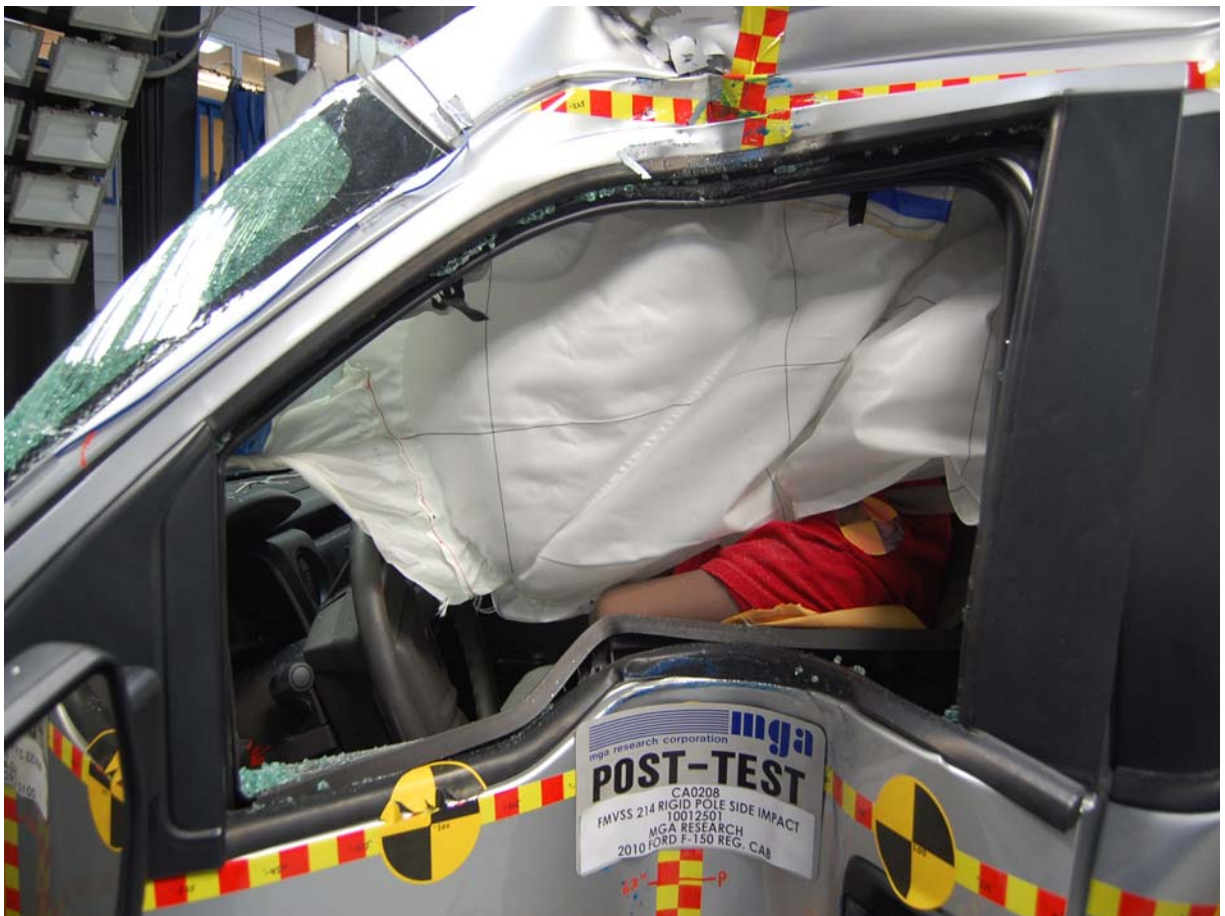
Post-Test Dummy with Door Closed (Impact Side)

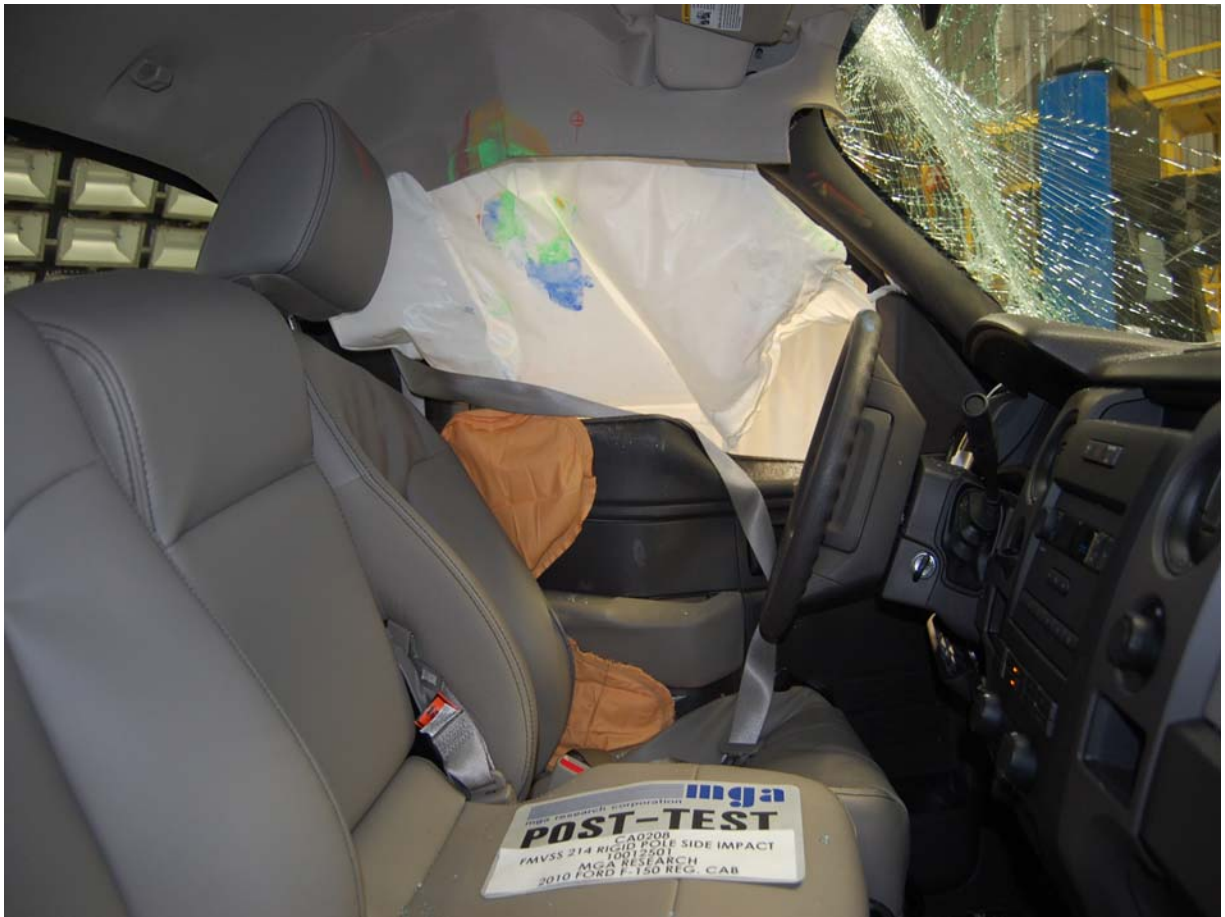
Post-Test Interior of Front Door Showing Dummy Impact Locations

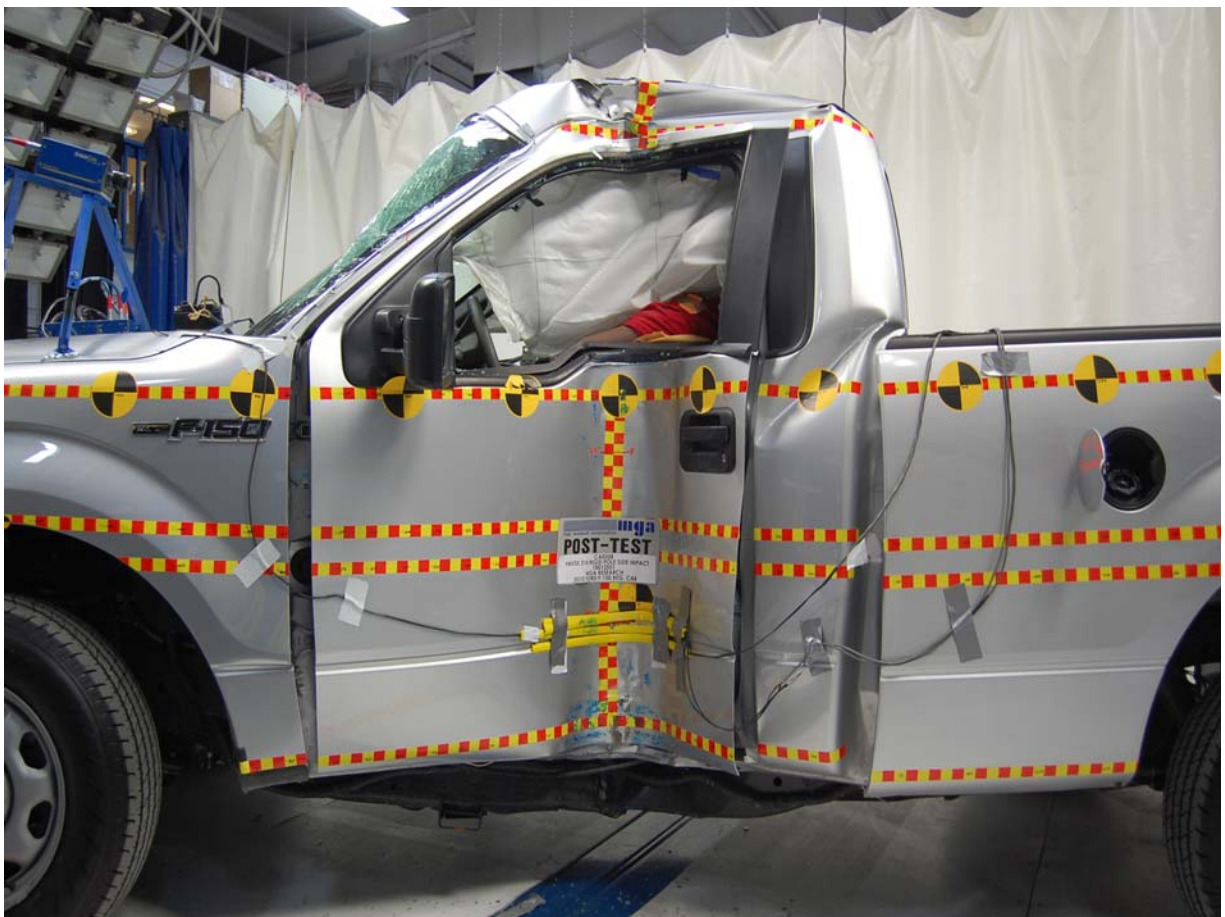
Post-Test Impact Zone Close-up View

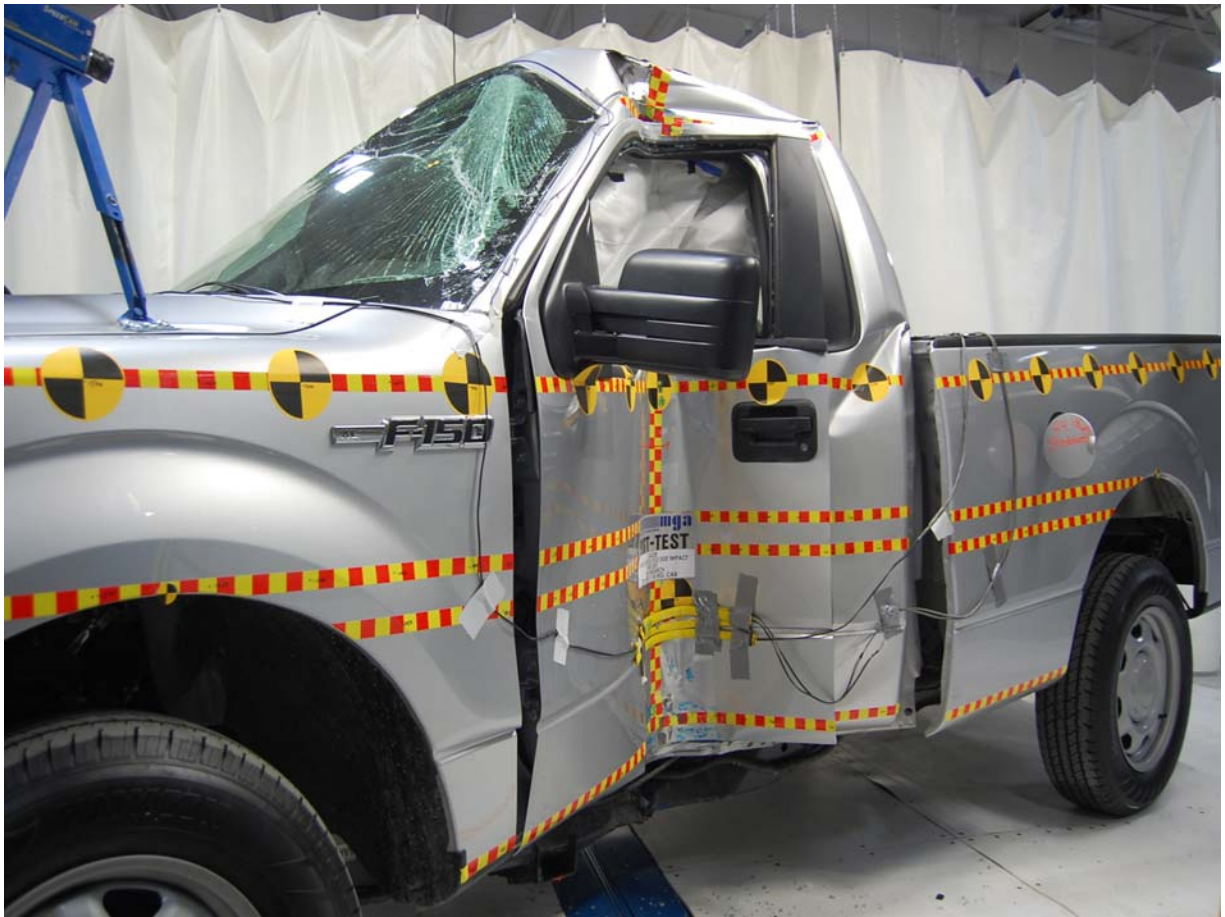
Post-Test  $\frac{3}{4}$  Front View of Impact Zone

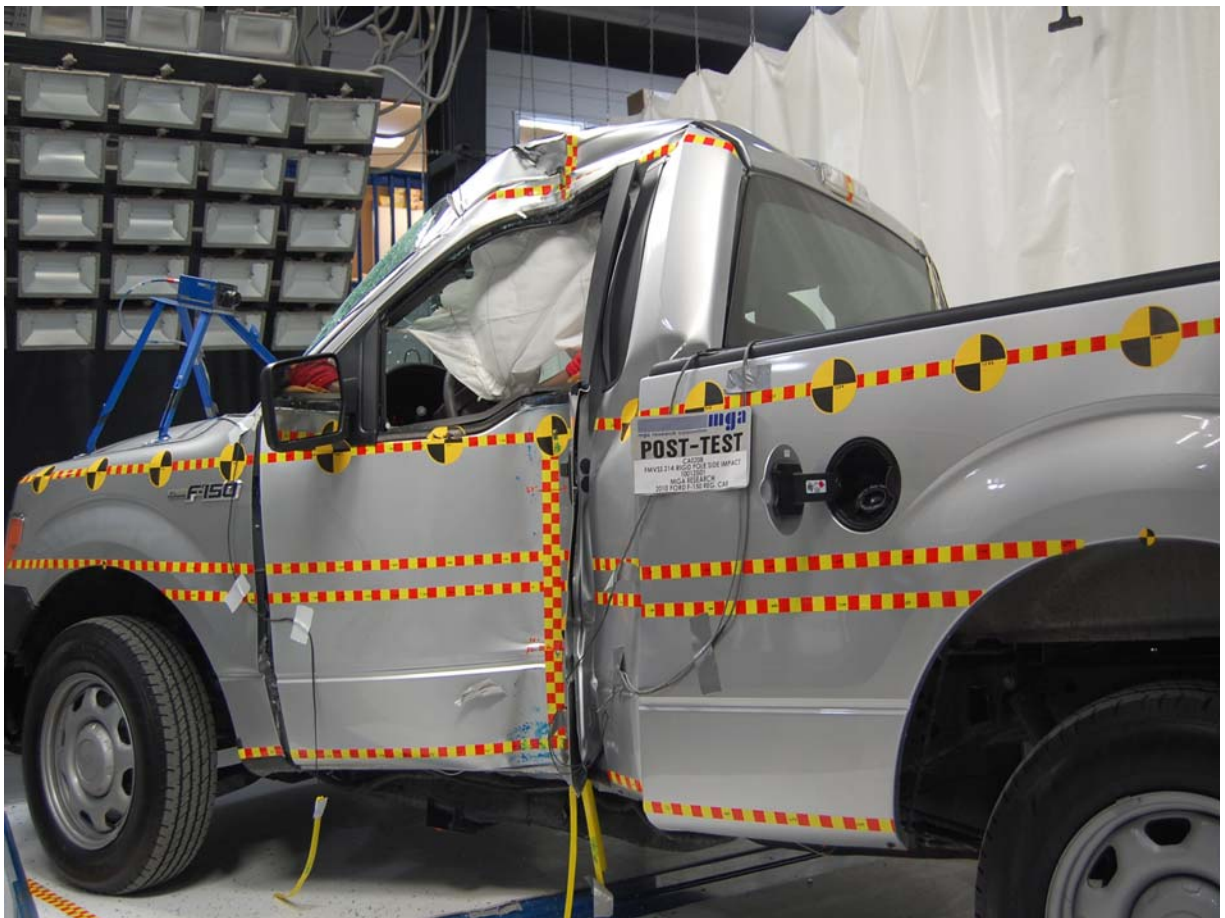
Post-Test  $\frac{3}{4}$  Rear View of Impact Zone

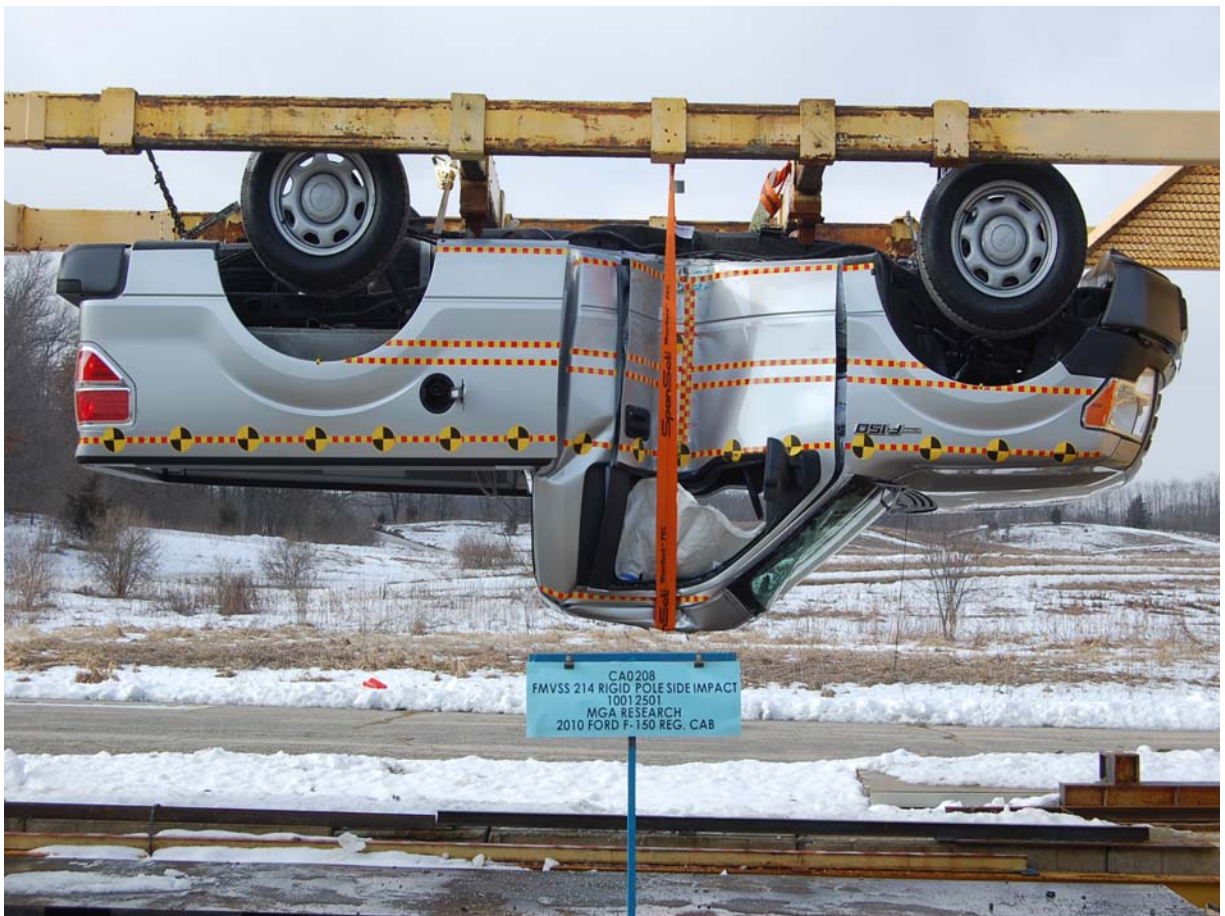
Post-Test Vehicle at 180 Degree Rollover

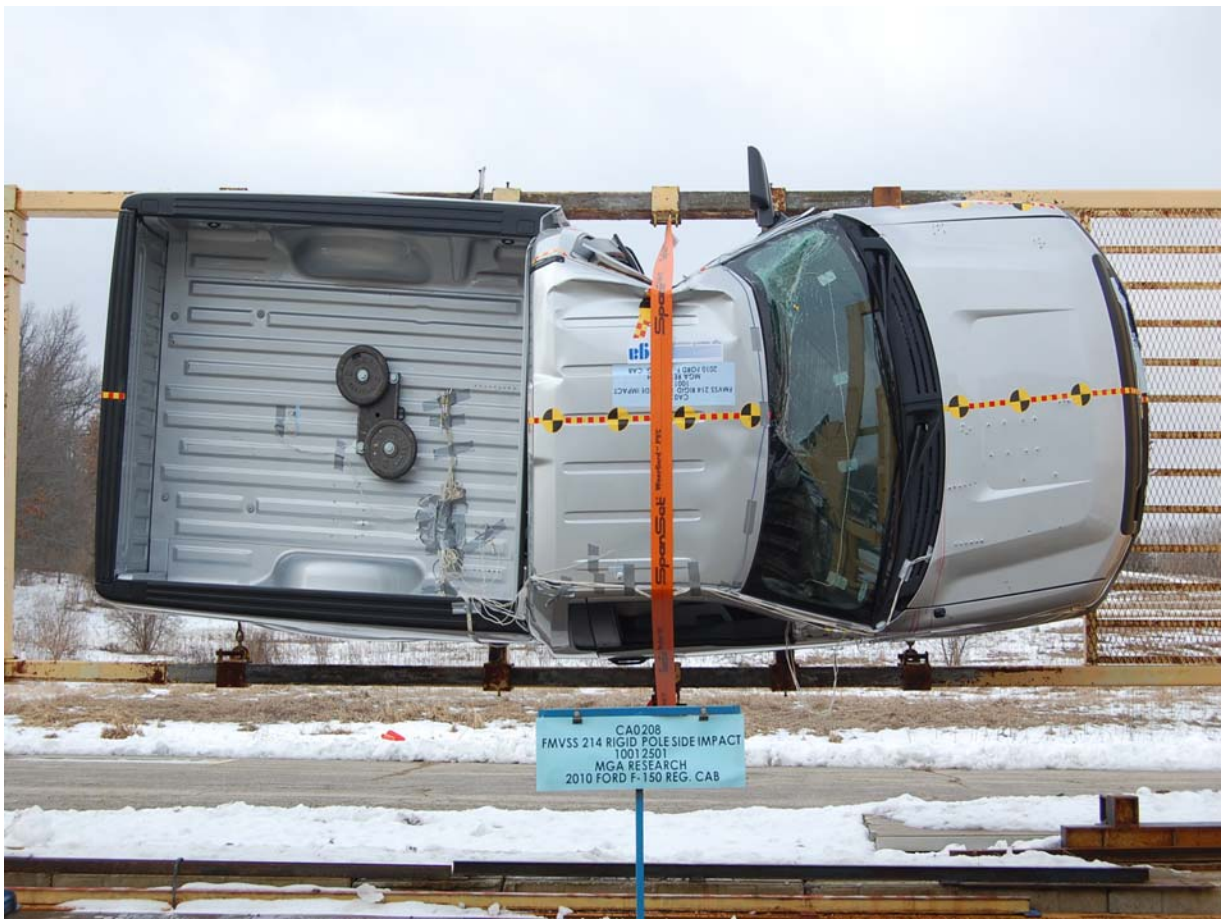
Post-Test Vehicle at 270 Degree Rollover

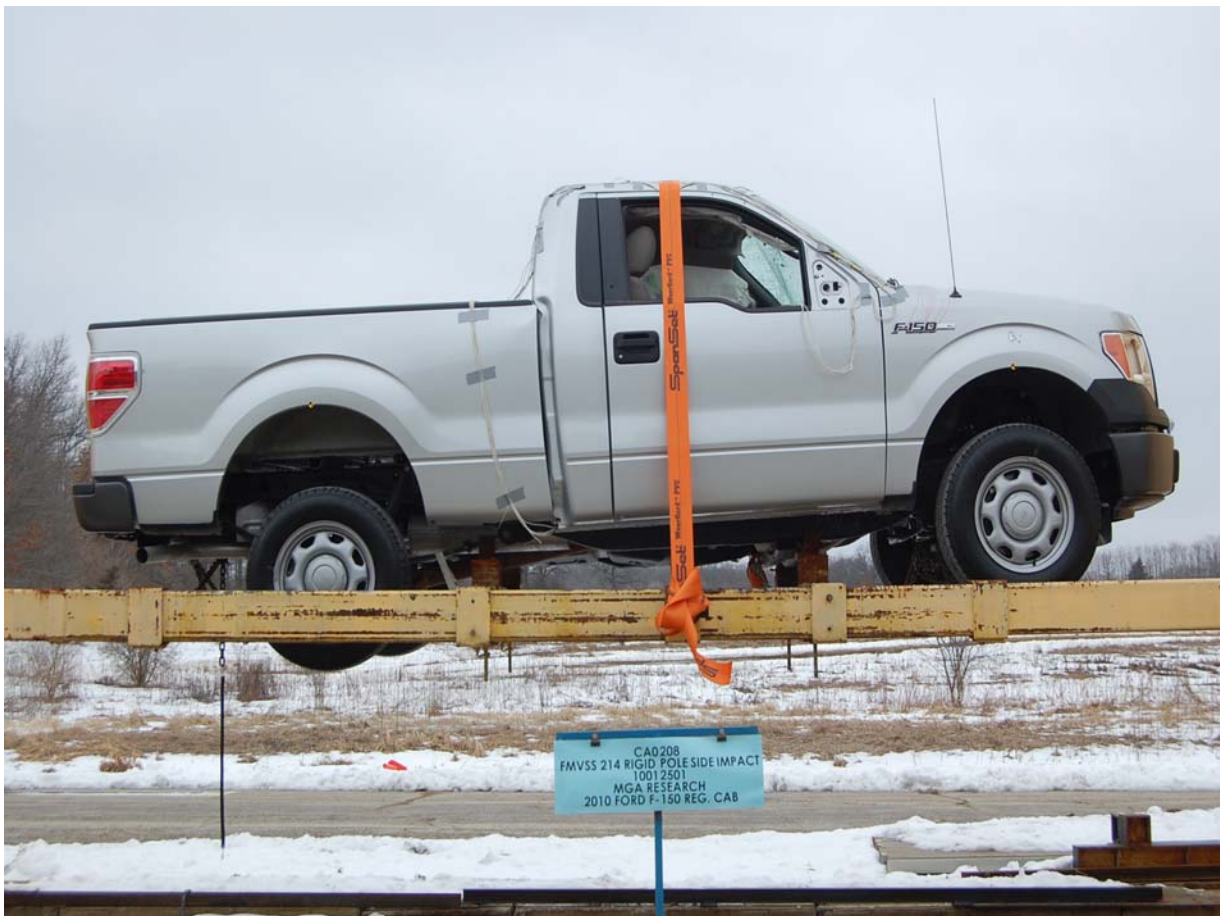
Post-Test Vehicle at 360 Degree Rollover
