REPORT NUMBER 124-GTL-10-001

SAFETY COMPLIANCE TESTING FOR FMVSS 124 ACCELERATOR CONTROL SYSTEMS

NISSAN MOTOR CO., LTD.
2010 INFINITY G37, PASSENGER CAR
NHTSA NO. CA5204

FINAL REPORT

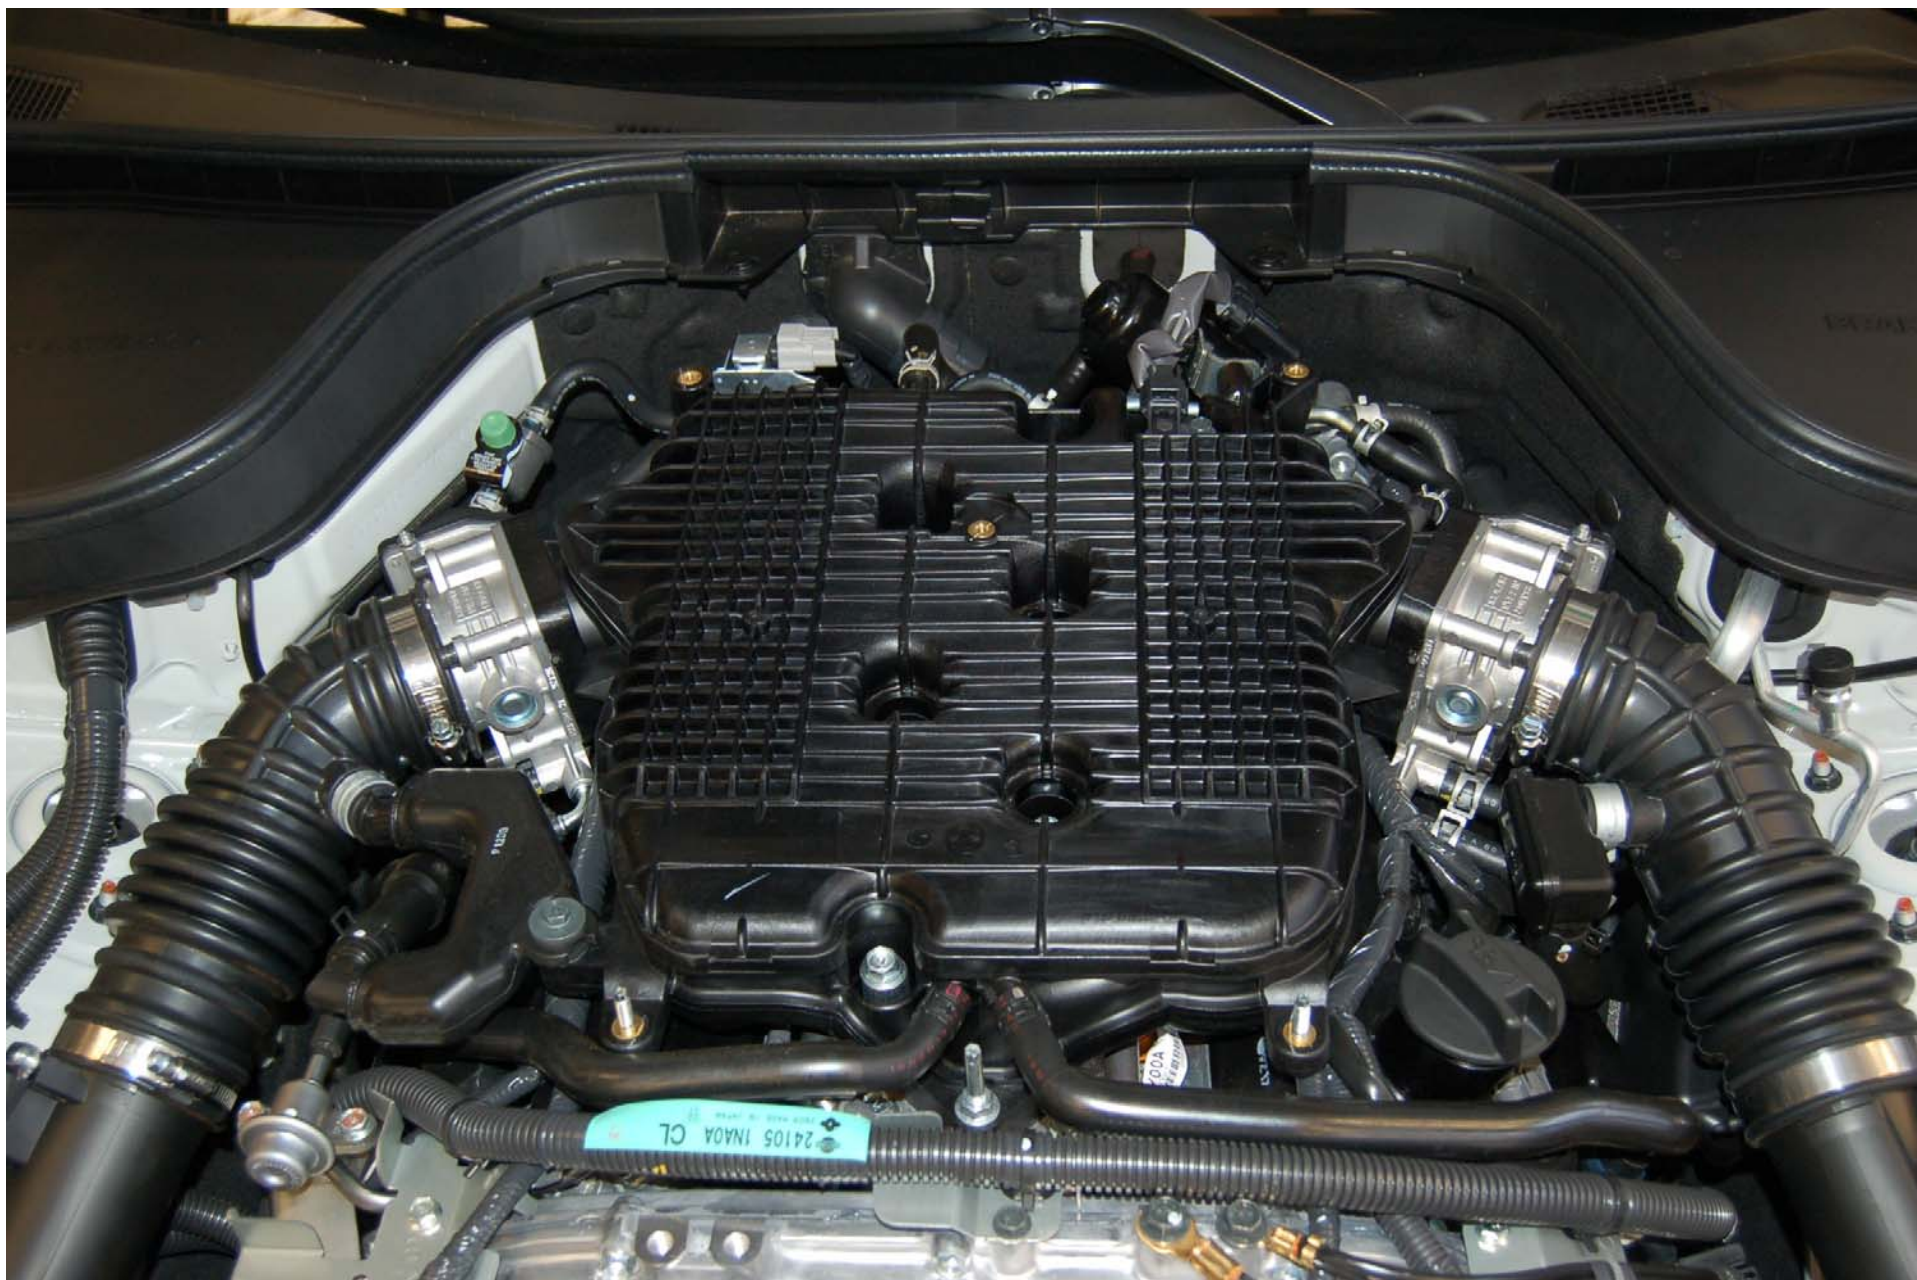
FIGURE 5.6
DUAL THROTTLE BODY LOCATIONS

The vehicle is equipped with twin throttle bodies. Both are the same and work in parallel control from the accelerator control signal. The accelerator control system for this vehicle is "Drive by Wire" utilizing an accelerator pedal position sensor which signal is read by the Engine Computer System (ECS), which in turn sends a signal to the throttle body control motor to open/close the throttle butterfly which position is read by a Throttle Plate Position Sensor (TPS). This signal is then sent back to the Engine Computer System (ECS) which then gives closed loop control of the accelerator system. Return Springs 1 and 2 are located in the accelerator pedal assembly. Return Spring 3 is located in the throttle body. Spring 4 is located in the throttle body but is not a return spring. This spring is for clearance adjustment only.

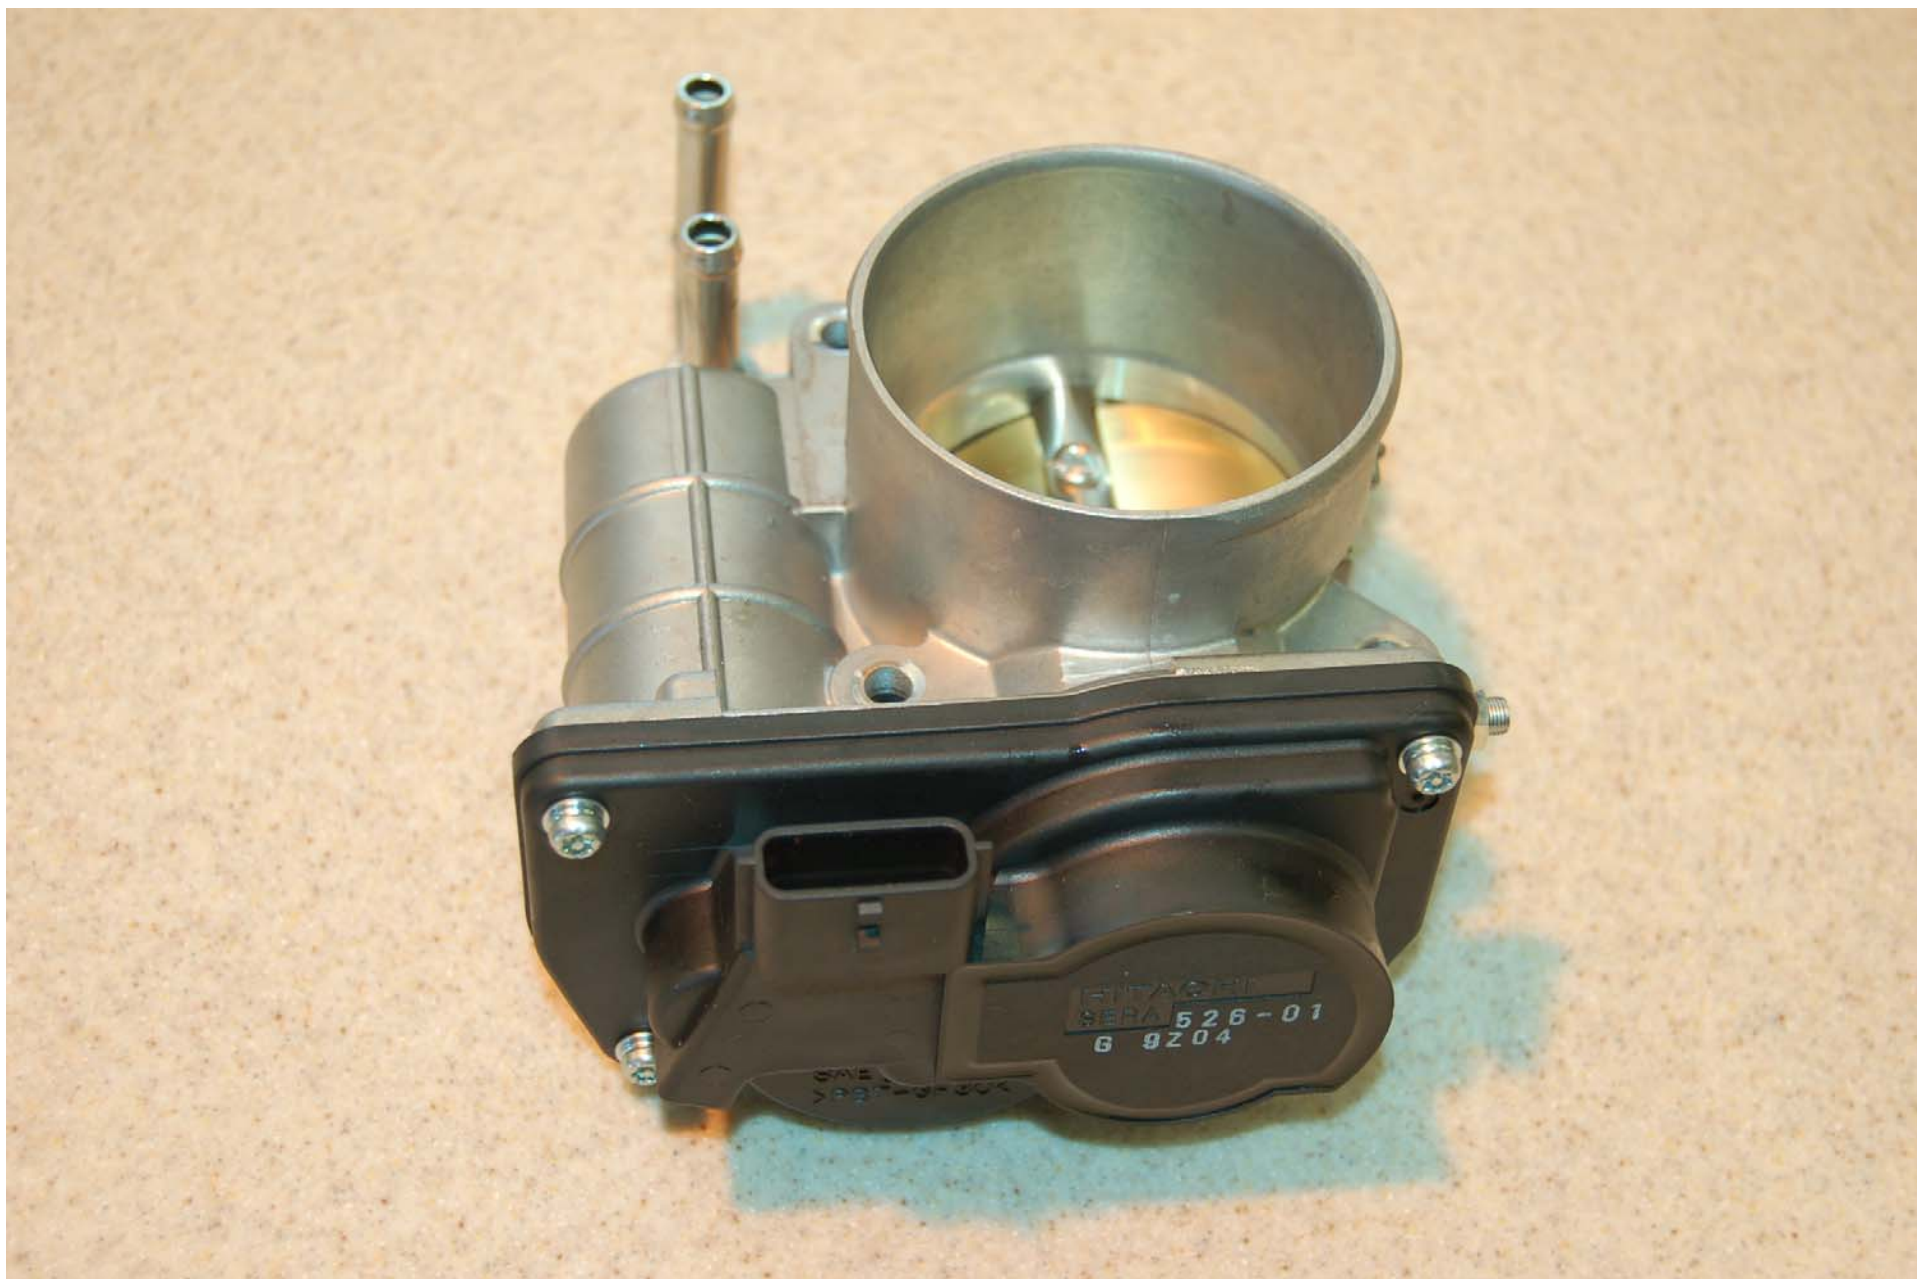
FIGURE 5.7
THROTTLE BODY ASSEMBLY

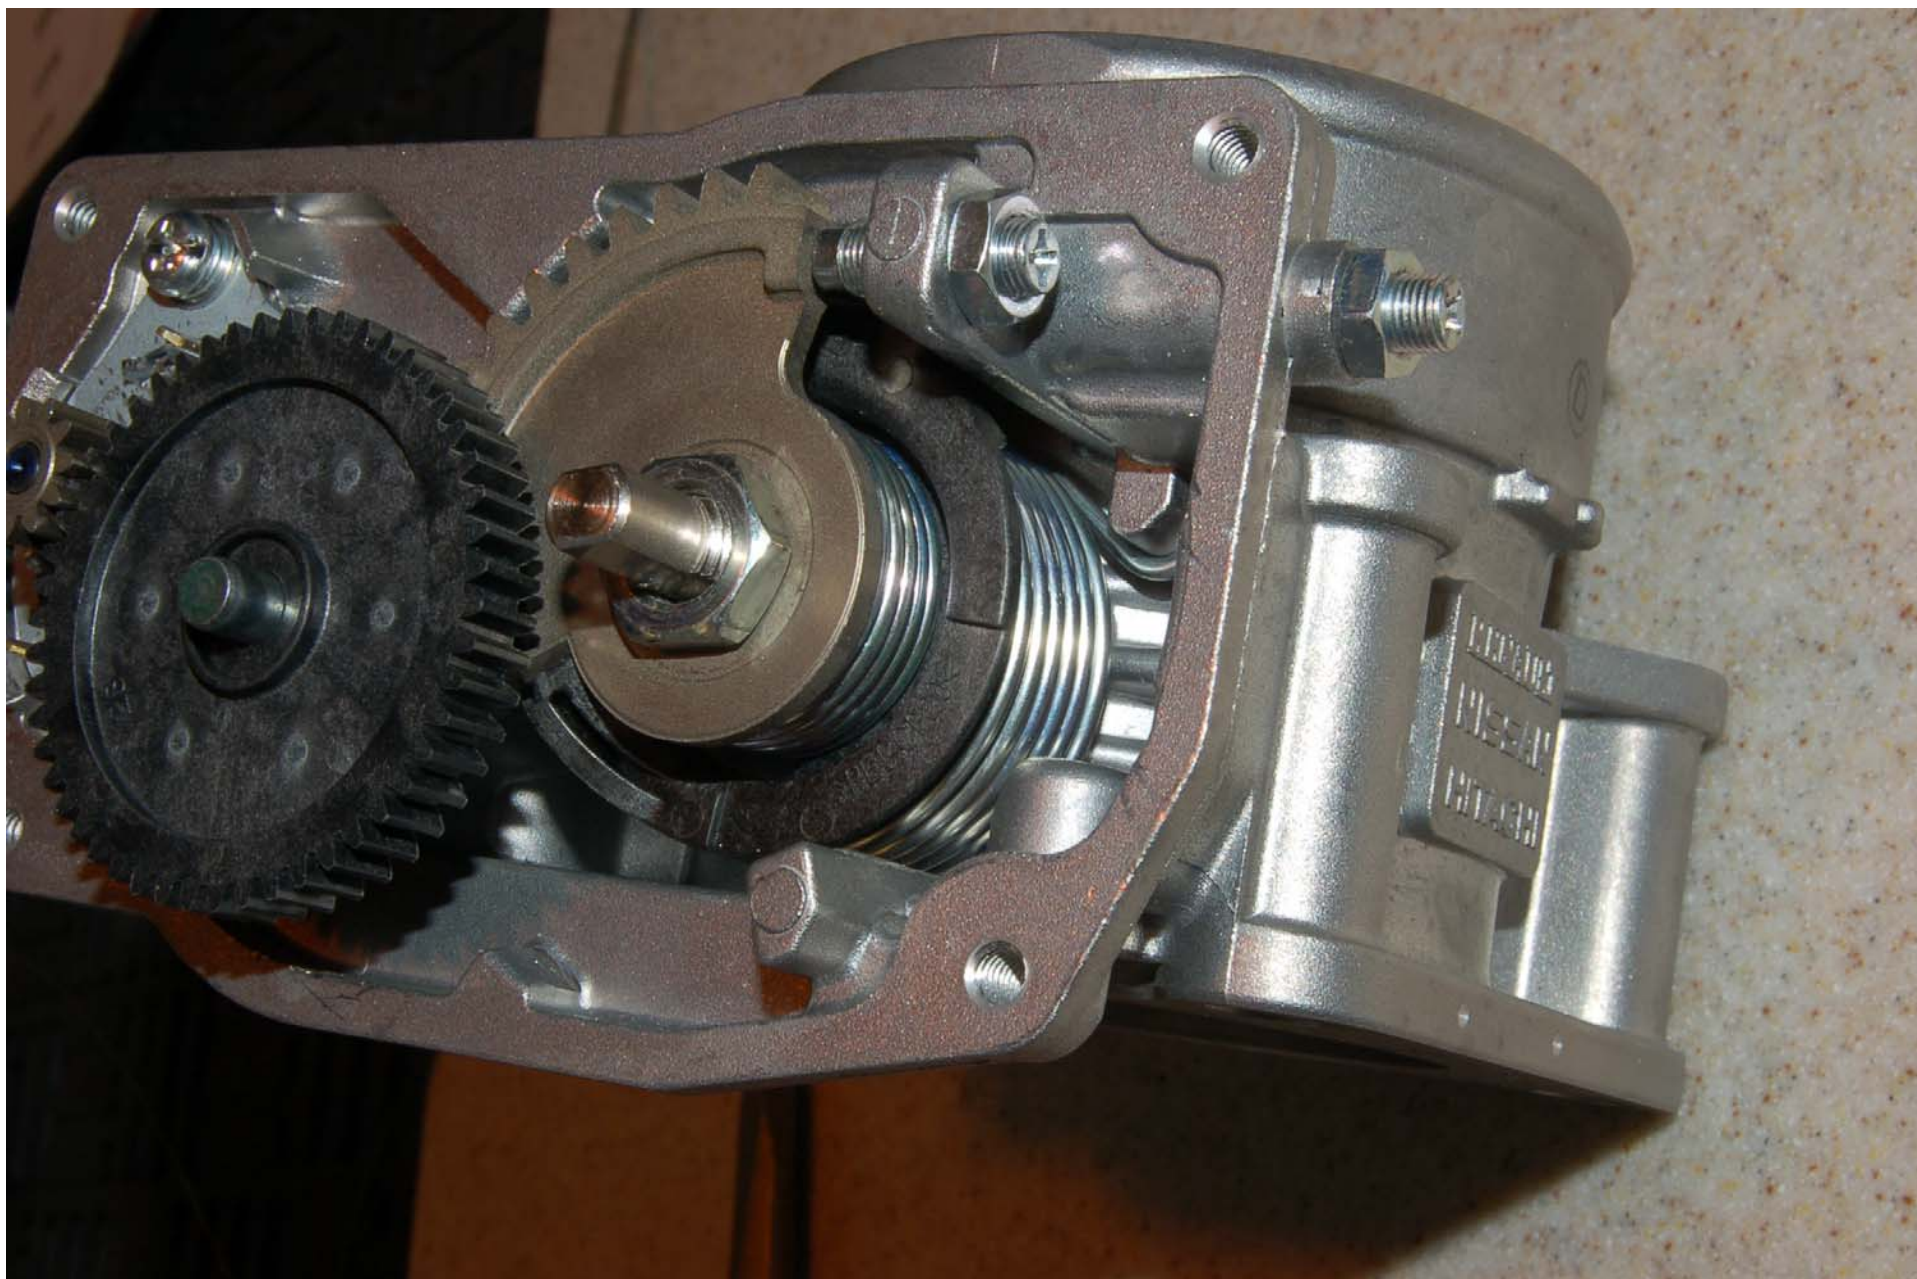
FIGURE 5.8
SPRINGS INSIDE THROTTLE BODY

SYSTEM CONDITION: #3 SPRING DISCONNECTED IN THROTTLE BODY

REMARKS: During engine start-up sequence the ECS can sense the spring fault and will only let the engine idle at 1000 RPM and will not allow throttle pedal control of the engine.

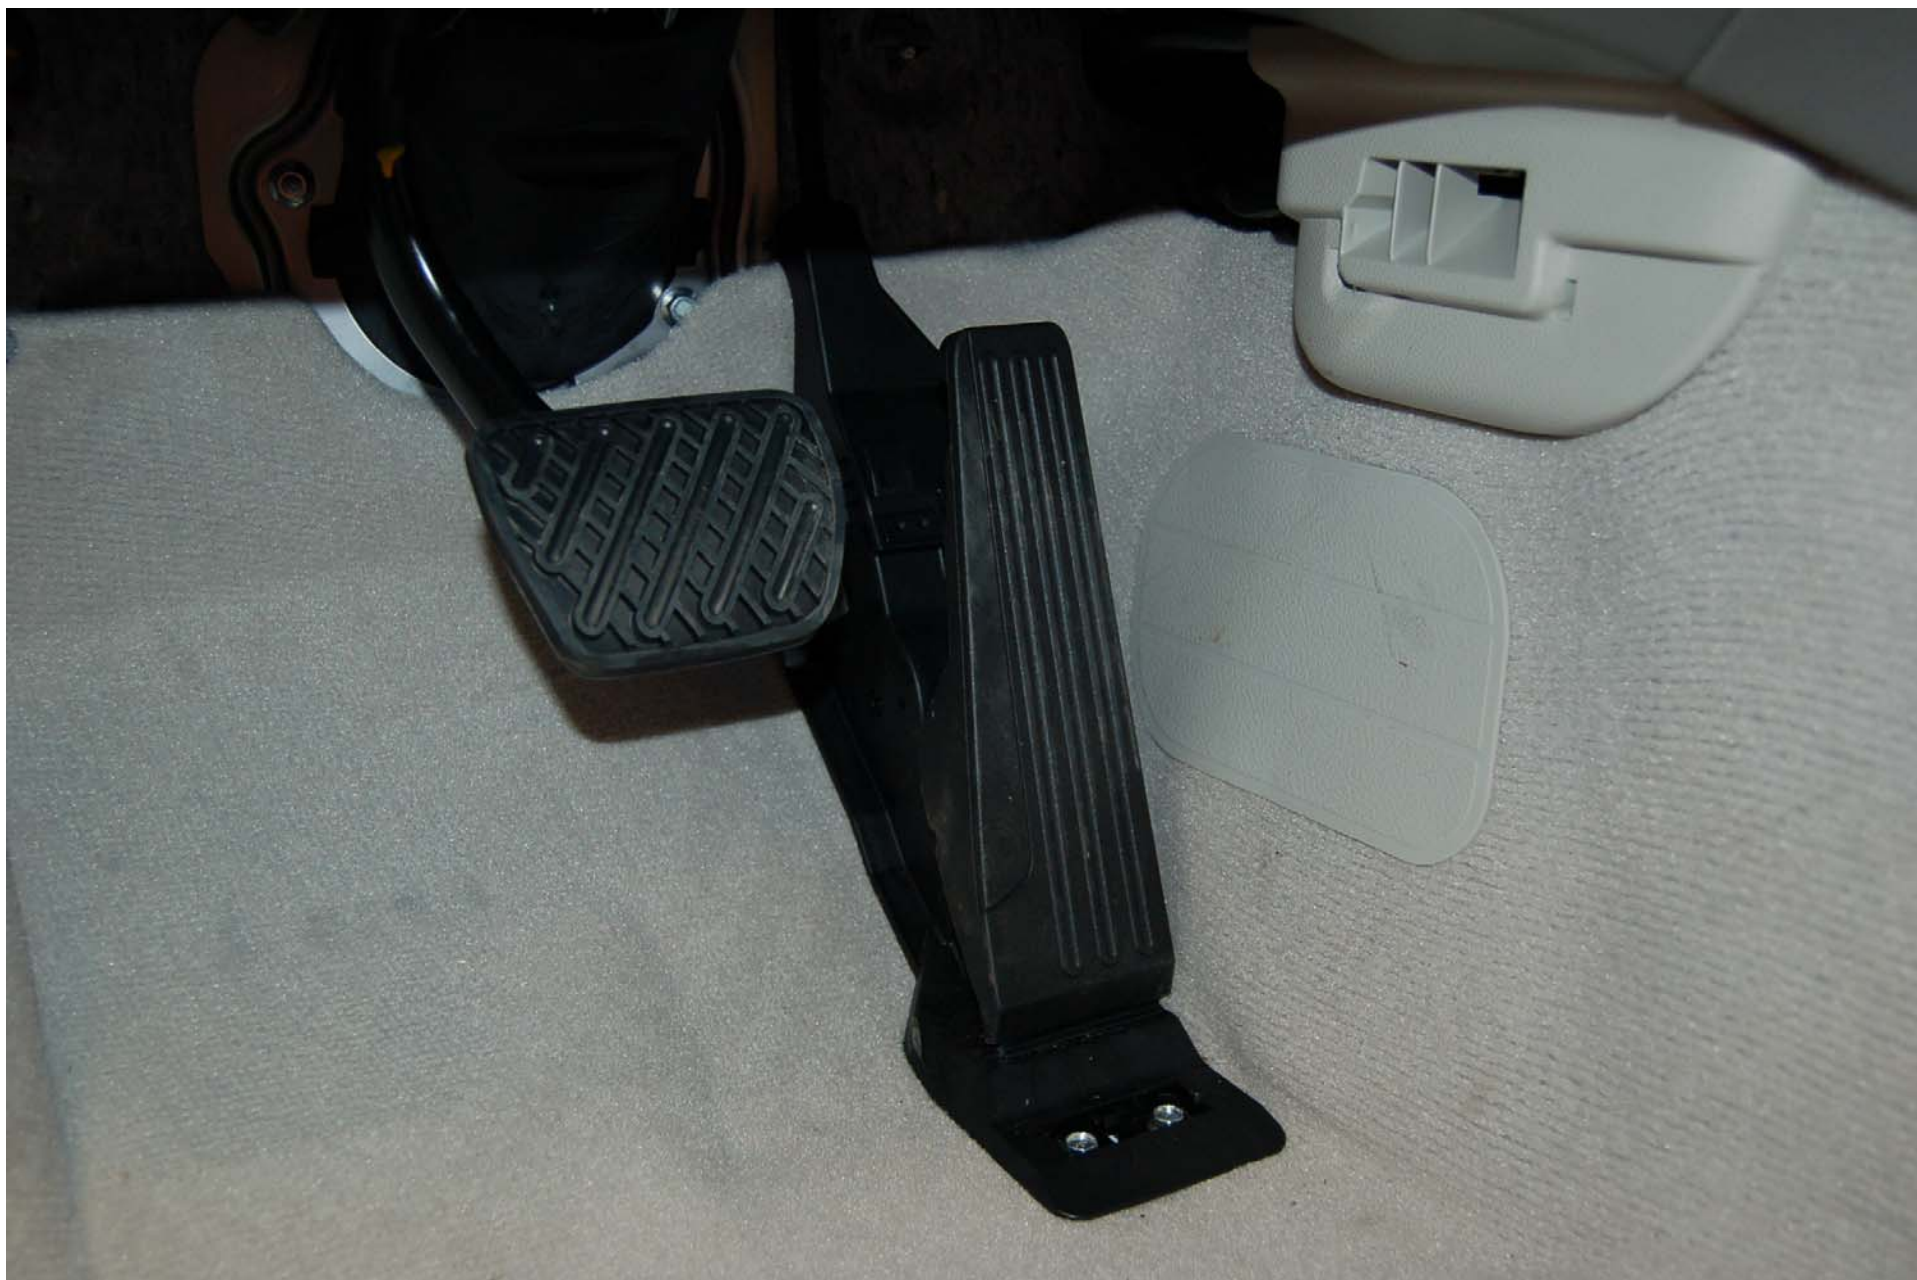
FIGURE 5.9
ACCELERATOR PEDAL SENSOR

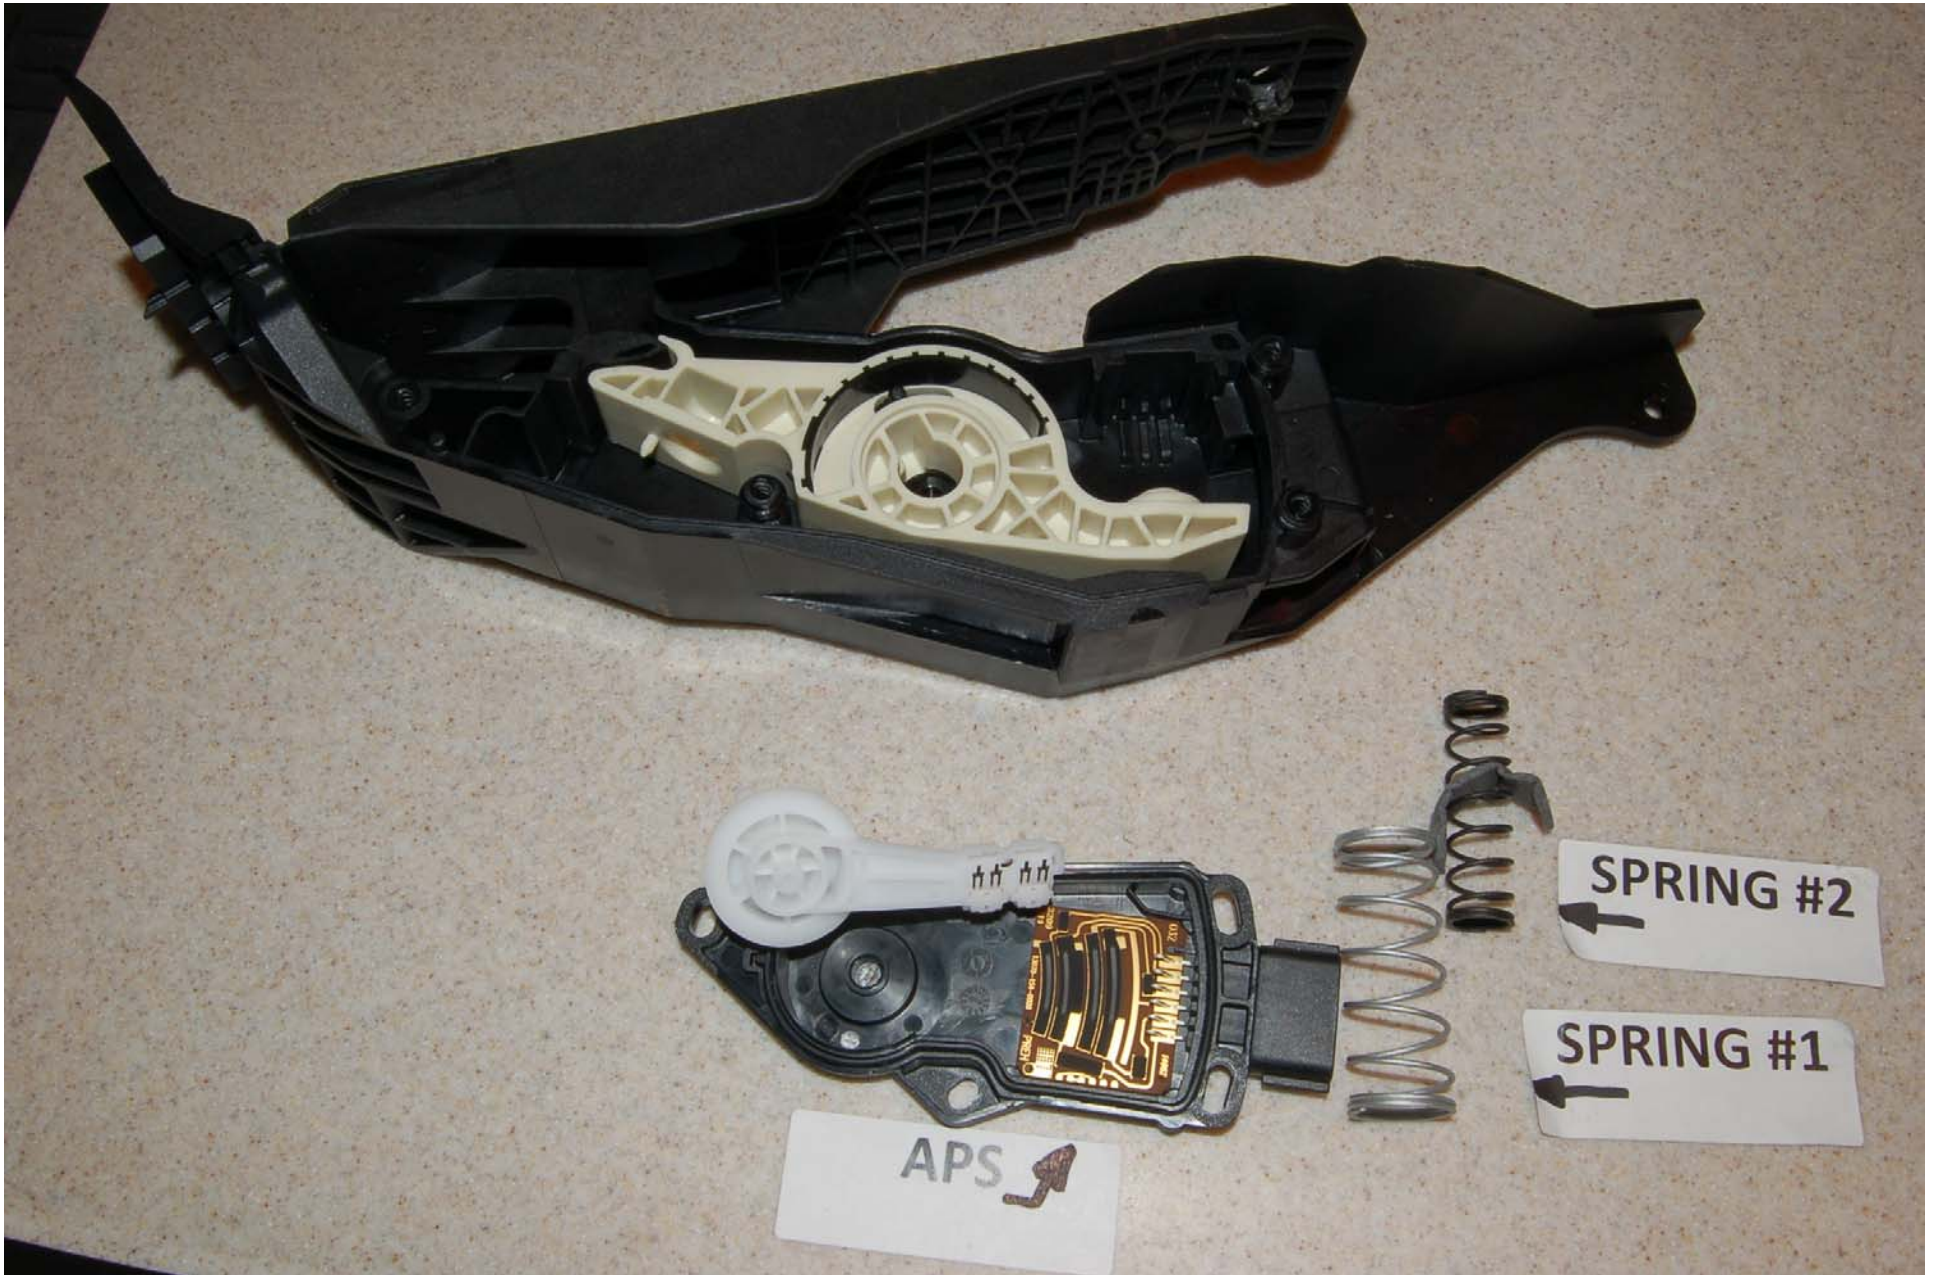
FIGURE 5.10
ACCELERATOR PEDAL SENSOR WITH SPRINGS 1 & 2

Return to idle times were determined for four throttle plate positions (25%, 50%, 75% and 100%) with the accelerator control system complete and with each of the two APS return springs in the accelerator pedal assembly independently disconnected and disconnection of the throttle body return spring #3. With each of the wires to the APS and throttle plate position sensor disconnected and shorted to ground, return to idle times were determined at the worst case condition – wide open throttle (100%).

SYSTEM CONDITION: #1 SPRING DISCONNECTED (OUTER SPRING) ON ACCELERATOR

SYSTEM CONDITION: #2 SPRING DISCONNECTED (INNER SPRING) ON ACCELERATOR

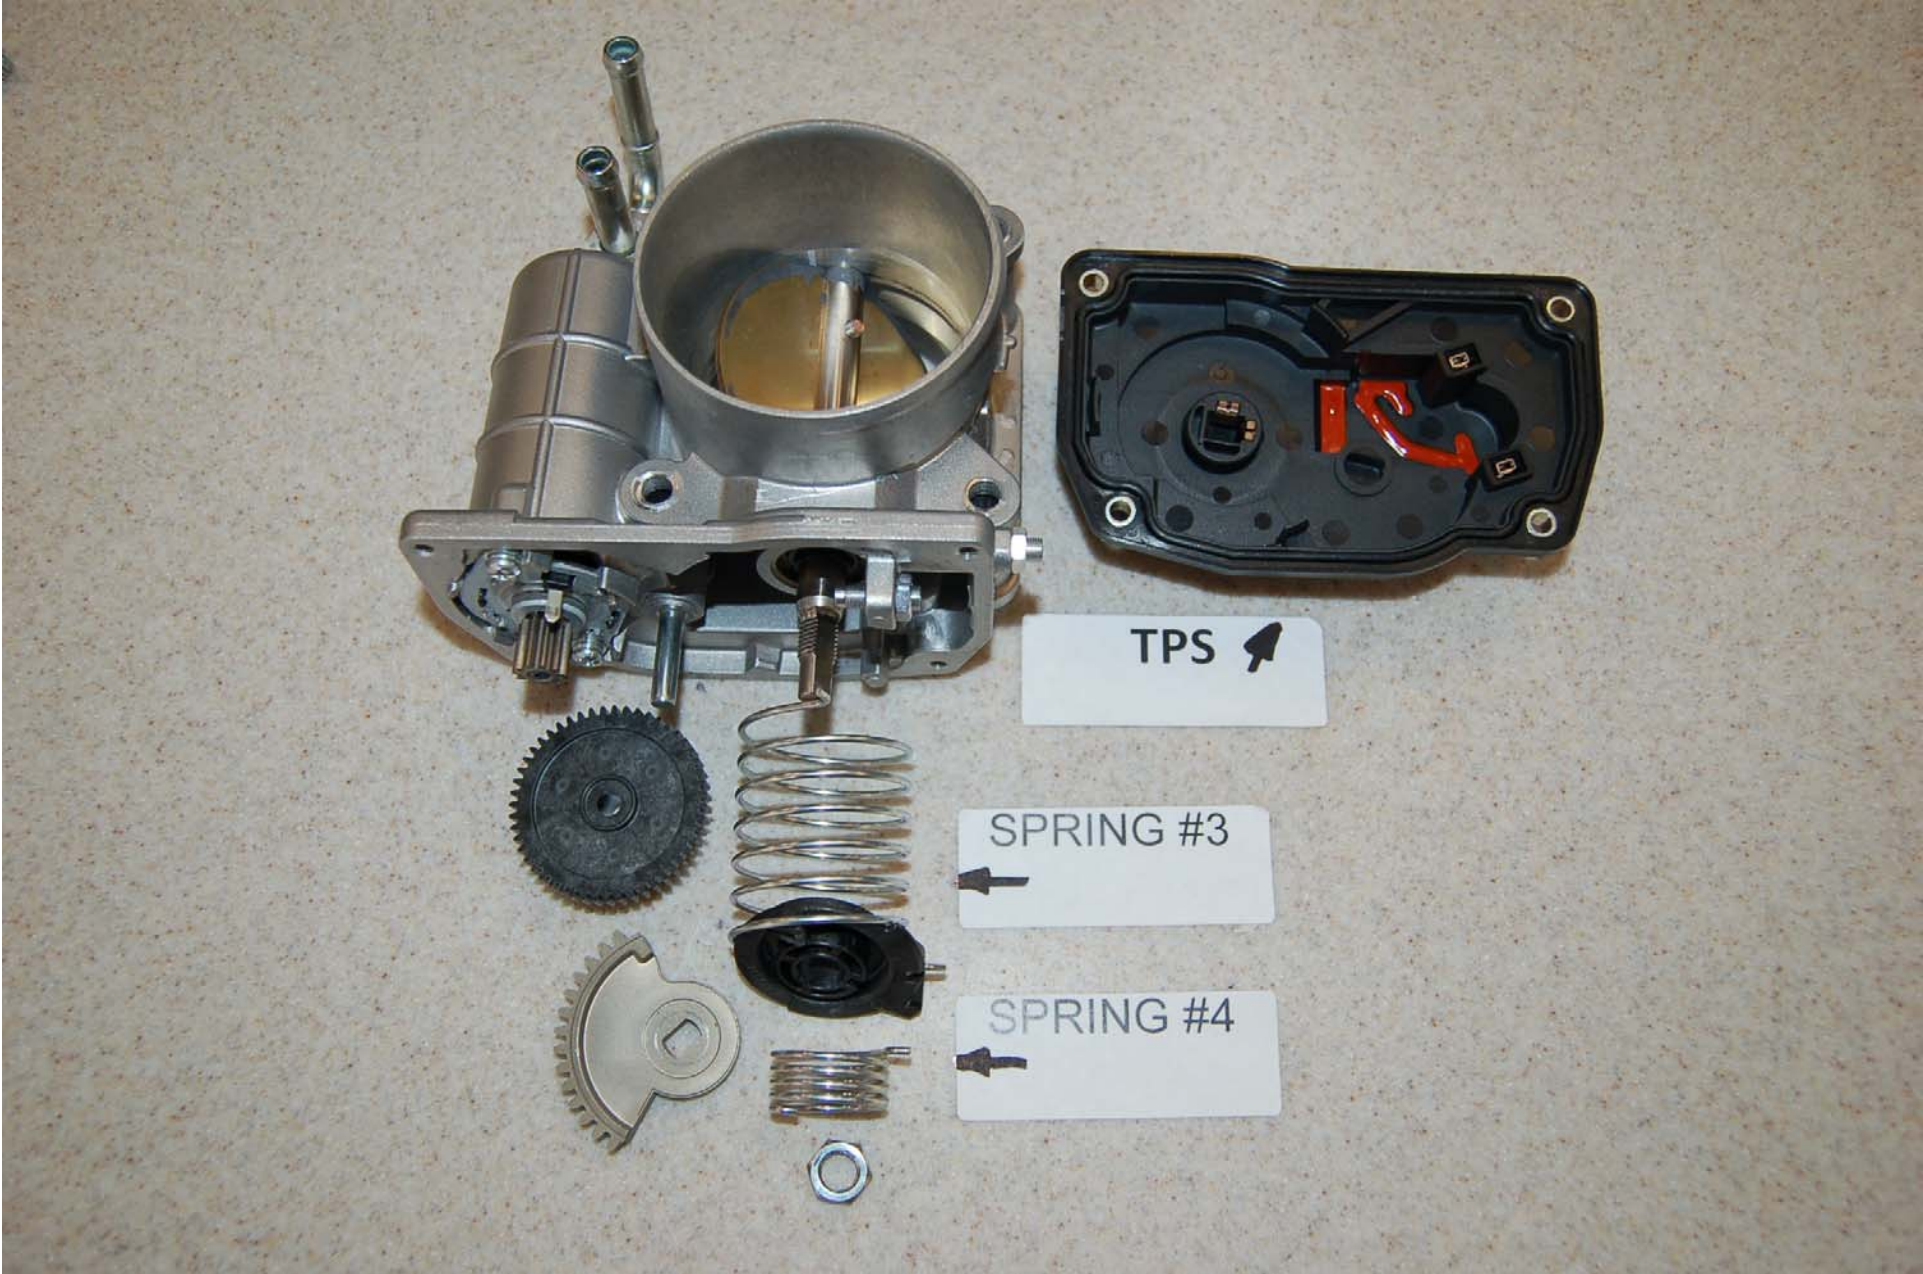
FIGURE 5.11
THROTTLE POSITION SENSOR WITH SPRINGS 3 & 4

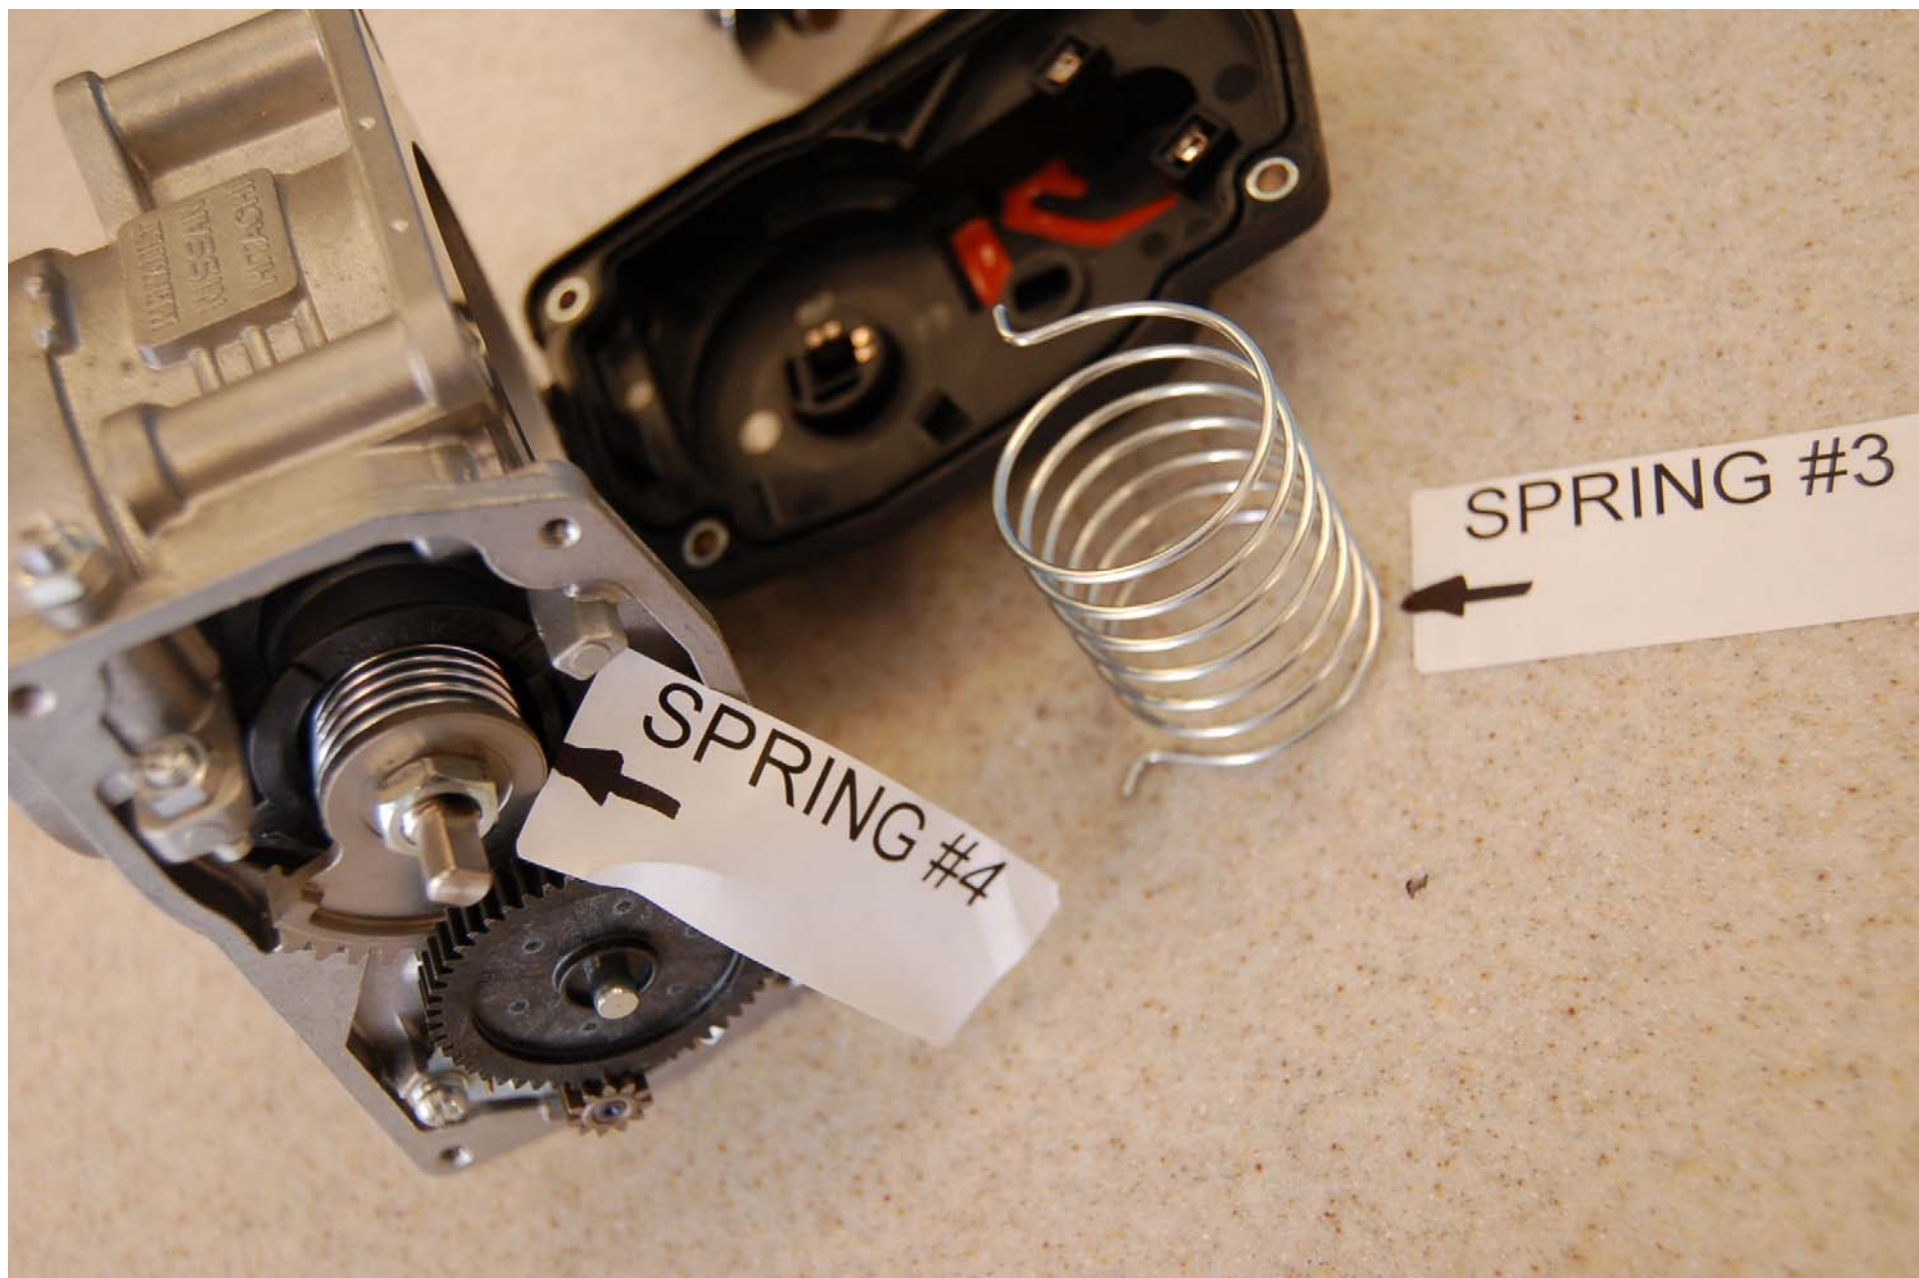
FIGURE 5.12
THROTTLE POSITION SENSOR WITH SPRINGS 3 & 4

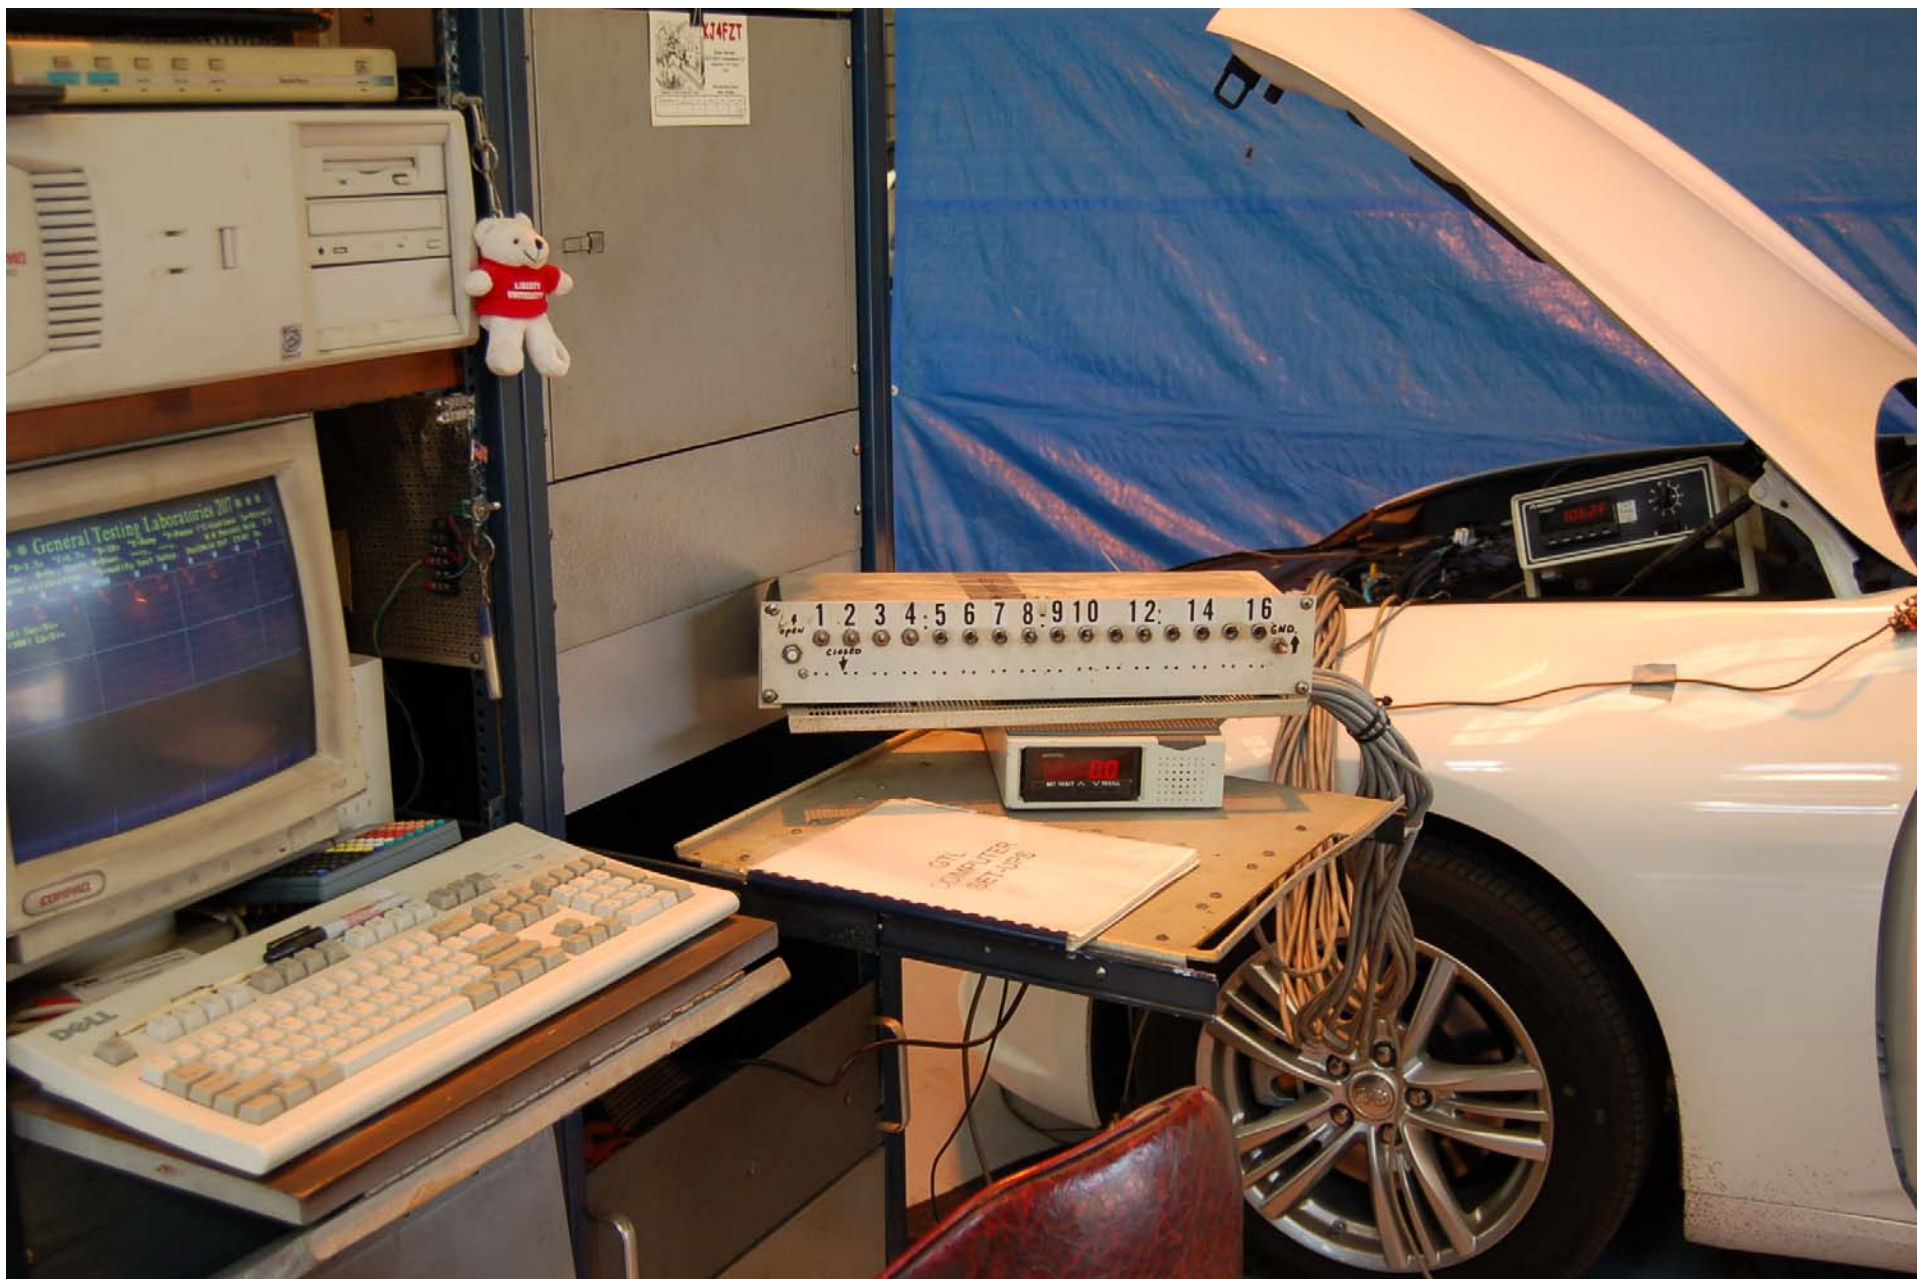
FIGURE 5.13
 TEST SET-UP WITH DATA RECORDING

Output from the vehicle throttle position sensor on the air throttle plate shaft was used to measure throttle position and data was recorded at 100 HZ with GTL's data acquisition system. Testing was conducted to simulate the normal removal of the driver's foot from the accelerator pedal. This was performed by depressing the accelerator with a control rod which incorporated an electrical contact strip in the depressing end. The accelerator was depressed to the required amount and then the control rod was quickly removed from the pedal, releasing the accelerator and activating the contact strip for time zero. Failures (excluding spring disconnect) were induced simultaneously with release of the accelerator pedal. Testing was performed with the vehicle in drive and the engine running. The test could not be conducted in

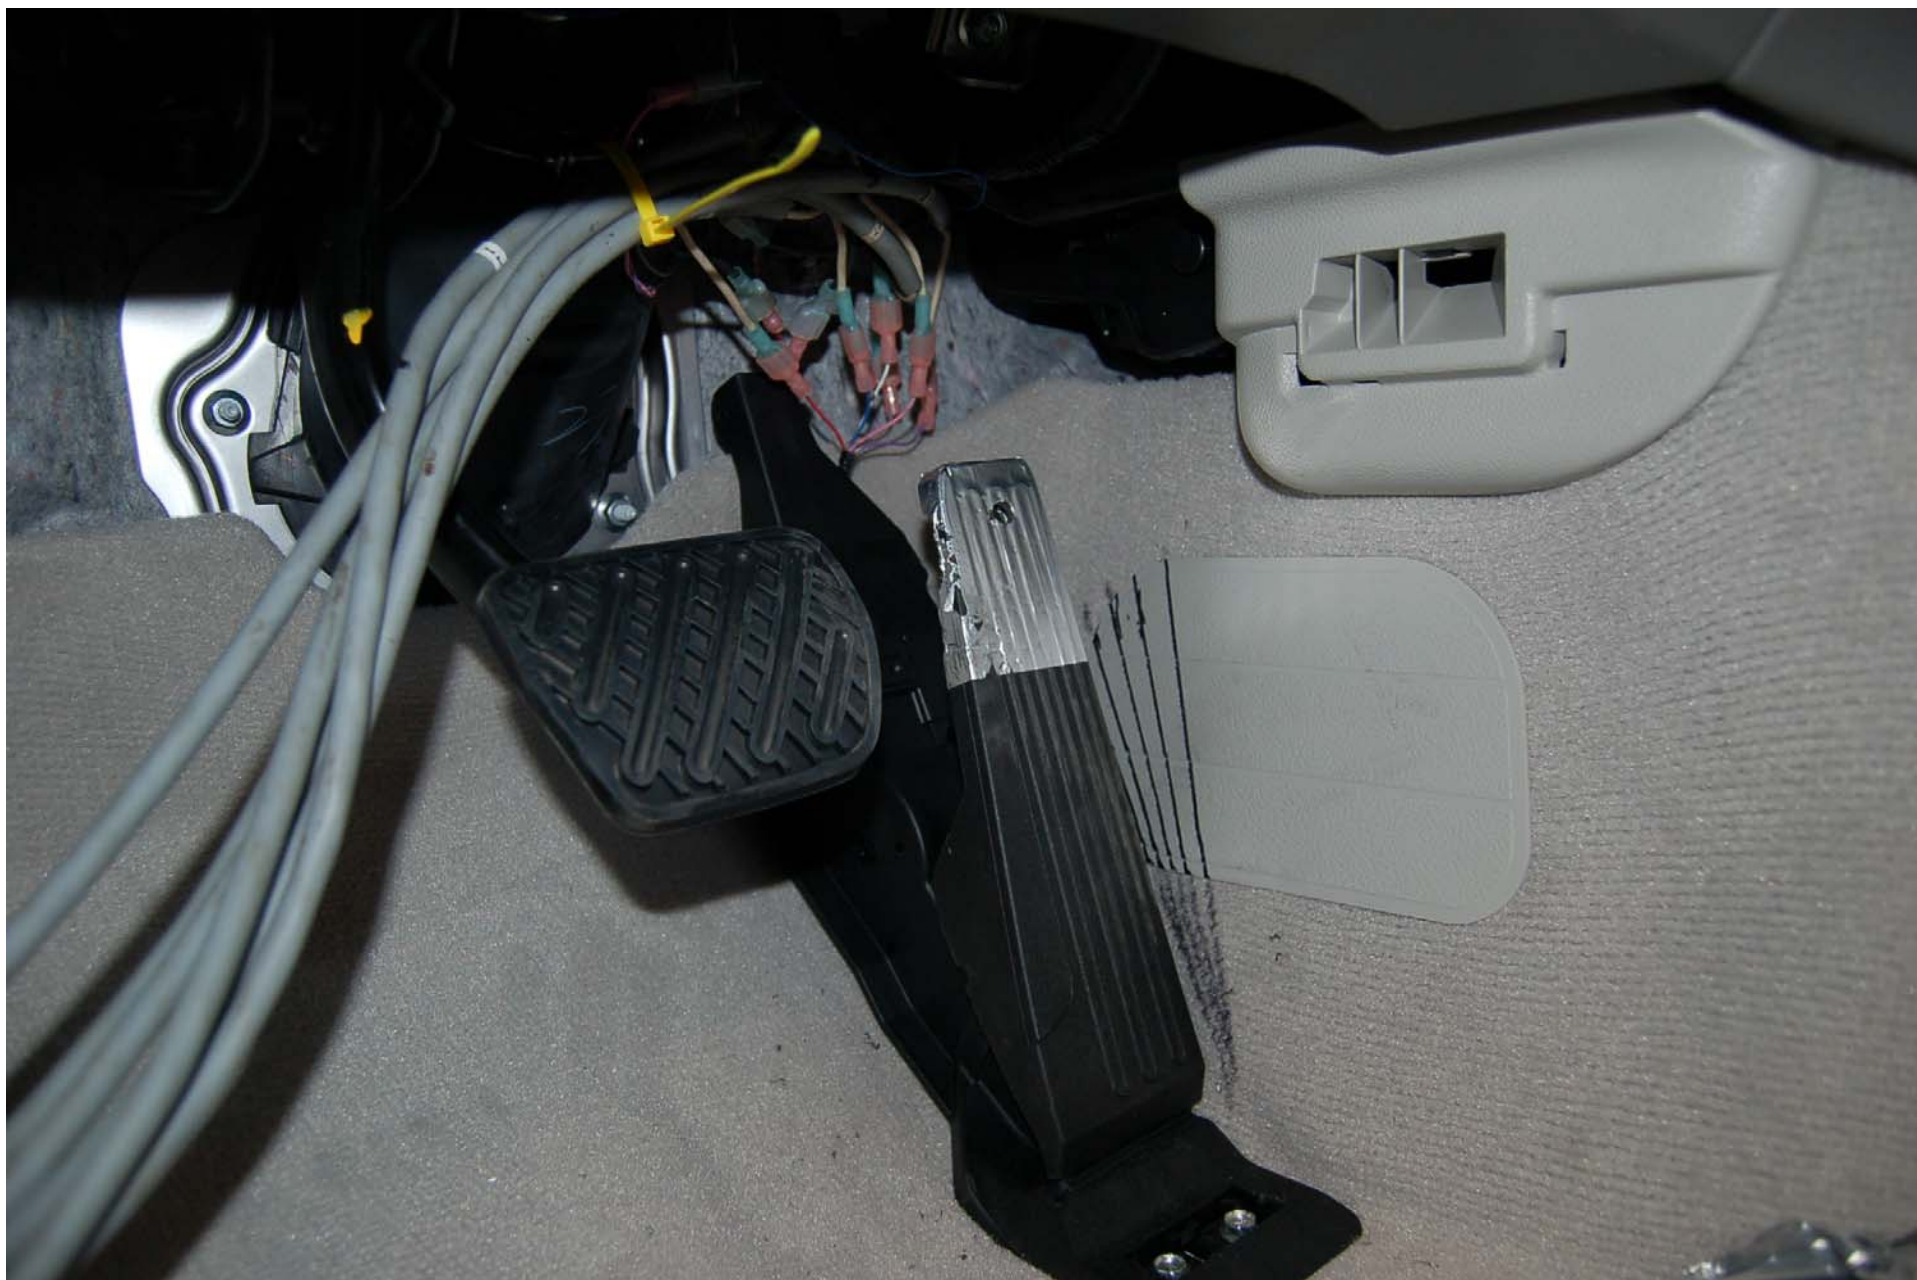
FIGURE 5.14
TEST WIRING HOOK-UP TO ACCELERATOR PEDAL SENSOR

In addition, tests were conducted with the APS and TPS connectors disconnected. It is noted that two of the six TPS connector pins controlled the throttle plate motor.
