REPORT NUMBER 124-GTL-10-001

SAFETY COMPLIANCE TESTING FOR FMVSS 124 ACCELERATOR CONTROL SYSTEMS

NISSAN MOTOR CO., LTD.
2010 INFINITY G37, PASSENGER CAR
NHTSA NO. CA5204

FINAL REPORT

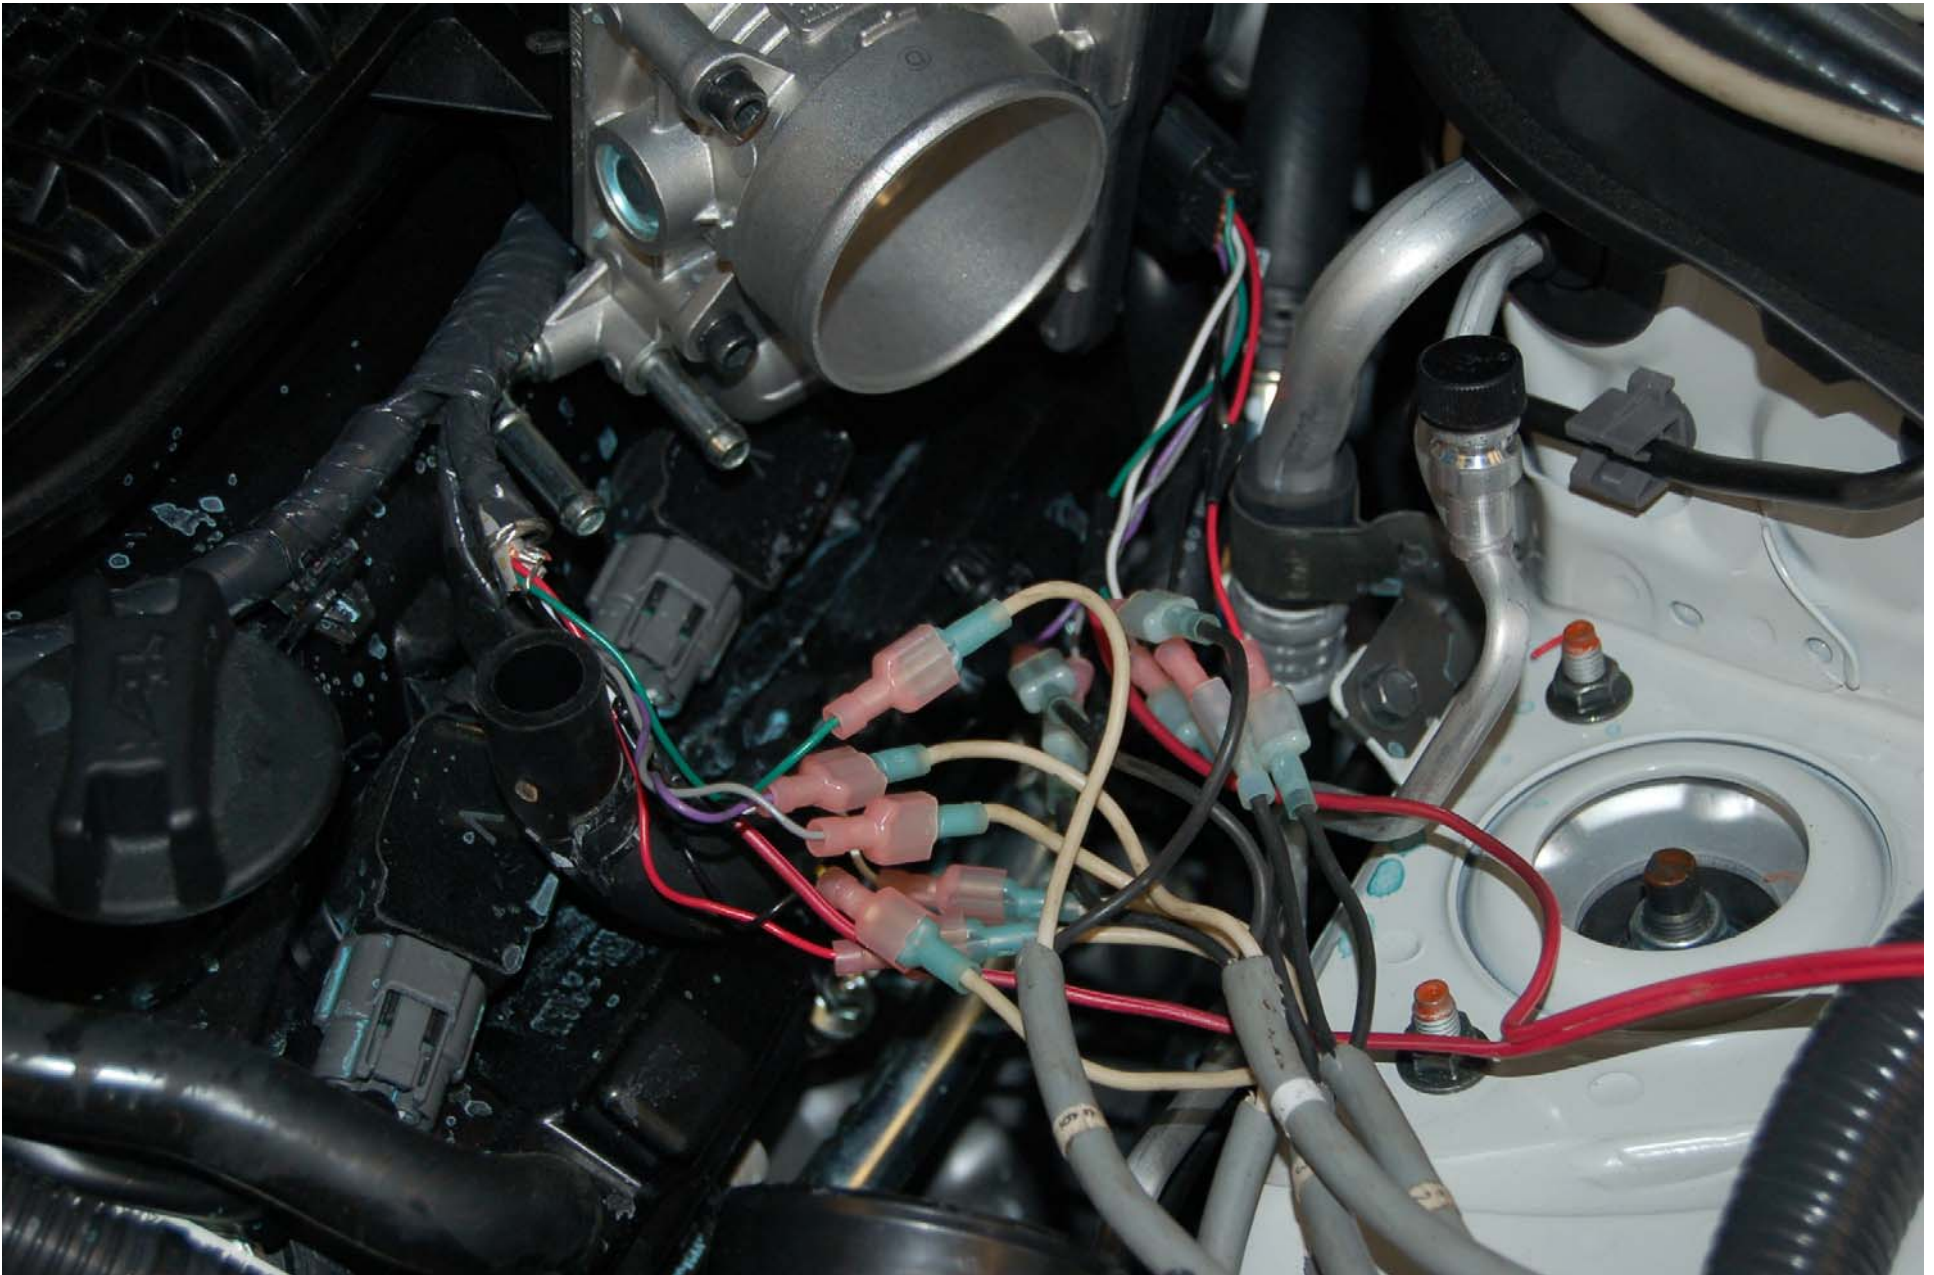
FIGURE 5.15
TEST WIRING HOOK-UP TO THROTTLE POSITION
SENSOR

In addition, tests were conducted with the APS and TPS connectors disconnected. It is noted that two of the six TPS connector pins controlled the throttle plate motor.

It is noted that disconnection of the TPS connector and shorting and severance of wires within the connector for one throttle body resulted in identical throttle plate responses in both throttle bodies. This occurred regardless of which TPS was faulted, thus the data provided is for one faulted throttle body TPS. This identical response of both throttle plates was also observed for faults to the APS. Data plots record this as a data trace overlay.

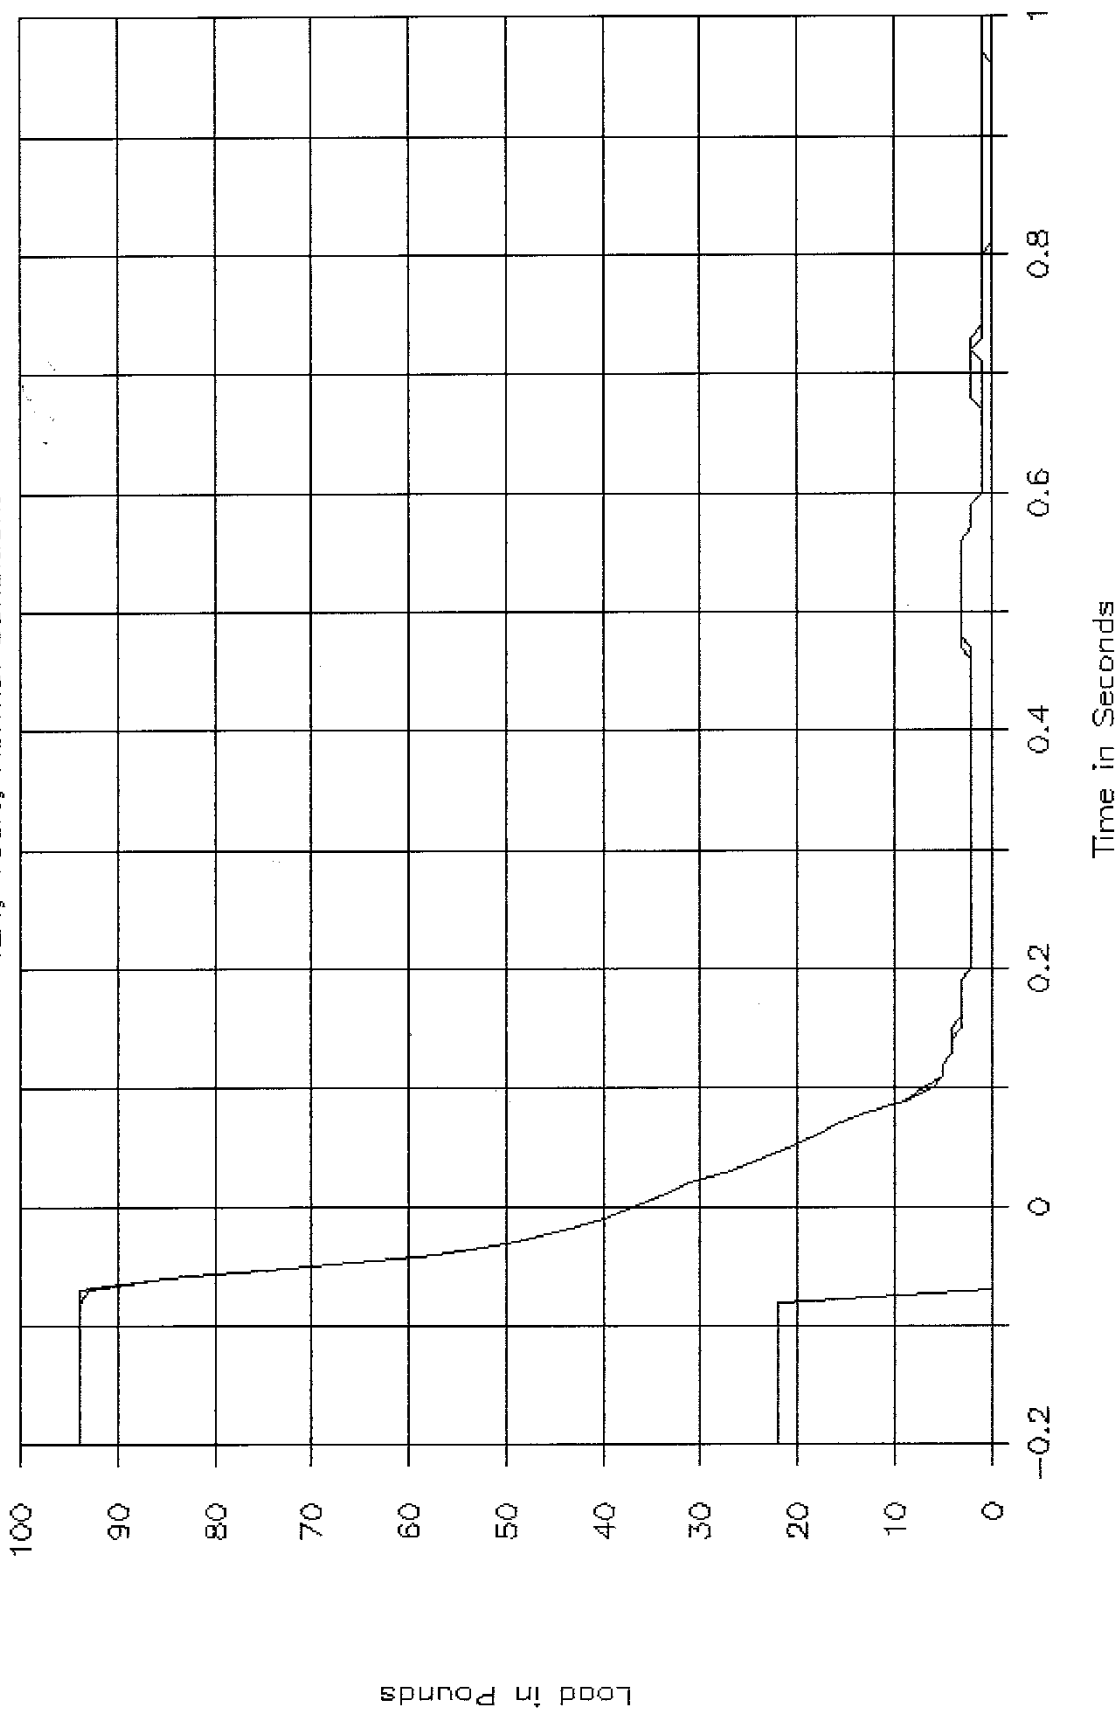
GTL 6359

124, 100%, Normal Condition.

GTL #	ACCELERATOR POSITION % WIDE OPEN THROTTLE (WOT)	THROTTLE POSITION SENSOR READING		RPM	TEMPERATURE (°C)		THROTTLE POSITION SENSOR READING @ IDLE (BASELINE)		RETURN TIME TO IDLE (Msec)	PASS/ FAIL
					ENGINE COOLANT	AMBIENT				
		#1	#2		#1	#2				
6359	100%	95%	94%	1000	200	87	1%	1%	600	P
6360	75%	70%	70%	1000	200	87	1%	1%	320	P
6361	50%	56%	56%	1000	200	87	1%	1%	270	P
6362	25%	24%	25%	1000	200	87	1%	1%	70	P

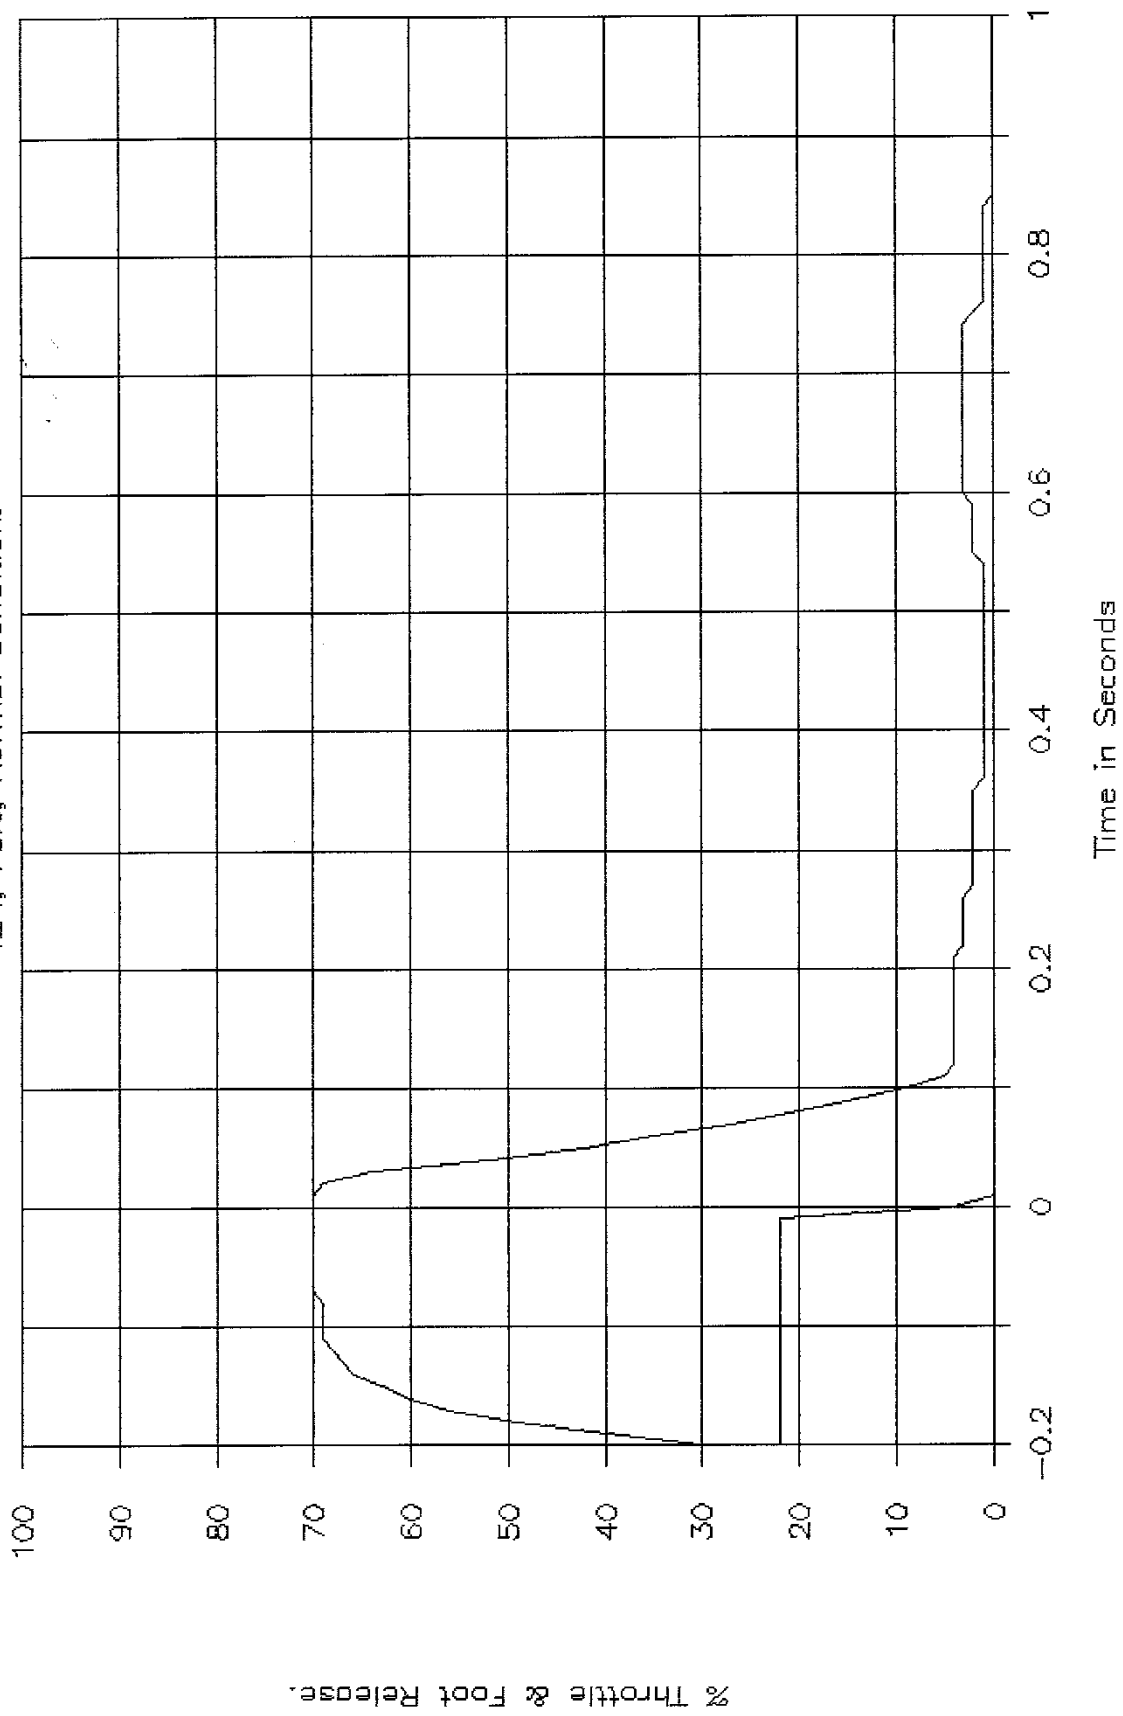
GTL 6360

124, 75%, Normal Condition.

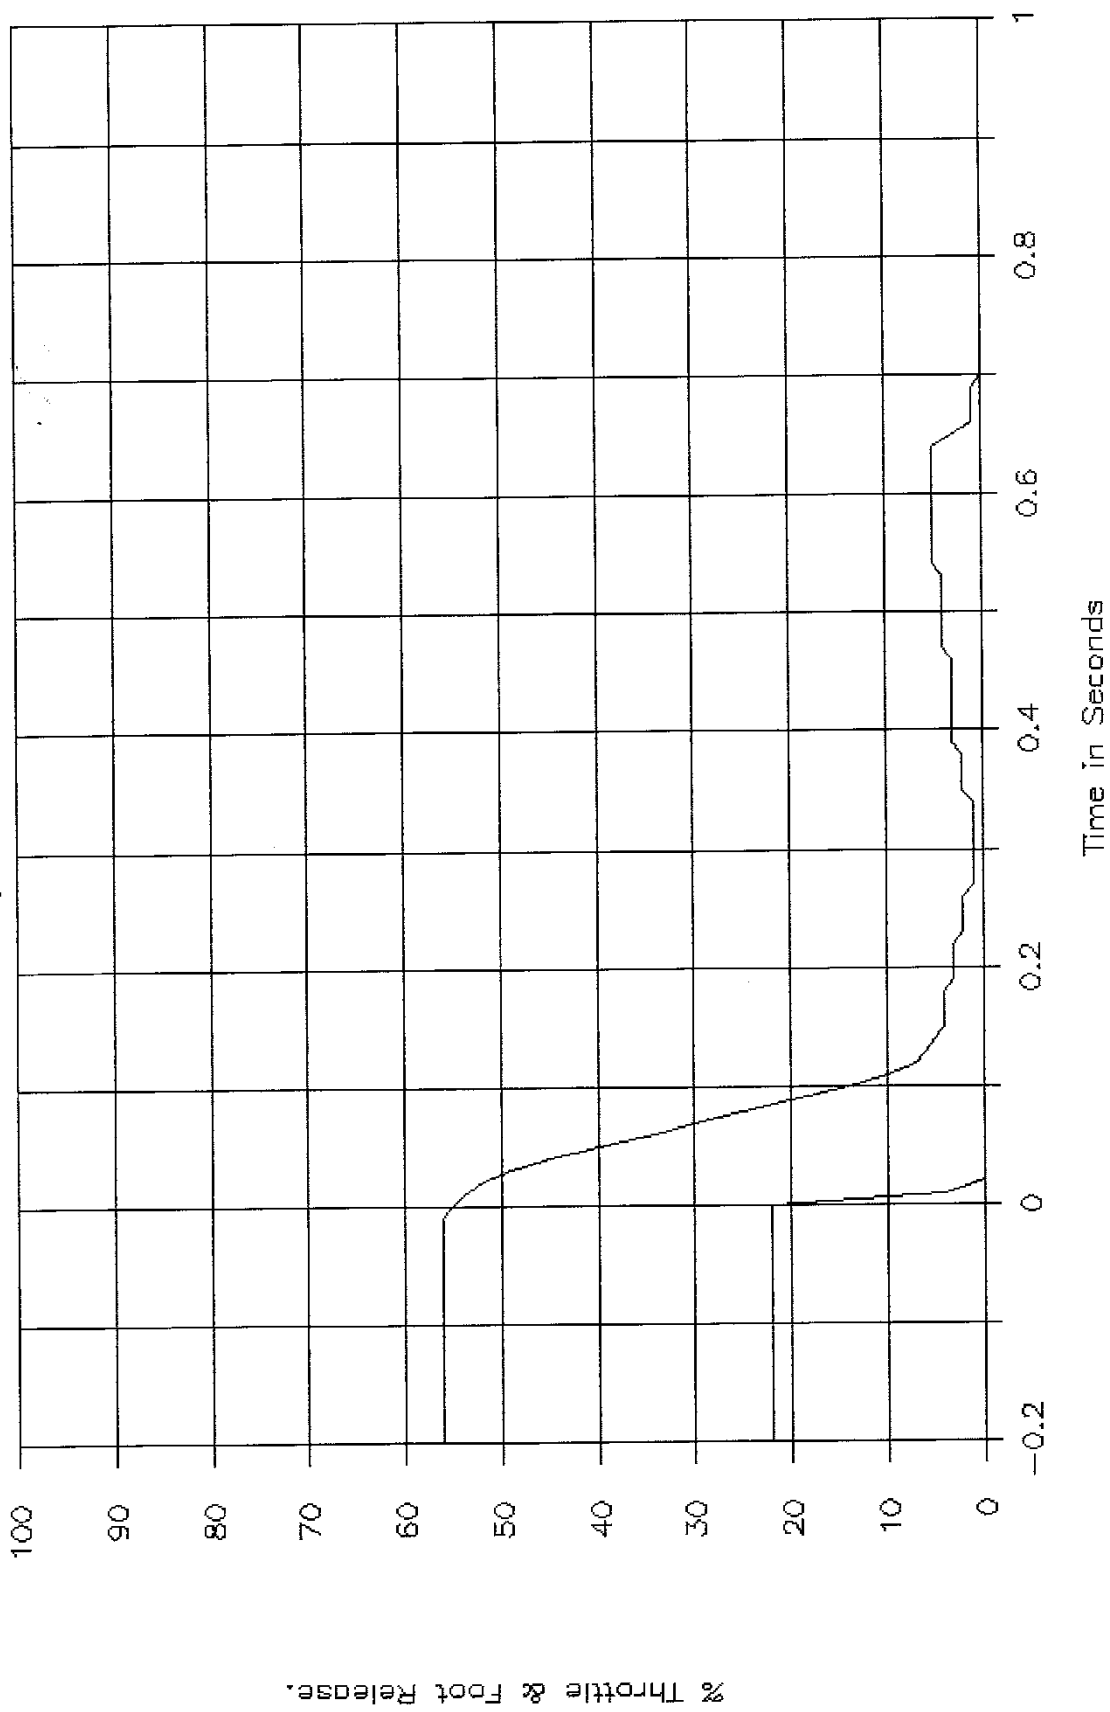
GTL 6361

124, 50% Normal Condition.

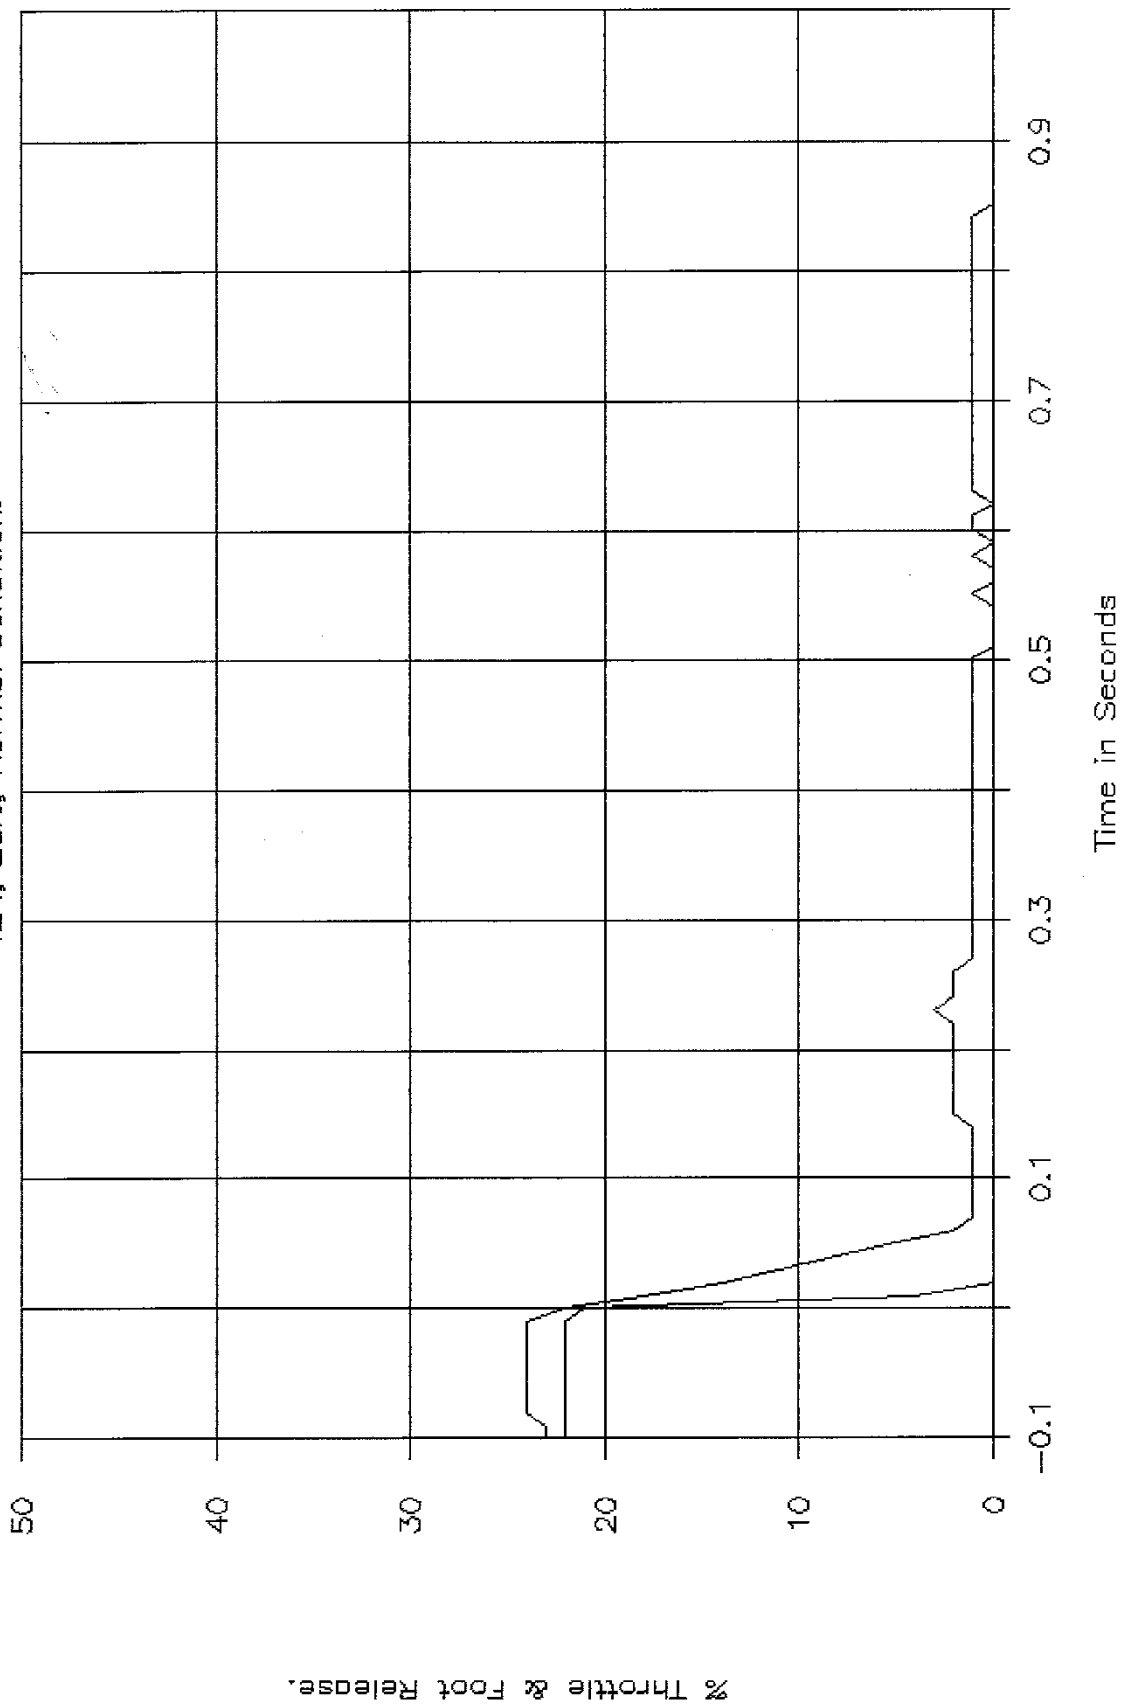
GTL 6362

124, 25%, Normal Condition.

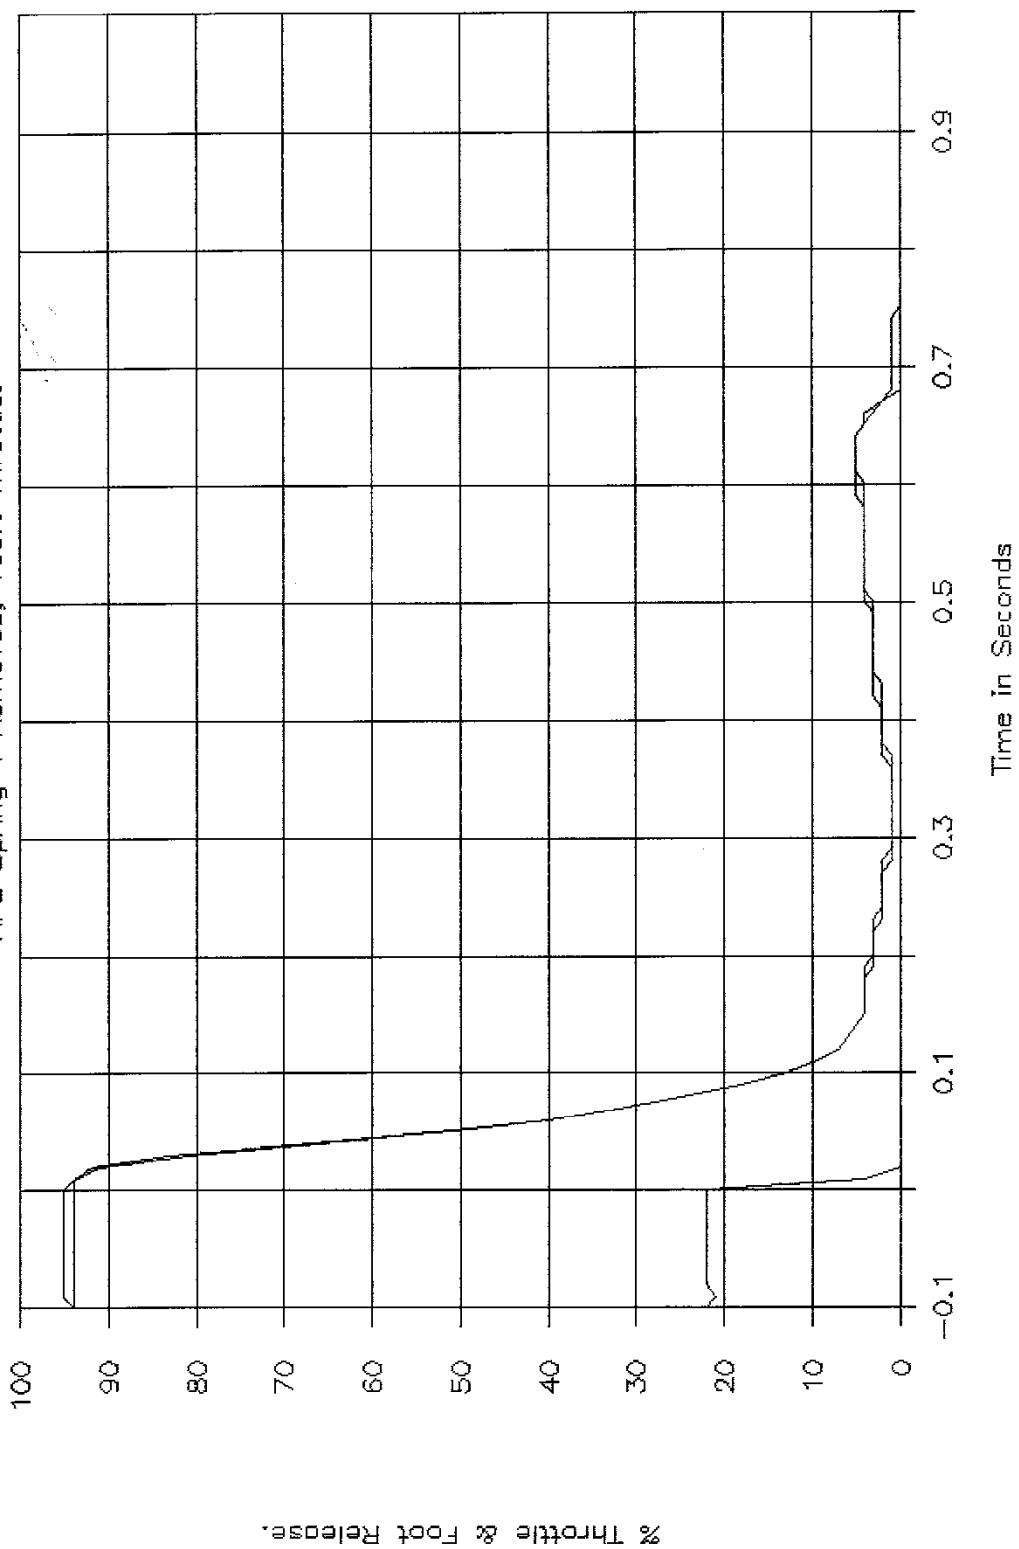
GTL 6363, NHTSA CA5204, FMVSS124.

APS Spring 1 Removed, 100% Throttle.

GTL #	ACCELERATOR POSITION % WIDE OPEN THROTTLE (WOT)	THROTTLE POSITION SENSOR READING		RPM	TEMPERATURE (°C)		THROTTLE POSITION SENSOR READING @ IDLE (BASELINE)		RETURN TIME TO IDLE (Msec)	PASS/ FAIL
		#1	#2		ENGINE COOLANT	AMBIENT	#1	#2		
		6363	100%		95%	95%	1000	200		
6364	75%	70%	69%	1000	200	86	1%	1%	280	P
6365	50%	57%	57%	1000	200	86	1%	1%	250	P
6366	25%	22%	21%	1000	204	86	1%	1%	190	P

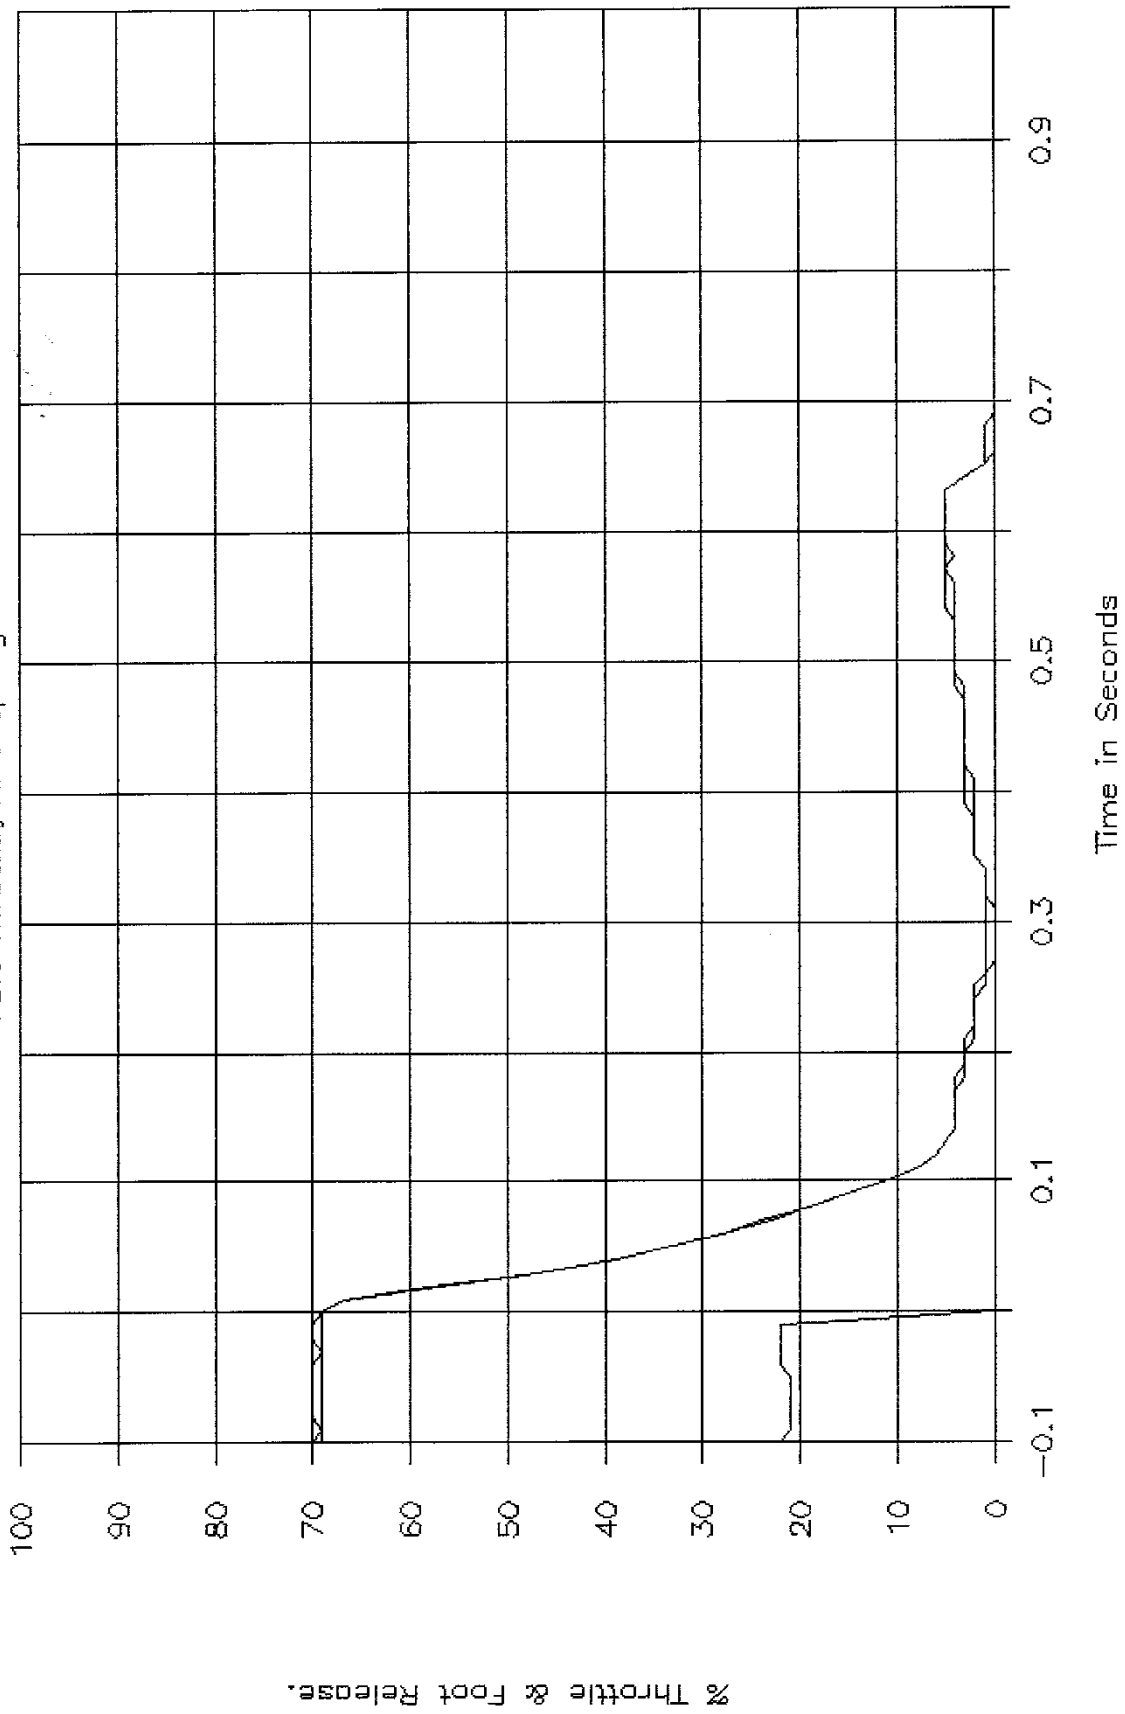
GTL 6364, NHTSA CA5204, FMVSS 124.

75% Throttle, APS Spring 1 Removed.

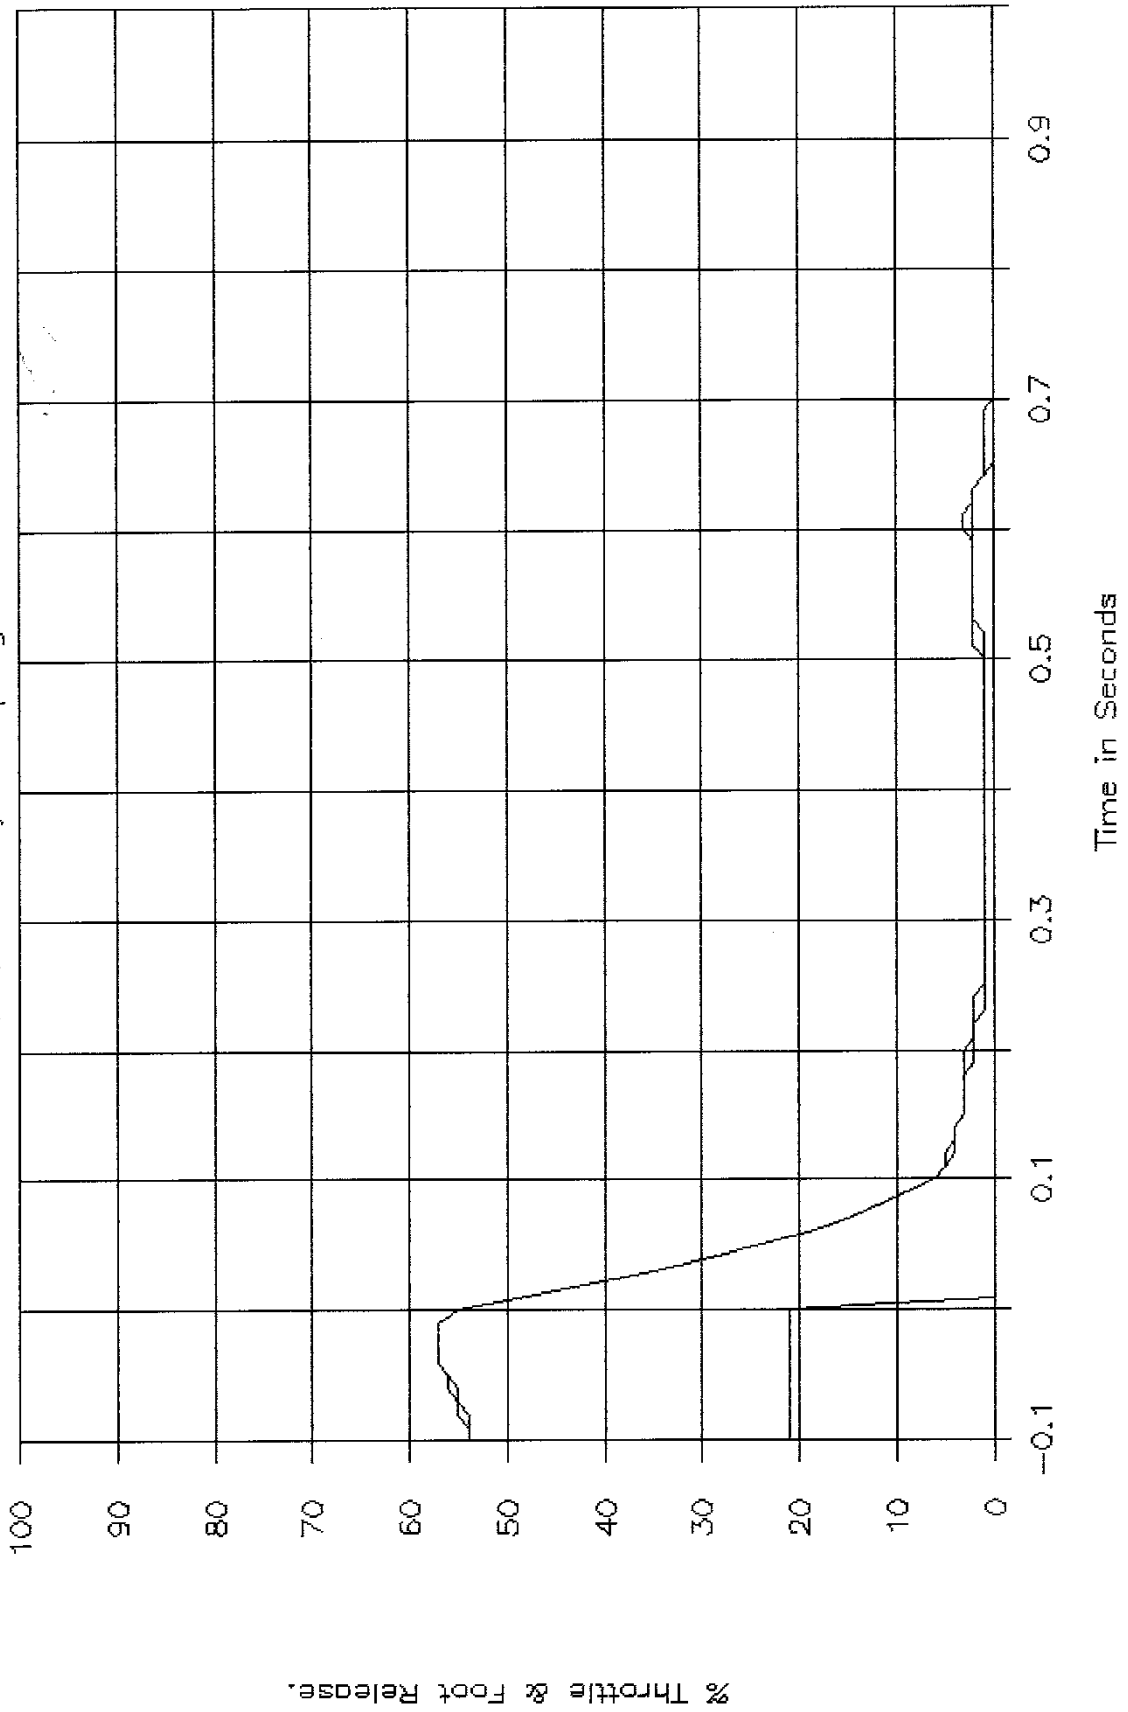
GTL 6365, NHTSA CA5204, FMVSS 124.

50% Throttle, APS Spring 1 Removed.

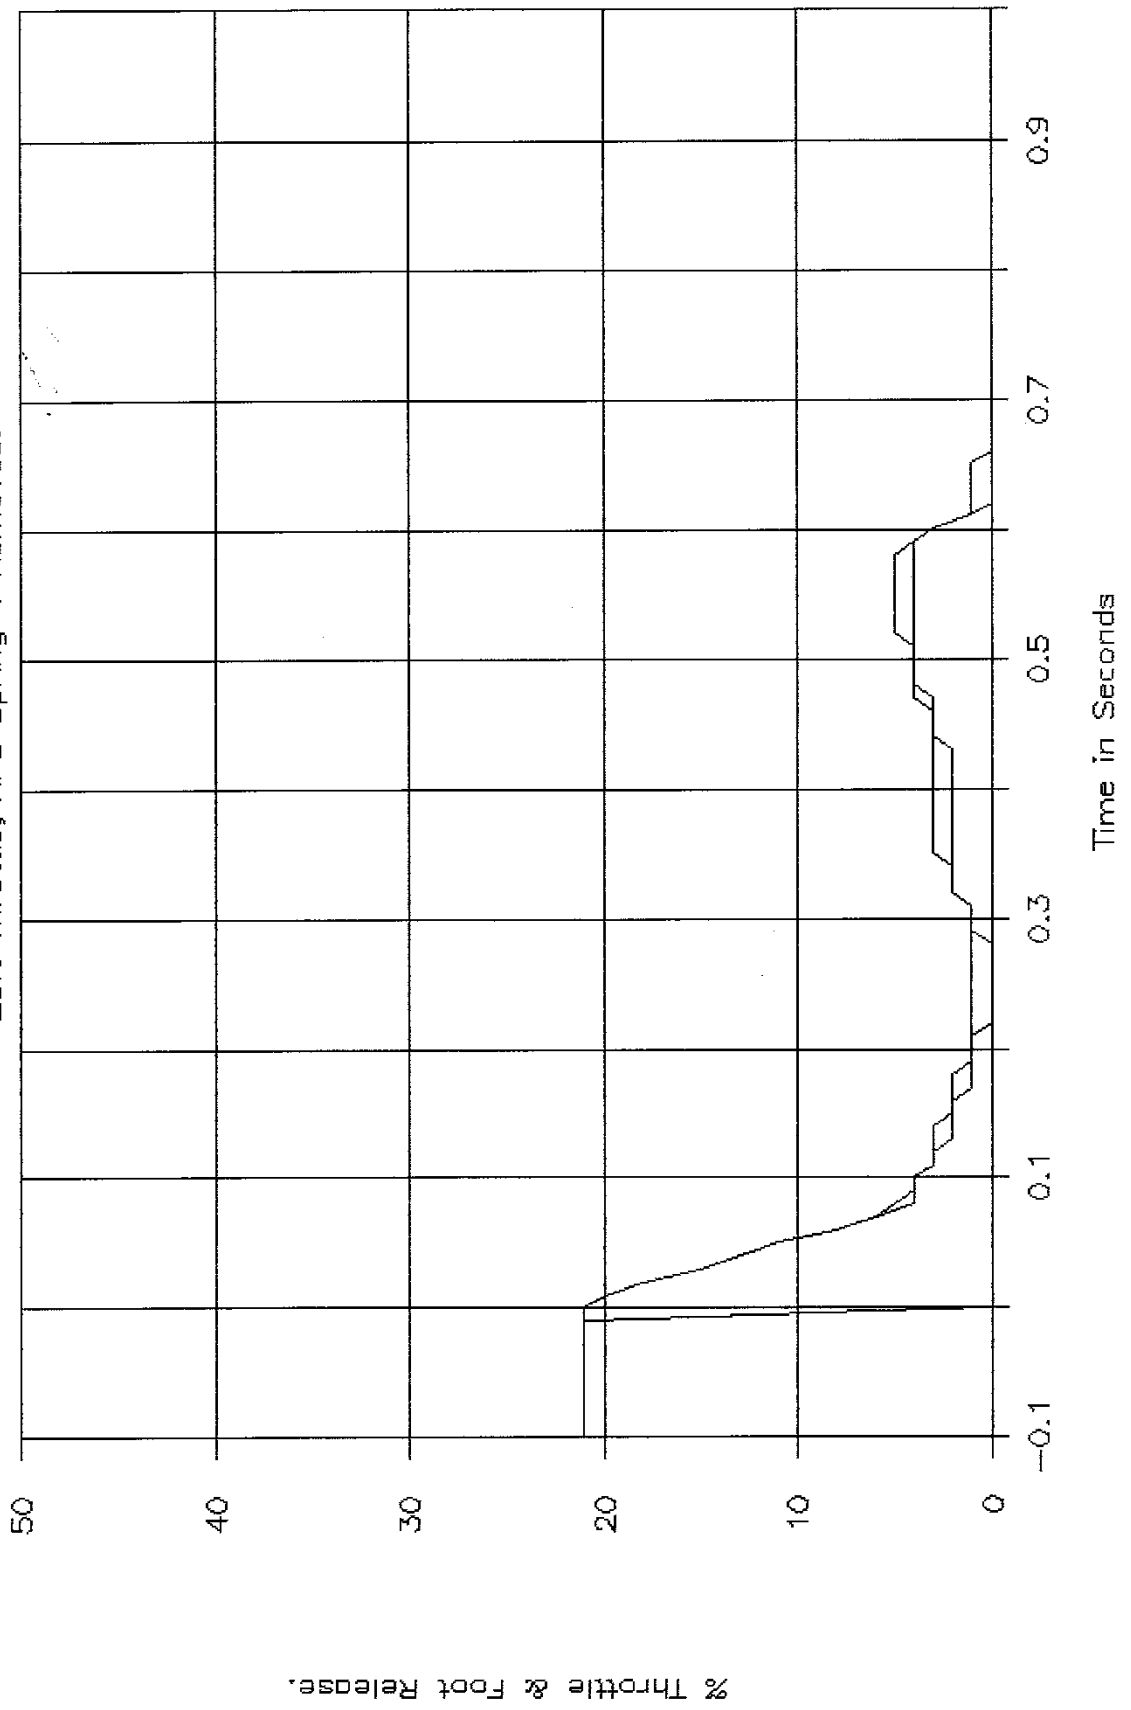
GTL 6366, NHTSA CA5204, FMVSS 124.

25% Throttle, APS Spring 1 Removed.

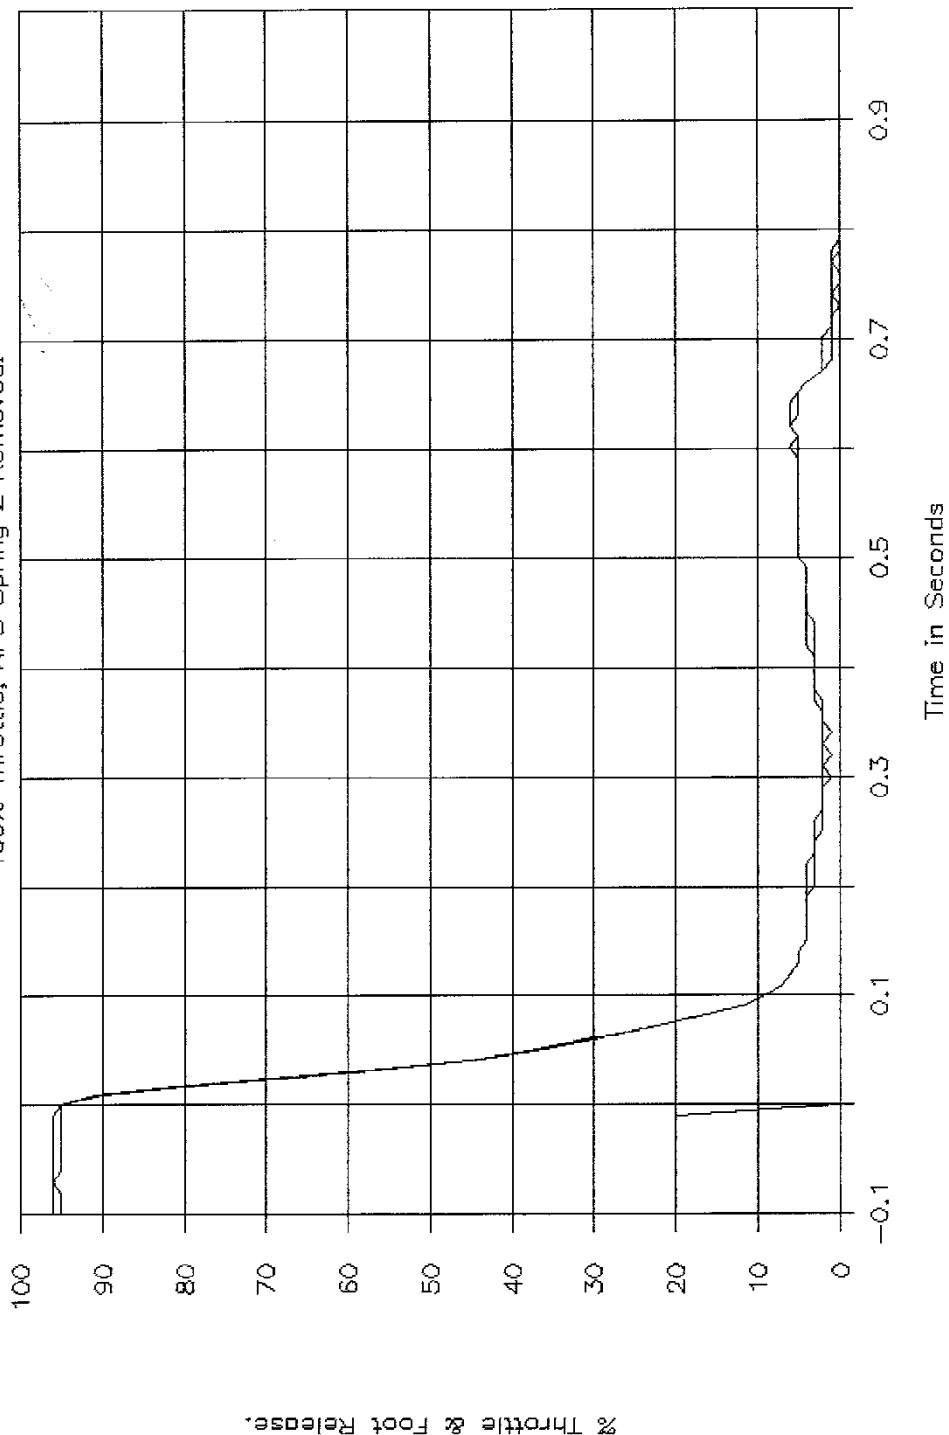
GTL 6367, NHTSA CA5204, FMVSS 124.

100% Throttle, APS Spring 2 Removed.

GTL #	ACCELERATOR POSITION % WIDE OPEN THROTTLE (WOT)	THROTTLE POSITION SENSOR READING		RPM	TEMPERATURE (°C)		THROTTLE POSITION SENSOR READING @ IDLE (BASELINE)		RETURN TIME TO IDLE (Msec)	PASS/ FAIL
		#1	#2		ENGINE COOLANT	AMBIENT	#1	#2		
6367	100%	96%	96%	1000	198	75	1%	1%	710	P
6368	75%	80%	80%	1000	202	75	1%	1%	690	P
6369	50%	48%	48%	1000	200	75	1%	1%	690	P
6370	25%	21%	21%	1000	200	75	1%	1%	669	P

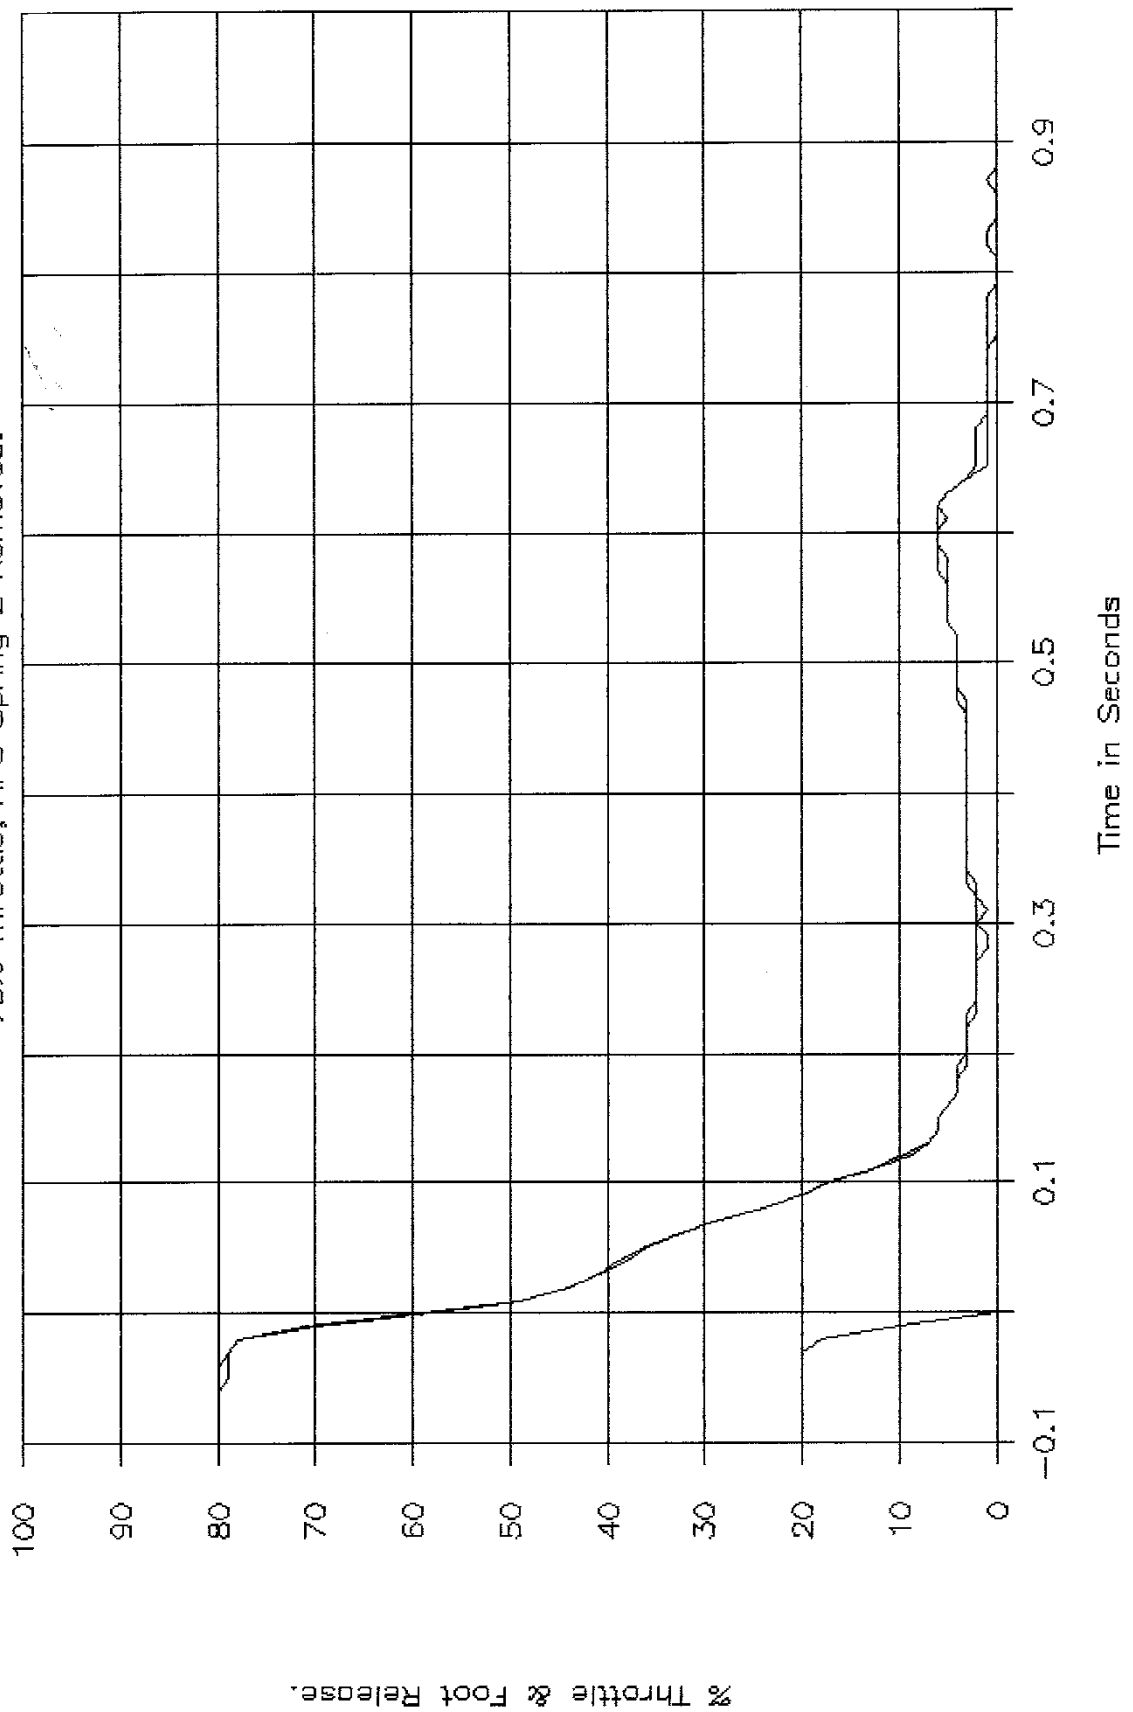
GTL 6368, NHTSA CA5204, FMVSS 124.

75% Throttle, APS Spring 2 Removed.
