REPORT NUMBER 124-GTL-10-001

SAFETY COMPLIANCE TESTING FOR FMVSS 124 ACCELERATOR CONTROL SYSTEMS

NISSAN MOTOR CO., LTD.
2010 INFINITY G37, PASSENGER CAR
NHTSA NO. CA5204

FINAL REPORT

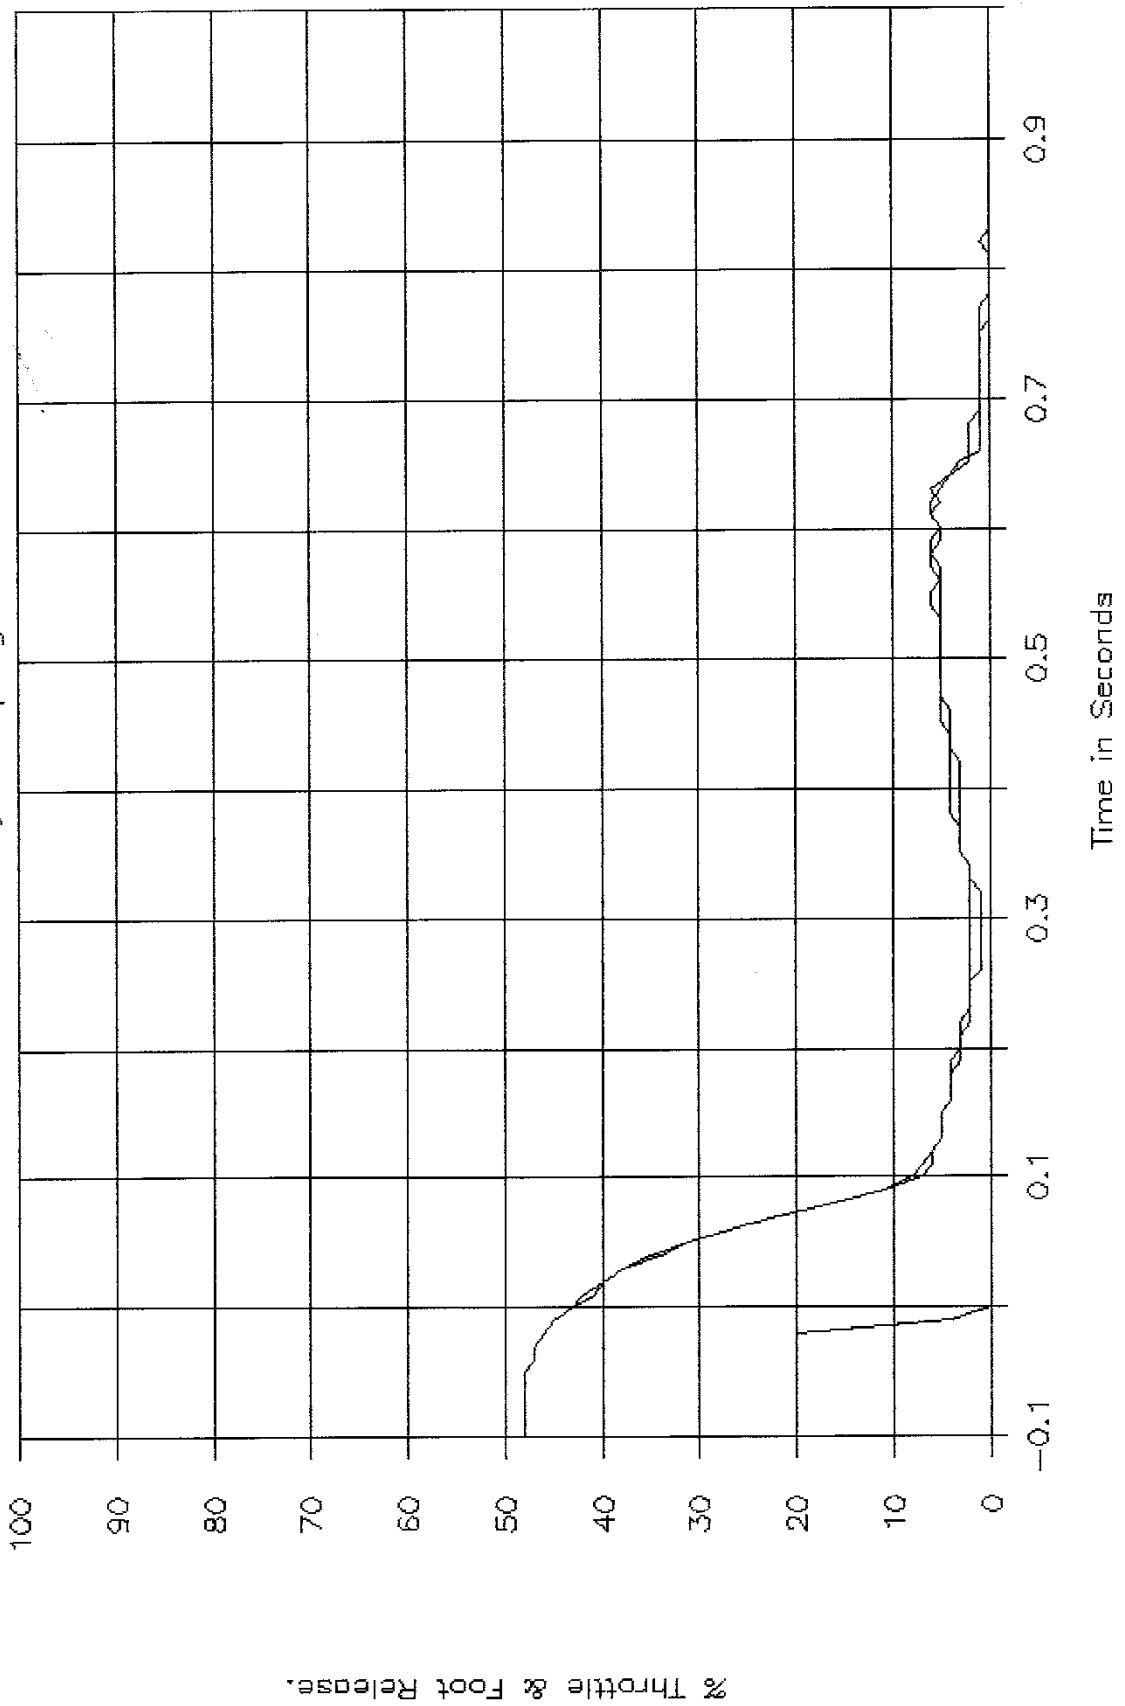
GTL 6369, NHTSA CA5204, FMVSS 124.

50% Throttle, APS Spring 2 Removed.

GTL #	ACCELERATOR POSITION % WIDE OPEN THROTTLE (WOT)	THROTTLE POSITION SENSOR READING		RPM	TEMPERATURE (°C)		THROTTLE POSITION SENSOR READING @ IDLE (BASELINE)		RETURN TIME TO IDLE (Msec)	PASS/ FAIL
		#1	#2		ENGINE COOLANT	AMBIENT	#1	#2		
6367	100%	96%	96%	1000	198	75	1%	1%	710	P
6368	75%	80%	80%	1000	202	75	1%	1%	690	P
6369	50%	48%	48%	1000	200	75	1%	1%	690	P
6370	25%	21%	21%	1000	200	75	1%	1%	669	P

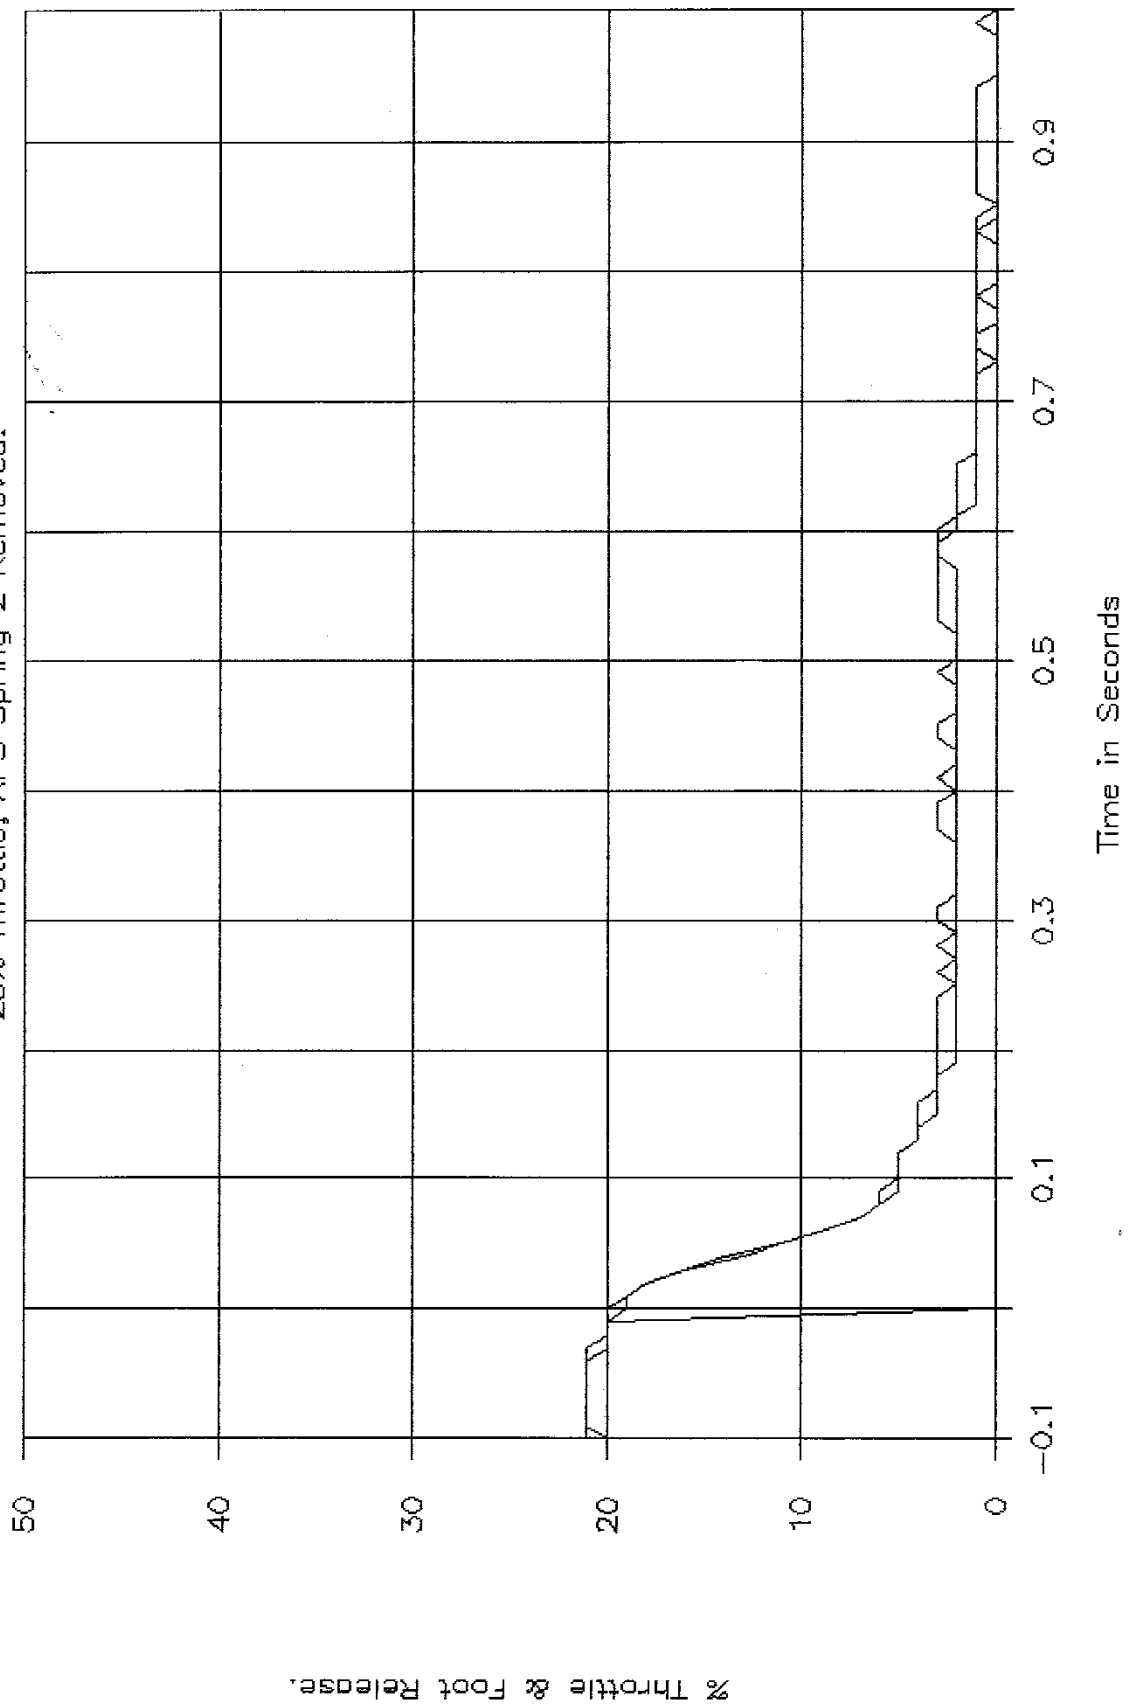
GTL 6370, NHTSA CA5204, FMVSS 124.

25% Throttle, APS Spring 2 Removed.

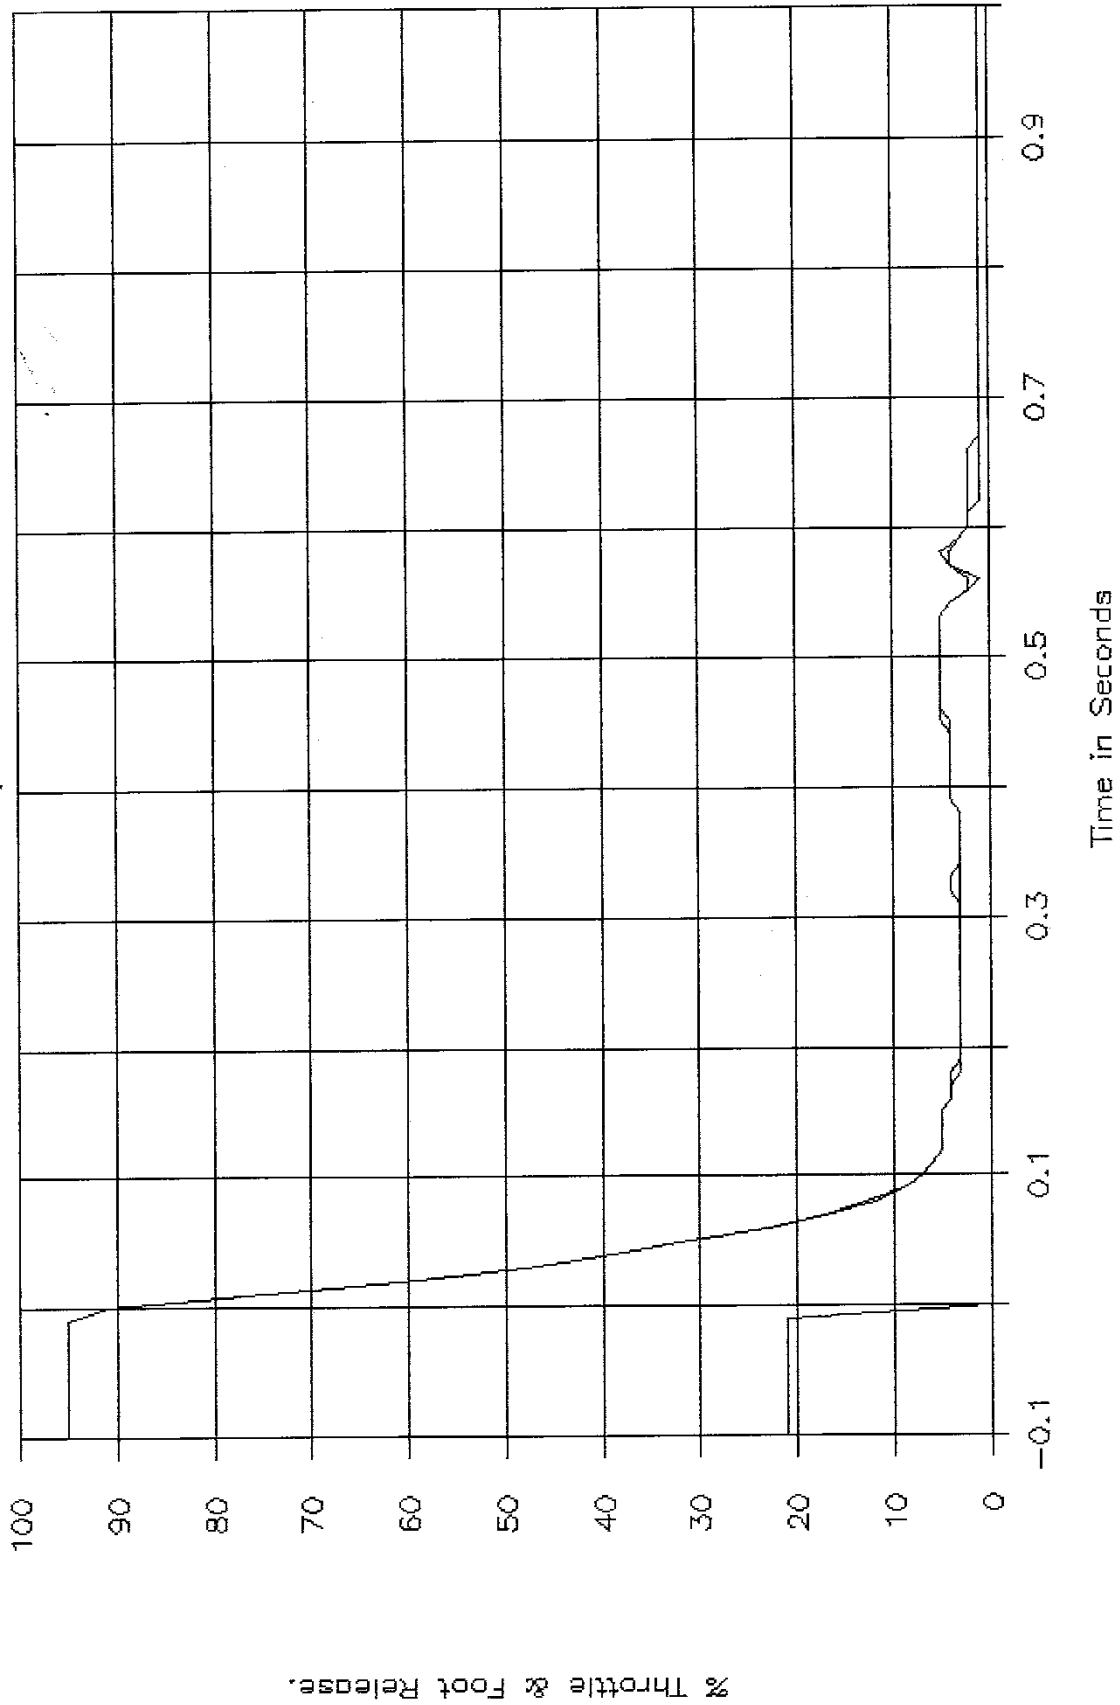
GTL 6378, NHTSA CA5204, FMVSS 124.

100% Throttle, APS Wire 1 Shorted.

GTL #	CONNECTOR	WIRE/PIN DESCRIPTION	FAULT CONDITION	ENGINE TEMP. °C	% THROTTLE/ RETURN TIME (MS)	PASS/FAIL/NOTES
6372	APS	#1/Red	OPEN	198	100/820	P
6373	APS	#2/White	OPEN	198	100/660	P
6374	APS	#3/Blue	OPEN	200	100/720	P
6375	APS	#4/Grey	OPEN	200	100/630	P
6376	APS	#5/Pink	OPEN	202	100/680	P
6377	APS	#6/Purple	OPEN	202	100/780	P
6378	APS	#1/Red	SHORT	201	100/670	P
6379	APS	#2/White	SHORT	198	100/610	P
6380	APS	#3/Blue	SHORT	200	100/0*	P
6381	APS	#4/Grey	SHORT	202	100/580*	P
6382	APS	#5/Pink	SHORT	201	100/640	P
6383	APS	#6/Purple	SHORT	201	100/690	P
6384	TPS	#1/Red	OPEN	198	100/200	P
6385	TPS	#2/Black	OPEN	199	100/250	P
6386	TPS	#3/White	OPEN	199	100/200**	P
6387	TPS	#4/Grey	OPEN	199	100/630	P
6388	TPS	#5/Purple	OPEN	201	100/370	P
6389	TPS	#6/Green	OPEN	200	100/360	P
6390	TPS	#1/Red	SHORT	204	100/420	P
6391	TPS	#2/Black	SHORT	201	100/790	P
6392	TPS	#3/White	SHORT	201	100/370	P
6393	TPS	#4/Grey	SHORT	199	100/230	P

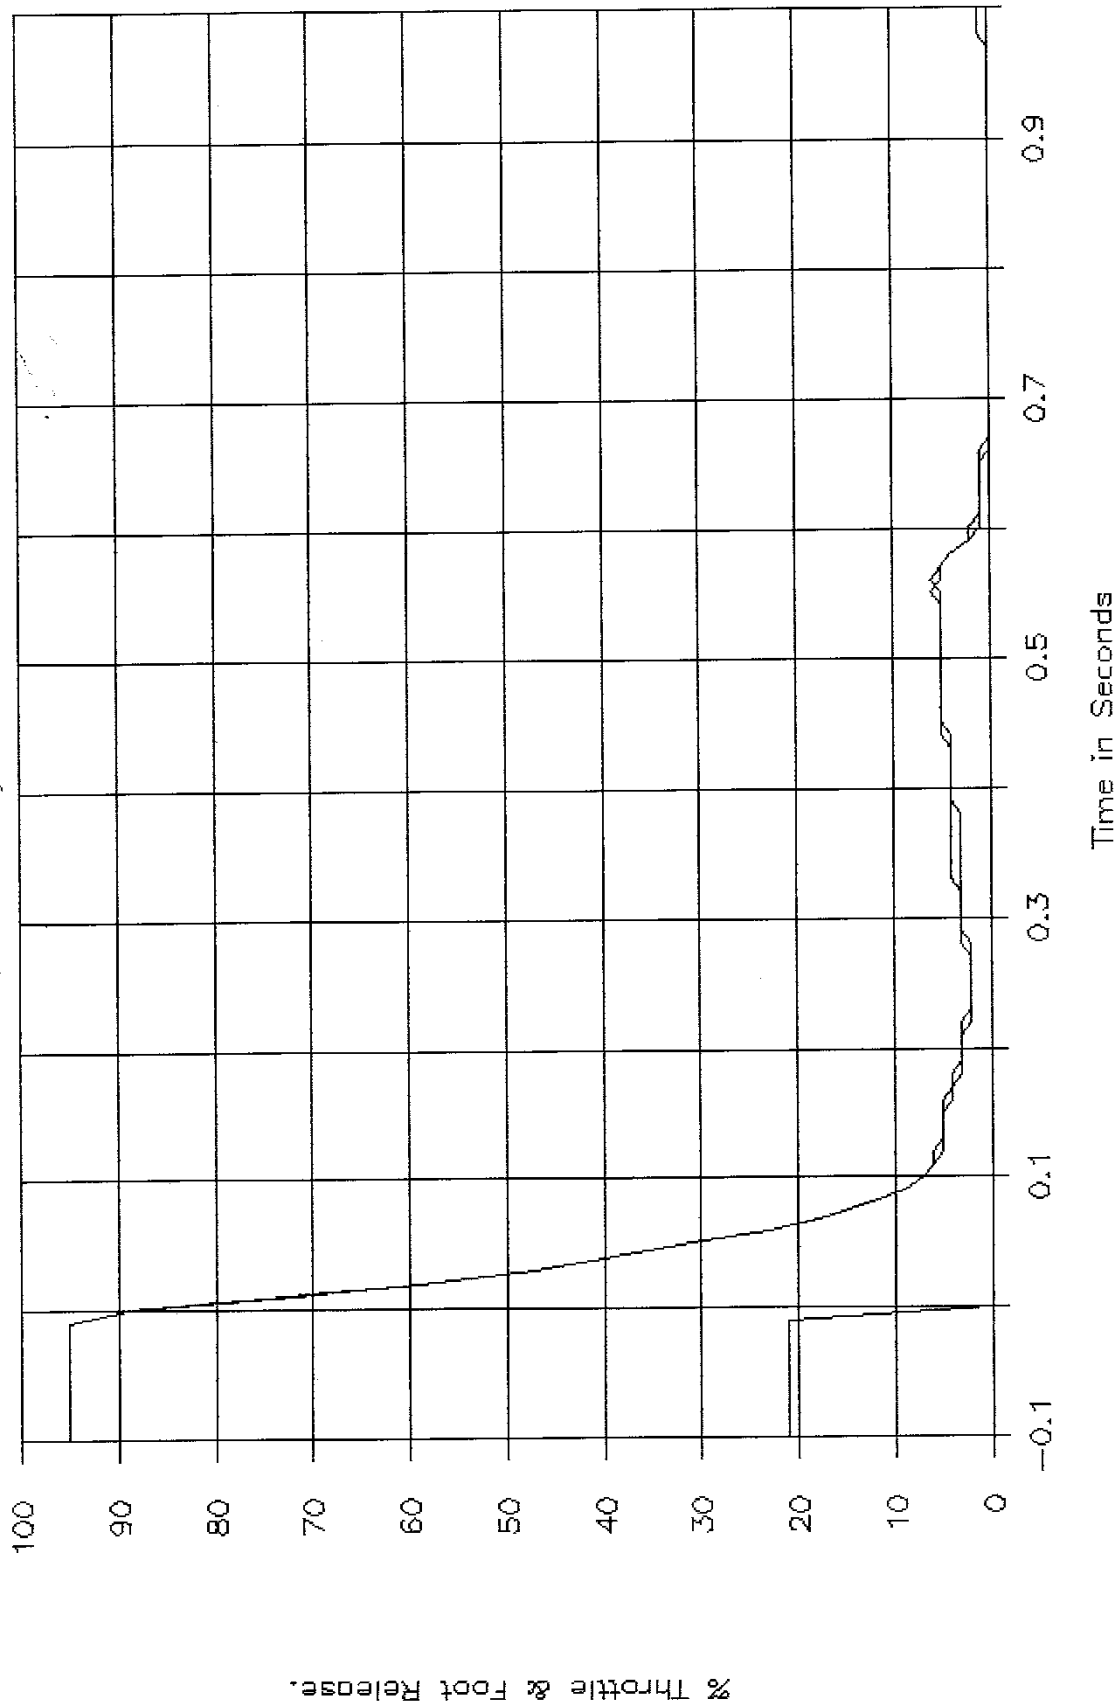
GTL 6379, NHTSA CA5204, FMVSS 124.

100% Throttle, APS Wire 2 Shorted.

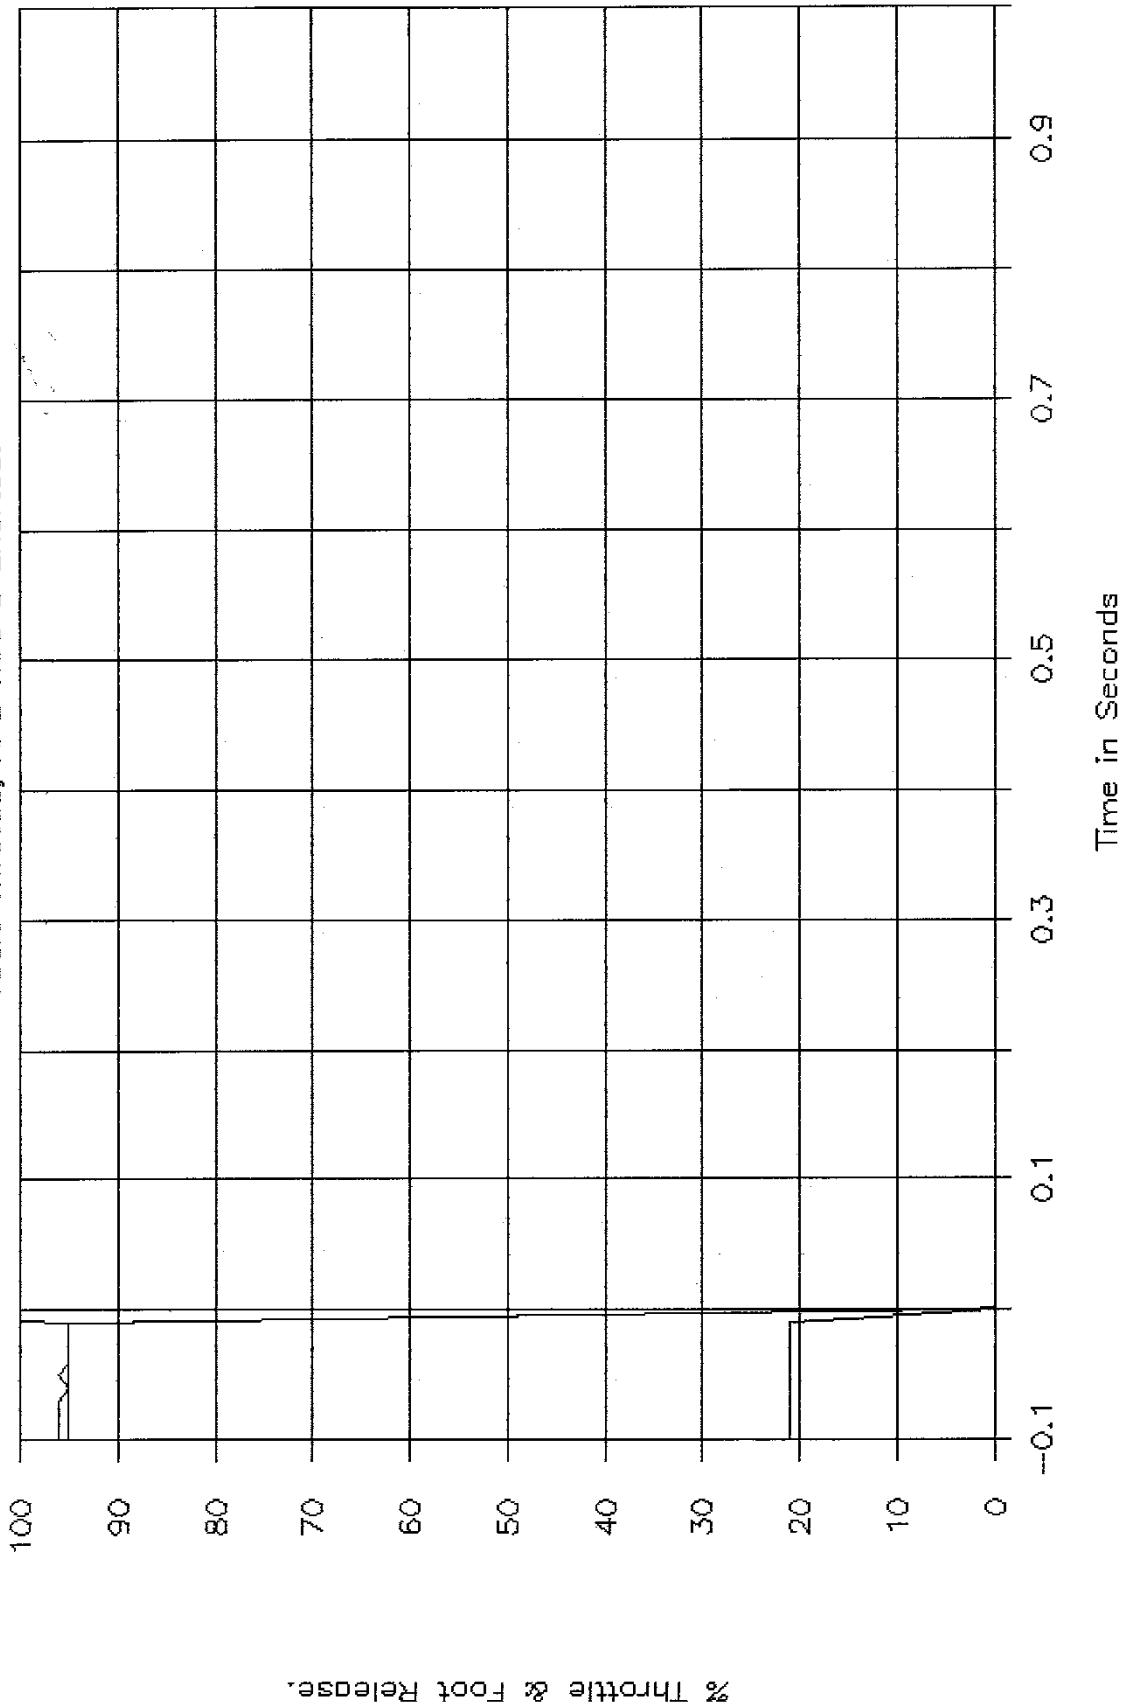
GTL 6380, NHTSA CA5204, FMVSS 124.

100% Throttle, APS Wire 3 Shorted.

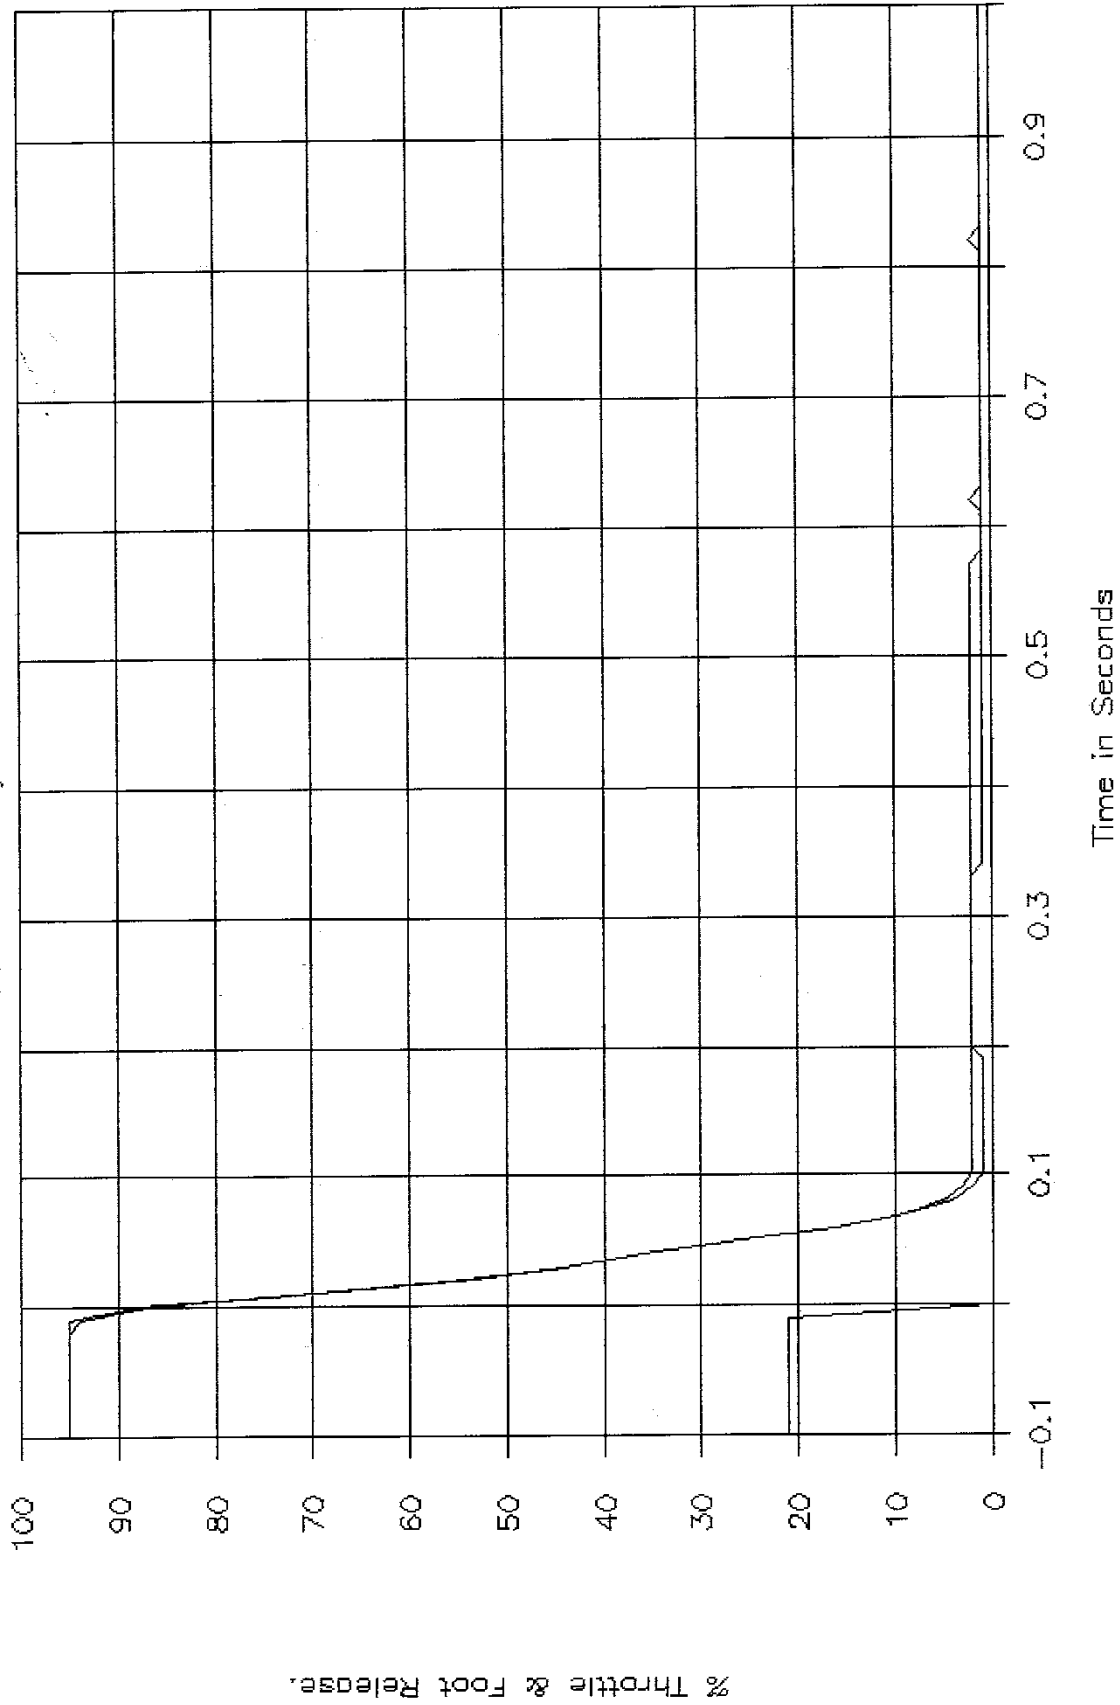
GTL 6381, NHTSA CA5204, FMVSS 124.

100% Throttle, APS Wire 4 Shorted.

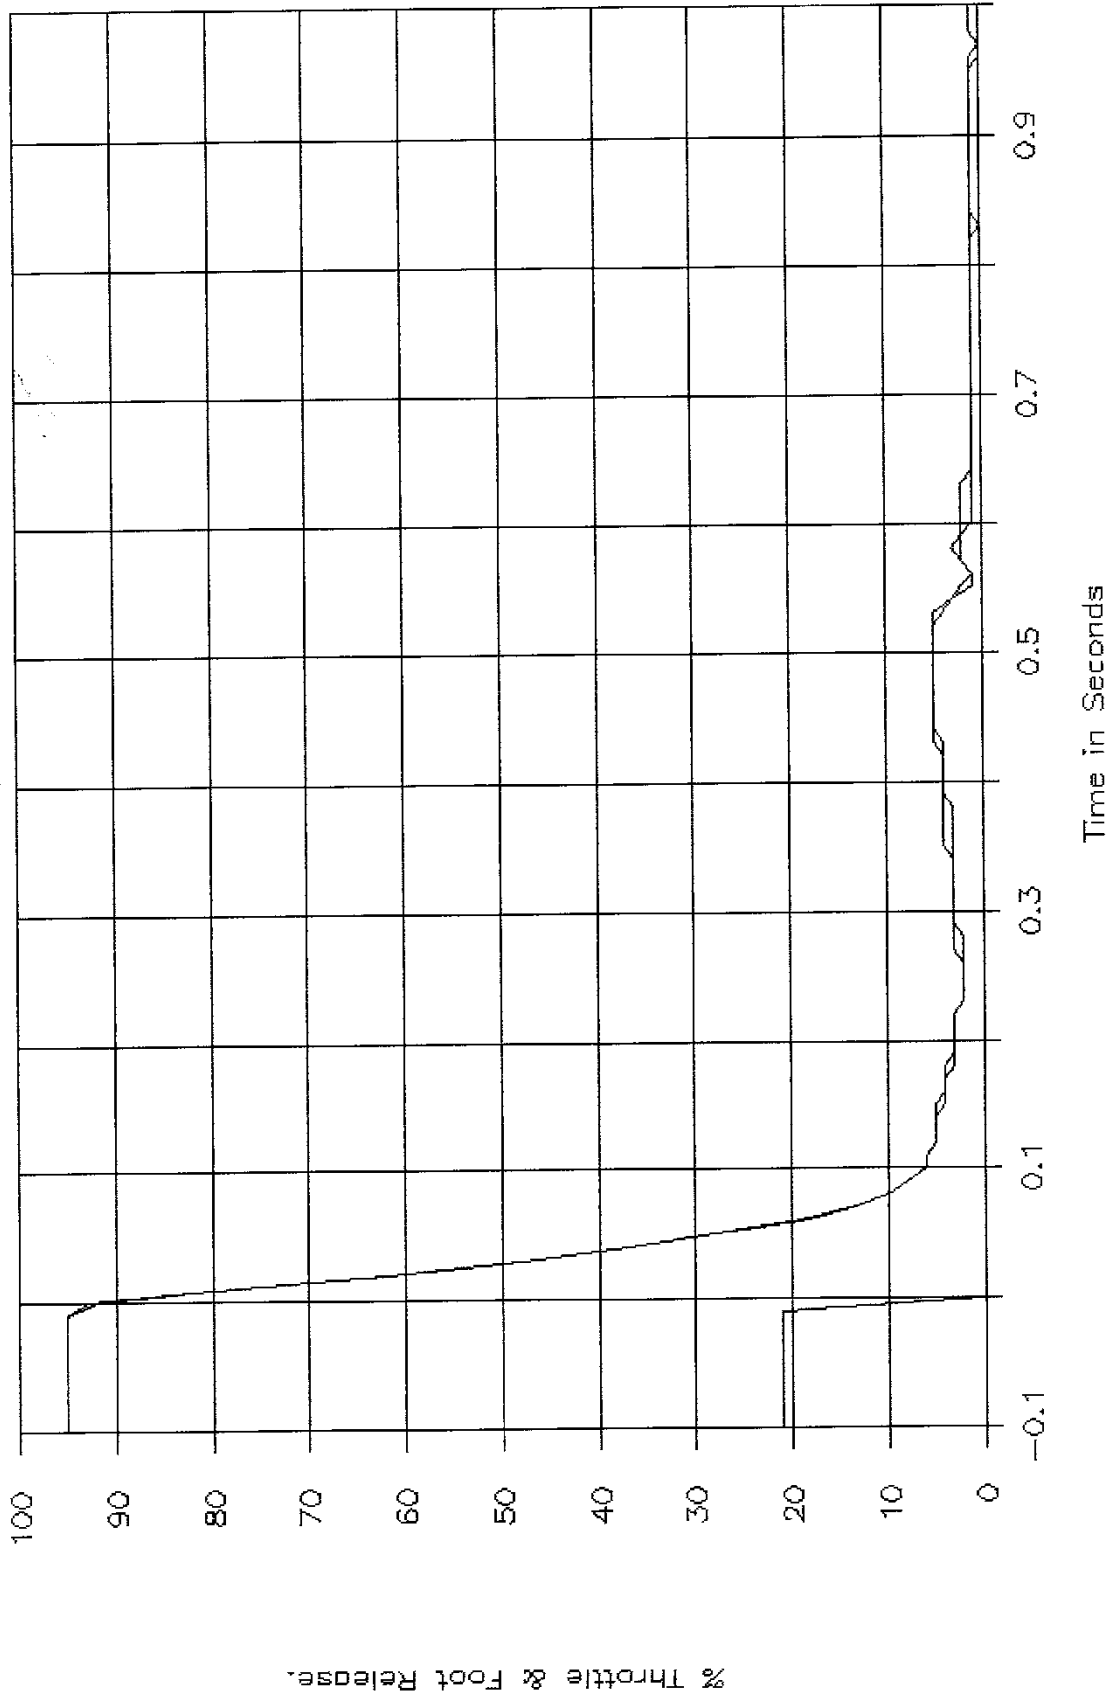
GTL 6382, NHTSA CA5204, FMVSS 124.

100% Throttle, APS Wire 5 Shorted.

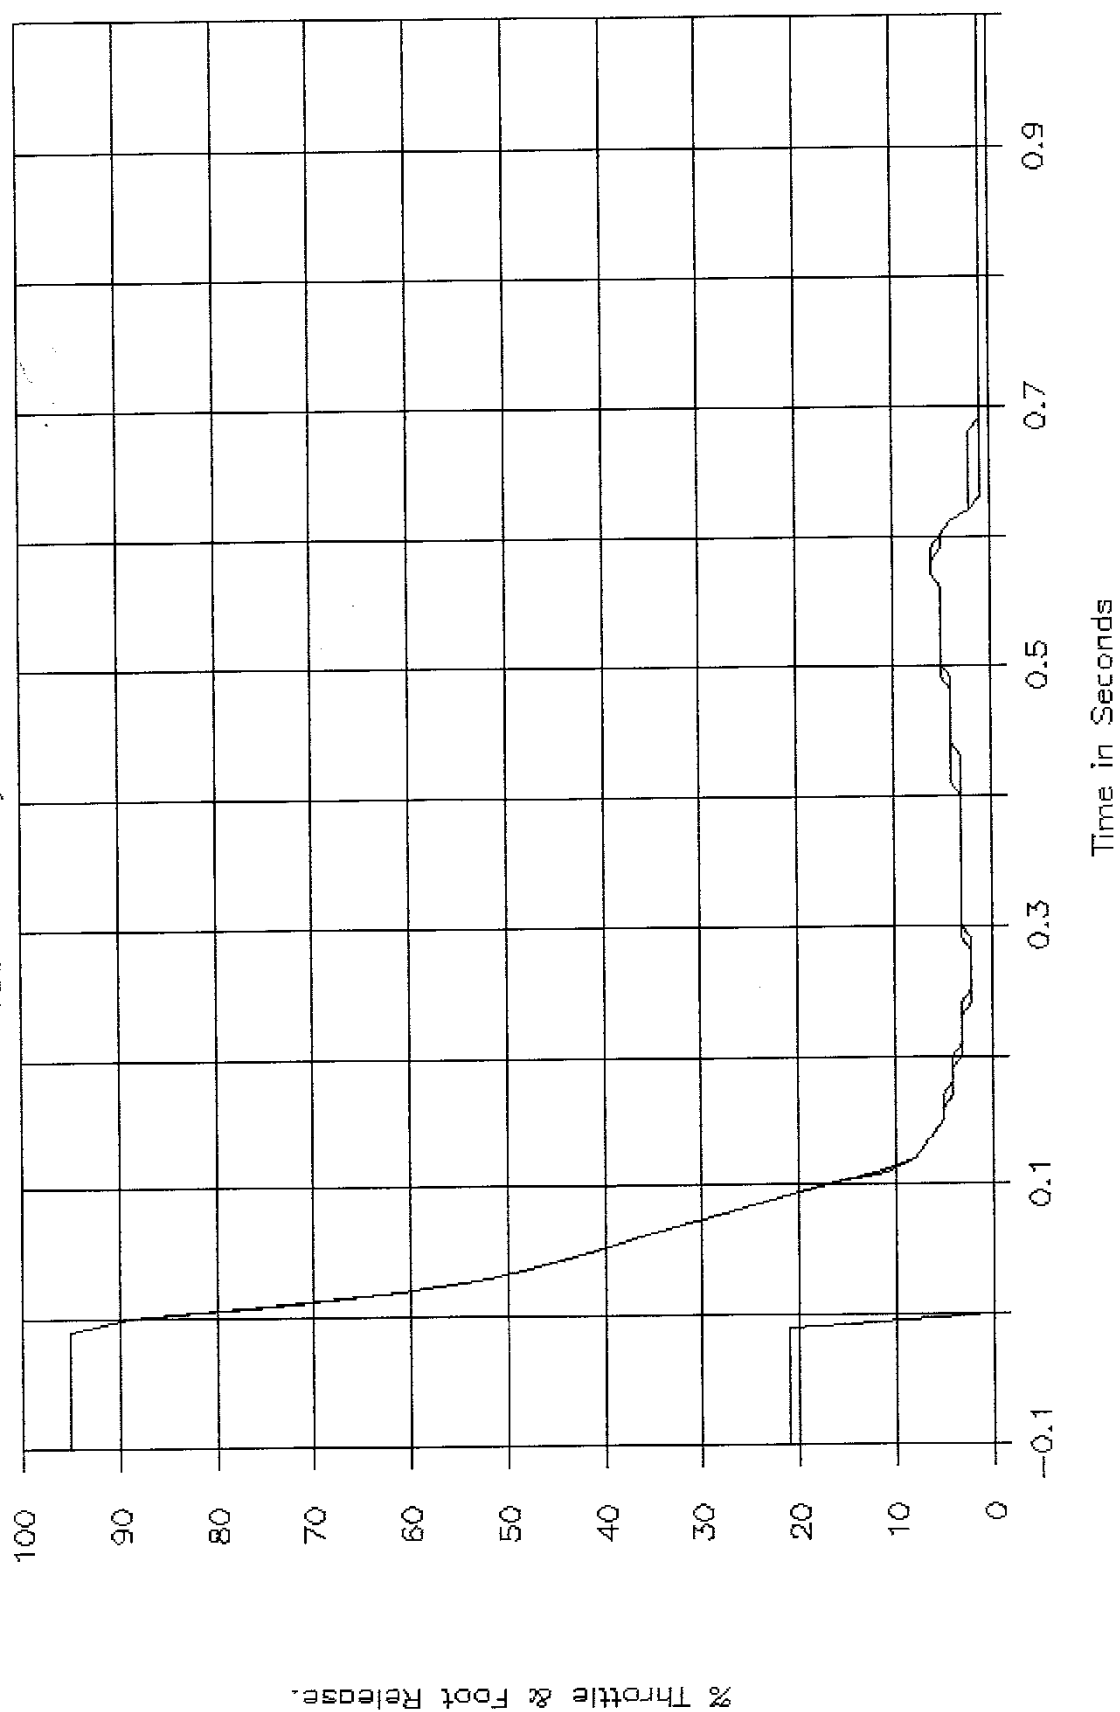
GTL 6383, NHTSA CA5204, FMVSS 124.

100% Throttle, APS Wire 6 Shorted.
