REPORT NUMBER 124-GTL-10-003

# SAFETY COMPLIANCE TESTING FOR FMVSS 124 ACCELERATOR CONTROL SYSTEMS

DAIMLER AG STUTTGART  
2010 MERCEDES GLK 350, MPV  
NHTSA NO. CA0514

**FINAL REPORT**

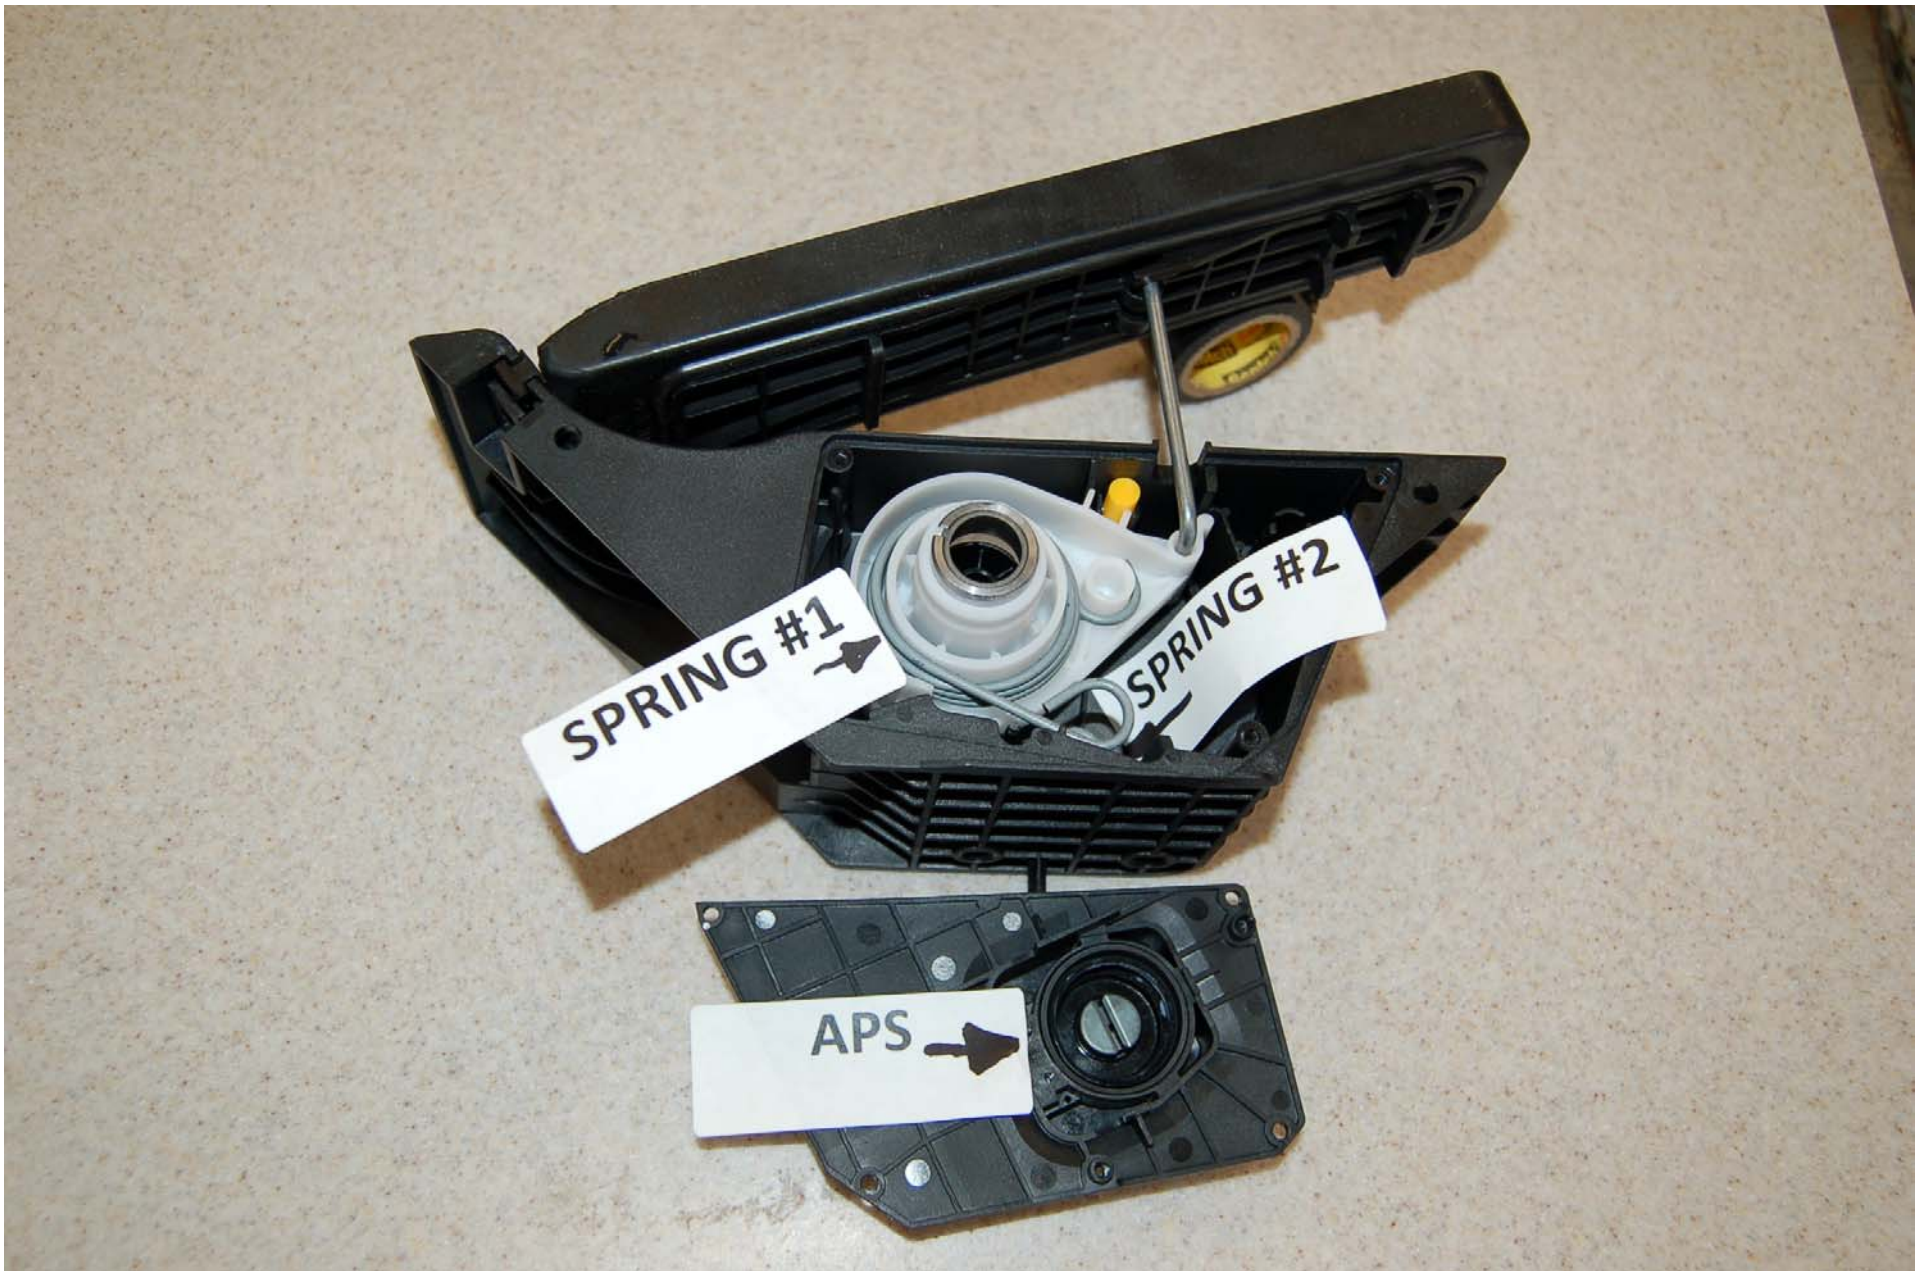
FIGURE 5.6  
ACCELERATOR PEDAL ASSEMBLY SHOWING SPRING  
1 & 2

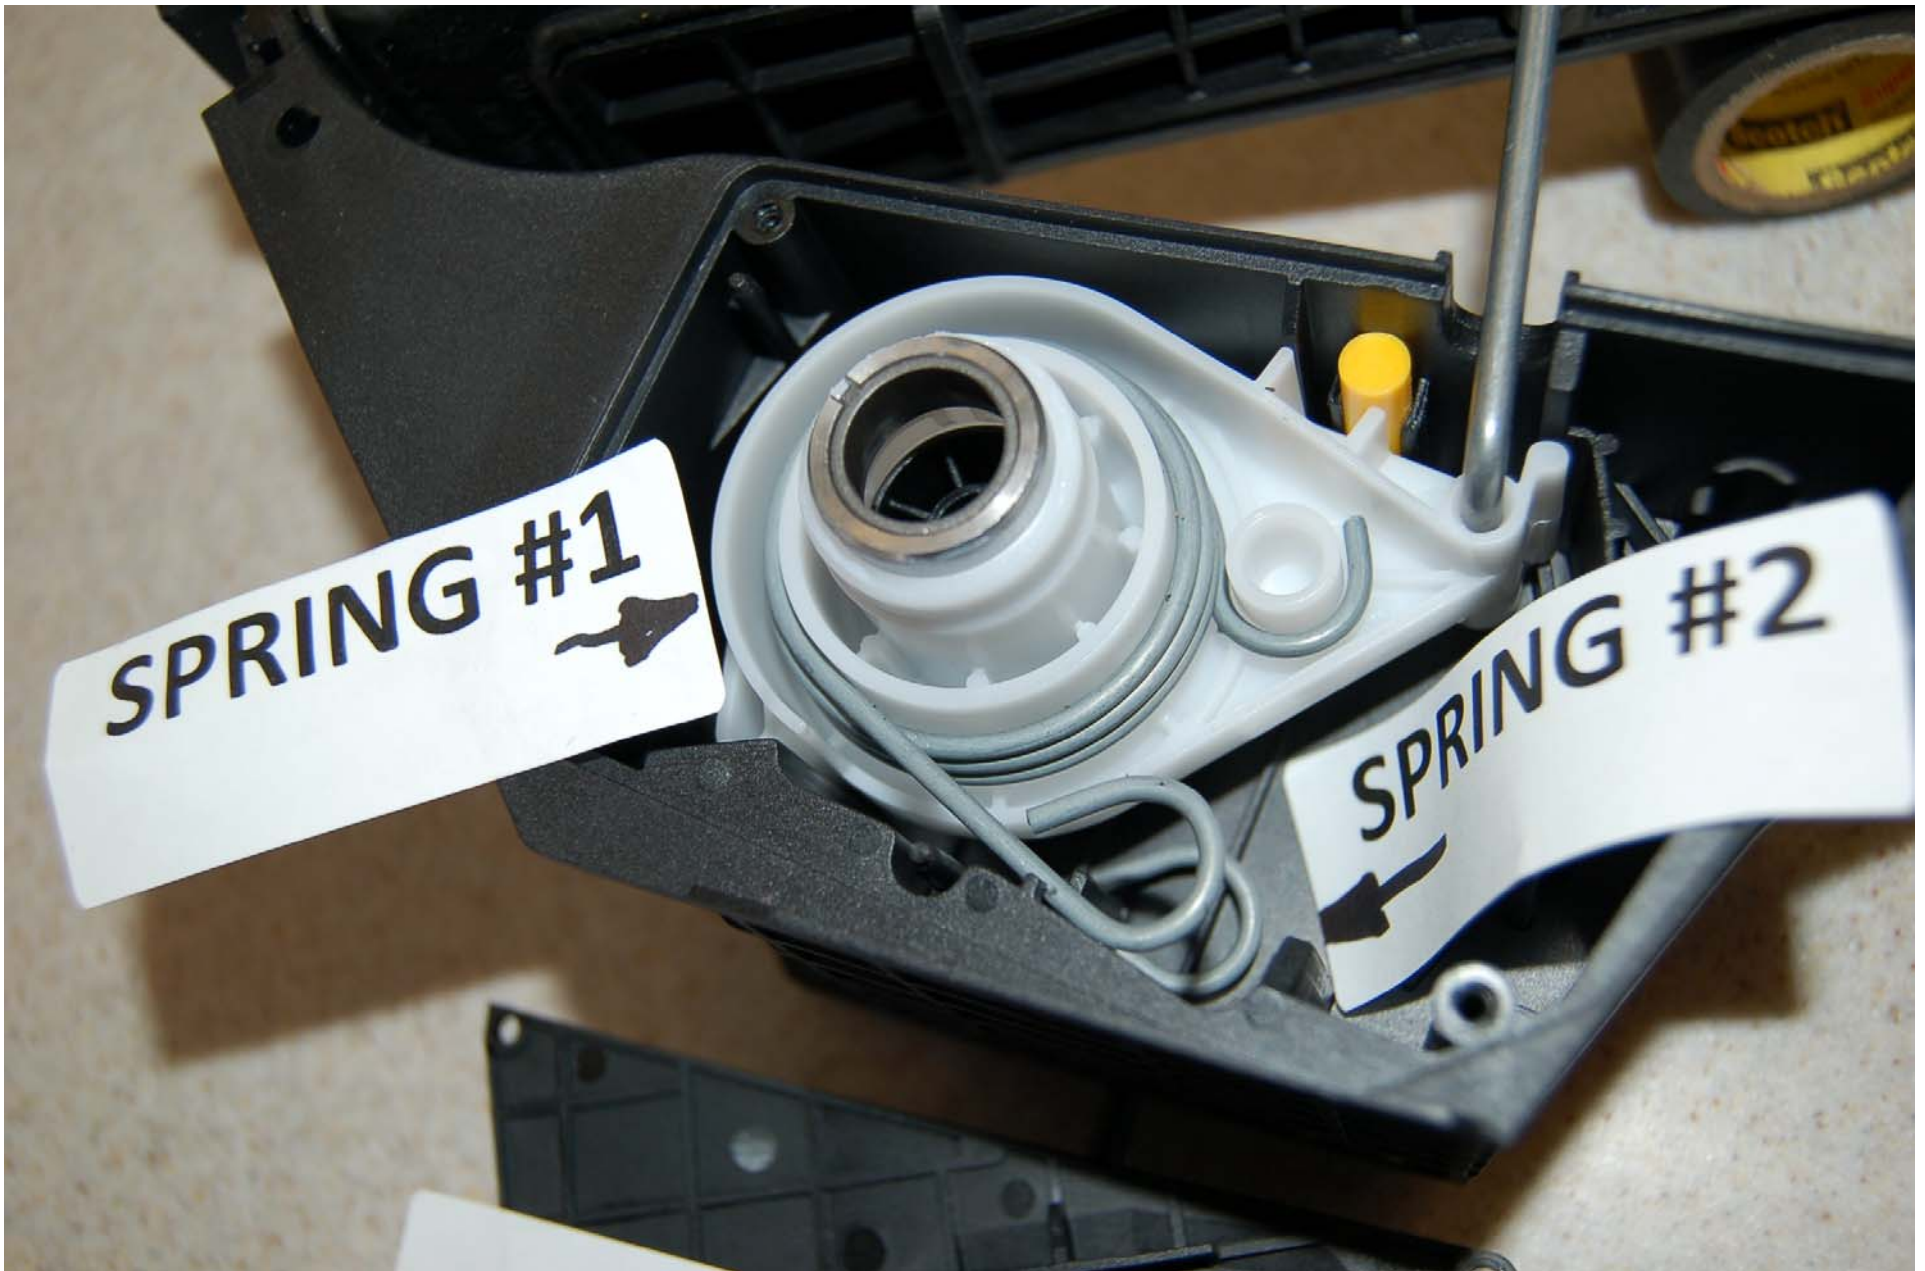
FIGURE 5.7  
CLOSE-UP OF SPRINGS 1 & 2

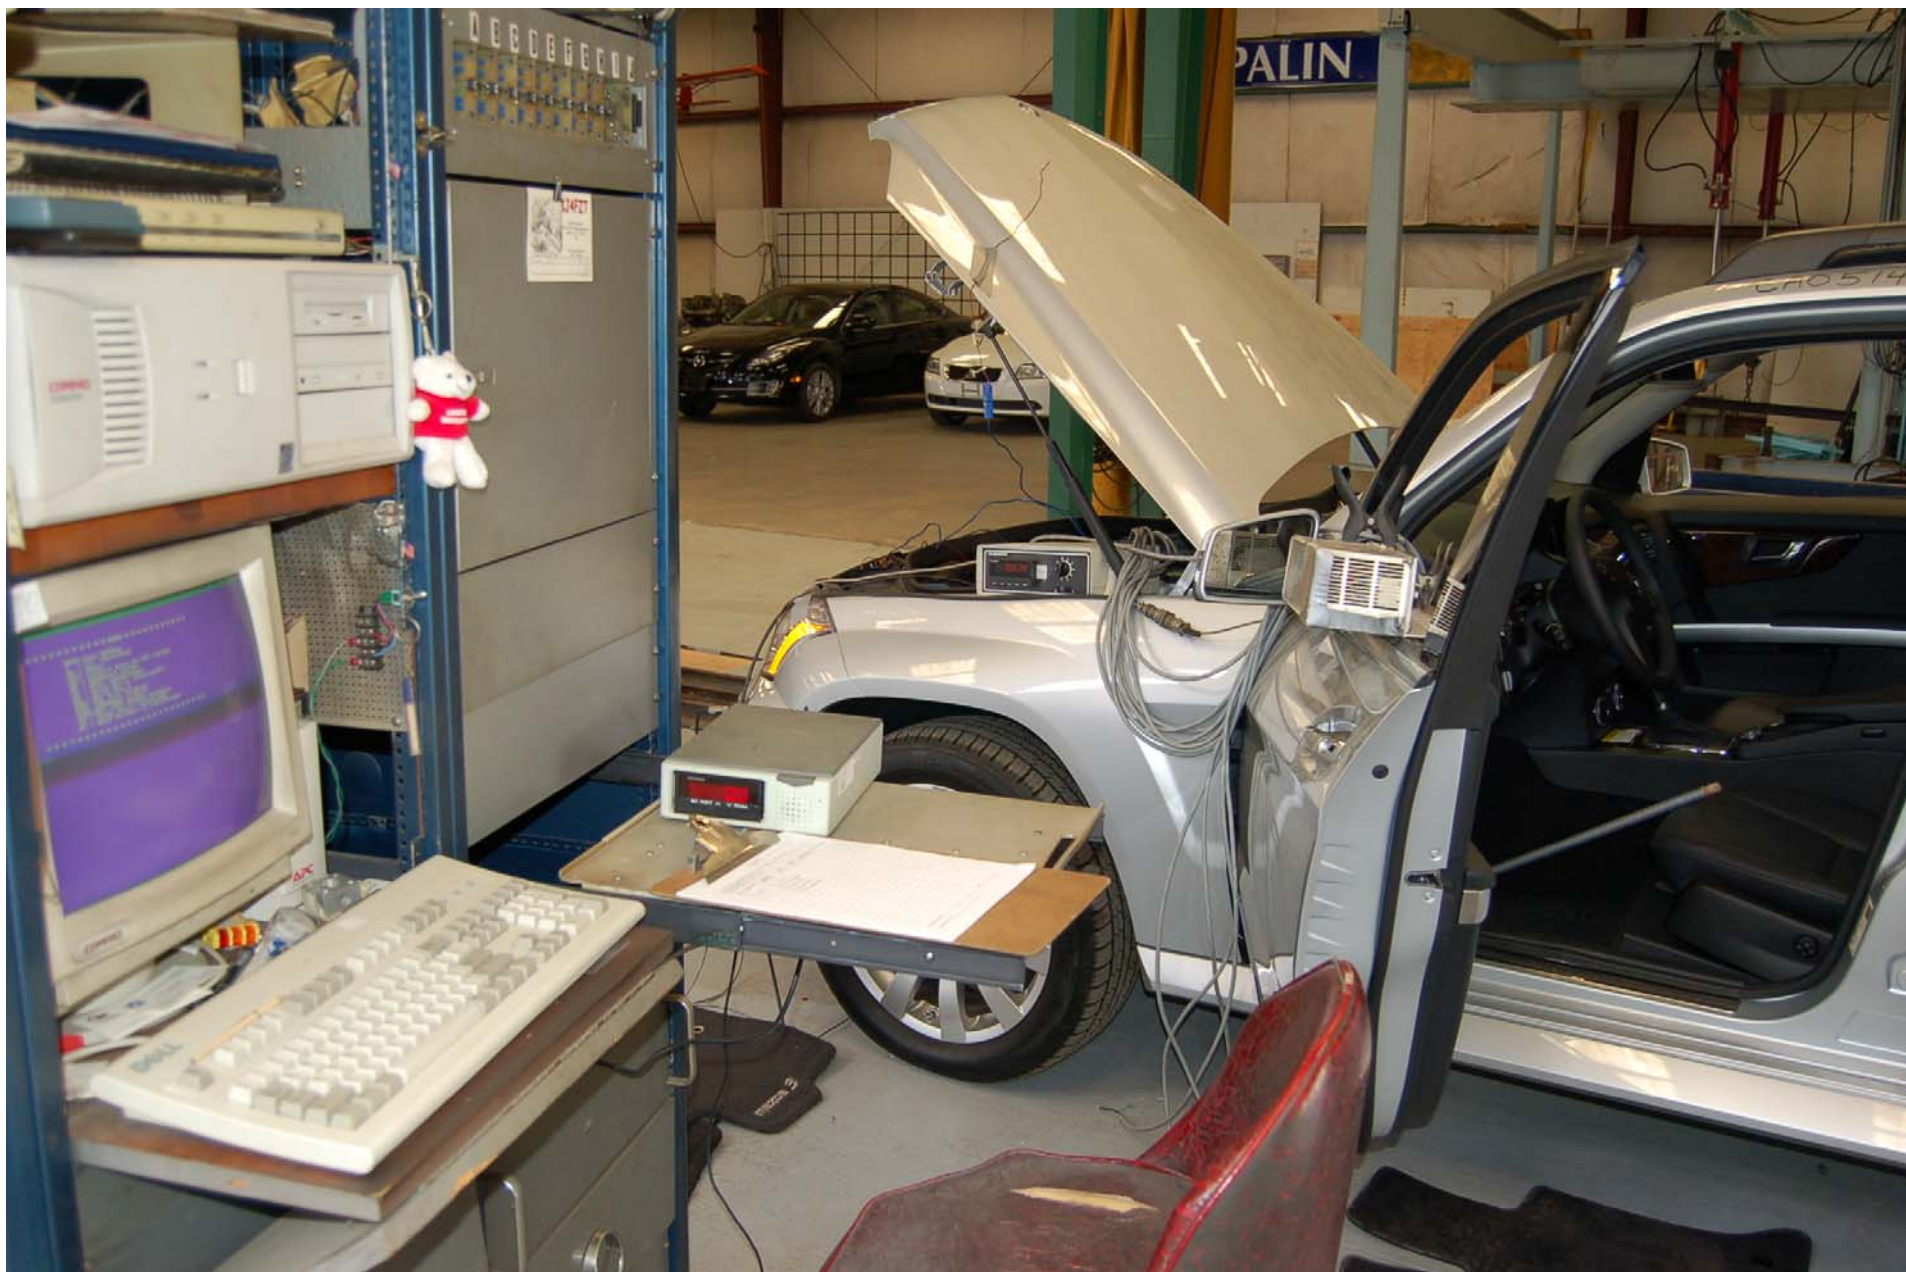
FIGURE 5.8  
TEST SET-UP

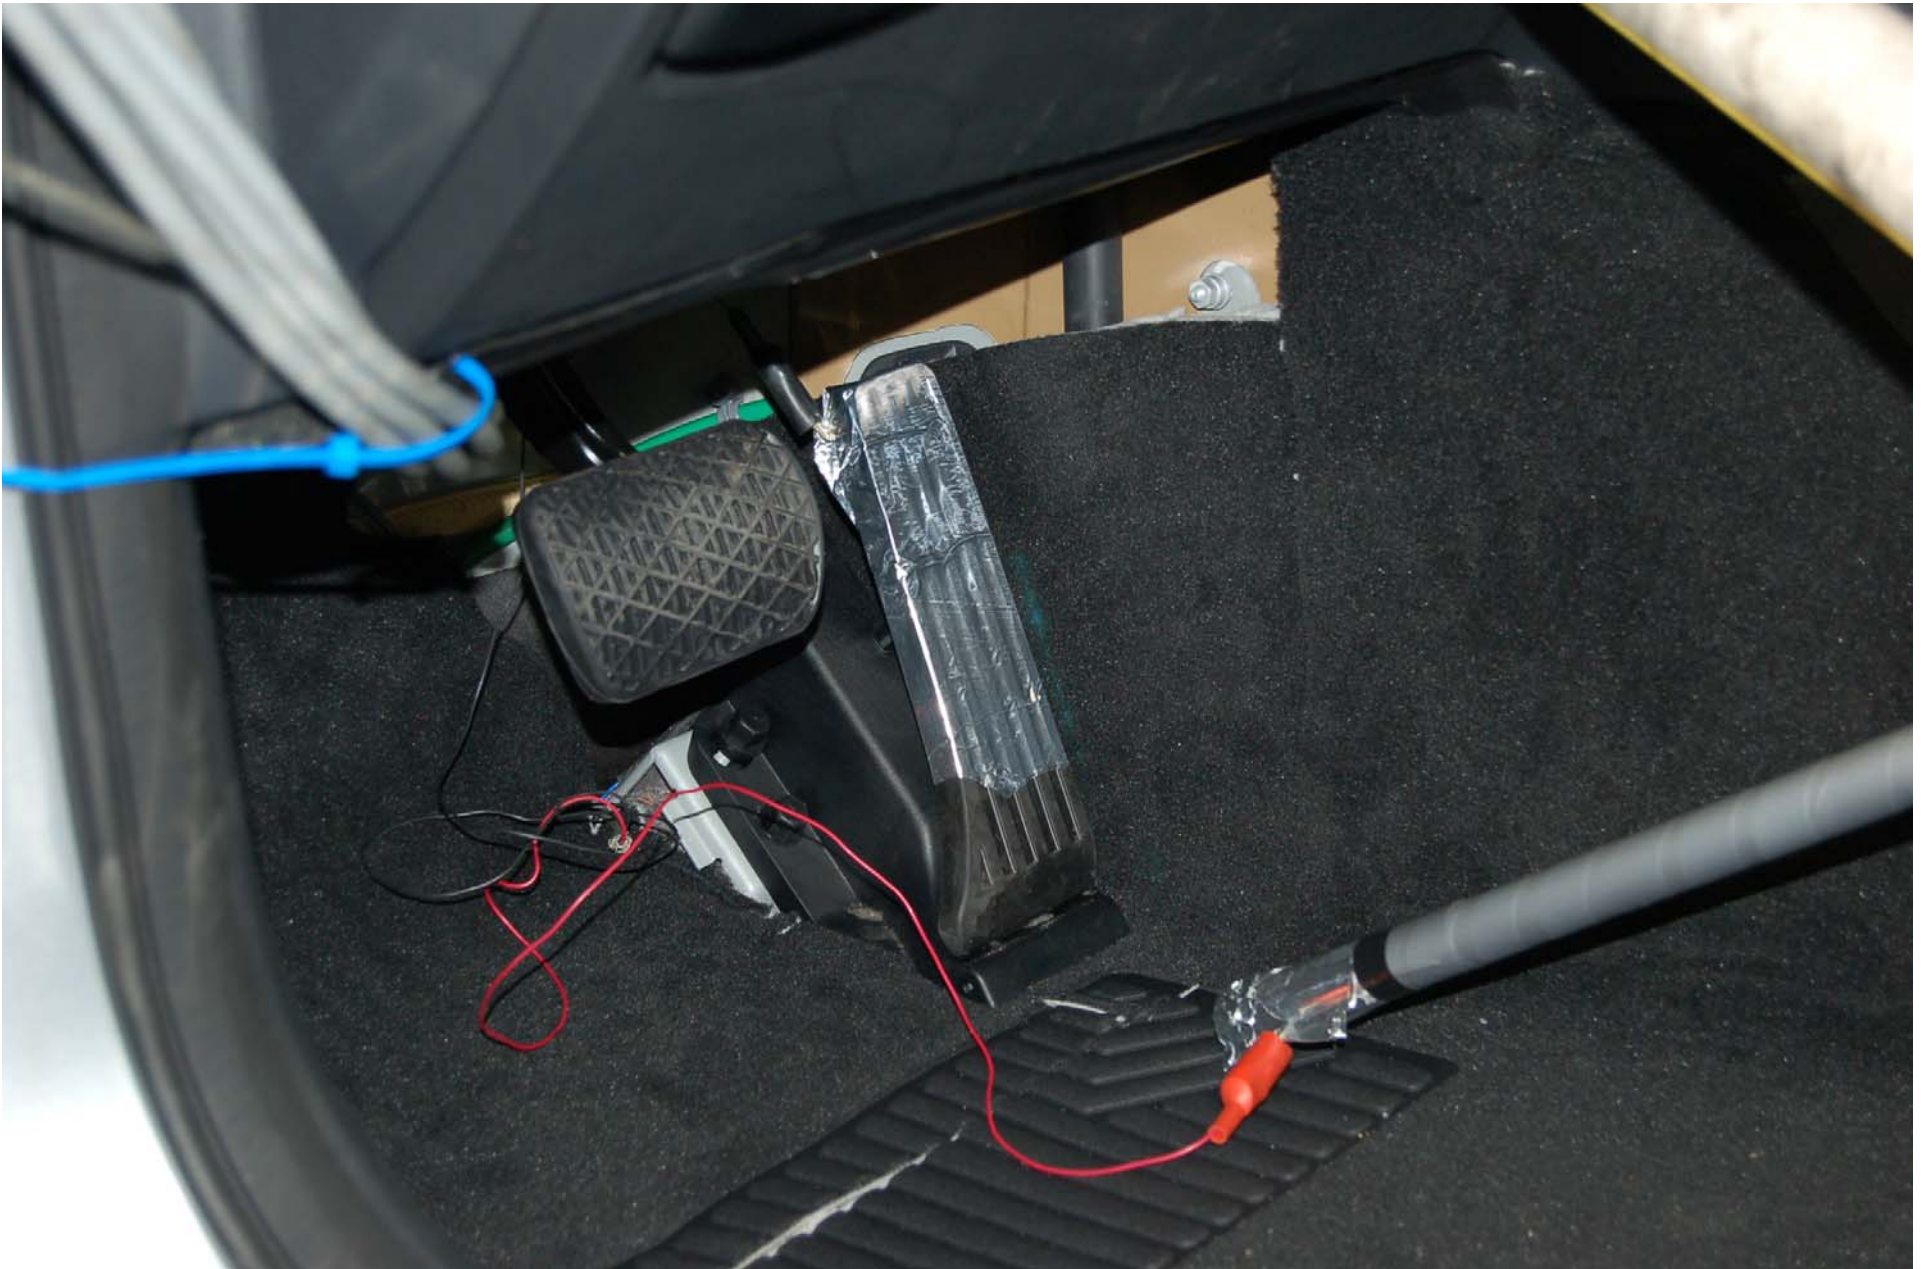
FIGURE 5.9  
ACCELERATOR TEST SET-UP

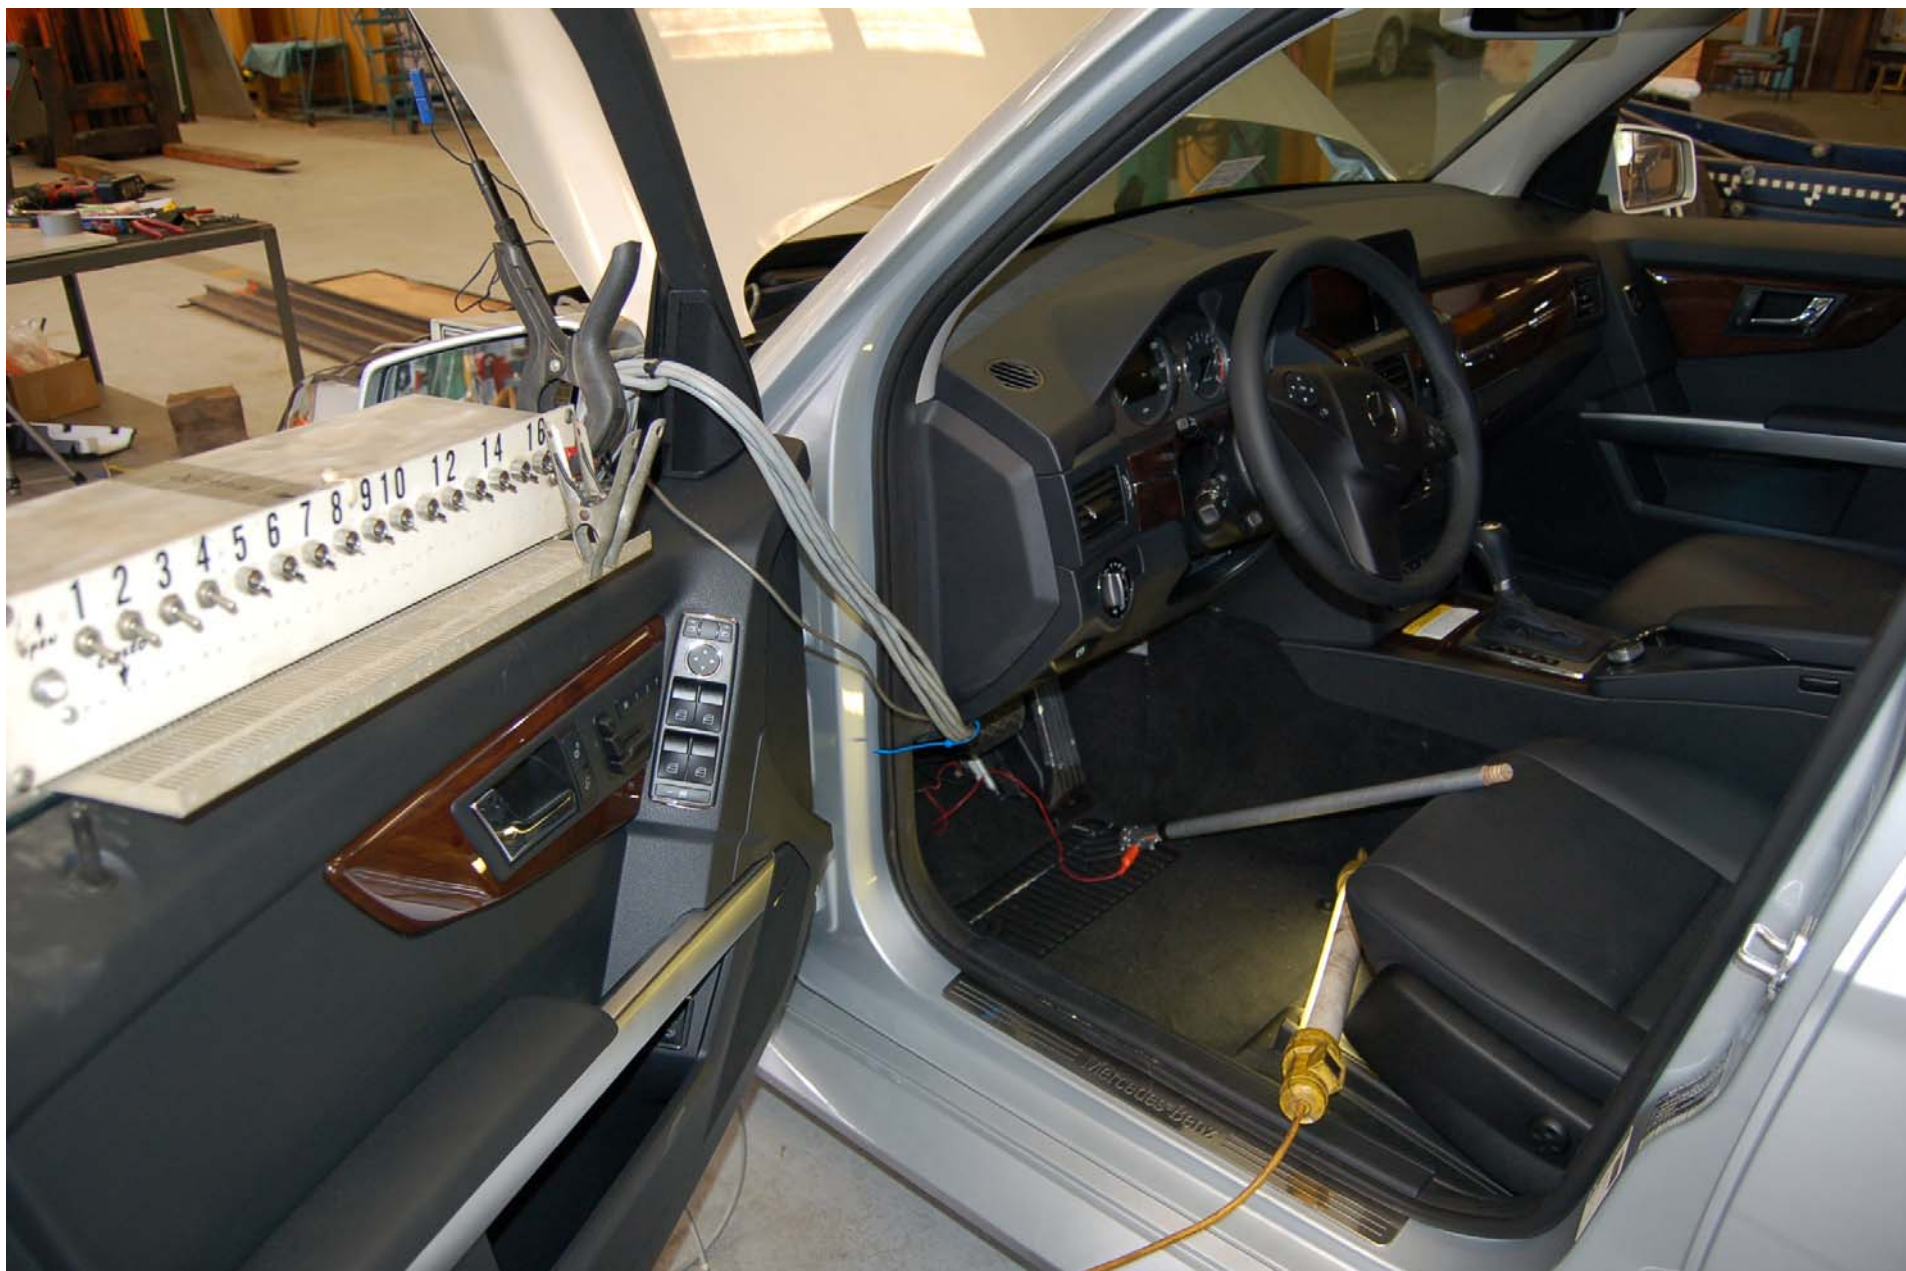
FIGURE 5.10  
WIRE OPEN/SHORTING SYSTEM

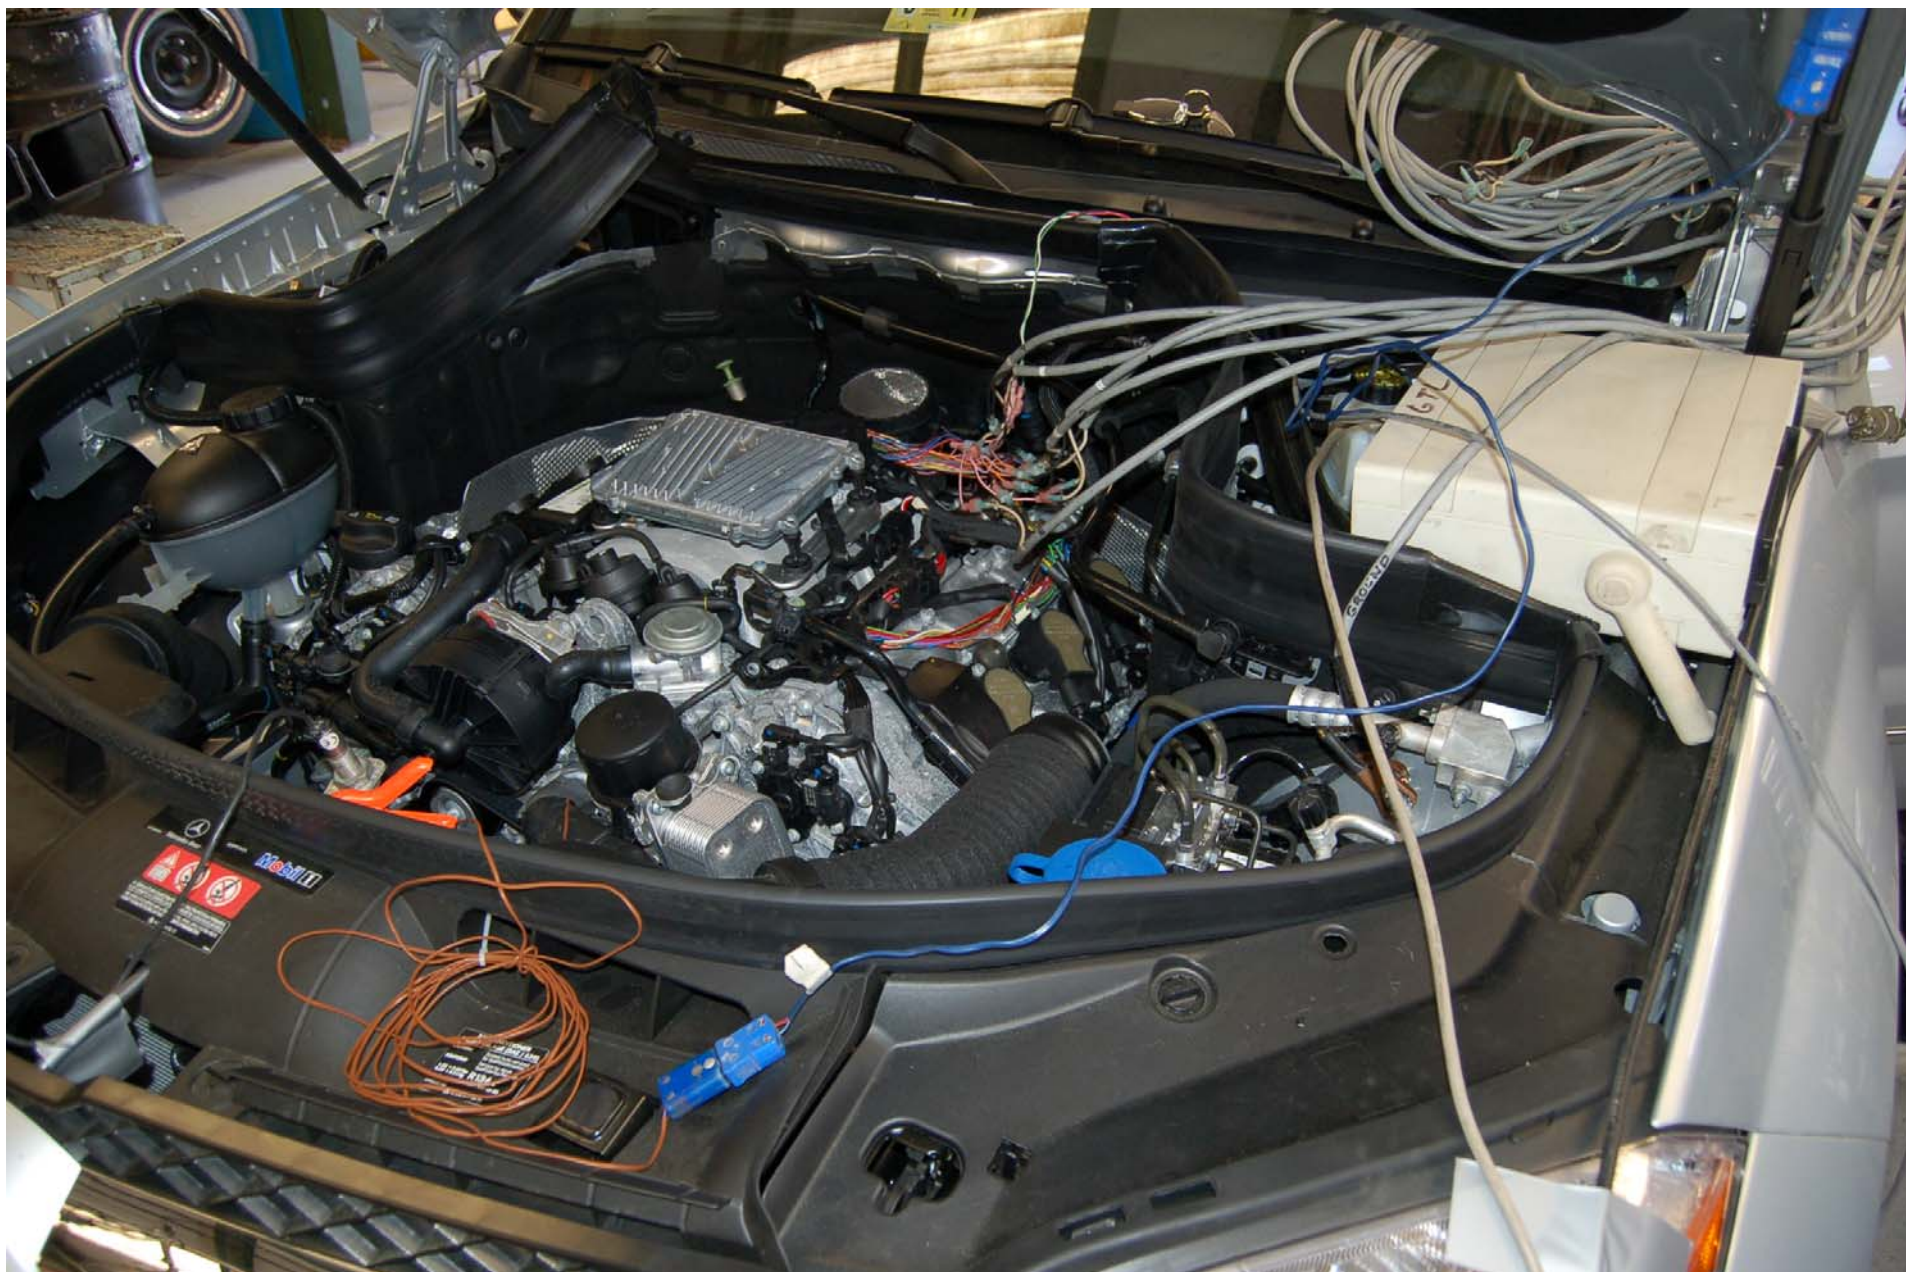
FIGURE 5.11  
ENGINE INSTRUMENTATION SET-UP

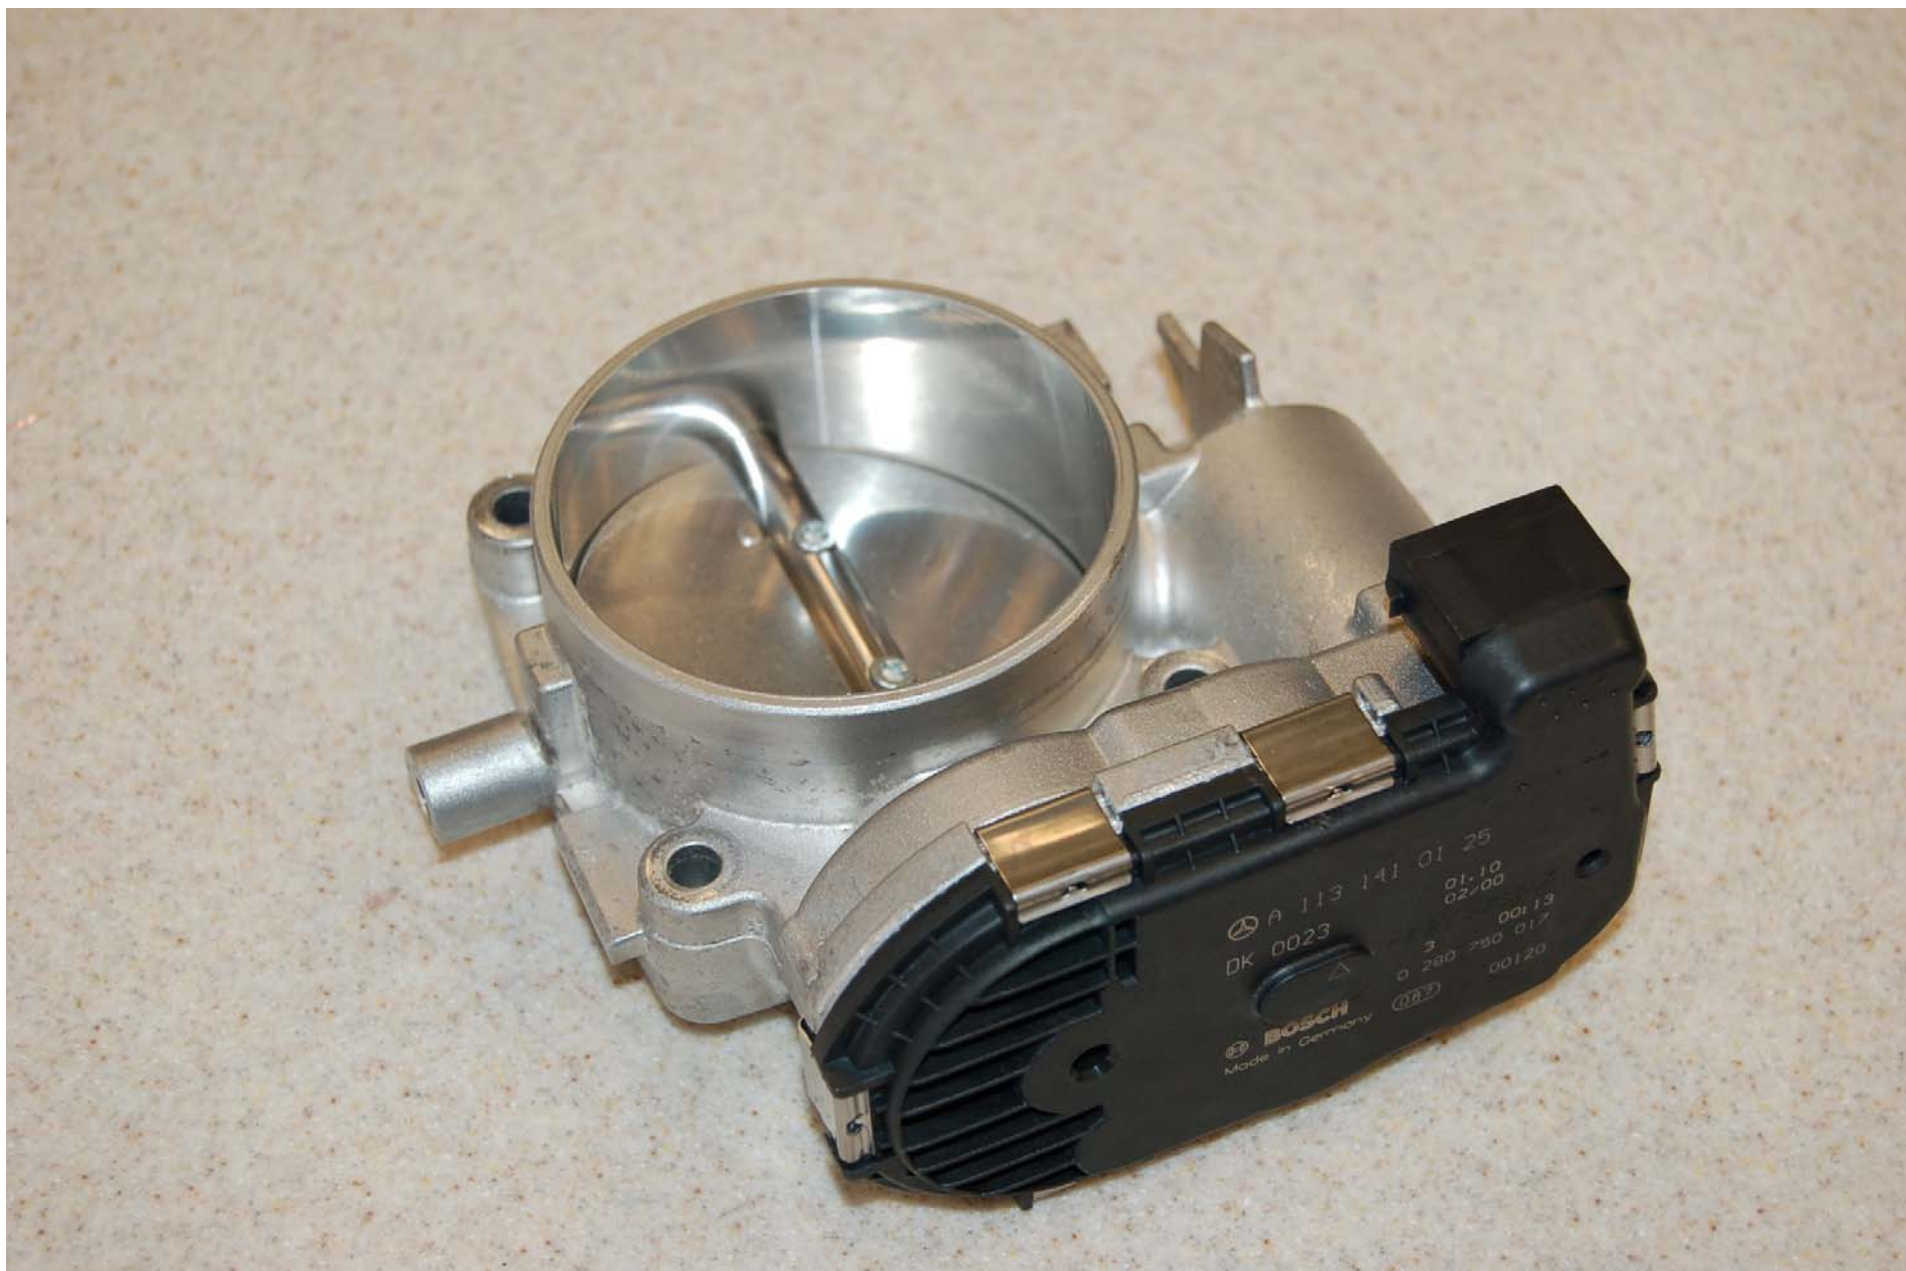
FIGURE 5.12  
THROTTLE BODY

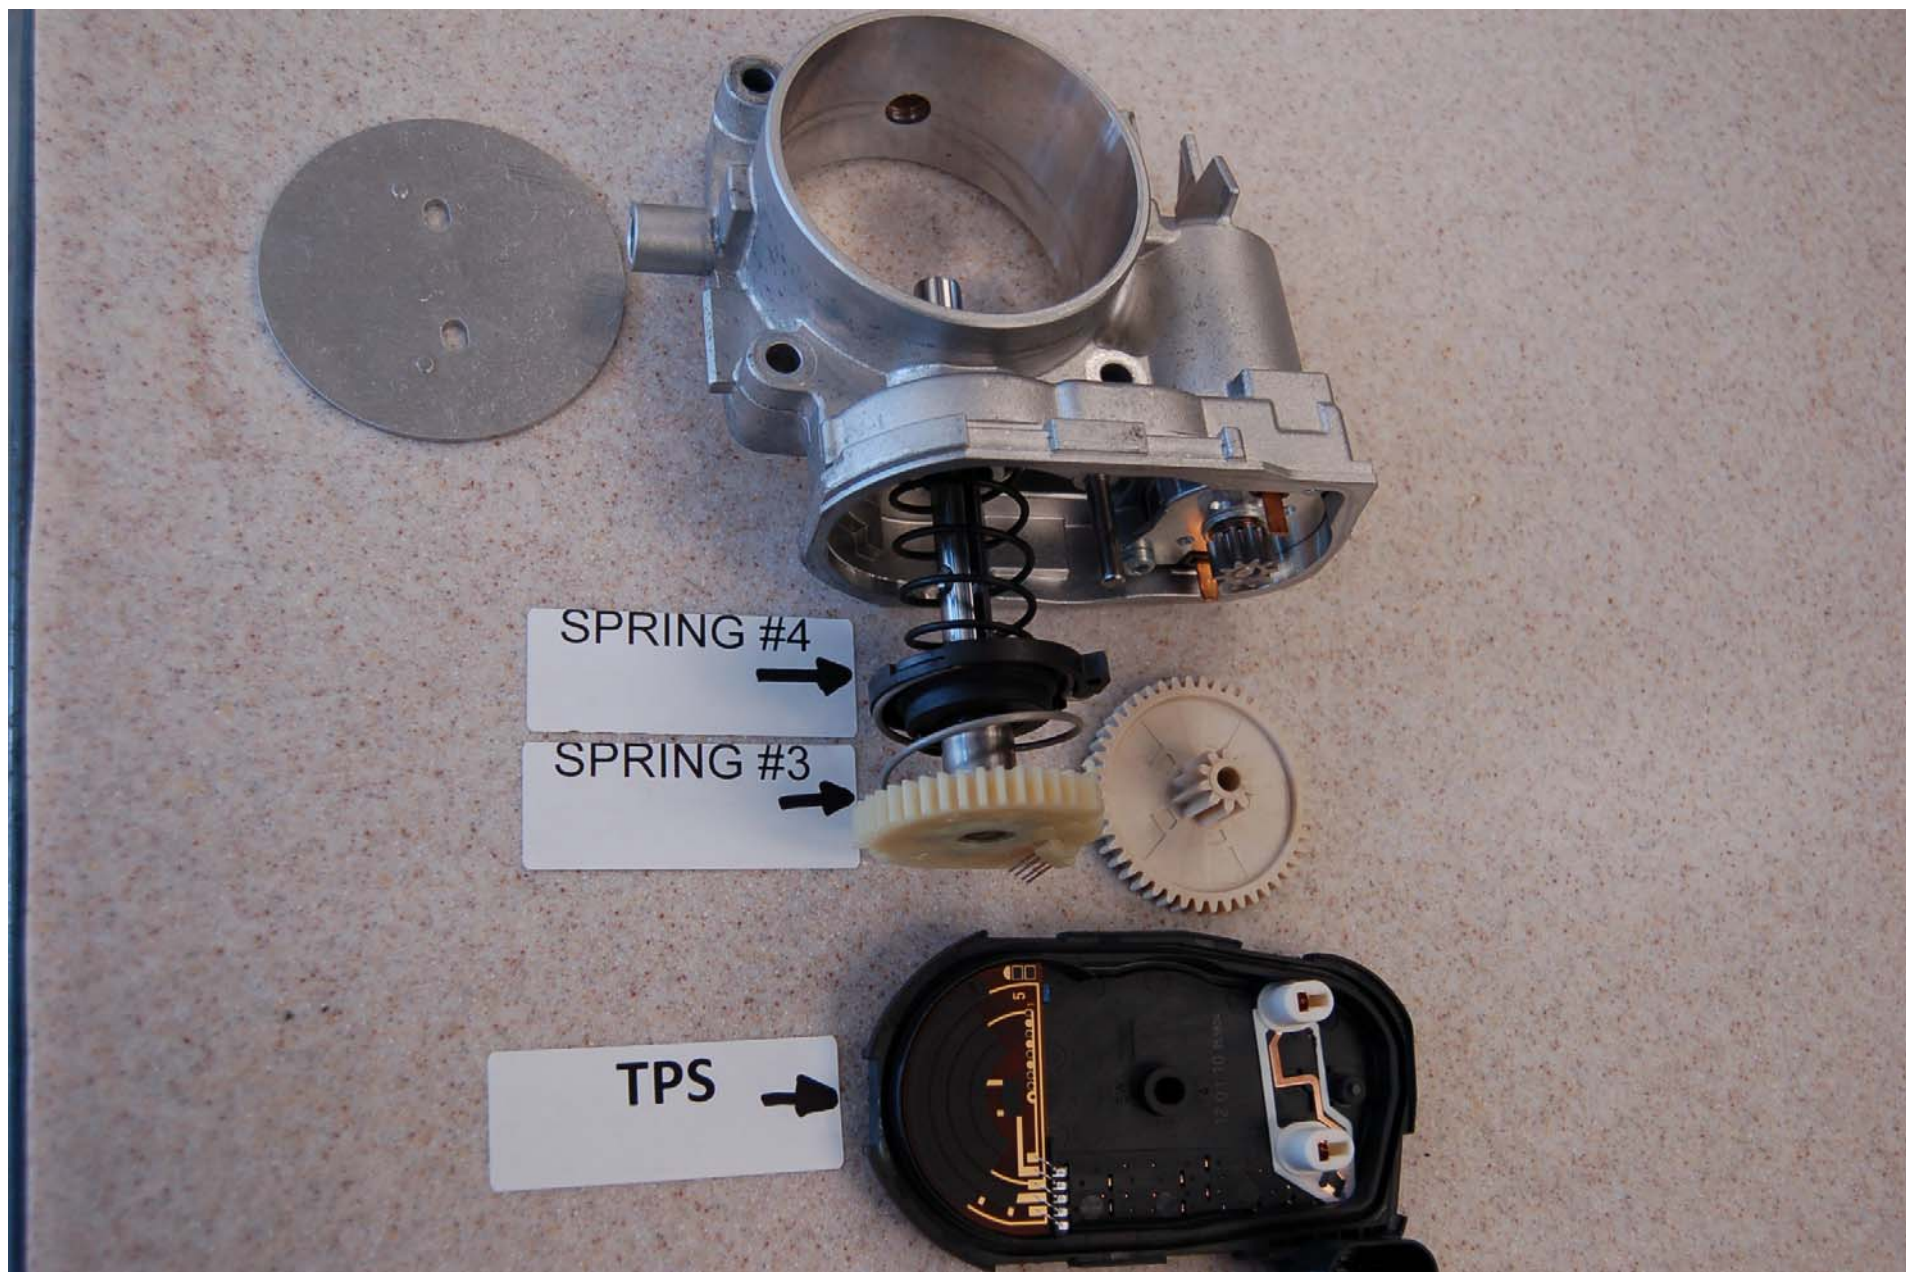
FIGURE 5.13  
THROTTLE BODY SHOWING SPRINGS 3 & 4

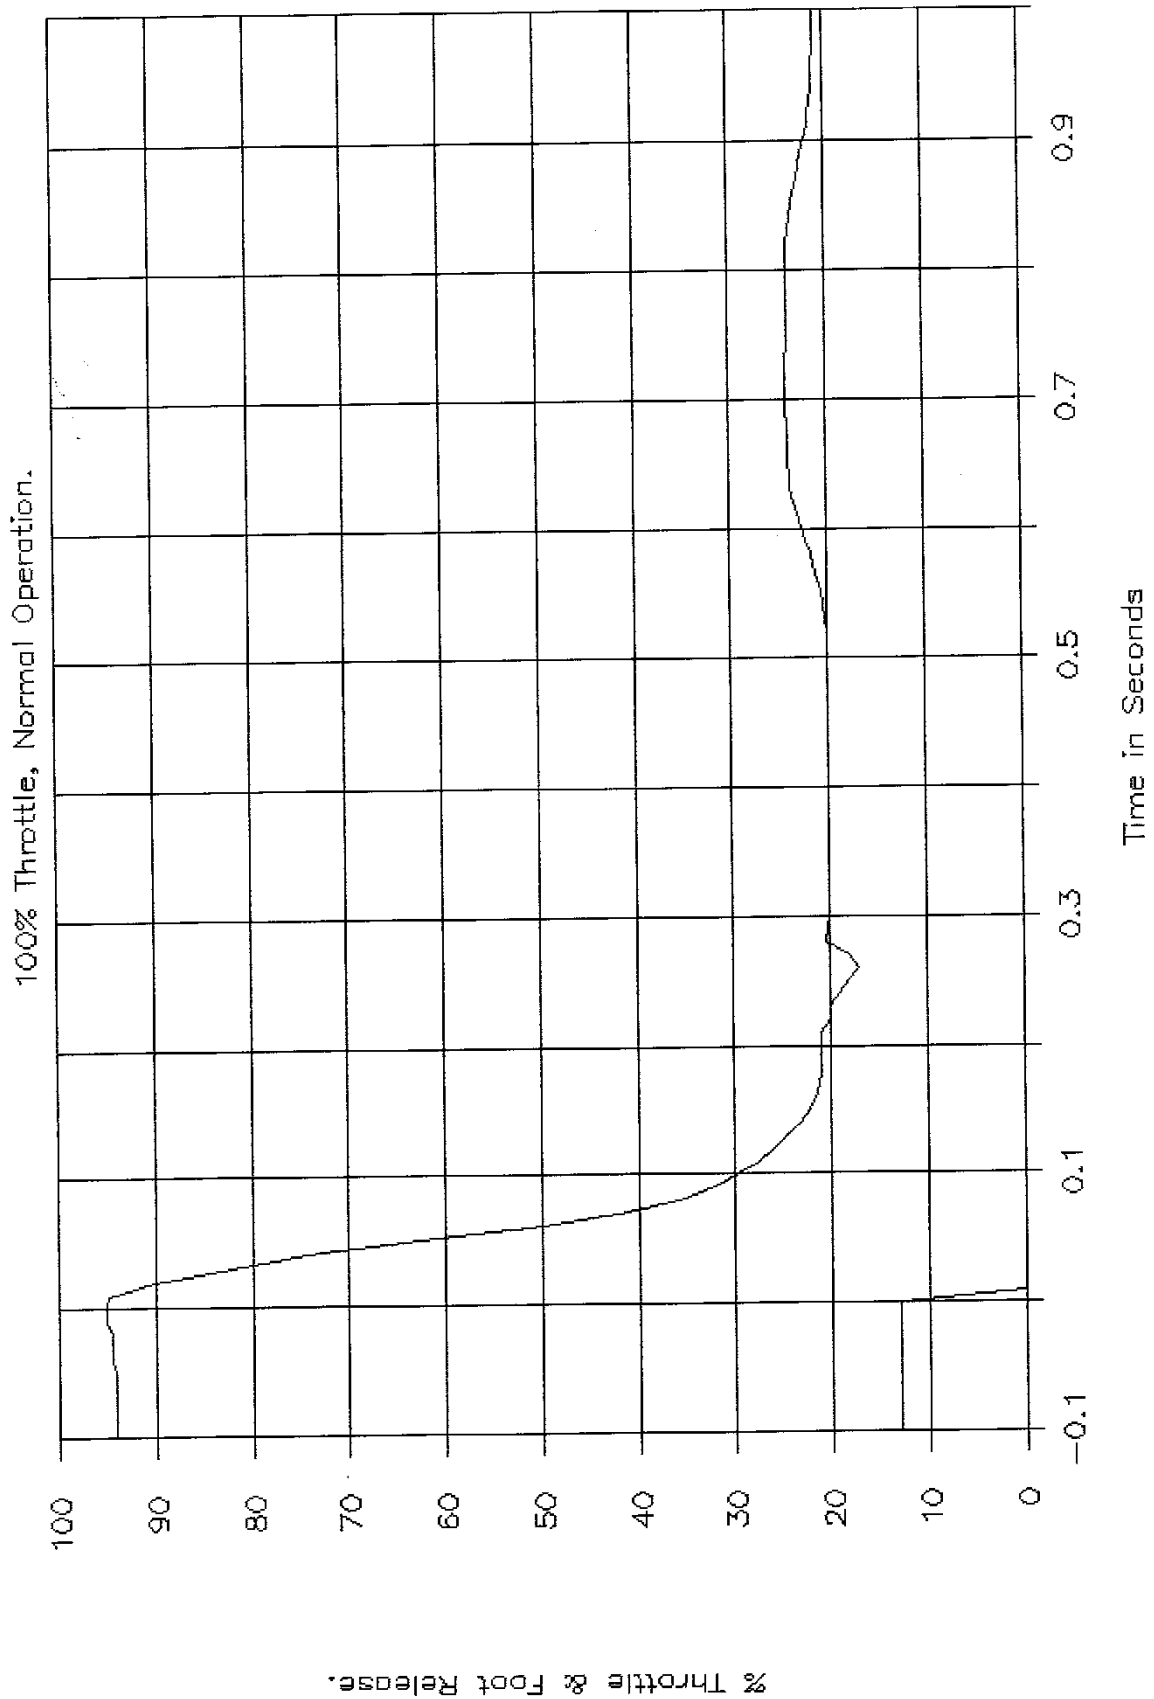
GTL 6446, NHTSA CA0514, FMVSS 124.

| GTL # | ACCELERATOR POSITION<br>% WIDE OPEN THROTTLE<br>(WOT) | THROTTLE POSITION<br>SENSOR<br>READING | RPM | TEMPERATURE (°C) | | THROTTLE POSITION<br>SENSOR<br>READING @<br>IDLE<br>(BASELINE) | RETURN<br>TIME TO<br>IDLE<br>(Msec) | PASS/<br>FAIL |
|---|---|--|---|---|---|--|---|---|
| 6446 | 100% | 100% | 600 | 194 | 75 | 16%-20% | 260 | P |
