REPORT NUMBER 124-GTL-10-003

# SAFETY COMPLIANCE TESTING FOR FMVSS 124 ACCELERATOR CONTROL SYSTEMS

DAIMLER AG STUTTGART  
2010 MERCEDES GLK 350, MPV  
NHTSA NO. CA0514

**FINAL REPORT**

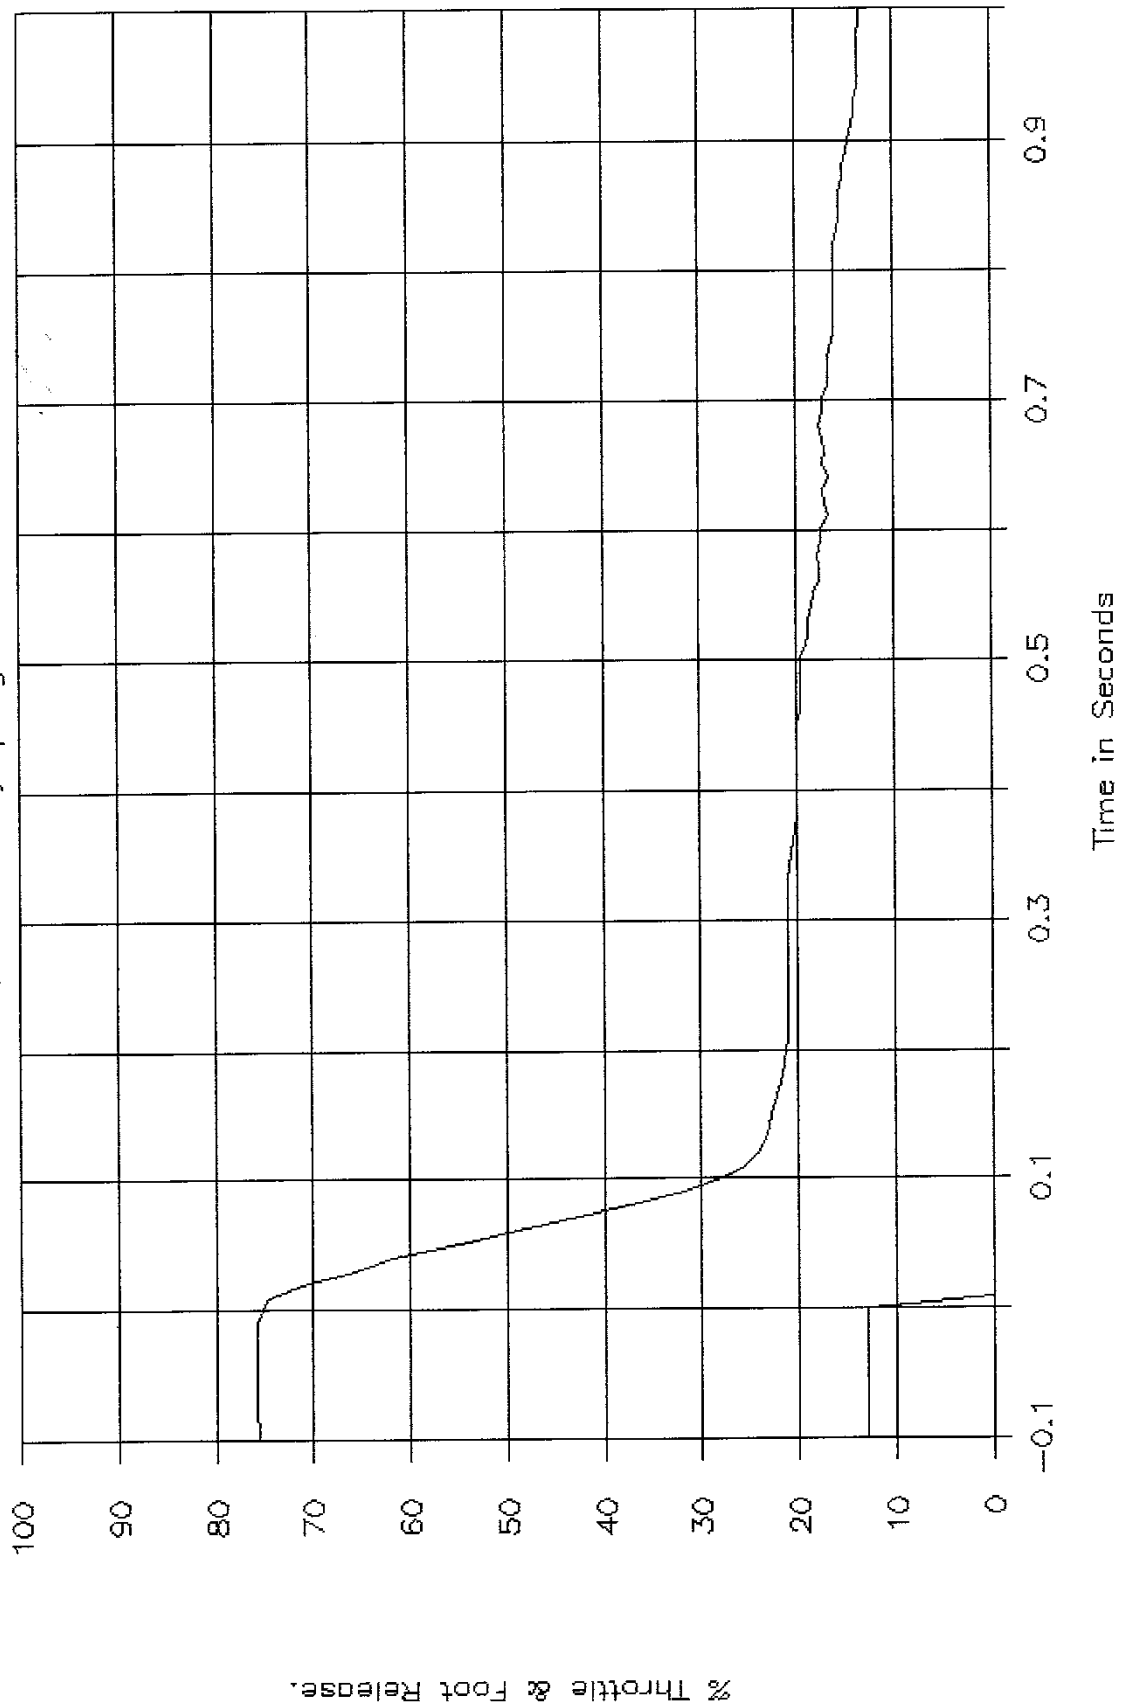
GTL 6454, NHTSA CA0514, FMVSS 124.

| GTL # | ACCELERATOR POSITION<br>% WIDE OPEN THROTTLE<br>(WOT) | THROTTLE POSITION<br>SENSOR<br>READING | RPM | TEMPERATURE (°C) | | THROTTLE POSITION<br>SENSOR<br>READING @<br>IDLE<br>(BASELINE) | RETURN<br>TIME TO<br>IDLE<br>(Msec) | PASS/<br>FAIL |
|---|---|--|---|---|---|--|---|---|
| 6454 | 75% | 75% | 600 | 197 | 63 | 16%-20% | 380 | P |

75% Throttle, Spring 1 Removed.

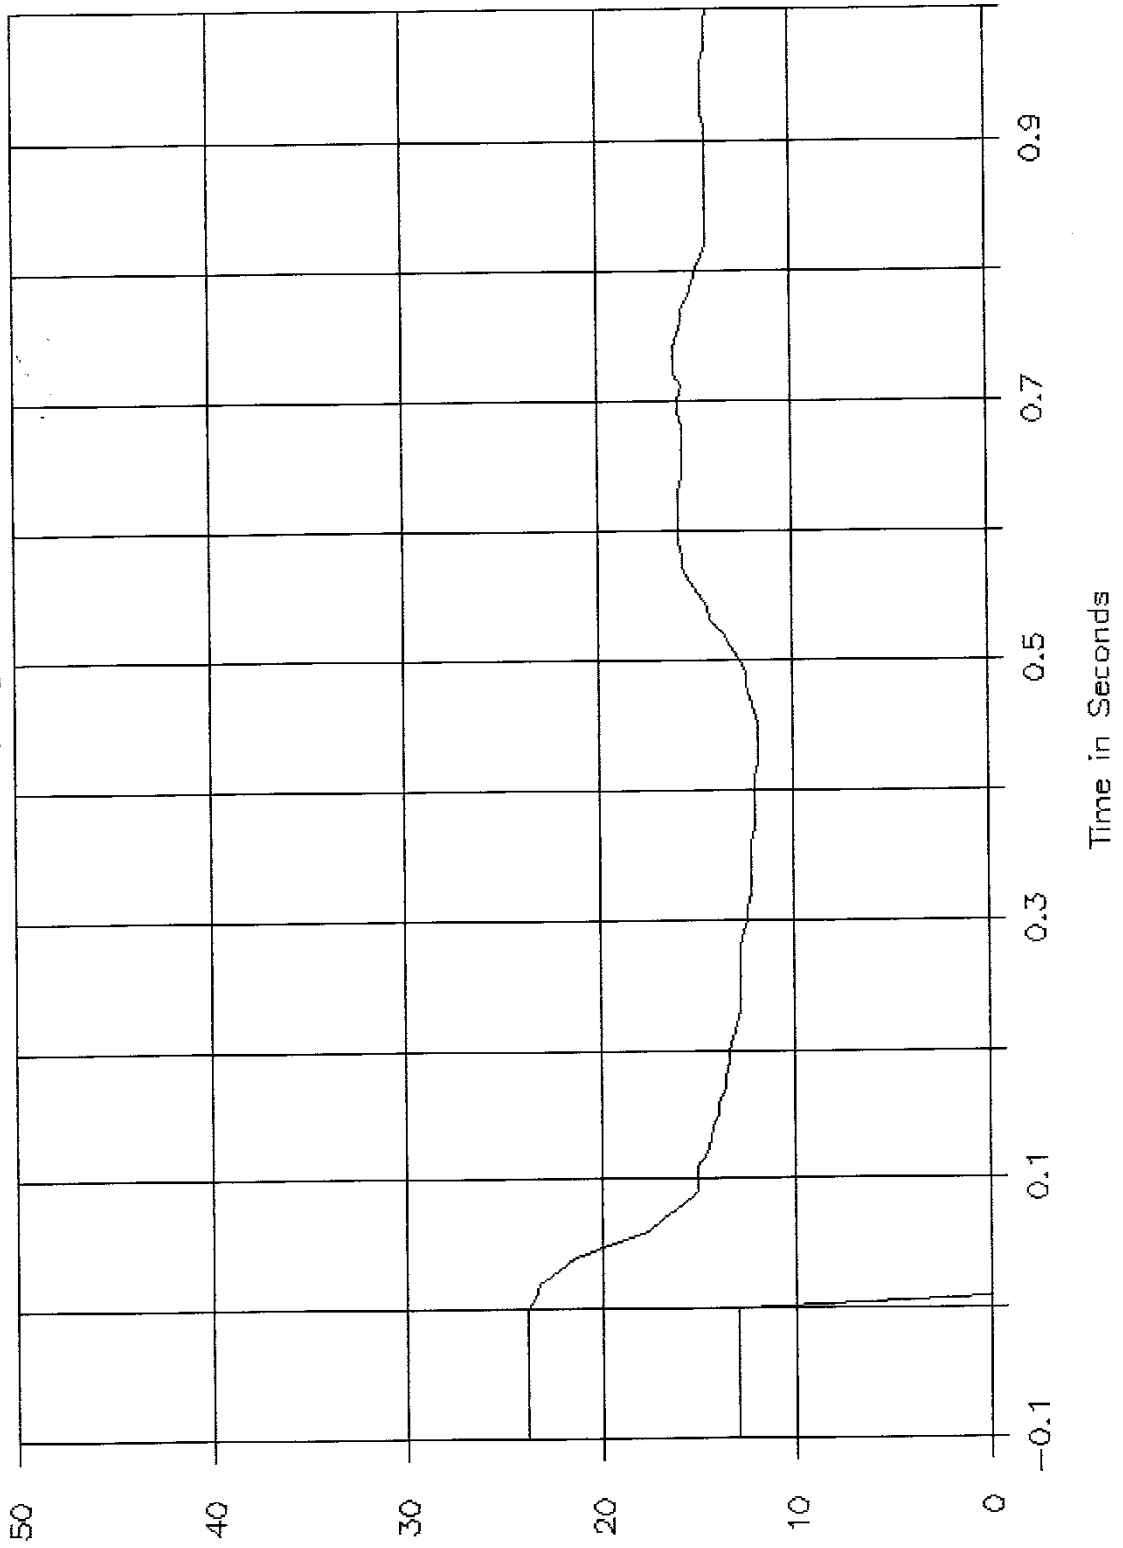
GTL 6456, NHTSA CA0514, FMVSS 124.

| GTL # | ACCELERATOR POSITION<br>% WIDE OPEN THROTTLE<br>(WOT) | THROTTLE POSITION<br>SENSOR<br>READING | RPM | TEMPERATURE (°C) | | THROTTLE POSITION<br>SENSOR<br>READING @<br>IDLE<br>(BASELINE) | RETURN<br>TIME TO<br>IDLE<br>(Msec) | PASS/<br>FAIL |
|---|---|--|---|---|---|--|---|---|
| 6456 | 25% | 24% | 600 | 200 | 63 | 16%-20% | 50 | P |

25% Throttle, Spring 1 Removed.

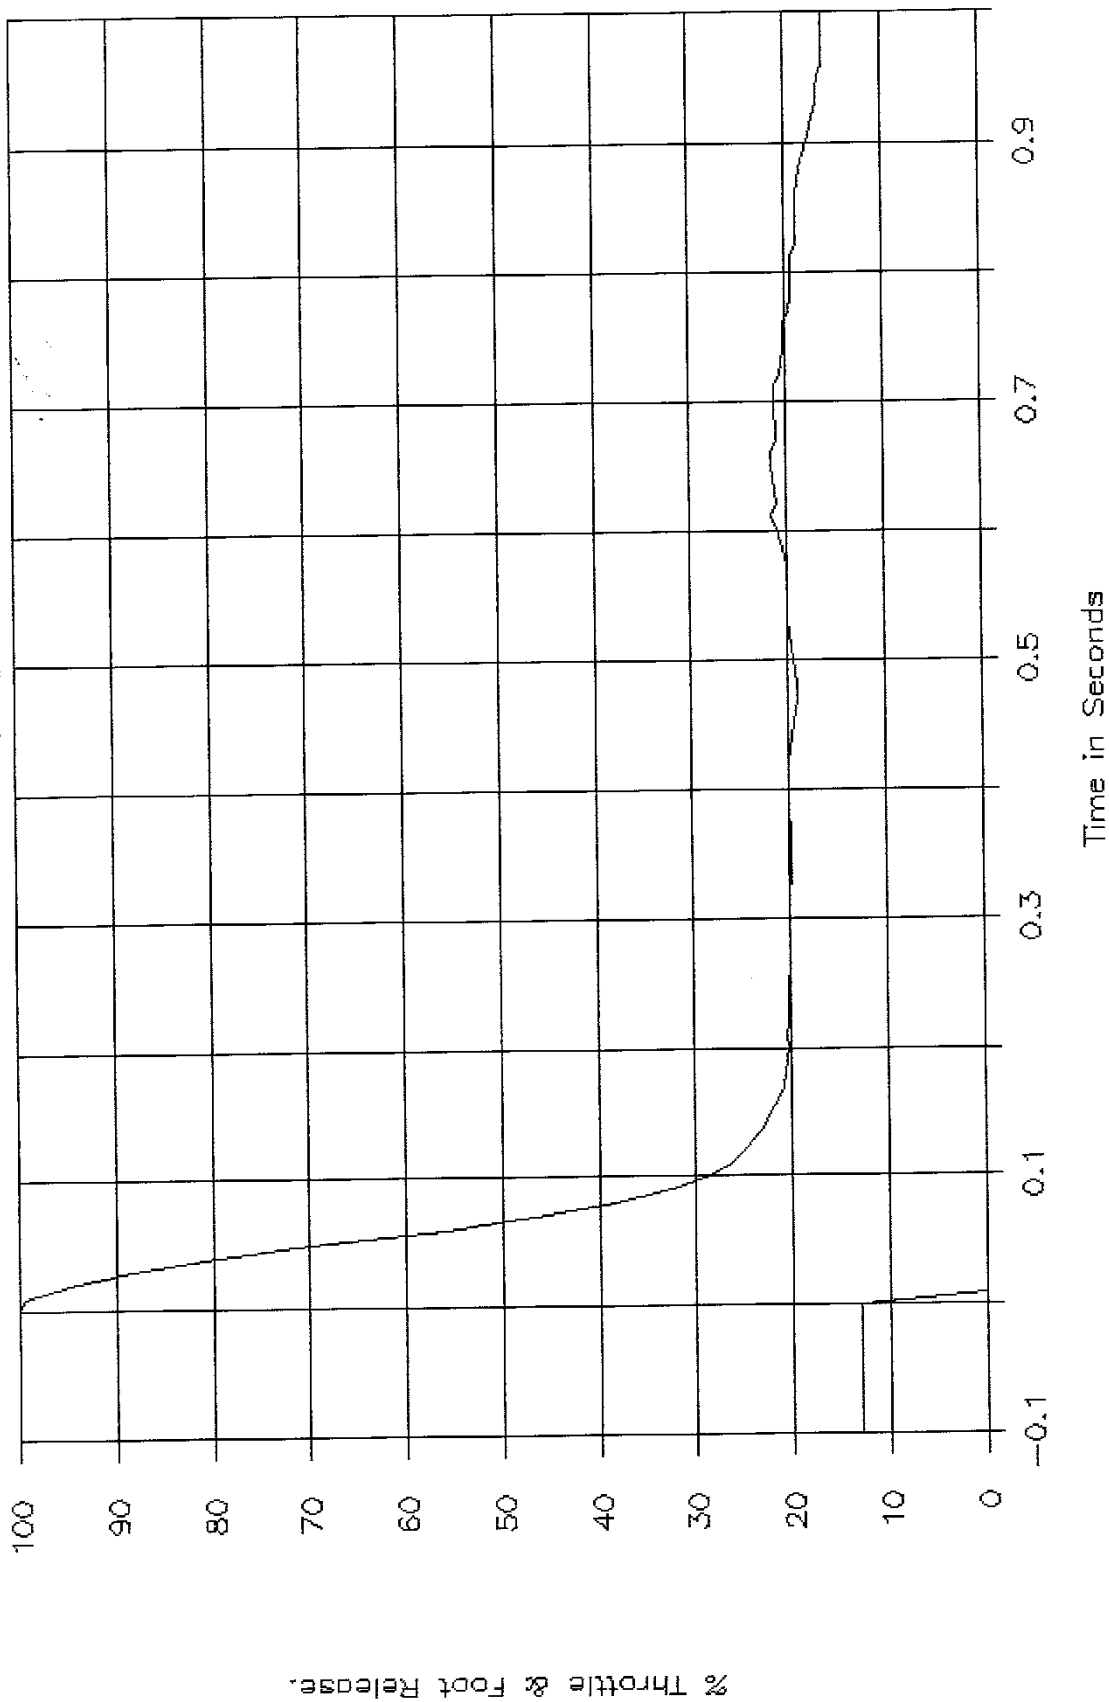
GTL 6457, NHTSA CA0514, FMVSS 124.

| GTL # | ACCELERATOR POSITION<br>% WIDE OPEN THROTTLE<br>(WOT) | THROTTLE POSITION<br>SENSOR<br>READING | RPM | TEMPERATURE (°C) | | THROTTLE POSITION<br>SENSOR<br>READING @<br>IDLE<br>(BASELINE) | RETURN<br>TIME TO<br>IDLE<br>(Msec) | PASS/<br>FAIL |
|---|---|--|---|---|---|--|---|---|
| 6457 | 100% | 100% | 600 | 198 | 63 | 16%-20% | 260 | P |

100% Throttle, Spring 2 Removed.

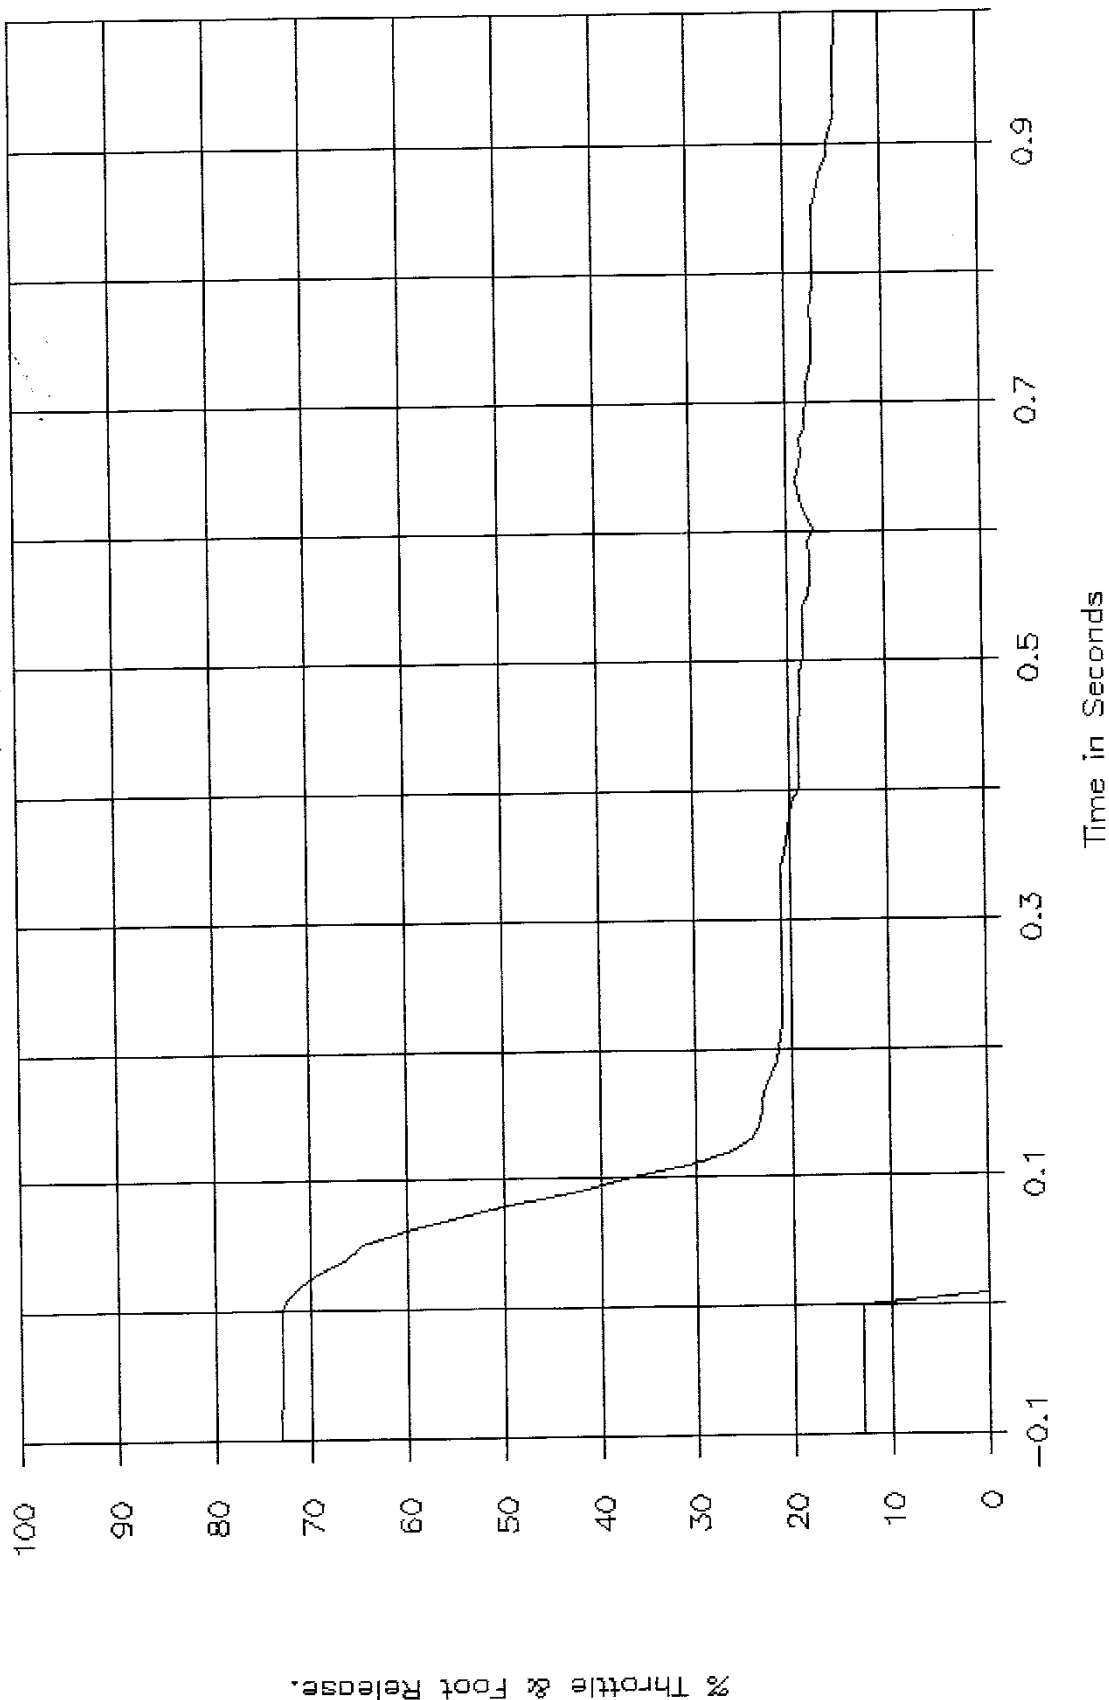
GTL 6458, NHTSA CA0514, FMVSS 124.

| GTL # | ACCELERATOR POSITION<br>% WIDE OPEN THROTTLE<br>(WOT) | THROTTLE POSITION<br>SENSOR<br>READING | RPM | TEMPERATURE (°C) | | THROTTLE POSITION<br>SENSOR<br>READING @<br>IDLE<br>(BASELINE) | RETURN<br>TIME TO<br>IDLE<br>(Msec) | PASS/<br>FAIL |
|---|---|--|---|---|---|--|---|---|
| 6458 | 75% | 73% | 600 | 200 | 63 | 16%-20% | 380 | P |

75% Throttle, Spring 2 Removed.

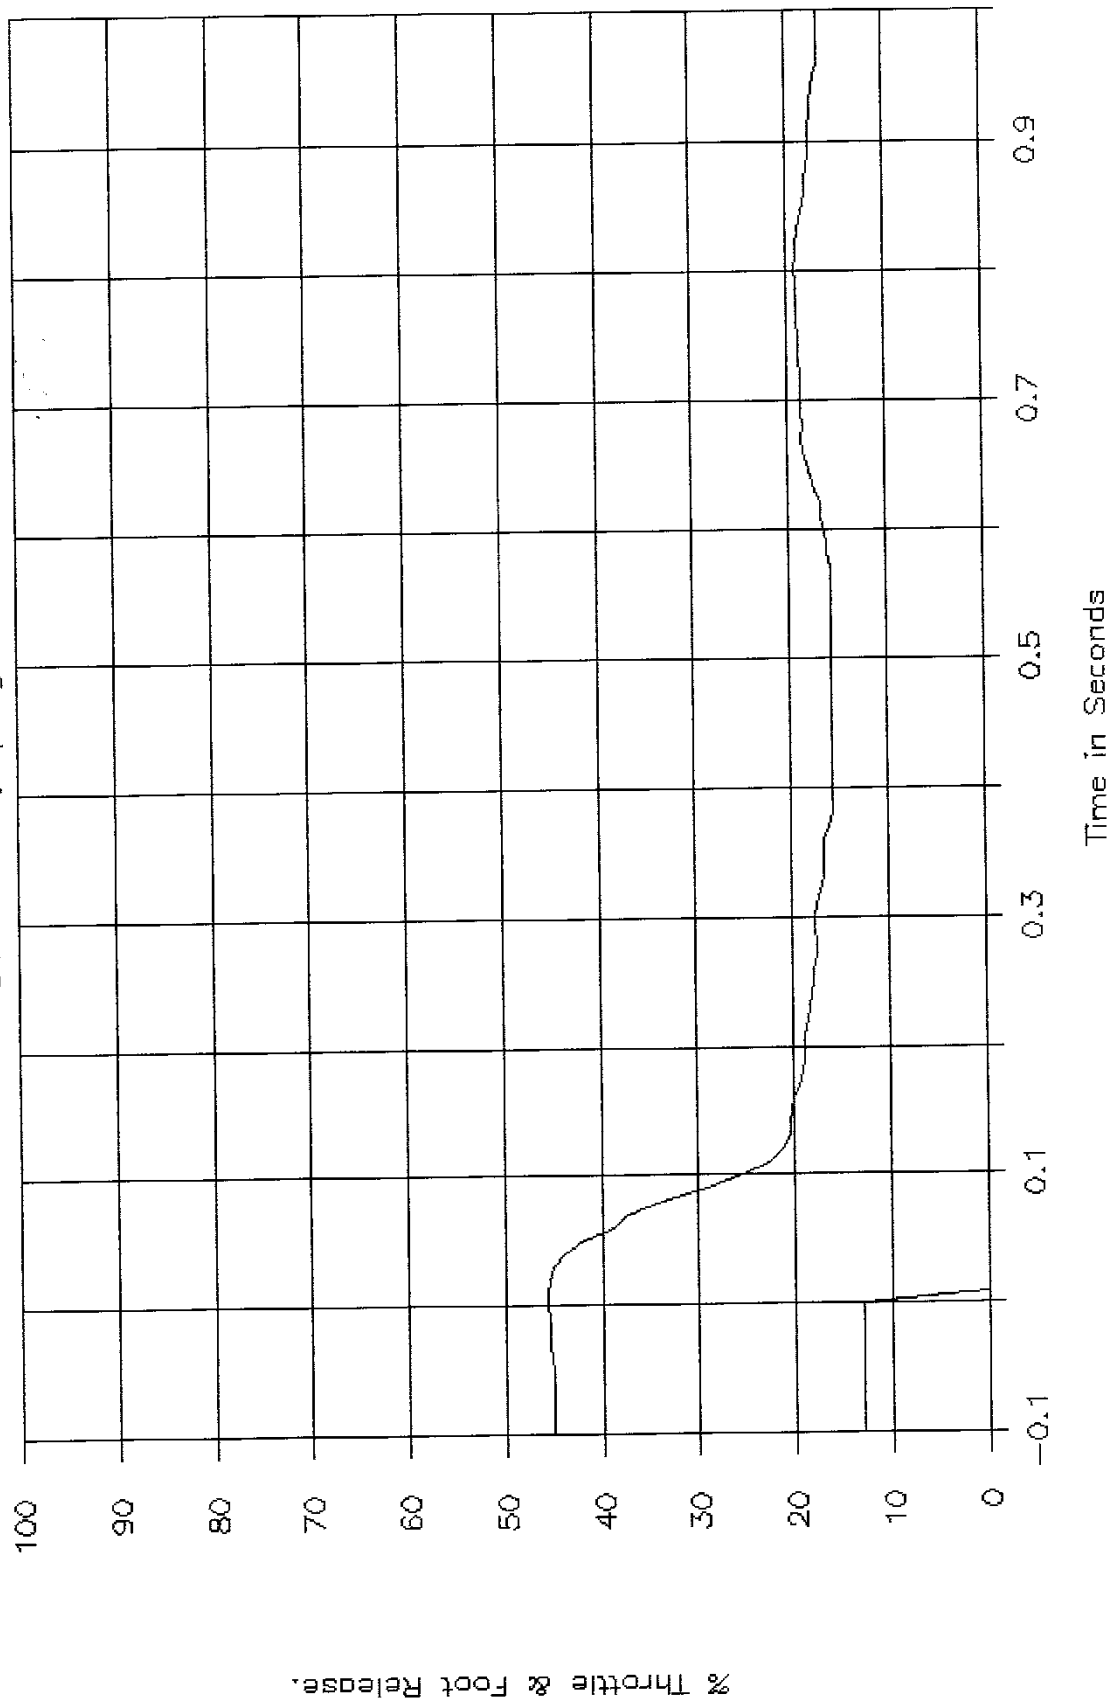
GTL 6459, NHTSA CA0514, FMVSS 124.

| GTL # | ACCELERATOR POSITION<br>% WIDE OPEN THROTTLE<br>(WOT) | THROTTLE POSITION<br>SENSOR<br>READING | RPM | TEMPERATURE (°C) | | THROTTLE POSITION<br>SENSOR<br>READING @<br>IDLE<br>(BASELINE) | RETURN<br>TIME TO<br>IDLE<br>(Msec) | PASS/<br>FAIL |
|---|---|--|---|---|---|--|---|---|
| 6459 | 50% | 46% | 600 | 200 | 63 | 16%-20% | 160 | P |

50% Throttle, Spring 2 Removed.

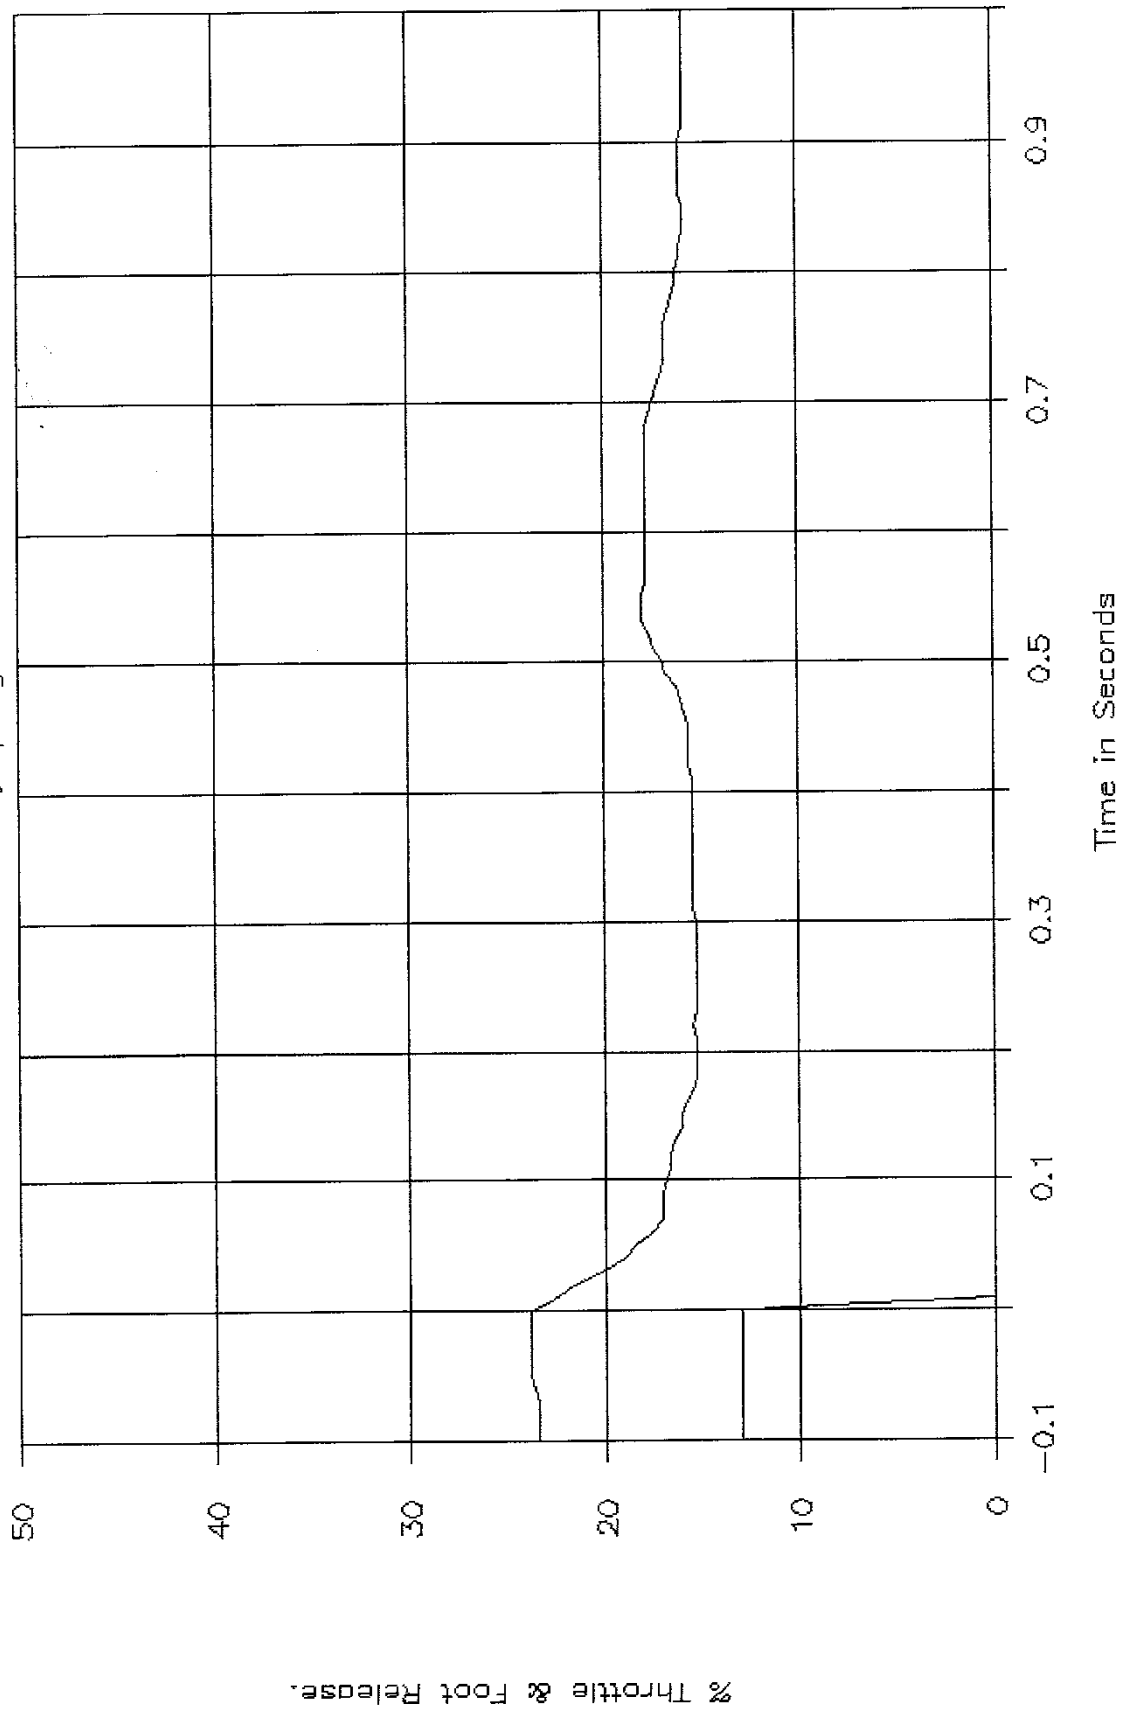
GTL 6460, NHTSA CA0514, FMVSS 124.

| GTL # | ACCELERATOR POSITION<br>% WIDE OPEN THROTTLE<br>(WOT) | THROTTLE POSITION<br>SENSOR<br>READING | RPM | TEMPERATURE (°C) | | THROTTLE POSITION<br>SENSOR<br>READING @<br>IDLE<br>(BASELINE) | RETURN<br>TIME TO<br>IDLE<br>(Msec) | PASS/<br>FAIL |
|---|---|--|---|---|---|--|---|---|
| 6460 | 25% | % | 600 | 201 | 63 | 16%-20% | 40 | P |

25% Throttle, Spring 2 Removed.

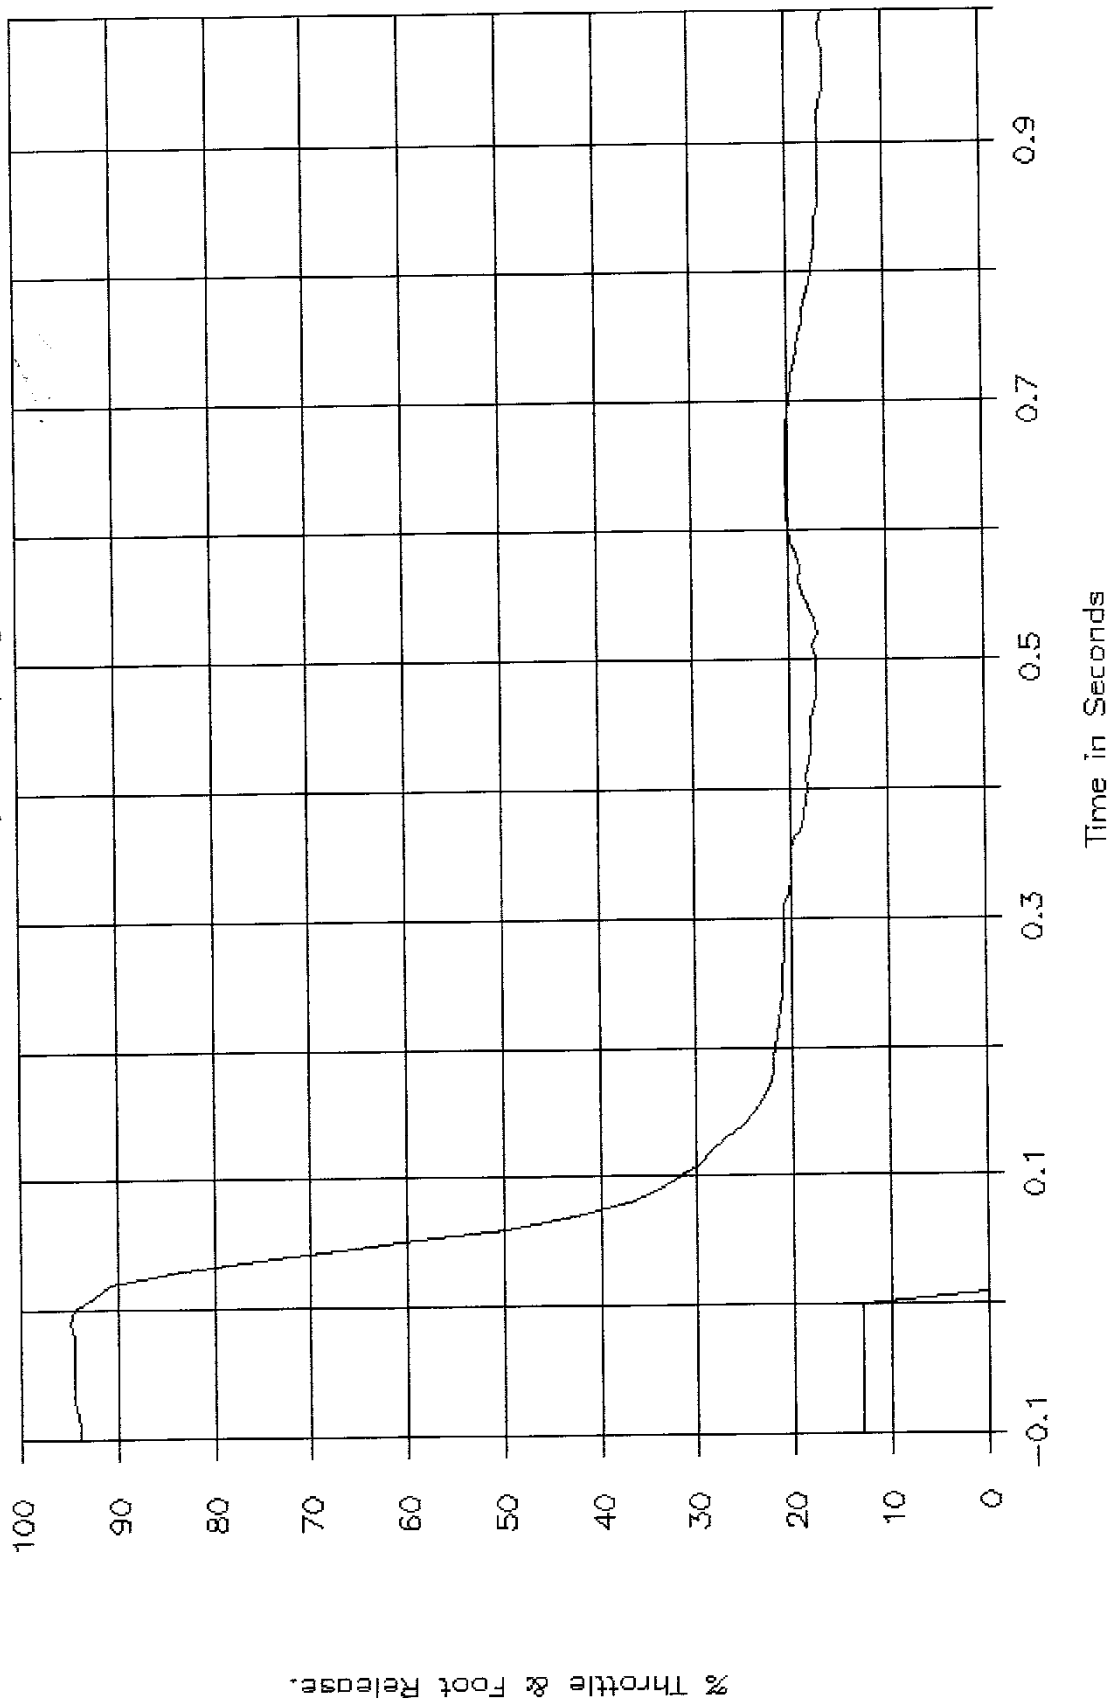
GTL 6485, NHTSA CA0514, FMVSS 124.

| GTL # | ACCELERATOR POSITION<br>% WIDE OPEN THROTTLE<br>(WOT) | THROTTLE POSITION<br>SENSOR READING | RPM | TEMPERATURE (°C) | | THROTTLE POSITION<br>SENSOR READING @<br>IDLE (BASELINE) | RETURN TIME TO<br>IDLE (Msec) | PASS/<br>FAIL |
|---|---|---|---|---|---|--|---|---|
| 6485 | 100% | 100% | 600 | 195 | 66 | 16%-20% | 330 | P |

100% Throttle, TPS Spring 3 Removed.

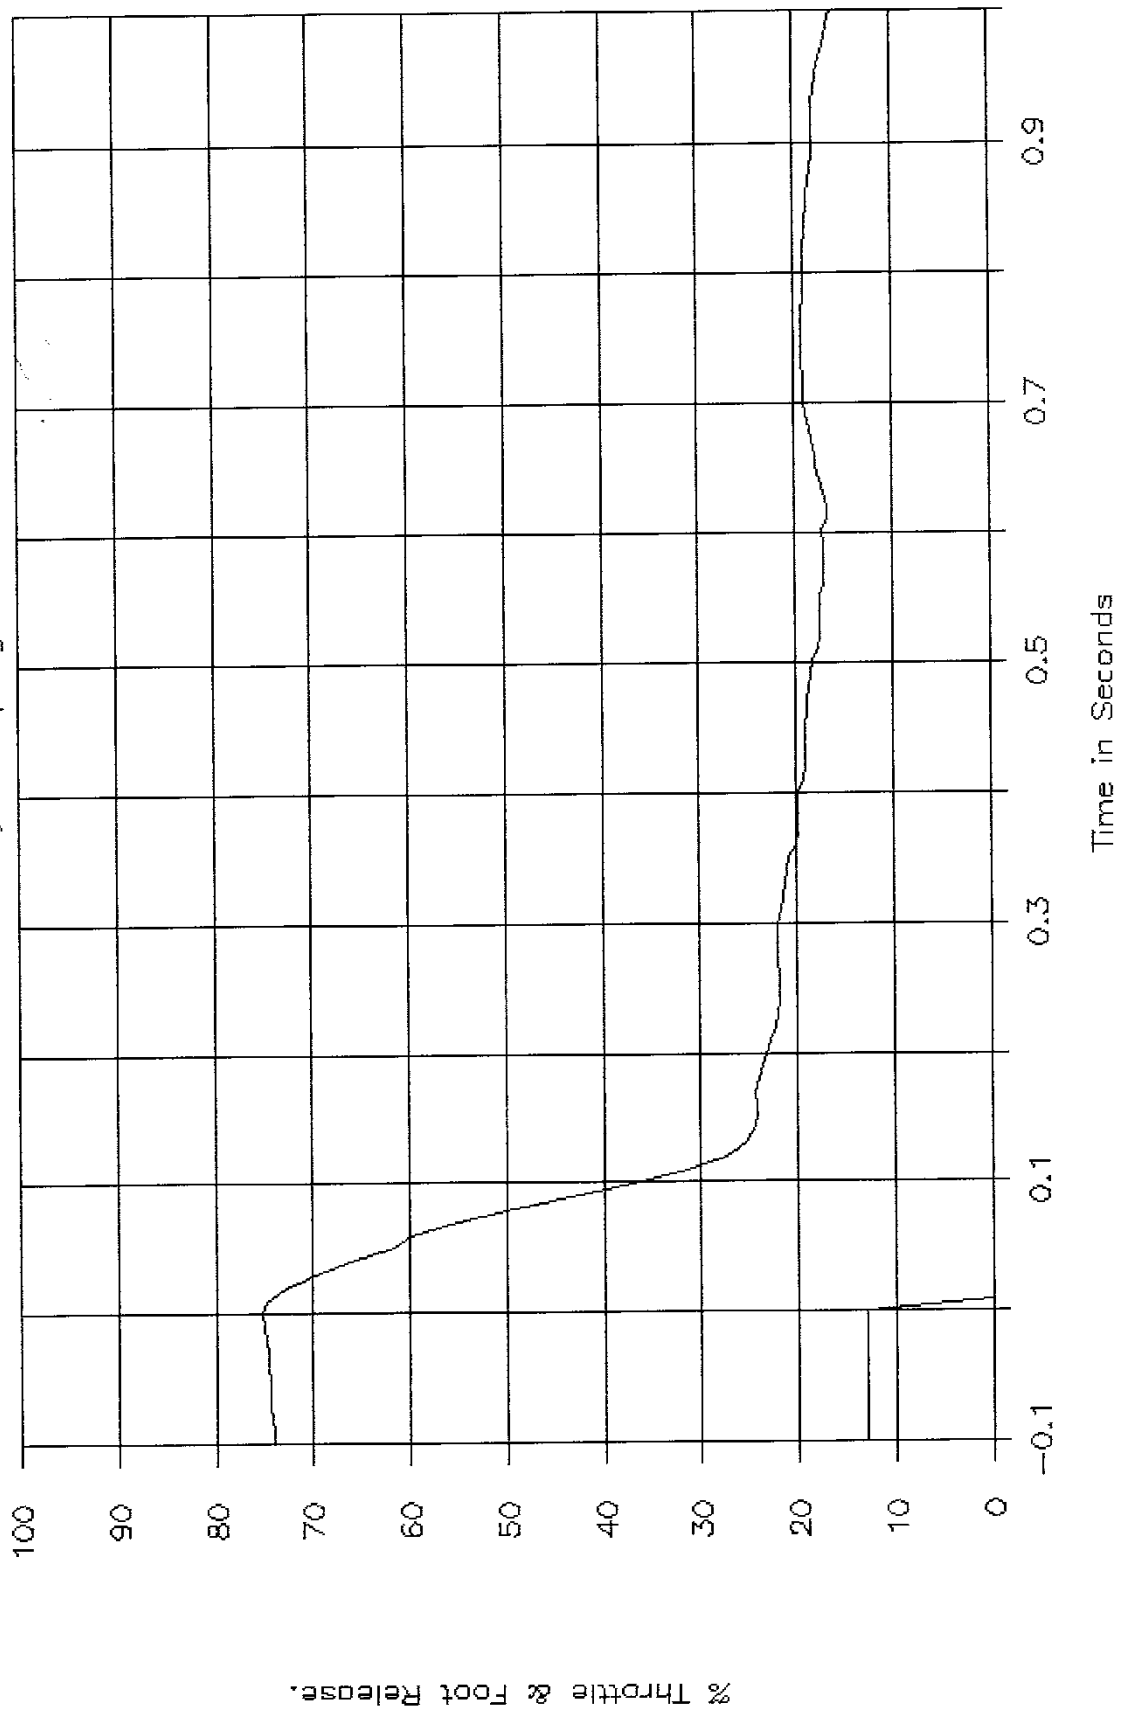
GTL 6486, NHTSA CA0514, FMVSS 124.

| GTL # | ACCELERATOR POSITION<br>% WIDE OPEN THROTTLE<br>(WOT) | THROTTLE POSITION<br>SENSOR READING | RPM | TEMPERATURE (°C) | | THROTTLE POSITION<br>SENSOR READING @<br>IDLE (BASELINE) | RETURN TIME TO<br>IDLE (Msec) | PASS/<br>FAIL |
|---|---|---|---|---|---|--|---|---|
| 6486 | 75% | 75% | 600 | 198 | 66 | 16%-20% | 360 | P |

75% Throttle, TPS Spring 3 Removed.

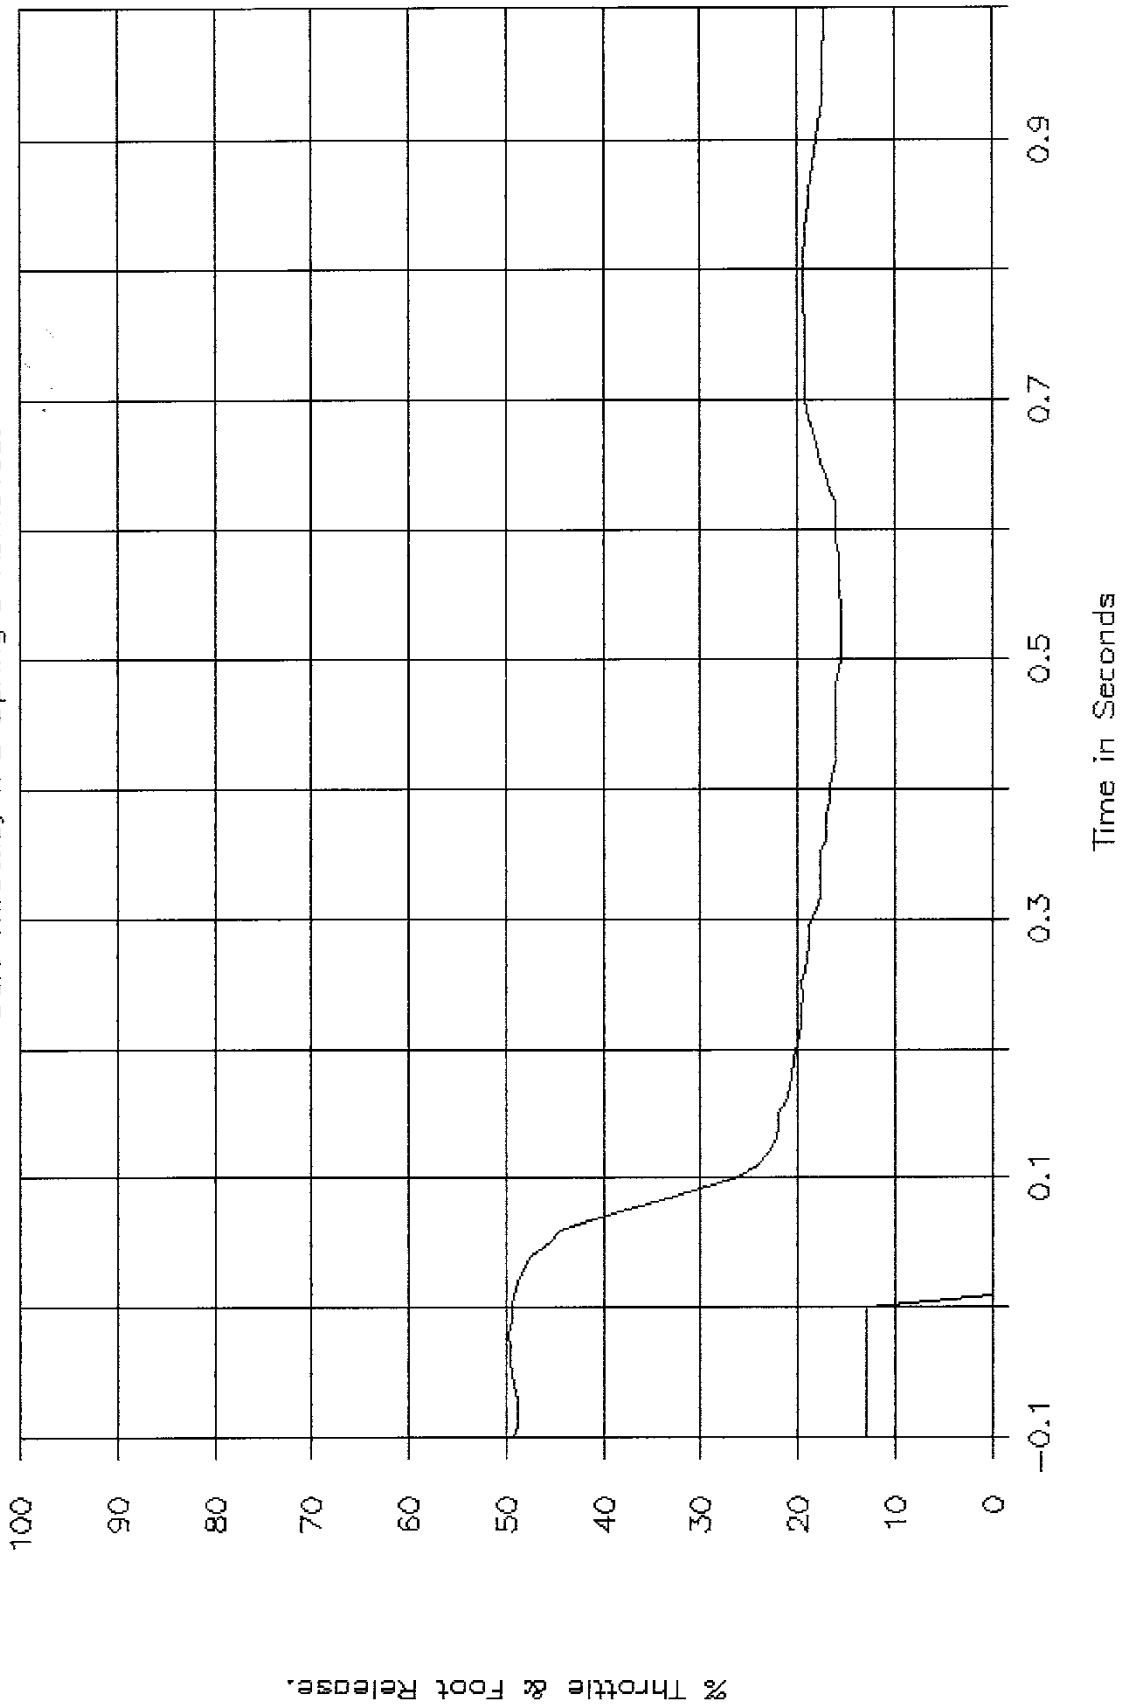
GTL 6487, NHTSA CA0514, FMVSS 124.

| GTL # | ACCELERATOR POSITION<br>% WIDE OPEN THROTTLE<br>(WOT) | THROTTLE POSITION<br>SENSOR READING | RPM | TEMPERATURE (°C) | | THROTTLE POSITION<br>SENSOR READING @<br>IDLE (BASELINE) | RETURN TIME TO<br>IDLE (Msec) | PASS/<br>FAIL |
|---|---|---|---|---|---|--|---|---|
| 6487 | 50% | 49% | 600 | 200 | 66 | 16%-20% | 210 | P |

50% Throttle, TPS Spring 3 Removed.

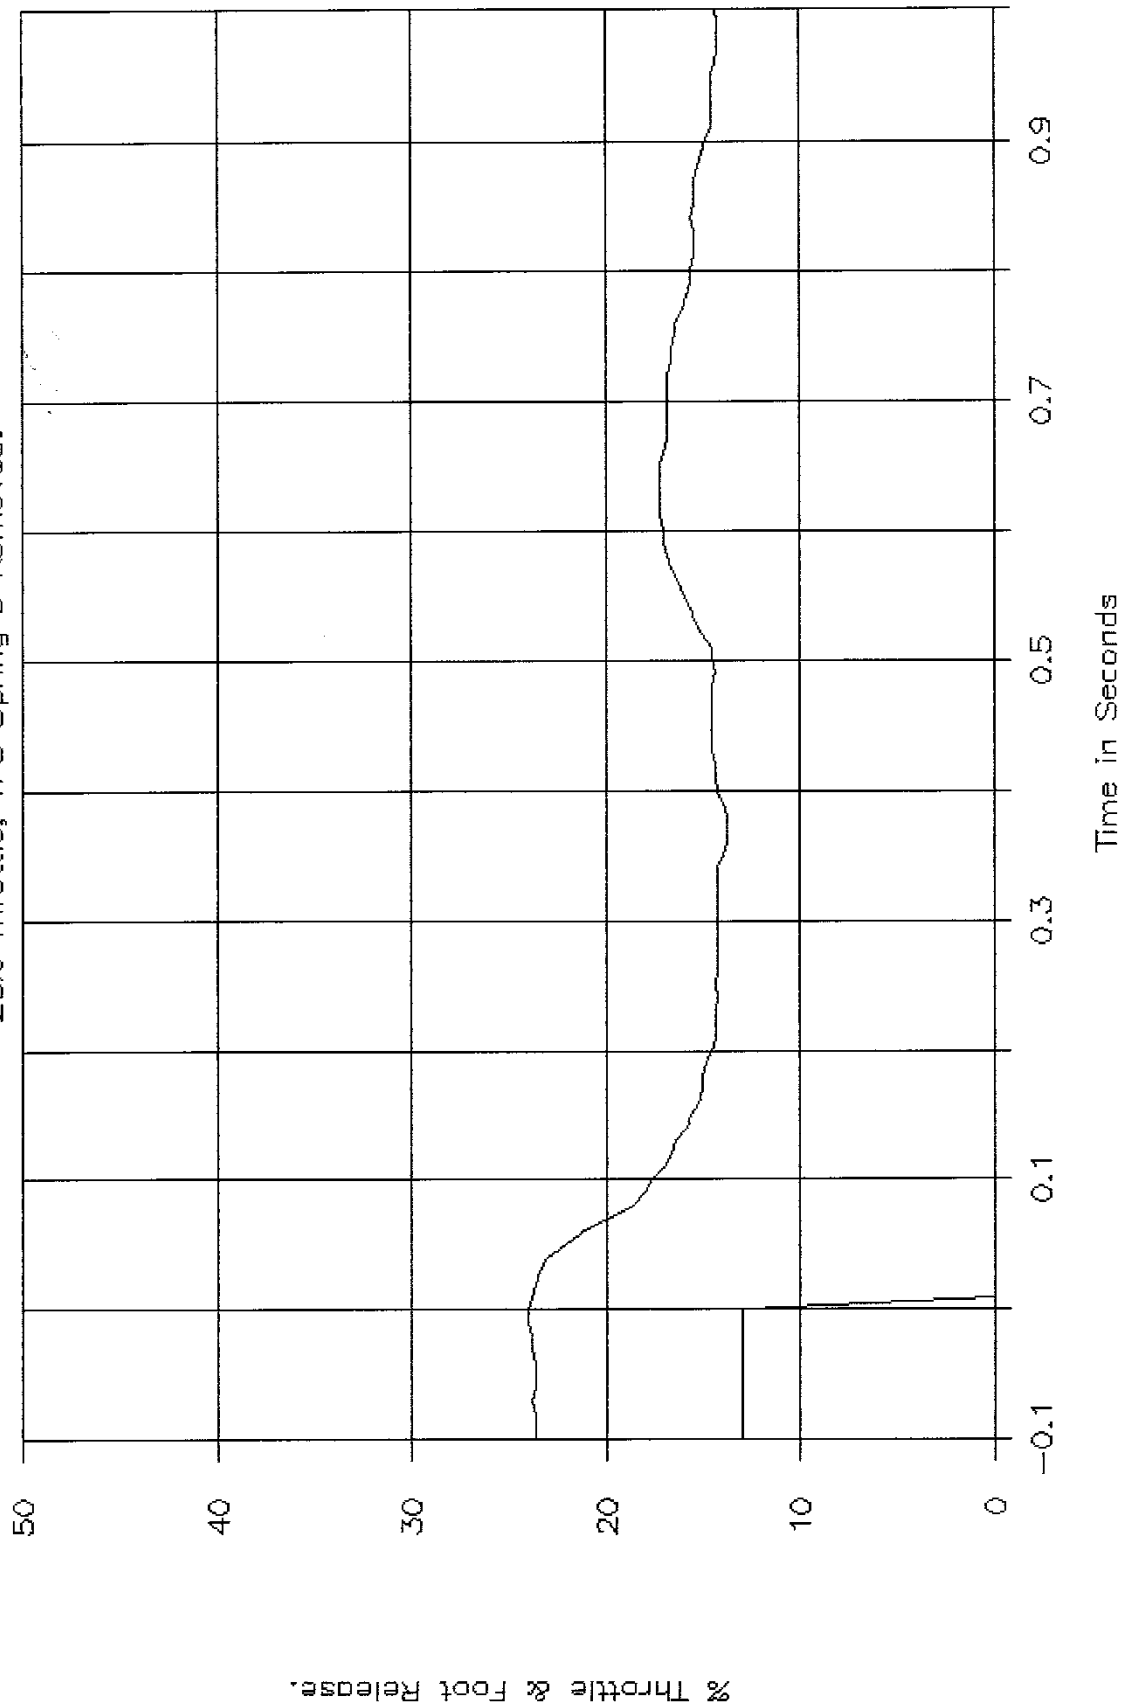
GTL 6488, NHTSA CA0514, FMVSS 124.

| GTL # | ACCELERATOR POSITION<br>% WIDE OPEN THROTTLE<br>(WOT) | THROTTLE POSITION<br>SENSOR READING | RPM | TEMPERATURE (°C) | | THROTTLE POSITION<br>SENSOR READING @<br>IDLE (BASELINE) | RETURN TIME TO<br>IDLE (Msec) | PASS/<br>FAIL |
|---|---|---|---|---|---|--|---|---|
| 6488 | 25% | 24% | 600 | 198 | 66 | 16%-20% | 70 | P |

25% Throttle, TPS Spring 3 Removed.

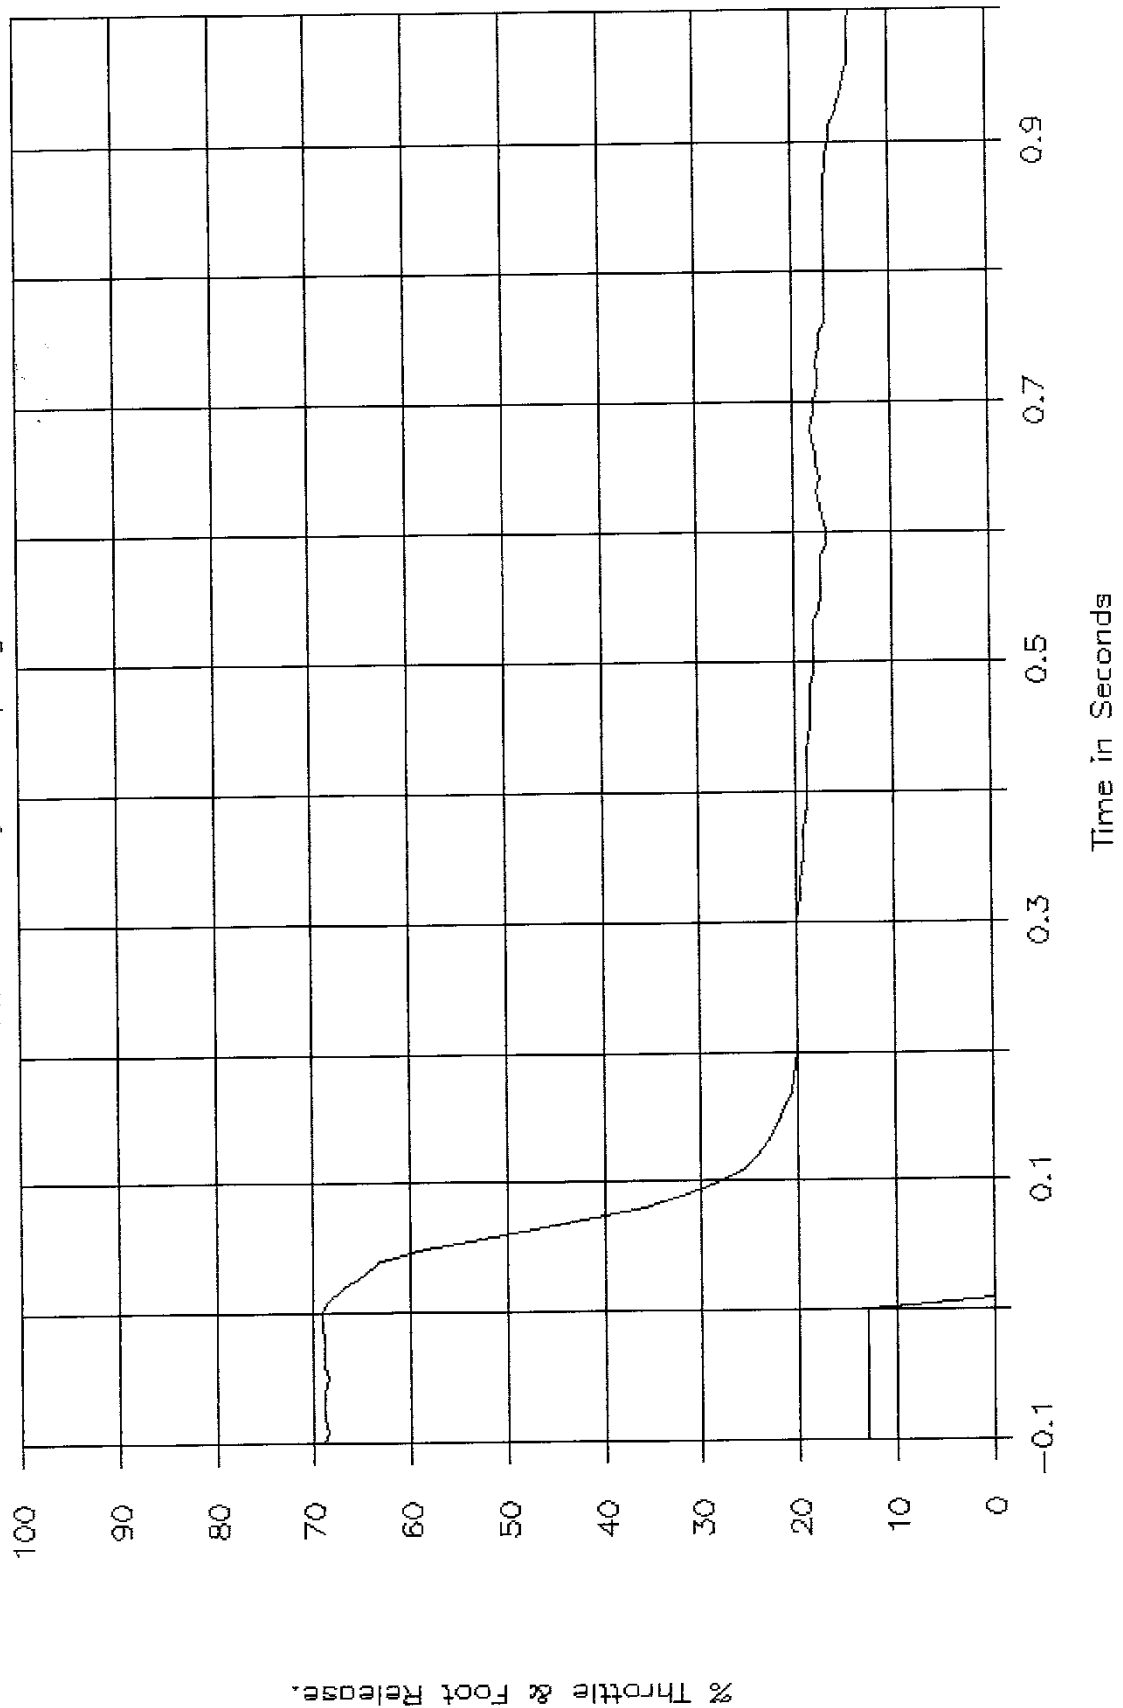
GTL 6490, NHTSA CA0514, FMVSS 124.

| GTL # | ACCELERATOR POSITION<br>% WIDE OPEN THROTTLE<br>(WOT) | THROTTLE POSITION<br>SENSOR<br>READING | RPM | TEMPERATURE (°C) | | THROTTLE POSITION<br>SENSOR<br>READING @<br>IDLE<br>(BASELINE) | RETURN<br>TIME TO<br>IDLE<br>(Msec) | PASS/<br>FAIL |
|---|---|--|---|---|---|--|---|---|
| 6490 | 75% | 69% | 600 | 198 | 66 | 16%-20% | 200 | P |

75% Throttle, TPS Spring 4 Removed.
