REPORT NUMBER 124-GTL-10-003

# SAFETY COMPLIANCE TESTING FOR FMVSS 124 ACCELERATOR CONTROL SYSTEMS

DAIMLER AG STUTTGART  
2010 MERCEDES GLK 350, MPV  
NHTSA NO. CA0514

**FINAL REPORT**

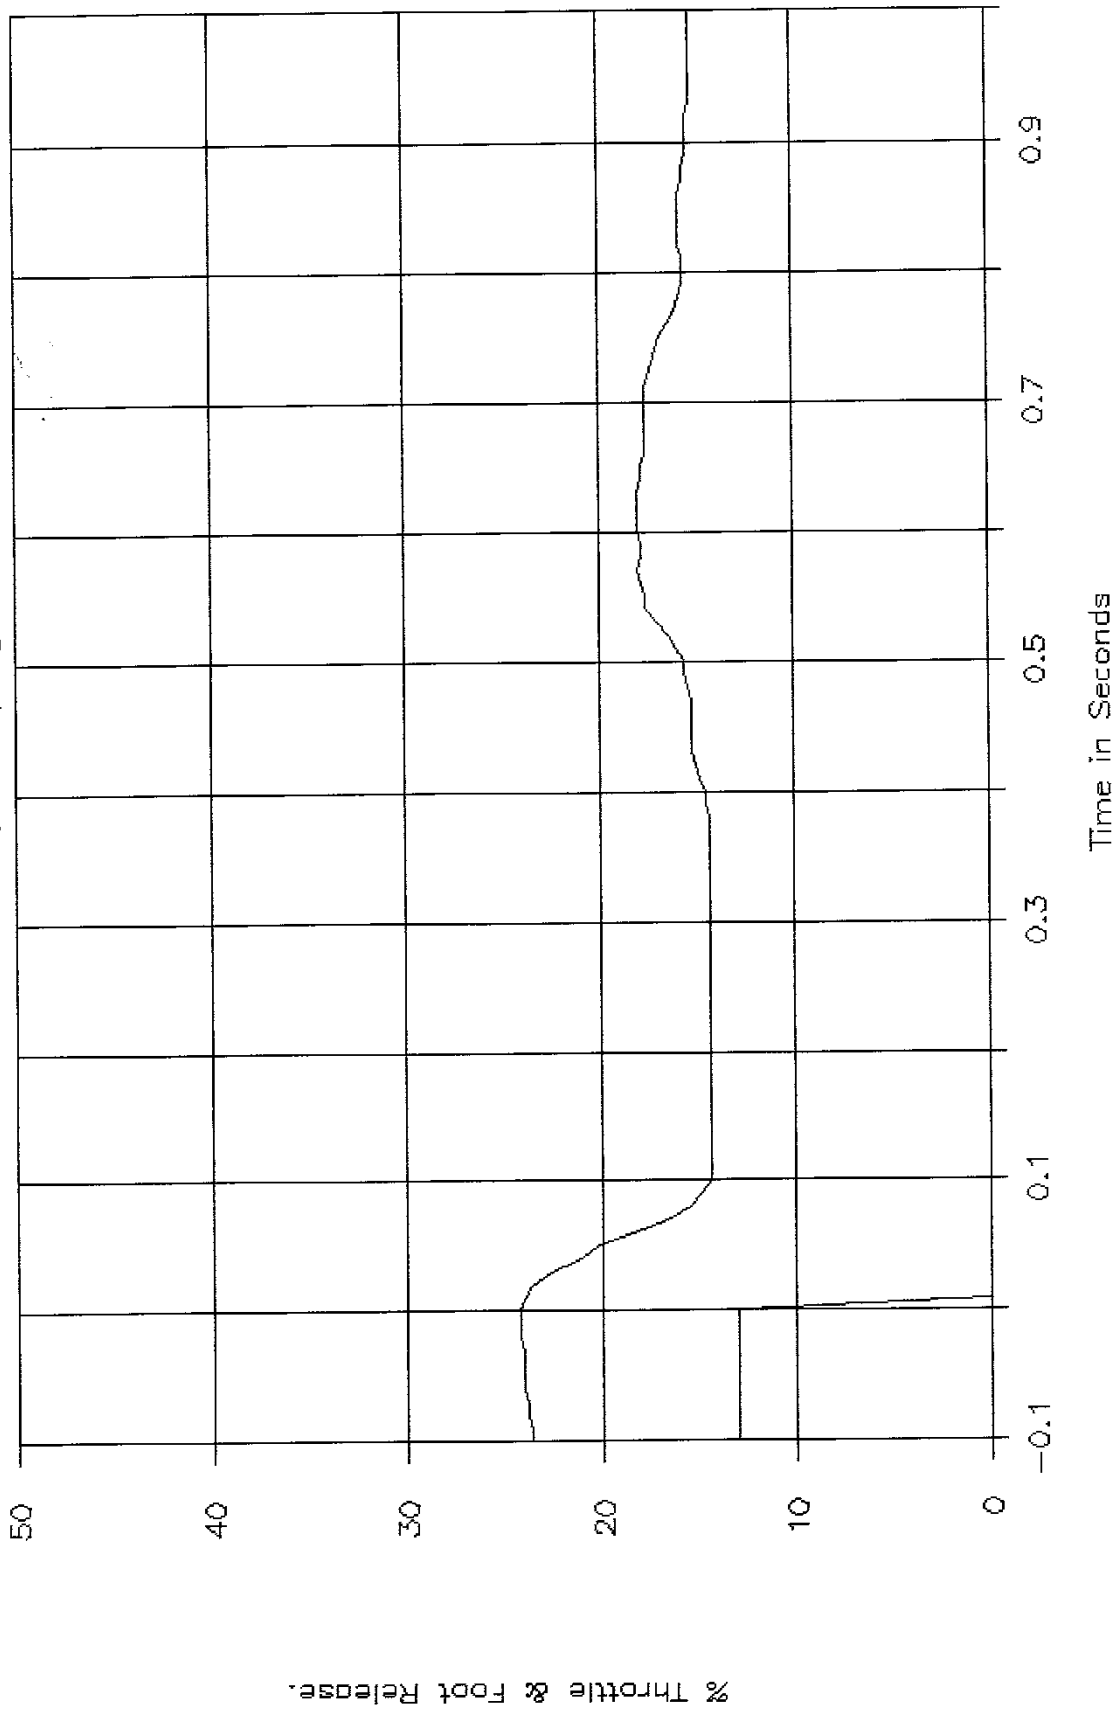
GTL 6492, NHTSA CA0514, FMVSS 124.

| GTL # | ACCELERATOR POSITION<br>% WIDE OPEN THROTTLE<br>(WOT) | THROTTLE POSITION<br>SENSOR<br>READING | RPM | TEMPERATURE (°C) | | THROTTLE POSITION<br>SENSOR<br>READING @<br>IDLE<br>(BASELINE) | RETURN<br>TIME TO<br>IDLE<br>(Msec) | PASS/<br>FAIL |
|---|---|--|---|---|---|--|---|---|
| 6492 | 25% | 24% | 600 | 200 | 66 | 16%-20% | 60 | P |

25% Throttle, TPS Spring 4 Removed.
