REPORT NUMBER: 217-MGA-2009-004

**SAFETY COMPLIANCE TESTING FOR
FMVSS NO. 217
SCHOOL BUS EMERGENCY EXITS AND WINDOW
RETENTION AND RELEASE**

**COLLINS BUS CORPORATION
2008 COLLINS GRAND BANTAM SCHOOL BUS
NHTSA NO.: C80900**

**PREPARED BY:
MGA RESEARCH CORPORATION
5000 WARREN ROAD
BURLINGTON, WI 53105**

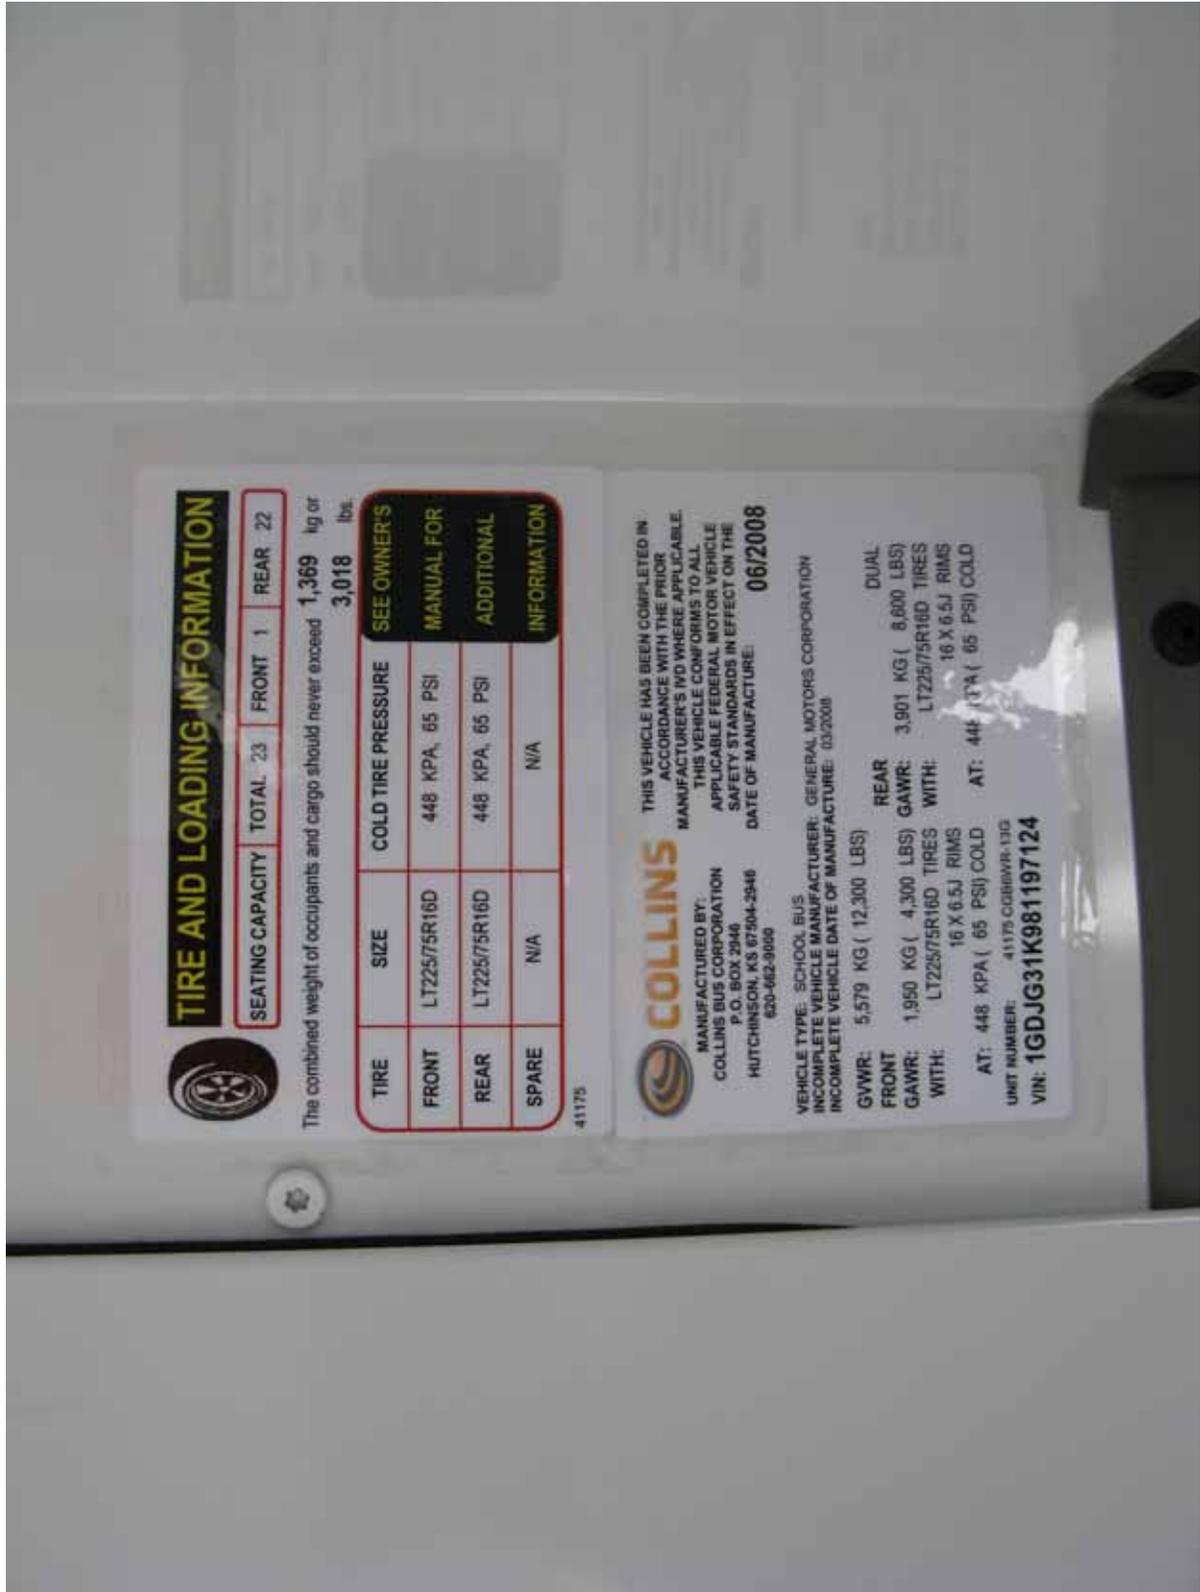
Certification Label and Tire Placard

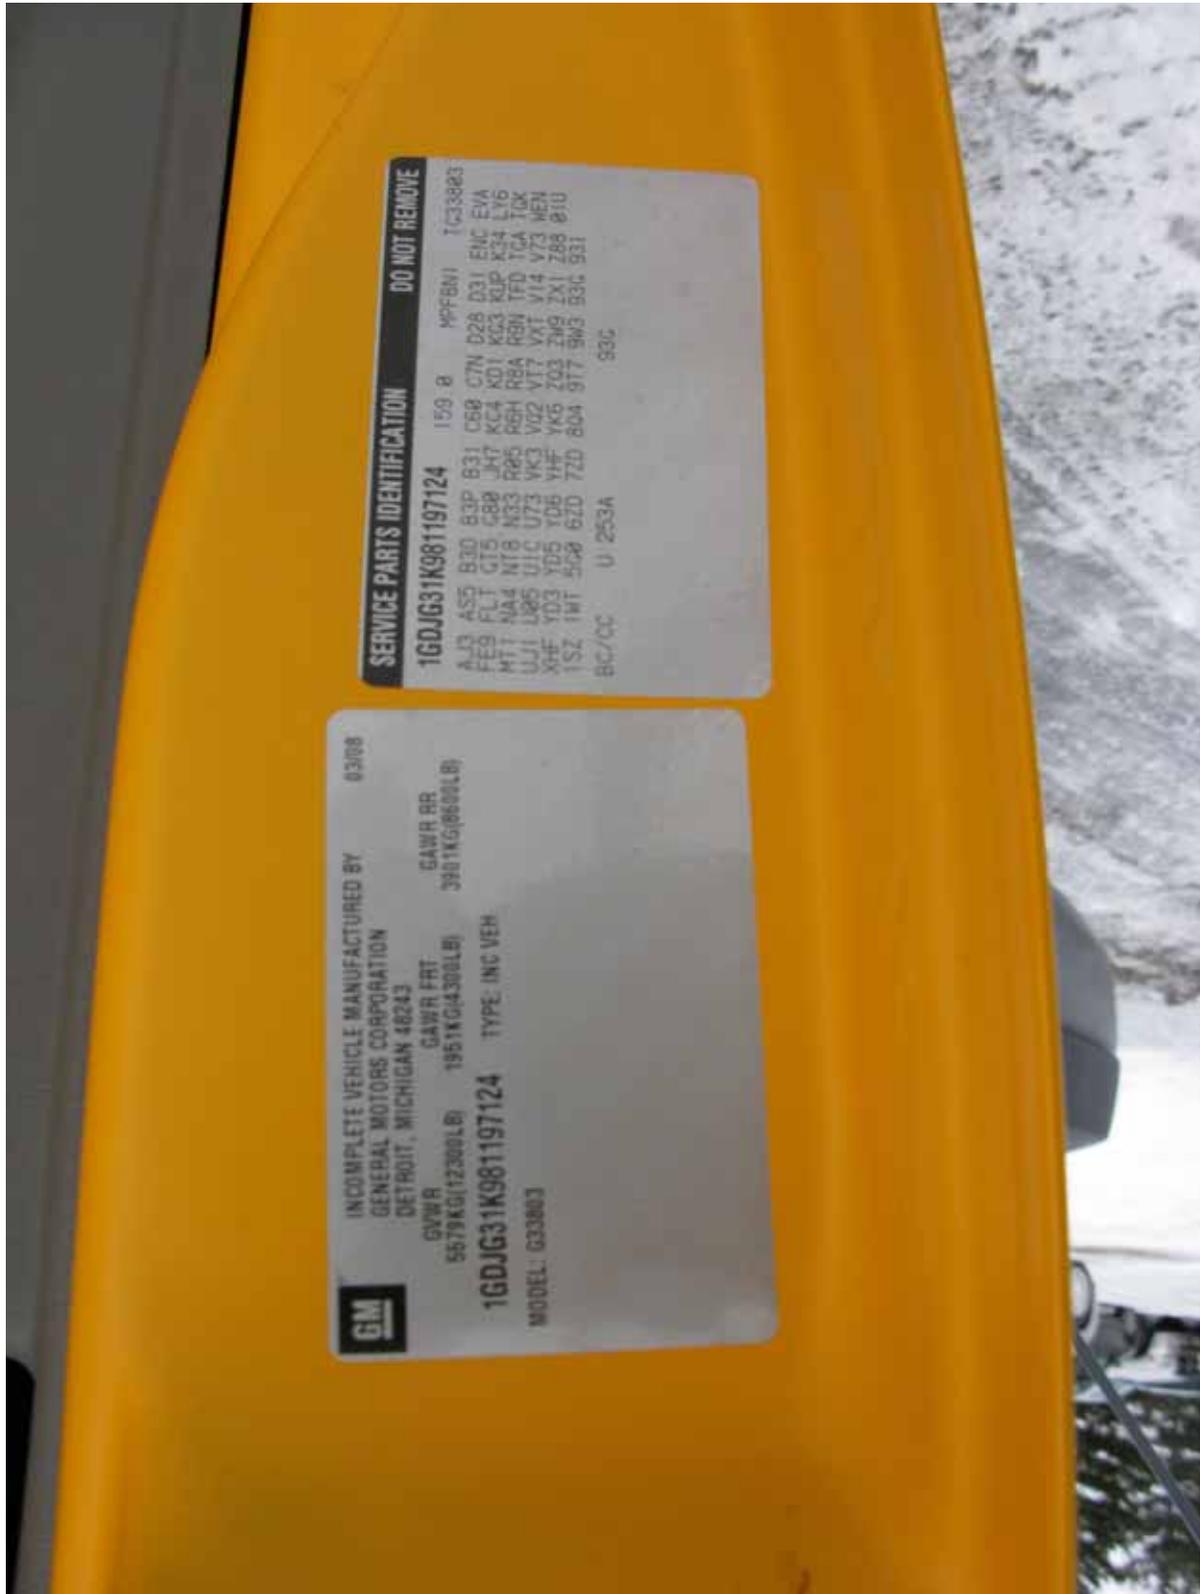
Vehicle Information Label

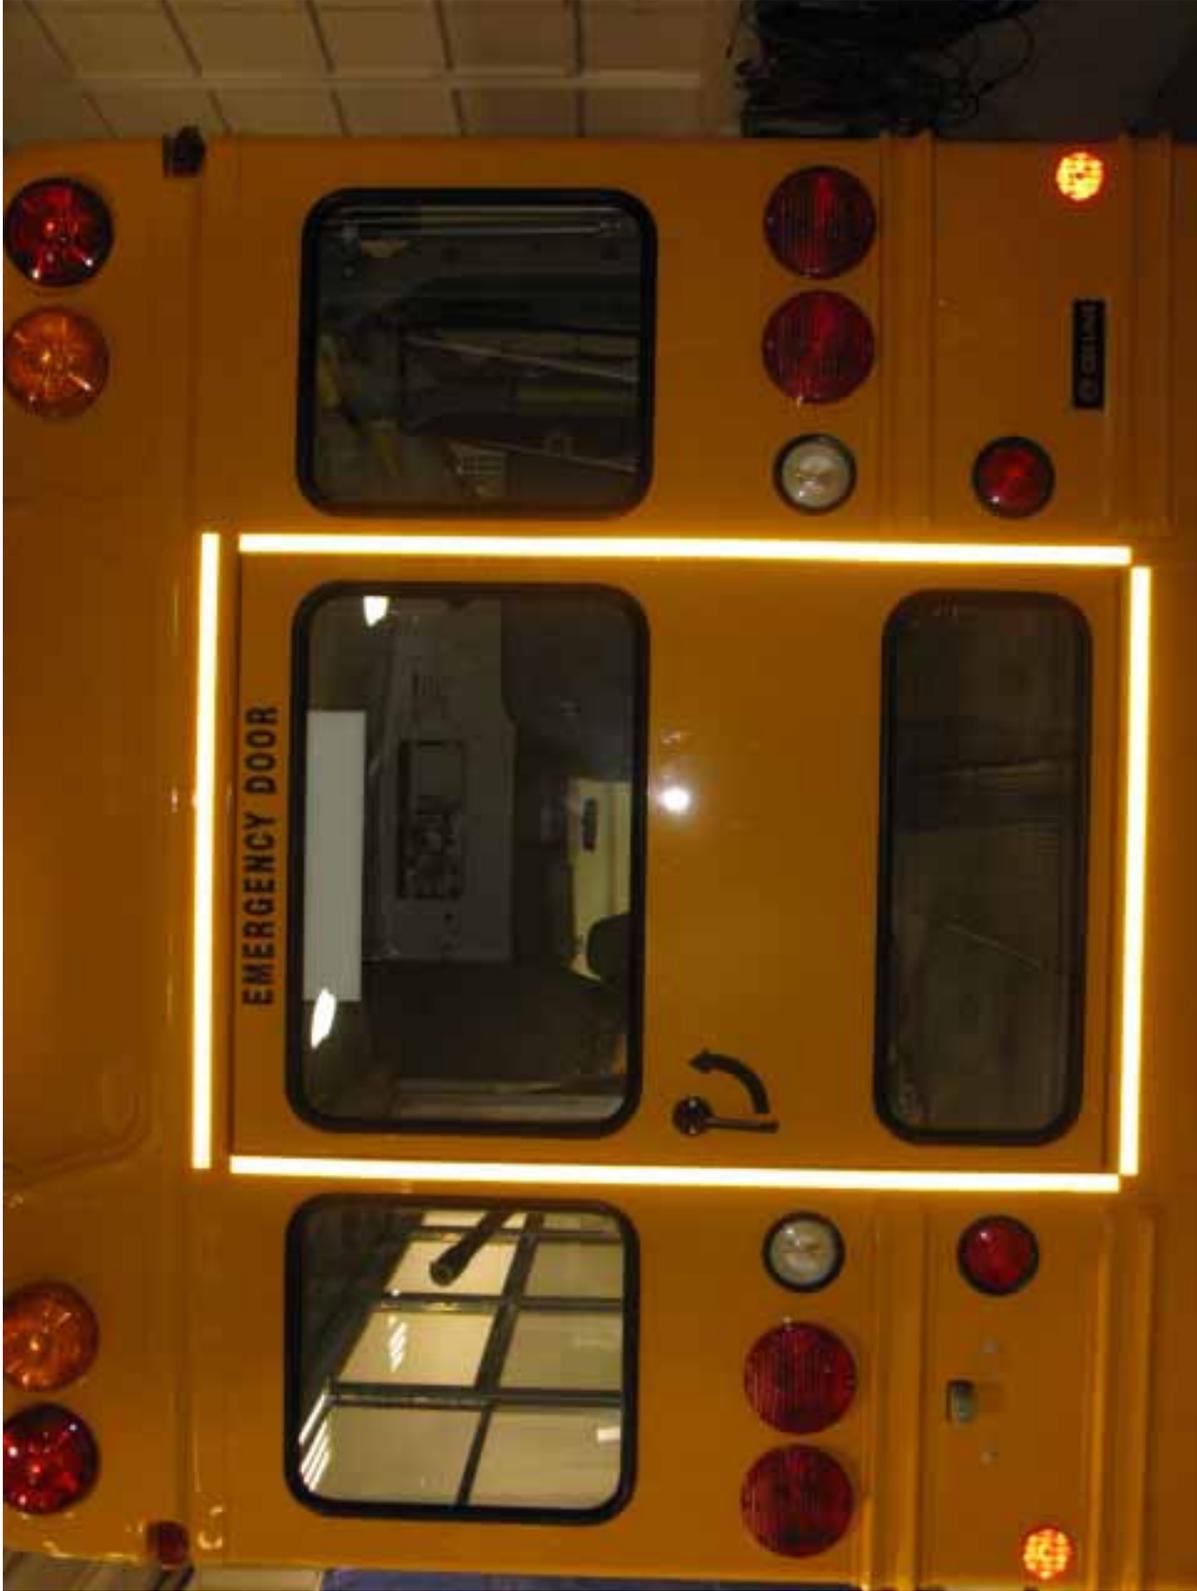
Exit Location	Rear Door
Exit Description	Emergency Door
Letter Height (cm)	5
Background Color	Yellow
Location Outside	Top of Door
Pass/Fail	Pass

Exit Location	Rear Door
Instructions	None
Letter Height (cm)	N/A
Letter Color	N/A
Background Color	Yellow
Distance From Release (cm)	2
Reflective Tape Color	Yellow
Reflective Tape Width (cm)	2.5
Pass/Fail	Pass

Exterior View of Rear Emergency Exit Door

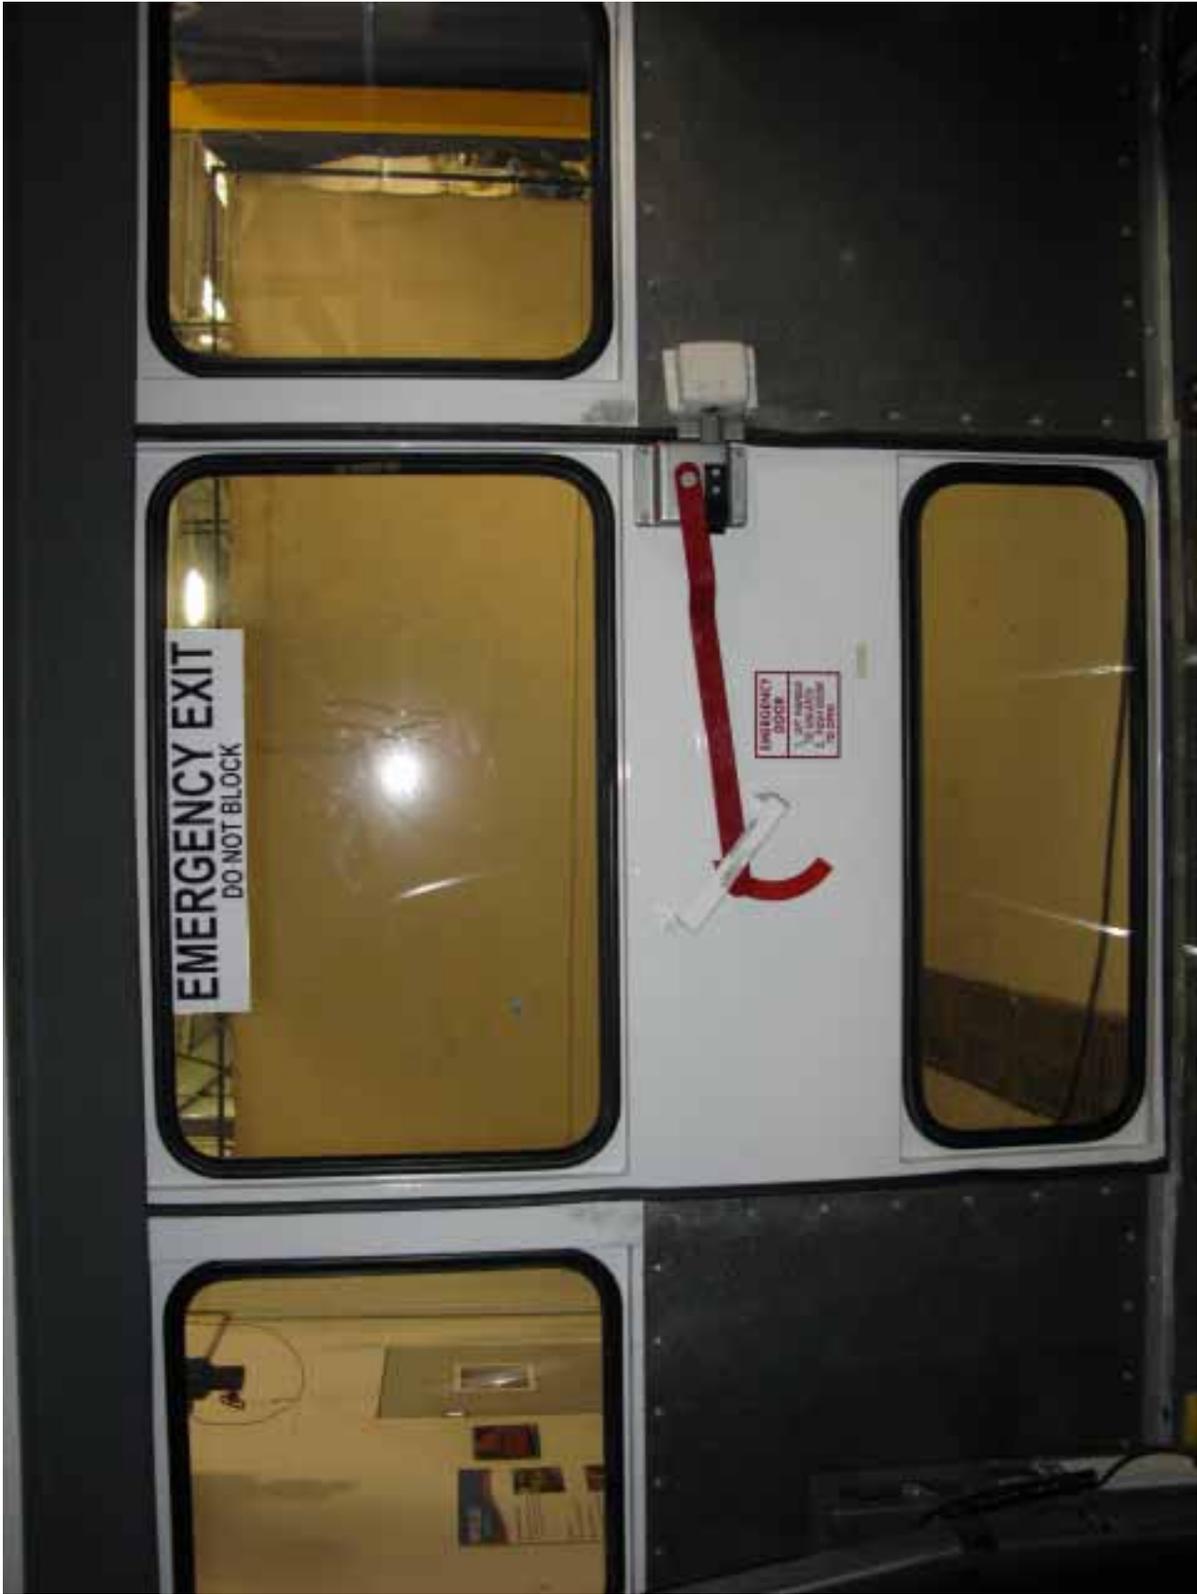
Exit Location	Rear Door
Exit Description	Emergency Door
Letter Height (cm)	5
Background Color	White
Location Inside	Top of Door Window
Pass/Fail	Pass

Interior View of Rear Emergency Exit Door

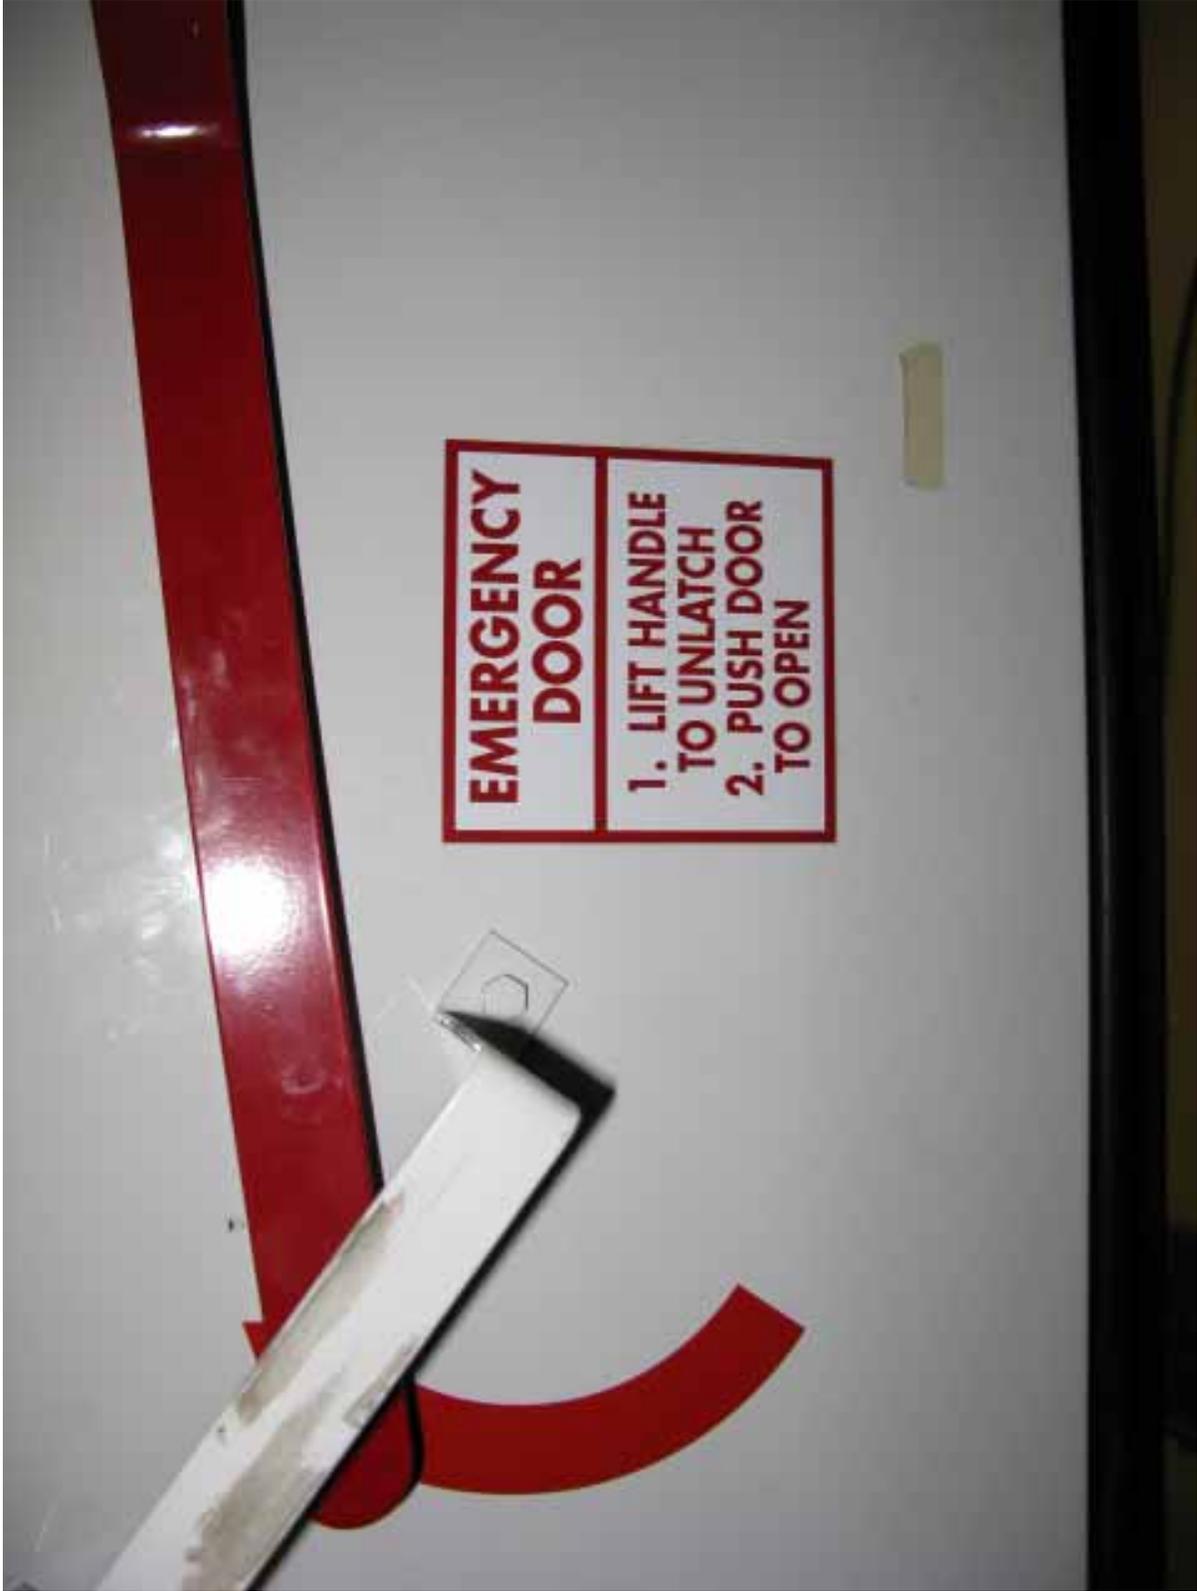
Exit Location	Rear Door
Instructions	1. Lift Handle to Unlatch. 2. Push Door to Open.
Letter Height (cm)	1.1
Letter Color	Red
Background Color	White
Distance From Release (cm)	5
Reflective Tape Color	N/A
Reflective Tape Width (cm)	N/A
Pass/Fail	Pass

Interior View of Rear Emergency Exit Door Instructions

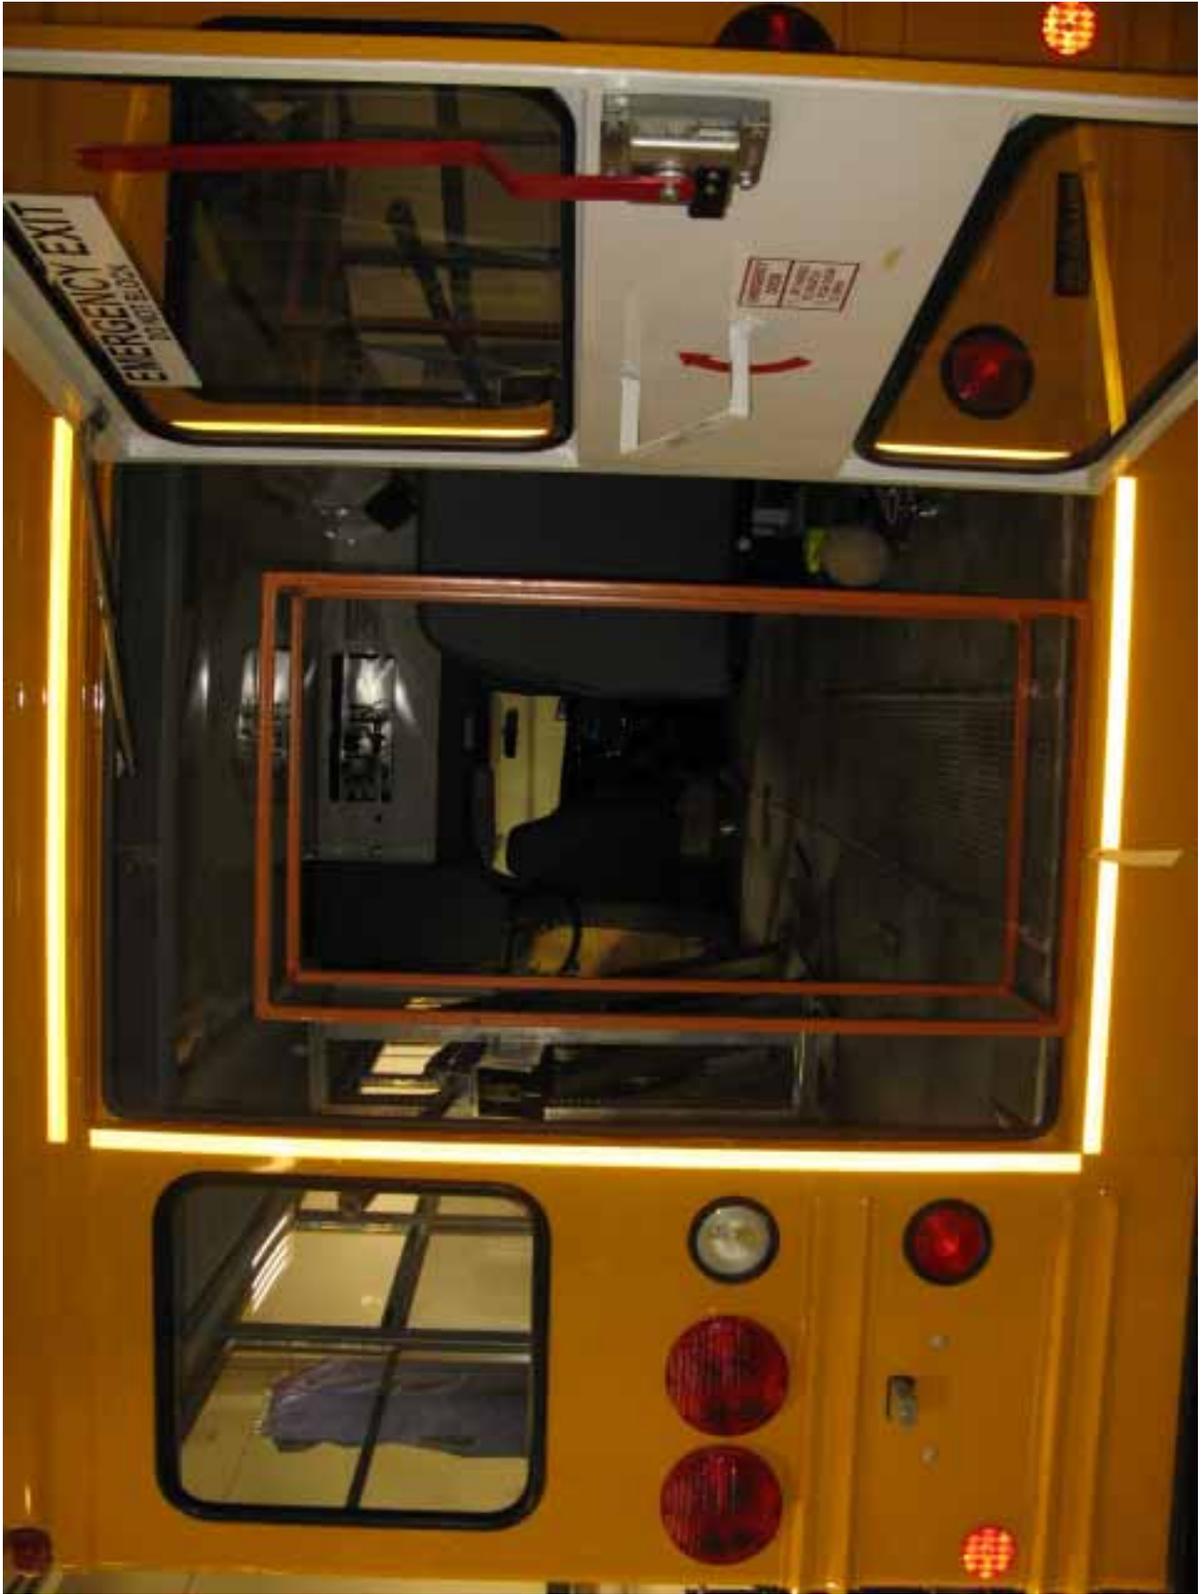
Exit Location	Exit Description	High/Low Force Area	Maximum Force Requirement Newtons	Actual Force Measured (N)	Motion(s) required to Open Exit	Actual Motion(s) to Open Exit	Passage of Ellipsoid or Parallelepiped	Pass/Fail
Rear Door	Exit Door	High	178	1. 13.0	Push Door to Open	Push to Open	114x61x30 Parallelepiped	Pass
				2. 10.8				
				3. 14.9				
				Average: 12.9

Rear Emergency Exit Door Parallelepiped Clearance

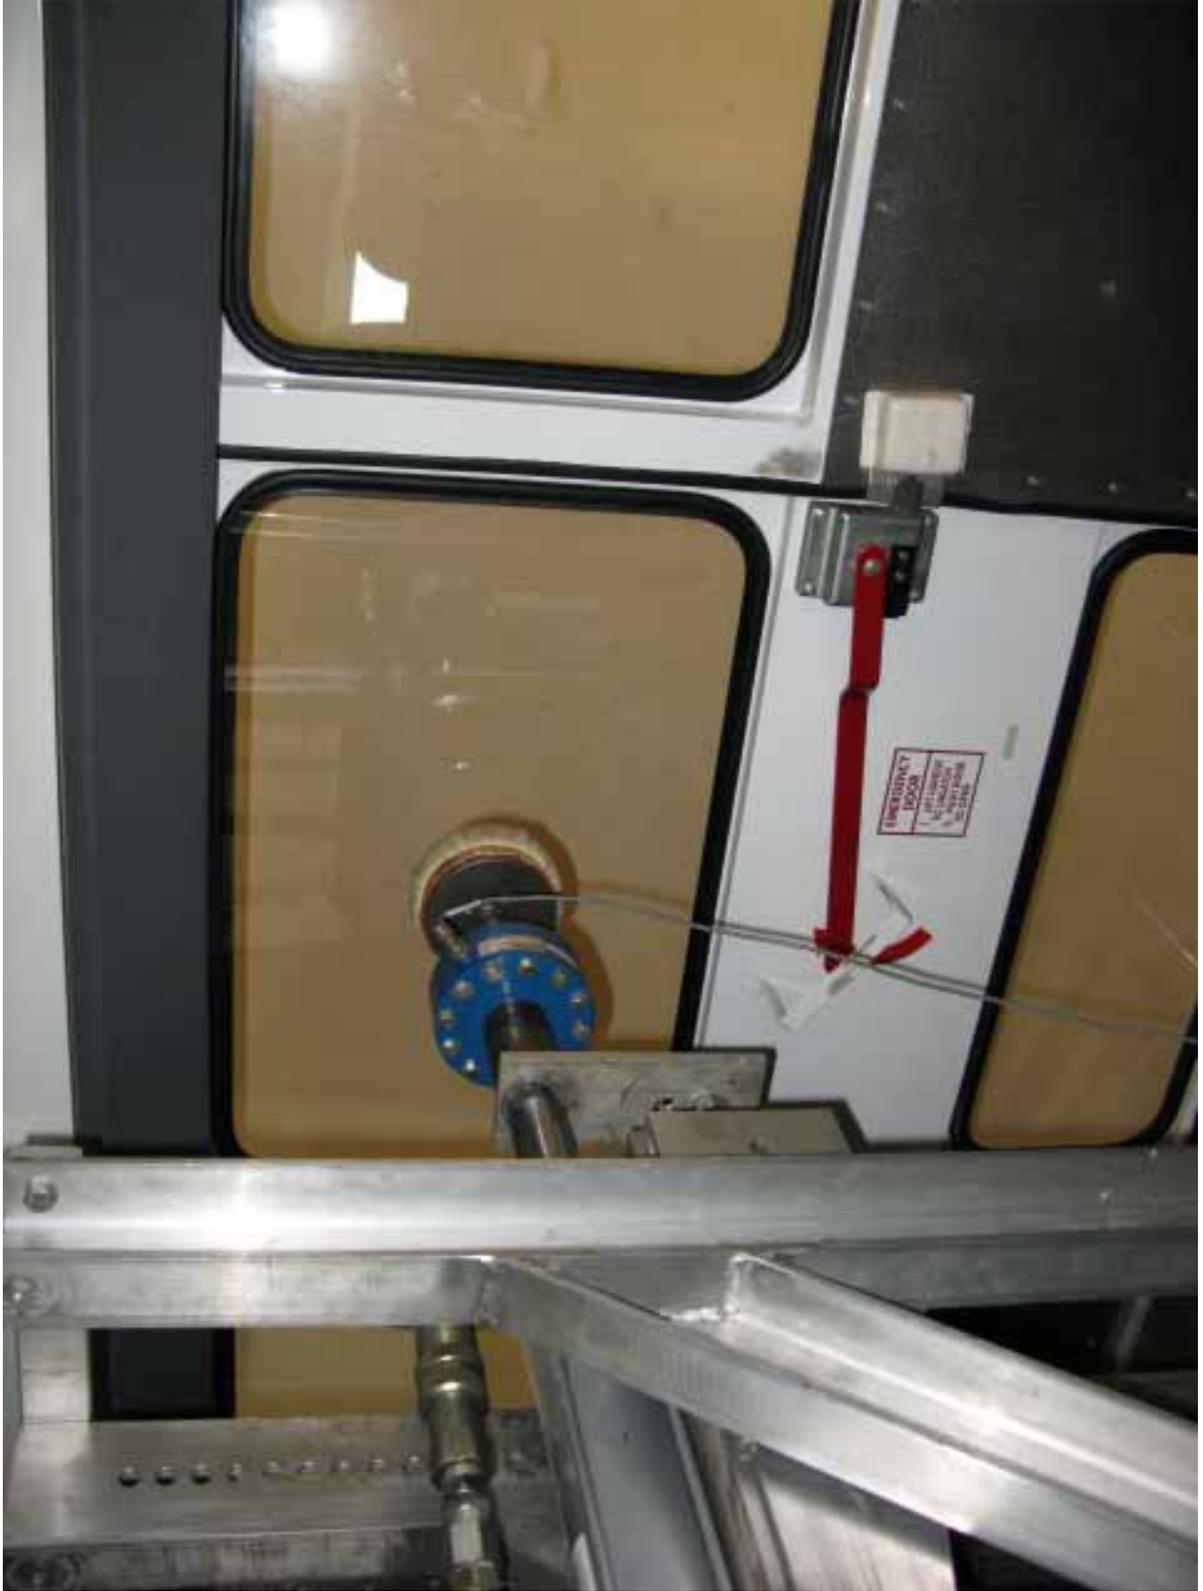
Loading Fixture

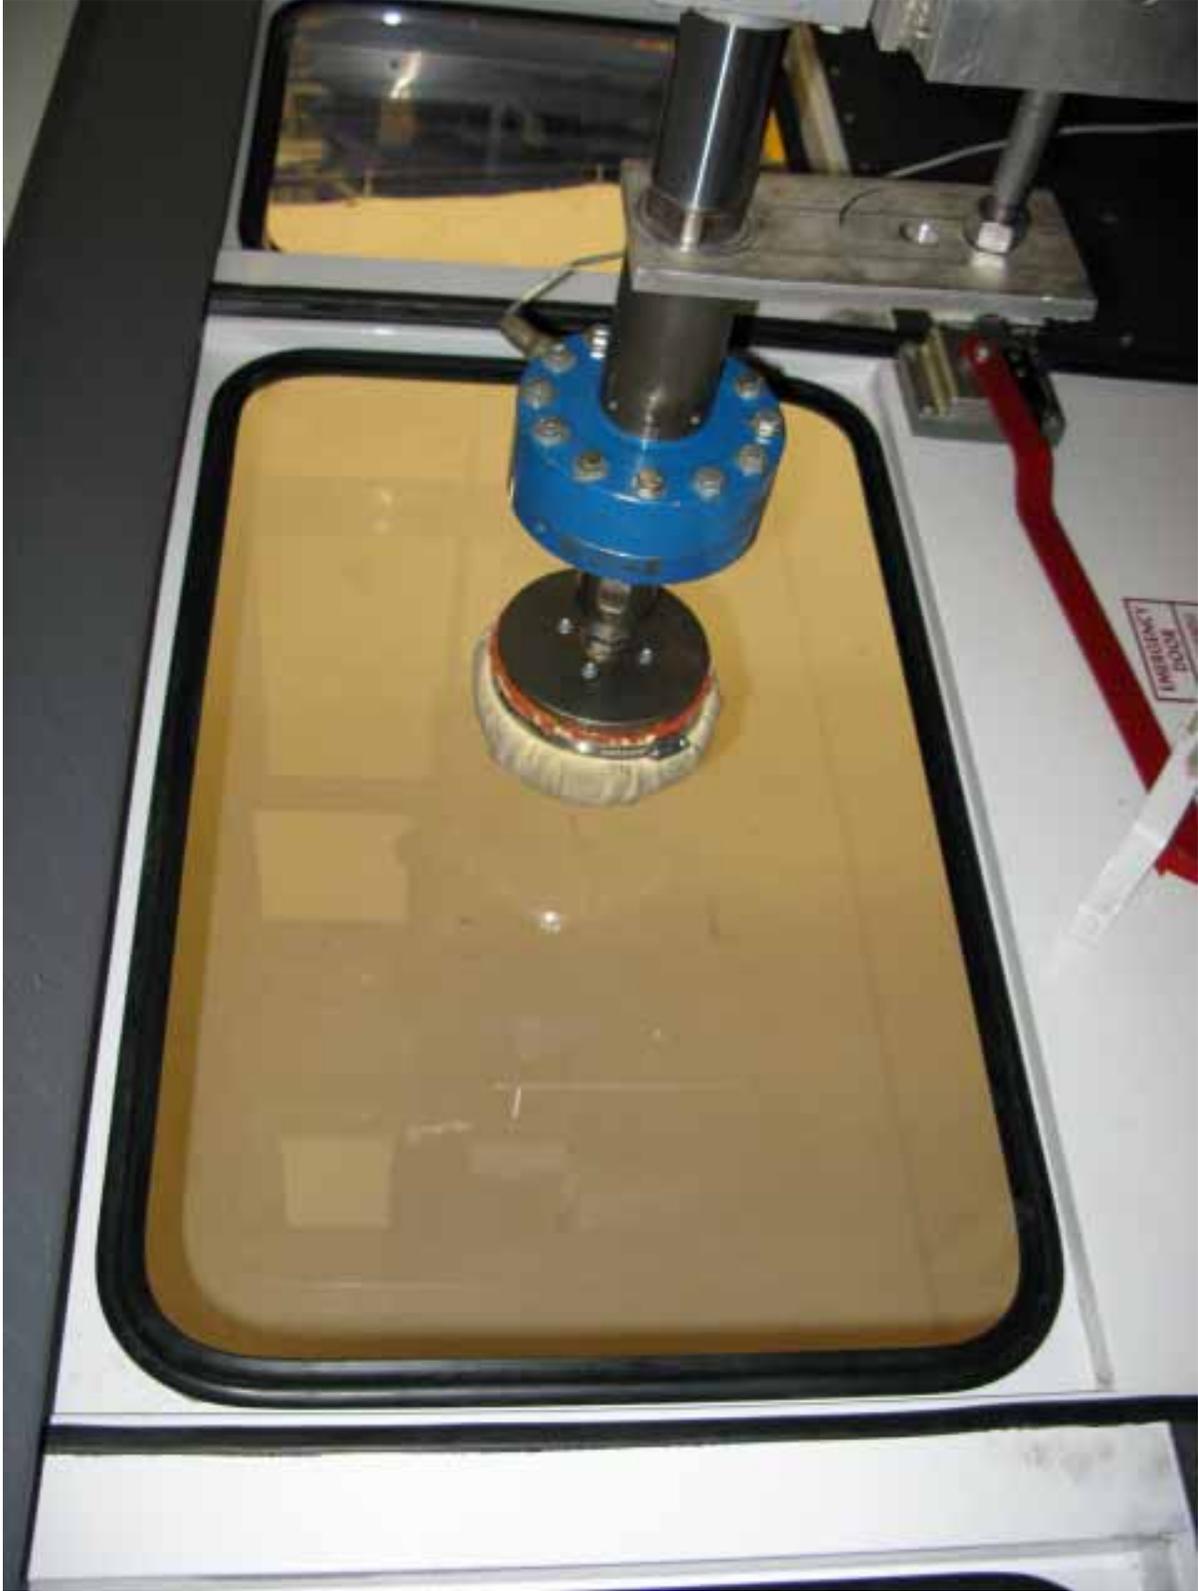
Retention Test of Rear Exit Door, Upper Window (Pre-Test)

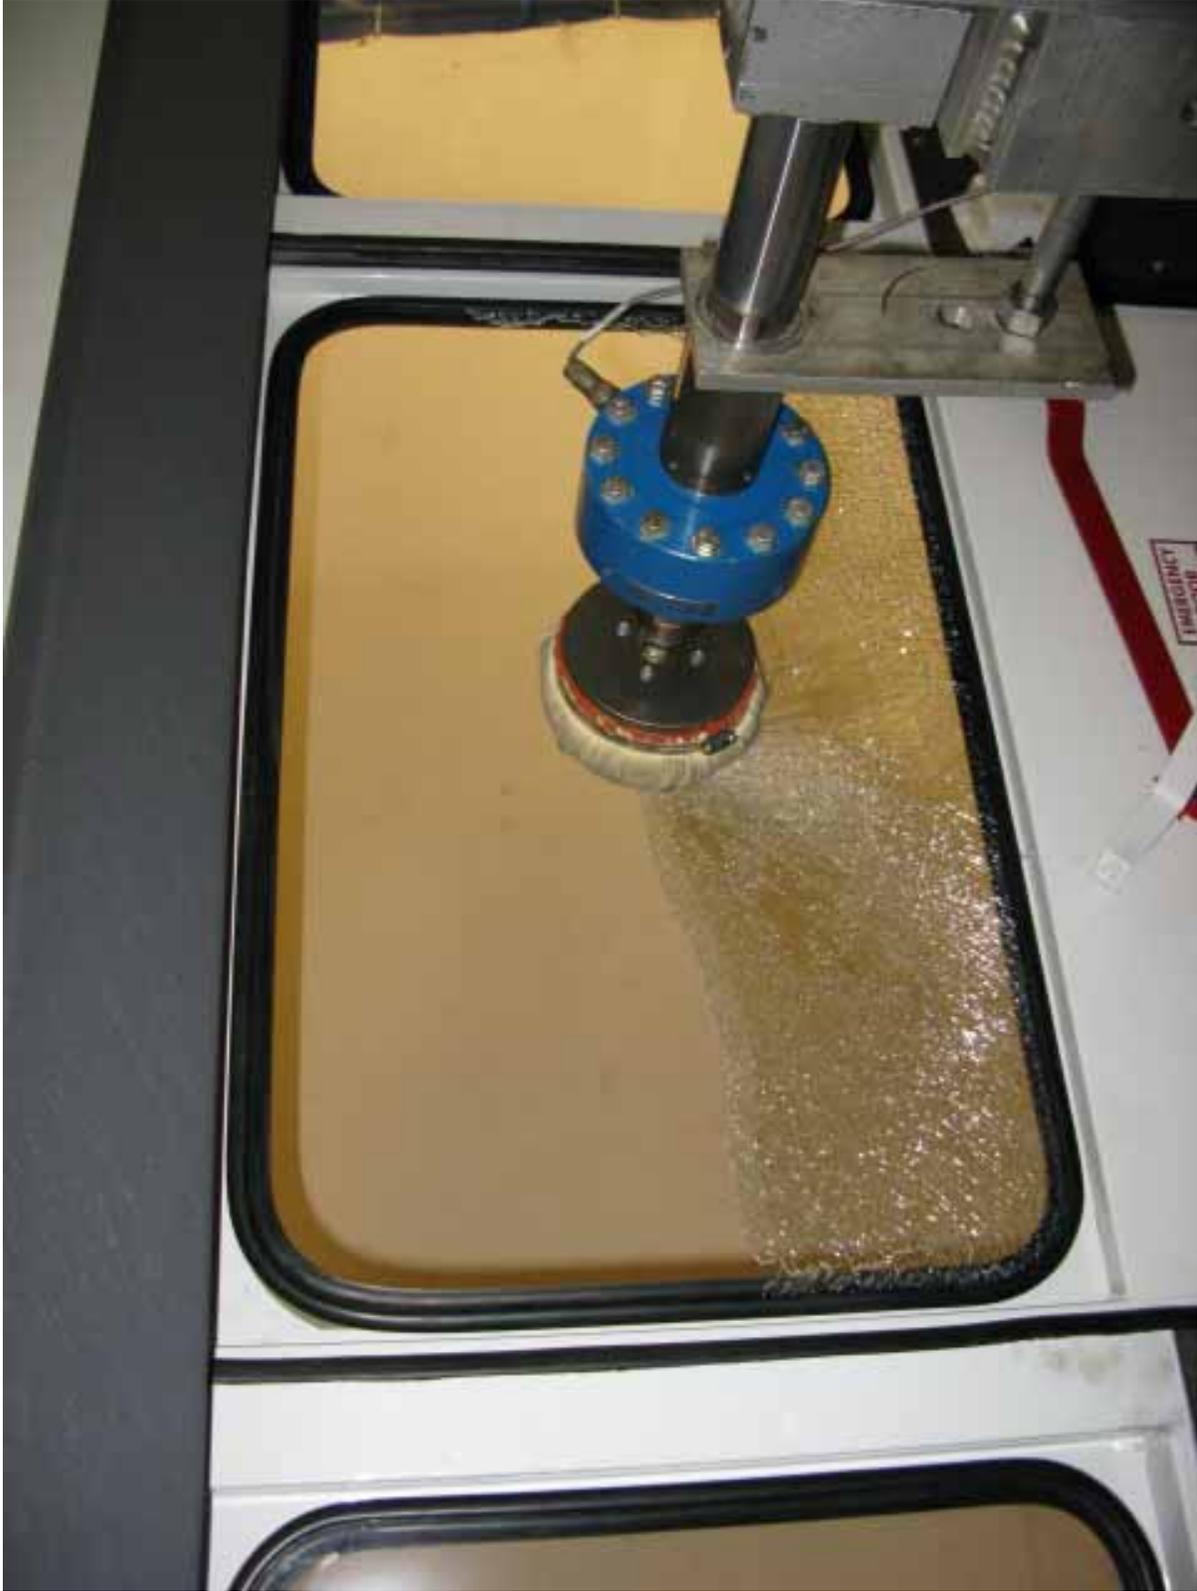
1	Test Window Identification:	Rear Exit Door Upper Window		
2	Provide a detailed description of the window such as fixed, push out, single or double glazed, horizontal or vertical sliding, etc.	Single Glazed Fixed		
3	Provide the horizontal and vertical glazing dimensions for each panel.	880 mm X 555 mm		
4	Did the window pass the retention requirements? Describe how the window structure and glazing withstood the force per the PASS/FAIL criteria:	Window Blow Out at 1550 N PASS		
5	Did the window pass the force tests to unlatch and open the exit after the completion of the retention test?	Unlatch Force Measured (N)	Open Force Measured (N)	Pass/ Fail
		1. 20.1	1. 12.2	Pass
		2. 20.4	2. 10.8	Pass
		3. 19.8	3. 10.7	Pass

Retention Test of Rear Exit Door, Upper Window (Post-Test)

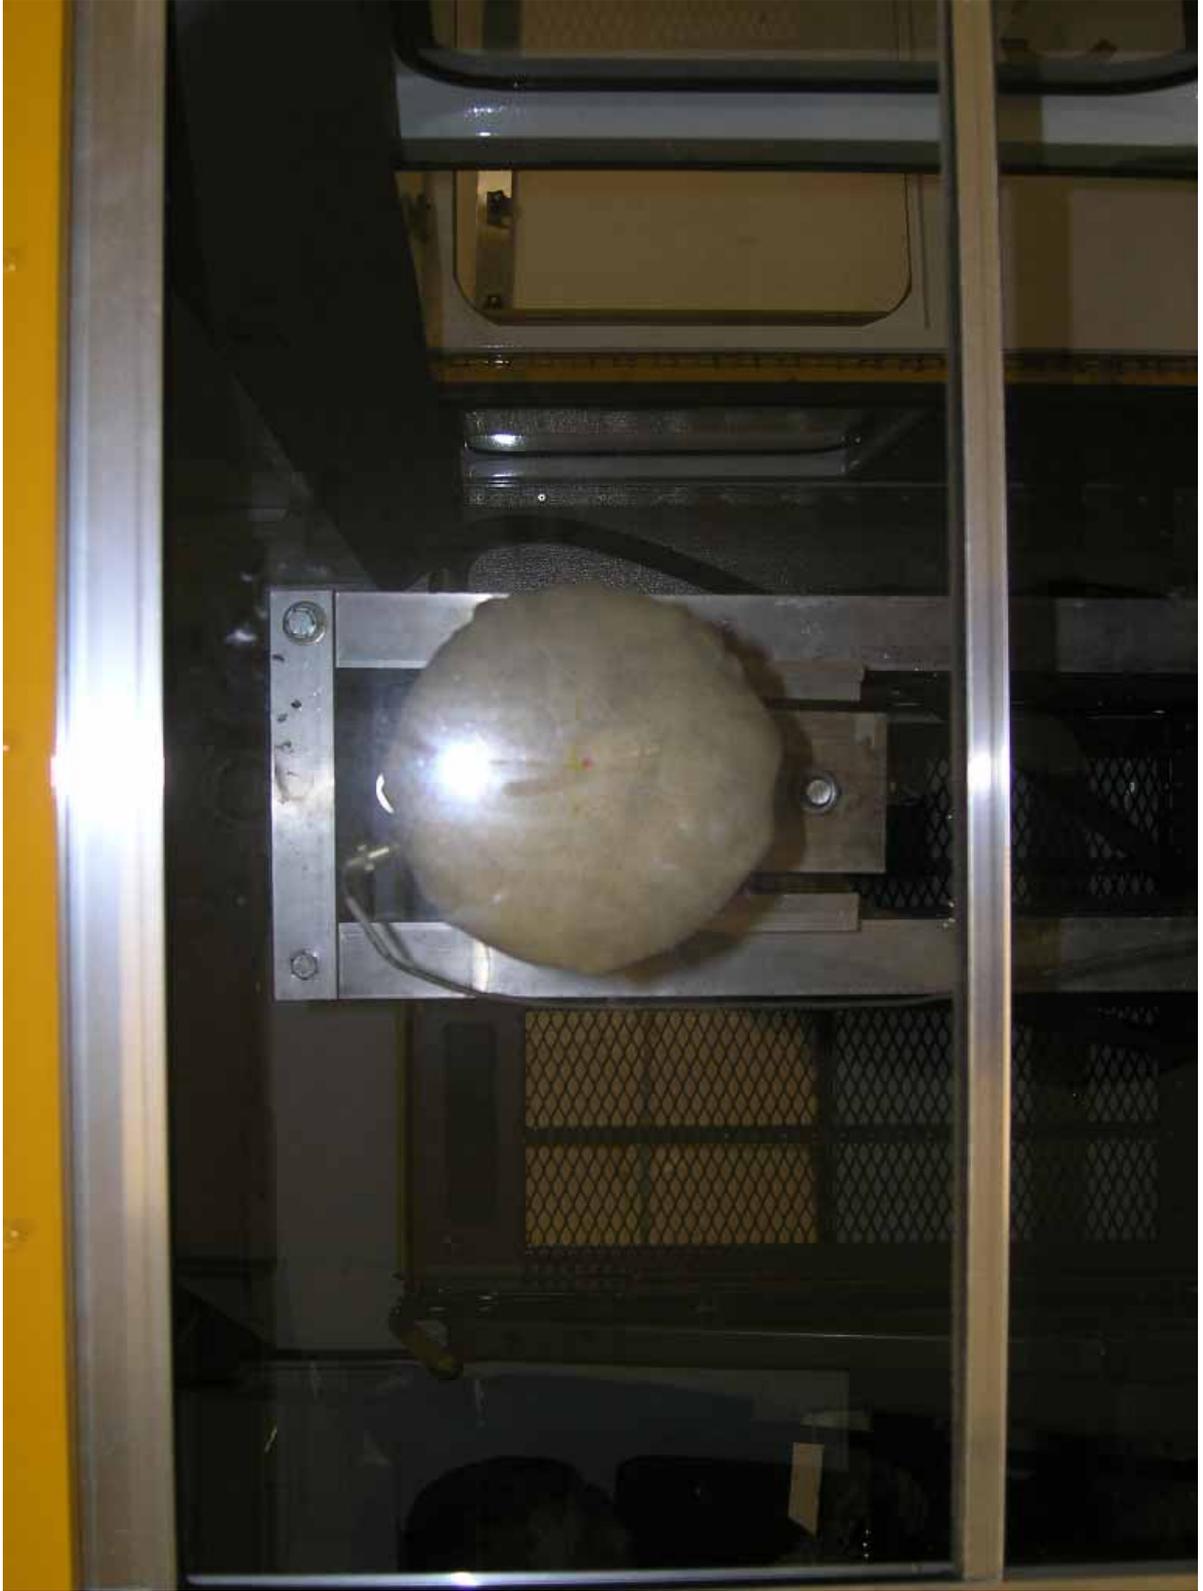
Retention Test of Left Side Window, Upper Half (Pre-Test)

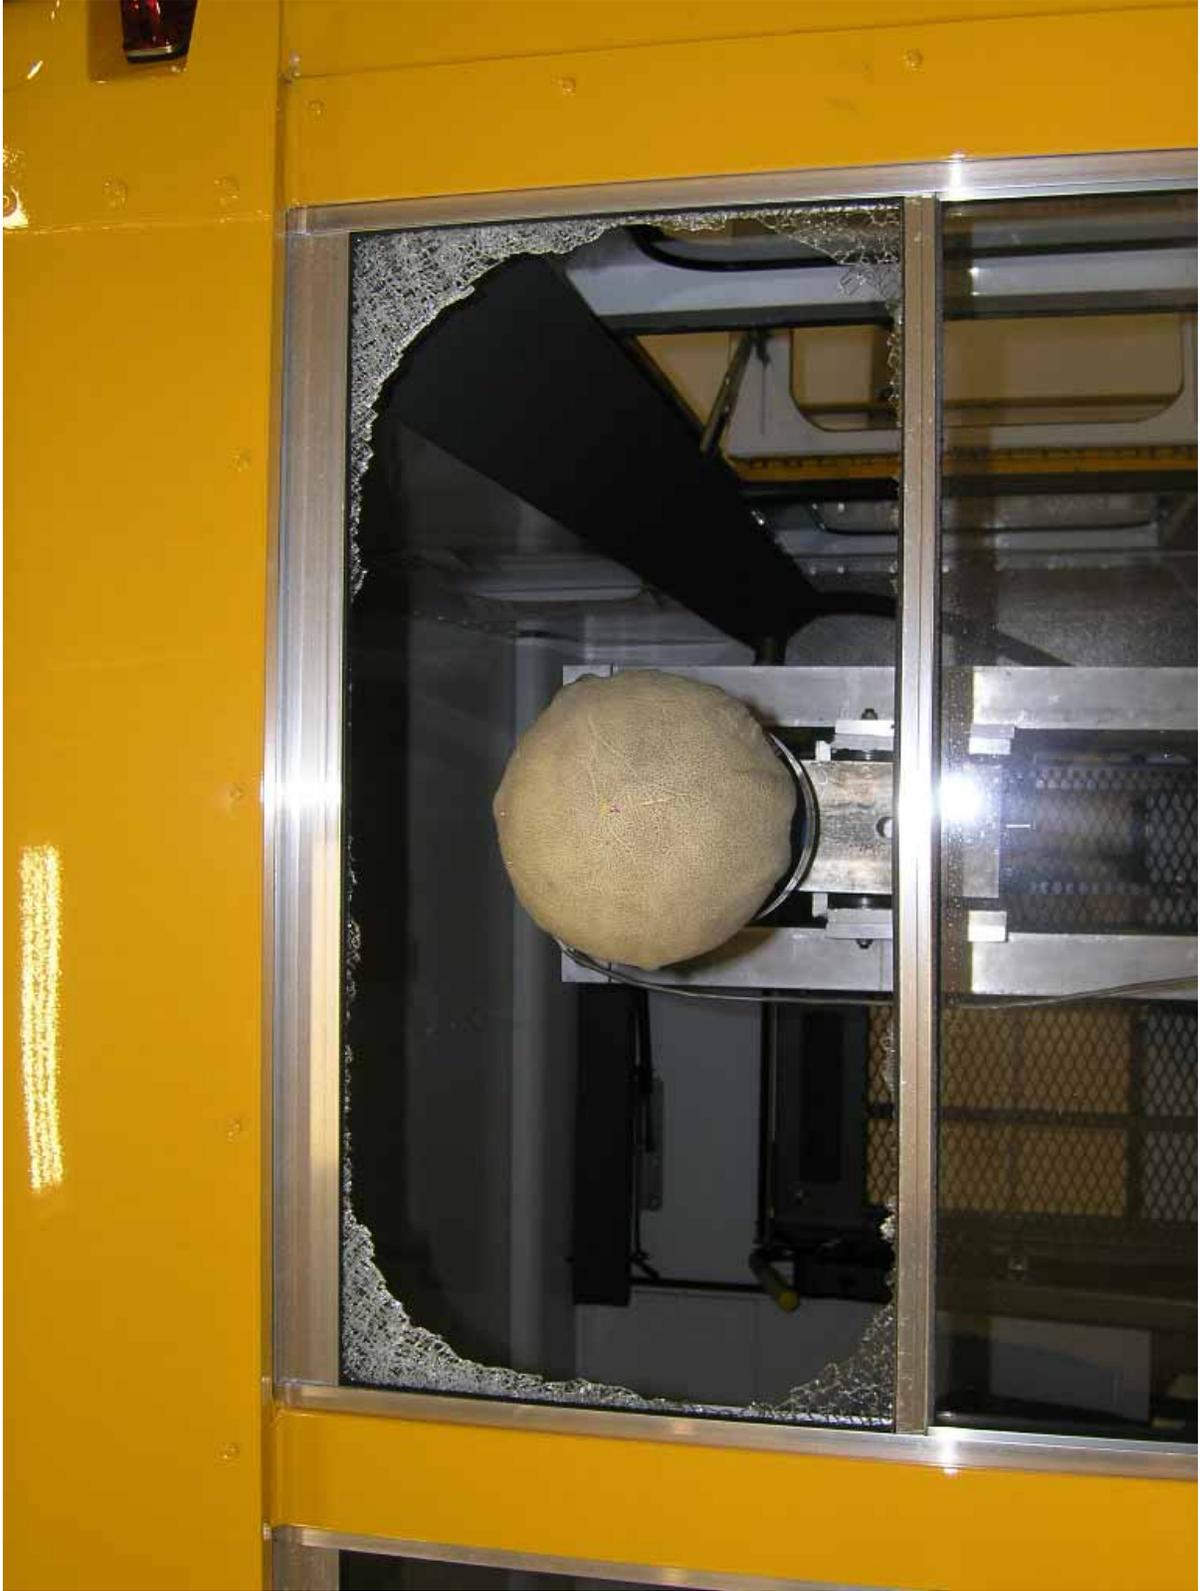
1	Test Window Identification:	Side Window (Rear Left) Top Half		
2	Provide a detailed description of the window such as fixed, push out, single or double glazed, horizontal or vertical sliding, etc.	Single Glaze Vertical Sliding		
3	Provide the horizontal and vertical glazing dimensions for each panel.	665 mm X 317 mm		
4	Did the window pass the retention requirements? Describe how the window structure and glazing withstood the force per the PASS/FAIL criteria:	Max Displacement was Reached PASS		
5	Did the window pass the force tests to unlatch and open the exit after the completion of the retention test?	Unlatch Force Measured (N)	Open Force Measured (N)	Pass/ Fail
		1. N/A	1. N/A	N/A
		2. N/A	2. N/A	N/A
		3. N/A	3. N/A	N/A

Retention Test of Left Side Window, Upper Half (Post-Test)
