REPORT NUMBER: 217-MGA-2009-004

**SAFETY COMPLIANCE TESTING FOR
FMVSS NO. 217
SCHOOL BUS EMERGENCY EXITS AND WINDOW
RETENTION AND RELEASE**

**COLLINS BUS CORPORATION
2008 COLLINS GRAND BANTAM SCHOOL BUS
NHTSA NO.: C80900**

**PREPARED BY:
MGA RESEARCH CORPORATION
5000 WARREN ROAD
BURLINGTON, WI 53105**

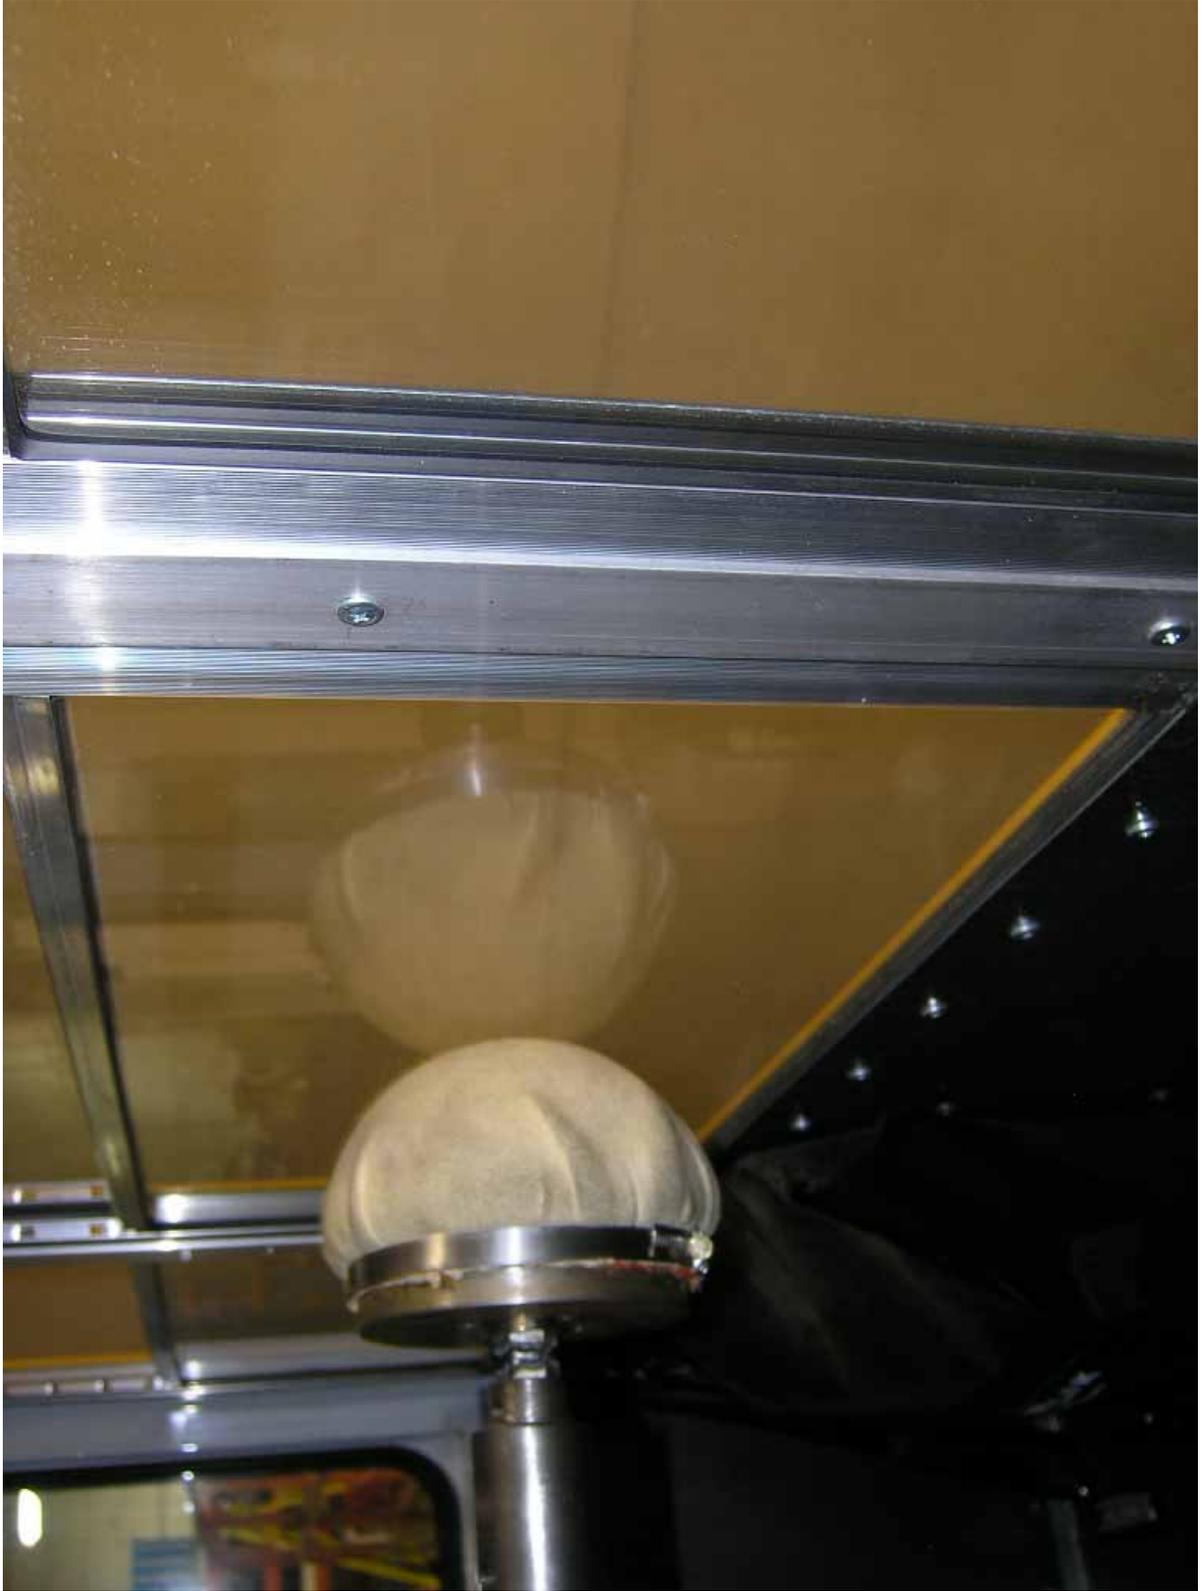
Retention Test of Left Side Window, Lower Half (Pre-Test)

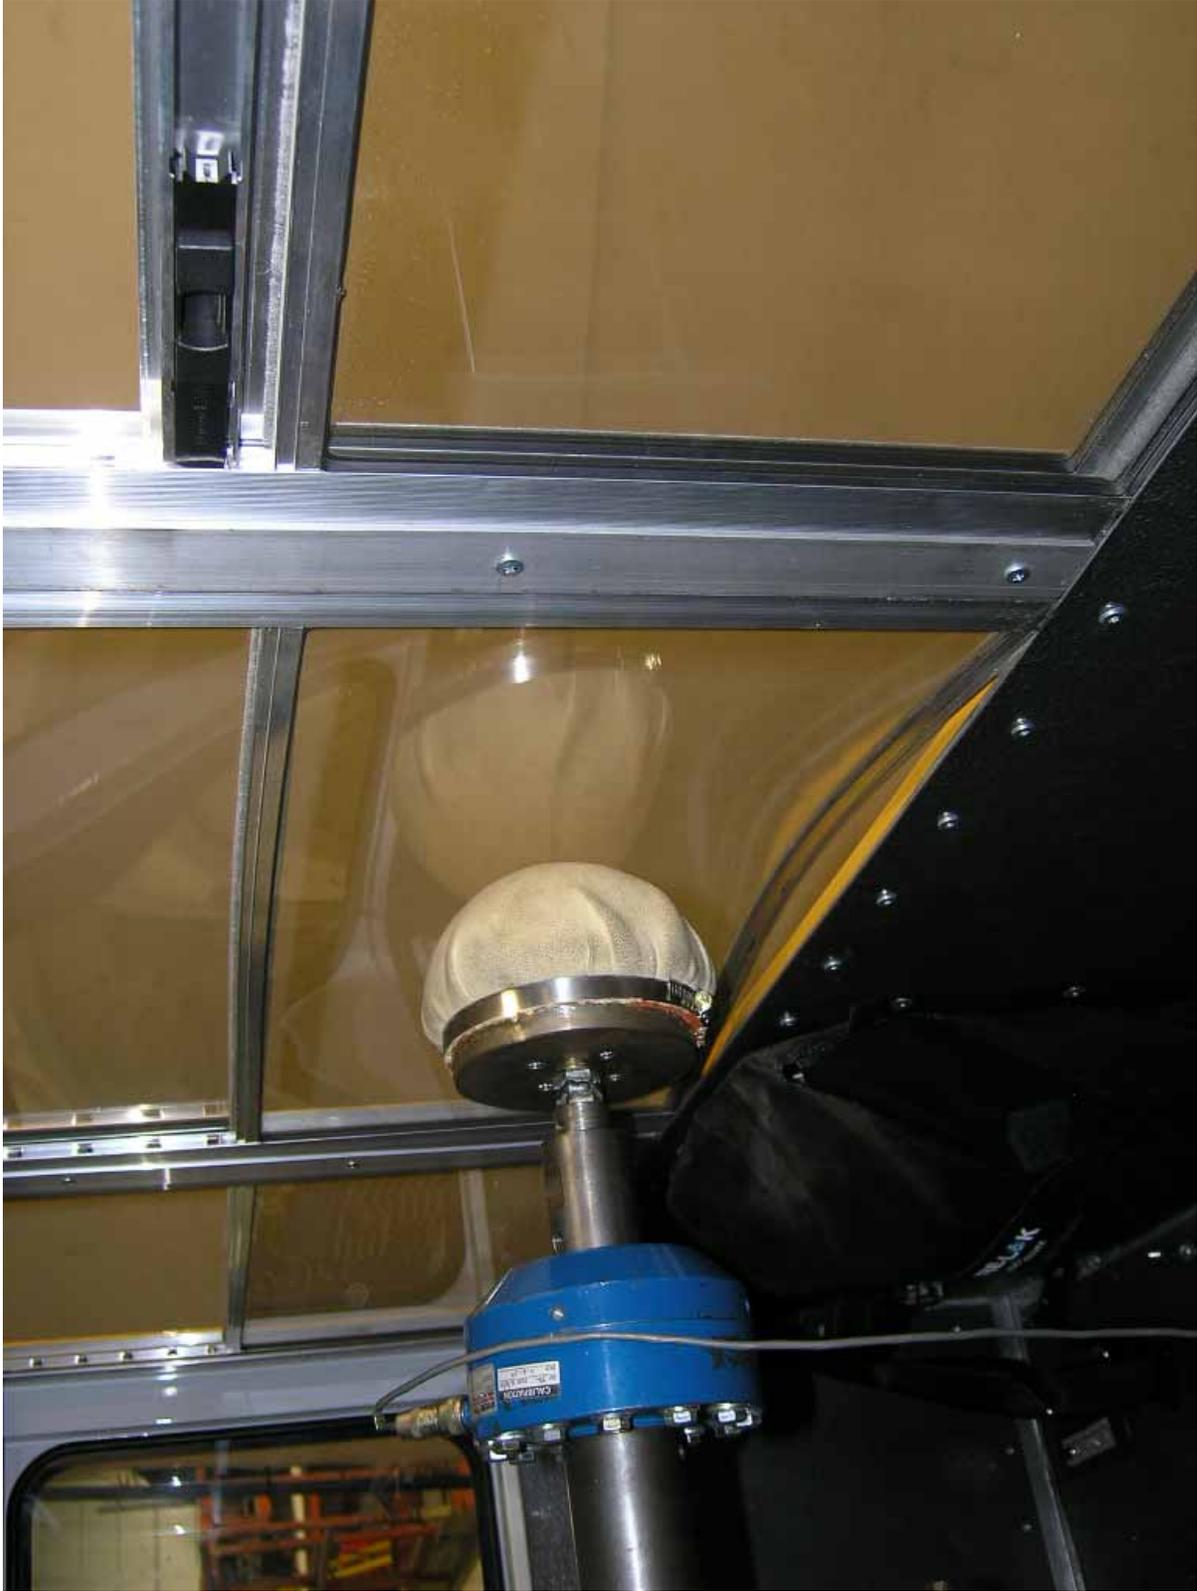
Comments: See section 5, page 44, photo number 23. Window bowed away from frame, passed 4" sphere check.

Retention Test of Left Side Window, Lower Half (Post-Test)

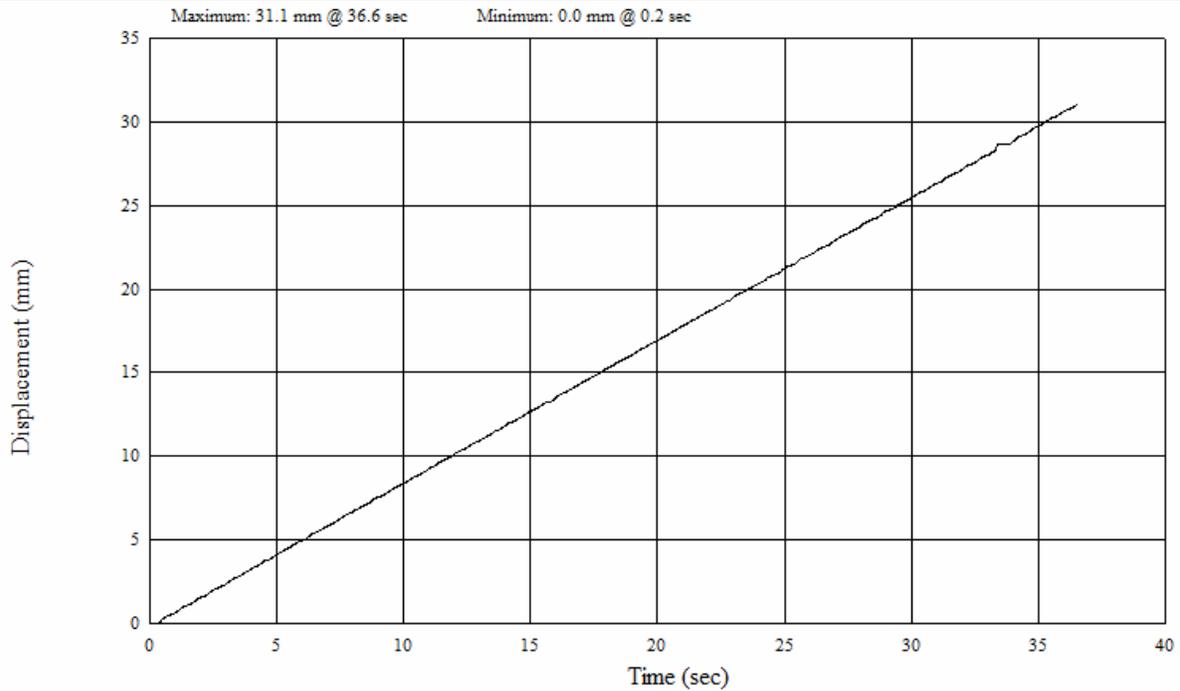
Displacement (mm) vs Time (sec)

File Name: Q09190DR.D7
Test Description: Q09190
Component: C80900 Rear Emergency Exit W1
Comments: Specification: FMVSS 217 Work Order: NHTSA

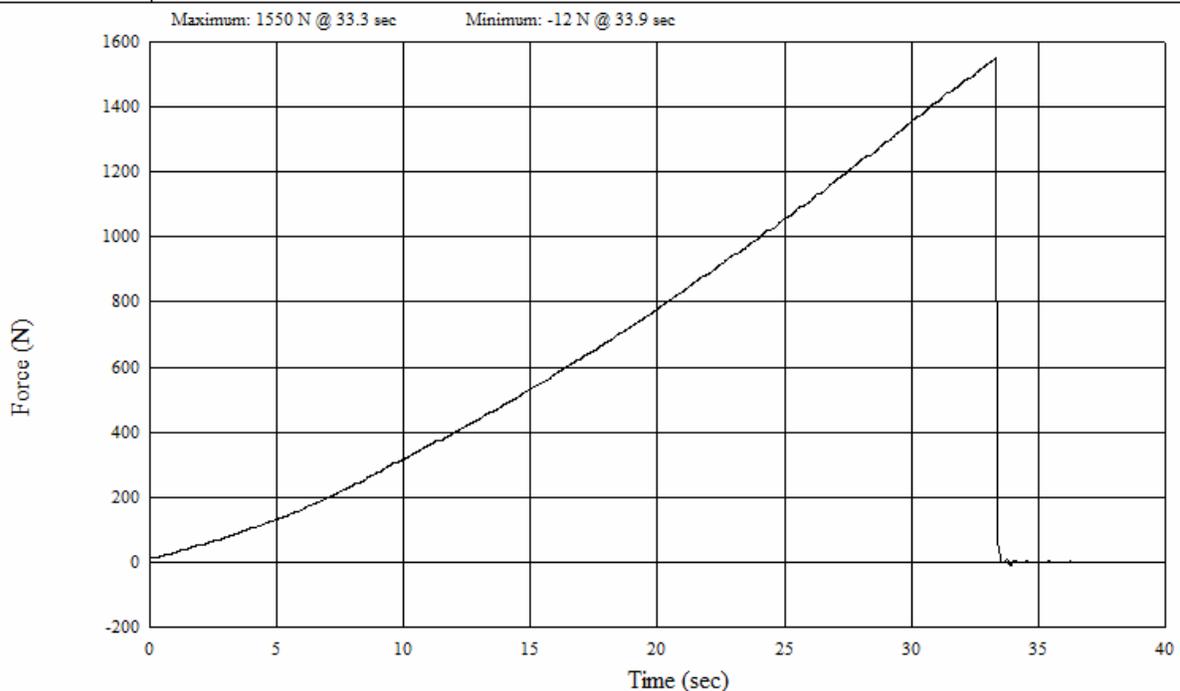
Force (N) vs Time (sec)

File Name: Q09190FR.F7
Test Description: Q09190
Component: C80900 Rear Emergency Exit W1
Comments: Specification: FMVSS 217 Work Order: NHTSA

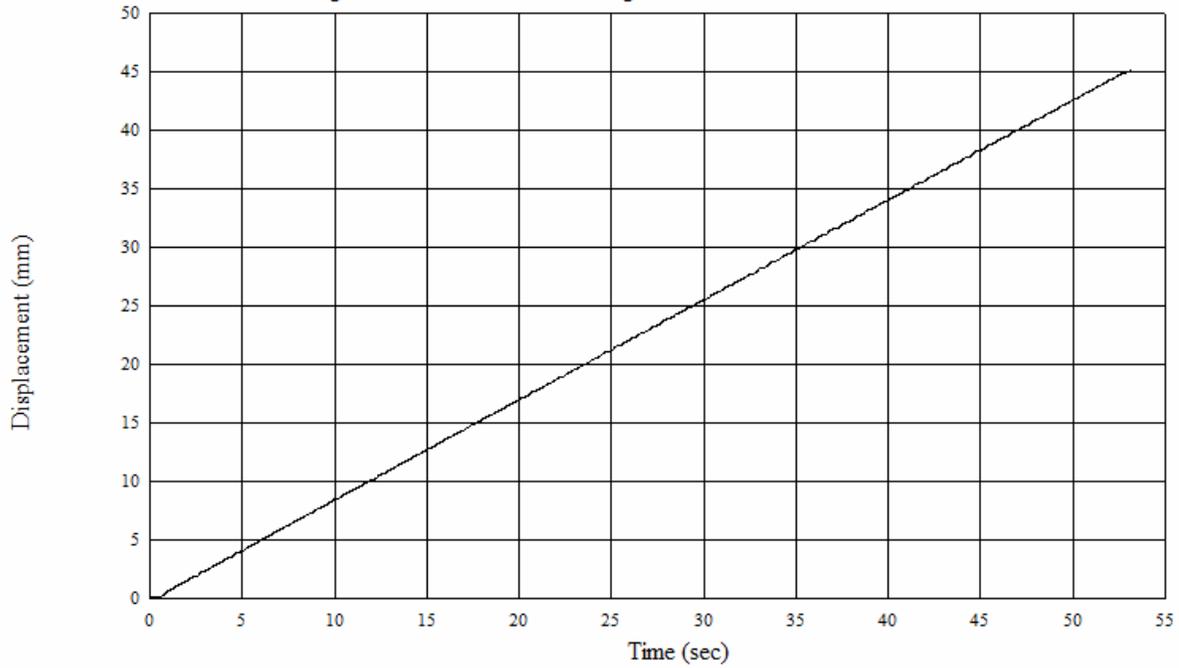
Displacement (mm) vs Time (sec)

Component: Window Retention Upper Side Window

Maximum: 45.1 mm @ 53.1 sec Minimum: 0.1 mm @ 0.2 sec

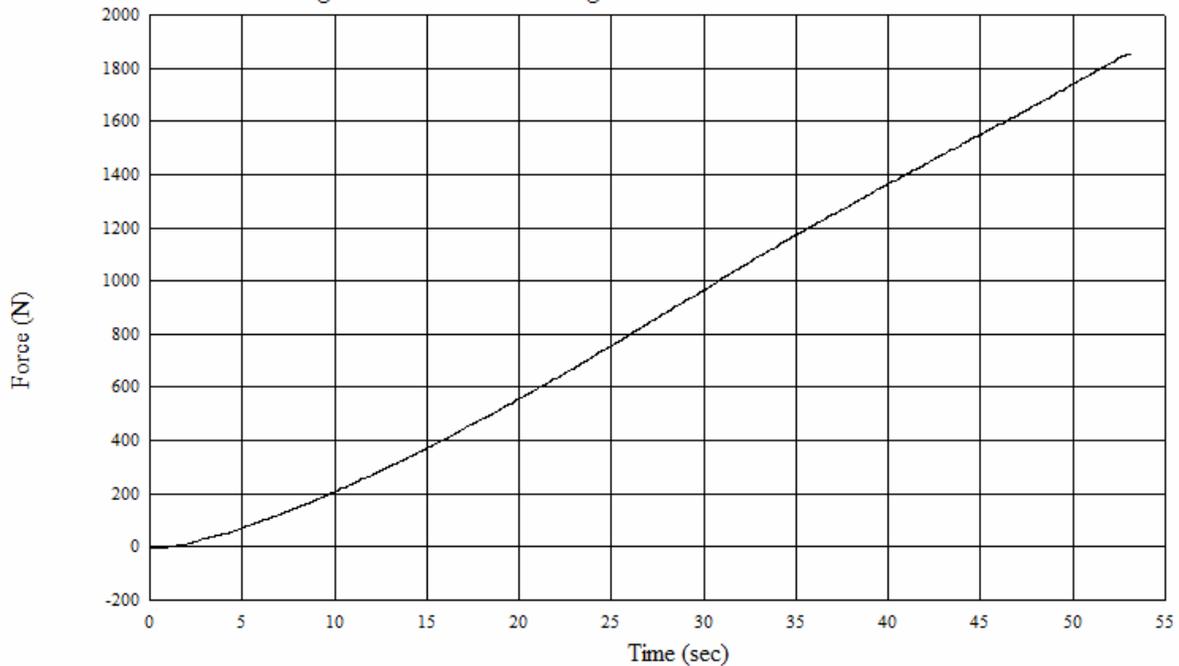
Force (N) vs Time (sec)

Component: Window Retention Upper Side Window

Maximum: 1853 N @ 53.1 sec Minimum: -5 N @ 0.2 sec

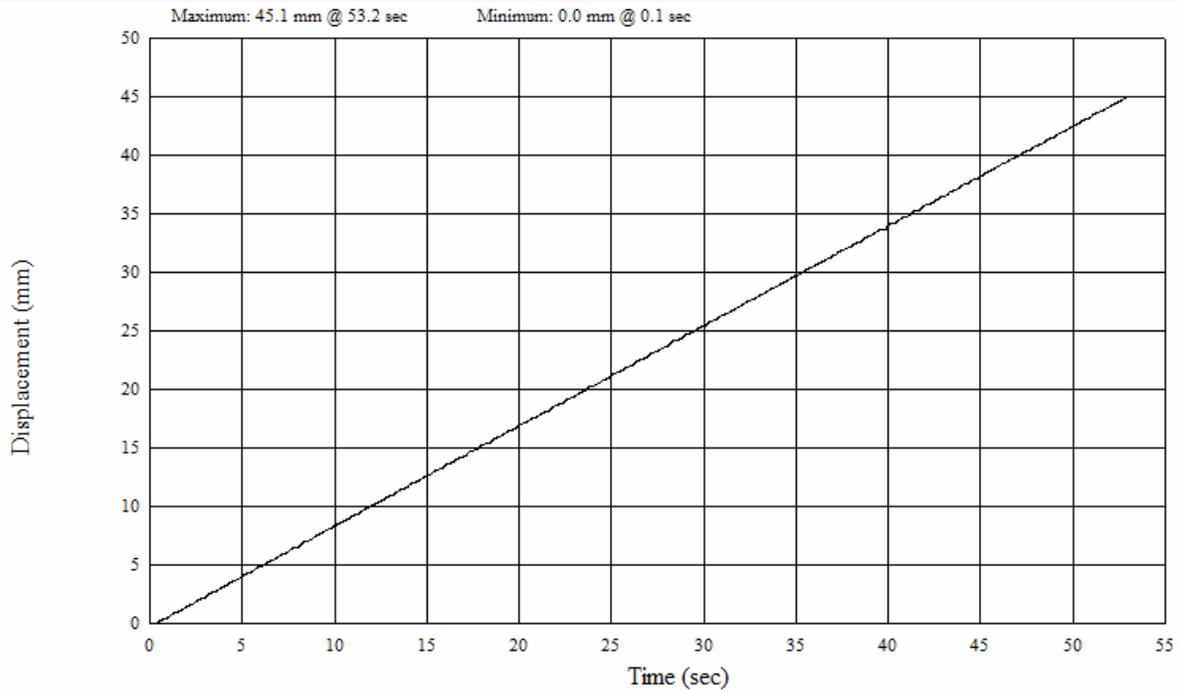
Displacement (mm) vs Time (sec)

Component: Window Retention Lower Side Window

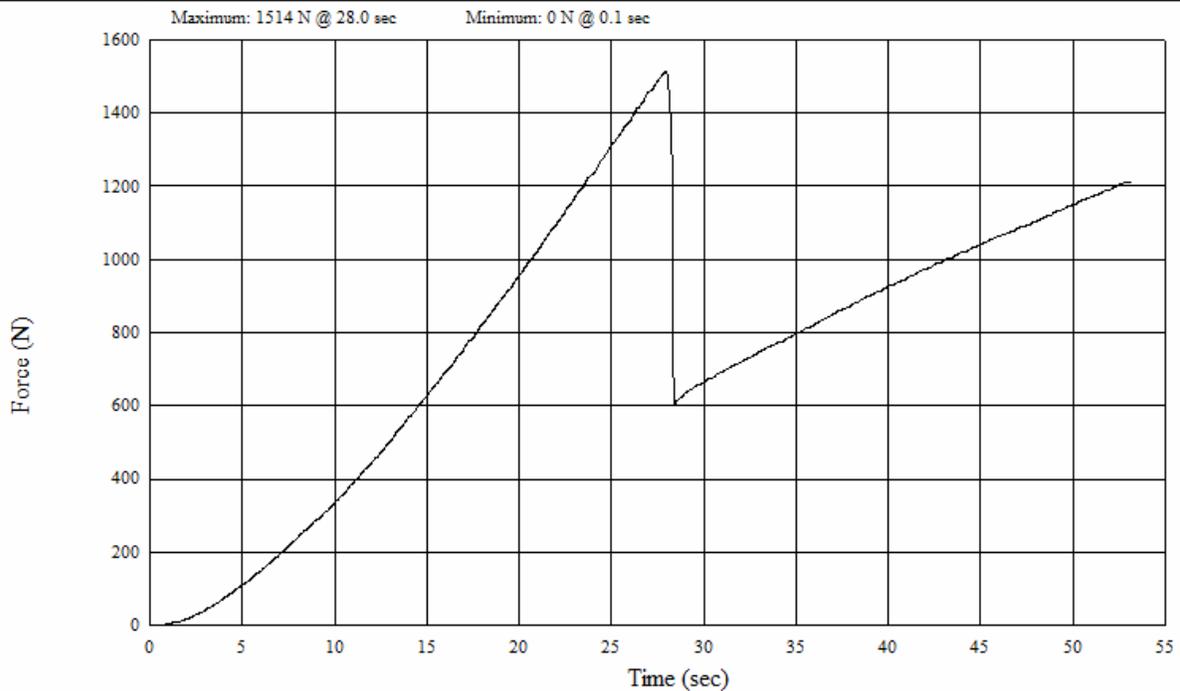
Force (N) vs Time (sec)

Component: Window Retention Lower Side Window
