REPORT NUMBER: 214MDB-CAL-10-3

**SAFETY COMPLIANCE TESTING FOR FMVSS 214
DYNAMIC SIDE IMPACT PROTECTION
MOVING DEFORMABLE BARRIER**

**BAYERISCHE MOTORENWERKE
2010 BMW 128i
2-DOOR CONVERTIBLE**

NHTSA NUMBER: CA0512

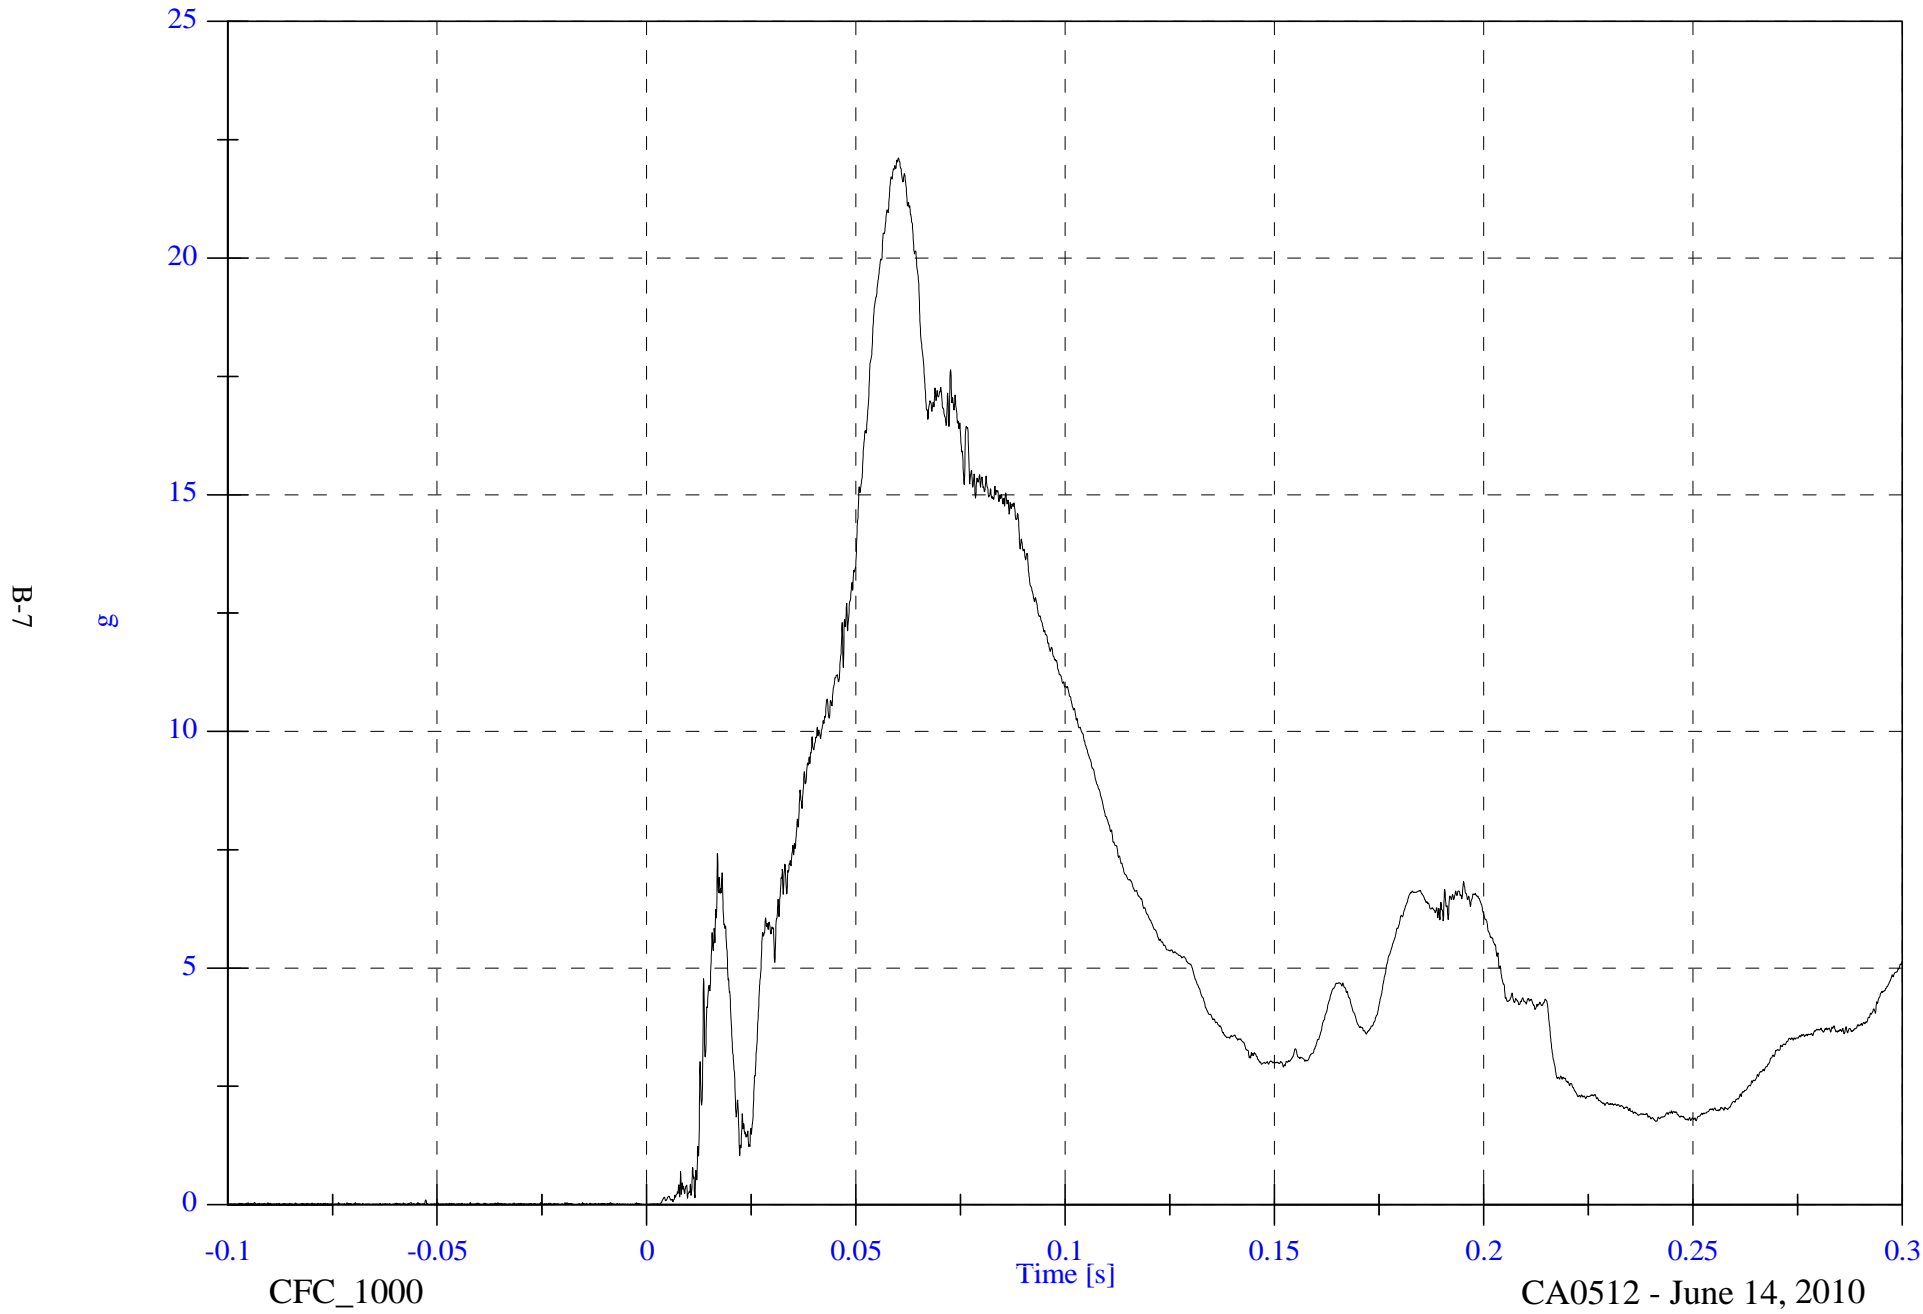
V2P1 Head Resultant

Max: 22.1 [g] at 0.060 [s]
Min: 0.0 [g] at -0.003 [s]

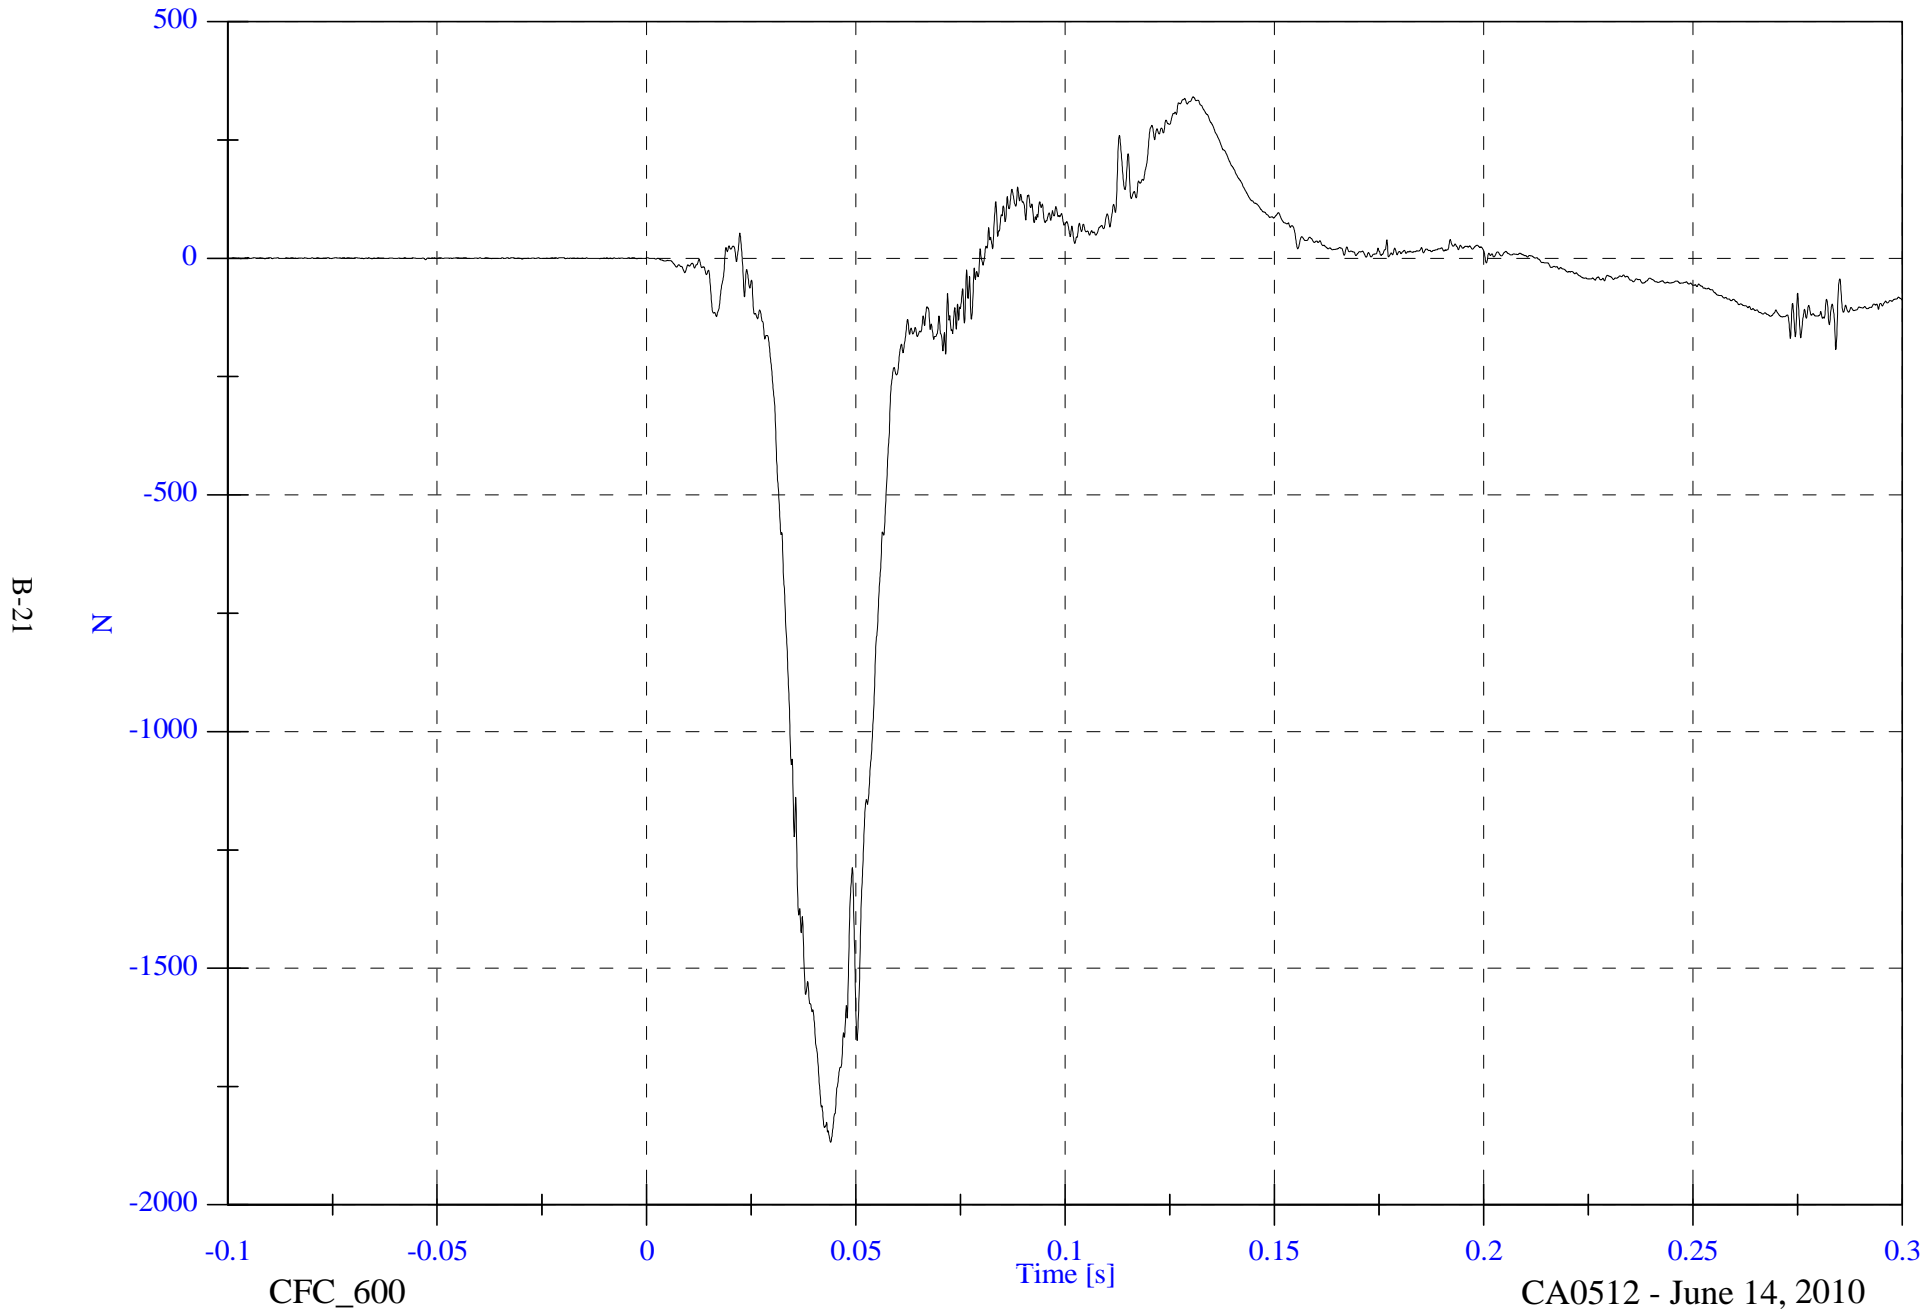
V2P1 Pubic Symphysis Fy

Max: 340.7 [N] at 0.131 [s]

Min: -1867.7 [N] at 0.044 [s]

<table><tr style="background-color: #d9ead3;"> <th style="width: 40%;"></th> <th style="width: 30%; text-align: center;">DRIVER</th> <th style="width: 30%; text-align: center;">PASS.</th> </tr><tr style="background-color: #d9d9d9;"> <td>Pubic Symphysis (N)</td> <td style="text-align: center;">-1867.7</td> <td></td> </tr></table>

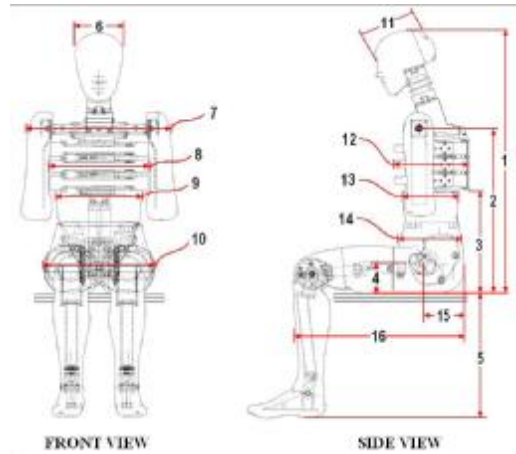
ES-2re External Measurements

Dim. No.	Description	Specification (mm)	Result	Pass/Fail
1	Sitting Height	900-918	912	Pass
2	Seat to Shoulder Joint	558-572	565	Pass
3	Seat to Lower Face of Thoracic Spine Box	346-356	352	Pass
4	Seat to Hip Joint (center of bolt)	97-103	101	Pass
5	Sole to Seat, Sitting	333-451	441	Pass
6	Head Width	152-158	155	Pass
7	Shoulder/Arm Width	461-479	473	Pass
8	Thorax Width	322-332	326	Pass
9	Abdomen Width	273-287	283	Pass
10	Pelvis Lap Width	359-373	369	Pass
11	Head Depth	196-206	199	Pass
12	Thorax Depth	262-272	266	Pass
13	Abdomen Depth	194-204	198	Pass
14	Pelvis Depth	235-245	242	Pass
15	Back of Buttocks to Hip Joint (center of bolt)	150-160	157	Pass
16	Back of Buttocks to Front Knee	597-615	605	Pass

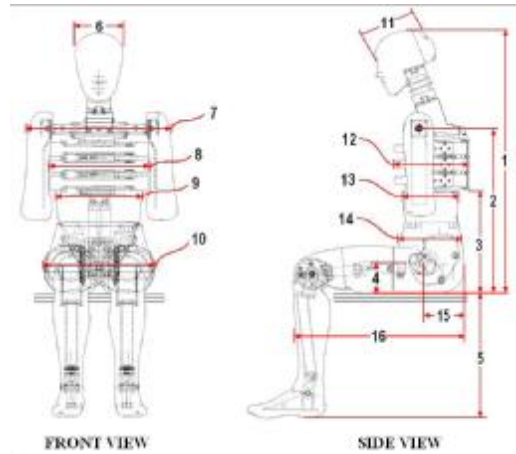
ES-2re External Measurements

Dim. No.	Description	Specification (mm)	Result	Pass/Fail
1	Sitting Height	900-918	912	Pass
2	Seat to Shoulder Joint	558-572	565	Pass
3	Seat to Lower Face of Thoracic Spine Box	346-356	352	Pass
4	Seat to Hip Joint (center of bolt)	97-103	101	Pass
5	Sole to Seat, Sitting	333-451	441	Pass
6	Head Width	152-158	155	Pass
7	Shoulder/Arm Width	461-479	473	Pass
8	Thorax Width	322-332	326	Pass
9	Abdomen Width	273-287	283	Pass
10	Pelvis Lap Width	359-373	369	Pass
11	Head Depth	196-206	199	Pass
12	Thorax Depth	262-272	266	Pass
13	Abdomen Depth	194-204	198	Pass
14	Pelvis Depth	235-245	242	Pass
15	Back of Buttocks to Hip Joint (center of bolt)	150-160	157	Pass
16	Back of Buttocks to Front Knee	597-615	605	Pass
