REPORT NUMBER 138-STF-10-004

SAFETY COMPLIANCE TESTING FOR FMVSS NO. 138 TIRE PRESSURE MONITORING SYSTEMS

MAZDA MOTOR CORPORATION
2010 MAZDA 6
FOUR-DOOR PASSENGER CAR
NHTSA NO. CA5402

FINAL REPORT

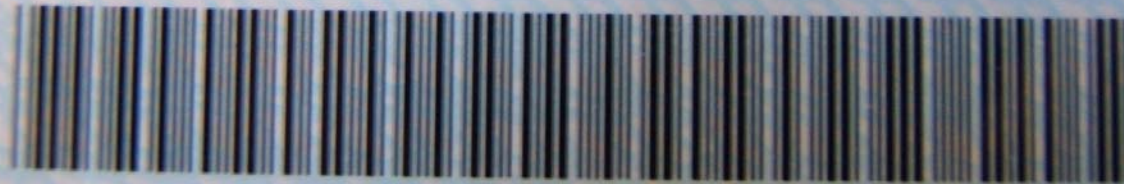
FIGURE 5.2
VEHICLE CERTIFICATION LABEL

EXT PNT:	36	Y			RC:		DSO:
WB	BRK	INT TR	TP/PS	R	AXLE	TR	SPR
				ZFP			▽F85B-1520472-AB

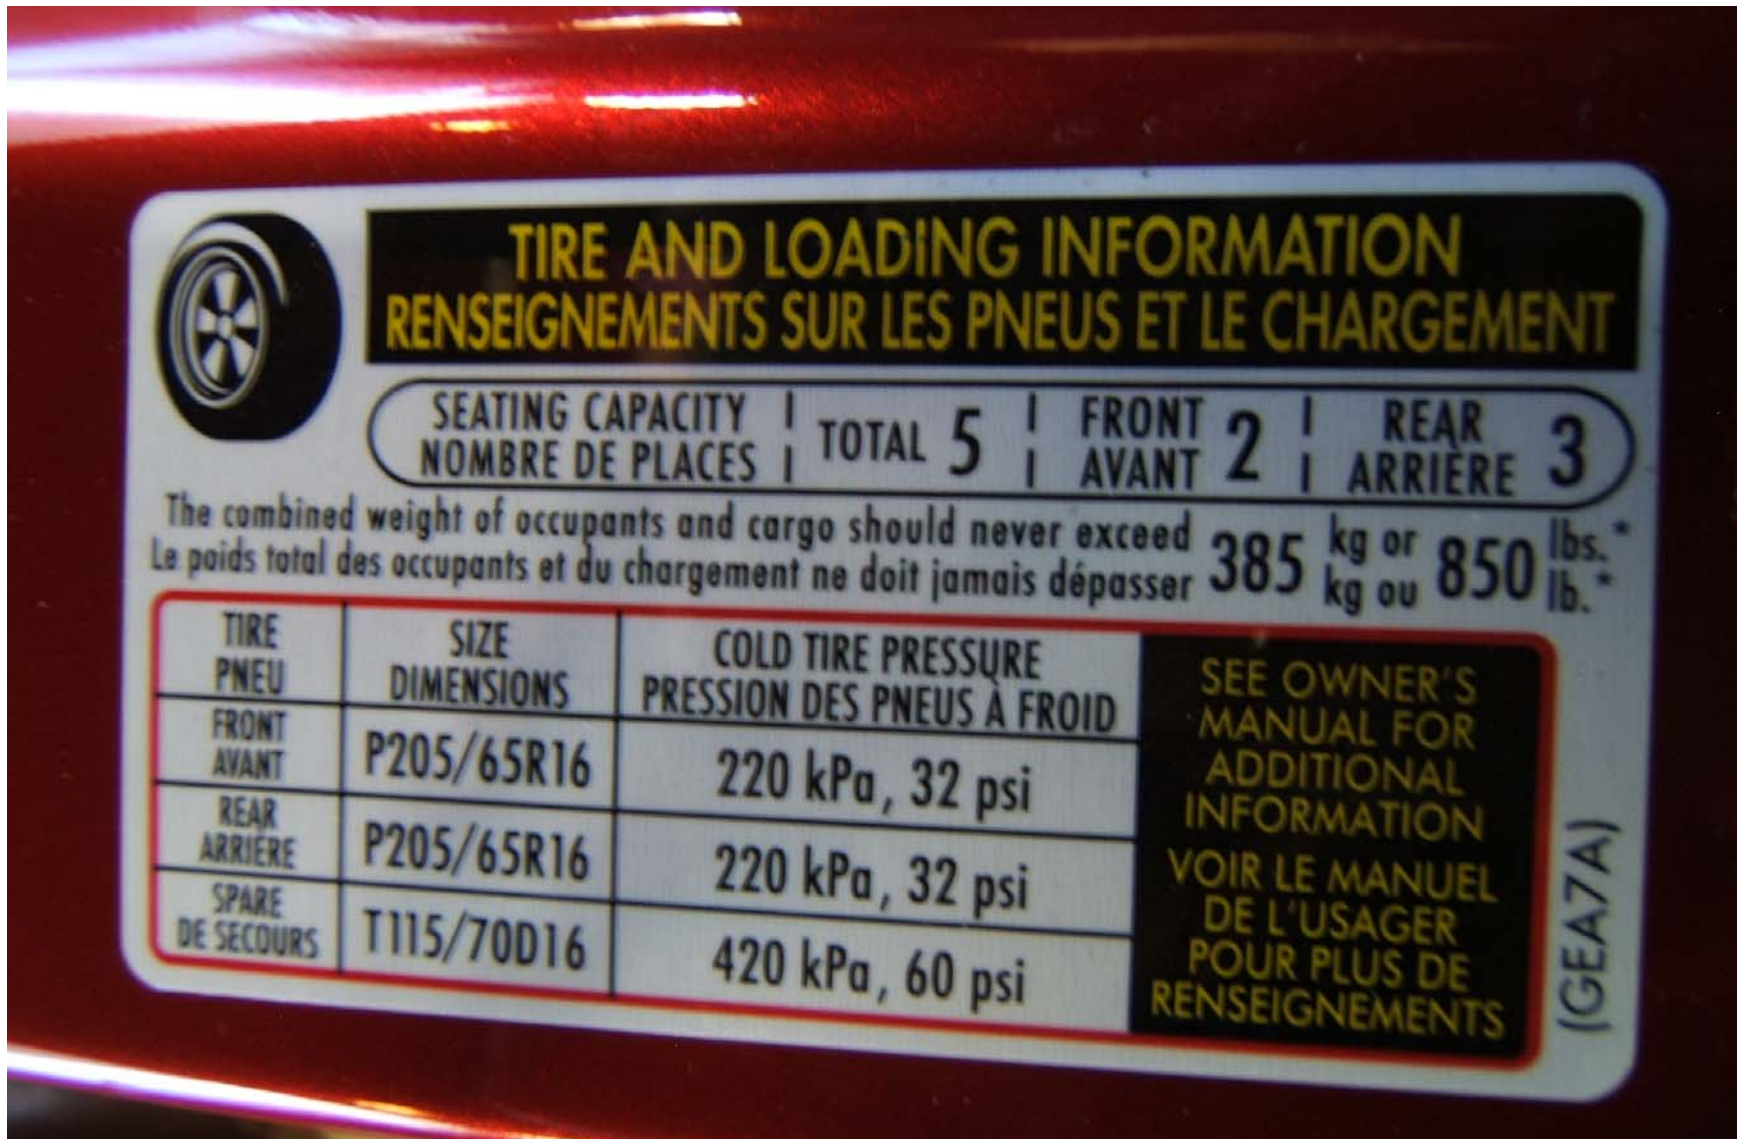
FIGURE 5.3
 VEHICLE PLACARD

Axle	Tire Size	Recommended Cold Inflation Pressure	Source
Front	P205/65R16	220 kPa (32 psi)	Vehicle placard
Rear	P205/65R16	220 kPa (32 psi)	Vehicle placard

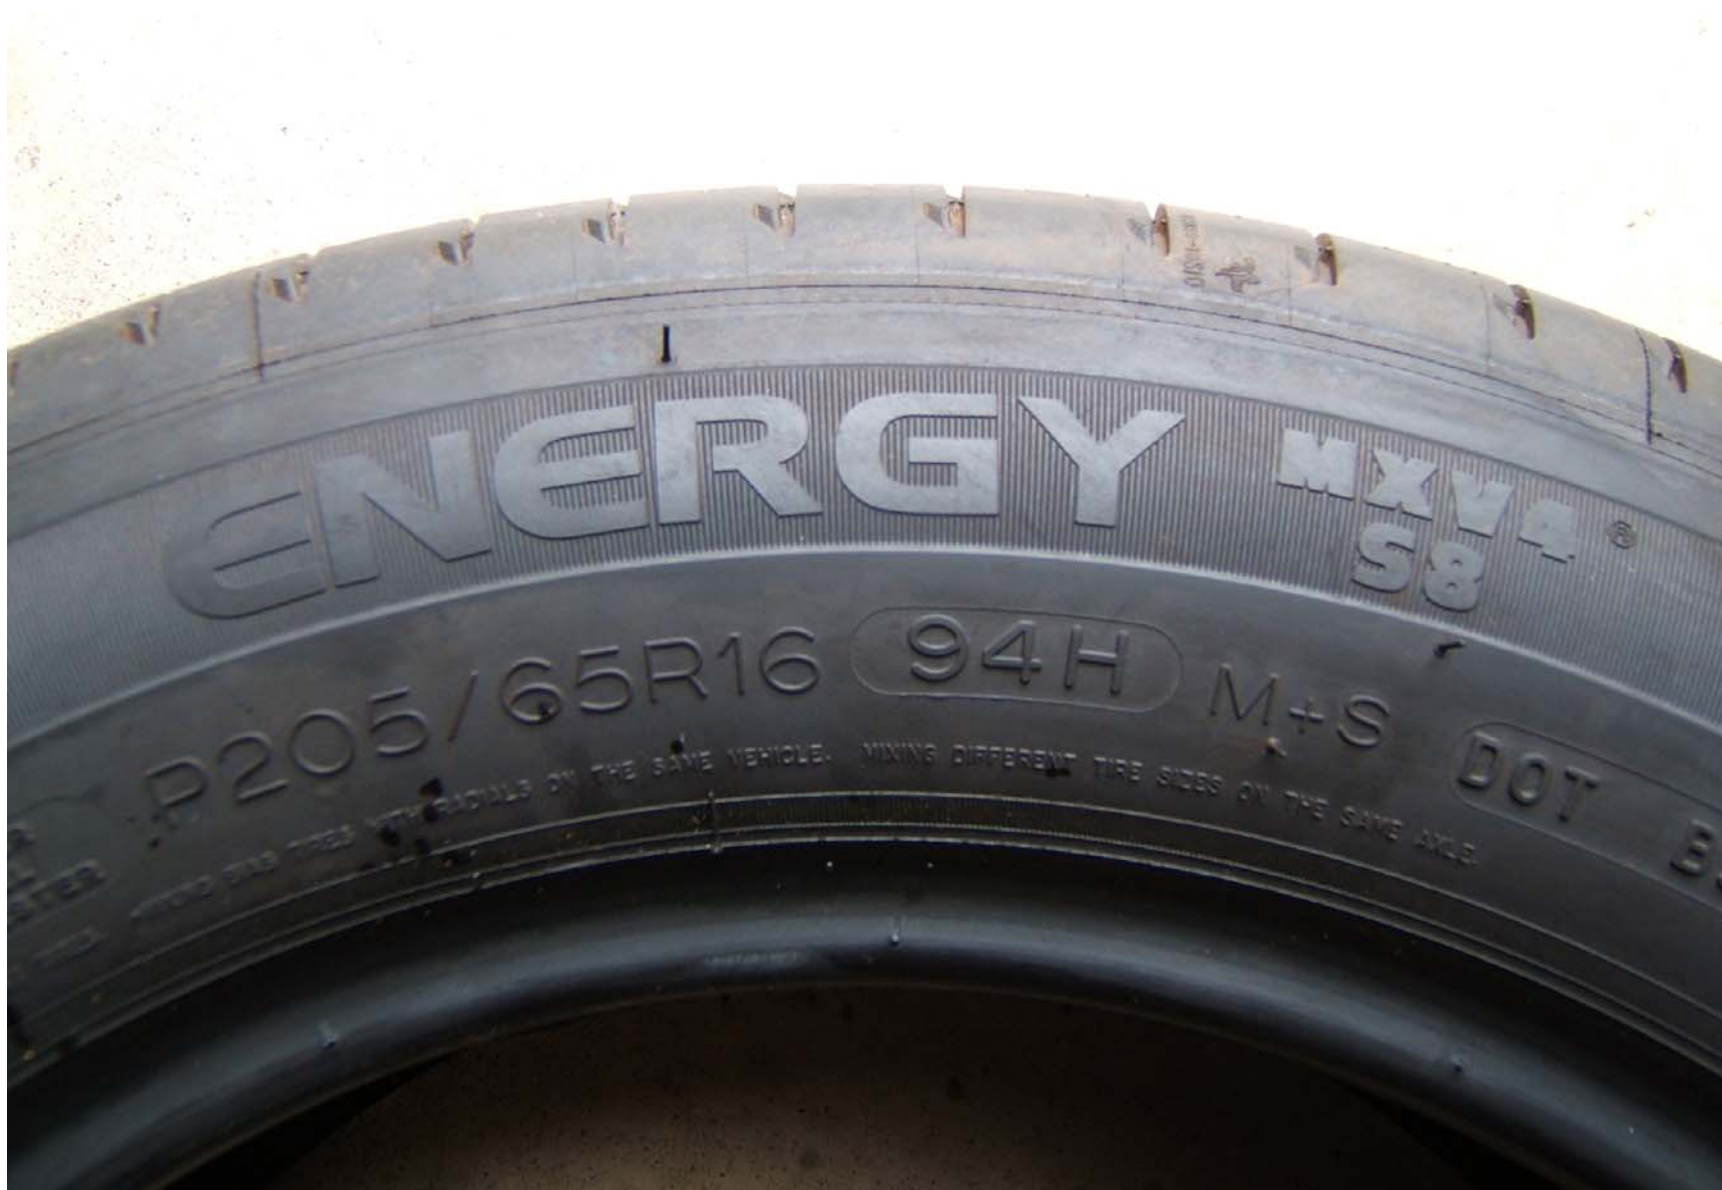
FIGURE 5.5
TIRE SHOWING MODEL, SIZE,
AND LOAD INDEX / SPEED RATING

Tire Size and Load Index / Speed Rating: P205/65R16 94H

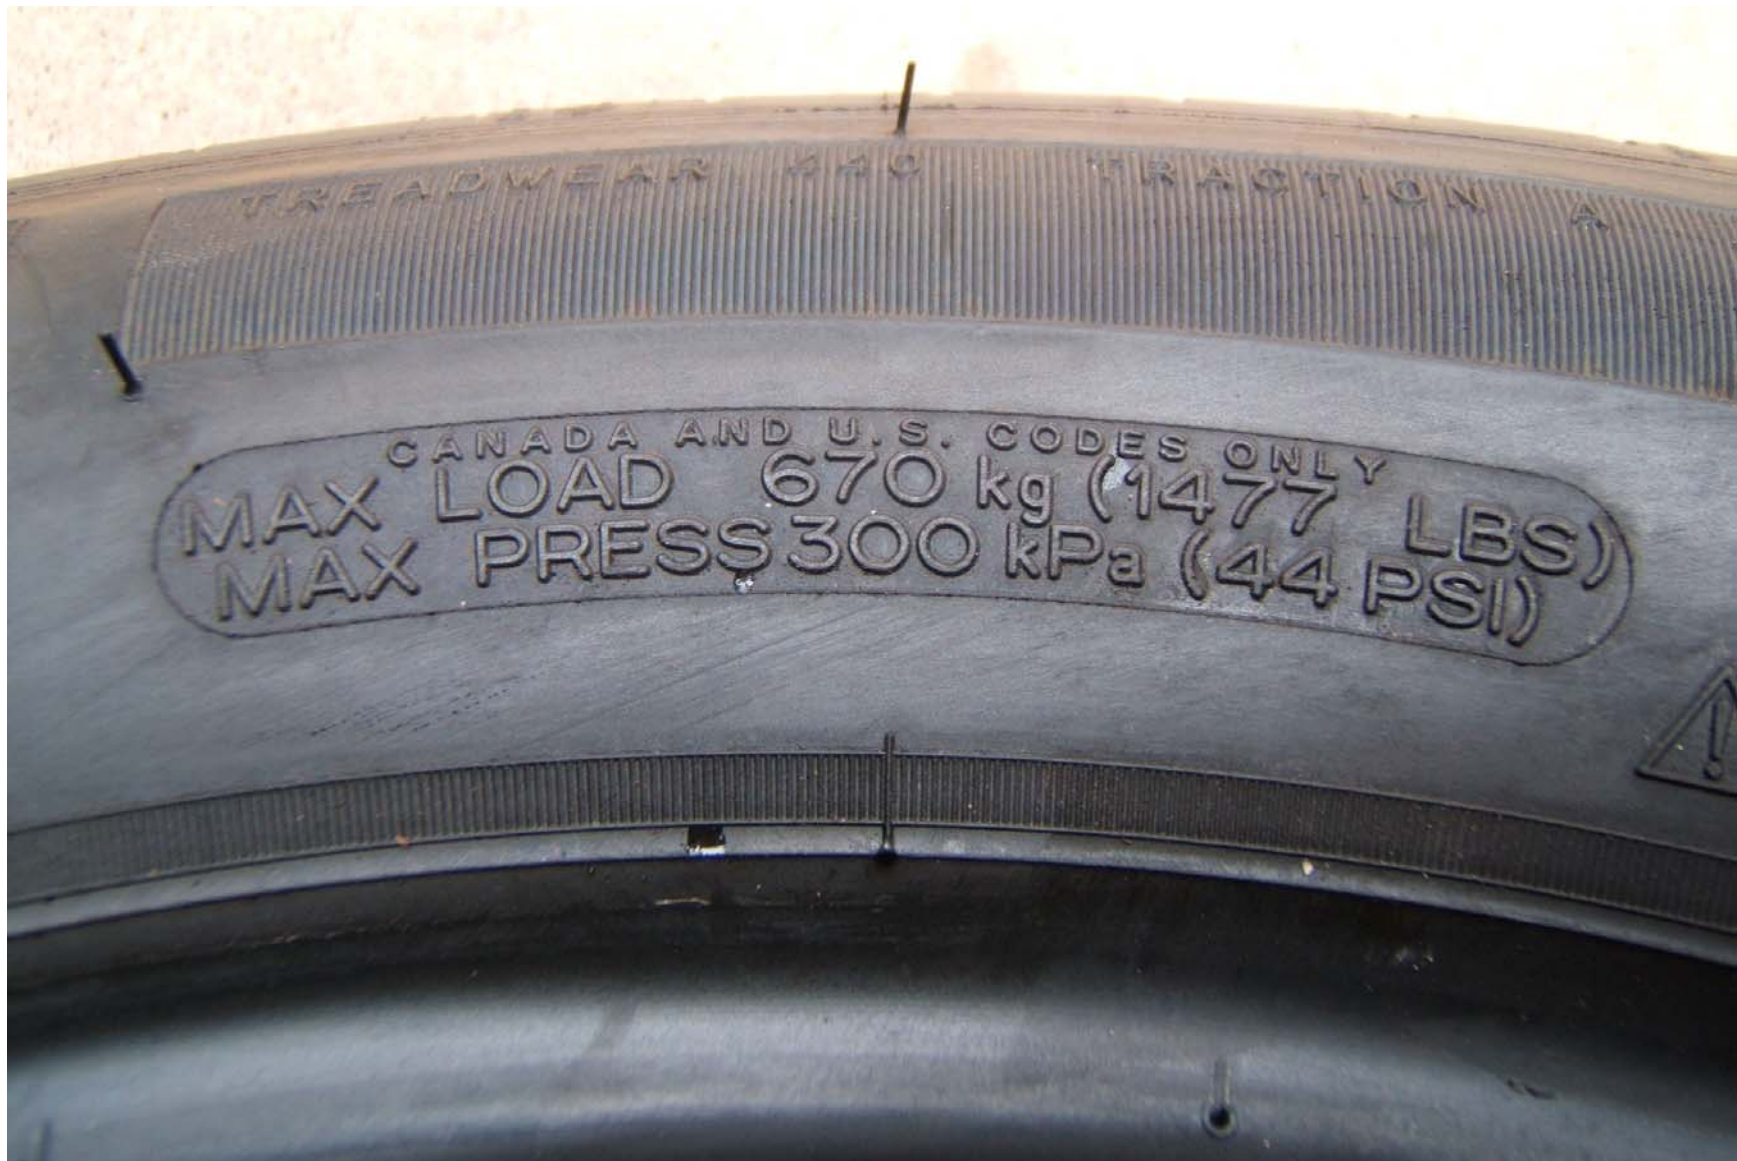
FIGURE 5.7
TIRE SHOWING MAX LOAD RATING
AND MAX COLD INFLATION PRESSURE

Sidewall Max Load Rating: 670 kg (1,477 lbs)

Max Inflation Pressure: 300 kPa (44 psi)

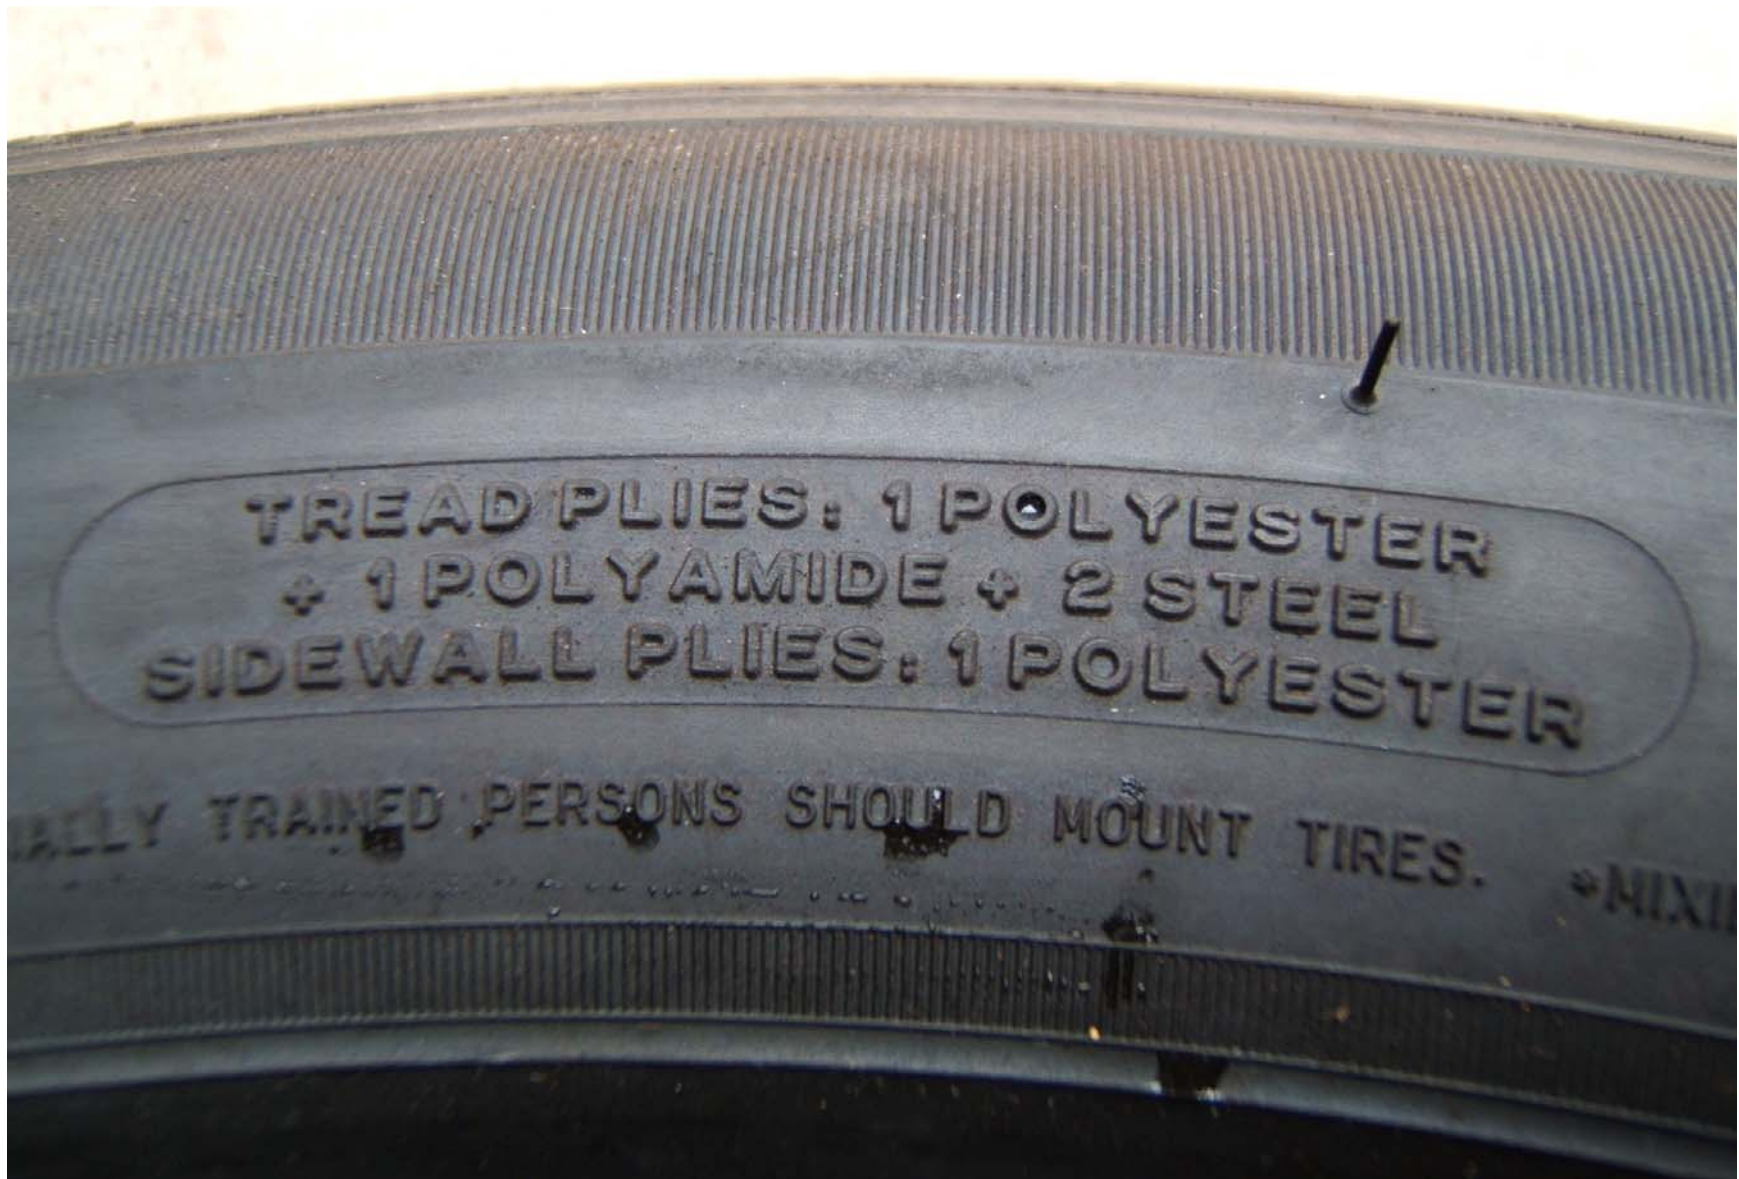
FIGURE 5.8
TIRE SHOWING SIDEWALL / TREAD CONSTRUCTION

Sidewall Construction (number of plies and ply material): 1 polyester

Tread Construction (number of plies and ply material): 1 polyester, 1 polyamide, 2 steel

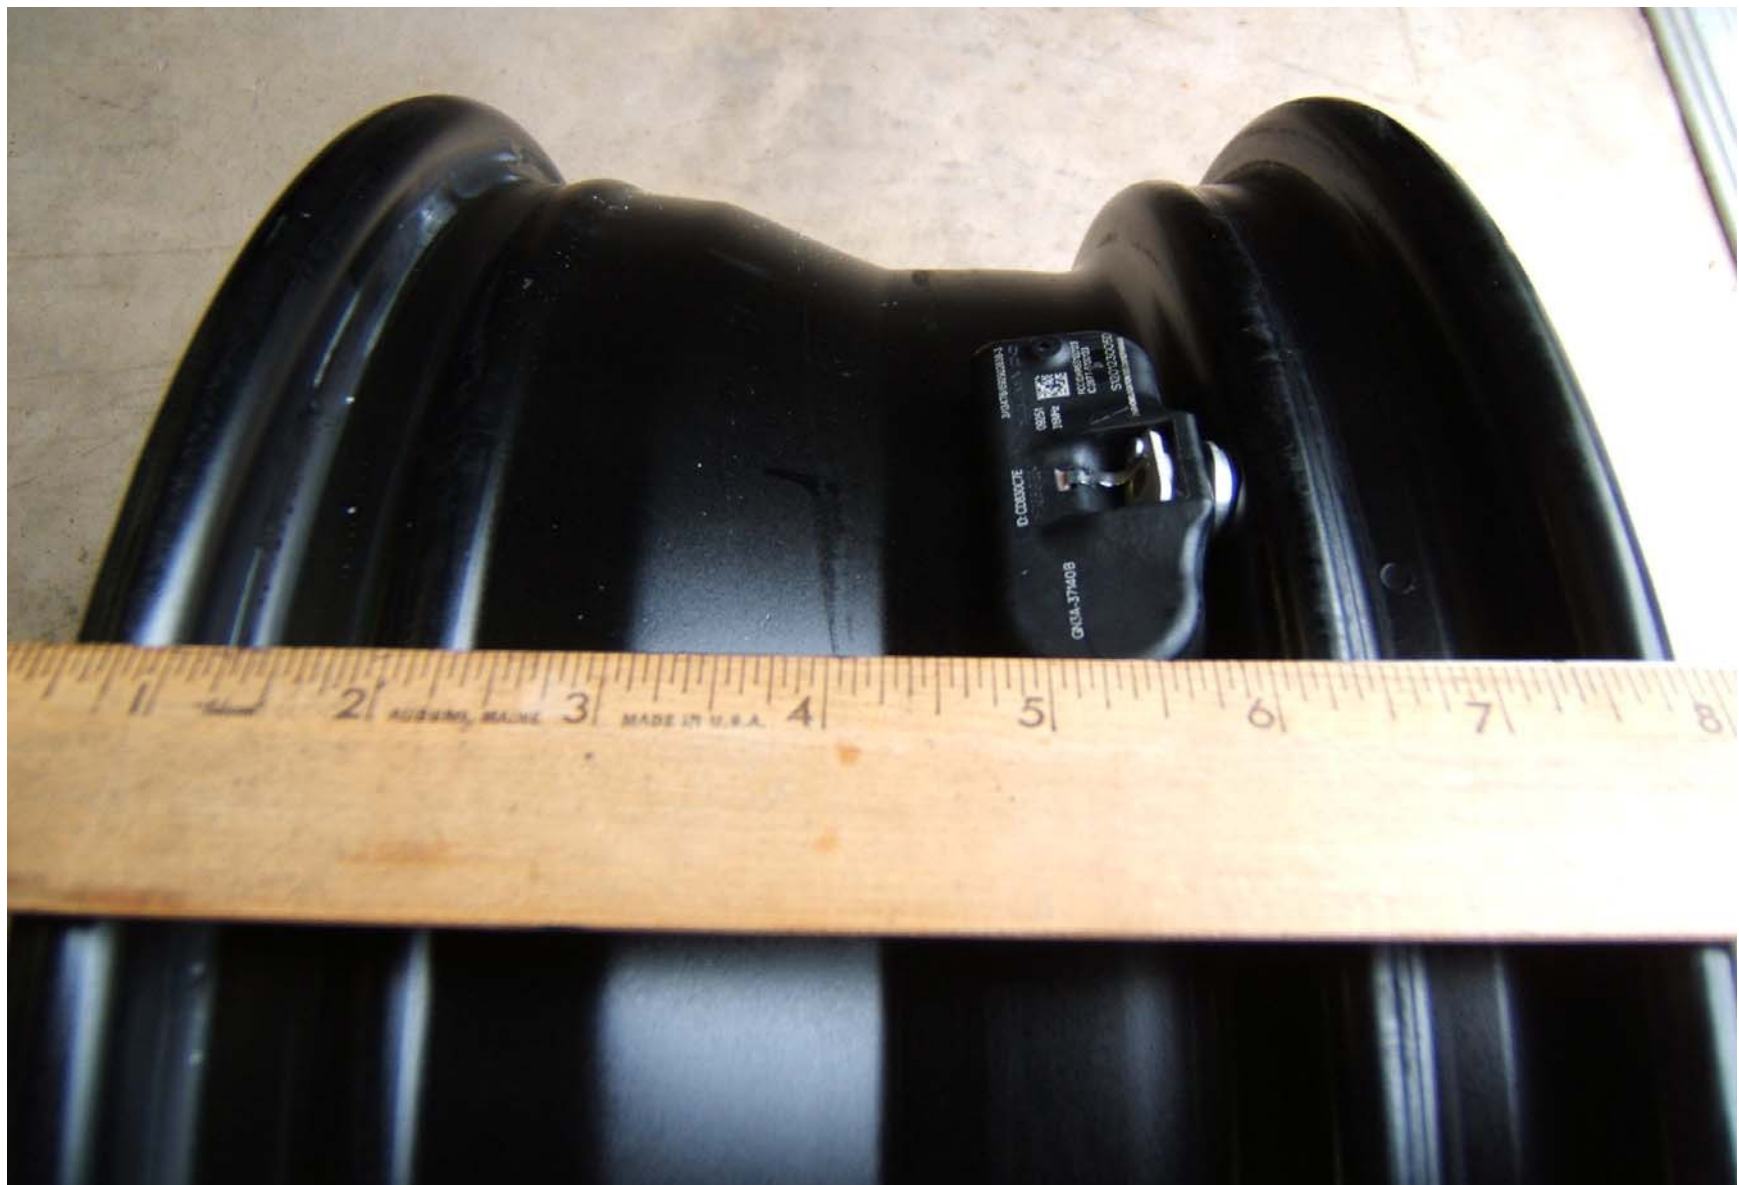
FIGURE 5.9
RIM SHOWING TPMS SENSOR AND RIM
CONTOUR FOR FULL WIDTH OF CROSS SECTION

TPMS MAKE/MODEL: Sensor: Continental Automotive; receiver: no independent ECU unit – system uses keyless receiver and control module.

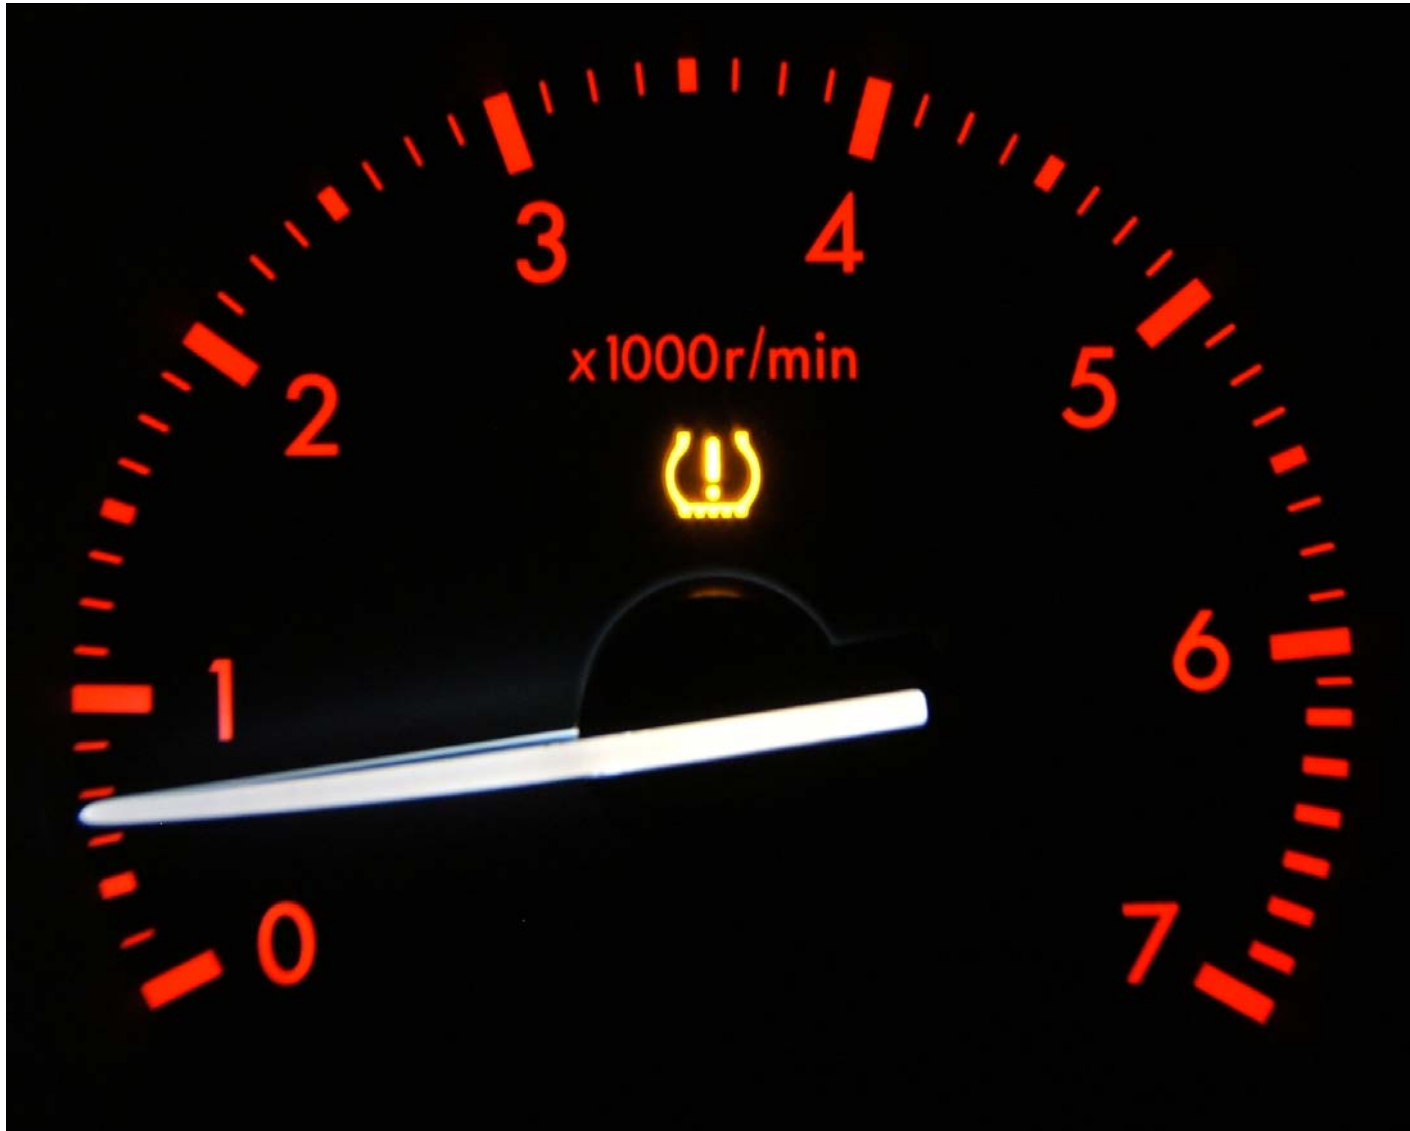
FIGURE 5.10
DISPLAY SHOWING COMBINATION LOW TIRE
PRESSURE WARNING/TPMS MALFUNCTION WARNING TELLTALE

() None () Dedicated Telltale (X) Combination low tire pressure/malfunction telltale

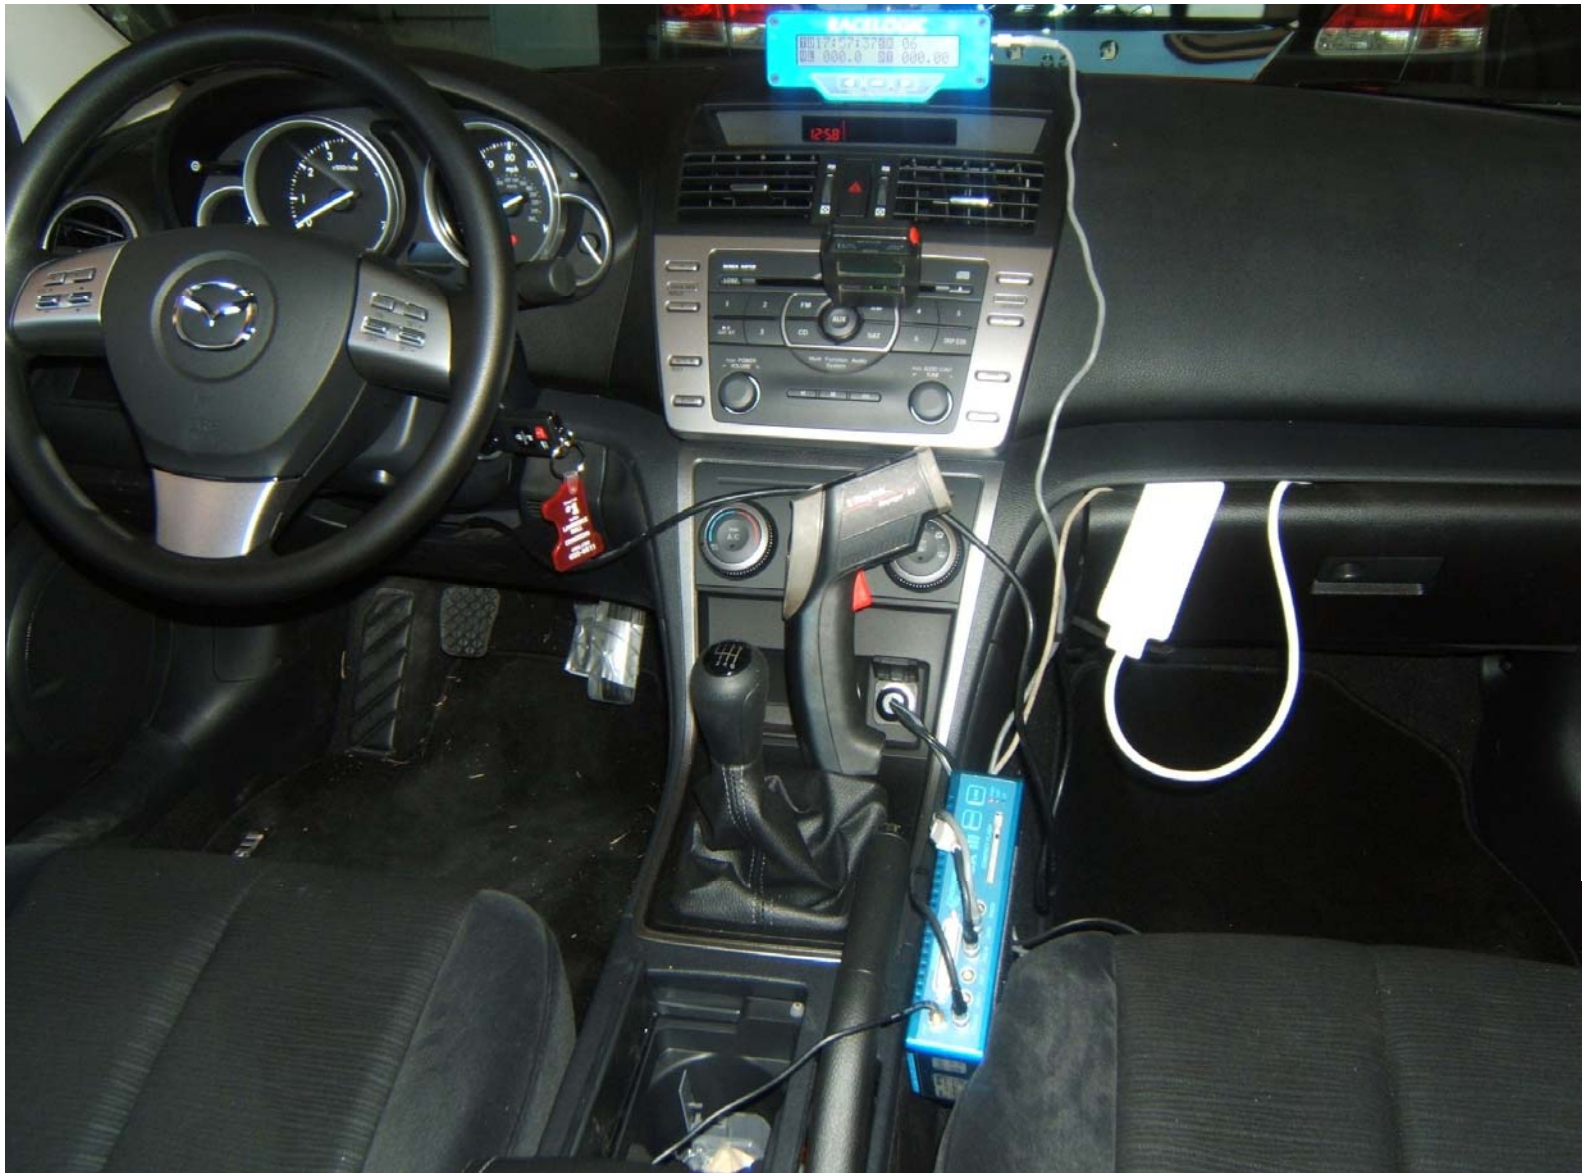
FIGURE 5.11
TEST INSTRUMENTATION INSTALLED IN VEHICLE

The vehicle was instrumented with a Racelogic VBOX III 100 Hz GPS Data Logger and brake pedal trigger. The VBOX uses GPS to measure vehicle speed, time, and distance. Test data were recorded to a compact flash card. During the test, a stopwatch was used to determine the approximate "cumulative driving time" during each test phase. Cumulative driving time does not include time during the brake application or when the vehicle speed was below 50 km/h or above 100 km/h. Upon completion of a tire deflation scenario, graphs were generated by VBOX software showing vehicle speed versus time during the test procedures. The graphs furnish a second by second analysis of each calibration and low inflation pressure detection phase (as appropriate). The cumulative driving time was calculated by post-processing the VBOX graph data, and is reported in Section 3 (Test Data) as 'Total Driving Time'.

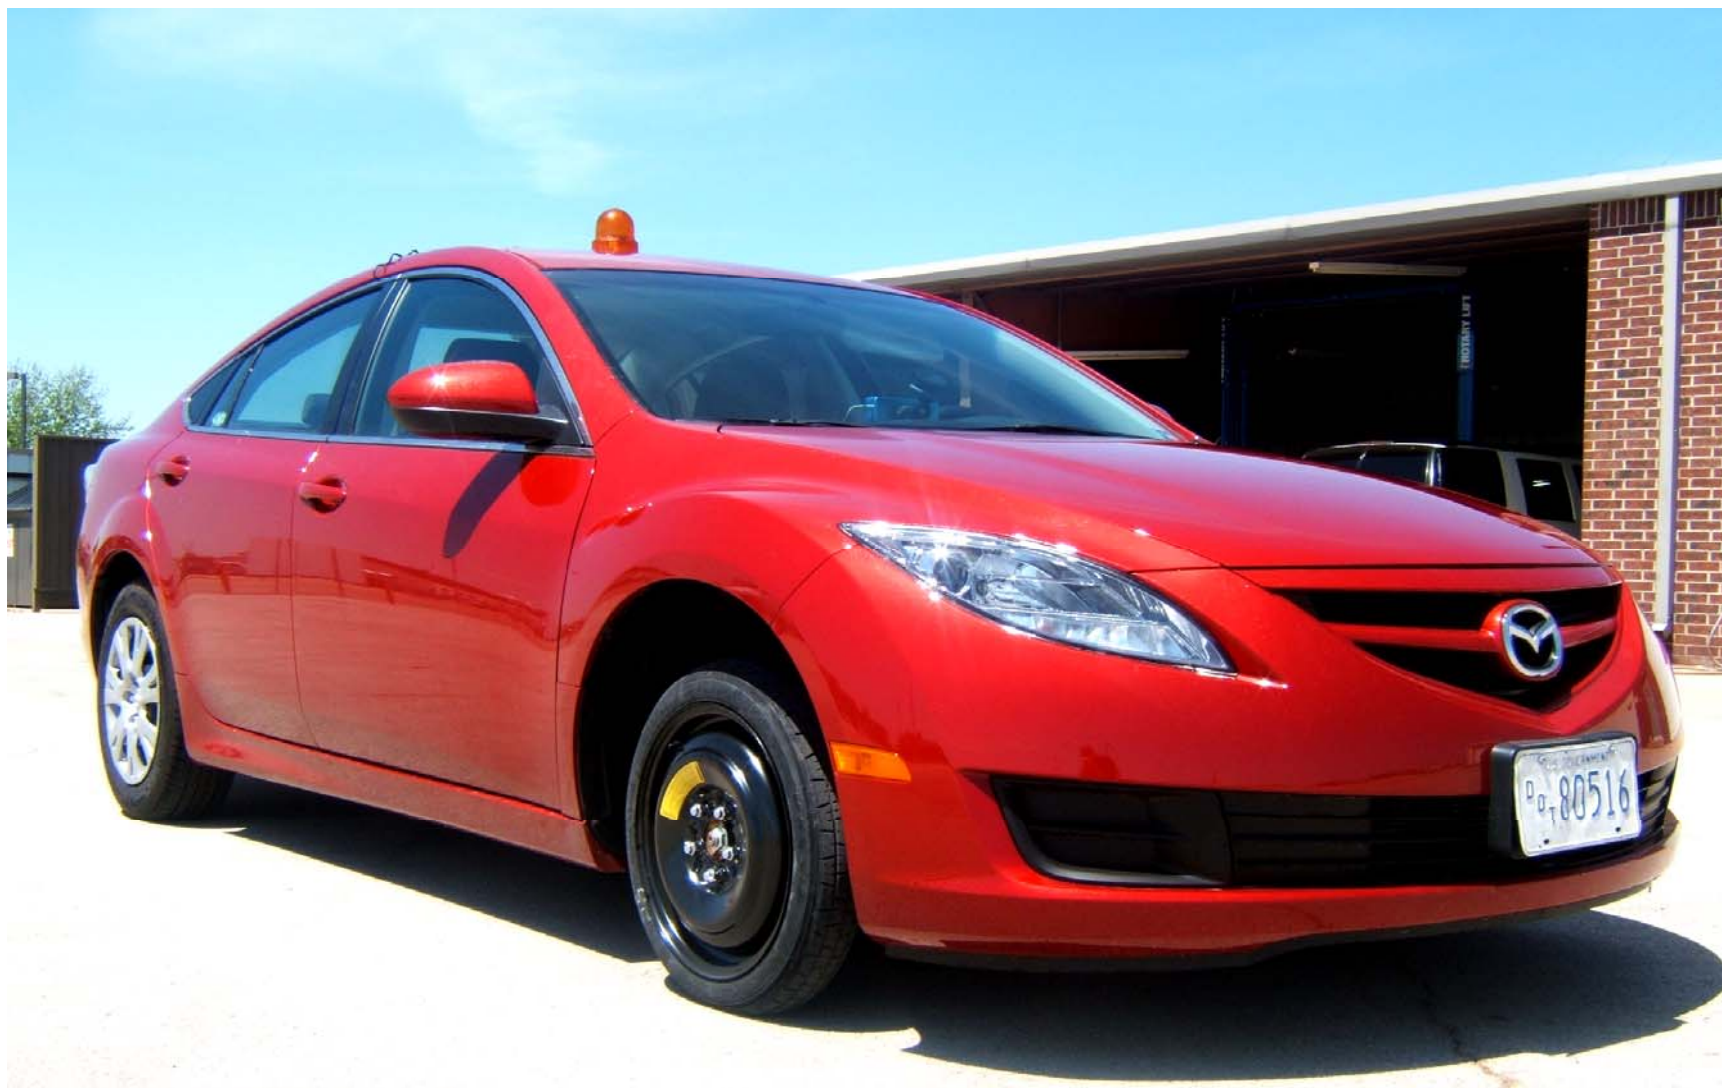
FIGURE 5.16
SPARE INSTALLED ON RIGHT FRONT

Two malfunction scenarios were performed on the Mazda 6. The first scenario was performed with the vehicle loaded to its LLVW. The malfunction was simulated by placing the compact spare tire, with no TPMS sensor, on the right front wheel position. The second scenario was performed by disconnecting the ABS unit wiring harness connector.

- G. Spare tire without TPMS sensor was applied to right front wheel position.

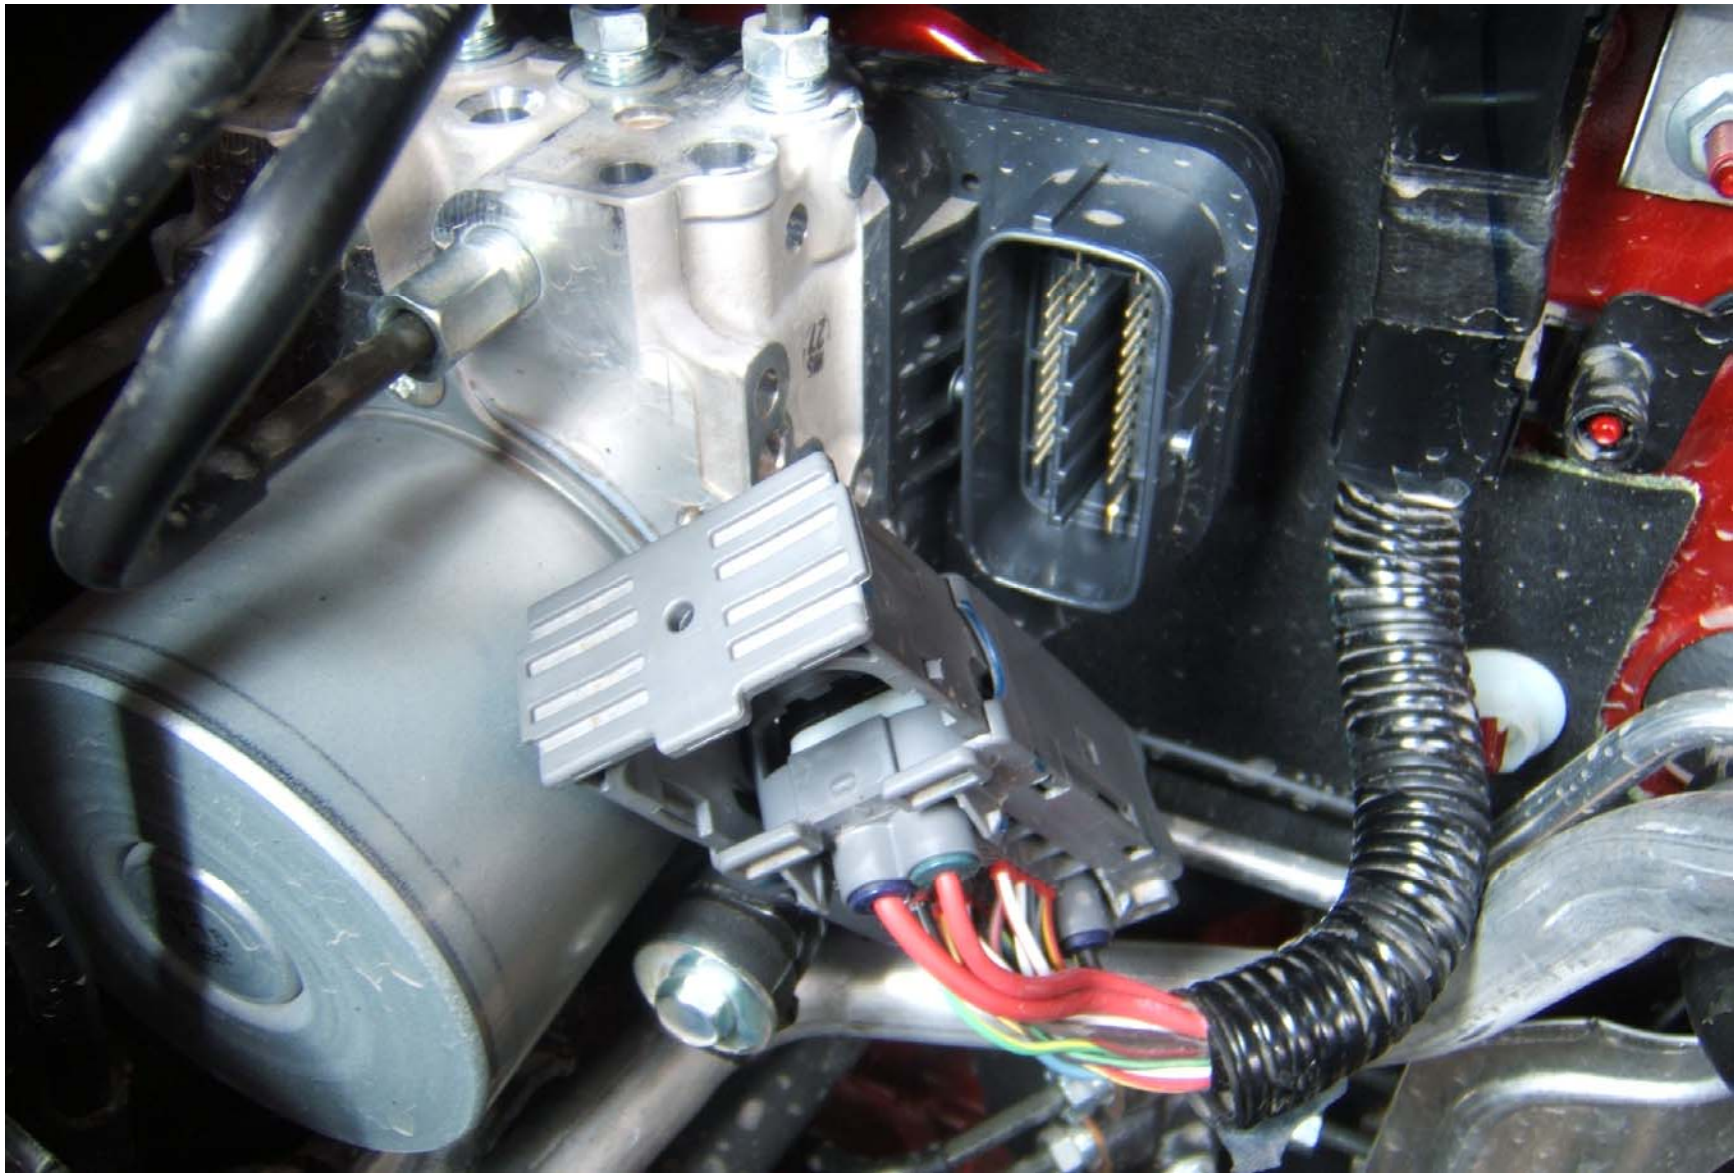
FIGURE 5.17
REMOVAL OF WIRING HARNESS
CONNECTOR FROM UNDER-HOOD ABS UNIT

- H. The wiring harness connector was disconnected from the under-hood ABS unit.

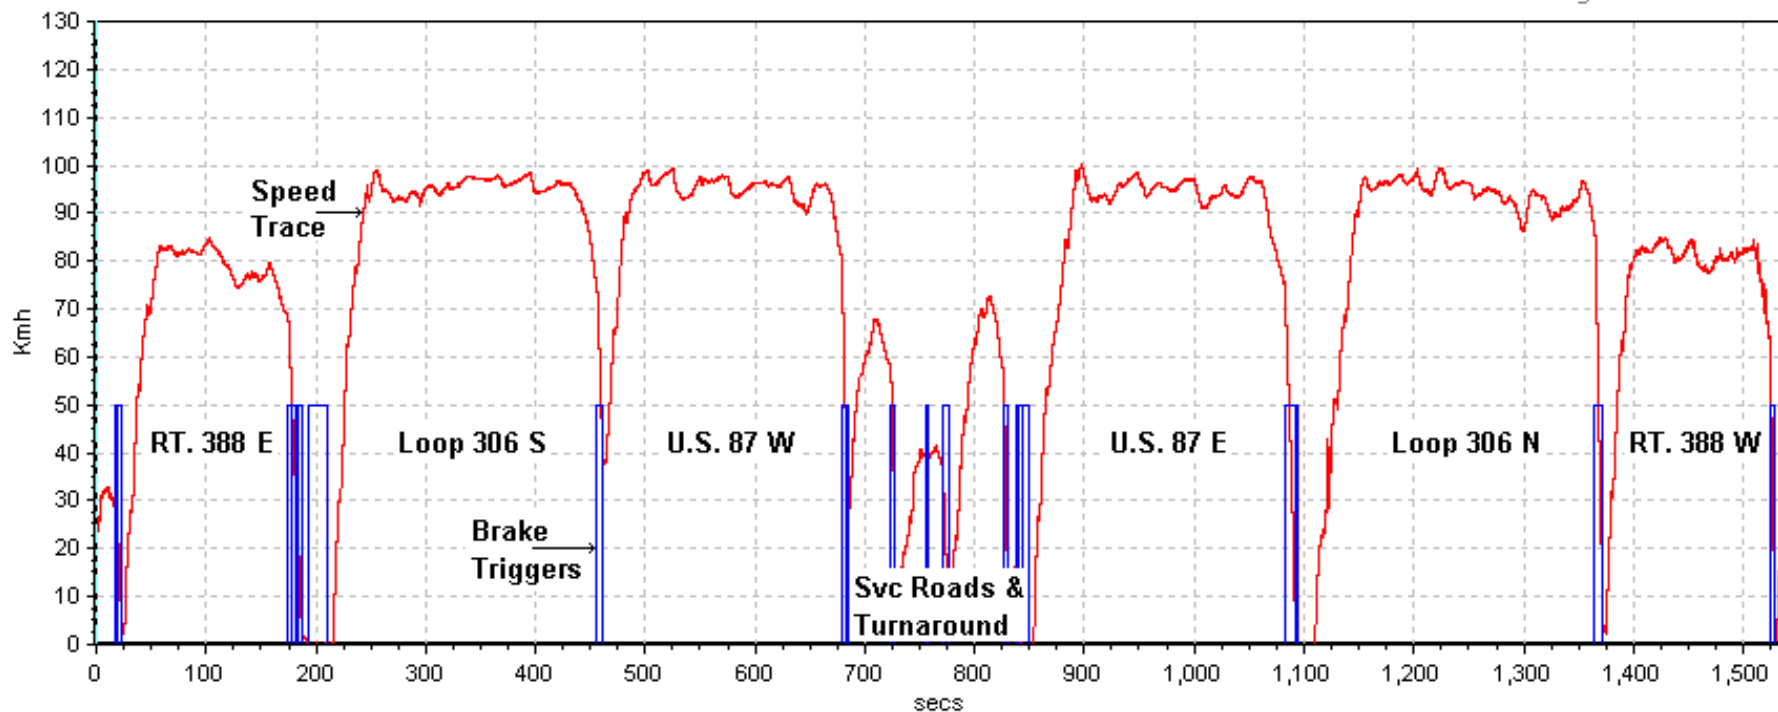
2010 Mazda 6 (CA5402) LR Calibration LLVW

LR Detection Phase: Telltale illuminated in 6 seconds. Driving was not necessary.

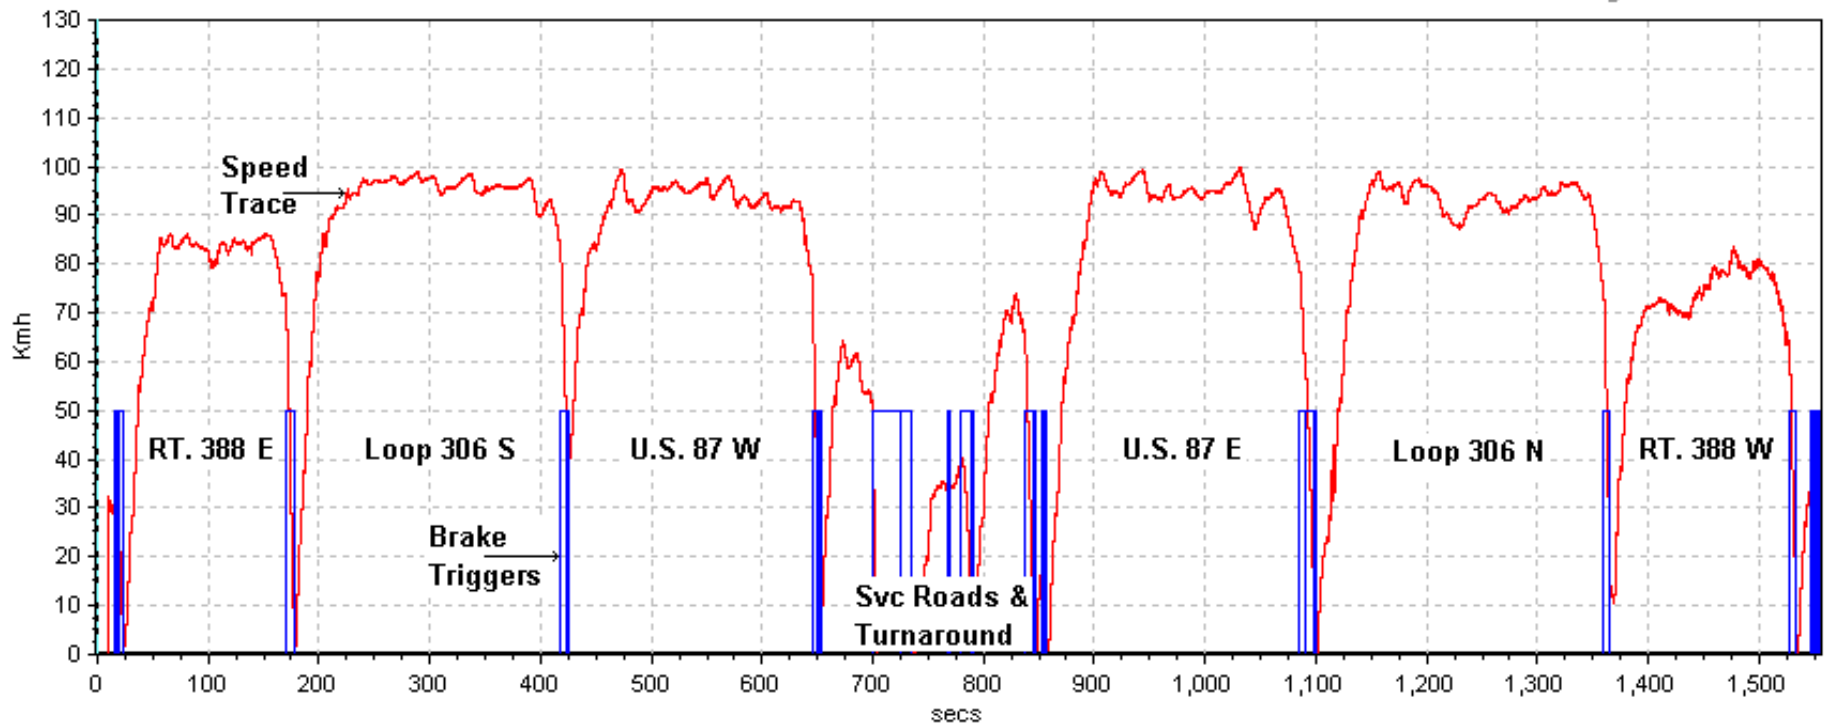
2010 Mazda 6 (CA5402) RR, RF Calibration LLVW

Scenario B: Right Rear, Right Front Tires at LLVW
Test Date: 4/28/10
Data File Time: 25:56 minutes
Cumulative Driving Time: 20:46 minutes
Start Point: GAFB north gate

RR, RF Detection Phase: Telltale illuminated in 35 seconds. Driving was not necessary.

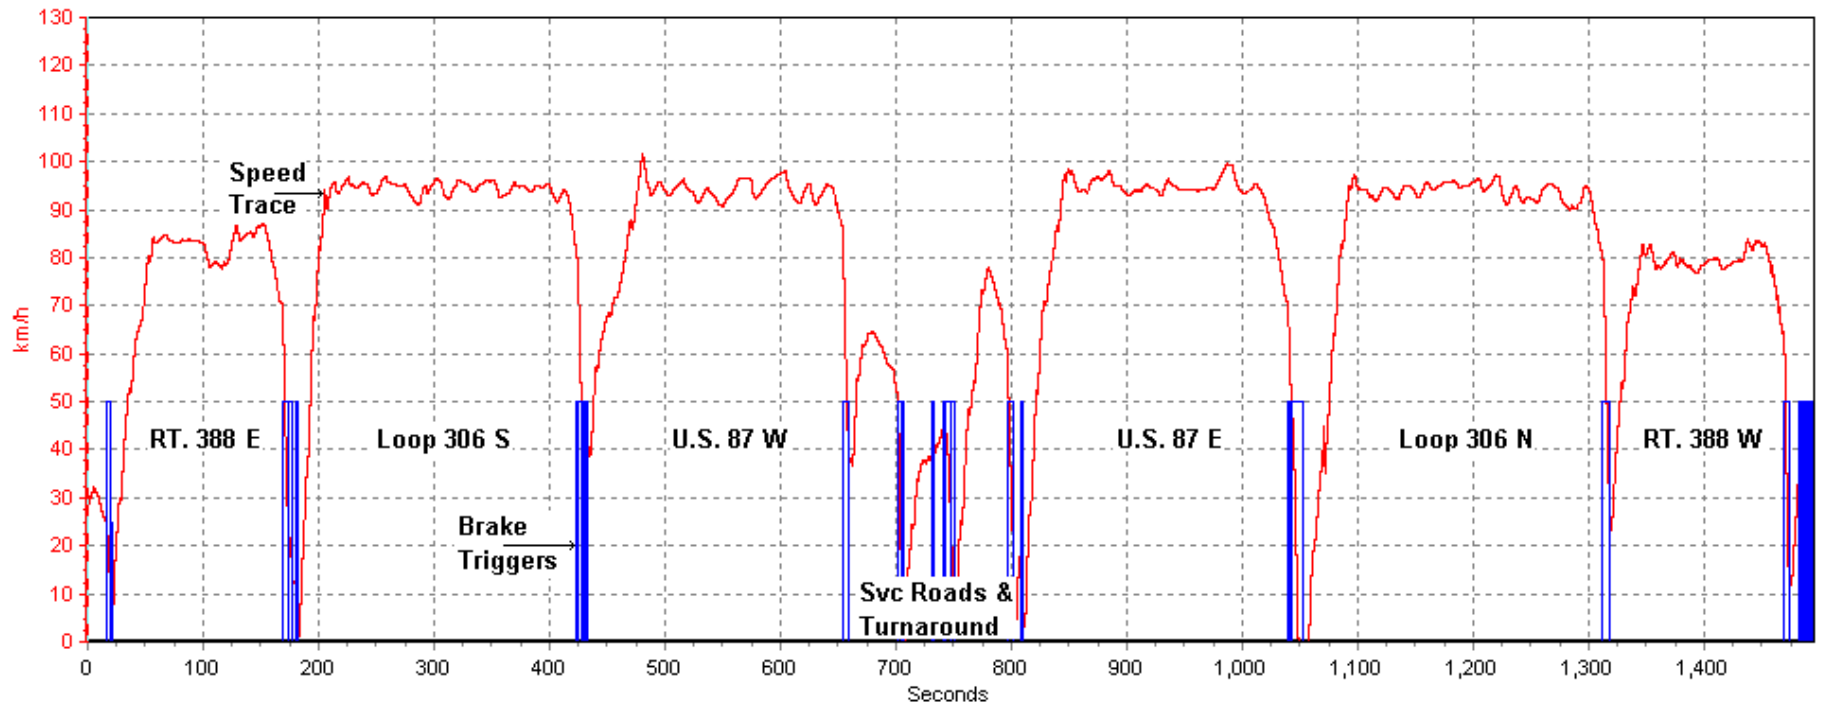
2010 Mazda 6 (CA5402) LF, LR, RR, RF Calibration LLVW

Scenario C: Left Front, Left Rear, Right Rear, Right Front Tires at LLVW
Test Date: 4/29/10
Data File Time: 24:55 minutes
Cumulative Driving Time: 20:43 minutes
Start Point: GAFB north gate

LF, LR, RR, RF Detection Phase: Telltale illuminated in 14 seconds. Driving was not necessary.
