REPORT NUMBER 138-STF-10-004

SAFETY COMPLIANCE TESTING FOR FMVSS NO. 138 TIRE PRESSURE MONITORING SYSTEMS

MAZDA MOTOR CORPORATION
2010 MAZDA 6
FOUR-DOOR PASSENGER CAR
NHTSA NO. CA5402

FINAL REPORT

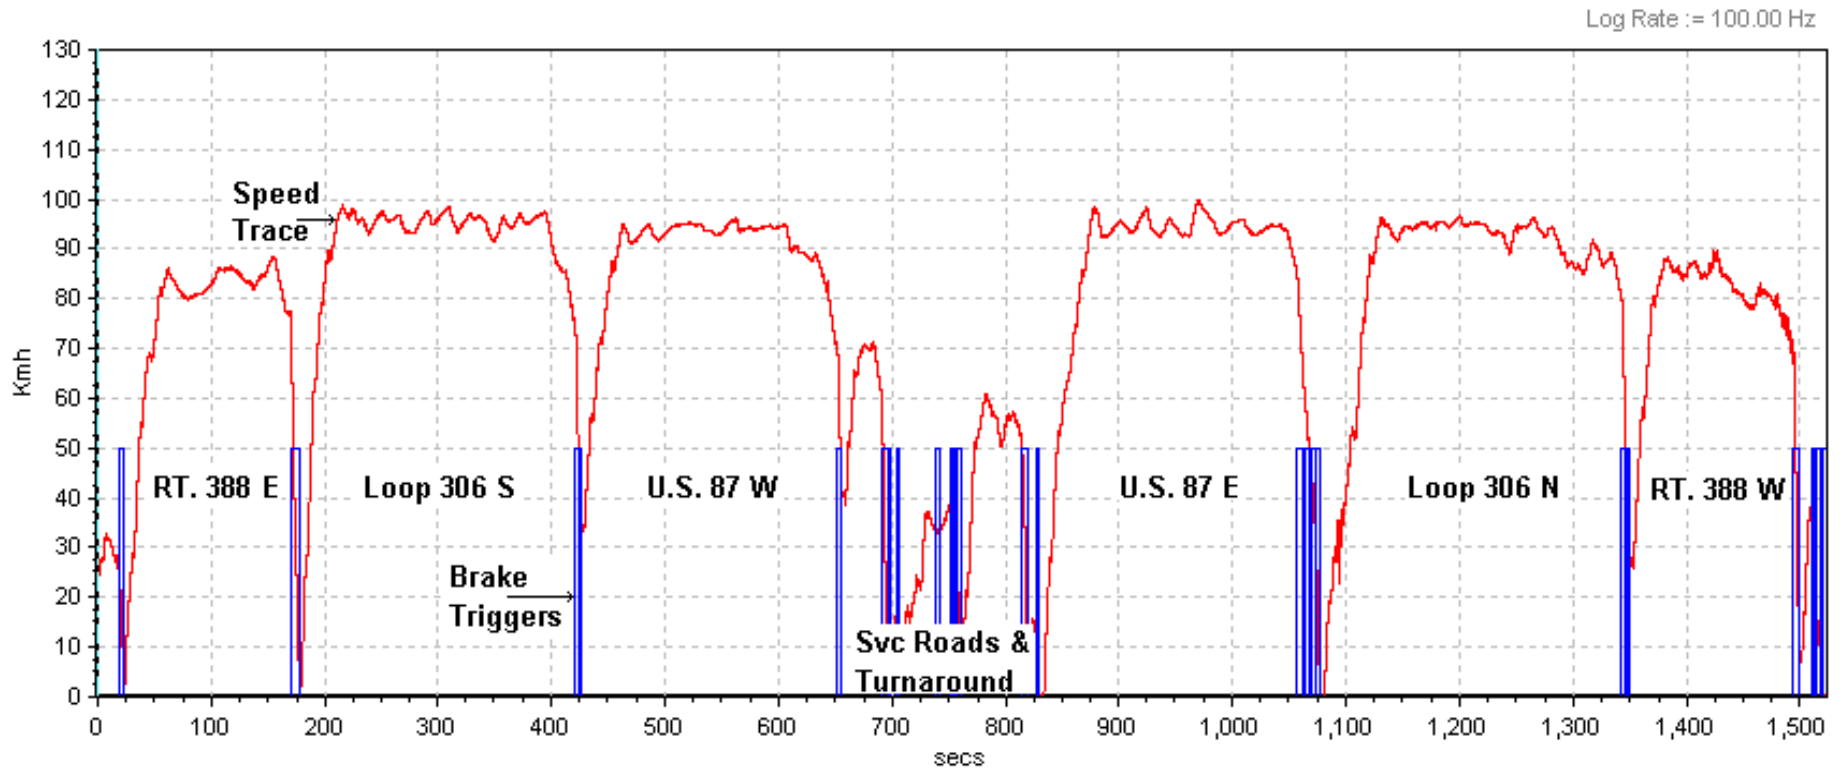
2010 Mazda 6 (CA5402) RF Calibration UWW+VCW

Scenario D: Right Front Tire at UVW + VCW
Test Date: 4/30/10
Data File Time: 25:24 minutes
Cumulative Driving Time: 20:38 minutes
Start Point: GAFB north gate

RF Detection Phase: Telltale illuminated in 7 seconds. Driving was not necessary.

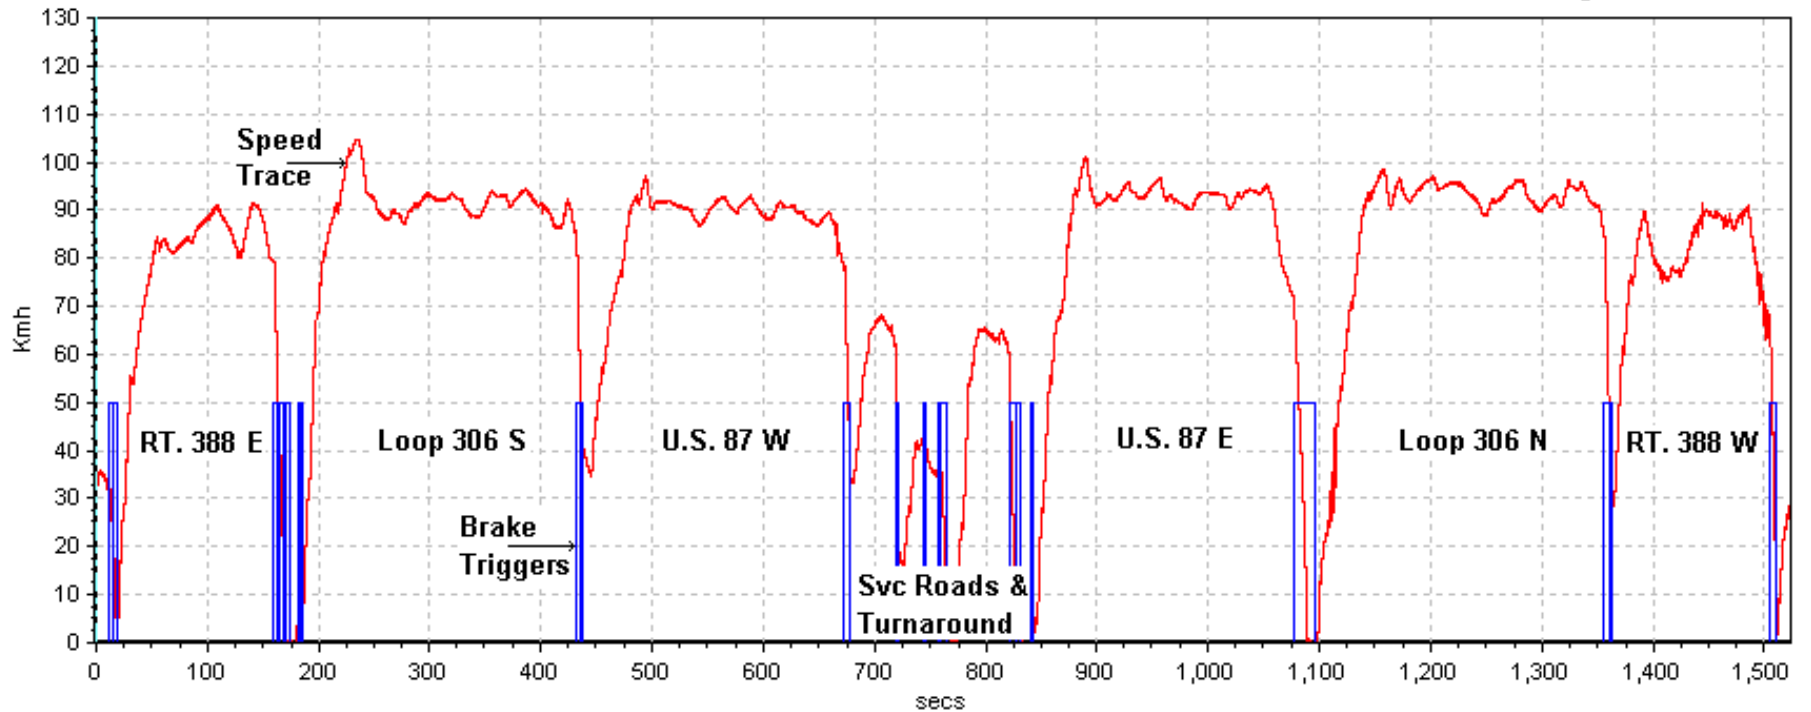
2010 Mazda 6 (CA5402) LR, RR Calibration UVW+VCW

Scenario E: Left Rear, Right Rear Tires at UVW + VCW
Test Date: 4/30/10
Data File Time: 25:24 minutes
Cumulative Driving Time: 20:32 minutes
Start Point: GAFB north gate

LR, RR Detection Phase: Telltale illuminated in 37 seconds. Driving was not necessary.

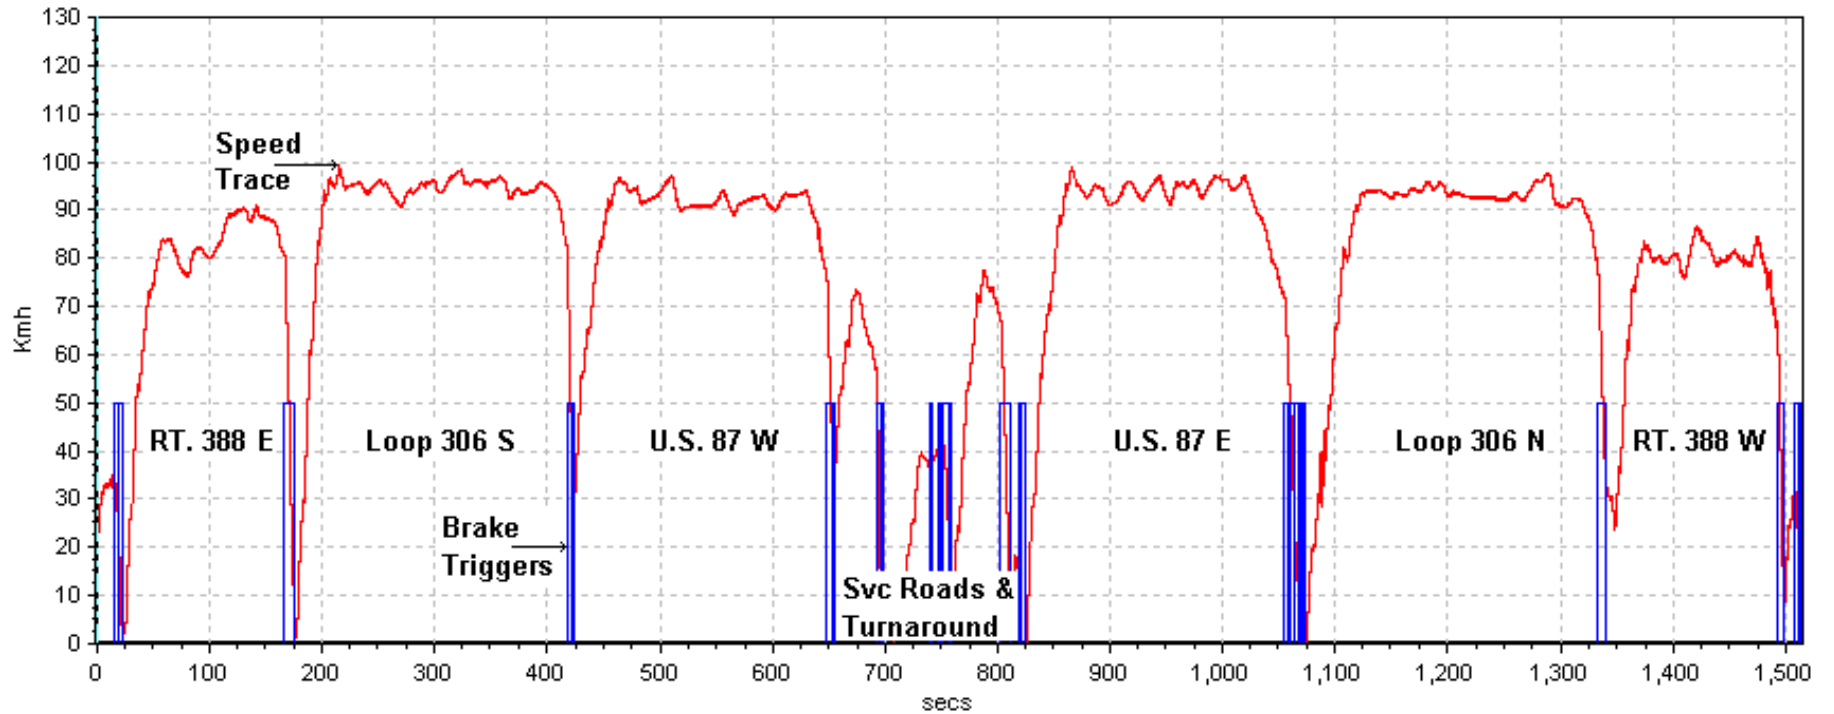
2010 Mazda 6 (CA5402) LF, LR, RR Calibration UVW+VCW

Scenario F: Left Front, Left Rear, Right Rear Tires at UVW + VCW
Test Date: 5/3/10
Data File Time: 25:16 minutes
Cumulative Driving Time: 20:35 minutes
Start Point: GAFB north gate

LF, LR, RR Detection Phase: Telltale illuminated in 13 seconds. Driving was not necessary.

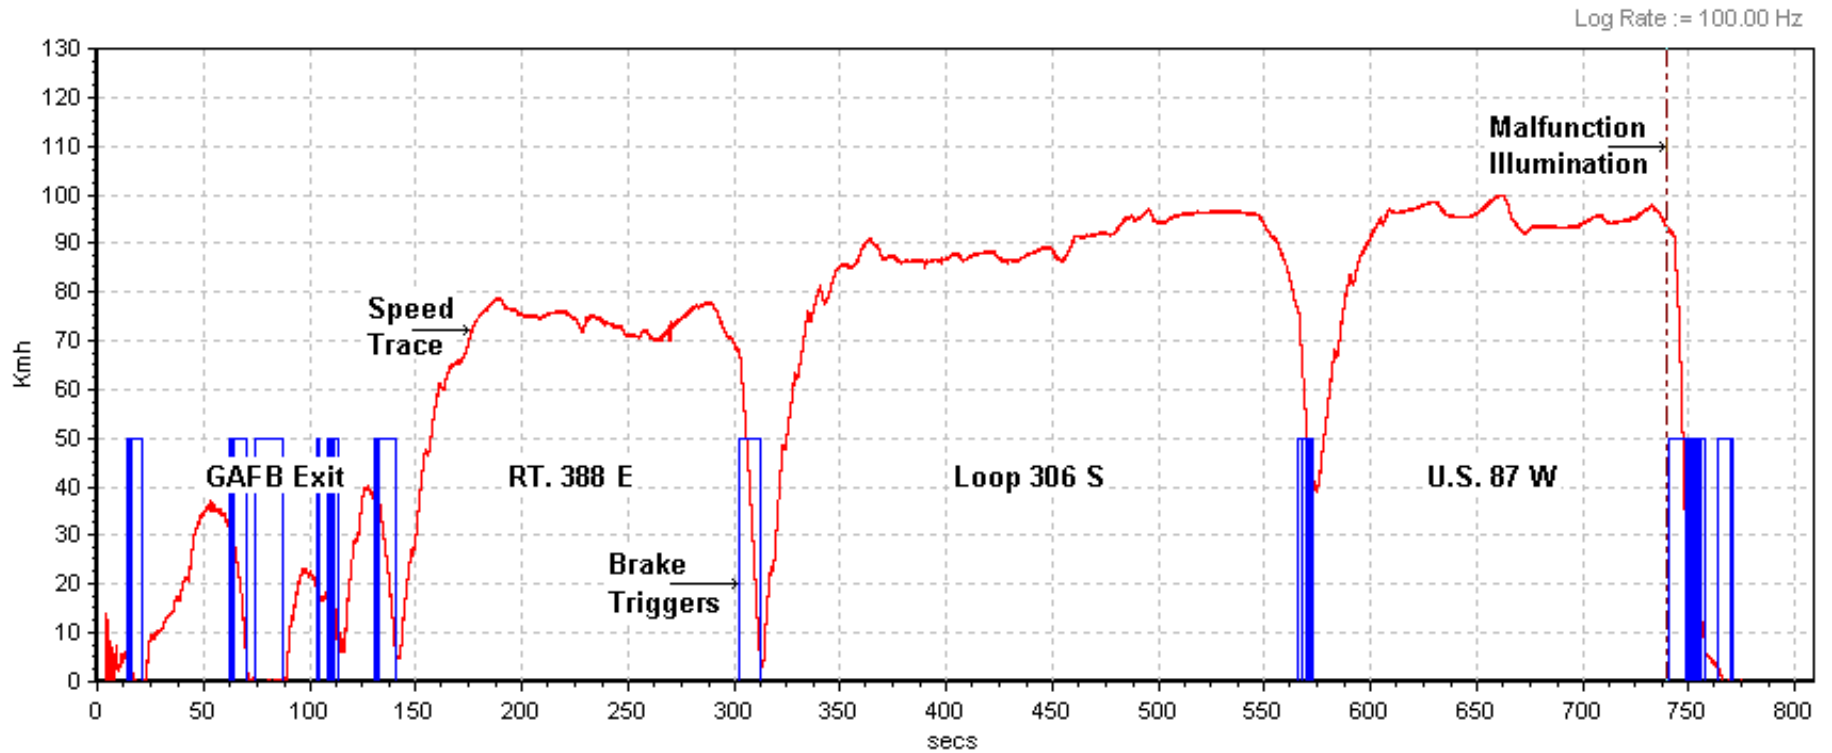
2010 Mazda 6 (CA5402) RF Spare Tire Malfunction Illumination LLVW

Scenario G: Malfunction Detection Test at LLVW
Test Date: 4/28/10
Data File Time: 13:29 minutes
Cumulative Driving Time: 9:08 minutes
Start Point: San Angelo Test Facility shop
