**SAFETY COMPLIANCE TESTING FOR FMVSS 201  
OCCUPANT PROTECTION IN INTERIOR IMPACT  
UPPER INTERIOR HEAD IMPACT PROTECTION**

**HONDA OF AMERICA MANUFACTURING COMPANY, INC.  
2010 Honda Crosstour**

NHTSA NUMBER: CA5303

FINAL REPORT

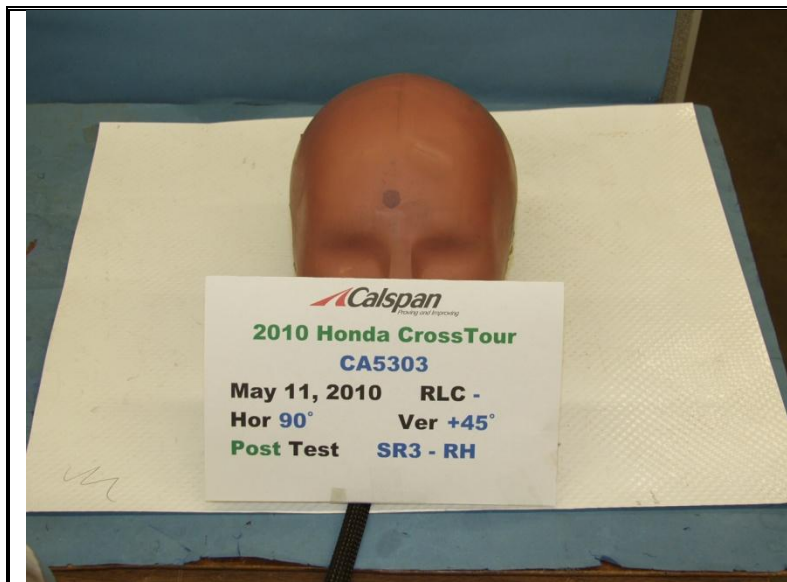
POST-IMPACT SR3 RH HEADFORM

Test Number:	01
Test Date:	11 May 2010
Target Location:	SR3 RH
Target Code:	SR3 RH
Horizontal Impact Angle:	90
Vertical Impact Angle:	45
Ambient Temperature:	20
Relative Humidity:	27.4%
Time of Impact:	10:43
Headform Number:	1142

Impact Point Description (from lower midpoint on midsagittal line)					
On Centerline	3	<input checked="" type="checkbox"/>	mm right	<input type="checkbox"/>	mm left
On Centerline	5				mm up

Free Motion HIC	169.4
HIC(d)	294.2
Impact Velocity (kph)	18.84
HIC T1 (msec)	1.9
HIC T2 (msec)	13.7

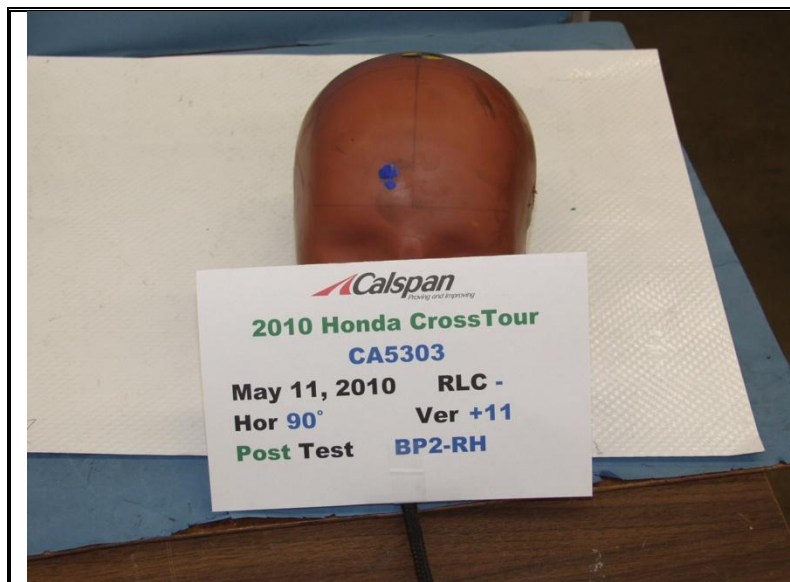
POST-IMPACT BP2 RH HEADFORM

Test Number:	02
Test Date:	11 May 2010
Target Location:	BP2 RH
Target Code:	BP2 RH
Horizontal Impact Angle:	90
Vertical Impact Angle:	11
Ambient Temperature:	21
Relative Humidity:	27.7%
Time of Impact:	11:27
Headform Number:	0355

Impact Point Description (from lower midpoint on midsagittal line)					
On Centerline	13	<input checked="" type="checkbox"/>	mm right	<input type="checkbox"/>	mm left
On Centerline	16				mm up

Free Motion HIC	598.6
HIC(d)	618.0
Impact Velocity (kph)	2.37
HIC T1 (msec)	2.1
HIC T2 (msec)	10.2

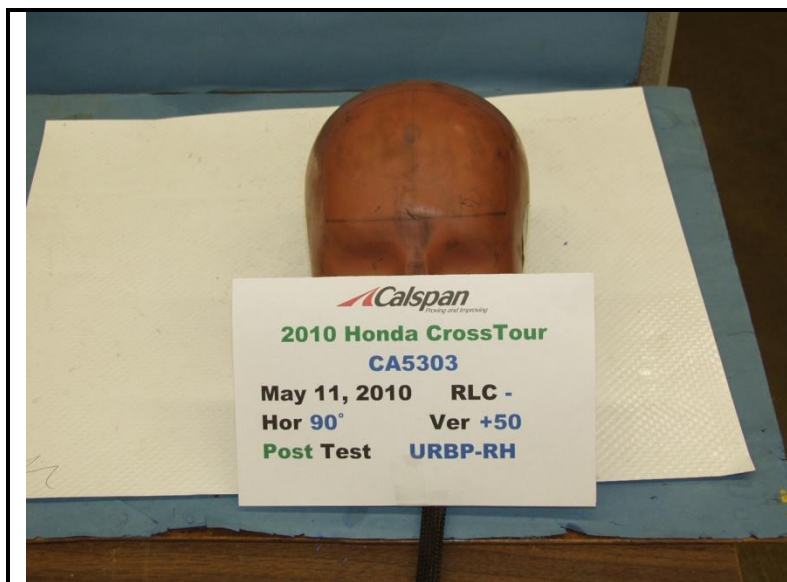
POST-IMPACT URBP RH HEADFORM

Test Number:	03
Test Date:	11 May 2010
Target Location:	URBP RH
Target Code:	URBP RH
Horizontal Impact Angle:	90
Vertical Impact Angle:	50
Ambient Temperature:	21
Relative Humidity:	27.5 %
Time of Impact:	12:12
Headform Number:	0062

Impact Point Description (from lower midpoint on midsagittal line)			
On Centerline	2	<input checked="" type="checkbox"/> mm right	<input type="checkbox"/> mm left
On Centerline	54	mm up

Free Motion HIC	319.2
HIC(d)	407.2
Impact Velocity (kph)	23.88
HIC T1 (msec)	3.8
HIC T2 (msec)	14.0

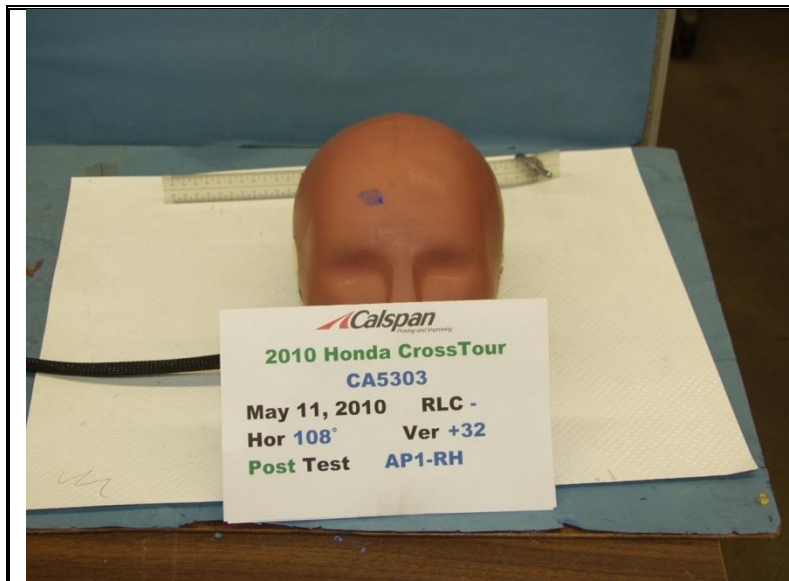
POST-IMPACT AP1 RH HEADFORM

Test Number:	05
Test Date:	11 May 2010
Target Location:	AP1 RH
Target Code:	AP1 RH
Horizontal Impact Angle:	108
Vertical Impact Angle:	32
Ambient Temperature:	21
Relative Humidity:	26.7%
Time of Impact:	2.48
Headform Number:	1142

Impact Point Description (from lower midpoint on midsagittal line)					
On Centerline	16	<input checked="" type="checkbox"/>	mm right	<input type="checkbox"/>	mm left
On Centerline	17				mm up

Free Motion HIC	374.8
HIC(d)	449.2
Impact Velocity (kph)	18.48
HIC T1 (msec)	4.6
HIC T2 (msec)	10.8

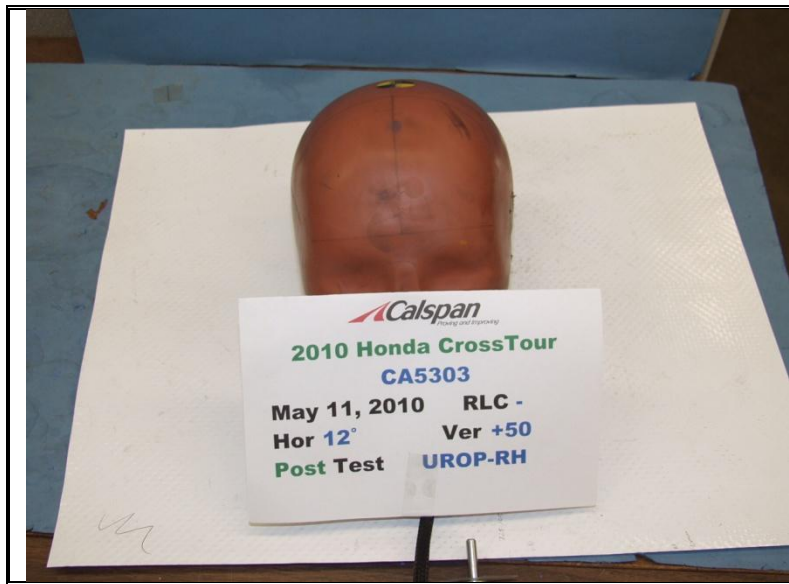
POST-IMPACT UROP RH HEADFORM

Test Number:	06
Test Date:	11 May 2010
Target Location:	UROP RH
Target Code:	UROP RH
Horizontal Impact Angle:	12
Vertical Impact Angle:	50
Ambient Temperature:	21
Relative Humidity:	27.0%
Time of Impact:	3:23
Headform Number:	0355

Impact Point Description (from lower midpoint on midsagittal line)			
On Centerline	-2	<input type="checkbox"/>	mm right <input checked="" type="checkbox"/> mm left
On Centerline	66		mm up

Free Motion HIC	129.7
HIC(d)	264.3
Impact Velocity (kph)	23.57
HIC T1 (msec)	3.4
HIC T2 (msec)	29.6

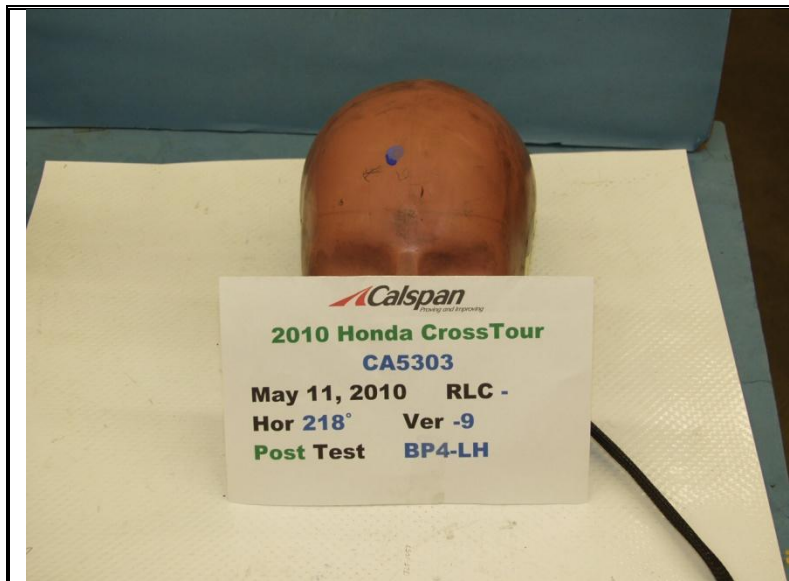
POST-IMPACT BP4 LH HEADFORM

Test Number:	08
Test Date:	11 May 2010
Target Location:	BP4 LH
Target Code:	BP4 LH
Horizontal Impact Angle:	218
Vertical Impact Angle:	-9
Ambient Temperature:	22
Relative Humidity:	25.4%
Time of Impact:	5:08
Headform Number:	0805

Impact Point Description (from lower midpoint on midsagittal line)					
On Centerline	9	<input checked="" type="checkbox"/>	mm right	<input type="checkbox"/>	mm left
On Centerline	35				mm up

Free Motion HIC	476.7
HIC(d)	526.0
Impact Velocity (kph)	23.35
HIC T1 (msec)	6.0
HIC T2 (msec)	10.3

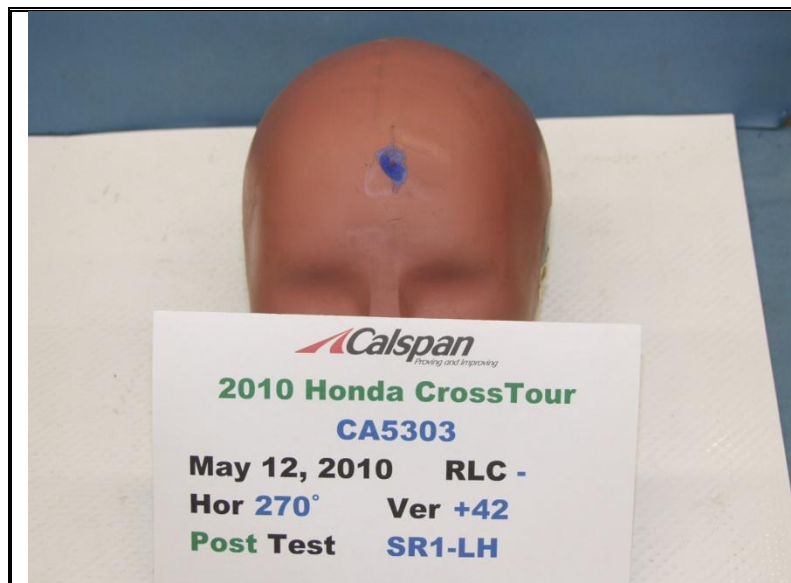
POST-IMPACT SR1 LH HEADFORM

Test Number:	10
Test Date:	12 May 2010
Target Location:	SR1 LH
Target Code:	SR1 LH
Horizontal Impact Angle:	270
Vertical Impact Angle:	42
Ambient Temperature:	21
Relative Humidity:	32.4%
Time of Impact:	10:37
Headform Number:	1142

Impact Point Description (from lower midpoint on midsagittal line)			
On Centerline	-8	<input type="checkbox"/>	mm right <input checked="" type="checkbox"/> mm left
On Centerline	29		mm up

Free Motion HIC	189.2
HIC(d)	309.2
Impact Velocity (kph)	18.54
HIC T1 (msec)	2.5
HIC T2 (msec)	11.2

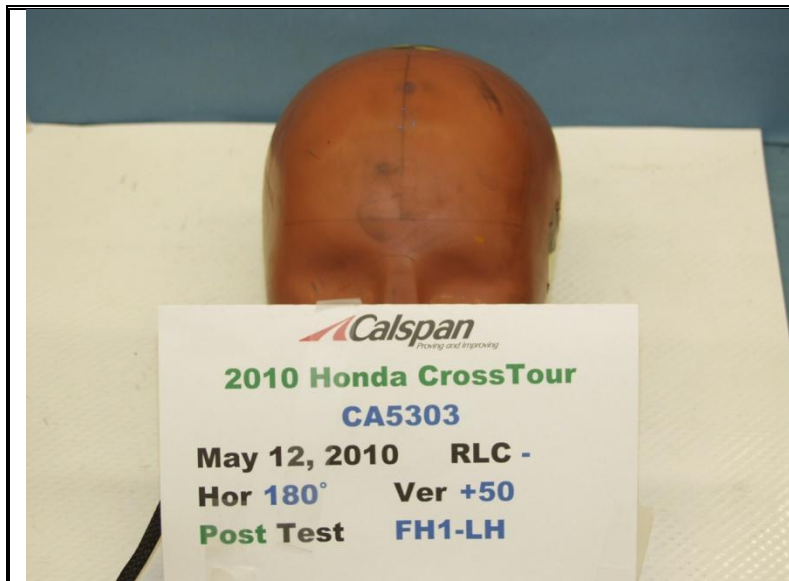
POST-IMPACT FH1 LH HEADFORM

Test Number:	11
Test Date:	12 May 2010
Target Location:	FH1 LH
Target Code:	FH1 LH
Horizontal Impact Angle:	180
Vertical Impact Angle:	50
Ambient Temperature:	21
Relative Humidity:	33.5%
Time of Impact:	11:07
Headform Number:	0355

Impact Point Description (from lower midpoint on midsagittal line)			
On Centerline	-1	<input type="checkbox"/>	mm right <input checked="" type="checkbox"/> mm left
On Centerline	46		mm up

Free Motion HIC	567.6
HIC(d)	594.7
Impact Velocity (kph)	23.51
HIC T1 (msec)	1.7
HIC T2 (msec)	12.6

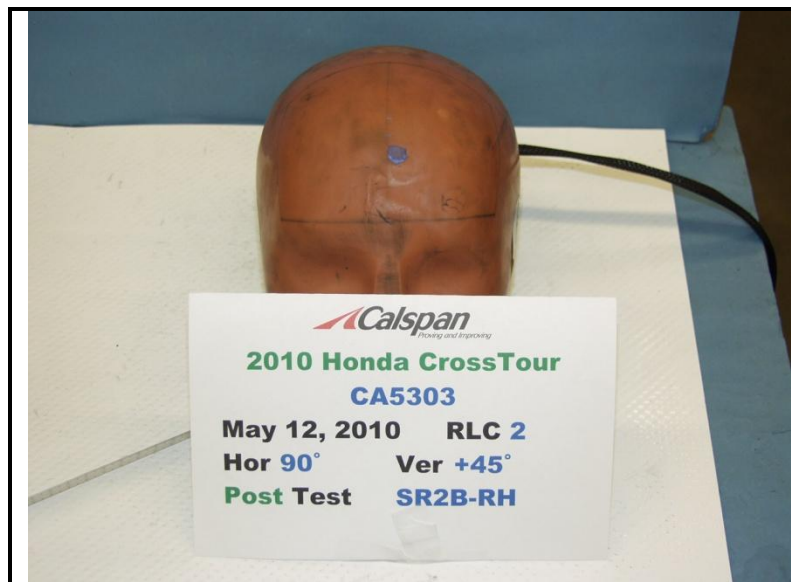
POST-IMPACT SR2B RH HEADFORM

Test Number:	12
Test Date:	12 May 2010
Target Location:	SR2B RH Relocated x2
Target Code:	SR2B RH
Horizontal Impact Angle:	90
Vertical Impact Angle:	45
Ambient Temperature:	21
Relative Humidity:	33.8%
Time of Impact:	12:05
Headform Number:	0062

Impact Point Description (from lower midpoint on midsagittal line)			
On Centerline	-5	<input type="checkbox"/>	mm right <input checked="" type="checkbox"/> mm left
On Centerline	32		mm up

Free Motion HIC	217.1
HIC(d)	330.2
Impact Velocity (kph)	18.96
HIC T1 (msec)	3.5
HIC T2 (msec)	15.8
