REPORT NUMBER: 221-MGA-2009-001

**SAFETY COMPLIANCE TESTING FOR
FMVSS NO.: 221
SCHOOL BUS BODY JOINT STRENGTH**

**IC CORPORATION
2009 IC RE300 SCHOOL BUS
NHTSA NO.: C90900**

**PREPARED BY:
MGA RESEARCH CORPORATION
5000 WARREN ROAD
BURLINGTON, WI 53105**

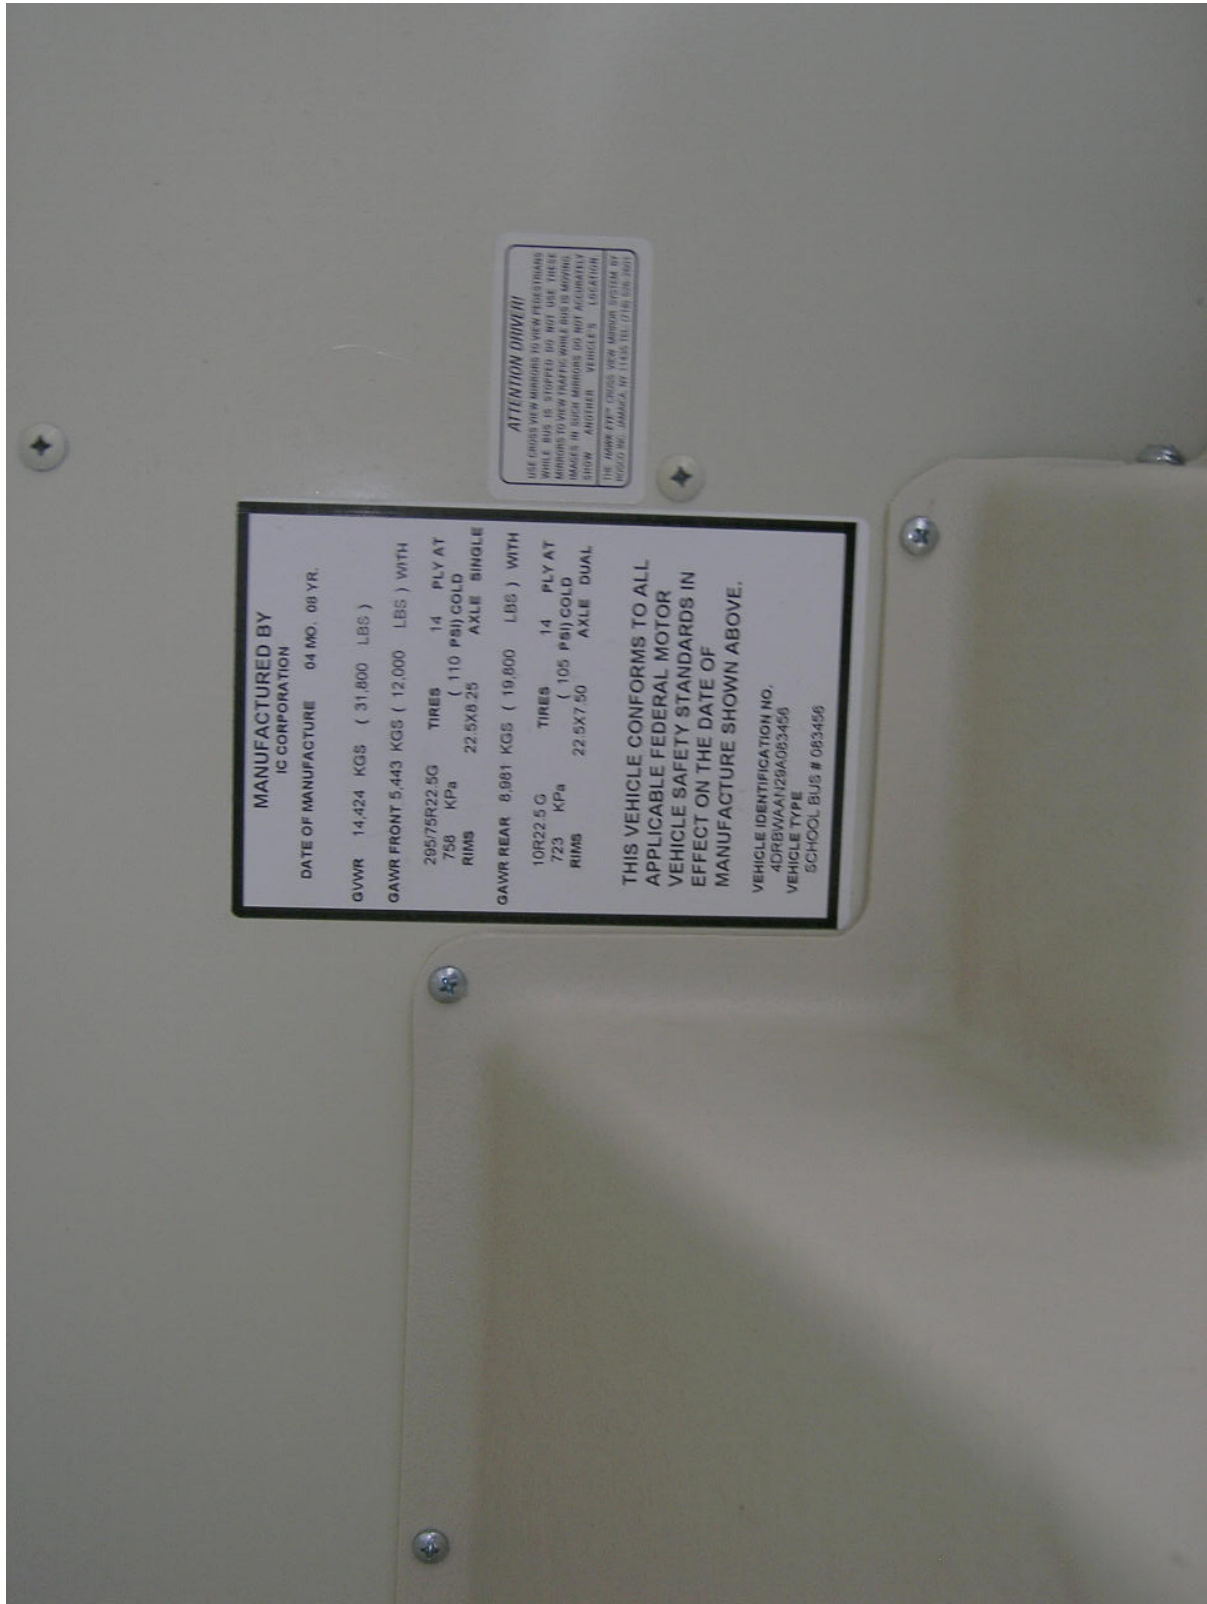
Close up View of Certification Label

GVWR 14,424 KGS (31,800 LBS)
GAWR FRONT 5,443 KGS (12,000 LBS) WITH
295/75R22.5G TIRES 14 PLY AT
758 KPa (110 PSI) COLD
RIMS 22.5X8.25 AXLE SINGLE

GAWR REAR 8,981 KGS (19,800 LBS) WITH
10R22.5G TIRES 14 PLY AT
723 KPa (105 PSI) COLD
RIMS 22.5X7.50 AXLE DUAL

VEHICLE IDENTIFICATION NO.
4DRBWAAN29A083456
VEHICLE TYPE
SCHOOL BUS # 083456

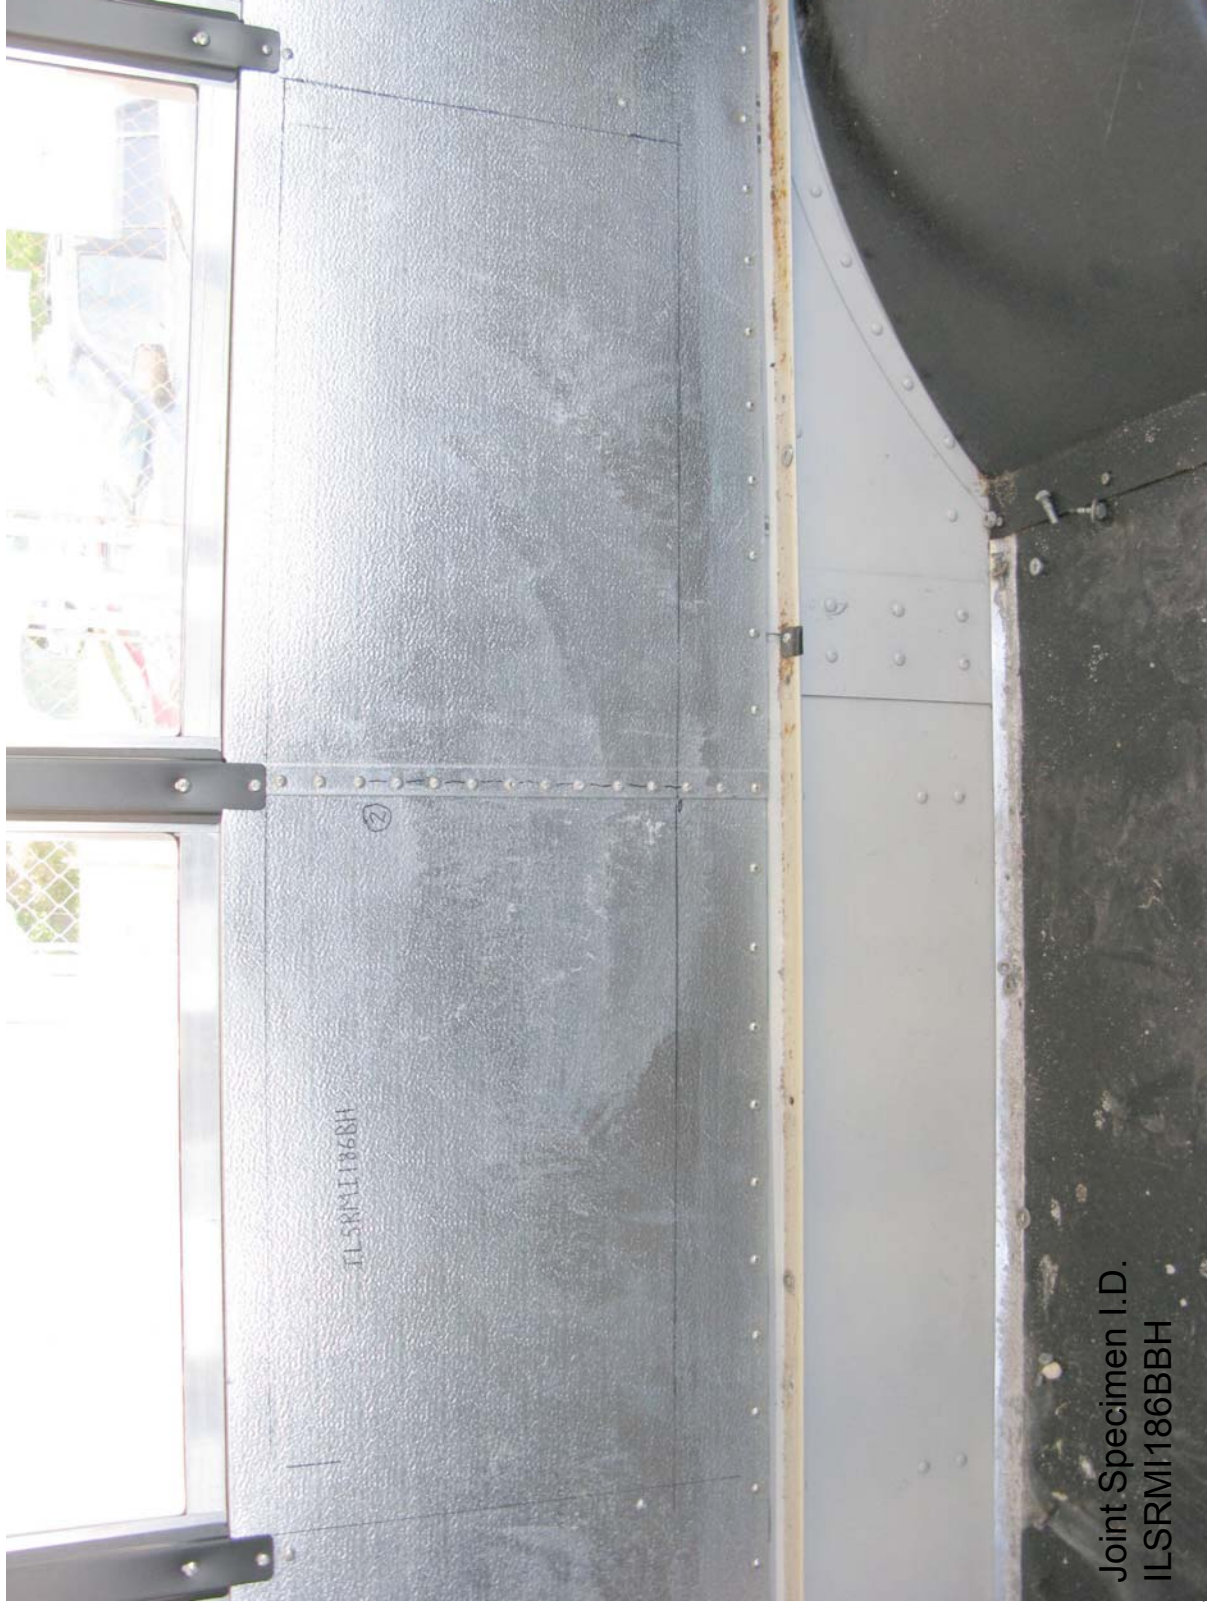
Location of Joint #1

Joint Specimen I.D.
ILSRMI186BBH

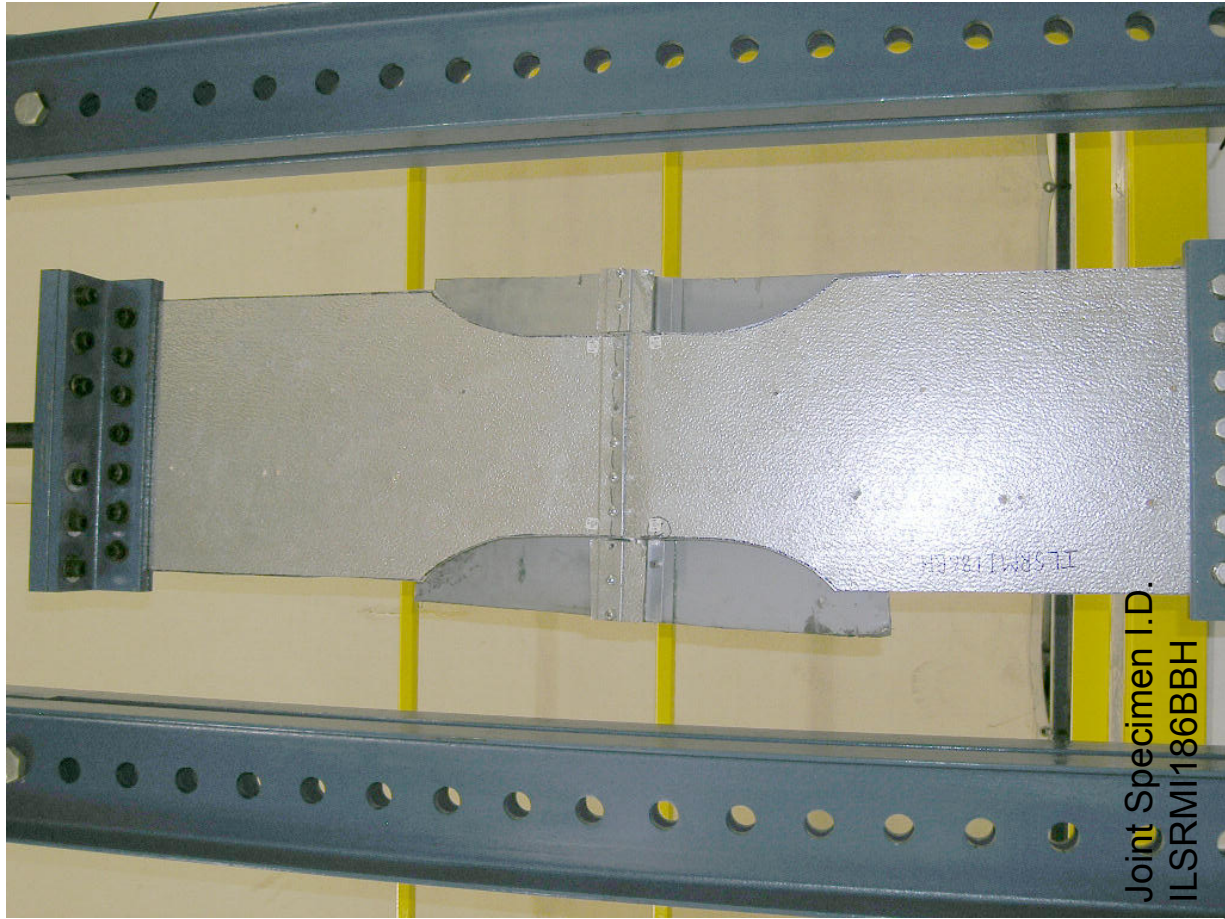
Post-Test of Joint #1

Weaker Member	Stronger Member
Material	ASTM 653, Grade 1008	N/A
Tensile Strength (MPa)	310.3	N/A
Gage/Thickness (mm)	22 / 0.762	N/A
Fastener Holes (No./Diameter – mm.)	6 / 4.39	N/A
Net Area (Sq. mm.)	134.7	N/A
Material Strength (N)	41,807.5	N/A
60% of Material Strength (N)	25,084.5	N/A
Maximum Load From Tensile Test of Joint (N)	28,538.0	N/A
PASS/FAIL	PASS	N/A

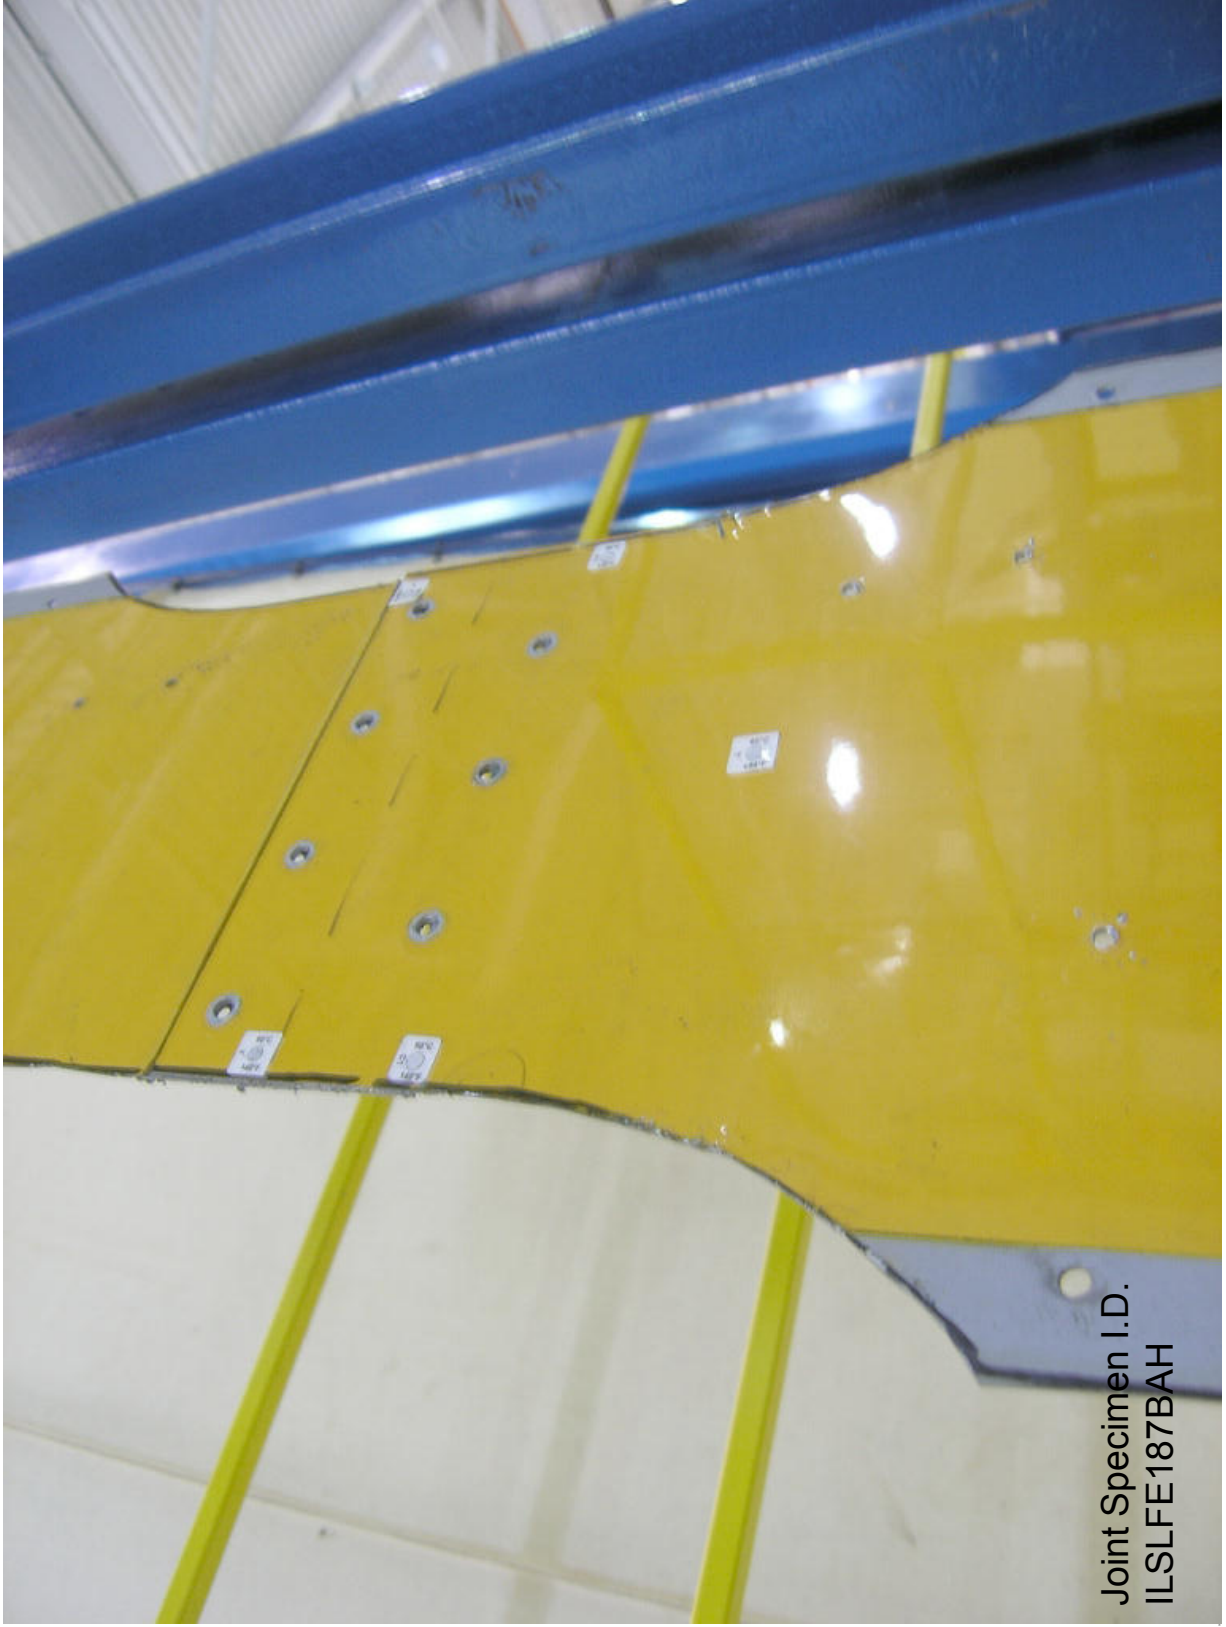
Post-Test of Joint #2

Weaker Member	Stronger Member
Material	ASTM 653, Grade 1008	N/A
Tensile Strength (MPa)	310.3	N/A
Gage/Thickness (mm)	16 / 1.524	N/A
Fastener Holes (No./Diameter – mm.)	7 / 5.16	N/A
Net Area (Sq. mm.)	254.7	N/A
Material Strength (N)	79,015.1	N/A
60% of Material Strength (N)	47,409.0	N/A
Maximum Load From Tensile Test of Joint (N)	49,764.0	N/A
PASS/FAIL	PASS	N/A

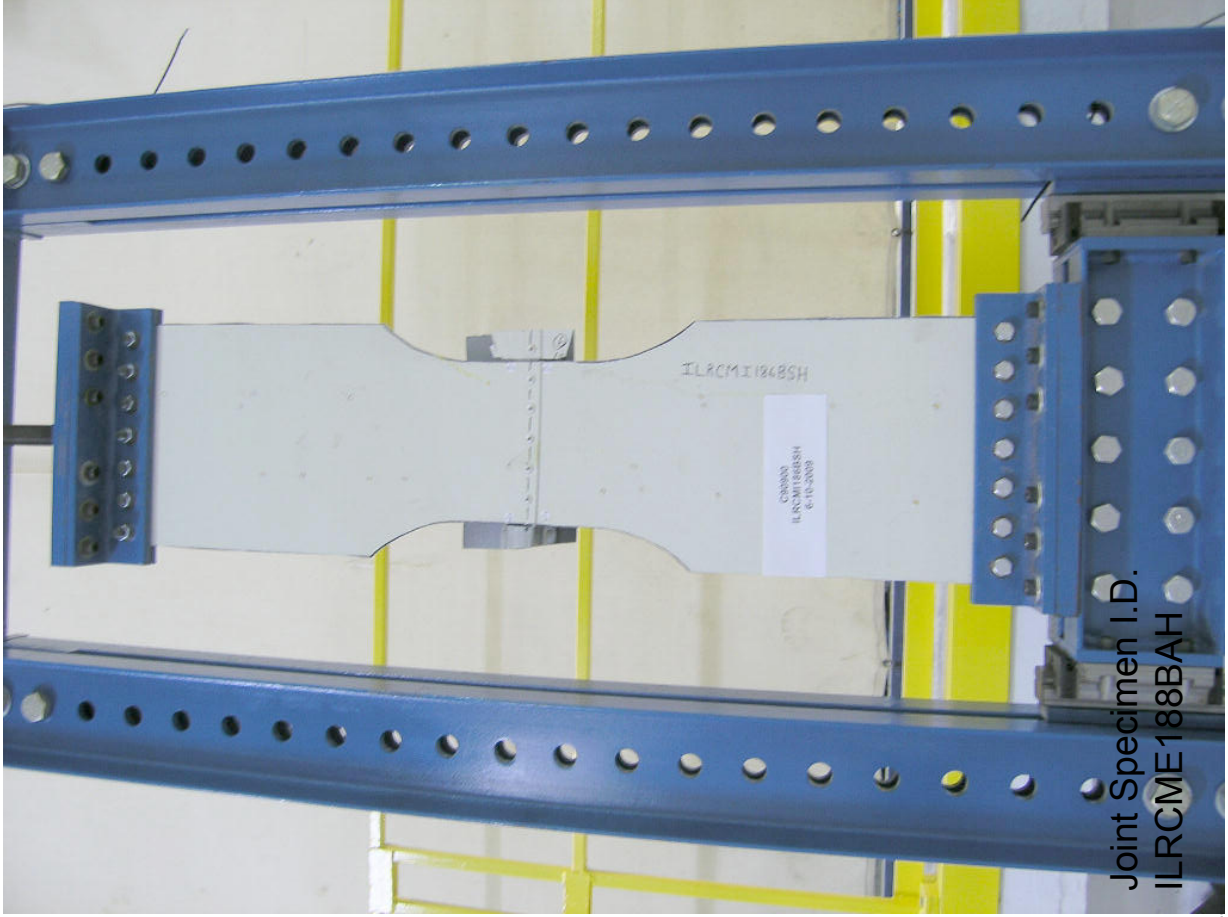
Pre-Test of Joint #3

Joint Specimen I.D.
ILRCME188BAH

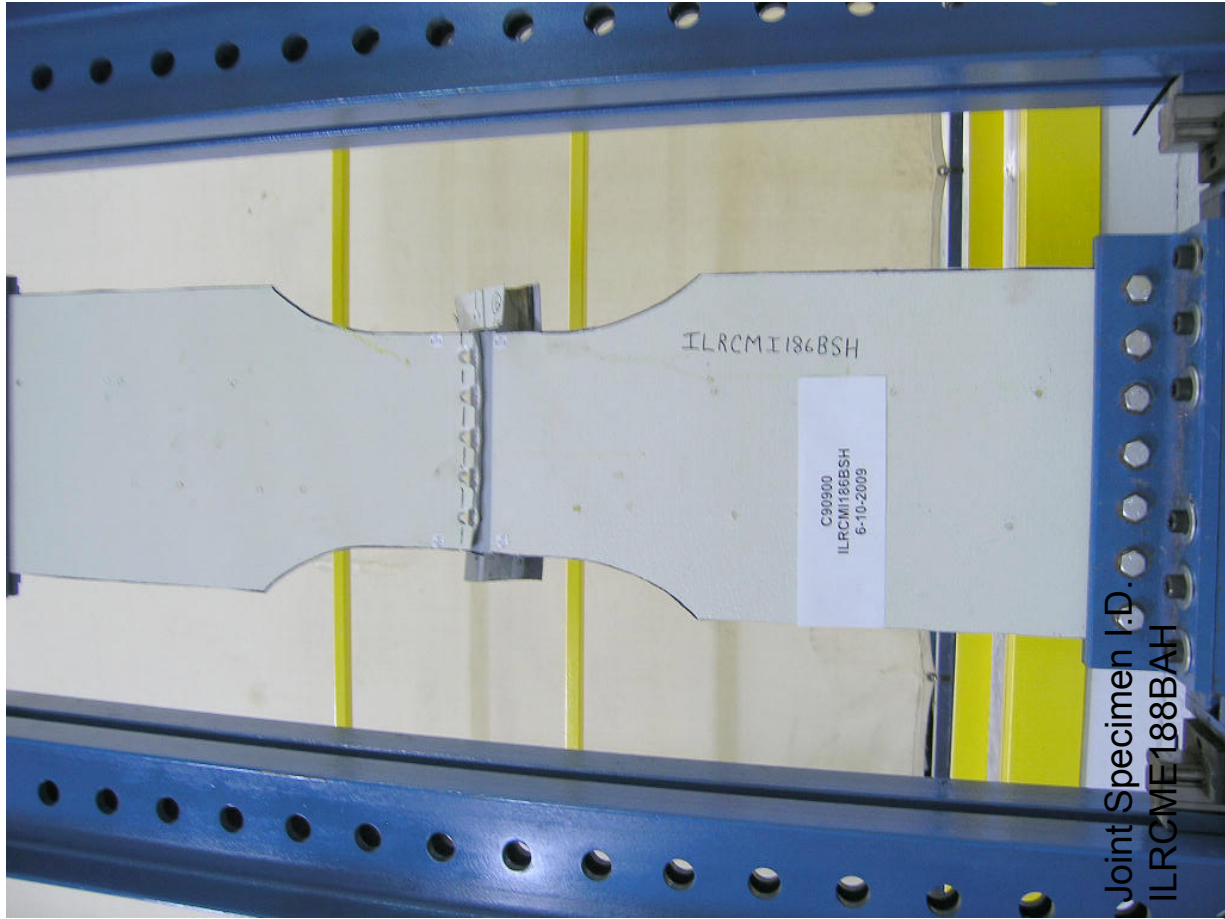
Post-Test of Joint #3

Weaker Member	Stronger Member
Material	ASTM 653, Grade 1008	N/A
Tensile Strength (MPa)	310.3	N/A
Gage/Thickness (mm)	22 / 0.762	N/A
Fastener Holes (No./Diameter – mm.)	5 / 4.39	N/A
Net Area (Sq. mm.)	138.1	N/A
Material Strength (N)	42,846.4	N/A
60% of Material Strength (N)	25,707.8	N/A
Maximum Load From Tensile Test of Joint (N)	30,403.0	N/A
PASS/FAIL	PASS	N/A

Joint Specimen I.D.
ILRCME188BAH

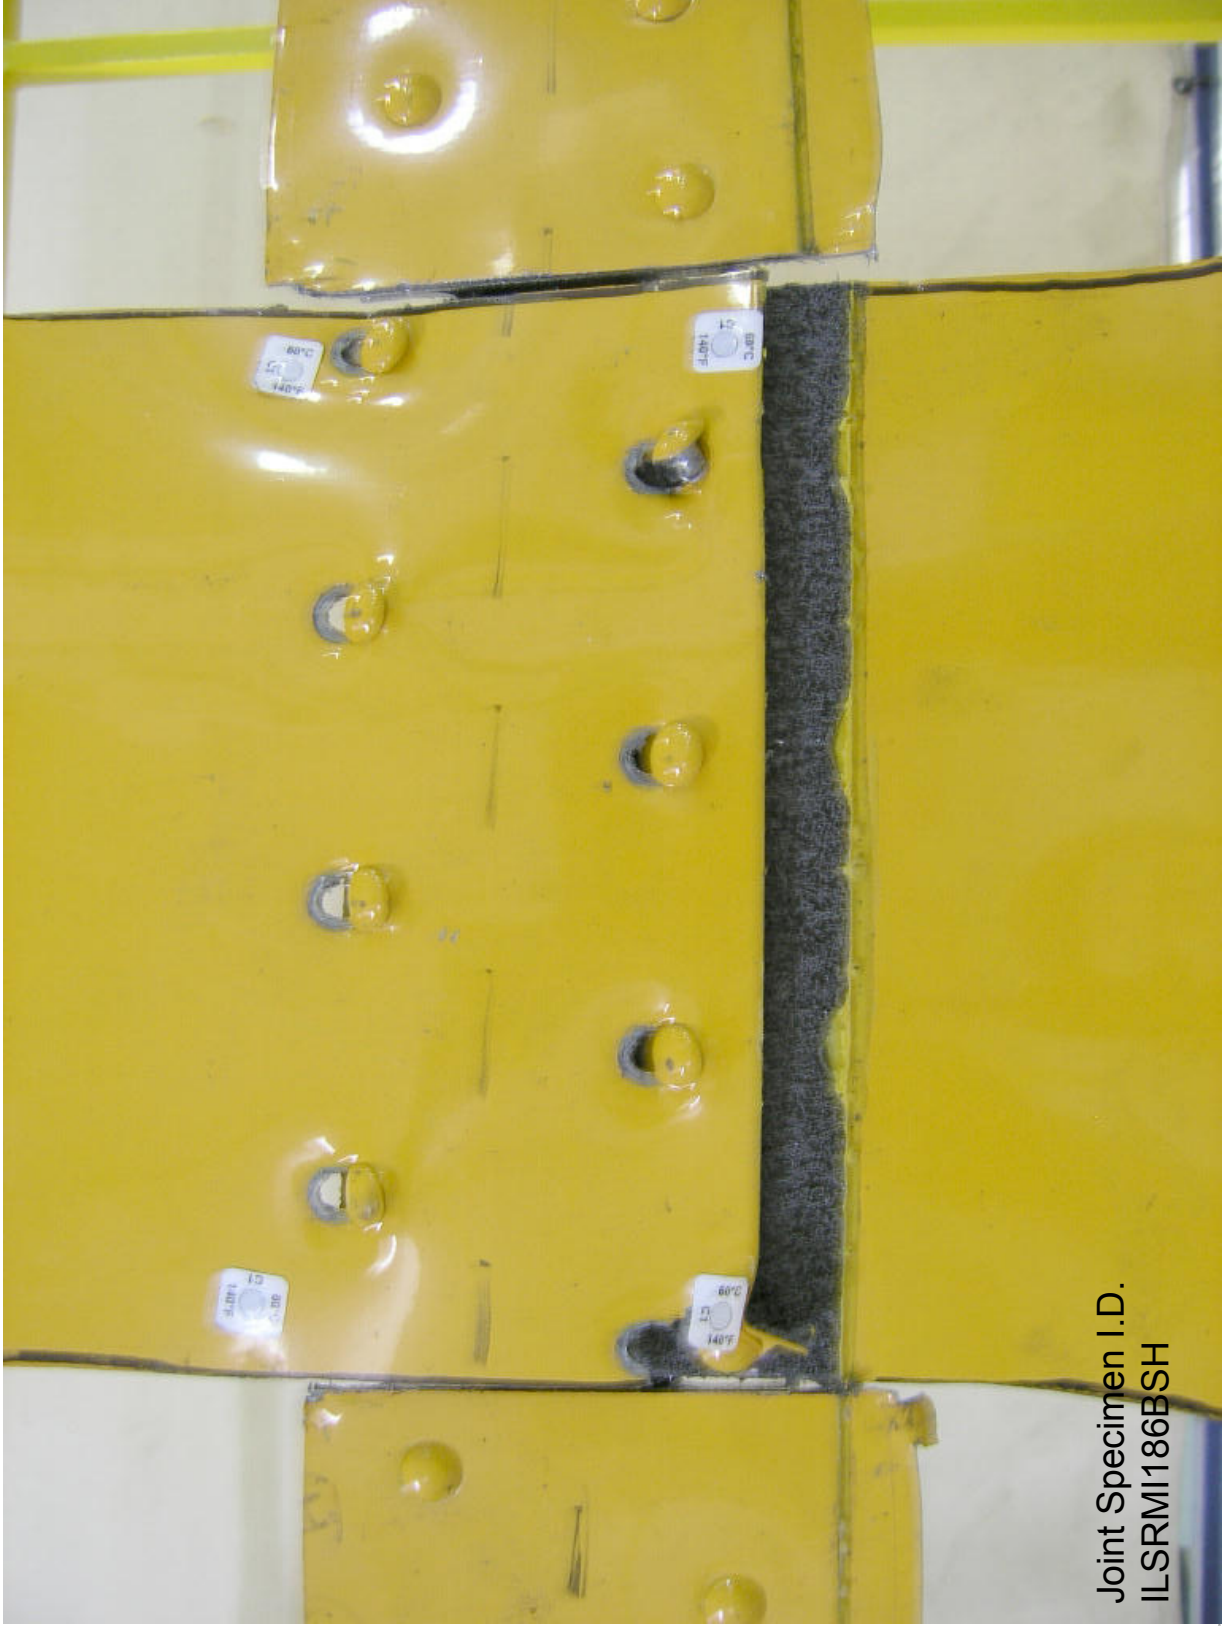
Post-Test of Joint #4

Weaker Member	Stronger Member
Material	ASTM 653, Grade 1008	N/A
Tensile Strength (MPa)	310.3	N/A
Gage/Thickness (mm)	20 / .0914	N/A
Fastener Holes (No./Diameter – mm.)	8 / 5.16	N/A
Net Area (Sq. mm.)	148.1	N/A
Material Strength (N)	45,946.2	N/A
60% of Material Strength (N)	27,567.7	N/A
Maximum Load From Tensile Test of Joint (N)	54,258.0	N/A
PASS/FAIL	PASS	N/A

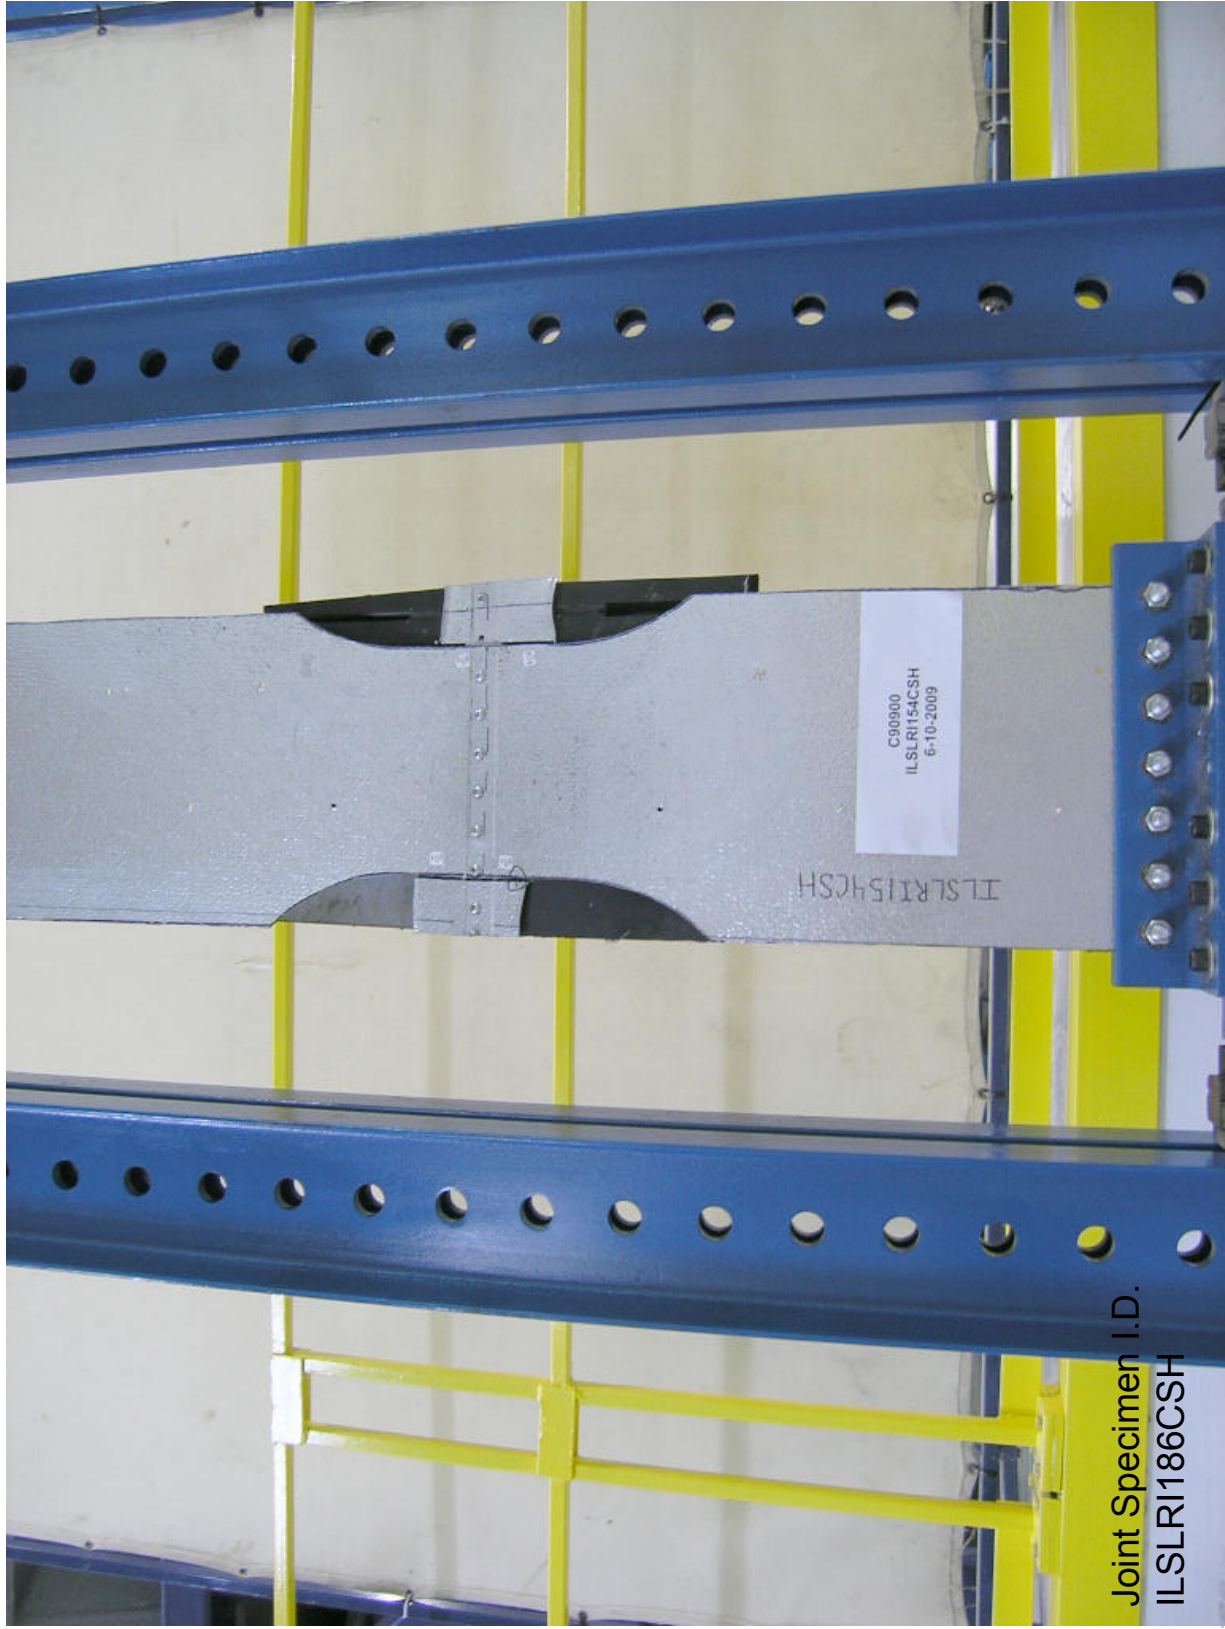
Pre-Test of Joint #5

Joint Specimen I.D.
ILSLR1186CSH

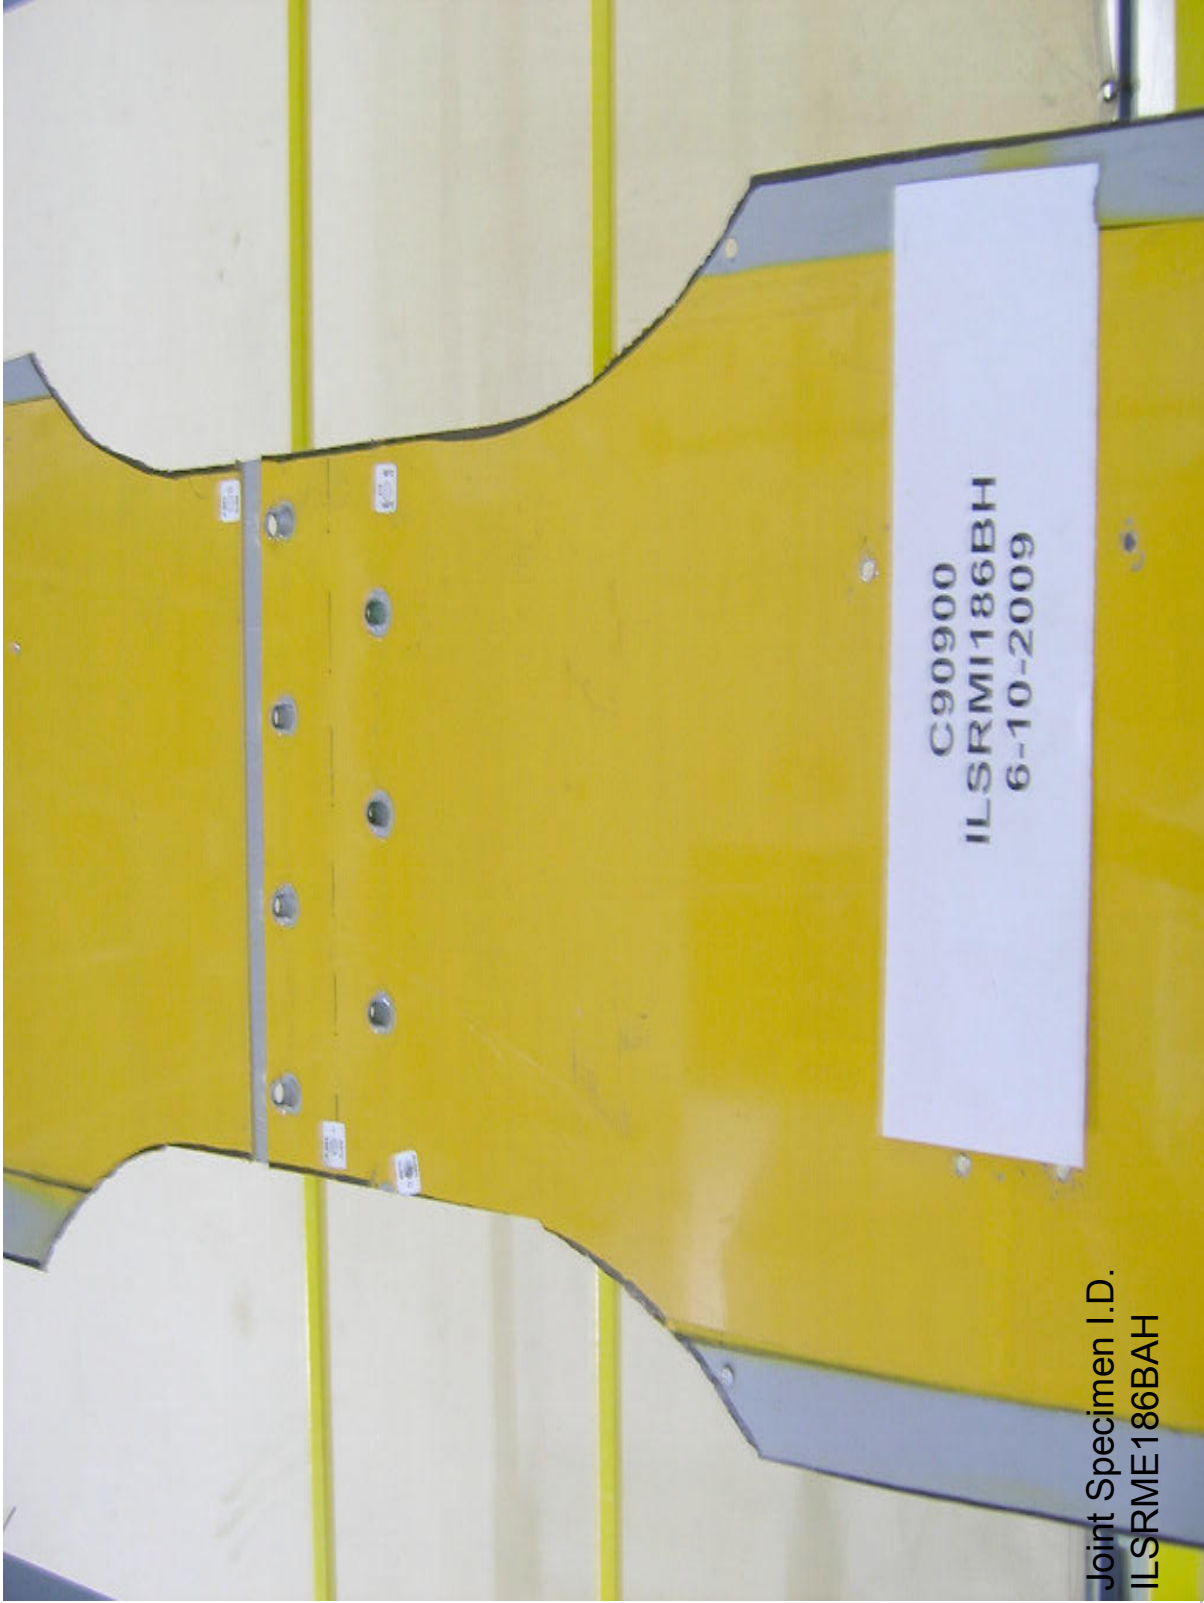
Post-Test of Joint #6

Weaker Member	Stronger Member
Material	ASTM 653, Grade 1008	N/A
Tensile Strength (MPa)	310.3	N/A
Gage/Thickness (mm)	16 / 1.524	N/A
Fastener Holes (No./Diameter – mm.)	7 / 5.16	N/A
Net Area (Sq. mm.)	254.7	N/A
Material Strength (N)	79,015.1	N/A
60% of Material Strength (N)	47,409.0	N/A
Maximum Load From Tensile Test of Joint (N)	72,249.0	N/A
PASS/FAIL	PASS	N/A

Joint Specimen I.D.
ILSRME186BAH

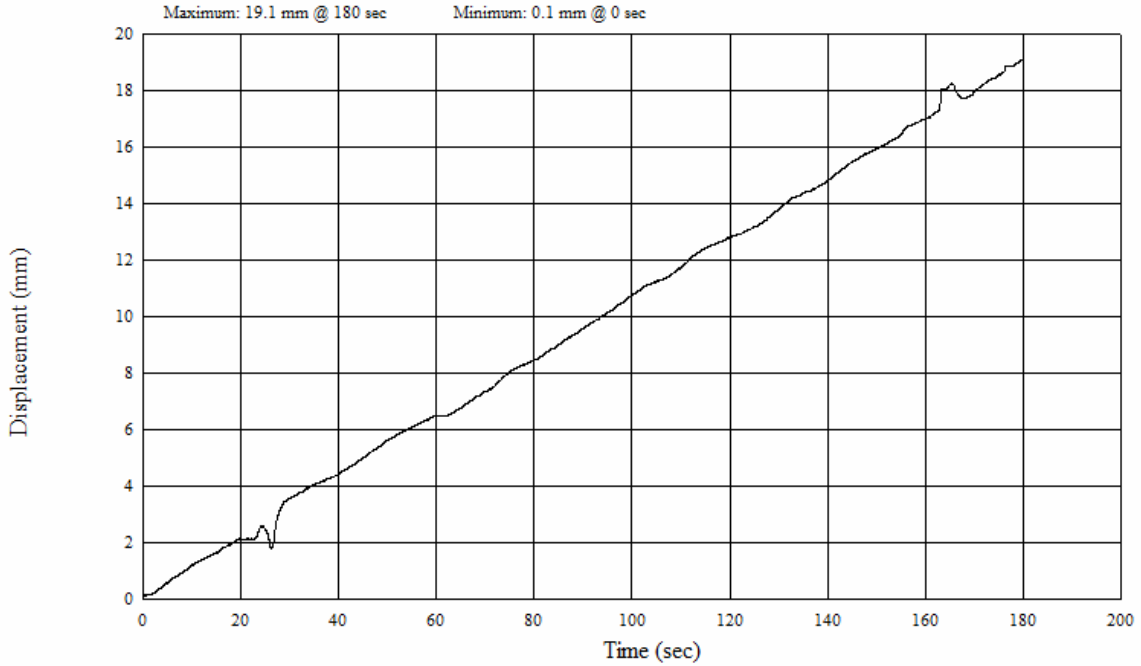
Displacement (mm) vs Time (sec)

The rate of load application was ¼ inch per minute. The force and displacement were recorded and displacement vs. time was plotted to monitor the displacement rate.

Test Description: FMVSS 221
Component ID: 2009 IC RE300 School Bus, NHTSA No.: C90900
Sample No.: 1
Test Date: June 10, 2009

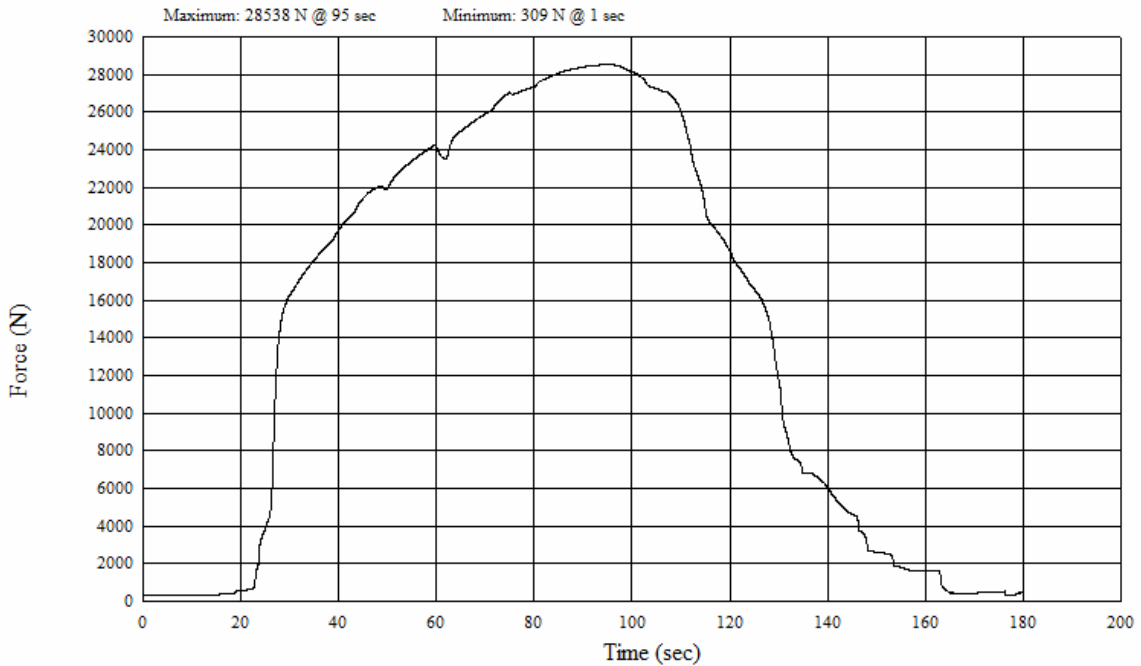
Force (N) vs Time (sec)

Test Description: FMVSS 221
Component ID: 2009 IC RE300 School Bus, NHTSA No.: C90900
Sample No.: 1
Test Date: June 10, 2009

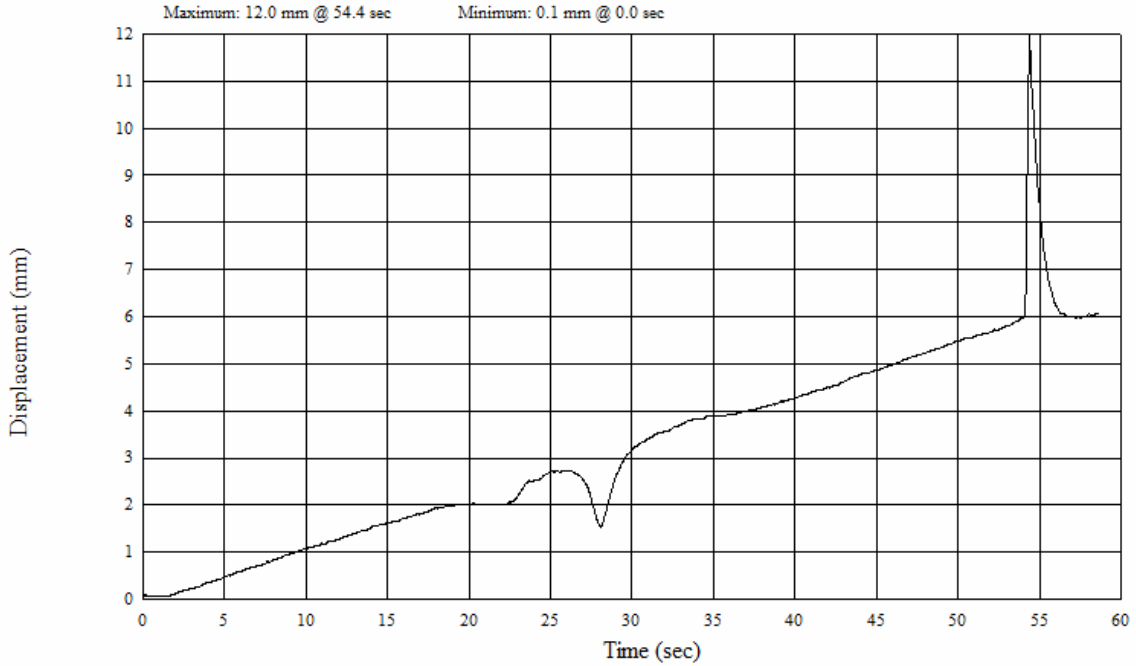
Displacement (mm) vs Time (sec)

Test Description: FMVSS 221
Component ID: 2009 IC RE300 School Bus, NHTSA No.: C90900
Sample No.: 2
Test Date: June 10, 2009

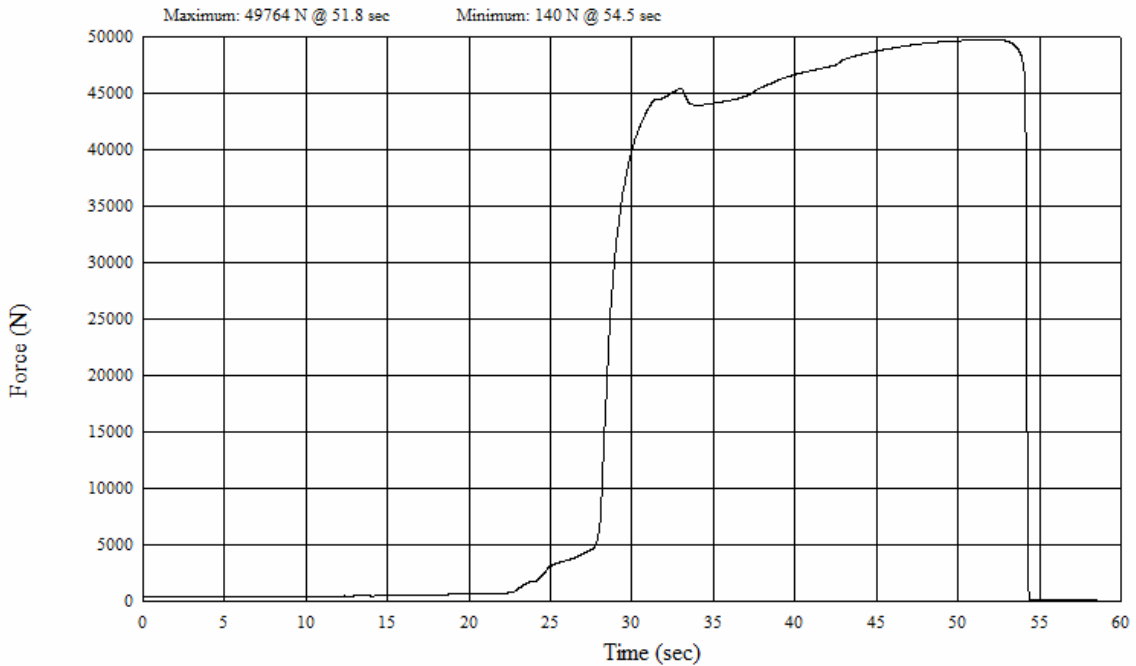
Force (N) vs Time (sec)

Test Description: FMVSS 221
Component ID: 2009 IC RE300 School Bus, NHTSA No.: C90900
Sample No.: 2
Test Date: June 10, 2009

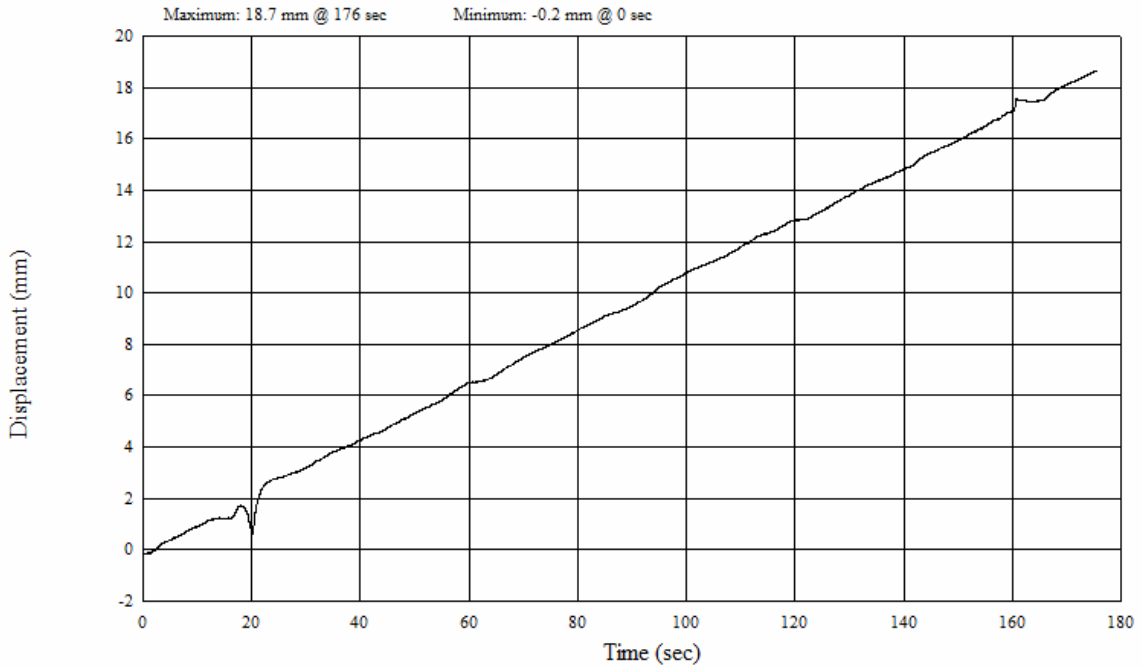
Displacement (mm) vs Time (sec)

Test Description: FMVSS 221
Component ID: 2009 IC RE300 School Bus, NHTSA No.: C90900
Sample No.: 3
Test Date: June 10, 2009

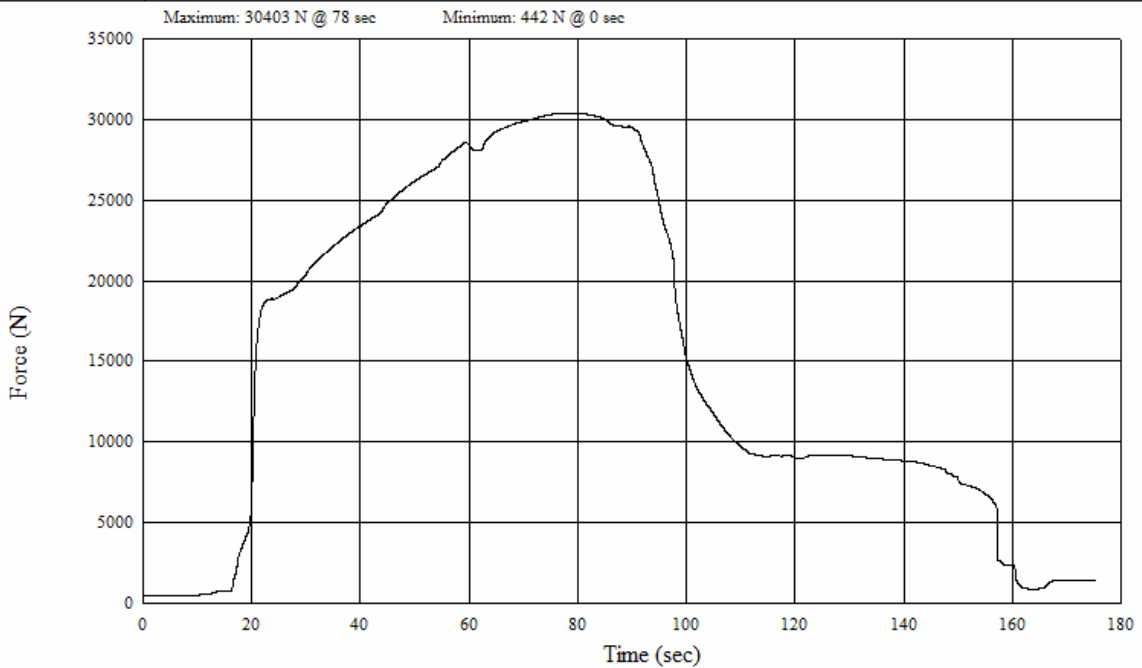
Force (N) vs Time (sec)

Test Description: FMVSS 221
Component ID: 2009 IC RE300 School Bus, NHTSA No.: C90900
Sample No.: 3
Test Date: June 10, 2009

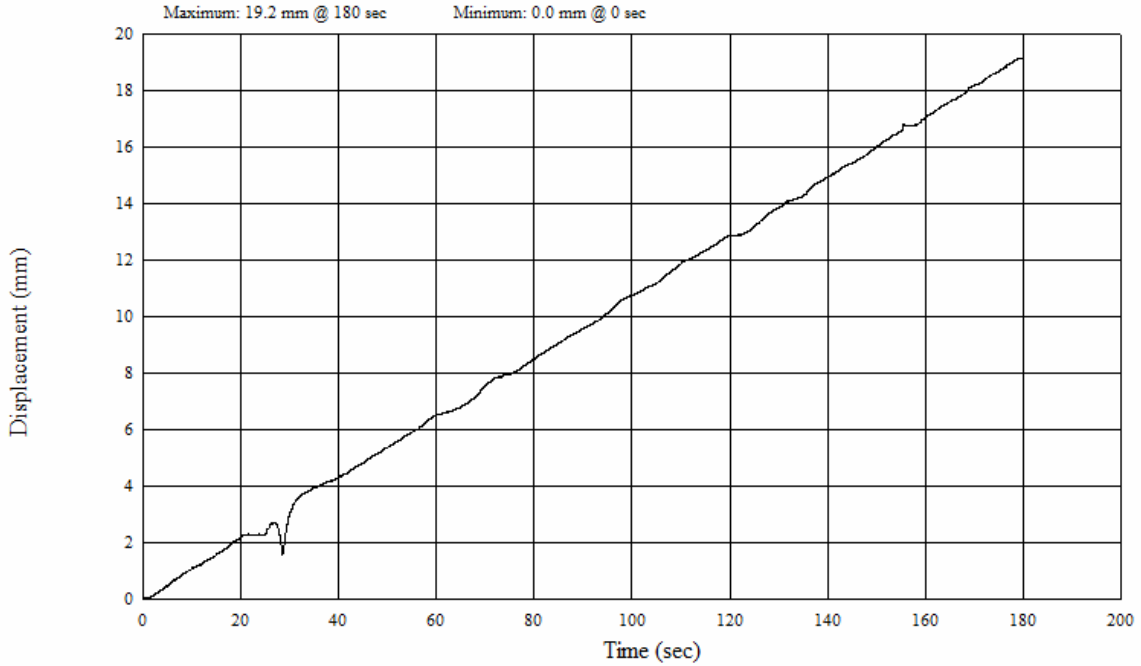
Displacement (mm) vs Time (sec)

Test Description: FMVSS 221
Component ID: 2009 IC RE300 School Bus, NHTSA No.: C90900
Sample No.: 4
Test Date: June 10, 2009

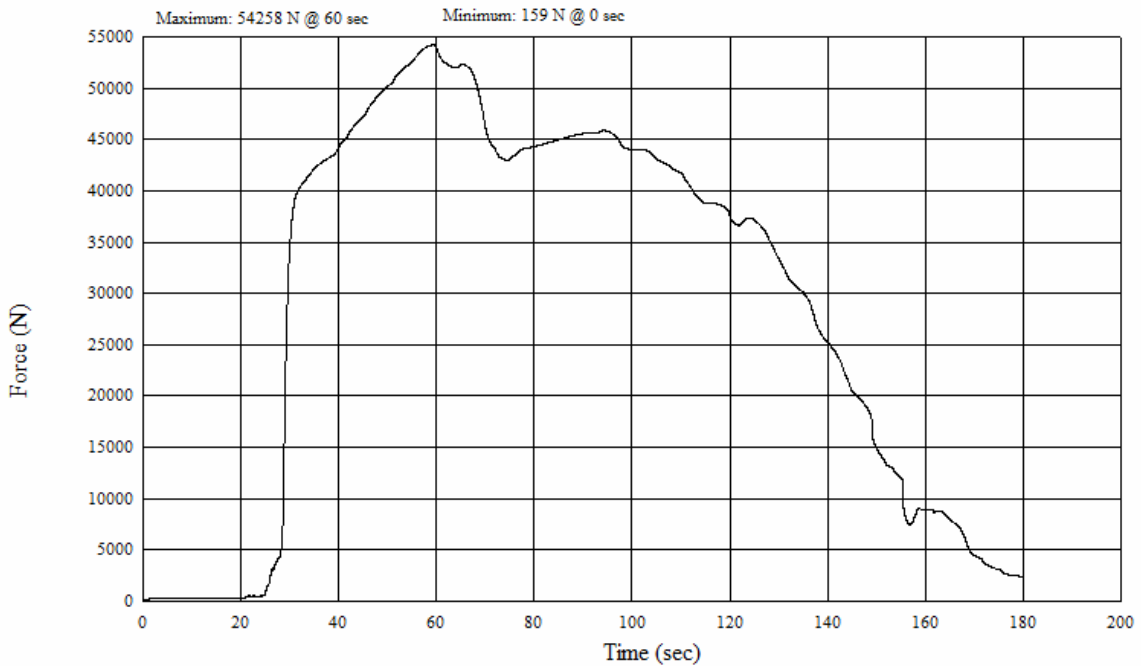
Force (N) vs Time (sec)

Test Description: FMVSS 221
Component ID: 2009 IC RE300 School Bus, NHTSA No.: C90900
Sample No.: 4
Test Date: June 10, 2009

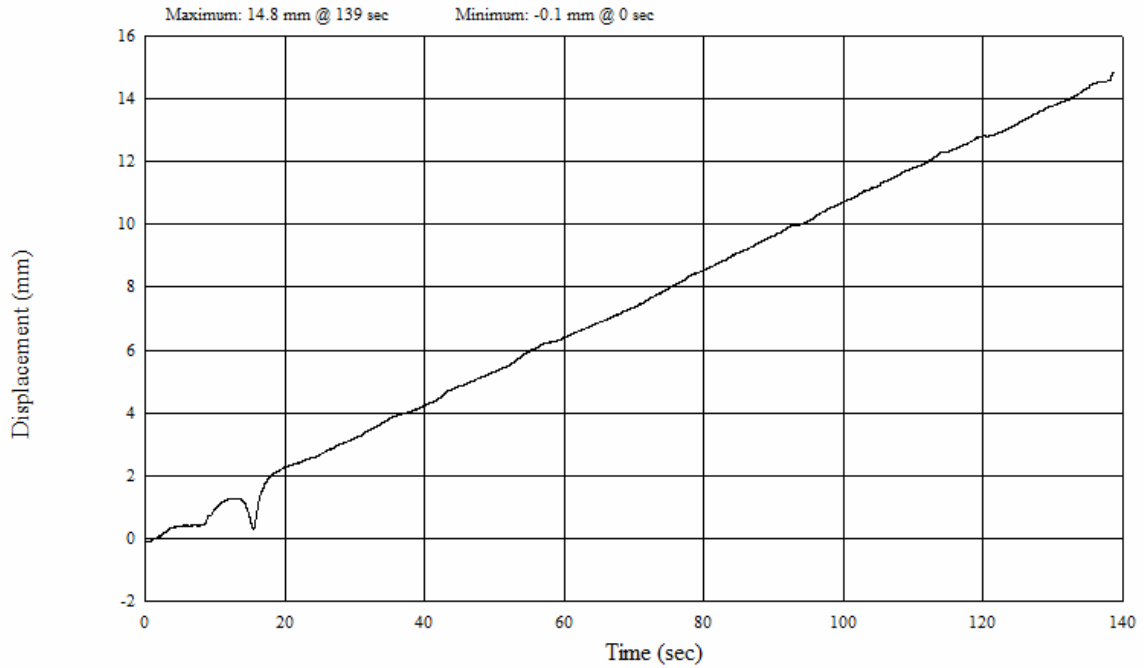
Displacement (mm) vs Time (sec)

Test Description: FMVSS 221
Component ID: 2009 IC RE300 School Bus, NHTSA No.: C90900
Sample No.: 5
Test Date: June 10, 2009
