REPORT NUMBER: 221-MGA-2009-001

**SAFETY COMPLIANCE TESTING FOR
FMVSS NO.: 221
SCHOOL BUS BODY JOINT STRENGTH**

**IC CORPORATION
2009 IC RE300 SCHOOL BUS
NHTSA NO.: C90900**

**PREPARED BY:
MGA RESEARCH CORPORATION
5000 WARREN ROAD
BURLINGTON, WI 53105**

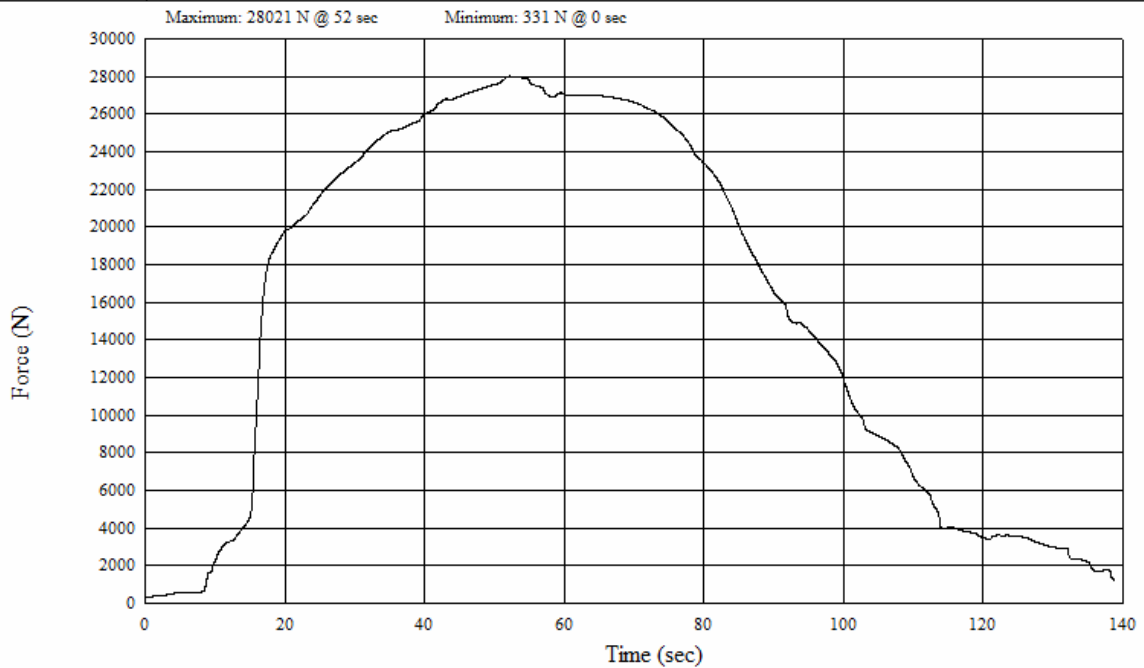
Force (N) vs Time (sec)

Test Description: FMVSS 221
Component ID: 2009 IC RE300 School Bus, NHTSA No.: C90900
Sample No.: 5
Test Date: June 10, 2009

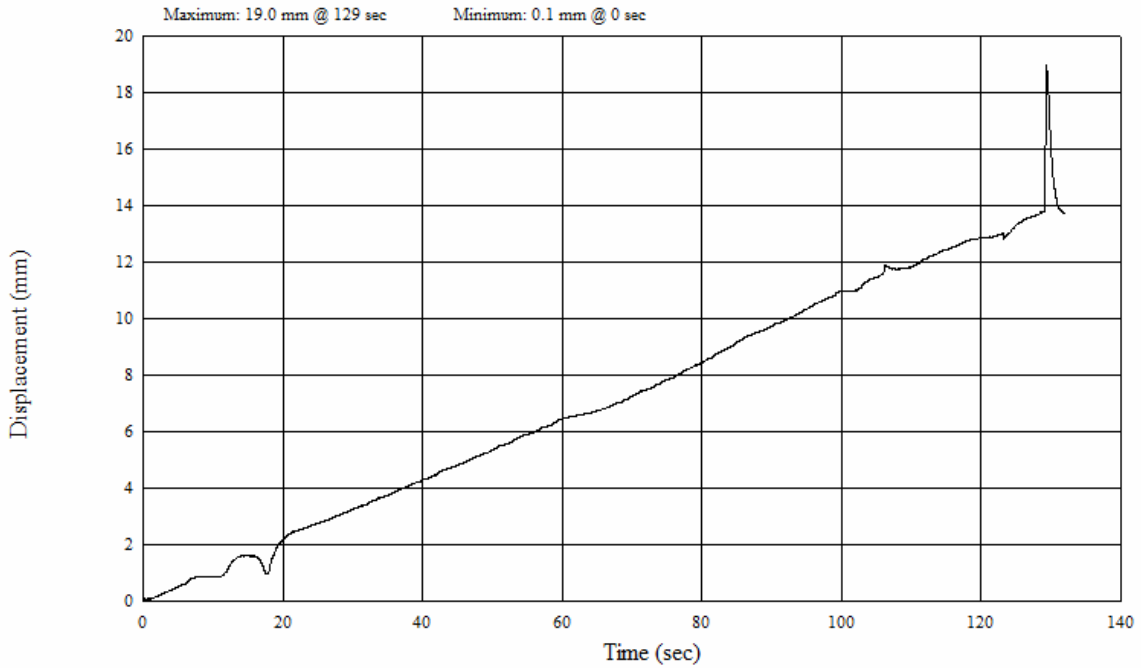
Displacement (mm) vs Time (sec)

Test Description: FMVSS 221
Component ID: 2009 IC RE300 School Bus, NHTSA No.: C90900
Sample No.: 6
Test Date: June 10, 2009

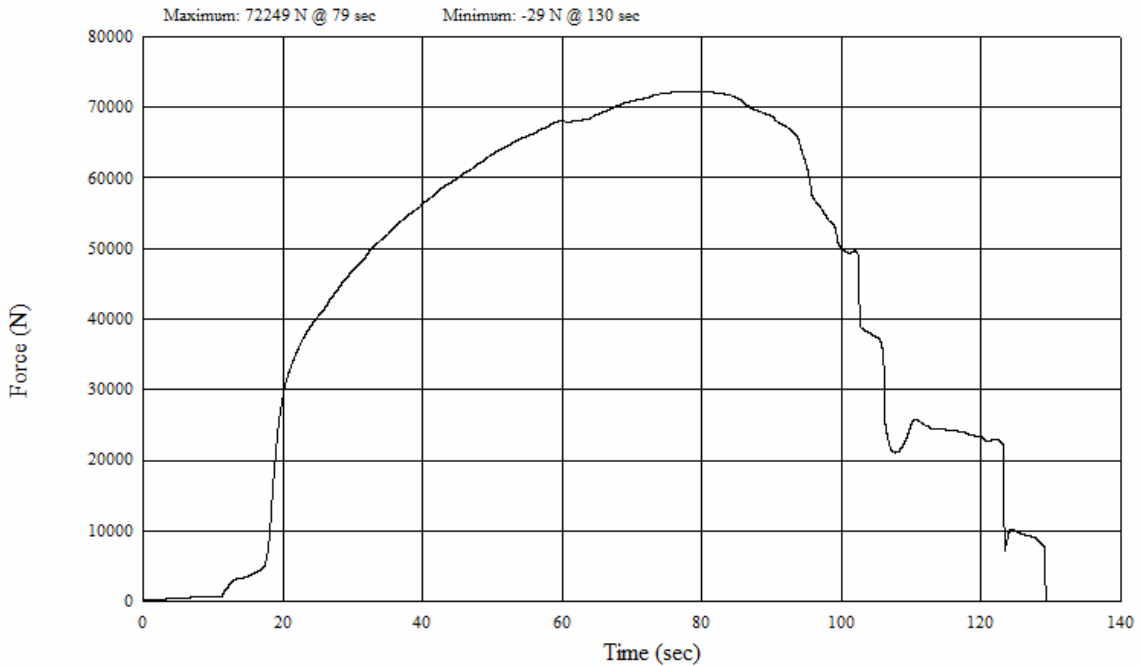
Force (N) vs Time (sec)

Test Description: FMVSS 221
Component ID: 2009 IC RE300 School Bus, NHTSA No.: C90900
Sample No.: 6
Test Date: June 10, 2009

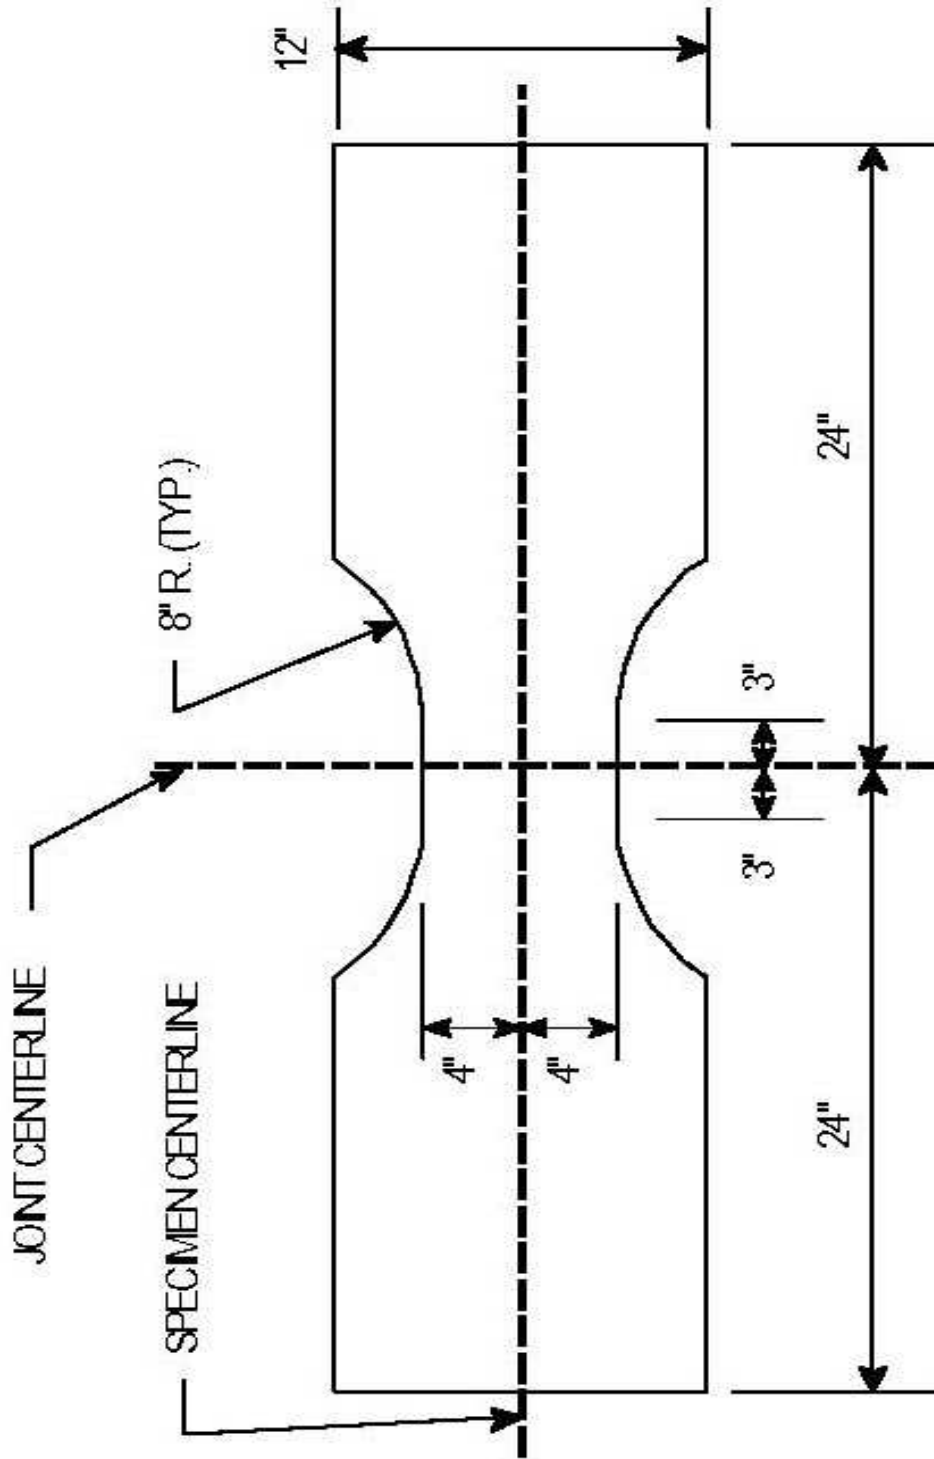
**DIMENSION REQUIREMENTS OF BODY PANEL SPECIMEN
WHOSE JOINT SEGMENT IS 8 INCHES LONG**

After each sample area had been removed from the bus, the sample was cut to the specific selected dimensions. Each specimen was carefully shaped to the final size using supports as specified in FMVSS 221. Additionally, temperature monitoring stickers were placed at the specified locations of each sample to ensure the sample temperature did not exceed 140°F during the shaping operation.
