REPORT NUMBER: 214P-MGA-2011-018

**SAFETY COMPLIANCE TESTING FOR FMVSS 214
DYNAMIC SIDE IMPACT PROTECTION
RIGID POLE**

**VOLVO CAR CORPORATION
2011 VOLVO S60 4-DR SEDAN
NHTSA NUMBER: CB5901**

**PREPARED BY:
MGA RESEARCH CORPORATION
5000 WARREN ROAD
BURLINGTON, WI 53105**

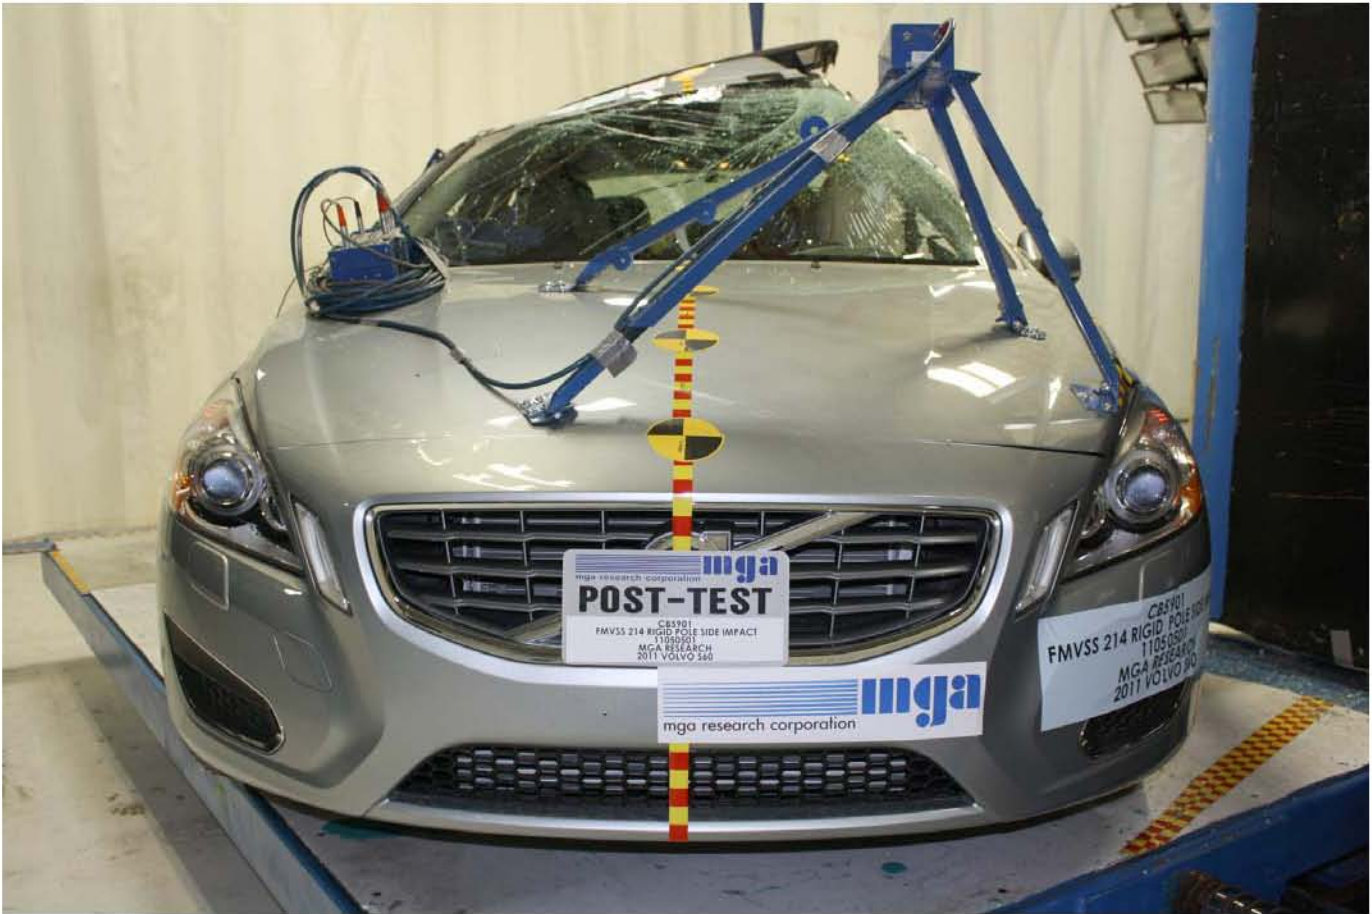
Post-Test Frontal View of Test Vehicle

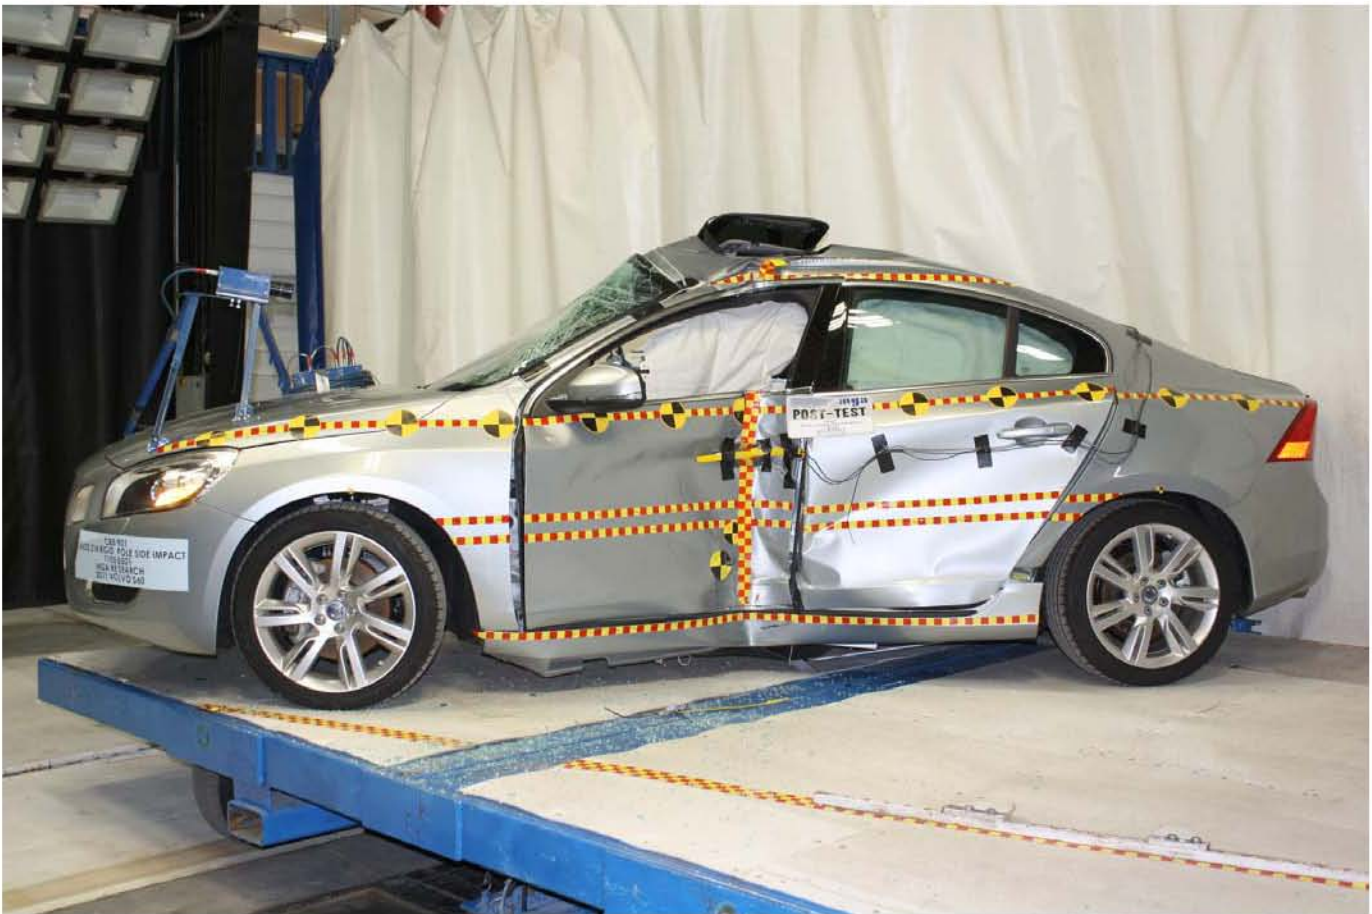
Post-Test Impacted Side View of Test Vehicle

Critical Areas of Performance	Observations and Conclusions
Pillar Performance	No Separation
Sill Separation	None
Windshield Damage	Cracked
Window Damage	Left Front Window Broke
Other Notable Effects	None

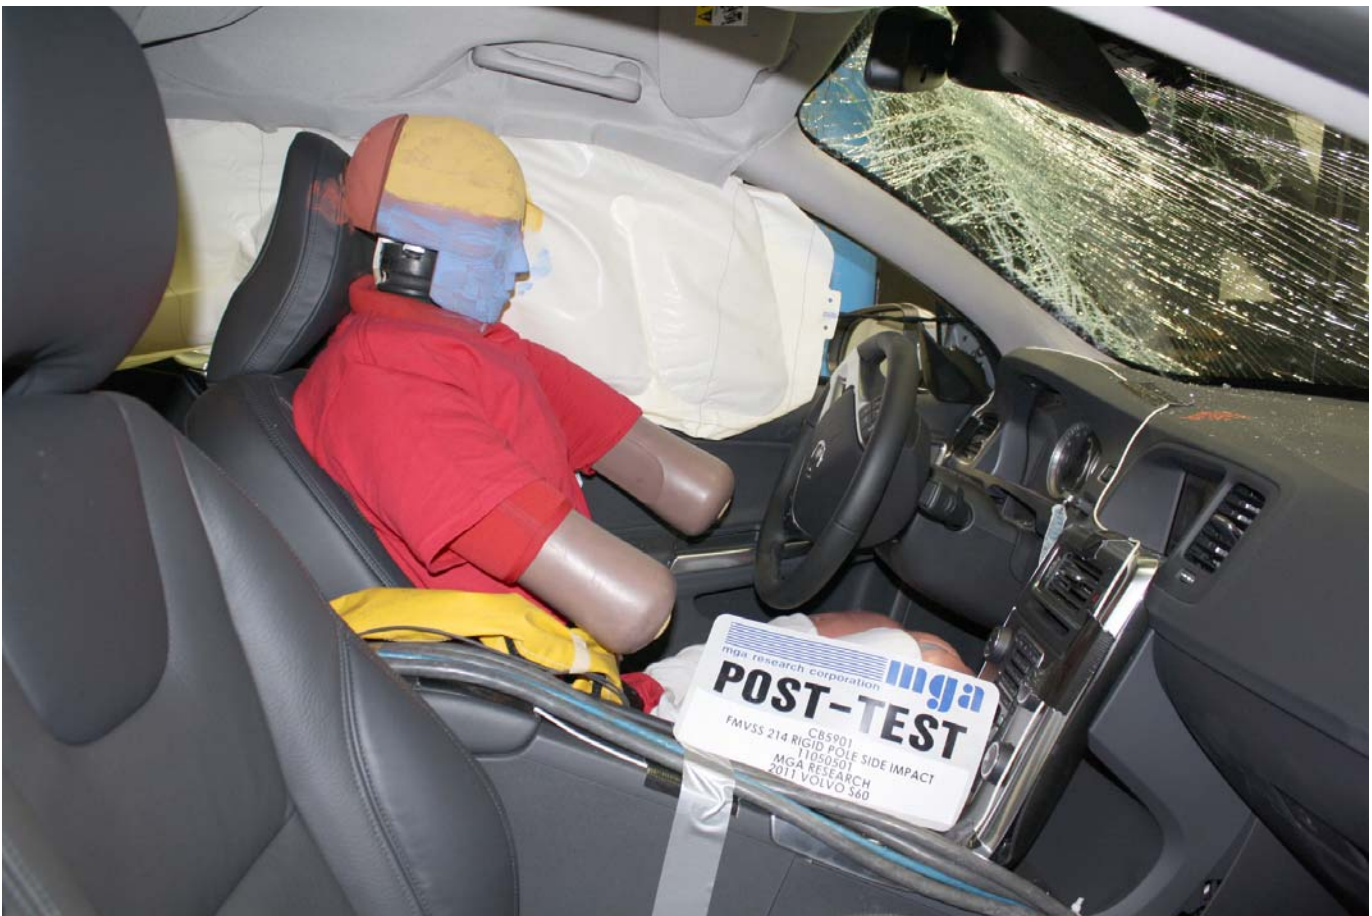
Post-Test Dummy Through Opposite Window

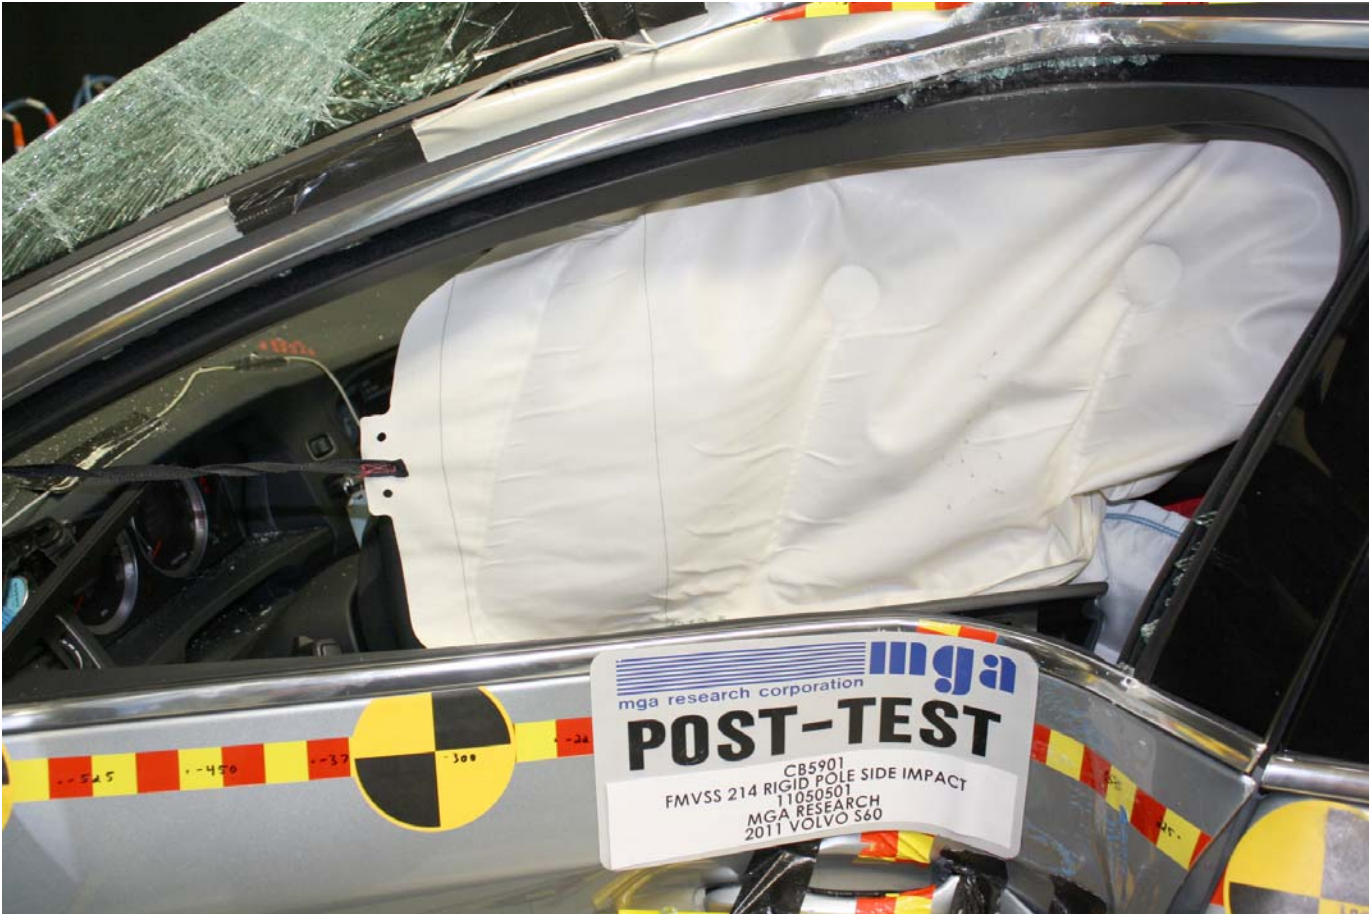
Post-Test Dummy with Door Closed (Impact Side)

Description	Front	Rear
Left Side Doors	Remained closed and jammed shut	Remained closed and jammed shut
Right Side Doors	Remained closed and operational	Remained closed and operational
Hatch and Other Doors		
Seat Movement	0	0
Seat Back Failure	None	None

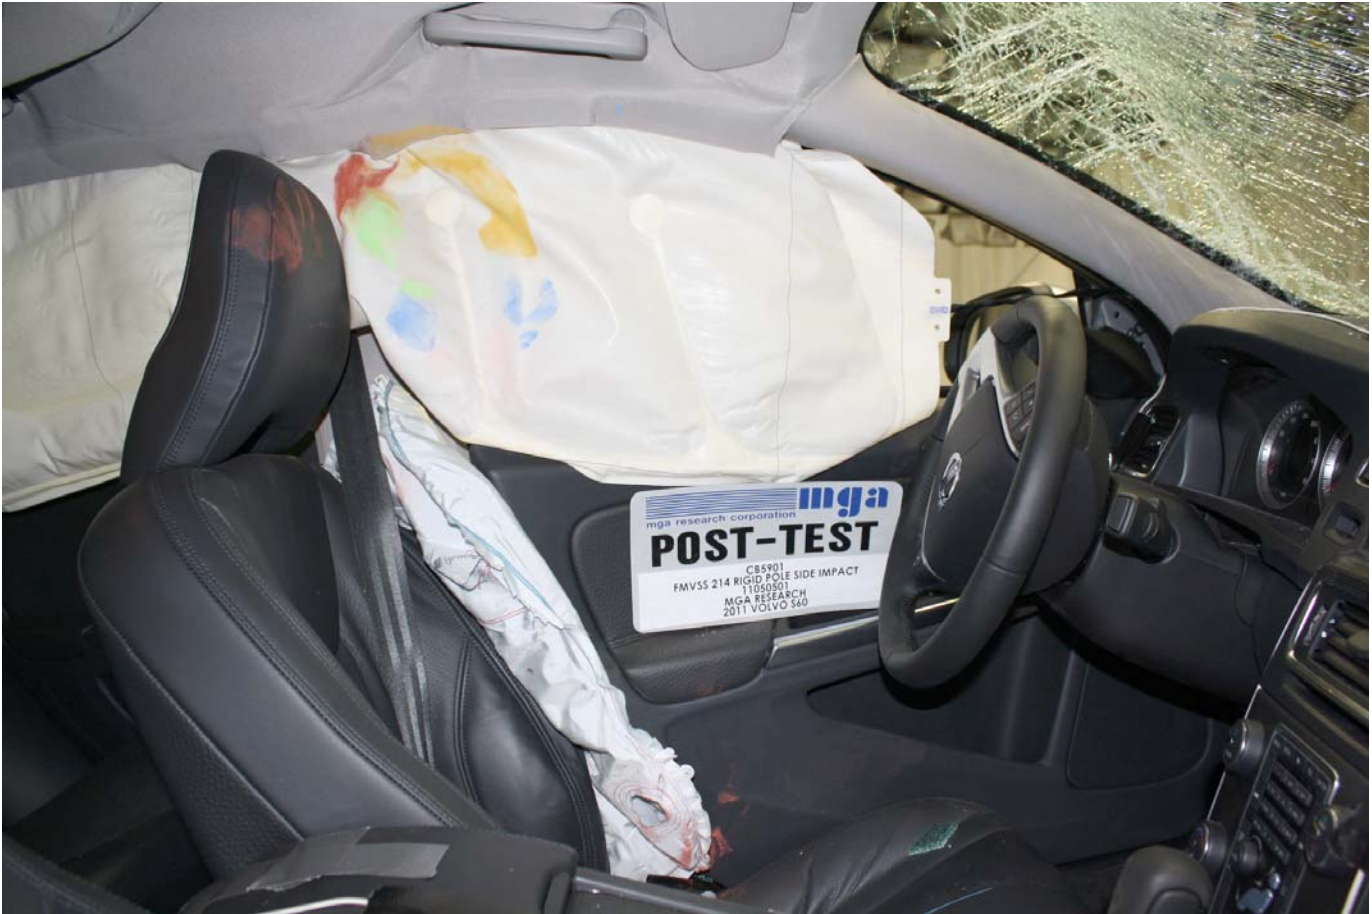
Post-Test Interior of Front Door Showing Dummy Impact Locations

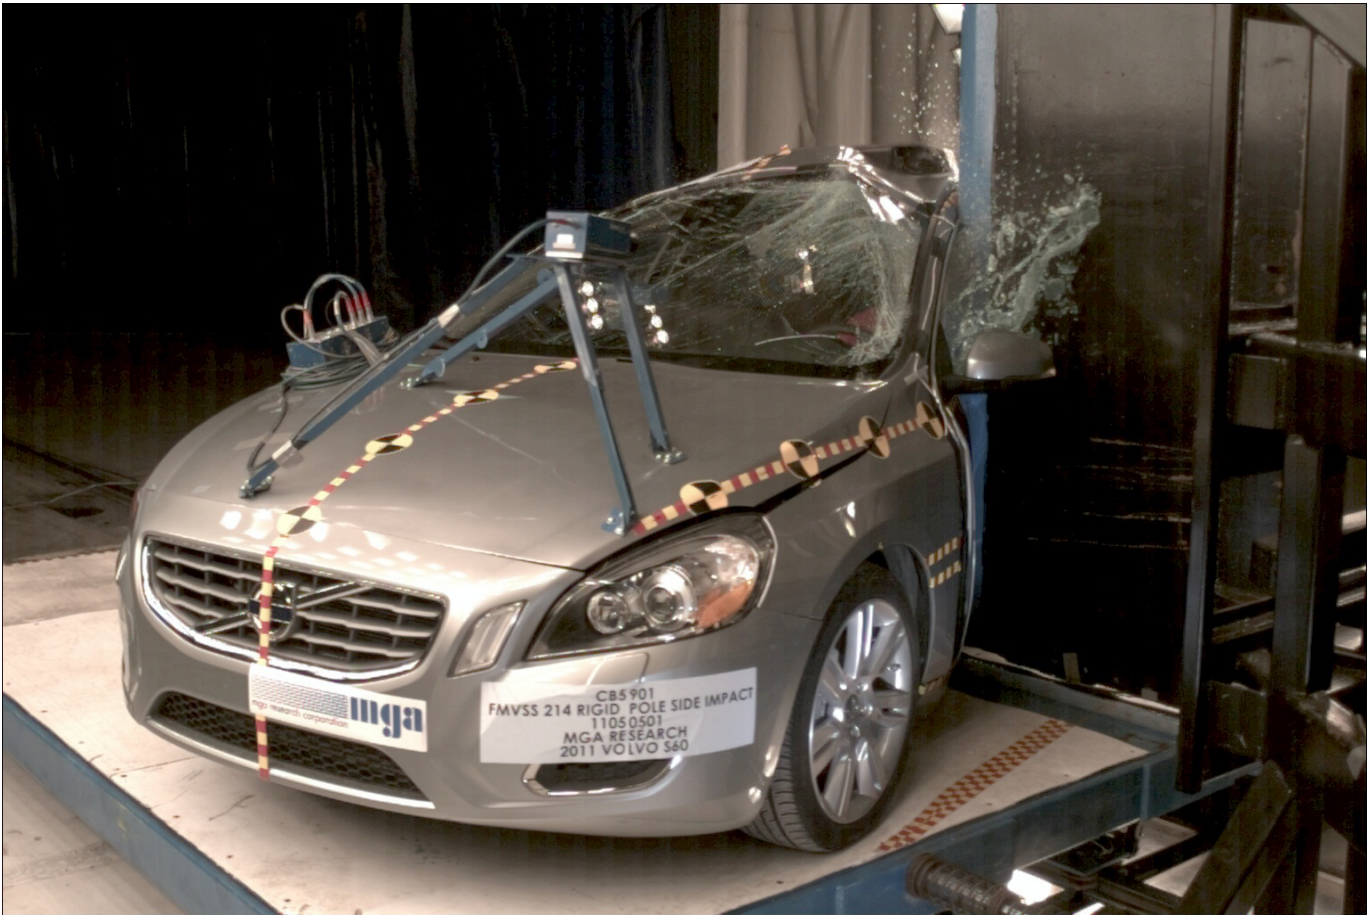
Impact Event

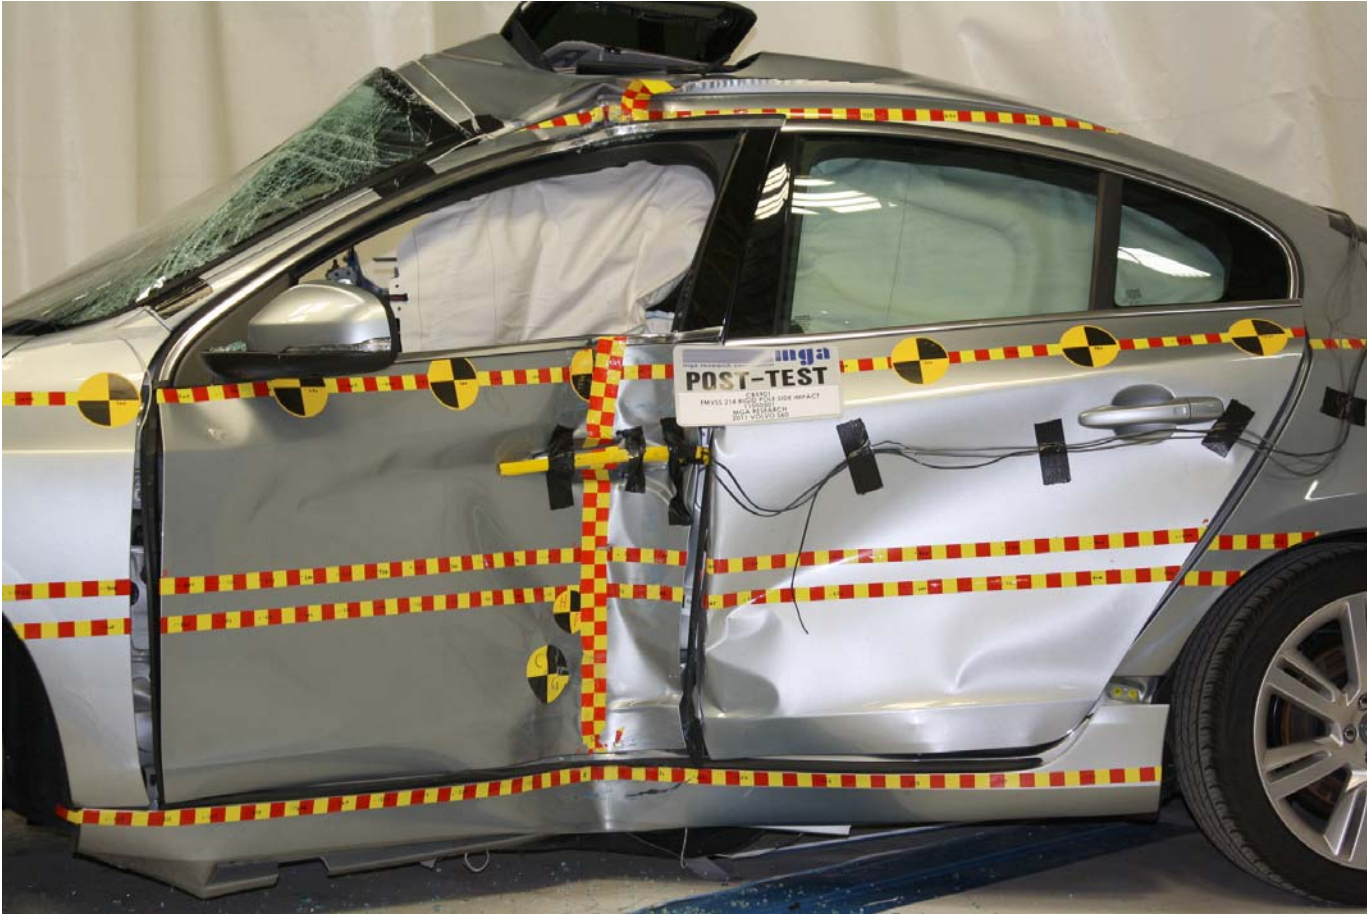
Post-Test Impact Zone Close-up View

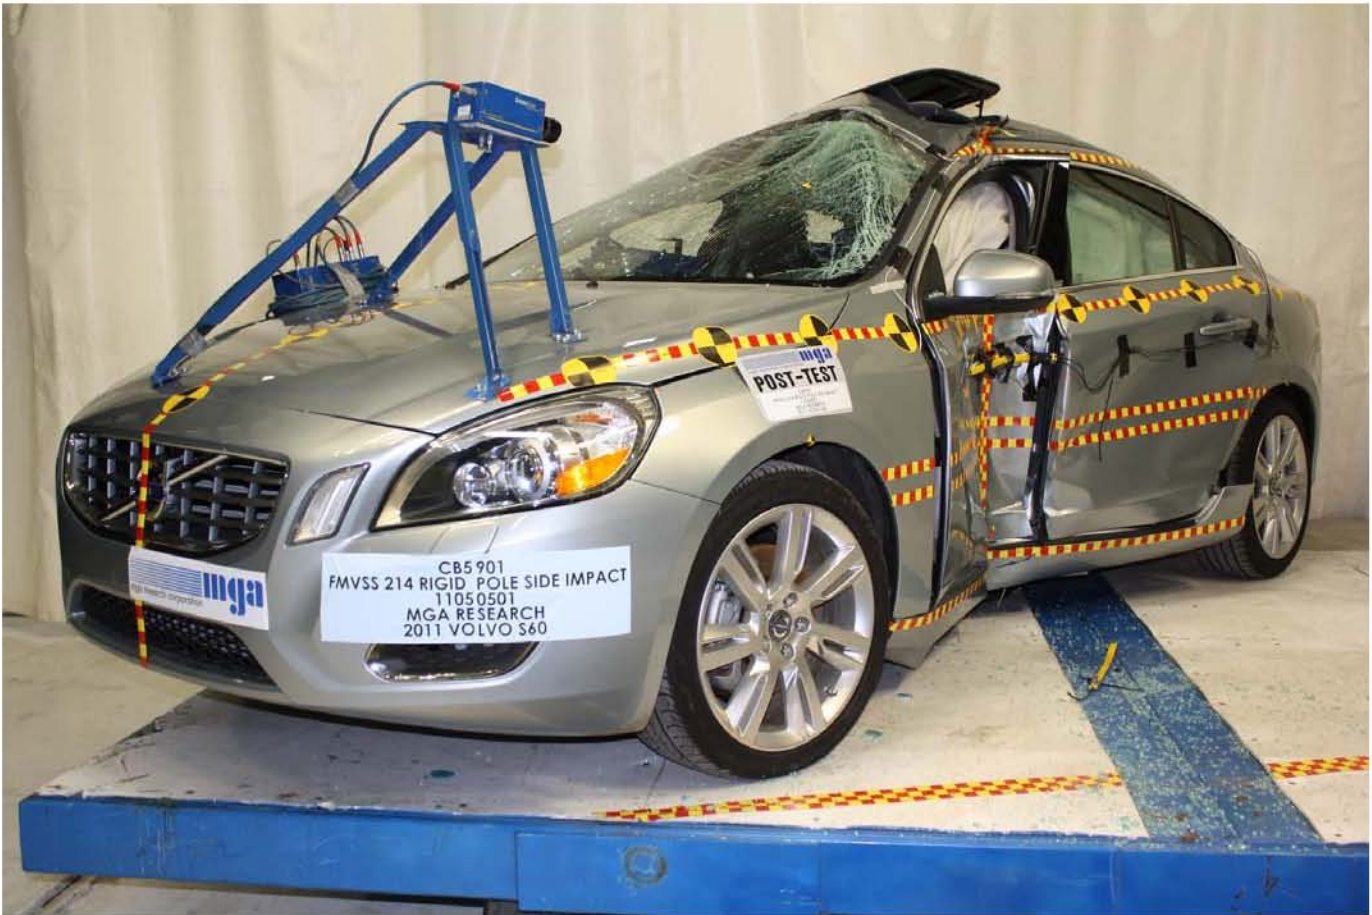
Post-Test $\frac{3}{4}$ Front View of Impact Zone

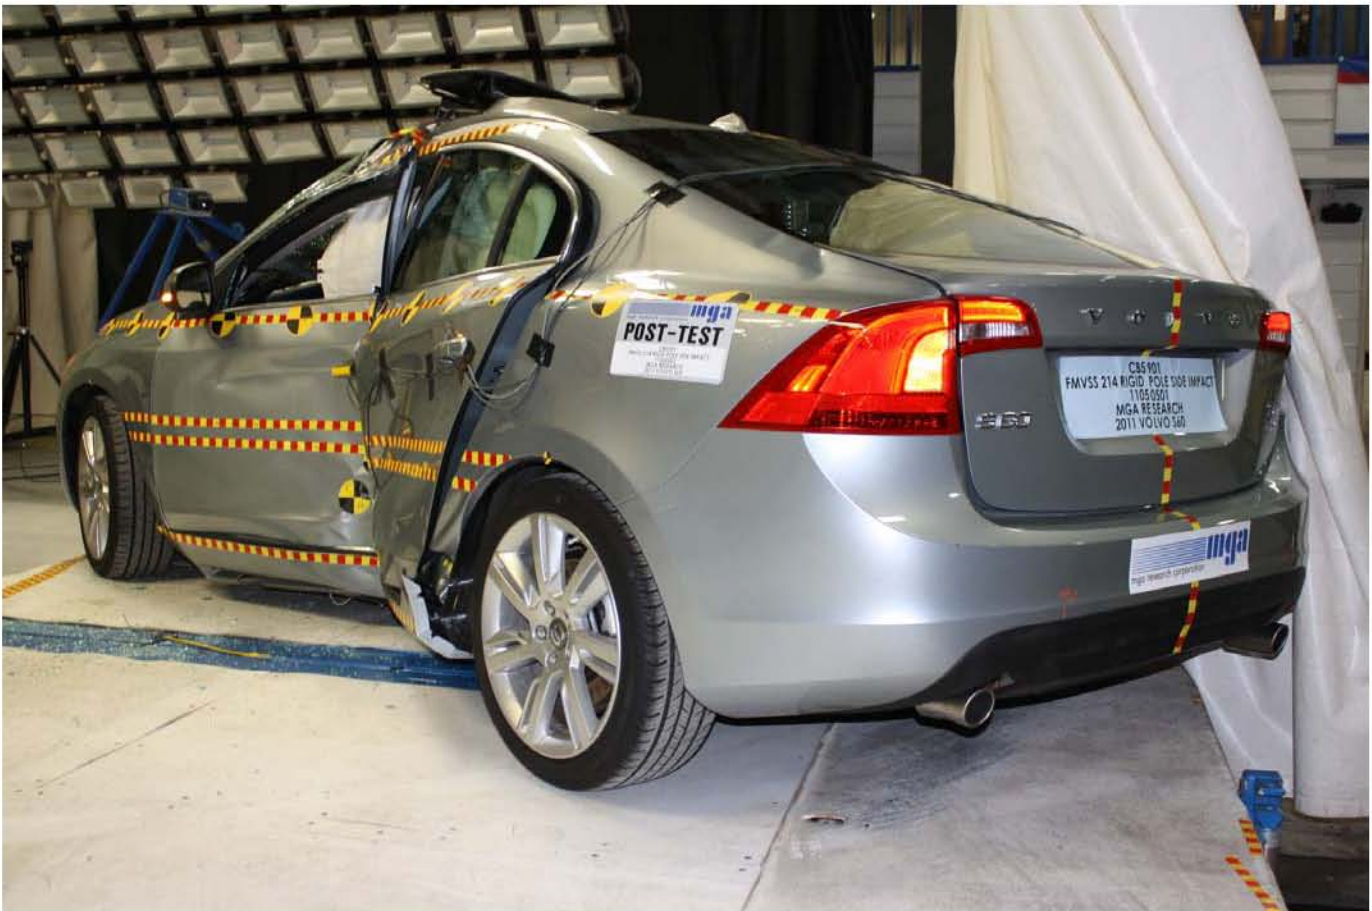
Post-Test $\frac{3}{4}$ Rear View of Impact Zone

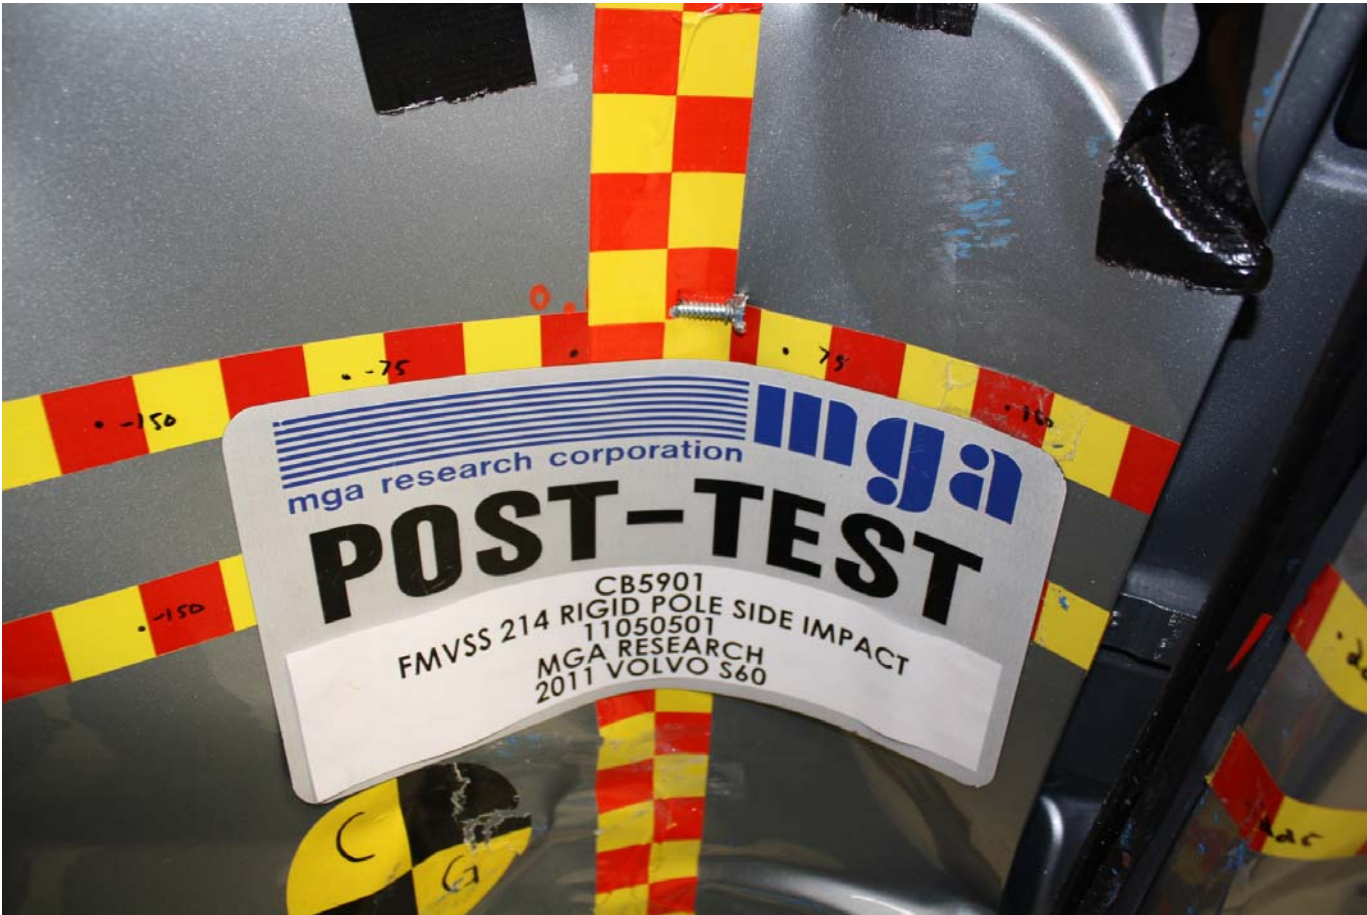
Post-Test Close-up View of Impact Point Target
