REPORT NUMBER: 214P-MGA-2011-009

**SAFETY COMPLIANCE TESTING FOR FMVSS 214
DYNAMIC SIDE IMPACT PROTECTION
RIGID POLE**

**TOYOTA MOTOR CORPORATION
2011 SCION TC 3-DR LIFTBACK
NHTSA NUMBER: CB5107**

**PREPARED BY:
MGA RESEARCH CORPORATION
5000 WARREN ROAD
BURLINGTON, WI 53105**

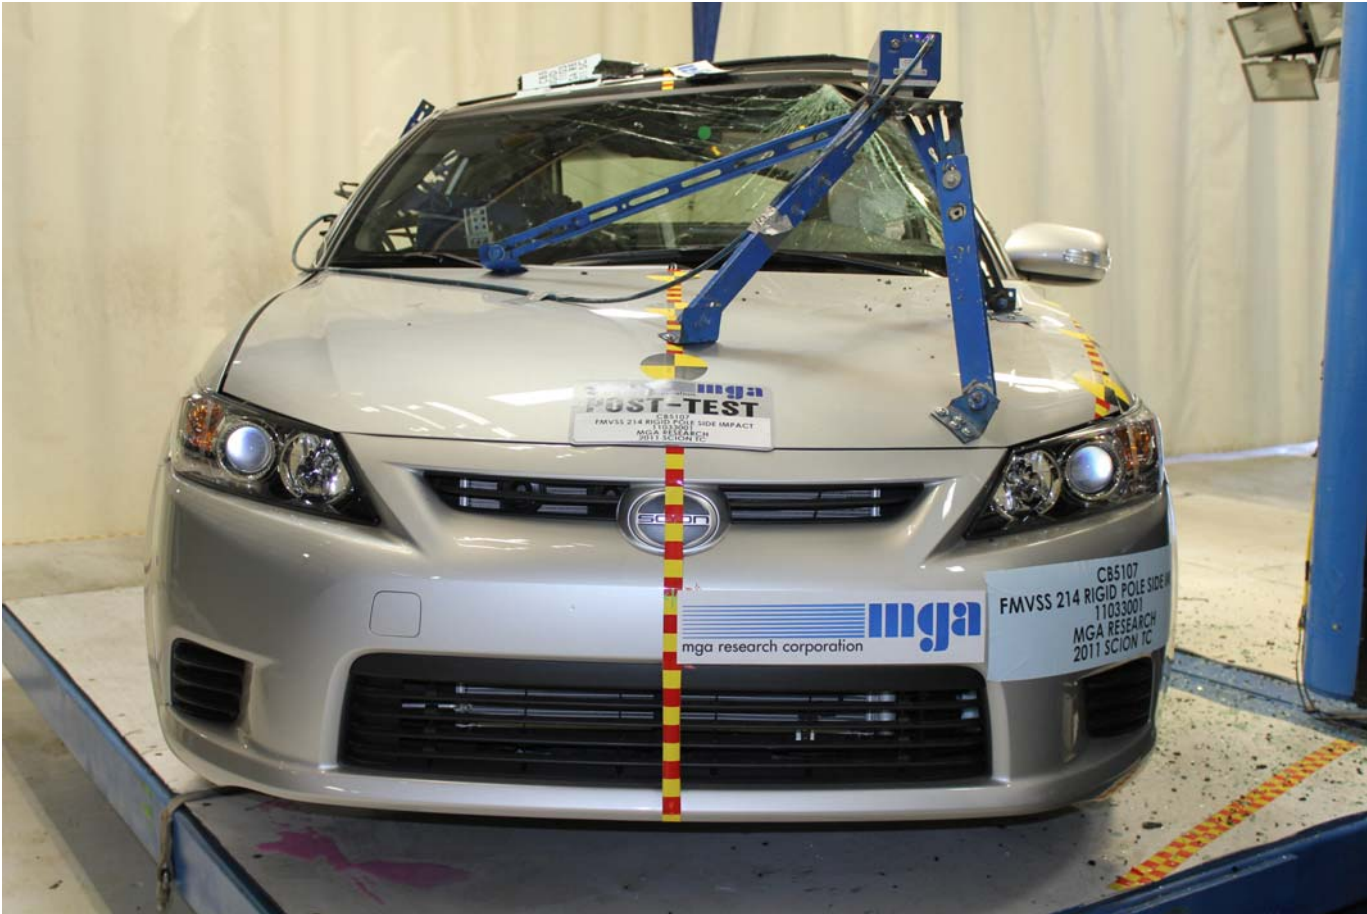
Post-Test Frontal View of Test Vehicle

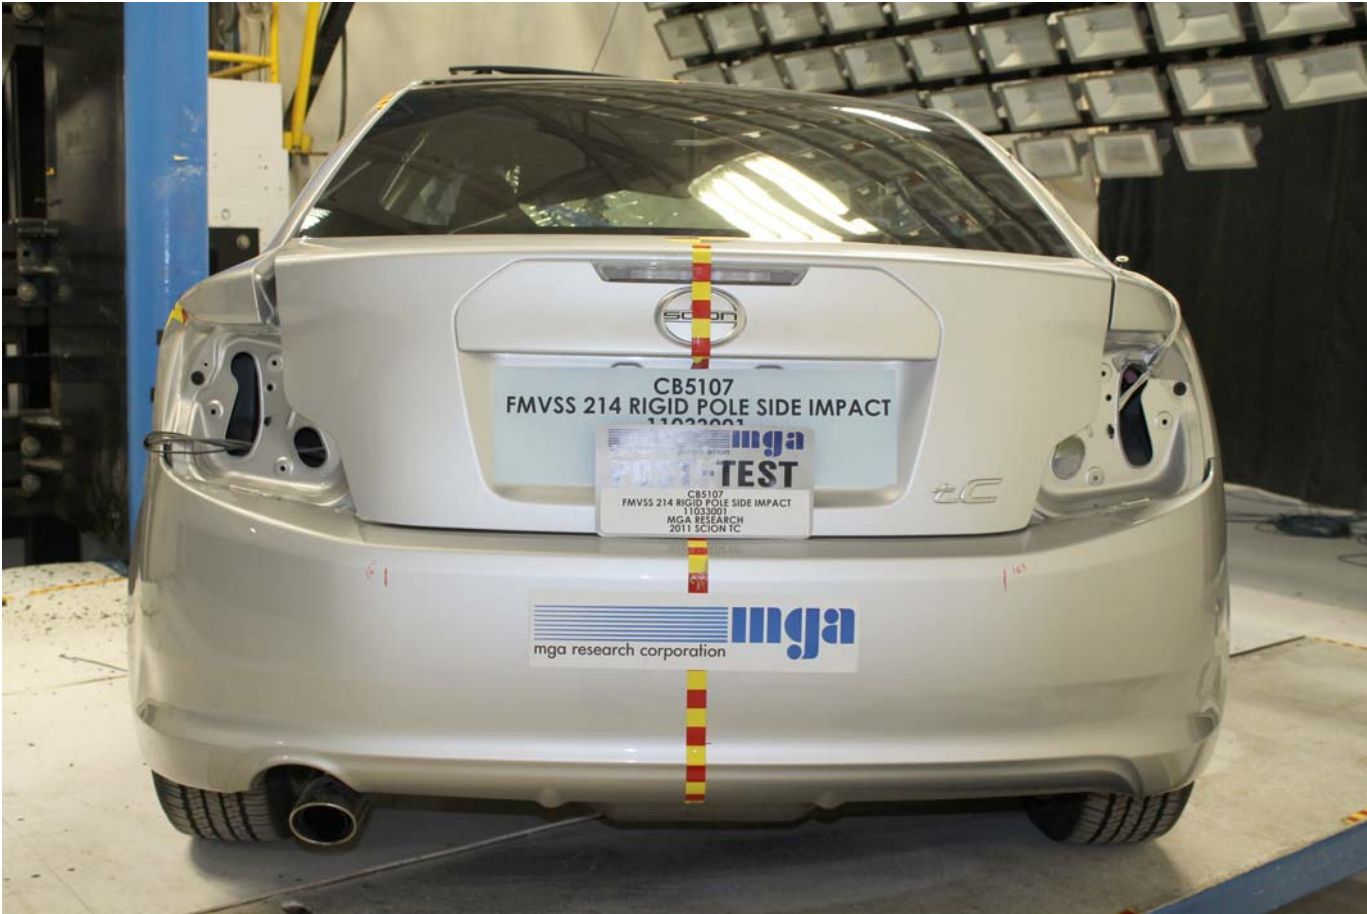
Post-Test Rear View of Test Vehicle

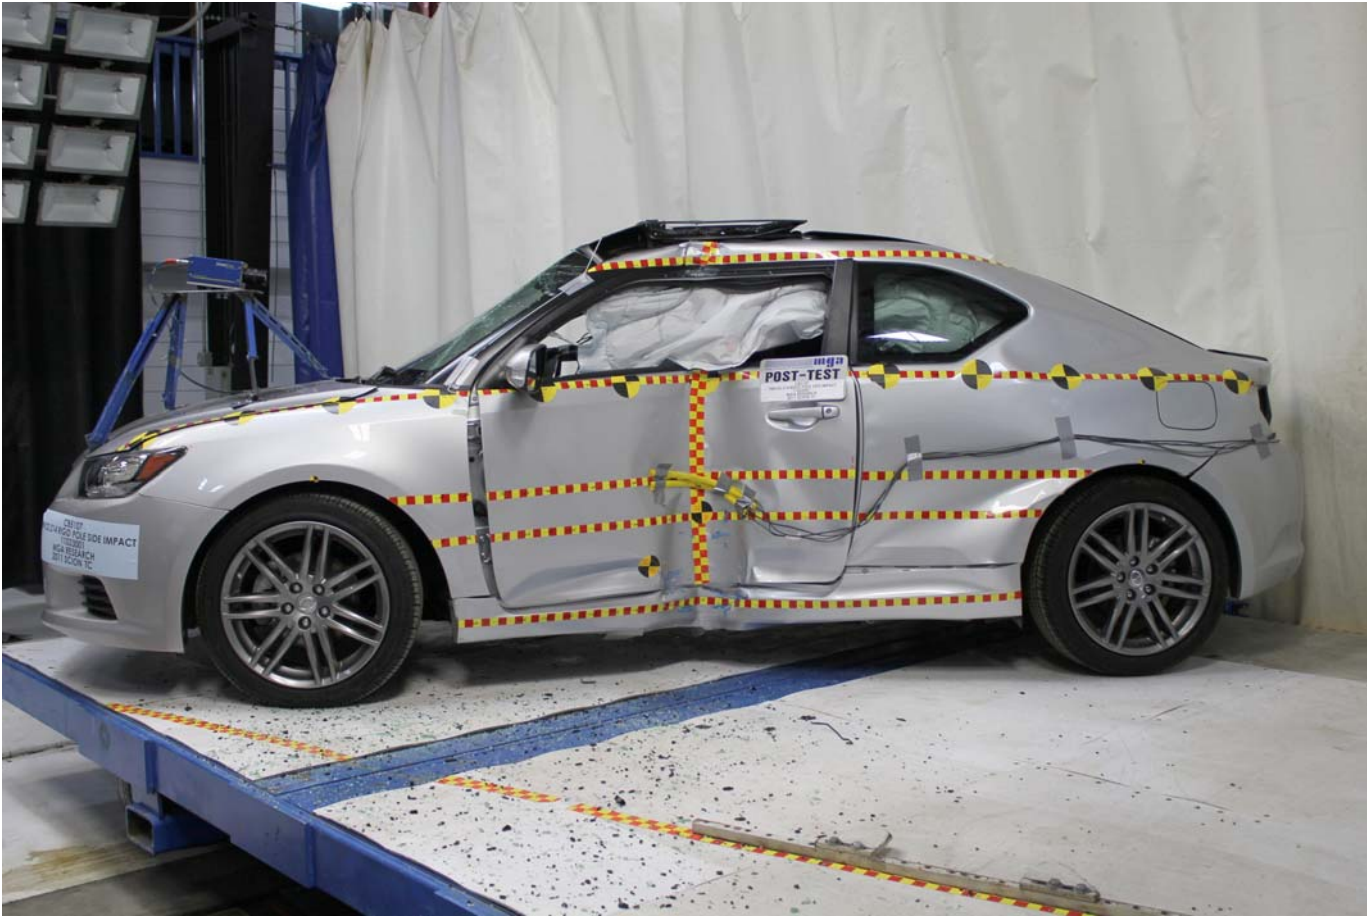
Post-Test Impacted Side View of Test Vehicle

Critical Areas of Performance	Observations and Conclusions
Pillar Performance	No Separation
Sill Separation	None
Windshield Damage	Cracked
Window Damage	Left Front Window and Sunroof Broke
Other Notable Effects	None

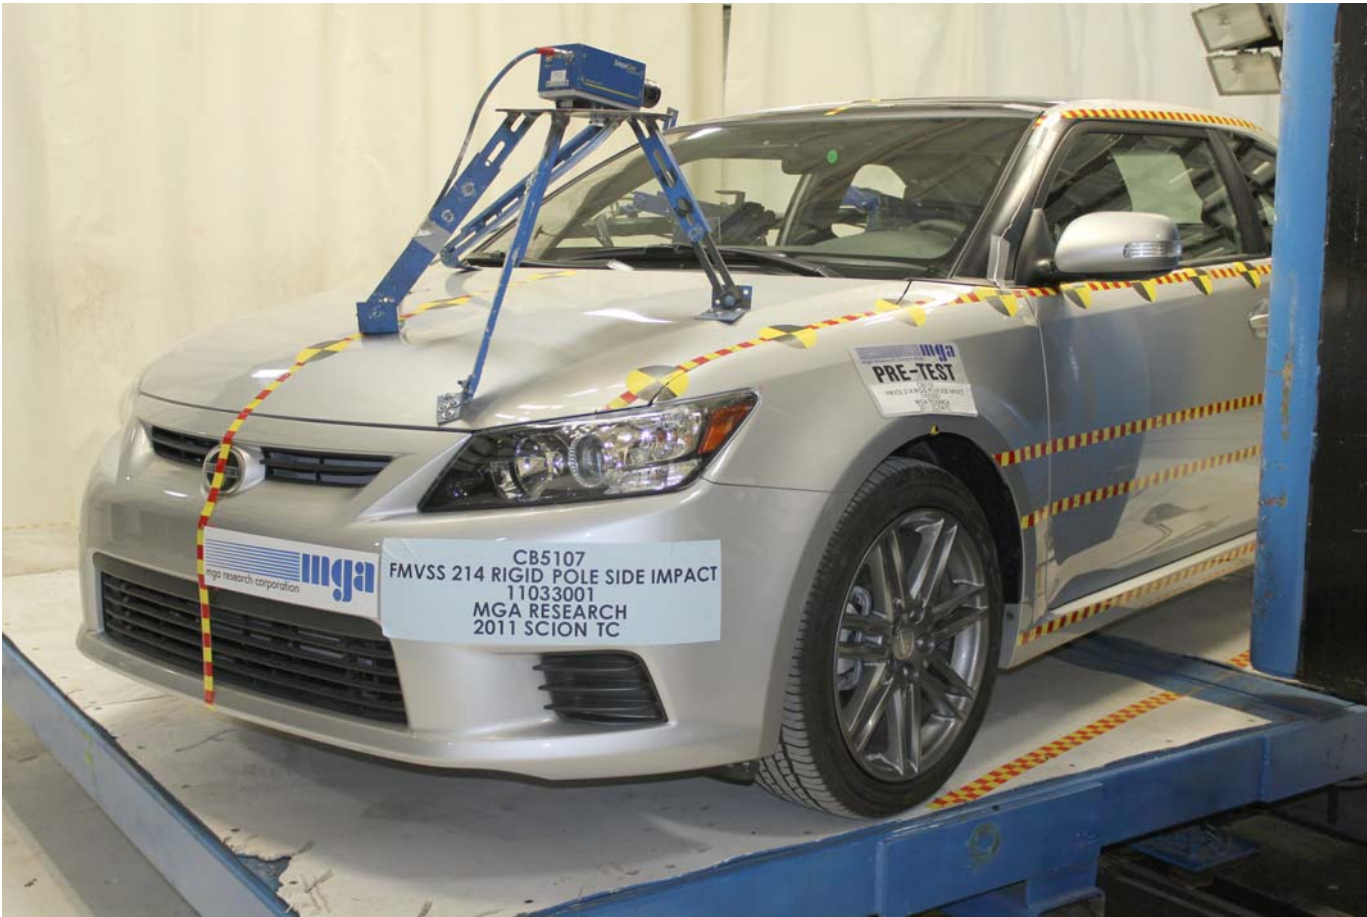
Pre-Test Left $\frac{3}{4}$ Front View of Vehicle and Pole

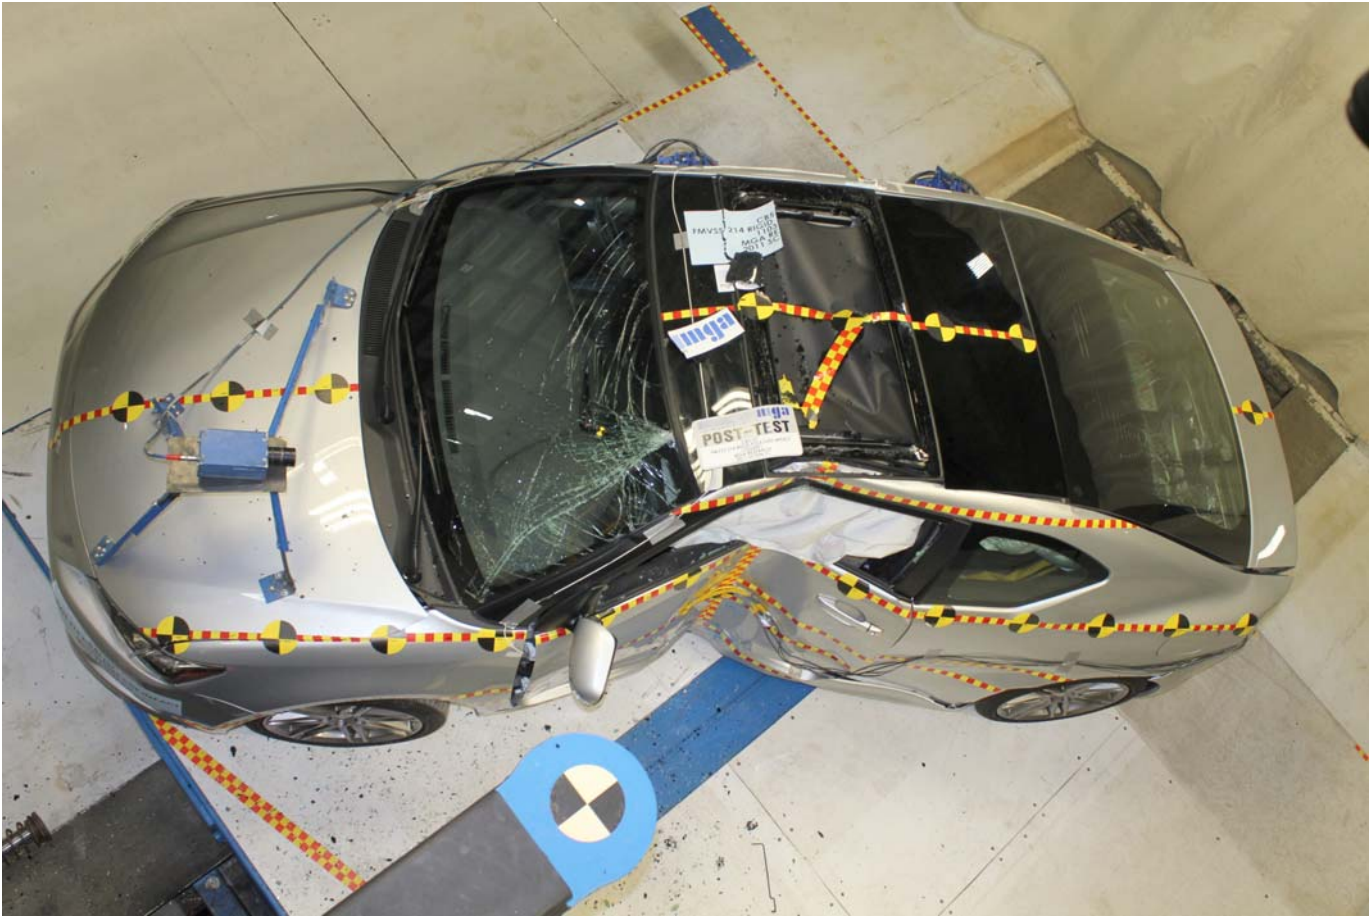
Post-Test Overhead View of Test Vehicle

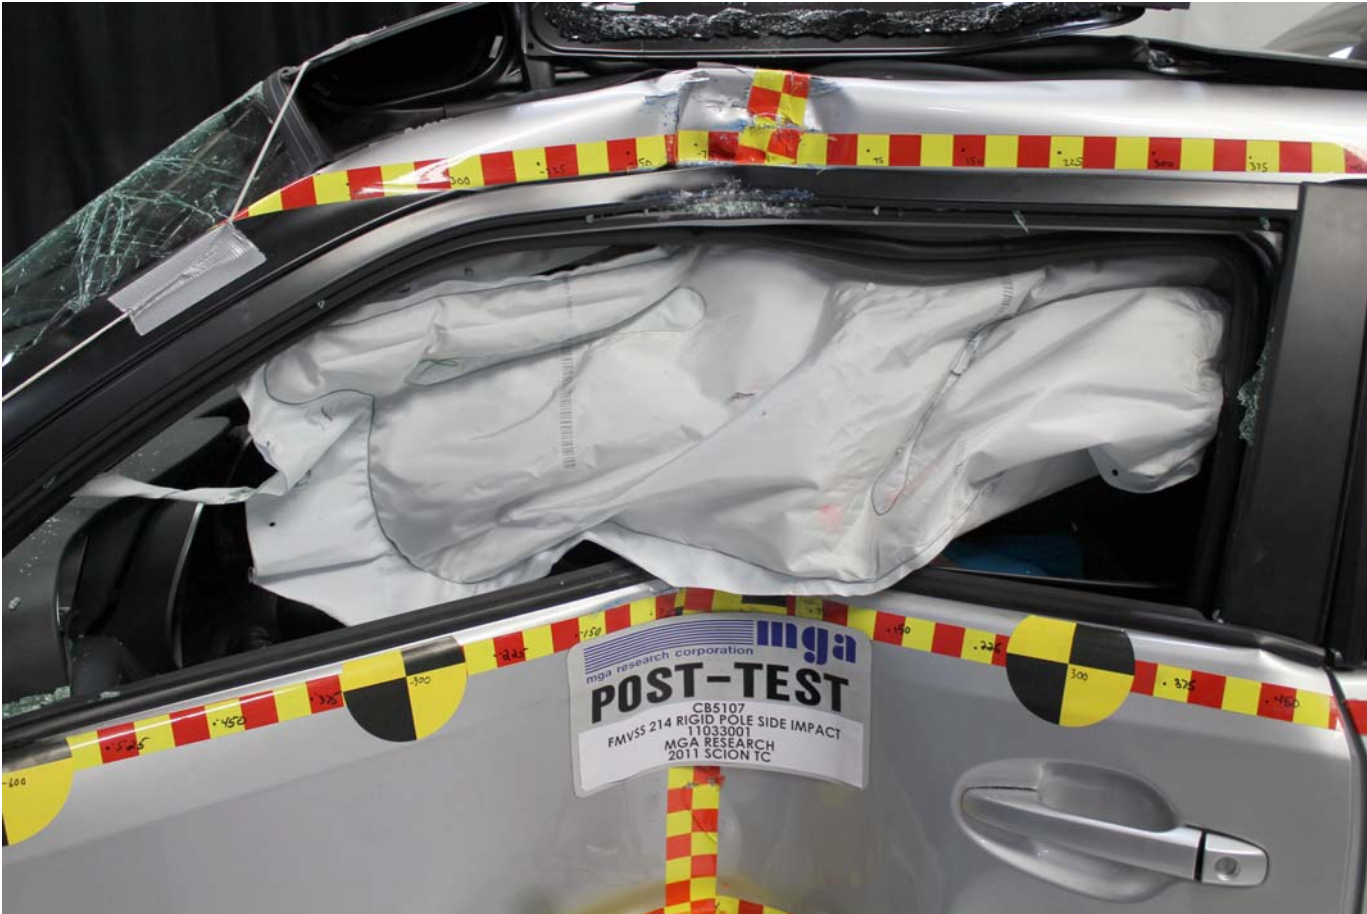
Post-Test Dummy with Door Closed (Impact Side)

Description	Front	Rear
Left Side Doors	Remained closed and jammed shut	Remained closed and jammed shut
Right Side Doors	Remained closed and operational	Remained closed and operational
Hatch and Other Doors	Remained closed and operational	Remained closed and operational
Seat Movement	0	0
Seat Back Failure	None	None

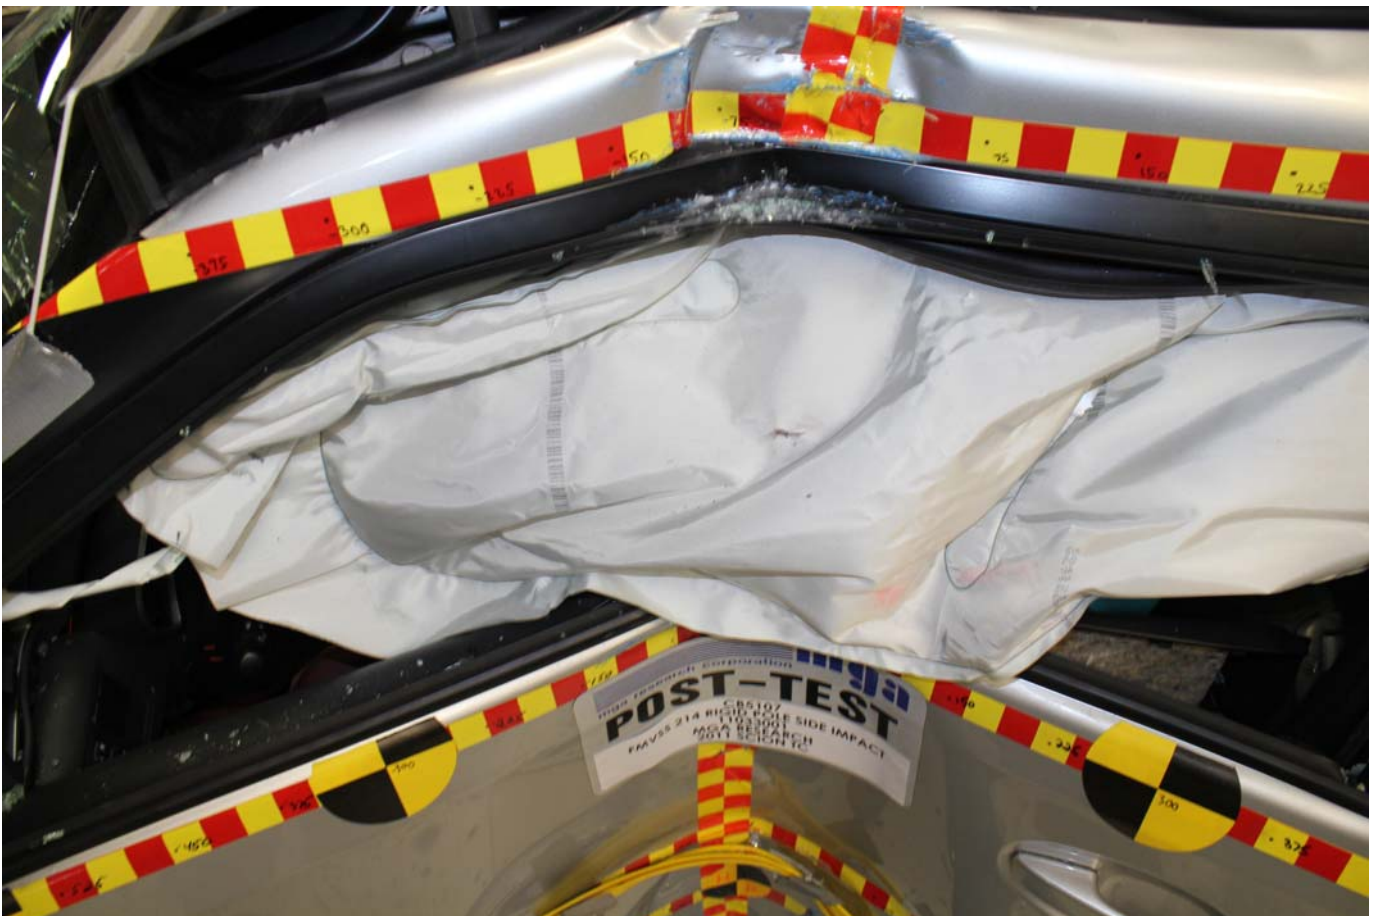
Post-Test Dummy Shoulder and Door Top View

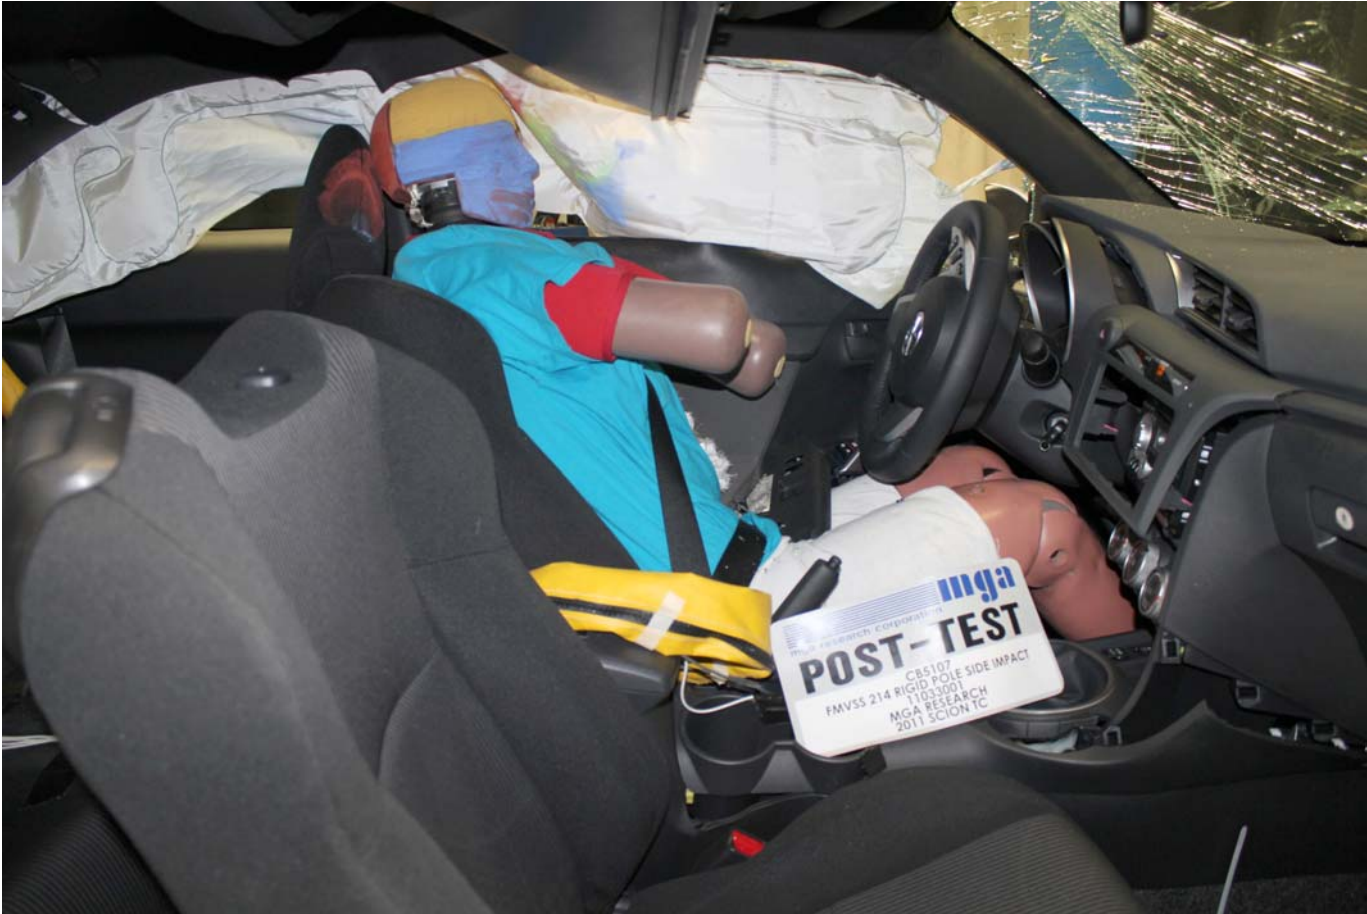
Post-Test Interior of Front Door Showing Dummy Impact Locations

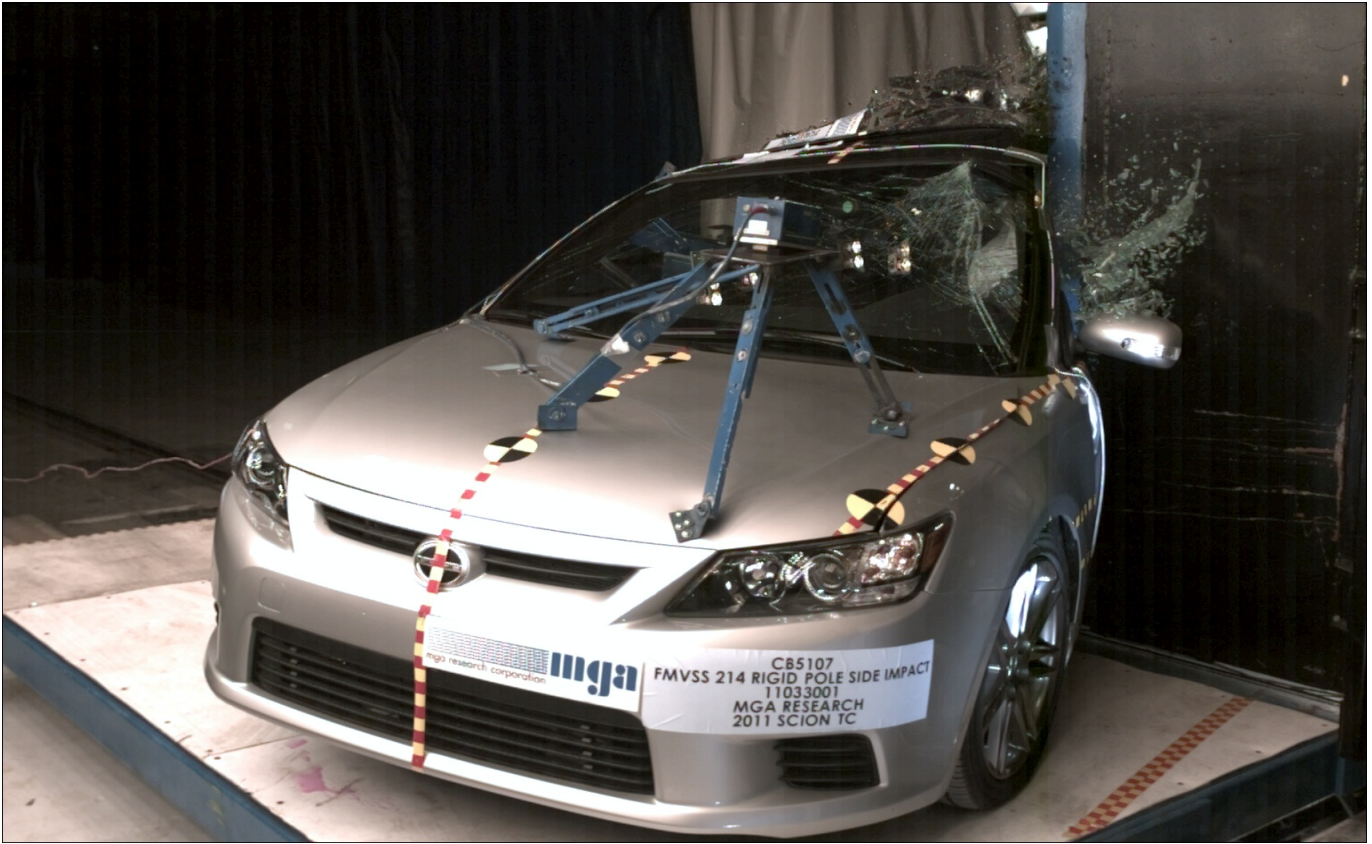
Impact Event

A rigid pole side impact test was conducted on a 2011 Scion tC 3-Dr Liftback. The subject vehicle was towed into the rigid pole at an angle of 75° and a velocity of 31.7 km/h. The test was conducted by MGA Research Corporation in Burlington, Wisconsin, on March 30, 2011. Pre-test and post-test photographs of the test vehicle and side impact dummy are included in Appendix A of this report.

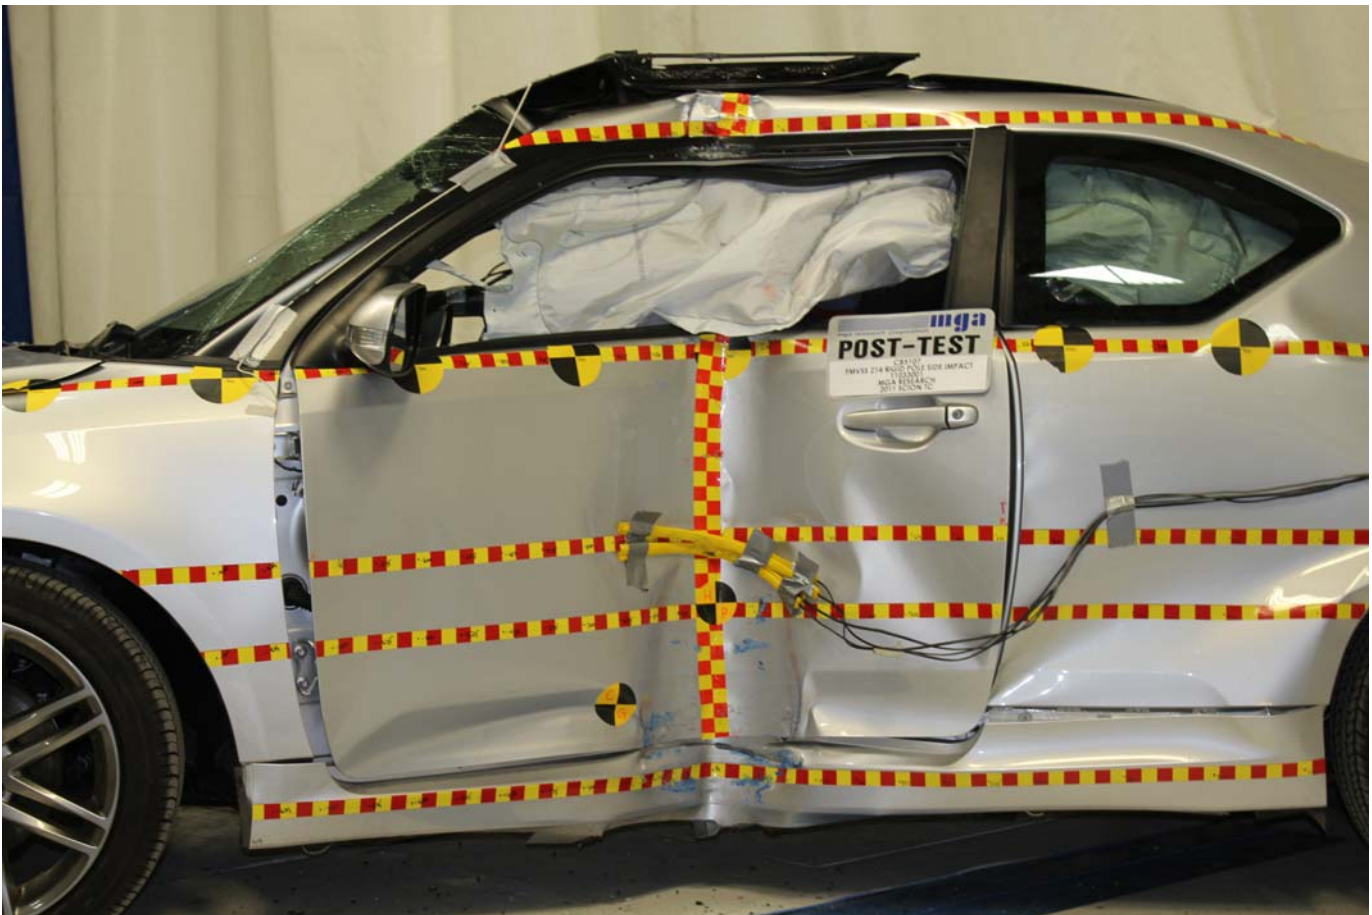
Post-Test Impact Zone Close-up View

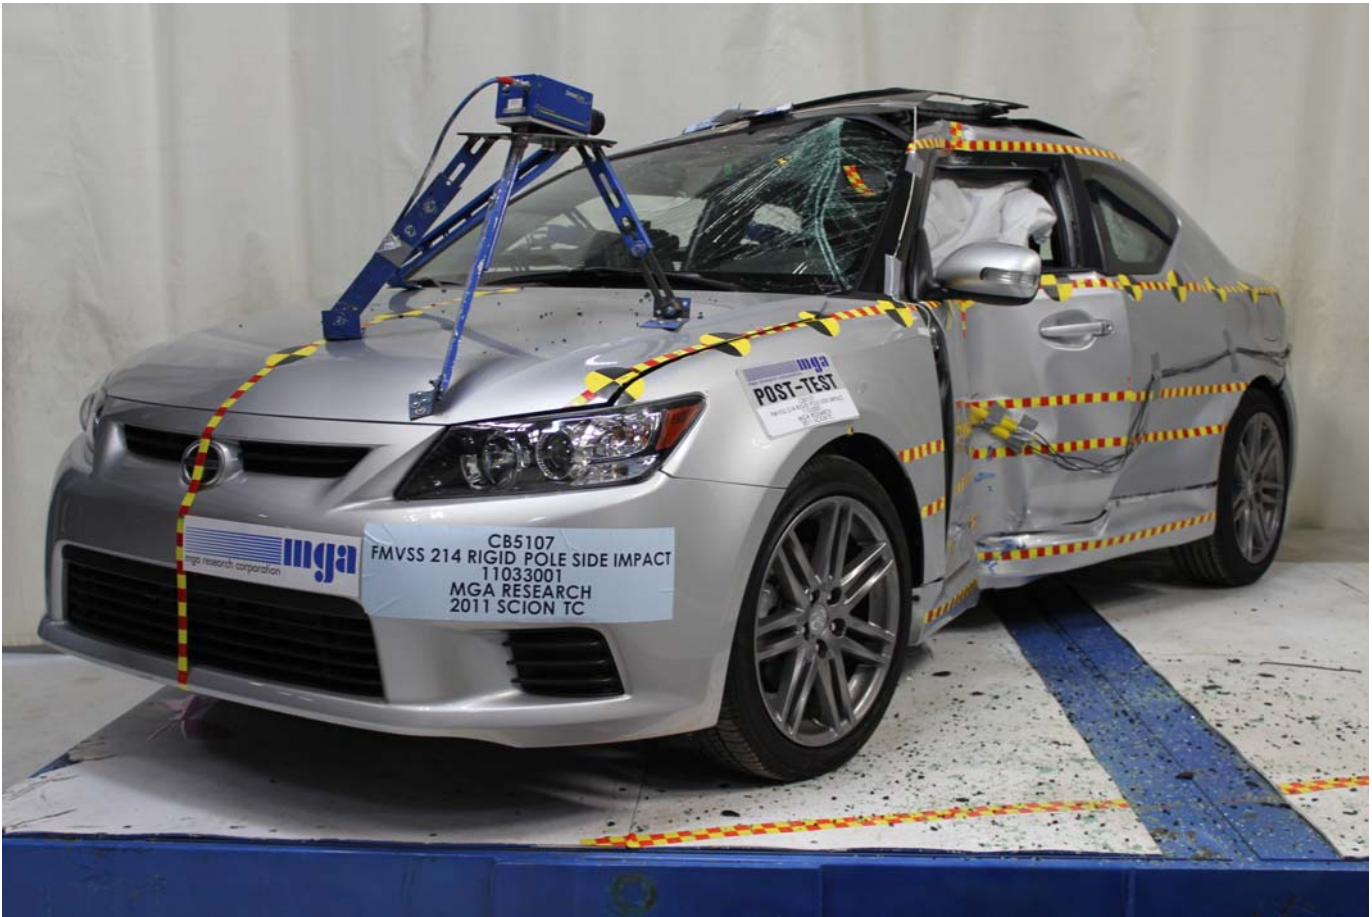
Post-Test $\frac{3}{4}$ Front View of Impact Zone

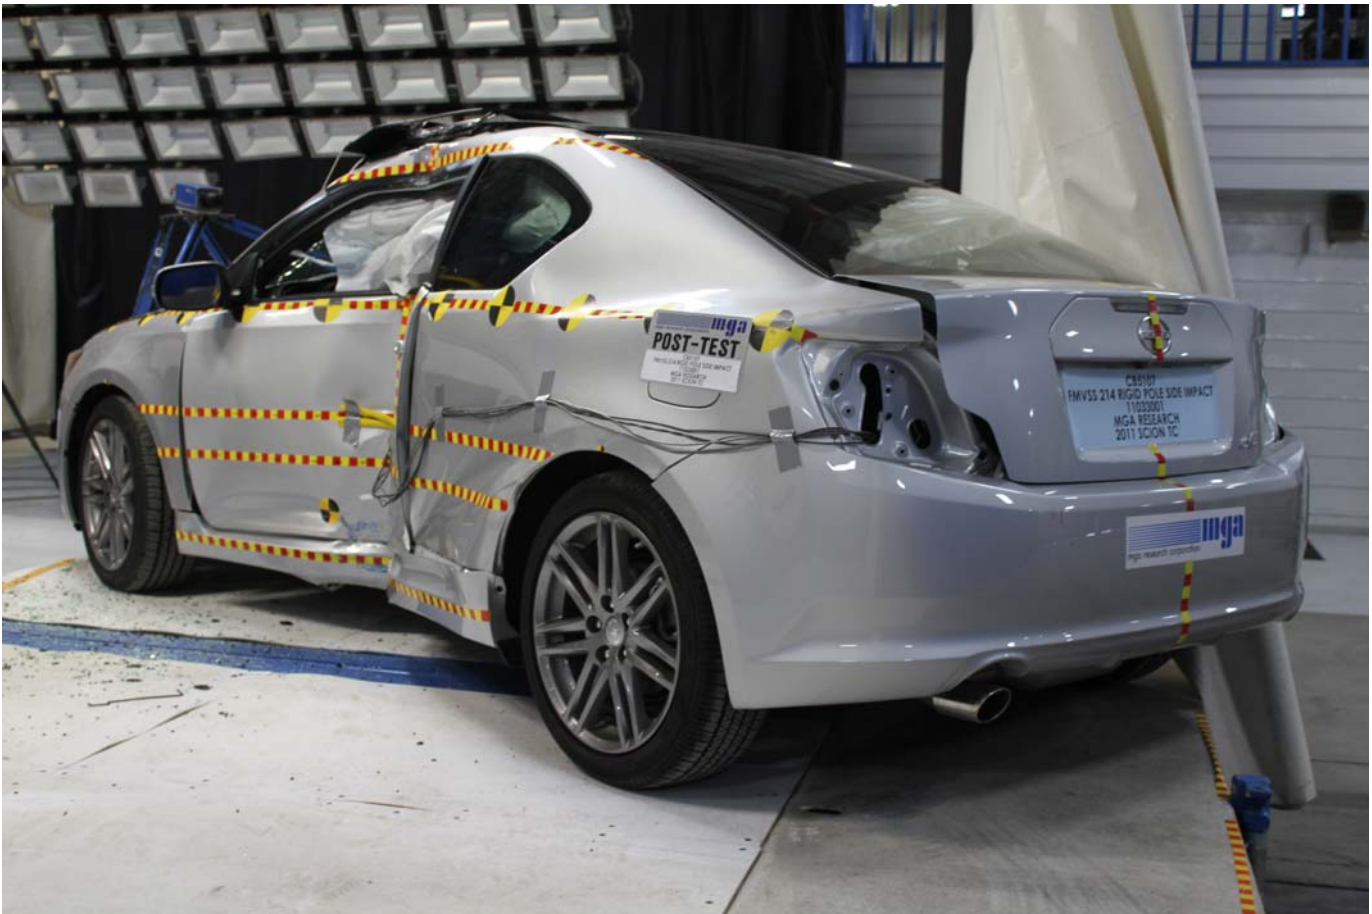
Post-Test $\frac{3}{4}$ Rear View of Impact Zone
