REPORT NUMBER: 214P-MGA-2011-010

**SAFETY COMPLIANCE TESTING FOR FMVSS 214
DYNAMIC SIDE IMPACT PROTECTION
RIGID POLE**

**KIA MOTORS CORPORATION
2011 KIA OPTIMA LX 4-DR SEDAN
NHTSA NUMBER: CB0510**

**PREPARED BY:
MGA RESEARCH CORPORATION
5000 WARREN ROAD
BURLINGTON, WI 53105**

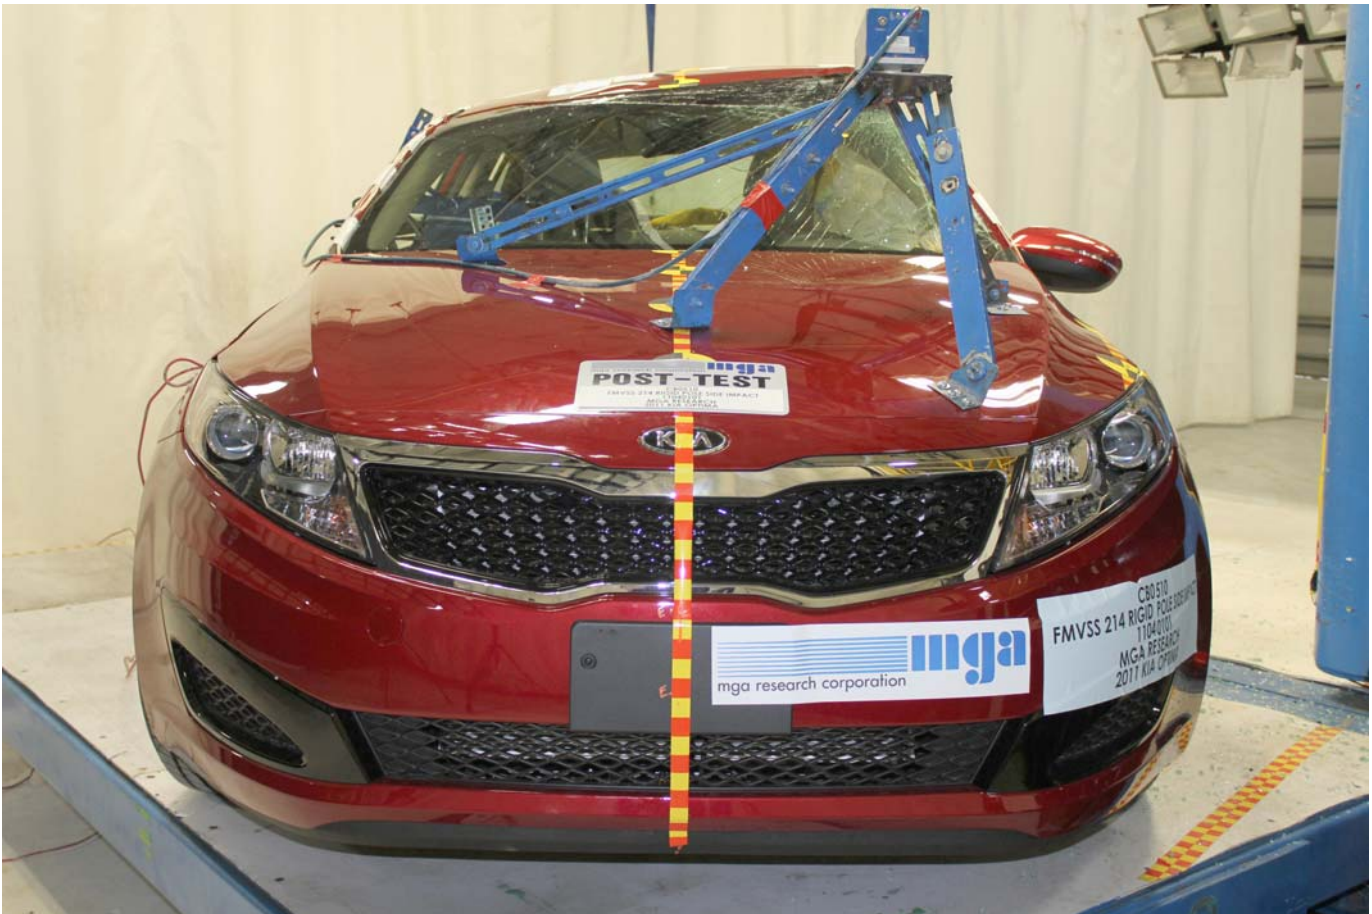
| Critical Areas of Performance | Observations and Conclusions |
|---|---|
| Windshield Damage | Cracked |

Post-Test Frontal View of Test Vehicle

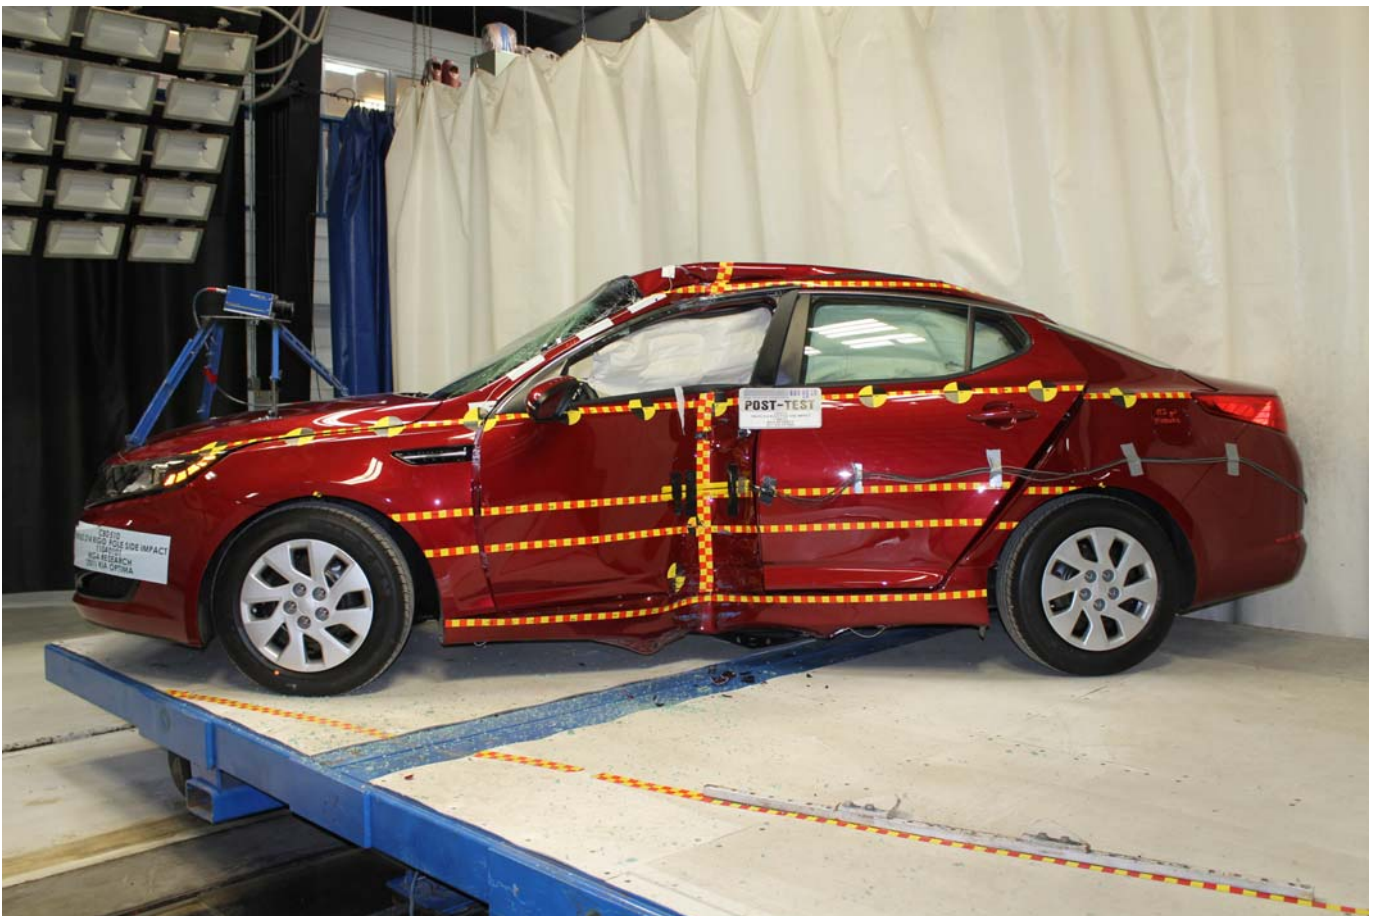
| Critical Areas of Performance | Observations and Conclusions |
|---|---|
| Window Damage | Left Front Window Broke |

Post-Test Impacted Side View of Test Vehicle

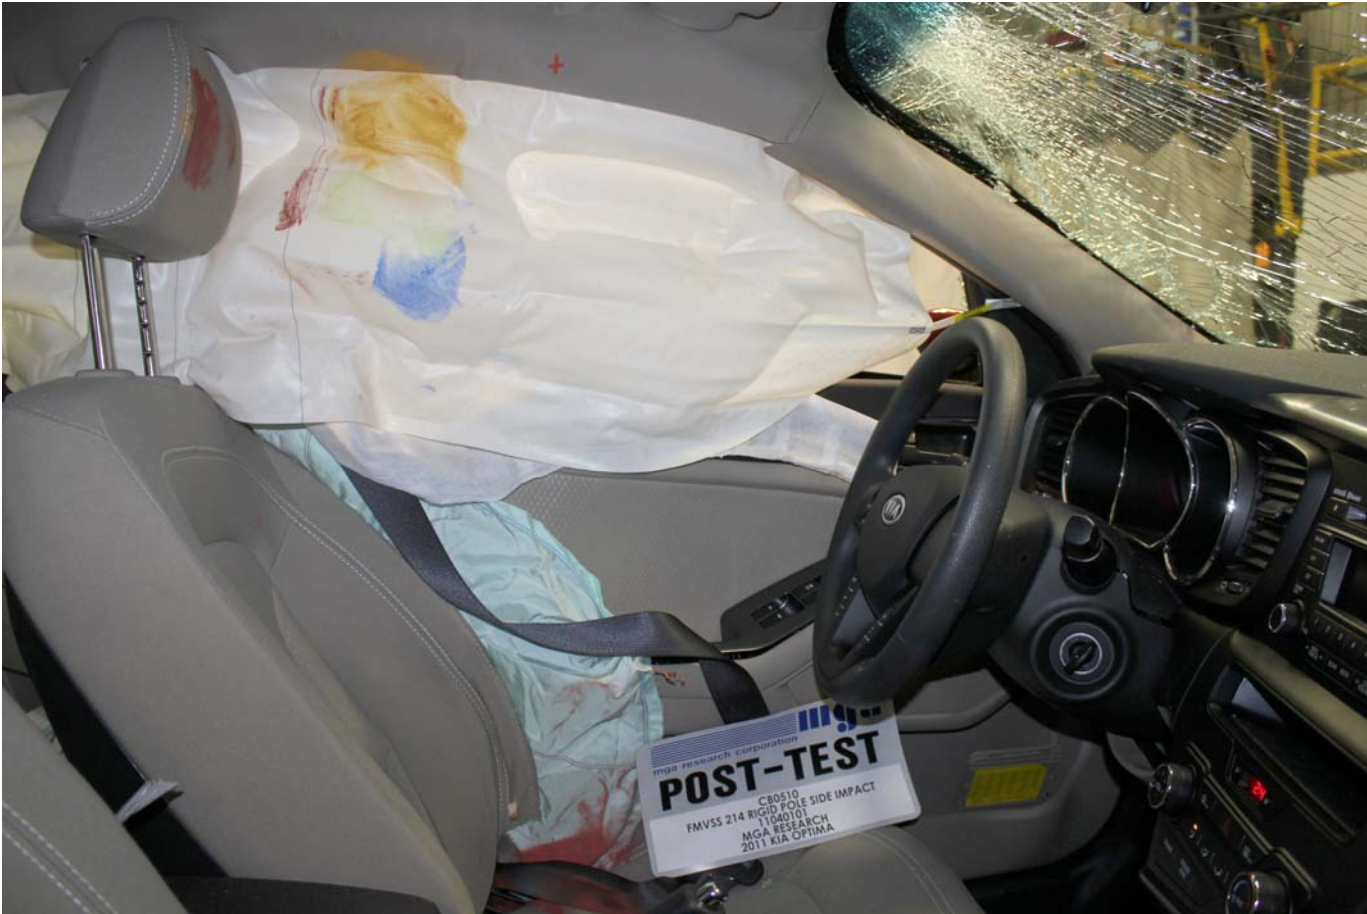
Post-Test Interior of Front Door Showing Dummy Impact Locations

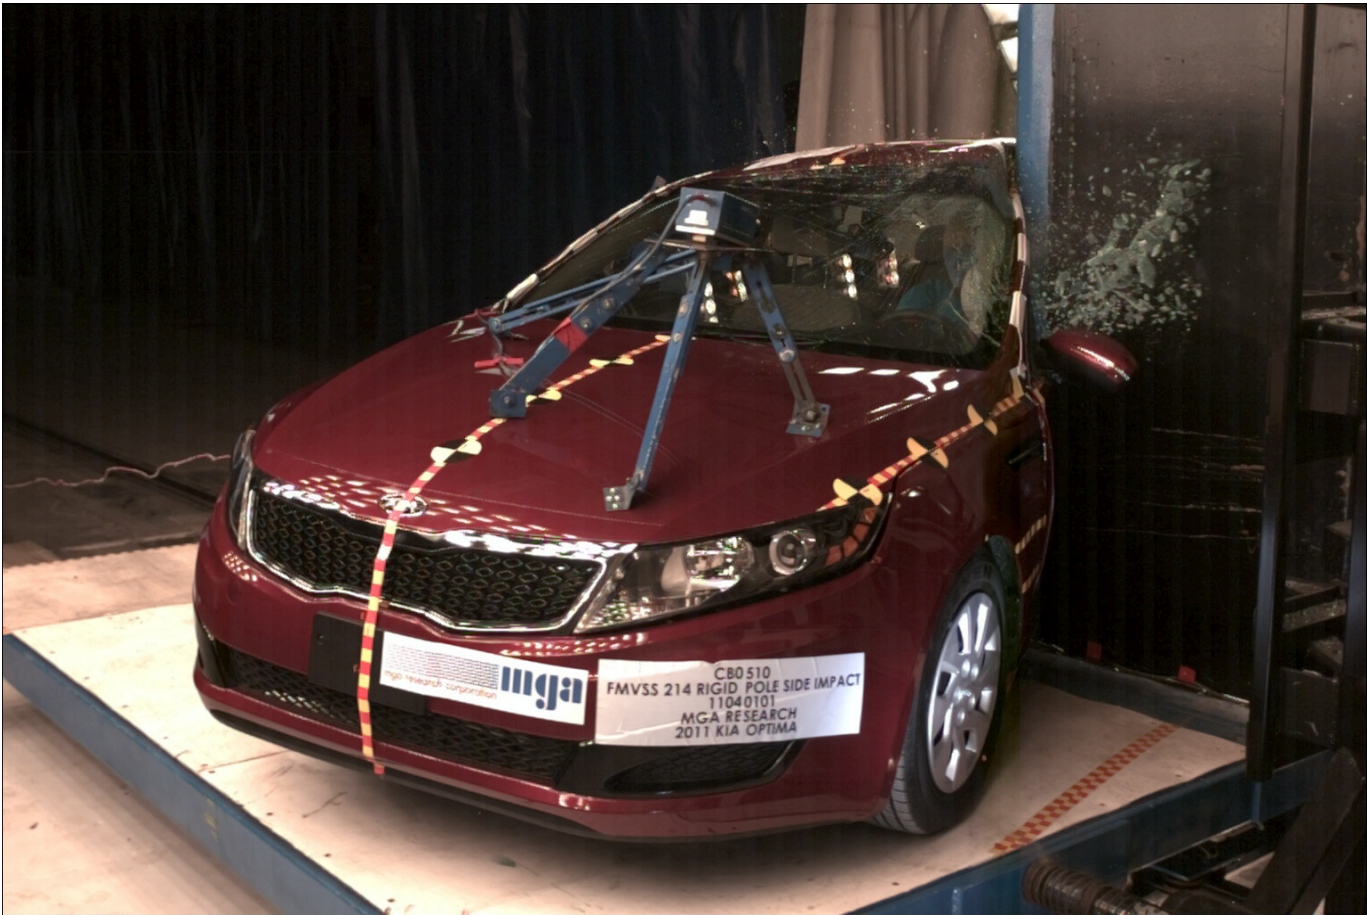
Impact Event

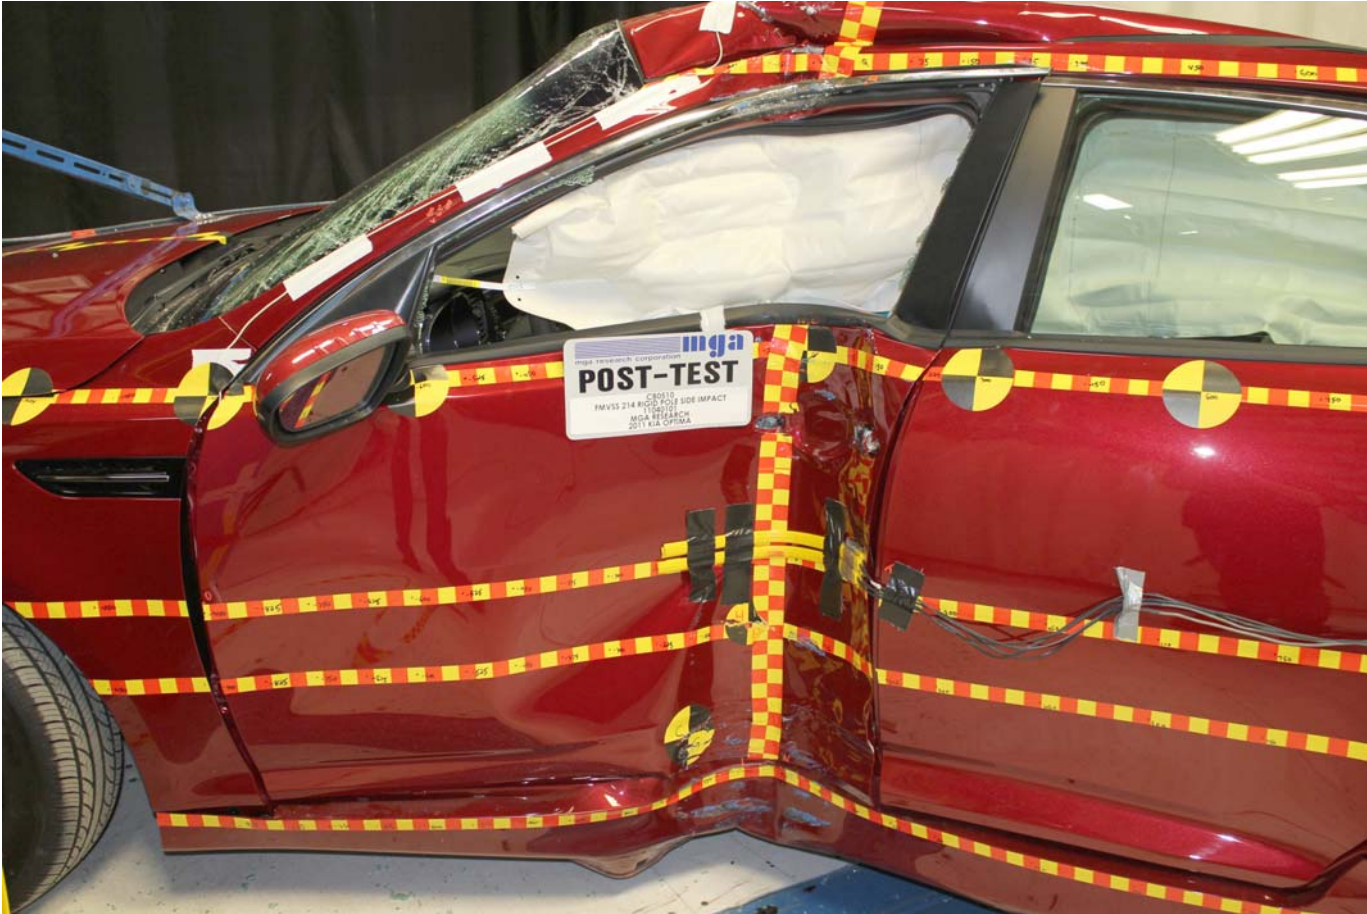
Post-Test Impact Zone Close-up View

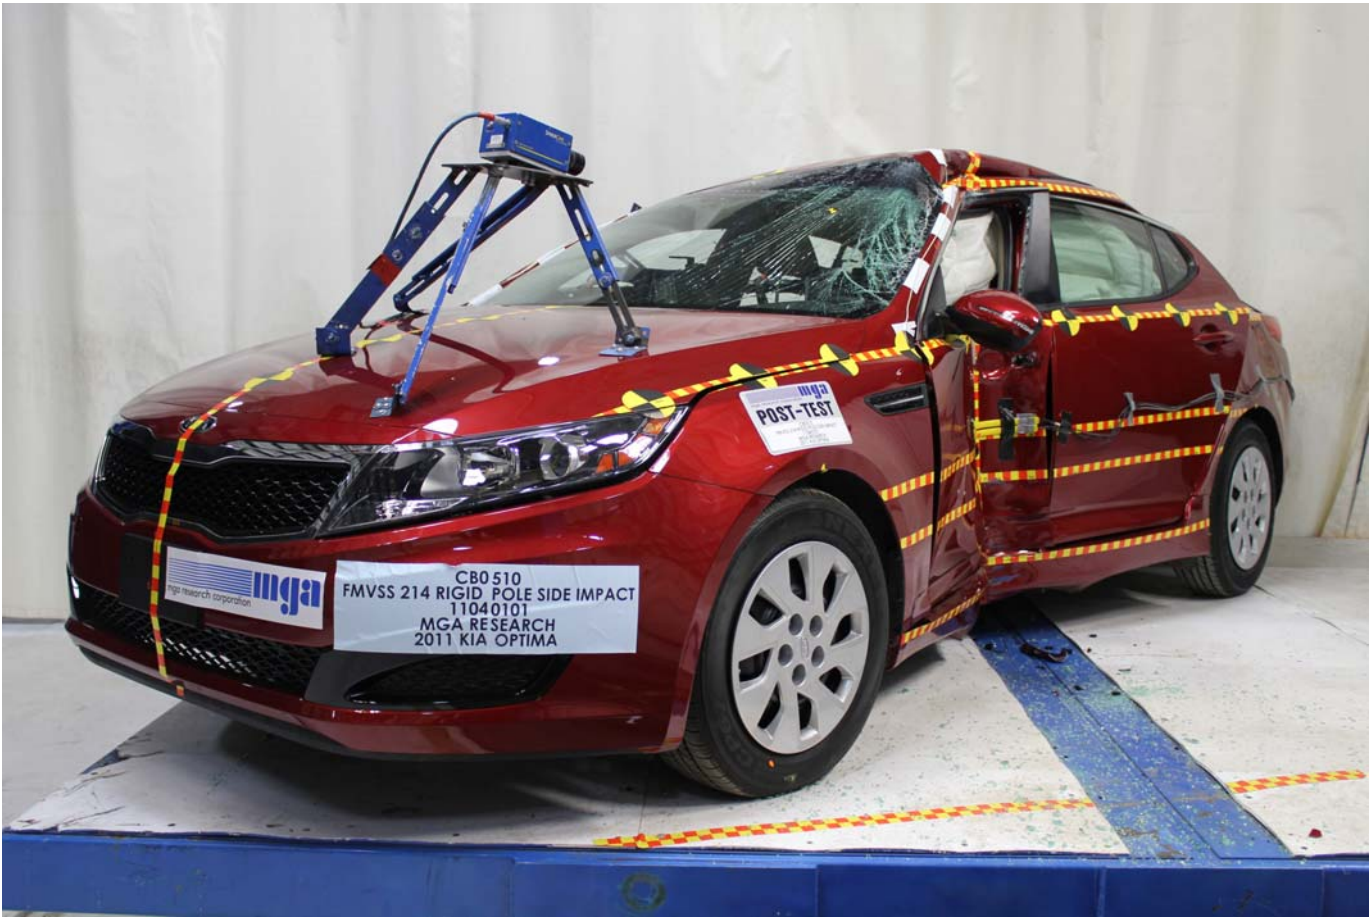
Post-Test $\frac{3}{4}$ Front View of Impact Zone

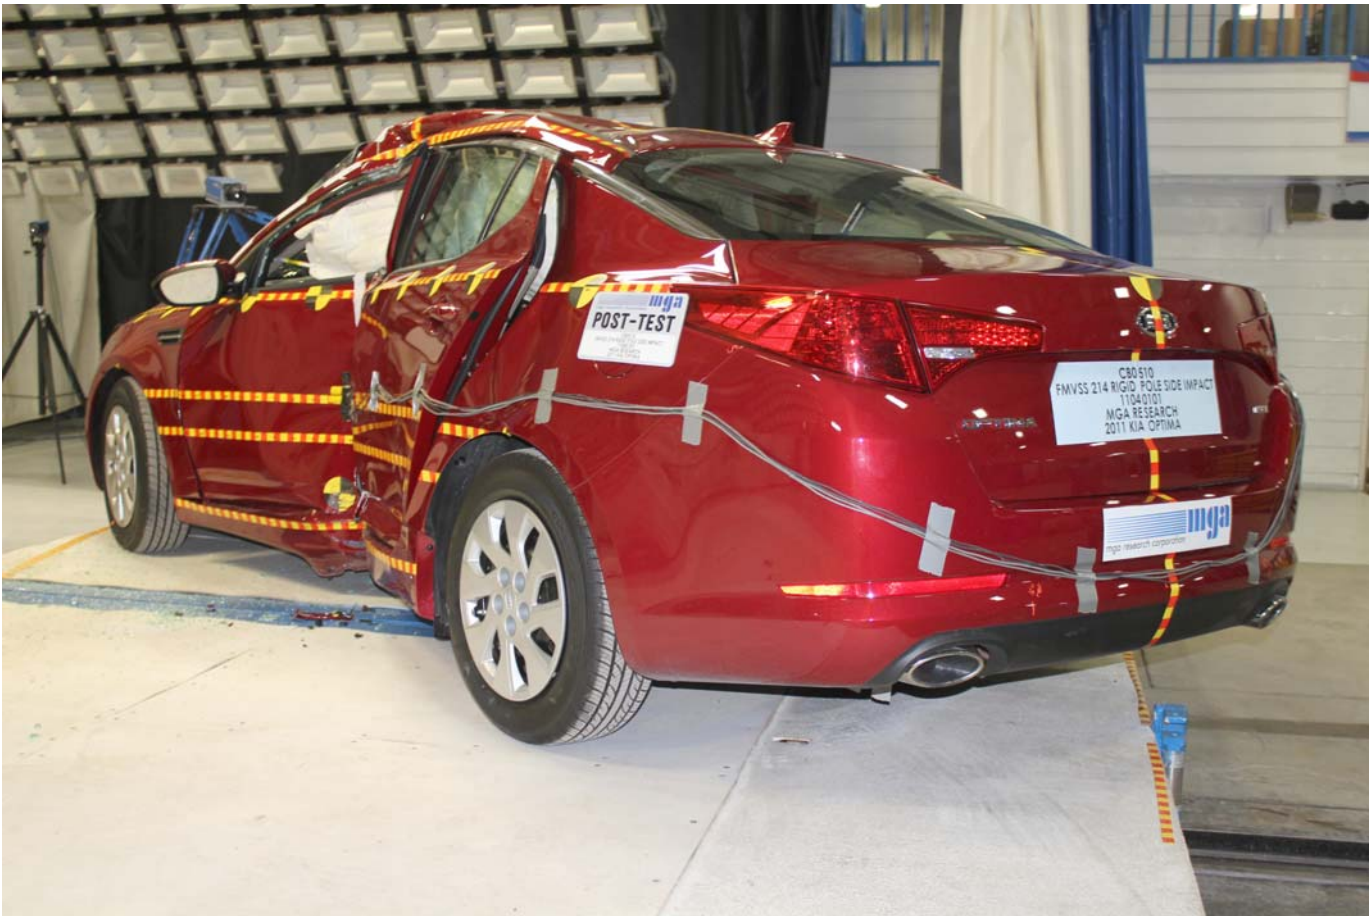
Post-Test $\frac{3}{4}$ Rear View of Impact Zone

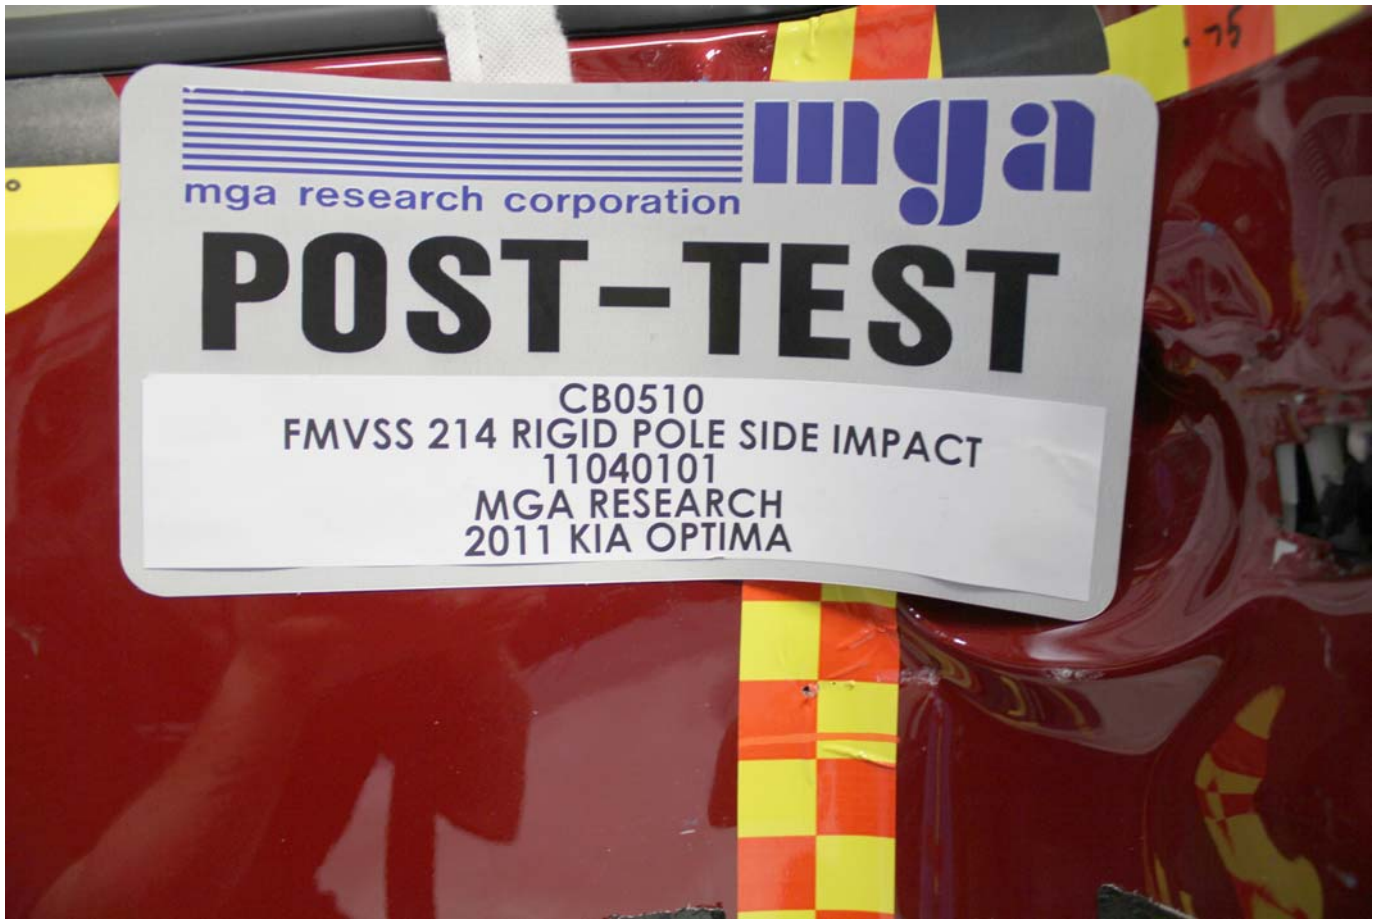
Post-Test Close-up View of Impact Point Target
