FINAL REPORT NUMBER 201UI-MGA-11-01

**SAFETY COMPLIANCE TESTING FOR FMVSS 201  
Occupant Protection In Interior Impact  
Upper Interior Head Impact Protection**

**HYUNDAI MOTOR MANUFACTURING ALABAMA, LLC  
2011 HYUNDAI ELANTRA GLS M/T  
NHTSA No. CB0509**

**MGA RESEARCH CORPORATION  
446 Executive Drive  
Troy, Michigan 48083**

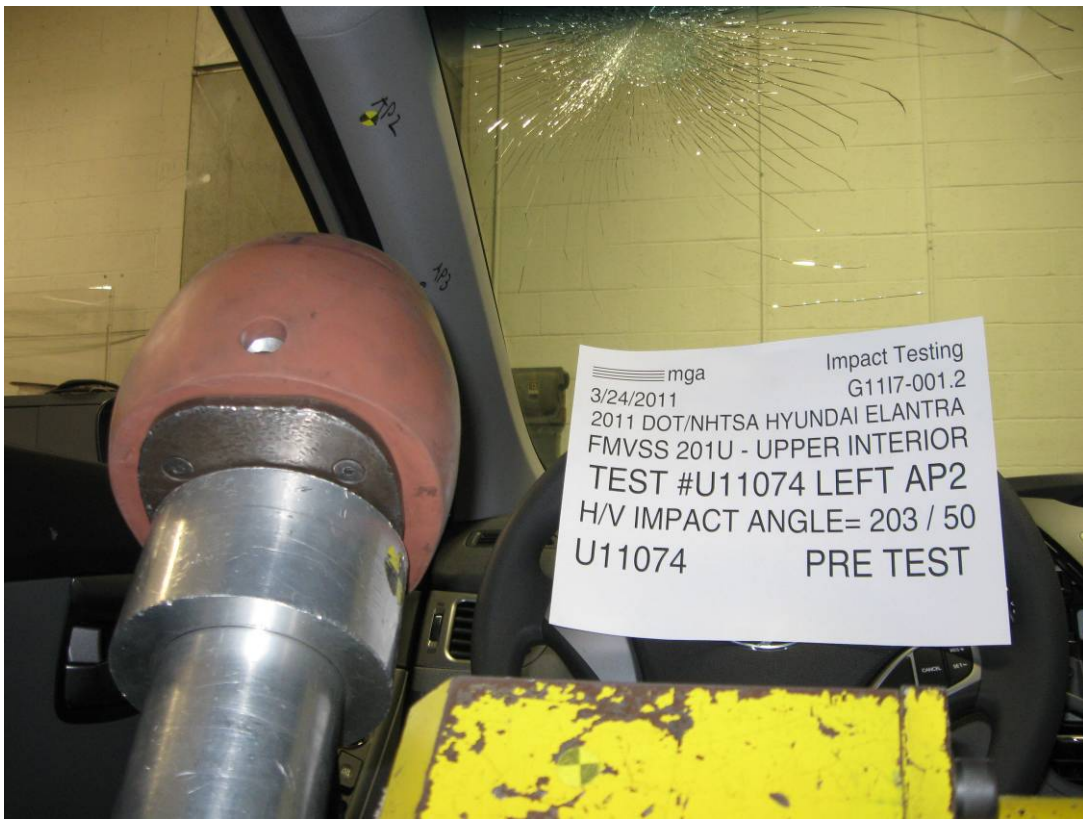
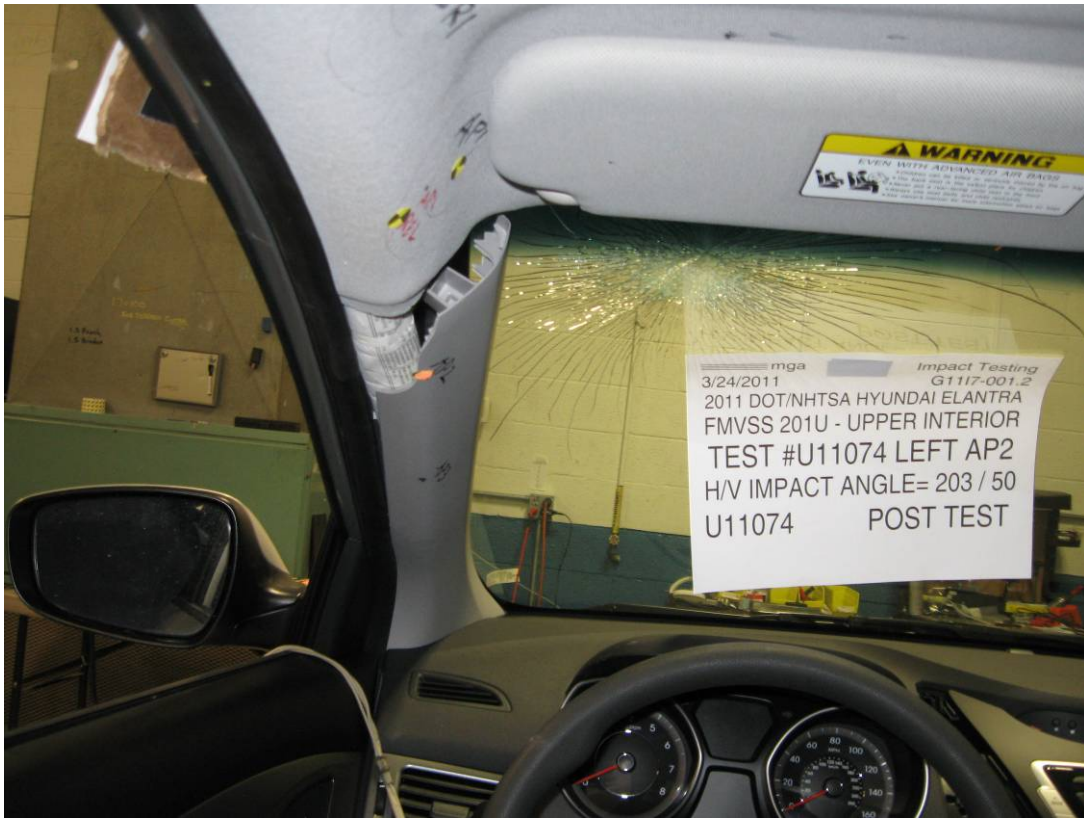
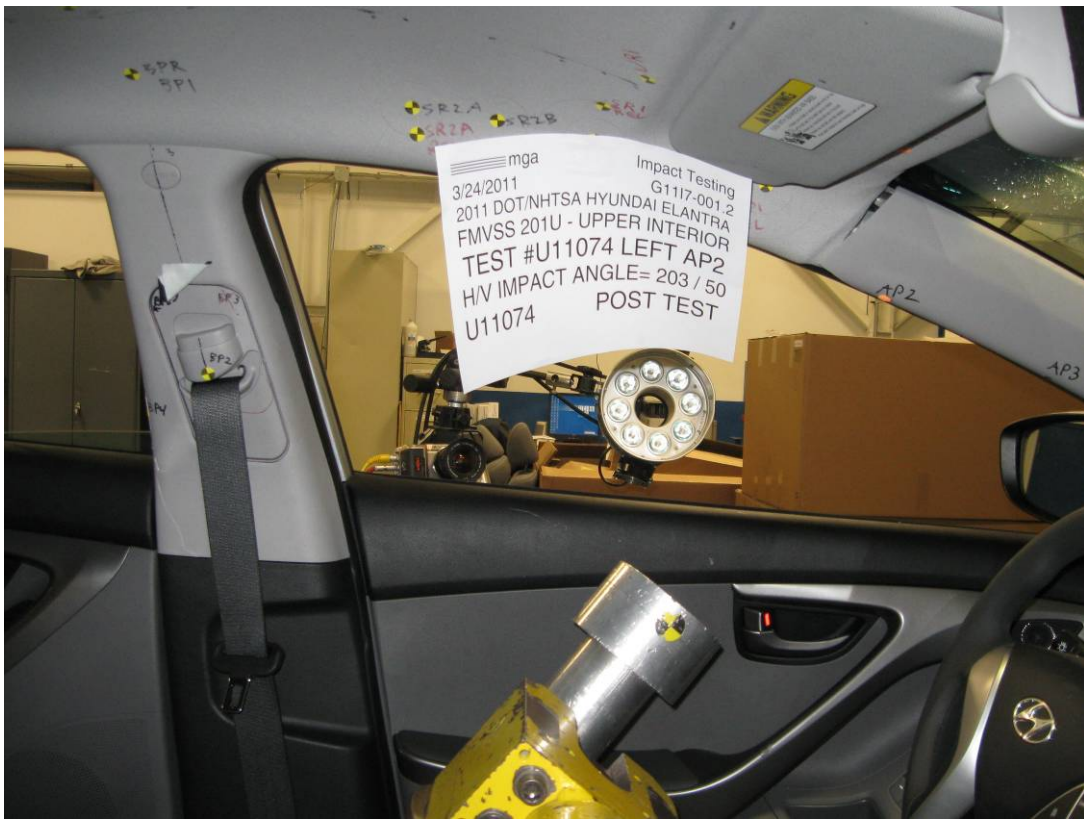
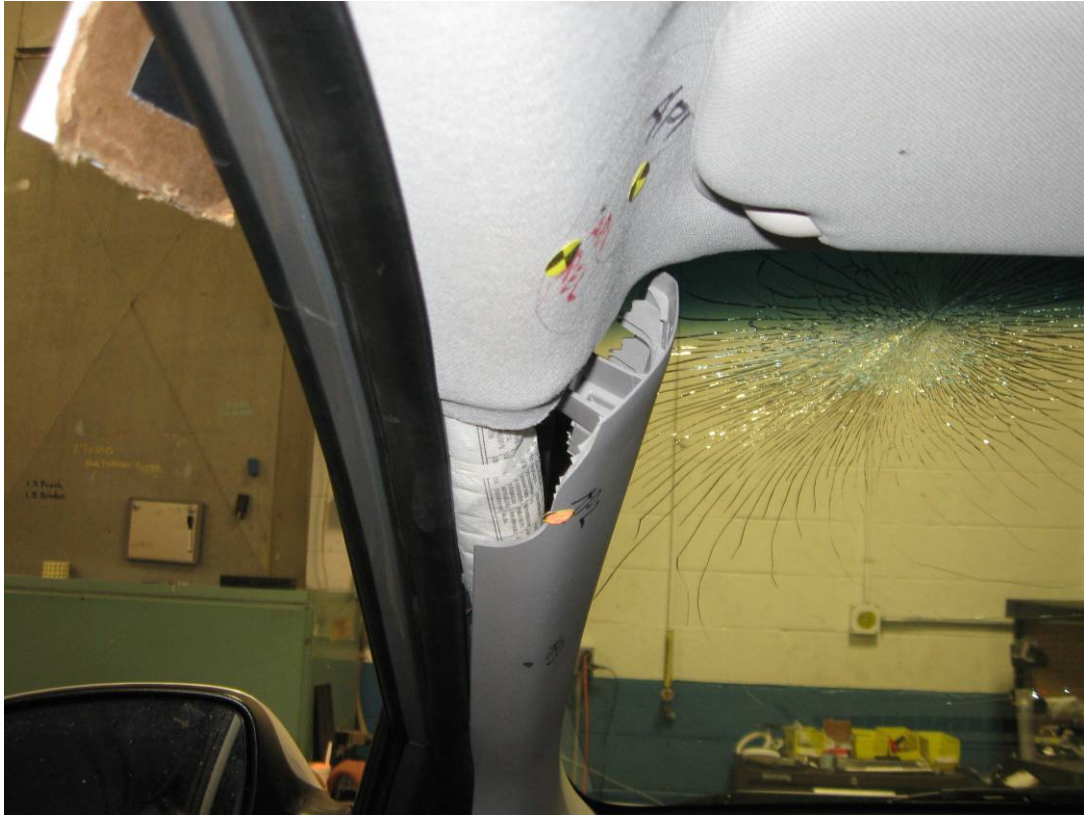
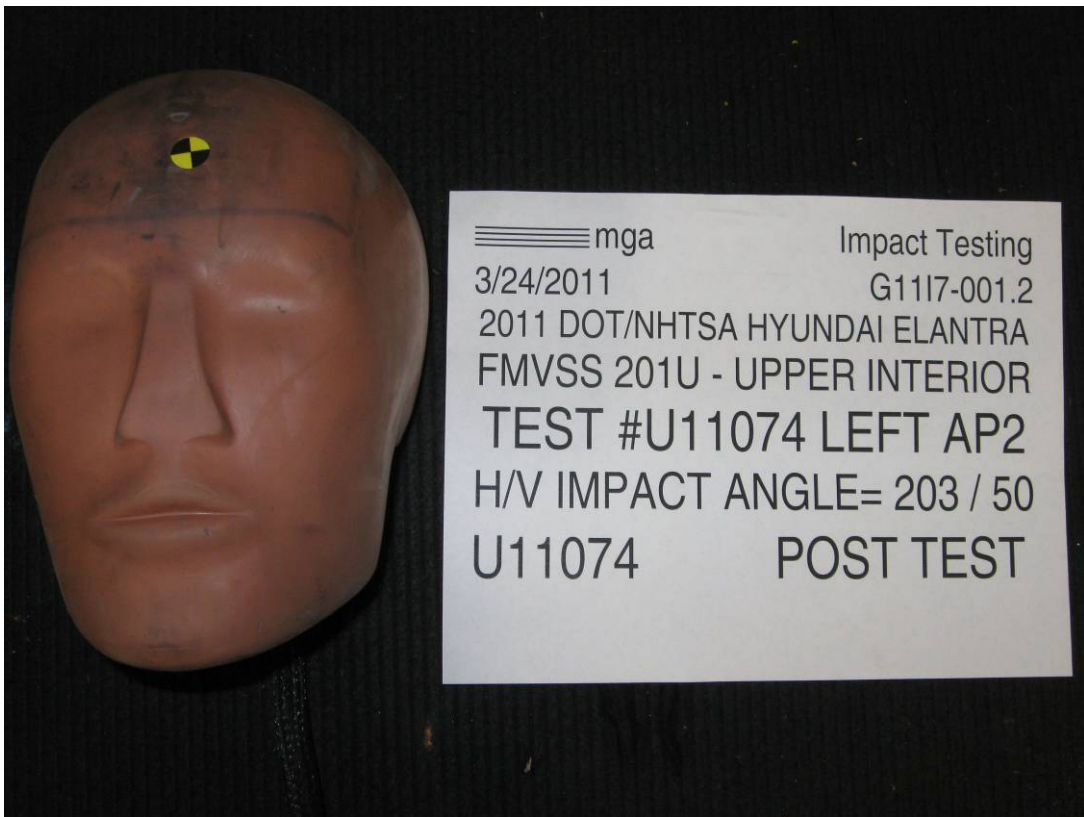
Cracked and dislodged trim.

AP2 Left: Cracked and dislodged trim.

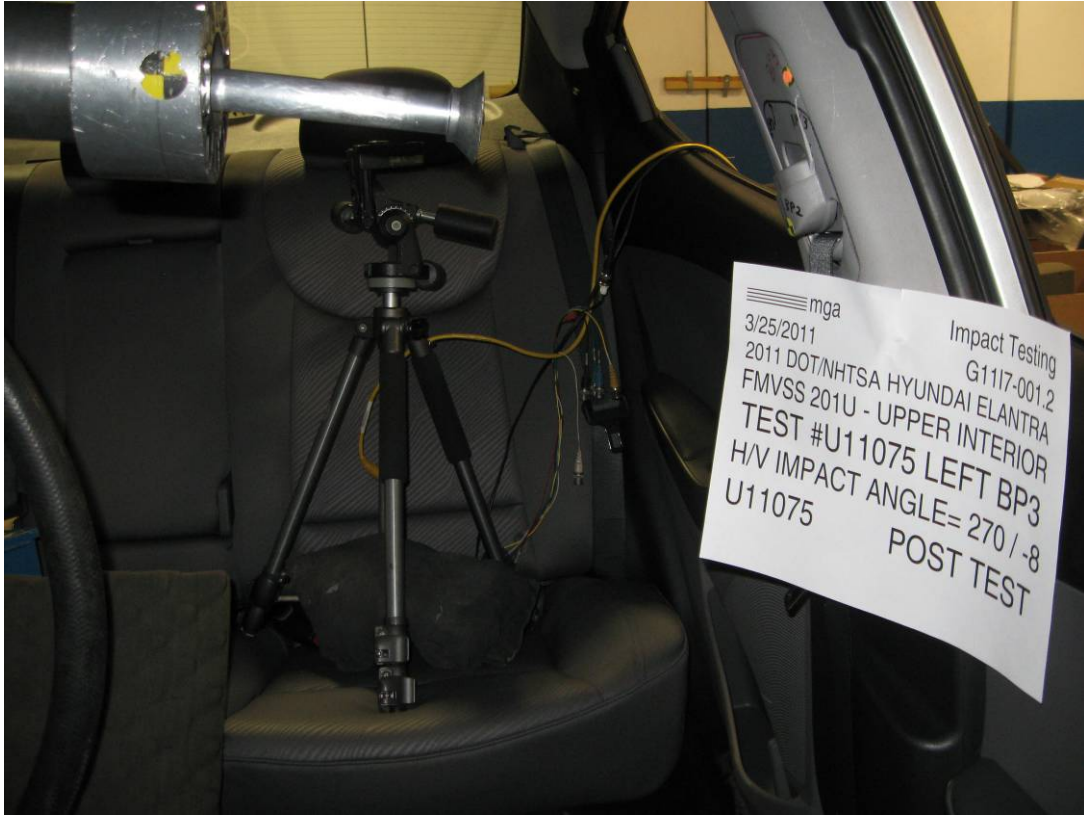
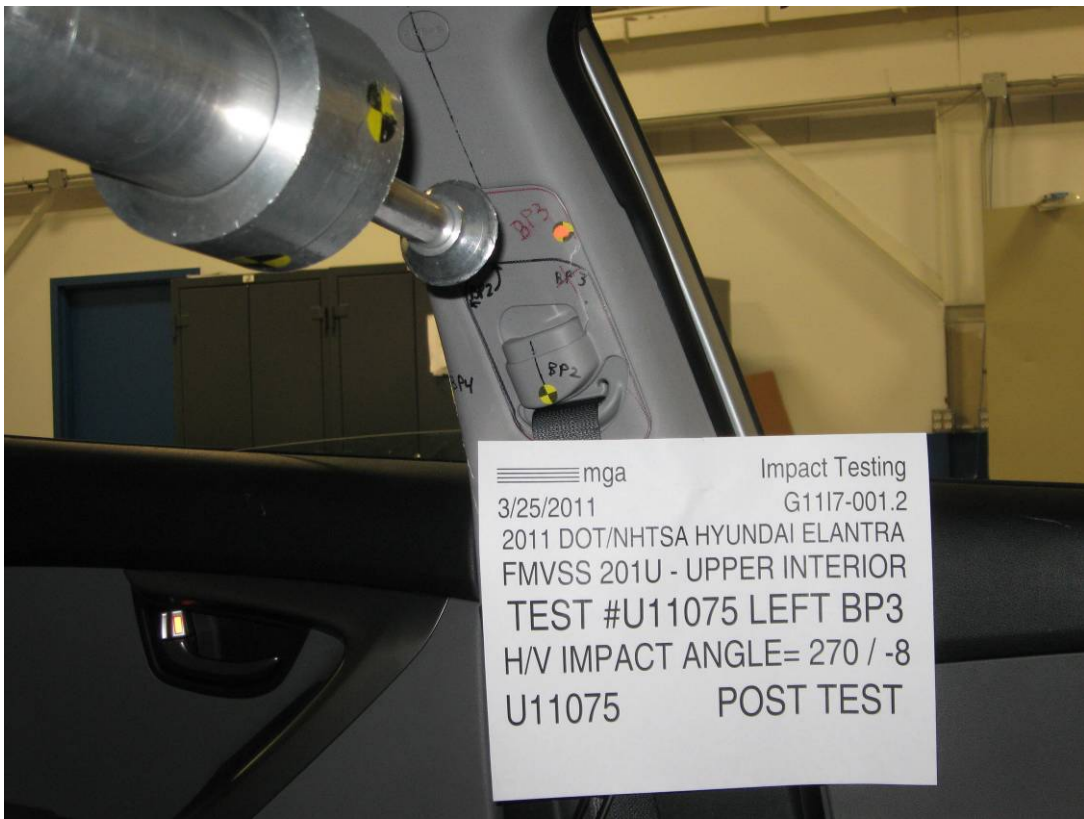
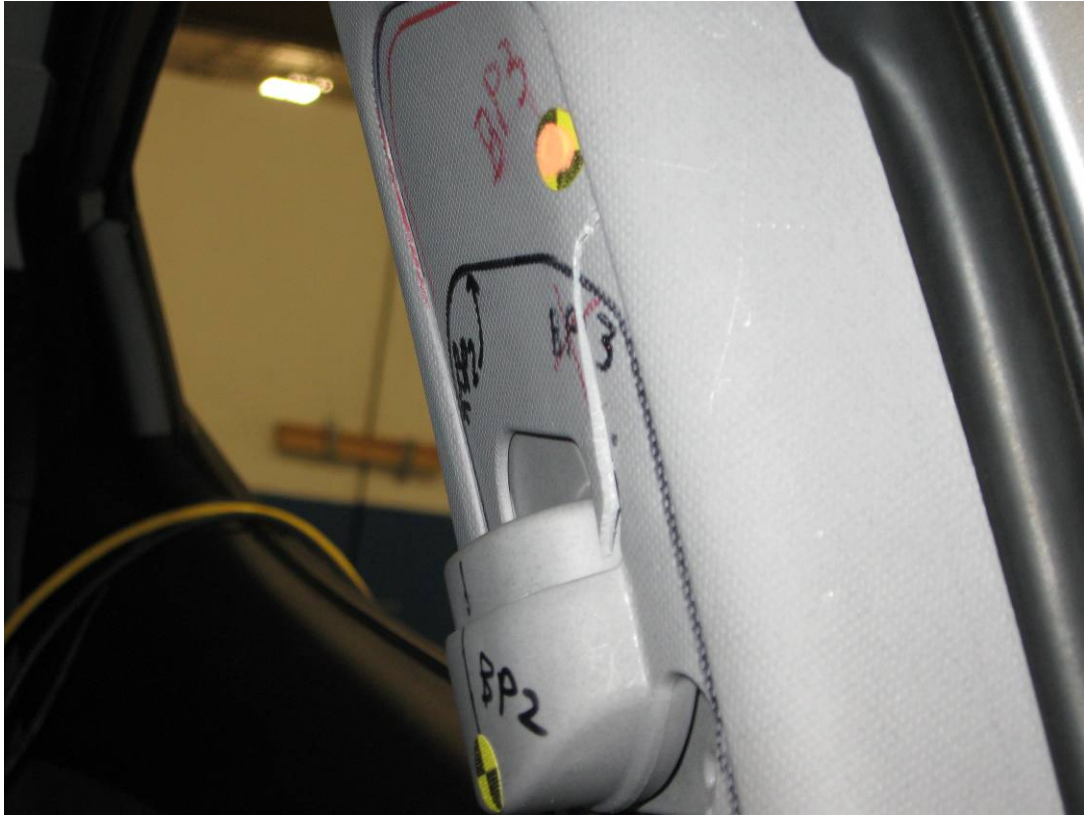
Cracked trim

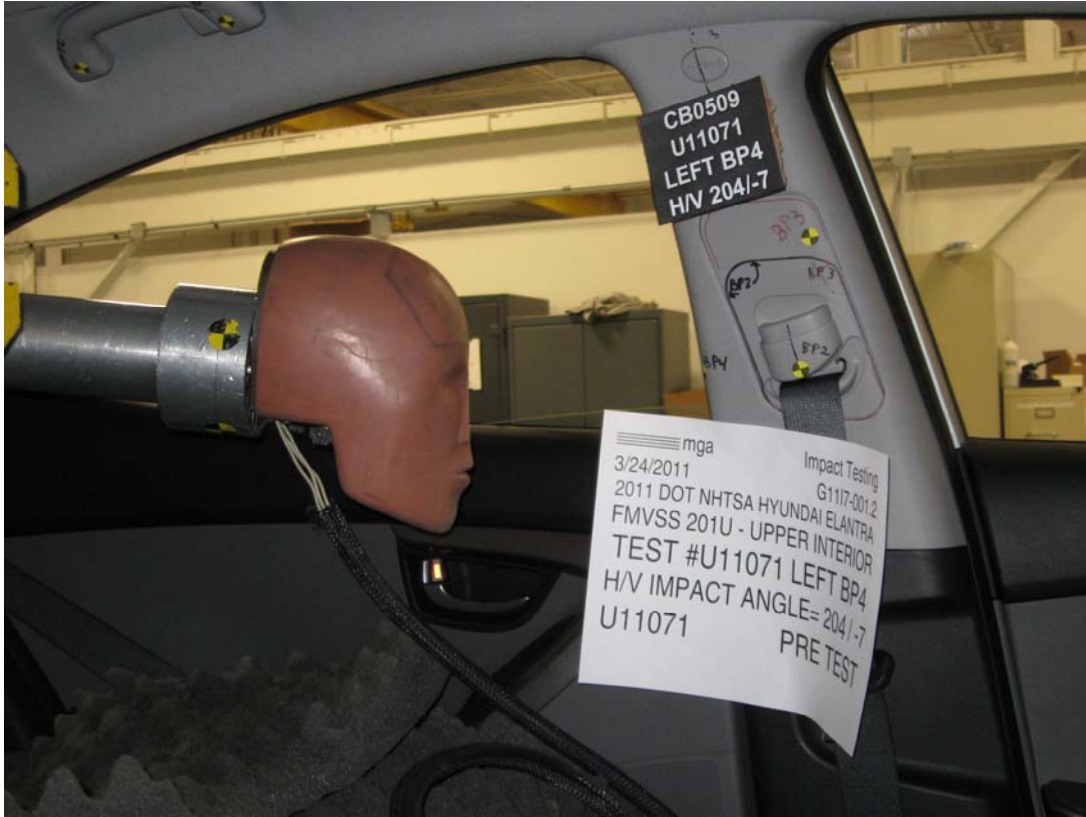
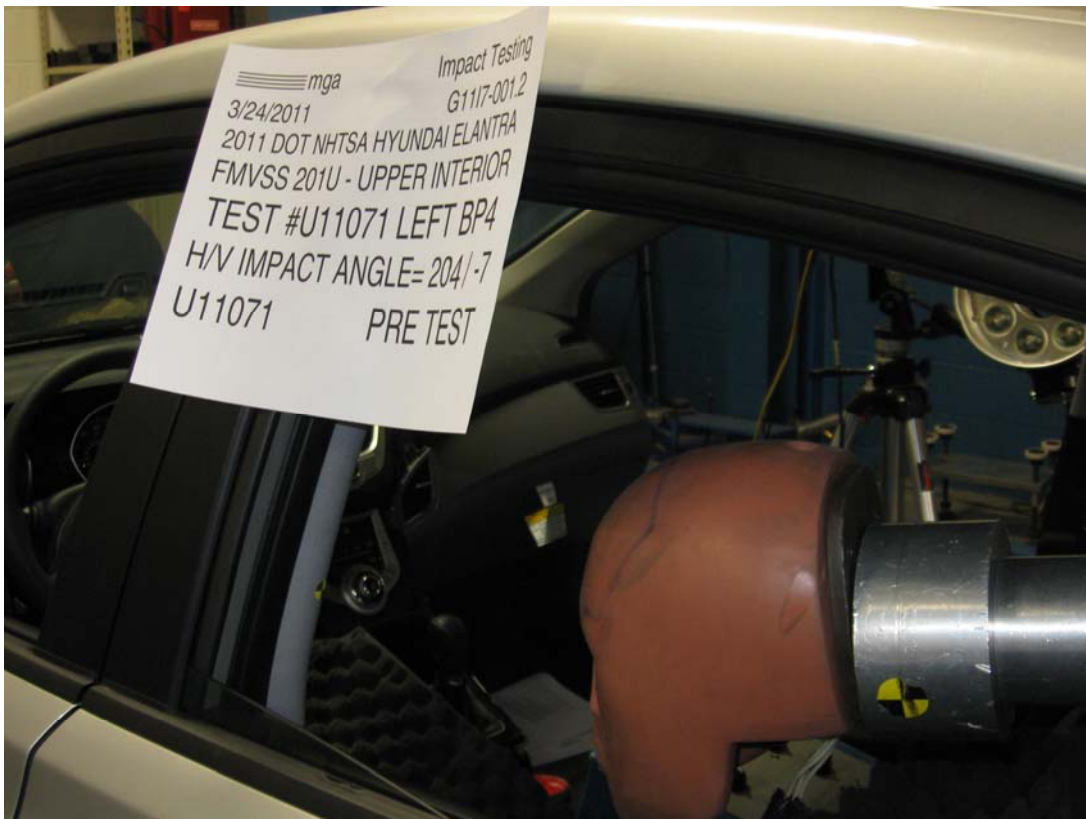
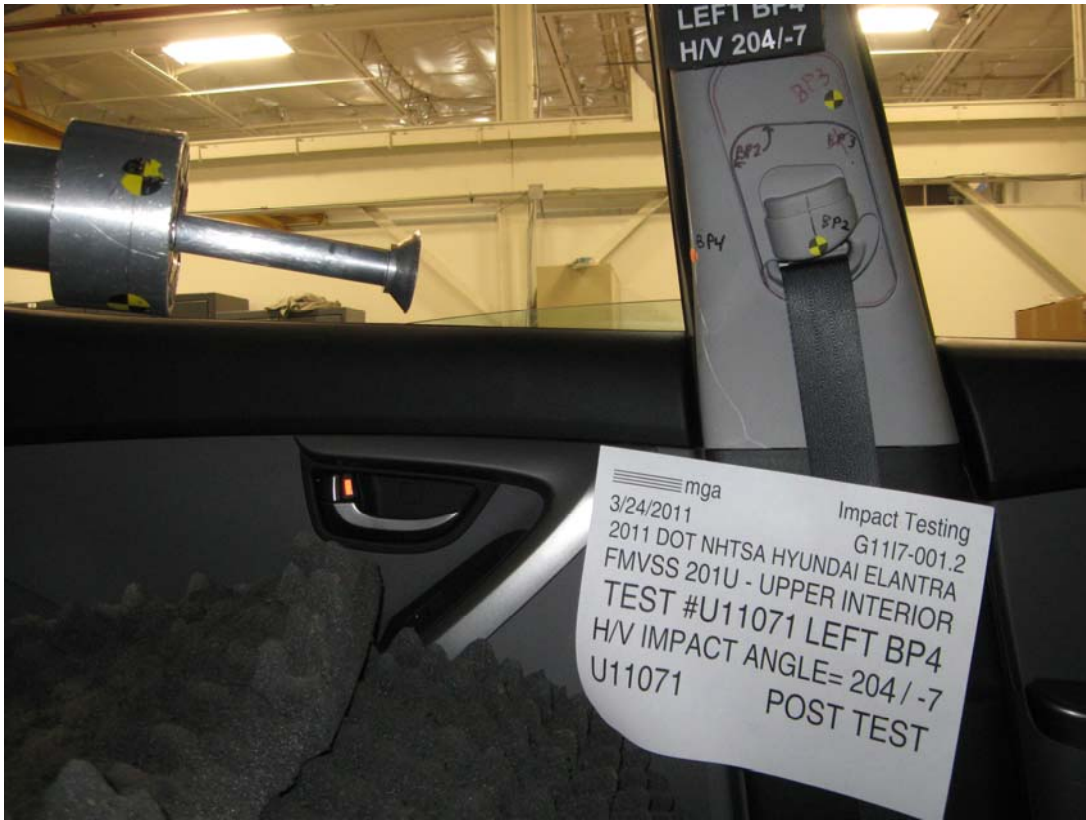
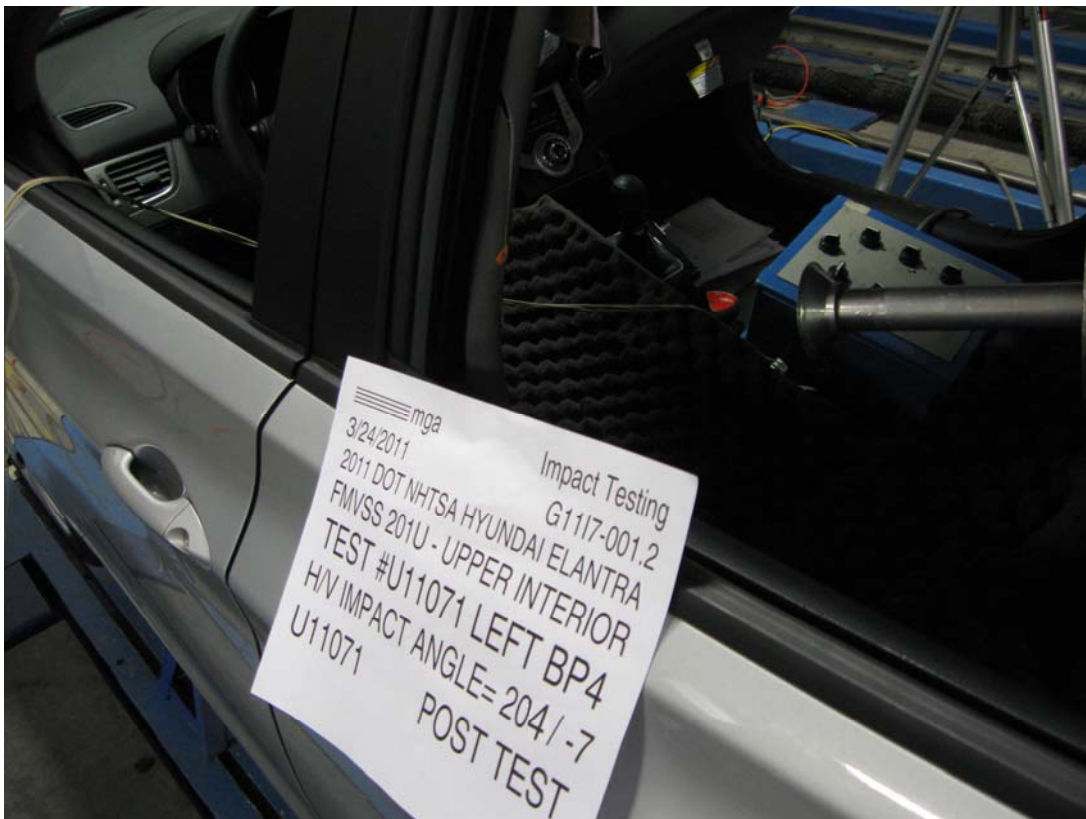
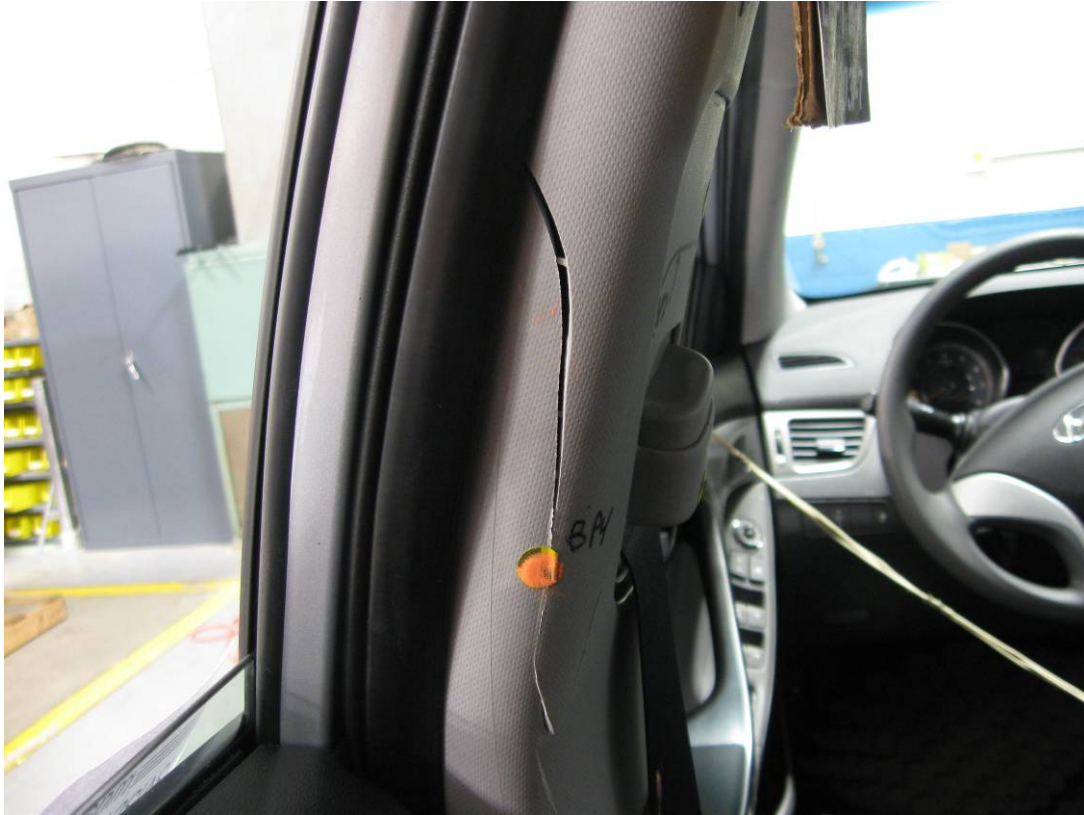
Cracked trim.
