DOT HS 812 718

**Special Crash Investigations
Remote Non-Traffic
Surveillance Hyperthermia
Fatality Investigation
Vehicle: 2001 Honda Accord
Location: Florida
Incident Date: July 2016**

**NON-TRAFFIC SURVEILLANCE
SPECIAL CRASH INVESTIGATIONS
CASE NO. CR16033
REMOTE HYPERTHERMIA FATALITY INVESTIGATION
VEHICLE: 2001 HONDA ACCORD
LOCATION: FLORIDA
INCIDENT DATE: JULY 2016**

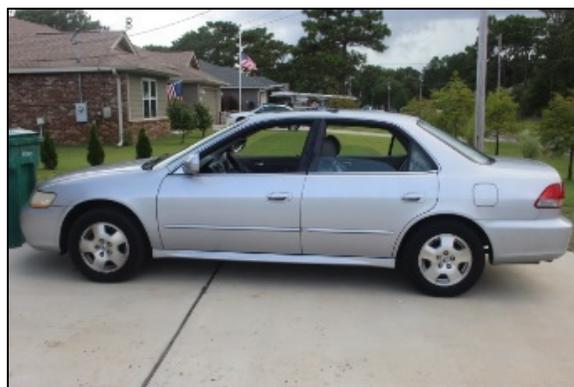
Figure 1: West-facing, left-side view of the 2001 Honda Accord. Image supplied by the police investigator.

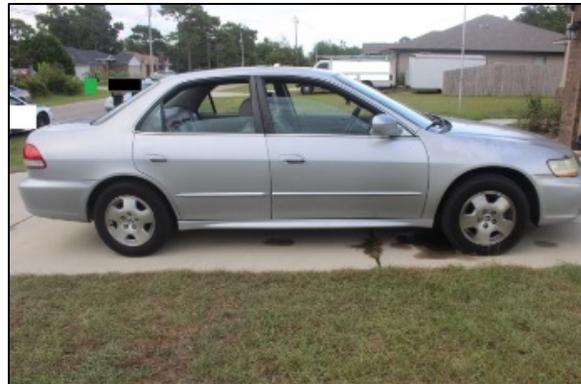
Figure 2. East-facing view of the Honda parked on the driveway of the residence. Image provided by the investigating police department.

The Honda was parked on the driveway facing south with the front of the vehicle positioned near the garage door on the west side of the driveway. All windows of the vehicle were closed. The terrain of the residence was flat with a slight negative grade of the driveway toward the street.

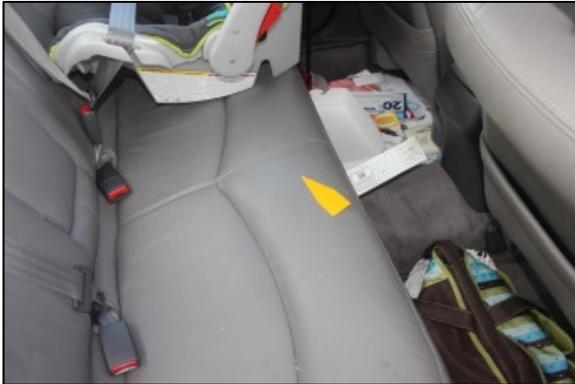
facing infant child restraint system (CRS) was secured to the second row left position by the vehicle's manual seat belt system. The forward aspect of the CRS was wedged against the front row left seat back. **Figures 3 and 4** show the interior of the 2001 Honda Accord.

Figure 3. Second row seat area of the 2001 Honda. Image provided by the investigating police department.

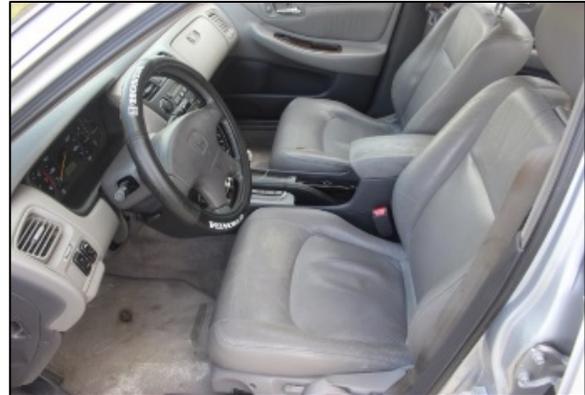
Figure 4. Front row of the 2001 Honda. Image provided by the investigating police department.

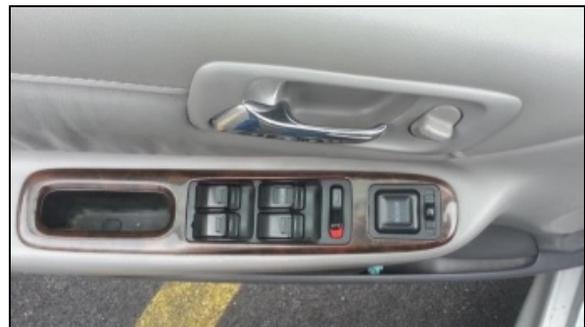
The Honda was equipped with power windows. A master switch panel was located on the mid-aspect of the driver's door panel that provided operation of all four door windows and a lock-out switch for the rear door windows. The switch panel was mounted on the horizontal surface of the sloped extension of the integrated armrest and door closer pull handle (**Figure 5**).

The driver's window was configured with a one touch auto-down and auto-up feature. All four power window switches required a push force to

lower the respective window and a pull force to raise and close the windows. The front right and both second row door panels were configured with power window switches for the respective window only. The switches operated in the same manner as the driver switches and were located in a similar position on the horizontal surface of the door armrests. The front door windows could fully retract into the door while the rear door windows did not fully open due to the contour of the rear door at the lower C-pillar. At the time of this incident, all four door windows

Figure 5. Power window switch panel on the driver's door of an exemplar vehicle.

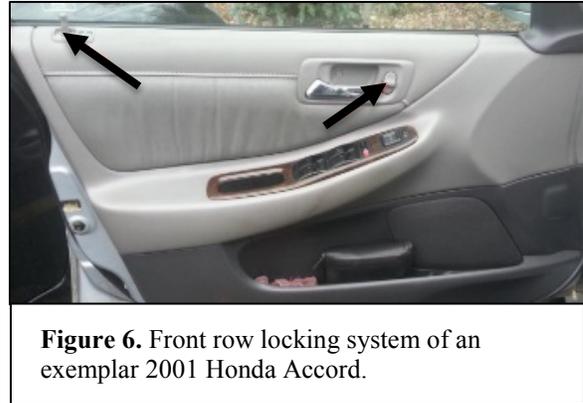
The Honda was equipped with a power locking system with a remote key fob. The lock button of the key fob required a single engagement to lock all four doors. The unlock button would unlock the driver's door on the first push of the button and the remaining right front and rear doors unlocked on two pushes of the key fob button. On the interior of the Honda, a vertically-mounted switch was positioned immediately forward of the door release lever (**Figure 6**). The switch had a tab that measured 2

cm (0.75 in) horizontally and protruded 1 cm (0.25 in) toward the interior to provide a finger touch for the switch. Downward pressure on the switch would lock all four doors while an upward pressure would unlock the doors. The rear doors were not equipped with power door lock switches. Unlike the power windows, the power door lock switches remained active at all times without energizing the ignition switch. All four doors were configured with plunger-type lock stalks that were located on the top surface of the door panels at the aft aspect. The cylindrical stalks extended 3 cm (1.2 in) above the door panels in the unlock mode and retracted 1 cm (0.5 in) when the power locks were enabled. In the locked position, the lock stalks protruded above the door panels to allow a person to pull the stalk upward to unlock the door. In the locked position, the front doors could not be opened from the inside by pulling on the door release lever. The lever action did not override the locking system. The rear doors remained locked in this scenario, as the locking stalk had to be lifted to open the doors.

Figure 6. Front row locking system of an exemplar 2001 Honda Accord.

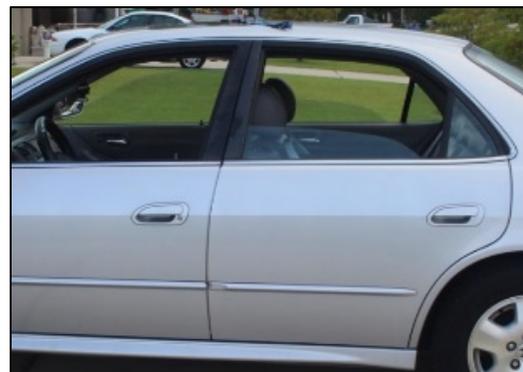
The four doors of the Honda were equipped with flush-mounted exterior door handles that required an upward pull force to open (**Figure 7**). The bottom edge of the front door handles on an exemplar 2001 Honda Accord were 75 cm (29.4 in) above the pavement while the rear handles were 78 cm (30.75 in) above the pavement. The vertical pull of the handle required approximately 2 cm (0.9 in) of upward lift to release the door latch and to open the doors. Both front doors were configured with key-operated locks.

Figure 7. Exterior door handles of the 2001 Honda. Image provided by the investigating police department.

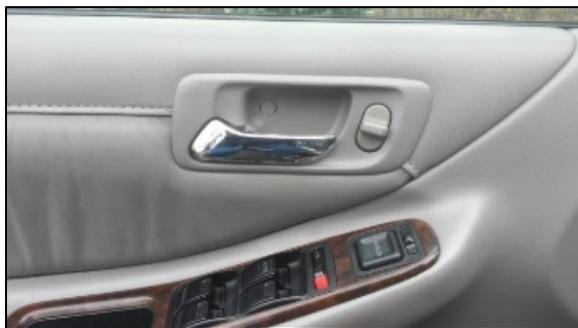
The interior door release levers were flush mounted to the upper mid-aspects of the front doors and the upper forward aspects of the rear doors. The levers were 11 cm (4.25 in) in length and were chrome plated, surrounded by a recessed pocket of the matching interior gray color to facilitate the operator's finger grip on the lever. All doors required a horizontal pull force to open the doors. **Figures 8 and 9** are images of the interior door release levers of an exemplar 2001 Honda Accord.

Figure 8. Driver's door release lever of an exemplar 2001 Honda Accord.

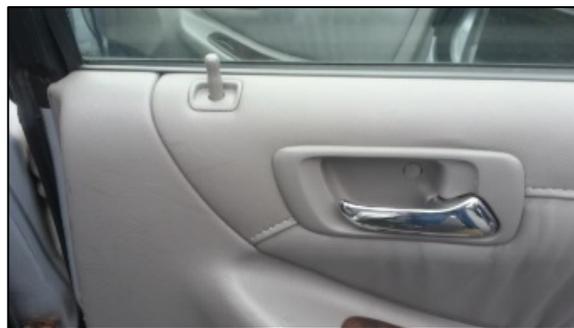
Figure 9. Left rear door release lever of an exemplar 2001 Honda Accord.

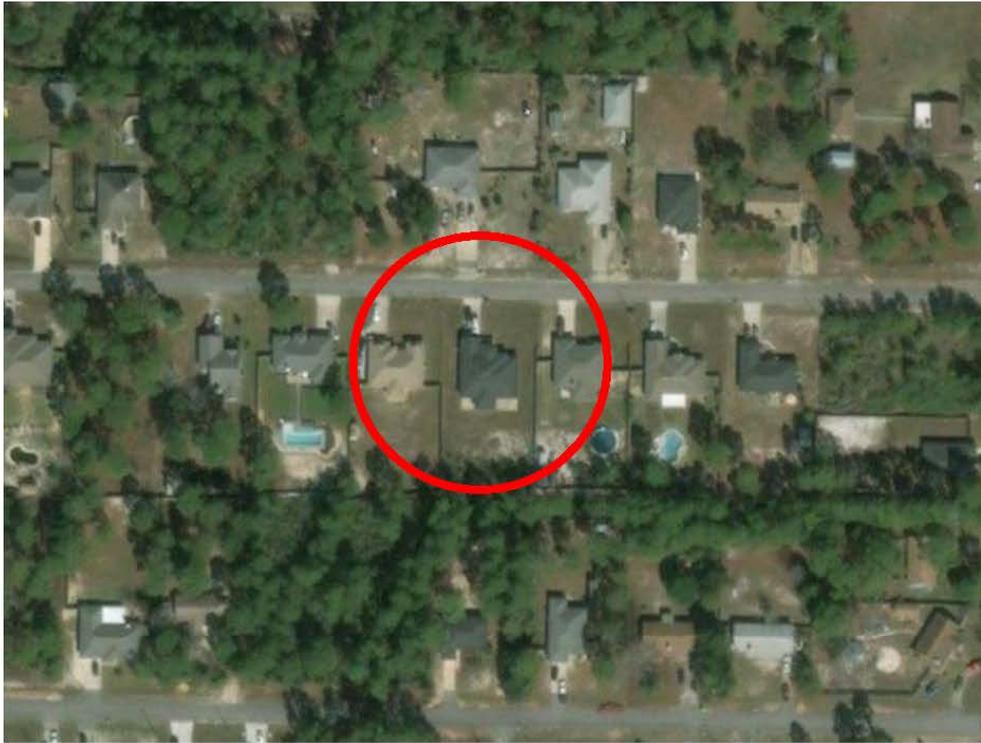
INCIDENT SITE DIAGRAM

**Incident Site:
Private Property**

V1: 2001 Honda Accord
