DOT HS 812 536

**Special Crash
Investigations
Non-Traffic Surveillance
Remote Hyperthermia
Fatality Investigation
Vehicle: 2016 Nissan
Rogue
Location: Pennsylvania
Incident Date: July 2016**

**NON-TRAFFIC SURVEILLANCE
SPECIAL CRASH INVESTIGATIONS
CASE NO. CR16034
REMOTE HYPERTHERMIA FATALITY INVESTIGATION
VEHICLE: 2016 NISSAN ROUGE
LOCATION: PENNSYLVANIA
INCIDENT DATE: JULY 2016**

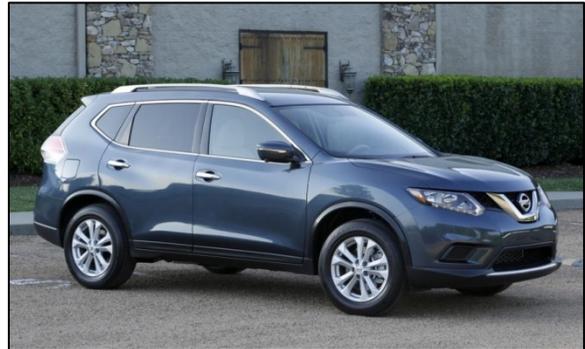
Figure 1: Right side view of an exemplar 2016 Nissan Rouge.

Figure 1 is an exemplar view of a 2016 Nissan Rouge. The female driver of the Nissan dropped off two other children at daycare facilities and proceeded directly to her work place without dropping off the 4-year-old female at a third facility. This child was seated in a belt-positioning booster child restraint system (CRS) in the second row left position of the Nissan. As the driver arrived at her work place, she parked the Nissan, exited the vehicle and locked the doors with the key fob. She returned to the Nissan approximately 6.5 hours later to find the child unresponsive on the front row right floor of the vehicle. The child was transported to a local hospital where she was pronounced deceased. The child was able to unbuckle the vehicle's safety belt system to remove herself from the CRS, but was not able to manually unlock the doors to exit the vehicle.

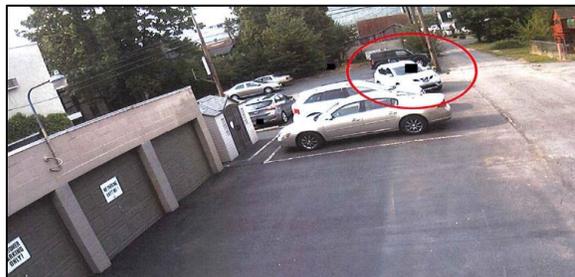
Figure 2: South-facing surveillance image of the incident site. Image obtained from the investigating police department.

The commercial business complex where the incident occurred consisted of a cluster of buildings oriented in a westerly direction on a narrow street in an urban location. A single-story garage area was located at the southwest corner of the building with four garage bays, each configured with a roll-up overhead door. An employee parking area was located immediately south of the garage and consisted of three marked parking spaces that were perpendicular to the street. Additional parking was provided behind the building on the south aspect with entrance from a narrow intersecting street. Several large trees were located to the west of the commercial building; however, these trees did not appear to provide shade to the three parking spaces. A security camera was mounted to the building that provided a view of the garage space and the three parking spaces located to the south of the garage area. The Nissan was parked in the third, most southern space of the parking facing west. The parking lot and the street surfaces were asphalt. **Figure 2** is a surveillance image of the Nissan entering the parking lot at the incident site.

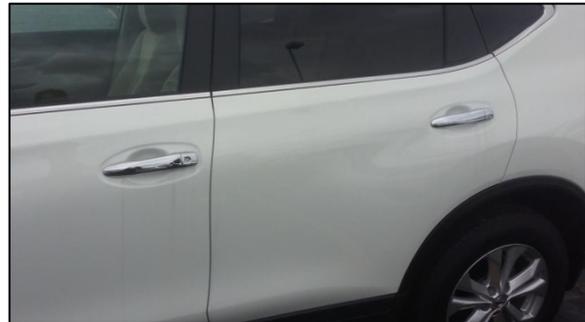
The Nissan was configured with a horizontal-pull style handle for the four doors (**Figure 3**). Based on an exemplar vehicle inspection, the vertical heights of the front door handles were 98 to 102 cm (38.5 to 40 in) above the pavement and the rear door handles were 106 to 109 cm (41.75 to 43 in) above the pavement.

Figure 3: Left plane exterior door handles of an exemplar 2016 Nissan Rouge.

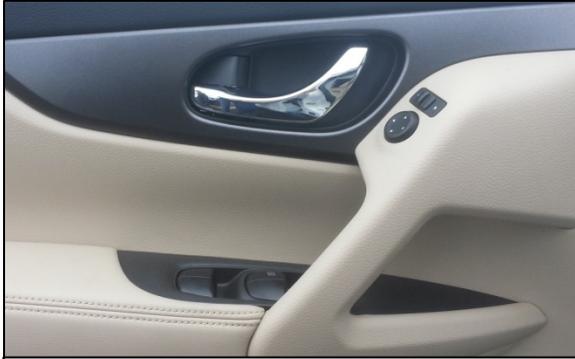
Based on the exemplar inspection, the interior door release levers were flush-mounted into the upper-mid aspects of the front door panels and into the upper-forward third of the rear door panels. The levers were 13 cm (5 in) in overall length and 6 cm (2.25 in) in height and were molded plastic, formed in an upward curve shape. All four door release levers were finished in chrome. The hinge point for the levers was at the aft aspect. The interior door release levers are depicted in **Figures 4 and 5**.

A manual rotating locking lever was mounted within the recess of all four door panels (**Figure 4 and 5**) directly above the aft aspect of the door release levers. These rotating lock levers were finished in gray and blended into the door panel with no specific identification or highlight marking. The levers were 4 cm (1.6 in) in length and 2 cm (0.9 in) in height.

Figure 4: Exemplar view of the front row (driver's) door release lever and rotating locking lever.

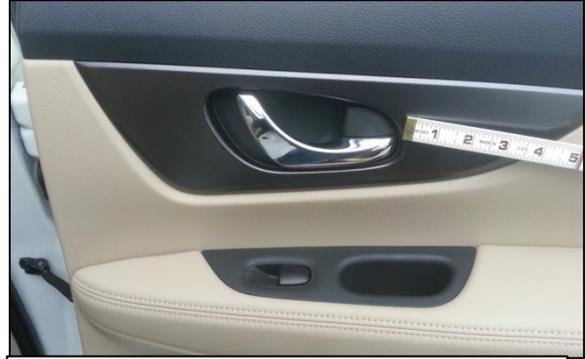
Figure 5: Second row right door release lever and the rotating locking lever of an exemplar vehicle.

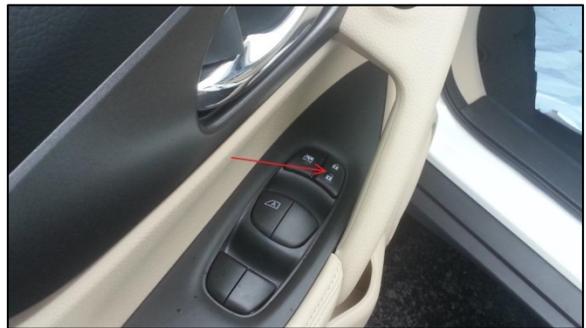
The Nissan was equipped with a power locking system with the manual rotating locking levers at each of the four doors. There were three available methods to lock/unlock the vehicle; one by depressing the lock or unlock function of the remote key fob, the second by engaging the front door panel interior-mounted power lock switch (**Figure 6**), and the third by manually engaging the rotating lock levers at each of the doors. The door panel-mounted power lock switch was a rocker-type switch that locked the doors by depressing the forward aspect of the switch and unlocked by depressing the aft aspect of the horizontally-mounted switch. This switch was located between the door panel and the door closure pull handle. The rotating locking levers would only lock the specific door while the power system locked all four doors and the rear lift gate. It should be noted that the unlock feature on the key fob required two engagements to unlock all doors inclusive of the lift gate while the driver's door only required a single engagement of the key fob unlock button. Once locked, none of the four doors would unlock from the inside by pulling on the interior door release levers. All four positions required a manual rotation of the locking lever or engagement of the power lock switch.

Figure 6: Power locking rocker switch on the forward aspect of the driver's door panel.

The Nissan was equipped with a power locking system that was activated by the key fob. Within the vehicle, electric door lock rocker switches were mounted to the front door panels forward of the door close pull handle. These switches could lock or unlock all doors in the Nissan with or without ignition activation. Separate rotating mechanical levers were mounted in the cavity of the flush-mounted door latch release levers. These rotating levers provided the manual lock or unlock functions of an individual door from inside the vehicle. The rear doors were also equipped with manually operated child locks that would lock out the interior rear door levers. The police investigation determined that simply pulling on the interior door release lever did not override the locking system. The doors would not open from the inside without activating one of the unlocking features. An SCI inspection of an exemplar Nissan Rouge confirmed the operation of the Nissan's door locks.

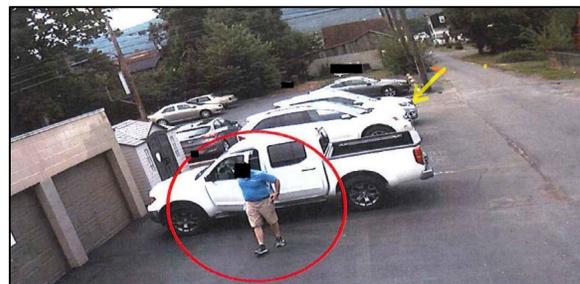
At approximately 1100 hours, the driver's live-in boyfriend and father of the victim arrived at her work place (**Figure 7**). The security camera captured him parking his pickup truck in front of the southern-most garage door, four parking spaces to the north of the Nissan Rouge (yellow arrow). He exited the vehicle and proceeded into the driver's work place. The male stayed at the work place for approximately one hour. During this hour, he asked the driver if she provided breakfast to the children. This discussion did not trigger a concerned response from the driver. As the male exited the building and began to walk to

Figure 7: South-facing view of location of the parked Nissan and the child's father arriving at the incident site. (Surveillance image provided by the investigating police department.)

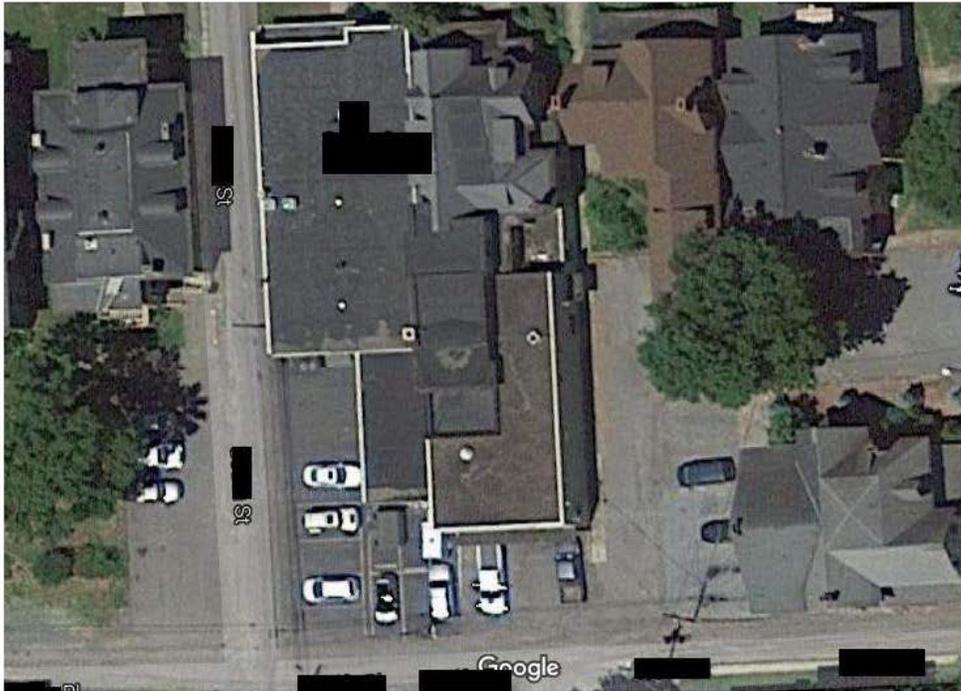
INCIDENT SITE DIAGRAM

**Incident Site:
Commercial Business Parking
Lot**

V1: 2016 Nissan Rogue
